# Visual Site Inspection Report

<b>Project Name</b>	H-600 Pipeline Spread G	<b>AFE</b>	124300137	<b>Spread</b>	H-600 Pipeline Spread G
<b>Contractor</b>	Precision			<b>Report #</b>	36181
<b>Inspector</b>	Clint Sears			<b>Date/Time</b>	4/4/2022 10:22 AM
<b>Permit #</b>	TBD	<b>Inspection Type</b>	VA SWPP	<b>Station Begin</b>	10749+92
<b>State</b>	VA	<b>Inspection Area</b>	Partial	<b>Station End</b>	10798+92
<b>County</b>	Giles	<b>Ground</b>	Damp	<b>Temperature (°F)</b>	44.00
<b>Municipality</b>	N/A	<b>Weather</b>	Cloudy	<b>Rain Gauge (in)</b>	0.00
				<b>Rain Accumulation Time (days)</b>	1.00

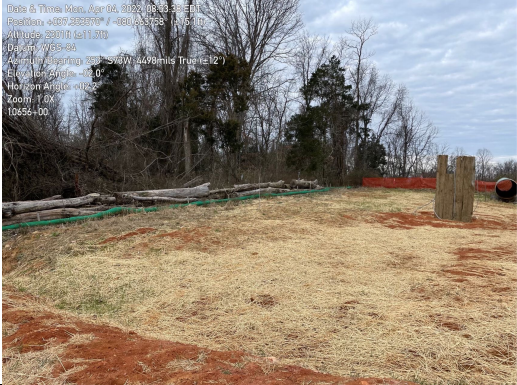
<b>GPS Location</b>	See photo	<b>GPS Location</b>	see photo		
<b>Field Station#</b>	10656+00	<b>Field Station#</b>	10674+00		
<b>Pic 7 Desc.</b>	Spread break	<b>Pic 8 Desc.</b>	Big Stoney

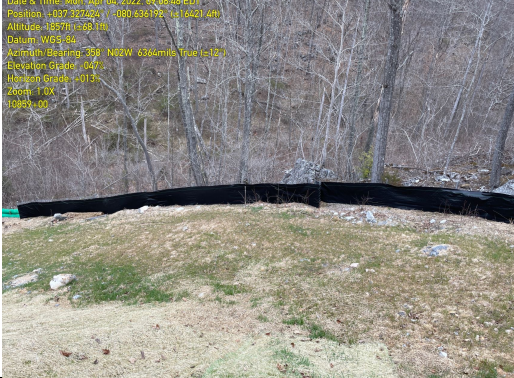
<b>GPS Location</b>	See photo	<b>GPS Location</b>	See photo		
<b>Field Station#</b>	10859+00	<b>Field Station#</b>	10858+00		
<b>Pic 1 Desc.</b>	Supersilt fence perimeter control in place	<b>Pic 2 Desc.</b>	End treatments in place		
<p>Date &amp; Time Mon, Apr 04, 2022, 09:18:41 EDT  Position: +037.337277 / -089.696194 (s11.62144)  Altitude: 2158m (s12.56)  Datum: WGS-84  Azimuth/Bearing: 204° N54W 540mils True (s12°)  Elevation Grade: +017°  Horizon Grade: +000°  Zoom: 1.0X  10854+00</p>

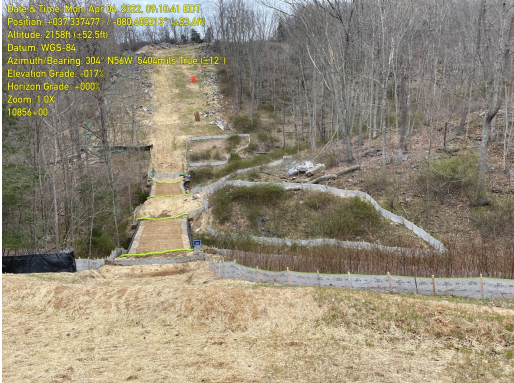
<b>GPS Location</b>	See photo	<b>GPS Location</b>	See photo		
<b>Field Station#</b>	10856+00	<b>Field Station#</b>	10848+00		
<b>Pic 3 Desc.</b>	Stream buffer in place	<b>Pic 4 Desc.</b>	CFS perimeter control in place		
<p>Date &amp; Time Mon, Apr 04, 2022, 09:26:46 EDT  Position: +037.339222 / -089.69679° (s11.640)  Altitude: 2410m (s13.10)  Datum: WGS-84  Azimuth/Bearing: 238° N20W 580mils True (s12°)  Elevation Grade: +016°  Horizon Grade: +004°  Zoom: 1.0X  10843+75</p>

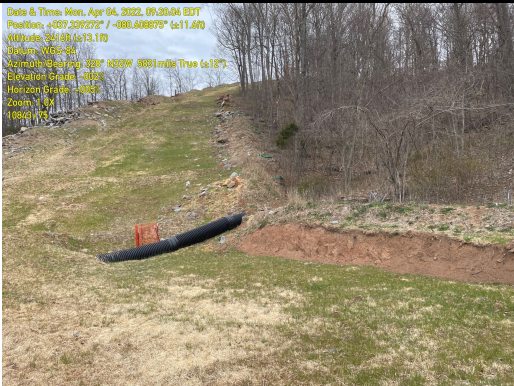
<b>GPS Location</b>	See photo	<b>GPS Location</b>	See photo		
<b>Field Station#</b>	10843+75	<b>Field Station#</b>	10840+30		
<b>Pic 5 Desc.</b>	Cleanwater diversion berm in place	<b>Pic 6 Desc.</b>	Daylight drain in place

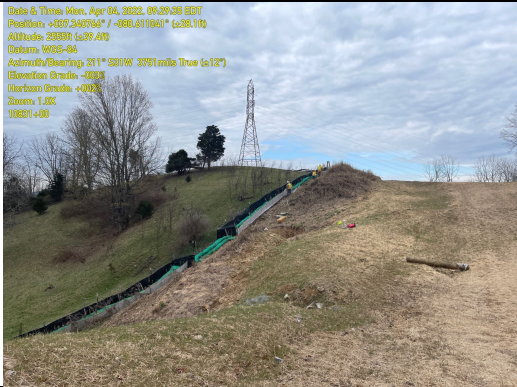
<b>GPS Location</b>		See photo		<b>GPS Location</b>	
<b>Field Station#</b>		10833+00		<b>Field Station#</b>	
<b>Pic 7 Desc.</b>		Waterbars in place		<b>Pic 8 Desc.</b>	
				Environmental maintenance crew replacing P1 at karst feature	
<p>Date &amp; Time: Mon, Apr 04, 2022, 09:34:45 EDT  Position: +037.342260° / -060.615821° (±25.50)  Altitude: 2487ft (±39.40)  Datum: WGS-84  Azimuth/Bearing: 268° S88°W 4346mils True (±12°)  Elevation Grade: -031%  Horizon Grade: -002%  Zoom: 1.0X  10815+00</p>

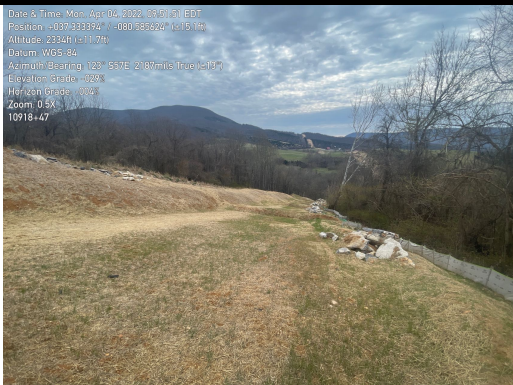
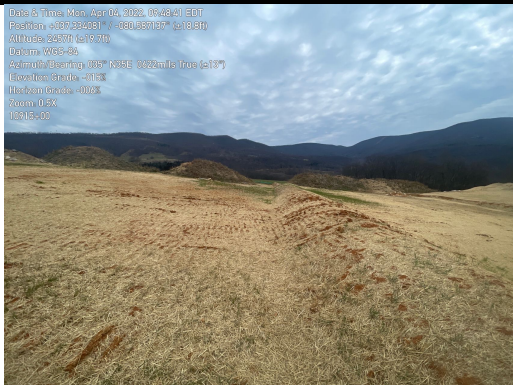
GPS Location				See Photo				GPS Location				See Photo			
Field Station#				10918+47				Field Station#				10915+00			
Pic 5 Desc.				Temporary stabilization of row				Pic 6 Desc.				Temporary water bar with adequate stabilization.

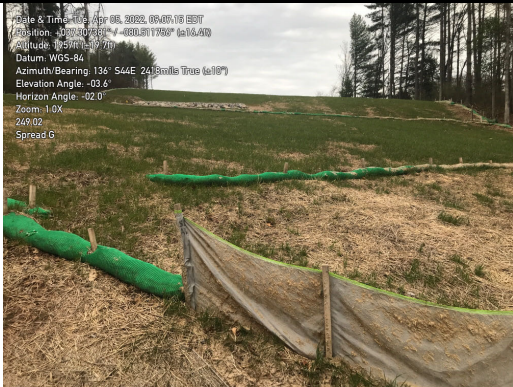
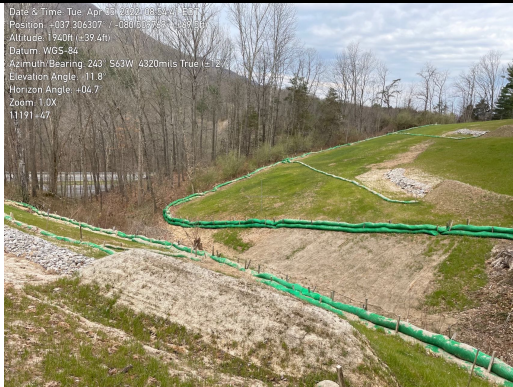
GPS Location		See photo				GPS Location		see photo			
Field Station#		11185+00				Field Station#		11191+47			
Pic 1 Desc.		Restored ROW, water bars (other)				Pic 2 Desc.		Drainage

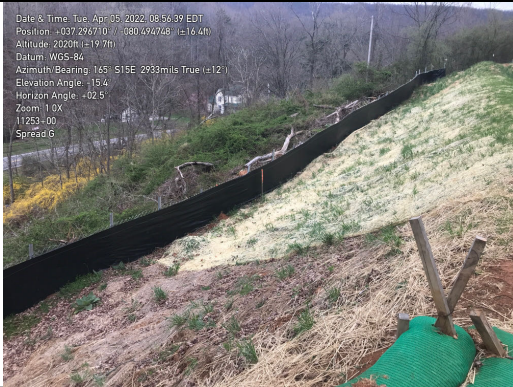
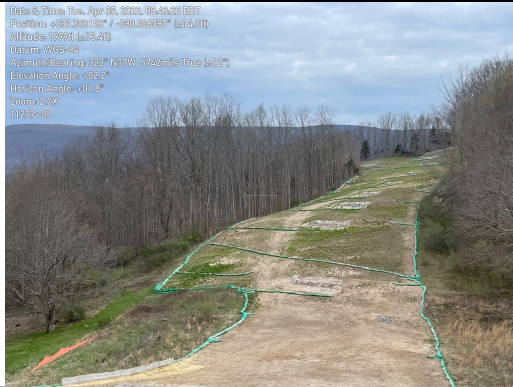
GPS Location		see photo				GPS Location		see photo			
Field Station#		11253+00				Field Station#		11207+00			
Pic 3 Desc.		Super silt fence				Pic 4 Desc.		Restored ROW

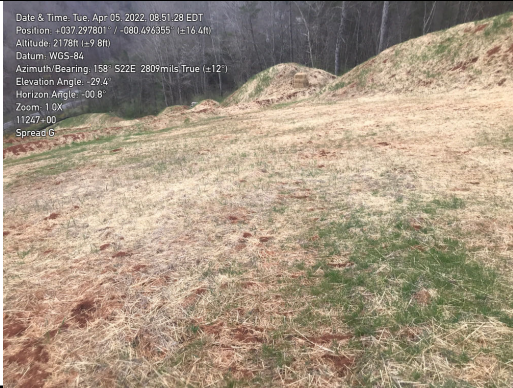
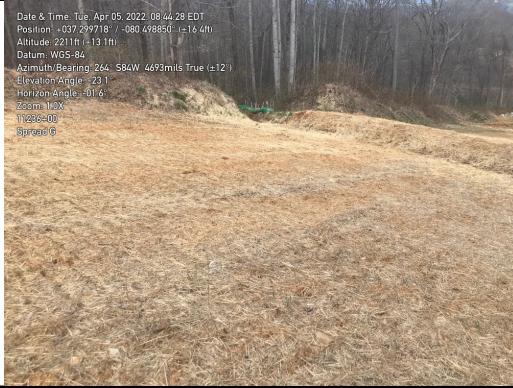
GPS Location		see photo				GPS Location		see photo			
Field Station#		11247+00				Field Station#		11236+00			
Pic 5 Desc.		Stabilized ROW				Pic 6 Desc.		Stabilized ROW, sump pit

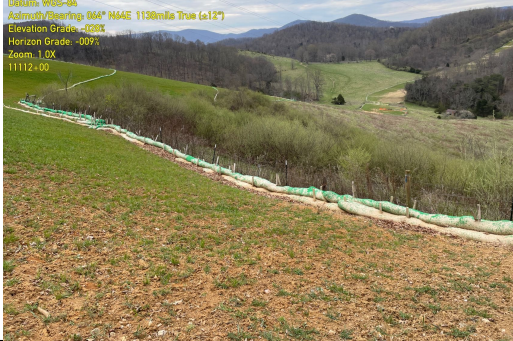
<b>GPS Location</b>	See photo	<b>GPS Location</b>	See photo		
<b>Field Station#</b>	11106+00	<b>Field Station#</b>	11112+00		
<b>Pic 1 Desc.</b>	CFS end treatments in place	<b>Pic 2 Desc.</b>	CFS triple stack perimeter control in place		
<p><small>Date &amp; Time: Tue, Apr 05, 2022, 09:11:04 EDT Position: +407.309044° / -800.521602° (s13970.50) Altitude: 21308 (s3.20) Datum: WGS-84 Azimuth/Bearing: 291° N89W 5170mils True (s12°) Elevation Grade: +012% Horizon Grade: -000% Zoom: 1.0x 11120+00</small></p>

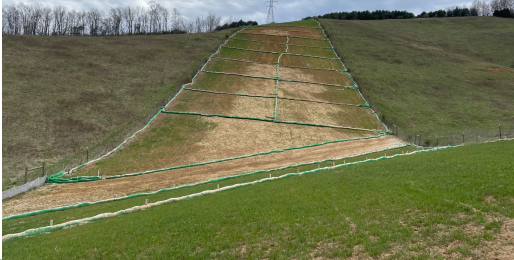
<b>GPS Location</b>	See photo	<b>GPS Location</b>	See photo		
<b>Field Station#</b>	11120+00	<b>Field Station#</b>	11134+00		
<b>Pic 3 Desc.</b>	Temporary CFS waterbars	<b>Pic 4 Desc.</b>	Permanent waterbars with level spreaders in place		
<p><small>Date &amp; Time: Tue, Apr 05, 2022, 09:19:28 EDT Position: +407.317620° / -800.521991° (s17.20) Altitude: 21148 (s29.60) Datum: WGS-84 Azimuth/Bearing: 054° N54E 0940mils True (s12°) Elevation Grade: -010% Horizon Grade: -000% Zoom: 1.0x 11141+00</small></p>

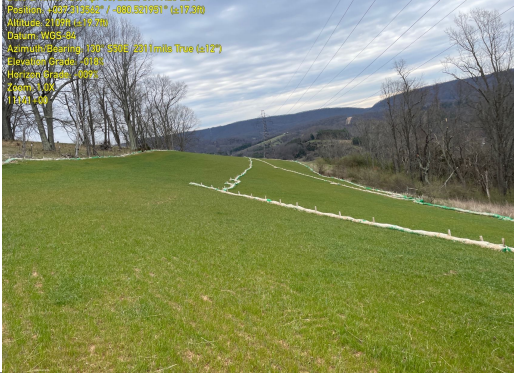
<b>Pic 5 Desc.</b>	Permanent vegetation present	<b>Pic 6 Desc.</b>	Cleanwater diversion berm in place

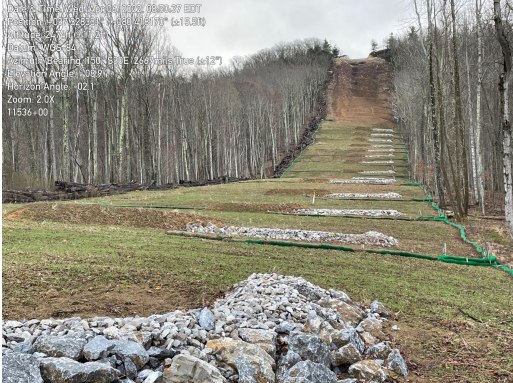
<b>GPS Location</b>	See photo	<b>GPS Location</b>	See photo		
<b>Field Station#</b>	11530+00	<b>Field Station#</b>	11536+00		
<b>Pic 3 Desc.</b>	Over seeding needed	<b>Pic 4 Desc.</b>	Picture showing condition of row

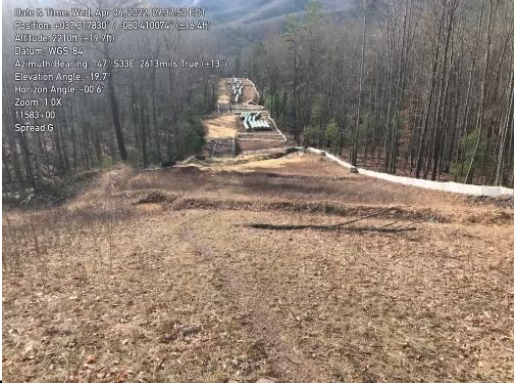
<b>GPS Location</b>	See photo	<b>GPS Location</b>	See photo		
<b>Field Station#</b>	11583+00	<b>Field Station#</b>	11568+00		
<b>Pic 5 Desc.</b>	Water bars in place	<b>Pic 6 Desc.</b>	ET in place

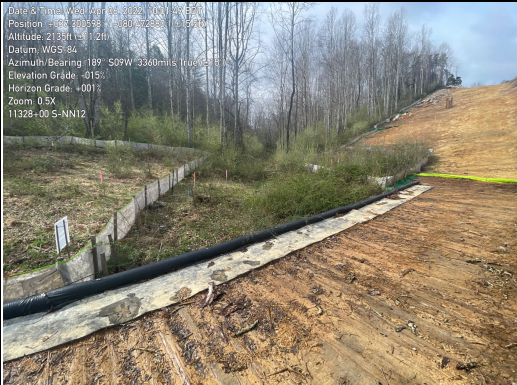
<b>GPS Location</b>	See Photo	<b>GPS Location</b>	See Photo		
<b>Field Station#</b>	11328+00	<b>Field Station#</b>	11300+00		
<b>Pic 7 Desc.</b>	View looking at the current stream and surrounding conditions. All at a stable repose at this time.	<b>Pic 8 Desc.</b>	Seven Oaks access road area. View looking at environmental maintenance equipment used to temporary stabilize and repair settlement area.

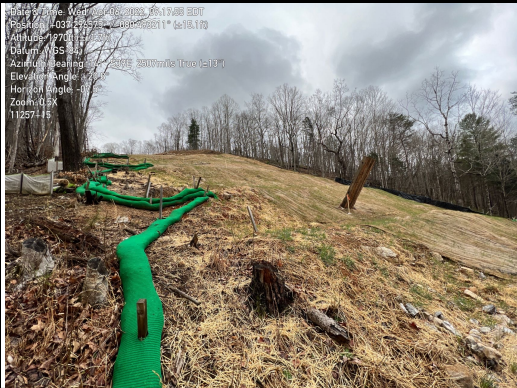
<b>GPS Location</b>	See Photo	<b>GPS Location</b>	See Photo		
<b>Field Station#</b>	11257+15	<b>Field Station#</b>	11330+00		
<b>Pic 9 Desc.</b>	Perimeter CFS and erosion blanket conditions. No issues at this time.	<b>Pic 10 Desc.</b>	Temporary water bar condition with adequate stabilization.

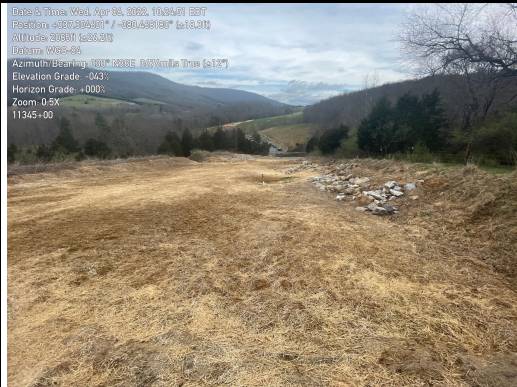
<b>Pic 11 Desc.</b>	Temporary stabilization of row.	<b>Pic 12 Desc.</b>

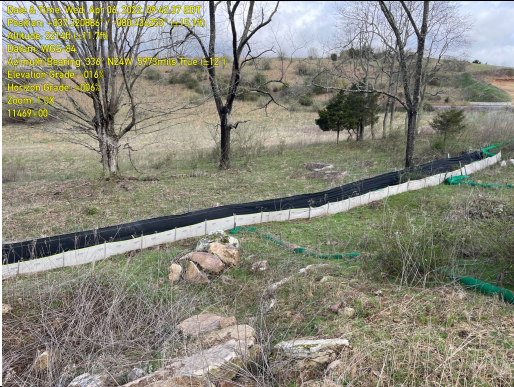
<b>GPS Location</b>	See photo		<b>GPS Location</b>	See photo	
<b>Field Station#</b>	11469+00		<b>Field Station#</b>	11466+00	
<b>Pic 1 Desc.</b>	Triple protection ECDs in place at karst feature		<b>Pic 2 Desc.</b>	Plunge pool in place

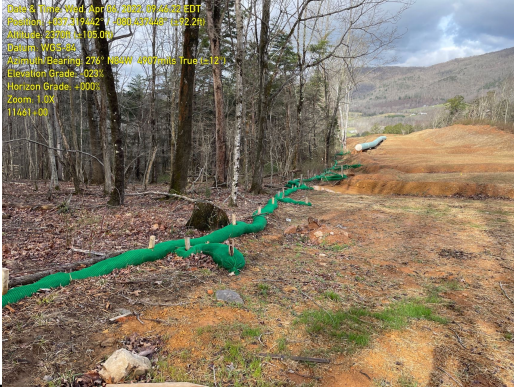
<b>GPS Location</b>	See photo		<b>GPS Location</b>	See photo	
<b>Field Station#</b>	11461+00		<b>Field Station#</b>	11457+00	
<b>Pic 3 Desc.</b>	CFS perimeter control in place		<b>Pic 4 Desc.</b>	Stone inlet protection in place

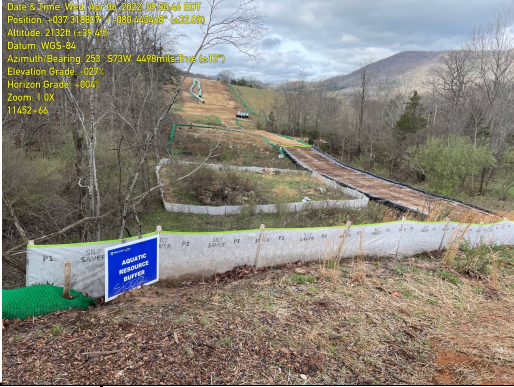
<b>GPS Location</b>	See photo		<b>GPS Location</b>	See photo	
<b>Field Station#</b>	11452+66		<b>Field Station#</b>	11448+00	
<b>Pic 5 Desc.</b>	Stream buffer in place		<b>Pic 6 Desc.</b>	Cleanwater diversion berm in place

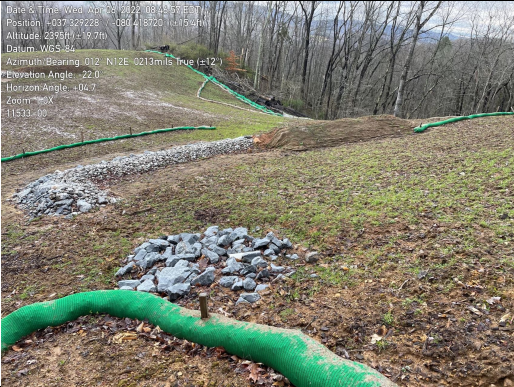
<b>GPS Location</b>	See photo	<b>GPS Location</b>	see photo		
<b>Field Station#</b>	11531+00	<b>Field Station#</b>	11533+00		
<b>Pic 1 Desc.</b>	ROW needing over seeded	<b>Pic 2 Desc.</b>	Water bar (other). Level spreader

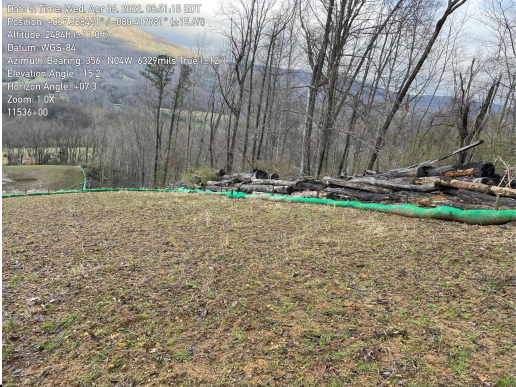
<b>GPS Location</b>	see photo	<b>GPS Location</b>	see photo		
<b>Field Station#</b>	11536+00	<b>Field Station#</b>	11588+50		
<b>Pic 3 Desc.</b>	Perimeter ECDs	<b>Pic 4 Desc.</b>	PP 20

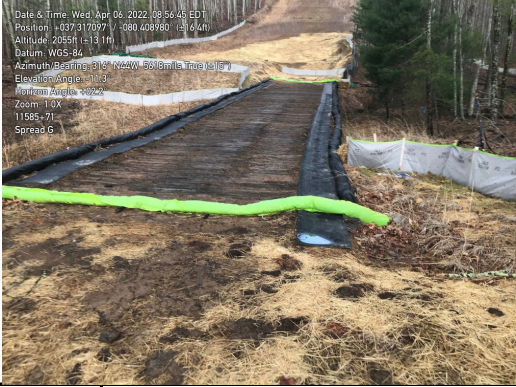
<b>GPS Location</b>	see photo	<b>GPS Location</b>	see photo		
<b>Field Station#</b>	11585+71	<b>Field Station#</b>	11569+00		
<b>Pic 5 Desc.</b>	PP 21	<b>Pic 6 Desc.</b>	Rock outlet

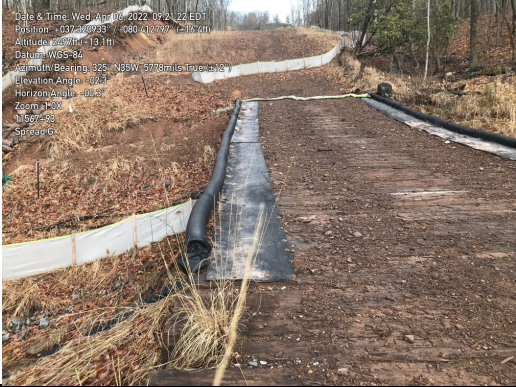
<b>GPS Location</b>	See photo		<b>GPS Location</b>	See photo	
<b>Field Station#</b>	11567+93		<b>Field Station#</b>	11600+01	
<b>Pic 7 Desc.</b>	PP 22		<b>Pic 8 Desc.</b>	Craig Creek RCE	
Insert image here			Insert image here		
<b>GPS Location</b>			<b>GPS Location</b>		
<b>Field Station#</b>			<b>Field Station#</b>		
<b>Pic 9 Desc.</b>			<b>Pic 10 Desc.</b>		
Insert image here			Insert image here		
<b>GPS Location</b>			<b>GPS Location</b>		
<b>Field Station#</b>			<b>Field Station#</b>		
<b>Pic 11 Desc.</b>			<b>Pic 12 Desc.</b>

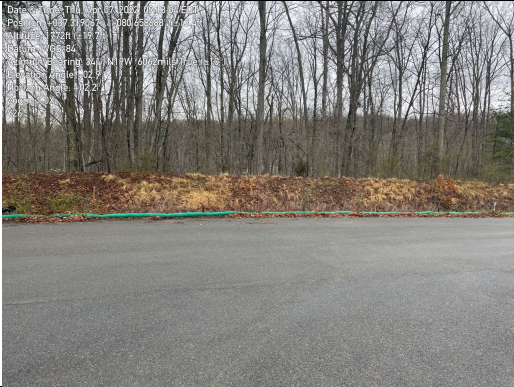
<b>GPS Location</b>	See photo	<b>GPS Location</b>	See photo		
<b>Field Station#</b>	12005+00	<b>Field Station#</b>	12005+00		
<b>Pic 1 Desc.</b>	CFS perimeter controls functional Y26	<b>Pic 2 Desc.</b>	Permanent stabilization in place y26

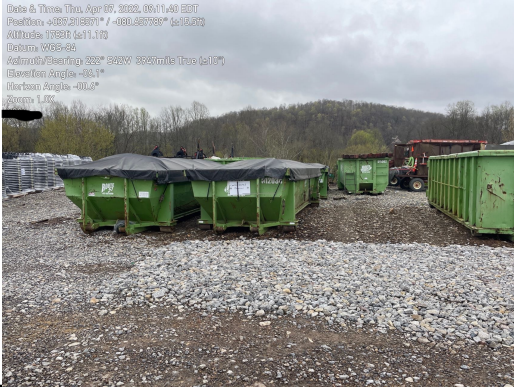
<b>GPS Location</b>	See photo	<b>GPS Location</b>	See photo		
<b>Field Station#</b>	12005+00	<b>Field Station#</b>	12005+00		
<b>Pic 3 Desc.</b>	Housekeeping in good condition y26	<b>Pic 4 Desc.</b>	Secondary containment in place y26

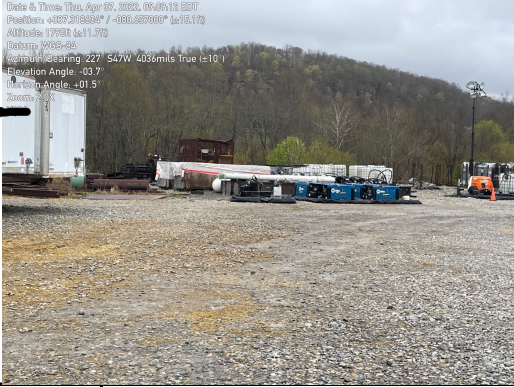
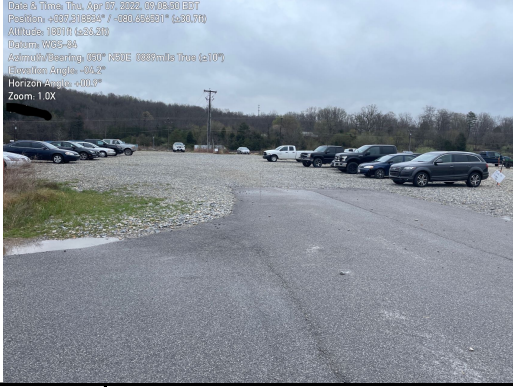
<b>GPS Location</b>	See photo	<b>GPS Location</b>	See photo		
<b>Field Station#</b>	12005+00	<b>Field Station#</b>	12005+00		
<b>Pic 5 Desc.</b>	Secondary containment in place y26	<b>Pic 6 Desc.</b>	RCE functional y26

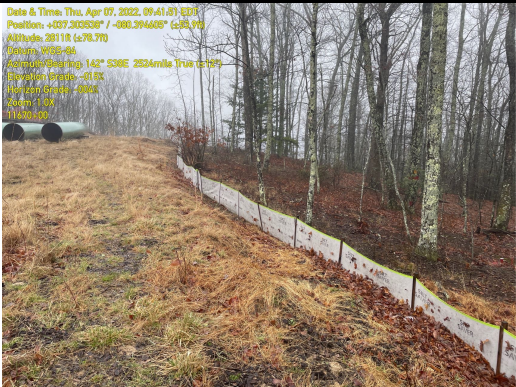
<b>GPS Location</b>	See photo	<b>GPS Location</b>	See photo		
<b>Field Station#</b>	11670+00	<b>Field Station#</b>	11673+00		
<b>Pic 1 Desc.</b>	P1 silt fence perimeter control in place	<b>Pic 2 Desc.</b>	End treatments in place		
<p>Date &amp; Time: Thu, Apr 07, 2022, 09:44:01 EDT  Position: +037.202321° / -080.394174° (±75.0M)  Altitude: 2008ft (±75.0M)  Datum: WGS 84  Azimuth/Bearing: 171° S05E 300mils True (±12°)  Elevation Grade: -020%  Horizon Grade: -011%  Horizon Grade: -000%  Zoom: 1.0X  11681+00</p>  		<p>Date &amp; Time: Thu, Apr 07, 2022, 09:44:13 EDT  Position: +037.202310° / -080.392631° (±75.0M)  Altitude: 2008ft (±75.0M)  Datum: WGS 84  Azimuth/Bearing: 170° S70E 196mils True (±12°)  Elevation Grade: -045%  Horizon Grade: -002%  Horizon Grade: -000%  Zoom: 1.0X  11683+50</p>

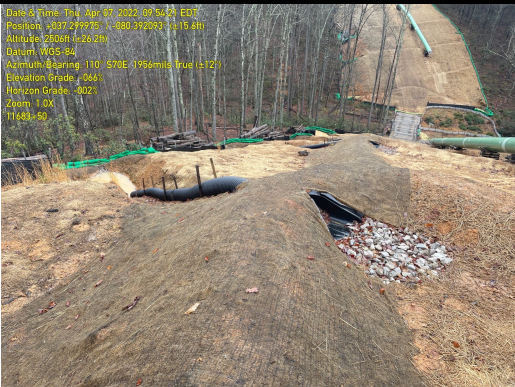
<b>GPS Location</b>	See photo	<b>GPS Location</b>	See photo		
<b>Field Station#</b>	11681+00	<b>Field Station#</b>	11683+50		
<b>Pic 3 Desc.</b>	CFS triple stack perimeter control in place	<b>Pic 4 Desc.</b>	Slope drain pipe in place		
<p>Date &amp; Time: Thu, Apr 07, 2022, 09:45:33 EDT  Position: +037.202307° / -080.394177° (±75.0M)  Altitude: 2011ft (±75.0M)  Datum: WGS 84  Azimuth/Bearing: 112° S08E 300mils True (±12°)  Elevation Grade: -015%  Horizon Grade: -004%  Horizon Grade: -000%  Zoom: 1.0X  11688+00</p>  		<p>Date &amp; Time: Thu, Apr 07, 2022, 10:05:28 EDT  Position: +037.202307° / -080.394608° (±75.0M)  Altitude: 2011ft (±75.0M)  Datum: WGS 84  Azimuth/Bearing: 112° S08E 301mils True (±12°)  Elevation Grade: -015%  Horizon Grade: -004%  Horizon Grade: -000%  Zoom: 1.0X  11704+75</p>

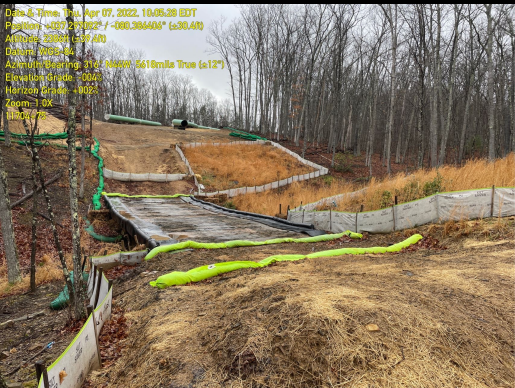
<b>Pic 5 Desc.</b>	Erosion control blanket in place	<b>Pic 6 Desc.</b>	Sediment filter logs in place

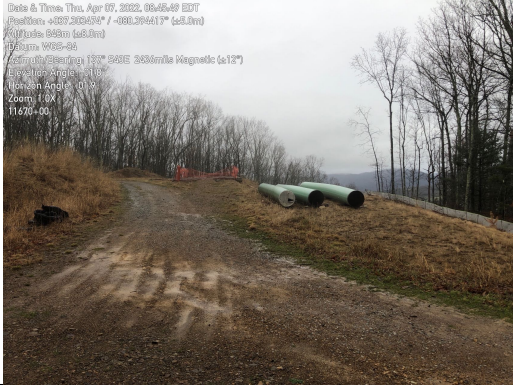
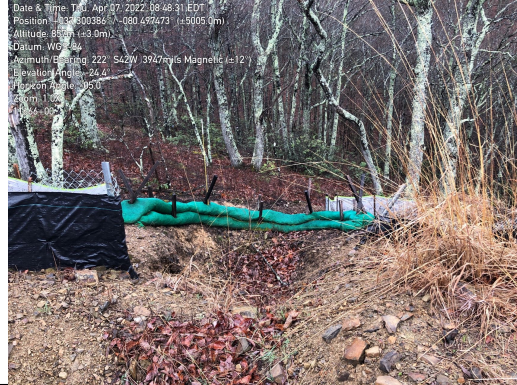
<p><small>Date &amp; Time: Thu, Apr 07, 2022, 08:48:31 EDT Position: +407.260944° / -860.474731° (±50.0m) Datum: WGS-84 Altitude: 818m (±6.0m) Azimuth/Bearing: 222° 54'00" 392mils Magnetic (±12°) Elevation Angle: +24.4° Horizon Angle: +04.0° Zoom: 1.00x 11666+00</small></p>			
<b>GPS Location</b>	On photo	<b>GPS Location</b>	On photo		
<b>Field Station#</b>	11670+00	<b>Field Station#</b>	11666+00		
<b>Pic 1 Desc.</b>	Top of Brush Mountain is stable.	<b>Pic 2 Desc.</b>	ECDs are acceptable at this time.

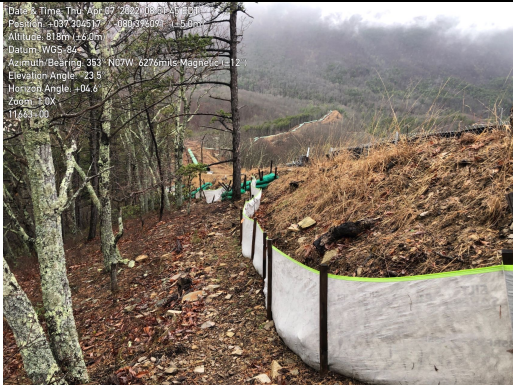
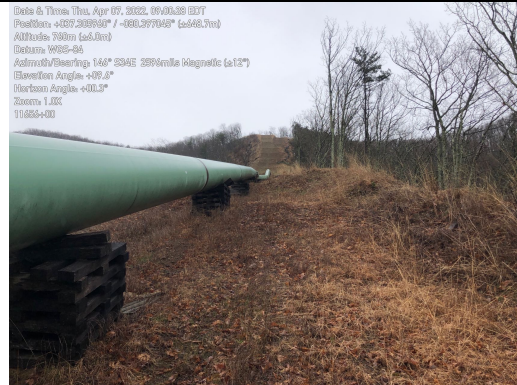
<b>GPS Location</b>	On photo	<b>GPS Location</b>	On photo		
<b>Field Station#</b>	11663+00	<b>Field Station#</b>	11656+00		
<b>Pic 3 Desc.</b>	ROW is stable with ECDs in place.	<b>Pic 4 Desc.</b>	ROW surface is stable with no movement of soils.

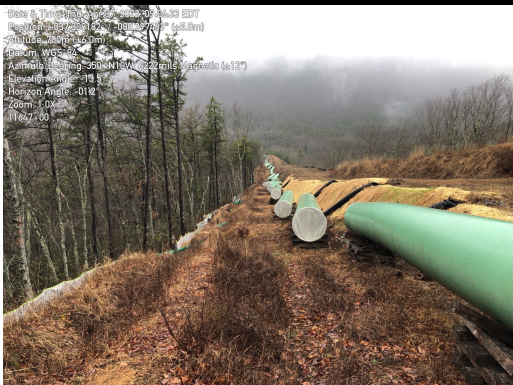
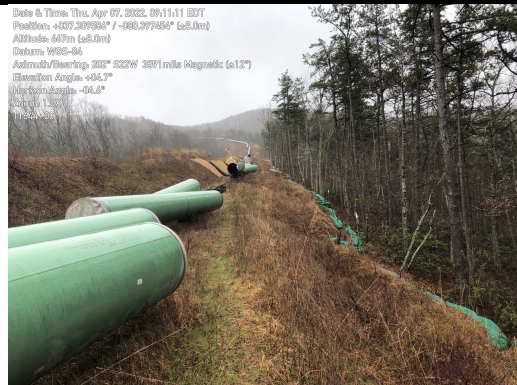
<b>Pic 5 Desc.</b>	ROW surface is stable with no erosion issues.	<b>Pic 6 Desc.</b>	ROW is stable. ECDs adequate at this time.

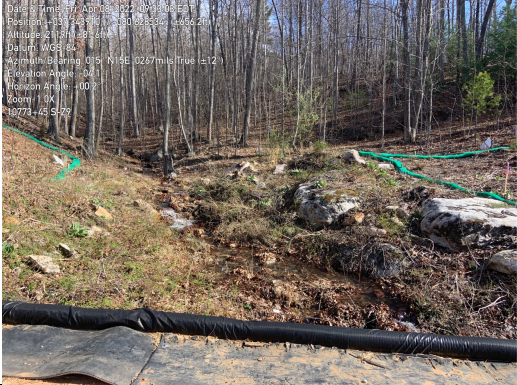
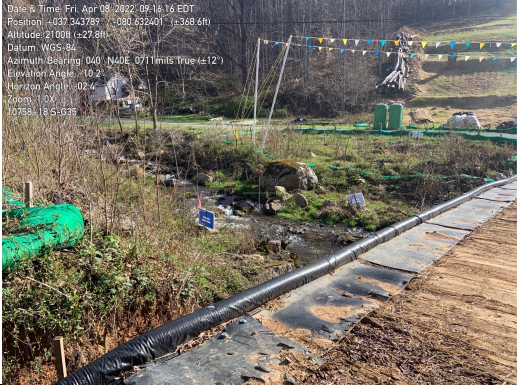
<b>GPS Location</b>	See photo	<b>GPS Location</b>	See photo		
<b>Field Station#</b>	10773+45	<b>Field Station#</b>	10758+18		
<b>Pic 7 Desc.</b>	Section of Row showing conditions and controls at S-Z9	<b>Pic 8 Desc.</b>	Section of Row showing conditions and controls at S-G35		
Insert image here		Insert image here			
<b>GPS Location</b>		<b>GPS Location</b>			
<b>Field Station#</b>		<b>Field Station#</b>			
<b>Pic 9 Desc.</b>		<b>Pic 10 Desc.</b>			
Insert image here		Insert image here			
<b>GPS Location</b>		<b>GPS Location</b>			
<b>Field Station#</b>		<b>Field Station#</b>			
<b>Pic 11 Desc.</b>		<b>Pic 12 Desc.</b>

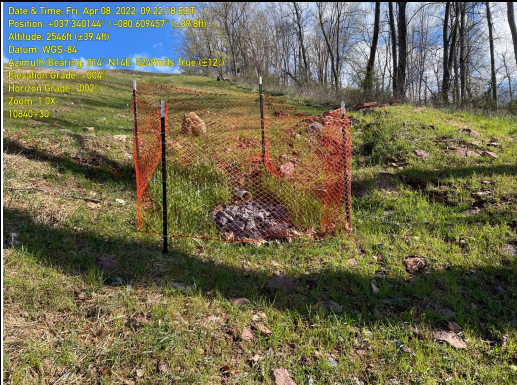
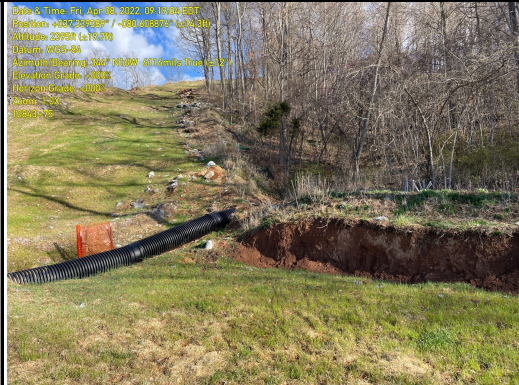
<b>GPS Location</b>	See photo	<b>GPS Location</b>	See photo		
<b>Field Station#</b>	10840+30	<b>Field Station#</b>	10843+75		
<b>Pic 7 Desc.</b>	Daylight drain in place	<b>Pic 8 Desc.</b>	Cleanwater diversion berm in place

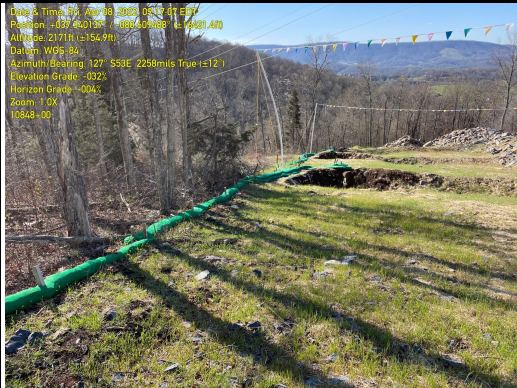
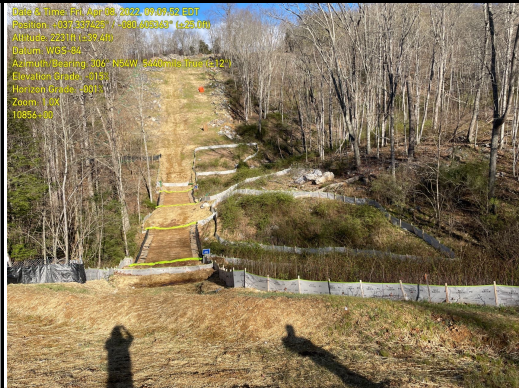
<b>GPS Location</b>	See photo	<b>GPS Location</b>	See photo		
<b>Field Station#</b>	10848+00	<b>Field Station#</b>	10856+00		
<b>Pic 9 Desc.</b>	CFS perimeter control in place	<b>Pic 10 Desc.</b>	Stream buffer in place

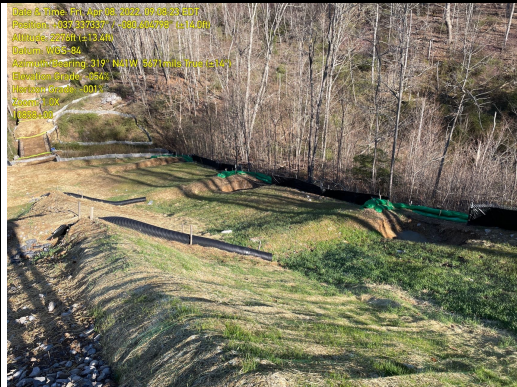
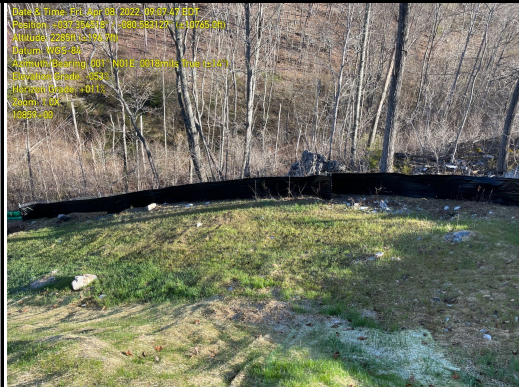
<b>GPS Location</b>	See photo	<b>GPS Location</b>	See photo		
<b>Field Station#</b>	10858+00	<b>Field Station#</b>	10859+00		
<b>Pic 11 Desc.</b>	End treatments in place	<b>Pic 12 Desc.</b>	Supersilt fence perimeter control in place
