# Visual Site Inspection Report

<b>Project Name</b>	H-600 Pipeline Spread G	<b>AFE</b>	124300137	<b>Spread</b>	H-600 Pipeline Spread G
<b>Contractor</b>	Precision			<b>Report #</b>	37174
<b>Inspector</b>	Joe Sweeden			<b>Date/Time</b>	5/2/2022 7:11 AM
<b>Permit #</b>	TBD	<b>Inspection Type</b>	VA SWPP	<b>Station Begin</b>	10859+46
<b>State</b>	VA	<b>Inspection Area</b>	Partial	<b>Station End</b>	10929+80
<b>County</b>	Giles	<b>Ground</b>	Damp	<b>Temperature (°F)</b>	60.00
<b>Municipality</b>	N/A	<b>Weather</b>	Sunny	<b>Rain Gauge (in)</b>	0.30
				<b>Rain Accumulation Time (days)</b>	1.00

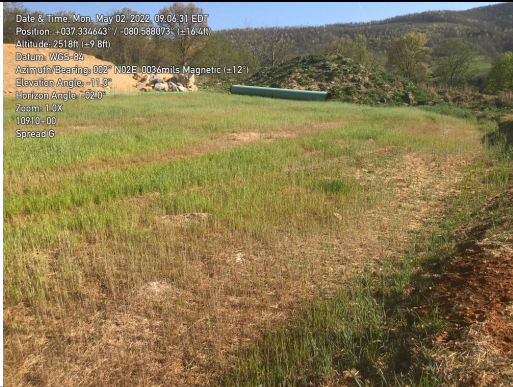
GPS Location		see photo				GPS Location		see photo			
Field Station#		10910+00				Field Station#		108770+01			
Pic 3 Desc.		Stabilized ROW				Pic 4 Desc.		Water bars/stabilized soil piles

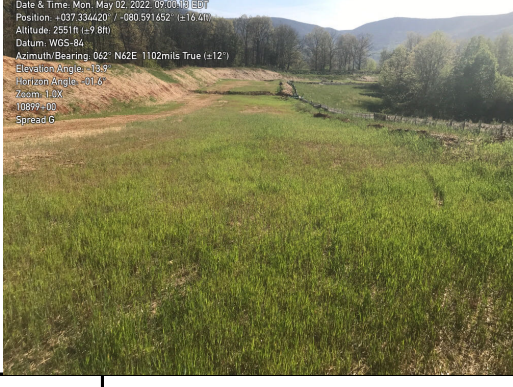
GPS Location		see photo				GPS Location		see photo			
Field Station#		10899+00				Field Station#		10883+10			
Pic 5 Desc.		Perimeter controls/ temporary vegetation				Pic 6 Desc.		SA 32

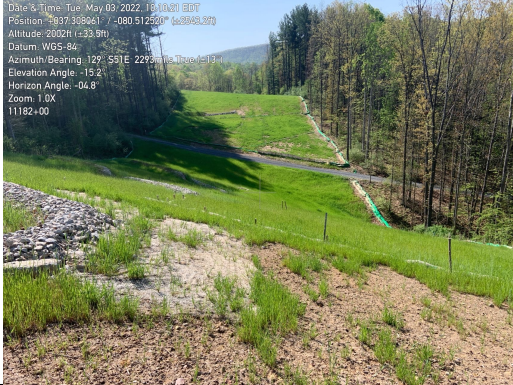
<p>Date &amp; Time: Tue May 03 2022 10:58:03 EDT Position: +037.35241 / -080.51250* (+33.3m) Altitude: 1875ft (+25.4m) Datum: WGS-84 Azimuth/Bearing: 100.000W 300.0mils True (+13.1) Elevation Angle: -15.2 Horizon Angle: -02.7 Zoom: 1.0X 11179+00</p>			
GPS Location	See photo		GPS Location	See photo	
Field Station#	11182+00		Field Station#	11179+00	
Pic 1 Desc.	Section of Row showing conditions and controls		Pic 2 Desc.	Section of Row showing conditions and controls

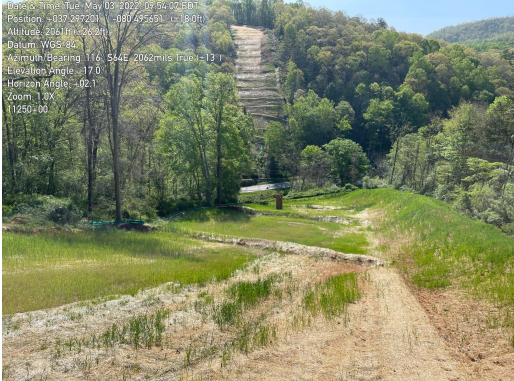
<b>GPS Location</b>	See photo	<b>GPS Location</b>	See photo		
<b>Field Station#</b>	11250+00	<b>Field Station#</b>	11239+00		
<b>Pic 1 Desc.</b>	Picture showing condition of row	<b>Pic 2 Desc.</b>	Inlet in place		
<p> <small> Date &amp; Time Tue May 03 2022 09:15:00 EDT  Position: 43°29'27.55" N 80°46'03.0" W (11200)  Altitude: 2033ft (+130ft)  Datum: WGS-84  Azimuth/Bearing: 170° S010W 1700mils True (+130°)  Elevation Angle: -09.0°  Horizon Angle: -04.1°  Zoom: 1.0x  11200+00 </small> </p>

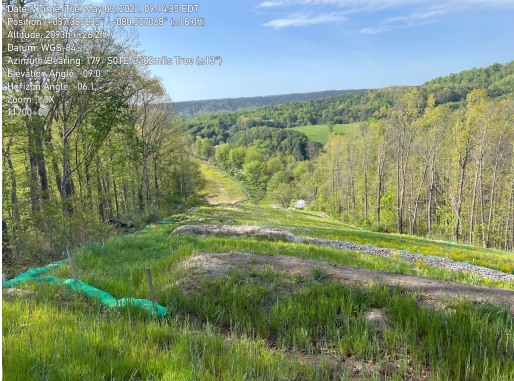
<b>GPS Location</b>	See photo	<b>GPS Location</b>	See photo		
<b>Field Station#</b>	11200+00	<b>Field Station#</b>	11196+00		
<b>Pic 3 Desc.</b>	Permanent water bars and level spreader in place	<b>Pic 4 Desc.</b>	Permanent stabilization in place		
<p> <small> Date &amp; Time Tue May 03 2022 09:03:35 EDT  Position: 43°29'27.22" N 80°46'01.92" W (11185)  Altitude: 1934ft (+39.4ft)  Datum: WGS-84  Azimuth/Bearing: 122.558° 2169mils True (+131°)  Elevation Angle: -09.2°  Horizon Angle: -01.2°  Zoom: 1.0x  11185+00 </small> </p>

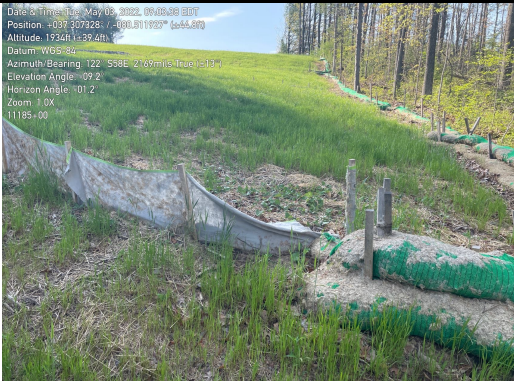
<b>Pic 5 Desc.</b>	P1 damaged and needs repaired	<b>Pic 6 Desc.</b>	Rock check dams in place

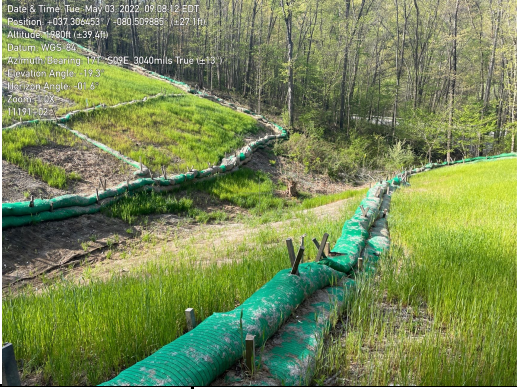
Insert image here			
<b>GPS Location</b>	See photo	<b>GPS Location</b>			
<b>Field Station#</b>	11191+02	<b>Field Station#</b>			
<b>Pic 7 Desc.</b>	Clean water drainage feature in place	<b>Pic 8 Desc.</b>			
Insert image here		Insert image here			
<b>GPS Location</b>		<b>GPS Location</b>			
<b>Field Station#</b>		<b>Field Station#</b>			
<b>Pic 9 Desc.</b>		<b>Pic 10 Desc.</b>			
Insert image here		Insert image here			
<b>GPS Location</b>		<b>GPS Location</b>			
<b>Field Station#</b>		<b>Field Station#</b>			
<b>Pic 11 Desc.</b>		<b>Pic 12 Desc.</b>

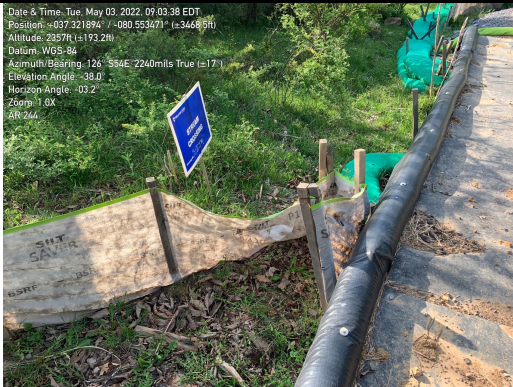
<p>Date &amp; Time: Tue, May 03, 2022, 09:15:53 EDT Position: +4937.222491° / -080.553471° (+3468.9ft) Altitude: 3257ft (+193.2m) Datum: WGS-84 Azimuth/Bearing: 126° S54E, 2240mils True (±17.1) Elevation Angle: -38.0° Horizon Angle: -03.2° Zoom: 1.0X 11016+80</p>			
GPS Location		See photo for GPS location and station.		GPS Location	
Field Station#		11023+80		Field Station#	
Pic 1 Desc.		Hole in P-1 silt fence.		Pic 2 Desc.	
				Priority one silt fence fabric torn.

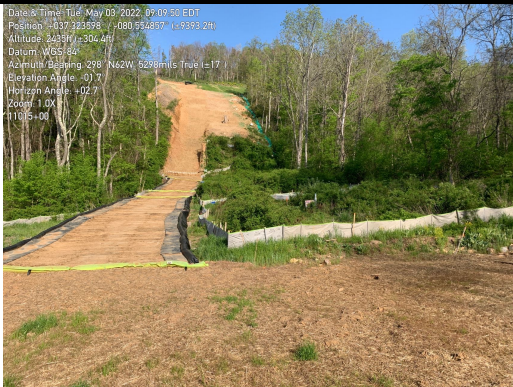
GPS Location		See photo for GPS location and station.		GPS Location	
Field Station#		11015+00		Field Station#	
Pic 3 Desc.		Sensitive resource buffer in place at stream S-RR5.		Pic 4 Desc.	
				Triple barrier ECDs in place at karst feature.

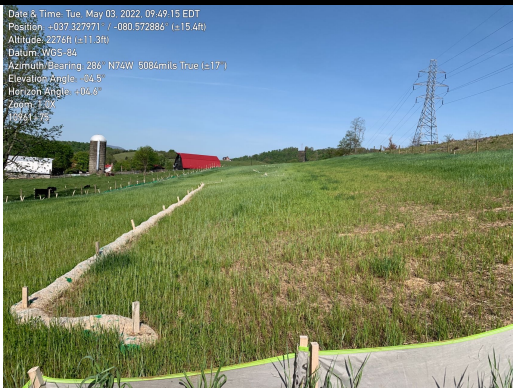
<p>Date &amp; Time: Tue, May 03, 2022, 10:07:51 EDT Position: +4937.231911° / -080.582639° (+15.4ft) Altitude: 2319ft (+11.3m) Datum: WGS-84 Azimuth/Bearing: 272° N81W, 4960mils True (±16.1) Elevation Angle: -14.2° Horizon Angle: -01.8° Zoom: 1.0X 10930+50</p>			
GPS Location		See photo for GPS location and station.		GPS Location	
Field Station#		10961+75		Field Station#	
Pic 5 Desc.		ROW permanently stabilized.		Pic 6 Desc.

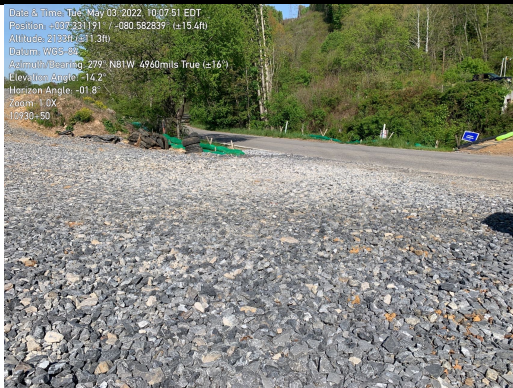
RCE in place at Doe Creek Road.

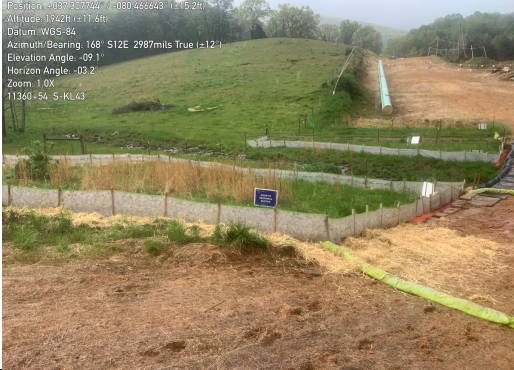
<b>GPS Location</b>		See photo		<b>GPS Location</b>	
<b>Field Station#</b>		11360+54		<b>Field Station#</b>	
<b>Pic 1 Desc.</b>		Section of Row showing conditions and controls at S-KL43		<b>Pic 2 Desc.</b>	
<p> <small> Date &amp; Time: Wed May 04, 2022 09:42:56 EDT  Position: +48°59'57.22" / -080°45'54.3" (-15.20)  Altitude: 231m (+11.4m)  Datum: WGS-84  Azimuth/Bearing: 223° S43W 3964mils True (+12°)  Elevation Angle: -14.7°  Horizon Angle: -02.0°  Zoom: 1.0x  11412+50 </small> </p>

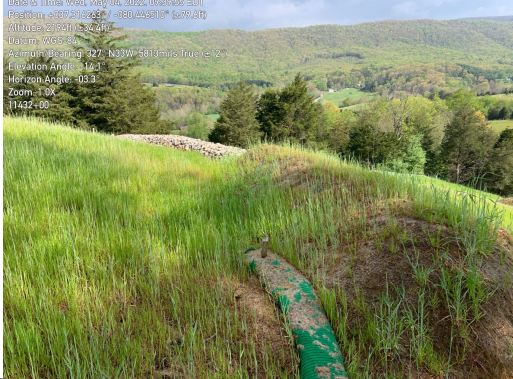
<b>GPS Location</b>		See photo		<b>GPS Location</b>	
<b>Field Station#</b>		11431+00		<b>Field Station#</b>	
<b>Pic 5 Desc.</b>		Section of Row showing conditions and controls		<b>Pic 6 Desc.</b>

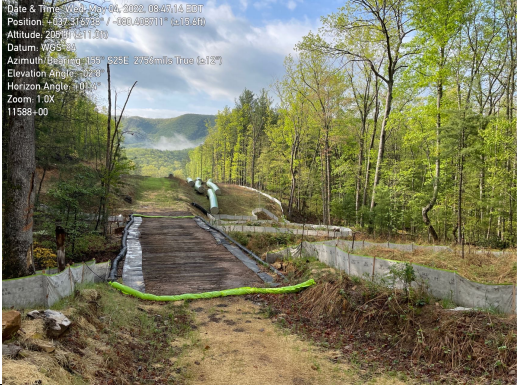
<p><small>Date &amp; Time: Wed May 04, 2022 08:40:46 EDT Position: 43° 15' 25" N / -68° 08' 00" W (52933) Altitude: 209 ft (63.7m) Datum: WGS-84 Azimuth/Bearing: 100° 25' 1" NSW 692mils True (513°) Elevation Angle: -00.1° Horizon Angle: -00.3° Zoom: 1.0X 11596+50</small></p>			
<b>GPS Location</b>	See photo	<b>GPS Location</b>	See photo		
<b>Field Station#</b>	11588+00	<b>Field Station#</b>	11596+50		
<b>Pic 7 Desc.</b>	Equipment bridge functional	<b>Pic 8 Desc.</b>	Perimeter controls in place

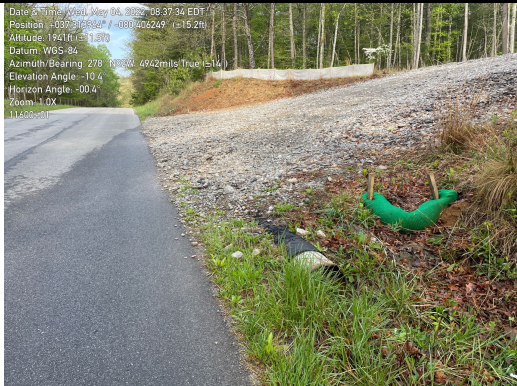
<b>GPS Location</b>	See photo	<b>GPS Location</b>			
<b>Field Station#</b>	11600+01	<b>Field Station#</b>			
<b>Pic 9 Desc.</b>	RCE functional	<b>Pic 10 Desc.</b>			
<p style="text-align: center;">Insert image here</p>		<p style="text-align: center;">Insert image here</p>			
<b>GPS Location</b>		<b>GPS Location</b>			
<b>Field Station#</b>		<b>Field Station#</b>			
<b>Pic 11 Desc.</b>		<b>Pic 12 Desc.</b>

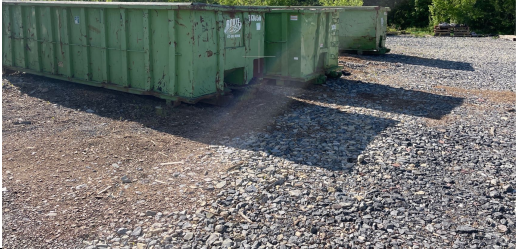
<b>GPS Location</b>	See photo	<b>GPS Location</b>	See photo		
<b>Field Station#</b>	12005+00	<b>Field Station#</b>	12005+00		
<b>Pic 1 Desc.</b>	Housekeeping trash in good condition y28	<b>Pic 2 Desc.</b>	CFS perimeter controls functional y28		
<p>Date &amp; Time: Thu May 05 2022 09:07:15 EDT  Position: +037.334539° / -080.80130° (-11.6W)  Altitude: 1555ft (+9.8ft)  Datum: WGS-84  Azimuth/Bearing: 254° S76W 450mils True (±10°)  Elevation Angle: -02.1°  Horizon Angle: +01.8°  Zoom: 1.0X  Y28</p>

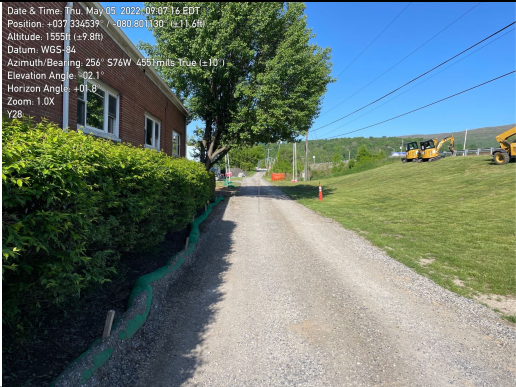
<b>GPS Location</b>	See photo	<b>GPS Location</b>	See photo		
<b>Field Station#</b>	12005+00	<b>Field Station#</b>	12005+00		
<b>Pic 3 Desc.</b>	CFS perimeter controls functional y28	<b>Pic 4 Desc.</b>	CFS perimeter controls functional y28		
<p>Date &amp; Time: Thu May 05 2022 09:04:32 EDT  Position: +037.334703° / -080.808128° (-11.5W)  Altitude: 1567ft (+9.7ft)  Datum: WGS-84  Azimuth/Bearing: 324° N43W 5162mils True (±10°)  Elevation Angle: -02.8°  Horizon Angle: -01.8°  Zoom: 1.0X  Y28</p>

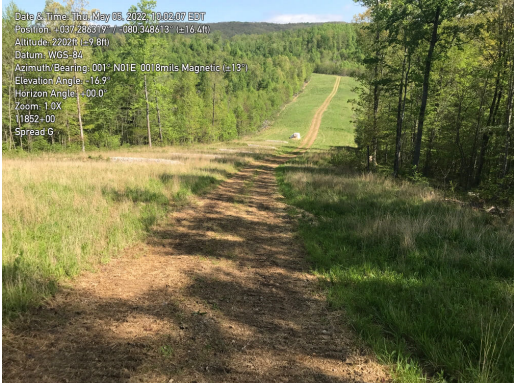
<b>GPS Location</b>		see photo		<b>GPS Location</b>	
<b>Field Station#</b>		11852+00		<b>Field Station#</b>	
<b>Pic 3 Desc.</b>		Water bars (other)		<b>Pic 4 Desc.</b>

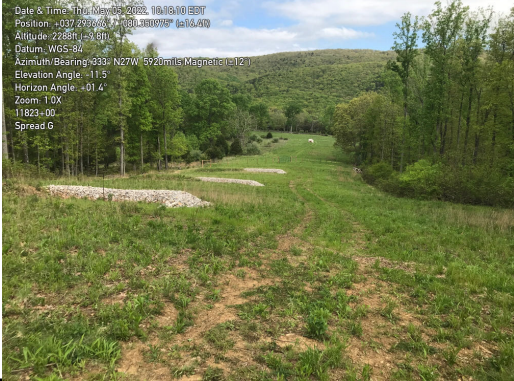
<b>GPS Location</b>		see photo		<b>GPS Location</b>	
<b>Field Station#</b>		11820+00		<b>Field Station#</b>	
<b>Pic 5 Desc.</b>		Level spreaders		<b>Pic 6 Desc.</b>

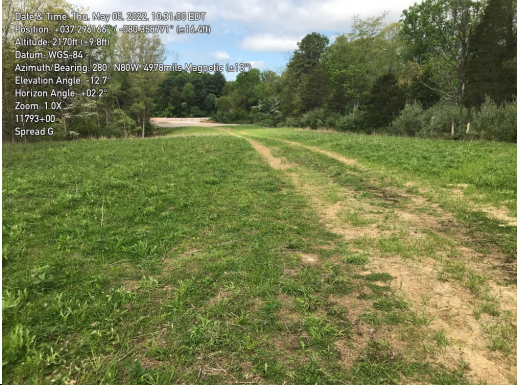
Insert image here	
<b>GPS Location</b>	See photo	<b>GPS Location</b>			
<b>Field Station#</b>	11793+00	<b>Field Station#</b>			
<b>Pic 7 Desc.</b>	Tabor RCE	<b>Pic 8 Desc.</b>			
Insert image here		Insert image here			
<b>GPS Location</b>		<b>GPS Location</b>			
<b>Field Station#</b>		<b>Field Station#</b>			
<b>Pic 9 Desc.</b>		<b>Pic 10 Desc.</b>			
Insert image here		Insert image here			
<b>GPS Location</b>		<b>GPS Location</b>			
<b>Field Station#</b>		<b>Field Station#</b>			
<b>Pic 11 Desc.</b>		<b>Pic 12 Desc.</b>

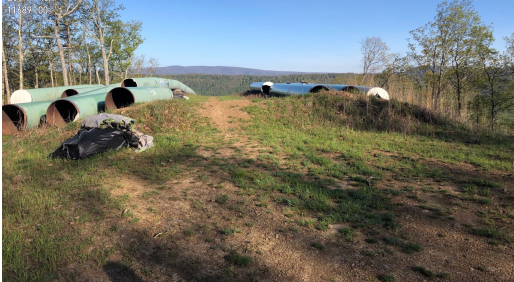
<b>GPS Location</b>	On photo	<b>GPS Location</b>	On photo		
<b>Field Station#</b>	11669+00	<b>Field Station#</b>	11664+00		
<b>Pic 1 Desc.</b>	Conditions stable at top of Brush Mountain.	<b>Pic 2 Desc.</b>	End treatments are functional and effectively controlling stormwater runoff.

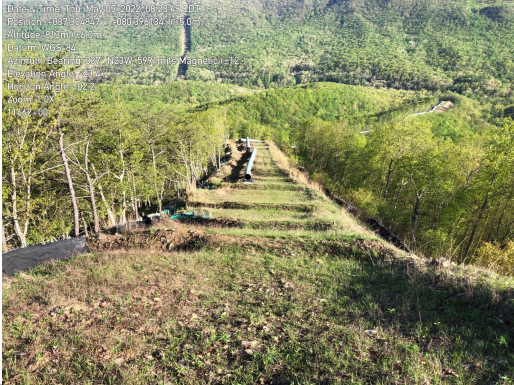
<b>GPS Location</b>	On photo	<b>GPS Location</b>	On photo		
<b>Field Station#</b>	11662+00	<b>Field Station#</b>	11656+00		
<b>Pic 3 Desc.</b>	Slope breakers functional. Grasses continue to emerge on JNF property.	<b>Pic 4 Desc.</b>	End treatments are functional. Worn CFS to be replaced once permits are curved and before any ground disturbance occurs.		
<p>Date &amp; Time: Thu May 05 2022 09:05:22 EDT  Position: +037.252329, -080.479680 (+5022.5m)  Altitude: 247m (+41.2m)  Datum: WGS 84  Azimuth Bearing: 170.510E 3022mils Magnetic (+12.1)  Elevation Angle: +04.5  Horizon Angle: +03.7  Zoom: 1.0x  11637+00</p>

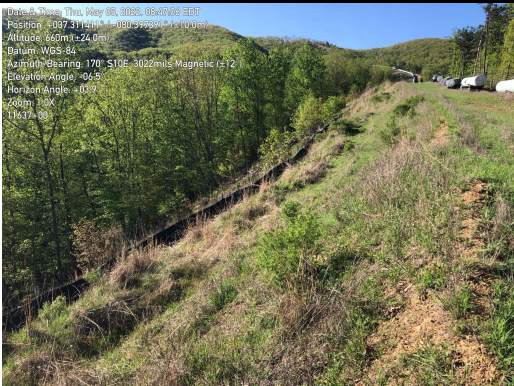
<b>GPS Location</b>	On photo	<b>GPS Location</b>	On photo		
<b>Field Station#</b>	11637+00	<b>Field Station#</b>	11626+50		
<b>Pic 5 Desc.</b>	Perimeter ECDs are in place and ROW stable.	<b>Pic 6 Desc.</b>	Sumps and end treatments are effective.

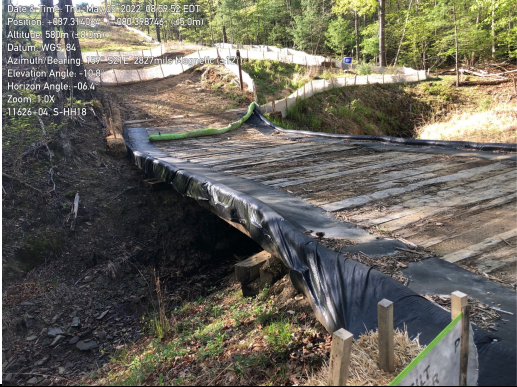
<p><small>Date &amp; Time: Thu, May 05, 2022, 09:59:21 EDT Position: +037.314005 / -080.402203 (±50.0m) Altitude: 581m (±32.0m) Datum: WGS-84 Azimuth/Bearing: 307.0°/31W 616°mils Magnetic (±12°) Elevation Angle: -10.3° Horizon Angle: -00.2° Zoom: 1.0X 11614+75</small></p>			
<b>GPS Location</b>	On photo	<b>GPS Location</b>	On photo		
<b>Field Station#</b>	11626+04	<b>Field Station#</b>	11614+75		
<b>Pic 7 Desc.</b>	The S-HH18 crossing is stable.	<b>Pic 8 Desc.</b>	Sumps and end treatments in good condition.

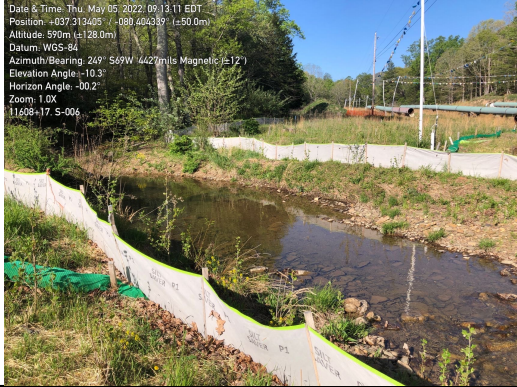
<b>GPS Location</b>	On photo	<b>GPS Location</b>			
<b>Field Station#</b>	11608+17	<b>Field Station#</b>			
<b>Pic 9 Desc.</b>	The S-006 crossing is stable.	<b>Pic 10 Desc.</b>			
Insert image here		Insert image here			
<b>GPS Location</b>		<b>GPS Location</b>			
<b>Field Station#</b>		<b>Field Station#</b>			
<b>Pic 11 Desc.</b>		<b>Pic 12 Desc.</b>

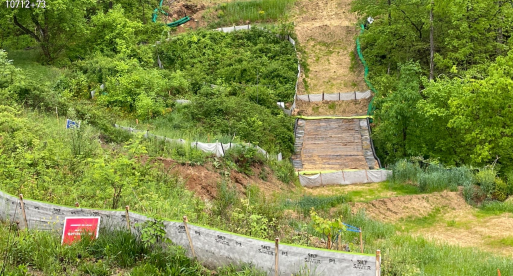
<b>GPS Location</b>	See photo	<b>GPS Location</b>	See photo		
<b>Field Station#</b>	10715+31	<b>Field Station#</b>	10712+73		
<b>Pic 1 Desc.</b>	Water bars in place	<b>Pic 2 Desc.</b>	Equipment bridge functional		
<p>Date &amp; Time Fri May 06, 2022 08:09:11 EDT  Position: +48°34'52.97" / -90.677748" (-100.678)  Altitude: 2419ft (-1.34ft)  Datum: WGS-84  Azimuth Bearing: 103° 57'E 1891mils True (+10°)  Elevation Angle: +0.1°  Horizon Angle: +0.3°  Zoom: 1.0x  10698+00</p>

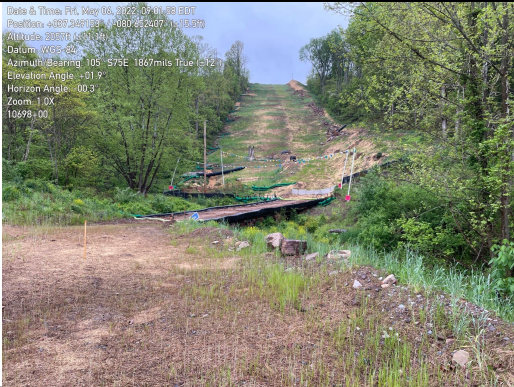
<b>GPS Location</b>	See photo	<b>GPS Location</b>	See photo		
<b>Field Station#</b>	10698+00	<b>Field Station#</b>	10703+00		
<b>Pic 3 Desc.</b>	P1 and wattles in place	<b>Pic 4 Desc.</b>	Water bars and ET in place		
<p>Date &amp; Time Fri May 06, 2022 08:09:11 EDT  Position: +48°34'52.97" / -90.677748" (-100.678)  Altitude: 2419ft (-1.34ft)  Datum: WGS-84  Azimuth Bearing: 103° 57'E 1891mils True (+10°)  Elevation Angle: +0.1°  Horizon Angle: +0.0°  Zoom: 1.0x  10694+00</p>

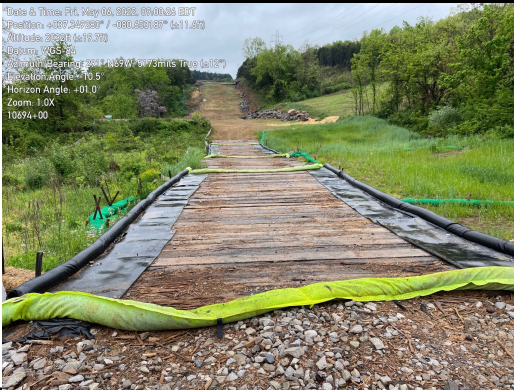
<b>GPS Location</b>	See photo	<b>GPS Location</b>	See photo		
<b>Field Station#</b>	10694+00	<b>Field Station#</b>	10733+20		
<b>Pic 5 Desc.</b>	Clean water drainage feature functional	<b>Pic 6 Desc.</b>	Equipment bridge functional

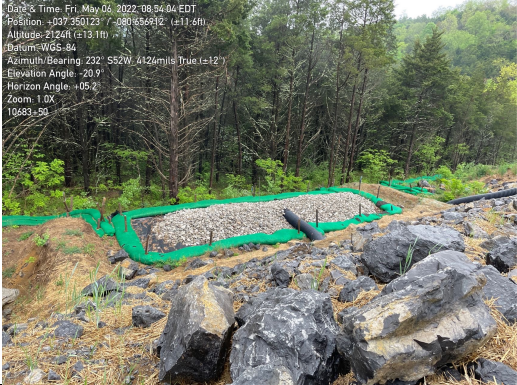
<b>GPS Location</b>	See photo	<b>GPS Location</b>	See photo		
<b>Field Station#</b>	10683+50	<b>Field Station#</b>	10748+00		
<b>Pic 7 Desc.</b>	Level spreader in place	<b>Pic 8 Desc.</b>	RCE functional

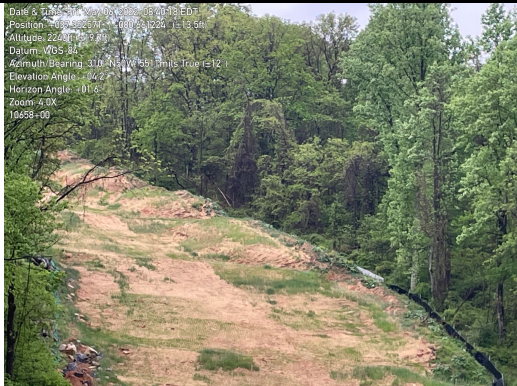
<p style="text-align: center;">Insert image here</p>			
<b>GPS Location</b>	See photo	<b>GPS Location</b>			
<b>Field Station#</b>	10658+00	<b>Field Station#</b>			
<b>Pic 9 Desc.</b>	Water bars and ET in place	<b>Pic 10 Desc.</b>			
<p style="text-align: center;">Insert image here</p>		<p style="text-align: center;">Insert image here</p>			
<b>GPS Location</b>		<b>GPS Location</b>			
<b>Field Station#</b>		<b>Field Station#</b>			
<b>Pic 11 Desc.</b>		<b>Pic 12 Desc.</b>

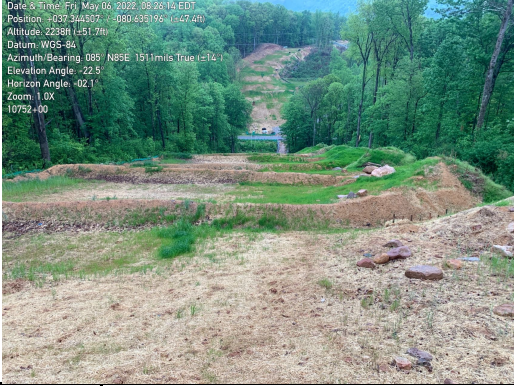
<b>GPS Location</b>	See photo.	<b>GPS Location</b>	See photo.		
<b>Field Station#</b>	10752+00	<b>Field Station#</b>	10758+00		
<b>Pic 1 Desc.</b>	Waterbars in place.	<b>Pic 2 Desc.</b>	Sensitive resource buffer in place at stream S-G35.

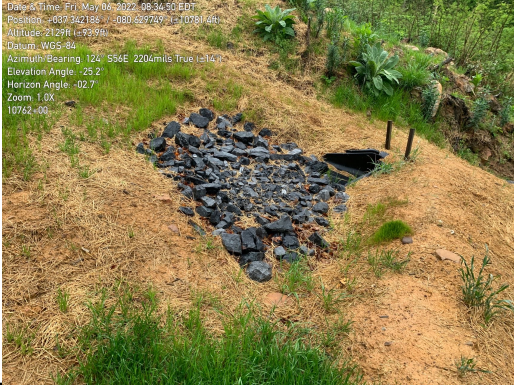
<b>GPS Location</b>	See photo.	<b>GPS Location</b>	See photo.		
<b>Field Station#</b>	10762+00	<b>Field Station#</b>	10766+50		
<b>Pic 3 Desc.</b>	Rock inlet in place at slope drain.	<b>Pic 4 Desc.</b>	Clean water diversion pipe and level spreader in place.

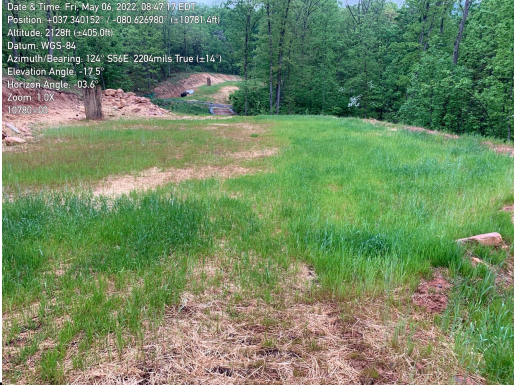
<b>GPS Location</b>	See photo.	<b>GPS Location</b>	See photo.		
<b>Field Station#</b>	10780+00	<b>Field Station#</b>	10797+00		
<b>Pic 5 Desc.</b>	ROW temporarily stabilized. Vegetation growth present.	<b>Pic 6 Desc.</b>	RCE in place at Cascade Road.

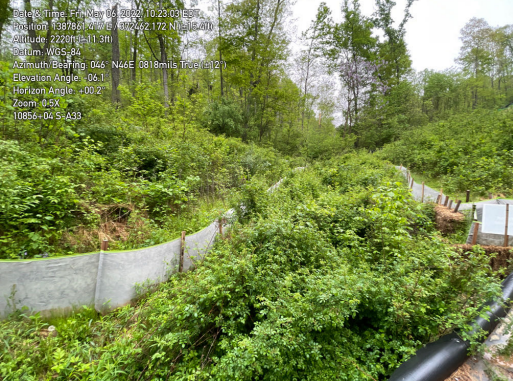
<b>GPS Location</b>	1	<b>GPS Location</b>	2		
<b>Field Station#</b>	10859+46	<b>Field Station#</b>	10856+04		
<b>Pic 1 Desc.</b>	Section of RoW showing conditions and controls.	<b>Pic 2 Desc.</b>	S-A33.

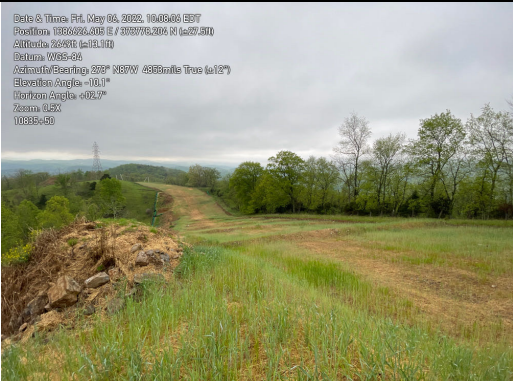
<b>GPS Location</b>	3	<b>GPS Location</b>	4		
<b>Field Station#</b>	10865+70	<b>Field Station#</b>	10835+50		
<b>Pic 3 Desc.</b>	S-A34.	<b>Pic 4 Desc.</b>	Section of RoW showing conditions and controls.

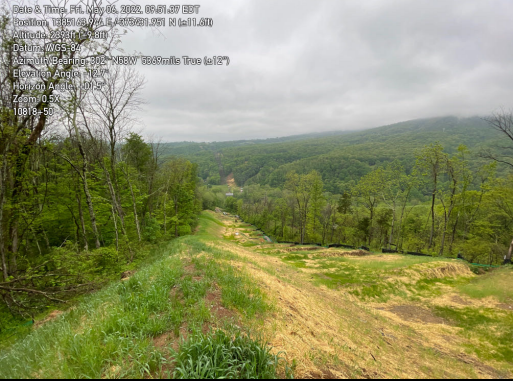
<b>GPS Location</b>	5	<b>GPS Location</b>	6		
<b>Field Station#</b>	10826+00	<b>Field Station#</b>	10818+50		
<b>Pic 5 Desc.</b>	CWDP outlet protection functional.	<b>Pic 6 Desc.</b>	Section of RoW showing conditions and controls.

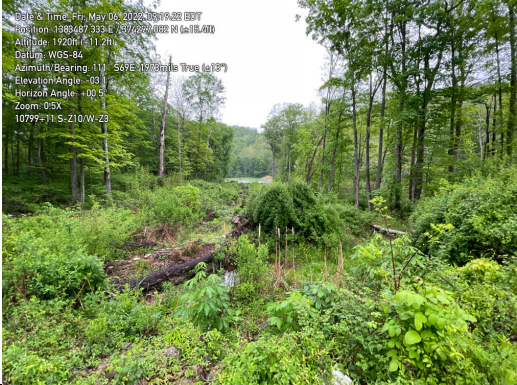
<b>GPS Location</b>	7	<b>GPS Location</b>	8		
<b>Field Station#</b>	10799+11	<b>Field Station#</b>	10801+52		
<b>Pic 7 Desc.</b>	Overview S-Z10/W-Z3.	<b>Pic 8 Desc.</b>	Overview S-Z11/S-Z12/S-Z13.		
Insert image here		Insert image here			
<b>GPS Location</b>		<b>GPS Location</b>			
<b>Field Station#</b>		<b>Field Station#</b>			
<b>Pic 9 Desc.</b>		<b>Pic 10 Desc.</b>			
Insert image here		Insert image here			
<b>GPS Location</b>		<b>GPS Location</b>			
<b>Field Station#</b>		<b>Field Station#</b>			
<b>Pic 11 Desc.</b>		<b>Pic 12 Desc.</b>
