# Visual Site Inspection Report

<b>Project Name</b>	H-600 Pipeline Spread G	<b>AFE</b>	124300137	<b>Spread</b>	H-600 Pipeline Spread G
<b>Contractor</b>	Precision			<b>Report #</b>	37483
<b>Inspector</b>	Daniel Fortune			<b>Date/Time</b>	5/9/2022 6:09 PM
<b>Permit #</b>	TBD	<b>Inspection Type</b>	VA SWPP	<b>Station Begin</b>	11023+80
<b>State</b>	VA	<b>Inspection Area</b>	Partial	<b>Station End</b>	11098+47
<b>County</b>	Giles	<b>Ground</b>	Damp	<b>Temperature (°F)</b>	51.00
<b>Municipality</b>	N/A	<b>Weather</b>	Sunny	<b>Rain Gauge (in)</b>	0.50
				<b>Rain Accumulation Time (days)</b>	2.00

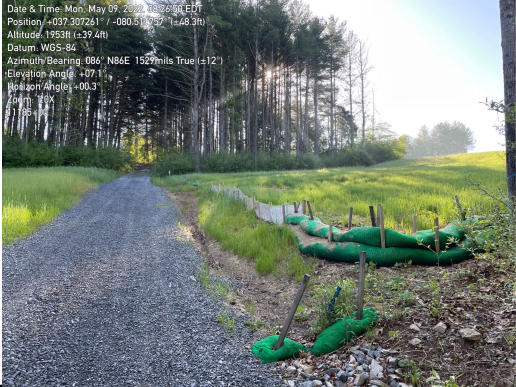
<p>Date &amp; Time: Mon, May 09, 2022, 08:30:36 EDT Position: -037.326881 / -080.519111 (-111.19) Altitude: 1920ft (-111.19) Datum: WGS-84 Azimuth/Bearing: 17.555E 330mils True (+12.5) Elevation Angle: -10.3 Horizon Angle: -02.9 Zoom: 2.0X 11193+00</p>			
<b>GPS Location</b>	See photo	<b>GPS Location</b>	See photo		
<b>Field Station#</b>	11191+02	<b>Field Station#</b>	11193+00		
<b>Pic 1 Desc.</b>	Clean water drainage feature functional	<b>Pic 2 Desc.</b>	Permanent water bars and level spreader in place

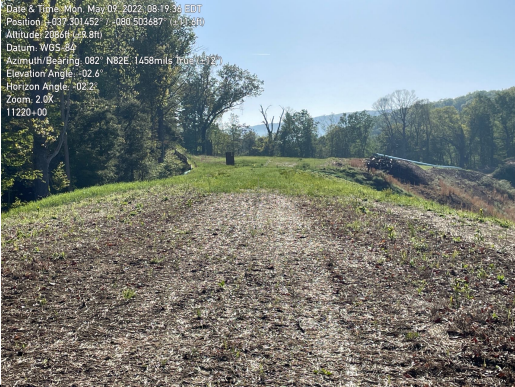
<b>GPS Location</b>	See photo	<b>GPS Location</b>	See photo		
<b>Field Station#</b>	11185+00	<b>Field Station#</b>	11220+00		
<b>Pic 3 Desc.</b>	Erosion control blanket in place	<b>Pic 4 Desc.</b>	Area being monitored on stabilization

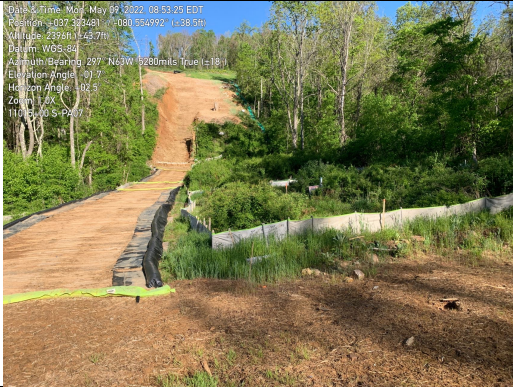
<p>Date &amp; Time: Mon, May 09, 2022, 09:06:56 EDT Position: +037.325741° / -080.554920° (±6295.9ft) Altitude: 2424ft (±179.0ft) Datum: WGS-84 Azimuth Bearing: 193° S±3W 3431mils True (±18°) Elevation Angle: -26.7° Horizon Angle: +03.6° Zoom: 1.0X 11008+75</p>			
GPS Location		See photo.		GPS Location		See photo.
Field Station#		11015+00		Field Station#		11008+75
Pic 1 Desc.		Sensitive resource buffer in place at streams S-PA09 and S-RR5.		Pic 2 Desc.		Clean water diversion pipe and level spreader in place.

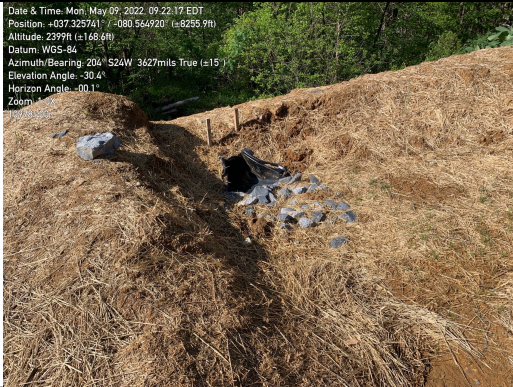
GPS Location		See photo.		GPS Location		See photo.
Field Station#		10978+00		Field Station#		10966+00
Pic 3 Desc.		Rock inlet in place at slope drain.		Pic 4 Desc.		Triple barrier ECDs in place at cave.

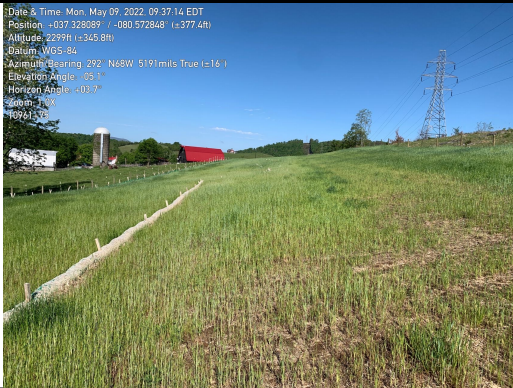
<p>Date &amp; Time: Mon, May 09, 2022, 09:55:34 EDT Position: +037.325741° / -080.554920° (±6295.9ft) Altitude: 2128ft (±111.3ft) Datum: WGS-84 Azimuth Bearing: 340° N±2W 3000mils True (±16°) Elevation Angle: -14.1° Horizon Angle: +00.1° Zoom: 1.0X 10930+25</p>			
GPS Location		See photo.		GPS Location		See photo.
Field Station#		10961+75		Field Station#		10930+25
Pic 5 Desc.		ROW permanently stabilized.		Pic 6 Desc.		RCE in place at Doe Creek Road.

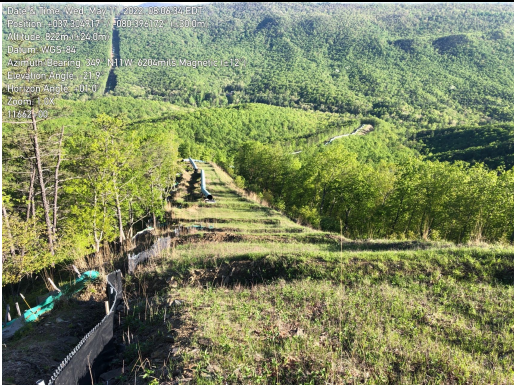
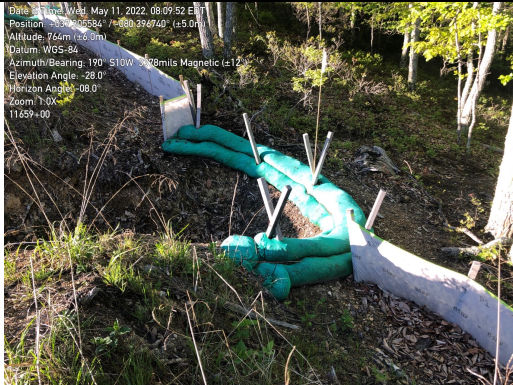
<b>GPS Location</b>	On photo	<b>GPS Location</b>	On photo		
<b>Field Station#</b>	11662+00	<b>Field Station#</b>	11659+00		
<b>Pic 3 Desc.</b>	Slope breakers are working properly.	<b>Pic 4 Desc.</b>	Perimeter ECDs are functional.

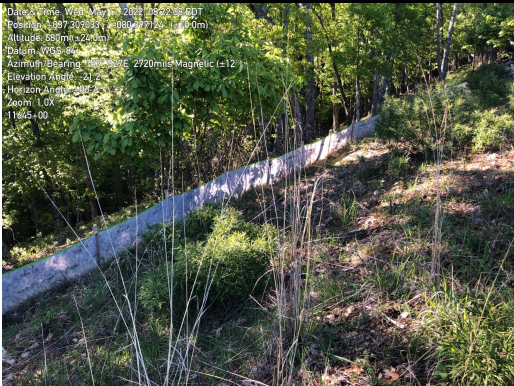
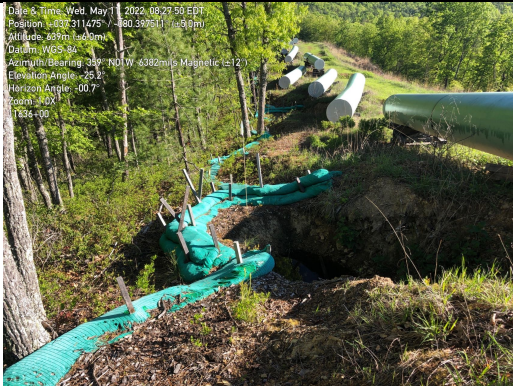
<b>GPS Location</b>	On photo	<b>GPS Location</b>	On photo		
<b>Field Station#</b>	11645+00	<b>Field Station#</b>	11636+00		
<b>Pic 5 Desc.</b>	Perimeter ECDs are in place.	<b>Pic 6 Desc.</b>	Sumps and end treatments are functioning.

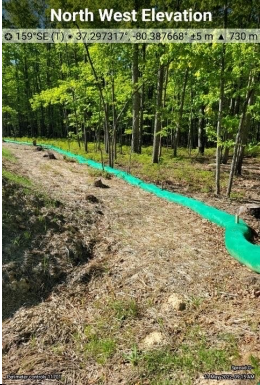
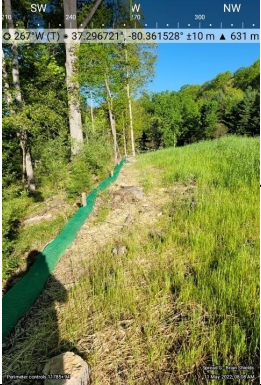
<p>North West Elevation Q 267°W (T) • 37.296721° -80.361528° ±10 m ▲ 631 m</p>			
<b>GPS Location</b>	See photo	<b>GPS Location</b>	See photo		
<b>Field Station#</b>	11701+00	<b>Field Station#</b>	11785+94		
<b>Pic 7 Desc.</b>	Perimeter controls are in place	<b>Pic 8 Desc.</b>	Section of Row showing conditions and controls

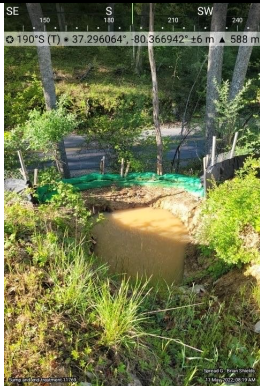
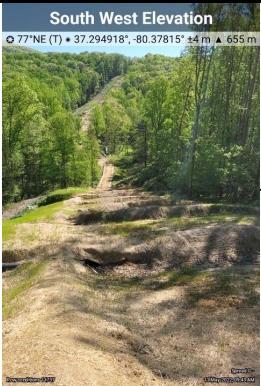
<p>South West Elevation Q 77°NE (T) • 37.294918° -80.37815° ±4 m ▲ 655 m</p>			
<b>GPS Location</b>	See photo	<b>GPS Location</b>	See photo		
<b>Field Station#</b>	11769+00	<b>Field Station#</b>	11737+00		
<b>Pic 9 Desc.</b>	Sump pit and perimeter controls are in acceptable condition	<b>Pic 10 Desc.</b>	Section of Row showing conditions and controls

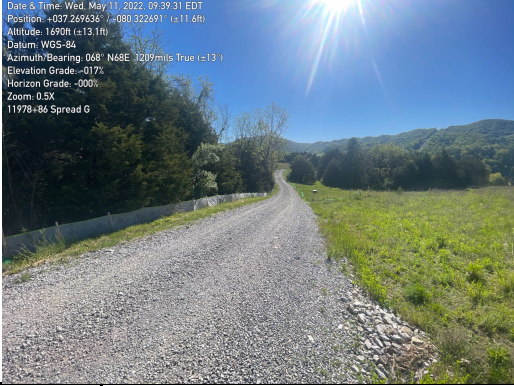
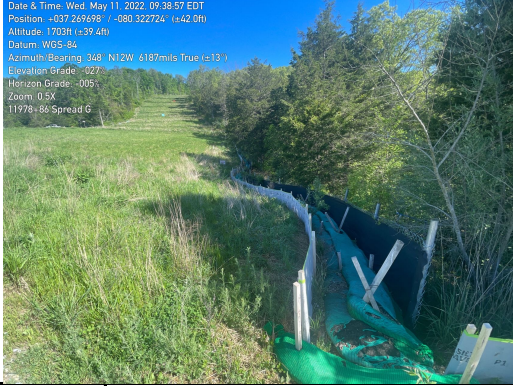
<p>Date &amp; Time: Wed, May 11, 2022 09:38:57 EDT Position: +037.269494° / +080.322724° (+142.0ft) Altitude: 1203ft (+29.6ft) Datum: WGS-84 Azimuth/Bearing: 348° N12W 6187mils True (+13.1) Elevation Grade: -027% Horizon Grade: -005% Zoom: 0.5X 11978+86 Spread G</p>			
<b>GPS Location</b>	See Photo	<b>GPS Location</b>	See Photo		
<b>Field Station#</b>	11978+86	<b>Field Station#</b>	11978+86		
<b>Pic 1 Desc.</b>	AR 266 and adjacent vegetated row conditions.	<b>Pic 2 Desc.</b>	Perimeter controls protecting presumed

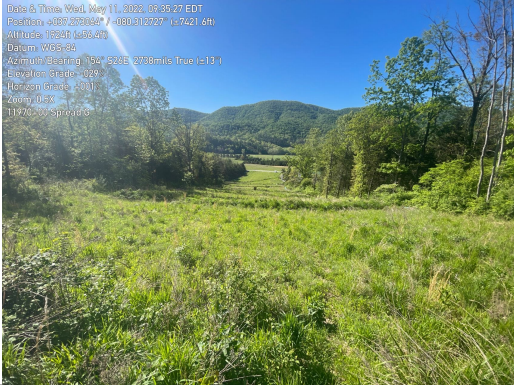
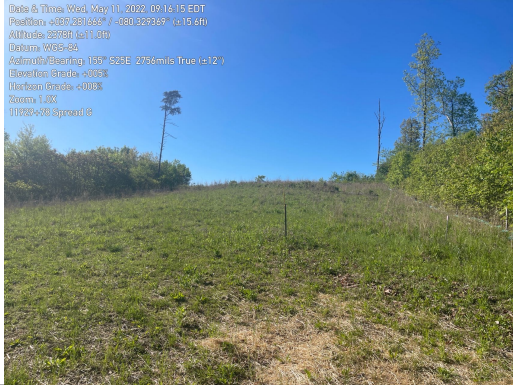
<b>GPS Location</b>	See Photo	<b>GPS Location</b>	See Photo		
<b>Field Station#</b>	11970+00	<b>Field Station#</b>	11929+78		
<b>Pic 3 Desc.</b>	Steep slope vegetated conditions and permanent water bar visual.	<b>Pic 4 Desc.</b>	ROW condition adjacent to AR 266

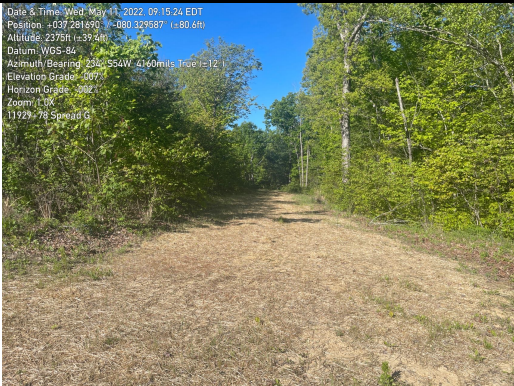
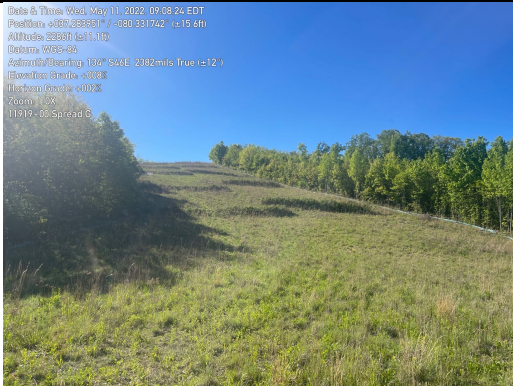
<b>Pic 5 Desc.</b>	AR 266 stabilization conditions.	<b>Pic 6 Desc.</b>	Staggered permanent water bar and heavily vegetated row conditions. Final Restoration Area.

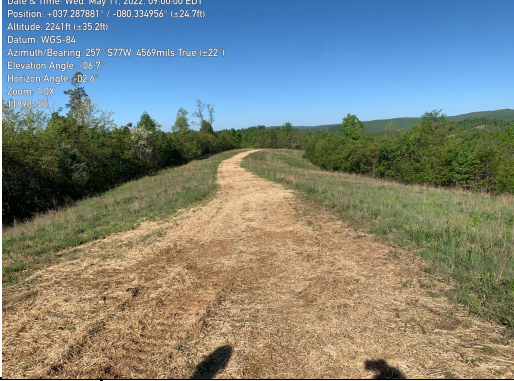
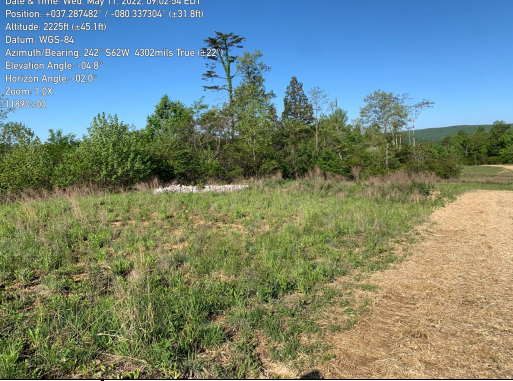
<b>GPS Location</b>	See photo.		<b>GPS Location</b>	See photo.	
<b>Field Station#</b>	11898+00		<b>Field Station#</b>	11890+00	
<b>Pic 1 Desc.</b>	ROW permanently restored. Travel lane seeded and mulch.		<b>Pic 2 Desc.</b>	Waterbar and level spreader in place.	
<p>Date &amp; Time: Wed, May 11, 2022, 09:10:13 EDT  Position: +037.289924 / -080.344865 (+15.6ft)  Altitude: 2188ft (+11.0ft)  Datum: WGS-84  Azimuth/Bearing: 044.164E 0918mils True (+19.1)  Elevation Angle: -69.7  Horizon Angle: -02.5  Zoom: 1.0X  11864+00 P-RL2</p>

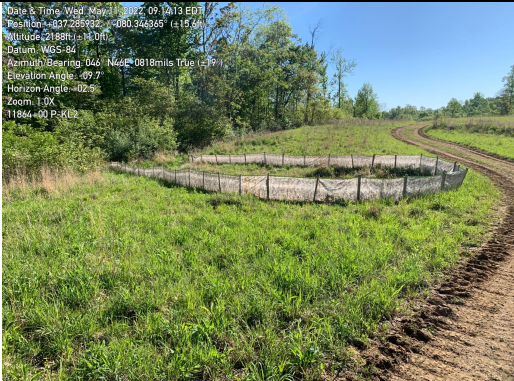
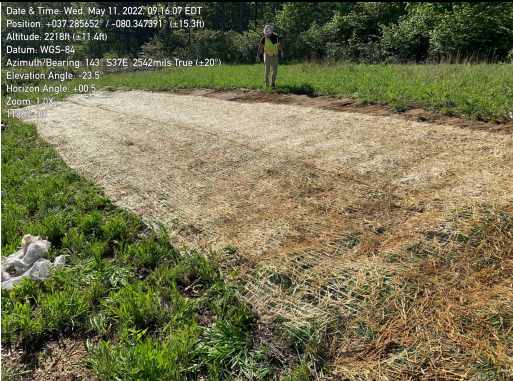
<b>GPS Location</b>	See photo.		<b>GPS Location</b>	See photo.	
<b>Field Station#</b>	11864+00		<b>Field Station#</b>	11860+00	
<b>Pic 3 Desc.</b>	Priority one silt fence in place at P-KL2.		<b>Pic 4 Desc.</b>	Location where sunken ditch was repaired. ECB installed on denuded soils.	
<p>Date &amp; Time: Wed, May 11, 2022, 10:34:19 EDT  Position: +037.297997 / -080.365541 (+15.6ft)  Altitude: 2228ft (+45.1ft)  Datum: WGS-84  Azimuth/Bearing: 323.137W 5742mils True (+23.1)  Elevation Angle: -21.1  Horizon Angle: -01.6  Zoom: 1.0X  11789+00</p>

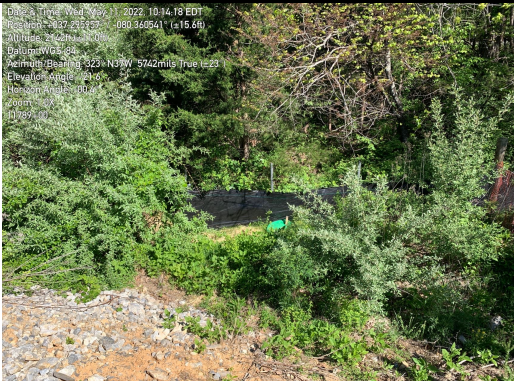
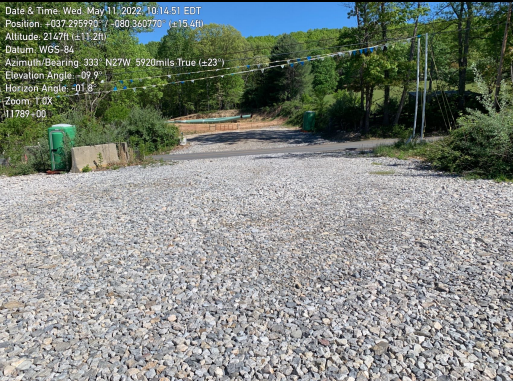
<b>Pic 5 Desc.</b>	Super silt fence in place along LOD.		<b>Pic 6 Desc.</b>	RCE in place at Mount Tabor Road crossing.

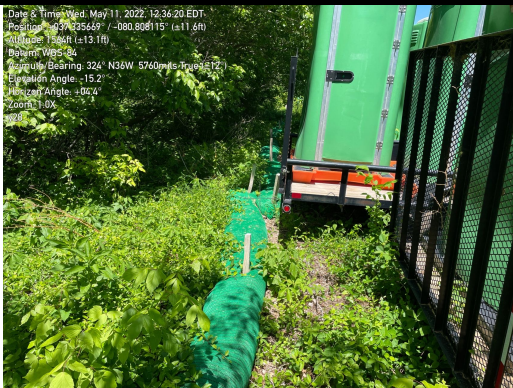
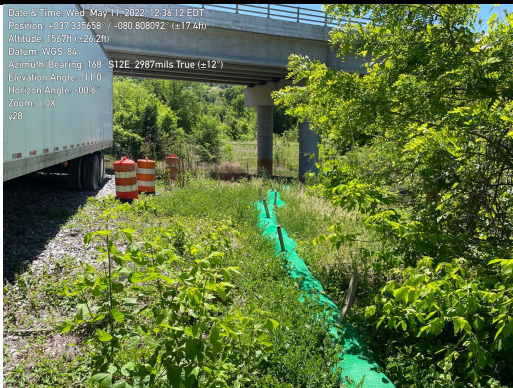
GPS Location	See photo		GPS Location	See photo	
Field Station#	12005+00		Field Station#	12005+00	
Pic 5 Desc.	CFS perimeter controls functional y28		Pic 6 Desc.	CFS perimeter controls functional y28

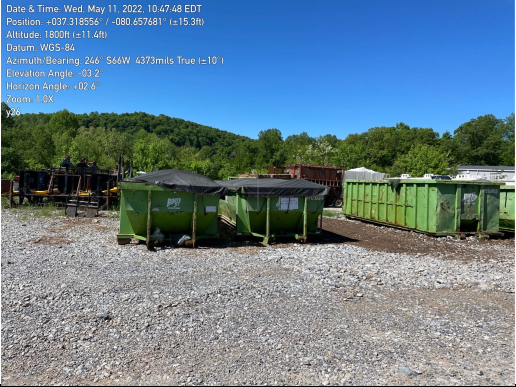
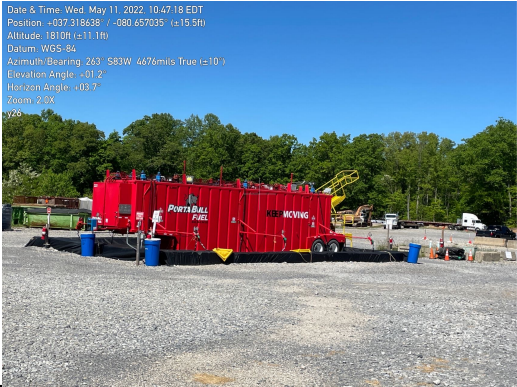
<b>GPS Location</b>	See photo	<b>GPS Location</b>	See photo		
<b>Field Station#</b>	12005+00	<b>Field Station#</b>	12005+00		
<b>Pic 13 Desc.</b>	CFS perimeter controls in place y26	<b>Pic 14 Desc.</b>	Housekeeping trash in good condition y26		
<p>Date &amp; Time: Wed, May 11, 2022, 10:47:18 EDT  Position: +037 318638 / -080 657035 (±15 5ft)  Altitude: 1810ft (±11.1ft)  Datum: WGS-84  Azimuth Bearing: 263° S83W 4676mils True (±10°)  Elevation Angle: +01.2°  Horizon Angle: +03.7°  Zoom: 2.0X  y26</p>

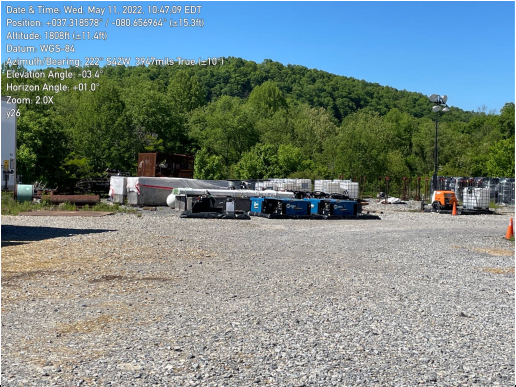
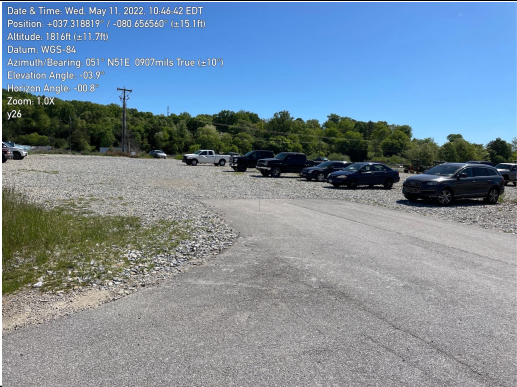
<b>GPS Location</b>	See photo	<b>GPS Location</b>	See photo		
<b>Field Station#</b>	12005+00	<b>Field Station#</b>	12005+00		
<b>Pic 15 Desc.</b>	Secondary containment in place y26	<b>Pic 16 Desc.</b>	Secondary containment in place y26		
<p>Date &amp; Time: Wed, May 11, 2022, 10:48:42 EDT  Position: +037 318819 / -080 656560 (±15 1ft)  Altitude: 1816ft (±11.7ft)  Datum: WGS-84  Azimuth Bearing: 051° N51E 0907mils True (±10°)  Elevation Angle: +02.9°  Horizon Angle: +00.9°  Zoom: 1.0X  y26</p>

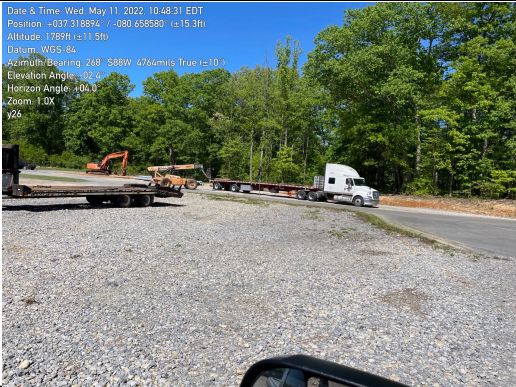
<b>GPS Location</b>	See photo	<b>GPS Location</b>	See photo		
<b>Field Station#</b>	12005+00	<b>Field Station#</b>	12005+00		
<b>Pic 17 Desc.</b>	RCE functional y26	<b>Pic 18 Desc.</b>	Construction of a parking lot started.

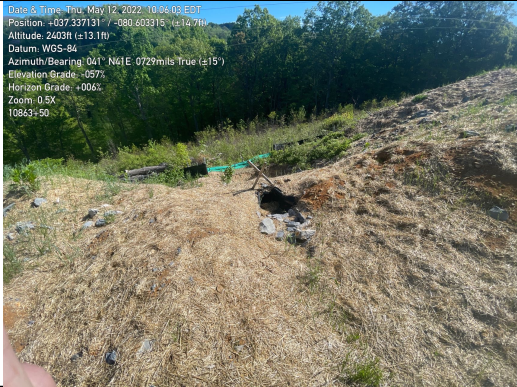
<b>GPS Location</b>	See Photo	<b>GPS Location</b>	See Photo		
<b>Field Station#</b>	10871+00	<b>Field Station#</b>	10863+50		
<b>Pic 11 Desc.</b>	TLS, Slope drain pipe, and sump pit conditions.	<b>Pic 12 Desc.</b>	Stone inlet protection condition.

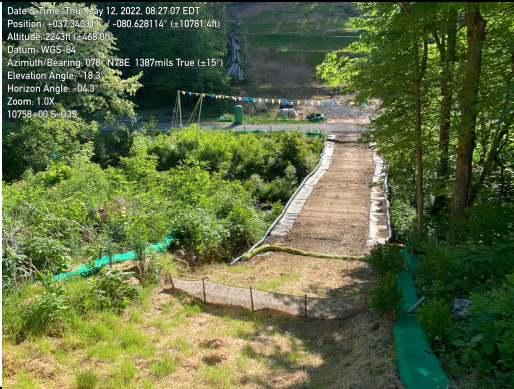
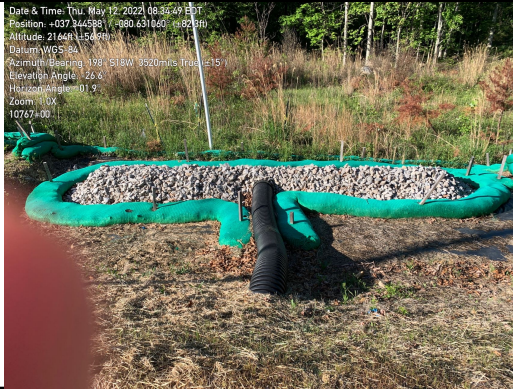
<b>GPS Location</b>	See photo.	<b>GPS Location</b>	See photo.		
<b>Field Station#</b>	10758+00	<b>Field Station#</b>	10767+00		
<b>Pic 3 Desc.</b>	Sensitive resource buffer in place at stream S-G35.	<b>Pic 4 Desc.</b>	Level spreader and clean water diversion pipe in place.		
<p>Date &amp; Time: Thu, May 12, 2022, 08:39:18 EDT  Position: +037.345924, -080.618689 (+15985.0ft)  Altitude: 1905ft (+18.3ft)  Datum: WGS-84  Azimuth/Bearing: 085° N85E 1511mils True (+15°)  Elevation Angle: -16.5°  Horizon Angle: -01.9°  Zoom: 1.0X  10792+00</p>

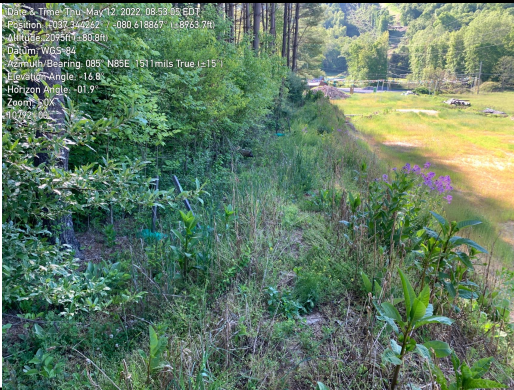
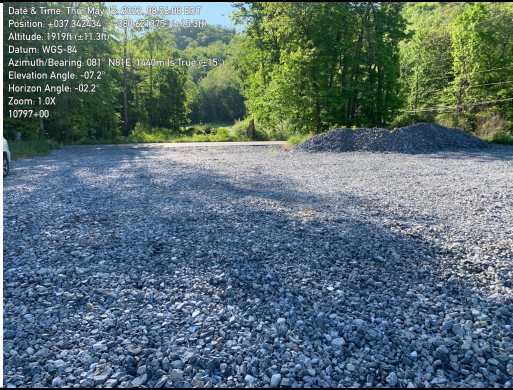
<b>GPS Location</b>	See photo.	<b>GPS Location</b>	See photo.		
<b>Field Station#</b>	10792+00	<b>Field Station#</b>	10797+00		
<b>Pic 5 Desc.</b>	Clean water diversion berm in place.	<b>Pic 6 Desc.</b>	RCE in place at Cascade Road.

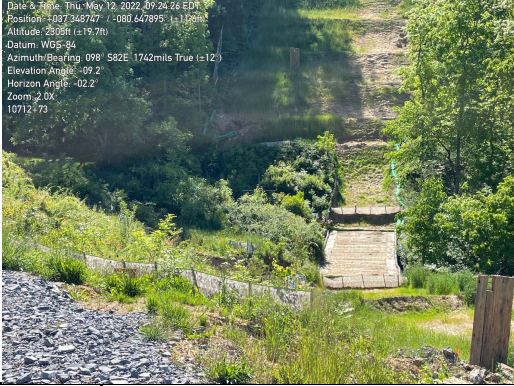
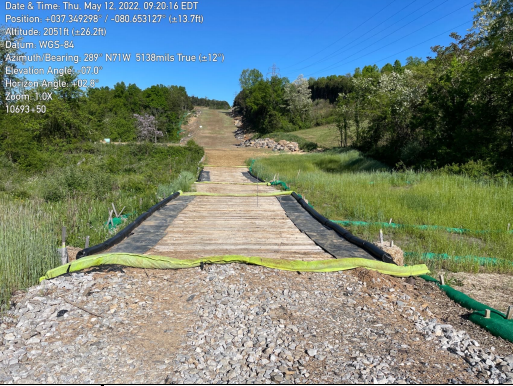
<p>Date &amp; Time: Thu, May 12, 2022, 09:20:16 EDT Position: +037.345298 / -080.653127 (+13.7m) Altitude: 2051ft (+62.2m) Datum: WGS-84 Azimuth/Bearing: 289° N21W 5138mils True (+12°) Elevation Angle: -07.0° Horizon Angle: -01.0° Zoom: 3.0x 10693+50</p>			
<b>GPS Location</b>	See photo	<b>GPS Location</b>	See photo		
<b>Field Station#</b>	10712+73	<b>Field Station#</b>	10693+50		
<b>Pic 1 Desc.</b>	Equipment bridge functional	<b>Pic 2 Desc.</b>	Clean water drainage feature functional

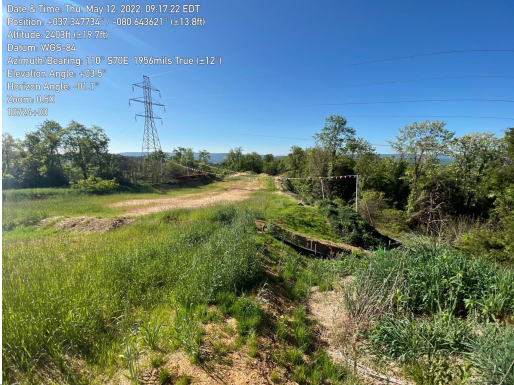
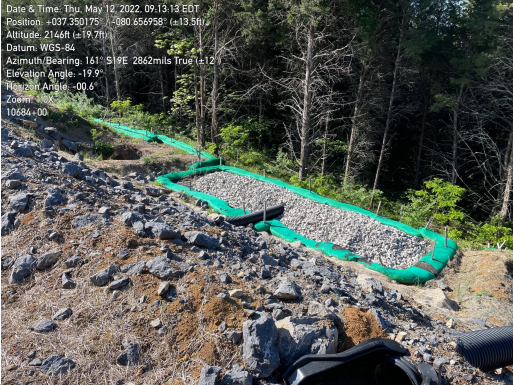
<b>GPS Location</b>	See photo	<b>GPS Location</b>	See photo		
<b>Field Station#</b>	10724+00	<b>Field Station#</b>	10684+00		
<b>Pic 3 Desc.</b>	Temporary stabilization in place	<b>Pic 4 Desc.</b>	Level spreader in place

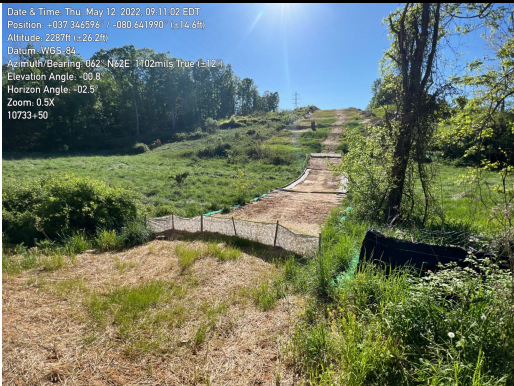
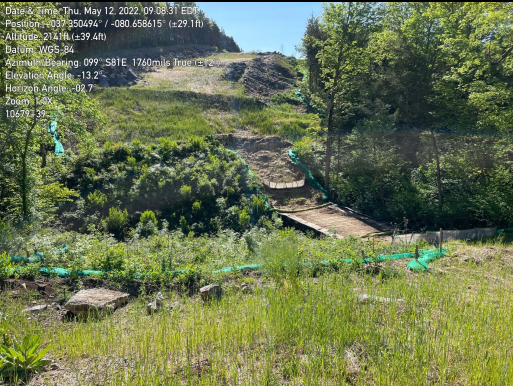
<p>Date &amp; Time: Thu, May 12, 2022, 09:08:31 EDT Position: +037.350424 / -080.658615 (+29.1m) Altitude: 2141ft (+65.4m) Datum: WGS-84 Azimuth/Bearing: 099° S81E 1760mils True (+12°) Elevation Angle: -13.2° Horizon Angle: -04.7° Zoom: 1.0x 10679+39</p>			
<b>GPS Location</b>	See photo	<b>GPS Location</b>	See photo		
<b>Field Station#</b>	10733+50	<b>Field Station#</b>	10679+39		
<b>Pic 5 Desc.</b>	Wattles and P1 in place	<b>Pic 6 Desc.</b>	Resource buffers in place

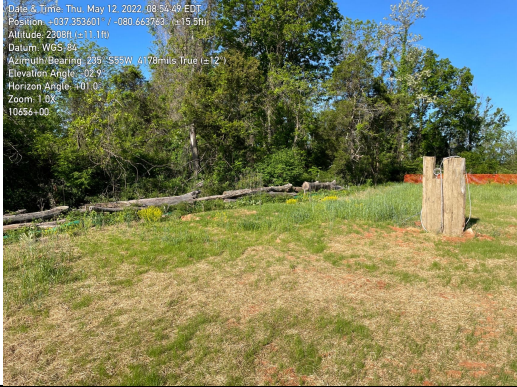
<b>GPS Location</b>	See photo	<b>GPS Location</b>	See photo		
<b>Field Station#</b>	10748+00	<b>Field Station#</b>	10656+00		
<b>Pic 9 Desc.</b>	RCE functional	<b>Pic 10 Desc.</b>	CFS perimeter controls functional		
Insert image here		Insert image here			
<b>GPS Location</b>		<b>GPS Location</b>			
<b>Field Station#</b>		<b>Field Station#</b>			
<b>Pic 11 Desc.</b>		<b>Pic 12 Desc.</b>

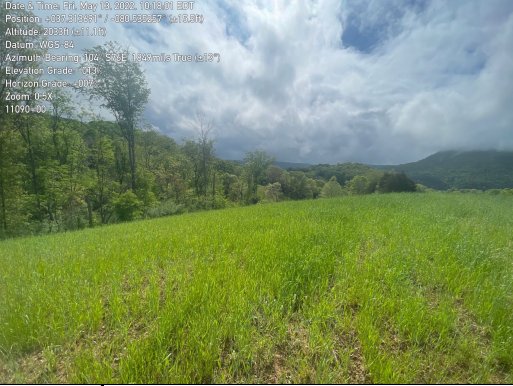
<b>GPS Location</b>	See Photo	<b>GPS Location</b>	See Photo		
<b>Field Station#</b>	11066+00	<b>Field Station#</b>	11065+84		
<b>Pic 3 Desc.</b>	Steep Slope stabilization	<b>Pic 4 Desc.</b>	Over view of steep slope stabilization and drainage feature.

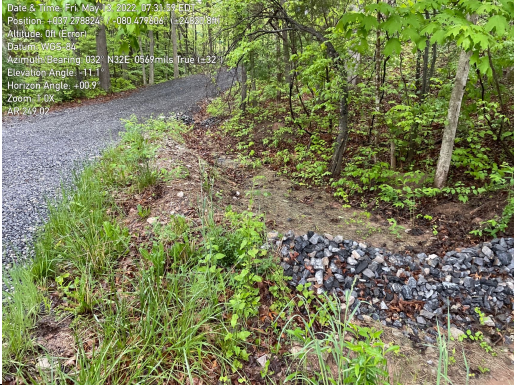
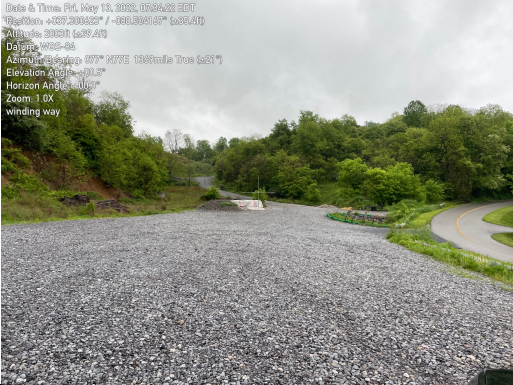
<b>GPS Location</b>	See photo	<b>GPS Location</b>	See photo		
<b>Field Station#</b>	11184+79	<b>Field Station#</b>	11227+59		
<b>Pic 1 Desc.</b>	Rock check dams in place	<b>Pic 2 Desc.</b>	RCE functional

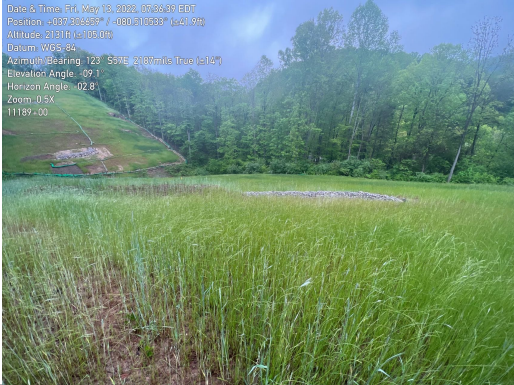
<b>GPS Location</b>	See photo	<b>GPS Location</b>	See photo		
<b>Field Station#</b>	11189+00	<b>Field Station#</b>	11191+00		
<b>Pic 3 Desc.</b>	Permanent water bars and level spreader in place	<b>Pic 4 Desc.</b>	Clean water drainage feature functional

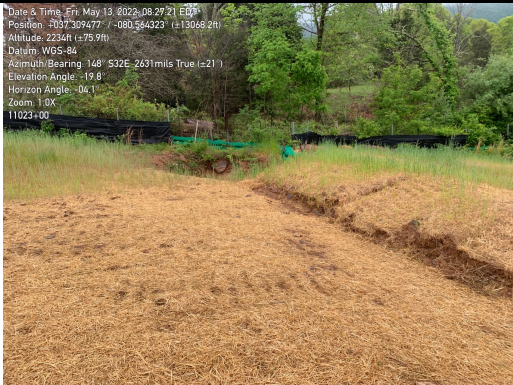
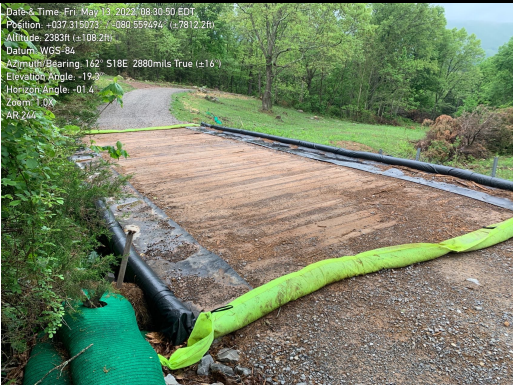
<p>Date &amp; Time: Fri, May 13, 2022, 08:00:50 EDT Position: +037331973 / +080559474 (+7812.2ft) Altitude: 2383ft (+108.2ft) Datum: WGS-84 Azimuth/Bearing: 162° S18E 2880mils True (+16°) Elevation Angle: -19.4° Horizon Angle: -01.4° Zoom: 1.0X 11023+80</p>		
GPS Location	See photo for GPS location.		GPS Location	See photo for GPS location.	
Field Station#	11023+00		Field Station#	11023+80	
Pic 1 Desc.	Waterbar, sump pit, and end treatment in place.		Pic 2 Desc.	Sensitive resource buffer in place at stream S-IJ18.

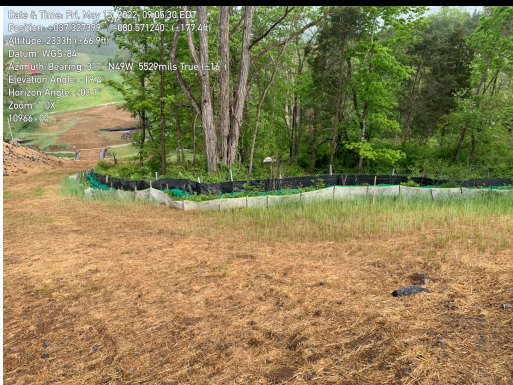
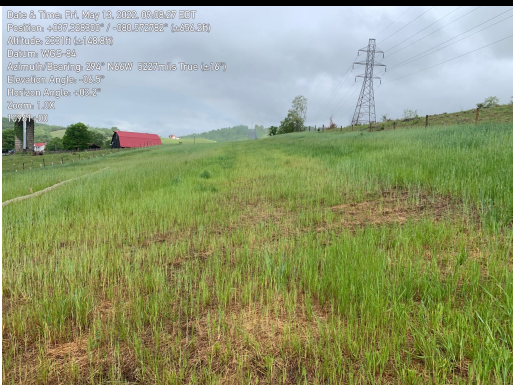
GPS Location	See photo for GPS location.		GPS Location	See photo for GPS location.	
Field Station#	10966+00		Field Station#	10961+00	
Pic 3 Desc.	Triple barrier ECDs in place at cave location.		Pic 4 Desc.	ROW permanently stabilized.

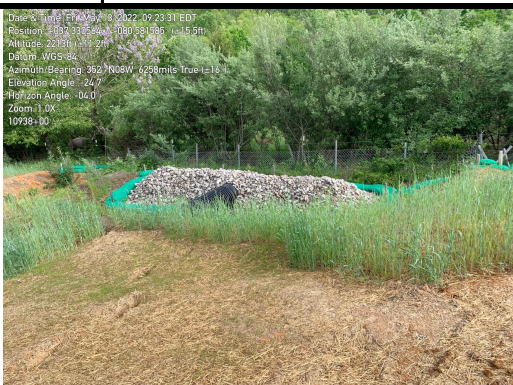
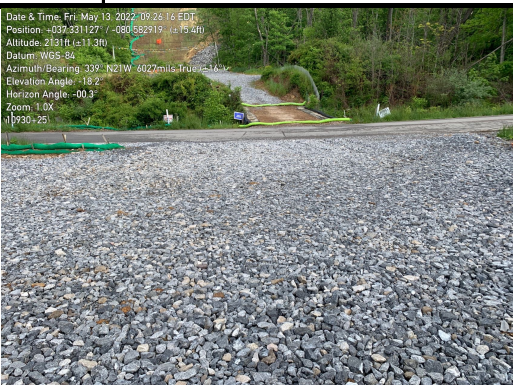
<p>Date &amp; Time: Fri, May 13, 2022, 09:26:16 EDT Position: +037331127 / +080582919 (+119.4ft) Altitude: 2131ft (+11.3ft) Datum: WGS-84 Azimuth/Bearing: 339° N21W 6027mils True (+31°) Elevation Angle: -18.2° Horizon Angle: -00.3° Zoom: 1.0X 10930+25</p>		
GPS Location	See photo for GPS location.		GPS Location	See photo for GPS location.	
Field Station#	10938+00		Field Station#	10930+25	
Pic 5 Desc.	Clean water diversion pipe and level spreader in place.		Pic 6 Desc.	RCE in place at Doe Creek Road.
