Visual Site Inspection Report

Project Name	H-600 Pipeline Spread H	AFE	124300138	Spread	H-600 Pipeline Spread H
Contractor	Precision			Report #	36684
Inspector	Bryan Cole			Date/Time	4/18/2022 2:30 PM
Permit #	TBD	Inspection Type	VA SWPP	Station Begin	13141+65
State	VA	Inspection Area	Partial	Station End	13316+21
County	Franklin	Ground	Wet	Temperature (°F)	34.00
Municipality	N/A	Weather	Snow/Sleet	Rain Gauge (in)	0.00
				Rain Accumulation Time (days)	0.00

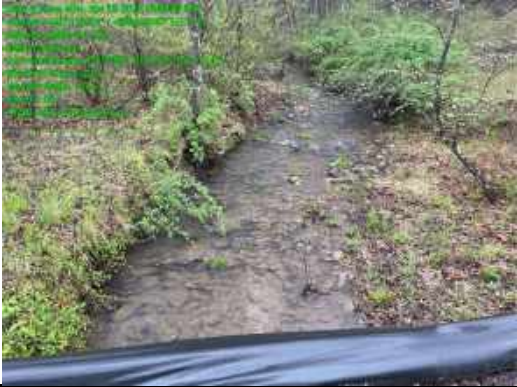
GPS Location	0	GPS Location	0		
Field Station#	13260+66	Field Station#	13260+66		
Pic 13 Desc.	MVP-S-II4 Downstream and corresponding buffer zone in good condition	Pic 14 Desc.	MVP-S-II4 Upstream and corresponding buffer zone in good condition

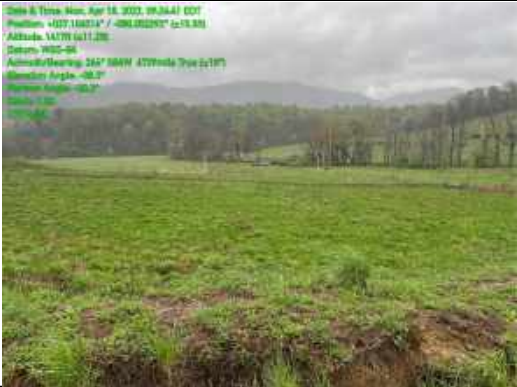
GPS Location	0	GPS Location	0		
Field Station#	13314+00	Field Station#	13316+21		
Pic 17 Desc.	ROW and ECDs In good condition and stable	Pic 18 Desc.	Wades Gap Road Crossing in good condition

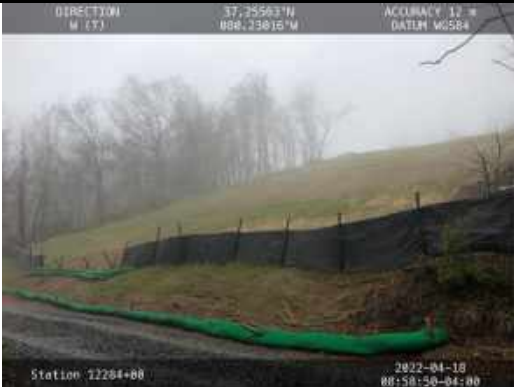
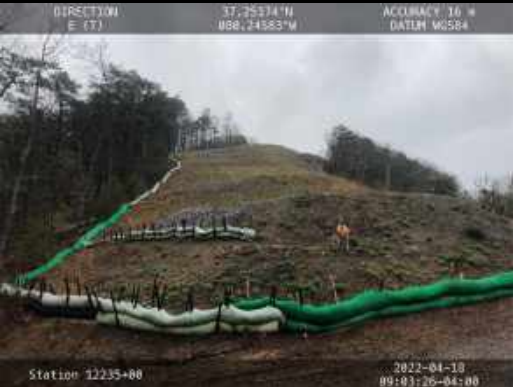
GPS Location	Please see photo for details.		GPS Location	Please see photo for details.	
Field Station#	12284+00		Field Station#	12235+00	
Pic 1 Desc.	Photo shows the stabilized ROW conditions with water bars and that all ECDs are installed and are functioning as designed.		Pic 2 Desc.	Photo shows stabilized ROW in permanent restoration area with permanent water bars installed equipped with level spreaders.

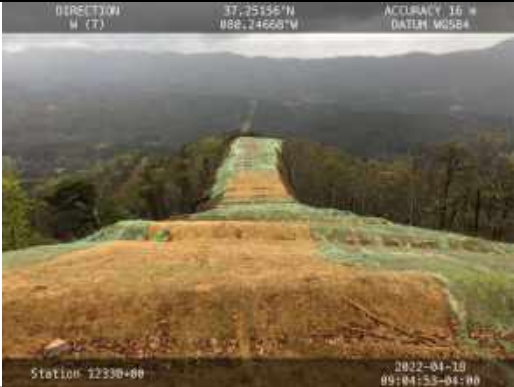
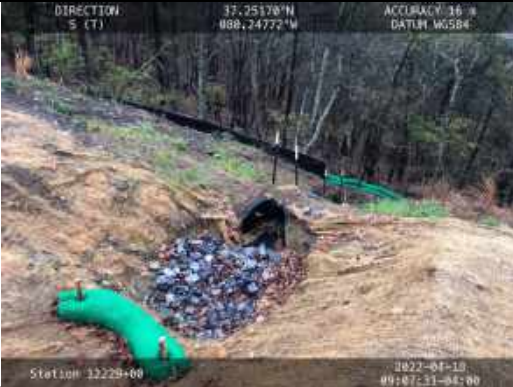
GPS Location	Please see photo for details.		GPS Location	Please see photo for details.	
Field Station#	12230+00		Field Station#	12229+00	
Pic 3 Desc.	Photo shows the stabilized ROW conditions with water bars and that all ECDs are installed and are functioning as designed.		Pic 4 Desc.	Photo shows slope drain pipe inlet with stone inlet protection.

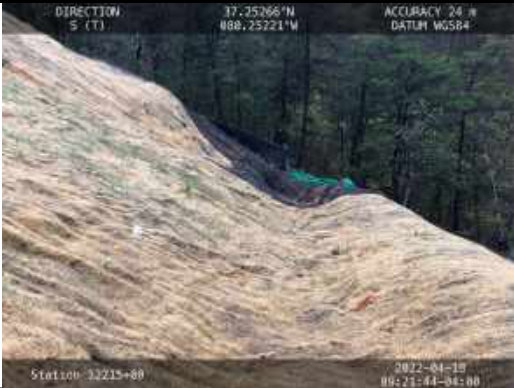
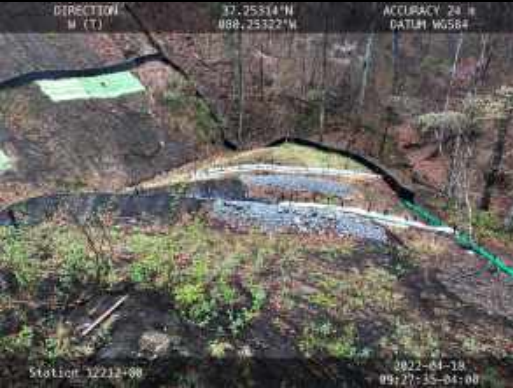
Field Station#	12215+00		Field Station#	12212+00	
Pic 5 Desc.	Photo shows stabilized ROW conditions as well as water bar, sump and water bar end treatment.		Pic 6 Desc.	Photo shows stabilized ROW in permanent restoration area with permanent water bars installed equipped with level spreaders.

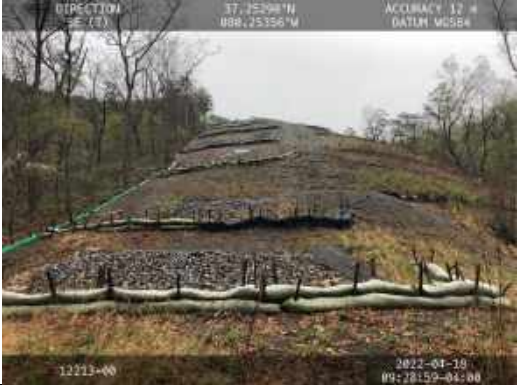
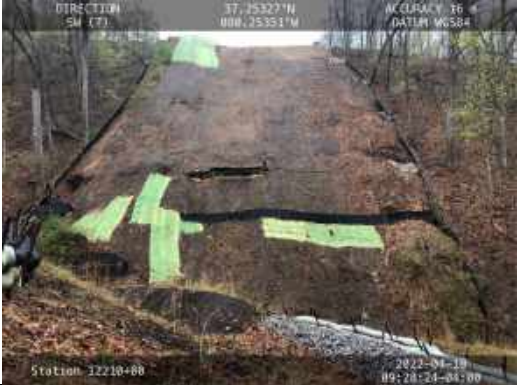
GPS Location	Please see photo for details.		GPS Location	Please see photo for details.	
Field Station#	12213+00		Field Station#	12210+00	
Pic 7 Desc.	Photo shows stabilized ROW in permanent restoration area with permanent water bars installed equipped with level spreaders.		Pic 8 Desc.	Photo shows the stabilized ROW conditions with water bars and that all ECDs are installed and are functioning as designed.

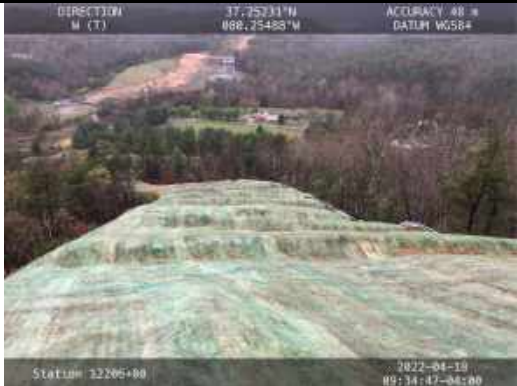
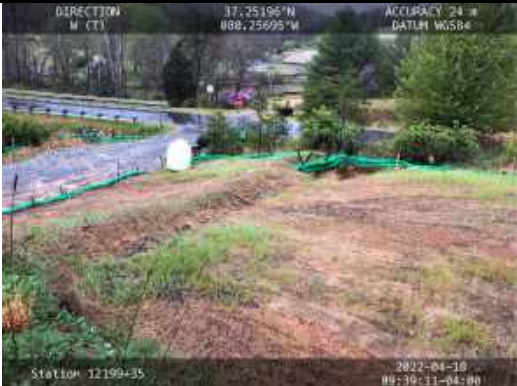
GPS Location	Please see photo for details.		GPS Location	Please see photo for details.	
Field Station#	12206+00		Field Station#	12199+35	
Pic 9 Desc.	Photo shows the stabilized ROW conditions with water bars and that all ECDs are installed and are functioning as designed.		Pic 10 Desc.	Photo shows stabilized ROW conditions as well as water bar, sump and water bar end treatment.

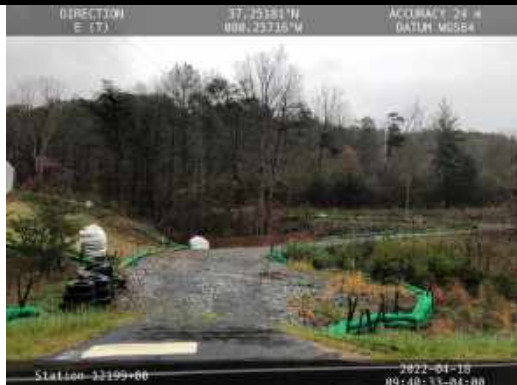
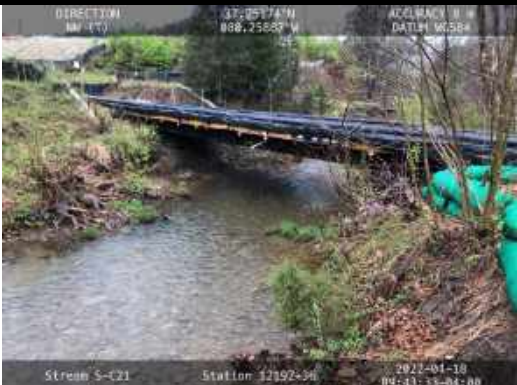
Field Station#	12199+00		Field Station#	12192+36	
Pic 11 Desc.	Photo shows RCE leading to MVP-ATWS-1375.		Pic 12 Desc.	Photo shows downstream view of Stream S-C21.

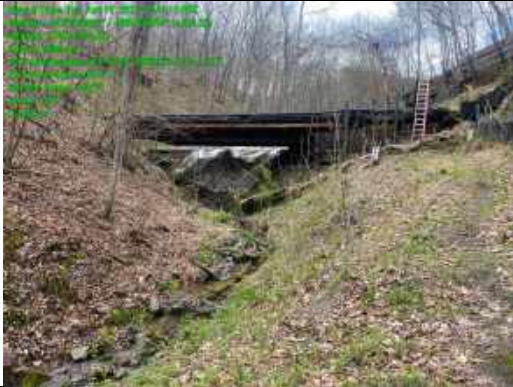
GPS Location	See photo for coordinates.		GPS Location	See photo for coordinates.	
Field Station#	12008+53		Field Station#	12031+51	
Pic 1 Desc.	S-G36, downstream, no turbidity noted in stream.		Pic 2 Desc.	S-G39, downstream side of equipment bridge, no turbidity noted in stream, no ROW impacts.

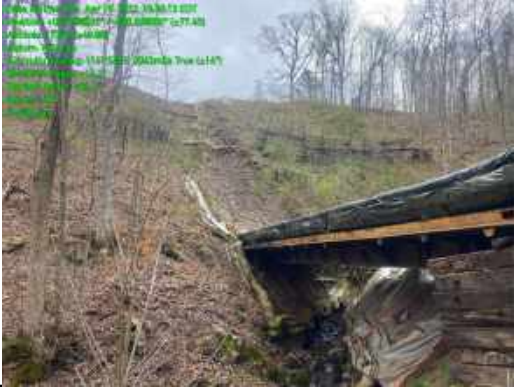
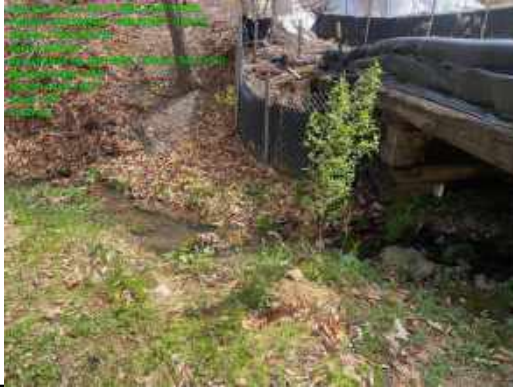
GPS Location	See photo for coordinates.		GPS Location	See photo for coordinates.	
Field Station#	12031+51		Field Station#	12035+11	
Pic 3 Desc.	Going away side of S-G39.		Pic 4 Desc.	S-G40, downstream, slight turbidity noted.

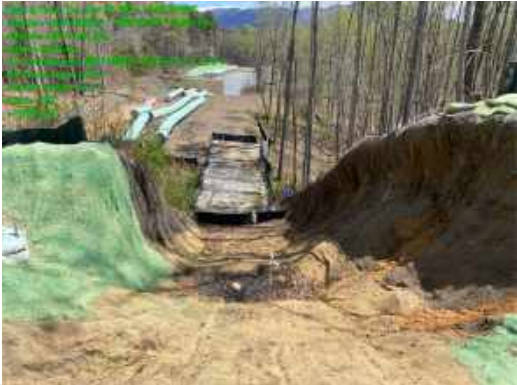
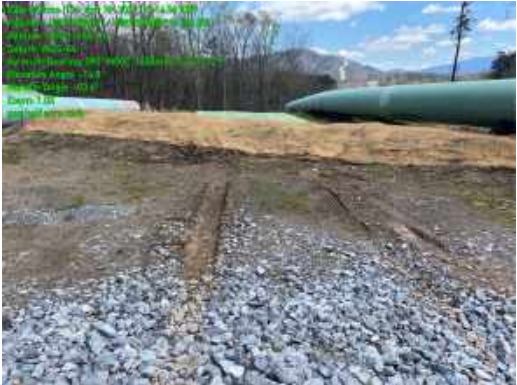
GPS Location	See photo for coordinates.		GPS Location	See photo for coordinates.	
Field Station#	12097+00		Field Station#	12104+00	
Pic 15 Desc.	S-MM13, ECDs functioning acceptably.		Pic 16 Desc.	Ruts added to Punch List.

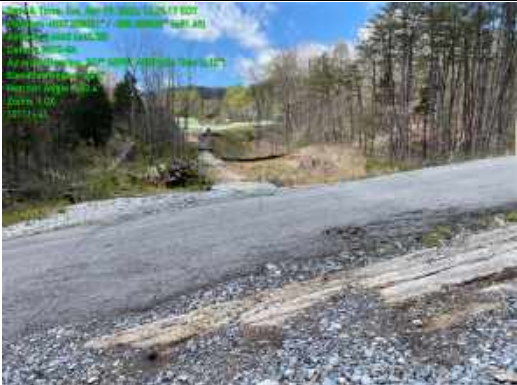
Insert image here	
GPS Location	See photo for coordinates.		GPS Location		
Field Station#	12111+41		Field Station#		
Pic 17 Desc.	MVP-MN-271, no environmental issues noted at crossing.		Pic 18 Desc.

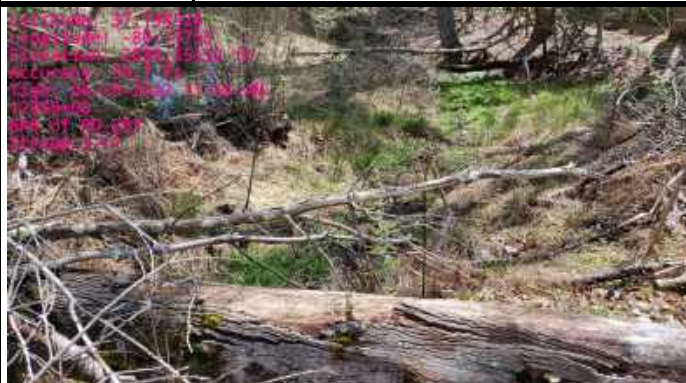
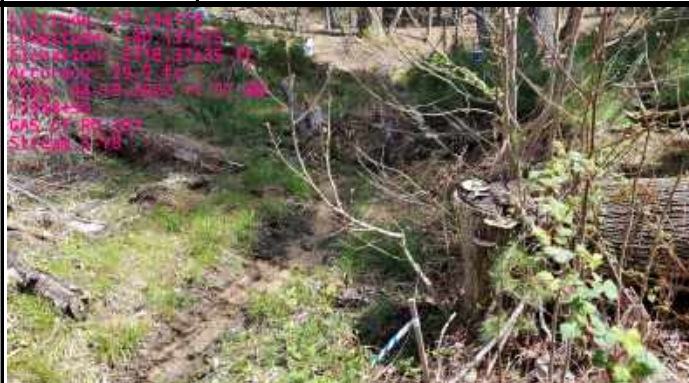
GPS Location	See pic for GPS location.		GPS Location	See pic for GPS location.	
Field Station#	12958+00		Field Station#	12958+50	
Pic 11 Desc.	Downstream side of stream S-Y7.		Pic 12 Desc.	Downstream side of stream S-Y8.

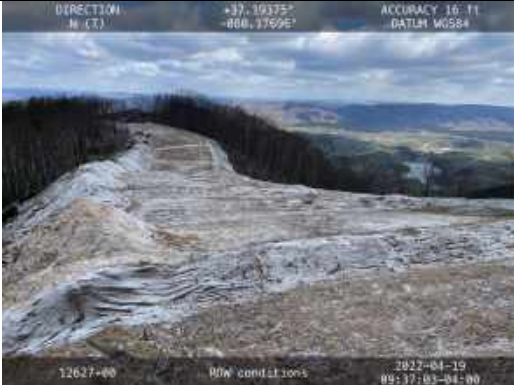
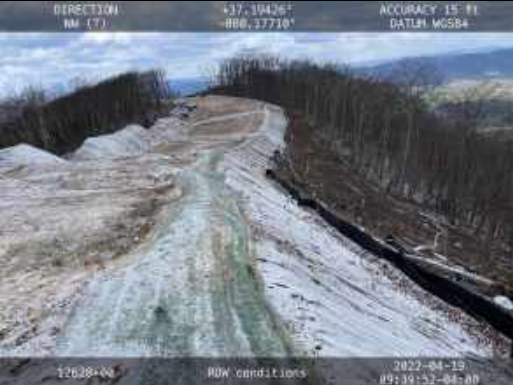
GPS Location	See photo for gps location data.		GPS Location	See photo for gps location data.	
Field Station#	12627+00		Field Station#	12628+00	
Pic 1 Desc.	Photo shows the ROW condition. ECDs are installed and functioning as designed		Pic 2 Desc.	Photo shows the ROW condition. ECDs are installed and functioning as designed

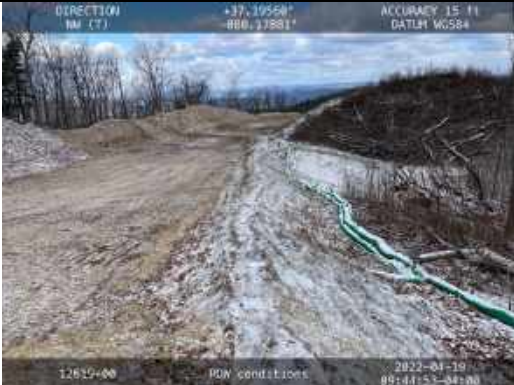
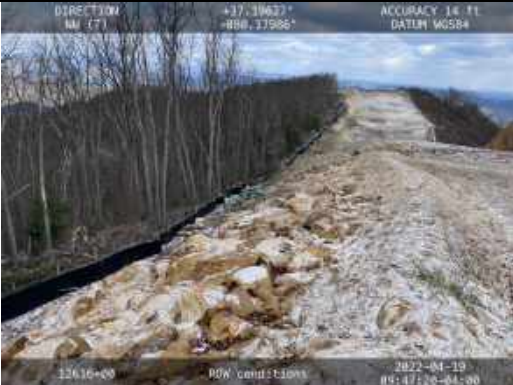
GPS Location	See photo for gps location data.		GPS Location	See photo for gps location data.	
Field Station#	12619+00		Field Station#	12616+00	
Pic 3 Desc.	Photo shows the ROW condition. ECDs are installed and functioning as designed		Pic 4 Desc.	Photo shows the ROW condition. ECDs are installed and functioning as designed

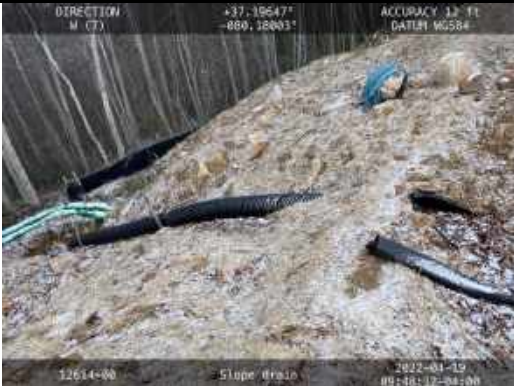
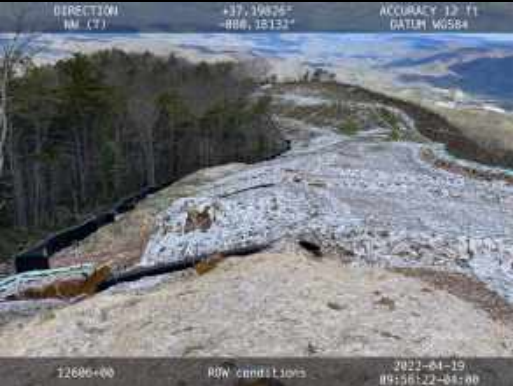
GPS Location	See photo for gps location data.		GPS Location	See photo for gps location data.	
Field Station#	12614+00		Field Station#	12606+00	
Pic 5 Desc.	Photo shows the ROW condition and slope drain. ECDs are installed and functioning as designed		Pic 6 Desc.	Photo shows the ROW condition. ECDs are installed and functioning as designed

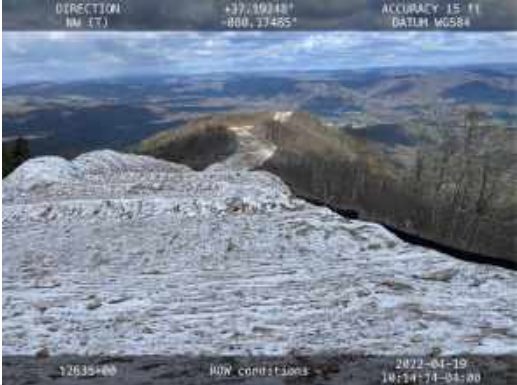
GPS Location	See photo for gps location data.		GPS Location	See photo for gps location data.	
Field Station#	12638+00		Field Station#	12635+00	
Pic 9 Desc.	Photo shows the ROW condition. ECDs are installed and functioning as designed		Pic 10 Desc.	Photo shows the ROW condition. ECDs are installed and functioning as designed

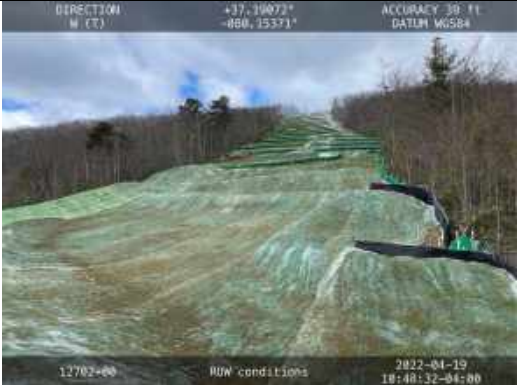
GPS Location	See photo for gps location data.		GPS Location	See photo for gps location data.	
Field Station#	12703+04		Field Station#	12702+00	
Pic 11 Desc.	Photo shows the ECDs along ATWS-1225.		Pic 12 Desc.	Photo shows the ROW condition. ECDs are installed and functioning as designed

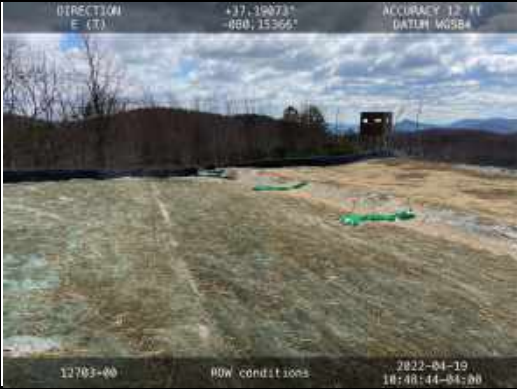
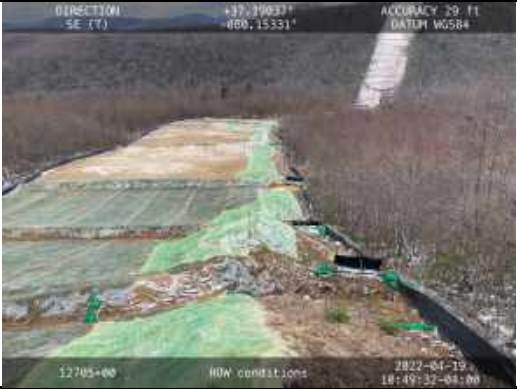
GPS Location	See photo for gps location data.		GPS Location	See photo for gps location data.	
Field Station#	12703+00		Field Station#	12705+00	
Pic 13 Desc.	Photo shows the ROW condition. ECDs are installed and functioning as designed		Pic 14 Desc.	Photo shows the ROW condition. ECDs are installed and functioning as designed

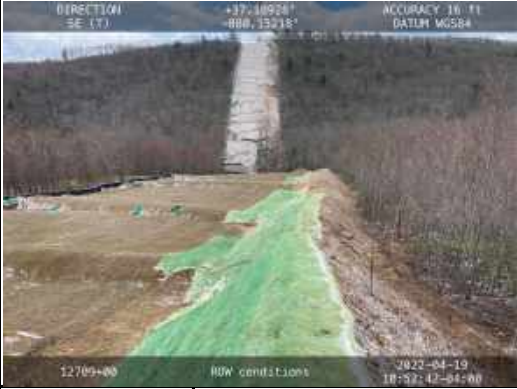
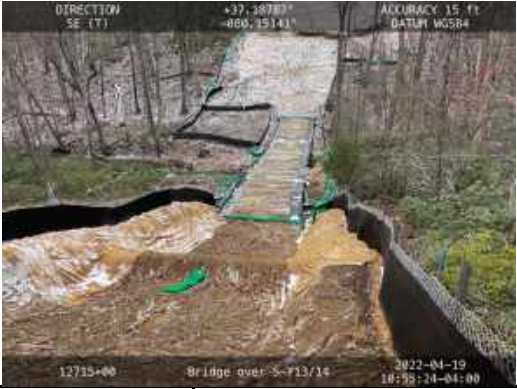
GPS Location	See photo for gps location data.		GPS Location	See photo for gps location data.	
Field Station#	12709+00		Field Station#	12715+00	
Pic 15 Desc.	Photo shows the ROW condition. ECDs are installed and functioning as designed		Pic 16 Desc.	Photo shows the ROW condition. ECDs are installed and functioning as designed

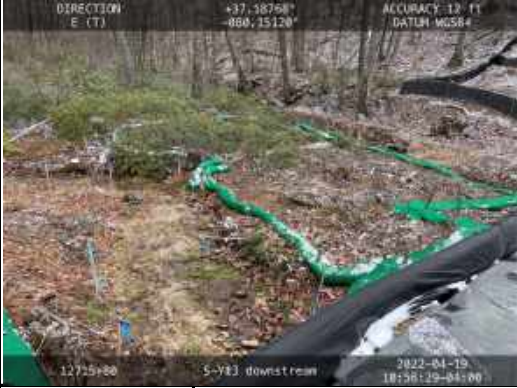
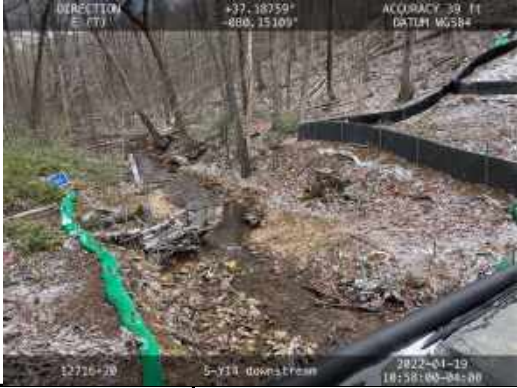
GPS Location	See photo for gps location data.		GPS Location	See photo for gps location data.	
Field Station#	12715+80		Field Station#	12716+20	
Pic 17 Desc.	Photo shows S-Y13 downstream from the bridge.		Pic 18 Desc.	Photo shows S-Y14 downstream from the bridge.

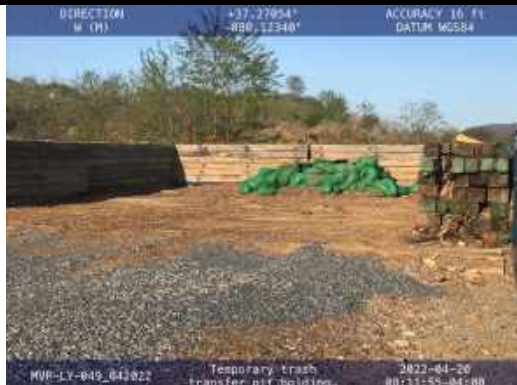
GPS Location	MVP-LY-049 See photo for gps data	GPS Location	MVP-LY-049 See photo for gps data		
Field Station#	+0	Field Station#	+0		
Pic 11 Desc.	Temporary trash transfer pit holding debris. Looking W.		Pic 12 Desc.	Trays and containment under toilets. Trays holding fluids. Looking N.

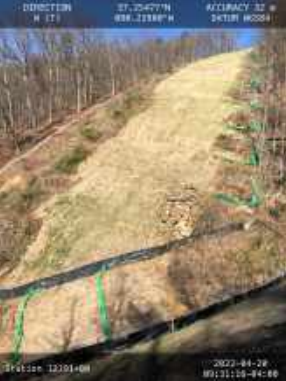
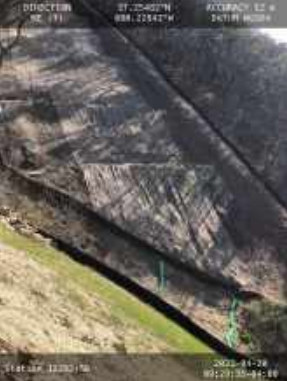
GPS Location	Please see photo for details.		GPS Location	Please see photo for details.	
Field Station#	12291+00		Field Station#	12292+50	
Pic 1 Desc.	Photo shows the stabilized ROW conditions with water bars and that all ECDs are installed and are functioning as designed.		Pic 2 Desc.	Photo shows the stabilized ROW conditions with water bars and that all ECDs are installed and are functioning as designed.

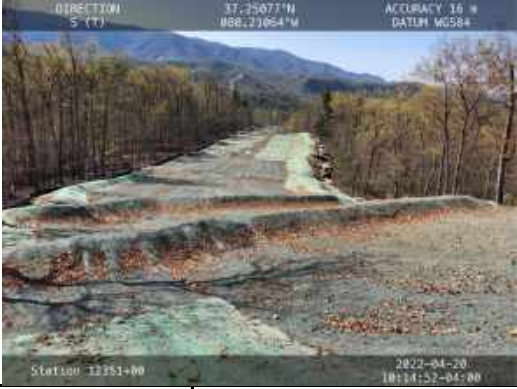
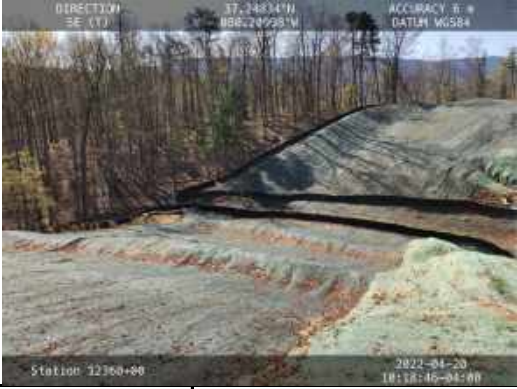
GPS Location	Please see photo for details.		GPS Location	Please see photo for details.	
Field Station#	12351+00		Field Station#	12360+00	
Pic 7 Desc.	Photo shows the stabilized ROW conditions with water bars and that all ECDs are installed and are functioning as designed.		Pic 8 Desc.	Photo shows the stabilized ROW conditions with water bars and that all ECDs are installed and are functioning as designed.

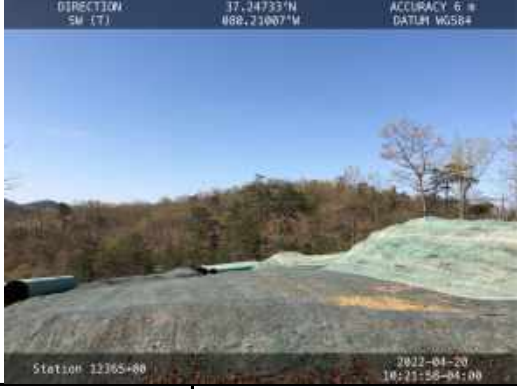
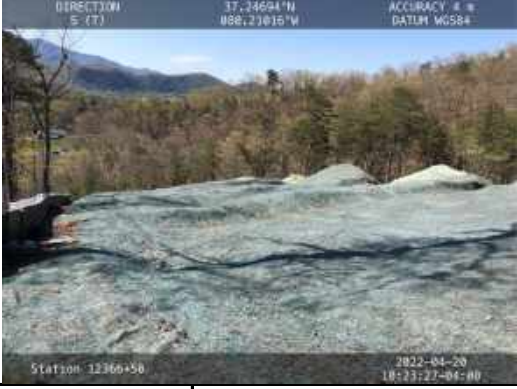
GPS Location	Please see photo for details.		GPS Location	Please see photo for details.	
Field Station#	12365+00		Field Station#	12366+50	
Pic 9 Desc.	Photo shows the stabilized ROW conditions with water bars and that all ECDs are installed and are functioning as designed.		Pic 10 Desc.	Photo shows the stabilized ROW conditions with water bars and that all ECDs are installed and are functioning as designed.

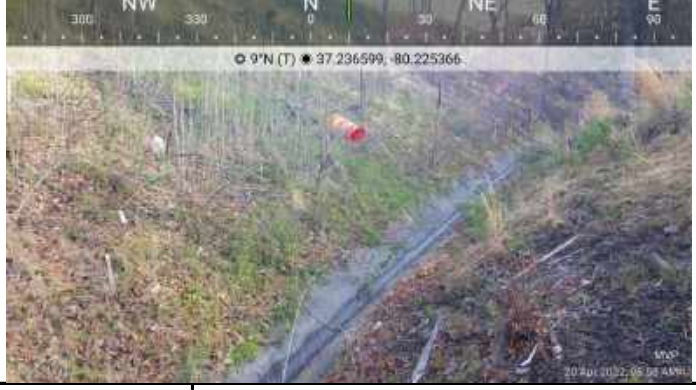
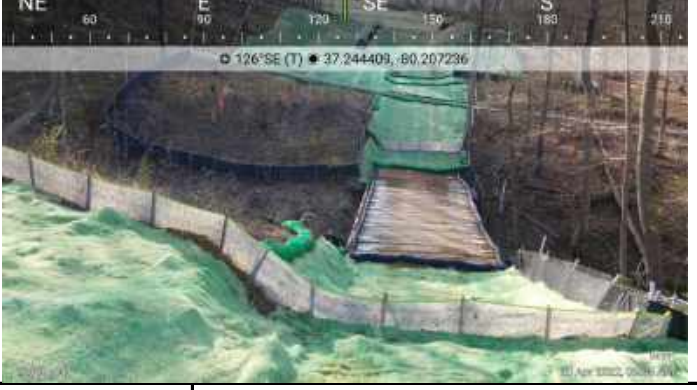
GPS Location	Please see photo for details.		GPS Location	Please see photo for details.	
Field Station#	12374+16		Field Station#	12380+04	
Pic 11 Desc.	Photo shows downstream view of Stream S-0016.		Pic 12 Desc.	Photo shows over view of Stream S-NN19 and its buffer zone from the coming in side.

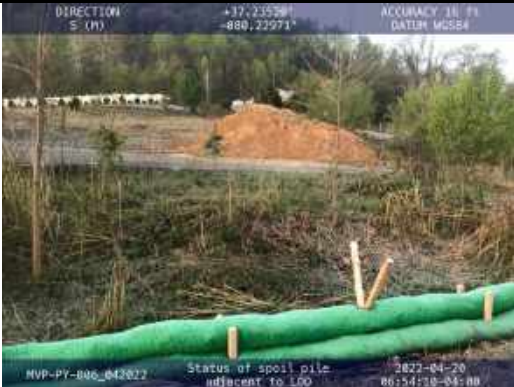
GPS Location	MVP-PY-006 See photo for gps data	GPS Location	MVP-PY-006 See photo for gps data		
Field Station#	+0	Field Station#	+0		
Pic 1 Desc.	Status of spoil pile adjacent to LOD on VDOT property. Soil pile not stabilized. Looking S.	Pic 2 Desc.	Condition of triple stack compost filter sock along west LOD. Looking N.

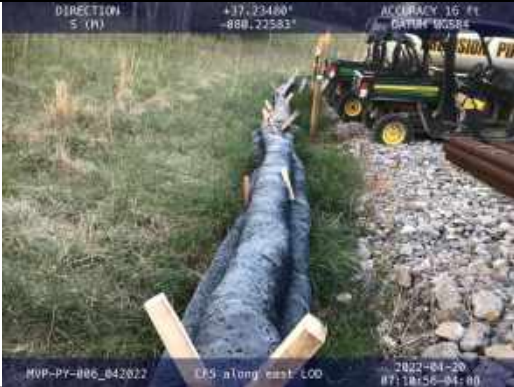
GPS Location	MVP-PY-006 See photo for gps data	GPS Location	MVP-PY-006 See photo for gps data		
Field Station#	+0	Field Station#	+0		
Pic 3 Desc.	Condition of triple stack compost filter sock along east LOD. s.	Pic 4 Desc.	Condition of triple stack compost filter sock and signage at feature W-008. Looking E.

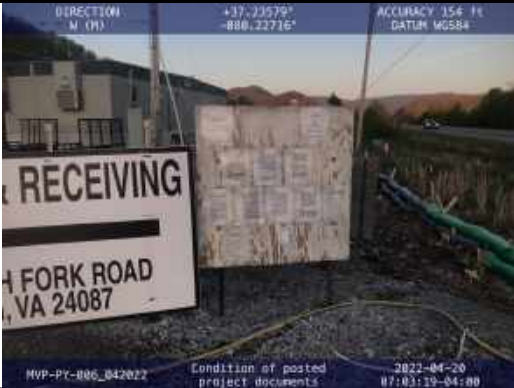
GPS Location	MVP-PY-006 See photo for gps data	GPS Location	MVP-PY-006 See photo for gps data		
Field Station#	+0	Field Station#	+0		
Pic 5 Desc.	Condition of posted project documents at main entrance. Looking W.	Pic 6 Desc.	North rock entrance no stone on public roadway. Looking E.

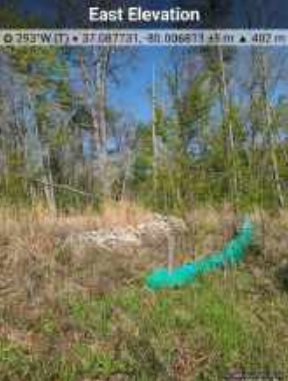
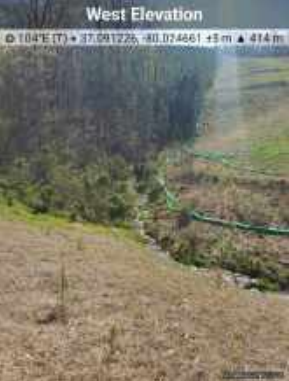
GPS Location	0000	GPS Location	0000		
Field Station#	13490+00	Field Station#	13425+01		
Pic 1 Desc.	Monitored ECDs and level spreaders during routine inspection. No issues observed at the time of inspection.		Pic 2 Desc.	Stream observation photo facing upstream, ECDs in place , no environmental issues observed at the time of inspection.	
	North West Elevation

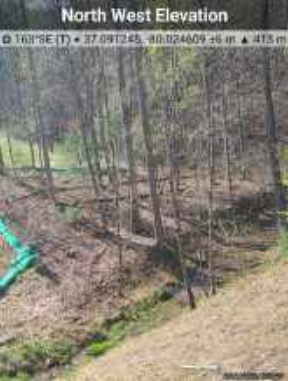
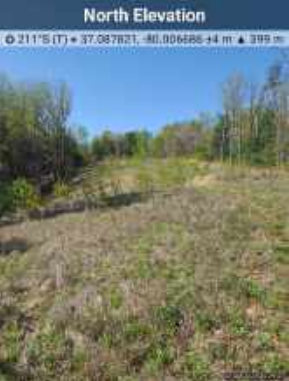
GPS Location	0000	GPS Location	00000		
Field Station#	13425+01	Field Station#	13489+20		
Pic 3 Desc.	Stream observation photo facing downstream during routine inspection today, no environmental issues observed at the time of inspection.		Pic 4 Desc.	Row photo showing vegetation , during routine inspection there were locust trees observed growing inside the LOD, no environmental issues were observed at the time of inspection.

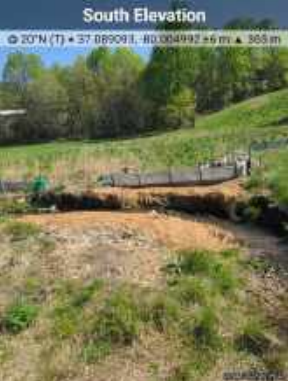
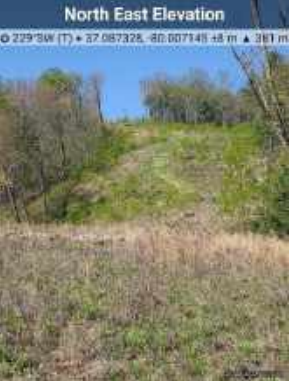
GPS Location	0000	GPS Location	0000		
Field Station#	13498+00	Field Station#	13481+00		
Pic 5 Desc.	Observed completed punch list item, the contractor installed new erosion control blanket on banks of stream.		Pic 6 Desc.	Row photo showing ECDs in travel lane, EI monitored water bars and lever spreaders during routine inspection today.

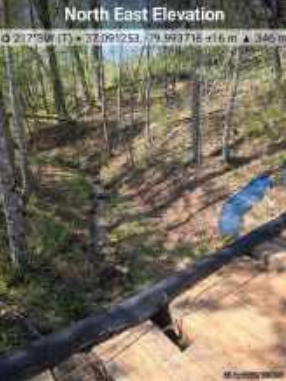
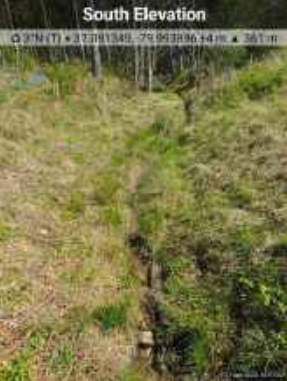
GPS Location	00000	GPS Location	00000		
Field Station#	13533+52	Field Station#	13533+52		
Pic 1 Desc.	Stream observation photo facing downstream during routine inspection today.		Pic 2 Desc.	Stream observation photo facing upstream during routine inspection today, no issues were observed at the time of inspection.

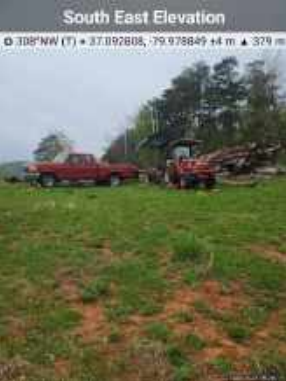
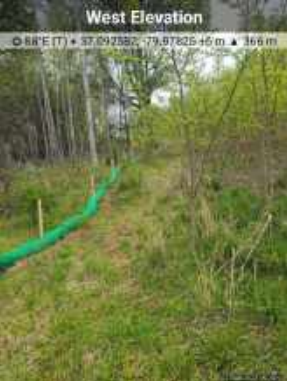
GPS Location	00000	GPS Location	00000		
Field Station#	13577+70	Field Station#	13580+00		
Pic 3 Desc.	Photo showing area where a land owner has set up a wood splitting operation on row.		Pic 4 Desc.	Monitored ECDs along the LOD during routine inspection today. No environmental issues observed at the time of inspection.

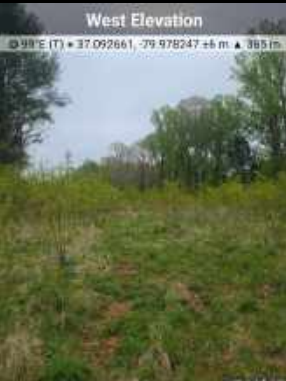
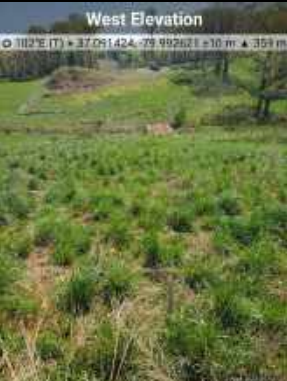
GPS Location	00000	GPS Location	00000		
Field Station#	13580+50	Field Station#	13538+00		
Pic 5 Desc.	Vegetation observation in permanent area of row with locust trees growing inside the LOD, no environmental issues observed at the time of inspection.		Pic 6 Desc.	Photo showing vegetation on both sides of stream crossing, good stabilization noted. No environmental issues observed at the time of inspection.

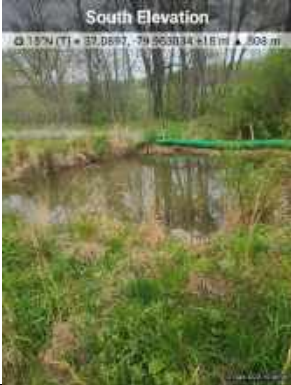
<p>Insert image here</p>		<p>Insert image here</p>	
GPS Location	00000	GPS Location			
Field Station#	13638+00	Field Station#			
Pic 7 Desc.	Monitored clean water diversion and plunge pool area. No issues were observed at the time of inspection.		Pic 8 Desc.		
<p>Insert image here</p>		<p>Insert image here</p>			
GPS Location		GPS Location			
Field Station#		Field Station#			
Pic 9 Desc.		Pic 10 Desc.			
<p>Insert image here</p>		<p>Insert image here</p>			
GPS Location		GPS Location			
Field Station#		Field Station#			
Pic 11 Desc.		Pic 12 Desc.

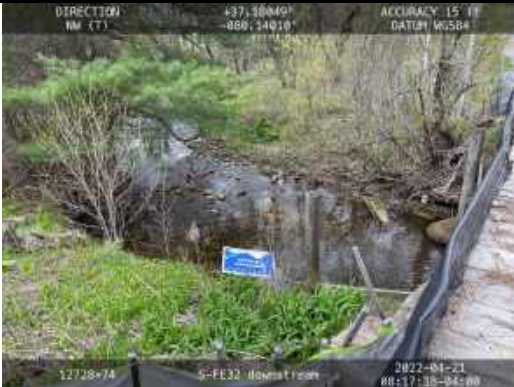
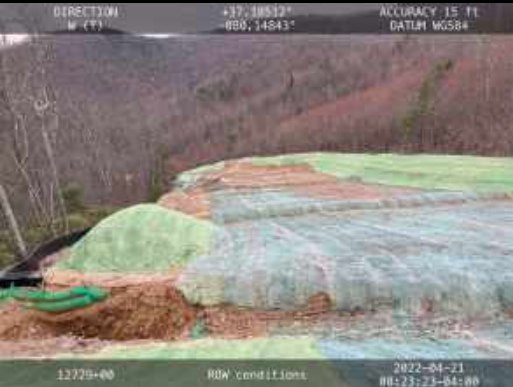
GPS Location	See photo for gps location data.		GPS Location	See photo for gps location data.	
Field Station#	12728+74		Field Station#	12729+00	
Pic 1 Desc.	Photo shows stream S-EF32 down stream from RO-280.		Pic 2 Desc.	Photo shows the ROW condition. ECDs are installed and functioning as designed.

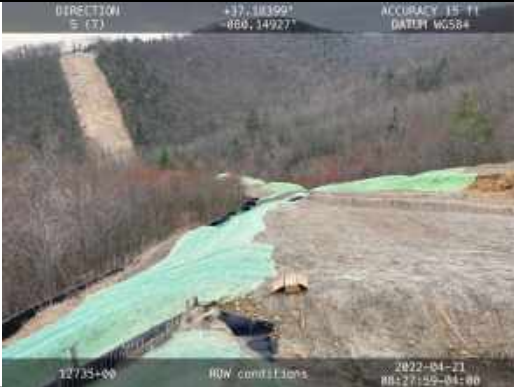
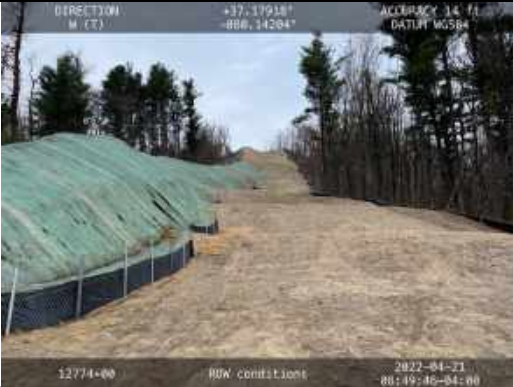
GPS Location	See photo for gps location data.		GPS Location	See photo for gps location data.	
Field Station#	12735+00		Field Station#	12774+00	
Pic 3 Desc.	Photo shows the ROW condition. ECDs are installed and functioning as designed.		Pic 4 Desc.	Photo shows the ROW condition. ECDs are installed and functioning as designed.

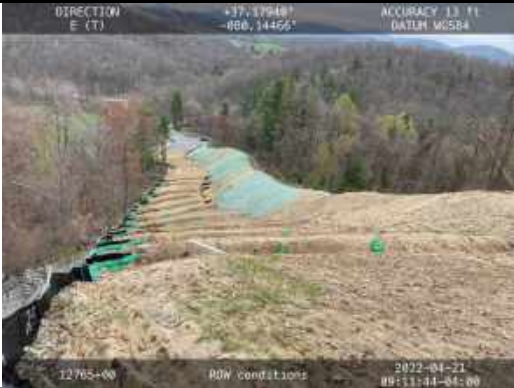
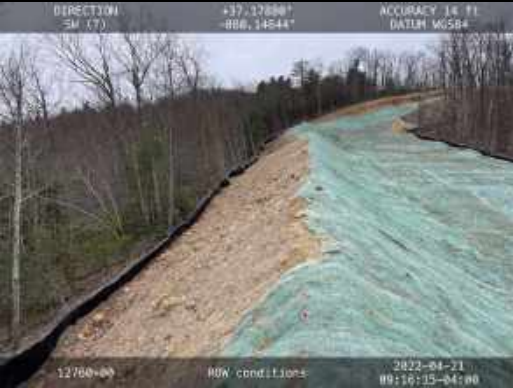
GPS Location	See photo for gps location data.		GPS Location	See photo for gps location data.	
Field Station#	12765+00		Field Station#	12760+00	
Pic 5 Desc.	Photo shows the ROW condition. ECDs are installed and functioning as designed.		Pic 6 Desc.	Photo shows the ROW condition. ECDs are installed and functioning as designed.

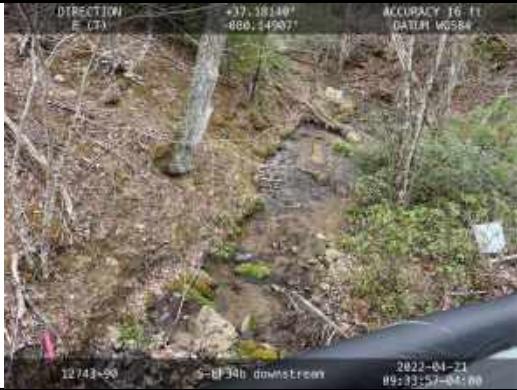
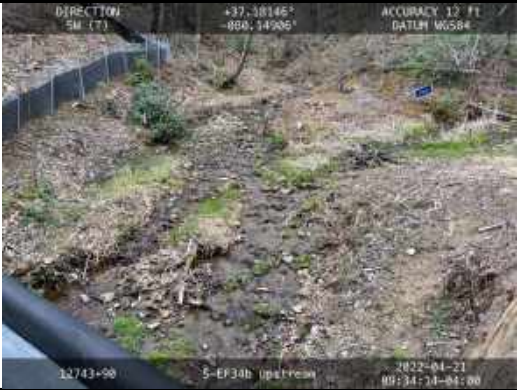
GPS Location	See photo for gps location data.		GPS Location	See photo for gps location data.	
Field Station#	12743+90		Field Station#	12743+90	
Pic 9 Desc.	Photo shows S-EF34b down stream from the bridge.		Pic 10 Desc.	Photo shows S-EF34b upstream from the bridge.

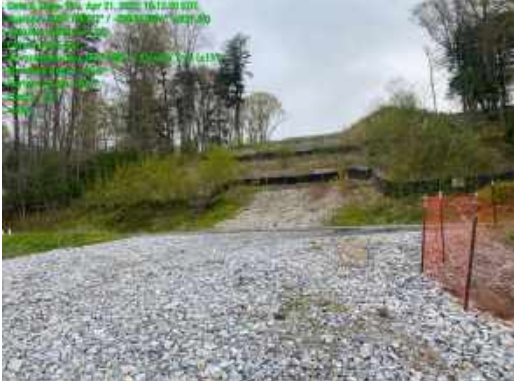
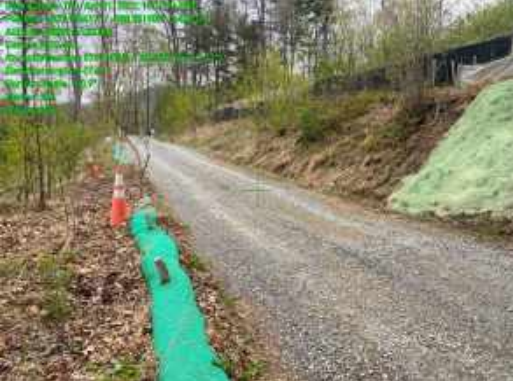
GPS Location	See photo for coordinates.		GPS Location	See photo for coordinates.	
Field Station#	13316+21		Field Station#	13317+02	
Pic 1 Desc.	Wades Gap road crossing.		Pic 2 Desc.	Private driveway on the going away side of Wades Gap.

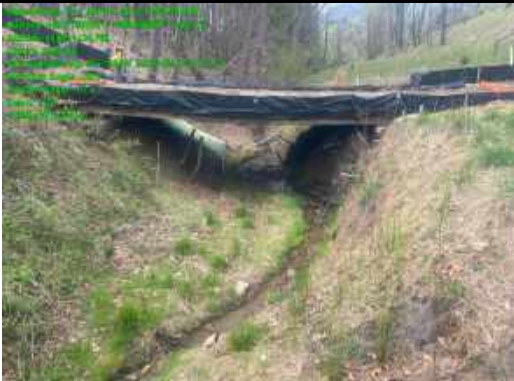
GPS Location	See photo for coordinates.		GPS Location	See photo for coordinates.	
Field Station#	13321+00		Field Station#	13321+47	
Pic 3 Desc.	S-GH15, ROW stabilized, ECDs in acceptable condition.		Pic 4 Desc.	S-GH15, ROW stabilized, ECDs in acceptable condition.

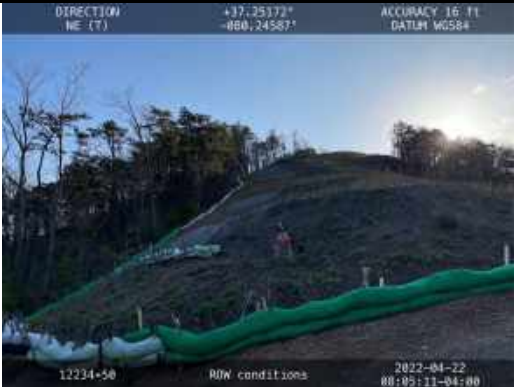
GPS Location	Please see photo for details.		GPS Location	Please see photo for details.	
Field Station#	12234+50		Field Station#	12230+00	
Pic 1 Desc.	Photo shows stabilized ROW conditions in final restoration area with permanent water bars equipped with level spreaders.		Pic 2 Desc.	Photo shows stone inlet protection and slope drain pipe.

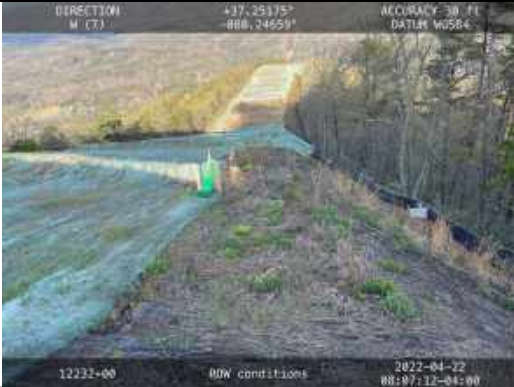
GPS Location	Please see photo for details.		GPS Location	Please see photo for details.	
Field Station#	12232+00		Field Station#	12207+00	
Pic 3 Desc.	Photo shows the stabilized ROW conditions with water bars and that all ECDs are installed and are functioning as designed.		Pic 4 Desc.	Photo shows the stabilized ROW conditions with water bars and that all ECDs are installed and are functioning as designed.

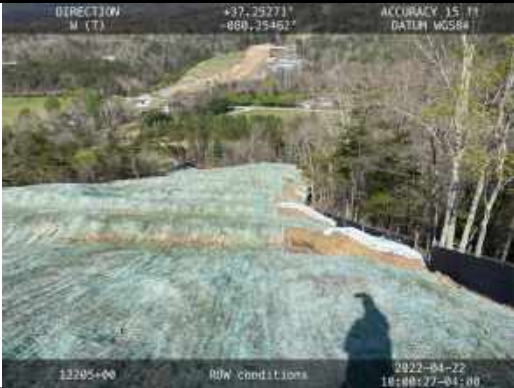
Field Station#	12205+00		Field Station#	12201+00	
Pic 5 Desc.	Photo shows the stabilized ROW conditions with water bars and that all ECDs are installed and are functioning as designed.		Pic 6 Desc.	Photo shows the stabilized ROW conditions with water bars and that all ECDs are installed and are functioning as designed.

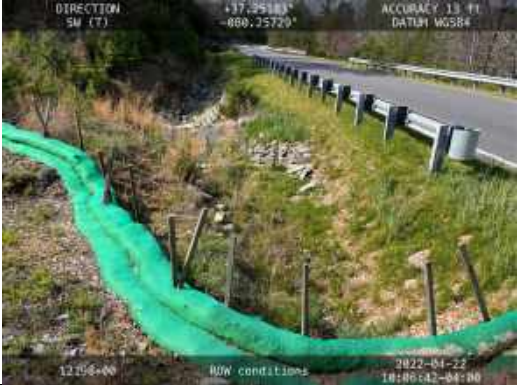
GPS Location	Please see photo for details.		GPS Location	Please see photo for details.	
Field Station#	12198+00		Field Station#	12198+64	
Pic 7 Desc.	Photo shows ECDs are installed and functioning as designed.		Pic 8 Desc.	Photo shows view of Stream S-0011.

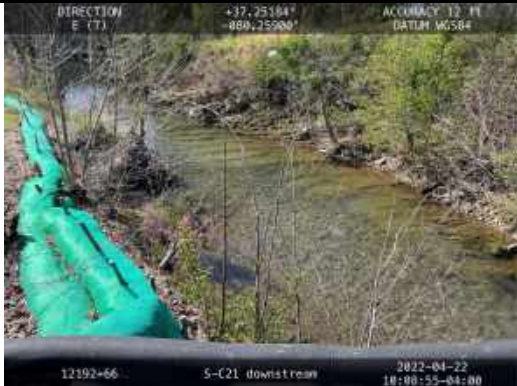
GPS Location	Please see photo for details.		GPS Location	Please see photo for details.	
Field Station#	12196+66		Field Station#	12175+00	
Pic 9 Desc.	Photo shows downstream view of Stream S-C21 from equipment bridge spanning the stream channel.		Pic 10 Desc.	Photo shows the stabilized ROW conditions with water bars and that all ECDs are installed and are functioning as designed.

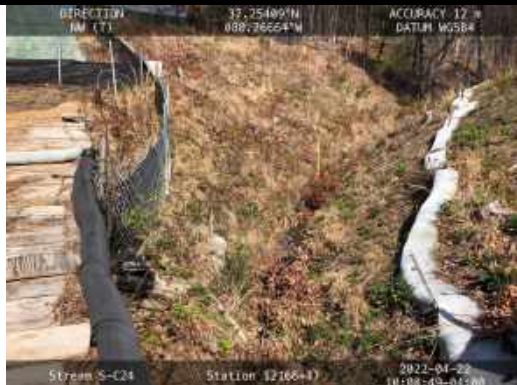
GPS Location	Please see photo for details.		GPS Location	Please see photo for details.	
Field Station#	12166+47		Field Station#	12163+05	
Pic 11 Desc.	Photo shows upstream view of Stream S-C24 from equipment bridge spanning the stream channel.		Pic 12 Desc.	Photo shows upstream overview from the coming in side of Stream S-C25 and its buffer zone.

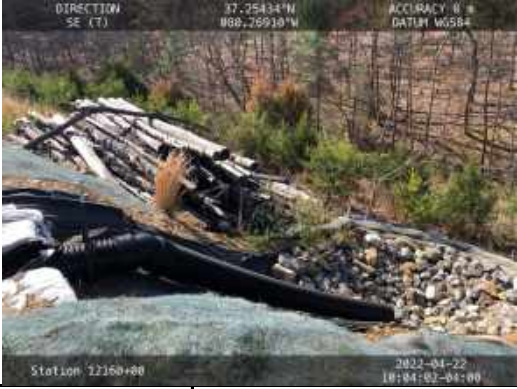
GPS Location	Please see photo for details.		GPS Location	Please see photo for details.	
Field Station#	12160+00		Field Station#	12156+00	
Pic 13 Desc.	Photo shows slope drain pipe along with plunge pool.		Pic 14 Desc.	Photo shows the stabilized ROW conditions with water bars and that all ECDs are installed and are functioning as designed.

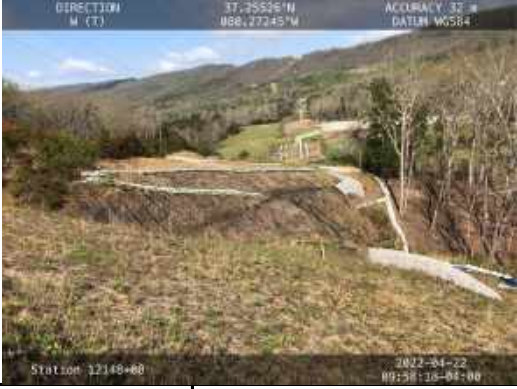
GPS Location	Please see photo for details.		GPS Location	Please see photo for details.	
Field Station#	12148+00		Field Station#	12144+25	
Pic 15 Desc.	Photo shows stabilized ROW conditions in final restoration area with permanent water bars equipped with level spreaders.		Pic 16 Desc.	Photo shows over view of Wetland W-C5.

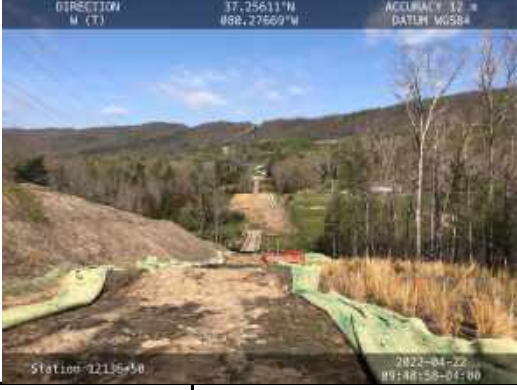
Pic 17 Desc.	Photo shows erosion control blanket separated in area where Roberts Corrosion installed anodes.		Pic 18 Desc.	Photo shows dewatering structure and its location that was needed for the task of installing anodes by Roberts Corrosion.

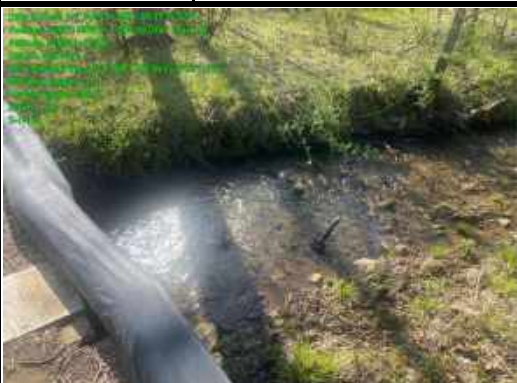
GPS Location	0		GPS Location	0	
Field Station#	13260+66		Field Station#	13260+66	
Pic 17 Desc.	MVP-S-II4 Downstream and Corresponding buffer zone in good condition		Pic 18 Desc.	MVP-S-II4 and Corresponding buffer zone in good condition
