Visual Site Inspection Report

Project Name	H-600 Pipeline Spread H	AFE	124300138	Spread	H-600 Pipeline Spread H
Contractor	Precision			Report #	37482
Inspector	Jonathan Altizer			Date/Time	5/9/2022 3:35 PM
Permit #	TBD	Inspection Type	VA SWPP	Station Begin	12725+00
State	VA	Inspection Area	Partial	Station End	12865+00
County	Roanoke	Ground	Damp	Temperature (°F)	70.00
Municipality	N/A	Weather	Sunny	Rain Gauge (in)	0.50
				Rain Accumulation Time (days)	2.00

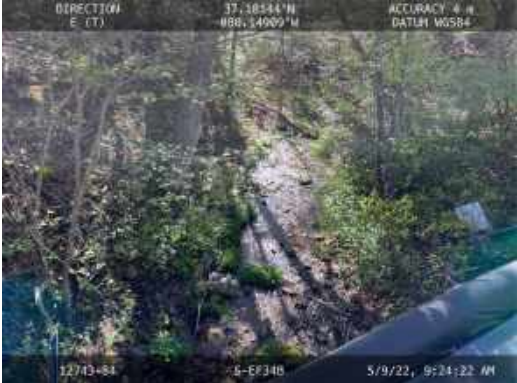
GPS Location	See photo		GPS Location	See photo	
Field Station#	12743+84		Field Station#	12744+00	
Pic 7 Desc.	Downstream of crossing at Stream S-EF34B		Pic 8 Desc.	Steep slope area is stable and ECDs are functional.

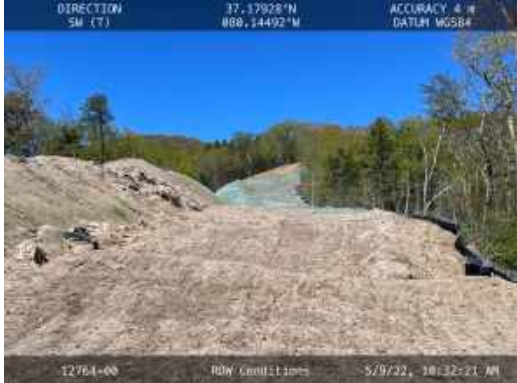
GPS Location	See photo		GPS Location	See photo	
Field Station#	12764+00		Field Station#	12767+00	
Pic 9 Desc.	Current ROW conditions. ROW is stable and ECDs are functional		Pic 10 Desc.	Current ROW conditions. ROW is stable and ECDs are functional

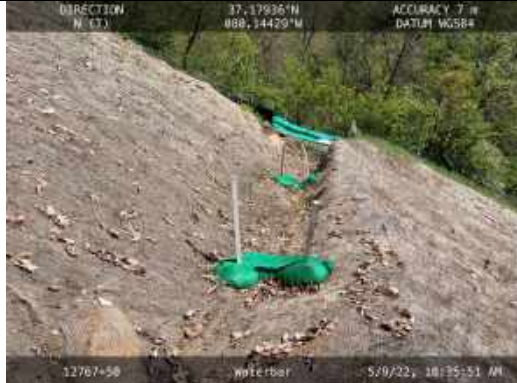
GPS Location	See photo		GPS Location	See photo	
Field Station#	12767+50		Field Station#	12768+50	
Pic 11 Desc.	Waterbar and CFS checks are functional		Pic 12 Desc.	Waterbar and CFS checks are functional

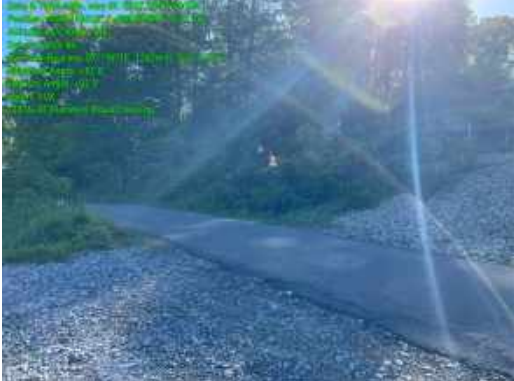
GPS Location	0	GPS Location	0		
Field Station#	13316+21	Field Station#	13317+02		
Pic 1 Desc.	Wades Gap Road Crossing in good condition	Pic 2 Desc.	Private drive in good condition, crews have begun maintenance removing shrubs and saplings along row

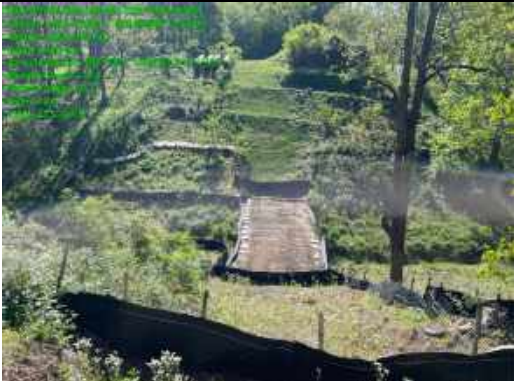
GPS Location	0	GPS Location	0		
Field Station#	13331+47	Field Station#	13325+30		
Pic 3 Desc.	MVP-S-GH15 and corresponding buffer zone In good condition	Pic 4 Desc.	MVP-S-GH14 and corresponding buffer zone In good condition

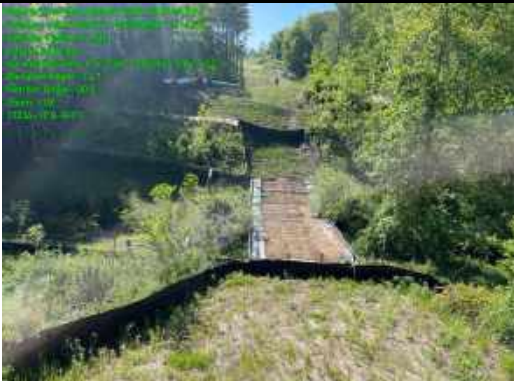
GPS Location	0	GPS Location	0		
Field Station#	13334+17	Field Station#	13337+13		
Pic 5 Desc.	MVP-S-GH11 and corresponding buffer zone In good condition	Pic 6 Desc.	MVP-S-GH9 and corresponding buffer zone In good condition

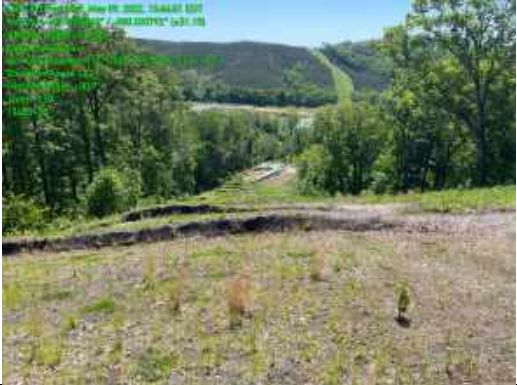
GPS Location	0	GPS Location	0		
Field Station#	13399+00	Field Station#	13403+00		
Pic 13 Desc.	ROW and ECDs In good condition and stable	Pic 14 Desc.	ROW and ECDs In good condition and stable

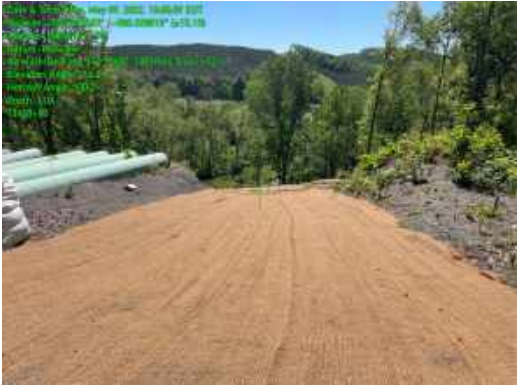
GPS Location	0	GPS Location	0		
Field Station#	13410+00	Field Station#	13413+05		
Pic 15 Desc.	ROW and ECDs In good condition and stable	Pic 16 Desc.	MVP-S-IJ1 and corresponding buffer zone In good condition

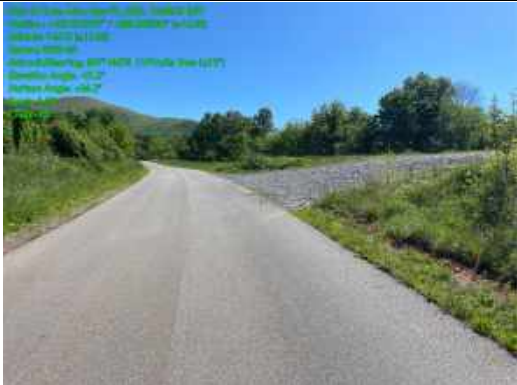
GPS Location	0	GPS Location	0		
Field Station#	13415+51	Field Station#	13422+00		
Pic 17 Desc.	Cahas Mountain Road Crossing in good condition	Pic 18 Desc.	RCE in good condition and functioning properly

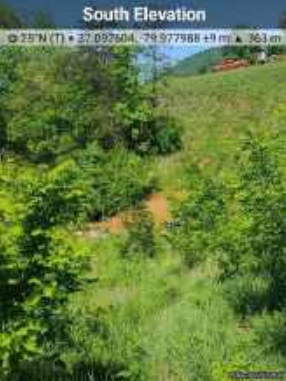
GPS Location	00000	GPS Location	0000		
Field Station#	13579+35	Field Station#	13622+50		
Pic 1 Desc.	Observed permanent area of row where locust trees are. During row inspection the EI monitored equipment bridge and stream crossing area. No environmental issues		Pic 2 Desc.	Additional row photo showing permanent area of row where the contractor will be performing work activities cutting trees from the LOD. O

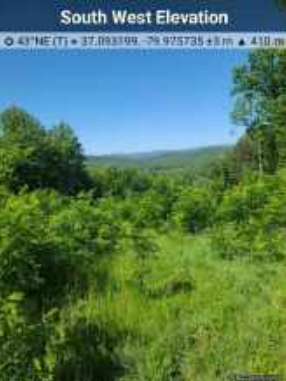
GPS Location	0000	GPS Location	0000		
Field Station#	13589+00	Field Station#	13598+00		
Pic 3 Desc.	Photo showing locust trees growing inside the row , contractor will be hand cutting as well as using a skid steer to cut down the locust trees throughout the week		Pic 4 Desc.	Observed travel lane area utilized by land owners. No environmental issues observed at the time of inspection.

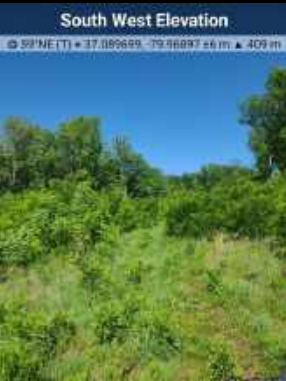
Field Station#	13610+40	Field Station#	13529+78		
Pic 5 Desc.	Photo showing locust trees growing inside the row , contractor will be hand cutting as well as using a skid steer to cut down the locust trees throughout the week		Pic 6 Desc.	Photo showing vegetation on row in a area where cattle are. No environmental issues observed at the time of inspection.

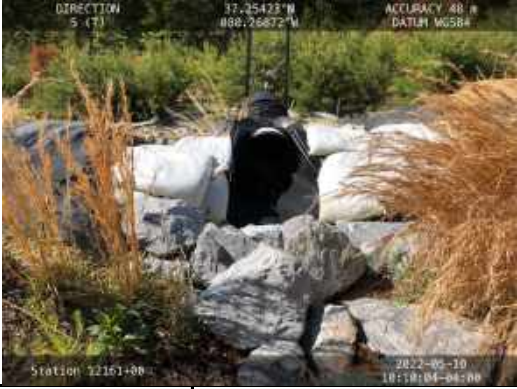
GPS Location	Please see photo for details.		GPS Location	Please see photo for details.	
Field Station#	12161+00		Field Station#	12161+00	
Pic 13 Desc.	Photo shows slope drain inlet with stone inlet protection.		Pic 14 Desc.	Photo shows slope drain pipe along with plunge pool.

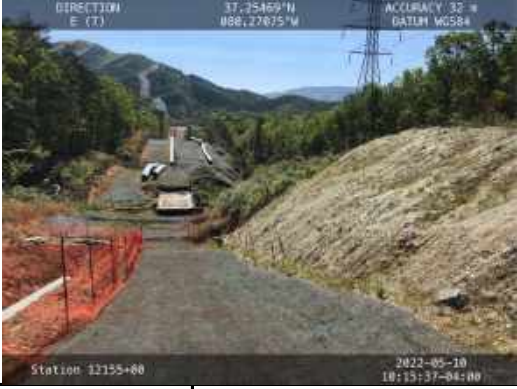
GPS Location	Please see photo for details.		GPS Location	Please see photo for details.	
Field Station#	12155+00		Field Station#	12149+00	
Pic 15 Desc.	Photo shows the stabilized ROW conditions with water bars and that all ECDs are installed and are functioning as designed.		Pic 16 Desc.	Stabilized ROW conditions in final restoration area on ROW. Permanent water bars installed equipped with level spreaders.

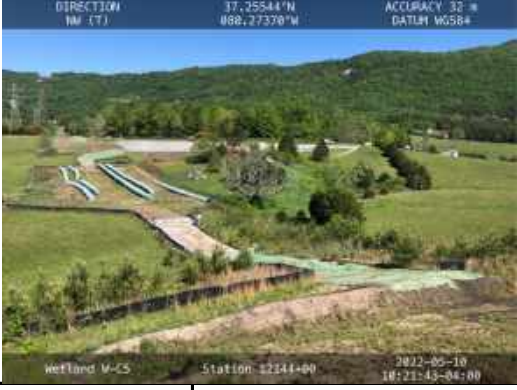
Pic 17 Desc.	Photo shows buffer for wetland W-C5 from the going away side.		Pic 18 Desc.	Photo shows over view of Streams S-C33 followed by S-C36.

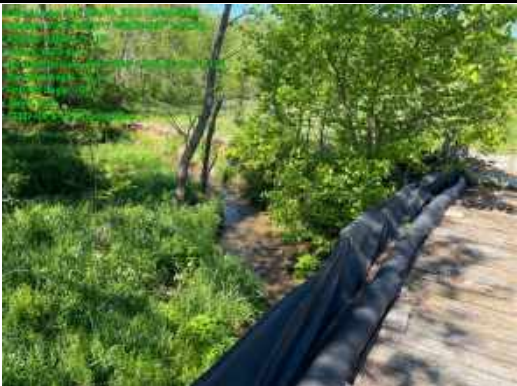
GPS Location	See photo for coordinates.		GPS Location	See photo for coordinates.	
Field Station#	13309+09		Field Station#	13308+50	
Pic 15 Desc.	S-GH7, downstream, no changes noted along stream banks.		Pic 16 Desc.	ROW stabilized.	
Insert image here			Insert image here		
GPS Location			GPS Location		
Field Station#			Field Station#		
Pic 17 Desc.			Pic 18 Desc.

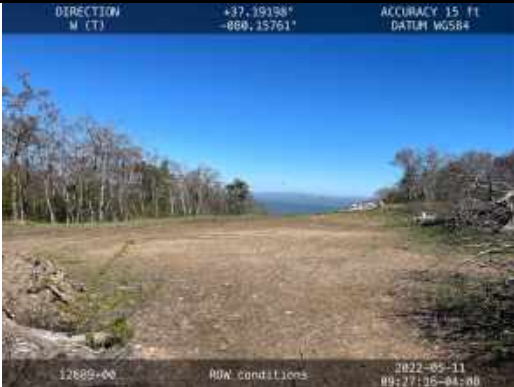
GPS Location	See photo for gps location data.		GPS Location	See photo for gps location data.	
Field Station#	12689+00		Field Station#	12691+00	
Pic 1 Desc.	Photo shows the ROW condition. ECDs are installed and functioning as designed.		Pic 2 Desc.	Photo shows the level spreader.

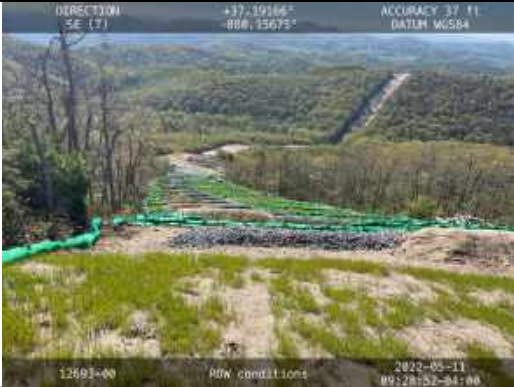
GPS Location	See photo for gps location data.		GPS Location	See photo for gps location data.	
Field Station#	12693+00		Field Station#	12638+00	
Pic 3 Desc.	Photo shows the ROW condition. ECDs are installed and functioning as designed.		Pic 4 Desc.	Photo shows the ROW condition. ECDs are installed and functioning as designed.

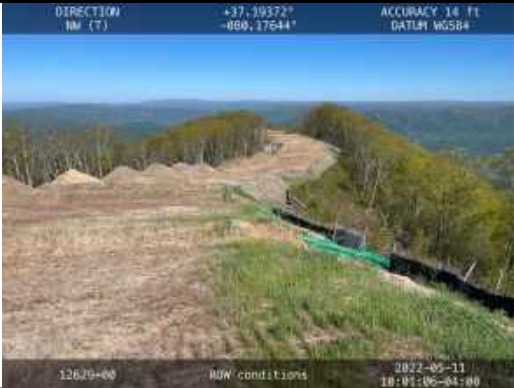
GPS Location	See photo for gps location data.		GPS Location	See photo for gps location data.	
Field Station#	12629+00		Field Station#	12625+00	
Pic 5 Desc.	Photo shows the ROW condition. ECDs are installed and functioning as designed.		Pic 6 Desc.	Photo shows the ROW condition. ECDs are installed and functioning as designed.

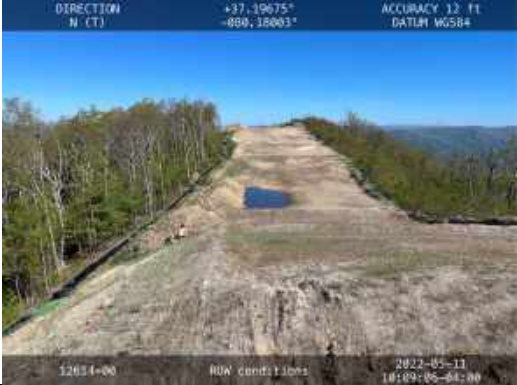
GPS Location	See photo for gps location data.		GPS Location	See photo for gps location data.	
Field Station#	12614+00		Field Station#	12615+00	
Pic 7 Desc.	Photo shows the ROW condition. ECDs are installed and functioning as designed.		Pic 8 Desc.	Photo shows the slope drain.

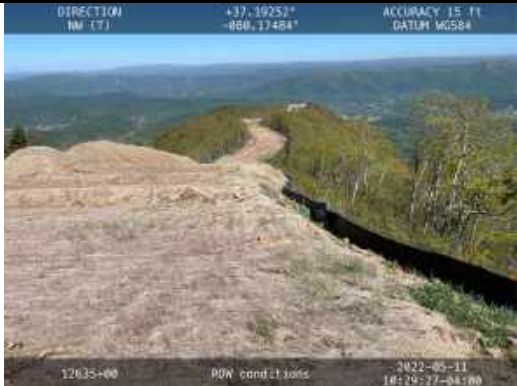
GPS Location	See photo for gps location data.		GPS Location	See photo for gps location data.	
Field Station#	12635+00		Field Station#	12702+00	
Pic 9 Desc.	Photo shows the ROW condition. ECDs are installed and functioning as designed.		Pic 10 Desc.	Photo shows the ROW condition. ECDs are installed and functioning as designed.

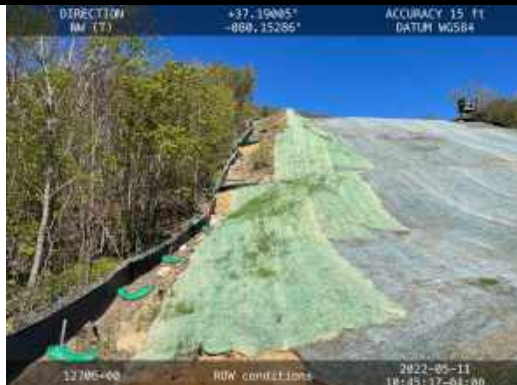
GPS Location	See photo for gps location data.		GPS Location	See photo for gps location data.	
Field Station#	12706+00		Field Station#	12609+00	
Pic 11 Desc.	Photo shows the ROW condition. ECDs are installed and functioning as designed.		Pic 12 Desc.	Photo shows the ROW condition. ECDs are installed and functioning as designed.

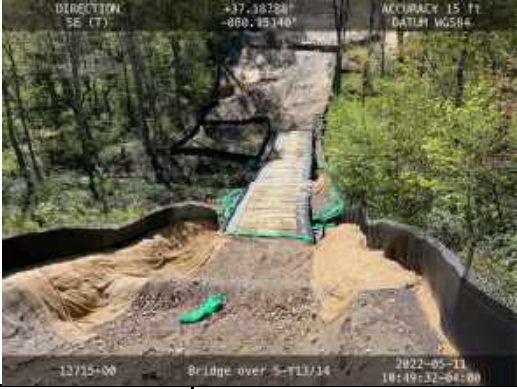
GPS Location	See photo for gps location data.		GPS Location	See photo for gps location data.	
Field Station#	12715+00		Field Station#	12715+80	
Pic 13 Desc.	Photo shows the bridge over streams s-Y13 and S-Y14.		Pic 14 Desc.	Photo shows stream S-Y13 down stream.

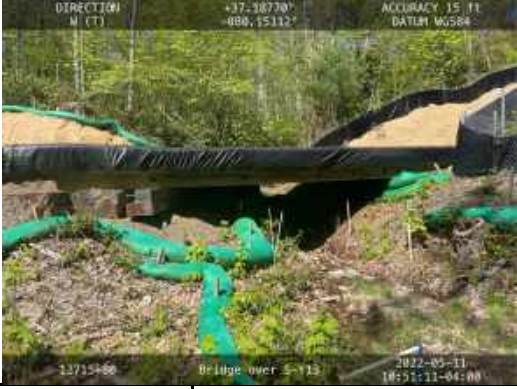
GPS Location	See photo for gps location data.		GPS Location	See photo for gps location data.	
Field Station#	12715+80		Field Station#	12716+20	
Pic 15 Desc.	Photo shows the bridge over stream S-Y13.		Pic 16 Desc.	Photo shows the bridge over stream S-Y14.

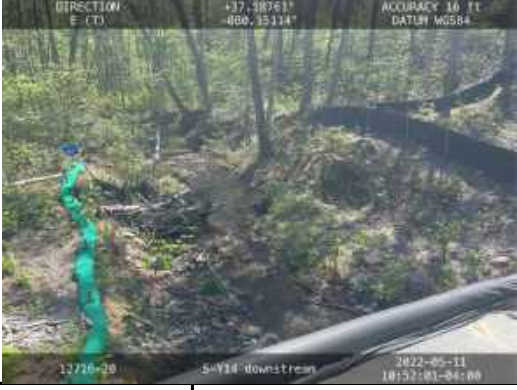
GPS Location	See photo for gps location data.		GPS Location	See photo for gps location data.	
Field Station#	12716+20		Field Station#	12716+50	
Pic 17 Desc.	Photo shows stream S-Y14 downstream from the bridge.		Pic 18 Desc.	Photo shows the ROW condition. ECDs are installed and functioning as designed.

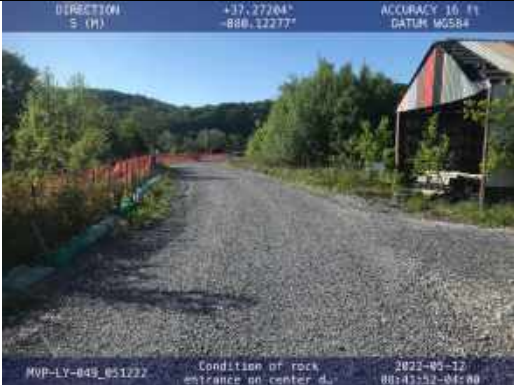
GPS Location	MVP-LY-049 See photo for gps data	GPS Location	MVP-LY-049 See photo for gps data		
Field Station#	+0	Field Station#	+0		
Pic 1 Desc.	Condition of rock entrance on center drive. Smaller stone applied over larger stone. Looking S.	Pic 2 Desc.	Condition of rock entrance on north drive. No sediment or debris on stone. Looking SW.

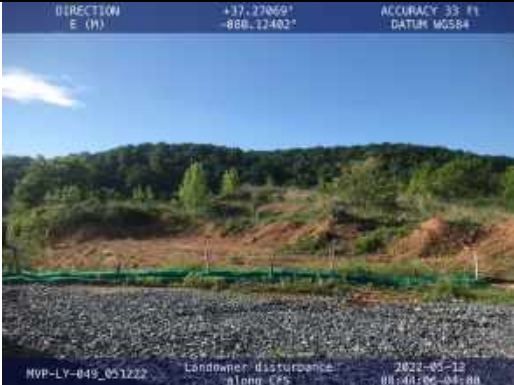
GPS Location	MVP-LY-049 See photo for gps data	GPS Location	MVP-LY-049 See photo for gps data		
Field Station#	+0	Field Station#	+0		
Pic 3 Desc.	Landowner soil disturbance along triple stack compost filter sock. No new damage to installed ECD's. Looking SW.	Pic 4 Desc.	Landowner soil disturbance along feature W-CV21A. Area not stabilized. Looking NW.

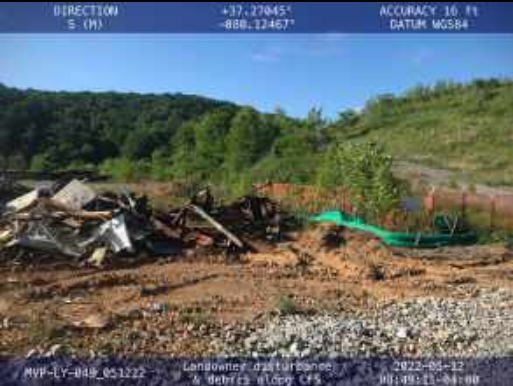
Pic 5 Desc.	Landowner soil disturbance west of feature W-CV21B. Areas not stabilized. Looking SW.	Pic 6 Desc.	Landowner soil disturbance and debris piled along triple stack compost filter sock and east of feature W-CV21B. Looking S.

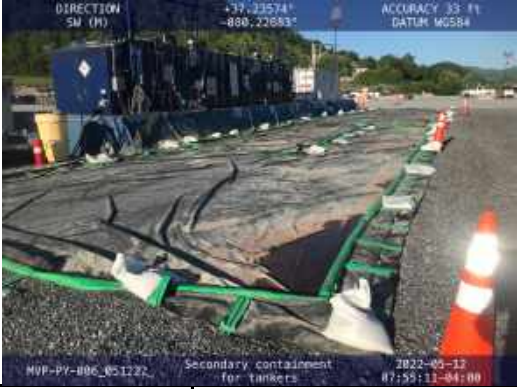
GPS Location	MVP-PY-006 See photo for gps data	GPS Location	MVP-PY-006 See photo for gps data		
Field Station#	+0	Field Station#	+0		
Pic 13 Desc.	Secondary containments in place for tankers offloading fuel. Containments showing signs of wear. Looking SW.	Pic 14 Desc.	Blue Bulk Fuel tanks no leaky fittings or nozzles. Looking S.

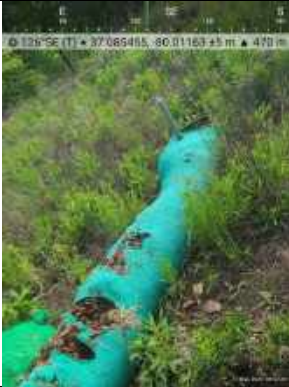
GPS Location	0000	GPS Location	0000		
Field Station#	13471+80	Field Station#	13493+00		
Pic 1 Desc.	CFS requires maintenance due to wildlife damages, documented and added to the punch list.	Pic 2 Desc.	Photo showing vegetation and stabilization on row after recent brush removed. No environmental issues observed at the time of inspection.

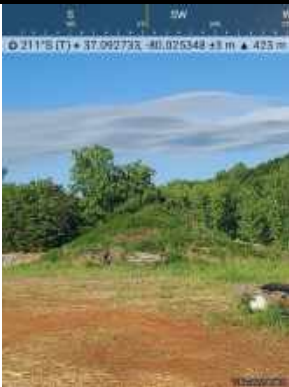
GPS Location	0000	GPS Location	0000		
Field Station#	13419+50	Field Station#	13430+00		
Pic 3 Desc.	Photo showing spoil pile after recent brush removed. No issues observed at the time of inspection.	Pic 4 Desc.	Monitored row ECDs , water bars and level spreaders. Good vegetation observed.

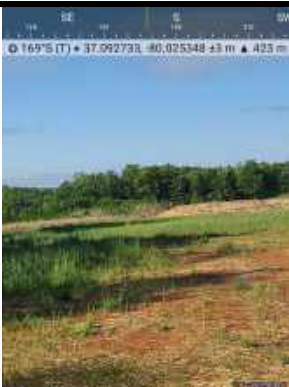
GPS Location	0000	GPS Location	0000		
Field Station#	12420+00	Field Station#	13471+80		
Pic 5 Desc.	Photo showing work space stabilization and spoil pile after recent work done removing brush. No issues observed at the time of inspection.	Pic 6 Desc.	CFS requires maintenance due to wildlife damages, documented and added to the punch list for repairs.

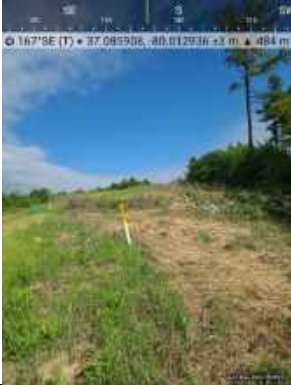
GPS Location	0000	GPS Location	0000		
Field Station#	13472+20	Field Station#	13467+00		
Pic 7 Desc.	Photo showing area with stabilization after recent work activities. No issues observed at the time of inspection.		Pic 8 Desc.	Monitored row conditions after recent mowing and tree cutting of trees under 5". No environmental issues observed at the time of inspection.	
Insert image here		Insert image here			
GPS Location		GPS Location			
Field Station#		Field Station#			
Pic 9 Desc.			Pic 10 Desc.		
Insert image here		Insert image here			
GPS Location		GPS Location			
Field Station#		Field Station#			
Pic 11 Desc.			Pic 12 Desc.

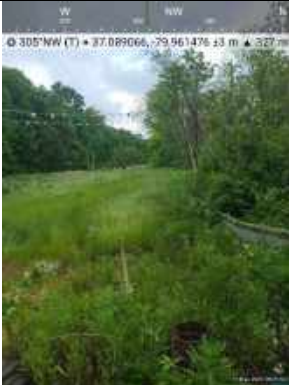
GPS Location	0000	GPS Location	0000		
Field Station#	13643+00	Field Station#	13643+53		
Pic 1 Desc.	Vegetation observation up row from stream crossing, ECDs monitored . All functioning at the time of inspection.		Pic 2 Desc.	Stream observation photo facing downstream during light rain events. No issues were observed at the time of inspection.

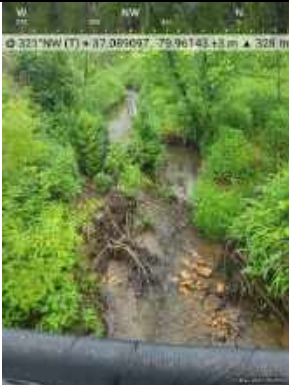
GPS Location	0000	GPS Location	0000		
Field Station#	13643+53	Field Station#	13541+50		
Pic 3 Desc.	Stream observation photo facing upstream during light rain events today.		Pic 4 Desc.	Row photo showing vegetation in permanent area of row. RCEs checked during light rain events.

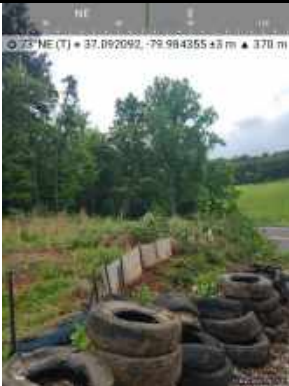
GPS Location	0000	GPS Location	0000		
Field Station#	13562+82	Field Station#	13626+17		
Pic 5 Desc.	Monitored area where trees under 5" were cut at Bethlehem rd crossing.		Pic 6 Desc.	Monitored stabilization activities done by the contractor after recent mowing activities.

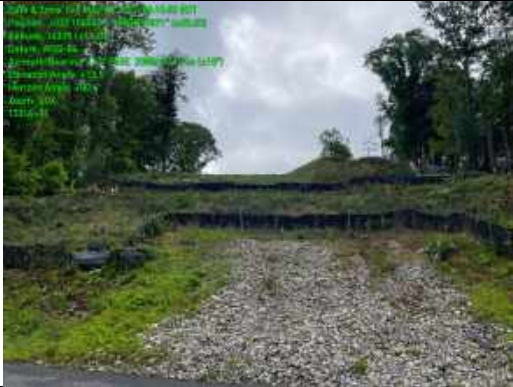
GPS Location	0	GPS Location	0		
Field Station#	13316+21	Field Station#	13316+21		
Pic 1 Desc.	Wades Gap Road Crossing in good condition		Pic 2 Desc.	ROW and ECDs In good condition and stable

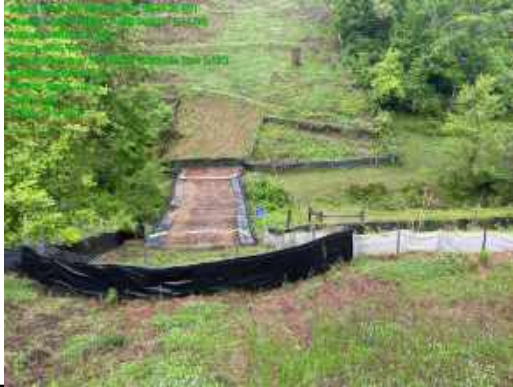
GPS Location	0	GPS Location	0		
Field Station#	13335+00	Field Station#	13334+17		
Pic 3 Desc.	ROW and ECDs In good condition and stable		Pic 4 Desc.	MVP-S-GH11 and corresponding buffer zone in good condition

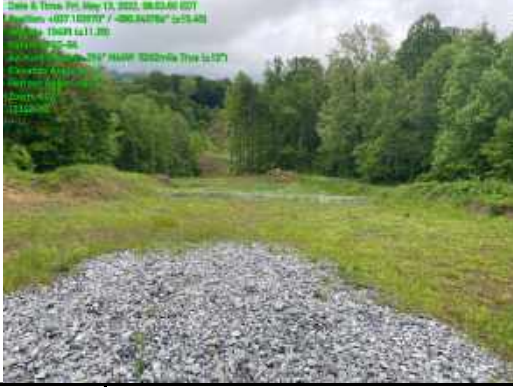
GPS Location	0	GPS Location	0		
Field Station#	13337+13	Field Station#	13342+00		
Pic 5 Desc.	MVP-S-GH9 and corresponding buffer zone in good condition		Pic 6 Desc.	ROW and ECDs In good condition and stable
