Visual Site Inspection Report

Project Name	H-600 Pipeline Spread I	AFE	124300139	Spread	H-600 Pipeline Spread I
Contractor	Precision			Report #	36412
Inspector	Ben Davenport			Date/Time	4/11/2022 9:38 AM
Permit #	TBD	Inspection Type	VA SWPP	Station Begin	14454+22
State	VA	Inspection Area	Partial	Station End	14546+75
County	Franklin	Ground	Damp	Temperature (°F)	66.00
Municipality	N/A	Weather	Sunny	Rain Gauge (in)	0.00
				Rain Accumulation Time (days)	0.00

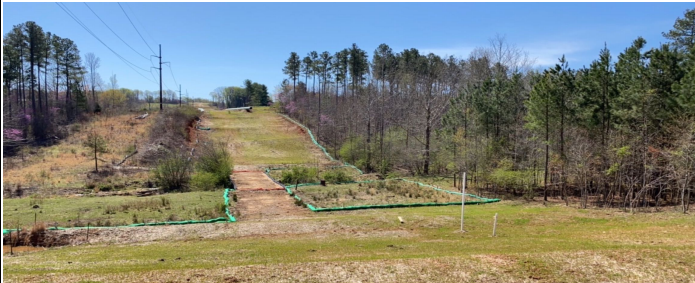
37°14" N 79°45'36" W 188°S COURSE -1' GPS 1142 SR-703, Glade Hill, VA 24092, United States 04.11.2022 11:19:10 Accur +/-15.4 Ft ALT 899 Ft			37°0'58" N 79°45'31" W 100°E COURSE 3' GPS 1401 SR-674, Glade Hill, VA 24092, United States 04.11.2022 12:05:14 Accur +/-594.0 Ft ALT 932 Ft		
GPS Location	5		GPS Location	6	
Field Station#	14496+58		Field Station#	14516+00	
Pic 5 Desc.	Equipment bridge and surrounding ECDs in place and functional at stream crossing and resource buffer; ROW stabilized and vegetated in temporary area.		Pic 6 Desc.	Slope drain pipe and outlet in place and functional.

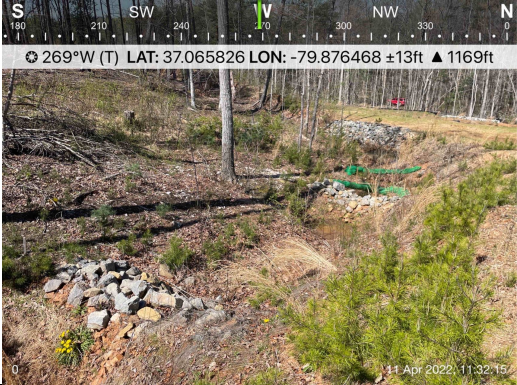
GPS Location	See photo	GPS Location			
Field Station#	14060+00	Field Station#			
Pic 13 Desc.	Rock checks are functioning as intended.	Pic 14 Desc.			
Insert image here		Insert image here			
GPS Location		GPS Location			
Field Station#		Field Station#			
Pic 15 Desc.		Pic 16 Desc.			
Insert image here		Insert image here			
GPS Location		GPS Location			
Field Station#		Field Station#			
Pic 17 Desc.		Pic 18 Desc.

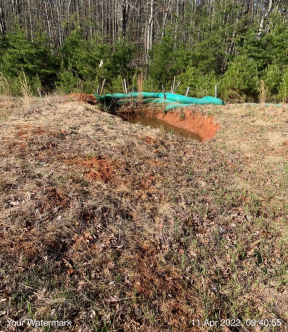
GPS Location	O	GPS Location	O		
Field Station#	15650+00	Field Station#	15654+00		
Pic 1 Desc.	Observing temporary stabilization,water bar, sump and end treatment	Pic 2 Desc.	Observing temporary stabilization		
East Elevation 250°W (T) ● 36°52'56"N, 79°24'49"W ±68136ft ▲ 772ft

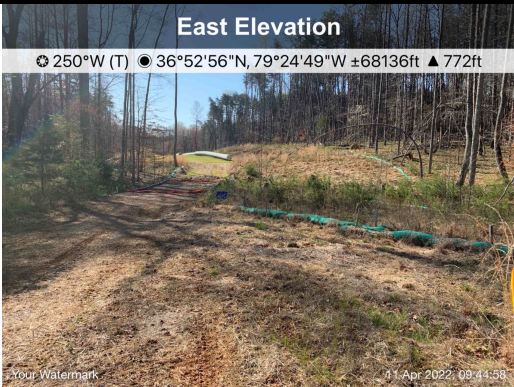
GPS Location	O	GPS Location	O		
Field Station#	15658+43	Field Station#	15693+89		
Pic 3 Desc.	Observing temporary stabilization, signage, buffer, equipment crossing and ECD's	Pic 4 Desc.	Observing road crossing and RCE's		
South West Elevation 33°NE (T) ● 36°52'49"N, 79°25'19"W ±1197ft ▲ 825ft

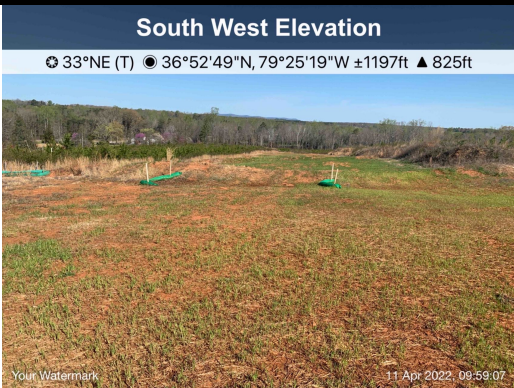
GPS Location	O	GPS Location	O		
Field Station#	15690+00	Field Station#	15735+00		
Pic 5 Desc.	Observing temporary stabilization,water bar and CFS Checks	Pic 6 Desc.	Observing temporary stabilization,CWD outlet and ECD's

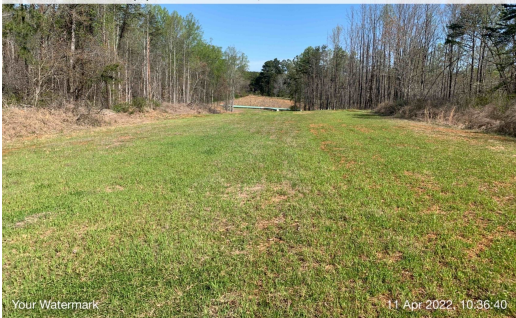
GPS Location	O	GPS Location	O		
Field Station#	15768+00	Field Station#	15763+80		
Pic 7 Desc.	Observing temporary stabilization and water bar	Pic 8 Desc.	Observing temporary stabilization, signage, buffer, equipment crossing and ECD's		
Insert image here		Insert image here			
GPS Location		GPS Location			
Field Station#		Field Station#			
Pic 9 Desc.		Pic 10 Desc.			
Insert image here		Insert image here			
GPS Location		GPS Location			
Field Station#		Field Station#			
Pic 11 Desc.		Pic 12 Desc.

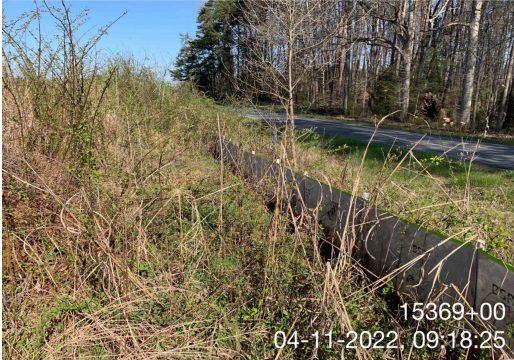
15365+00 04-11-2022, 09:21:57			
GPS Location	0	GPS Location	0		
Field Station#	15369+00	Field Station#	15365+00		
Pic 1 Desc.	P1 silt fence in acceptable condition	Pic 2 Desc.	Waterbar end treatment and permanent vegetative stabilization in acceptable conditions		
⚙ 198°S (T) ● 36°55'21"N, 79°30'44"W ±16ft ▲ 764ft

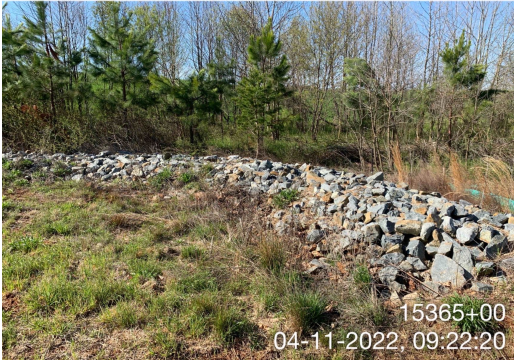
15340+00 04-11-2022, 09:56:20			
GPS Location	0	GPS Location	0		
Field Station#	15365+00	Field Station#	15340+00		
Pic 3 Desc.	Waterbar end treatment in acceptable condition	Pic 4 Desc.	Temporary vegetative stabilization in acceptable condition		
⚙ 246°SW (T) ● 36°55'35"N, 79°31'10"W ±22ft ▲ 771ft

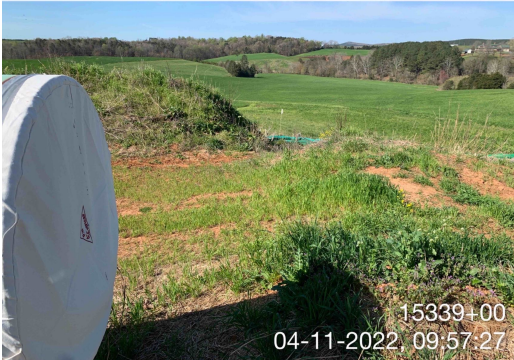
GPS Location	0	GPS Location	0		
Field Station#	15339+00	Field Station#	15339+00		
Pic 5 Desc.	Waterbar in acceptable condition	Pic 6 Desc.	Waterbar end treatment in acceptable condition

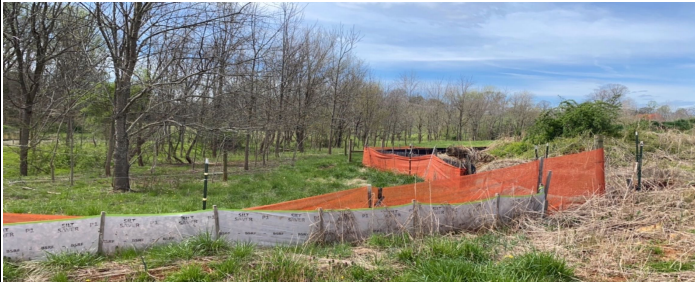
37°02' N 79°44'35" W 185°S COURSE 249° GPS Glade Hill, VA 24092, United States 04.12.2022 10:54:45 Accur +/-15.3 Ft ALT 846 Ft			37°01' N 79°44'34" W 322°NW COURSE -1° GPS Glade Hill, VA 24092, United States 04.12.2022 10:53:53 Accur +/-353.7 Ft ALT 877 Ft		
GPS Location	1	GPS Location	2		
Field Station#	14566+23	Field Station#	14582+85		
Pic 1 Desc.	Perimeter controls in good condition.		Pic 2 Desc.	Equipment bridge and surrounding ECDs in place and functional at stream crossing and resource buffer.

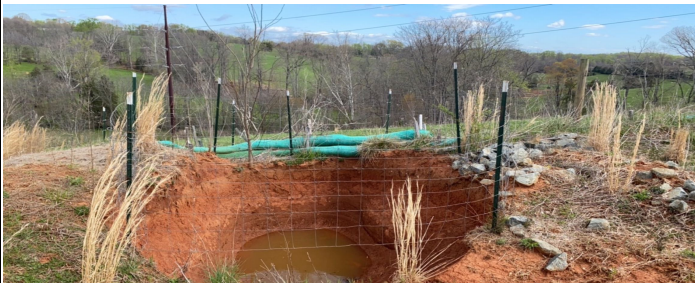
Field Station#	14591+00	Field Station#	14606+00		
Pic 3 Desc.	Sump pit and CFS end treatment performing intended functions.		Pic 4 Desc.	Plunge pool performing intended function.

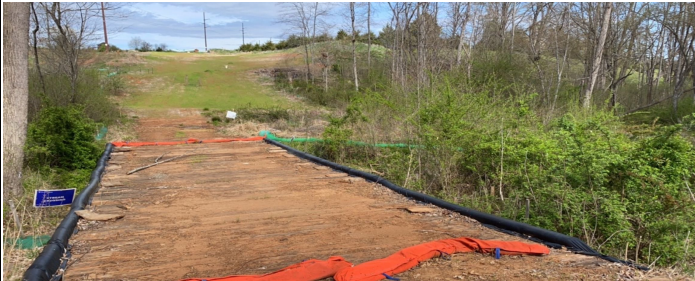
36°59'44" N 79°44'6" W 64°NE COURSE 213° GPS Union Hall, VA 24176, United States 04.12.2022 10:39:04 Accur +/-85.8 Ft ALT 866 Ft			36°59'44" N 79°44'5" W 188°S COURSE -1° GPS Union Hall, VA 24176, United States 04.12.2022 10:39:29 Accur +/-82.0 Ft ALT 874 Ft		
GPS Location	5	GPS Location	6		
Field Station#	14611+17	Field Station#	14614+43		
Pic 5 Desc.	Equipment bridge and surrounding ECDs in place and functional at stream crossing and resource buffer.		Pic 6 Desc.	Temporary diversion berm stabilized and vegetated; ROW stabilized and vegetated in temporary area.

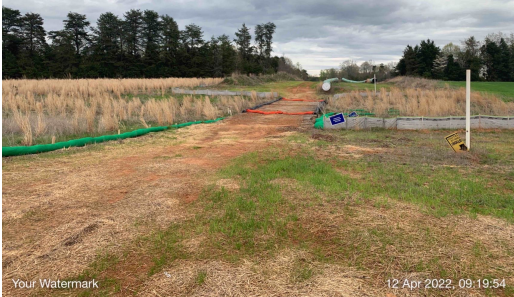
Your Watermark 12 Apr 2022, 09:22:59			
GPS Location	O	GPS Location	O		
Field Station#	15781+22	Field Station#	15784+00		
Pic 1 Desc.	Observing temporary stabilization, signage, buffer, equipment crossing and ECD's	Pic 2 Desc.	Observing temporary stabilization, CWD outlet and ECD's		
West Elevation 90°E (T) 36°51'53"N, 79°23'56"W ±12017ft ▲ 810ft

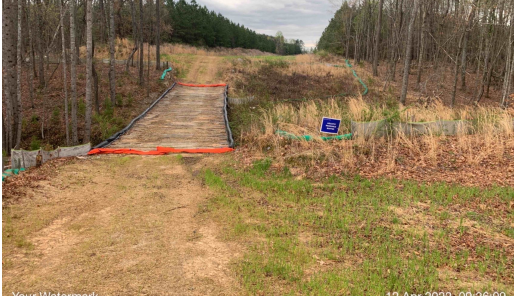
Your Watermark 12 Apr 2022, 09:53:20			
GPS Location	O	GPS Location	O		
Field Station#	15794+77	Field Station#	15826+77		
Pic 3 Desc.	Observing temporary stabilization, signage, buffer, equipment crossing and ECD's	Pic 4 Desc.	Observing road crossing and RCE's

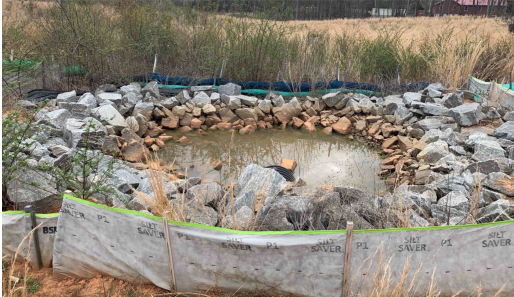
Your Watermark 12 Apr 2022, 10:05:56			
GPS Location	O	GPS Location	O		
Field Station#	15825+00	Field Station#	15852+88		
Pic 5 Desc.	Observing temporary stabilization, plunge pool and ECD's	Pic 6 Desc.	Observing temporary stabilization, signage, buffer, equipment crossing and ECD's

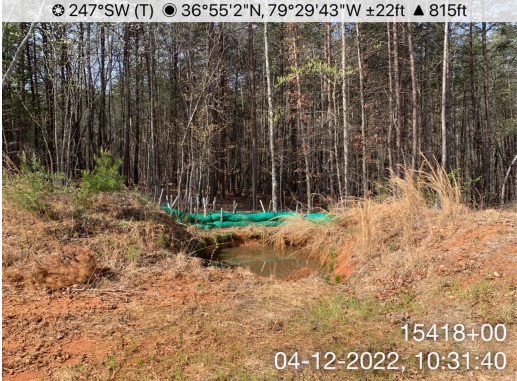
GPS Location	0	GPS Location	0		
Field Station#	15418+00	Field Station#	15414+00		
Pic 7 Desc.	Waterbar end treatment in acceptable condition	Pic 8 Desc.	Sensitive resource buffer and P1 silt fence in acceptable conditions

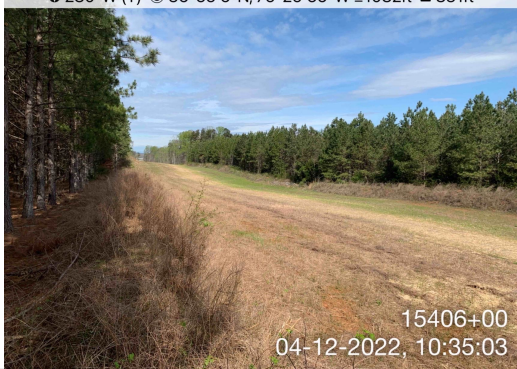
<p style="text-align: center;">Insert image here</p>			
GPS Location	0	GPS Location			
Field Station#	15406+00	Field Station#			
Pic 9 Desc.	Clean water diversion berm in acceptable condition	Pic 10 Desc.			
<p style="text-align: center;">Insert image here</p>		<p style="text-align: center;">Insert image here</p>			
GPS Location		GPS Location			
Field Station#		Field Station#			
Pic 11 Desc.		Pic 12 Desc.

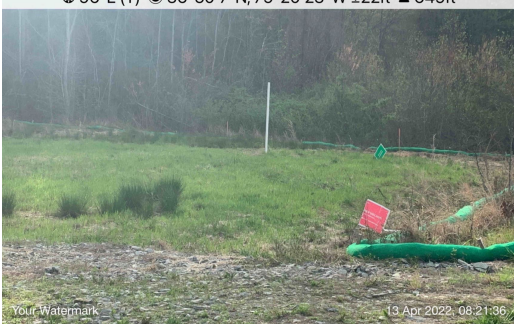
GPS Location	O		GPS Location	O	
Field Station#	14+00		Field Station#	22+00	
Pic 1 Desc.	Observing temporary stabilization, RCE, signage, buffer and ECD's		Pic 2 Desc.	Observing temporary stabilization, signage and buffer	
North East Elevation ☉ 204°SW (T) ● 36°50'6"N, 79°20'23"W ±82ft ▲ 651ft

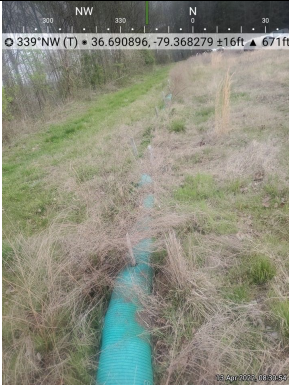
GPS Location	0	GPS Location	0		
Field Station#	0+00	Field Station#	0+00		
Pic 1 Desc.	LY-048 West perimeter CFS		Pic 2 Desc.	LY-048 Housekeeping

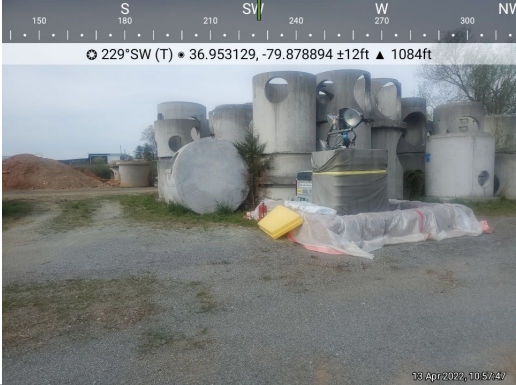
GPS Location	0	GPS Location	0		
Field Station#	0+00	Field Station#	0+00		
Pic 3 Desc.	ANC-006 Secondary containment		Pic 4 Desc.	ANC-006 Stormwater drain inlet protection

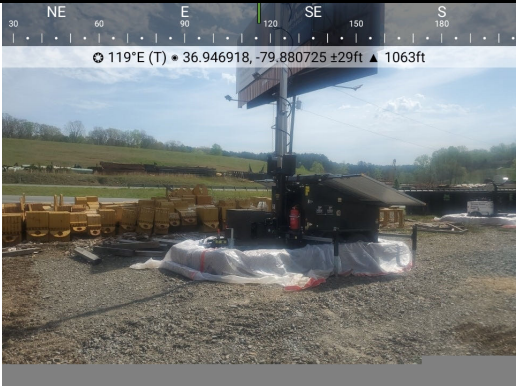
GPS Location	0	GPS Location	0		
Field Station#	0+00	Field Station#	0+00		
Pic 5 Desc.	LY-032 Secondary containment		Pic 6 Desc.	LY-032 Rock entrance

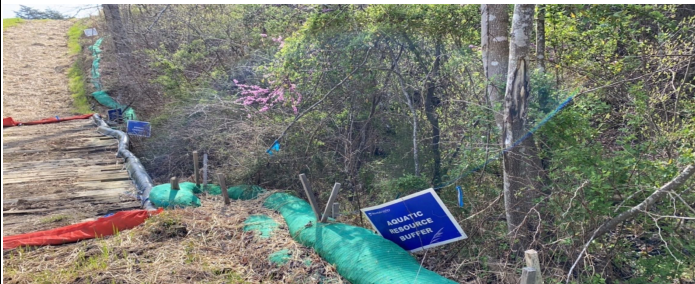
36°59'16" N 79°42'43" W 201°S COURSE 248' GPS Union Hall, VA 24176, United States 04.13.2022 09:57:23 Accur +/-15.3 Ft ALT 897 Ft			36°59'16" N 79°42'47" W 296°NW COURSE 222' GPS Union Hall, VA 24176, United States 04.13.2022 09:58:47 Accur +/-15.3 Ft ALT 954 Ft		
GPS Location	1	GPS Location	2		
Field Station#	14657+00	Field Station#	14670+00		
Pic 1 Desc.	Signage visible and intact at stream crossing.		Pic 2 Desc.	Sump pit and CFS end treatment performing intended functions.

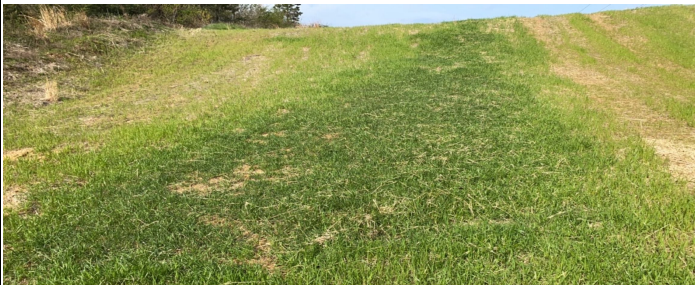
Pic 3 Desc.	ROW stabilized and vegetated in temporary area.		Pic 4 Desc.	Perimeter controls in place and functional.

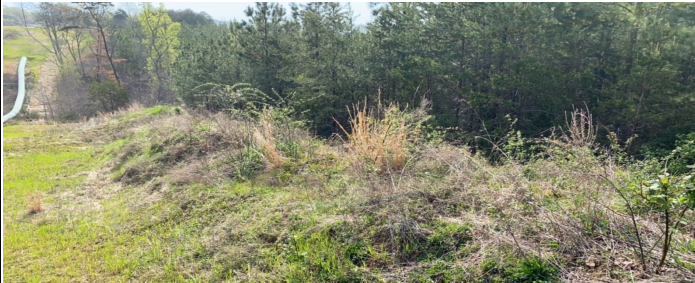
36°59'16" N 79°42'47" W 165°S COURSE 208' GPS Union Hall, VA 24176, United States 04.13.2022 09:58:42 Accur +/-15.4 Ft ALT 954 Ft			36°59'16" N 79°42'41" W 316°NW COURSE 292' GPS Union Hall, VA 24176, United States 04.13.2022 09:56:27 Accur +/-25.5 Ft ALT 927 Ft		
GPS Location	5	GPS Location	6		
Field Station#	14686+00	Field Station#	14689+36		
Pic 5 Desc.	Temporary diversion berm stabilized and vegetated.		Pic 6 Desc.	Equipment bridge and surrounding ECDs in place and functional at stream crossing and resource buffer.

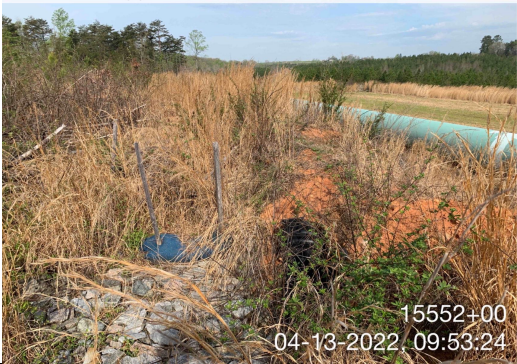
GPS Location	0	GPS Location	0		
Field Station#	15552+00	Field Station#	15580+00		
Pic 7 Desc.	Clean water diversion pipe in acceptable condition	Pic 8 Desc.	Waterbar in acceptable condition

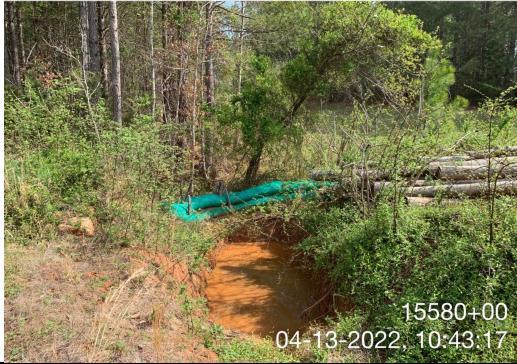
GPS Location	0	GPS Location	0		
Field Station#	15580+00	Field Station#	15498+00		
Pic 9 Desc.	Waterbar end treatment in acceptable condition	Pic 10 Desc.	Solar farm ECDs appear to be in acceptable conditions		
Insert image here		Insert image here			
GPS Location		GPS Location			
Field Station#		Field Station#			
Pic 11 Desc.		Pic 12 Desc.

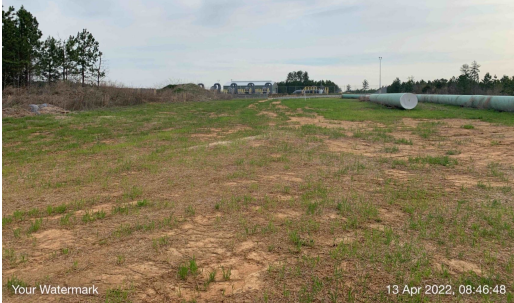
<small>Your Watermark 13 Apr 2022, 08:46:52</small>		
GPS Location	O		GPS Location	O	
Field Station#	16024+00		Field Station#	16020+00	
Pic 1 Desc.	Observing temporary stabilization		Pic 2 Desc.	Observing temporary stabilization and water bars	
North West Elevation ☉ 116°SE (T) ● 36°49'50"N, 79°20'39"W ±2805ft ▲ 625ft

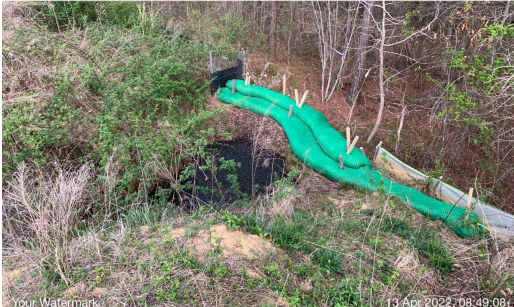
<small>Your Watermark 13 Apr 2022, 08:50:10</small>		
GPS Location	O		GPS Location	O	
Field Station#	16018+00		Field Station#	16016+36	
Pic 3 Desc.	Observing temporary stabilization, sump and end treatment		Pic 4 Desc.	Observing temporary stabilization, signage, buffer, equipment crossing and ECD's

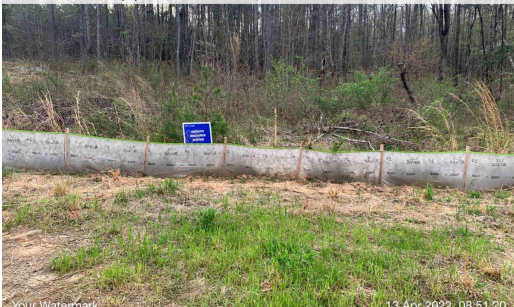
<small>Your Watermark 13 Apr 2022, 08:52:41</small>		
GPS Location	O		GPS Location	O	
Field Station#	16015+50		Field Station#	16010+00	
Pic 5 Desc.	Observing temporary stabilization, signage, buffer and ECD's		Pic 6 Desc.	Observing temporary stabilization, CWD outlet and ECD's

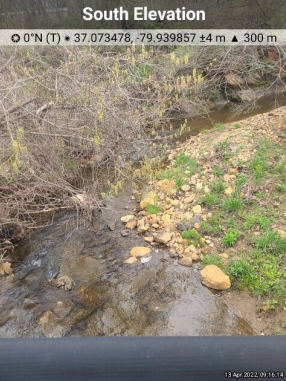
GPS Location	0000	GPS Location	0000		
Field Station#	13755+49	Field Station#	13770+69		
Pic 1 Desc.	Stream observation photo facing downstream during routine inspection today. No environmental issues observed at the time of inspection.		Pic 2 Desc.	Photo showing S-MM42 after the contractor completed the punch list item , installed erosion control blanket.	
	North Elevation

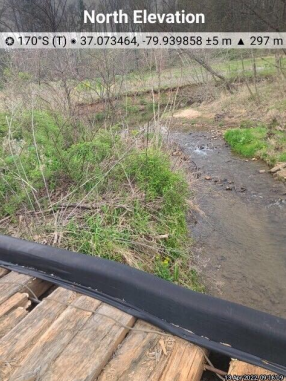
GPS Location	0000	GPS Location	00000		
Field Station#	13755+49	Field Station#	13770+69		
Pic 3 Desc.	Stream observation photo facing upstream during routine inspection today, no environmental issues observed at the time of inspection.		Pic 4 Desc.	Photo showing S-MM42 after the contractor completed the punch list item , installed erosion control blanket.	
	North West Elevation

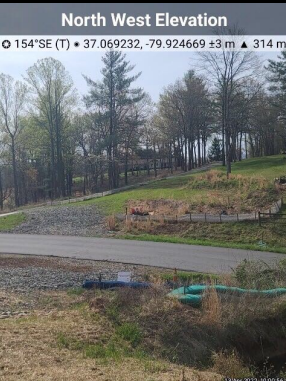
GPS Location	00000	GPS Location	00000		
Field Station#	13811+66	Field Station#	13806+90		
Pic 5 Desc.	Monitored RCEs and ECDs at road crossings, no issues observed at the time of inspection.		Pic 6 Desc.	Stream observation photo showing stabilization on hill sides, ECDs in place and functioning at the time of inspection.

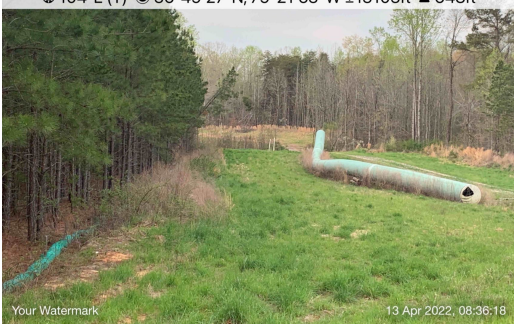
Your Watermark 13 Apr 2022, 08:36:18		North Elevation 180°S (T) 36°49'45"N, 79°20'40"W ±104ft ▲ 622ft   Your Watermark 13 Apr 2022, 08:41:52			
GPS Location	O	GPS Location	O		
Field Station#	6+00	Field Station#	12+65		
Pic 1 Desc.	Observing temporary stabilization and access road		Pic 2 Desc.	Observing temporary stabilization, signage, buffer, equipment crossing and ECD's	
West Elevation 72°E (T) 36°49'43"N, 79°20'40"W ±13ft ▲ 628ft   Your Watermark 13 Apr 2022, 08:42:57		North East Elevation 246°SW (T) 36°49'43"N, 79°20'40"W ±13ft ▲ 630ft   Your Watermark 13 Apr 2022, 08:43:09			
GPS Location	O	GPS Location	O		
Field Station#	13+50	Field Station#	15+00		
Pic 3 Desc.	Observing temporary stabilization, water bar, sump, end treatment and ECD's		Pic 4 Desc.	Observing temporary stabilization and signage

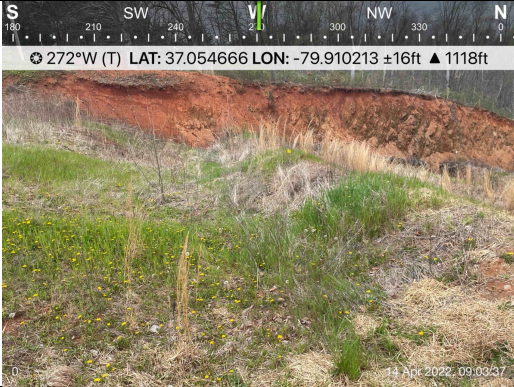
GPS Location	See photo		GPS Location	See photo	
Field Station#	13892+00		Field Station#	13891+00	
Pic 1 Desc.	Waterbars are in good condition and functioning		Pic 2 Desc.	Slope remains stabilized

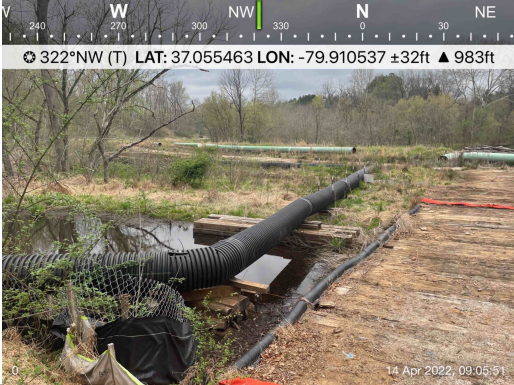
GPS Location	See photo		GPS Location	See photo	
Field Station#	13889+00		Field Station#	13876+00	
Pic 3 Desc.	Slope drain is functioning as intended		Pic 4 Desc.	P1 is in good condition at all stream and wetland buffers

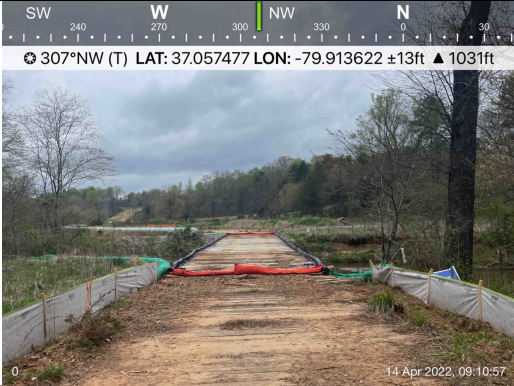
GPS Location	See photo		GPS Location	See photo	
Field Station#	13875+73		Field Station#	13895+00	
Pic 5 Desc.	Equipment bridge ECDs are in good condition and functioning		Pic 6 Desc.	Stockpile remains stabilized

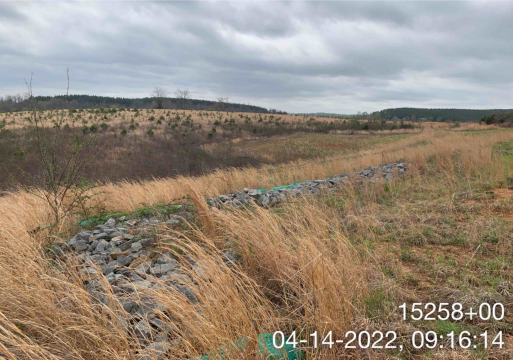
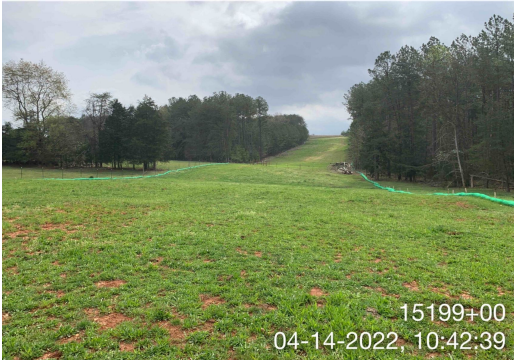
15258+00 04-14-2022, 09:16:14			
GPS Location	0	GPS Location	0		
Field Station#	15257+00	Field Station#	15258+00		
Pic 1 Desc.	Permanent vegetative stabilization and waterbar in acceptable conditions	Pic 2 Desc.	Waterbar end treatment in acceptable condition		
89°E (T) 36°56'25"N, 79°33'44"W ±39ft ▲ 794ft

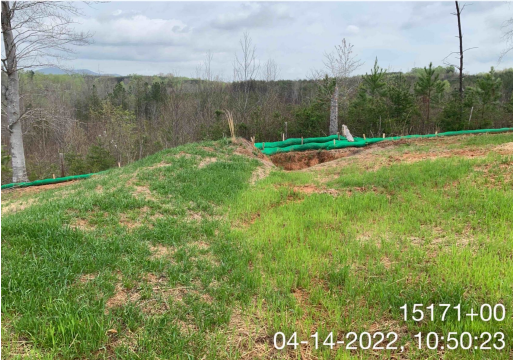
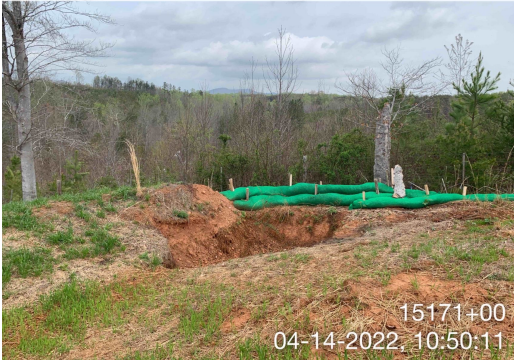
15171+00 04-14-2022, 10:50:23			
GPS Location	0	GPS Location	0		
Field Station#	15199+00	Field Station#	15171+00		
Pic 3 Desc.	Permanent vegetative stabilization in acceptable condition	Pic 4 Desc.	Waterbar in acceptable condition		
356°N (T) 36°56'36"N, 79°34'13"W ±13ft ▲ 791ft

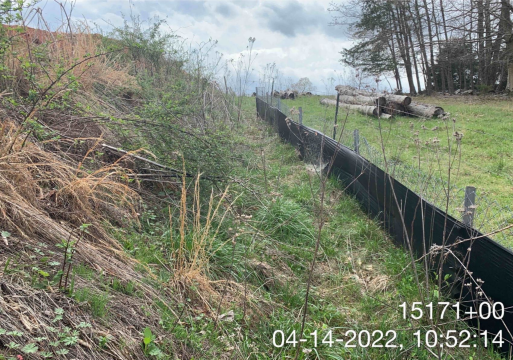
GPS Location	0	GPS Location	0		
Field Station#	15171+00	Field Station#	15171+00		
Pic 5 Desc.	Waterbar end treatment in acceptable condition	Pic 6 Desc.	Super silt fence in acceptable condition

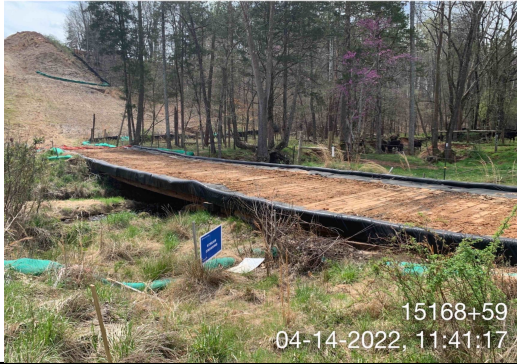
<p>15168+59 04-14-2022, 11:41:17</p>		  <p>15143+00 04-14-2022, 11:48:27</p>			
GPS Location	0	GPS Location	0		
Field Station#	15168+59	Field Station#	15143+00		
Pic 9 Desc.	Equipment bridge in acceptable condition		Pic 10 Desc.	P1 silt fence in acceptable condition	
Insert image here			Insert image here		
GPS Location		GPS Location			
Field Station#		Field Station#			
Pic 11 Desc.			Pic 12 Desc.

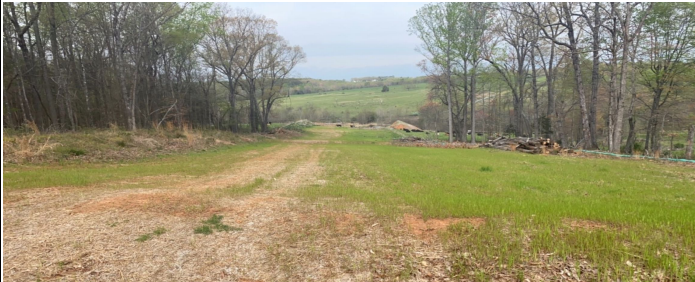
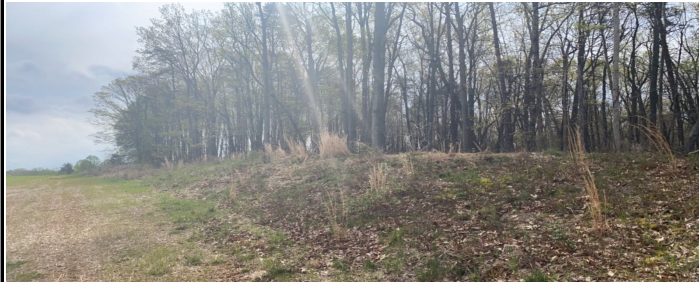
37°1'52" N 79°47'5" W 351°N COURSE 110° GPS Glade Hill, VA 24092, United States 04.14.2022 10:02:47 Accur +/-15.3 Ft ALT 1044 Ft			37°1'51" N 79°47'3" W 193°S COURSE 217° GPS Glade Hill, VA 24092, United States 04.14.2022 10:04:54 Accur +/-15.4 Ft ALT 1063 Ft		
GPS Location	1	GPS Location	2		
Field Station#	14349+00	Field Station#	14361+00		
Pic 1 Desc.	ROW stabilized and vegetated in temporary area.	Pic 2 Desc.	Temporary diversion berm stabilized and vegetated.

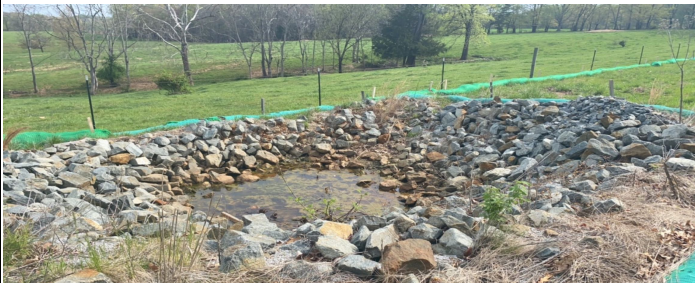
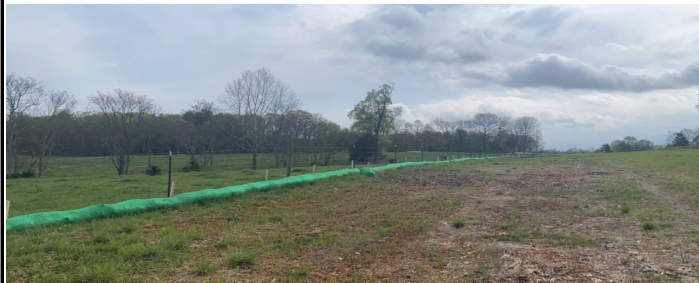
Pic 3 Desc.	Plunge pool performing intended function.	Pic 4 Desc.	Perimeter CFS in good condition.

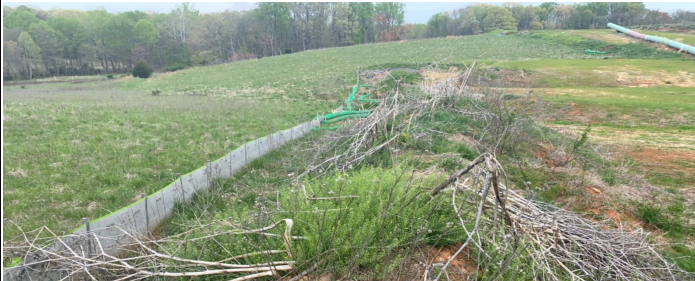
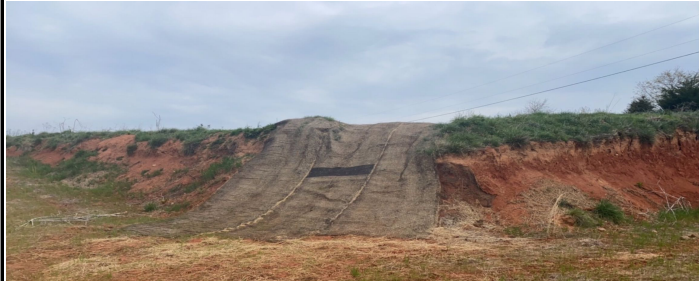
37°1'35" N 79°46'8" W 345°N COURSE 212° GPS 2753-2799 Webster Rd, Glade Hill, VA 24092, United States 04.14.2022 09:56:42 Accur +/-15.5 Ft ALT 1105 Ft			37°1'38" N 79°46'9" W 81°E COURSE 349° GPS 2701-2751 Webster Rd, Glade Hill, VA 24092, United States 04.14.2022 09:54:50 Accur +/-15.3 Ft ALT 1108 Ft		
GPS Location	5	GPS Location	6		
Field Station#	14448+00	Field Station#	14450+00		
Pic 5 Desc.	Perimeter P1 silt fence in place and functional.	Pic 6 Desc.	Erosion control blanket performing intended function.

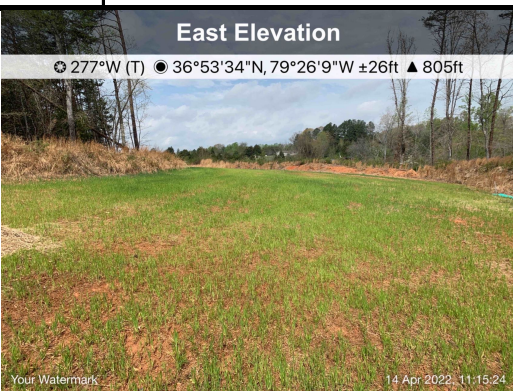
</div> <div>Your Watermark14 Apr 2022, 11:15:24</div>		
GPS Location			O		
Field Station#			15630+00		
Pic 5 Desc.			Observing temporary stabilization,CWD outlet and ECD's		
GPS Location			O		
Field Station#			15628+00		
Pic 6 Desc.			Observing temporary stabilization and CWD berm

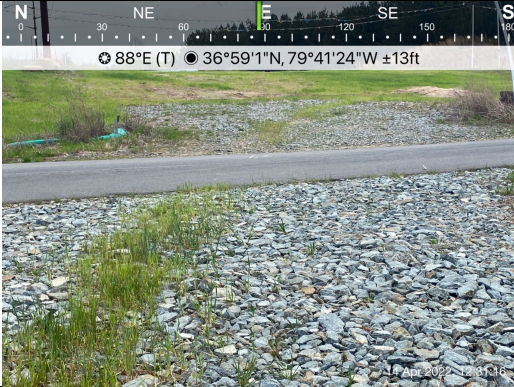
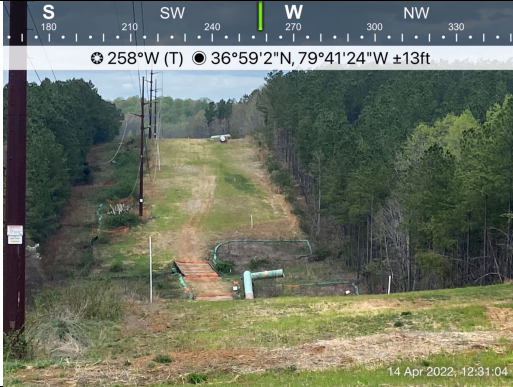
GPS Location	0	GPS Location	0		
Field Station#	14758+00	Field Station#	14748+00		
Pic 1 Desc.	Approximately 14758+00. Overview of road crossing and RCEs.		Pic 2 Desc.	Approximately 14748+00. Overview of ROW.

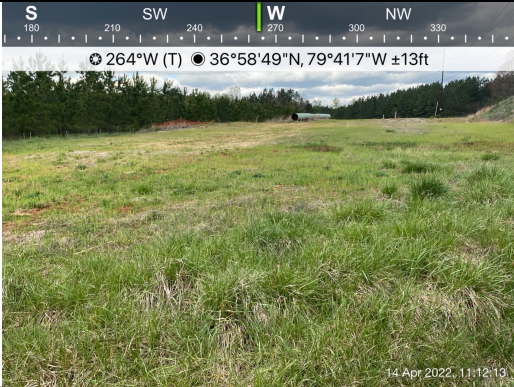
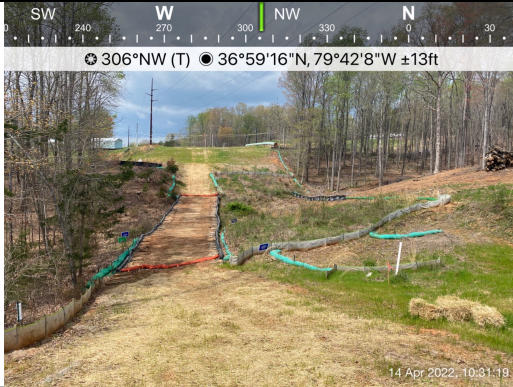
GPS Location	0	GPS Location	0		
Field Station#	14775+00	Field Station#	14716+50		
Pic 3 Desc.	Approximately 14775+00. Overview of ROW.		Pic 4 Desc.	Approximately 14716+50. Overview of wetland crossing, equipment bridge and ECDs at wetland W-H11. Third party disturbance and ECDs beyond LOD on north end of wetland.

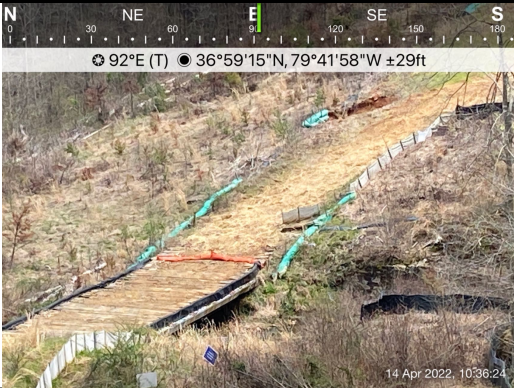
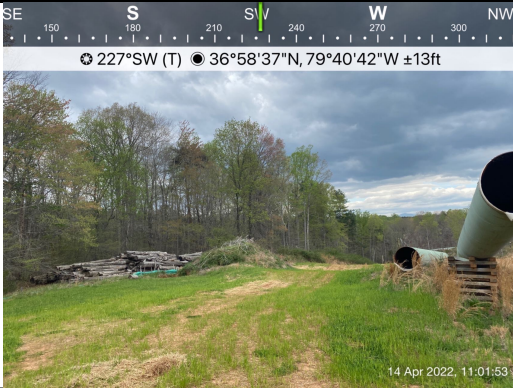
GPS Location	0	GPS Location	0		
Field Station#	14729+10	Field Station#	14801+00		
Pic 5 Desc.	Approximately 14729+19. Overview of stream crossing, equipment bridge and ECDs at stream S-A20.		Pic 6 Desc.	Approximately 14801+00. Overview of ROW.

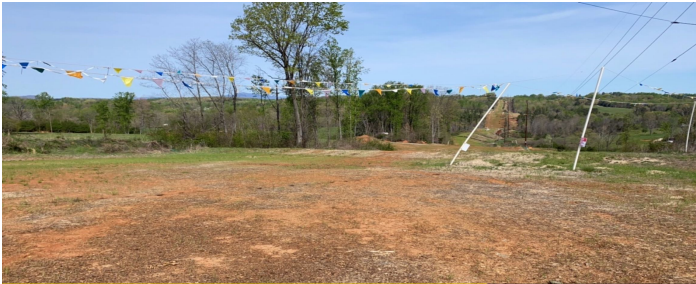
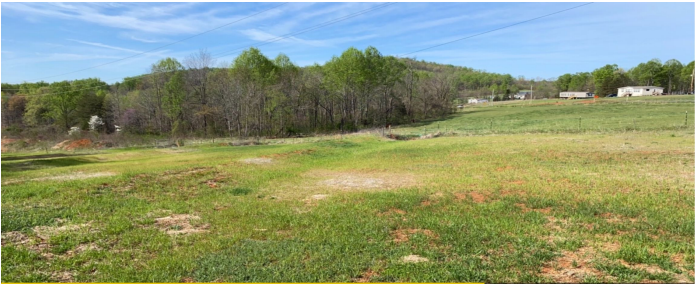
<small>37°0'40" N 79°45'16" W 20°N COURSE -1° GPS 1705 SR-674, Glade Hill, VA 24092, United States 04.15.2022 10:29:26 Accur +/-40.6 Ft ALT 0 Ft</small>			<small>37°0'38" N 79°45'16" W 310°NW COURSE 0° GPS 1694 SR-674, Glade Hill, VA 24092, United States 04.15.2022 10:21:40 Accur +/-135.5 Ft ALT 0 Ft</small>		
GPS Location	1	GPS Location	2		
Field Station#	14520+00	Field Station#	14528+00		
Pic 1 Desc.	ROW stabilized and vegetated in temporary area.	Pic 2 Desc.	ROW stabilized and vegetated in temporary area.

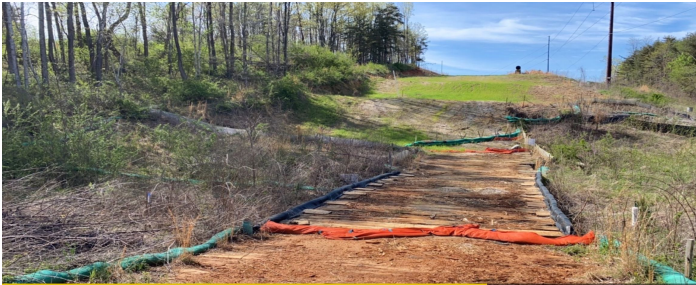
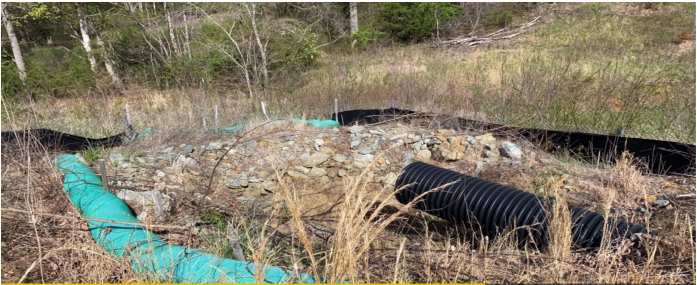
Field Station#	14531+58	Field Station#	14533+00		
Pic 3 Desc.	Equipment bridge and surrounding ECDs in place and functional at stream crossing and resource buffer.	Pic 4 Desc.	Plunge pool performing intended function.

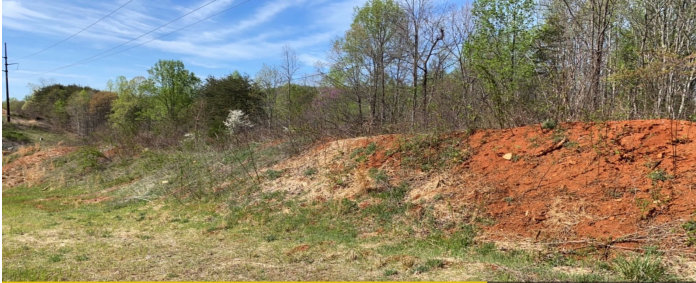
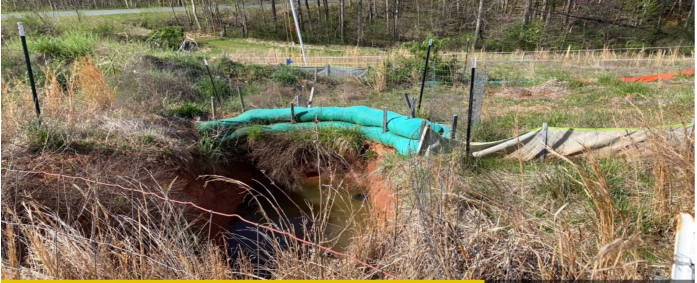
<small>37°0'37" N 79°45'13" W 203°S COURSE 184° GPS 1694 SR-674, Glade Hill, VA 24092, United States 04.15.2022 10:22:54 Accur +/-112.1 Ft ALT 1060 Ft</small>			<small>37°0'21" N 79°45'11" W 273°W COURSE -1° GPS 2-98 Tobacco Rd, Glade Hill, VA 24092, United States 04.15.2022 10:02:56 Accur +/-119.0 Ft ALT 947 Ft</small>		
GPS Location	5	GPS Location	6		
Field Station#	14536+00	Field Station#	14544+00		
Pic 5 Desc.	Temporary diversion berm stabilized and vegetated.	Pic 6 Desc.	Sump pit and CFS end treatment performing intended functions.

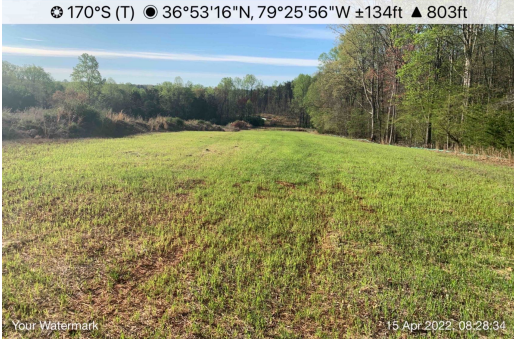
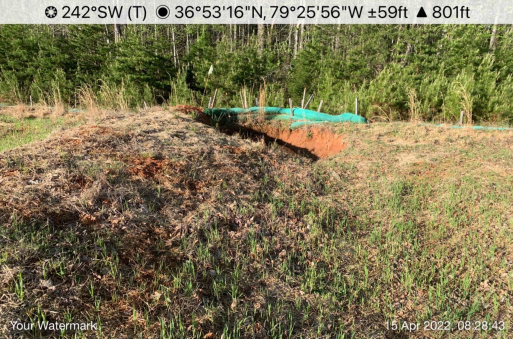
<small>Your Watermark 15 Apr 2022 08:28:43</small>			
GPS Location	O	GPS Location	O		
Field Station#	15653+00	Field Station#	15650+00		
Pic 1 Desc.	Observing temporary stabilization	Pic 2 Desc.	Observing temporary stabilization, water bar, sump and end treatment		
South West Elevation ☉ 66°NE (T) ● 36°52'48"N, 79°25'32"W ±2339ft ▲ 757ft

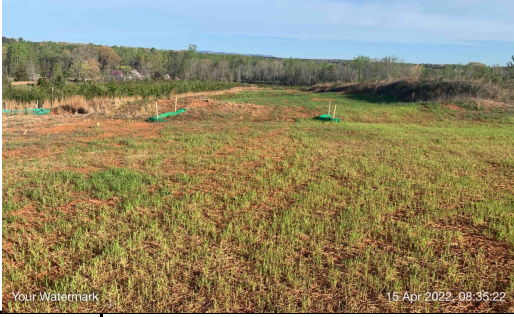
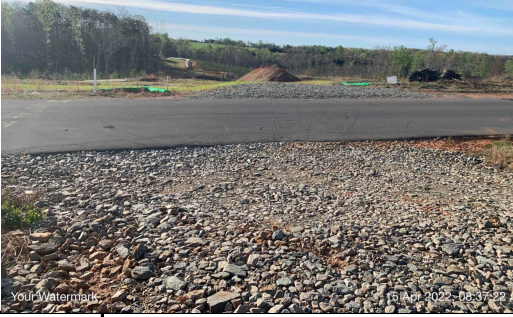
<small>Your Watermark 15 Apr 2022 08:37:22</small>			
GPS Location	O	GPS Location	O		
Field Station#	15690+00	Field Station#	15693+89		
Pic 3 Desc.	Observing temporary stabilization, water bar and CFS checks	Pic 4 Desc.	Observing road crossing and RCE's

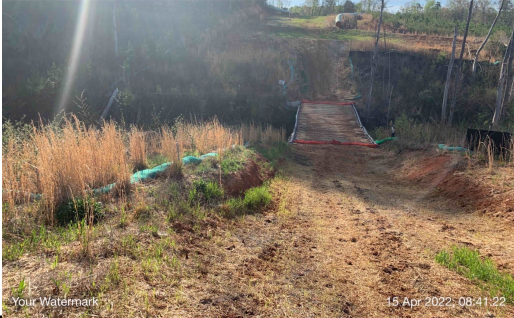
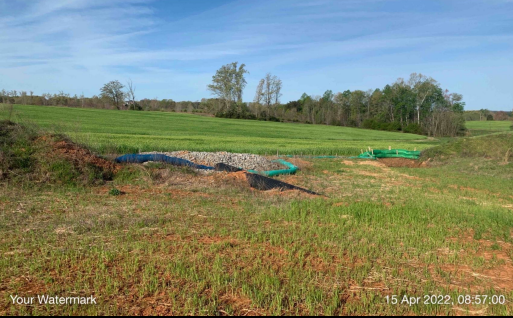
<small>Your Watermark 15 Apr 2022 08:57:00</small>			
GPS Location	O	GPS Location	O		
Field Station#	15700+46	Field Station#	15735+00		
Pic 5 Desc.	Observing temporary stabilization, signage, buffer, equipment crossing and ECD's	Pic 6 Desc.	Observing temporary stabilization, CWD outlet and ECD's

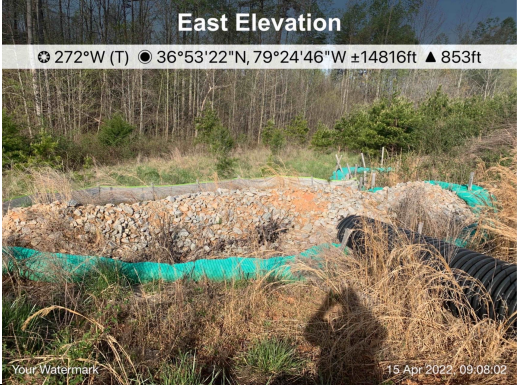
GPS Location	O	GPS Location			
Field Station#	15720+00	Field Station#			
Pic 7 Desc.	Observing temporary stabilization,CWD outlet and ECD's	Pic 8 Desc.			
Insert image here		Insert image here			
GPS Location		GPS Location			
Field Station#		Field Station#			
Pic 9 Desc.		Pic 10 Desc.			
Insert image here		Insert image here			
GPS Location		GPS Location			
Field Station#		Field Station#			
Pic 11 Desc.		Pic 12 Desc.

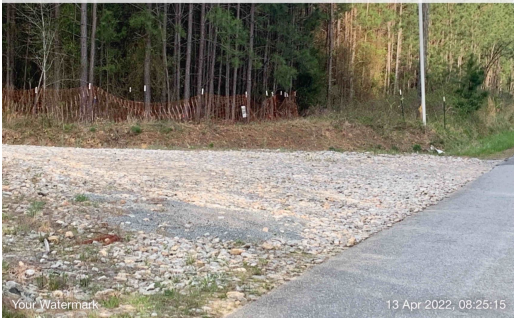
<p>Your Watermark 13 Apr 2022, 08:28:13</p>		
GPS Location	O		GPS Location	O	
Field Station#	00+00		Field Station#	00+00	
Pic 1 Desc.	Observing RCE		Pic 2 Desc.	Observing rock drain,temporary stabilization,erosion control blanket and cfs checks	
<p>North West Elevation</p> <p>☉ 139°SE (T) ● 36°49'57"N, 79°20'36"W ±13ft ▲ 649ft</p>

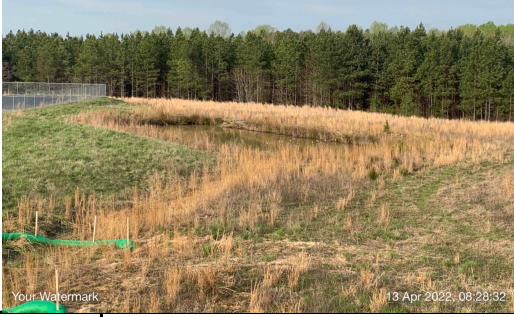
<p>Your Watermark 13 Apr 2022, 08:30:49</p>		
GPS Location	O		GPS Location	O	
Field Station#	00+00		Field Station#	00+00	
Pic 3 Desc.	Observing temporary stabilization and sediment basin		Pic 4 Desc.	Observing temporary stabilization and sediment basin

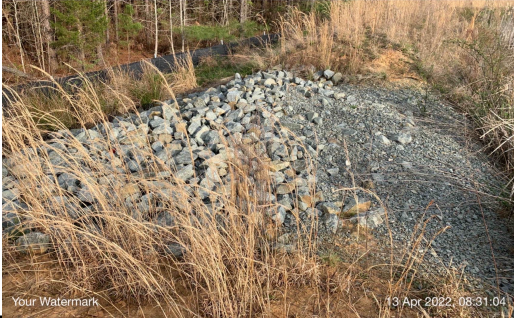
<p>Your Watermark 13 Apr 2022, 08:31:17</p>		
GPS Location	O		GPS Location	O	
Field Station#	00+00		Field Station#	00+00	
Pic 5 Desc.	Observing temporary stabilization and overflow at sediment basin		Pic 6 Desc.	Observing lay down yard
