Visual Site Inspection Report

Project Name	H-600 Pipeline Spread I	AFE	124300139	Spread	H-600 Pipeline Spread I
Contractor	Precision			Report #	36694
Inspector	Ben Farmer			Date/Time	4/18/2022 2:52 PM
Permit #	TBD	Inspection Type	VA SWPP	Station Begin	14062+17
State	VA	Inspection Area	Partial	Station End	14171+36
County	Franklin	Ground	Wet	Temperature (°F)	38.00
Municipality	N/A	Weather	Light Rain	Rain Gauge (in)	0.00
				Rain Accumulation Time (days)	0.00

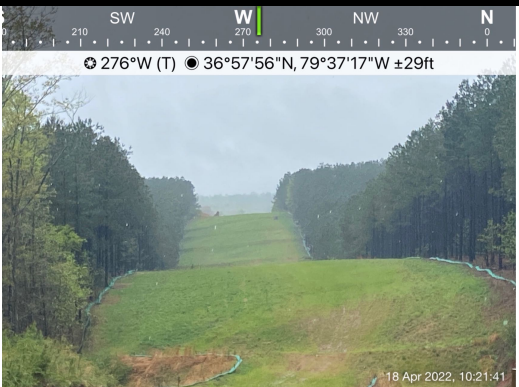
GPS Location	0		GPS Location	0	
Field Station#	14970+00		Field Station#	14981+00	
Pic 3 Desc.	Approximately 14970+00. Overview of ROW. Permanent vegetation.		Pic 4 Desc.	Approximately 14981+00. Overview of road crossing and RCEs.

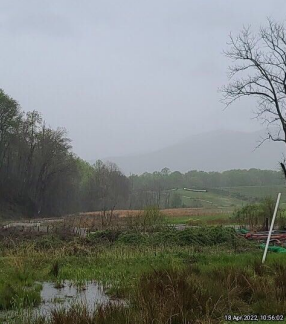
GPS Location	0000	GPS Location	0000		
Field Station#	13679+90	Field Station#	13690+80		
Pic 1 Desc.	Row photo during rain events, no environmental issues observed at the time of inspection.		Pic 2 Desc.	Monitored ECDs and stabilization during rain events, no environmental issues observed at the time of inspection.	
	South Elevation 12°N (T) • 37.074757, -79.940963 ±3 m ▲ 312 m

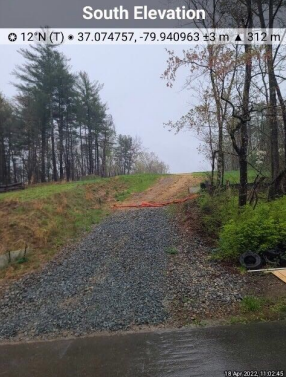
GPS Location	0000	GPS Location	0000		
Field Station#	13748+21	Field Station#	13748+20		
Pic 3 Desc.	Monitored RCEs during rain events today, no environmental issues observed at the time of inspection.		Pic 4 Desc.	Monitored ECDs and stabilization during rain events, no environmental issues observed at the time of inspection.

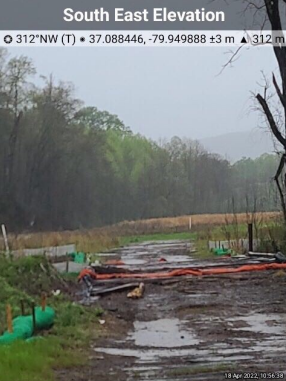
GPS Location	0000	GPS Location	00000		
Field Station#	13678+71	Field Station#	13679+40		
Pic 5 Desc.	Monitored stream crossing and ECDs during rain events, no environmental issues observed at the time of inspection.		Pic 6 Desc.	Row photo taken during rain events, row was saturated . No environmental issues observed at the time of inspection I

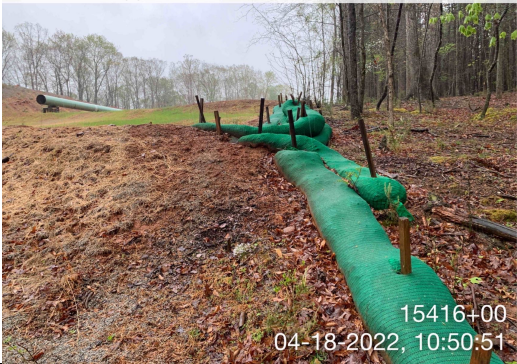
15419+00 04-18-2022, 10:52:59			
GPS Location	0	GPS Location	0		
Field Station#	15416+00	Field Station#	15419+00		
Pic 7 Desc.	Perimeter CFS in acceptable condition	Pic 8 Desc.	Waterbar in acceptable condition		
236°SW (T) 36°55'2"N, 79°29'43"W ±62ft ▲814ft

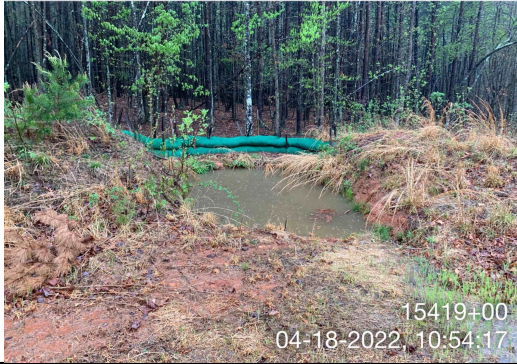
15412+00 04-18-2022, 11:10:17			
GPS Location	0	GPS Location	0		
Field Station#	15419+00	Field Station#	15412+00		
Pic 9 Desc.	Waterbar end treatment in acceptable condition	Pic 10 Desc.	Super silt fence and CFS in acceptable conditions		
44°NE (T) 36°55'48"N, 79°31'48"W ±16420ft ▲816ft

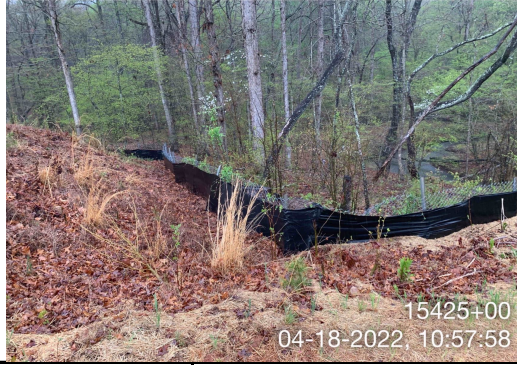
GPS Location	0	GPS Location	0		
Field Station#	15425+00	Field Station#	15478+00		
Pic 11 Desc.	Super silt fence in acceptable condition	Pic 12 Desc.	Solar farm ECDs appear to be in acceptable conditions

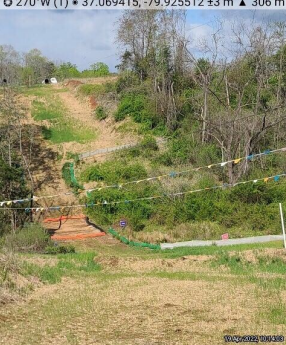
GPS Location	00000	GPS Location	0000		
Field Station#	13806+90	Field Station#	13784+20		
Pic 1 Desc.	Row photo showing stabilization on hill sides above stream crossing, all ECDs in place and functioning at the time of inspection.		Pic 2 Desc.	Rock lined channel and plunge pool observed and functional after recent rain events.	
	East Elevation 293°W (T) • 37.06978, -79.932821 ±7 m ▲ 305 m

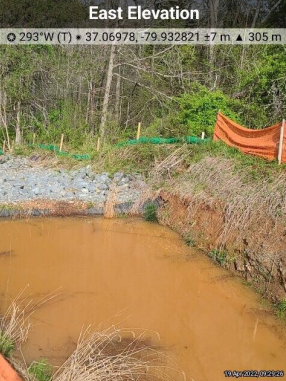
GPS Location	0000	GPS Location	0000		
Field Station#	13784+35	Field Station#	13840+20		
Pic 3 Desc.	Observed sump pit and ECDs after recent rain events, all functioning properly at the time of inspection.		Pic 4 Desc.	Monitored clean water diversion pipe and sump pit during inspection today, no issues observed at the time of inspection.

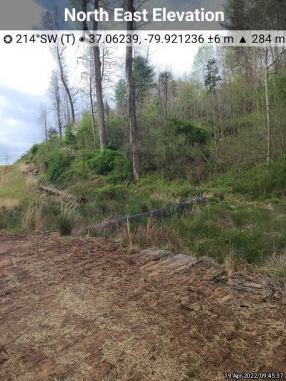
GPS Location	00000	GPS Location	00000		
Field Station#	13840+20	Field Station#	13826+90		
Pic 5 Desc.	Additional photo showing clean water diversion pipe in place. No issues observed at the time of inspection.		Pic 6 Desc.	Monitored ECDs along the LOD, observed sump pits throughout the row. No environmental issues observed at the time of inspection.

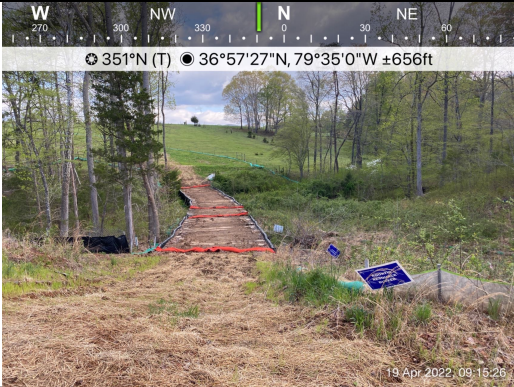
GPS Location	0	GPS Location	0		
Field Station#	15103+75	Field Station#	15126+40		
Pic 3 Desc.	Approximately 15103+75. Overview of stream crossings, equipment bridges and ECDs at streams S-G8 S-Q15.		Pic 4 Desc.	Approximately 15126+40. Overview of stream crossing, equipment bridge and ECDs at stream S-A6.

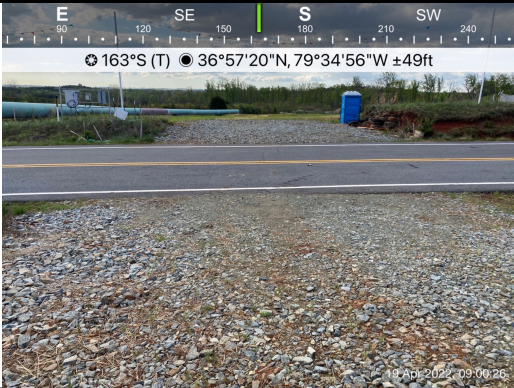
GPS Location	0	GPS Location	0		
Field Station#	15112+50	Field Station#	15100+00		
Pic 5 Desc.	Approximately 15112+50. Overview of road crossing and RCEs.		Pic 6 Desc.	Approximately 15100+00. Overview of ROW. Permanent vegetation.

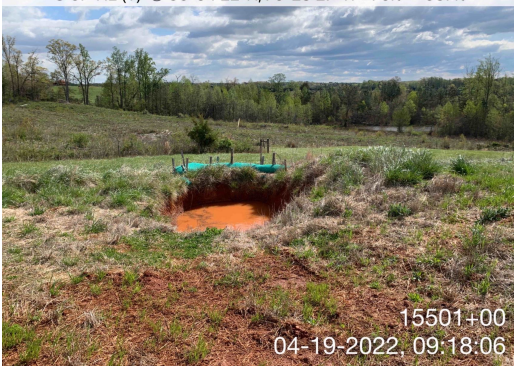
GPS Location	0		GPS Location	0	
Field Station#	15501+00		Field Station#	15520+50	
Pic 1 Desc.	Waterbar end treatment in acceptable condition		Pic 2 Desc.	Sensitive resource buffer and P1 silt fence in acceptable conditions

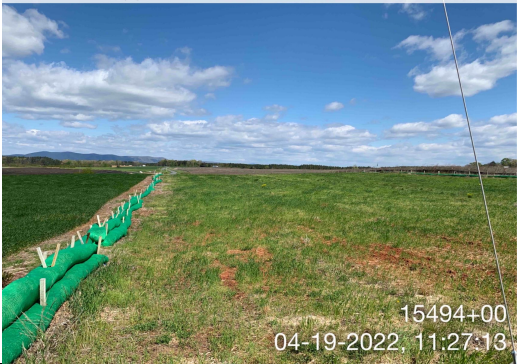
15578+00 04-19-2022, 12:10:57			
GPS Location	0	GPS Location	0		
Field Station#	15494+00	Field Station#	15578+00		
Pic 7 Desc.	Permanent vegetative stabilization and perimeter CFS in acceptable conditions	Pic 8 Desc.	Slope drain pipe in acceptable condition		
52°NE (T) 36°53'25"N, 79°29'0"W ±15803ft ▲ 832ft

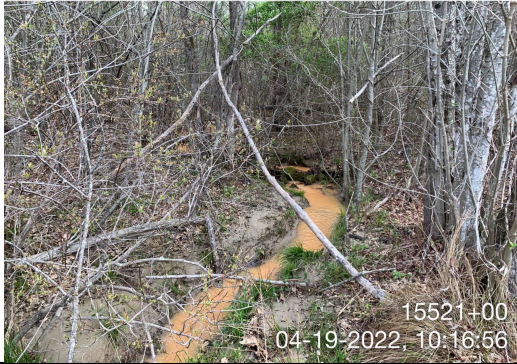
15542+19 04-19-2022, 10:35:22			
GPS Location	0	GPS Location	0		
Field Station#	15521+00	Field Station#	15542+19		
Pic 9 Desc.	Turbid water entering MVP ROW at stream S-MM8 from upstream activities not related to MVP	Pic 10 Desc.	Turbid water entering MVP ROW at stream S-CC5 from upstream activities not related to MVP

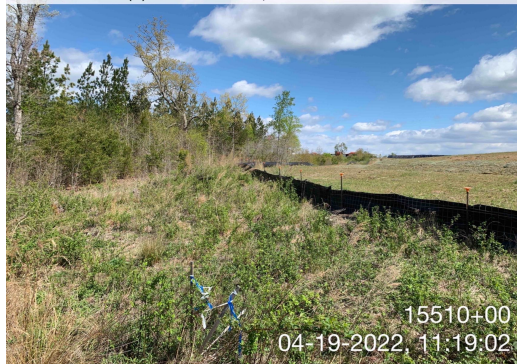
15504+00 04-19-2022, 11:22:44			
GPS Location	0	GPS Location	0		
Field Station#	15510+00	Field Station#	15504+00		
Pic 11 Desc.	Solar farm ECDs appear to be in acceptable conditions	Pic 12 Desc.	Solar farm ECDs appear to be in acceptable conditions

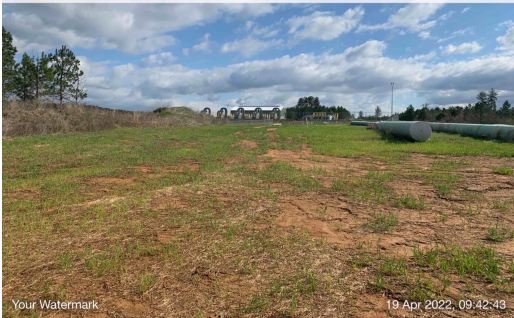
<small>Your Watermark 19 Apr 2022, 09:42:56</small>			
GPS Location	O	GPS Location	O		
Field Station#	16023+00	Field Station#	16020+00		
Pic 1 Desc.	Observing temporary stabilization	Pic 2 Desc.	Observing temporary stabilization and water bar		
North Elevation 181°S (T) 36°49'49"N, 79°20'42"W ±6660ft ▲615ft

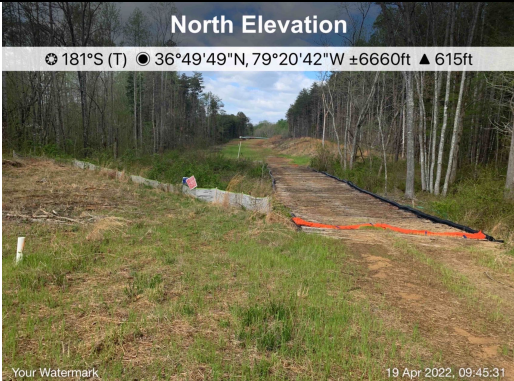
<small>Your Watermark 19 Apr 2022, 09:47:41</small>			
GPS Location	O	GPS Location	O		
Field Station#	16016+36	Field Station#	16010+00		
Pic 3 Desc.	Observing temporary stabilization, signage, buffer, equipment crossing and ECD's	Pic 4 Desc.	Observing temporary stabilization, CWD outlet and ECD's

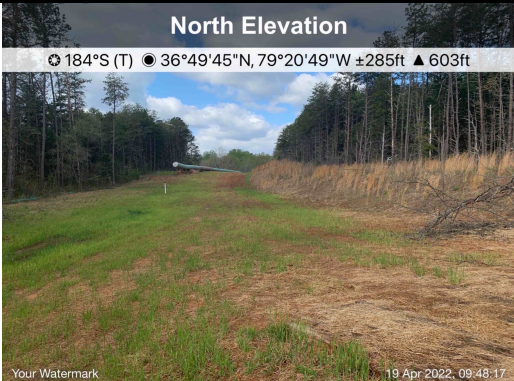
<small>Your Watermark 19 Apr 2022, 09:49:34</small>			
GPS Location	O	GPS Location	O		
Field Station#	16008+00	Field Station#	16005+00		
Pic 5 Desc.	Observing temporary stabilization and CWD berm	Pic 6 Desc.	Observing temporary stabilization, sump and end treatment

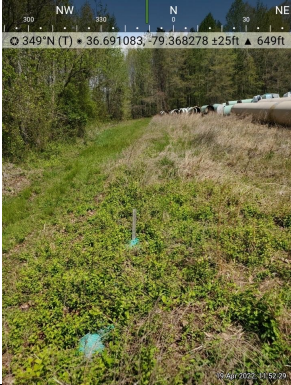
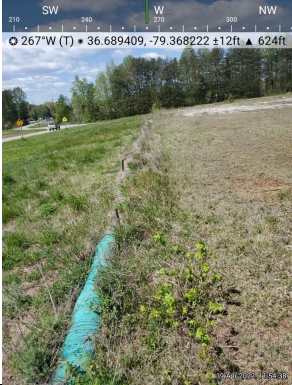
GPS Location	0	GPS Location	0		
Field Station#	0+00	Field Station#	0+00		
Pic 7 Desc.	LY-048 West Perimeter CFS	Pic 8 Desc.	LY-048 South perimeter CFS		
Insert image here		Insert image here			
GPS Location		GPS Location			
Field Station#		Field Station#			
Pic 9 Desc.		Pic 10 Desc.			
Insert image here		Insert image here			
GPS Location		GPS Location			
Field Station#		Field Station#			
Pic 11 Desc.		Pic 12 Desc.

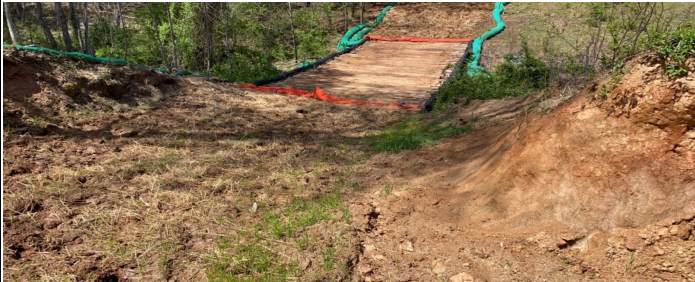
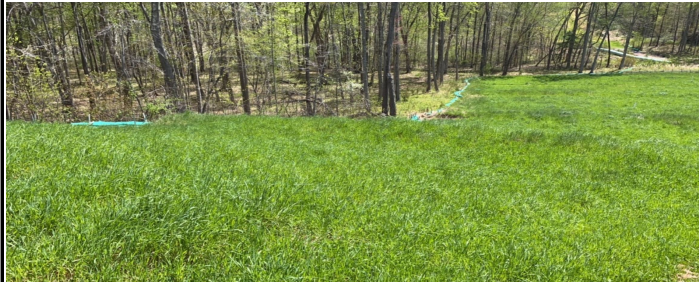
36°59'16" N 79°43'2" W 279°W COURSE 288° GPS Union Hall, VA 24176, United States 04.19.2022 12:19:31 Accur +/-99.3 Ft ALT 967 Ft			36°59'24" N 79°43'24" W 140°SE COURSE -1° GPS 9400-9598 Old Franklin Tpke, Union Hall, VA 24176, United States 04.19.2022 11:57:05 Accur +/-49.0 Ft ALT 979 Ft		
GPS Location	1	GPS Location	2		
Field Station#	14673+10	Field Station#	14652+00		
Pic 1 Desc.	Routine maintenance. Minor erosion channel leading to bridge wattles overtopping with sediment. Repair and stabilize area.		Pic 2 Desc.	ROW stabilized and vegetated in final cleanup area. Water bars in place and functional.

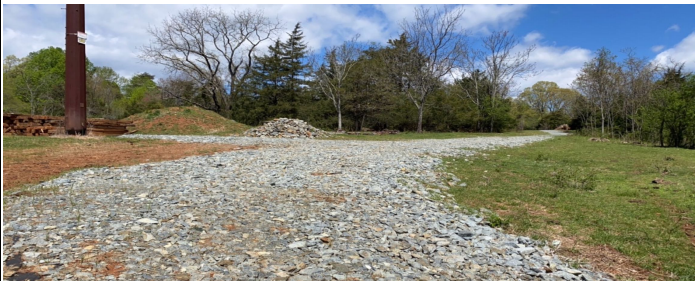
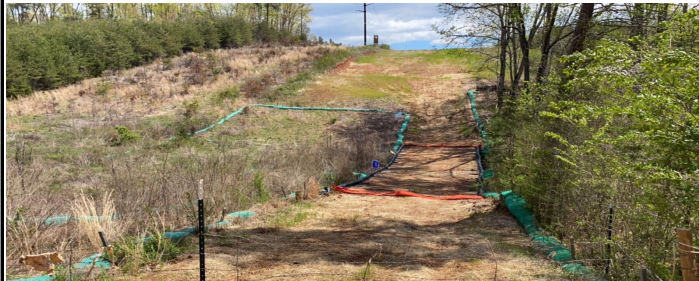
36°59'17" N 79°42'58" W 339°N COURSE 289° GPS Union Hall, VA 24176, United States 04.19.2022 12:17:55 Accur +/-47.1 Ft ALT 966 Ft			36°59'16" N 79°42'54" W 107°E COURSE 55° GPS Union Hall, VA 24176, United States 04.19.2022 12:16:11 Accur +/-74.9 Ft ALT 951 Ft		
GPS Location	5	GPS Location	6		
Field Station#	14676+75	Field Station#	14680+37		
Pic 5 Desc.	RCE for access road in good condition.		Pic 6 Desc.	Equipment bridge and surrounding ECDs in place and functional at stream crossing and resource buffer.

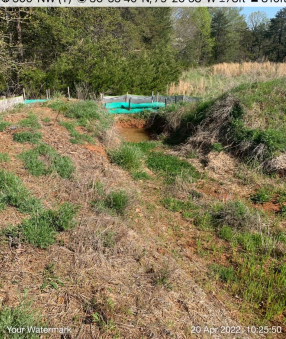
Your Watermark 20 Apr 2022 10:25:50			South East Elevation 329°NW (T) 36°53'39"N, 79°26'54"W ±301ft ▲ 829ft   Your Watermark 20 Apr 2022 10:28:44	
GPS Location	O	GPS Location	O		
Field Station#	15585+00	Field Station#	15590+00		
Pic 1 Desc.	Observing temporary stabilization, water bar, sump, end treatment and ECD's	Pic 2 Desc.	Observing temporary stabilization and water bars		
	East Elevation 249°W (T) 36°53'33"N, 79°26'23"W ±22ft ▲ 818ft   Your Watermark 20 Apr 2022 10:36:09			North West Elevation 134°SE (T) 36°53'38"N, 79°24'47"W ±16325ft ▲ 824ft   Your Watermark 20 Apr 2022 10:42:18	
GPS Location	O	GPS Location	O		
Field Station#	15614+94	Field Station#	15619+48		
Pic 3 Desc.	Observing temporary stabilization, signage, buffer, equipment crossing and ECD's	Pic 4 Desc.	Observing road crossing and RCE's

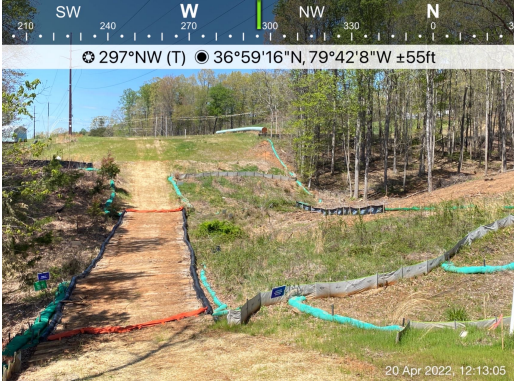
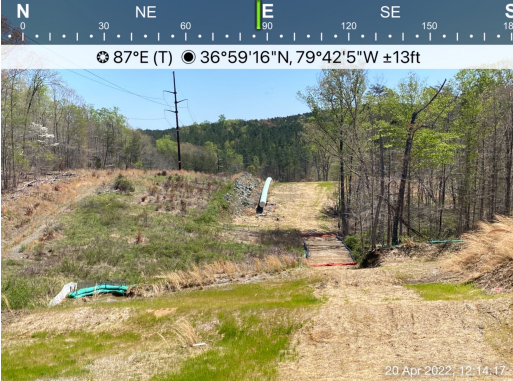
GPS Location	0	GPS Location	0		
Field Station#	14716+92	Field Station#	14722+50		
Pic 3 Desc.	Approximately 14716+92. Overview of stream crossing, equipment bridge and ECDs at stream S-H30. Third party disturbance along and beyond LOD north end uphill of wetland.		Pic 4 Desc.	Approximately 14722+50. Overview of ROW.

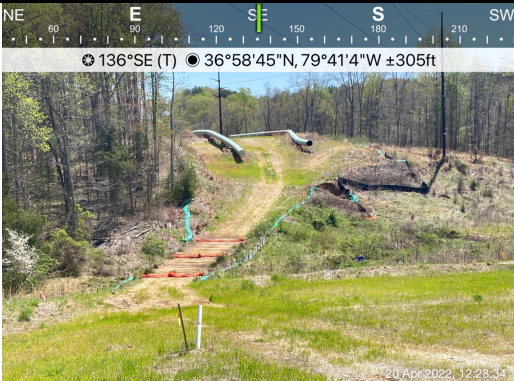
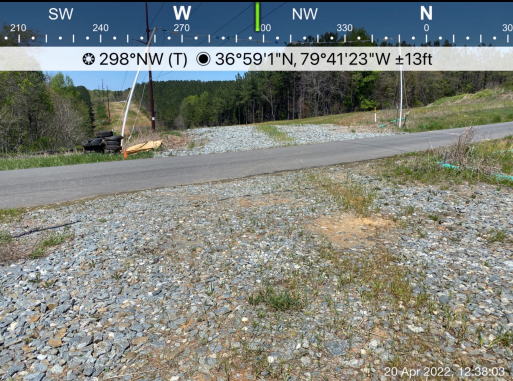
GPS Location	0	GPS Location	0		
Field Station#	14782+25	Field Station#	14758+00		
Pic 5 Desc.	Approximately 14782+25. Overview of ROW.		Pic 6 Desc.	Approximately 14758+00. Overview of road crossing and RCES.

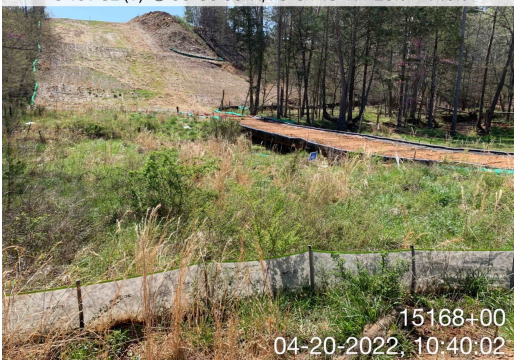
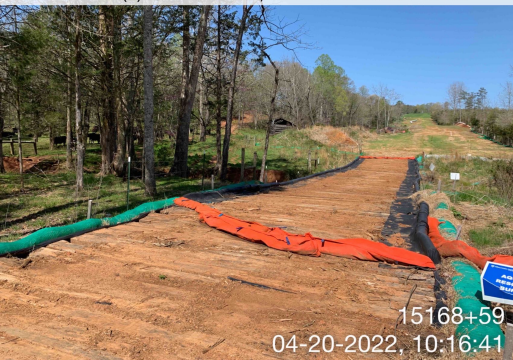
GPS Location	0	GPS Location	0		
Field Station#	15168+00	Field Station#	15168+59		
Pic 5 Desc.	P1 silt fence and sensitive resource buffer in acceptable conditions	Pic 6 Desc.	Equipment bridge in acceptable condition

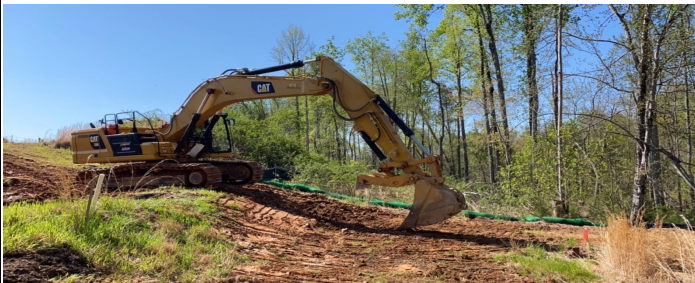
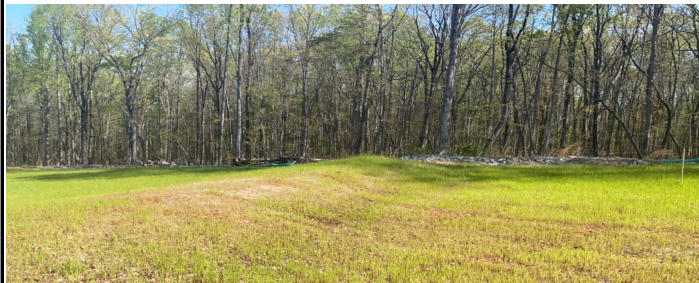
Pic 3 Desc.	Contractor performing environmental maintenance in section.		Pic 4 Desc.	Water bar performing intended function. ROW stabilized and vegetated in temporary area.

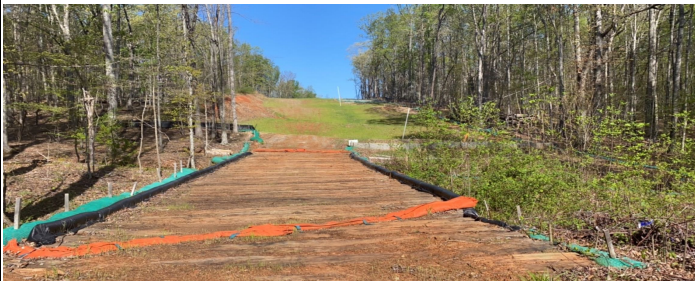
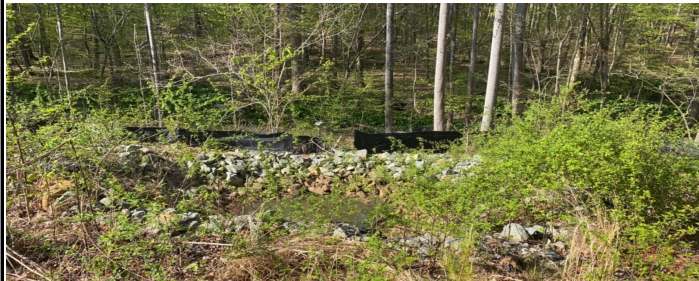
37°1'43" N 79°46'28" W 316°NW COURSE 297° GPS Glade Hill, VA 24092, United States 04.20.2022 09:52:47 Accur +/-46.0 Ft ALT 1025 Ft			37°1'40" N 79°46'16" W 293°W COURSE 304° GPS Glade Hill, VA 24092, United States 04.20.2022 09:49:12 Accur +/-913.6 Ft ALT 1104 Ft		
GPS Location	5		GPS Location	6	
Field Station#	14438+33		Field Station#	14443+00	
Pic 5 Desc.	Equipment bridge and surrounding ECDs in place and functional at stream crossing and resource buffer.		Pic 6 Desc.	Plunge pool performing intended function.

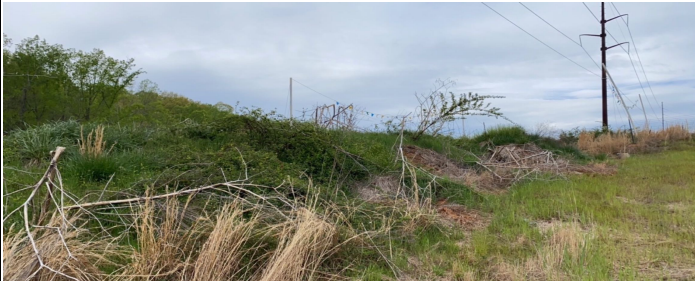
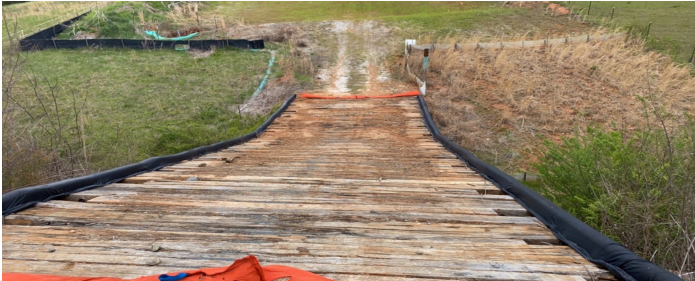
37°020' N 79°45'10" W 323°NW COURSE 271' GPS 1-99 Tobacco Rd, Glade Hill, VA 24092, United States 04.21.2022 14:19:45 Accur +/-15.3 Ft ALT 946 Ft			37°020' N 79°45'10" W 299°NW COURSE 282' GPS 1-99 Tobacco Rd, Glade Hill, VA 24092, United States 04.21.2022 14:19:43 Accur +/-15.3 Ft ALT 944 Ft		
GPS Location	5		GPS Location	6	
Field Station#	14537+50		Field Station#	14546+33	
Pic 5 Desc.	Temporary diversion berm stabilized and vegetated.		Pic 6 Desc.	Equipment bridge and surrounding ECDs in place and functional at stream crossing and resource buffer.

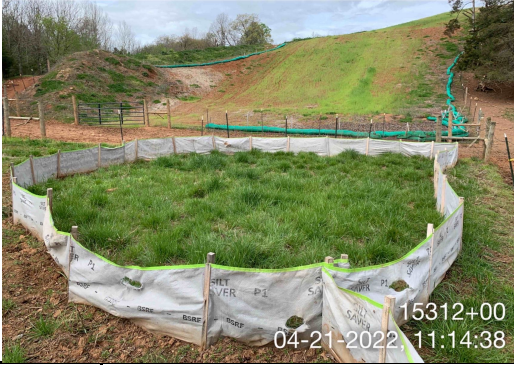
15312+00 04-21-2022, 11:14:38	
GPS Location	0	GPS Location	0		
Field Station#	15312+00	Field Station#	15359+00		
Pic 1 Desc.	P1 silt fence damaged by livestock (4 panels)	Pic 2 Desc.	Waterbar in acceptable condition		
⬤ 356°N (T) ⬤ 36°55'24"N, 79°30'49"W ±19ft ▲ 745ft

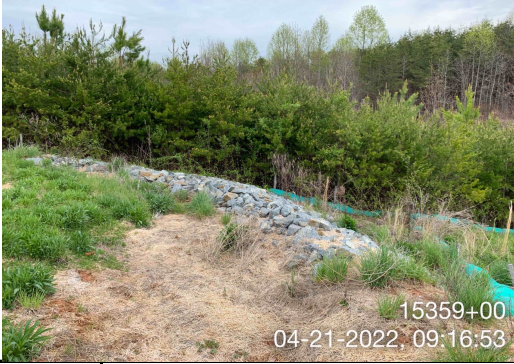
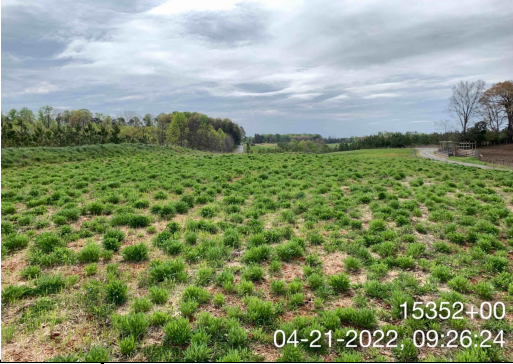
15359+00 04-21-2022, 09:16:53	
GPS Location	0	GPS Location	0		
Field Station#	15359+00	Field Station#	15352+00		
Pic 3 Desc.	Waterbar end treatment in acceptable condition	Pic 4 Desc.	Permanent vegetative stabilization in acceptable condition		
⬤ 125°SE (T) ⬤ 36°55'37"N, 79°31'10"W ±118ft ▲ 781ft

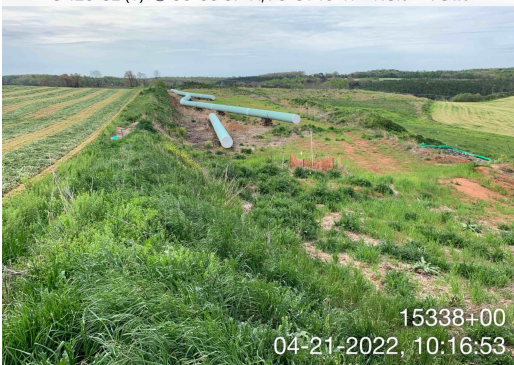
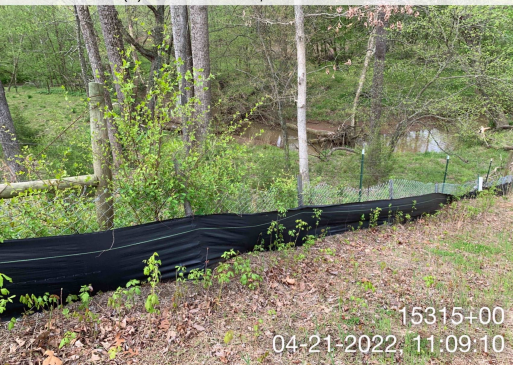
GPS Location	0	GPS Location	0		
Field Station#	15338+00	Field Station#	15315+00		
Pic 5 Desc.	Clean water diversion berm and temporary vegetative stabilization in acceptable condition	Pic 6 Desc.	Super silt fence in acceptable condition

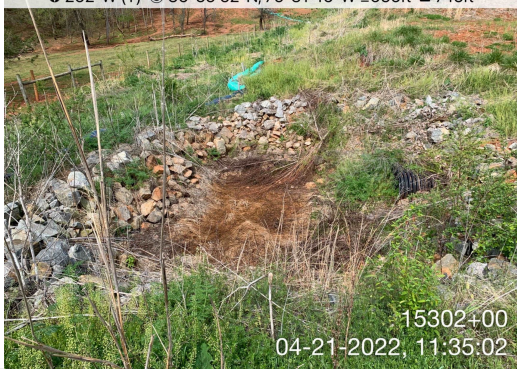
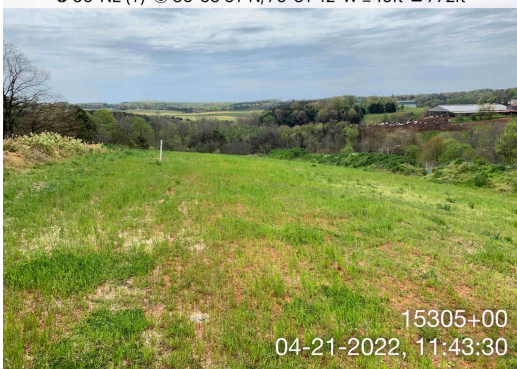
GPS Location	0	GPS Location	0		
Field Station#	15302+00	Field Station#	15305+00		
Pic 9 Desc.	Clean water diversion pipe and plunge pool in acceptable conditions		Pic 10 Desc.	Temporary vegetative stabilization in acceptable condition	
Insert image here		Insert image here			
GPS Location		GPS Location			
Field Station#		Field Station#			
Pic 11 Desc.			Pic 12 Desc.

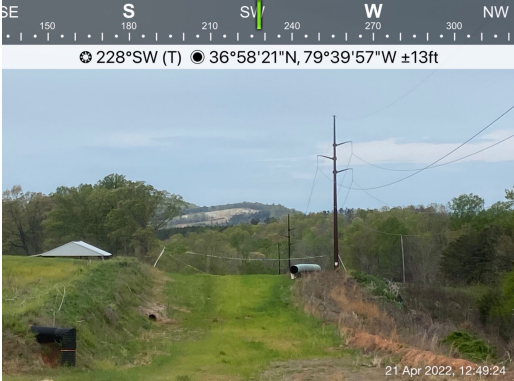
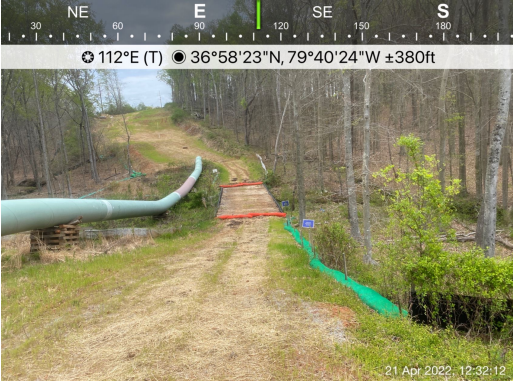
GPS Location	0	GPS Location	0		
Field Station#	14840+00	Field Station#	14823+50		
Pic 3 Desc.	Approximately 14840+00. Overview of ROW.	Pic 4 Desc.	Approximately 14823+50. Overview of stream crossing, equipment bridge and ECDs at stream S-A13.

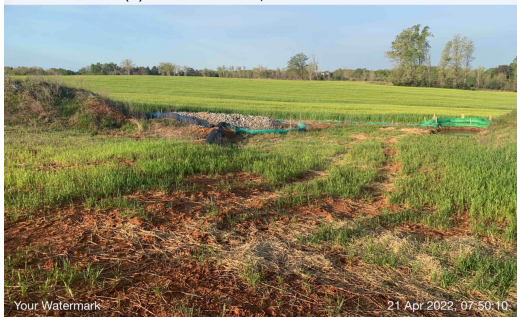
GPS Location	O	GPS Location	O		
Field Station#	15700+40	Field Station#	15734+50		
Pic 7 Desc.	Observing temporary stabilization, signage, buffer, equipment crossing and ECD's	Pic 8 Desc.	Observing safety fence that requires maintenance		
North Elevation 196°S (T) 36°52'24"N, 79°24'41"W ±13ft ▲ 868ft

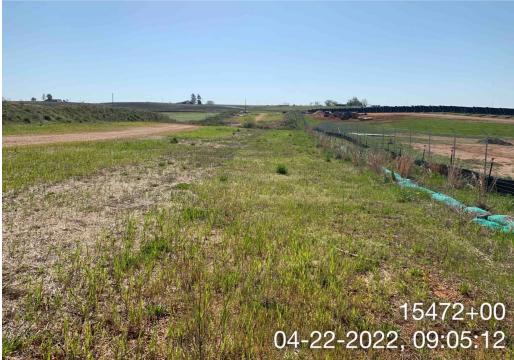
<p>15472+00 04-22-2022, 09:05:12</p>

<p>15462+00 04-22-2022, 09:21:06</p>			
GPS Location	0	GPS Location	0		
Field Station#	15472+00	Field Station#	15462+00		
Pic 1 Desc.	Temporary vegetative stabilization and perimeter CFS in acceptable conditions	Pic 2 Desc.	Waterbar in acceptable condition

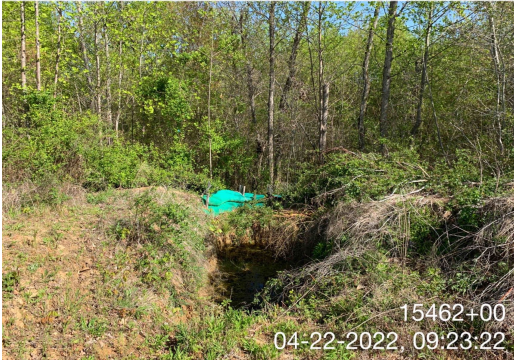
<p>15462+00 04-22-2022, 09:23:22</p>

<p>15457+00 04-22-2022, 09:43:27</p>			
GPS Location	0	GPS Location	0		
Field Station#	15462+00	Field Station#	15457+00		
Pic 3 Desc.	Waterbar end treatment in acceptable condition	Pic 4 Desc.	Sump pit in acceptable condition

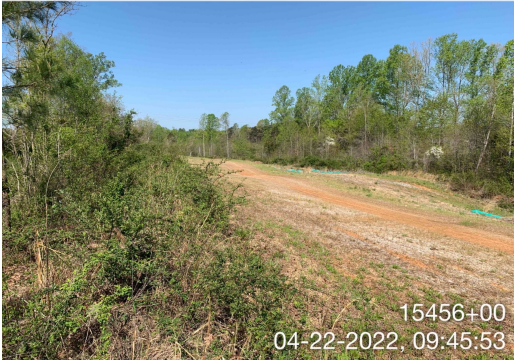
<p>15456+00 04-22-2022, 09:45:53</p>

<p>15447+00 04-22-2022, 10:18:59</p>			
GPS Location	0	GPS Location	0		
Field Station#	15456+00	Field Station#	15447+00		
Pic 5 Desc.	Clean water diversion berm in acceptable condition	Pic 6 Desc.	P1 silt fence in acceptable condition

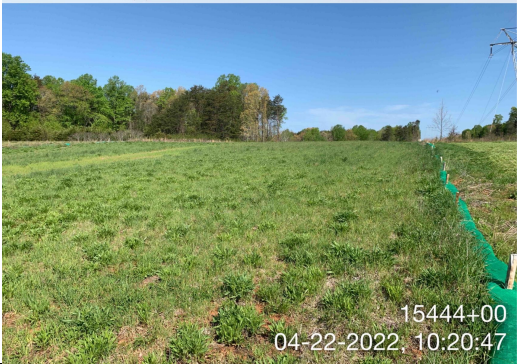
GPS Location	0	GPS Location	0		
Field Station#	15444+00	Field Station#	15413+00		
Pic 7 Desc.	Permanent vegetative stabilization and perimeter CFS in acceptable conditions	Pic 8 Desc.	Super silt fence in acceptable condition		
113°SE (T) 36°55'3"N, 79°29'48"W ±16ft ▲ 780ft

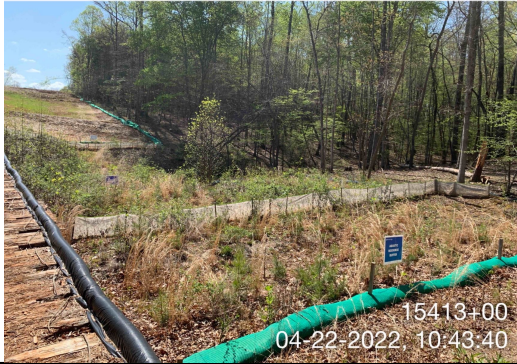
GPS Location	0	GPS Location	0		
Field Station#	15413+00	Field Station#	15379+00		
Pic 9 Desc.	CFS and P1 silt fence in acceptable conditions	Pic 10 Desc.	Temporary vegetative stabilization in acceptable condition		
226°SW (T) 36°54'45"N, 79°29'0"W ±13ft ▲ 850ft

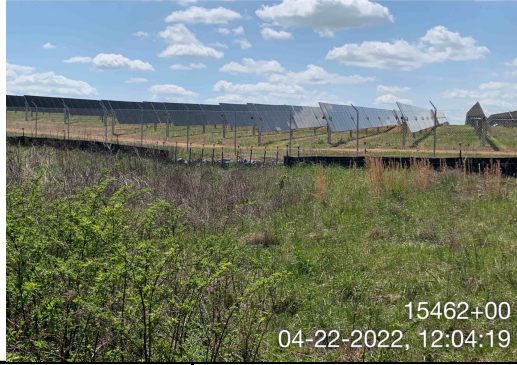
Insert image here			
GPS Location	0	GPS Location			
Field Station#	15462+00	Field Station#			
Pic 11 Desc.	Solar farm ECDs appear to be in acceptable conditions	Pic 12 Desc.

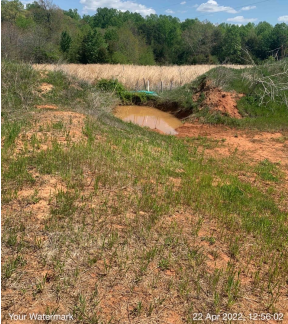
</div> <div>Your Watermark 22 Apr 2022, 12:57:53</div>			
GPS Location		O		GPS Location		O	
Field Station#		15776+00		Field Station#		15781+22	
Pic 1 Desc.		Observing temporary stabilization,water bar, sump and end treatment		Pic 2 Desc.		Observing temporary stabilization, signage, buffer, equipment crossing and ECD's	
		<div>North Elevation</div> <div>182°S (T) 36°52'15"N, 79°23'59"W ±12942ft ▲ 810ft</div> <div>

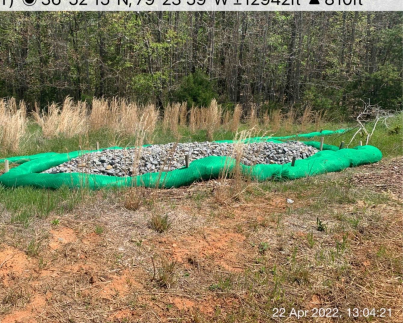
GPS Location		O		GPS Location		O	
Field Station#		15778+00		Field Station#		15794+77	
Pic 3 Desc.		Observing temporary stabilization,CWD outlet and ECD's		Pic 4 Desc.		Observing temporary stabilization,water bar,signage, buffer, equipment crossing and ECD's	
		<div>South East Elevation</div> <div>322°NW (T) 36°51'20"N, 79°23'36"W ±150ft ▲ 845ft</div> <div>

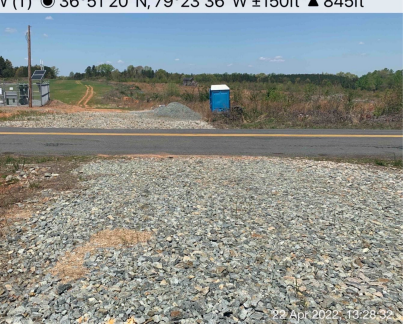
</div> <div>Your Watermark 22 Apr 2022, 13:30:11</div>	
GPS Location		O		GPS Location		O	
Field Station#		15826+77		Field Station#		15825+00	
Pic 5 Desc.		Observing road crossing RCE's		Pic 6 Desc.		Observing temporary stabilization,plunge pool and ECD's

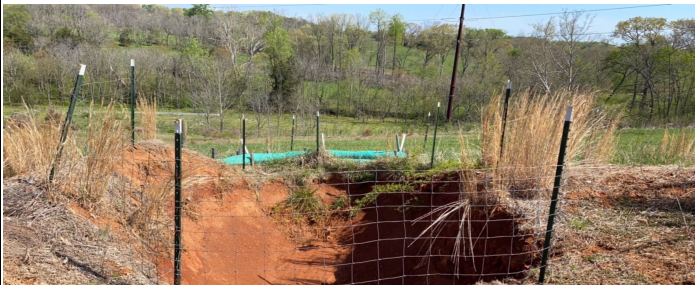
37°0'0" N 79°44'30" W 352°N COURSE 304° GPS 753 Simmons Creek Rd, Union Hall, VA 24176, United States 04.22.2022 10:56:34 Accur +/-33.4 Ft ALT 888 Ft			37°0'0" N 79°44'29" W 220°SW COURSE 110° GPS 753 Simmons Creek Rd, Union Hall, VA 24176, United States 04.22.2022 10:57:13 Accur +/-37.1 Ft ALT 888 Ft		
GPS Location	1	GPS Location	2		
Field Station#	14582+85	Field Station#	14587+00		
Pic 1 Desc.	Equipment bridge and surrounding ECDs in place and functional at stream crossing and resource buffer.		Pic 2 Desc.	Water bar performing intended function.

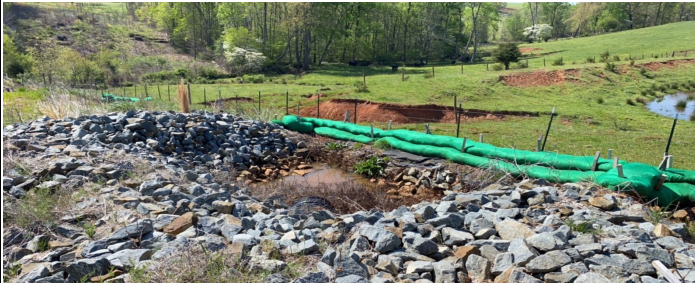
GPS Location	3	GPS Location	4		
Field Station#	14591+00	Field Station#	14595+00		
Pic 3 Desc.	Sump pit and CFS end treatment performing intended functions.		Pic 4 Desc.	ROW stabilized and vegetated in temporary area.
