Visual Site Inspection Report

Project Name	H-603 Pipeline Spread I	AFE	124300139	Spread	H-603 Pipeline Spread I	
Contractor	Precision			Report #	36934	
Inspector	John White			Date/Time	4/25/2022 11:20 AM	
Permit #	TBD	Inspection Type	VA SWPP	Station Begin	00+00	
State	VA	Inspection Area	Full	Station End	24+53	
County	Pittsylvania	Ground	Dry	Temperature (°F)	80.00	
Municipality	Chatham	Weather	Sunny	Rain Gauge (in)	0.00	
				Rain Accumulation Time (days)	6.00

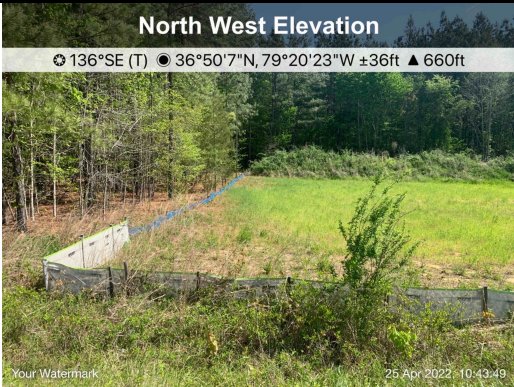
GPS Location	O	GPS Location	O		
Field Station#	14+00	Field Station#	22+00		
Pic 1 Desc.	Observing temporary stabilization and ECD's	Pic 2 Desc.	Observing temporary stabilization, signage and buffer		
East Elevation 259°W (T) 36°50'4"N, 79°20'30"W ±131ft ▲ 645ft

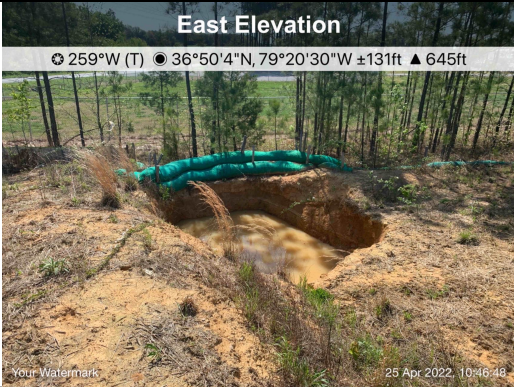
GPS Location	O	GPS Location	O		
Field Station#	12+00	Field Station#	6+00		
Pic 3 Desc.	Observing temporary stabilization, water bar, sump and end treatment	Pic 4 Desc.	Observing temporary stabilization		
Insert image here			Insert image here		
GPS Location		GPS Location			
Field Station#		Field Station#			
Pic 5 Desc.		Pic 6 Desc.

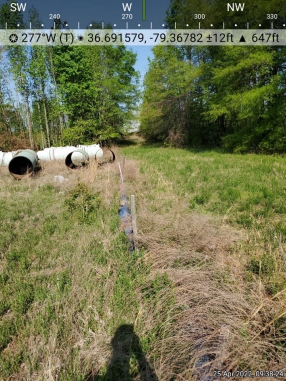
GPS Location	0	GPS Location	0		
Field Station#	0+00	Field Station#	0+00		
Pic 1 Desc.	LY-048 North perimeter CFS		Pic 2 Desc.	LY-048 Temporary vegetation

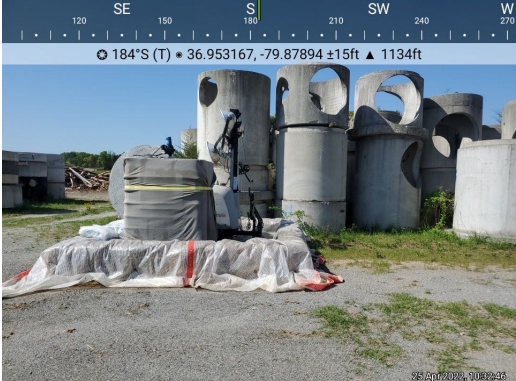
GPS Location	0	GPS Location	0		
Field Station#	0+00	Field Station#	0+00		
Pic 3 Desc.	ANC-006 Secondary containment		Pic 4 Desc.	ANC-006 Clean out debris from stormwater drain inlet

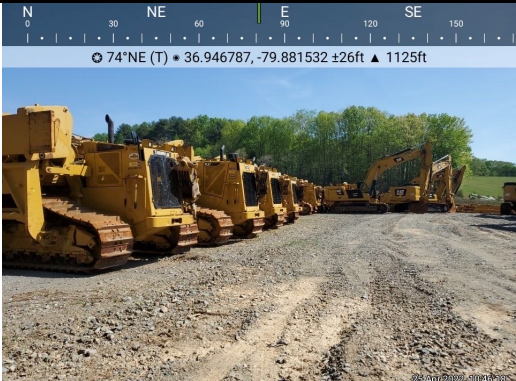
GPS Location	0	GPS Location	0		
Field Station#	0+00	Field Station#	0+00		
Pic 5 Desc.	LY-032 Equipment staging		Pic 6 Desc.	LY-032 Secondary containment's

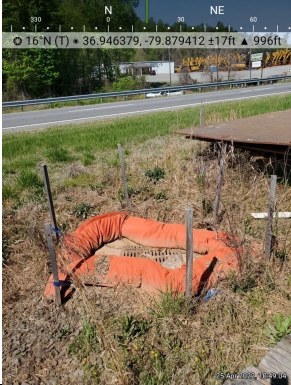
GPS Location	0	GPS Location	0		
Field Station#	0+00	Field Station#	0+00		
Pic 7 Desc.	LY-033 Stormwater drain inlet protection	Pic 8 Desc.	LY-033 Staging area and RCE.		
Insert image here		Insert image here			
GPS Location		GPS Location			
Field Station#		Field Station#			
Pic 9 Desc.		Pic 10 Desc.			
Insert image here		Insert image here			
GPS Location		GPS Location			
Field Station#		Field Station#			
Pic 11 Desc.		Pic 12 Desc.

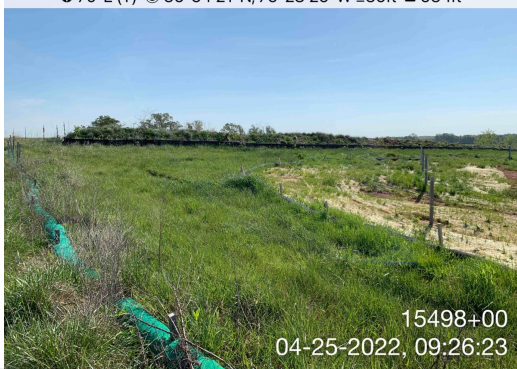
<p style="text-align: center;">Insert image here</p>			
GPS Location	0	GPS Location			
Field Station#	15498+00	Field Station#			
Pic 9 Desc.	Solar farm ECDs appear to be in acceptable conditions		Pic 10 Desc.		
<p style="text-align: center;">Insert image here</p>			<p style="text-align: center;">Insert image here</p>		
GPS Location		GPS Location			
Field Station#		Field Station#			
Pic 11 Desc.			Pic 12 Desc.

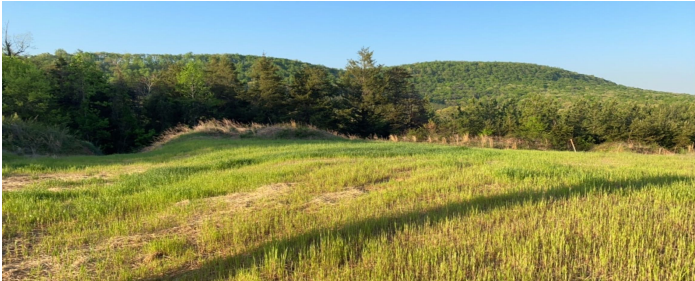
04.25.2022 07:39:39 Accur +/-15.5 Ft ALT 943 Ft			04.25.2022 07:36:54 Accur +/-70.2 Ft ALT 0 Ft		
GPS Location	5		GPS Location	6	
Field Station#	14686+00		Field Station#	14692+00	
Pic 5 Desc.	ROW stabilized and vegetated in temporary area.		Pic 6 Desc.	Water bar performing intended function.

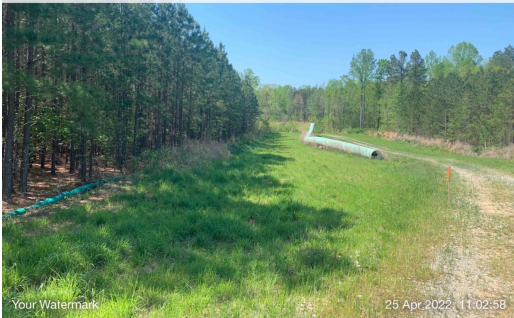
GPS Location	O	GPS Location	O		
Field Station#	6+00	Field Station#	12+65		
Pic 1 Desc.	Observing temporary stabilization and ECD's	Pic 2 Desc.	Observing temporary stabilization, signage, buffer, equipment crossing and ECD's		
South East Elevation 334°NW (T) 36°49'44"N, 79°20'40"W ±13ft ▲619ft

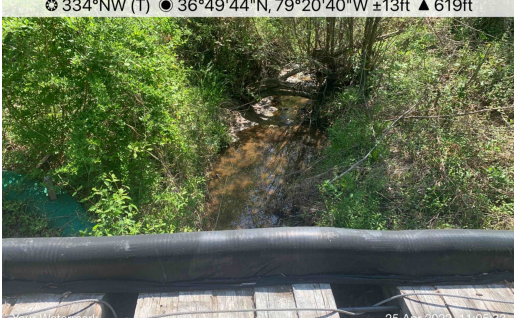
GPS Location	O	GPS Location	O		
Field Station#	12+65	Field Station#	13+50		
Pic 3 Desc.	Observing stream side board on equipment crossing and ECD's	Pic 4 Desc.	Observing temporary stabilization, water bar, sump, end treatment and ECD's		
Insert image here			Insert image here		
GPS Location		GPS Location			
Field Station#		Field Station#

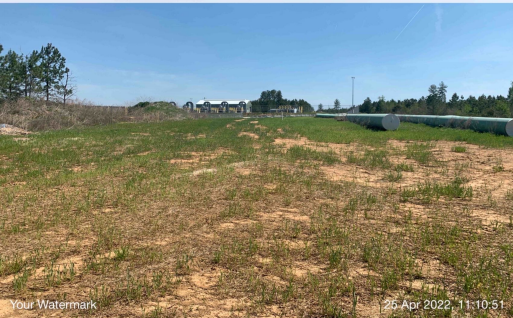
GPS Location	O		GPS Location	O	
Field Station#	15951+72		Field Station#	16024+00	
Pic 1 Desc.	Observing wetland, temporary stabilization, equipment crossing and ECD's		Pic 2 Desc.	Observing temporary stabilization	
North West Elevation 123°SE (T) 36°49'50"N, 79°20'37"W ±32ft ▲ 643ft

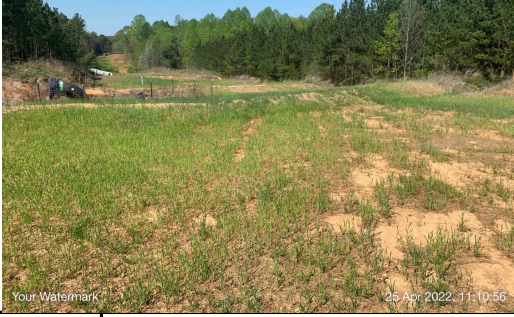
GPS Location	O		GPS Location	O	
Field Station#	16022+00		Field Station#	16020+00	
Pic 3 Desc.	Observing temporary stabilization and water bars		Pic 4 Desc.	Observing temporary stabilization, sump, end treatment and ECD's	
North East Elevation 220°SW (T) 36°49'28"N, 79°22'13"W ±24412ft ▲ 622ft

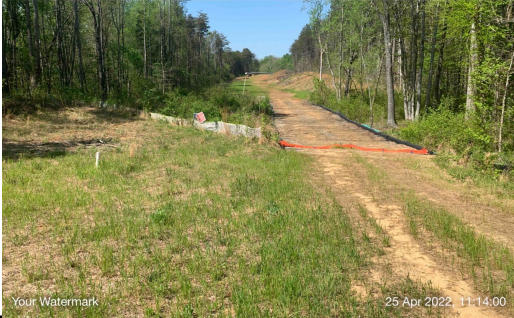
GPS Location	O		GPS Location	O	
Field Station#	16016+36		Field Station#	16016+36	
Pic 5 Desc.	Observing temporary stabilization, signage, buffer, equipment crossing and ECD's		Pic 6 Desc.	Observing side board on equipment crossing and stream

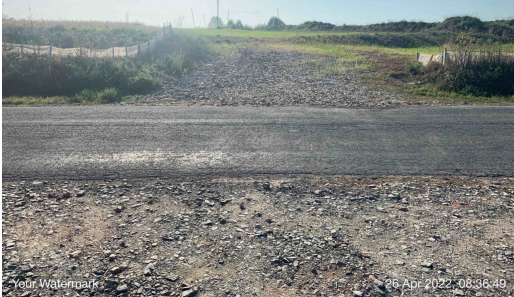
GPS Location	O	GPS Location	O		
Field Station#	15584+23	Field Station#	15590+00		
Pic 1 Desc.	Observing road crossing and RCE's	Pic 2 Desc.	Observing temporary stabilization and water bars		
East Elevation ☉ 292°W (T) ● 36°53'40"N, 79°26'49"W ±167ft ▲ 776ft

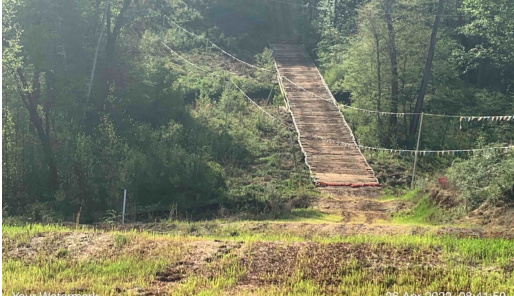
GPS Location	O	GPS Location	O		
Field Station#	15595+60	Field Station#	15617+00		
Pic 3 Desc.	Observing temporary stabilization, water bars, signage, buffer, equipment crossing and ECD's	Pic 4 Desc.	Observing temporary stabilization, water bar, sump and end treatment		
North Elevation ☉ 173°S (T) ● 36°52'54"N, 79°24'32"W ±5433ft ▲ 798ft

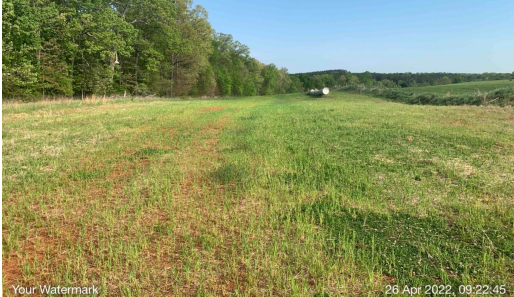
GPS Location	O	GPS Location	O		
Field Station#	15642+00	Field Station#	15636+45		
Pic 5 Desc.	Observing temporary stabilization	Pic 6 Desc.	Observing temporary stabilization, signage, buffer, equipment crossing and ECD's

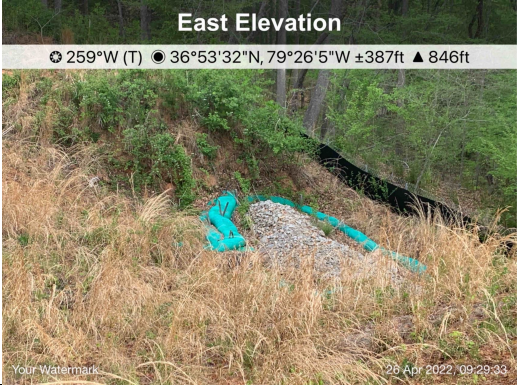
GPS Location	O	GPS Location			
Field Station#	15632+00	Field Station#			
Pic 7 Desc.	Observing temporary stabilization,CWD outlet and ECD's	Pic 8 Desc.			
Insert image here		Insert image here			
GPS Location		GPS Location			
Field Station#		Field Station#			
Pic 9 Desc.		Pic 10 Desc.			
Insert image here		Insert image here			
GPS Location		GPS Location			
Field Station#		Field Station#			
Pic 11 Desc.		Pic 12 Desc.

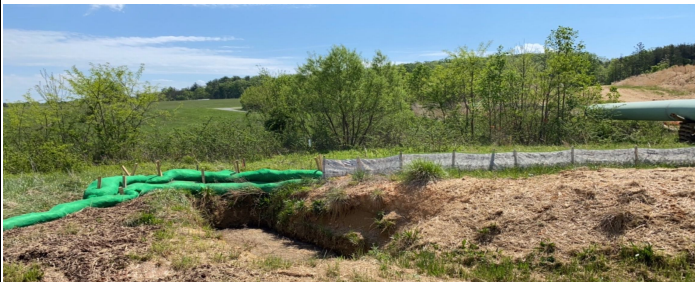
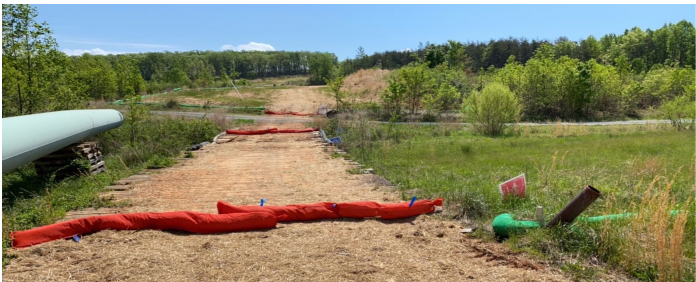
37°2'34" N 79°48'33" W 191°S COURSE 100° GPS 530 Farm View Rd, Glade Hill, VA 24092, United States 04.26.2022 11:54:40 Accur +/-37.1 Ft ALT 1056 Ft			37°2'34" N 79°48'33" W 141°SE COURSE 286° GPS 530 Farm View Rd, Glade Hill, VA 24092, United States 04.26.2022 11:57:11 Accur +/-120.3 Ft ALT 1061 Ft		
GPS Location	1	GPS Location	2		
Field Station#	14313+00	Field Station#	14314+79		
Pic 1 Desc.	Contractor replaced damaged ECDs throughout section.		Pic 2 Desc.	Equipment bridge and surrounding ECDs in place and functional at stream crossing and resource buffer.

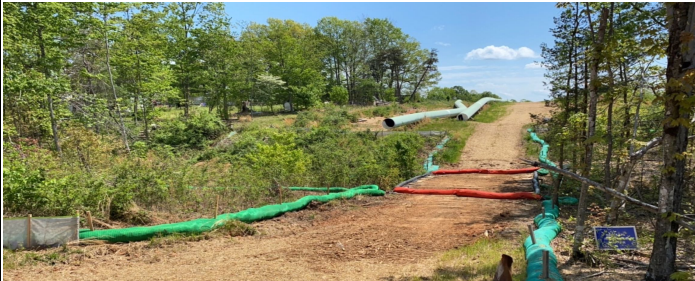
37°2'18" N 79°48'17" W 108°E COURSE 157° GPS 1634-1816 Golden View Rd, Glade Hill, VA 24092, United States 04.26.2022 12:04:25 Accur +/-114.8 Ft ALT 1165 Ft			37°1'35" N 79°46'6" W 57°NE COURSE 153° GPS 2753-2799 Webster Rd, Glade Hill, VA 24092, United States 04.26.2022 12:13:07 Accur +/-15.4 Ft ALT 1092 Ft		
GPS Location	5	GPS Location	6		
Field Station#	14338+56	Field Station#	14454+22		
Pic 5 Desc.	Equipment bridge and surrounding ECDs in place and functional at stream crossing and resource buffer.		Pic 6 Desc.	Contractor replaced rock on RCE after completion of activity in section.

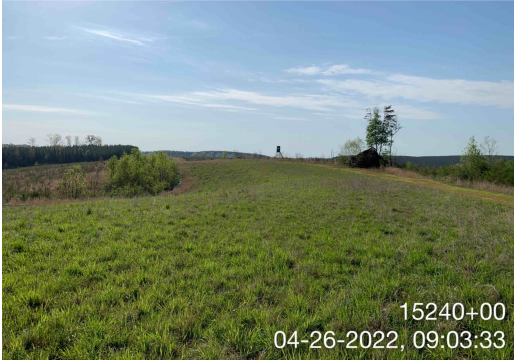
15260+00 04-26-2022, 09:08:42			
GPS Location	0	GPS Location	0		
Field Station#	15240+00	Field Station#	15260+00		
Pic 1 Desc.	Permanent vegetative stabilization in acceptable condition	Pic 2 Desc.	Perimeter CFS in acceptable condition		
27°NE (T) 36°56'23"N, 79°33'36"W ±666ft ▲ 815ft

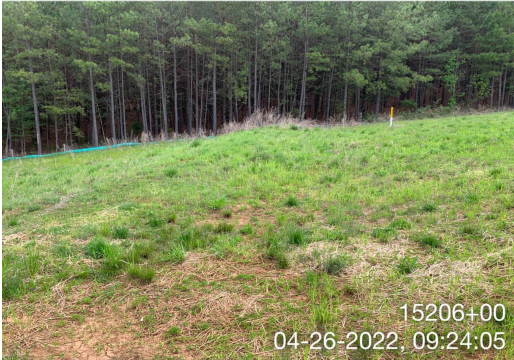
15206+00 04-26-2022, 09:24:41			
GPS Location	0	GPS Location	0		
Field Station#	15206+00	Field Station#	15206+00		
Pic 3 Desc.	Waterbar in acceptable condition	Pic 4 Desc.	Waterbar end treatment in acceptable condition		
274°W (T) 36°56'24"N, 79°33'35"W ±13ft ▲ 831ft

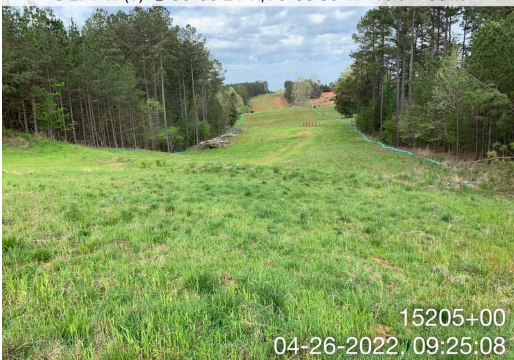
GPS Location	0	GPS Location	0		
Field Station#	15205+00	Field Station#	15159+00		
Pic 5 Desc.	Permanent vegetative stabilization in acceptable condition	Pic 6 Desc.	Waterbar in acceptable condition

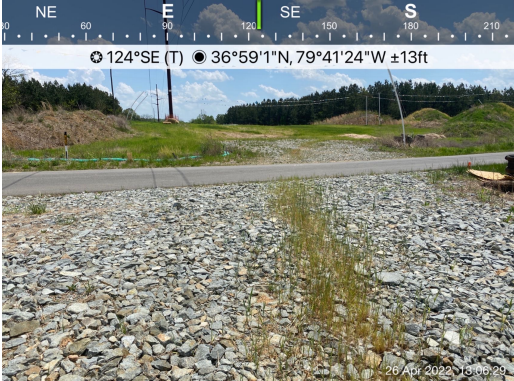
GPS Location	0	GPS Location	0		
Field Station#	14758+00	Field Station#	14775+00		
Pic 3 Desc.	Approximately 14758+00. Overview of road crossing and RCEs.	Pic 4 Desc.	Approximately 14775+00. Overview of ROW.

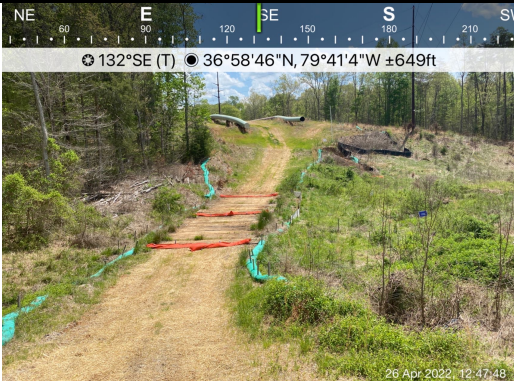
GPS Location	0	GPS Location	0		
Field Station#	14782+25	Field Station#	14788+77		
Pic 5 Desc.	Approximately 14782+25. Overview of stream crossing, equipment bridge and ECDs at stream S-MM48.	Pic 6 Desc.	Approximately 14788+77. Overview of stream crossing, equipment bridge and ECDs at stream S-H25.

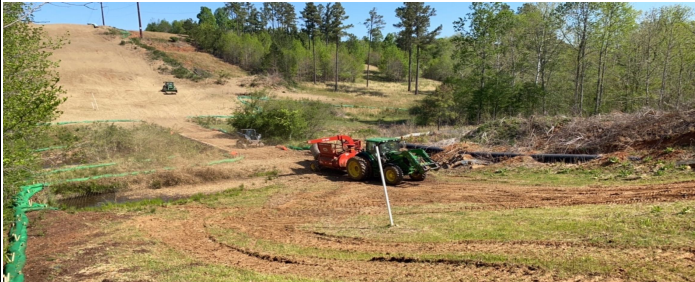
37°1'0" N 79°45'35" W 45°NE COURSE 259' GPS 1142 SR-703, Glade Hill, VA 24092, United States 04.27.2022 10:33:56 Accur +/-15.9 Ft ALT 894 Ft			37°0'47" N 79°45'22" W 255°W COURSE 318' GPS Glade Hill, VA 24092, United States 04.27.2022 10:24:24 Accur +/-15.4 Ft ALT 966 Ft		
GPS Location	1	GPS Location	2		
Field Station#	14496+00	Field Station#	14521+00		
Pic 1 Desc.	Contractor seeding and stabilizing ROW.	Pic 2 Desc.	Contractor removing damaged ECDs per punch list item.

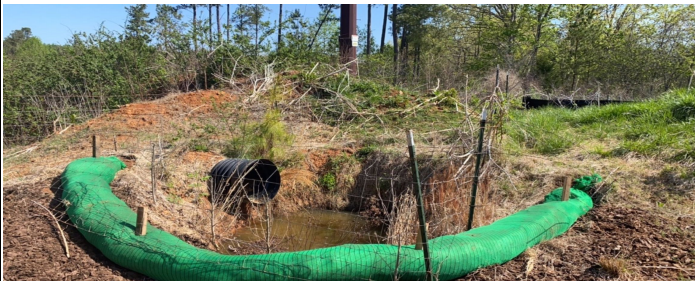
37°0'59" N 79°45'33" W 37°NE COURSE 232' GPS 1979 SR-674, Glade Hill, VA 24092, United States 04.27.2022 10:30:25 Accur +/-102.8 Ft ALT 944 Ft			37°0'52" N 79°45'27" W 33°NE COURSE 334' GPS 1979 SR-674, Glade Hill, VA 24092, United States 04.27.2022 10:26:37 Accur +/-54.4 Ft ALT 961 Ft		
GPS Location	5	GPS Location	6		
Field Station#	14501+50	Field Station#	14509+00		
Pic 5 Desc.	Contractor replaced damaged ECDs per punch list item.	Pic 6 Desc.	Contractor replaced damaged ECDs per punch list item.

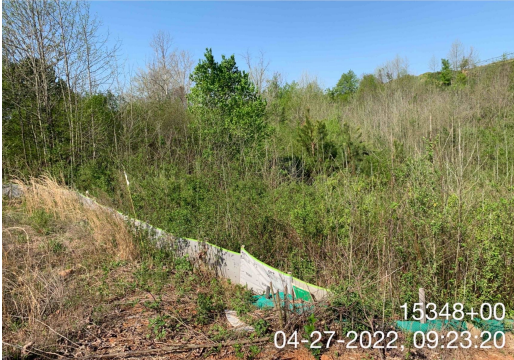
<p>15348+00 04-27-2022, 09:23:20</p>		  <p>15338+00 04-27-2022, 10:02:48</p>			
GPS Location	0	GPS Location	0		
Field Station#	15348+00	Field Station#	15338+00		
Pic 1 Desc.	P1 silt fence in acceptable condition	Pic 2 Desc.	Clean water diversion pipe and plunge pool in acceptable conditions		
  <p>15325+00 04-27-2022, 10:18:19</p>

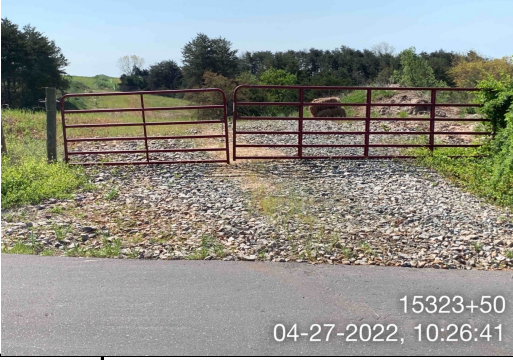
<p>15323+50 04-27-2022, 10:26:41</p>			
GPS Location	0	GPS Location	0		
Field Station#	15325+00	Field Station#	15323+50		
Pic 3 Desc.	Perimeter CFS and temporary vegetative stabilization in acceptable conditions	Pic 4 Desc.	Rock construction entrance in acceptable condition		
  <p>15301+00 04-27-2022, 10:38:02</p>

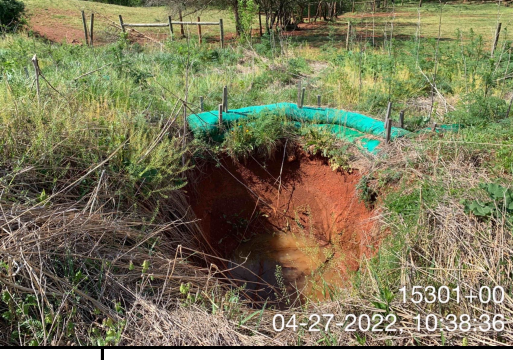
<p>15301+00 04-27-2022, 10:38:36</p>			
GPS Location	0	GPS Location	0		
Field Station#	15301+00	Field Station#	15301+00		
Pic 5 Desc.	Waterbar in acceptable condition	Pic 6 Desc.	Waterbar end treatment in acceptable condition

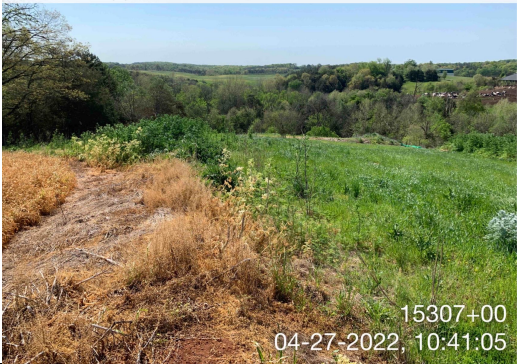
<p>15312+00 04-27-2022, 10:55:06</p>			
GPS Location	0	GPS Location	0		
Field Station#	15307+00	Field Station#	15312+00		
Pic 7 Desc.	Clean water diversion berm and temporary vegetative stabilization in acceptable condition	Pic 8 Desc.	Temporary vegetative stabilization in acceptable condition		
Insert image here		Insert image here			
GPS Location		GPS Location			
Field Station#		Field Station#			
Pic 9 Desc.		Pic 10 Desc.			
Insert image here		Insert image here			
GPS Location		GPS Location			
Field Station#		Field Station#			
Pic 11 Desc.		Pic 12 Desc.

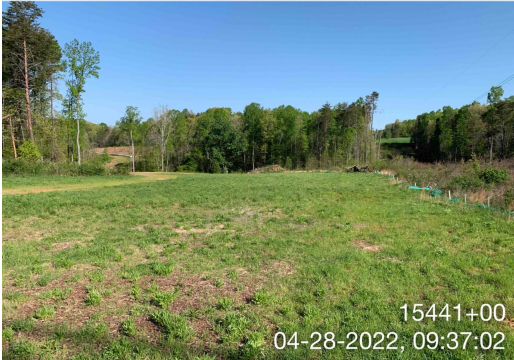
GPS Location	0	GPS Location	0		
Field Station#	15441+00	Field Station#	15434+00		
Pic 3 Desc.	Permanent vegetative stabilization in acceptable condition	Pic 4 Desc.	Waterbar in acceptable condition

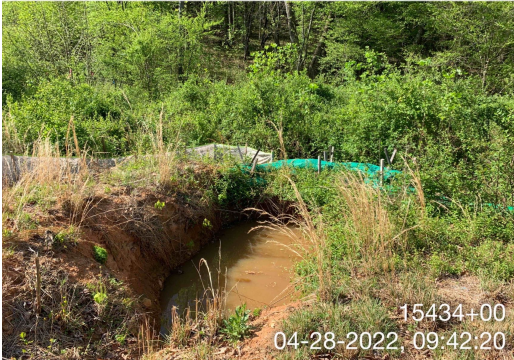
GPS Location	0	GPS Location	0		
Field Station#	15434+00	Field Station#	15428+00		
Pic 5 Desc.	Waterbar end treatment in acceptable condition	Pic 6 Desc.	Super silt fence in acceptable condition

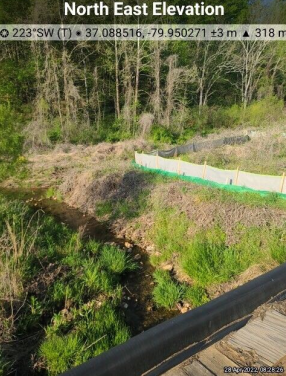
GPS Location	00000	GPS Location	0000		
Field Station#	13678+71	Field Station#	13738+90		
Pic 1 Desc.	Stream observation photo facing downstream during routine inspection today, all ECDs in place and functioning at the time of inspection.		Pic 2 Desc.	Vegetation observation photo in permanent area of row. Good stabilization noted during inspection.	
	North West Elevation

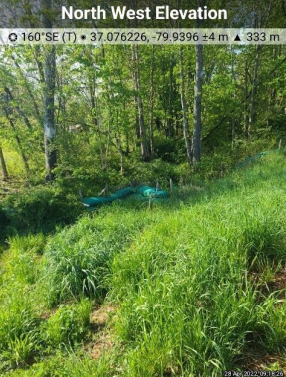
GPS Location	000	GPS Location	0000		
Field Station#	13741+00	Field Station#	13678+71		
Pic 3 Desc.	Monitored sump pit and end treatment during routine inspection, no environmental issues observed at the time of inspection.		Pic 4 Desc.	Stream observation photo facing upstream during routine inspection today. No issues were observed at the time of inspection.	
	North East Elevation

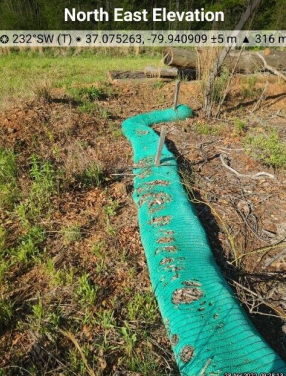
GPS Location	0000	GPS Location	0000		
Field Station#	13747+45	Field Station#	13691+20		
Pic 5 Desc.	CFS requires maintenance due to wildlife damage, documented and added to the punch list.		Pic 6 Desc.	Inspected ECDs round wetland area inside work space, no issues were observed at the time of inspection.

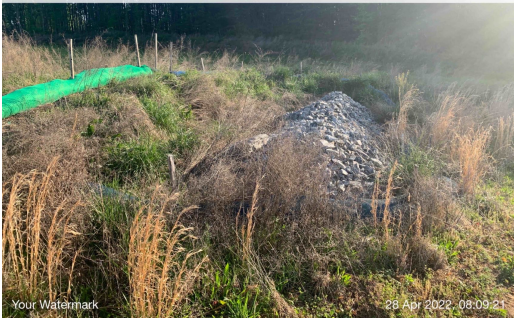
GPS Location	O	GPS Location	O		
Field Station#	15835+00	Field Station#	15837+00		
Pic 1 Desc.	Observing temporary stabilization,CWD outlet and ECD's	Pic 2 Desc.	Observing rock lined channel and ECD's		
South Elevation 20°N (T) 36°51'21"N, 79°23'31"W ±964ft ▲ 837ft

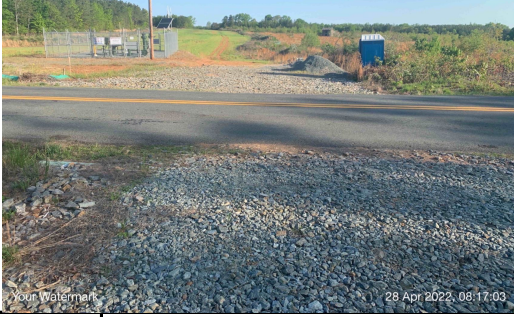
GPS Location	O	GPS Location	O		
Field Station#	15826+77	Field Station#	15825+00		
Pic 3 Desc.	Observing road crossing and RCE's	Pic 4 Desc.	Observing temporary stabilization,plunge pool and ECD's		
North Elevation 191°S (T) 36°51'34"N, 79°23'24"W ±10925ft ▲ 786ft

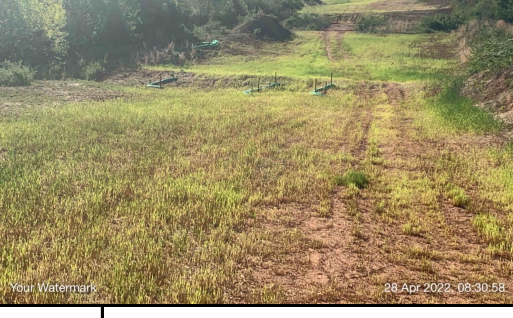
Field Station#	15852+88	Field Station#	15860+00		
Pic 5 Desc.	Observing temporary stabilization, signage, buffer, equipment crossing and ECD's	Pic 6 Desc.	Observing temporary stabilization,water bar and CFS checks

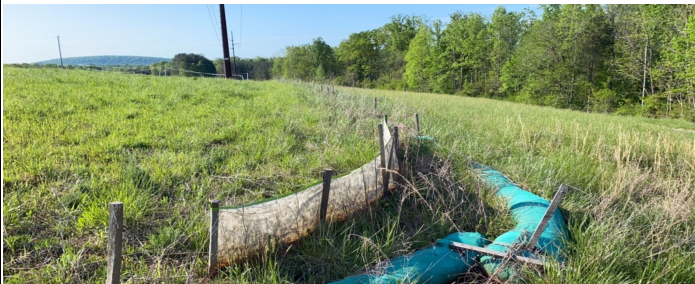
37°02'0" N 79°45'10" W 171°S COURSE -1° GPS 04.28.2022 08:58:59 Sorry no results found Accur +/-184.4 Ft ALT 951 Ft			37°01'8" N 79°45'9" W 243°SW COURSE -1° GPS 04.28.2022 09:00:30 Sorry no results found Accur +/-216.1 Ft ALT 951 Ft		
GPS Location	1	GPS Location	2		
Field Station#	14548+00	Field Station#	14551+00		
Pic 1 Desc.	Routine maintenance. Replace damaged/worn perimeter CFS.		Pic 2 Desc.	Routine maintenance. Replace damaged/worn P1 silt fence and CFS at plunge pool.

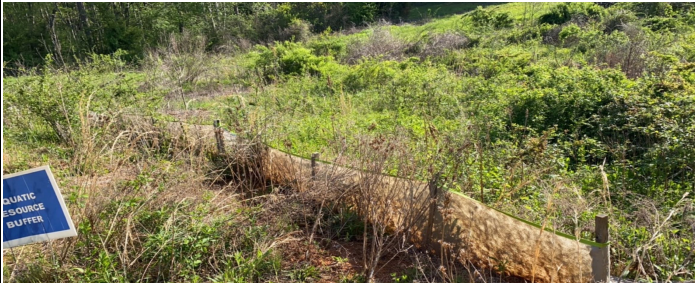
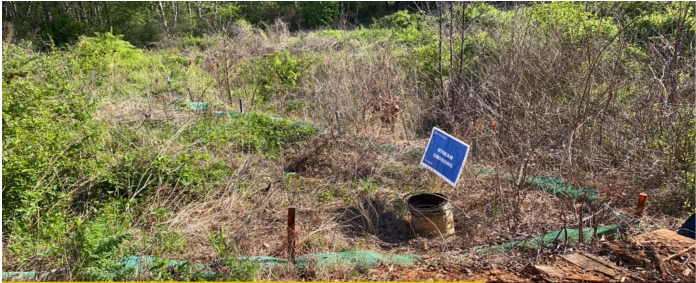
37°04' N 79°44'52" W 99°E COURSE -1° GPS 04.28.2022 09:14:25 594 Tobacco Rd, Glade Hill, VA 24092, United States Accur +/-121.9 Ft ALT 878 Ft			37°04' N 79°44'52" W 81°E COURSE -1° GPS 04.28.2022 09:15:11 594 Tobacco Rd, Glade Hill, VA 24092, United States Accur +/-91.1 Ft ALT 883 Ft		
GPS Location	5	GPS Location	6		
Field Station#	14567+60	Field Station#	14568+10		
Pic 5 Desc.	Routine maintenance. Replace worn P1 silt fence in resource buffer.		Pic 6 Desc.	Routine maintenance. Replace damaged/worn CFS in resource buffer.

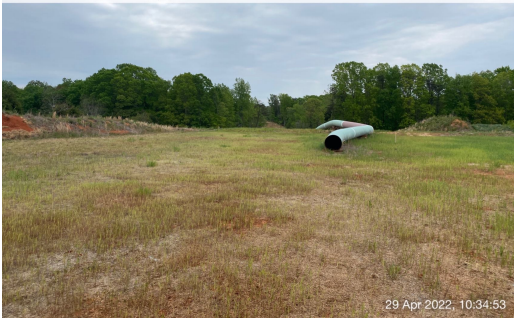
<small>29 Apr 2022, 10:29:54</small>			
GPS Location	0	GPS Location	0		
Field Station#	15068+00	Field Station#	15085+00		
Pic 1 Desc.	Approximately 15068+00. Overview of ROW.	Pic 2 Desc.	Approximately 15085+00. Overview of ROW.

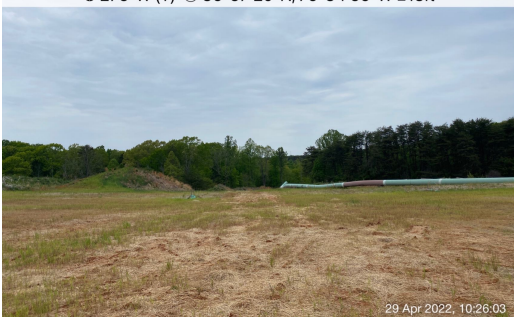
<small>29 Apr 2022, 10:25:03</small>			
GPS Location	0	GPS Location	0		
Field Station#	15110+00	Field Station#	15113+50		
Pic 3 Desc.	Approximately 15110+00. Overview of ROW.	Pic 4 Desc.	Approximately 15113+50. Overview of road crossing and RCEs.

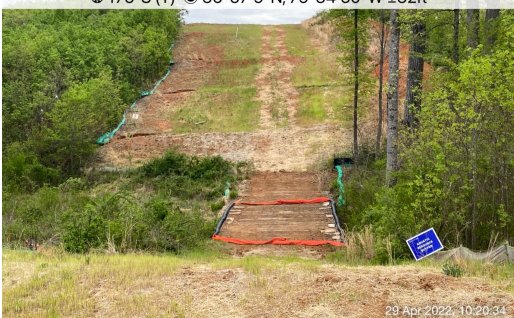
<small>29 Apr 2022, 09:27:02</small>			
GPS Location	0	GPS Location	0		
Field Station#	15126+40	Field Station#	15140+00		
Pic 5 Desc.	Approximately 15126+40. Overview of stream crossing, equipment bridge and ECDs at stream S-A6.	Pic 6 Desc.	Approximately 15140+00. Overview of ROW.

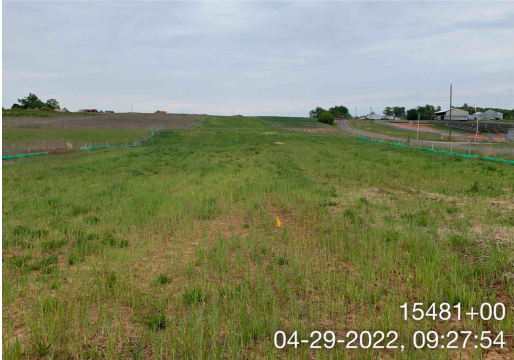
GPS Location	0	GPS Location	0		
Field Station#	15481+00	Field Station#	15507+77		
Pic 1 Desc.	Permanent vegetative stabilization in acceptable condition	Pic 2 Desc.	Equipment bridge in acceptable condition

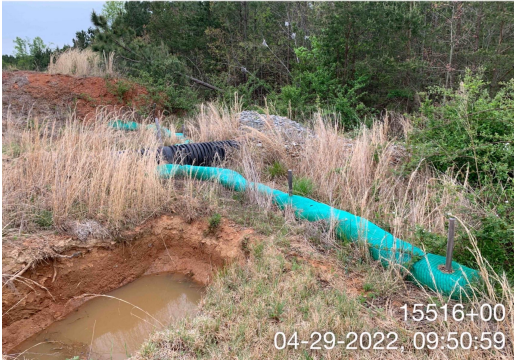
GPS Location	0	GPS Location	0		
Field Station#	15516+00	Field Station#	15514+00		
Pic 3 Desc.	Sump pit and clean water diversion pipe in acceptable conditions	Pic 4 Desc.	Waterbar end treatment in acceptable condition

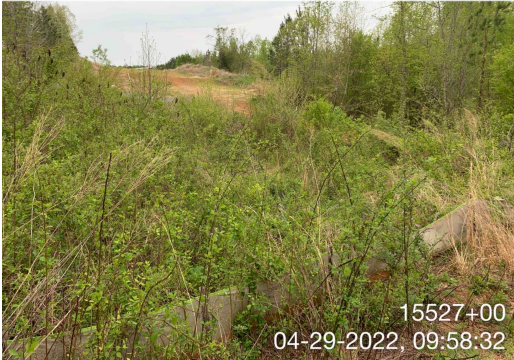
GPS Location	0	GPS Location	0		
Field Station#	15527+00	Field Station#	15530+00		
Pic 5 Desc.	P1 silt fence in acceptable condition	Pic 6 Desc.	Clean water diversion berm and temporary vegetative stabilization in acceptable conditions

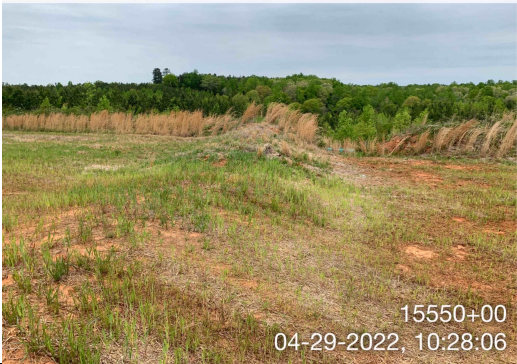
15550+00 04-29-2022, 10:28:06		315°NW (T) 36°53'54"N, 79°27'36"W ±19ft ▲ 841ft

15550+00 04-29-2022, 10:28:31			
GPS Location	0	GPS Location	0		
Field Station#	15550+00	Field Station#	15550+00		
Pic 7 Desc.	Waterbar in acceptable condition	Pic 8 Desc.	Waterbar end treatment in acceptable condition		
81°E (T) 36°53'54"N, 79°27'36"W ±13ft ▲ 838ft

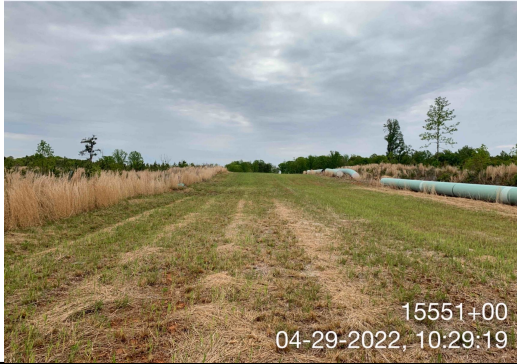
15551+00 04-29-2022, 10:29:19		75°E (T) 36°53'47"N, 79°27'15"W ±242ft ▲ 791ft

15568+00 04-29-2022, 11:11:11			
GPS Location	0	GPS Location	0		
Field Station#	15551+00	Field Station#	15568+00		
Pic 9 Desc.	Temporary vegetative stabilization in acceptable condition	Pic 10 Desc.	Temporary vegetative stabilization in acceptable condition		
297°NW (T) 36°53'41"N, 79°27'4"W ±347ft ▲ 771ft

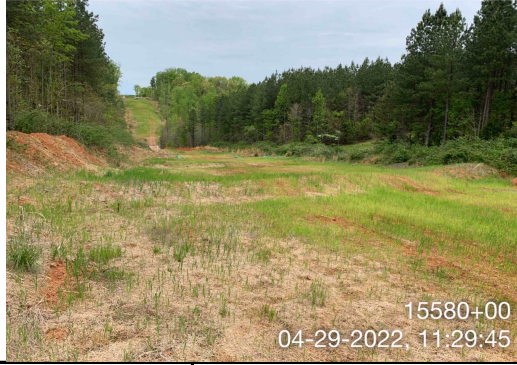
15580+00 04-29-2022, 11:29:45		345°N (T) 36°54'18"N, 79°28'14"W ±29ft ▲ 875ft

GPS Location	0	GPS Location	0		
Field Station#	15580+00	Field Station#	15510+00		
Pic 11 Desc.	Temporary vegetative stabilization and waterbar in acceptable conditions	Pic 12 Desc.	Solar farm ECDs appear to be in acceptable conditions

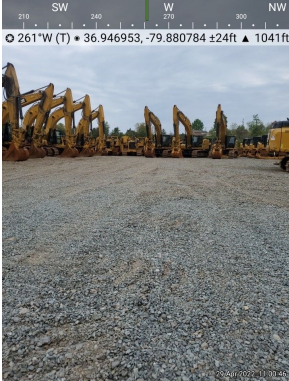
GPS Location	0	GPS Location	0		
Field Station#	0+00	Field Station#	0+00		
Pic 1 Desc.	LY-032 Rock construction entrance	Pic 2 Desc.	LY-032 Secondary containment

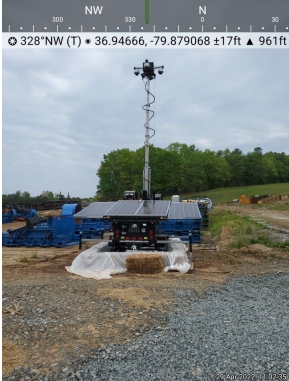
GPS Location	0	GPS Location	0		
Field Station#	0+00	Field Station#	0+00		
Pic 3 Desc.	LY-033 Secondary containment	Pic 4 Desc.	LY-033 Stormwater drain inlet protection

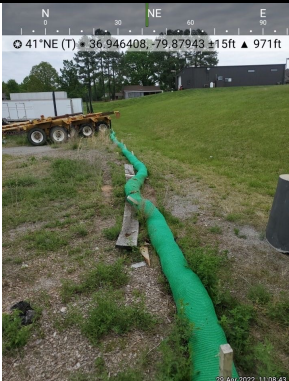
GPS Location	0	GPS Location	0		
Field Station#	0+00	Field Station#	0+00		
Pic 5 Desc.	ANC-006 Southeast perimeter CFS	Pic 6 Desc.	ANC-006 Stormwater drain inlet protection

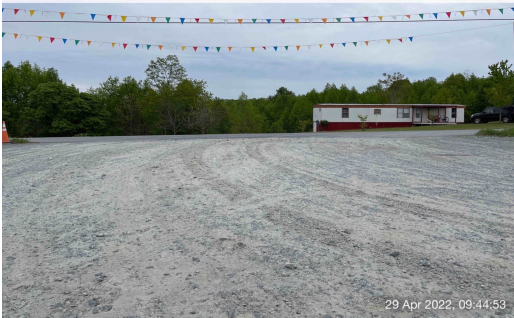
GPS Location	See picture		GPS Location	See picture	
Field Station#	0000+00		Field Station#	0000+00	
Pic 1 Desc.	RCE for LY-045 in good condition.		Pic 2 Desc.	Perimeter ECD's on on west side of LY-045 in good condition.	
	North Elevation 184°S (T) 36°58'14"N, 79°52'9"W ±13ft ▲1193ft  			South West Elevation 41°NE (T) 36°58'16"N, 79°52'12"W ±13ft ▲1186ft  	
GPS Location	See picture		GPS Location	See picture	
Field Station#	0000+00		Field Station#	0000+00	
Pic 3 Desc.	Secondary containment structure on north end of LY-045 in good condition.		Pic 4 Desc.	Secondary containment structure for fuel cell at LY-046 in good condition.	
	North Elevation 199°S (T) 36°58'16"N, 79°52'11"W ±13ft ▲1180ft

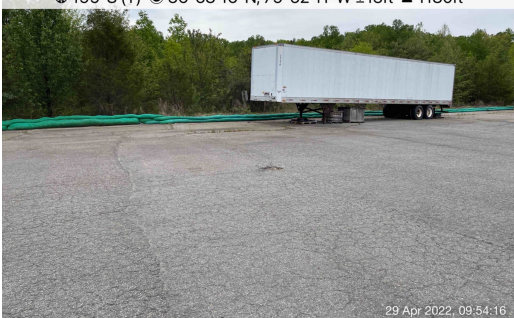
GPS Location	See picture		GPS Location	See picture	
Field Station#	0000+00		Field Station#	0000+00	
Pic 5 Desc.	Perimeter ECD's on south end of LY-046 in acceptable condition.		Pic 6 Desc.	Perimeter ECD's on west side of LY-046 in acceptable condition.

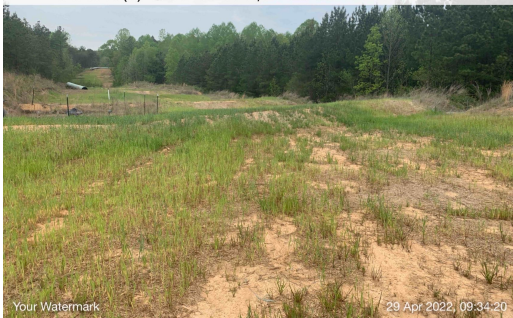
</div> <div>Your Watermark 29 Apr 2022, 09:34:08</div>		
GPS Location	O		GPS Location	O	
Field Station#	16023+00		Field Station#	16025+00	
Pic 1 Desc.	Observing temporary stabilization and water bars		Pic 2 Desc.	Observing temporary stabilization	
<div>South Elevation</div> <div>☉ 13°N (T) ● 36°49'50"N, 79°20'41"W ±55ft ▲ 620ft</div> <div>

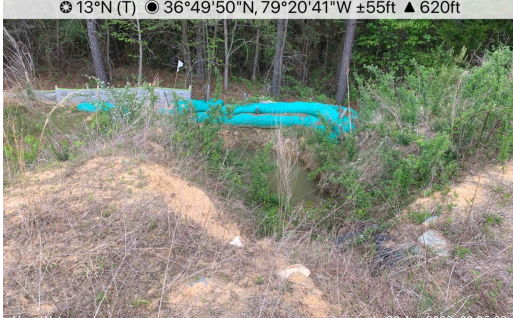
Field Station#	16020+00		Field Station#	16016+36	
Pic 3 Desc.	Observing temporary stabilization, sump and end treatment		Pic 4 Desc.	Observing temporary stabilization, signage, buffer, equipment crossing and ECD's	
<div>West Elevation</div> <div>☉ 100°E (T) ● 36°49'47"N, 79°20'45"W ±2417ft ▲ 608ft</div> <div>

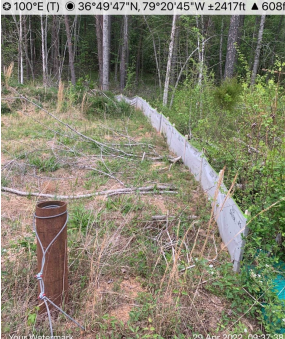
</div> <div>Your Watermark 29 Apr 2022, 09:38:58</div>		
GPS Location	O		GPS Location	O	
Field Station#	16015+50		Field Station#	16010+00	
Pic 5 Desc.	Observing temporary stabilization and ECD's		Pic 6 Desc.	Observing temporary stabilization, CWD outlet and ECD's

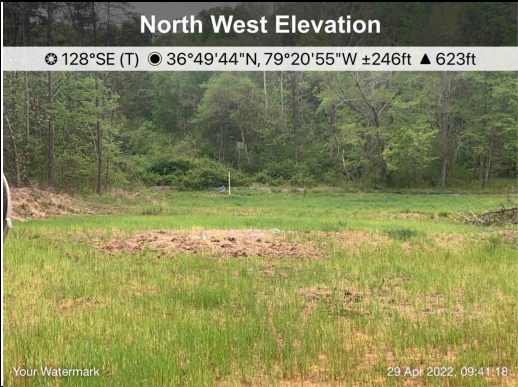
GPS Location	O	GPS Location			
Field Station#	16004+00	Field Station#			
Pic 7 Desc.	Observing temporary stabilization, signage, buffer and water bars	Pic 8 Desc.			
Insert image here		Insert image here			
GPS Location		GPS Location			
Field Station#		Field Station#			
Pic 9 Desc.		Pic 10 Desc.			
Insert image here		Insert image here			
GPS Location		GPS Location			
Field Station#		Field Station#			
Pic 11 Desc.		Pic 12 Desc.

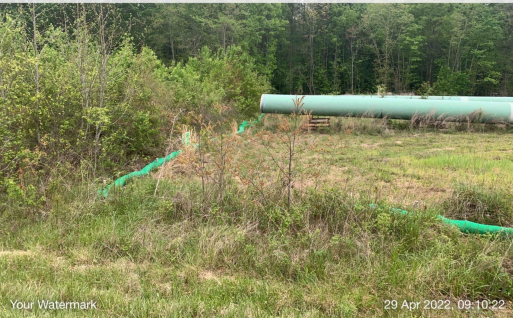
GPS Location	O	GPS Location	O		
Field Station#	14+00	Field Station#	20+00		
Pic 1 Desc.	Observing temporary stabilization, signage, buffer, RCE and ECD's		Pic 2 Desc.	Observing temporary stabilization, signage and buffer	
North Elevation 158°S (T) 36°50'6"N, 79°20'24"W ±72ft ▲657ft

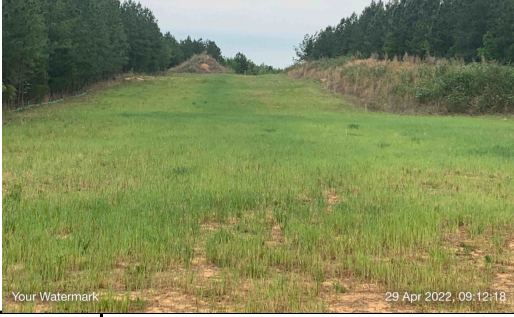
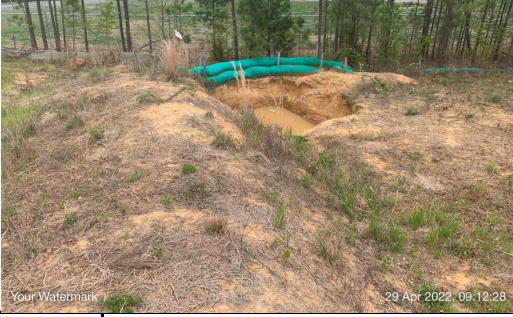
GPS Location	O	GPS Location	O		
Field Station#	6+00	Field Station#	12+00		
Pic 3 Desc.	Observing temporary stabilization and water bar		Pic 4 Desc.	Observing temporary stabilization, water bar, sump and end treatment	
Insert image here			Insert image here		
GPS Location		GPS Location			
Field Station#		Field Station#			
Pic 5 Desc.			Pic 6 Desc.

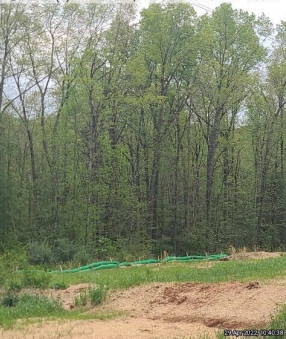
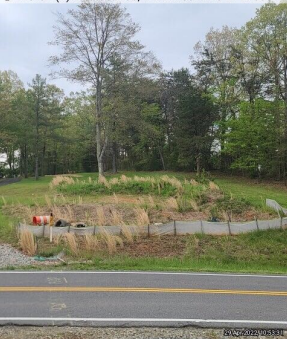
GPS Location	00000	GPS Location	0000		
Field Station#	13827+30	Field Station#	13812+00		
Pic 1 Desc.	Observed perimeter ECDs during row inspection today, no environmental issues observed at the time of inspection.		Pic 2 Desc.	Monitored ECDs at road crossings during inspection, no issues were observed.	
	North Elevation

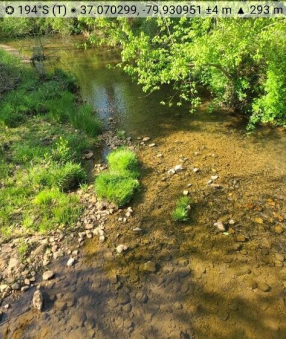
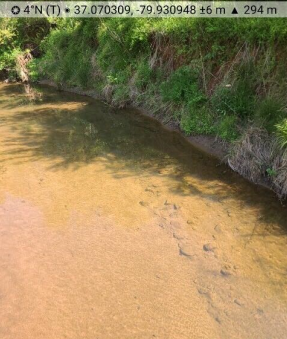
GPS Location	0000	GPS Location	0000		
Field Station#	13790+47	Field Station#	13790+47		
Pic 3 Desc.	Stream observation photo facing downstream during routine inspection today. No issues were observed at the time of inspection.		Pic 4 Desc.	Stream observation photo facing upstream during routine inspection today.	
	West Elevation

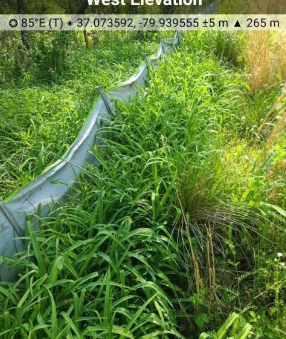
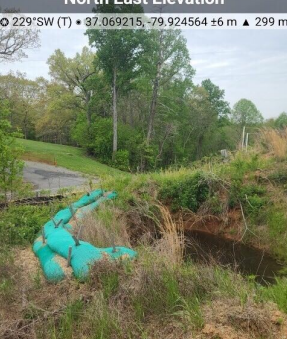
Pic 5 Desc.	Monitored perimeter ECDs during inspection today, no environmental issues observed at the time of inspection.		Pic 6 Desc.	Monitored sump pits and end treatment during routine inspection.

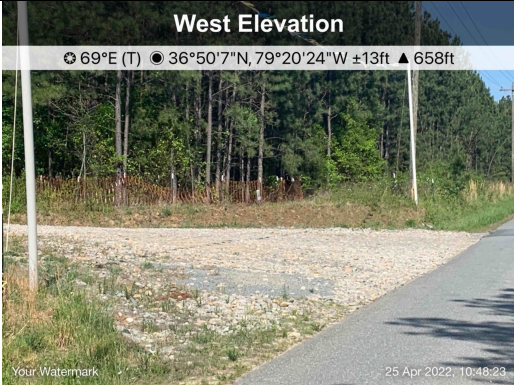
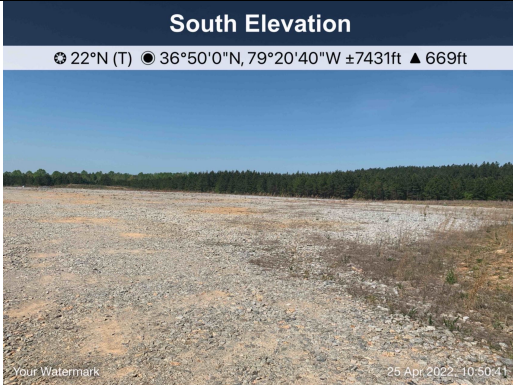
Your Watermark 25 Apr 2022, 10:50:41		
GPS Location	O		GPS Location	O	
Field Station#	00+00		Field Station#	00+00	
Pic 1 Desc.	Observing RCE		Pic 2 Desc.	Observing temporary stabilization and Lay down yard	
South East Elevation 311°NW (T) 36°50'5"N, 79°20'31"W ±1742ft ▲664ft

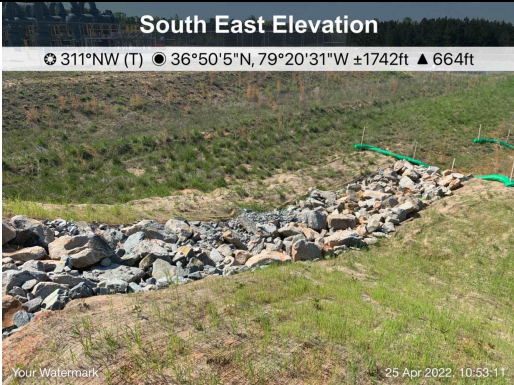
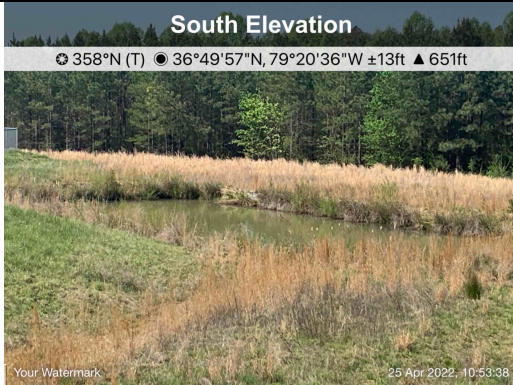
Your Watermark 25 Apr 2022, 10:53:38		
GPS Location	O		GPS Location	O	
Field Station#	00+00		Field Station#	00+00	
Pic 3 Desc.	Observing temporary stabilization, erosion control blanket, CFS checks and rock drain		Pic 4 Desc.	Observing temporary stabilization and sediment basin	
West Elevation 101°E (T) 36°50'1"N, 79°20'38"W ±1669ft ▲664ft

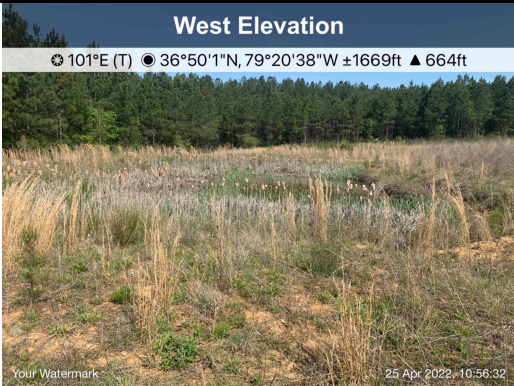
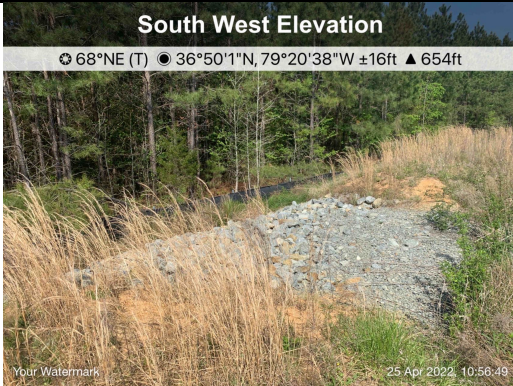
GPS Location	O		GPS Location	O	
Field Station#	00+00		Field Station#	00+00	
Pic 5 Desc.	Observing temporary stabilization and sediment basin		Pic 6 Desc.	Observing temporary stabilization and rock overflow at sediment basin

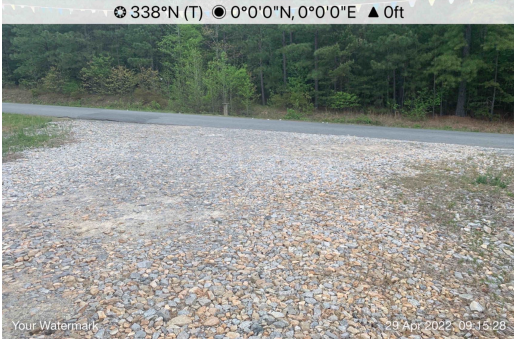
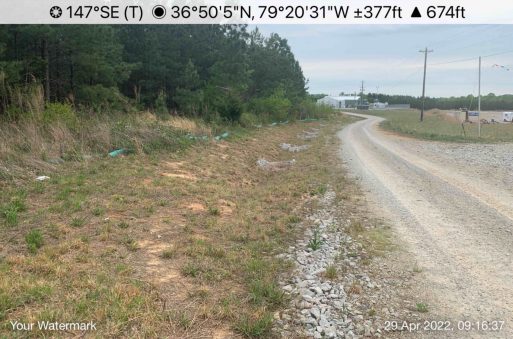
GPS Location	O		GPS Location	O	
Field Station#	00+00		Field Station#	00+00	
Pic 1 Desc.	Observing RCE		Pic 2 Desc.	Observing temporary stabilization, access road, rock check dams and ECD's	
North East Elevation 216°SW (T) 36°50'4"N, 79°20'29"W ±318ft ▲ 673ft

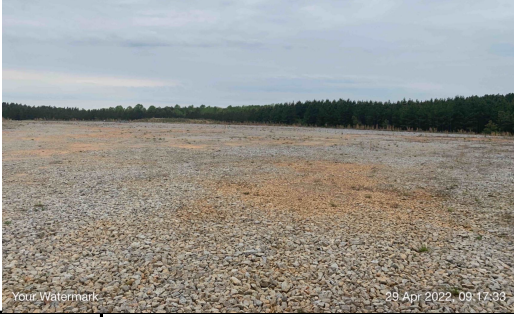
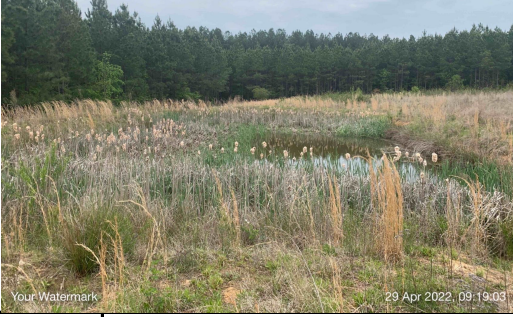
GPS Location	O		GPS Location	O	
Field Station#	00+00		Field Station#	00+00	
Pic 3 Desc.	Observing Lay down yard		Pic 4 Desc.	Observing temporary stabilization and sediment basin	
South East Elevation 318°NW (T) 36°49'56"N, 79°20'36"W ±301ft ▲ 596ft

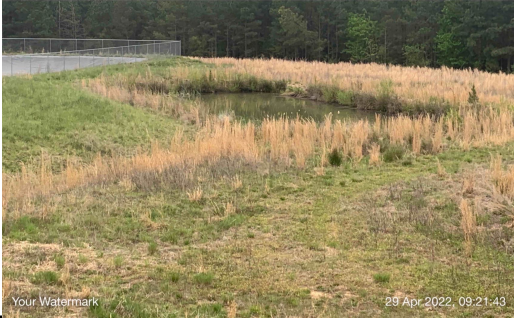
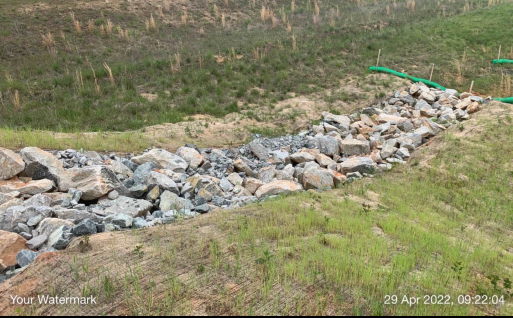
Pic 5 Desc.	Observing temporary stabilization and sediment basin		Pic 6 Desc.	Observing temporary stabilization, rock drain, erosion control blanket and cfs checks
