Visual Site Inspection Report

Project Name	H-600 Pipeline Spread I	AFE	124300139	Spread	H-600 Pipeline Spread I
Contractor	Precision			Report #	37184
Inspector	Charles Head			Date/Time	5/2/2022 9:31 AM
Permit #	TBD	Inspection Type	VA SWPP	Station Begin	14694+77
State	VA	Inspection Area	Full	Station End	14802+19
County	Franklin	Ground	Dry	Temperature (°F)	70.00
Municipality	N/A	Weather	Sunny	Rain Gauge (in)	0.25
				Rain Accumulation Time (days)	2.00

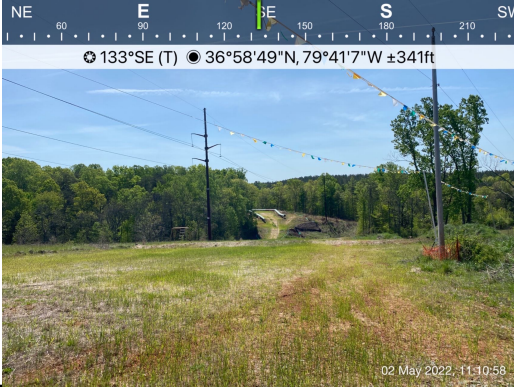
GPS Location	0	GPS Location	0		
Field Station#	14779+00	Field Station#	14766+11		
Pic 3 Desc.	Approximately 14779+00. Overview of ROW.	Pic 4 Desc.	Approximately 14766+11. Overview of stream crossing, equipment bridge and ECDs at stream S-MM44.

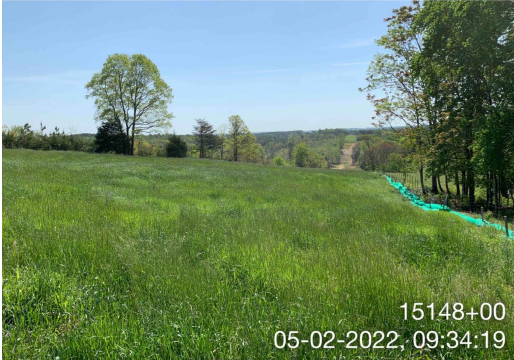
15155+00 05-02-2022, 09:48:47			
GPS Location	0	GPS Location	0		
Field Station#	15148+00	Field Station#	15155+00		
Pic 1 Desc.	Permanent vegetative stabilization and perimeter CFS in acceptable conditions	Pic 2 Desc.	Waterbar in acceptable condition		
184°S (T) 36°56'45"N, 79°34'32"W ±36ft ▲ 824ft

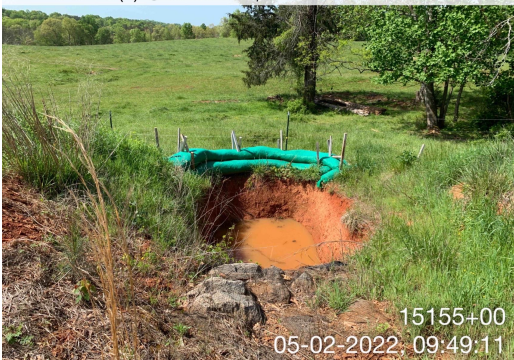
15160+00 05-02-2022, 09:52:08			
GPS Location	0	GPS Location	0		
Field Station#	15155+00	Field Station#	15160+00		
Pic 3 Desc.	Waterbar end treatment in acceptable condition	Pic 4 Desc.	Perimeter P1 silt fence in acceptable condition		
179°S (T) 36°56'37"N, 79°34'16"W ±88ft ▲ 738ft

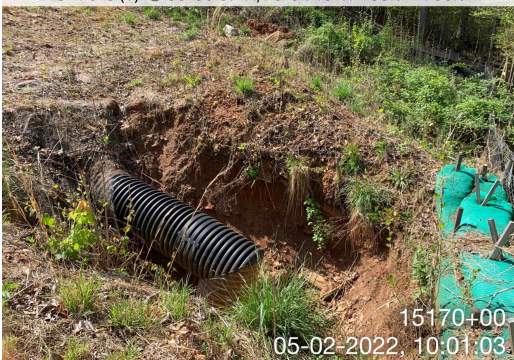
GPS Location	0	GPS Location	0		
Field Station#	15170+00	Field Station#	15192+00		
Pic 5 Desc.	Slope drain pipe and sump pit in acceptable conditions	Pic 6 Desc.	Waterbar in acceptable condition

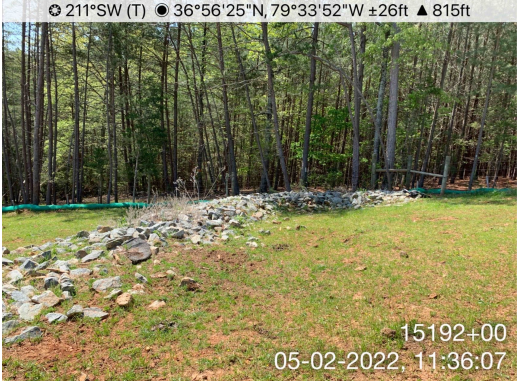
<p>15254+00 05-02-2022, 12:17:54</p>			
GPS Location	0	GPS Location	0		
Field Station#	15192+00	Field Station#	15254+00		
Pic 7 Desc.	Waterbar end treatment in acceptable condition	Pic 8 Desc.	Perimeter CFS and permanent vegetative stabilization in acceptable conditions		
Insert image here		Insert image here			
GPS Location		GPS Location			
Field Station#		Field Station#			
Pic 9 Desc.		Pic 10 Desc.			
Insert image here		Insert image here			
GPS Location		GPS Location			
Field Station#		Field Station#			
Pic 11 Desc.		Pic 12 Desc.

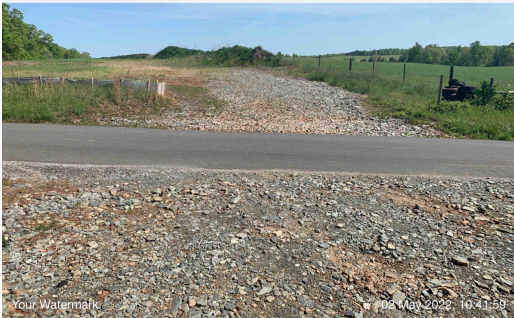
GPS Location	O	GPS Location	O		
Field Station#	15647+03	Field Station#	15643+00		
Pic 1 Desc.	Observing road crossing and RCE's	Pic 2 Desc.	Observing temporary stabilization		
North Elevation 178°S (T) 36°53'29"N, 79°26'0"W ±32ft ▲ 781ft

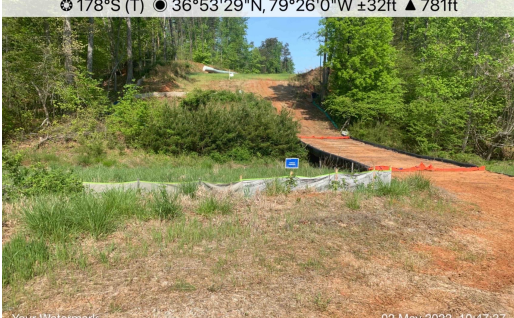
GPS Location	O	GPS Location	O		
Field Station#	15636+45	Field Station#	15632+00		
Pic 3 Desc.	Observing temporary stabilization, signage, buffer, equipment crossing and ECD's	Pic 4 Desc.	Observing temporary stabilization, CWD outlet and ECD's		
West Elevation 69°E (T) 36°53'30"N, 79°26'4"W ±5521ft ▲ 786ft

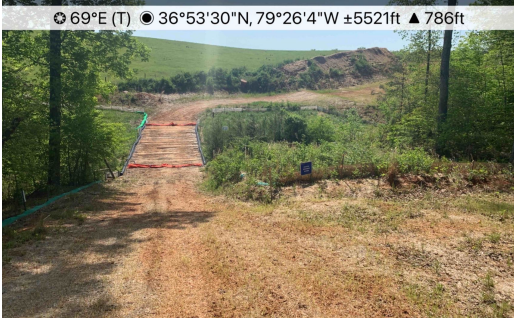
GPS Location	O	GPS Location	O		
Field Station#	15636+45	Field Station#	15617+00		
Pic 5 Desc.	Observing temporary stabilization, signage, buffer, equipment crossing and ECD's	Pic 6 Desc.	Observing temporary stabilization, water bar, sump and end treatment

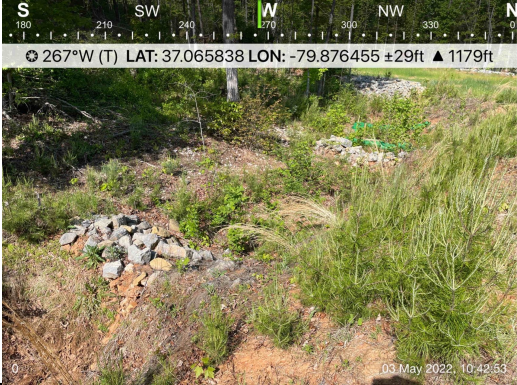
<p style="text-align: center;">Insert image here</p>			
GPS Location	See photo		GPS Location		
Field Station#	14060+00		Field Station#		
Pic 15 Desc.	Check dams are functioning as intended.		Pic 16 Desc.		
<p style="text-align: center;">Insert image here</p>			<p style="text-align: center;">Insert image here</p>		
GPS Location			GPS Location		
Field Station#			Field Station#		
Pic 17 Desc.			Pic 18 Desc.

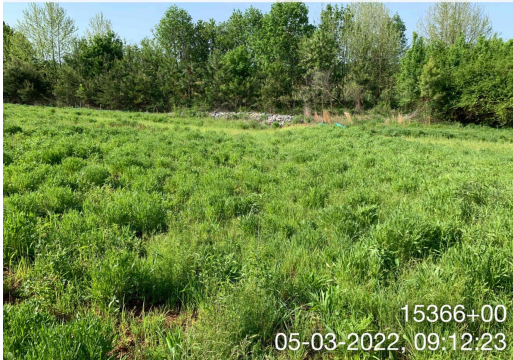
</div> <div>15366+00 05-03-2022, 09:14:37</div>		
GPS Location	0		GPS Location	0	
Field Station#	15366+00		Field Station#	15366+00	
Pic 1 Desc.	Permanent vegetative stabilization and waterbar in acceptable conditions		Pic 2 Desc.	Waterbar end treatment in acceptable condition	
<div>📍 144°SE (T) ● 36°55'27"N, 79°30'55"W ±42ft ▲ 755ft</div> <div>

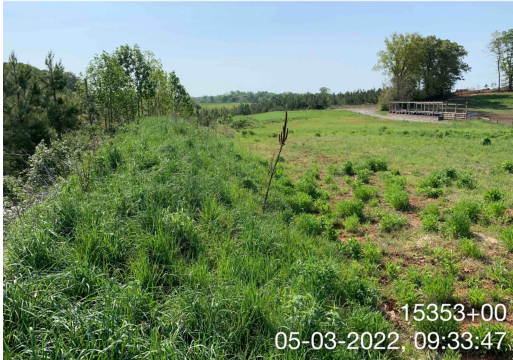
</div> <div>15347+00 05-03-2022, 10:03:54</div>		
GPS Location	0		GPS Location	0	
Field Station#	13353+00		Field Station#	13347+00	
Pic 3 Desc.	Temporary vegetative stabilization in acceptable condition		Pic 4 Desc.	P1 silt fence and sensitive resource buffer in acceptable conditions

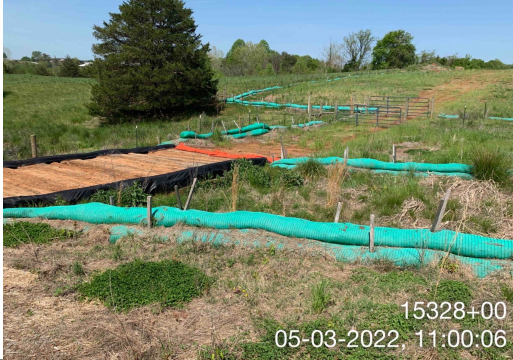
</div> <div>15317+00 05-03-2022, 11:33:10</div>		
GPS Location	0		GPS Location	0	
Field Station#	15328+00		Field Station#	15317+00	
Pic 5 Desc.	CFS and equipment bridge in acceptable conditions		Pic 6 Desc.	Super silt fence in acceptable condition

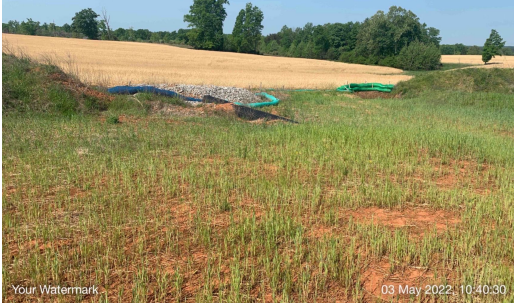
GPS Location	O		GPS Location	O	
Field Station#	15735+00		Field Station#	15740+00	
Pic 1 Desc.	Observing temporary stabilization,CWD outlet,sump and end treatment		Pic 2 Desc.	Observing temporary stabilization	
South Elevation 359°N (T) 36°52'46"N, 79°25'15"W ±6066ft ▲815ft

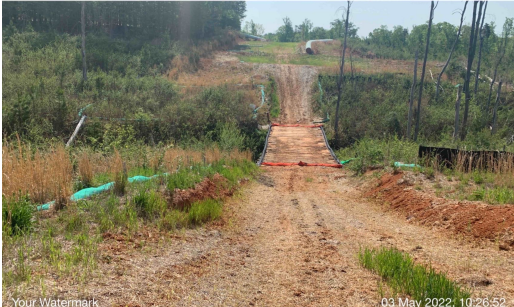
GPS Location	O		GPS Location	O	
Field Station#	15700+40		Field Station#	15693+89	
Pic 3 Desc.	Observing temporary stabilization, signage, buffer, equipment crossing and ECD's		Pic 4 Desc.	Observing road crossing and RCE's	
South West Elevation 31°NE (T) 36°53'16"N, 79°25'56"W ±55ft ▲800ft

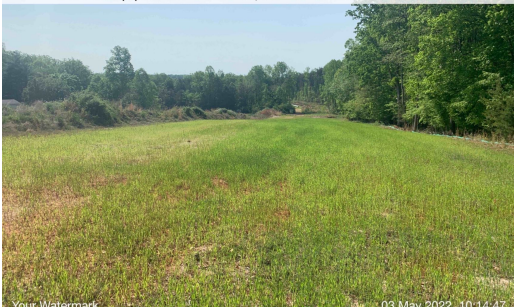
GPS Location	O		GPS Location	O	
Field Station#	15652+00		Field Station#	15650+00	
Pic 5 Desc.	Observing temporary stabilization		Pic 6 Desc.	Observing temporary stabilization,water bar, sump and end treatment

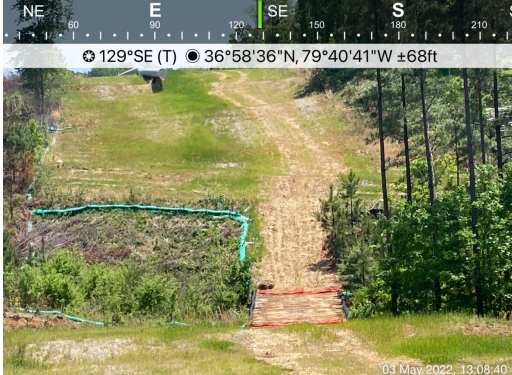
GPS Location	0		GPS Location	0	
Field Station#	14805+00		Field Station#	14841+00	
Pic 1 Desc.	Approximately 14805+00. Overview of ROW.		Pic 2 Desc.	Approximately 14841+00. Overview of ROW.

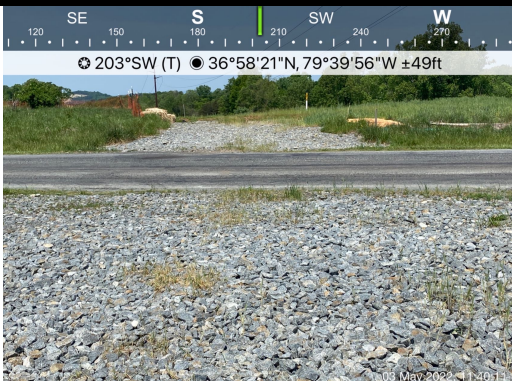
GPS Location	0		GPS Location	0	
Field Station#	14845+50		Field Station#	14850+00	
Pic 3 Desc.	Approximately 14845+50. Overview of road crossing and RCEs.		Pic 4 Desc.	Approximately 14850+00. Overview of ROW.

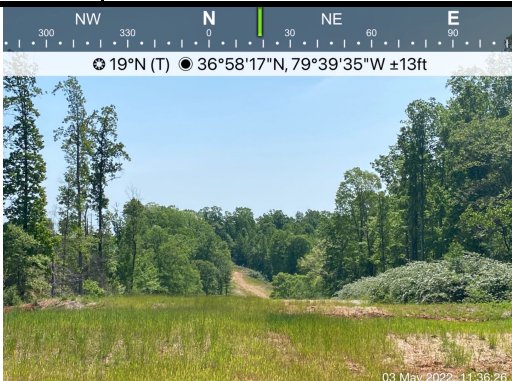
GPS Location	0		GPS Location	0	
Field Station#	14864+00		Field Station#	14921+00	
Pic 5 Desc.	Approximately 14864+00. Overview of ROW.		Pic 6 Desc.	Approximately 14921+00. Overview of ROW.

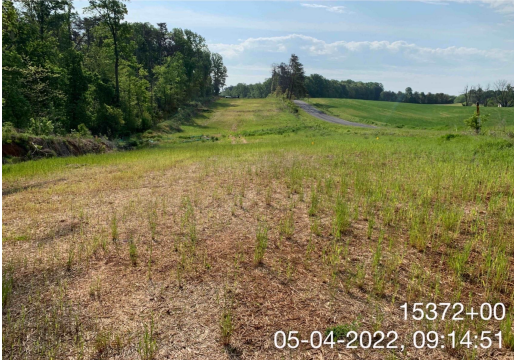
GPS Location	0	GPS Location	0		
Field Station#	15372+00	Field Station#	15374+00		
Pic 1 Desc.	Temporary vegetative stabilization in acceptable condition		Pic 2 Desc.	Sump pit in acceptable condition

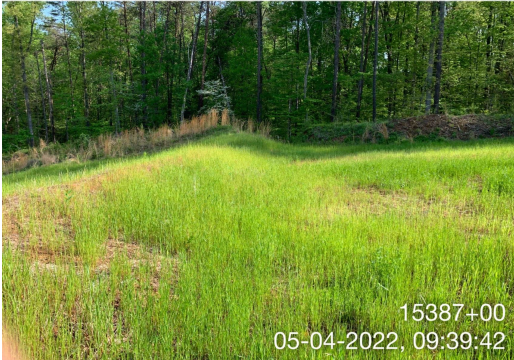
GPS Location	0	GPS Location	0		
Field Station#	15387+00	Field Station#	15387+00		
Pic 3 Desc.	Waterbar in acceptable condition		Pic 4 Desc.	Waterbar end treatment in acceptable condition

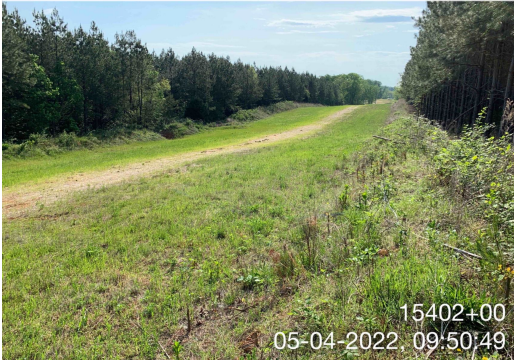
GPS Location	0	GPS Location	0		
Field Station#	15402+00	Field Station#	15414+13		
Pic 5 Desc.	Clean water diversion berm and temporary vegetative stabilization in acceptable conditions		Pic 6 Desc.	Equipment bridge in acceptable condition

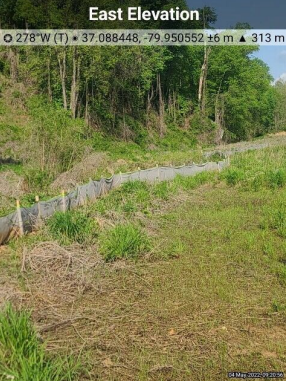
GPS Location	00000	GPS Location	00000		
Field Station#	13678+00	Field Station#	137702+78		
Pic 1 Desc.	Monitored ECDs along the row edge protection adjacent stream. No issues observed at the time of inspection.		Pic 2 Desc.	Monitored ECDs at wetland crossing, all in place and functioning at the time of inspection.	
	North East Elevation

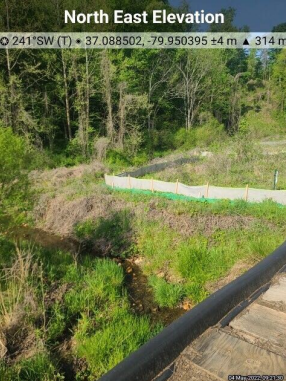
GPS Location	0000	GPS Location	00000		
Field Station#	13678+72	Field Station#	13695+22		
Pic 3 Desc.	Stream observation photo facing downstream, ECDs in place at stream crossing. No environmental issues observed at the time of inspection.		Pic 4 Desc.	Photo showing vegetation, ECDs in place around wetland area. No environmental issues observed at the time of inspection.	
	South East Elevation

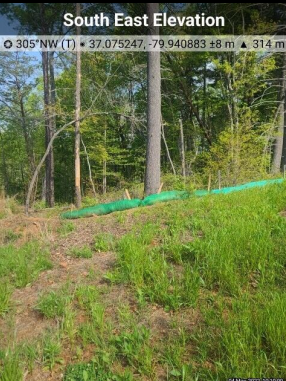
GPS Location	0000	GPS Location	0000		
Field Station#	13747+45	Field Station#	13705+65		
Pic 5 Desc.	Observed recently repaired punch list item, documented as completed.		Pic 6 Desc.	Stream buffer P1 in place and functioning at the time of inspection.

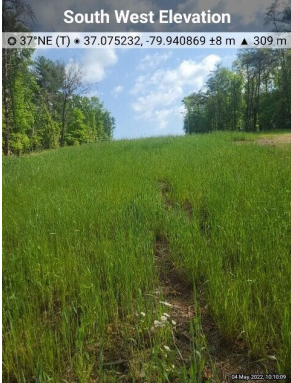
GPS Location	0000	GPS Location	00000		
Field Station#	13704+70	Field Station#	13704+90		
Pic 7 Desc.	Vegetation observation photo in permanent area of row. Good coverage noted.		Pic 8 Desc.	Stream observation photo facing downstream during routine inspection today. No issues were observed at the time of inspection.	
Insert image here		Insert image here			
GPS Location		GPS Location			
Field Station#		Field Station#			
Pic 9 Desc.		Pic 10 Desc.			
Insert image here		Insert image here			
GPS Location		GPS Location			
Field Station#		Field Station#			
Pic 11 Desc.		Pic 12 Desc.

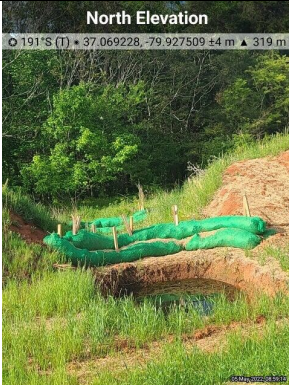
GPS Location	00000	GPS Location	00000		
Field Station#	13801+90	Field Station#	13783+80		
Pic 1 Desc.	Observed sump pits and end treatment during row travel today, all functioning at the time of inspection.		Pic 2 Desc.	Monitored ECDs and plunge pool during routine inspection, no issues were observed at the time of inspection.	
	North Elevation

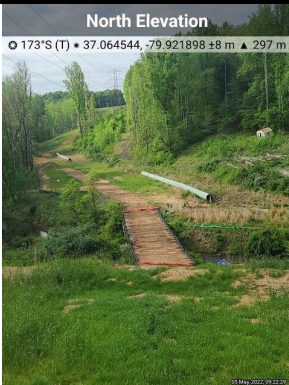
GPS Location	0000	GPS Location	0000		
Field Station#	13833+70	Field Station#	13831+00		
Pic 3 Desc.	Observed stabilization and monitored equipment crossings at stream crossings. No environmental issues observed at the time of inspection.		Pic 4 Desc.	Observed sump pits and end treatment during row inspection today. No issues were observed at the time of inspection.	
	North Elevation

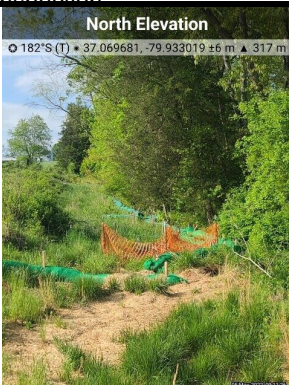
Field Station#	13784+35	Field Station#	13802+55		
Pic 5 Desc.	CFS monitored along work space area. Good stabilization noted. No environmental issues observed at the time of inspection.		Pic 6 Desc.	Row photo showing stabilization on row where pipe is stored in upland areas. No environmental issues observed at the time of inspection.

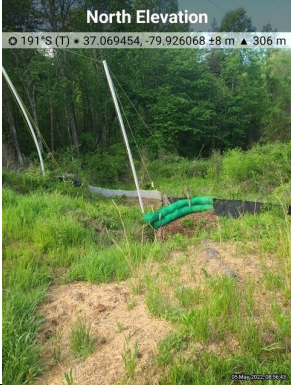
GPS Location	0000	GPS Location	0000		
Field Station#	13806+55	Field Station#	13830+70		
Pic 7 Desc.	Monitored ECDs and sump pits throughout. All functioning at the time of inspection.		Pic 8 Desc.	Monitored perimeter CFS and reinforced silt fence throughout row inspection today. All hot to date and functioning at the time of inspection.	
Insert image here		Insert image here			
GPS Location		GPS Location			
Field Station#		Field Station#			
Pic 9 Desc.			Pic 10 Desc.		
Insert image here		Insert image here			
GPS Location		GPS Location			
Field Station#		Field Station#			
Pic 11 Desc.			Pic 12 Desc.

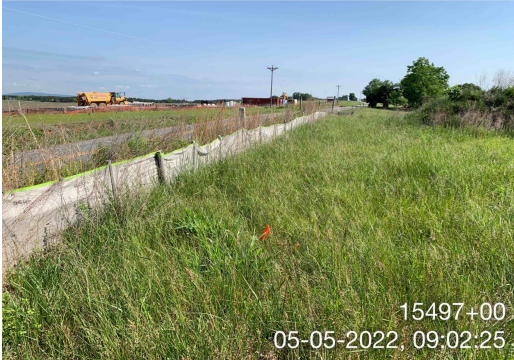
15494+00 05-05-2022, 09:07:32			
GPS Location	0	GPS Location	0		
Field Station#	15497+00	Field Station#	15494+00		
Pic 1 Desc.	P1 silt fence in acceptable condition	Pic 2 Desc.	Permanent vegetative stabilization and perimeter CFS in acceptable conditions		
197°S (T) 36°54'12"N, 79°28'7"W ±1033ft ▲ 849ft

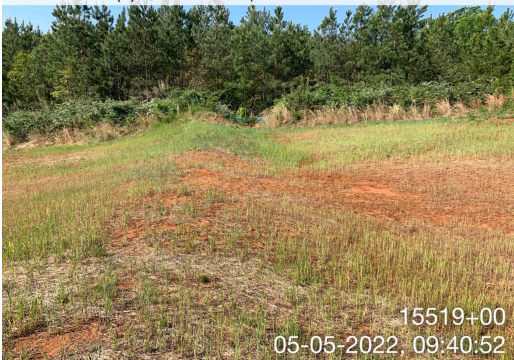
15519+00 05-05-2022, 09:41:13			
GPS Location	0	GPS Location	0		
Field Station#	15519+00	Field Station#	15519+00		
Pic 3 Desc.	Waterbar in acceptable condition	Pic 4 Desc.	Waterbar end treatment in acceptable condition		
98°E (T) 36°54'2"N, 79°27'53"W ±1000ft ▲ 828ft

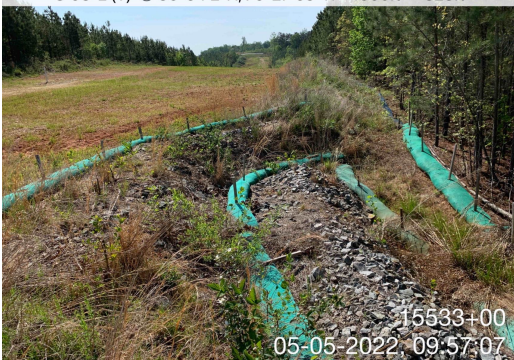
GPS Location	0	GPS Location	0		
Field Station#	15533+00	Field Station#	15539+00		
Pic 5 Desc.	Clean water diversion pipe and CFS in acceptable conditions	Pic 6 Desc.	Temporary vegetative stabilization in acceptable condition

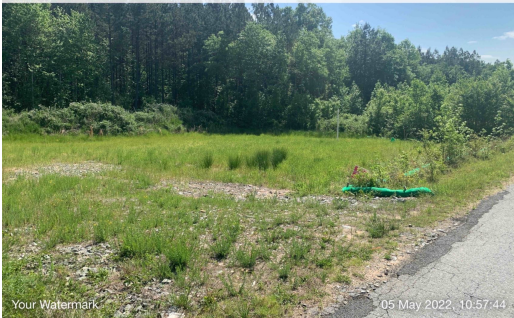
GPS Location	O	GPS Location	O		
Field Station#	14+00	Field Station#	22+00		
Pic 1 Desc.	Observing temporary stabilization, RCE, signage, buffer and ECD's	Pic 2 Desc.	Observing temporary stabilization, signage and buffer		
North East Elevation 241°SW (T) 36°50'5"N, 79°20'31"W ±164ft ▲653ft

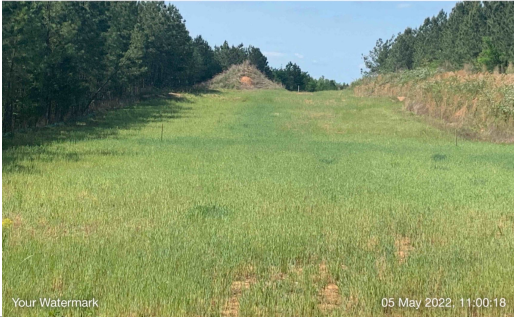
GPS Location	O	GPS Location	O		
Field Station#	6+00	Field Station#	12+00		
Pic 3 Desc.	Observing temporary stabilization and water bar	Pic 4 Desc.	Observing temporary stabilization, sump and end treatment		
Insert image here			Insert image here		
GPS Location		GPS Location			
Field Station#		Field Station#			
Pic 5 Desc.		Pic 6 Desc.

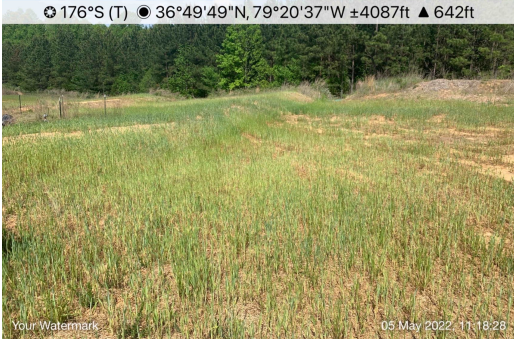
<small>Your Watermark 05 May 2022, 11:18:33</small>			
GPS Location	O	GPS Location	O		
Field Station#	16022+00	Field Station#	16025+00		
Pic 1 Desc.	Observing temporary stabilization and water bar	Pic 2 Desc.	Observing temporary stabilization		
North Elevation 175°S (T) 36°49'51"N, 79°20'39"W ±2585ft ▲641ft

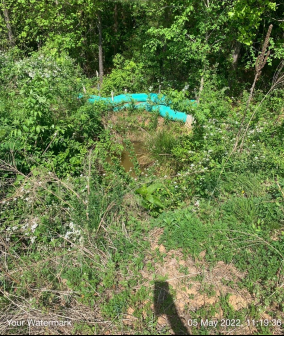
<small>Your Watermark 05 May 2022, 11:33:29</small>			
GPS Location	O	GPS Location	O		
Field Station#	16020+00	Field Station#	16016+36		
Pic 3 Desc.	Observing temporary stabilization, sump and end treatment	Pic 4 Desc.	Observing temporary stabilization, signage, buffer, equipment crossing and ECD's

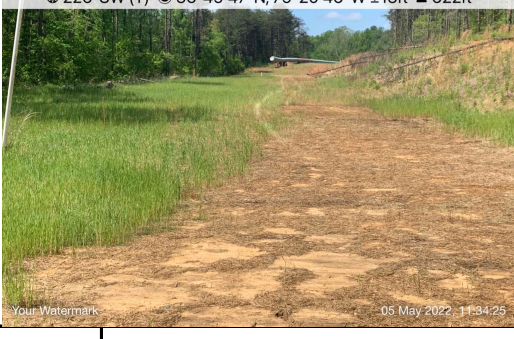
<small>Your Watermark 05 May 2022, 11:34:42</small>			
GPS Location	O	GPS Location	O		
Field Station#	16015+00	Field Station#	16015+50		
Pic 5 Desc.	Observing temporary stabilization and 3rd party traffic	Pic 6 Desc.	Observing temporary stabilization, signage, buffer and ECD's

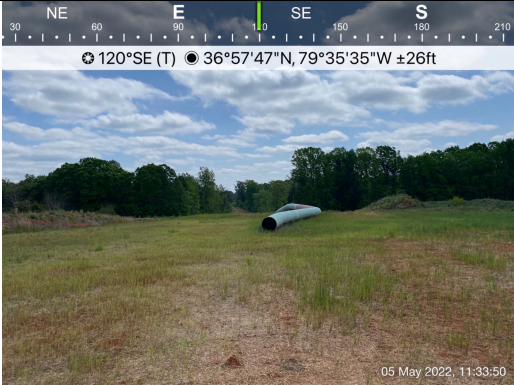
GPS Location	0	GPS Location	0		
Field Station#	15067+00	Field Station#	15072+86		
Pic 1 Desc.	Approximately 15067+00. Overview of ROW.	Pic 2 Desc.	Approximately 15072+86. Overview of stream crossing, equipment bridge and ECDs at stream S-G11.

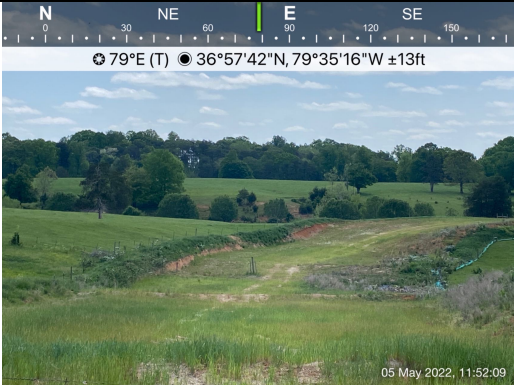
GPS Location	0	GPS Location	0		
Field Station#	15087+00	Field Station#	15113+50		
Pic 3 Desc.	Approximately 15087+00. Overview of ROW.	Pic 4 Desc.	Approximately 15113+50. Overview of ROW.

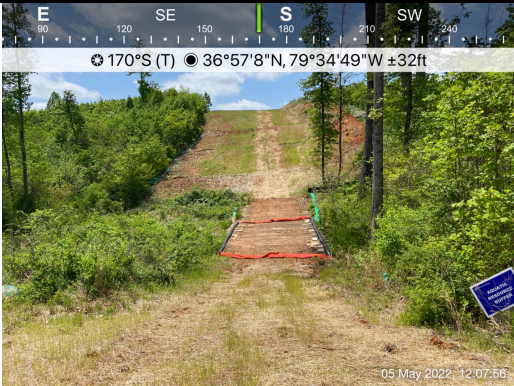
GPS Location	0	GPS Location	0		
Field Station#	15126+40	Field Station#	15131+00		
Pic 5 Desc.	Approximately 15126+40. Overview of stream crossing, equipment bridge and ECDs at stream S-A6.	Pic 6 Desc.	Approximately 15131+00. Overview of ROW.

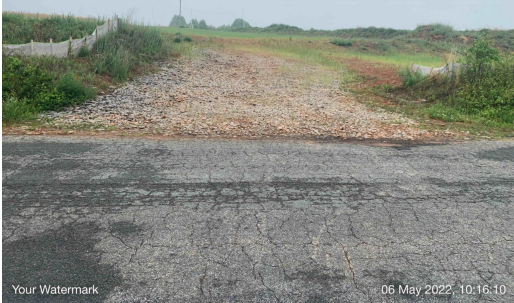
<small>Your Watermark 06 May 2022, 10:16:44</small>			
GPS Location	O	GPS Location	O		
Field Station#	15584+23	Field Station#	15585+50		
Pic 1 Desc.	Observing road crossing and RCE	Pic 2 Desc.	Observing temporary stabilization, water bar, sump and end treatment		
West Elevation 71°E (T) 36°53'38"N, 79°26'55"W ±2785ft ▲ 813ft

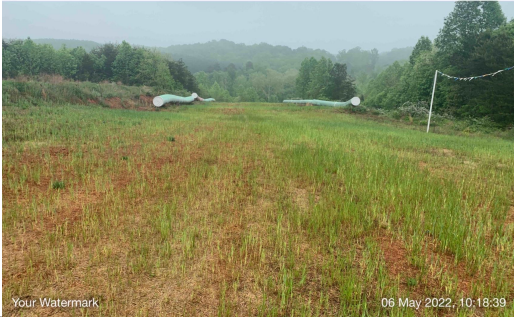
<small>Your Watermark 06 May 2022, 10:26:45</small>			
GPS Location	O	GPS Location	O		
Field Station#	15590+00	Field Station#	15614+94		
Pic 3 Desc.	Observing temporary stabilization and water bars	Pic 4 Desc.	Observing temporary stabilization, signage, buffer, equipment crossing and ECD's

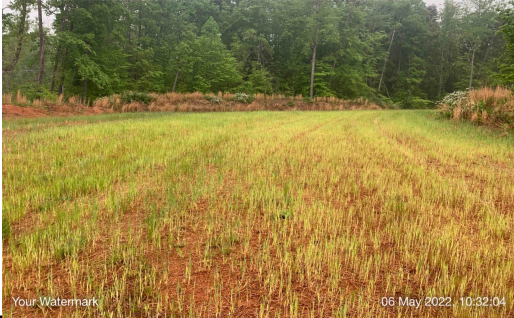
<small>Your Watermark 06 May 2022, 10:33:22</small>			
GPS Location	O	GPS Location	O		
Field Station#	15627+00	Field Station#	15630+00		
Pic 5 Desc.	Observing temporary stabilization and CWD berm	Pic 6 Desc.	Observing temporary stabilization, CWD outlet and ECD's

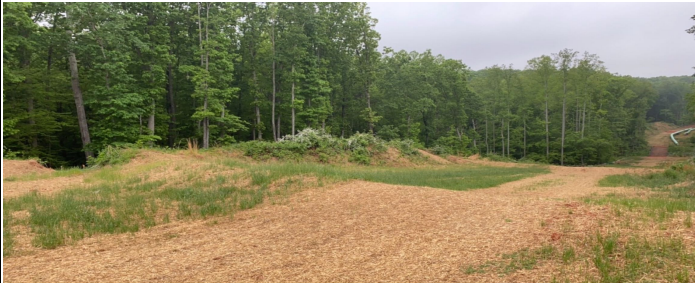
37°1'40" N 79°46'15" W 267°W COURSE 306° GPS Glade Hill, VA 24092, United States 05.06.2022 10:11:03 Accur +/-33.5 Ft ALT 1100 Ft			37°1'39" N 79°46'12" W 261°W COURSE 117° GPS Glade Hill, VA 24092, United States 05.06.2022 10:10:03 Accur +/-80.7 Ft ALT 0 Ft		
GPS Location	5		GPS Location	6	
Field Station#	14426+00		Field Station#	14446+00	
Pic 5 Desc.	Water bar performing intended function; ROW stabilized and vegetated in temporary area.		Pic 6 Desc.	Sump pit and CFS end treatment performing intended functions.

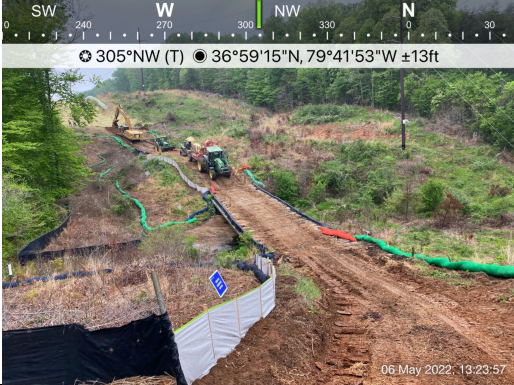
GPS Location	0	GPS Location	0		
Field Station#	14729+19	Field Station#	14696+00		
Pic 1 Desc.	Approximately 14729+19. Overview of stream crossing, equipment bridge and ECDs at stream S-A20. Contractor is mulching and grading for stabilization.		Pic 2 Desc.	Approximately 14696+00. Overview of ROW.

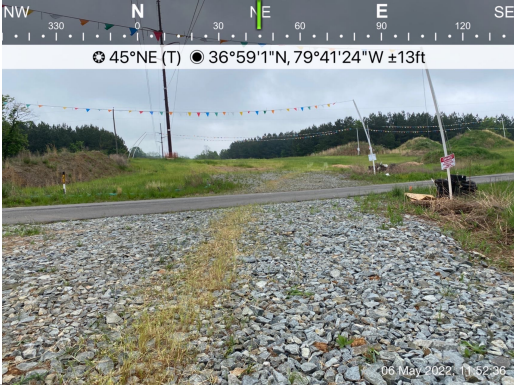
GPS Location	0	GPS Location	0		
Field Station#	14758+00	Field Station#	14800+00		
Pic 3 Desc.	Approximately 14758+00. Overview of road crossing and RCEs.		Pic 4 Desc.	Approximately 14800+00. Overview of ROW.

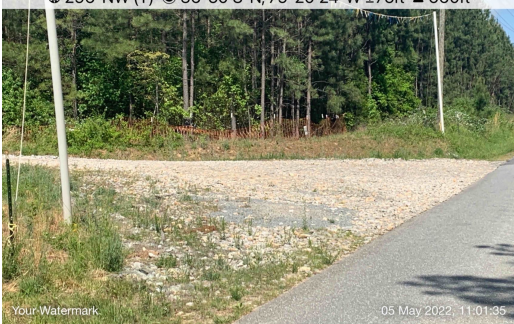
GPS Location	O		GPS Location	O	
Field Station#	00+00		Field Station#	00+00	
Pic 1 Desc.	Observing RCE		Pic 2 Desc.	Observing temporary stabilization, rock check dams and ECD's	
North West Elevation 130°SE (T) 36°49'57"N, 79°20'36"W ±101ft ▲648ft

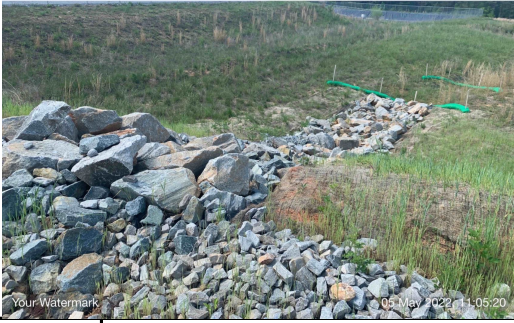
GPS Location	O		GPS Location	O	
Field Station#	00+00		Field Station#	00+00	
Pic 3 Desc.	Observing temporary stabilization, rock drain and CFS checks		Pic 4 Desc.	Observing lay down yard	
North Elevation 164°S (T) 36°49'57"N, 79°20'36"W ±13ft ▲650ft

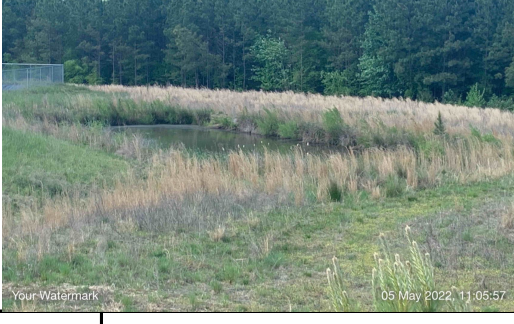
Pic 5 Desc.	Observing temporary stabilization and sediment basin		Pic 6 Desc.	Observing temporary stabilization and storm water pond
