# Visual Site Inspection Report

<b>Project Name</b>	H-600 Pipeline Spread G	<b>AFE</b>	124300137	<b>Spread</b>	H-600 Pipeline Spread G
<b>Contractor</b>	Precision			<b>Report #</b>	37925
<b>Inspector</b>	Rob Robertson			<b>Date/Time</b>	5/23/2022 10:59 AM
<b>Permit #</b>	TBD	<b>Inspection Type</b>	VA SWPP	<b>Station Begin</b>	11600+01
<b>State</b>	VA	<b>Inspection Area</b>	Full	<b>Station End</b>	11670+00
<b>County</b>	Montgomery	<b>Ground</b>	Wet	<b>Temperature (°F)</b>	65.00
<b>Municipality</b>	N/A	<b>Weather</b>	Light Rain	<b>Rain Gauge (in)</b>	0.10
				<b>Rain Accumulation Time (days)</b>	1.00

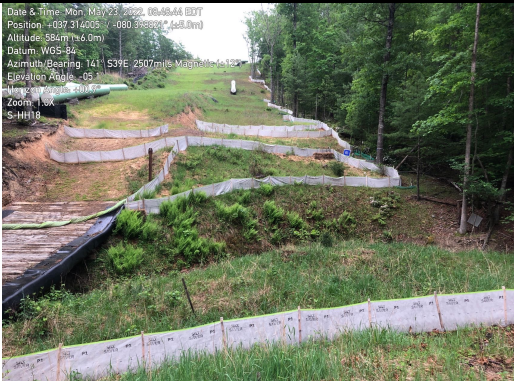
<b>GPS Location</b>	On photo	<b>GPS Location</b>	On photo		
<b>Field Station#</b>	11626+04	<b>Field Station#</b>	11614+20		
<b>Pic 5 Desc.</b>	The S-HH18 crossing is stable.	<b>Pic 6 Desc.</b>	The S-RR14 crossing is stable.

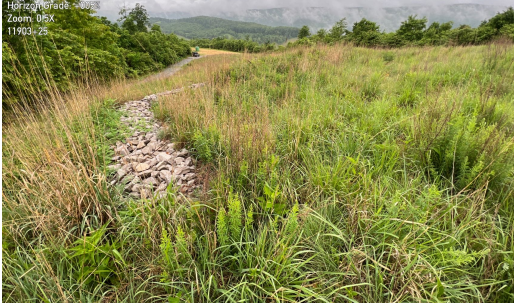
<b>GPS Location</b>	See photo	<b>GPS Location</b>	See photo		
<b>Field Station#</b>	11903+25	<b>Field Station#</b>	11910+00		
<b>Pic 1 Desc.</b>	Level spreader in place	<b>Pic 2 Desc.</b>	Permanent vegetation present		
<p>Date &amp; Time: Mon, May 23, 2022, 09:38:07 EDT  Position: +039.28274° / +080.33022° (+15.5ft)  Altitude: 2390ft (+11.1ft)  Datum: WGS-84  Azimuth/Bearing: 301° N59W 595mils True (+12°)  Elevation Grade: +03%  Horizon Grade: +00%  Zoom: 0.5X  11925+00</p>

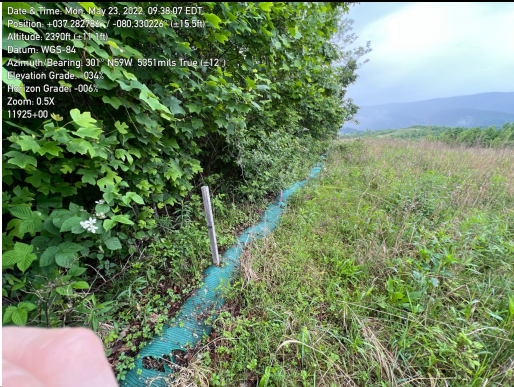
<b>GPS Location</b>	See photo	<b>GPS Location</b>	See photo		
<b>Field Station#</b>	11925+00	<b>Field Station#</b>	11930+50		
<b>Pic 3 Desc.</b>	CFS perimeter control in place	<b>Pic 4 Desc.</b>	P1 silt fence perimeter control in place		
<p>Date &amp; Time: Mon, May 23, 2022, 09:16:49 EDT  Position: +039.25597° / +080.33597° (+13.5ft)  Altitude: 1930ft (+13.3ft)  Datum: WGS-84  Azimuth/Bearing: 335° N55W 530mils True (+10°)  Elevation Grade: +00%  Horizon Grade: +00%  Zoom: 0.5X  11974+50</p>

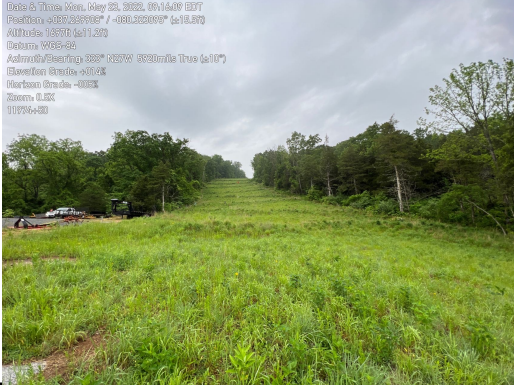
<b>GPS Location</b>	See photo	<b>GPS Location</b>	See photo		
<b>Field Station#</b>	11974+50	<b>Field Station#</b>	11988+25		
<b>Pic 5 Desc.</b>	Waterbars in place	<b>Pic 6 Desc.</b>	RCE in place

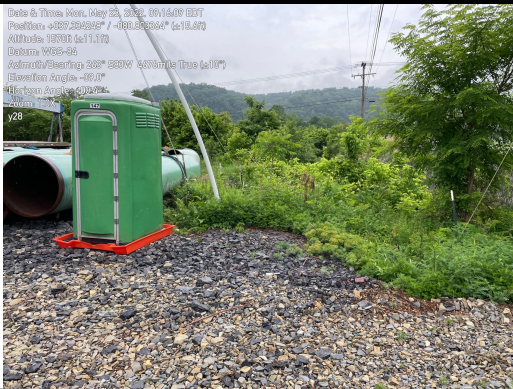
GPS Location	See photo		GPS Location	See photo	
Field Station#	12005+00		Field Station#	12005+00	
Pic 3 Desc.	CFS perimeter controls functional y28		Pic 4 Desc.	RCE functional y28

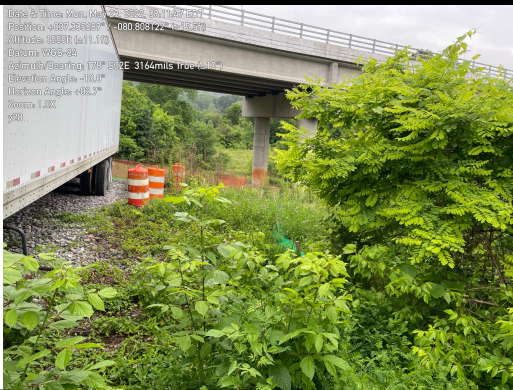
GPS Location	See photo		GPS Location	See photo	
Field Station#	12005+00		Field Station#	12005+00	
Pic 5 Desc.	CFS perimeter controls functional y28		Pic 6 Desc.	Containment in place

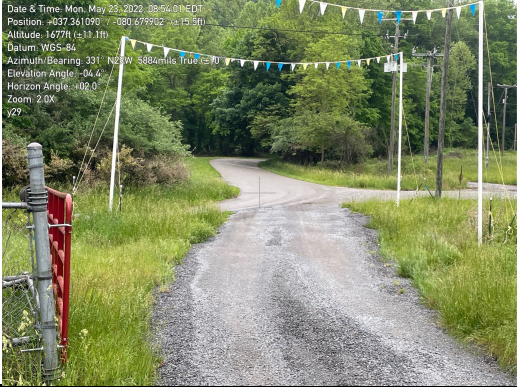
<b>GPS Location</b>	See photo	<b>GPS Location</b>	See photo		
<b>Field Station#</b>	12005+00	<b>Field Station#</b>	12005+00		
<b>Pic 7 Desc.</b>	RCE functional y29	<b>Pic 8 Desc.</b>	Broad base dips functional y29		
<p>Date &amp; Time: Mon, May 23, 2022 08:51:51 EDT  Position: +037.362275 / -080.679291 (+15.5h)  Altitude: 1718ft (+11.1h)  Datum: WGS-84  Azimuth/Bearing: 173° S07E 3076mils True (+10°)  Elevation Angle: -56.5°  Horizon Angle: -105.7°  Zoom: 1.0X  y29</p>

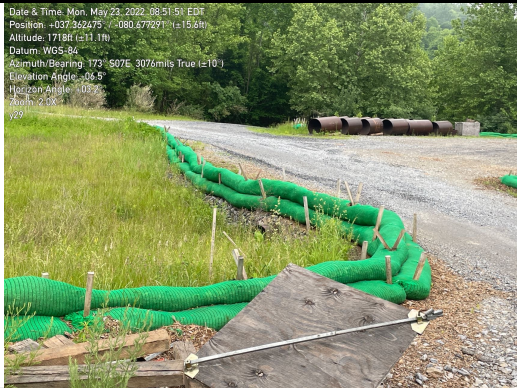
<b>GPS Location</b>	See photo	<b>GPS Location</b>	See photo		
<b>Field Station#</b>	12005+00	<b>Field Station#</b>	12005+00		
<b>Pic 9 Desc.</b>	Culvert in place y29	<b>Pic 10 Desc.</b>	Housekeeping trash in good condition y29		
<p>Date &amp; Time: Mon, May 23, 2022 09:04:04 EDT  Position: +037.363185 / -080.679581 (+15.5h)  Altitude: 1700ft (+11.1h)  Datum: WGS-84  Azimuth/Bearing: 162° N2W 590mils True (+10°)  Elevation Angle: -40.3°  Horizon Angle: -101.1°  Zoom: 1.0X  y29</p>

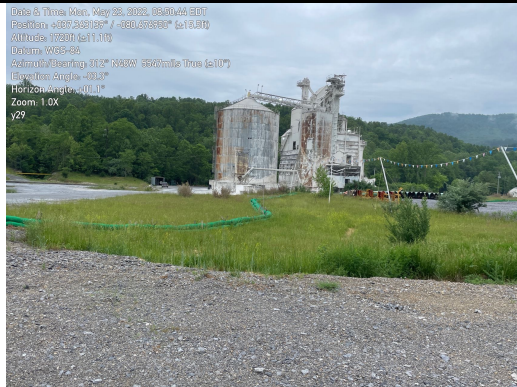
<b>GPS Location</b>	See photo	<b>GPS Location</b>	See photo		
<b>Field Station#</b>	12005+00	<b>Field Station#</b>	12005+00		
<b>Pic 11 Desc.</b>	Permanent stabilization in place y29	<b>Pic 12 Desc.</b>	CFS perimeter controls functional y29

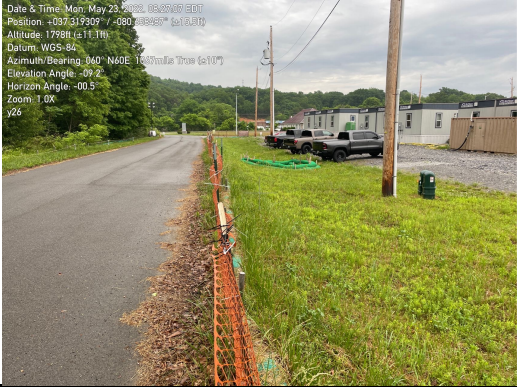
<b>GPS Location</b>	See photo	<b>GPS Location</b>	See photo		
<b>Field Station#</b>	12005+00	<b>Field Station#</b>	12005+00		
<b>Pic 13 Desc.</b>	CFS perimeter controls functional y26	<b>Pic 14 Desc.</b>	Construction zone in parking lot monitoring it.y26		
<p>Date &amp; Time Mon, May 23, 2022 05:25:05 EDT  Position: +037.519309° / -080.48345° (±11.81)  Altitude: 1804ft (±11.7ft)  Datum: WGS-84  Azimuth/Bearing: 207° N207W 402mils True (±10°)  Elevation Angle: +89.2°  Horizon Angle: -00.5°  Zoom: 1.0X  y26</p>

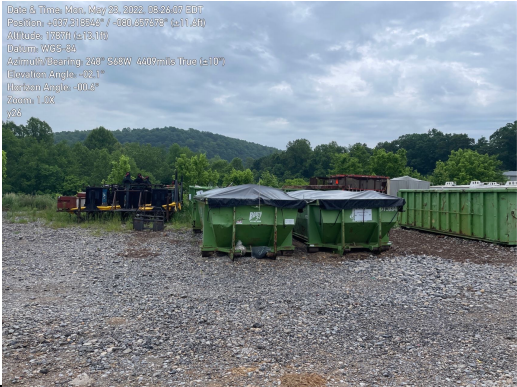
<b>GPS Location</b>	See photo	<b>GPS Location</b>	See photo		
<b>Field Station#</b>	12005+00	<b>Field Station#</b>	12005+00		
<b>Pic 15 Desc.</b>	Housekeeping trash in good condition y26	<b>Pic 16 Desc.</b>	Secondary containment in place y26		
<p>Date &amp; Time Mon, May 23, 2022 05:25:05 EDT  Position: +037.519309° / -080.48345° (±11.81)  Altitude: 1804ft (±11.7ft)  Datum: WGS-84  Azimuth/Bearing: 207° N207W 402mils True (±10°)  Elevation Angle: +89.2°  Horizon Angle: -00.5°  Zoom: 2.0X  y26</p>

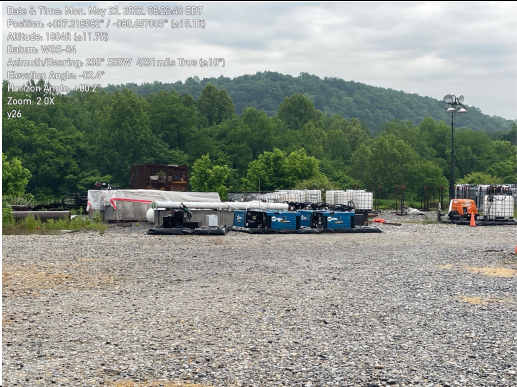
<b>GPS Location</b>	See photo	<b>GPS Location</b>	See photo		
<b>Field Station#</b>	12005+00	<b>Field Station#</b>	12005+00		
<b>Pic 17 Desc.</b>	Secondary containment in place y26	<b>Pic 18 Desc.</b>	RCE functional y26

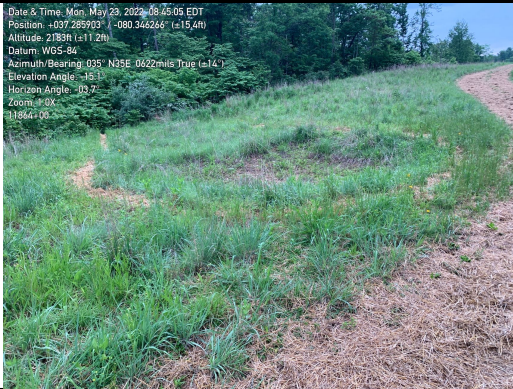
<p>Date &amp; Time: Mon, May 23, 2022, 08:46:01 EDT Position: #037 298992 / -080 344286 (±15.4ft) Altitude: 2133ft (±11.2ft) Datum: WGS-84 Azimuth/Bearing: 267° S67W 439mils True (±14°) Elevation Angle: -05.3° Horizon Angle: -00.4° Zoom: 1.0X 11890+00</p>			
GPS Location				See photo for GPS location.				GPS Location				See photo for GPS location.			
Field Station#				11864+00				Field Station#				11890+00			
Pic 1 Desc.				Sensitive resource P-KL2.				Pic 2 Desc.				ROW permanently stabilized. Waterbar and level spreader in place.

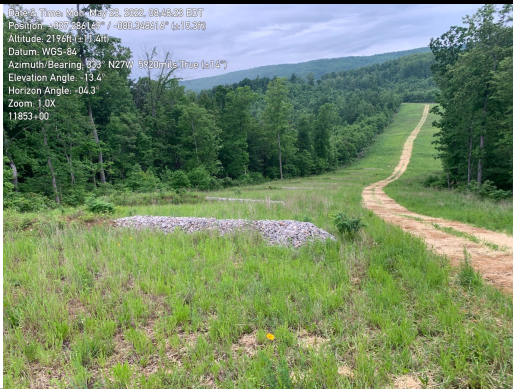
GPS Location				See photo for GPS location.				GPS Location				See photo for GPS location.			
Field Station#				11853+00				Field Station#				11789+00			
Pic 3 Desc.				ROW restored. Waterbars and level spreaders in place.				Pic 4 Desc.				Rain gauge at Mount Tabor Road reads 0.01.

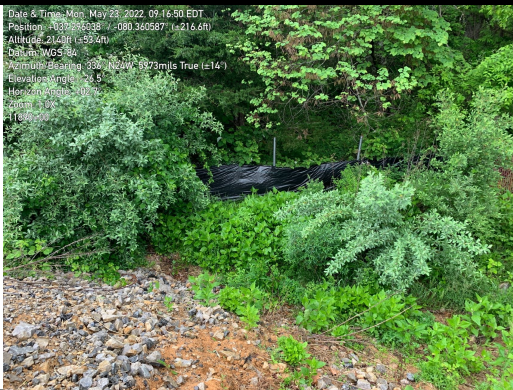
Field Station#				11790+00				Field Station#				11789+00			
Pic 5 Desc.				Super silt fence in place along LOD.				Pic 6 Desc.				RCE in place at Mount Tabor Road.

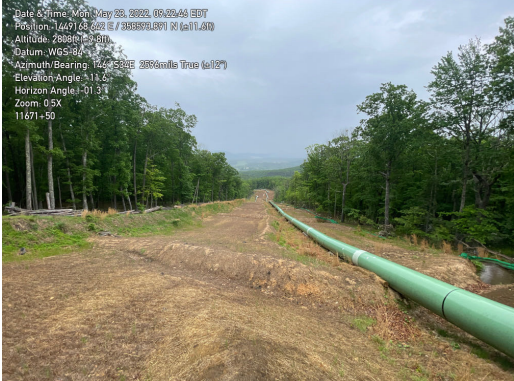
<b>GPS Location</b>	1	<b>GPS Location</b>	2		
<b>Field Station#</b>	11671+50	<b>Field Station#</b>	11687+42		
<b>Pic 1 Desc.</b>	Section of RoW showing conditions and controls.	<b>Pic 2 Desc.</b>	Overview S-MN21.

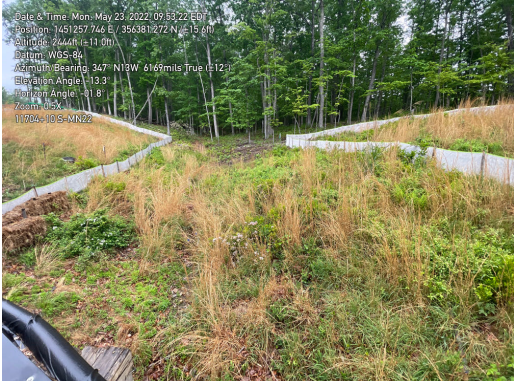
<b>GPS Location</b>	3	<b>GPS Location</b>	4		
<b>Field Station#</b>	11704+10	<b>Field Station#</b>	11710+00		
<b>Pic 3 Desc.</b>	S-MN22.	<b>Pic 4 Desc.</b>	Section of RoW showing conditions and controls.

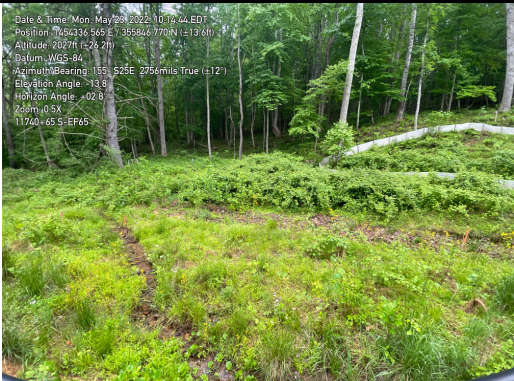
<b>GPS Location</b>	5	<b>GPS Location</b>	6		
<b>Field Station#</b>	11740+65	<b>Field Station#</b>	11743+97		
<b>Pic 5 Desc.</b>	S-EF65.	<b>Pic 6 Desc.</b>	S-EF62.

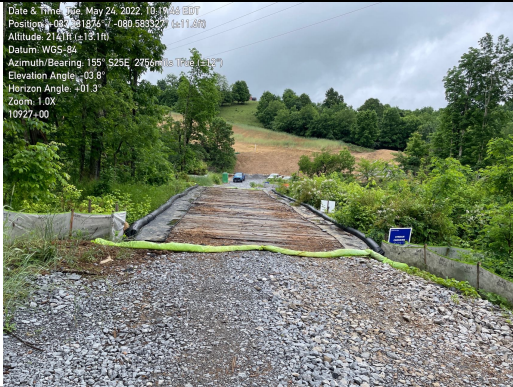
GPS Location		See photo		GPS Location		See photo
Field Station#		10927+00		Field Station#		10925+00
Pic 3 Desc.		Wattles in place		Pic 4 Desc.		Water bars and ET in place

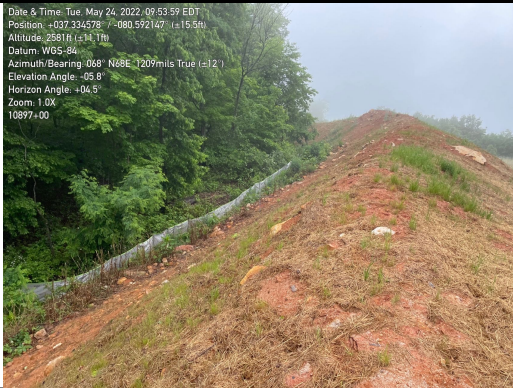
GPS Location		See photo		GPS Location		See photo
Field Station#		10897+00		Field Station#		10882+50
Pic 5 Desc.		Perimeter controls in place		Pic 6 Desc.		Equipment bridge functional

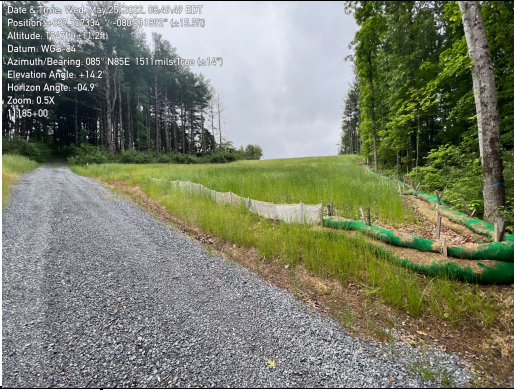
<p>Date &amp; Time: Wed, May 25, 2022, 08:48:06 EDT Position: +097.506502° / -080.569810° (-15.08) Altitude: 1968ft (-11.2ft) Datum: WGS-84 Azimuth/Bearing: 190° S10W 317mils True (-14°) Elevation Angle: -01.0° Horizon Angle: -03.5° Zoom: 0.5X 11189+00</p>			
<b>GPS Location</b>	See Photo	<b>GPS Location</b>	See Photo		
<b>Field Station#</b>	11185+00	<b>Field Station#</b>	11189+00		
<b>Pic 1 Desc.</b>	Access road	<b>Pic 2 Desc.</b>	Level spreader

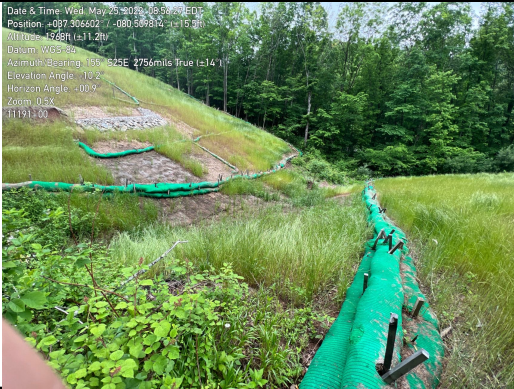
<b>GPS Location</b>	See Photo	<b>GPS Location</b>	See Photo		
<b>Field Station#</b>	11191+00	<b>Field Station#</b>	11206+00		
<b>Pic 3 Desc.</b>	Drainage Feature	<b>Pic 4 Desc.</b>	Restoration continued monitoring growth and overseeding

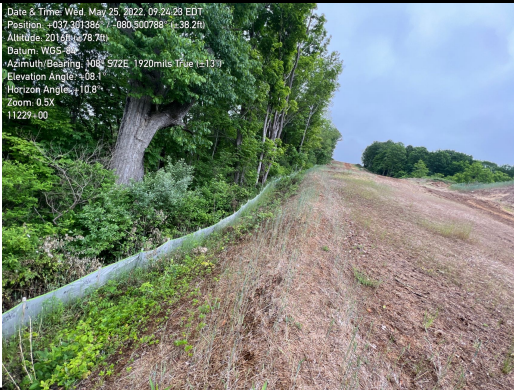
<p>Date &amp; Time: Wed, May 25, 2022, 09:26:06 EDT Position: +097.506502° / -080.569810° (-15.08) Altitude: 2002m (-81.3ft) Datum: WGS-84 Azimuth/Bearing: 317° S23W 308mils True (-13°) Elevation Angle: -13.3° Horizon Angle: -01.9° Zoom: 0.5X 11239+00</p>			
<b>GPS Location</b>	See Photo	<b>GPS Location</b>	See Photo		
<b>Field Station#</b>	11229+00	<b>Field Station#</b>	11239+00		
<b>Pic 5 Desc.</b>	Perimeter controls	<b>Pic 6 Desc.</b>	Sump pit

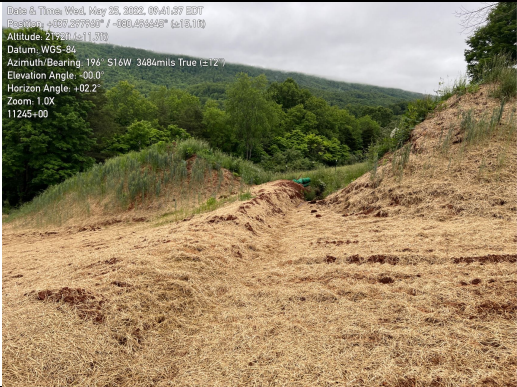
<b>GPS Location</b>	See Photo	<b>GPS Location</b>	See Photo		
<b>Field Station#</b>	11245+00	<b>Field Station#</b>	11248+00		
<b>Pic 7 Desc.</b>	Water bar end treatment	<b>Pic 8 Desc.</b>	Water bars

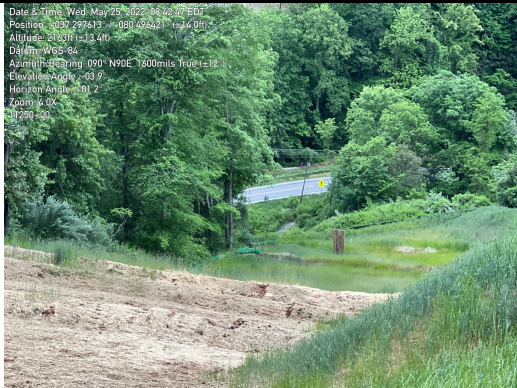
Insert image here	
<b>GPS Location</b>	See Photo	<b>GPS Location</b>			
<b>Field Station#</b>	11250+00	<b>Field Station#</b>			
<b>Pic 9 Desc.</b>	Stream overview	<b>Pic 10 Desc.</b>			
Insert image here		Insert image here			
<b>GPS Location</b>		<b>GPS Location</b>			
<b>Field Station#</b>		<b>Field Station#</b>			
<b>Pic 11 Desc.</b>		<b>Pic 12 Desc.</b>

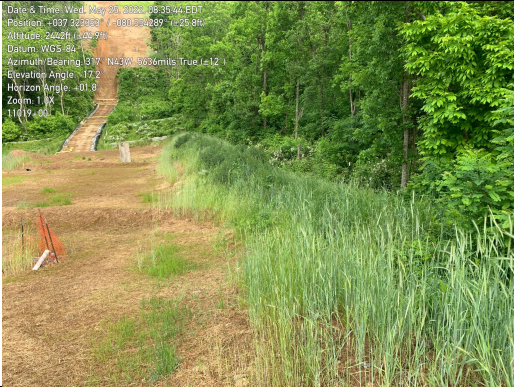
<b>GPS Location</b>	See photo for GPS location.		<b>GPS Location</b>	See photo for GPS location.	
<b>Field Station#</b>	11019+00		<b>Field Station#</b>	11011+50	
<b>Pic 1 Desc.</b>	Clean water diversion berm in place.		<b>Pic 2 Desc.</b>	Clean water diversion pipe inlet in place.

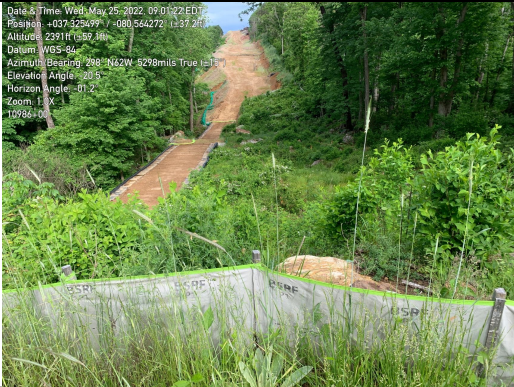
<b>GPS Location</b>	See photo for GPS location.		<b>GPS Location</b>	See photo for GPS location.	
<b>Field Station#</b>	10986+00		<b>Field Station#</b>	10966+00	
<b>Pic 3 Desc.</b>	Sensitive resource buffer in place at streams S-E24 and S-E25.		<b>Pic 4 Desc.</b>	Triple barrier ECDs in place at cave feature.

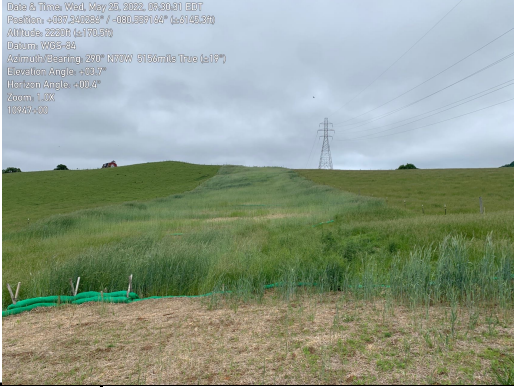
<b>GPS Location</b>	See photo for GPS location.		<b>GPS Location</b>	See photo for GPS location.	
<b>Field Station#</b>	10947+00		<b>Field Station#</b>	10930+25	
<b>Pic 5 Desc.</b>	ROW permanently stabilized.		<b>Pic 6 Desc.</b>	RCE in place at Doe Creek Road.

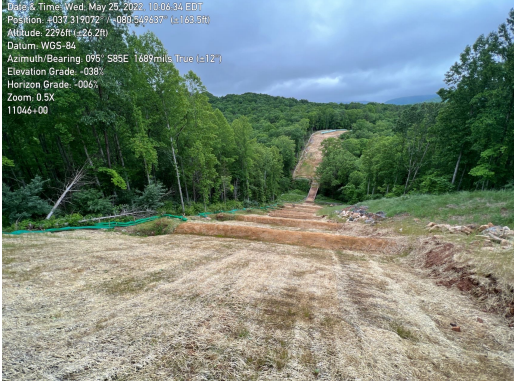
<b>GPS Location</b>	See photo	<b>GPS Location</b>	See photo		
<b>Field Station#</b>	11046+00	<b>Field Station#</b>	11049+75		
<b>Pic 3 Desc.</b>	End treatments in place	<b>Pic 4 Desc.</b>	Stream buffer in place

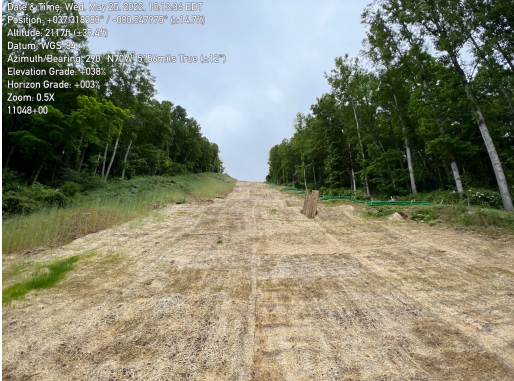
<b>GPS Location</b>	See photo	<b>GPS Location</b>	See photo		
<b>Field Station#</b>	11048+00	<b>Field Station#</b>	11053+30		
<b>Pic 5 Desc.</b>	Erosion control blanket in place	<b>Pic 6 Desc.</b>	P1 silt fence perimeter control in place

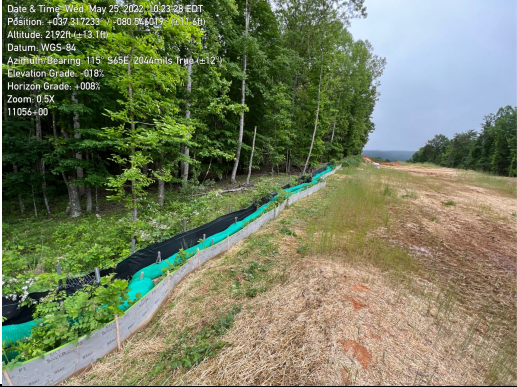
<p>Date &amp; Time: Wed, May 25, 2022, 10:56:06 EDT Position: +037 317334 / -080 964444 (±11.80) Altitude: 2177ft (±9.84) Datum: WGS-84 Azimuth/Bearing: 138° S51E 2009mils True (±12°) Elevation Grade: -025% Horizon Grade: +005% Zoom: 0.5X 11064+00</p>			
<b>GPS Location</b>	See photo	<b>GPS Location</b>	See photo		
<b>Field Station#</b>	11056+00	<b>Field Station#</b>	11064+00		
<b>Pic 7 Desc.</b>	Triple protection ECDs in place at karst feature	<b>Pic 8 Desc.</b>	Waterbars in place

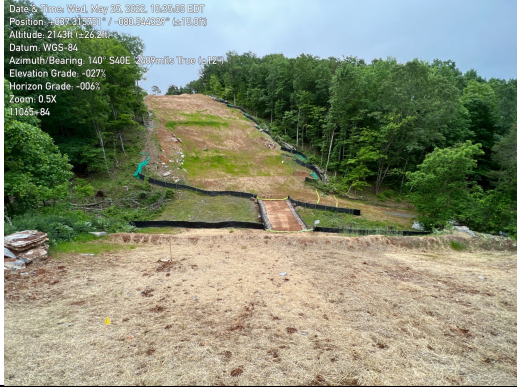
<b>GPS Location</b>	See photo	<b>GPS Location</b>	See photo		
<b>Field Station#</b>	11065+84	<b>Field Station#</b>	11073+00		
<b>Pic 9 Desc.</b>	Cleanwater drainage feature in place	<b>Pic 10 Desc.</b>	Permanent vegetation in place

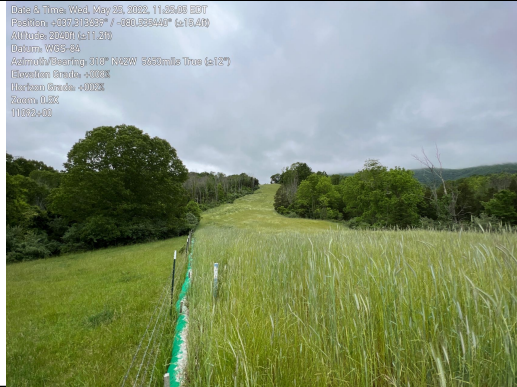
<p>Date &amp; Time: Wed, May 25, 2022, 11:05:49 EDT Position: +037 312692 / -080 959456 (±12.10) Altitude: 1920ft (±11.70) Datum: WGS-84 Azimuth/Bearing: 109° S81E 2401mils True (±12°) Elevation Grade: -014% Horizon Grade: -000% Zoom: 0.5X 11098+30</p>			
<b>GPS Location</b>	See photo	<b>GPS Location</b>	See photo		
<b>Field Station#</b>	11092+00	<b>Field Station#</b>	11098+30		
<b>Pic 11 Desc.</b>	CFS perimeter control in place	<b>Pic 12 Desc.</b>	RCE in place

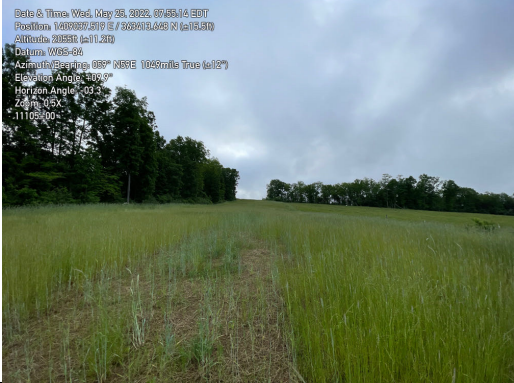
GPS Location 1		GPS Location 2			
Field Station# 11105+00		Field Station# 11117+00			
Pic 1 Desc. Section of restored RoW showing conditions and controls.		Pic 2 Desc. Section of restored RoW showing conditions and controls.

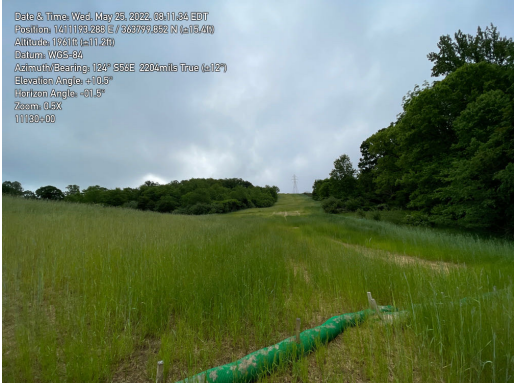
GPS Location 3		GPS Location 4			
Field Station# 11130+00		Field Station# 11134+00			
Pic 3 Desc. Section of restored RoW showing conditions and controls.		Pic 4 Desc. Representative photo of permanent waterbar and level spreaders installed.

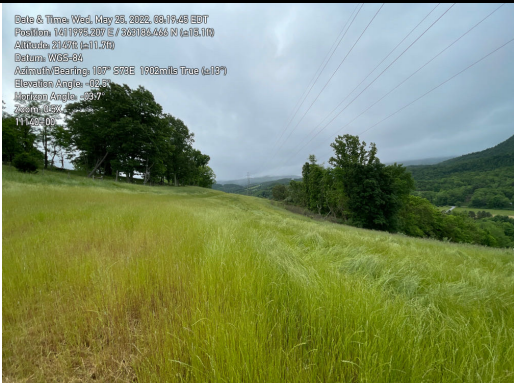
GPS Location 5		GPS Location 6			
Field Station# 11140+00		Field Station# 11146+50			
Pic 5 Desc. Section of restored RoW showing conditions and controls.		Pic 6 Desc. CWDP outlet protection functional.

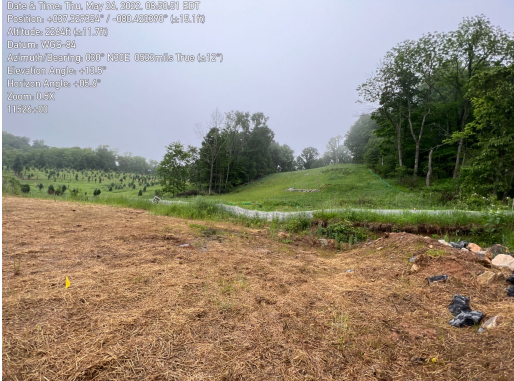
<b>GPS Location</b>	See Photo	<b>GPS Location</b>	See Photo		
<b>Field Station#</b>	11526+00	<b>Field Station#</b>	11530+00		
<b>Pic 1 Desc.</b>	Stabilization and restoration	<b>Pic 2 Desc.</b>	Perimeter controls

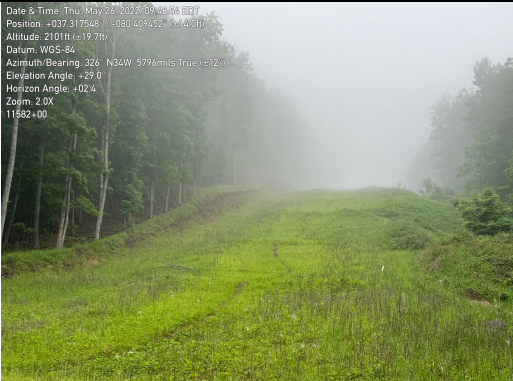
<b>GPS Location</b>	See Photo	<b>GPS Location</b>	See Photo		
<b>Field Station#</b>	11532+00	<b>Field Station#</b>	11582+00		
<b>Pic 3 Desc.</b>	Level spreader	<b>Pic 4 Desc.</b>	Section of ROW showing conditions

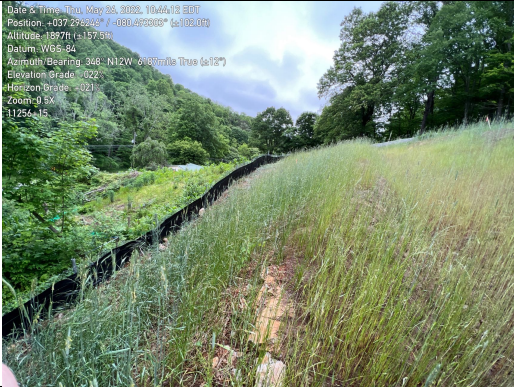
<b>GPS Location</b>	See photo		<b>GPS Location</b>	See photo	
<b>Field Station#</b>	11256+15		<b>Field Station#</b>	11256+00	
<b>Pic 1 Desc.</b>	Supersilt fence in place		<b>Pic 2 Desc.</b>	Waterbars in place	
<p>Date &amp; Time: Thu, May 26, 2022, 10:45:45 EDT  Position: -837.296227° / -880.491372° (+10.17ft)  Altitude: 2113ft (+1127ft)  Datum: WGS-84  Azimuth/Bearing: 304° N45W 580mils True (+12°)  Elevation Grade: -000°  Horizon Grade: -000°  Zoom: 0.5X  11261+50</p>

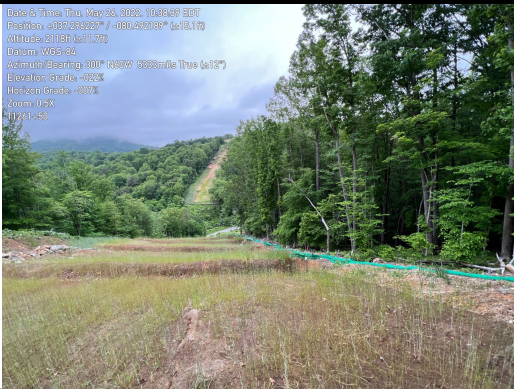
<b>GPS Location</b>	See photo		<b>GPS Location</b>	See photo	
<b>Field Station#</b>	11261+50		<b>Field Station#</b>	11263+00	
<b>Pic 3 Desc.</b>	End treatments in place		<b>Pic 4 Desc.</b>	CFS triple stack perimeter control in place	
<p>Date &amp; Time: Thu, May 26, 2022, 10:23:20 EDT  Position: -837.294152° / -880.487151° (+10.1ft)  Altitude: 2273ft (+1170ft)  Datum: WGS-84  Azimuth/Bearing: 174° S06E 3093mils True (+12°)  Elevation Grade: -052°  Horizon Grade: -002°  Zoom: 0.5X  11271+00</p>

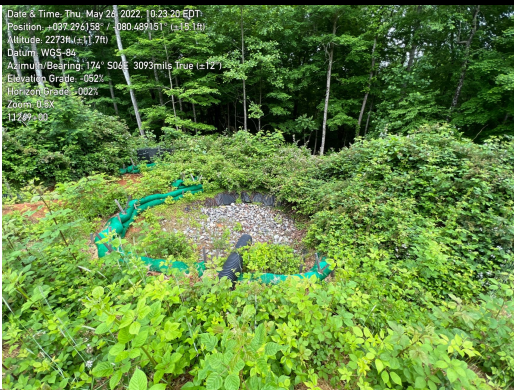
<b>GPS Location</b>	See photo		<b>GPS Location</b>	See photo	
<b>Field Station#</b>	11269+00		<b>Field Station#</b>	11271+00	
<b>Pic 5 Desc.</b>	Plunge pool in place		<b>Pic 6 Desc.</b>	Stone inlet protection in place

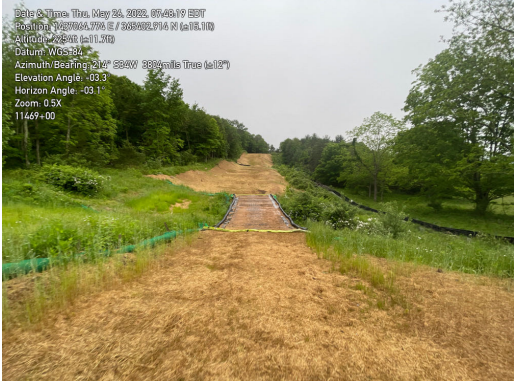
<b>GPS Location</b>	1	<b>GPS Location</b>	2		
<b>Field Station#</b>	11469+00	<b>Field Station#</b>	11451+87		
<b>Pic 1 Desc.</b>	Section of RoW showing conditions and controls.		<b>Pic 2 Desc.</b>	S-0012.

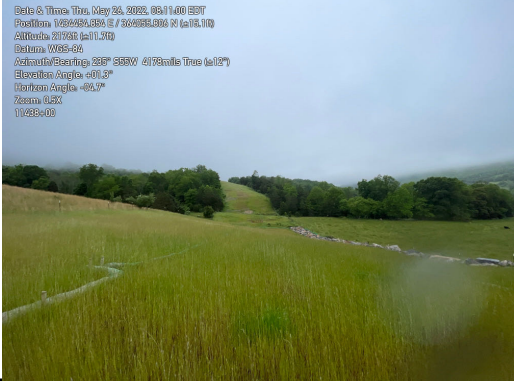
<b>GPS Location</b>	5	<b>GPS Location</b>	6		
<b>Field Station#</b>	11438+00	<b>Field Station#</b>	11432+00		
<b>Pic 5 Desc.</b>	Section of restored RoW showing conditions and controls.		<b>Pic 6 Desc.</b>	Representative photo of permanent waterbar and level spreaders installed.

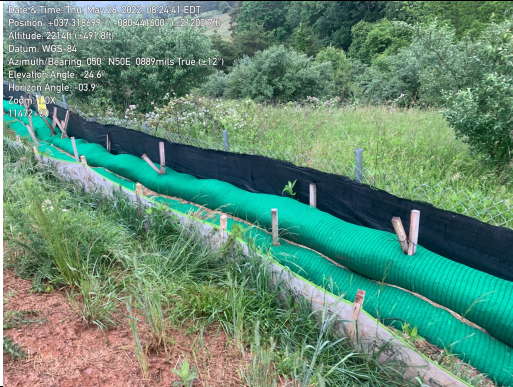
<p>Date &amp; Time: Thu, May 26, 2022, 08:24:04 EDT Position: +027.312337° / -080.41500° (-1502.60m) Altitude: 2233ft (-684m) Datum: WGS-84 Azimuth/Bearing: 087° N08E 1507mils True (+12°) Elevation Angle: -24.6° Horizon Angle: -03.9° Zoom: 1.0X 11476+00</p>			
GPS Location		See photo for GPS location.						GPS Location		See photo for GPS location.					
Field Station#		11472+00						Field Station#		11476+00					
Pic 1 Desc.		Triple barrier ECDs in place along LOD.						Pic 2 Desc.		Rock inlet in place at slope drain pipe.

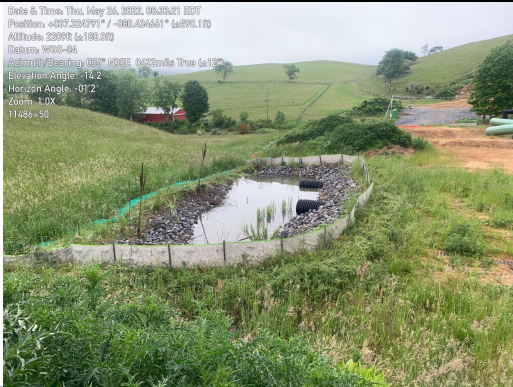
GPS Location		See photo for GPS location.						GPS Location		See photo for GPS location.					
Field Station#		11486+50						Field Station#		11490+00					
Pic 3 Desc.		Plunge pool in place.						Pic 4 Desc.		RCE in place at Stevers Gap Road.

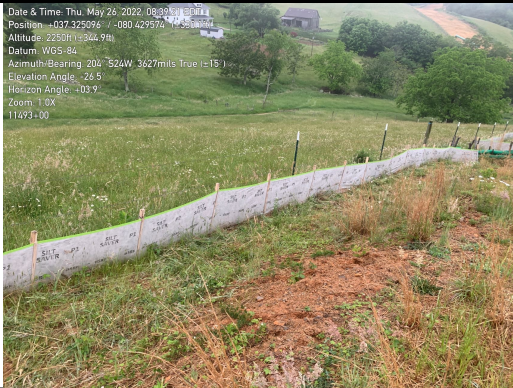
Pic 5 Desc.		Priority one silt fence in place along LOD.						Pic 6 Desc.		Rock lined channel in place at convey water.

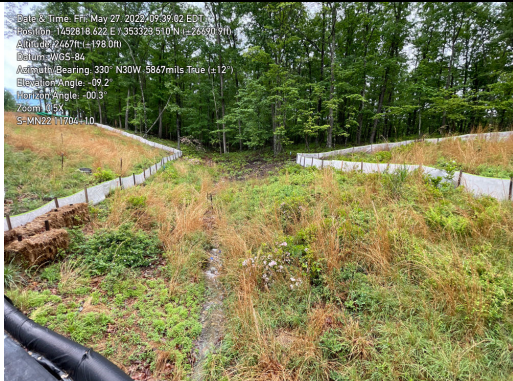
<b>GPS Location</b>	3	<b>GPS Location</b>	4		
<b>Field Station#</b>	11687+42	<b>Field Station#</b>	11704+10		
<b>Pic 3 Desc.</b>	Upstream S-MN21 dammed by naturally fallen trees and debris.	<b>Pic 4 Desc.</b>	S-MN22.

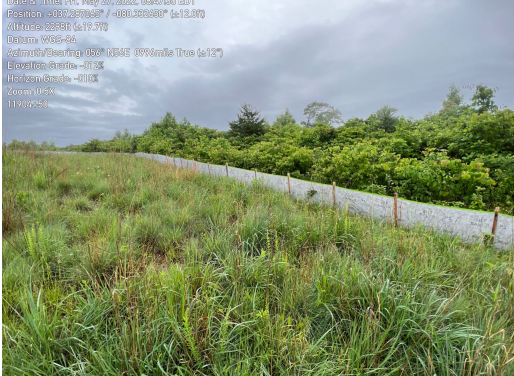
<b>GPS Location</b>	See photo	<b>GPS Location</b>	See photo		
<b>Field Station#</b>	11904+50	<b>Field Station#</b>	11920+00		
<b>Pic 1 Desc.</b>	P1 silt fence perimeter control in place	<b>Pic 2 Desc.</b>	Permanent vegetation present		
<p>Date &amp; Time Fri, May 27, 2022 05:54:40 EDT  Position: +40°23'56"N / -89.5558° W (-12.47)  Altitude: 2330 ft (-17.37)  Datum: WGS-84  Azimuth/Bearing: 134° S45E 399mils True (-13°)  Elevation Grade: -40%  Horizon Grade: -00%  Zoom: 0.5X  11922+00</p>

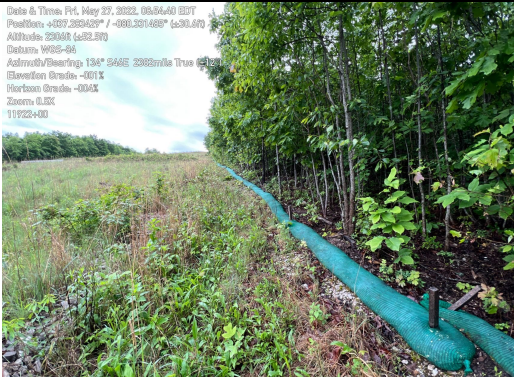
<b>GPS Location</b>	See photo	<b>GPS Location</b>	See photo		
<b>Field Station#</b>	11922+00	<b>Field Station#</b>	11923+00		
<b>Pic 3 Desc.</b>	CFS perimeter control in place	<b>Pic 4 Desc.</b>	Level spreader in place		
<p>Date &amp; Time Fri, May 27, 2022 06:12:40 EDT  Position: +40°23'56"N / -89.5558° W (-12.47)  Altitude: 2330 ft (-17.37)  Datum: WGS-84  Azimuth/Bearing: 134° S45E 399mils True (-13°)  Elevation Grade: -40%  Horizon Grade: -00%  Zoom: 0.5X  11947+00</p>

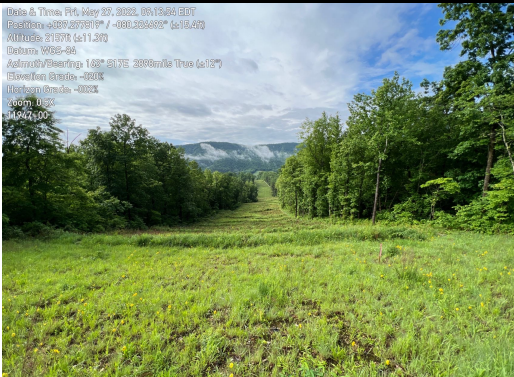
<b>GPS Location</b>	See photo	<b>GPS Location</b>	See photo		
<b>Field Station#</b>	11947+00	<b>Field Station#</b>	11900+81		
<b>Pic 5 Desc.</b>	Waterbars in place	<b>Pic 6 Desc.</b>	RCE in place

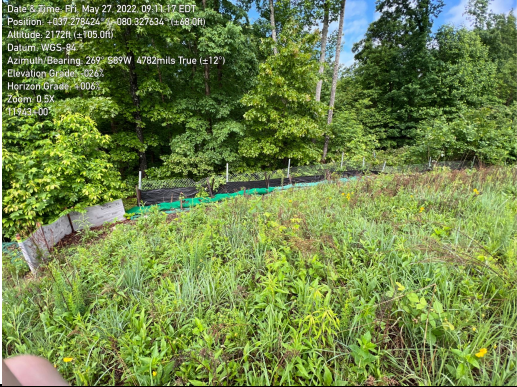
<b>Field Station#</b>	11943+00	<b>Field Station#</b>	11965+00		
<b>Pic 7 Desc.</b>	Triple protection ECDs in place at karst feature	<b>Pic 8 Desc.</b>	P1 silt fence perimeter control in place		
<small>           Date &amp; Time: Fri, May 27, 2022, 09:29:01 EDT            Position: +037.271164°N +080.306664°W (-645.0ft)            Altitude: 1920ft (+60.0ft)            Datum: WGS-84            Azimuth/Bearing: 148° 30'SE 3370mils True (+12°)            Elevation Grade: -03%            Horizon Grade: -01%            Zoom: 0.5X            11972+00         </small>

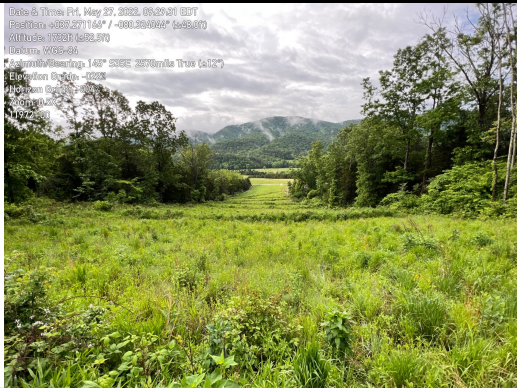
<b>GPS Location</b>	See photo	<b>GPS Location</b>	See photo		
<b>Field Station#</b>	11972+00	<b>Field Station#</b>	11978+50		
<b>Pic 9 Desc.</b>	Waterbars in place	<b>Pic 10 Desc.</b>	Triple protection ECDs in place at karst feature		
<small>           Date &amp; Time: Fri, May 27, 2022, 09:29:03 EDT            Position: +037.267592°N +080.322342°W (-15.0ft)            Altitude: 1702ft (+11.2ft)            Datum: WGS-84            Azimuth/Bearing: 072° N22E 1280mils True (+12°)            Elevation Grade: -04%            Horizon Grade: -00%            Zoom: 0.5X            AR-266         </small>

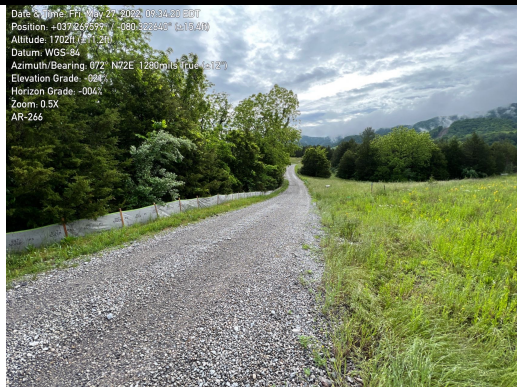
<b>GPS Location</b>	See photo	<b>GPS Location</b>	See photo		
<b>Field Station#</b>	11978+54	<b>Field Station#</b>	11988+96		
<b>Pic 11 Desc.</b>	RCE in place	<b>Pic 12 Desc.</b>	Catawba rain gauge measured 1.2" of rainfall

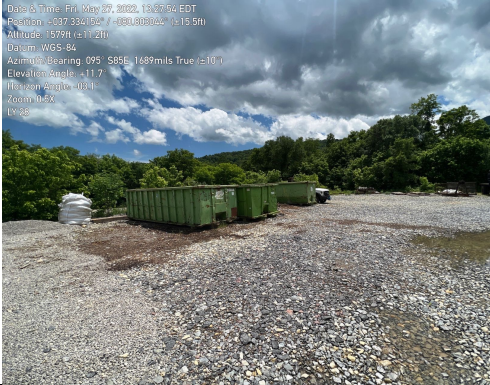
<b>GPS Location</b>	LY28	<b>GPS Location</b>	LY 28		
<b>Field Station#</b>	12005+00	<b>Field Station#</b>	12005+00		
<b>Pic 13 Desc.</b>	Trash house keeping	<b>Pic 14 Desc.</b>	Secondary containment on placate		
<p>Date &amp; Time: Fri, May 27, 2022, 13:56:40 EDT  Position: +337.334162° / -88.803167° (-15.4h)  Altitude: 1580ft (+11.2h)  Datum: WGS-84  Azimuth/Bearing: 318° N32W 1689mils True (+10°)  Deviation Angle: +0.0°  Horizontal Angle: -01.3°  Zoom: 1.0X  LY 28</p>

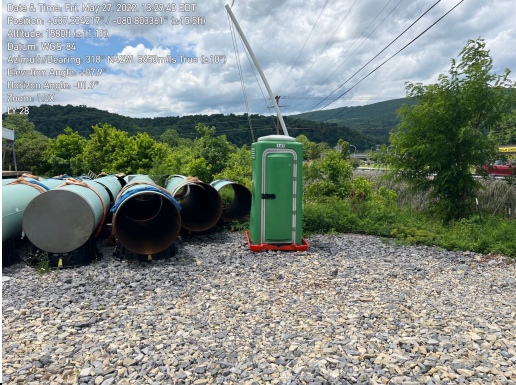
<b>GPS Location</b>	LY28	<b>GPS Location</b>	LY 28		
<b>Field Station#</b>	12005+00	<b>Field Station#</b>	12005+00		
<b>Pic 15 Desc.</b>	Secondary containment in place	<b>Pic 16 Desc.</b>	Perimeter controls		
<p>Date &amp; Time: Fri, May 27, 2022, 13:56:50 EDT  Position: +337.334162° / -88.803167° (-15.4h)  Altitude: 1581ft (+11.2h)  Datum: WGS-84  Azimuth/Bearing: 320° N20E 1689mils True (+10°)  Deviation Angle: +0.3°  Horizontal Angle: -00.6°  Zoom: 1.0X  LY 28</p>

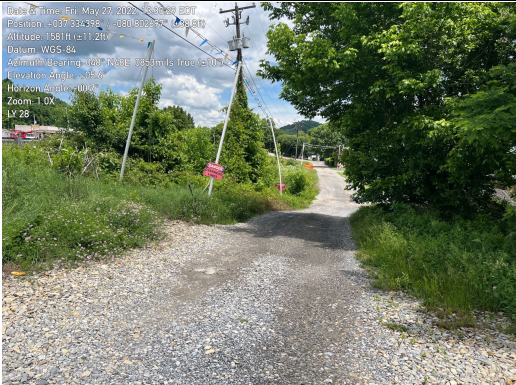
<b>GPS Location</b>	LY 28	<b>GPS Location</b>	LY 28		
<b>Field Station#</b>	12005+00	<b>Field Station#</b>	12005+00		
<b>Pic 17 Desc.</b>	Access Road	<b>Pic 18 Desc.</b>	RCE

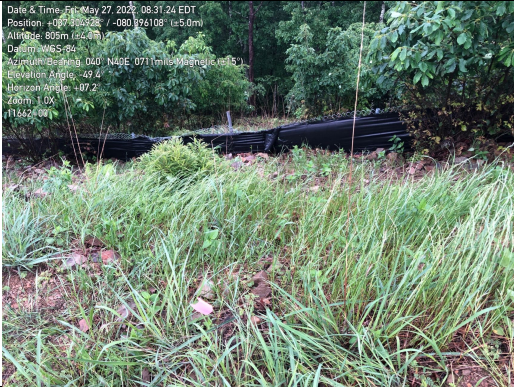
<p>Date &amp; Time: Fri, May 27, 2022, 08:31:23 EDT Position: +037.305343, -080.376635 (+5.0m) Altitude: 777m (+5.0m) Datum: WGS-84 Azimuth: +102° +1813m (+12°) Elevation Angle: -30.6° Horizon Angle: -32.8° Zoom: 1.0X 11659+00</p>			
<b>GPS Location</b>	On photo	<b>GPS Location</b>	On photo		
<b>Field Station#</b>	11665+00	<b>Field Station#</b>	11659+00		
<b>Pic 1 Desc.</b>	Communication; SSF fabric torn and in need of replacement.	<b>Pic 2 Desc.</b>	Sumps and end treatments checked for maintenance needs.

E&S BMPs	Compliance Level	Corrective Action	Corrective Time Frame	Date Repaired
Silt Fence (Reinforce Filter Fence)	Communication	Repair and/or replace SSF fabric		
Cleanwater Diversion Berm	Acceptable			
Cleanwater Diversion Pipe	Acceptable			
Compost Filter Sock	Acceptable			
Equipment Bridge	Acceptable			
Sensitive Resource Buffer	Acceptable			
Waterbar	Acceptable			
Waterbar End Treatment	Acceptable

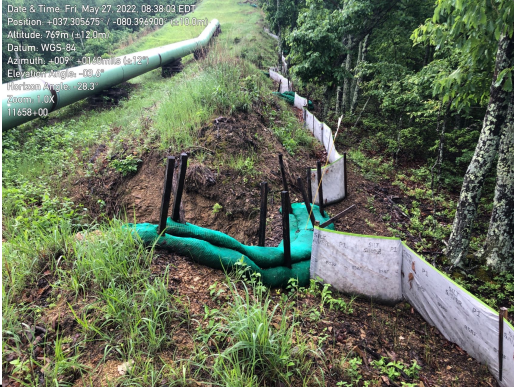
<b>GPS Location</b>	On photo	<b>GPS Location</b>	On photo		
<b>Field Station#</b>	11658+00	<b>Field Station#</b>	11661+00		
<b>Pic 3 Desc.</b>	Perimeter ECDs are in place and effective.	<b>Pic 4 Desc.</b>	Perimeter ECDs were checked for maintenance needs.

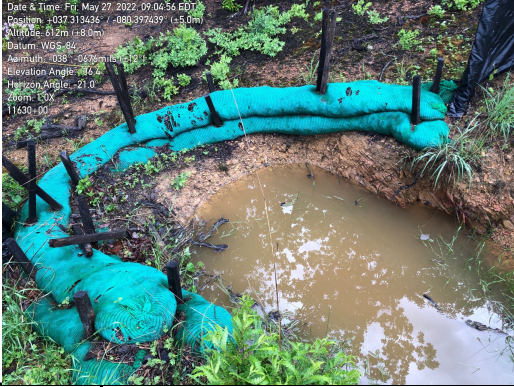
<p>Date &amp; Time: Fri, May 27, 2022, 09:10:04 EDT Position: +037.319595, -080.378929 (+5.0m) Altitude: 590m (+5.0m) Datum: WGS-84 Azimuth: +077° +1369mils (+12°) Elevation Angle: -20.2° Horizon Angle: -28.8° Zoom: 1.0X 11626+50</p>			
<b>GPS Location</b>	On photo	<b>GPS Location</b>	On photo		
<b>Field Station#</b>	11630+00	<b>Field Station#</b>	11626+50		
<b>Pic 5 Desc.</b>	Sumps and end treatments functioning properly.	<b>Pic 6 Desc.</b>	Sumps and end treatments are functional.

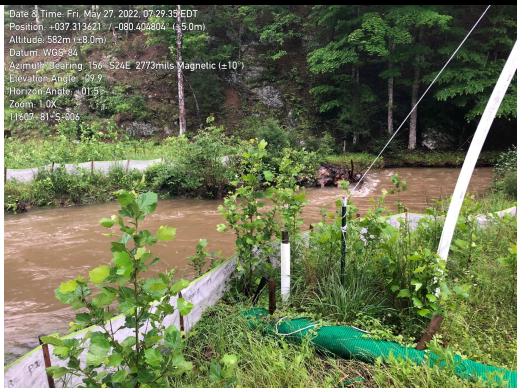
<b>GPS Location</b>	On photo	<b>GPS Location</b>			
<b>Field Station#</b>	11607+81	<b>Field Station#</b>			
<b>Pic 9 Desc.</b>	The S-006 crossing is currently stable.	<b>Pic 10 Desc.</b>			
<div style="text-align: center;">Insert image here</div>		<div style="text-align: center;">Insert image here</div>			
<b>GPS Location</b>		<b>GPS Location</b>			
<b>Field Station#</b>		<b>Field Station#</b>			
<b>Pic 11 Desc.</b>		<b>Pic 12 Desc.</b>

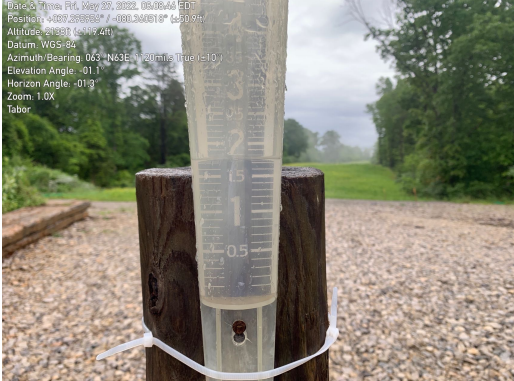
GPS Location	See photo for GPS location.		GPS Location	See photo for GPS location.	
Field Station#	11789+00		Field Station#	11890+00	
Pic 1 Desc.	Rain gauge at Mount Tabor Road reads 1.8 inches.		Pic 2 Desc.	ROW permanently restored. Waterbar and level spreader in place.

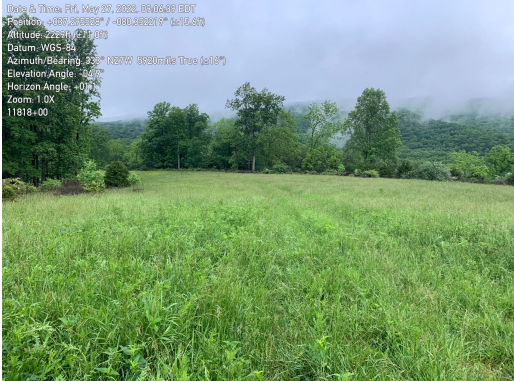
GPS Location	See photo for GPS location.		GPS Location	See photo for GPS location.	
Field Station#	11818+00		Field Station#	11840+00	
Pic 3 Desc.	ROW permanently restored.		Pic 4 Desc.	ROW permanently restored. Waterbar and level spreader in place.

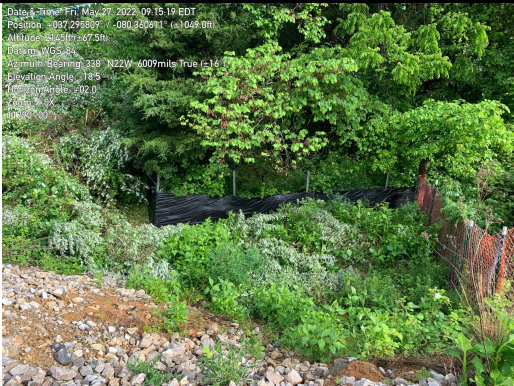
GPS Location	See photo for GPS location.		GPS Location	See photo for GPS location.	
Field Station#	11790+00		Field Station#	11789+00	
Pic 5 Desc.	Super silt fence in place along LOD.		Pic 6 Desc.	RCE in place at Mount Tabor Road crossing.

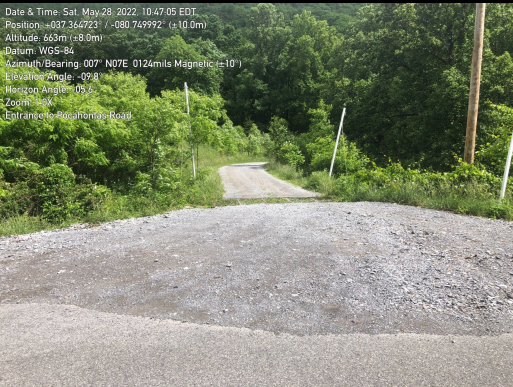
<b>GPS Location</b>	On photo	<b>GPS Location</b>	On photo		
<b>Field Station#</b>	12005+00	<b>Field Station#</b>	10458+97		
<b>Pic 1 Desc.</b>	Yard 37.	<b>Pic 2 Desc.</b>	Entrance to Pocahontas Road. No evidence of traffic this morning.		
<p>Date &amp; Time: Sat, May 28, 2022, 11:00:00 EDT  Position: +037.319353° / -080.666041° (+0.0m)  Altitude: 618m (+13.8m)  Datum: WGS-84  Azimuth/Bearing: 300° N48W 5540mils Magnetic (+10°)  Elevation Angle: +05.4°  Horizon Angle: +00.4°  Zoom: 1.0X  Norcross Road, 10599+95</p>  		<p>Date &amp; Time: Sat, May 28, 2022, 11:30:30 EDT  Position: +037.342123° / -080.621289° (+10.0m)  Altitude: 563m (+32.0m)  Datum: WGS-84  Azimuth/Bearing: 181° S01W 3290mils Magnetic (+07°)  Elevation Angle: +00.7°  Horizon Angle: -04.7°  Zoom: 1.0X  Cascade Drive 10798+83</p>

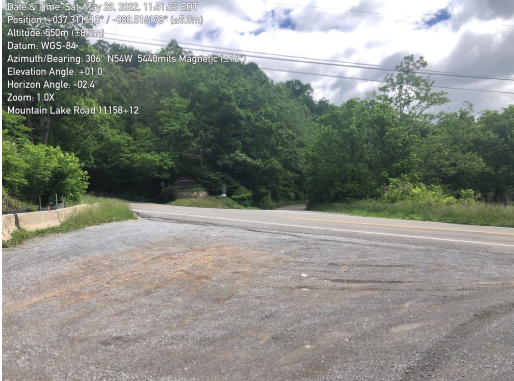
<b>GPS Location</b>	On photo	<b>GPS Location</b>	On photo		
<b>Field Station#</b>	10599+95	<b>Field Station#</b>	10798+83		
<b>Pic 3 Desc.</b>	No protester sightings in the Norcross Road or Big Stony Road area.	<b>Pic 4 Desc.</b>	No protest activity in Cascade Drive area. ROW stable.		
<p>Date &amp; Time: Sat, May 28, 2022, 11:01:00 EDT  Position: +037.319353° / -080.666041° (+0.0m)  Altitude: 650m (+5.0m)  Datum: WGS-84  Azimuth/Bearing: 304° N54W 5440mils Magnetic (+10°)  Elevation Angle: +01.0°  Horizon Angle: -02.4°  Zoom: 1.0X  Mountain Lake Road 11158+12</p>

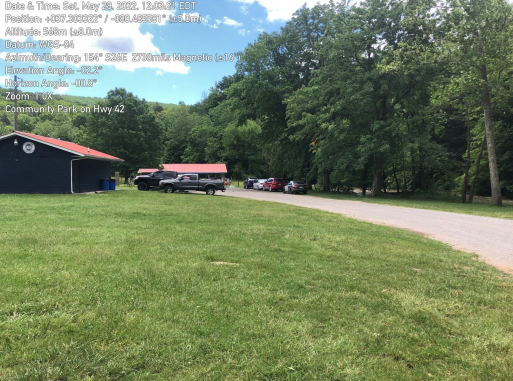
<b>Field Station#</b>	11158+12	<b>Field Station#</b>	11298+08		
<b>Pic 5 Desc.</b>	No protest activity at Mountain Lake Road area. ROW stable.	<b>Pic 6 Desc.</b>	No protesters at the Newport Community Park.

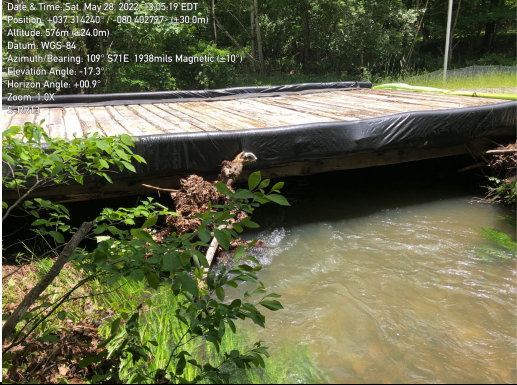
<p>Date &amp; Time: Sat, May 28, 2022, 12:06:19 EDT Position: +037.316240° / -080.402727° (±5.0m) Altitude: 676m (±6.0m) Datum: WGS-84 Azimuth/Bearing: 109° S71E 1938mils Magnetic (±10°) Elevation Angle: -17.3° Horizon Angle: -00.9° Zoom: 1.0X S-PP21</p>			
<b>GPS Location</b>	On photo	<b>GPS Location</b>	On photo		
<b>Field Station#</b>	11254+88	<b>Field Station#</b>	11613+69		
<b>Pic 7 Desc.</b>	Recently installed "MVP Blast Zone" signage installed on Hwy 42 in Newport VA.	<b>Pic 8 Desc.</b>	The S-RR13 crossing. Root ball still lodged against bridge. Bridge remains intact.

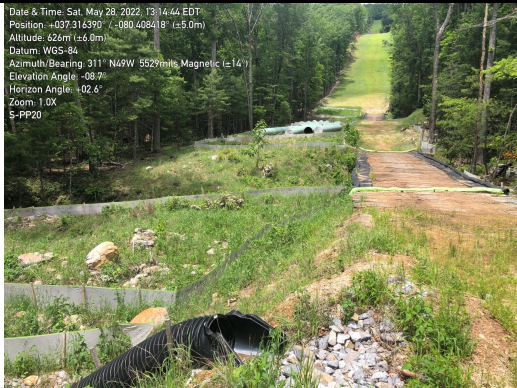
<p>Date &amp; Time: Sat, May 28, 2022, 13:40:17 EDT Position: +037.317230° / -080.405111° (±5.0m) Altitude: 631m (±6.0m) Datum: WGS-84 Azimuth/Bearing: 165° S15E 2933mils Magnetic (±14°) Elevation Angle: -12.4° Horizon Angle: -01.3° Zoom: 1.0X S-PP21</p>			
<b>GPS Location</b>	On photo	<b>GPS Location</b>	On photo		
<b>Field Station#</b>	11588+41	<b>Field Station#</b>	11585+48		
<b>Pic 9 Desc.</b>	The S-PP20 crossing is stable.	<b>Pic 10 Desc.</b>	The SPP21 crossing shows no impact.

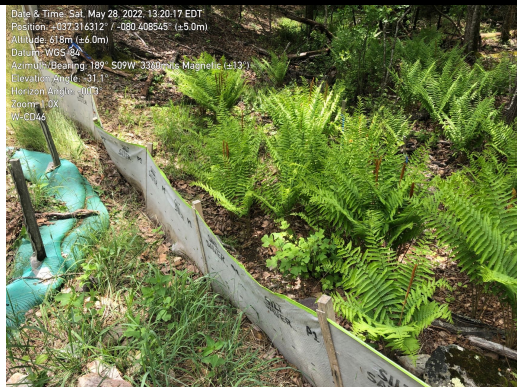
<b>GPS Location</b>	On photo	<b>GPS Location</b>	On photo		
<b>Field Station#</b>	11589+25	<b>Field Station#</b>	11670+00		
<b>Pic 11 Desc.</b>	Adjacent wetland W-CD46 has no impact.	<b>Pic 12 Desc.</b>	Approximately 8 vehicles parked at entrance to FS Road 188. None appeared to belong to protest group.
