# Visual Site Inspection Report

<b>Project Name</b>	H-600 Pipeline Spread G	<b>AFE</b>	124300137	<b>Spread</b>	H-600 Pipeline Spread G
<b>Contractor</b>	Precision			<b>Report #</b>	38181
<b>Inspector</b>	David Schoolcraft			<b>Date/Time</b>	5/30/2022 1:03 PM
<b>Permit #</b>	TBD	<b>Inspection Type</b>	VA SWPP	<b>Station Begin</b>	10655+00
<b>State</b>	VA	<b>Inspection Area</b>	Full	<b>Station End</b>	10749+92
<b>County</b>	Giles	<b>Ground</b>	Damp	<b>Temperature (°F)</b>	85.00
<b>Municipality</b>	N/A	<b>Weather</b>	Sunny	<b>Rain Gauge (in)</b>	0.00
				<b>Rain Accumulation Time (days)</b>	1.00

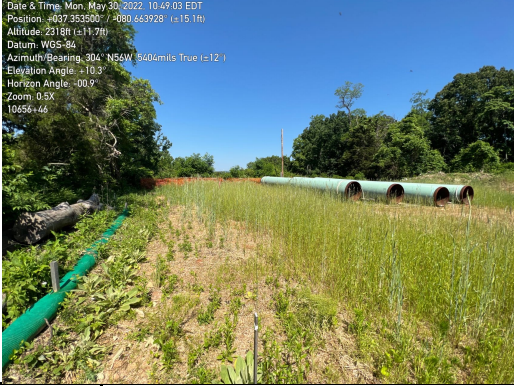
<p>Date &amp; Time: Mon, May 30, 2022, 10:51:41 EDT Position: +037 353550 / -080 666169 (+11.7ft) Altitude: 2247ft (+11.7ft) Datum: WGS-84 Azimuth/Bearing: 072° N72E 3280mils True (+12°) Elevation Angle: -00.5° Horizon Angle: -04.4° Zoom: 0.5X 10661+00</p>		<b>GPS Location</b>	See Photo
<b>Field Station#</b>	10656+46	<b>Field Station#</b>	10661+00	<b>GPS Location</b>	See Photo
<b>Pic 1 Desc.</b>	Perimeter controls	<b>Pic 2 Desc.</b>	Stabilization water bars

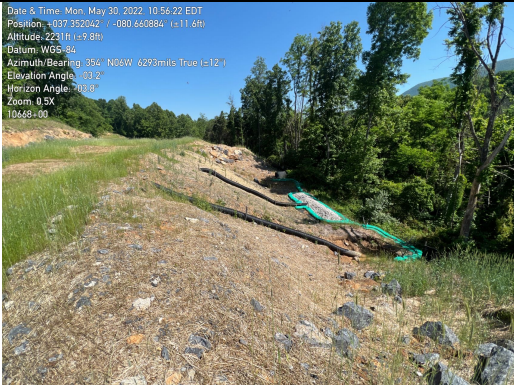
<b>Field Station#</b>	10668+00	<b>Field Station#</b>	10674+90	<b>GPS Location</b>	See Photo
<b>Pic 3 Desc.</b>	Stone outlet protections	<b>Pic 4 Desc.</b>	RCE

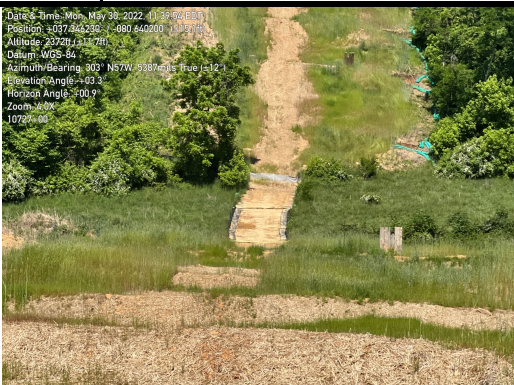
<p>Date &amp; Time: Mon, May 30, 2022, 11:42:30 EDT Position: +037 345922 / -080 637632 (+11.6ft) Altitude: 2245ft (+11.7ft) Datum: WGS-84 Azimuth/Bearing: 151° S29E 2684mils True (+12°) Elevation Angle: -20.0° Horizon Angle: -00.1° Zoom: 0.5X 10741+00</p>		<b>GPS Location</b>	See Photo
<b>Field Station#</b>	10727+00	<b>Field Station#</b>	10741+00	<b>GPS Location</b>	See Photo
<b>Pic 5 Desc.</b>	Drainage feature	<b>Pic 6 Desc.</b>	Sump pit end treatment

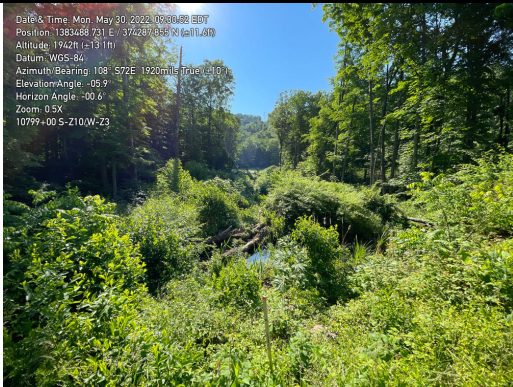
Date & Time: Mon, May 30, 2022, 09:30:09 EDT Position: 1383458.731 E / 374287.345 N (±11.4M) Altitude: 1926ft (±13.1ft) Datum: WGS-84 Azimuth/Bearing: 108° S72E 1920mils True (±10°) Elevation/Angle: -05.9° Horizon Angle: -00.6° Zoom: 0.5X 10799+00 S-Z10/W-Z3				Date & Time: Mon, May 30, 2022, 09:42:26 EDT Position: 1383755.022 E / 374168.056 N (±11.4M) Altitude: 2344ft (±9.8ft) Datum: WGS-84 Azimuth/Bearing: 303° N57W 5387mils True (±12°) Elevation/Angle: -05.7° Horizon Angle: -01.6° Zoom: 0.5X 10801+52 S-Z11/S-Z12/S-Z13											
GPS Location				1				GPS Location				2			
Field Station#				10799+00				Field Station#				0801+52			
Pic 1 Desc.				S-Z10/W-Z3.				Pic 2 Desc.				S-Z11/S-Z12/S-Z13.

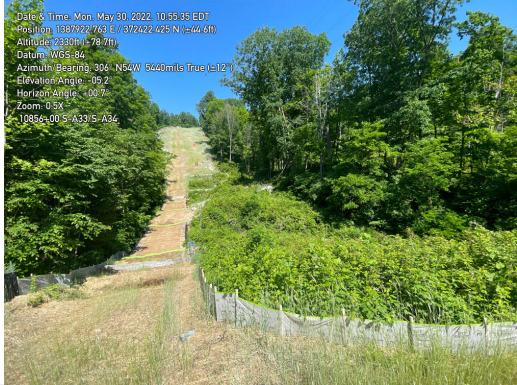
<p style="text-align: center;">Insert image here</p>			
<b>GPS Location</b>	9	<b>GPS Location</b>			
<b>Field Station#</b>	10956+00	<b>Field Station#</b>			
<b>Pic 9 Desc.</b>	Overview S-A33/S-A34.	<b>Pic 10 Desc.</b>			
<p style="text-align: center;">Insert image here</p>		<p style="text-align: center;">Insert image here</p>			
<b>GPS Location</b>		<b>GPS Location</b>			
<b>Field Station#</b>		<b>Field Station#</b>			
<b>Pic 11 Desc.</b>		<b>Pic 12 Desc.</b>

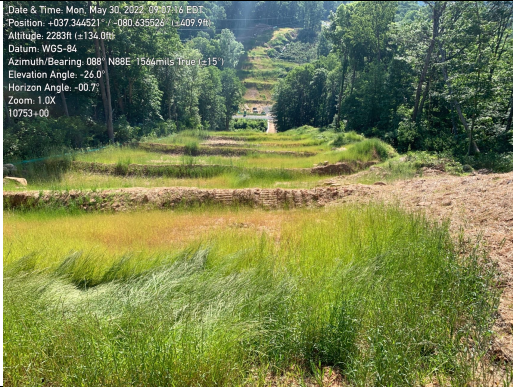
<p>Date &amp; Time: Mon, May 30, 2022, 09:10:19 EDT Position: +037.344387° / -080.633693° (+239.9ft) Altitude: 2156ft (+229.9ft) Datum: WGS-84 Azimuth/Bearing: 042° N42E 0747mils True (+13°) Elevation Angle: -12.8° Horizon Angle: -04.3° Zoom: 1.0x 10758+00 S-G35</p>			
GPS Location		See photo for GPS location.		GPS Location	
Field Station#		10753+00		Field Station#	
Pic 1 Desc.		Waterbars in place.		Pic 2 Desc.	
				Sensitive resource buffer in place at stream S-G35.

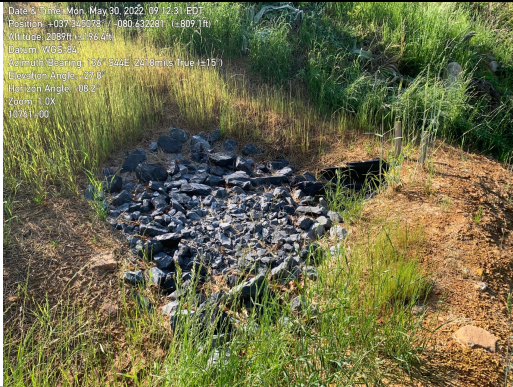
GPS Location		See photo for GPS location.		GPS Location	
Field Station#		10761+00		Field Station#	
Pic 3 Desc.		Rock inlet protection at slope drain pipe.		Pic 4 Desc.	
				Clean water diversion pipe and level spreader in place.

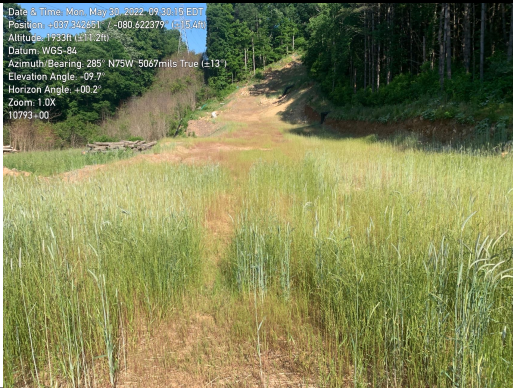
<p>Date &amp; Time: Mon, May 30, 2022, 09:20:08 EDT Position: +037.342634° / -080.620161° (+619.3ft) Altitude: 1925ft (+110.1ft) Datum: WGS-84 Azimuth/Bearing: 125° S55E 4222mils True (+13°) Elevation Angle: -08.5° Horizon Angle: -00.7° Zoom: 1.0x 10797+92</p>			
GPS Location		See photo for GPS location.		GPS Location	
Field Station#		10793+00		Field Station#	
Pic 5 Desc.		ROW temporarily stabilized.		Pic 6 Desc.

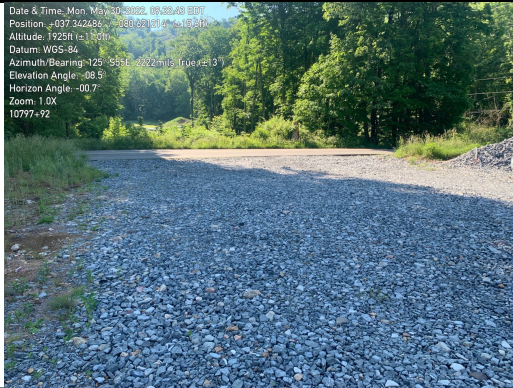
RCE in place at Cascade Road.

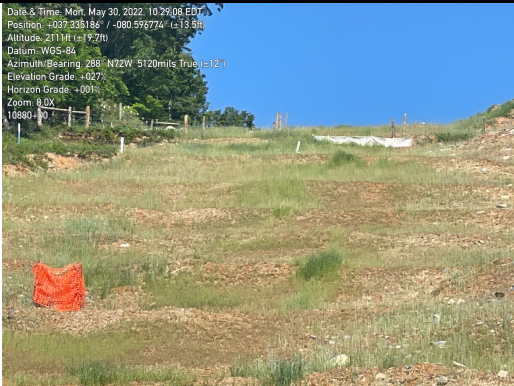
<b>Pic 5 Desc.</b>	View of steep slope temporary stabilization		<b>Pic 6 Desc.</b>	Stabilization of steep slope and additional P1 silt fencing to contain further soil sluffing.

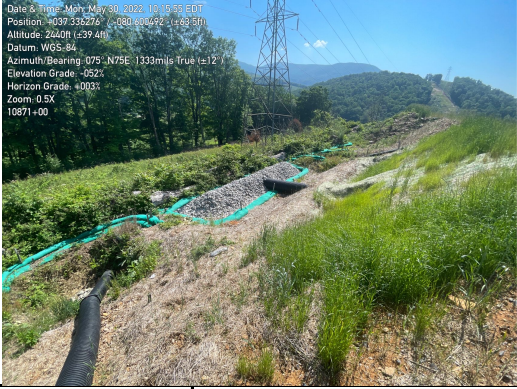
<b>GPS Location</b>	See Photo	<b>GPS Location</b>	See Photo		
<b>Field Station#</b>	10871+00	<b>Field Station#</b>	10875+00		
<b>Pic 7 Desc.</b>	Temporary level spreader and slope drain pipe conditions.	<b>Pic 8 Desc.</b>	Temporary stabilization and current condition of temporary water bar.		
Insert image here		Insert image here			
<b>GPS Location</b>		<b>GPS Location</b>			
<b>Field Station#</b>		<b>Field Station#</b>			
<b>Pic 9 Desc.</b>		<b>Pic 10 Desc.</b>			
Insert image here		Insert image here			
<b>GPS Location</b>		<b>GPS Location</b>			
<b>Field Station#</b>		<b>Field Station#</b>			
<b>Pic 11 Desc.</b>		<b>Pic 12 Desc.</b>

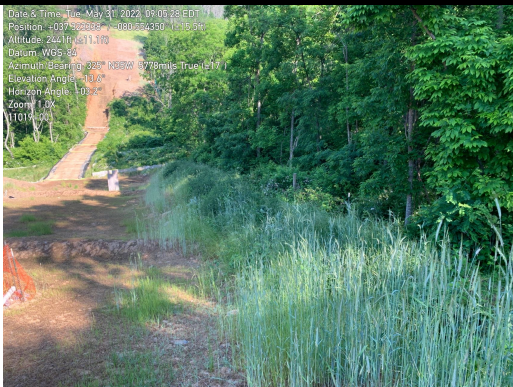
<p>Date &amp; Time: Tue, May 31, 2022, 09:05:25 EDT Position: +037.3244027 / -080.554781 / +421.2ft Altitude: 2411ft (+49.8ft) Datum: WGS-84 Azimuth/Bearing: 225° S45W 400mils True (+17) Elevation/Angle: -26.1° Horizon/Angle: -00.8° Zoom: 1.0x 11017+00</p>			
GPS Location	See photo for GPS location.		GPS Location	See photo for GPS location.	
Field Station#	11019+00		Field Station#	11017+00	
Pic 1 Desc.	Clean water diversion berm in place.		Pic 2 Desc.	Slope drain in place over fill slope.

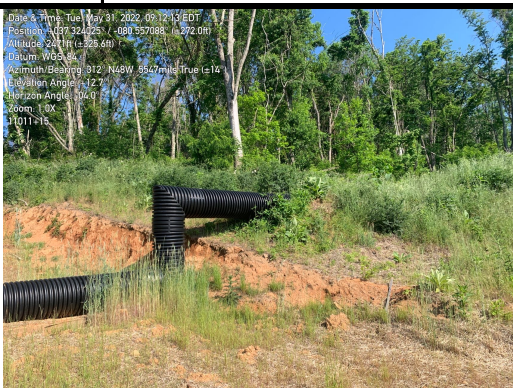
GPS Location	See photo for GPS location.		GPS Location	See photo for GPS location.	
Field Station#	11011+15		Field Station#	10986+00	
Pic 3 Desc.	Clean water diversion pipe inlet and clean water diversion berm in place.		Pic 4 Desc.	Sensitive resource buffer in place at streams S-E24 and S-E25.

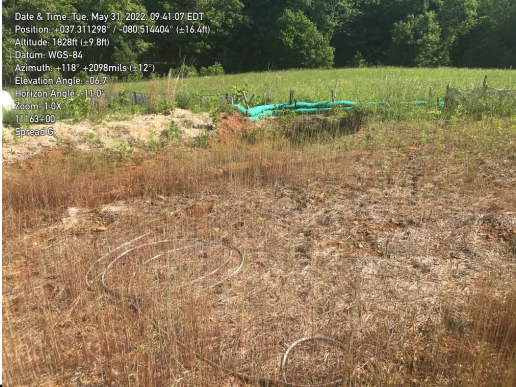
<b>GPS Location</b>	see photo		<b>GPS Location</b>	see photo	
<b>Field Station#</b>	11163+00		<b>Field Station#</b>	11146+00	
<b>Pic 3 Desc.</b>	Water bar end treatment		<b>Pic 4 Desc.</b>	Water bar, stabilized ROW

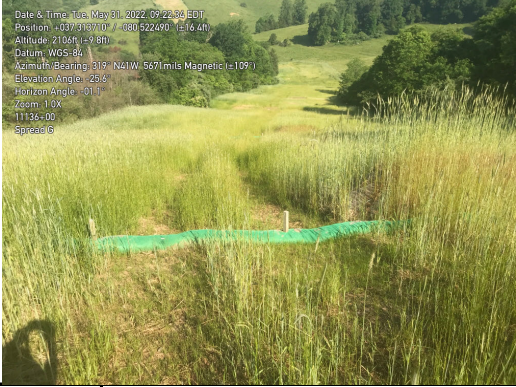
<b>GPS Location</b>	see photo		<b>GPS Location</b>	see photo	
<b>Field Station#</b>	11136+00		<b>Field Station#</b>	11122+00	
<b>Pic 5 Desc.</b>	Compost sock		<b>Pic 6 Desc.</b>	Water way

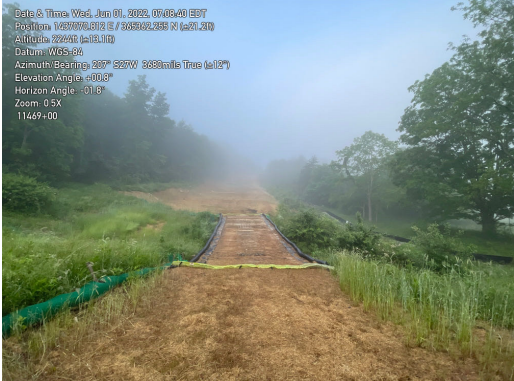
<b>GPS Location</b>	1	<b>GPS Location</b>	2		
<b>Field Station#</b>	11469+00	<b>Field Station#</b>	11451+87		
<b>Pic 1 Desc.</b>	Section of RoW showing conditions and controls.		<b>Pic 2 Desc.</b>	S-0012.

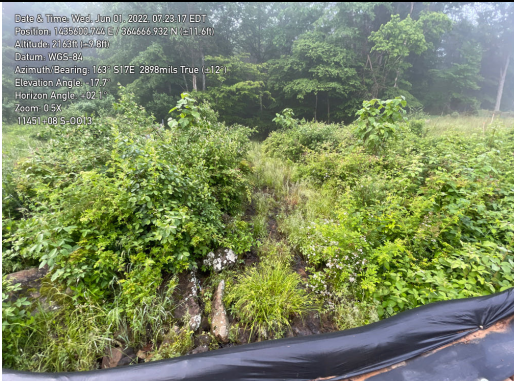
<b>GPS Location</b>	3	<b>GPS Location</b>	4		
<b>Field Station#</b>	11451+08	<b>Field Station#</b>	11448+93		
<b>Pic 3 Desc.</b>	S-0013.		<b>Pic 4 Desc.</b>	S-0014/W-CD12.

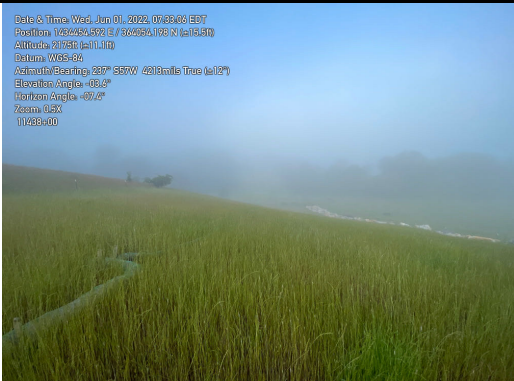
<b>GPS Location</b>	5	<b>GPS Location</b>	6		
<b>Field Station#</b>	11438+00	<b>Field Station#</b>	11432+00		
<b>Pic 5 Desc.</b>	Section of restored RoW showing conditions and controls.		<b>Pic 6 Desc.</b>	Representative photo of permanent waterbar and level spreaders installed.

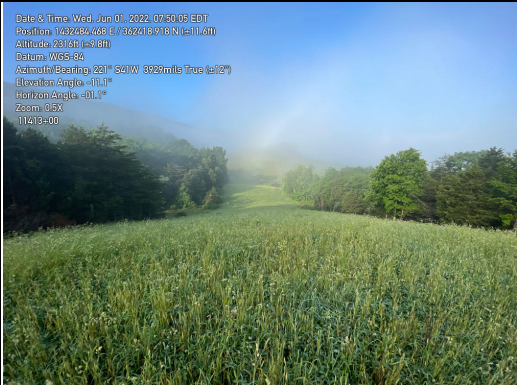
</div></div></div>			
<b>GPS Location</b>	7		<b>GPS Location</b>	8	
<b>Field Station#</b>	11413+00		<b>Field Station#</b>	11397+00	
<b>Pic 7 Desc.</b>	Section of restored RoW showing conditions and controls.		<b>Pic 8 Desc.</b>	Section of restored RoW showing conditions and controls.

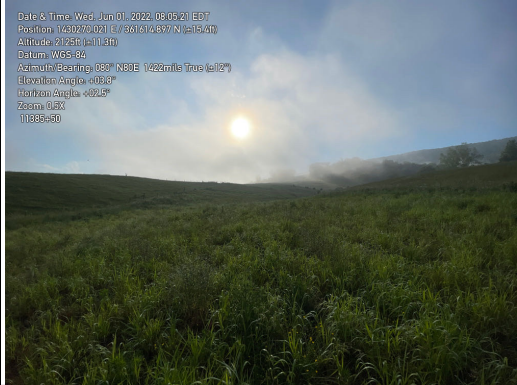
</div></div></div>			
<b>GPS Location</b>	9		<b>GPS Location</b>	10	
<b>Field Station#</b>	11385+50		<b>Field Station#</b>	11377+00	
<b>Pic 9 Desc.</b>	Section of restored RoW showing conditions and controls.		<b>Pic 10 Desc.</b>	Section of restored RoW showing conditions and controls.	
<div><div><div>Date &amp; Time Wed Jun 01, 2022 08:40:42 EDT Position 1632437.425 E / 3367437.13 N (a11.40) Altitude 2039ft (a11.40) Datum WGS-84 Azimuth/Bearing 121° S58E 2151mils True (a12°) Elevation Angle -18.3° Horizon Angle -40.9° Zoom 0.5X 11360+54 S-KL43</div><div>

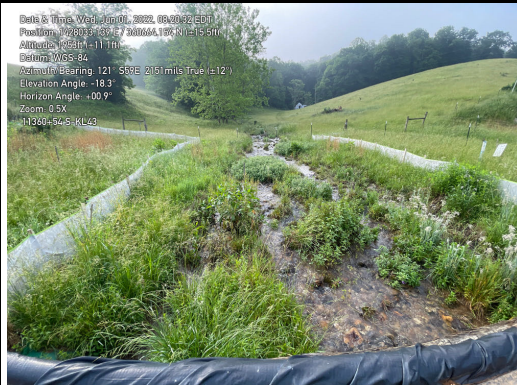
<b>GPS Location</b>	11		<b>GPS Location</b>	12	
<b>Field Station#</b>	11360+54		<b>Field Station#</b>	11353+67	
<b>Pic 11 Desc.</b>	S-KL43.		<b>Pic 12 Desc.</b>	RCE Old Furnace.

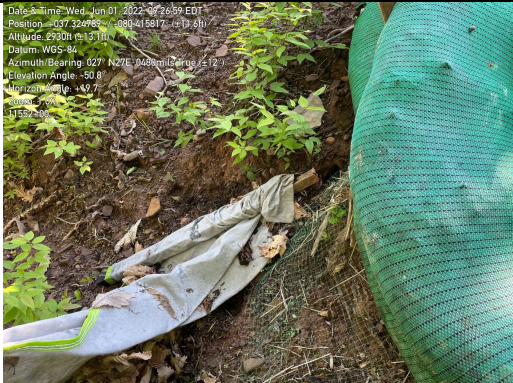
<p>Date &amp; Time: Wed Jun 01 2022 09:28:59 EDT Position: +037.339152° / +080.429538° (+11.91ft) Altitude: +2270ft (+9.8ft) Datum: WGS-84 Azimuth/Bearing: 027° N27E 0438mils True (+12°) Elevation Angle: +50.8° Horizon Angle: +40.7° Zoom: 0.5X 11552+00</p>			
<b>GPS Location</b>	See Photo	<b>GPS Location</b>	See Photo		
<b>Field Station#</b>	11548+00	<b>Field Station#</b>	11552+00		
<b>Pic 5 Desc.</b>	Section of ROW showing conditions and controls	<b>Pic 6 Desc.</b>	Damaged P1 Needs Replaced

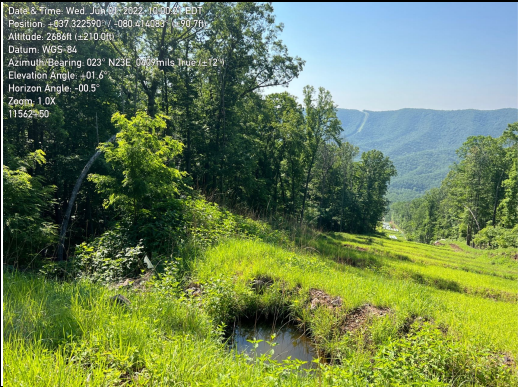
GPS Location	See photo	GPS Location	See Photo		
Field Station#	11562+50	Field Station#	11553+75		
Pic 7 Desc.	Sump Pit	Pic 8 Desc.	Water bars		
<p><small>Date &amp; Time: Wed Jun 01 2022 10:53:13 EDT Position: -837.311000°W -080.412990°W (-837.31°W -080.41°W) Altitude: 2958ft (±135.0ft) Datum: WGS-84 Azimuth/Bearing: 006° N06E 1150mils True (±12°) Elevation Angle: +16.3° Horizon Angle: -02.4° Zoom: 0.5X 11567+93</small></p>

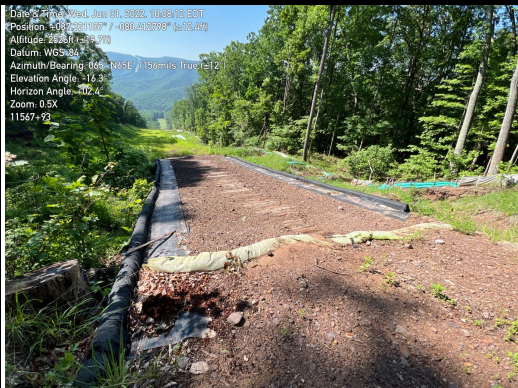
GPS Location	See Photo	GPS Location	See Photo		
Field Station#	11567+93	Field Station#	11567+93		
Pic 9 Desc.	Waddles on bridge need replaced both sides S-PP22	Pic 10 Desc.	P1 Silt fence needs replaced and waddles for outlet protection need replaced. S-PP22		
<p><small>Date &amp; Time: Wed Jun 01 2022 10:15:16 EDT Position: -837.318701°W -080.409341°W (-837.32°W -080.41°W) Altitude: 2275ft (±133.0ft) Datum: WGS-84 Azimuth/Bearing: 088° N08E 1171mils True (±12°) Elevation Angle: -10.7° Horizon Angle: -02.7° Zoom: 0.5X 11578+50</small></p>

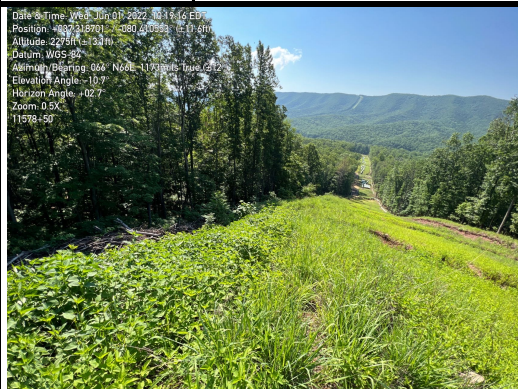
Pic 11 Desc.	Section of ROW showing conditions and controls	Pic 12 Desc.	Stream Overview S-PP21

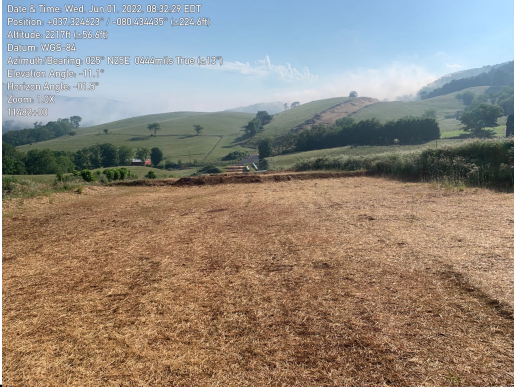
<b>GPS Location</b>	See photo for GPS location.		<b>GPS Location</b>	See photo for GPS location.	
<b>Field Station#</b>	11482+00		<b>Field Station#</b>	11490+00	
<b>Pic 3 Desc.</b>	Waterbars in place. ROW temporarily stabilized with seed and mulch.		<b>Pic 4 Desc.</b>	RCE in place at Stevers Gap Road.

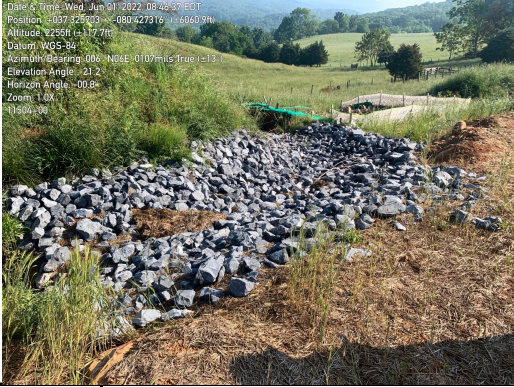
<b>GPS Location</b>	See photo for GPS location.		<b>GPS Location</b>	See photo for GPS location.	
<b>Field Station#</b>	11504+00		<b>Field Station#</b>	11519+00	
<b>Pic 5 Desc.</b>	Rock lined channel in place.		<b>Pic 6 Desc.</b>	Sensitive resource buffer in place at stream S-PP4.

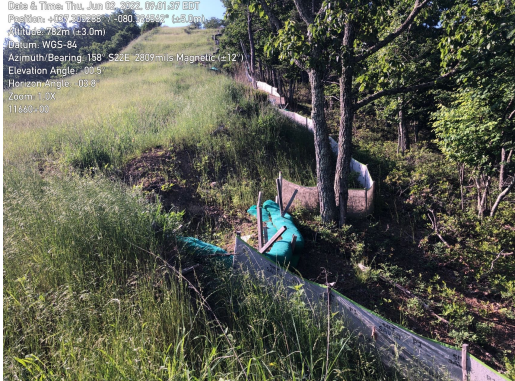
<b>GPS Location</b>	On photo	<b>GPS Location</b>	On photo		
<b>Field Station#</b>	11665+00	<b>Field Station#</b>	11660+00		
<b>Pic 1 Desc.</b>	Slope breakers functional. ROW surface stable.	<b>Pic 2 Desc.</b>	ECDs in place. ROW is currently stable.

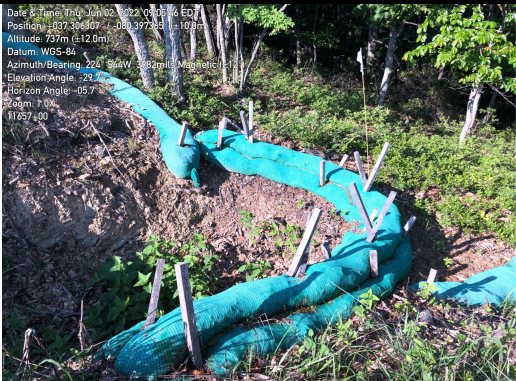
<b>GPS Location</b>	On photo	<b>GPS Location</b>	On photo		
<b>Field Station#</b>	11657+00	<b>Field Station#</b>	11634+00		
<b>Pic 3 Desc.</b>	No sediment collecting in sumps or migrating beyond limits.	<b>Pic 4 Desc.</b>	Perimeter ECDs are in place. ROW stable.

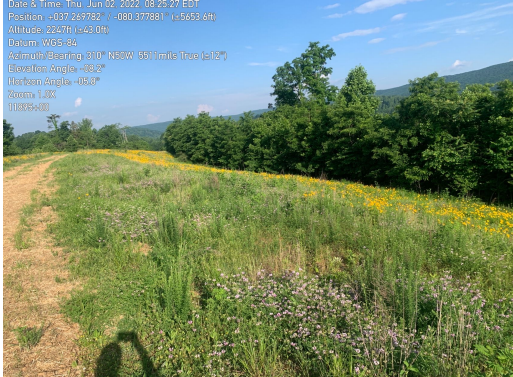
</div></div>					
	<b>GPS Location</b>		See photo for GPS location.	<b>GPS Location</b>	See photo for GPS location.		
	<b>Field Station#</b>		11895+00	<b>Field Station#</b>	11830+00		
<b>Pic 1 Desc.</b>	ROW permanently restored.	<b>Pic 2 Desc.</b>	ROW permanently restored. Waterbars with level spreaders in place.

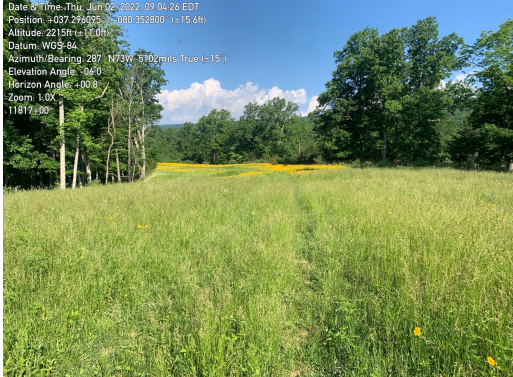
</div></div>					
	<b>GPS Location</b>		See photo for GPS location.	<b>GPS Location</b>	See photo for GPS location.		
	<b>Field Station#</b>		11817+00	<b>Field Station#</b>	11789+00		
<b>Pic 3 Desc.</b>	ROW permanently restored.	<b>Pic 4 Desc.</b>	RCE in place at Mount Tabor Road.				
<div><div><div>Date &amp; Time: Thu, Jun 02, 2022, 09:14:52 EDT Position: +037.259742° / -080.360341° (+5075.7ft) Altitude: 2233ft (+60.5ft) Datum: WGS-84 Azimuth/Bearing: 328° N32W 5831mils True (+15°) Elevation Angle: -21.7° Horizon Angle: +01.4° Zoom: 1.0X 11790+00</div>

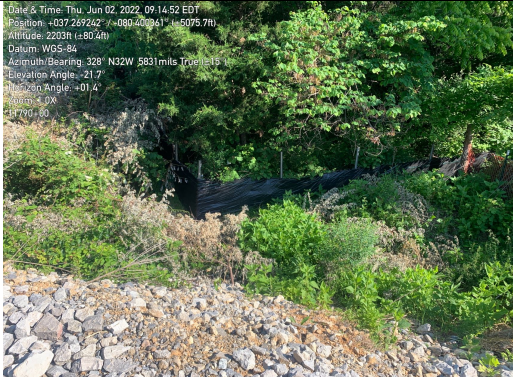
<b>GPS Location</b>		See photo for GPS location.	<b>GPS Location</b>	See photo for GPS location.		
	<b>Field Station#</b>		11790+00	<b>Field Station#</b>	11864+00		
<b>Pic 5 Desc.</b>	Super silt fence in place along LOD.	<b>Pic 6 Desc.</b>	Sensitive resource P-KL2.

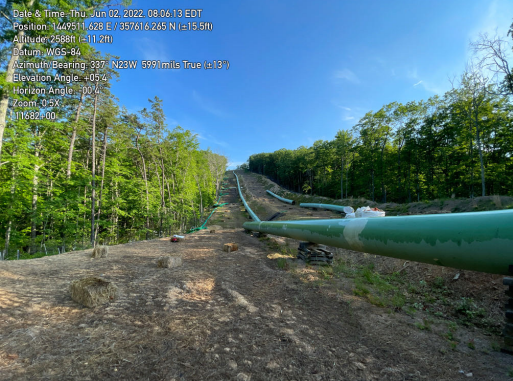
<p>Date &amp; Time: Thu, Jun 02, 2022, 08:06:13 EDT Position: 144951.428 E / 357616.265 N (+15.5m) Altitude: 258.8m (+11.2m) Datum: WGS-84 Azimuth/Bearing: 337° N23W 59.9mils True (+13°) Elevation Angle: -05.4° Horizon Angle: -00.4° Zoom: 0.5X #11682+00</p>		<b>GPS Location</b>	1
<b>Field Station#</b>		1669+00	<b>GPS Location</b>	2	
<b>Pic 1 Desc.</b>		Section of RoW showing conditions and controls.	<b>Pic 2 Desc.</b>	Crews currently over seeding and establishing stabilization on partially denuded soils.

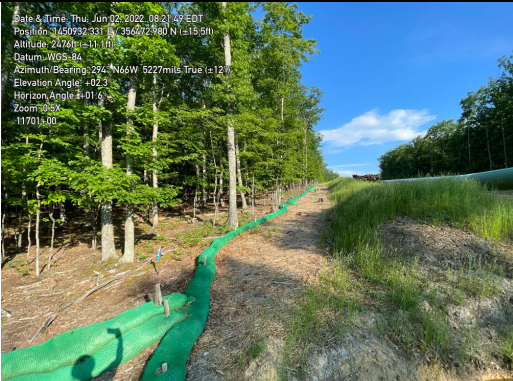
<b>Field Station#</b>		11687+42	<b>GPS Location</b>	4	
<b>Pic 3 Desc.</b>		S-MN21.	<b>Pic 4 Desc.</b>	CFS perimeter controls functional.

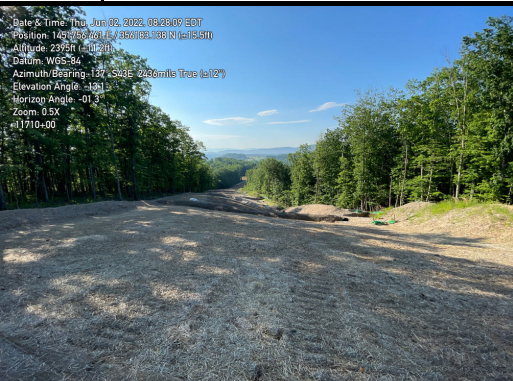
<p>Date &amp; Time: Thu, Jun 02, 2022, 08:28:07 EDT Position: 145133.401 E / 354183.133 N (+15.5m) Altitude: 239.5m (+11.2m) Datum: WGS-84 Azimuth/Bearing: 124° S34E 24.6mils True (+12°) Elevation Angle: -19.1° Horizon Angle: -01.3° Zoom: 0.5X #11710+00</p>		<b>GPS Location</b>	5
<b>Field Station#</b>		11705+10	<b>GPS Location</b>	6	
<b>Pic 5 Desc.</b>		S-MN22.	<b>Pic 6 Desc.</b>	Section of RoW showing conditions and controls.

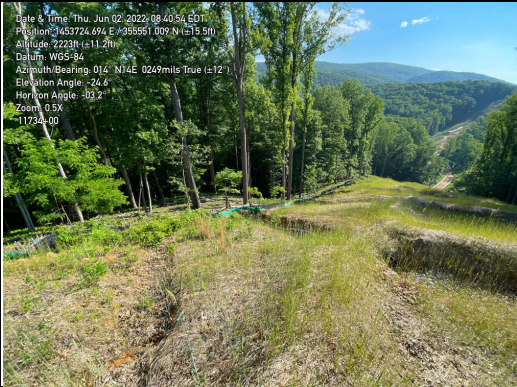
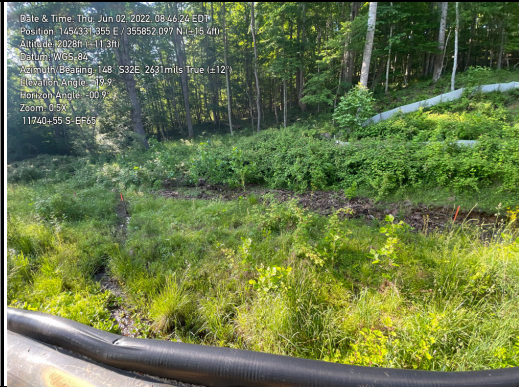
<p>Date &amp; Time: Thu, Jun 02, 2022, 08:46:22 EDT Position: 1454231.355 E / 355852.097 N (±15.5m) Altitude: 2023ft (±11.2m) Datum: WGS-84 Azimuth/Bearing: 148° S32E 2631mils True (±12°) Elevation Angle: -18.9° Horizon Angle: -00.9° Zoom: 0.5X 11740+55 S-EF65</p>		
GPS Location	7	GPS Location	8		
Field Station#	11734+00	Field Station#	11740+55		
Pic 7 Desc.	Section of RoW showing conditions and controls.		Pic 8 Desc.	S-EF65.

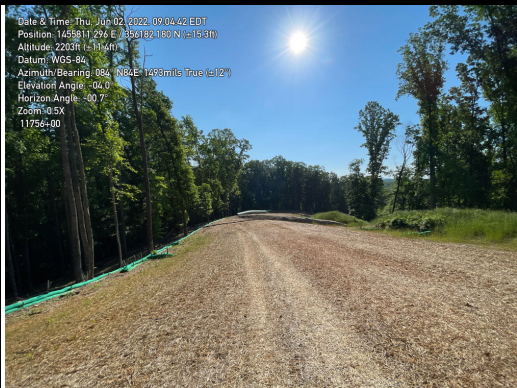
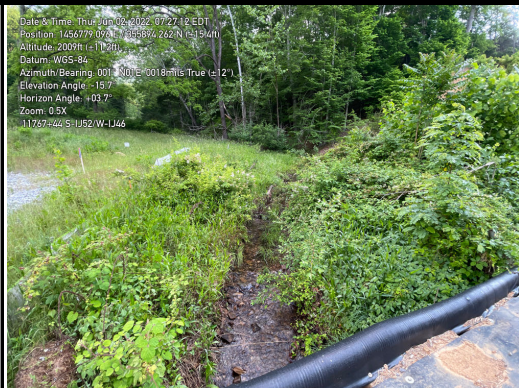
GPS Location	9	GPS Location	10		
Field Station#	11756+00	Field Station#	11767+44		
Pic 9 Desc.	Section of RoW showing conditions and controls.		Pic 10 Desc.	S-IJ52/W-IJ46.

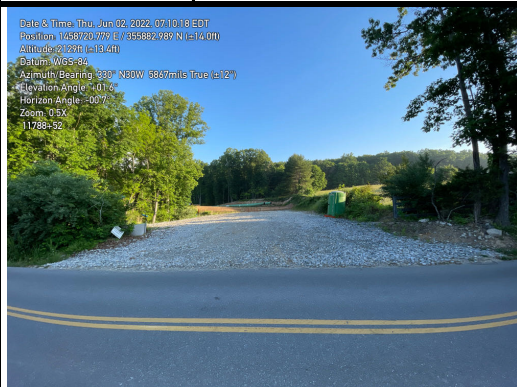
<p>Date &amp; Time: Thu, Jun 02, 2022, 07:10:18 EDT Position: 1458720.772 E / 355882.498 N (±15.5m) Altitude: 2120ft (±11.4m) Datum: WGS-84 Azimuth/Bearing: 330° N80W 5567mils True (±12°) Elevation Angle: -01.6° Horizon Angle: -00.7° Zoom: 0.5X 11788+52</p>			Insert image here		
GPS Location	11	GPS Location			
Field Station#	11788+52	Field Station#			
Pic 11 Desc.	RCE off Mt Tabor rd.		Pic 12 Desc.

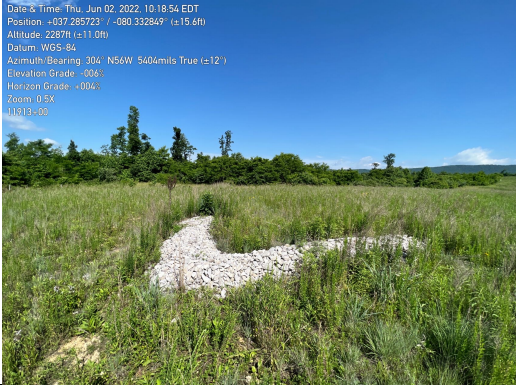
<p>Insert image here</p>		
<b>GPS Location</b>	See photo	<b>GPS Location</b>			
<b>Field Station#</b>	11913+00	<b>Field Station#</b>			
<b>Pic 13 Desc.</b>	Permanent level spreader and vegetated row conditions. No issues at this time.	<b>Pic 14 Desc.</b>			
<p>Insert image here</p>		<p>Insert image here</p>			
<b>GPS Location</b>		<b>GPS Location</b>			
<b>Field Station#</b>		<b>Field Station#</b>			
<b>Pic 15 Desc.</b>		<b>Pic 16 Desc.</b>			
<p>Insert image here</p>		<p>Insert image here</p>			
<b>GPS Location</b>		<b>GPS Location</b>			
<b>Field Station#</b>		<b>Field Station#</b>			
<b>Pic 17 Desc.</b>		<b>Pic 18 Desc.</b>

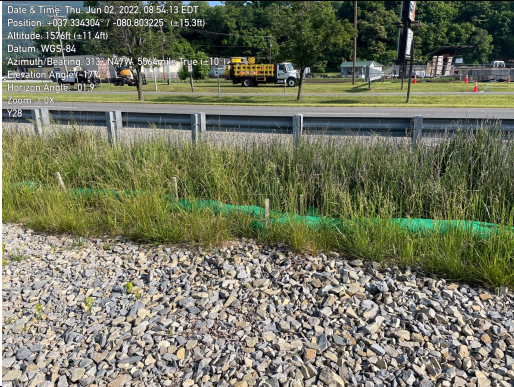
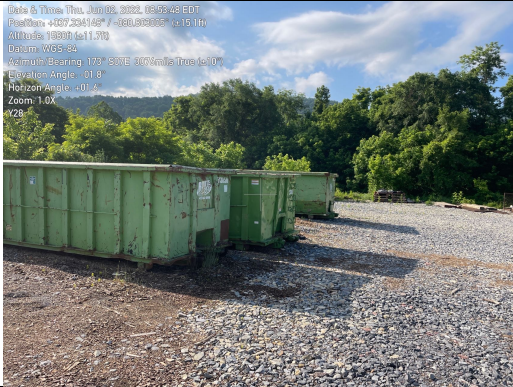
<b>GPS Location</b>	See photo	<b>GPS Location</b>	See photo		
<b>Field Station#</b>	12005+00	<b>Field Station#</b>	12005+00		
<b>Pic 1 Desc.</b>	CFS perimeter controls functional y28	<b>Pic 2 Desc.</b>	Housekeeping trash in good condition y28		
<p>Date &amp; Time: Thu Jun 02, 2022, 08:53:28 EDT  Position: +037.334273° / -080.802619° (-11.1ft)  Altitude: 1520ft (-11.1ft)  Datum: WGS-84  Azimuth/Bearing: 205° S25°W, 364mils true (-10°)  Elevation Angle: -01.5°  Horizon Angle: -00.2°  Zoom: 2.0X  Y28</p>

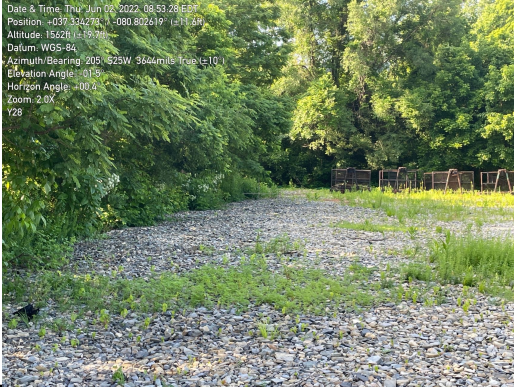
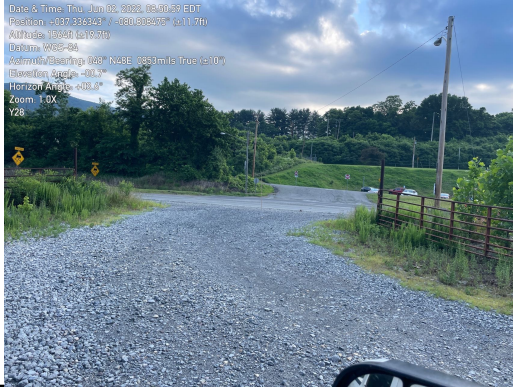
<b>GPS Location</b>	See photo	<b>GPS Location</b>	See photo		
<b>Field Station#</b>	12005+00	<b>Field Station#</b>	12005+00		
<b>Pic 3 Desc.</b>	CFS perimeter controls functional y28 Permanent stabilization in place	<b>Pic 4 Desc.</b>	RCE functional y28		
<p>Date &amp; Time: Thu Jun 02, 2022, 08:57:45 EDT  Position: +037.334361° / -080.803041° (-11.4ft)  Altitude: 1520ft (-11.4ft)  Datum: WGS-84  Azimuth/Bearing: 318° N42°W, 565mils true (-10°)  Elevation Angle: -19.1°  Horizon Angle: -05.1°  Zoom: 1.0X  Y28</p>

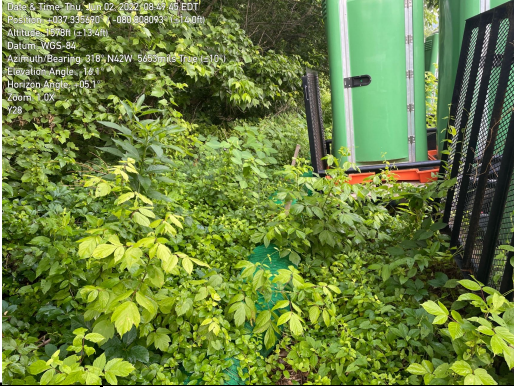
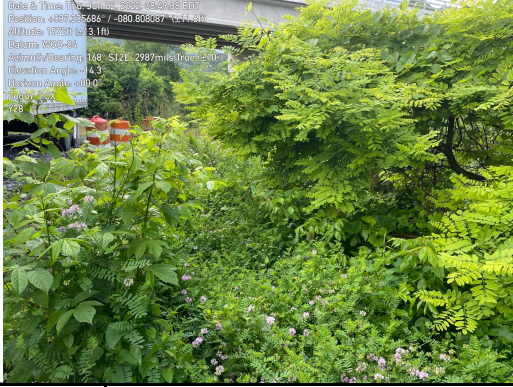
<b>Pic 5 Desc.</b>	CFS perimeter controls in place y28	<b>Pic 6 Desc.</b>	CFS perimeter controls in place y28

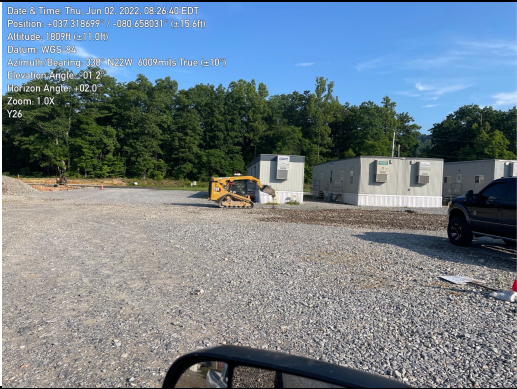
<b>GPS Location</b>		See photo		<b>GPS Location</b>	
<b>Field Station#</b>		12005+00		<b>Field Station#</b>	
<b>Pic 7 Desc.</b>		Crew working on parking lot y26		<b>Pic 8 Desc.</b>	
<p>Date &amp; Time: Thu, Jun 02, 2022, 08:25:49 EDT  Position: +037.318702 / -080.657174 / ±15.5ft  Altitude: 1808ft (±11.2ft)  Datum: WGS 84  Azimuth/Bearing: 251° S71W 668mils True (±10°)  Elevation Angle: +00.3°  Horizon Angle: +01.8°  Zoom: 2.0X  Y26</p>

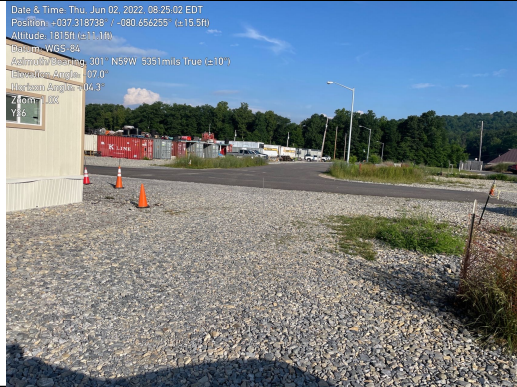
<b>GPS Location</b>		See photo		<b>GPS Location</b>	
<b>Field Station#</b>		12005+00		<b>Field Station#</b>	
<b>Pic 9 Desc.</b>		Secondary containment in place y26		<b>Pic 10 Desc.</b>	
<p>Date &amp; Time: Thu, Jun 02, 2022, 08:25:02 EDT  Position: +037.318738 / -080.656255 / ±15.5ft  Altitude: 1815ft (±11.1ft)  Datum: WGS 84  Azimuth/Bearing: 301° N59W 5351mils True (±10°)  Elevation Angle: +07.0°  Horizon Angle: +04.3°  Zoom: 1.0X  Y26</p>

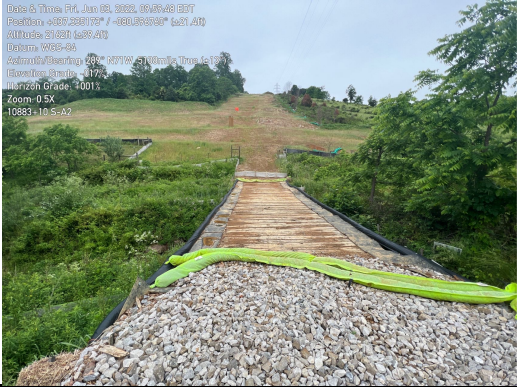
<b>GPS Location</b>	See photo	<b>GPS Location</b>	See photo		
<b>Field Station#</b>	10881+20	<b>Field Station#</b>	10883+10		
<b>Pic 5 Desc.</b>	Temporary vegetated water bar conditions.	<b>Pic 6 Desc.</b>	S-A32 Stream conditions.

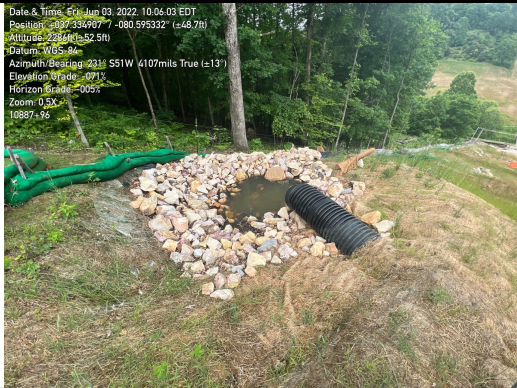
<b>GPS Location</b>	See photo	<b>GPS Location</b>	See photo		
<b>Field Station#</b>	10887+96	<b>Field Station#</b>	10887+96		
<b>Pic 9 Desc.</b>	Plunge pool conditions.	<b>Pic 10 Desc.</b>	Perimeter CFS and temporary end treatment conditions.

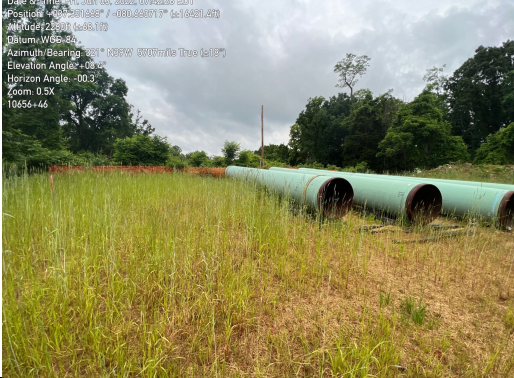
<b>GPS Location</b>	See Photo	<b>GPS Location</b>	See Photo		
<b>Field Station#</b>	10656+46	<b>Field Station#</b>	10660+00		
<b>Pic 1 Desc.</b>	Stabilization	<b>Pic 2 Desc.</b>	Perimeter controls		
<p>Date &amp; Time: Fri, Jun 03, 2022, 05:00:00 EDT  Position: +027.314665° / +080.63677° (+1021.14)  Altitude: 2339ft (+71.03)  Datum: WGS-84  Azimuth/Bearing: 272° N02W 4926mils True (+12°)  Elevation Angle: -01.5°  Horizon Angle: -06.5°  Zoom: 0.5X  10668+00</p>

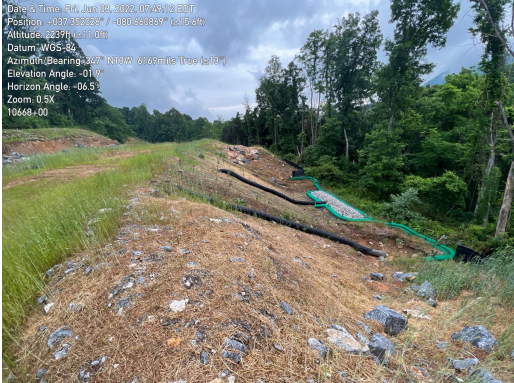
<b>GPS Location</b>	See Photo	<b>GPS Location</b>	See Photo		
<b>Field Station#</b>	10668+00	<b>Field Station#</b>	10737+00		
<b>Pic 3 Desc.</b>	Outlet protection	<b>Pic 4 Desc.</b>	Waterbars		
<p>Date &amp; Time: Fri, Jun 03, 2022, 08:22:47 EDT  Position: +027.314665° / +080.641629° (+1040.21)  Altitude: 2263ft (+68.37)  Datum: WGS-84  Azimuth/Bearing: 104° S74E 1884mils True (+12°)  Elevation Angle: -13.3°  Horizon Angle: -100.9°  Zoom: 0.5X  10733+18</p>

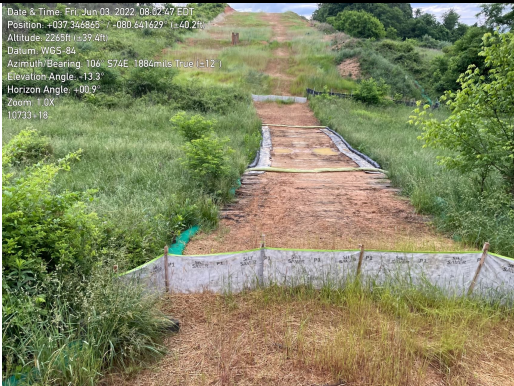
<b>GPS Location</b>	See Photo	<b>GPS Location</b>	See photo		
<b>Field Station#</b>	10733+18	<b>Field Station#</b>	10749+00		
<b>Pic 5 Desc.</b>	Equipment Bridge	<b>Pic 6 Desc.</b>	RCE

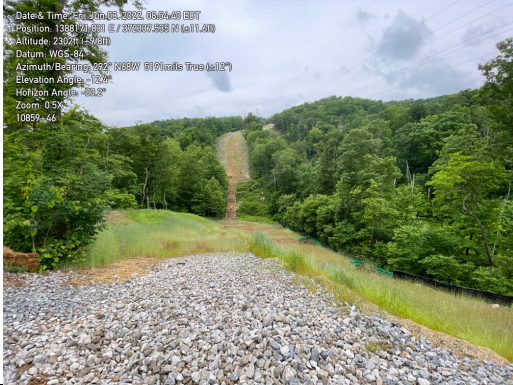
<p>Date &amp; Time: Fri, Jun 03, 2022, 08:10:07 EDT Position: 138788.067 E / 372664.292 N (+11.70) Altitude: 2188ft (+78.70) Datum: WGS-84 Azimuth/Bearing: 056° 14' 56" E 83° 45' 04" W Elevation Angle: -12.7° Horizon Angle: +01.7° Zoom: 0.5X 10856+04</p>			
GPS Location	1	GPS Location	2		
Field Station#	10859+46	Field Station#	10856+04		
Pic 1 Desc.	Section of RoW showing conditions and controls.	Pic 2 Desc.	S-A33.

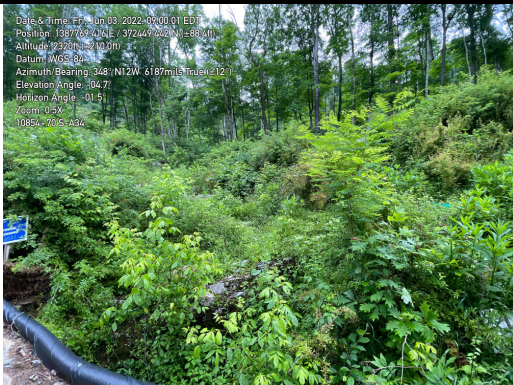
GPS Location	3	GPS Location	4		
Field Station#	10854+70	Field Station#	10843+00		
Pic 3 Desc.	S-A34.	Pic 4 Desc.	CWDP outlet protection functional.

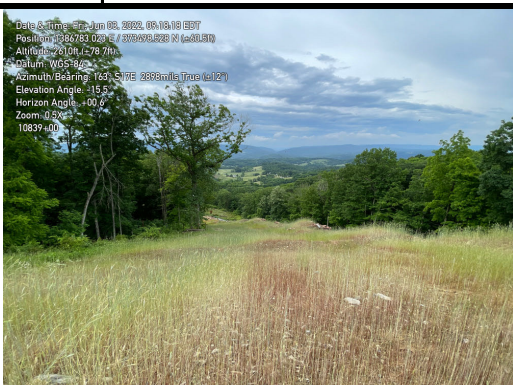
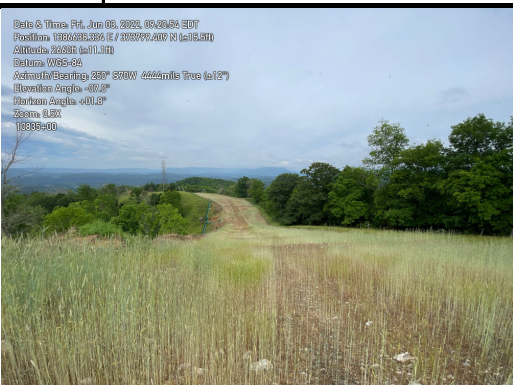
<p>Date &amp; Time: Fri, Jun 03, 2022, 09:20:54 EDT Position: 138285.333 E / 373770.437 N (+10.50) Altitude: 2636ft (+78.70) Datum: WGS-84 Azimuth/Bearing: 230° 57' 00" W 44° 44' 00" E Elevation Angle: -09.0° Horizon Angle: +01.0° Zoom: 0.5X 10835+00</p>			
GPS Location	5	GPS Location	6		
Field Station#	10839+00	Field Station#	10835+00		
Pic 5 Desc.	Section of RoW showing conditions and controls.	Pic 6 Desc.	Section of RoW showing conditions and controls.
