Visual Site Inspection Report

Project Name	H-600 Pipeline Spread G	AFE	124300137	Spread	H-600 Pipeline Spread G
Contractor	Precision			Report #	38691
Inspector	Jared Saunders			Date/Time	6/13/2022 3:33 PM
Permit #	TBD	Inspection Type	VA SWPP	Station Begin	11471+56
State	VA	Inspection Area	Partial	Station End	11524+16
County	Craig	Ground	Dry	Temperature (°F)	85.00
Municipality	N/A	Weather	Sunny	Rain Gauge (in)	0.00
				Rain Accumulation Time (days)	1.00

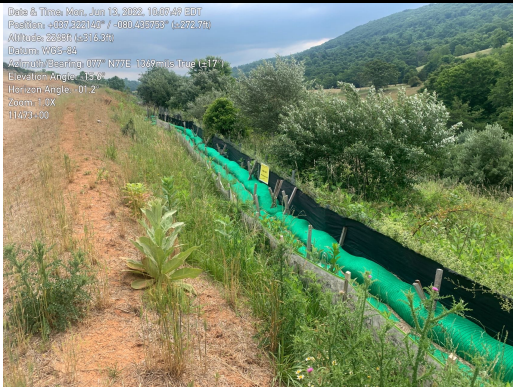
</div></div></div>			
GPS Location	See photo for GPS location.		GPS Location	See photo for GPS location.		
Field Station#	11473+00		Field Station#	11477+00		
Pic 1 Desc.	Triple barrier ECDs in place at off ROW karst feature.		Pic 2 Desc.	Rock inlet in place at slope drain.		
<div><div><div>Date & Time: Mon Jun 13 2022 10:46:16 EDT Position: +080.233249° / +400.431471° (+15.4m) Altitude: 2219ft (+15.4m) Datum: WGS-84 Azimuth/Bearing: 025° N25E 044mils True (+16°) Elevation Angle: -23.3° Horizon Angle: 100.9° Zoom: 1.0x 11490+00</div><div>

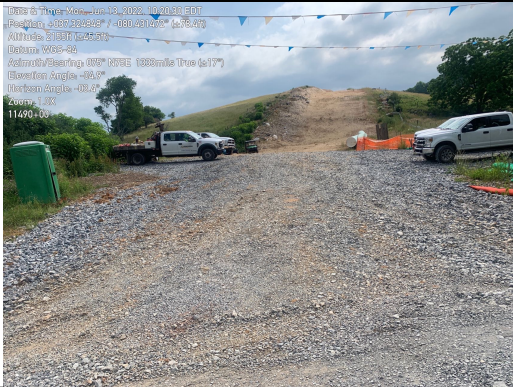
GPS Location	See photo for GPS location.		GPS Location	See photo for GPS location.		
Field Station#	11490+00		Field Station#	11495+00		
Pic 3 Desc.	RCE in place at Stevers Gap Road.		Pic 4 Desc.	Sloughing spoil pile repaired and stabilized with ECB.		
<div><div><div>Date & Time: Mon Jun 13 2022 10:29:12 EDT Position: +080.222029° / +400.428475° (+15.4m) Altitude: 2213ft (+15.4m) Datum: WGS-84 Azimuth/Bearing: 025° N25E 044mils True (+16°) Elevation Angle: -23.3° Horizon Angle: 101.1° Zoom: 1.0x 11503+00</div><div>

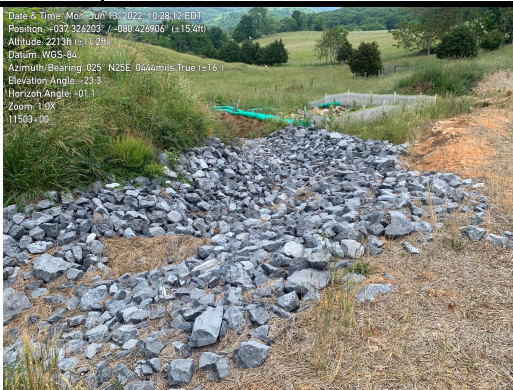
Field Station#	11503+00		Field Station#	11506+00		
Pic 5 Desc.	Rock lined channel in place.		Pic 6 Desc.	Clean water diversion pipe and plunge pool in place.

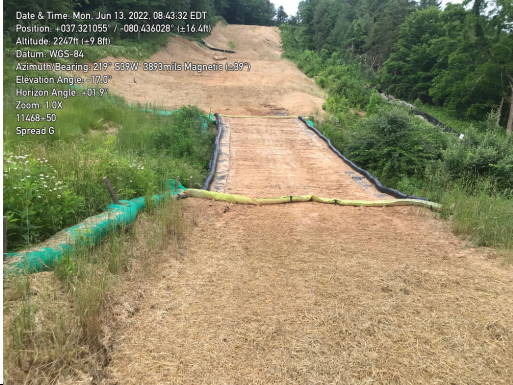
GPS Location				See photo				GPS Location				see photo			
Field Station#				11468+50				Field Station#				11471+00			
Pic 1 Desc.				S-CD 14				Pic 2 Desc.				Repaired slough

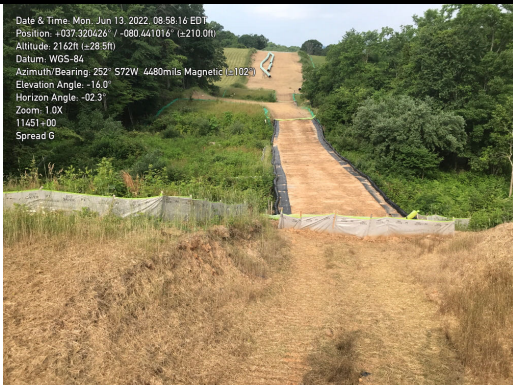
GPS Location				see photo				GPS Location				see photo			
Field Station#				11451+00				Field Station#				11410+00			
Pic 3 Desc.				S-OO 12 & 13				Pic 4 Desc.				Restored ROW

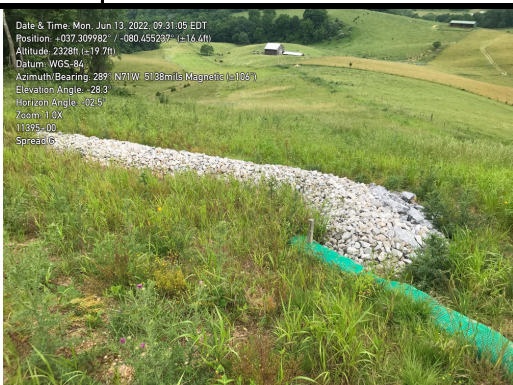
GPS Location				see photo				GPS Location				see photo			
Field Station#				11395+00				Field Station#				11389+00			
Pic 5 Desc.				Water bars				Pic 6 Desc.				Water bars

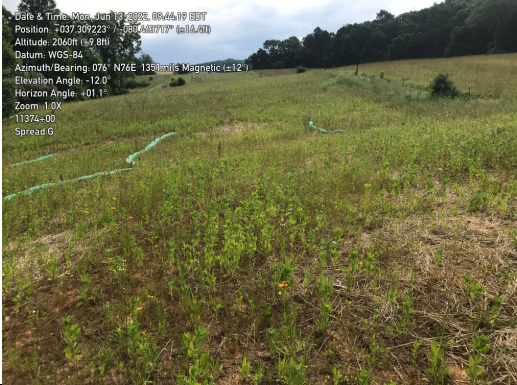
GPS Location	See photo	GPS Location	See photo		
Field Station#	11374+00	Field Station#	11360+00		
Pic 7 Desc.	Water bars (other)	Pic 8 Desc.	S-KL 43		
Insert image here		Insert image here			
GPS Location		GPS Location			
Field Station#		Field Station#			
Pic 9 Desc.		Pic 10 Desc.			
Insert image here		Insert image here			
GPS Location		GPS Location			
Field Station#		Field Station#			
Pic 11 Desc.		Pic 12 Desc.

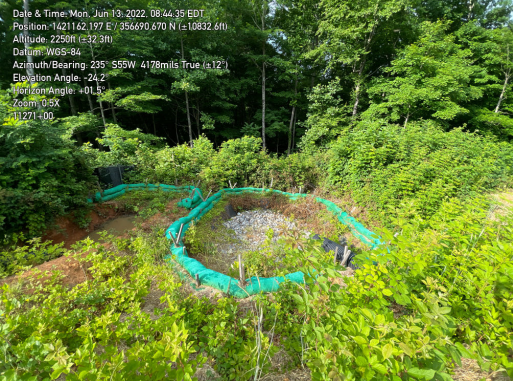
GPS Location	1	GPS Location	2		
Field Station#	11264+00	Field Station#	11271+00		
Pic 1 Desc.	Section of RoW showing conditions and controls.		Pic 2 Desc.	Plunge pool functional.

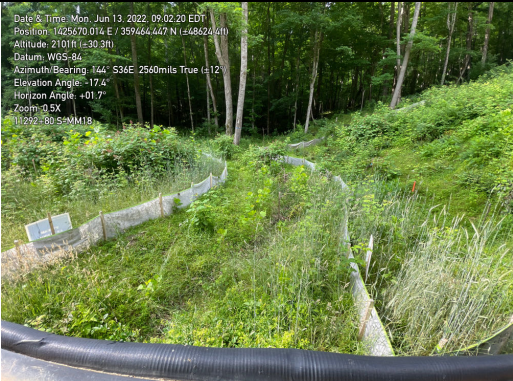
GPS Location	3	GPS Location	4		
Field Station#	11286+00	Field Station#	11292+80		
Pic 3 Desc.	Perimeter controls functional.		Pic 4 Desc.	S-MM18.

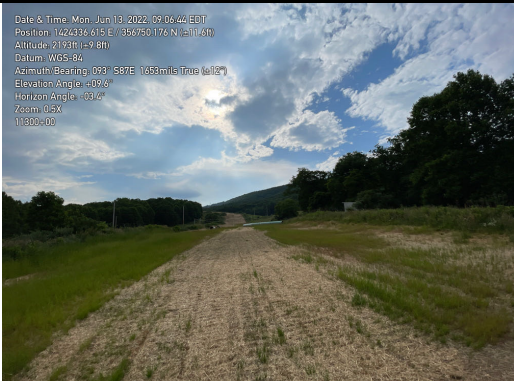
GPS Location	5	GPS Location	6		
Field Station#	11300+00	Field Station#	11319+00		
Pic 5 Desc.	Section of RoW showing conditions and controls.		Pic 6 Desc.	Section of RoW showing conditions and controls.

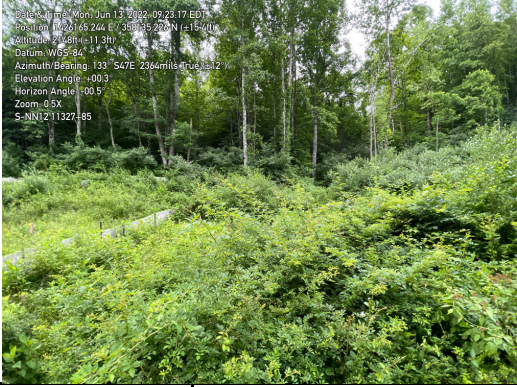
GPS Location	7	GPS Location	8		
Field Station#	11327+85	Field Station#	11352+97		
Pic 7 Desc.	S-NN12.	Pic 8 Desc.	S-NN11.

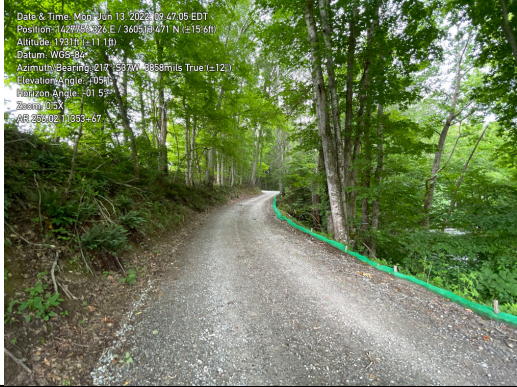
<p style="text-align: center;">Insert image here</p>			
GPS Location	9	GPS Location	10		
Field Station#	11353+67	Field Station#			
Pic 9 Desc.	AR 256.02.	Pic 10 Desc.			
<p style="text-align: center;">Insert image here</p>		<p style="text-align: center;">Insert image here</p>			
GPS Location	11	GPS Location	12		
Field Station#		Field Station#			
Pic 11 Desc.		Pic 12 Desc.

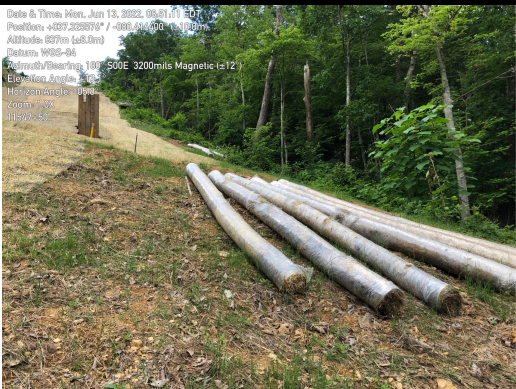
<p>Date & Time: Mon, Jun 13, 2022, 08:41:01 EDT Position: +037.32879° / -080.41400° (±100.0m) Altitude: 827m (±6.0m) Datum: WGS 84 Azimuth/Bearing: 180° S00E 3200mils Magnetic (±12°) Elevation Angle: -21.1° Horizon Angle: -00.4° Zoom: 1.0X 11502+00 ROW stable</p>

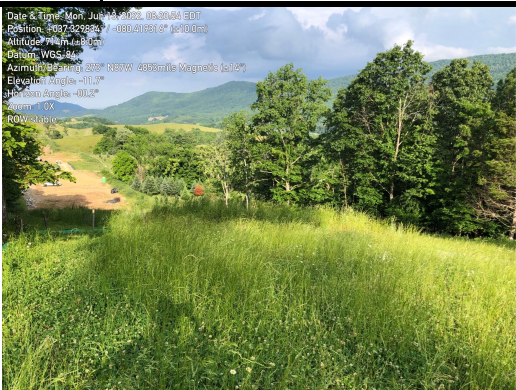
<p>Date & Time: Mon, Jun 13, 2022, 08:26:06 EDT Position: +037.32928° / -080.41867° (±5.0m) Altitude: 714m (±6.0m) Datum: WGS 84 Azimuth/Bearing: 158° S08E 2773mils Magnetic (±16°) Elevation Angle: -07.7° Horizon Angle: -00.4° Zoom: 1.0X ROW stable</p>

<p>Date & Time: Mon, Jun 13, 2022, 08:26:06 EDT Position: +037.32928° / -080.41867° (±5.0m) Altitude: 714m (±6.0m) Datum: WGS 84 Azimuth/Bearing: 158° S08E 2773mils Magnetic (±16°) Elevation Angle: -07.7° Horizon Angle: -00.4° Zoom: 1.0X ROW stable</p>		
GPS Location	On photo		GPS Location	On photo	
Field Station#	11530+00		Field Station#	11535+00	
Pic 5 Desc.	ROW stable in restored areas.		Pic 6 Desc.	ROW stable in restored areas.

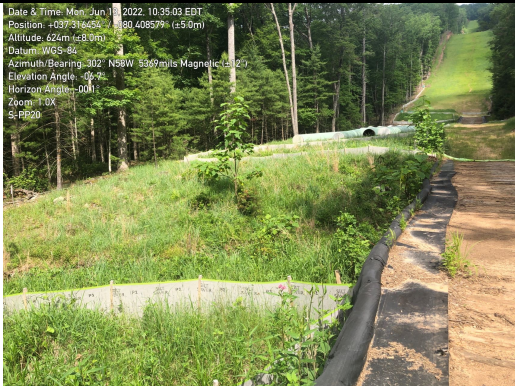
<p>Date & Time: Mon, Jun 13, 2022, 10:35:03 EDT Position: +037.316453° / -080.408579° (±5.0m) Altitude: 626m (±6.0m) Datum: WGS-84 Azimuth/Bearing: 302° N36W 3369mils Magnetic (±12°) Elevation Angle: +00° Horizon Angle: +00° Zoom: 1.0X S-PP20</p>

GPS Location	On photo	GPS Location	On photo		
Field Station#	11585+48	Field Station#	11588+41		
Pic 9 Desc.	The S-PP21 crossing is stable.	Pic 10 Desc.	The S-PP20 crossing is stable.		
Insert image here		Insert image here			
GPS Location		GPS Location			
Field Station#		Field Station#			
Pic 11 Desc.		Pic 12 Desc.

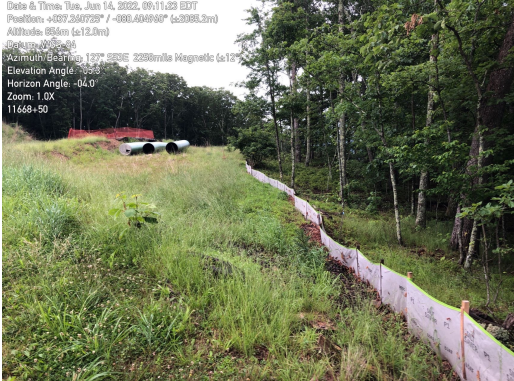
GPS Location	On photo	GPS Location	On photo		
Field Station#	11668+50	Field Station#	11664+00		
Pic 1 Desc.	Top of Brush Mountain is stable.	Pic 2 Desc.	ECDs in place and functional along LOD.

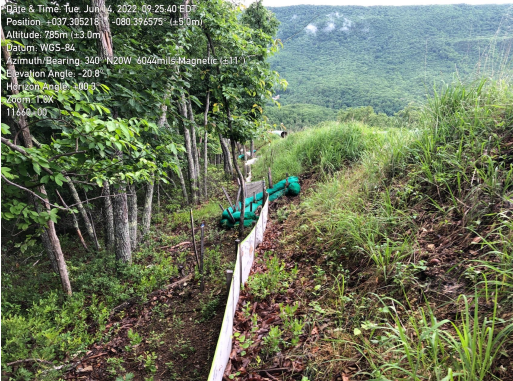
GPS Location	On photo	GPS Location	On photo		
Field Station#	11663+75	Field Station#	11660+00		
Pic 3 Desc.	COMMUNICATION. Replace worn P1.	Pic 4 Desc.	ECDs in place and functional.

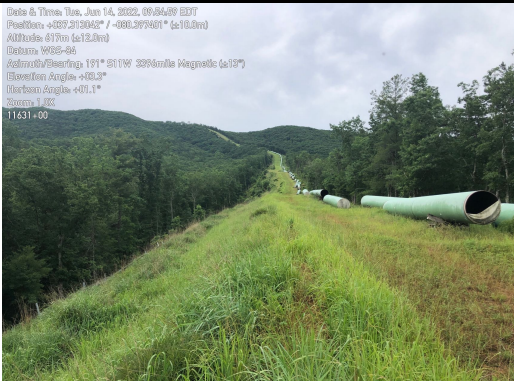
GPS Location	On photo	GPS Location	On photo		
Field Station#	11631+00	Field Station#	11629+00		
Pic 5 Desc.	Slope breakers functional. ROW stable.	Pic 6 Desc.	Slope breakers, sumps and end treatments in place and effective.

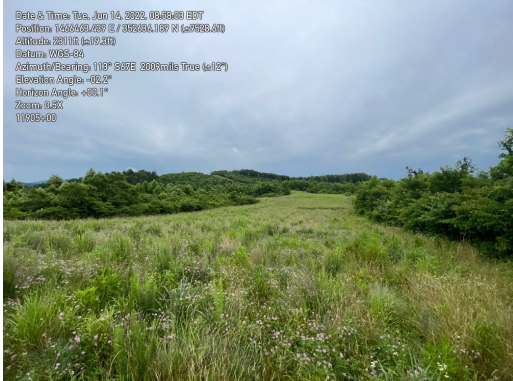
</div></div>			
GPS Location	1	GPS Location	2		
Field Station#	11905+00	Field Station#	11910+00		
Pic 1 Desc.	Section of restored RoW showing conditions and controls.	Pic 2 Desc.	Representative photo of permanent waterbar and level spreaders installed.		
<div><div><div>Date & Time: Tue, Jun 14, 2022, 08:06:49 EDT Position: 1453384.189 E / 3323371.789 N (±5492.4M) Altitude: 2233ft (±17.3M) Bearing: 105-04 Azimuth/Bearing: 145° 58'E 330m True (±12°) Elevation Angle: +05.0° Horizon Angle: +02.5° Zoom: 0.5X 11921+00</div>

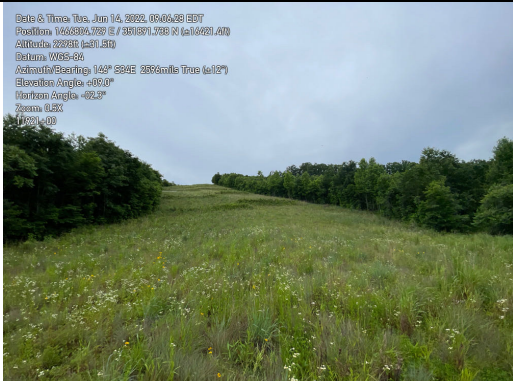
GPS Location	3	GPS Location	4		
Field Station#	11921+00	Field Station#	11928+00		
Pic 3 Desc.	Section of partially restored RoW showing conditions and controls.	Pic 4 Desc.	Section of partially restored RoW showing conditions and controls. No		
<div><div><div>Date & Time: Tue, Jun 14, 2022, 08:15:44 EDT Position: 1457771.678 E / 3325544.521 N (±5824.1M) Altitude: 2233ft (±17.3M) Bearing: 105-04 Azimuth/Bearing: 164° 53'E 330m True (±12°) Elevation Angle: +03.1° Horizon Angle: +01.1° Zoom: 0.5X 11936+00</div>

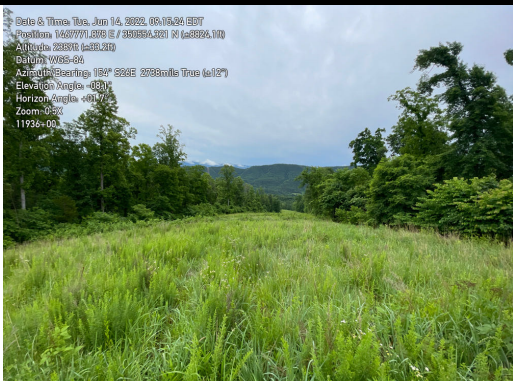
</div></div>			
GPS Location	5	GPS Location	6		
Field Station#	11936+00	Field Station#	11947+00		
Pic 5 Desc.	Section of partially restored RoW showing conditions and controls.	Pic 6 Desc.	Section of partially restored RoW showing conditions and controls.

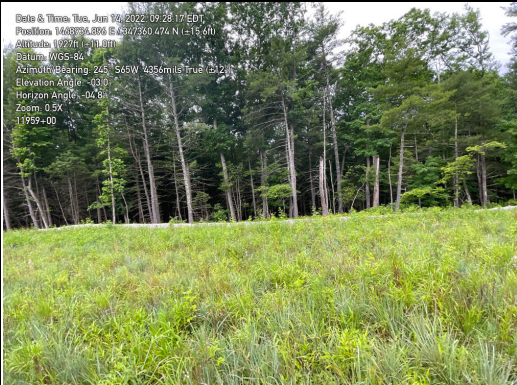
GPS Location			7		GPS Location			8	
Field Station#			11959+00		Field Station#			11971+00	
Pic 7 Desc.			Perimeter controls functional.		Pic 8 Desc.			Section of partially restored RoW showing conditions and controls.	
<p>Date & Time: Tue, Jun 14, 2022, 09:56:40 EDT Position: 14096.9708 E / 3468180.948 N (+16.50) Altitude: 11978 (+11.00) Datum: WGS-84 Azimuth/Bearing: 012° N16E 8179mils True (+15°) Elevation Angle: -11.2° Horizon Angle: -02.2° Zoom: 0.5X 11978+50</p>

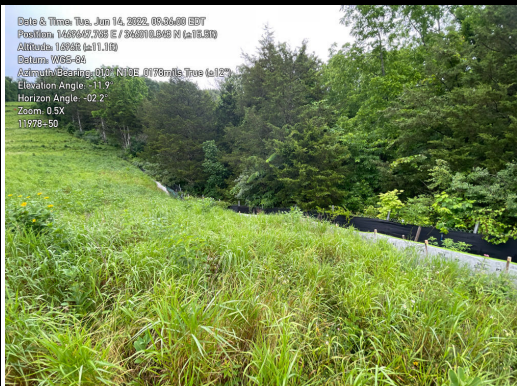
GPS Location			9		GPS Location			10	
Field Station#			11978+50		Field Station#			11989+00	
Pic 9 Desc.			Karst feature protection functional.		Pic 10 Desc.			Rain gauge indicating 0.1 of accumulation.	
<p>Date & Time: Tue, Jun 14, 2022, 08:24:24 EDT Position: 14715.7291 E / 3468350.070 N (+16.50) Altitude: 1405 (+11.00) Datum: WGS-84 Azimuth/Bearing: 071° N71E 1242mils True (+18°) Elevation Angle: -02.3° Horizon Angle: -04.4° Zoom: 0.5X 11993+00</p>

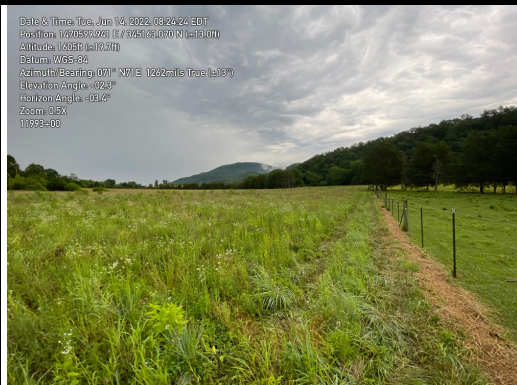
GPS Location			11		GPS Location			12	
Field Station#			11993+00		Field Station#			12001+50	
Pic 11 Desc.			Section of restored RoW where temporary controls have been recently removed.		Pic 12 Desc.			W-NN6.

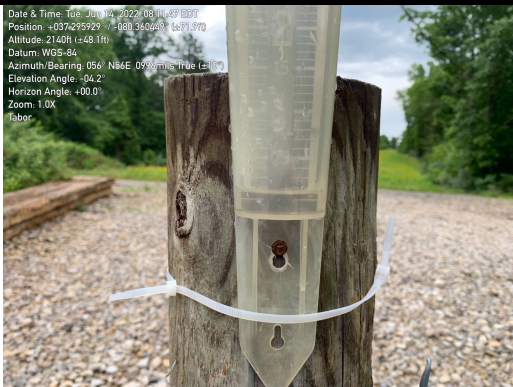
<p>Date & Time: Tue, Jun 14, 2022, 08:34:24 EDT Position: -037.29574° / -080.34643° (±10.0m) Altitude: 2142ft (±43.1ft) Datum: WGS-84 Azimuth/Bearing: 326° N34W 579mils True (±14°) Elevation Angle: -09.1° Horizon Angle: -04.7° Zoom: 1.0x 11894+00</p>			
GPS Location	See photo for GPS location.		GPS Location	See photo for GPS location.	
Field Station#	11789+00		Field Station#	11894+00	
Pic 1 Desc.	Rain gauge at Mount Tabor Road reads 0.2 inches.		Pic 2 Desc.	ROW permanently stabilized.

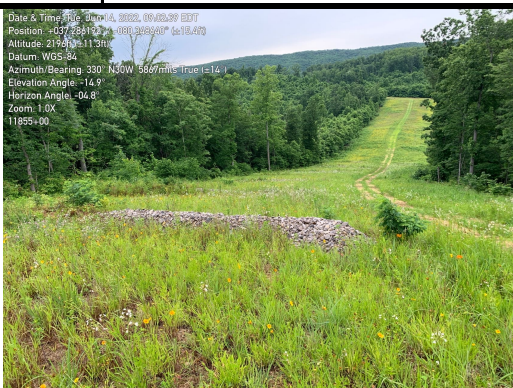
GPS Location	See photo for GPS location.		GPS Location	See photo for GPS location.	
Field Station#	11855+00		Field Station#	11830+00	
Pic 3 Desc.	ROW permanently restored. Waterbars with level spreaders in place.		Pic 4 Desc.	ROW permanently restored. Waterbars with level spreaders in place.

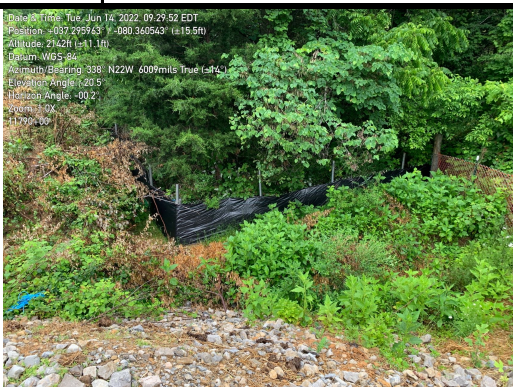
Pic 5 Desc.	Super silt fence in place along LOD.		Pic 6 Desc.	RCE in place at Mount Tabor Road.

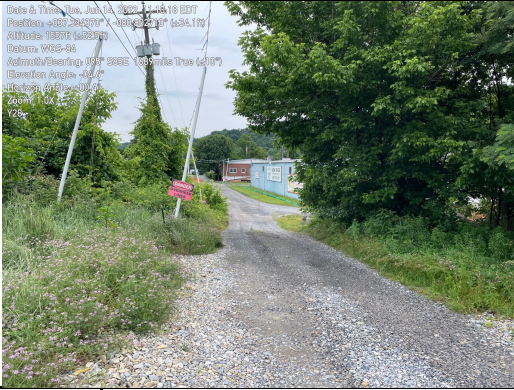
<p>Date & Time: Tue, Jun 14, 2022, 11:09:54 EDT Position: +487.334997° / -860.803152° (+15.116) Altitude: 1569ft (+58.893) Datum: WGS-84 Azimuth/Bearing: 335° N25W 5954mils True (+10°) Elevation Angle: -00.1° Horizon Angle: -00.2° Zoom: 1.0X</p>			
GPS Location	See photo	GPS Location	See photo		
Field Station#	12005+00	Field Station#	12005+00		
Pic 1 Desc.	CFS perimeter controls functional y28 Permanent stabilization in place	Pic 2 Desc.	CFS perimeter controls functional y28

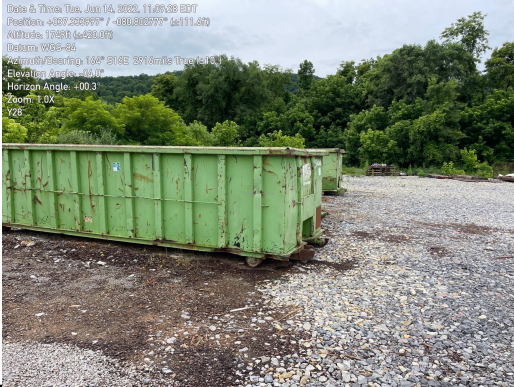
GPS Location	See photo	GPS Location	See photo		
Field Station#	12005+00	Field Station#	12005+00		
Pic 3 Desc.	Housekeeping trash in good condition y28	Pic 4 Desc.	RCE functional y28

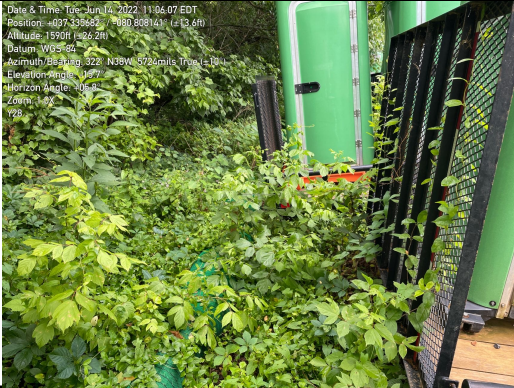
<p>Date & Time: Tue, Jun 14, 2022, 11:06:39 EDT Position: +487.334997° / -860.803152° (+15.116) Altitude: 1569ft (+58.893) Datum: WGS-84 Azimuth/Bearing: 300° N28E 5633mils True (+10°) Elevation Angle: -00.4° Horizon Angle: -00.4° Zoom: 1.0X Y28</p>			
GPS Location	See photo	GPS Location	See photo		
Field Station#	12005+00	Field Station#	12005+00		
Pic 5 Desc.	CFS perimeter controls in place y28	Pic 6 Desc.	Drip pan in place y28

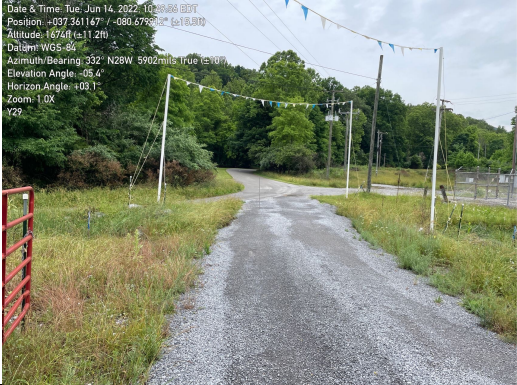
GPS Location	See photo	GPS Location	See photo		
Field Station#	12005+00	Field Station#	12005+00		
Pic 7 Desc.	RCE functional y29	Pic 8 Desc.	Broad base dips functional y29		
<p>Date & Time: Tue, Jun 14, 2022, 10:47:32 EDT Position: +037.362417° / -080.672777° (s15.51) Altitude: 1712ft (s15.51) Datum: WGS-84 Azimuth/Bearing: 171° S91E 3040mils True (s10) Elevation Angle: -15.8° Horizon Angle: -01.5° Zoom: 1.0X Y29</p>

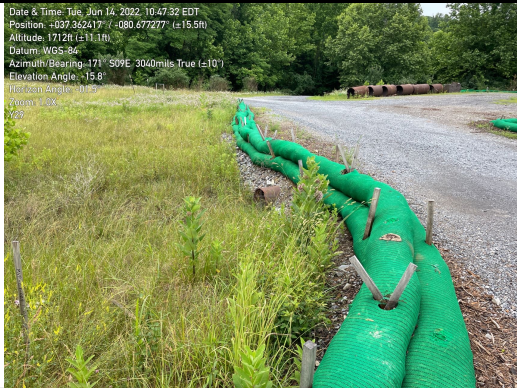
GPS Location	See photo	GPS Location	See photo		
Field Station#	12005+00	Field Station#	12005+00		
Pic 9 Desc.	Culvert in place y29	Pic 10 Desc.	Housekeeping trash in good condition		
<p>Date & Time: Tue, Jun 14, 2022, 10:45:59 EDT Position: +037.361147° / -080.679928° (s11.21) Altitude: 1713ft (s11.21) Datum: WGS-84 Azimuth/Bearing: 10° N29W 5806mils True (s10) Elevation Angle: -02.3° Horizon Angle: -01.1° Zoom: 1.0X Y29</p>

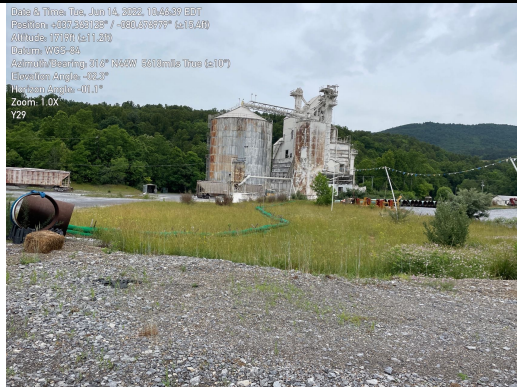
GPS Location	See photo	GPS Location	See photo		
Field Station#	12005+00	Field Station#	12005+00		
Pic 11 Desc.	Permanent stabilization in place y29	Pic 12 Desc.	CFS perimeter controls functional y29

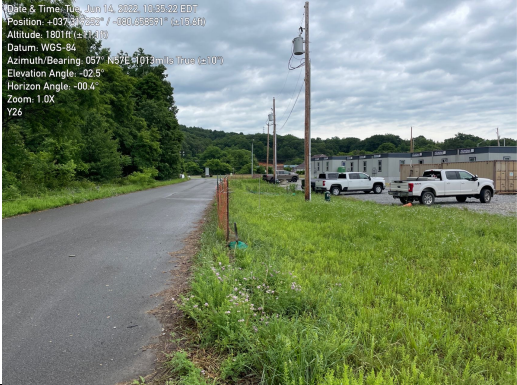
<p> Date & Time Tue, Jun 14, 2022, 10:54:26 EDT Position: +037.21833° / -80.08551° (+19.43) Altitude: 1801ft (+11.20) Datum: WGS-84 Azimuth/Bearing: 221° NS/W 282° 40' 00" True (+10°) Elevation Angle: -32.5° Horizon Angle: -90.4° Zoom: 1.0X Y26 </p>			
GPS Location	See photo	GPS Location	See photo		
Field Station#	12005+00	Field Station#	12005+00		
Pic 13 Desc.	Permanent stabilization in place CFS perimeter controls in place y26	Pic 14 Desc.	Housekeeping trash in good condition y26

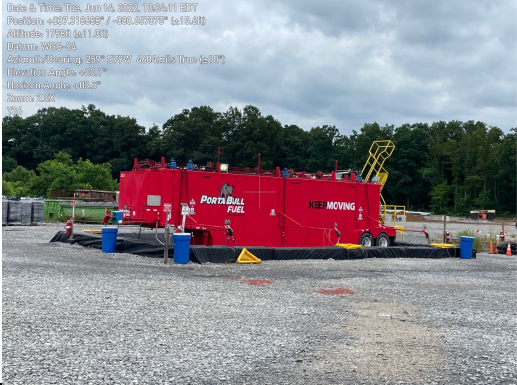
GPS Location	See photo	GPS Location	See photo		
Field Station#	12005+00	Field Station#	12005+00		
Pic 15 Desc.	Secondary containment in place y26	Pic 16 Desc.	Secondary containment in place y26

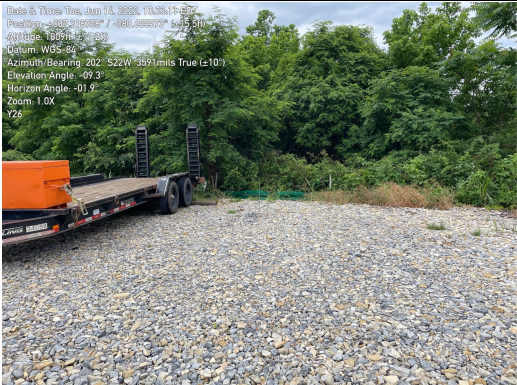
<p> Date & Time Tue, Jun 14, 2022, 10:54:26 EDT Position: +037.21833° / -80.08551° (+19.43) Altitude: 1801ft (+11.20) Datum: WGS-84 Azimuth/Bearing: 100° NS/E 105mils True (+10°) Elevation Angle: -32.5° Horizon Angle: -90.4° Zoom: 1.0X Y26 </p>			
GPS Location	See photo	GPS Location	See photo		
Field Station#	12005+00	Field Station#	12005+00		
Pic 17 Desc.	CFS perimeter controls in place y26	Pic 18 Desc.	RCE functional y26

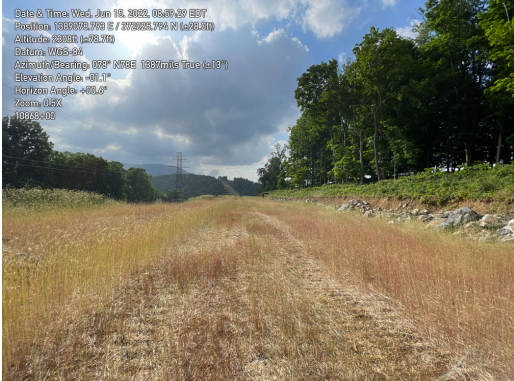
GPS Location	1	GPS Location	2		
Field Station#	10868+00	Field Station#	10872+00		
Pic 1 Desc.	Section of RoW showing conditions and controls.	Pic 2 Desc.	CWDP outlet protection functional.

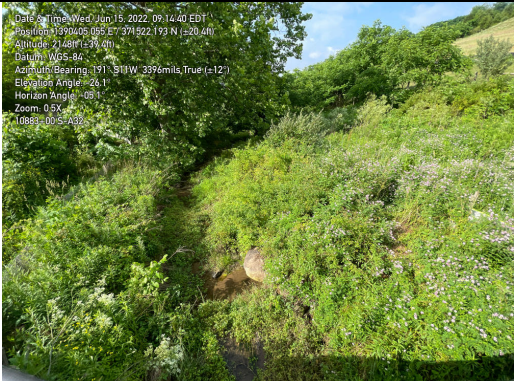
GPS Location	3	GPS Location	4		
Field Station#	10883+00	Field Station#	10887+50		
Pic 3 Desc.	S-A32.	Pic 4 Desc.	Plunge pool functional.

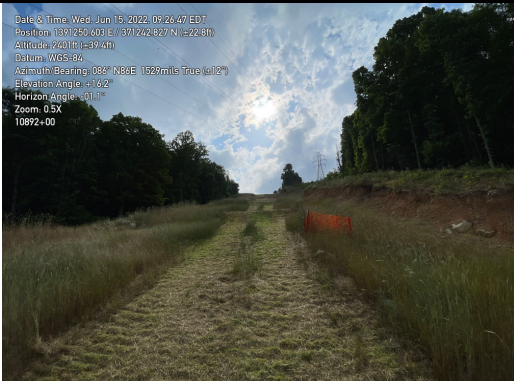
GPS Location	5	GPS Location	6		
Field Station#	10892+00	Field Station#	10898+50		
Pic 5 Desc.	Section of RoW showing conditions and controls.	Pic 6 Desc.	Section of RoW showing conditions and controls.

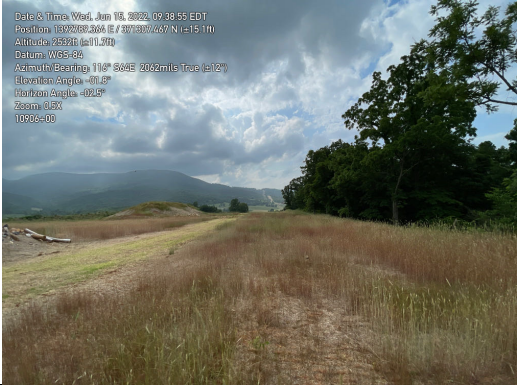
GPS Location	7	GPS Location	8		
Field Station#	10906+00	Field Station#	10919+00		
Pic 7 Desc.	Section of RoW showing conditions and controls.		Pic 8 Desc.	Section of RoW showing conditions and controls.

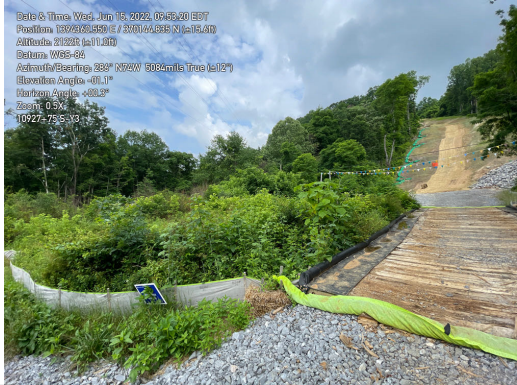
GPS Location	9	GPS Location	10		
Field Station#	10927+75	Field Station#	10929+65		
Pic 9 Desc.	Overview of S-Y3.		Pic 10 Desc.	S-Y2.	
<p>Insert image here</p>		<p>Insert image here</p>			
GPS Location		GPS Location			
Field Station#		Field Station#			
Pic 11 Desc.			Pic 12 Desc.

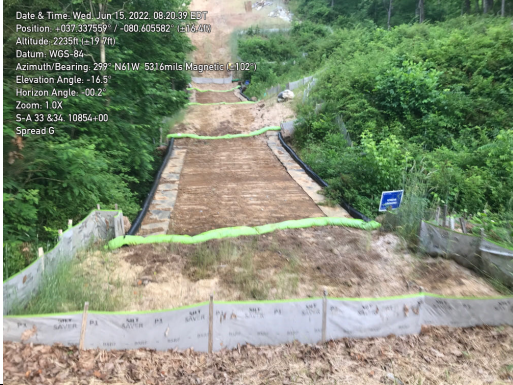
<p>Date & Time: Wed, Jun 15, 2022, 08:20:39 EDT Position: +037.337259° / -080.605582° (-16.4N) Altitude: 2235ft (+19.7ft) Datum: WGS-84 Azimuth/Bearing: 29° N61W 5336mils Magnetic (+102°) Elevation Angle: -14.5° Horizon Angle: -00.2° Zoom: 1.0X S-A 33 & 34, 10854+00 Spread G</p>				<p>Date & Time: Wed, Jun 15, 2022, 08:28:05 EDT Position: +037.338745° / -080.607679° (-16.4N) Altitude: 2368ft (+9.8ft) Datum: WGS-84 Azimuth/Bearing: 125° S65E 2222mils Magnetic (+14°) Elevation Angle: -23.6° Horizon Angle: -03.3° Zoom: 1.0X 10848+00, S-Z 14 Spread G</p>											
GPS Location				See photo				GPS Location				see photo			
Field Station#				10854+00				Field Station#				10848+00			
Pic 1 Desc.				S-A 33 & 34				Pic 2 Desc.				Sump/end treatments

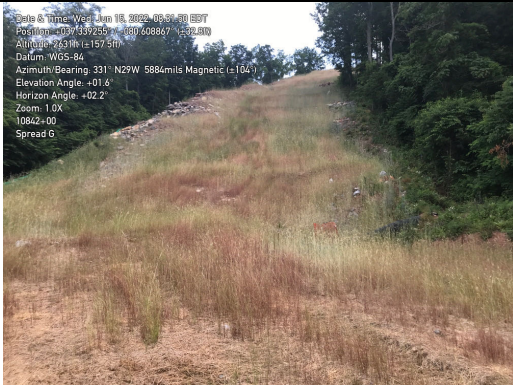
GPS Location				see photo				GPS Location				see photo			
Field Station#				10842+00				Field Station#				10834+00			
Pic 3 Desc.				Temporary vegetation				Pic 4 Desc.				Temporary Vegetation

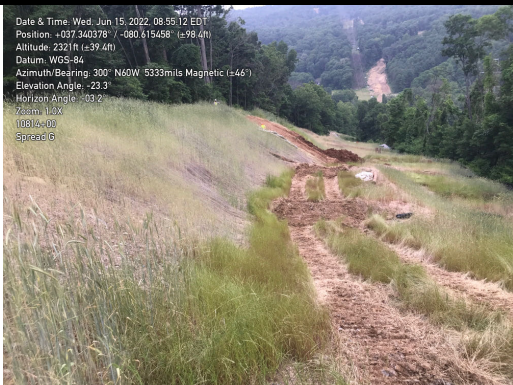
<p>Date & Time: Wed, Jun 15, 2022, 08:55:12 EDT Position: +037.340378° / -080.615458° (-16.4N) Altitude: 2321ft (+39.4ft) Datum: WGS-84 Azimuth/Bearing: 300° N60W 5333mils Magnetic (+46°) Elevation Angle: -23.3° Horizon Angle: -03.2° Zoom: 1.0X 10814+00 Spread G</p>				<p>Date & Time: Wed, Jun 15, 2022, 08:59:48 EDT Position: +037.340890° / -080.617753° (-16.4N) Altitude: 2121ft (+9.8ft) Datum: WGS-84 Azimuth/Bearing: 291° N69W 5173mils Magnetic (+13°) Elevation Angle: -23.1° Horizon Angle: -03.2° Zoom: 1.0X 10808+00, S-Z 14 Spread G</p>											
GPS Location				see photo				GPS Location				see photo			
Field Station#				10814+00				Field Station#				10808+00			
Pic 5 Desc.				Repair work on soil stockpile				Pic 6 Desc.				S-Z 14

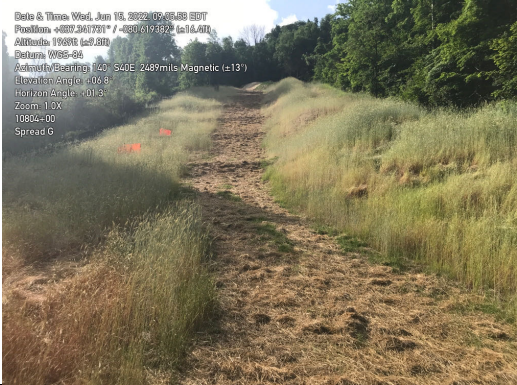
GPS Location	See photo	GPS Location	see photo		
Field Station#	10804+00	Field Station#	10802+00		
Pic 7 Desc.	Stabilized ROW	Pic 8 Desc.	S-Z 13		
Insert image here		Insert image here			
GPS Location		GPS Location			
Field Station#		Field Station#			
Pic 9 Desc.		Pic 10 Desc.			
Insert image here		Insert image here			
GPS Location		GPS Location			
Field Station#		Field Station#			
Pic 11 Desc.		Pic 12 Desc.

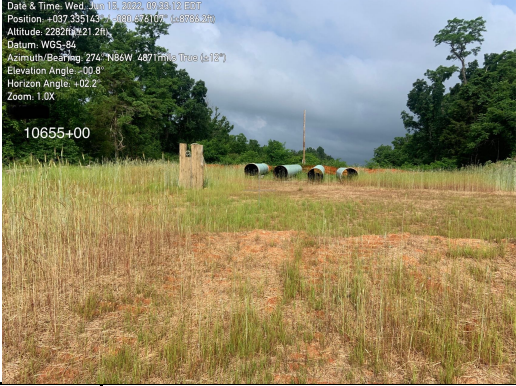
GPS Location	See photo	GPS Location	See photo		
Field Station#	10655+00	Field Station#	10679+36		
Pic 1 Desc.	Section of Row showing conditions and controls	Pic 2 Desc.	Section of Row showing conditions and controls at S-G30 and 29		
<p>Date & Time: Wed Jun 15, 2022 08:58:24 EDT Position: -037.349133 / -080.652680 (+13803.7ft) Altitude: 2047ft (+19.6ft) Datum: WGS-84 Azimuth/Bearing: 288° N72°W 3502ftmils True (+12°) Elevation Angle: +23.5° Horizon Angle: +02.7° Zoom: 1.0X 10689+92</p>

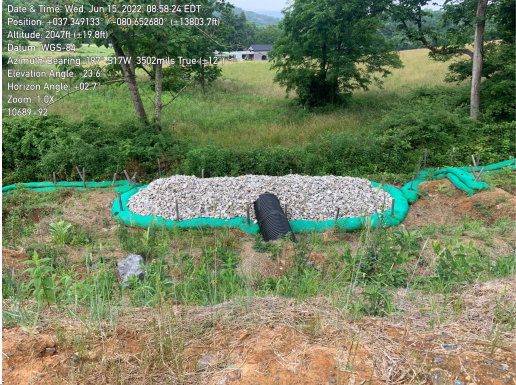
GPS Location	See photo	GPS Location	See photo		
Field Station#	10689+92	Field Station#	10698+15		
Pic 3 Desc.	Clean water diversion pipe and level spreader are in acceptable condition	Pic 4 Desc.	Section of Row showing conditions and controls at S-G32		
<p>Date & Time: Wed Jun 15, 2022 08:42:39 EDT Position: -037.346893 / -080.644589 (+217.4ft) Altitude: 2311ft (+87.9ft) Datum: WGS-84 Azimuth/Bearing: 284° N74°W 5084ftmils True (+12°) Elevation Angle: +25.9° Horizon Angle: +00.3° Zoom: 1.0X 10704+30</p>

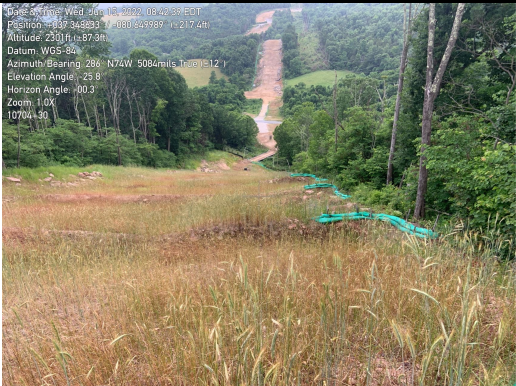
GPS Location	See photo	GPS Location	See photo		
Field Station#	10704+30	Field Station#	10710+15		
Pic 5 Desc.	Section of Row showing conditions and controls	Pic 6 Desc.	Section of Row showing conditions and controls

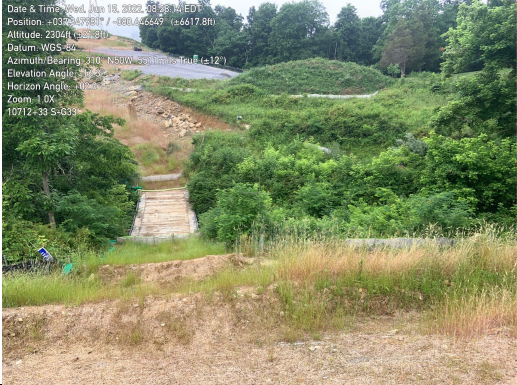
GPS Location	See photo	GPS Location	See photo		
Field Station#	10712+33	Field Station#	10736+35		
Pic 7 Desc.	Overview of S-G33	Pic 8 Desc.	Section of Row showing conditions and controls		
<p>Date & Time: Wed, Jun 15, 2022, 07:56:43 EDT Position: +037.345786° / -080.44643° (±1281.6ft) Altitude: 2222ft (±32.9ft) Datum: WGS-84 Azimuth/Bearing: 275° N88W 489mils True (±12°) Elevation Angle: -08.1° Horizon Angle: +02.2° Zoom: 1.0X 10742+50</p>

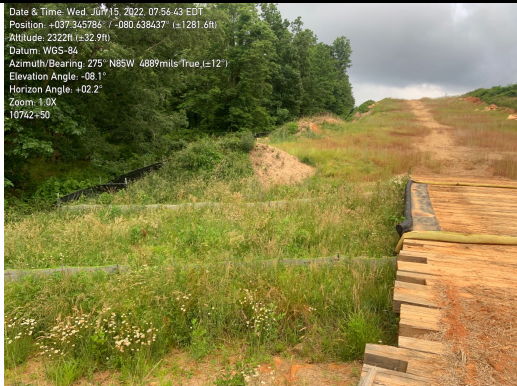
GPS Location	See photo	GPS Location	See photo		
Field Station#	10742+50	Field Station#	10732+38		
Pic 9 Desc.	Section of Row showing conditions and controls at drainage feature	Pic 10 Desc.	Section of Row showing conditions and controls at W-Z11		
<p>Date & Time: Wed, Jun 15, 2022, 08:22:40 EDT Position: +037.346351° / -080.446039° (±133.7ft) Altitude: 2384ft (±34.8ft) Datum: WGS-84 Azimuth/Bearing: 100° S10E 3022mils True (±12°) Elevation Angle: +21.1° Horizon Angle: -05.8° Zoom: 1.0X 10715+50</p>

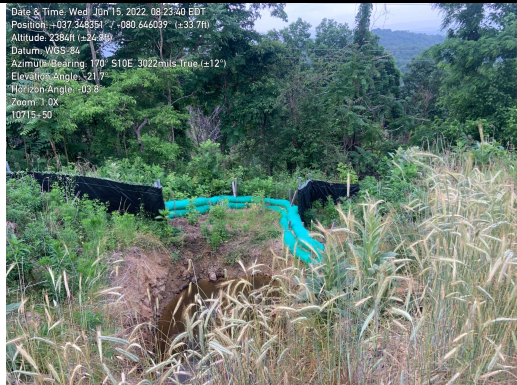
GPS Location	See photo	GPS Location	See photo		
Field Station#	10715+50	Field Station#	10729+05		
Pic 11 Desc.	Sump pit, CFS and SSF are in acceptable condition	Pic 12 Desc.	Section of Row showing conditions and controls

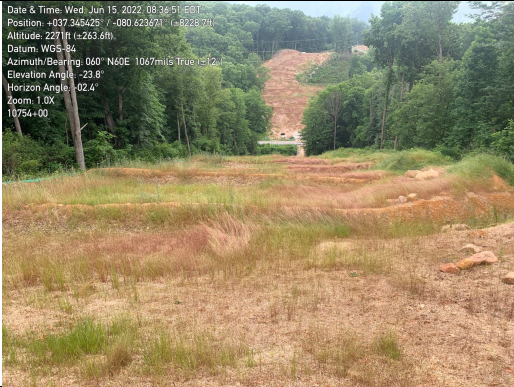
GPS Location	See photo for GPS location.		GPS Location	See photo for GPS location.	
Field Station#	10754+00		Field Station#	10758+50	
Pic 1 Desc.	ROW temporarily stabilized. Waterbars in place.		Pic 2 Desc.	Sensitive resource buffer in place at stream S-G35.	
<p>Date & Time: Wed Jun 15 2022 08:43:41 EDT Position: +037 342992 / -080 617139 (+9032.6ft) Altitude: 2093ft (+748.4ft) Datum: WGS-84 Azimuth/Bearing: 113° S48E 1091mils True (+12°) Elevation Angle: -25.5° Horizon Angle: -02.9° Zoom: 1.0X 10762+00</p>

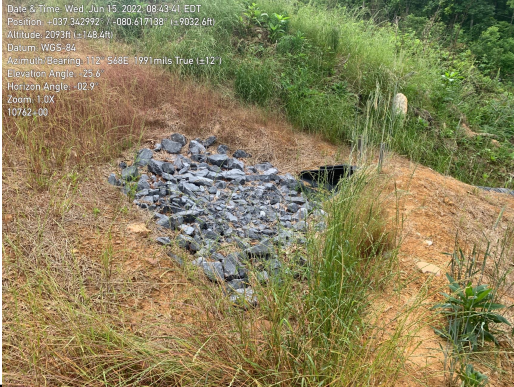
GPS Location	See photo for GPS location.		GPS Location	See photo for GPS location.	
Field Station#	10762+00		Field Station#	10772+00	
Pic 3 Desc.	Rock inlet in place at slope drain.		Pic 4 Desc.	Clean water diversion pipe and level spreader in place.	
<p>Date & Time: Wed Jun 15 2022 09:40:00 EDT Position: +037 341022 / -080 626198 (+6472.4ft) Altitude: 1927ft (+58.8ft) Datum: WGS-84 Azimuth/Bearing: 111° S49E 1093mils True (+12°) Elevation Angle: -03.0° Horizon Angle: -02.7° Zoom: 1.0X 10793+00</p>

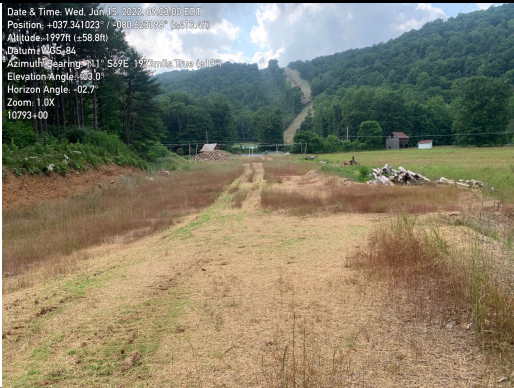
GPS Location	See photo for GPS location.		GPS Location	See photo for GPS location.	
Field Station#	10773+00		Field Station#	10797+00	
Pic 5 Desc.	ROW temporarily stabilized.		Pic 6 Desc.	RCE in place at Cascade Road crossing.

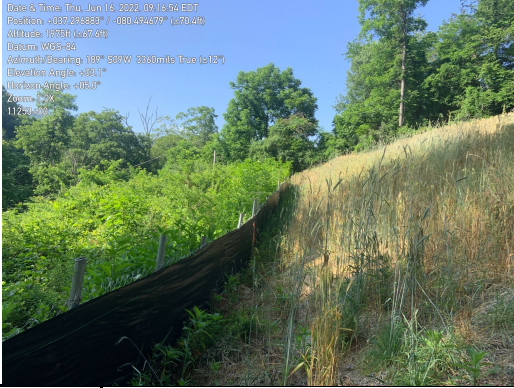
<p>Date & Time: Thu, Jun 16, 2022, 09:45:50 EDT Position: +097.301674° / -080.501337° (+164.6ft) Altitude: 2091ft (+164.6ft) Datum: WGS-84 Azimuth/Bearing: 157° S21E 2791mils True (+12°) Elevation Angle: +0.0° Horizon Angle: +00.7° Zoom: 1.0X 11248+00</p>			
GPS Location	See photo	GPS Location	See photo		
Field Station#	11253+00	Field Station#	11248+00		
Pic 1 Desc.	SSF is in place and in acceptable condition	Pic 2 Desc.	Section of Row showing conditions and controls

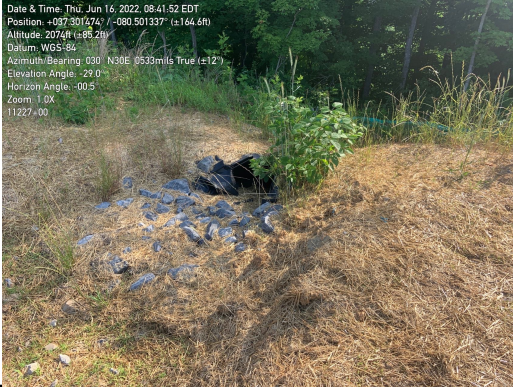
GPS Location	See photo	GPS Location	See photo		
Field Station#	11234+50	Field Station#	11227+00		
Pic 3 Desc.	Section of Row showing conditions and controls	Pic 4 Desc.	Stone inlet protection is in acceptable condition

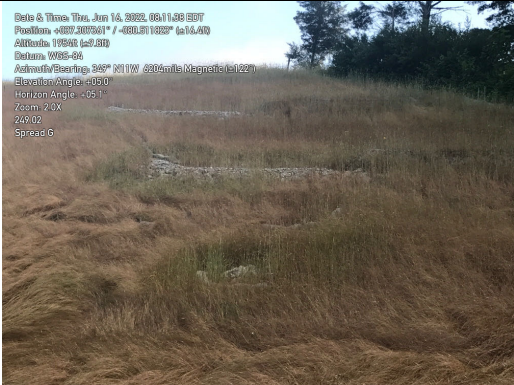
GPS Location		See photo		GPS Location	
Field Station#		11184+50		Field Station#	
Pic 1 Desc.		Water bars/ level spreaders		Pic 2 Desc.

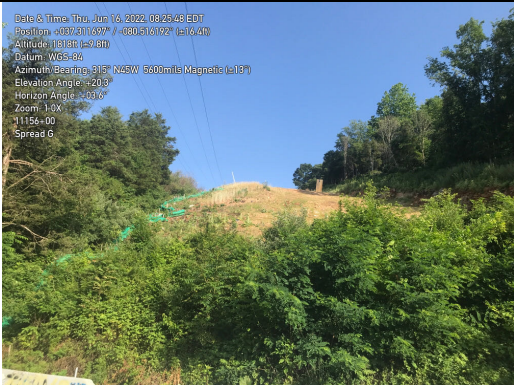
GPS Location		see photo		GPS Location	
Field Station#		11156+00		Field Station#	
Pic 3 Desc.		Mountain Lake, perimeter controls		Pic 4 Desc.

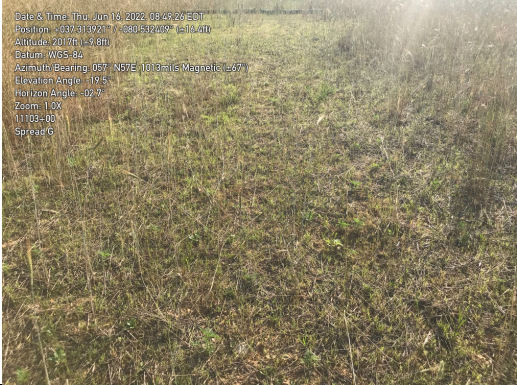
GPS Location	See photo	GPS Location	see photo		
Field Station#	11103+00	Field Station#	11099+00		
Pic 7 Desc.	Permanent vegetation	Pic 8 Desc.	245.02		
Insert image here		Insert image here			
GPS Location		GPS Location			
Field Station#		Field Station#			
Pic 9 Desc.		Pic 10 Desc.			
Insert image here		Insert image here			
GPS Location		GPS Location			
Field Station#		Field Station#			
Pic 11 Desc.		Pic 12 Desc.

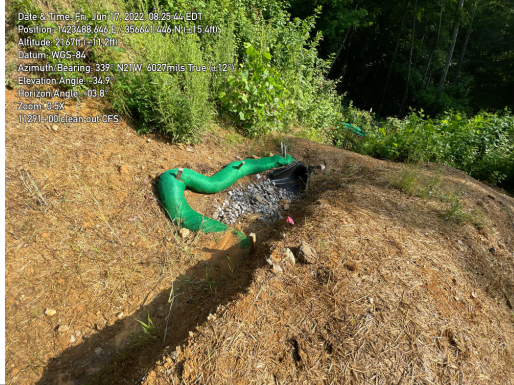
<p>Date & Time: Fri, Jun 17, 2022, 08:25:42 EDT Position: 1424488.441 E / 354661.446 N (+15.4M) Altitude: 2171ft (+11.9M) Datum: WGS-84 Azimuth/Bearing: 339° N21°W 4027mils True (+12°) Elevation Angle: -34.9° Horizon Angle: -03.6° Zoom: 0.5X 11291+00 Clean out CFS</p>

GPS Location	3	GPS Location	4		
Field Station#	11286+00	Field Station#	11291+00		
Pic 3 Desc.	Section of RoW showing conditions and controls.	Pic 4 Desc.	Clean out CFS.

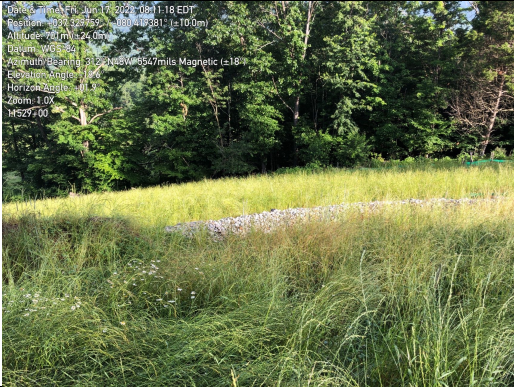
GPS Location	On photo	GPS Location	On photo		
Field Station#	11529+00	Field Station#	11537+00		
Pic 1 Desc.	ROW stable. Level spreader in place.	Pic 2 Desc.	ROW stable. Level spreader acceptable.

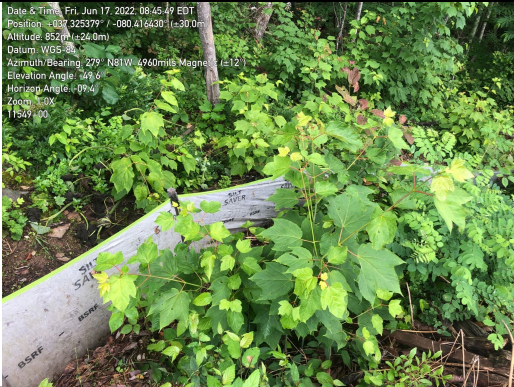
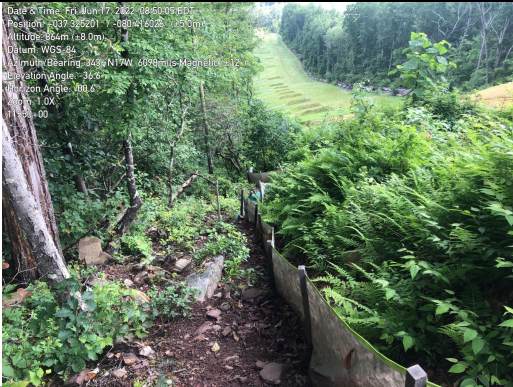
GPS Location	On photo	GPS Location	On photo		
Field Station#	11549+00	Field Station#	11550+00		
Pic 3 Desc.	Perimeter ECDs are in place.	Pic 4 Desc.	Perimeter ECDs are in place.

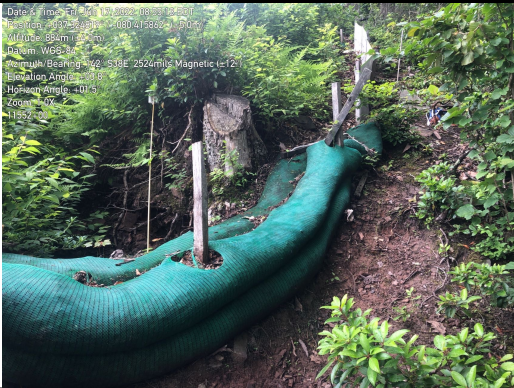
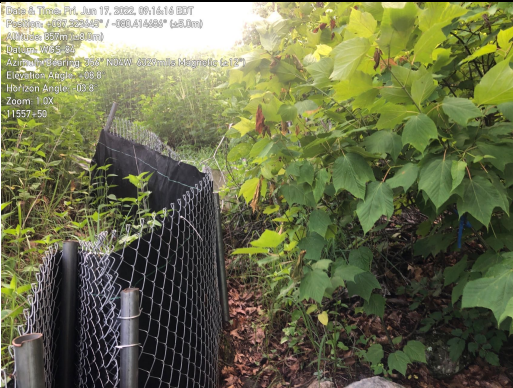
GPS Location	On photo	GPS Location	On photo		
Field Station#	11552+00	Field Station#	11557+50		
Pic 5 Desc.	End treatments functioning.	Pic 6 Desc.	Perimeter ECDs are in acceptable condition.

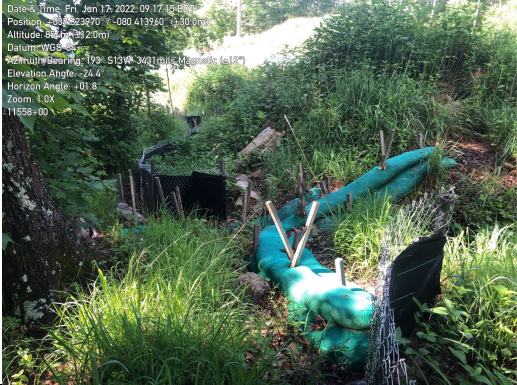
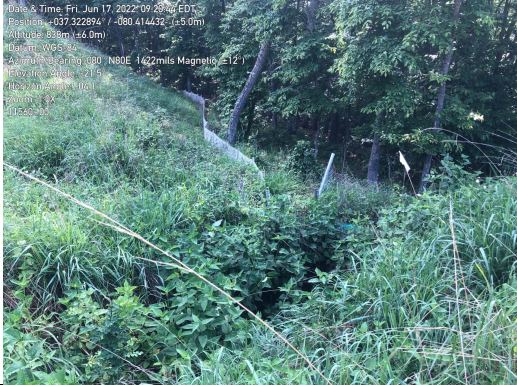
GPS Location	On photo		GPS Location	On photo	
Field Station#	11558+00		Field Station#	11560+00	
Pic 7 Desc.	ECDs functioning.		Pic 8 Desc.	ECDs are acceptable for now.

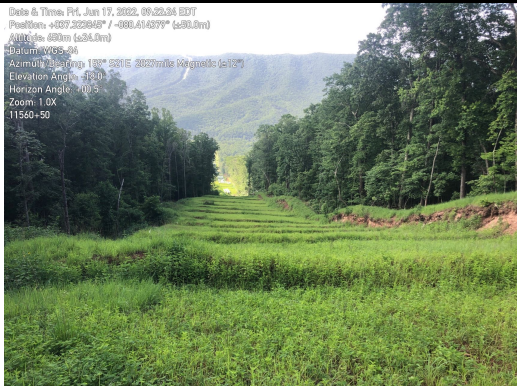
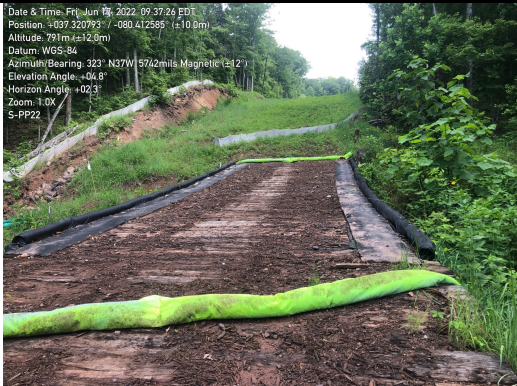
GPS Location	On photo		GPS Location	On photo	
Field Station#	11560+50		Field Station#	11568+22	
Pic 9 Desc.	Slope breakers functional. ROW surface stable.		Pic 10 Desc.	The S-PP22 crossing remains stable.

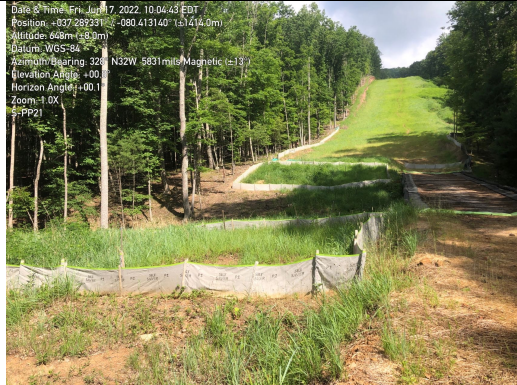
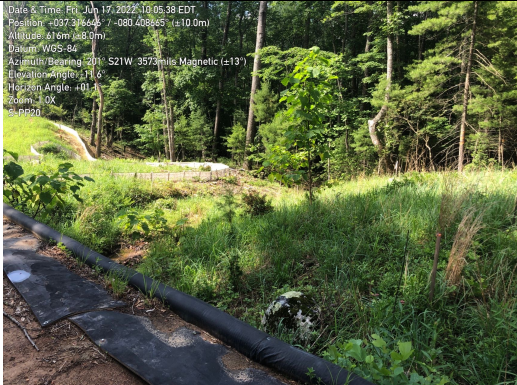
GPS Location	On photo		GPS Location	On photo	
Field Station#	11585+48		Field Station#	11588+41	
Pic 11 Desc.	The S-PP21 crossing remains stable.		Pic 12 Desc.	The S-PP20 crossing is stable.

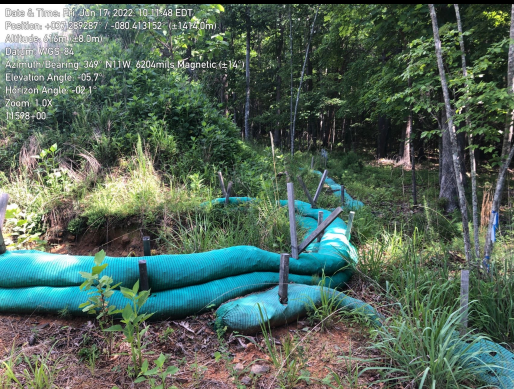
GPS Location	On photo	GPS Location			
Field Station#	11598+00	Field Station#			
Pic 13 Desc.	Perimeter ECDs are in place and functional.	Pic 14 Desc.			
Insert image here		Insert image here			
GPS Location		GPS Location			
Field Station#		Field Station#			
Pic 15 Desc.		Pic 16 Desc.			
Insert image here		Insert image here			
GPS Location		GPS Location			
Field Station#		Field Station#			
Pic 17 Desc.		Pic 18 Desc.
