# Visual Site Inspection Report

<b>Project Name</b>	H-600 Pipeline Spread G	<b>AFE</b>	124300137	<b>Spread</b>	H-600 Pipeline Spread G
<b>Contractor</b>	Precision			<b>Report #</b>	38453
<b>Inspector</b>	Patrick Shields			<b>Date/Time</b>	6/6/2022 3:46 PM
<b>Permit #</b>	TBD	<b>Inspection Type</b>	VA SWPP	<b>Station Begin</b>	11023+80
<b>State</b>	VA	<b>Inspection Area</b>	Full	<b>Station End</b>	11098+47
<b>County</b>	Giles	<b>Ground</b>	Dry	<b>Temperature (°F)</b>	72.00
<b>Municipality</b>	N/A	<b>Weather</b>	Sunny	<b>Rain Gauge (in)</b>	0.00
				<b>Rain Accumulation Time (days)</b>	1.00

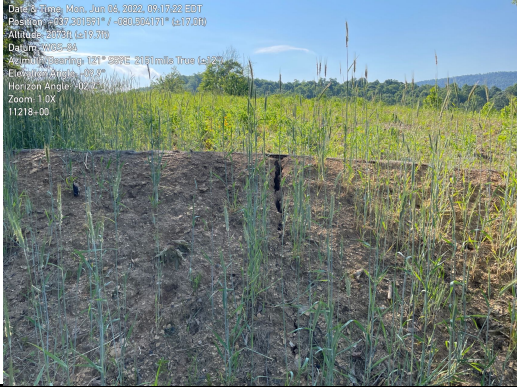
<p><small>Date &amp; Time: Mon, Jun 06, 2022, 09:17:28 EDT Position: +43°53'55.7"N / -83°03'51.7"W (-83.06447) Altitude: 3745ft (±19.7m) Datum: WGS-84 Azimuth/Bearing: 111° SSI: 2171mils True (±1.2°) Elevation Angle: -0.0 Horizon Angle: -0.2 Zoom: 1.0X 11218+00</small></p>			
<b>GPS Location</b>	See photo	<b>GPS Location</b>	See photo		
<b>Field Station#</b>	11226+00	<b>Field Station#</b>	11218+00		
<b>Pic 7 Desc.</b>	Crew fixing subsidence	<b>Pic 8 Desc.</b>	Monitoring subsidence in restored area

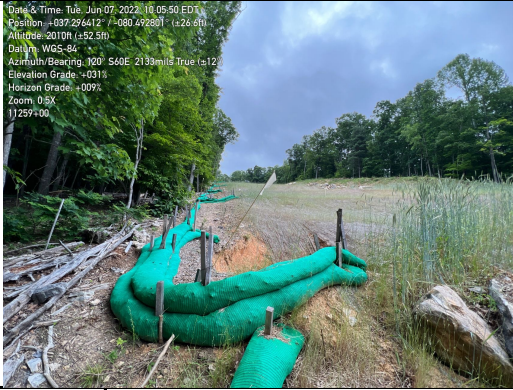
<p>Date &amp; Time: Tue Jun 07, 2022 10:05:50 EDT Position: +037.294412 / -080.492801 (±20.8m) Altitude: 2010ft (±52.5m) Datum: WGS-84 Azimuth/Bearing: 120° S60E 2133mils True (±12°) Elevation Grade: +031% Horizon Grade: +009% Zoom: 0.5X 11259+00</p>			
<b>GPS Location</b>	See photo	<b>GPS Location</b>	See photo		
<b>Field Station#</b>	11256+50	<b>Field Station#</b>	11259+00		
<b>Pic 1 Desc.</b>	P1 silt fence perimeter control in place	<b>Pic 2 Desc.</b>	End treatments in place

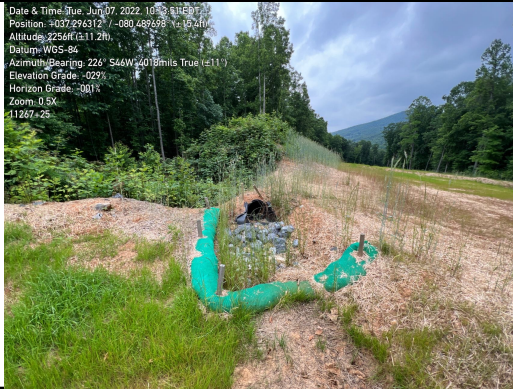
<b>GPS Location</b>	See photo	<b>GPS Location</b>	See photo		
<b>Field Station#</b>	11263+00	<b>Field Station#</b>	11267+25		
<b>Pic 3 Desc.</b>	CFS triple stack perimeter control in place	<b>Pic 4 Desc.</b>	Stone inlet protection in place

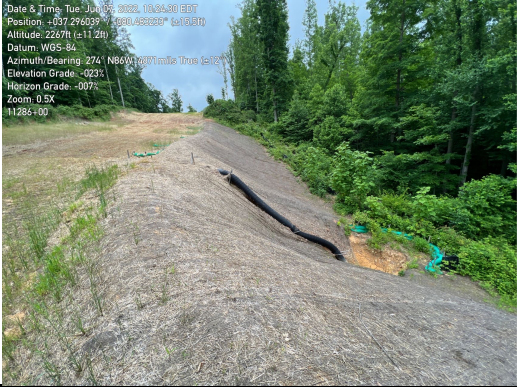
<b>GPS Location</b>	See photo	<b>GPS Location</b>	See photo		
<b>Field Station#</b>	11286+00	<b>Field Station#</b>	11293+00		
<b>Pic 7 Desc.</b>	Erosion control blanket in place	<b>Pic 8 Desc.</b>	Stream buffer in place		
<small>Date &amp; Time: Tue Jun 07 2022 10:42:01 EDT Position: +037.298304° / -880.474811° (-81°53'0") Altitude: 2280ft (-694.4m) Datum: WGS-84 Azimuth/Bearing: 367° R12W 4169mils True (-12°) Elevation Grade: -020% Horizon Grade: +002% Zoom: 0.5X 11317+00</small>

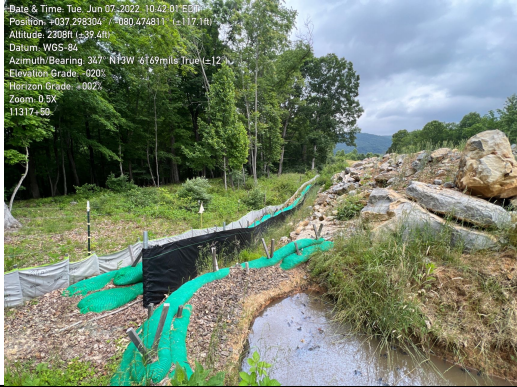
<b>GPS Location</b>	See photo	<b>GPS Location</b>	See photo		
<b>Field Station#</b>	11317+50	<b>Field Station#</b>	11325+00		
<b>Pic 9 Desc.</b>	Triple protection ECDs in place at karst feature	<b>Pic 10 Desc.</b>	Waterbars in place		
<small>Date &amp; Time: Tue Jun 07 2022 10:45:11 EDT Position: +037.302944° / -880.476765° (-81°53'0") Altitude: 2233ft (-680.2m) Datum: WGS-84 Azimuth/Bearing: 009° N09E 0631mils True (-12°) Elevation Grade: +003% Horizon Grade: -001% Zoom: 0.5X 11338+00</small>

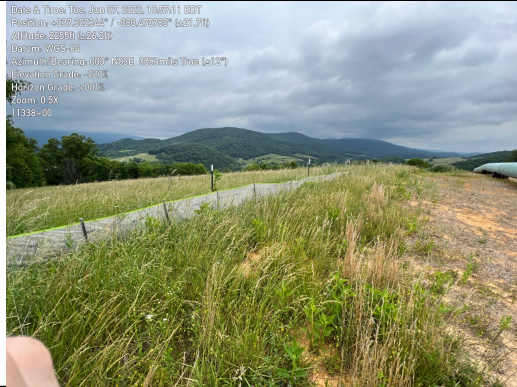
<b>GPS Location</b>	See photo	<b>GPS Location</b>	See photo		
<b>Field Station#</b>	11338+00	<b>Field Station#</b>	11353+47		
<b>Pic 11 Desc.</b>	P1 silt fence perimeter control in place	<b>Pic 12 Desc.</b>	RCE in place

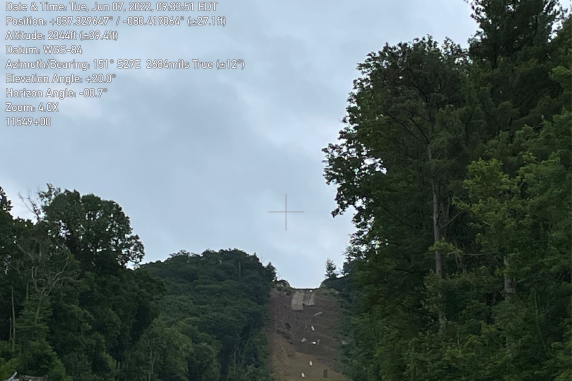
<b>GPS Location</b>	See photo	<b>GPS Location</b>	See photo		
<b>Field Station#</b>	11549+00	<b>Field Station#</b>	11532+00		
<b>Pic 1 Desc.</b>	Crew working on stabilization	<b>Pic 2 Desc.</b>	Permanent water bars and level spreader in place

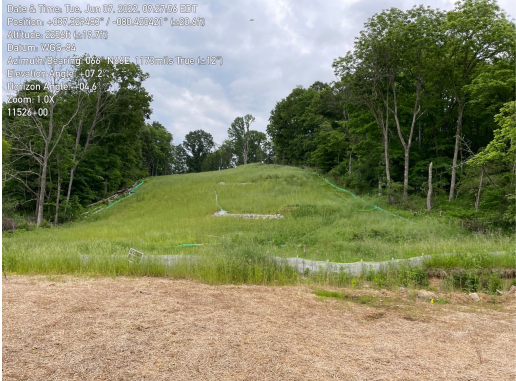
<b>GPS Location</b>	See photo	<b>GPS Location</b>	See photo		
<b>Field Station#</b>	11526+00	<b>Field Station#</b>	11584+00		
<b>Pic 3 Desc.</b>	Clean water drainage feature in place	<b>Pic 4 Desc.</b>	ET in place

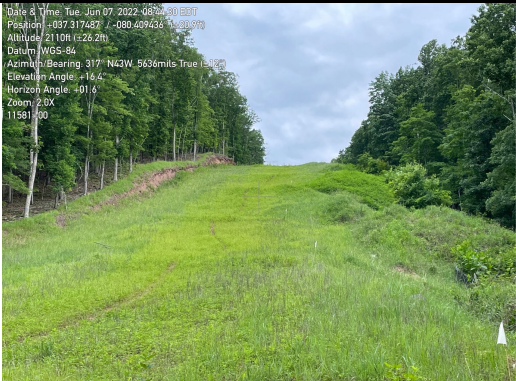
<b>GPS Location</b>	See photo	<b>GPS Location</b>	See photo		
<b>Field Station#</b>	11581+00	<b>Field Station#</b>	11585+00		
<b>Pic 5 Desc.</b>	Picture showing condition of row	<b>Pic 6 Desc.</b>	Resource buffers in place

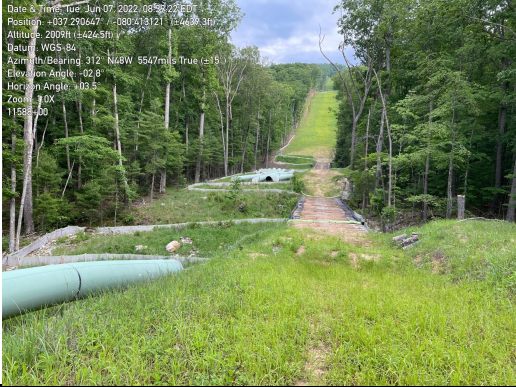
<b>GPS Location</b>	See photo	<b>GPS Location</b>	See photo		
<b>Field Station#</b>	11588+00	<b>Field Station#</b>	11598+00		
<b>Pic 7 Desc.</b>	Equipment bridge functional	<b>Pic 8 Desc.</b>	Picture showing condition of row

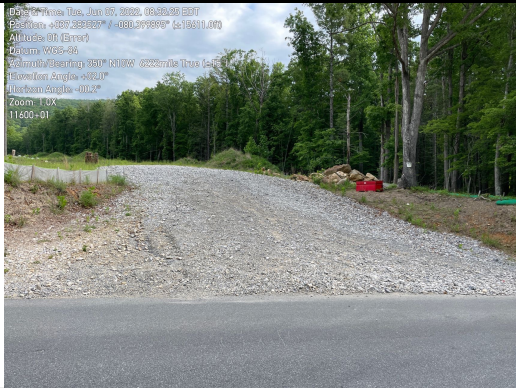
<div style="text-align: center;">Insert image here</div>			
<b>GPS Location</b>	See photo	<b>GPS Location</b>			
<b>Field Station#</b>	11600+01	<b>Field Station#</b>			
<b>Pic 9 Desc.</b>	RCE functional	<b>Pic 10 Desc.</b>			
<div style="text-align: center;">Insert image here</div>		<div style="text-align: center;">Insert image here</div>			
<b>GPS Location</b>		<b>GPS Location</b>			
<b>Field Station#</b>		<b>Field Station#</b>			
<b>Pic 11 Desc.</b>		<b>Pic 12 Desc.</b>

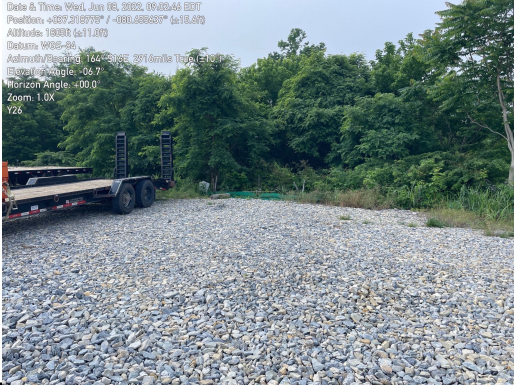
<b>GPS Location</b>	See photo	<b>GPS Location</b>	See photo		
<b>Field Station#</b>	12005+00	<b>Field Station#</b>	12005+00		
<b>Pic 5 Desc.</b>	CFS perimeter controls functional y26	<b>Pic 6 Desc.</b>	RCE functional y26

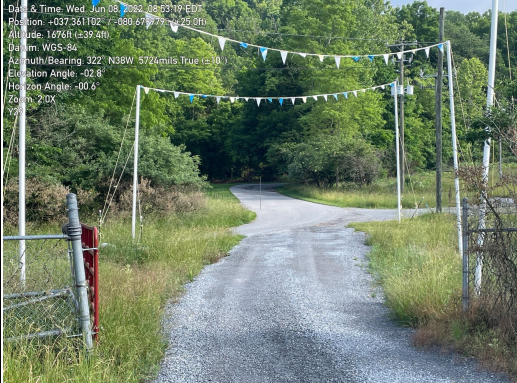
GPS Location				See photo							
Field Station#				12005+00							
Pic 7 Desc.				RCE functional y29							
<p>Date &amp; Time: Wed Jun 08 2022 08:52:25 EDT Position: +037.361102° / -080.672261° (+22.0ft) Altitude: 1724ft (+52.7ft) Datum: WGS-84 Azimuth/Bearing: 286° S86W 472mils True (+10°) Elevation Angle: -02.6° Horizon Angle: -00.3° Zoom: 2.0X Y29</p>

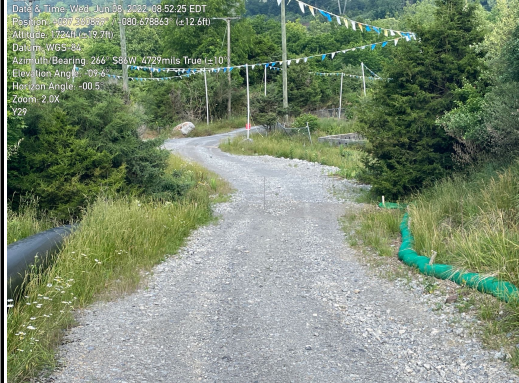
GPS Location				See photo							
Field Station#				12005+00							
Pic 8 Desc.				Broad base dips functional y29							
<p>Date &amp; Time: Wed Jun 08 2022 08:53:45 EDT Position: +037.363114° / -080.672261° (+30.5ft) Altitude: 1708ft (+51.0ft) Datum: WGS-84 Azimuth/Bearing: 186° S86W 3307mils True (+10°) Elevation Angle: -07.2° Horizon Angle: -01.6° Zoom: 1.0X Y29</p>

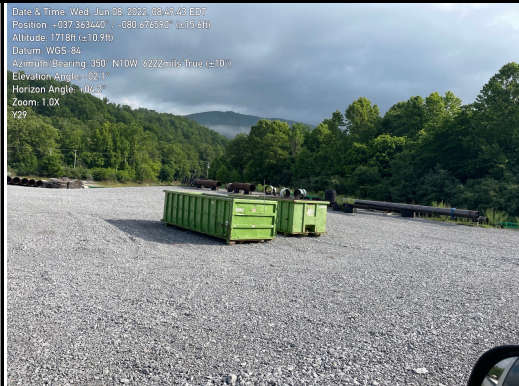
GPS Location				See photo							
Field Station#				12005+00							
Pic 12 Desc.				CFS perimeter controls functional y29

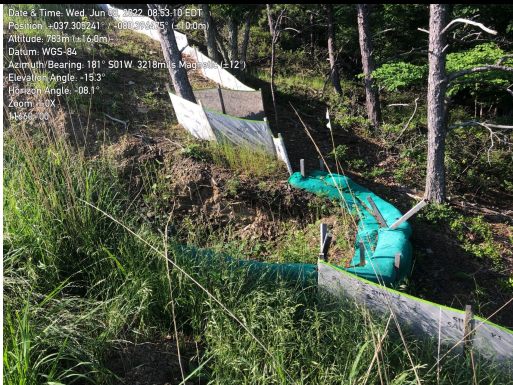
GPS Location		On photo				GPS Location		On photo			
Field Station#		11660+00				Field Station#		11658+00			
Pic 3 Desc.		Perimeter ECDs are in place.				Pic 4 Desc.		ROW stable, ECDs in place.

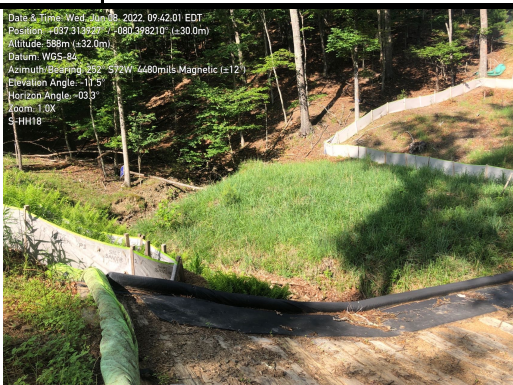
GPS Location		On photo				GPS Location		On photo			
Field Station#		11626+04				Field Station#		11618+00			
Pic 5 Desc.		The S-HH18 crossing is currently				Pic 6 Desc.		Private land between S-RR14 and the JNF property line.

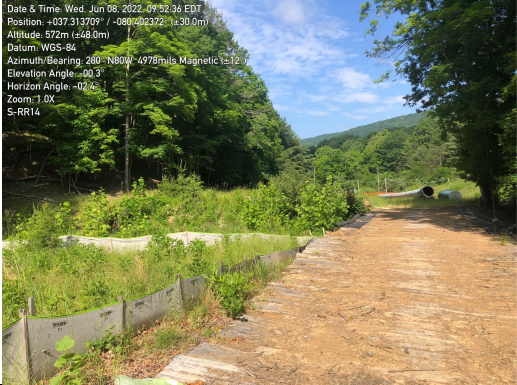
<b>GPS Location</b>	On photo		<b>GPS Location</b>	On photo	
<b>Field Station#</b>	11614+20		<b>Field Station#</b>	11607+81	
<b>Pic 7 Desc.</b>	The S-RR14 crossing is stable.		<b>Pic 8 Desc.</b>	The S-006 crossing is stable.

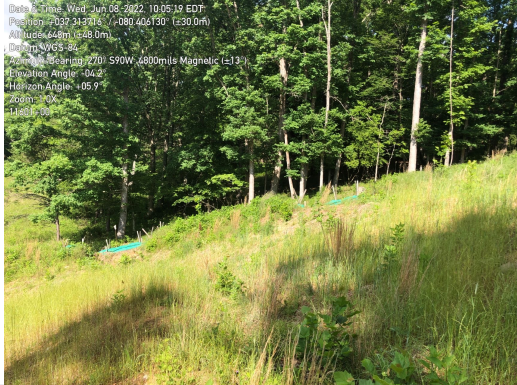
Insert image here	
<b>GPS Location</b>	On photo		<b>GPS Location</b>		
<b>Field Station#</b>	11601+00		<b>Field Station#</b>		
<b>Pic 9 Desc.</b>	The ROW is currently stable.		<b>Pic 10 Desc.</b>		
Insert image here		Insert image here			
<b>GPS Location</b>			<b>GPS Location</b>		
<b>Field Station#</b>			<b>Field Station#</b>		
<b>Pic 11 Desc.</b>			<b>Pic 12 Desc.</b>

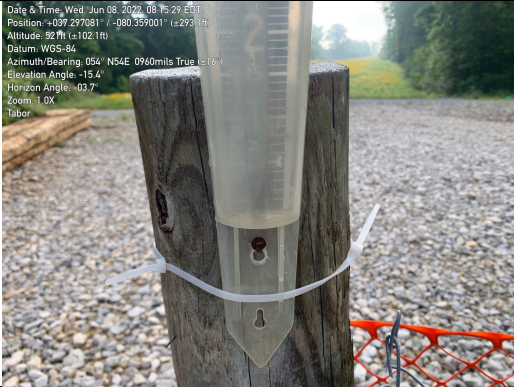
<p>Date &amp; Time: Wed Jun 08 2022 08:43:50 EDT Position: +037.296887 / -080.358927 (+293.8ft) Altitude: 83 ft (+102.0ft) Datum: WGS-84 Azimuth/Bearing: 088° N24W 1010mils True (+16°) Elevation Angle: -11.2° Horizon Angle: -01.1° Zoom: 1.0X 11896+00</p>			
<b>GPS Location</b>	See photo for GPS location.		<b>GPS Location</b>	See photo for GPS location.	
<b>Field Station#</b>	11790+00		<b>Field Station#</b>	11896+00	
<b>Pic 1 Desc.</b>	Rain gauge at Mount Tabor Road crossing.		<b>Pic 2 Desc.</b>	ROW permanently restored.

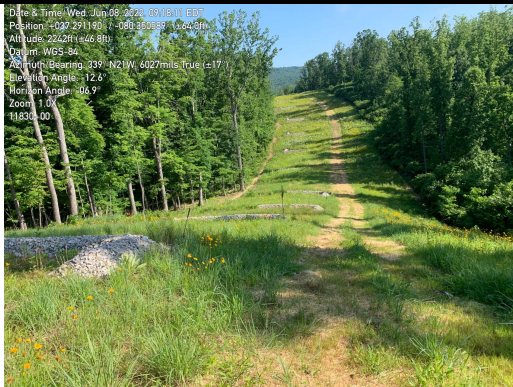
<b>GPS Location</b>	See photo for GPS location.		<b>GPS Location</b>	See photo for GPS location.	
<b>Field Station#</b>	11885+00		<b>Field Station#</b>	11830+00	
<b>Pic 3 Desc.</b>	ROW permanently restored. Permanent waterbar with level spreader in place.		<b>Pic 4 Desc.</b>	ROW permanently restored. Permanent waterbars with level spreaders in place.

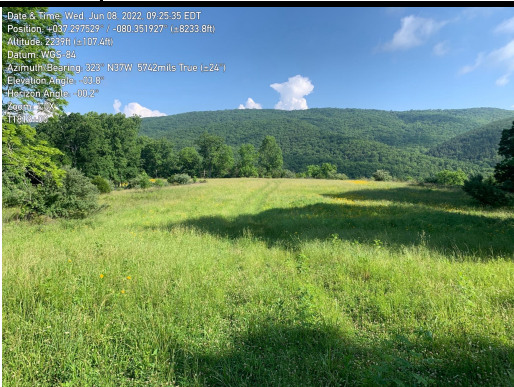
<b>Field Station#</b>	11819+00		<b>Field Station#</b>	11789+00	
<b>Pic 5 Desc.</b>	ROW permanently restored.		<b>Pic 6 Desc.</b>	RCE in place at Mount Tabor Road crossing.

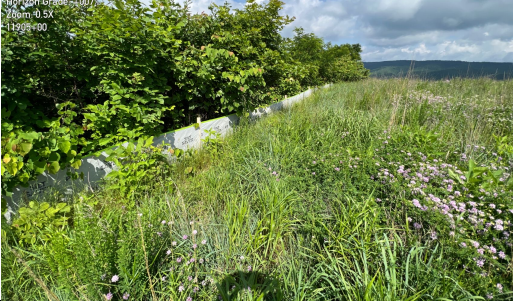
GPS Location		See photo				GPS Location		See photo			
Field Station#		11900+81				Field Station#		11905+00			
Pic 1 Desc.		RCE in place				Pic 2 Desc.		P1 silt fence perimeter control in place			
<p>Date &amp; Time: Wed Jun 08 2022 10:34:00 EDT Position: +037 283658 / +080 331438 (+26.0m) Altitude: 2293ft (+92.9m) Datum: WGS-84 Azimuth Bearing: 130° S48E 234mils True (+12°) Elevation Grade: +015% Horizon Grade: +001° Zoom: 0.5X 11920+00</p>  								<p>Date &amp; Time: Wed Jun 08 2022 10:35:07 EDT Position: +037 283658 / +080 331438 (+26.0m) Altitude: 2293ft (+92.9m) Datum: WGS-84 Azimuth Bearing: 130° S48E 234mils True (+12°) Elevation Grade: +007% Horizon Grade: +003° Zoom: 0.5X 11922+00</p>

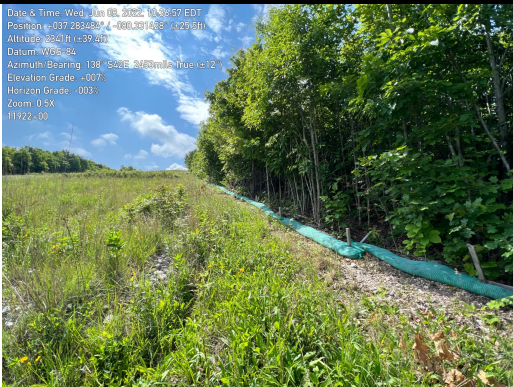
GPS Location		See photo				GPS Location		See photo			
Field Station#		11920+00				Field Station#		11922+00			
Pic 3 Desc.		Permanent vegetation present				Pic 4 Desc.		CFS perimeter control in place			
<p>Date &amp; Time: Wed Jun 08 2022 10:39:24 EDT Position: +037 283658 / +080 326388 (+101.2m) Altitude: 2293ft (+92.9m) Datum: WGS-84 Azimuth Bearing: 342° N18W 6080mils True (+18°) Elevation Grade: +015% Horizon Grade: +000° Zoom: 0.5X 11930+00</p>

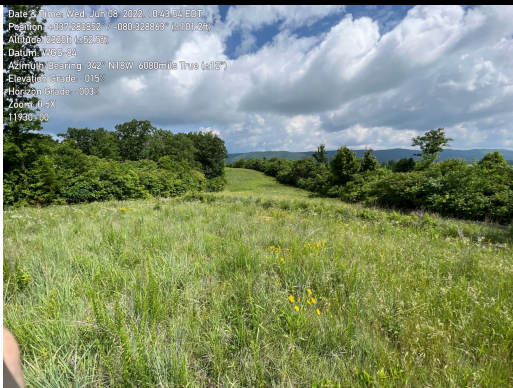
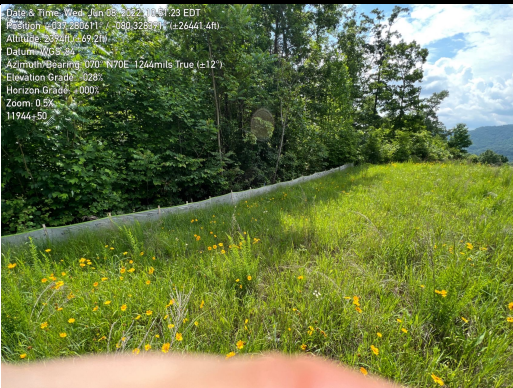
GPS Location		See photo				GPS Location		See photo			
Field Station#		11930+00				Field Station#		11944+50			
Pic 5 Desc.		Permanent vegetation present				Pic 6 Desc.		P1 silt fence perimeter control in place

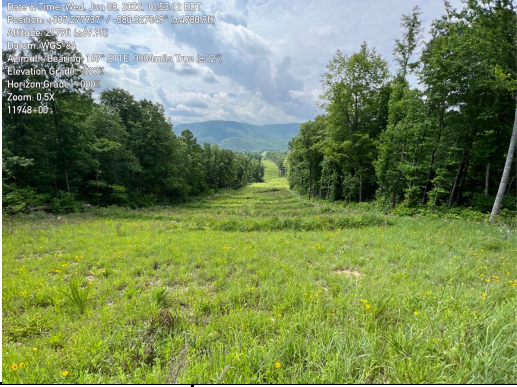
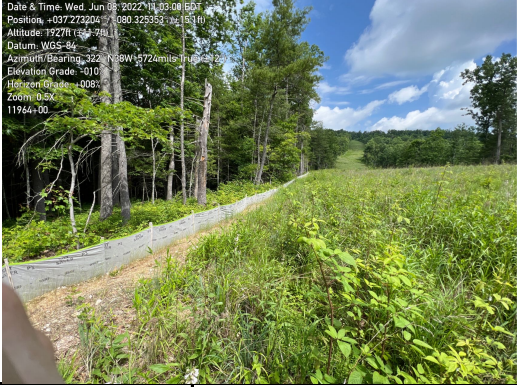
<p><small>Date &amp; Time: Wed, Jun 08, 2022, 11:03:08 EDT Position: +037.272204° / -080.32533° (45° 15' 11") Altitude: 1927ft (588.31m) Datum: WGS-84 Azimuth/Bearing: 142° 16' 50" (North is True (±12°)) Elevation Grade: -0.0% Horizon Grade: -0.0% Zoom: 0.5X 11964+00</small></p>			
<b>GPS Location</b>	See photo	<b>GPS Location</b>	See photo		
<b>Field Station#</b>	11948+00	<b>Field Station#</b>	11964+00		
<b>Pic 7 Desc.</b>	Waterbars in place	<b>Pic 8 Desc.</b>	P1 silt fence perimeter control in place

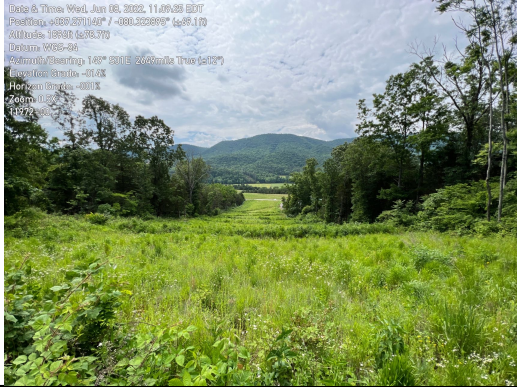
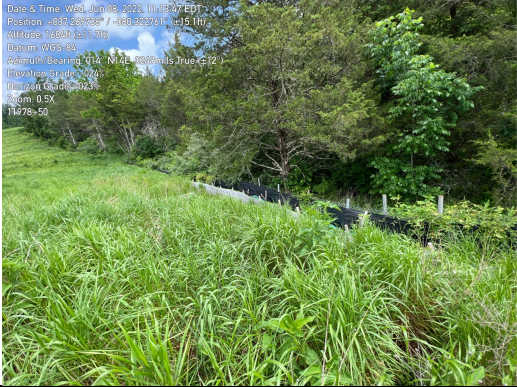
<b>GPS Location</b>	See photo	<b>GPS Location</b>	See photo		
<b>Field Station#</b>	11972+00	<b>Field Station#</b>	11978+50		
<b>Pic 9 Desc.</b>	Waterbars in place	<b>Pic 10 Desc.</b>	Triple protection ECDs in place at karst feature		
Insert image here		Insert image here			
<b>GPS Location</b>		<b>GPS Location</b>			
<b>Field Station#</b>		<b>Field Station#</b>			
<b>Pic 11 Desc.</b>		<b>Pic 12 Desc.</b>

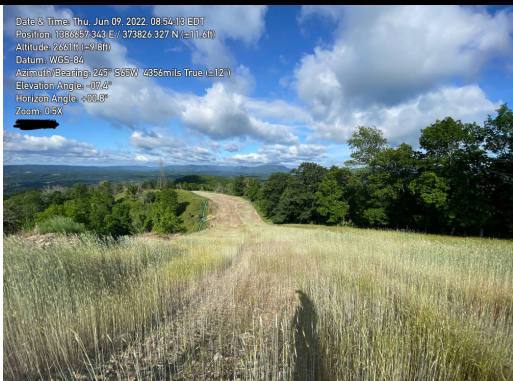
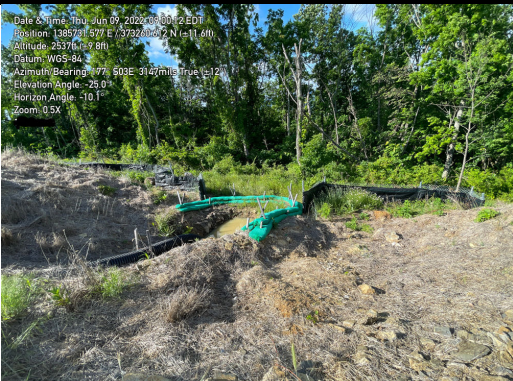
GPS Location	5	GPS Location	6		
Field Station#	10835+50	Field Station#	10824+50		
Pic 5 Desc.	Section of RoW showing conditions and controls. """"	Pic 6 Desc.	Waterbar end treatment functional.

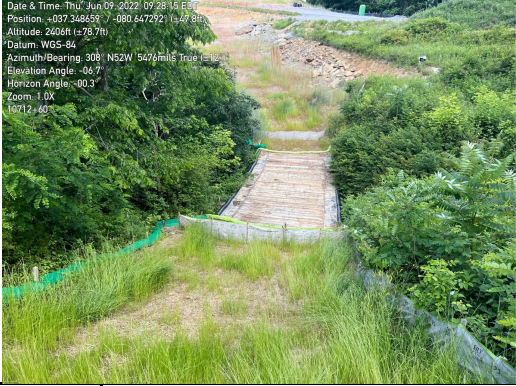
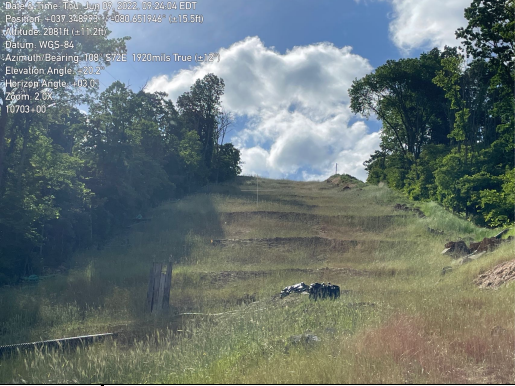
<p>Date &amp; Time: Thu Jun 09, 2022, 08:24:34 EDT Position: +037 349263.7 / -080.531048° (-15.51ft) Altitude: 2881ft (-19.2ft) Datum: WGS-84 Azimuth/Bearing: 108° S20E 1920mils True (-3.3) Elevation Angle: +1.3° Horizon Angle: -01.0° Zoom: 1.0X 10703+00</p>			
<b>GPS Location</b>	See photo	<b>GPS Location</b>	See photo		
<b>Field Station#</b>	10712+60	<b>Field Station#</b>	10703+00		
<b>Pic 1 Desc.</b>	Equipment bridge functional	<b>Pic 2 Desc.</b>	Water bars and ET in place

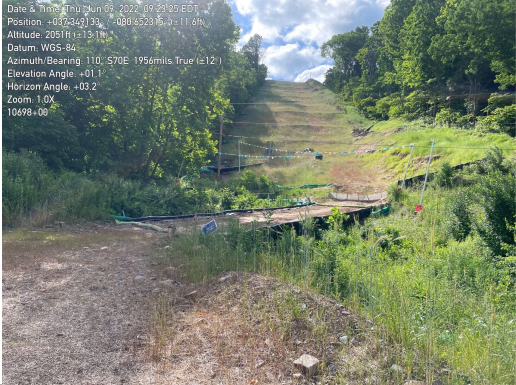
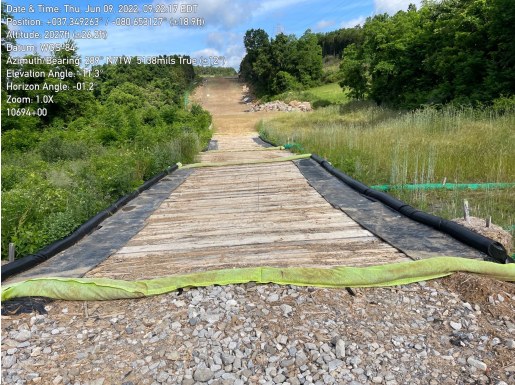
<b>GPS Location</b>	See photo	<b>GPS Location</b>	See photo		
<b>Field Station#</b>	10698+00	<b>Field Station#</b>	10694+00		
<b>Pic 3 Desc.</b>	Wattles and P1 in place	<b>Pic 4 Desc.</b>	Clean water drainage feature in place

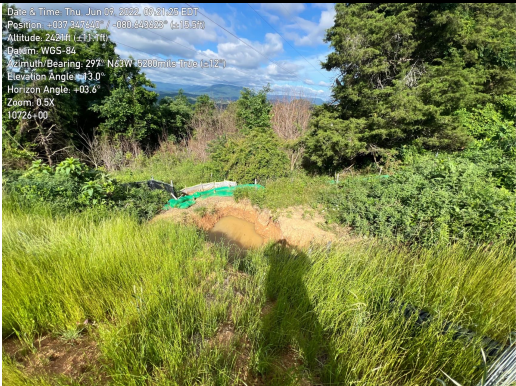
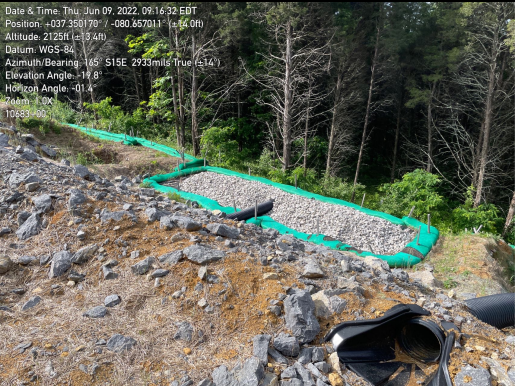
<p>Date &amp; Time: Thu Jun 09, 2022, 08:16:32 EDT Position: +037 350170.7 / -080.67011° (-5.60ft) Altitude: 2125ft (-13.4ft) Datum: WGS-84 Azimuth/Bearing: 165° S15E 2933mils True (-14.1) Elevation Angle: -11.8° Horizon Angle: -01.4° Zoom: 1.0X 10683+00</p>			
<b>GPS Location</b>	See photo	<b>GPS Location</b>	See photo		
<b>Field Station#</b>	10726+00	<b>Field Station#</b>	10683+00		
<b>Pic 5 Desc.</b>	ET functional	<b>Pic 6 Desc.</b>	Level spreader in place

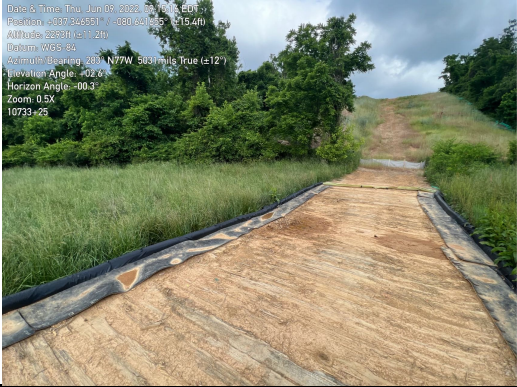
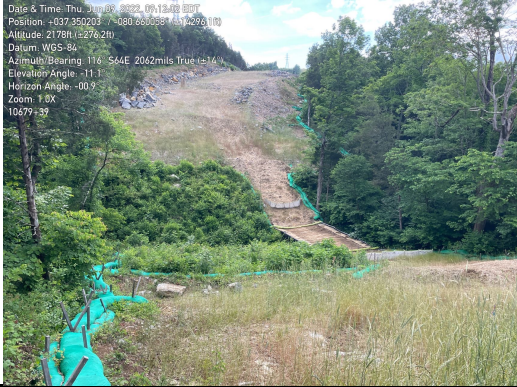
<p>Date &amp; Time: Thu, Jun 09, 2022, 09:18:48 EDT Position: +037.350203° / -080.633653° (-15.296ft) Altitude: 2178ft (+276.2ft) Datum: WGS-84 Azimuth/Bearing: 116° S44E 2042mils True (+16.1) Elevation Angle: +11.1° Horizon Angle: -00.5° Zoom: 1.0X 10679+39</p>		<b>GPS Location</b>	See photo
<b>Field Station#</b>	10733+25	<b>Field Station#</b>	10679+39	<b>GPS Location</b>	See photo
<b>Pic 7 Desc.</b>	Equipment bridge functional	<b>Pic 8 Desc.</b>	Resource buffers in place	<b>GPS Location</b>	See photo

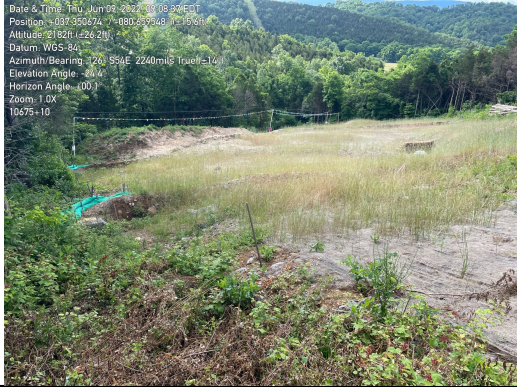
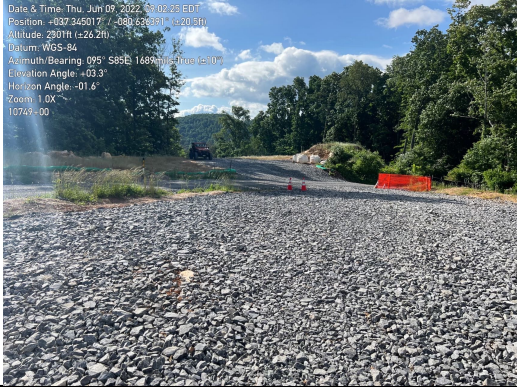
<b>Field Station#</b>	10675+10	<b>Field Station#</b>	10749+00	<b>GPS Location</b>	See photo
<b>Pic 9 Desc.</b>	Erosion control blanket in place	<b>Pic 10 Desc.</b>	RCE functional	<b>GPS Location</b>	See photo

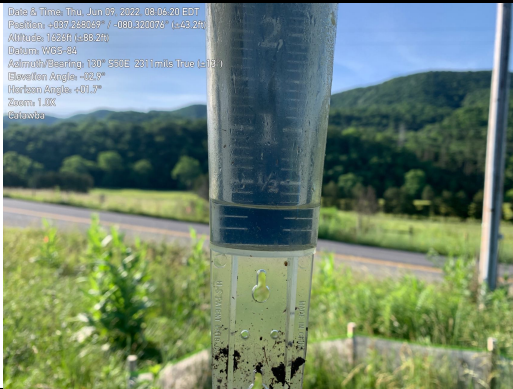
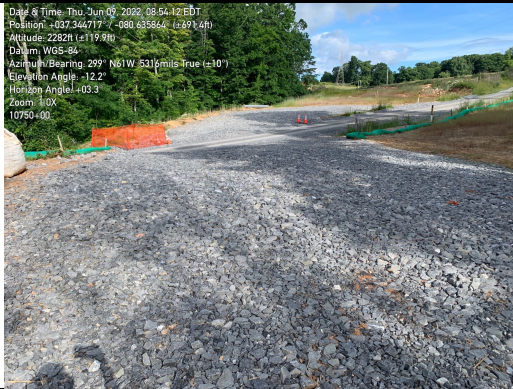
<p>Date &amp; Time: Thu, Jun 09, 2022, 08:56:41 EDT Position: +037.3445777 / -080.635142 (-15.7ft) Altitude: 2236ft (+10.8ft) Datum: WGS-84 Azimuth/Bearing: 043° N43E 1100mils True (+12°) Elevation Angle: -20.9° Horizon Angle: -06.0° Zoom: 1.0X 10753+00</p>				<p>Date &amp; Time: Thu, Jun 09, 2022, 08:56:42 EDT Position: +037.3447177 / -080.635664 (-16.9ft) Altitude: 2282ft (+119.8ft) Datum: WGS-84 Azimuth/Bearing: 299° N61W 531mils True (+10°) Elevation Angle: -12.2° Horizon Angle: +03.3° Zoom: 1.0X 10750+00</p>											
<b>GPS Location</b>				See photo for GPS location.				<b>GPS Location</b>				See photo for GPS location.			
<b>Field Station#</b>				11990+00				<b>Field Station#</b>				10750+00			
<b>Pic 1 Desc.</b>				Rain gauge at Catawba Road reads 0.3 inches.				<b>Pic 2 Desc.</b>				RCE in place at Hendrickson Road.

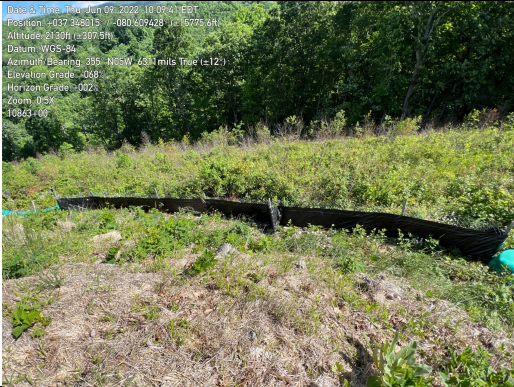
<p>Date &amp; Time: Thu, Jun 09, 2022, 10:13:14 EDT Position: +037.334293° / -080.600731° (+13.2ft) Altitude: 2434ft (+19.7ft) Datum: WGS-84 Azimuth/Bearing: 140° S40E 249mils True (+15mils) Elevation Grade: +001° Horizon Grade: +003° Zoom: 0.5X 10871+00</p>			
<b>GPS Location</b>	See photo	<b>GPS Location</b>	See photo		
<b>Field Station#</b>	10863+00	<b>Field Station#</b>	10871+00		
<b>Pic 1 Desc.</b>	Supersilt fence perimeter control	<b>Pic 2 Desc.</b>	Cleanwater diversion berm in place

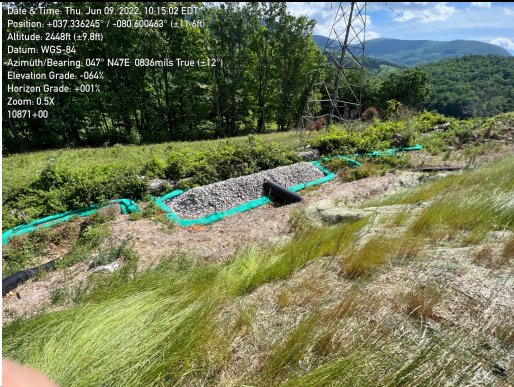
<b>GPS Location</b>	See photo	<b>GPS Location</b>	See photo		
<b>Field Station#</b>	10871+00	<b>Field Station#</b>	10875+00		
<b>Pic 3 Desc.</b>	Cleanwater diversion outlet protection in place	<b>Pic 4 Desc.</b>	CFS perimeter control in place

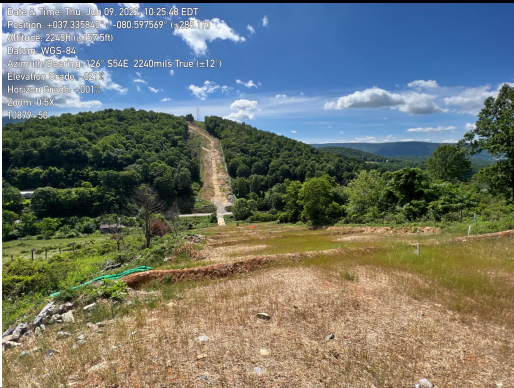
<p>Date &amp; Time: Thu, Jun 09, 2022, 10:30:34 EDT Position: +037.334569° / -080.596373° (+2004.7ft) Altitude: 2223ft (+18.7ft) Datum: WGS-84 Azimuth/Bearing: 119° S61E 2116mils True (+12°) Elevation Grade: +027° Horizon Grade: +002° Zoom: 0.5X 10883+10</p>			
<b>GPS Location</b>	See photo	<b>GPS Location</b>	See photo		
<b>Field Station#</b>	10879+50	<b>Field Station#</b>	10883+10		
<b>Pic 5 Desc.</b>	Waterbars in place	<b>Pic 6 Desc.</b>	Stream buffer in place

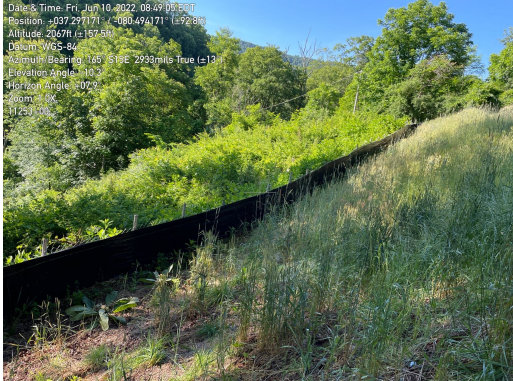
</div></div></div>			
GPS Location	See photo		GPS Location	See photo	
Field Station#	11253+00		Field Station#	11249+00	
Pic 1 Desc.	SSF in place		Pic 2 Desc.	Picture showing condition of row	
<div><div><div>Date &amp; Time: Fri, Jun 10, 2022 08:43:20 EDT Position: -037.227372° / -080.496142° (-92.8ft) Altitude: 2157ft (-19.7ft) Datum: WGS-84 Azimuth/Bearing: 285° S 29W 3644mils True (-13) Elevation Angle: -06.9 Horizon Angle: -04.6 Zoom: 1.0X 11248+00</div><div>

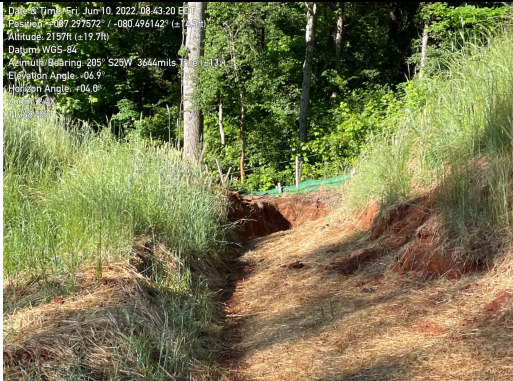
GPS Location	See photo		GPS Location	See photo	
Field Station#	11248+00		Field Station#	11227+00	
Pic 3 Desc.	ET in place		Pic 4 Desc.	Picture showing condition of row	
<div><div><div>Date &amp; Time: Fri, Jun 10, 2022 08:50:43 EDT Position: -037.231252° / -080.506655° (-92.8ft) Altitude: 2071ft (-14.8ft) Datum: WGS-84 Azimuth/Bearing: 127° S 53E 2268mils True (-13) Elevation Angle: -10.8 Horizon Angle: -02.2 Zoom: 1.0X 11217+00</div><div>

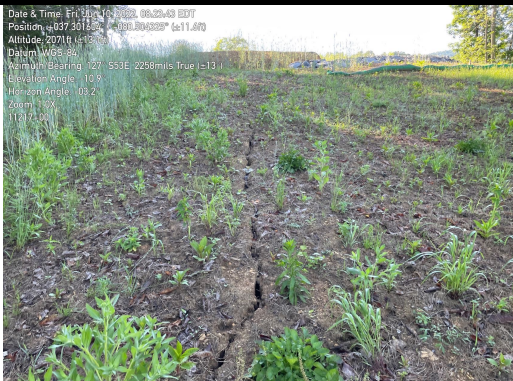
</div></div></div>			
GPS Location	See photo		GPS Location	See photo	
Field Station#	11217+00		Field Station#	11205+00	
Pic 5 Desc.	Area being monitored for subsidence		Pic 6 Desc.	Area being monitored for stabilization

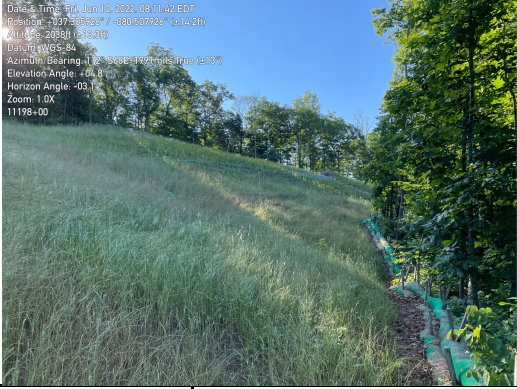
<b>GPS Location</b>	See photo	<b>GPS Location</b>	See photo		
<b>Field Station#</b>	11198+00	<b>Field Station#</b>	11190+00		
<b>Pic 7 Desc.</b>	CFS perimeter controls functional	<b>Pic 8 Desc.</b>	Permanent water bars and level spreader in place

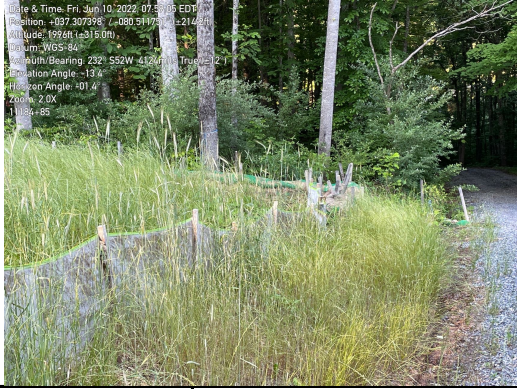
<p style="text-align: center;">Insert image here</p>			
<b>GPS Location</b>	See photo	<b>GPS Location</b>			
<b>Field Station#</b>	11184+85	<b>Field Station#</b>			
<b>Pic 9 Desc.</b>	Rock check dams in place	<b>Pic 10 Desc.</b>			
<p style="text-align: center;">Insert image here</p>		<p style="text-align: center;">Insert image here</p>			
<b>GPS Location</b>		<b>GPS Location</b>			
<b>Field Station#</b>		<b>Field Station#</b>			
<b>Pic 11 Desc.</b>		<b>Pic 12 Desc.</b>

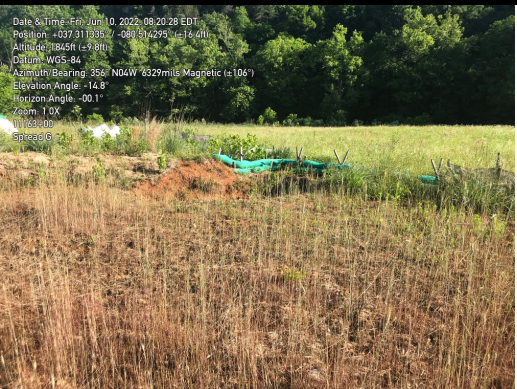
GPS Location	See photo		GPS Location	see photo	
Field Station#	11184+00		Field Station#	11163+00	
Pic 1 Desc.	249.02		Pic 2 Desc.	Sump, water bar end treatments

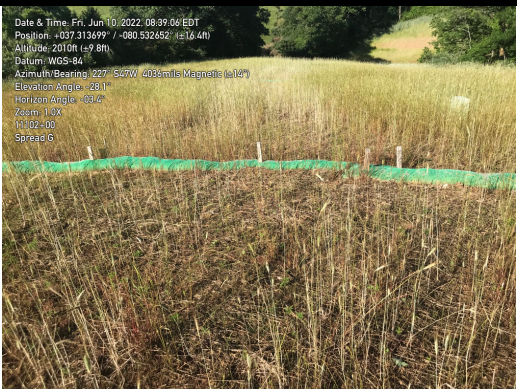
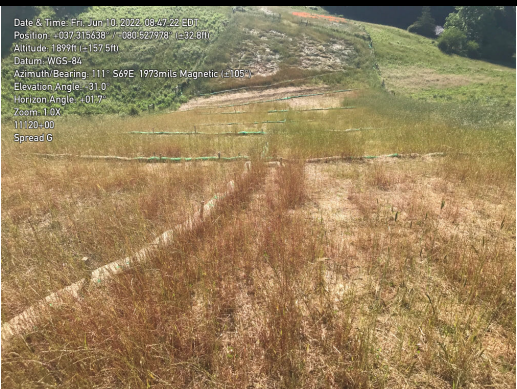
GPS Location	see photo		GPS Location	see photo	
Field Station#	11102+00		Field Station#	11120+00	
Pic 3 Desc.	Restored ROW		Pic 4 Desc.	Restored ROW

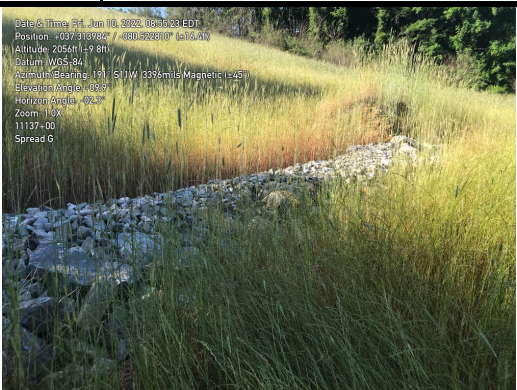
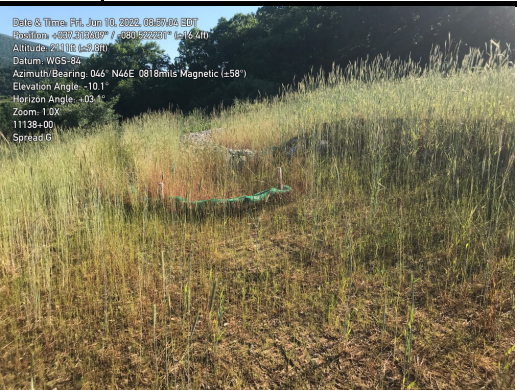
GPS Location	see photo		GPS Location	see photo	
Field Station#	11137+00		Field Station#	11138+00	
Pic 5 Desc.	Water bar		Pic 6 Desc.	Water bar (other)

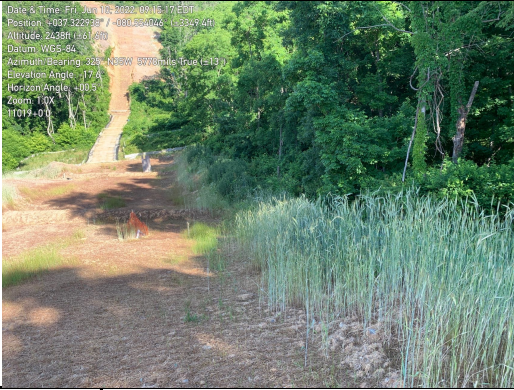
<p>Date &amp; Time: Fri, Jun 10, 2022, 09:10:08 EDT Position: +037.319116° / -080.559222° (+1349.17) Altitude: 2647ft (+120.8m) Datum: WGS-84 Azimuth Bearing: 307° N53W 408mils True (+13) Elevation Angle: +00.2 Horizon Angle: +00.7 Zoom: 1.0X 11016+00</p>			
<b>GPS Location</b>	See photo for GPS location.		<b>GPS Location</b>	See photo for GPS location.	
<b>Field Station#</b>	11019+00		<b>Field Station#</b>	11016+00	
<b>Pic 1 Desc.</b>	Clean water after diversion berm in place.		<b>Pic 2 Desc.</b>	sensitive resource buffer in place at streams S-PA07 and S-RR5.

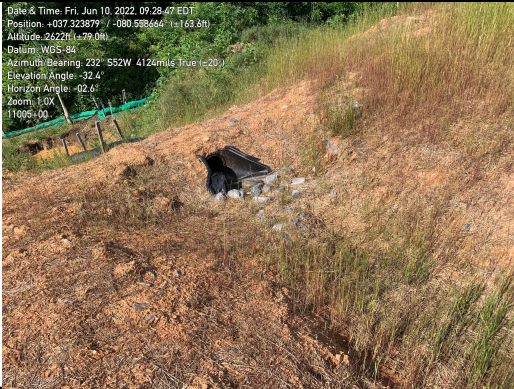
<p>Date &amp; Time: Fri, Jun 10, 2022, 09:29:52 EDT Position: +037.32980° / -080.559398° (+656.2ft) Altitude: 2643ft (+113.9ft) Datum: WGS-84 Azimuth Bearing: 190° S10W 337mils True (+17) Elevation Angle: -24.7 Horizon Angle: +0.4 Zoom: 1.0X 11003+00</p>			
<b>GPS Location</b>	See photo for GPS location.		<b>GPS Location</b>	See photo for GPS location.	
<b>Field Station#</b>	11005+00		<b>Field Station#</b>	11003+00	
<b>Pic 3 Desc.</b>	Rock inlet in place at slope drain pipe.		<b>Pic 4 Desc.</b>	Clean water diversion pipe and level spreader in place.

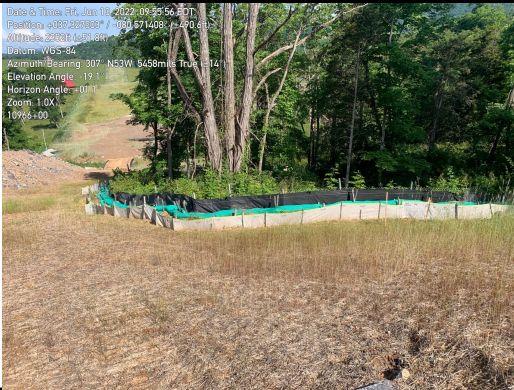
<b>GPS Location</b>	See photo for GPS location.		<b>GPS Location</b>	See photo for GPS location.	
<b>Field Station#</b>	10966+00		<b>Field Station#</b>	10930+25	
<b>Pic 5 Desc.</b>	Triple barrier ECD in place at cave feature.		<b>Pic 6 Desc.</b>	RCE in place at Doe Creek Road.

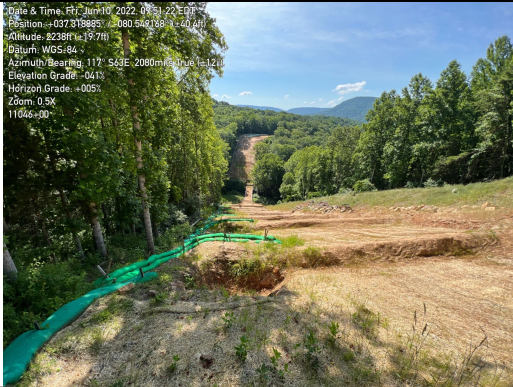
GPS Location		See photo						GPS Location		See photo	
Field Station#		11046+00						Field Station#		11049+75	
Pic 3 Desc.		End treatments in place						Pic 4 Desc.		Stream buffer in place

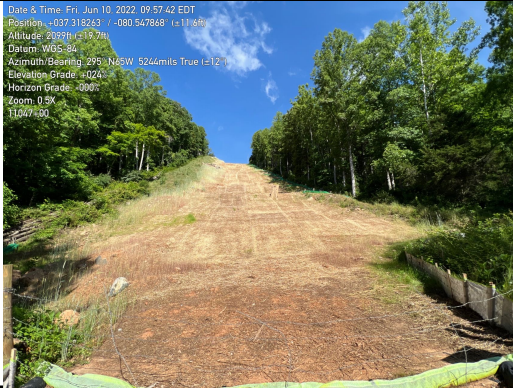
GPS Location		See photo						GPS Location		See photo	
Field Station#		11047+00						Field Station#		11053+50	
Pic 5 Desc.		Erosion control blanket in place						Pic 6 Desc.		P1 silt fence perimeter control in place

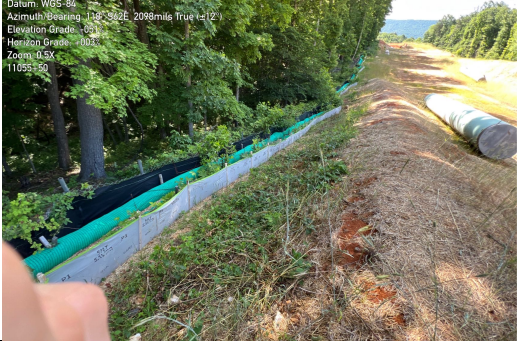
<b>GPS Location</b>		See photo		<b>GPS Location</b>	
<b>Field Station#</b>		11055+50		<b>Field Station#</b>	
<b>Pic 7 Desc.</b>		Triple protection ECDs in place at karst feature		<b>Pic 8 Desc.</b>	
<p>Date &amp; Time: Fri Jun 10, 2022, 10:11:05 EDT  Position: +037.317491 / -080.549201 (+14.1ft)  Altitude: 2026ft (+19.0ft)  Datum: WGS-84  Azimuth/Bearing: 137°/201E 2200mils True (+12°)  Elevation Grade: -028%  Horizon Grade: -005%  Zoom: 0.5X  11065+84</p>

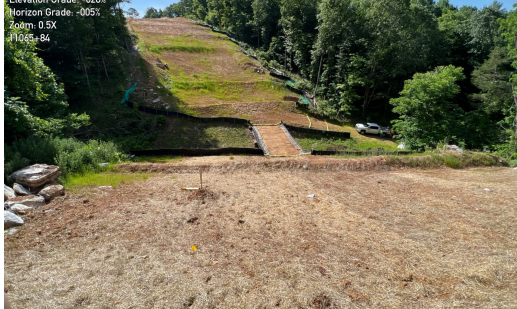
<b>GPS Location</b>		See photo		<b>GPS Location</b>	
<b>Field Station#</b>		11065+84		<b>Field Station#</b>	
<b>Pic 9 Desc.</b>		Cleanwater drainage feature in place		<b>Pic 10 Desc.</b>	
<p>Date &amp; Time: Fri Jun 10, 2022, 11:06:51 EDT  Position: +037.313588 / -080.535345 (+15.3ft)  Altitude: 2019ft (+19.0ft)  Datum: WGS-84  Azimuth/Bearing: 313°/N47W 6590mils True (+12°)  Elevation Grade: -003%  Horizon Grade: -001%  Zoom: 0.5X  11089+00</p>

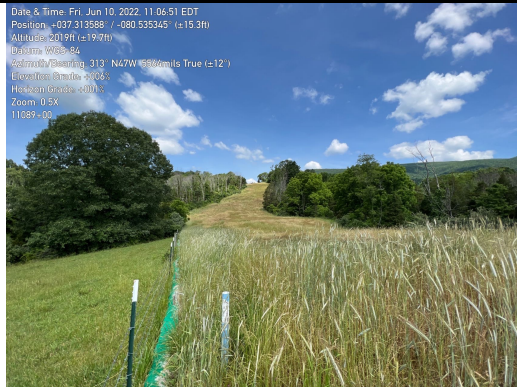
<b>GPS Location</b>		See photo		<b>GPS Location</b>	
<b>Field Station#</b>		11089+00		<b>Field Station#</b>	
<b>Pic 11 Desc.</b>		Permanent vegetation present		<b>Pic 12 Desc.</b>
