# Visual Site Inspection Report

<b>Project Name</b>	H-600 Pipeline Spread H	<b>AFE</b>	124300138	<b>Spread</b>	H-600 Pipeline Spread H
<b>Contractor</b>	Precision			<b>Report #</b>	37712
<b>Inspector</b>	Jordan Davis			<b>Date/Time</b>	5/16/2022 3:28 PM
<b>Permit #</b>	TBD	<b>Inspection Type</b>	VA SWPP	<b>Station Begin</b>	12119+17
<b>State</b>	VA	<b>Inspection Area</b>	Partial	<b>Station End</b>	12284+75
<b>County</b>	Montgomery	<b>Ground</b>	Damp	<b>Temperature (°F)</b>	75.00
<b>Municipality</b>	N/A	<b>Weather</b>	Cloudy	<b>Rain Gauge (in)</b>	0.30
				<b>Rain Accumulation Time (days)</b>	2.00

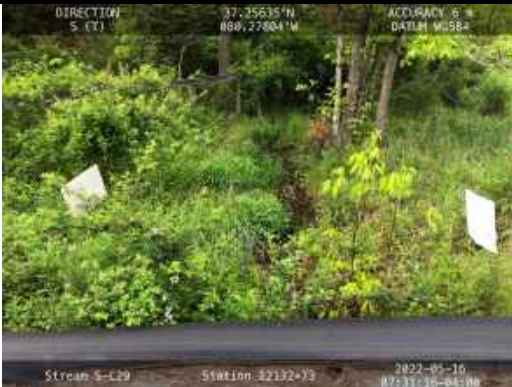
<b>GPS Location</b>	Please see photo for details.		<b>GPS Location</b>	Please see photo for details.	
<b>Field Station#</b>	12132+73		<b>Field Station#</b>	12139+50	
<b>Pic 3 Desc.</b>	Photo shows downstream of Stream S-C29.		<b>Pic 4 Desc.</b>	Photo shows overview of Wetland W-C6 from coming in side.

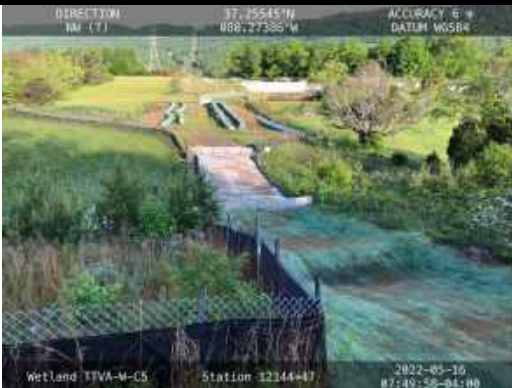
<b>GPS Location</b>	Please see photo for details.		<b>GPS Location</b>	Please see photo for details.	
<b>Field Station#</b>	12144+47		<b>Field Station#</b>	12166+47	
<b>Pic 5 Desc.</b>	Photo shows overview of Wetland TTVA-W-C5 from the going away side.		<b>Pic 6 Desc.</b>	Photo shows overview of Stream S-C24 from the coming in side.

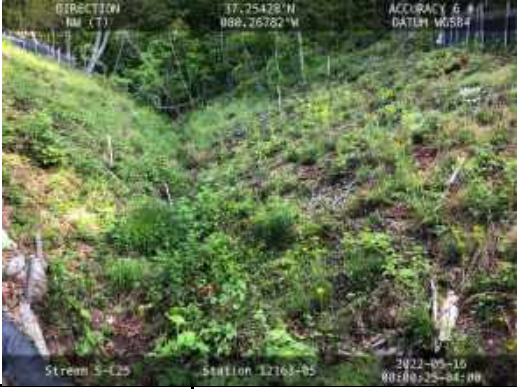
<p>Stream S-C25 Station 12163+05 2022-05-16 00:00:25-04:00</p>

<p>Station 12175+00 2022-05-16 00:07:21-04:00</p>			
<b>GPS Location</b>	Please see photo for details.		<b>GPS Location</b>	Please see photo for details.	
<b>Field Station#</b>	12163+05		<b>Field Station#</b>	12175+00	
<b>Pic 7 Desc.</b>	Photo shows upstream of Stream S-C25.		<b>Pic 8 Desc.</b>	Photo shows stabilized ROW conditions.

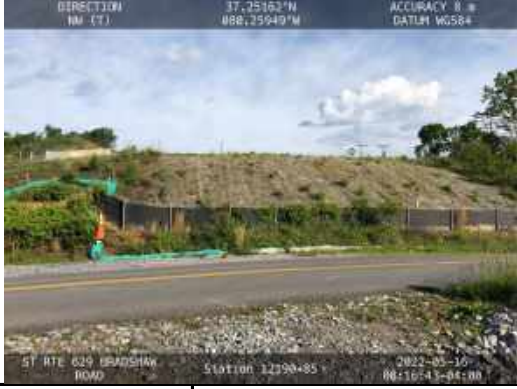
<p>ST RTE 629 BRADSHAW ROAD Station 12190+85 2022-05-16 00:10:43-04:00</p>

<p>Stream S-C21 Station 12192+36 2022-05-16 00:17:47-04:00</p>			
<b>GPS Location</b>	Please see photo for details.		<b>GPS Location</b>	Please see photo for details.	
<b>Field Station#</b>	12190+85		<b>Field Station#</b>	12192+36	
<b>Pic 9 Desc.</b>	Photo shows ST RTE 629 BRADSHAW ROAD from the going away side.		<b>Pic 10 Desc.</b>	Photo shows upstream view of Stream S-C21.

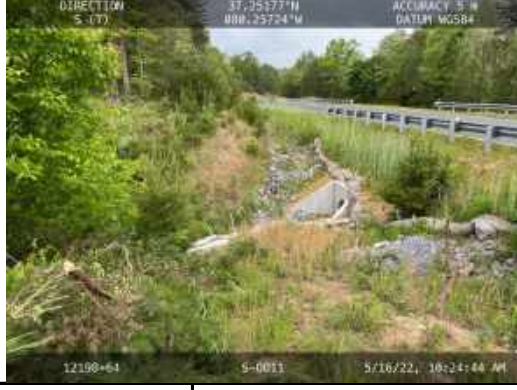
<p>12198+64 S-0011 5/16/22, 10:24:44 AM</p>

<p>12213+00 Vegetative maintenance 5/16/22, 9:52:47 AM</p>			
<b>GPS Location</b>	Please see photo for details.		<b>GPS Location</b>	Please see photo for details.	
<b>Field Station#</b>	12198+64		<b>Field Station#</b>	12213+00	
<b>Pic 11 Desc.</b>	Photo shows overview of Stream S-0011 on the upstream side.		<b>Pic 12 Desc.</b>	Photo shows environmental crew doing vegetative maintenance.

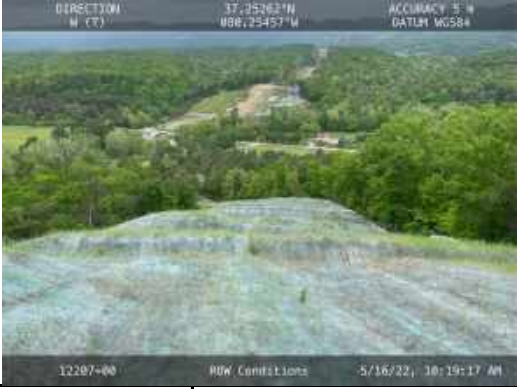
<b>GPS Location</b>	Please see photo for details.		<b>GPS Location</b>	Please see photo for details.	
<b>Field Station#</b>	12207+00		<b>Field Station#</b>	12226+00	
<b>Pic 13 Desc.</b>	Photo shows stabilized ROW conditions with water bars installed and functioning as designed.		<b>Pic 14 Desc.</b>	Photo shows stone inlet protection for slope drain pipe.

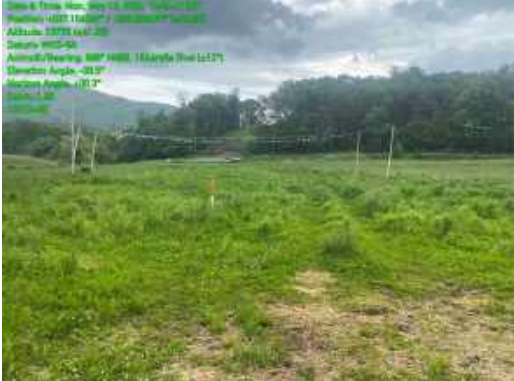
<b>GPS Location</b>	0	<b>GPS Location</b>	0		
<b>Field Station#</b>	13310+00	<b>Field Station#</b>	13309+09		
<b>Pic 1 Desc.</b>	ROW and ECDs In good condition and stable	<b>Pic 2 Desc.</b>	MVP-S-GH7 and corresponding buffer zone in good condition

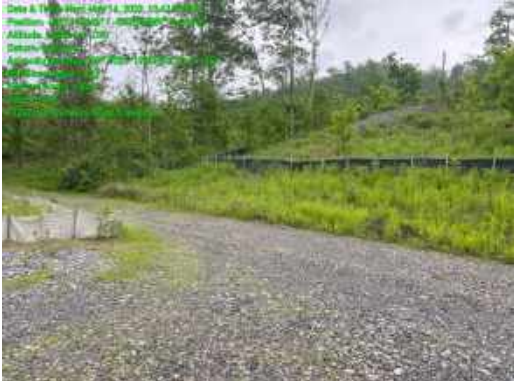
<b>GPS Location</b>	0	<b>GPS Location</b>	0		
<b>Field Station#</b>	13262+62	<b>Field Station#</b>	13260+66		
<b>Pic 3 Desc.</b>	Flanders Road Crossing in good condition	<b>Pic 4 Desc.</b>	MVP-S-II4 and corresponding buffer zone in good condition

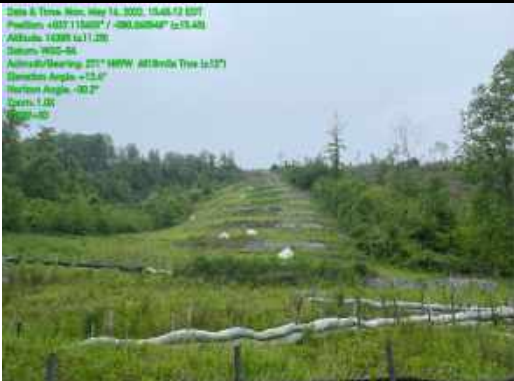
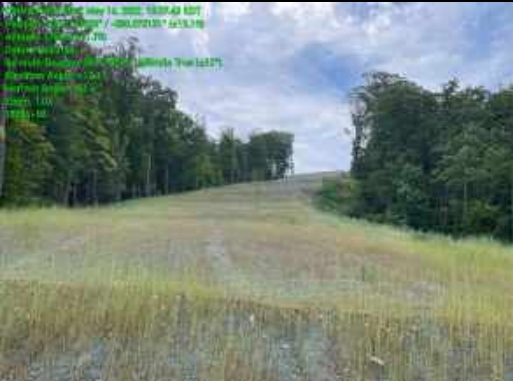
<b>GPS Location</b>	0	<b>GPS Location</b>	0		
<b>Field Station#</b>	13259+00	<b>Field Station#</b>	13204+00		
<b>Pic 5 Desc.</b>	ROW and ECDs In good condition and stable	<b>Pic 6 Desc.</b>	ROW and ECDs In good condition and stable

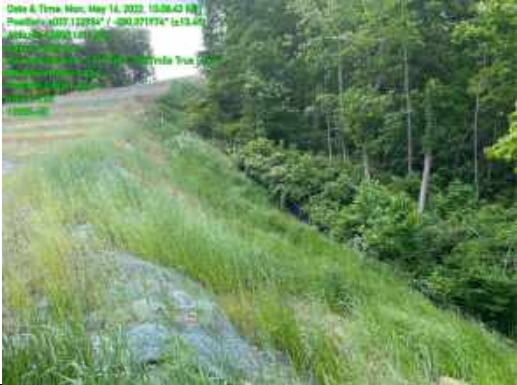
<b>GPS Location</b>	0	<b>GPS Location</b>	0		
<b>Field Station#</b>	13205+00	<b>Field Station#</b>	13202+50		
<b>Pic 7 Desc.</b>	ROW and ECDs In good condition and stable	<b>Pic 8 Desc.</b>	Slope drain pipe in good condition

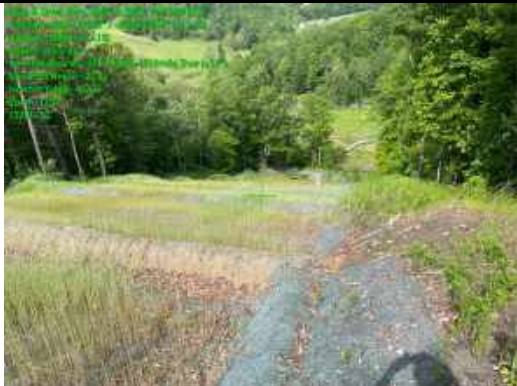
<b>GPS Location</b>	0	<b>GPS Location</b>	0		
<b>Field Station#</b>	13201+50	<b>Field Station#</b>	13197+55		
<b>Pic 9 Desc.</b>	ROW and ECDs In good condition and stable	<b>Pic 10 Desc.</b>	Dillion Mill Road Crossing in good condition

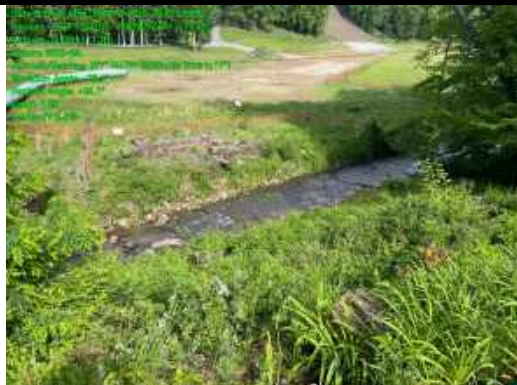
<b>GPS Location</b>	0	<b>GPS Location</b>	0		
<b>Field Station#</b>	13196+79	<b>Field Station#</b>	13196+31		
<b>Pic 11 Desc.</b>	MVP-S-D8 and corresponding buffer zone in good condition	<b>Pic 12 Desc.</b>	MVP-S-D10 and corresponding buffer zone in good condition

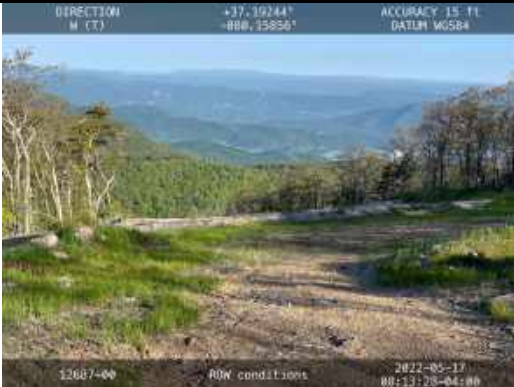
<b>GPS Location</b>	See photo for gps location data.		<b>GPS Location</b>	See photo for gps location data.	
<b>Field Station#</b>	12687+00		<b>Field Station#</b>	12689+00	
<b>Pic 1 Desc.</b>	Photo shows the ROW condition. ECDs are installed and functioning as designed.		<b>Pic 2 Desc.</b>	Photo shows the RCE at Honeysuckle Road.

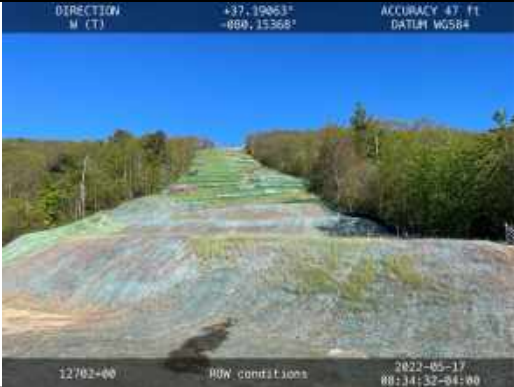
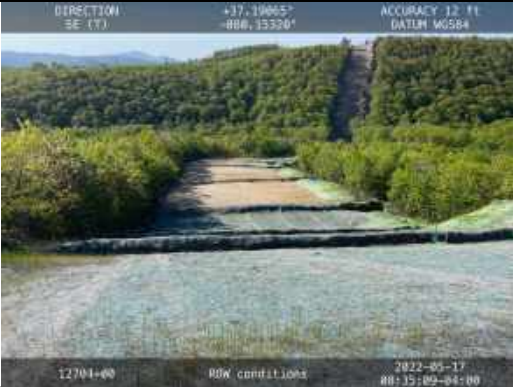
<b>GPS Location</b>	See photo for gps location data.		<b>GPS Location</b>	See photo for gps location data.	
<b>Field Station#</b>	12702+00		<b>Field Station#</b>	12704+00	
<b>Pic 3 Desc.</b>	Photo shows the ROW condition. ECDs are installed and functioning as designed.		<b>Pic 4 Desc.</b>	Photo shows the ROW condition. ECDs are installed and functioning as designed.

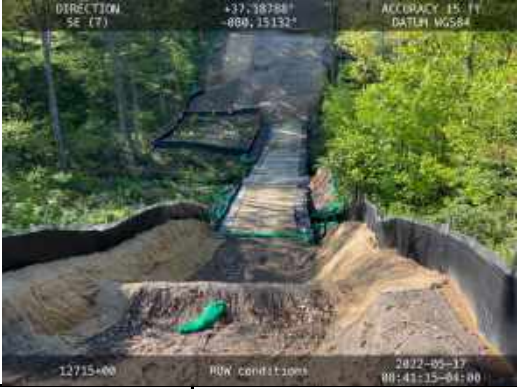
<b>GPS Location</b>	See photo for gps location data.		<b>GPS Location</b>	See photo for gps location data.	
<b>Field Station#</b>	12715+00		<b>Field Station#</b>	12715+80	
<b>Pic 7 Desc.</b>	Photo shows the bridge over streams S-Y13 and S-Y14.		<b>Pic 8 Desc.</b>	Photo shows S-Y13 downstream from the bridge.

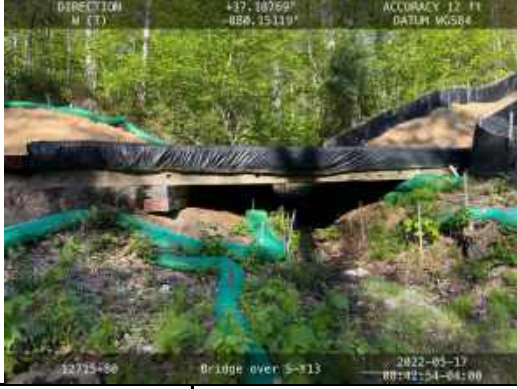
<b>GPS Location</b>	See photo for gps location data.		<b>GPS Location</b>	See photo for gps location data.	
<b>Field Station#</b>	12715+80		<b>Field Station#</b>	12716+20	
<b>Pic 9 Desc.</b>	Photo shows the bridge over stream S-Y13.		<b>Pic 10 Desc.</b>	Photo shows the bridge over stream S-Y14.

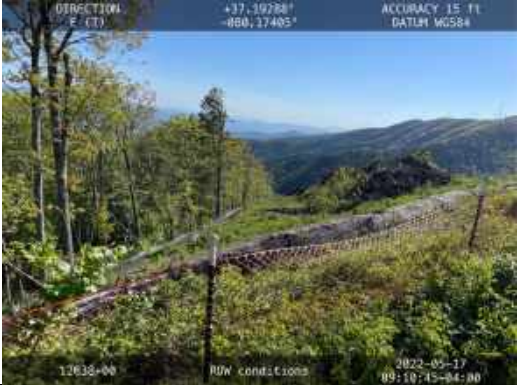
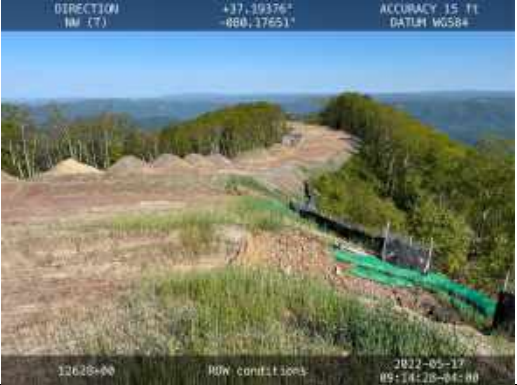
<b>GPS Location</b>	See photo for gps location data.		<b>GPS Location</b>	See photo for gps location data.	
<b>Field Station#</b>	12635+00		<b>Field Station#</b>	12628+00	
<b>Pic 13 Desc.</b>	Photo shows the ROW condition. ECDs are installed and functioning as designed.		<b>Pic 14 Desc.</b>	Photo shows the ROW condition. ECDs are installed and functioning as designed.

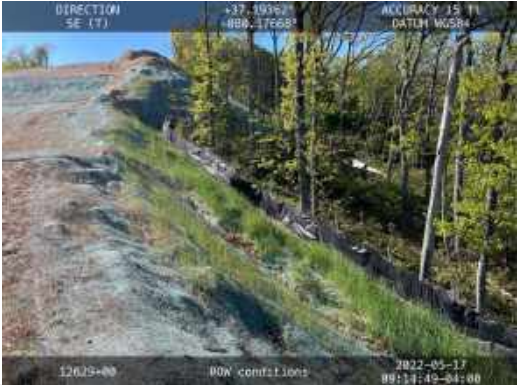
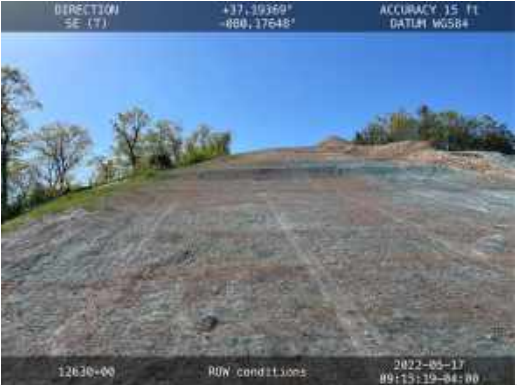
<b>GPS Location</b>	See photo for gps location data.		<b>GPS Location</b>	See photo for gps location data.	
<b>Field Station#</b>	12629+00		<b>Field Station#</b>	12630+00	
<b>Pic 15 Desc.</b>	Photo shows the ROW condition. ECDs are installed and functioning as designed.		<b>Pic 16 Desc.</b>	Photo shows the ROW condition. ECDs are installed and functioning as designed.

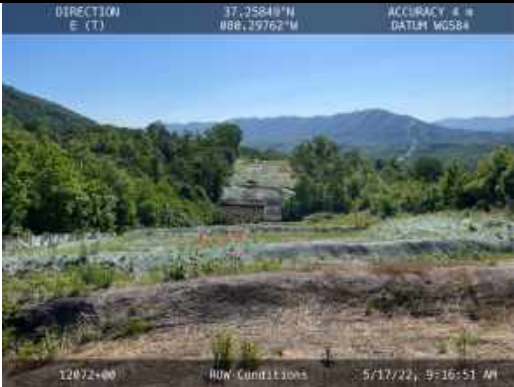
<b>GPS Location</b>	See photo		<b>GPS Location</b>	See photo	
<b>Field Station#</b>	12072+00		<b>Field Station#</b>	12076+95	
<b>Pic 1 Desc.</b>	Current ROW conditions. ROW is stable. ECDs are functional.		<b>Pic 2 Desc.</b>	Overview of Stream S-MM15

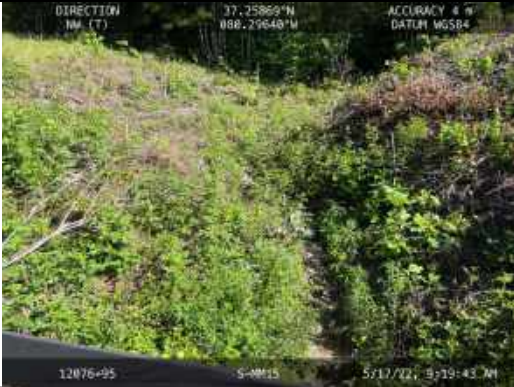
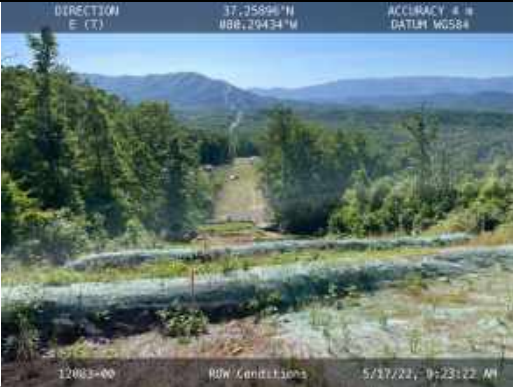
<b>GPS Location</b>	See photo		<b>GPS Location</b>	See photo	
<b>Field Station#</b>	12076+95		<b>Field Station#</b>	12083+00	
<b>Pic 3 Desc.</b>	Upstream of crossing at Stream S-MM15		<b>Pic 4 Desc.</b>	Current ROW conditions. ROW is stable. ECDs are functional.

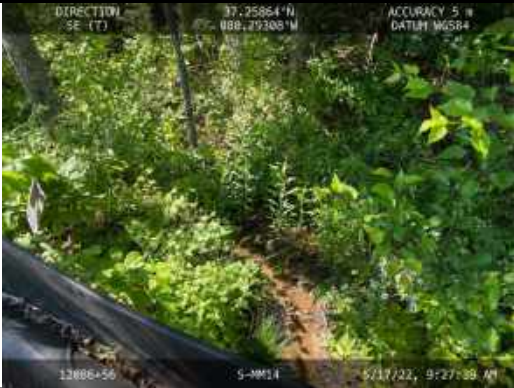
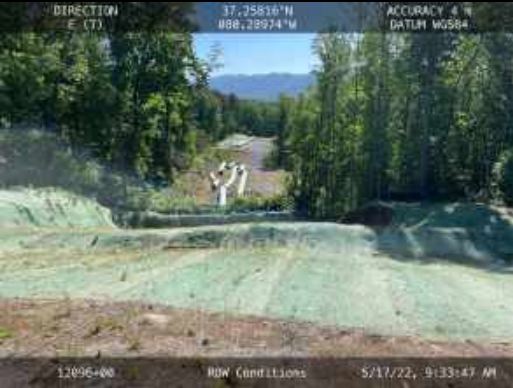
<b>GPS Location</b>	See photo		<b>GPS Location</b>	See photo	
<b>Field Station#</b>	12086+56		<b>Field Station#</b>	12096+00	
<b>Pic 5 Desc.</b>	Downstream of crossing at Stream S-MM14		<b>Pic 6 Desc.</b>	Current ROW conditions. ROW is stable. ECDs are functional.

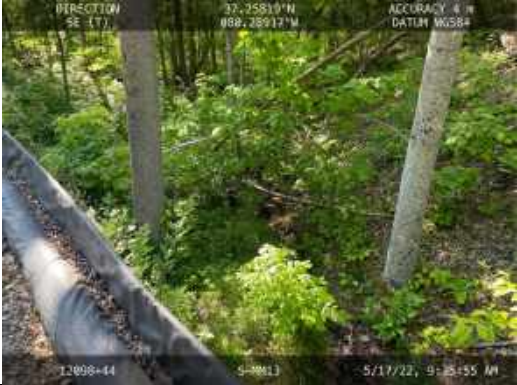
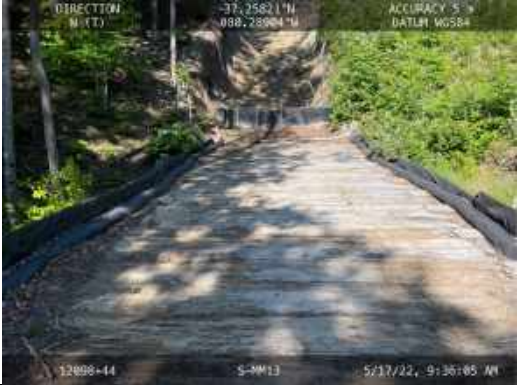
<b>GPS Location</b>	See photo		<b>GPS Location</b>	See photo	
<b>Field Station#</b>	12098+44		<b>Field Station#</b>	12098+44	
<b>Pic 7 Desc.</b>	Downstream of crossing at Stream S-MM13		<b>Pic 8 Desc.</b>	Equipment bridge over Stream S-MM13

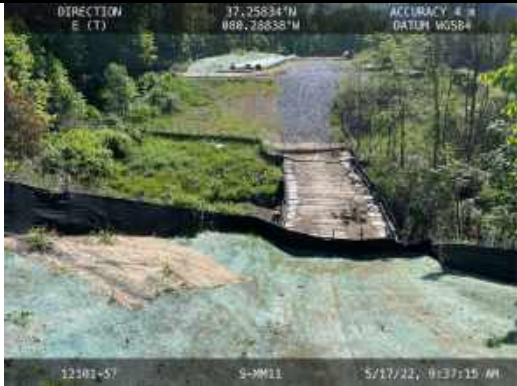
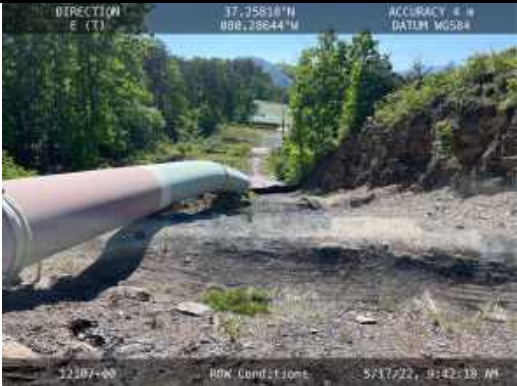
<b>GPS Location</b>	See photo		<b>GPS Location</b>	See photo	
<b>Field Station#</b>	12101+57		<b>Field Station#</b>	12107+00	
<b>Pic 9 Desc.</b>	Overview of stream S-MM11		<b>Pic 10 Desc.</b>	Current ROW conditions. ROW is stable. ECDs are functional.

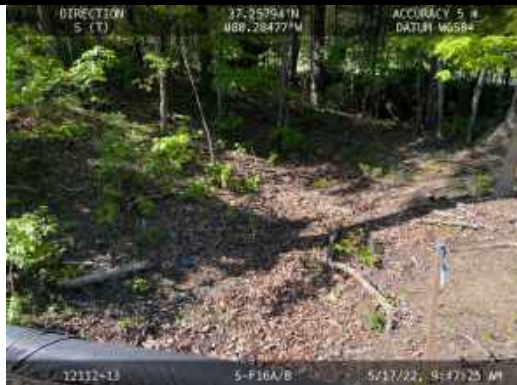
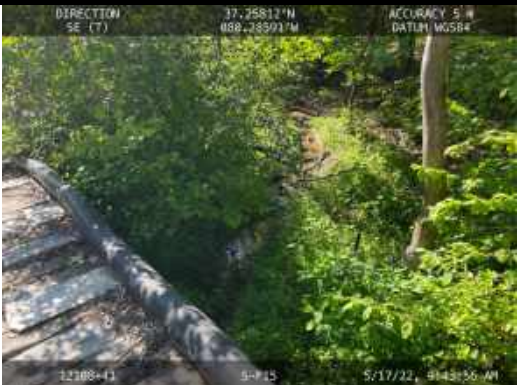
<b>GPS Location</b>	See photo		<b>GPS Location</b>	See photo	
<b>Field Station#</b>	12112+13		<b>Field Station#</b>	12108+41	
<b>Pic 11 Desc.</b>	Downstream of crossing at Stream S-F16A/B		<b>Pic 12 Desc.</b>	Downstream of crossing at Stream S-F15

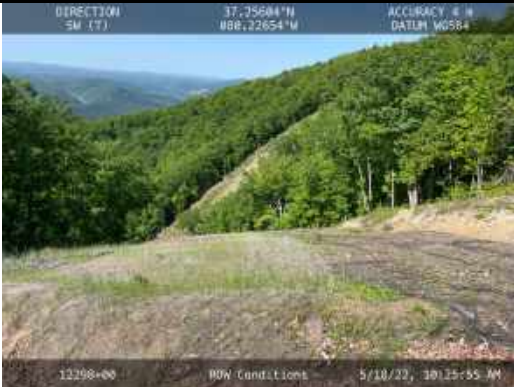
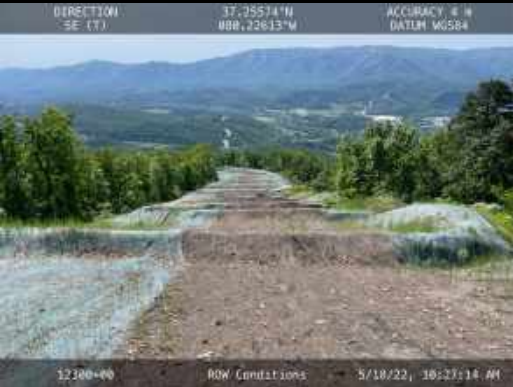
<b>GPS Location</b>	Please see photo for details.		<b>GPS Location</b>	Please see photo for details.	
<b>Field Station#</b>	12298+00		<b>Field Station#</b>	12300+00	
<b>Pic 1 Desc.</b>	Photo shows the stabilized ROW conditions with water bars and that all ECDs are installed and are functioning as designed.		<b>Pic 2 Desc.</b>	Photo shows the stabilized ROW conditions with water bars and that all ECDs are installed and are functioning as designed.

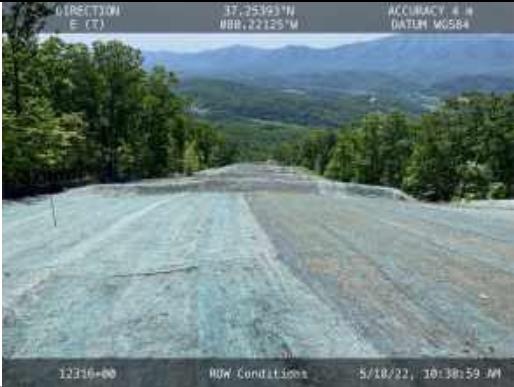
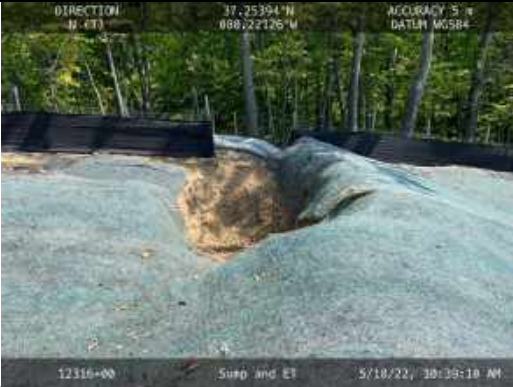
<b>GPS Location</b>	Please see photo for details.		<b>GPS Location</b>	Please see photo for details.	
<b>Field Station#</b>	12316+00		<b>Field Station#</b>	12316+00	
<b>Pic 3 Desc.</b>	Photo shows the stabilized ROW conditions with water bars and that all ECDs are installed and are functioning as designed.		<b>Pic 4 Desc.</b>	Photo shows where water bar meets sump equipped with end treatment.

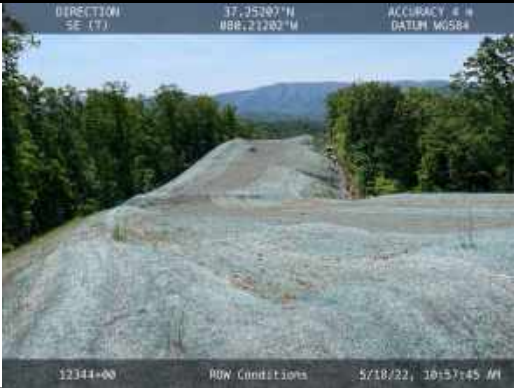
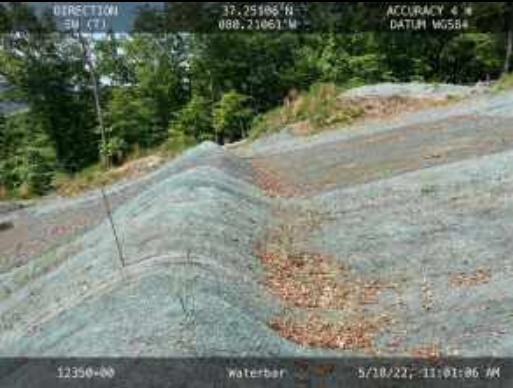
<b>GPS Location</b>	Please see photo for details.		<b>GPS Location</b>	Please see photo for details.	
<b>Field Station#</b>	12344+00		<b>Field Station#</b>	12350+00	
<b>Pic 5 Desc.</b>	Photo shows the stabilized ROW conditions with water bars and that all ECDs are installed and are functioning as designed.		<b>Pic 6 Desc.</b>	Photo shows the stabilized ROW conditions with water bars and that all ECDs are installed and are functioning as designed.

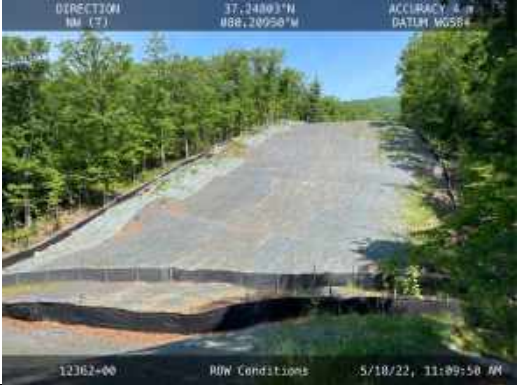
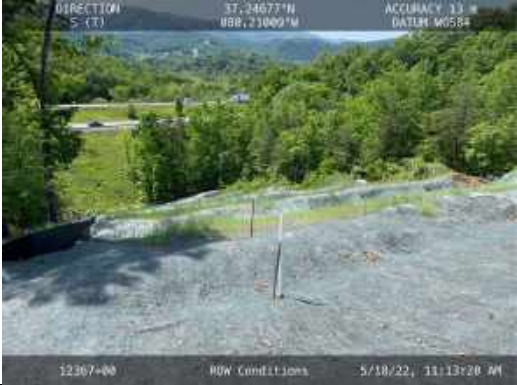
<b>GPS Location</b>	Please see photo for details.		<b>GPS Location</b>	Please see photo for details.	
<b>Field Station#</b>	12362+00		<b>Field Station#</b>	12367+00	
<b>Pic 7 Desc.</b>	Photo shows the stabilized ROW conditions with water bars and that all ECDs are installed and are functioning as designed.		<b>Pic 8 Desc.</b>	Photo shows the stabilized ROW conditions with water bars and that all ECDs are installed and are functioning as designed.

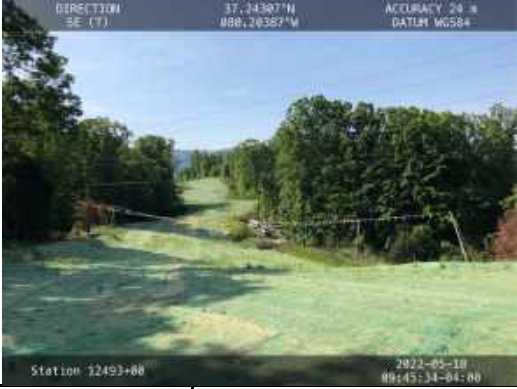
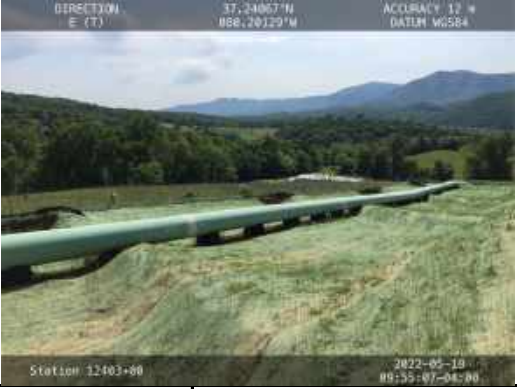
<b>GPS Location</b>	Please see photo for details.		<b>GPS Location</b>	Please see photo for details.	
<b>Field Station#</b>	12393+00		<b>Field Station#</b>	12403+00	
<b>Pic 13 Desc.</b>	Photo shows the stabilized ROW conditions with water bars and that all ECDs are installed and are functioning as designed.		<b>Pic 14 Desc.</b>	Photo shows the stabilized ROW conditions with water bars and that all ECDs are installed and are functioning as designed.

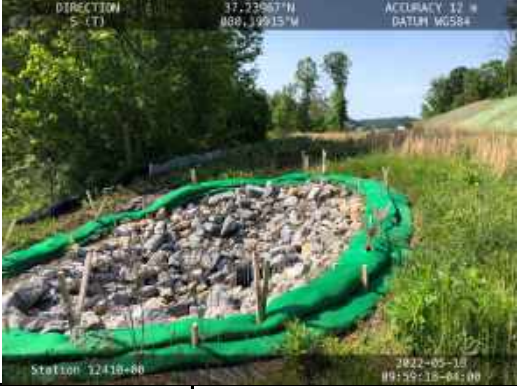
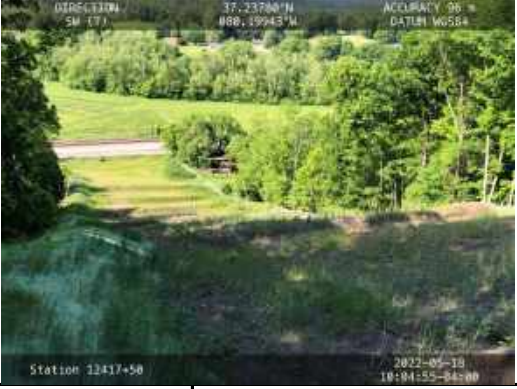
<b>GPS Location</b>	Please see photo for details.		<b>GPS Location</b>	Please see photo for details.	
<b>Field Station#</b>	12410+00		<b>Field Station#</b>	12417+50	
<b>Pic 15 Desc.</b>	Photo shows plunge pool for clean water diversion.		<b>Pic 16 Desc.</b>	Photo shows the stabilized ROW conditions with water bars and that all ECDs are installed and are functioning as designed.

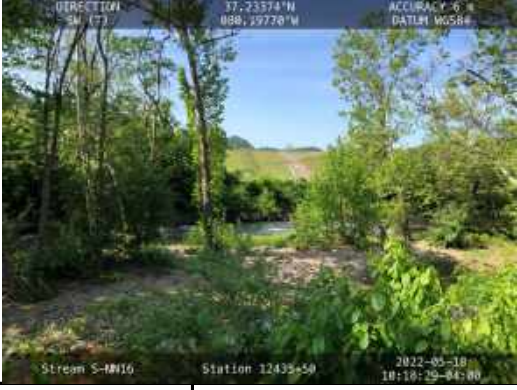
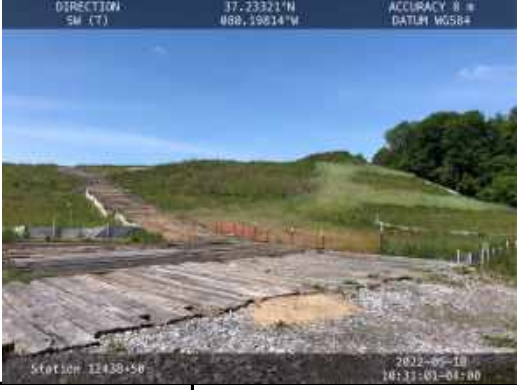
<b>GPS Location</b>	Please see photo for details.		<b>GPS Location</b>	Please see photo for details.	
<b>Field Station#</b>	12435+50		<b>Field Station#</b>	12438+50	
<b>Pic 17 Desc.</b>	Photo shows view of Stream S-NN16 from the coming in side.		<b>Pic 18 Desc.</b>	Photo shows the stabilized ROW conditions with water bars and that all ECDs are installed and are functioning as designed.

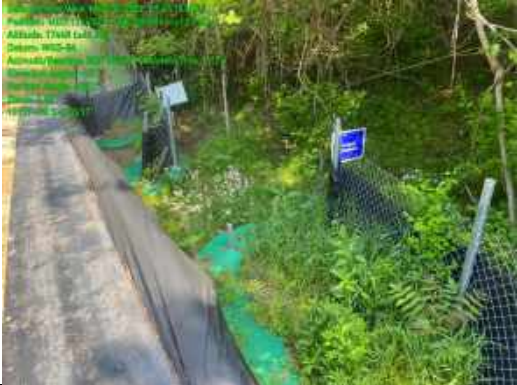
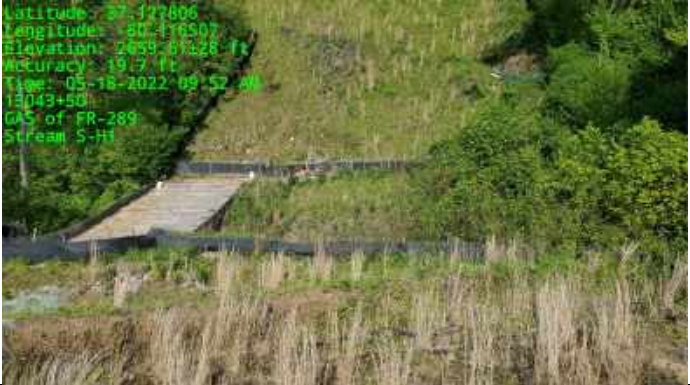
<b>GPS Location</b>	See pic for GPS location.		<b>GPS Location</b>	See pic for GPS location.	
<b>Field Station#</b>	13137+78		<b>Field Station#</b>	13043+50	
<b>Pic 7 Desc.</b>	Upstream side of stream S-D14/17.		<b>Pic 8 Desc.</b>	Stream crossing S-H1 from the GAS.

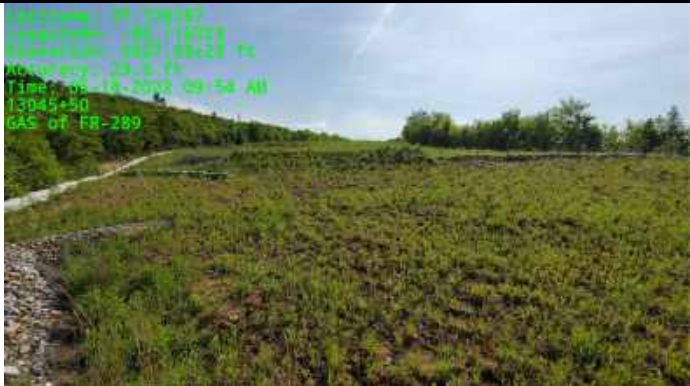
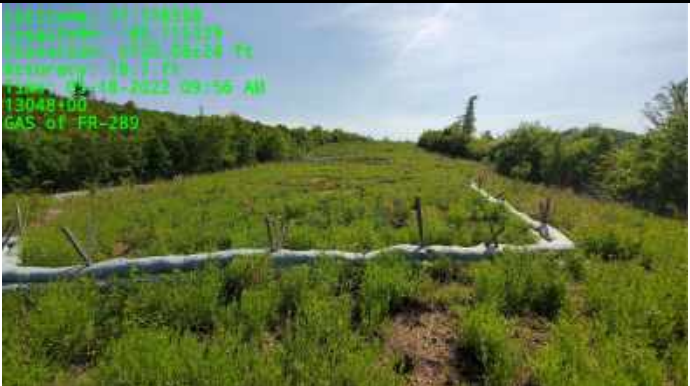
<b>GPS Location</b>	See pic for GPS location.		<b>GPS Location</b>	See pic for GPS location.	
<b>Field Station#</b>	13045+50		<b>Field Station#</b>	13048+00	
<b>Pic 9 Desc.</b>	Current ROW conditions.		<b>Pic 10 Desc.</b>	Current ROW conditions.

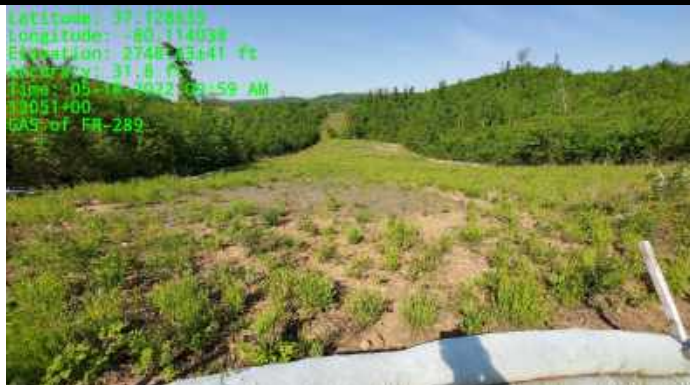
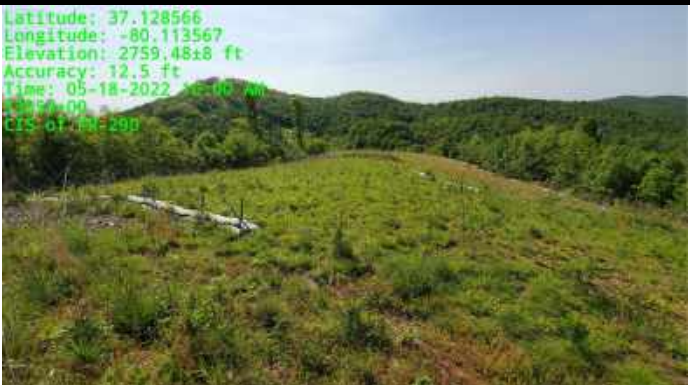
<b>GPS Location</b>	See pic for GPS location.		<b>GPS Location</b>	See pic for GPS location.	
<b>Field Station#</b>	13051+00		<b>Field Station#</b>	13053+00	
<b>Pic 11 Desc.</b>	Current ROW conditions.		<b>Pic 12 Desc.</b>	Current ROW conditions.

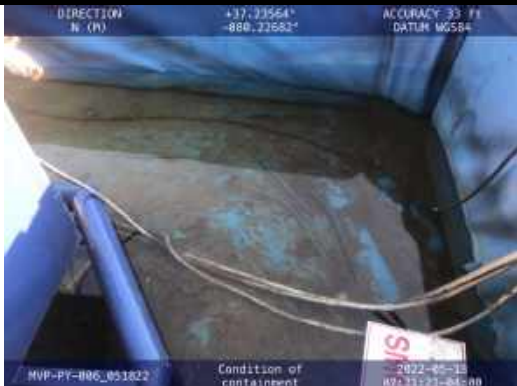
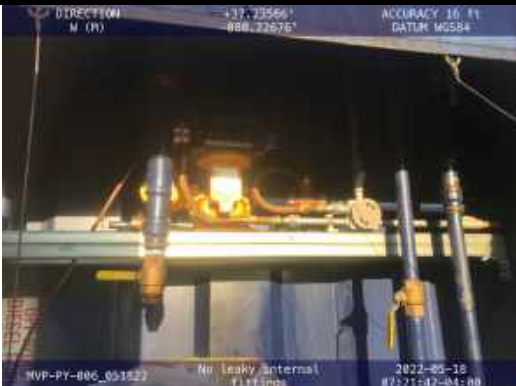
<b>GPS Location</b>	MVP-PY-006 See photo for gps data	<b>GPS Location</b>	MVP-PY-006 See photo for gps data		
<b>Field Station#</b>	+0	<b>Field Station#</b>	+0		
<b>Pic 9 Desc.</b>	Blue Bulk Fuel tanks containment holding stormwater. Looking N.	<b>Pic 10 Desc.</b>	Blue Bulk Fuel tanks no leaky internal fittings. Looking W.

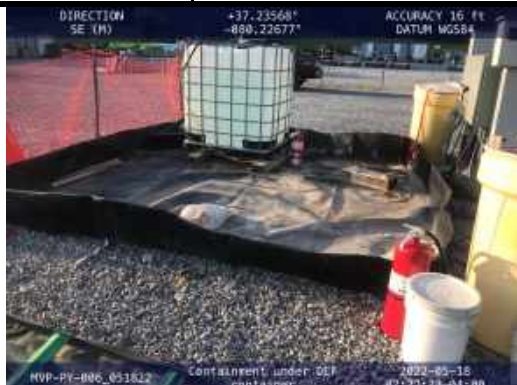
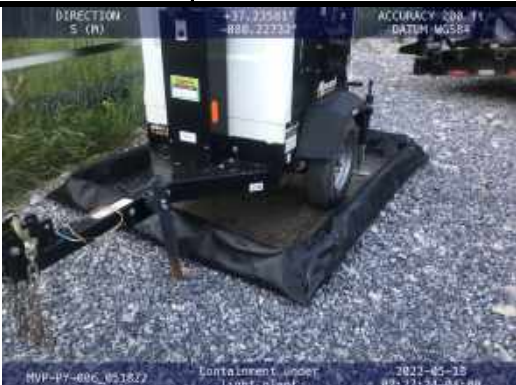
<b>Pic 11 Desc.</b>	Secondary containment under DEF container was free of fluids. Looking SE.	<b>Pic 12 Desc.</b>	Secondary containment under light plant was free of fluids. Looking S.

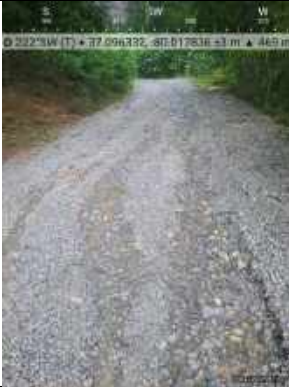
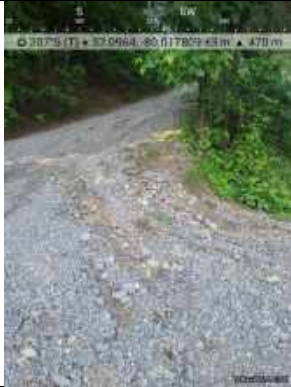
<b>GPS Location</b>	0000	<b>GPS Location</b>	0000		
<b>Field Station#</b>	13437+75	<b>Field Station#</b>	13437+75		
<b>Pic 1 Desc.</b>	Additional photo showing Access rd MVP-FR-293.02 requires maintenance after recent rain events caused some washing. Added to the punch list for repair.		<b>Pic 2 Desc.</b>	Access rd MVP-FR-293.02 requires maintenance after recent rain events caused some washing. Added to the punch list for repair.

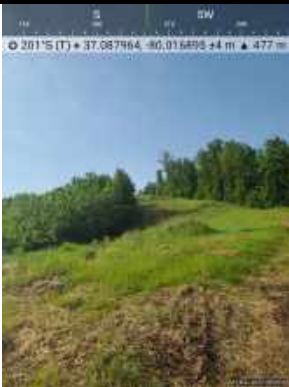
<b>GPS Location</b>	0000	<b>GPS Location</b>	00000		
<b>Field Station#</b>	13451+90	<b>Field Station#</b>	13443+00		
<b>Pic 3 Desc.</b>	Monitored row conditions after recent mowing activities, ECDs in place. No environmental issues observed at the time of inspection.		<b>Pic 4 Desc.</b>	Row photo showing stabilization, water bars and level spreaders in place and functioning.

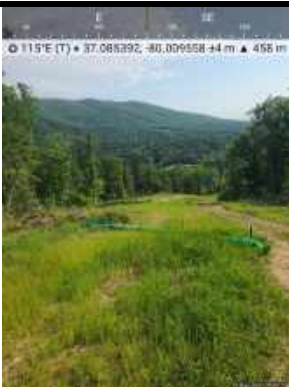
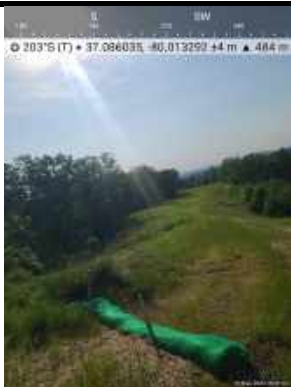
<b>GPS Location</b>	0000	<b>GPS Location</b>	0000		
<b>Field Station#</b>	13480+00	<b>Field Station#</b>	13460+45		
<b>Pic 5 Desc.</b>	Monitored row conditions after recent mowing activities, ECDs in place. No environmental issues observed at the time of inspection.		<b>Pic 6 Desc.</b>	Monitored row conditions after recent mowing activities, ECDs in place. No environmental issues observed at the time of inspection.

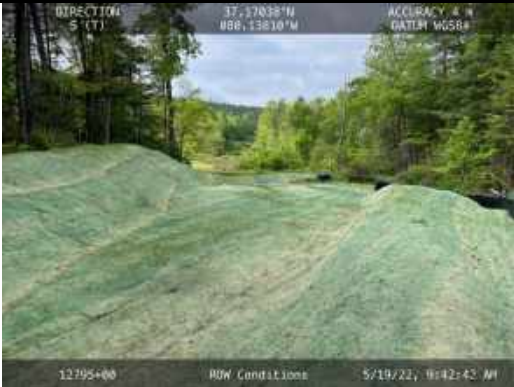
<b>GPS Location</b>	See photo		<b>GPS Location</b>	See photo	
<b>Field Station#</b>	12795+00		<b>Field Station#</b>	12793+71	
<b>Pic 1 Desc.</b>	Current ROW conditions. ROW is stable and ECDs are functional		<b>Pic 2 Desc.</b>	Downstream of crossing at Stream S-IJ82

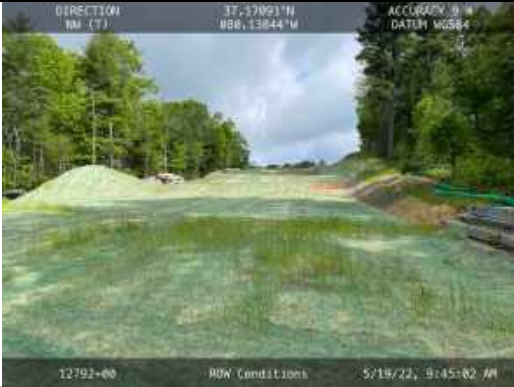
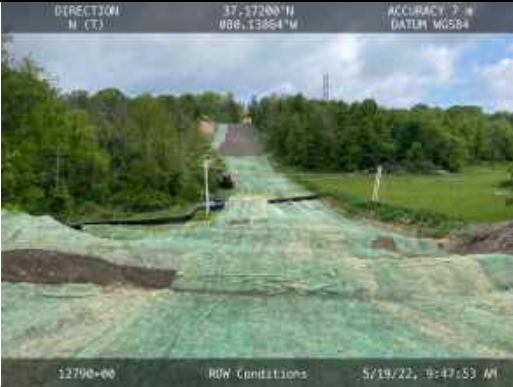
<b>GPS Location</b>	See photo		<b>GPS Location</b>	See photo	
<b>Field Station#</b>	12792+00		<b>Field Station#</b>	12790+00	
<b>Pic 3 Desc.</b>	Current ROW conditions. ROW is stable and ECDs are functional		<b>Pic 4 Desc.</b>	Current ROW conditions. ROW is stable and ECDs are functional

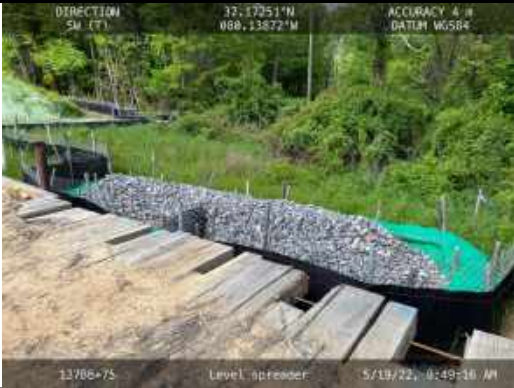
<b>GPS Location</b>	See photo		<b>GPS Location</b>	See photo	
<b>Field Station#</b>	12786+75		<b>Field Station#</b>	12782+00	
<b>Pic 5 Desc.</b>	Level spreader is functional		<b>Pic 6 Desc.</b>	Current ROW conditions. ROW is stable and ECDs are functional

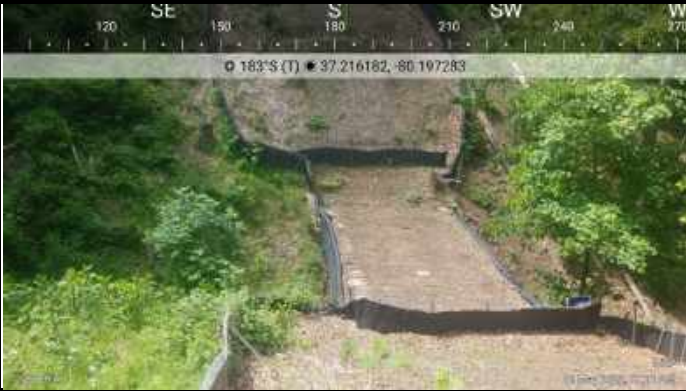
GPS Location	See Above		GPS Location	See Above	
Field Station#	12519+41		Field Station#	12530+00	
Pic 13 Desc.	Overview of Waterbody S-EF19. ECDs are functional and ROW is stable.		Pic 14 Desc.	ROW Overview (temporary stabilization). ECDs are functional and ROW is stable.

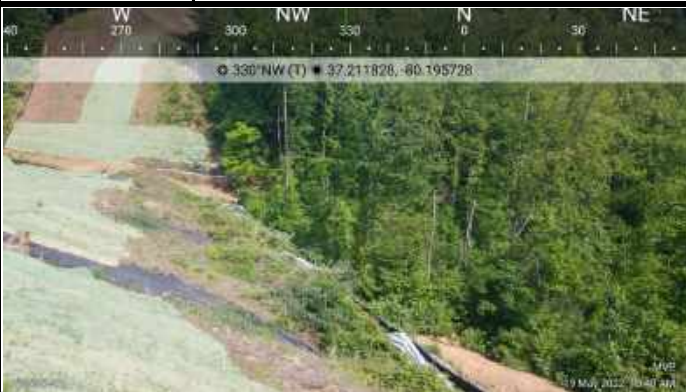
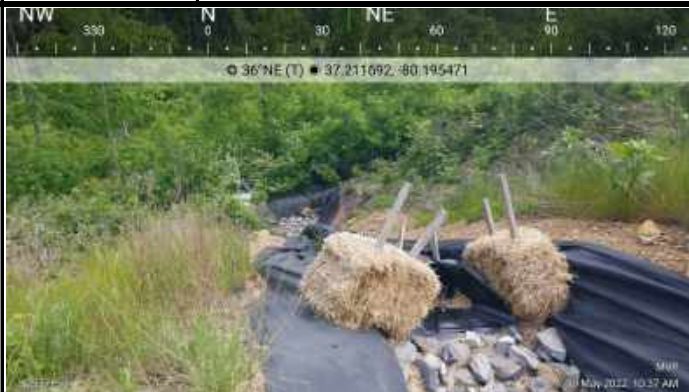
GPS Location	See Above		GPS Location	See Above	
Field Station#	12535+00		Field Station#	12537+50	
Pic 15 Desc.	ROW Overview (temporary stabilization). ECDs are functional and ROW is stable.		Pic 16 Desc.	ROW Overview (temporary stabilization). ECDs are functional and ROW is stable.

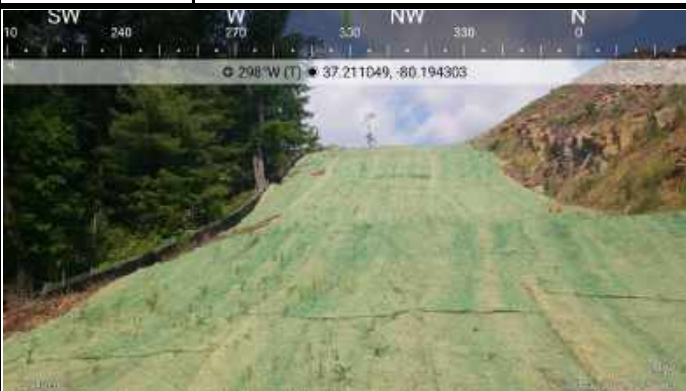
GPS Location	See Above		GPS Location	See Above	
Field Station#	12540+00		Field Station#	12544+06	
Pic 17 Desc.	ROW Overview (temporary stabilization). ECDs are functional and ROW is stable.		Pic 18 Desc.	ECDs are functional and Access road MN-278.01 (Yellow Finch Lane) area is stable.

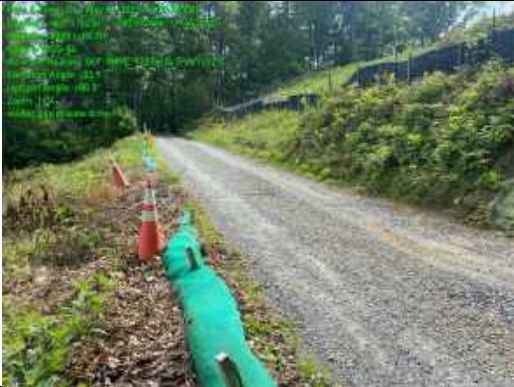
<b>GPS Location</b>	See photo for coordinates.		<b>GPS Location</b>	See photo for coordinates.	
<b>Field Station#</b>	13317+02		<b>Field Station#</b>	13319+66	
<b>Pic 1 Desc.</b>	Private drive in acceptable condition.		<b>Pic 2 Desc.</b>	Right of way stabilized.

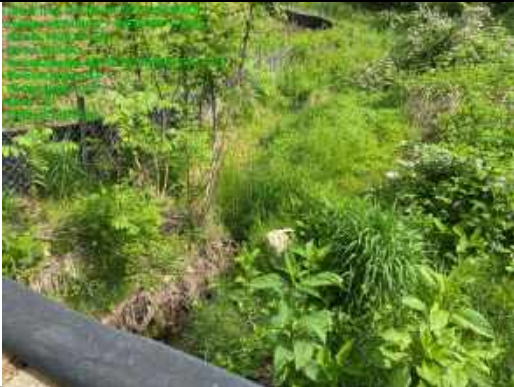
<b>GPS Location</b>	See photo for coordinates.		<b>GPS Location</b>	See photo for coordinates.	
<b>Field Station#</b>	13321+47		<b>Field Station#</b>	13321+47	
<b>Pic 3 Desc.</b>	S-GH15, upstream, no turbidity noted, bank erosion noted upstream of equipment bridge.		<b>Pic 4 Desc.</b>	S-GH15, downstream, no turbidity noted.

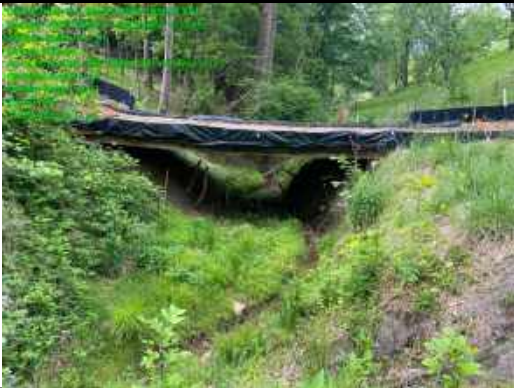
<b>GPS Location</b>	See photo for coordinates.		<b>GPS Location</b>	See photo for coordinates.	
<b>Field Station#</b>	13325+30		<b>Field Station#</b>	13323+43	
<b>Pic 5 Desc.</b>	S-GH14, upstream, looking downstream; no changes noted along stream banks.		<b>Pic 6 Desc.</b>	Right of way stabilized.

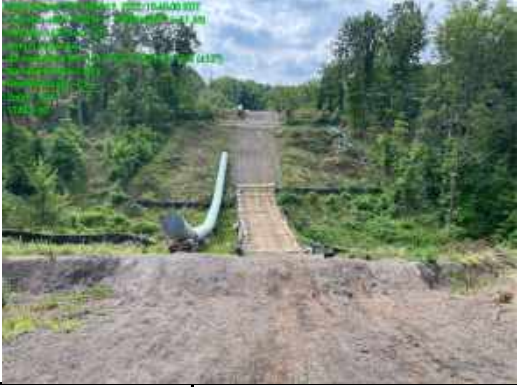
<b>GPS Location</b>	See photo for coordinates.		<b>GPS Location</b>	See photo for coordinates.	
<b>Field Station#</b>	13353+00		<b>Field Station#</b>	13358+64	
<b>Pic 13 Desc.</b>	Right of way stabilized.		<b>Pic 14 Desc.</b>	S-RR11, right of way stabilized, perimeter controls in acceptable condition.

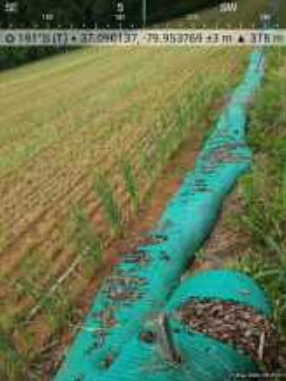
<b>GPS Location</b>	00000	<b>GPS Location</b>	0000		
<b>Field Station#</b>	13649+00	<b>Field Station#</b>	13526+15		
<b>Pic 1 Desc.</b>	CFS needs replaced due to land owner damages , documented and added to the punch list for repair.		<b>Pic 2 Desc.</b>	Monitored CFS at Private drive crossing during routine inspection. No environmental issues observed at the time of inspection.

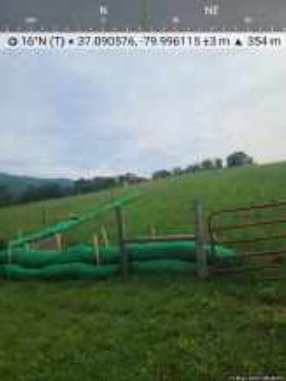
<b>GPS Location</b>	0000	<b>GPS Location</b>	0000		
<b>Field Station#</b>	13526+15	<b>Field Station#</b>	13543+40		
<b>Pic 3 Desc.</b>	Monitored CFS at Private drive crossing during routine inspection. No environmental issues observed at the time of inspection.		<b>Pic 4 Desc.</b>	Row photo showing permanent area of row where a land owner has mowed inside the LOD.

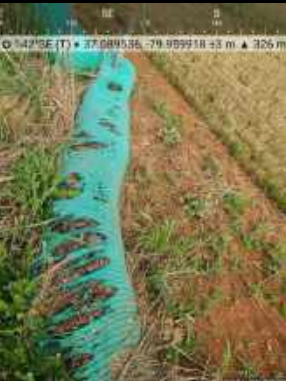
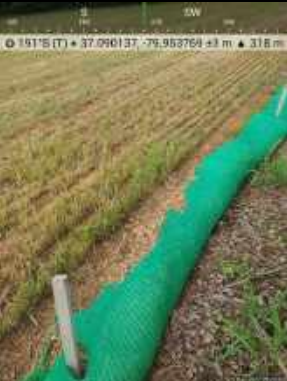
<b>Field Station#</b>	13654+00	<b>Field Station#</b>	13644+00		
<b>Pic 5 Desc.</b>	CFS needs replaced due to land owner damage. Documented and added to the punch list.		<b>Pic 6 Desc.</b>	CFS needs replaced due to land owner damage. Documented and added to the punch list.

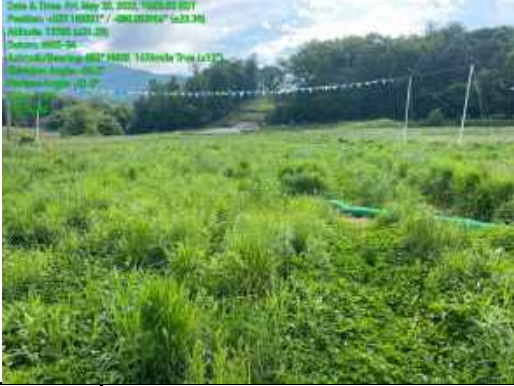
<b>GPS Location</b>	0	<b>GPS Location</b>	0		
<b>Field Station#</b>	13310+00	<b>Field Station#</b>	13309+09		
<b>Pic 1 Desc.</b>	ROW and ECDs In good condition and stable		<b>Pic 2 Desc.</b>	MVP-S-GH7 and corresponding buffer zone in good condition

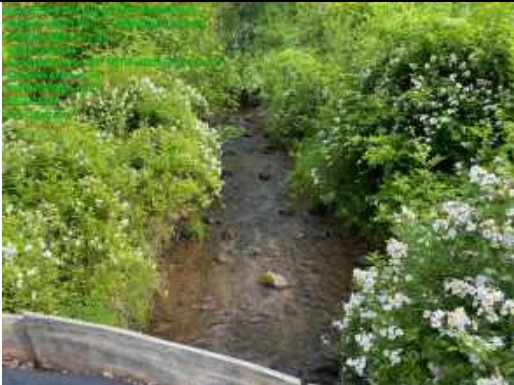
<b>GPS Location</b>	0	<b>GPS Location</b>	0		
<b>Field Station#</b>	13260+66	<b>Field Station#</b>	13261+00		
<b>Pic 3 Desc.</b>	MVP-S-II4 and corresponding buffer zone in good condition		<b>Pic 4 Desc.</b>	ROW and ECDs In good condition and stable

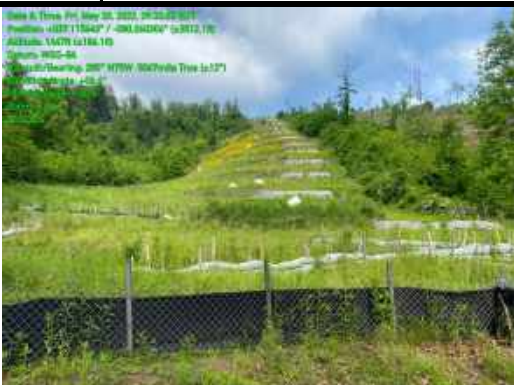
<b>GPS Location</b>	0	<b>GPS Location</b>	0		
<b>Field Station#</b>	13259+00	<b>Field Station#</b>	13196+31		
<b>Pic 5 Desc.</b>	ROW and ECDs In good condition and stable		<b>Pic 6 Desc.</b>	MVP-S-D10 and corresponding buffer zone in good condition

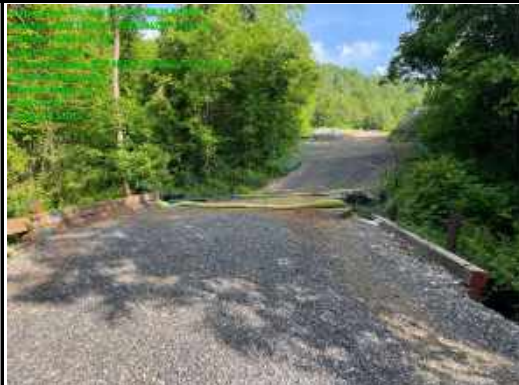
GPS Location	0		GPS Location	0	
Field Station#	13144+00		Field Station#	13141+53	
Pic 17 Desc.	ROW and ECDs In good condition and stable		Pic 18 Desc.	MVP-S-D14 and corresponding buffer zone in good condition

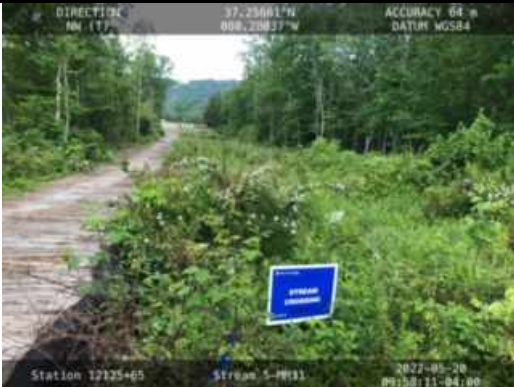
<b>GPS Location</b>	See Above		<b>GPS Location</b>	See Above	
<b>Field Station#</b>	12125+65		<b>Field Station#</b>	12132+73	
<b>Pic 1 Desc.</b>	Overview of Waterbody S-MM31. ECDs functional and in good condition.		<b>Pic 2 Desc.</b>	Overview of Waterbody S-C29. ECDs functional and in good condition.

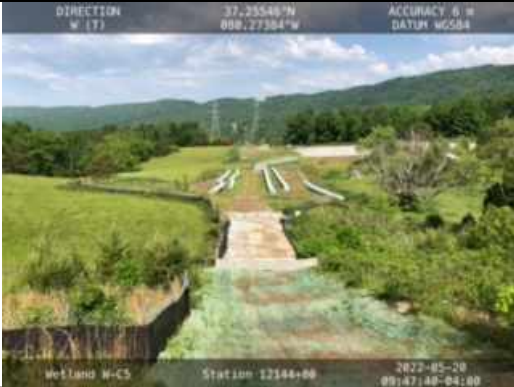
<b>GPS Location</b>	See Above		<b>GPS Location</b>	See Above	
<b>Field Station#</b>	12144+00		<b>Field Station#</b>	12158+50	
<b>Pic 3 Desc.</b>	Overview of Wetland W-C5. ECDs functional and in good condition.		<b>Pic 4 Desc.</b>	ROW Overview. ECDs functional and in good condition and ROW is stable.

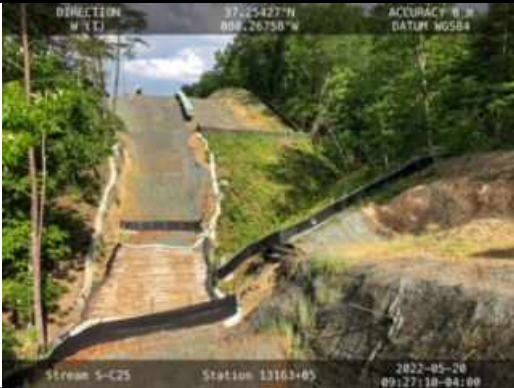
<b>GPS Location</b>	See Above		<b>GPS Location</b>	See Above	
<b>Field Station#</b>	12163+05		<b>Field Station#</b>	12166+47	
<b>Pic 5 Desc.</b>	Overview of Waterbody S-C25. ECDs functional and in good condition.		<b>Pic 6 Desc.</b>	Overview of Waterbody S-C24. ECDs functional and in good condition.
