# Visual Site Inspection Report

<b>Project Name</b>	H-600 Pipeline Spread H	<b>AFE</b>	124300138	<b>Spread</b>	H-600 Pipeline Spread H
<b>Contractor</b>	Precision	<b>Report #</b>	38425		
<b>Inspector</b>	Pat Davis	<b>Date/Time</b>	6/6/2022 4:00 PM		
<b>Permit #</b>	TBD	<b>Inspection Type</b>	VA SWPP	<b>Station Begin</b>	+0
<b>State</b>	VA	<b>Inspection Area</b>	Partial	<b>Station End</b>	+0
<b>County</b>	Montgomery	<b>Ground</b>	Dry	<b>Temperature (°F)</b>	65.00
<b>Municipality</b>	N/A	<b>Weather</b>	Sunny	<b>Rain Gauge (in)</b>	0.00
				<b>Rain Accumulation Time (days)</b>	0.00

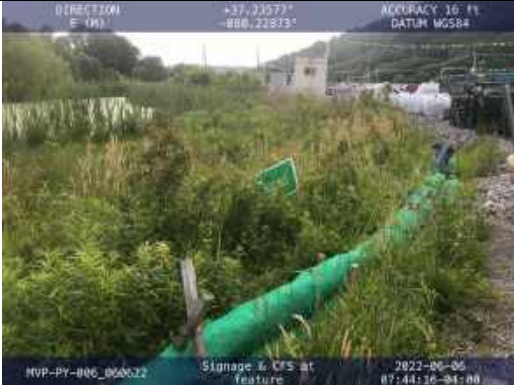
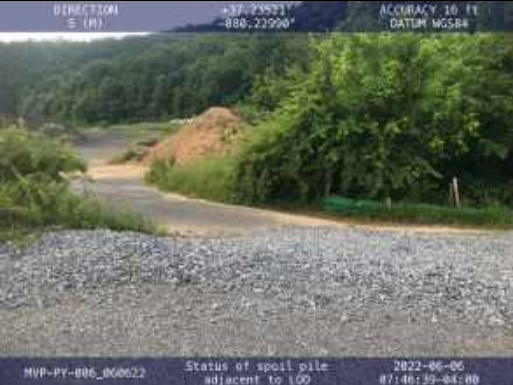
<b>GPS Location</b>	MVP-PY-006 See photo for gps data	<b>GPS Location</b>	MVP-PY-006 See photo for gps data		
<b>Field Station#</b>	+0	<b>Field Station#</b>	+0		
<b>Pic 1 Desc.</b>	Signage and triple stack compost filter sock at feature W-008. Looking E.		<b>Pic 2 Desc.</b>	Status of spoil pile adjacent to LOD. Soil pile not stabilized. Looking S.

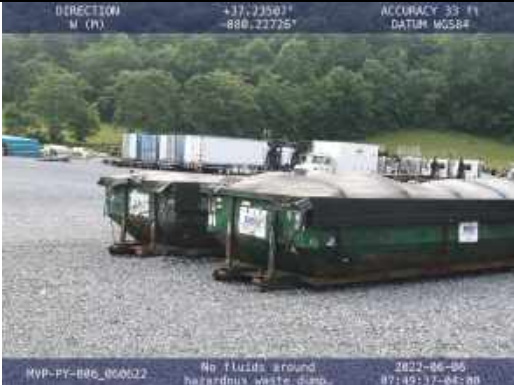
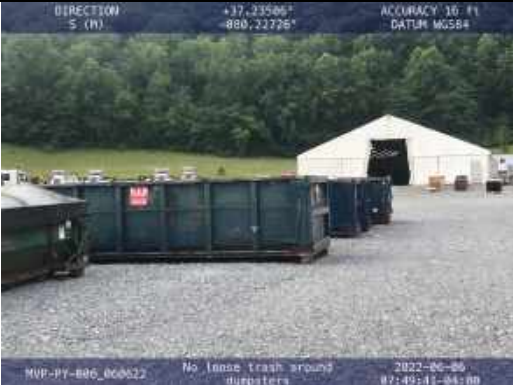
<b>GPS Location</b>	MVP-PY-006 See photo for gps data	<b>GPS Location</b>	MVP-PY-006 See photo for gps data		
<b>Field Station#</b>	+0	<b>Field Station#</b>	+0		
<b>Pic 3 Desc.</b>	No fluids or deposits around hazardous waste dumpsters. Looking SE.		<b>Pic 4 Desc.</b>	No loose trash around dumpsters or in the yard. Looking S.

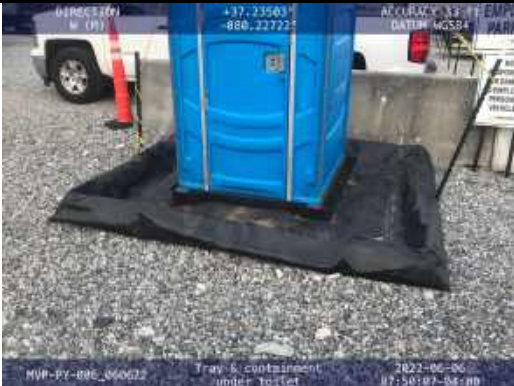
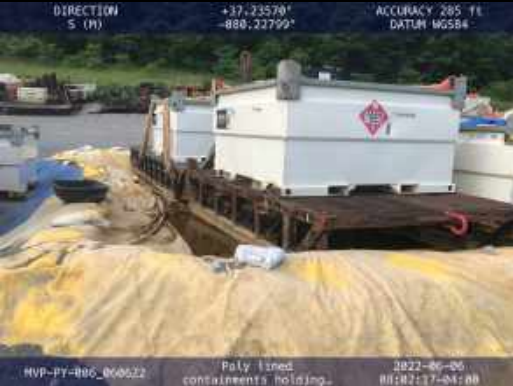
<b>Field Station#</b>	+0	<b>Field Station#</b>	+0		
<b>Pic 5 Desc.</b>	Tray & containment under toilet. Tray holding fluids. Looking W.		<b>Pic 6 Desc.</b>	Poly lined rock berm containments hold stormwater. Looking S.

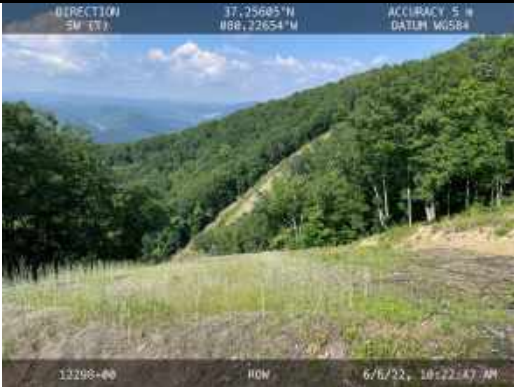
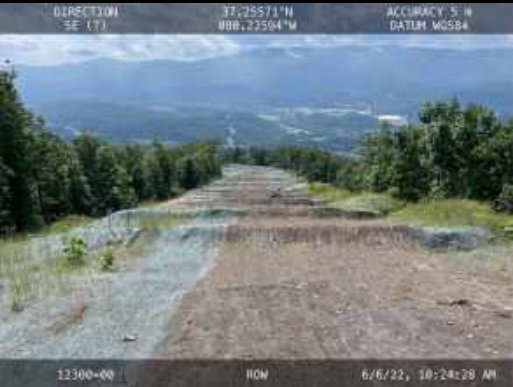
<b>GPS Location</b>	Please see photo for details.		<b>GPS Location</b>	Please see photo for details.	
<b>Field Station#</b>	12298+00		<b>Field Station#</b>	12300+00	
<b>Pic 1 Desc.</b>	Photo shows the stabilized ROW conditions with waterbars and that all ECDs are installed and are functioning as designed.		<b>Pic 2 Desc.</b>	Photo shows the stabilized ROW conditions with waterbars and that all ECDs are installed and are functioning as designed.

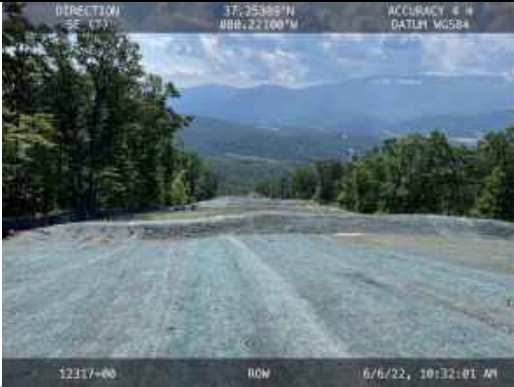
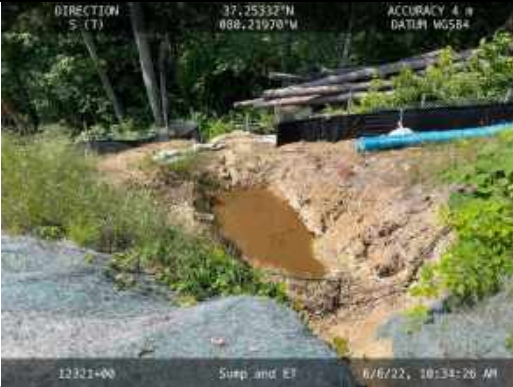
<b>GPS Location</b>	Please see photo for details.		<b>GPS Location</b>	Please see photo for details.	
<b>Field Station#</b>	12317+00		<b>Field Station#</b>	12321+00	
<b>Pic 3 Desc.</b>	Photo shows the stabilized ROW conditions with waterbars and that all ECDs are installed and are functioning as designed.		<b>Pic 4 Desc.</b>	Photo shows sump with standing water along with end treatment.

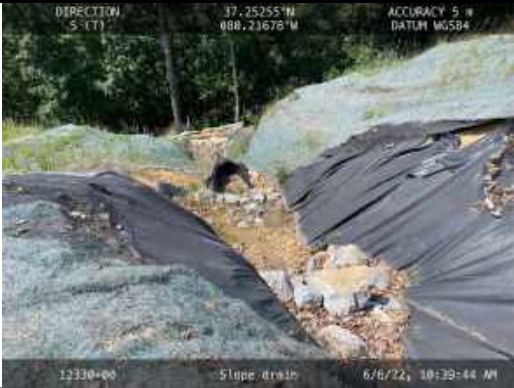
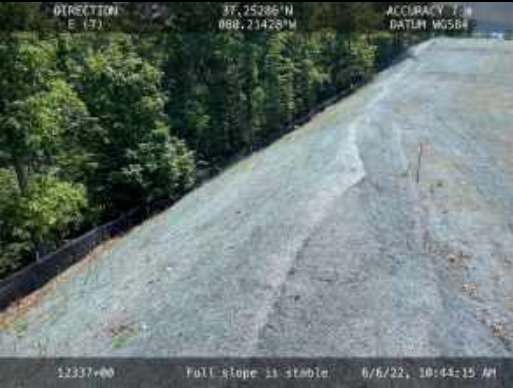
<b>GPS Location</b>	Please see photo for details.		<b>GPS Location</b>	Please see photo for details.	
<b>Field Station#</b>	12330+00		<b>Field Station#</b>	12337+00	
<b>Pic 5 Desc.</b>	Photo shows slope drain pipe inlet with stone inlet protection.		<b>Pic 6 Desc.</b>	Photo shows the stabilized ROW conditions with waterbars and that all ECDs are installed and are functioning as designed.

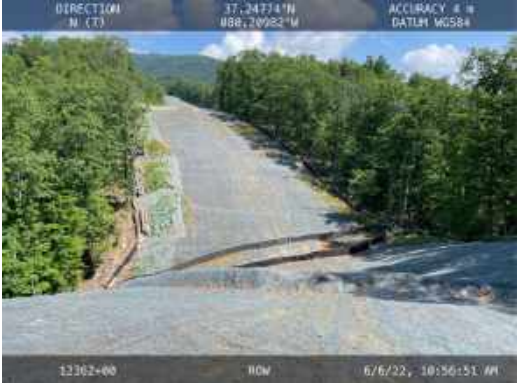
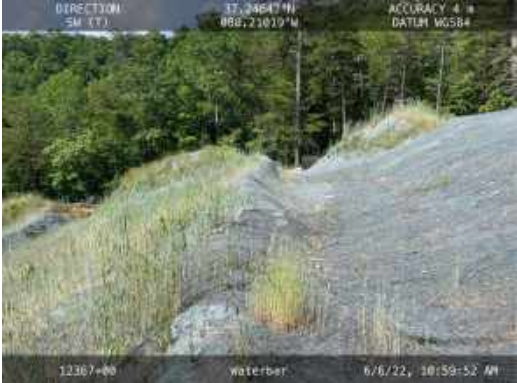
<b>GPS Location</b>	Please see photo for details.		<b>GPS Location</b>	Please see photo for details.	
<b>Field Station#</b>	12362+00		<b>Field Station#</b>	12367+00	
<b>Pic 7 Desc.</b>	Photo shows the stabilized ROW conditions with waterbars and that all ECDs are installed and are functioning as designed.		<b>Pic 8 Desc.</b>	Photo shows the stabilized ROW conditions with waterbars and that all ECDs are installed and are functioning as designed.

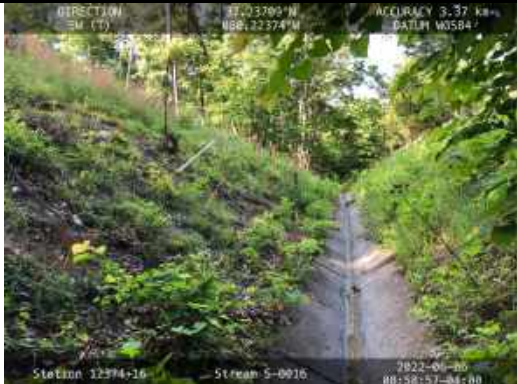
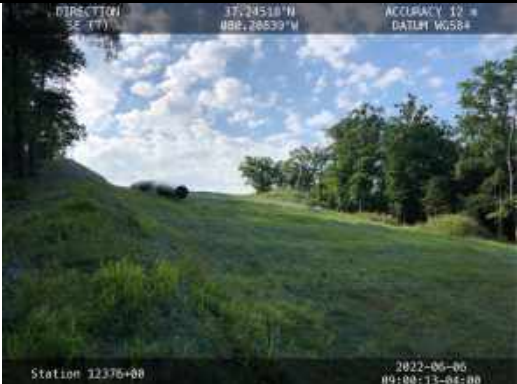
<b>GPS Location</b>	Please see photo for details.		<b>GPS Location</b>	Please see photo for details.	
<b>Field Station#</b>	12374+16		<b>Field Station#</b>	12376+00	
<b>Pic 9 Desc.</b>	Photo shows upstream view of Stream S-0016.		<b>Pic 10 Desc.</b>	Photo shows the stabilized ROW conditions with waterbars and that all ECDs are installed and are functioning as designed.

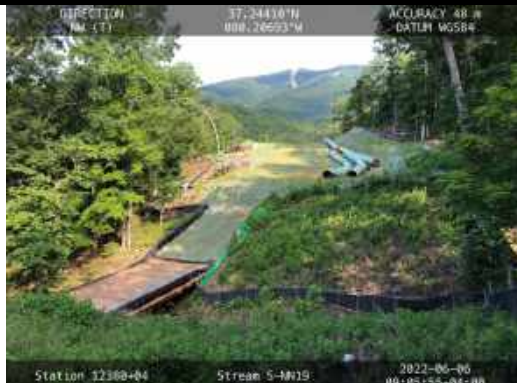
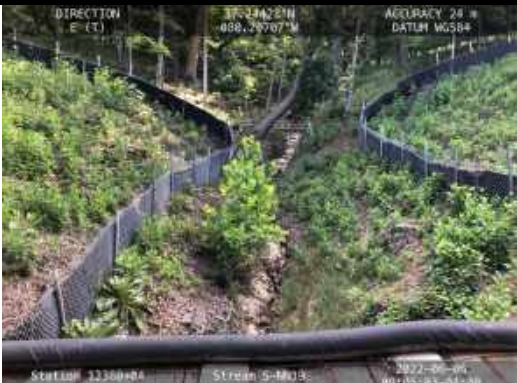
<b>GPS Location</b>	Please see photo for details.		<b>GPS Location</b>	Please see photo for details.	
<b>Field Station#</b>	12380+04		<b>Field Station#</b>	12380+04	
<b>Pic 11 Desc.</b>	Photo shows overview of Stream S-NN19 and its buffer zone from the going away side.		<b>Pic 12 Desc.</b>	Photo shows upstream view of Stream S-NN19 from the equipment bridge spanning the stream channel.

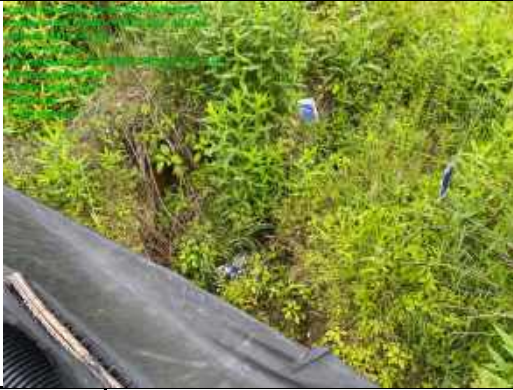
<b>GPS Location</b>	See photo for coordinates.		<b>GPS Location</b>	See photo for coordinates.	
<b>Field Station#</b>	13024+06		<b>Field Station#</b>	13024+06	
<b>Pic 1 Desc.</b>	S-G24, upstream, UTV disturbance noted.		<b>Pic 2 Desc.</b>	S-G24, upstream, water entering delineated stream channel just upstream of bridge.

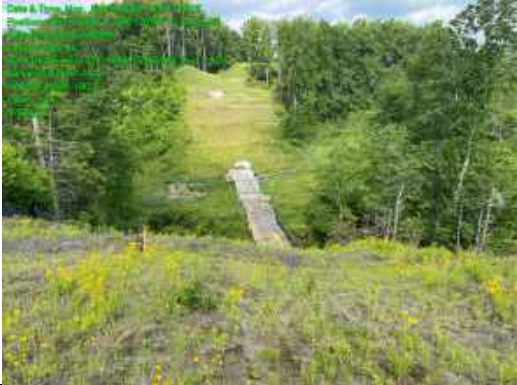
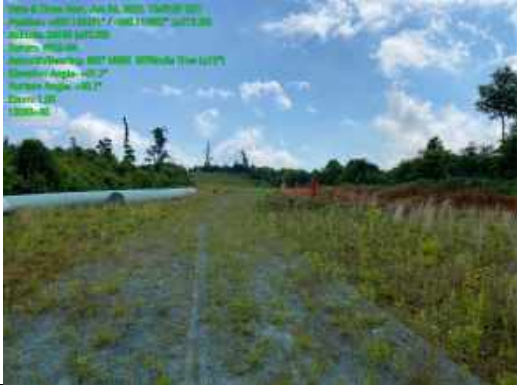
<b>GPS Location</b>	See photo for coordinates.		<b>GPS Location</b>	See photo for coordinates.	
<b>Field Station#</b>	13024+06		<b>Field Station#</b>	13030+00	
<b>Pic 7 Desc.</b>	S-G24 and S-G25, right of way stabilized.		<b>Pic 8 Desc.</b>	Right of way stabilized.

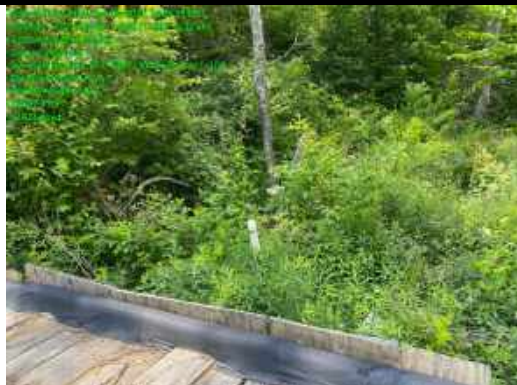
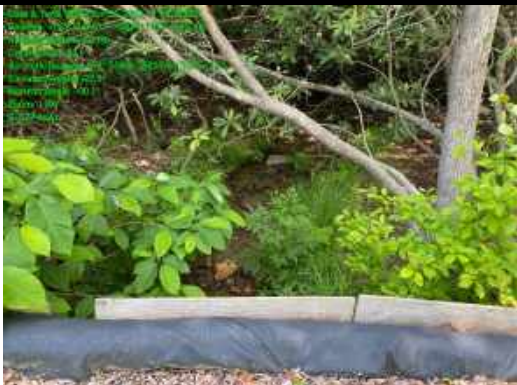
<b>GPS Location</b>	See photo for coordinates.		<b>GPS Location</b>	See photo for coordinates.	
<b>Field Station#</b>	13061+89		<b>Field Station#</b>	13062+96	
<b>Pic 11 Desc.</b>	S-G26, downstream, banks well vegetated.		<b>Pic 12 Desc.</b>	S-G27, downstream, no turbidity noted.

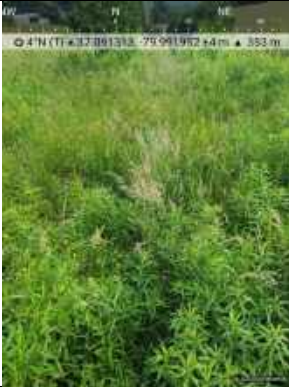
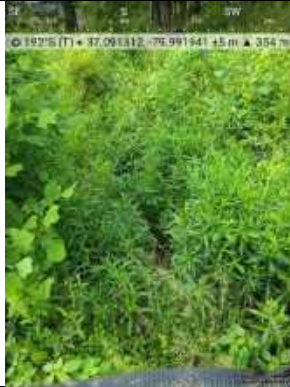
<b>GPS Location</b>	0000	<b>GPS Location</b>	0000		
<b>Field Station#</b>	13539+14	<b>Field Station#</b>	13539+14		
<b>Pic 1 Desc.</b>	Stream observation photo facing upstream during routine inspection, no issues observed at the time of inspection.		<b>Pic 2 Desc.</b>	Stream observation photo facing downstream during routine inspection today. No issues observed at the time of inspection.

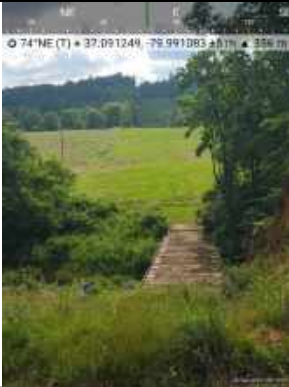
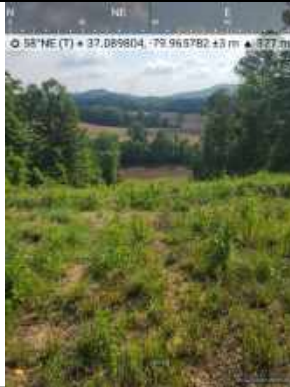
<b>GPS Location</b>	0000	<b>GPS Location</b>	000		
<b>Field Station#</b>	13541+54	<b>Field Station#</b>	13628+22		
<b>Pic 3 Desc.</b>	Row photo showing equipment bridge in place, good stabilization noted up hill from the stream crossing.		<b>Pic 4 Desc.</b>	Row photo showing area where recent mowing activities were done during the approved time. No environmental issues observed at the time of inspection.

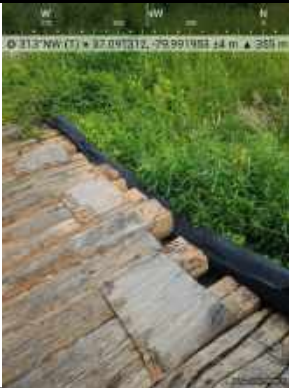
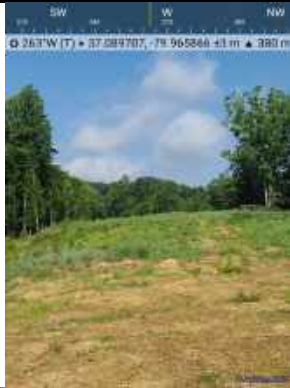
<b>GPS Location</b>	0000	<b>GPS Location</b>	000		
<b>Field Station#</b>	13539+14	<b>Field Station#</b>	13626+00		
<b>Pic 5 Desc.</b>	Splash protection on equipment bridge requires maintenance, documented and added to the punch list for repair.		<b>Pic 6 Desc.</b>	Row photo showing area where recent mowing activities were done during the approved time. No environmental issues observed at the time of inspection.

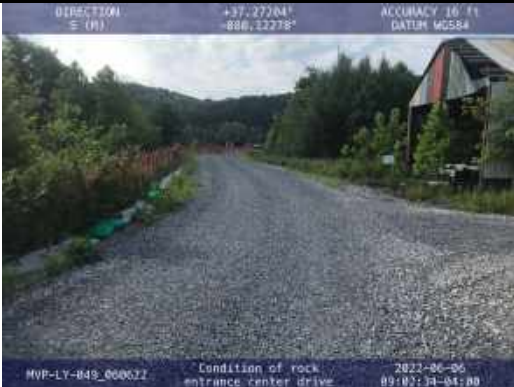
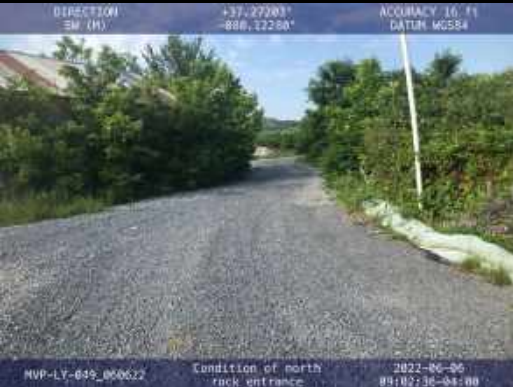
(Summary Spread 10) EI preformed SWPPP Inspection on Yard MVP-LY-049 Check raingauge and found 0 rainfall. Both rock entrances had no sediment of debris on the stone. The rock entrance on the center drive has had smaller stone applied over larger stone. EI continues to monitor the landowner has disturbed a soil pile along the compost filter sock. The area has not been stabilized. No new damage to the installed ECD's. The landowner has cleared brush and opened a soil pile along the edge of feature W-CV21A. The area is not stabilized. The soil pile is not project related however it is on property the project has rented. The landowner has disturbed two areas approximately 60 feet and 120 feet west of the feature W-CV21B. No impacts to feature. These areas are not stabilized. The landowner has disturbed soil and debris piled next to the compost filter sock and east of feature W-CV21B. The area has not been stabilized. No fluids or debris were found around the hazardous waste dumpster. No loose trash noted around the north dumpster or in the yard. EI inspected the area around the temporary trash transfer pit, was holding debris. EI observed no debris around the metal only dumpster. The compost filter sock was in place and functioning around the sand pile. EI inspected the area around and under the equipment stored in the yard for leaks. No new leaks found. EI inspected the area around the stored trucks and trailers for new leaks. No new leaks found. The restoration supplies were under cover. The trays and containments under the toilets, trays were holding fluids. EI checked the boundary of the LOD and found the triple stack compost filter sock and the safety fence, triple stack compost filter sock was functioning, and is being over grown with vegetation. Check the condition of the posted project documents at the entrance. No other environmental issues were noted during todays inspection.

<b>GPS Location</b>	MVP-LY-049 See photo for gps data	<b>GPS Location</b>	MVP-LY-049 See photo for gps data		
<b>Field Station#</b>	+0	<b>Field Station#</b>	+0		
<b>Pic 1 Desc.</b>	Condition of rock entrance on center drive. Larger stone has been covered with smaller stone. Looking S.	<b>Pic 2 Desc.</b>	Condition of rock entrance on the north entrance. No sediment or debris on stone. Looking SW.

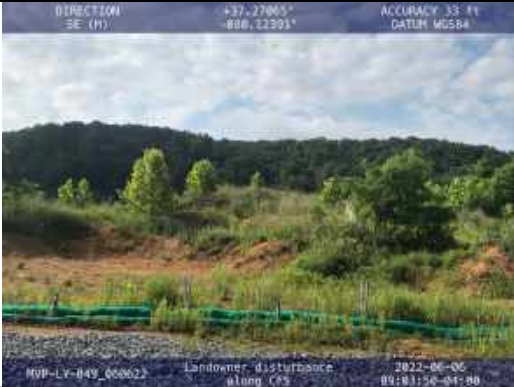
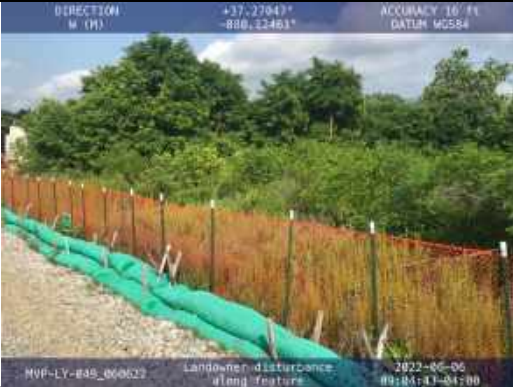
<b>GPS Location</b>	MVP-LY-049 See photo for gps data	<b>GPS Location</b>	MVP-LY-049 See photo for gps data		
<b>Field Station#</b>	+0	<b>Field Station#</b>	+0		
<b>Pic 3 Desc.</b>	Landowner soil disturbance along compost filter sock. Area not stabilized. Looking SE.	<b>Pic 4 Desc.</b>	Landowner soil disturbance along feature W-CV21A. Area not stabilized. Looking W.

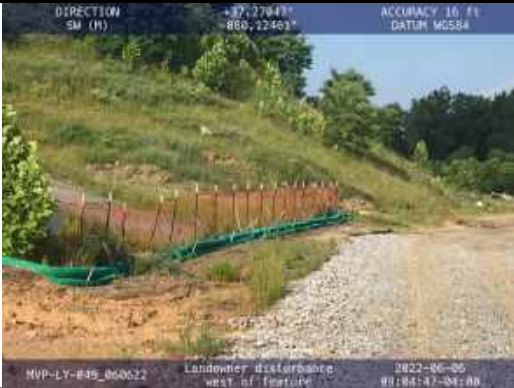
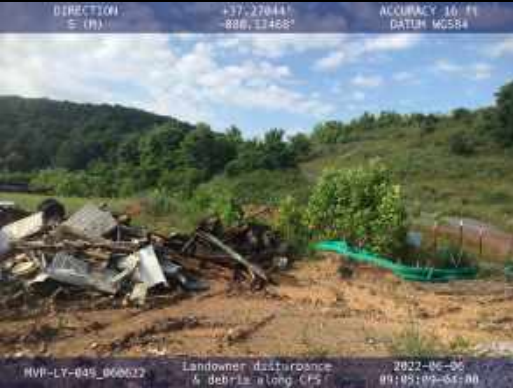
<b>Field Station#</b>	+0	<b>Field Station#</b>	+0		
<b>Pic 5 Desc.</b>	Landowner disturbance west of feature W-CV21B. Areas not stabilized. Looking SW.	<b>Pic 6 Desc.</b>	Landowner soil disturbance and debris piled along triple stack compost filter sock and east of feature W-CV21B. Looking S.

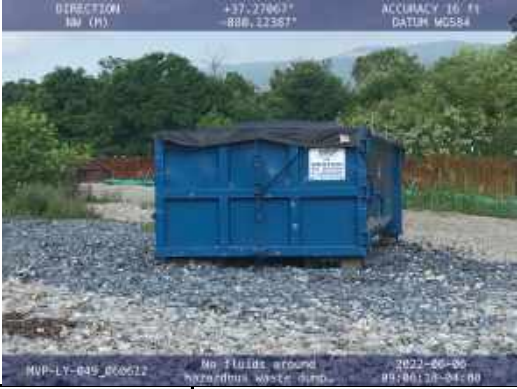
<b>GPS Location</b>	MVP-LY-049 See photo for gps data		<b>GPS Location</b>	MVP-LY-049 See photo for gps data	
<b>Field Station#</b>	+0		<b>Field Station#</b>	+0	
<b>Pic 7 Desc.</b>	No fluids or deposits around hazardous waste dumpster. Looking NW.		<b>Pic 8 Desc.</b>	No loose trash around north dumpster or in the yard. Looking W.

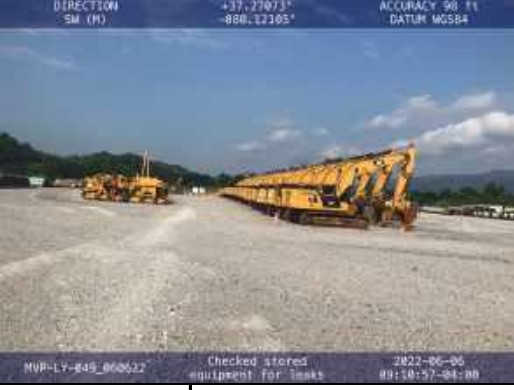
<b>GPS Location</b>	MVP-LY-049 See photo for gps data		<b>GPS Location</b>	MVP-LY-049 See photo for gps data	
<b>Field Station#</b>	+0		<b>Field Station#</b>	+0	
<b>Pic 11 Desc.</b>	Compost filter sock in place and functioning around sand pile. Looking W.		<b>Pic 12 Desc.</b>	Checked stored equipment for new leaks. No new leaks noted. Looking SW.

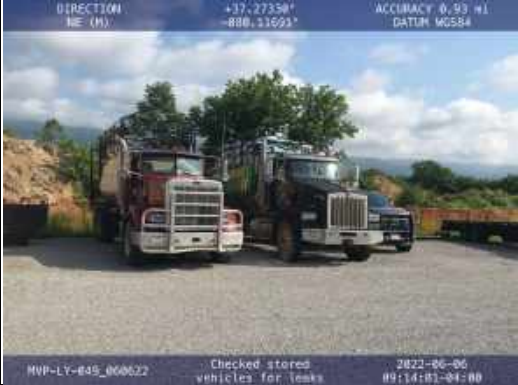
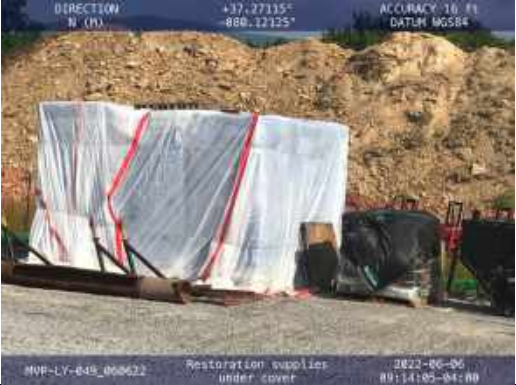
<b>GPS Location</b>	MVP-LY-049 See photo for gps data		<b>GPS Location</b>	MVP-LY-049 See photo for gps data	
<b>Field Station#</b>	+0		<b>Field Station#</b>	+0	
<b>Pic 13 Desc.</b>	Checked stored vehicles for new leaks. No new leaks noted. Looking NE.		<b>Pic 14 Desc.</b>	Restoration supplies under cover. Looking N.

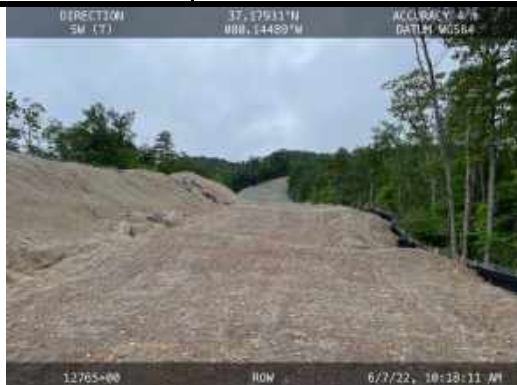
<b>GPS Location</b>	See photo		<b>GPS Location</b>	See photo	
<b>Field Station#</b>	12743+84		<b>Field Station#</b>	12744+00	
<b>Pic 9 Desc.</b>	Downstream of crossing at Stream S-EF34B		<b>Pic 10 Desc.</b>	Current ROW conditions. ROW is stable and ECDs are functional.

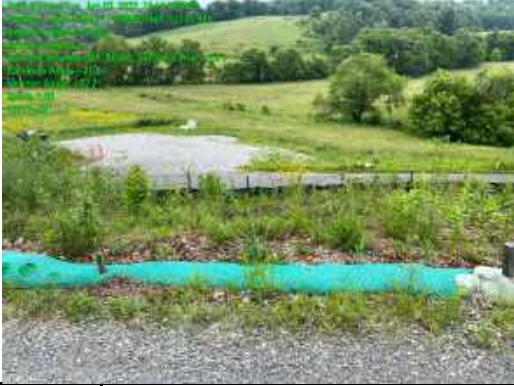
<b>GPS Location</b>	0	<b>GPS Location</b>	0		
<b>Field Station#</b>	13317+02	<b>Field Station#</b>	13320+00		
<b>Pic 1 Desc.</b>	Wades Gap Road Crossing in good condition	<b>Pic 2 Desc.</b>	MVP-S-GH15 and corresponding buffer zone In good condition

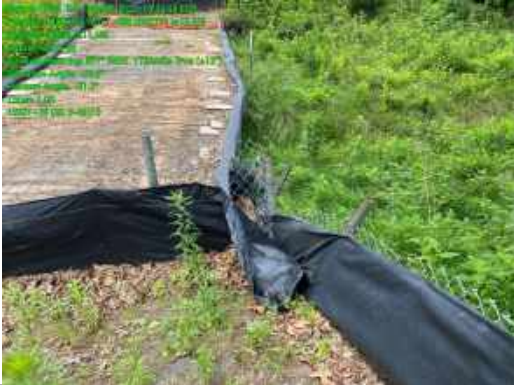
<b>A/E</b>	124300138	<b>Date/Time</b>	6/7/2022 2:19 PM	<b>Report #</b>	38481
<b>6. PCSM BMPs</b> (List BMPs and note if installed and maintained as per the plan. If corrective action is needed, a picture is required.)					
<b>PCSM BMPs</b>	<b>Compliance Level</b>	<b>Corrective Action</b>	<b>Corrective Time Frame</b>	<b>Date Repaired</b>	
<b>7. Identify all remedial measures that have been taken since the previous inspection was conducted.</b>					
<b>Comments</b> (Reference above questions as appropriate.)					
<p>A SWPPP inspection was performed from Wade's Gap Road Crossing to Cahas Mountain Road Crossing, Station 13316+21 to 13422+00. Included in today's inspection were streams S-GH15, S-GH14, S-GH11 S-GH9, S-RR08, S-RR09, S-RR11, S-IJ1, W-IJ1, S-IJ2, W-IJ2, and S-IJ3. No impacts were observed at any of these streams or their corresponding buffer zones. Private driveways at Sta. No. 13317+02 and Sta. No. 13355+28 (Gun Club) were both in acceptable condition. No off ROW impacts were observed and no other additional environmental concerns were noted during this inspection period</p> <p>One 72 hour maintenance item was observed and punch listed, repair SSF fabric, and completed.</p>

<b>GPS Location</b>	0	<b>GPS Location</b>	0		
<b>Field Station#</b>	13321+25	<b>Field Station#</b>	13321+25		
<b>Pic 3 Desc.</b>	Repair SSF fabric, 72 hour punch list item	<b>Pic 4 Desc.</b>	Punch list item repaired same day and in good condition

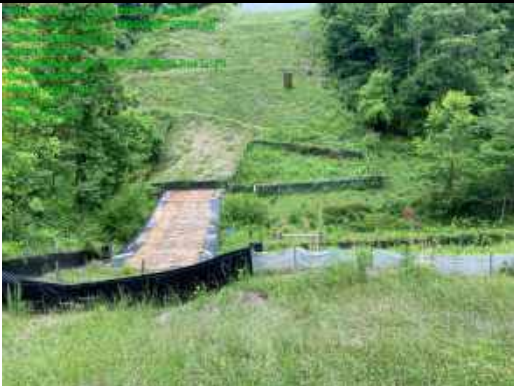
<b>GPS Location</b>	0	<b>GPS Location</b>	0		
<b>Field Station#</b>	13334+17	<b>Field Station#</b>	13337+13		
<b>Pic 5 Desc.</b>	MVP-S-GH11 and corresponding buffer zone In good condition	<b>Pic 6 Desc.</b>	MVP-S-GH9 and corresponding buffer zone In good condition

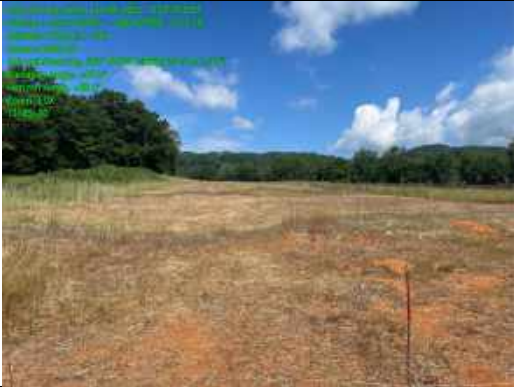
<b>GPS Location</b>	0	<b>GPS Location</b>	0		
<b>Field Station#</b>	13185+00	<b>Field Station#</b>	13175+00		
<b>Pic 1 Desc.</b>	ROW and ECDs In good condition and stable	<b>Pic 2 Desc.</b>	ROW and ECDs In good condition and stable

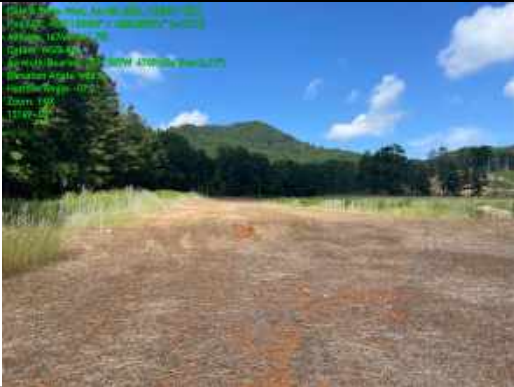
<b>GPS Location</b>	0	<b>GPS Location</b>	0		
<b>Field Station#</b>	13169+00	<b>Field Station#</b>	13161+50		
<b>Pic 3 Desc.</b>	ROW and ECDs In good condition and stable	<b>Pic 4 Desc.</b>	Slope drain pipe in good condition and functioning properly

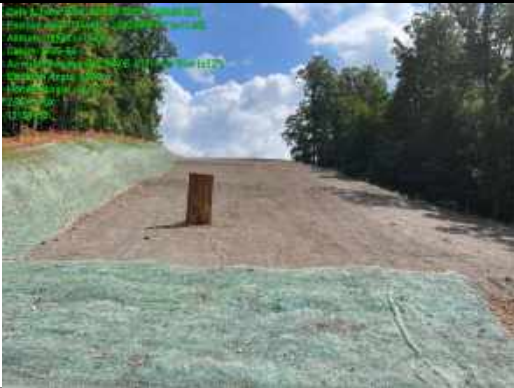
<b>GPS Location</b>	0	<b>GPS Location</b>	0		
<b>Field Station#</b>	13158+50	<b>Field Station#</b>	13157+22		
<b>Pic 5 Desc.</b>	ROW and ECDs In good condition and stable	<b>Pic 6 Desc.</b>	MVP-S-D11 and corresponding buffer zone in good condition

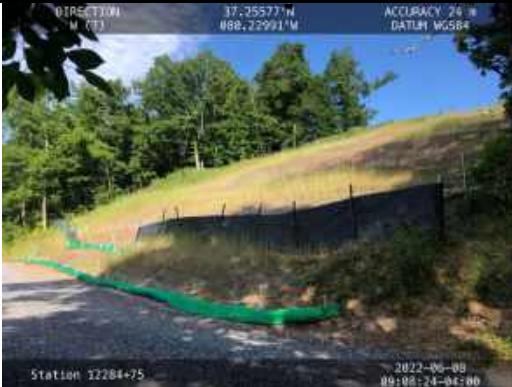
<b>GPS Location</b>	Please see photo for details.		<b>GPS Location</b>	Please see photo for details.	
<b>Field Station#</b>	12284+75		<b>Field Station#</b>	12236+50	
<b>Pic 1 Desc.</b>	Photo shows the stabilized ROW conditions with water bars and that all ECDs are installed and are functioning as designed.		<b>Pic 2 Desc.</b>	Photo shows stabilized permanent restoration section of ROW with permanent slope breakers and level spreaders.

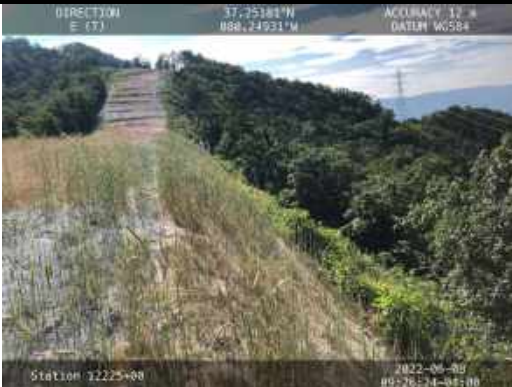
<b>GPS Location</b>	Please see photo for details.		<b>GPS Location</b>	Please see photo for details.	
<b>Field Station#</b>	12225+00		<b>Field Station#</b>	12215+00	
<b>Pic 3 Desc.</b>	Photo shows the stabilized ROW conditions with water bars and that all ECDs are installed and are functioning as designed.		<b>Pic 4 Desc.</b>	Photo shows the stabilized ROW conditions with water bars and that all ECDs are installed and are functioning as designed.

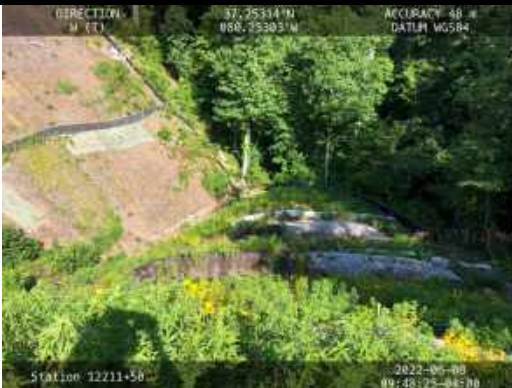
<b>GPS Location</b>	Please see photo for details.		<b>GPS Location</b>	Please see photo for details.	
<b>Field Station#</b>	12211+50		<b>Field Station#</b>	12213+00	
<b>Pic 5 Desc.</b>	Photo shows stabilized permanent restoration section of ROW with permanent slope breakers and level spreaders.		<b>Pic 6 Desc.</b>	Photo shows stabilized permanent restoration section of ROW with permanent slope breakers and level spreaders.

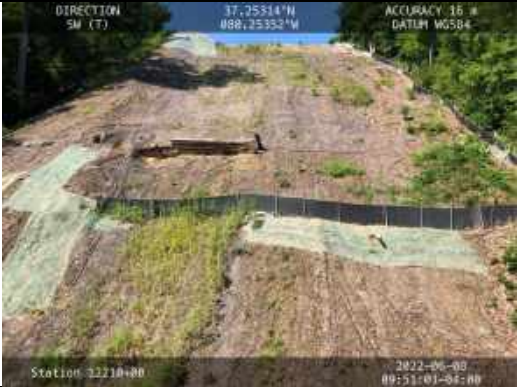
<b>GPS Location</b>	Please see photo for details.		<b>GPS Location</b>	Please see photo for details.	
<b>Field Station#</b>	12210+00		<b>Field Station#</b>	12208+50	
<b>Pic 7 Desc.</b>	Photo shows the stabilized ROW conditions with water bars and that all ECDs are installed and are functioning as designed.		<b>Pic 8 Desc.</b>	Photo shows the stabilized ROW conditions with water bars and that all ECDs are installed and are functioning as designed.

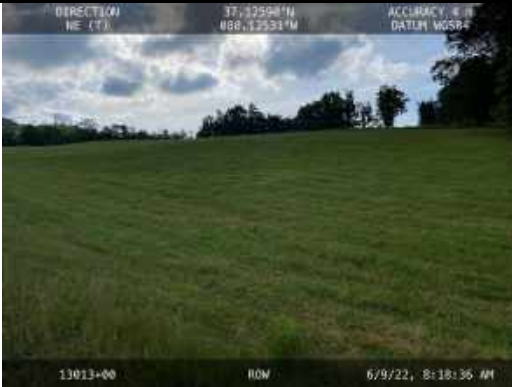
<b>GPS Location</b>	See photo		<b>GPS Location</b>	See photo	
<b>Field Station#</b>	13013+00		<b>Field Station#</b>	13012+00	
<b>Pic 1 Desc.</b>	Permanent vegetation is well established		<b>Pic 2 Desc.</b>	Permanent vegetation is well established

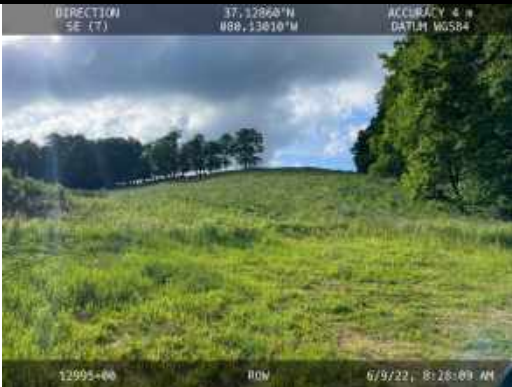
<b>GPS Location</b>	See photo		<b>GPS Location</b>	See photo	
<b>Field Station#</b>	12995+00		<b>Field Station#</b>	12975+00	
<b>Pic 3 Desc.</b>	Permanent vegetation is well established		<b>Pic 4 Desc.</b>	Current ROW conditions. ROW is stable. ECDs are functional.

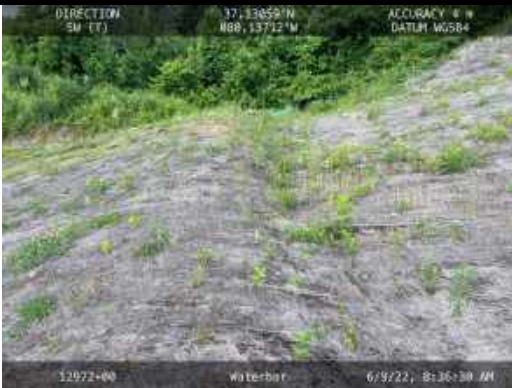
<b>GPS Location</b>	See photo		<b>GPS Location</b>	See photo	
<b>Field Station#</b>	12972+00		<b>Field Station#</b>	12956+93	
<b>Pic 5 Desc.</b>	Waterbar is functional		<b>Pic 6 Desc.</b>	Landowner spring box is undisturbed

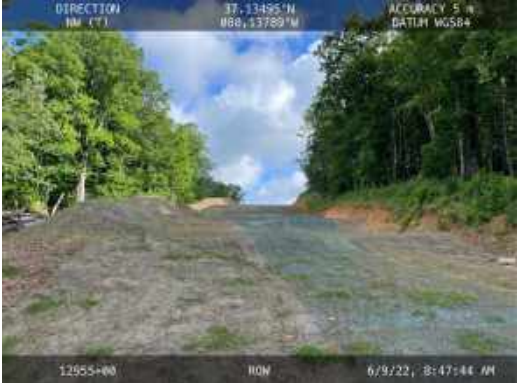
<b>GPS Location</b>	See photo		<b>GPS Location</b>	See photo	
<b>Field Station#</b>	12955+00		<b>Field Station#</b>	12927+00	
<b>Pic 7 Desc.</b>	Current ROW conditions. ROW is stable. ECDs are functional.		<b>Pic 8 Desc.</b>	Current ROW conditions. ROW is stable. ECDs are functional.

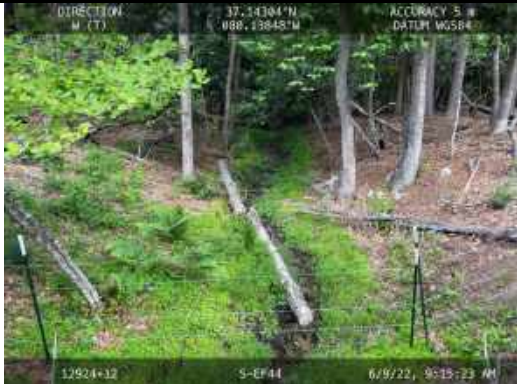
<b>GPS Location</b>	See photo		<b>GPS Location</b>	See photo	
<b>Field Station#</b>	12924+12		<b>Field Station#</b>	12904+00	
<b>Pic 9 Desc.</b>	Downstream of crossing at Stream S-EF44		<b>Pic 10 Desc.</b>	Current ROW conditions. ROW is stable. ECDs are functional.

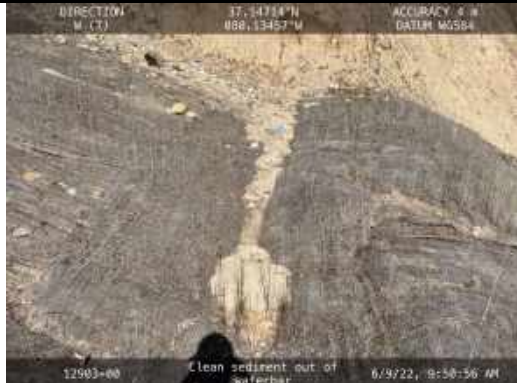
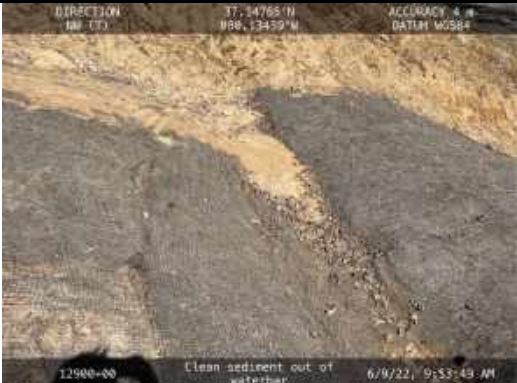
<b>GPS Location</b>	See photo		<b>GPS Location</b>	See photo	
<b>Field Station#</b>	12903+00		<b>Field Station#</b>	12900+00	
<b>Pic 11 Desc.</b>	Sediment has accumulated in throat of waterbar		<b>Pic 12 Desc.</b>	Sediment has accumulated in throat of waterbar

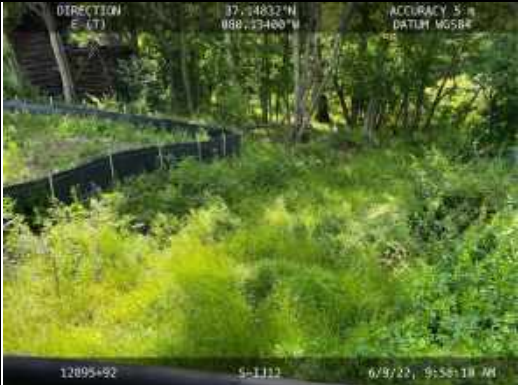
<b>GPS Location</b>	See photo		<b>GPS Location</b>	See photo	
<b>Field Station#</b>	12895+92		<b>Field Station#</b>	12893+00	
<b>Pic 13 Desc.</b>	Downstream of crossing at Stream S-IJ12		<b>Pic 14 Desc.</b>	Current ROW conditions. ROW is stable. ECDs are functional.

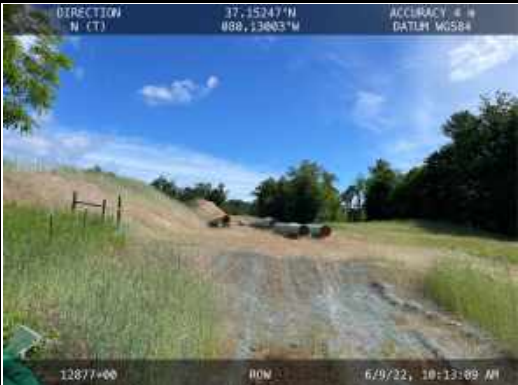
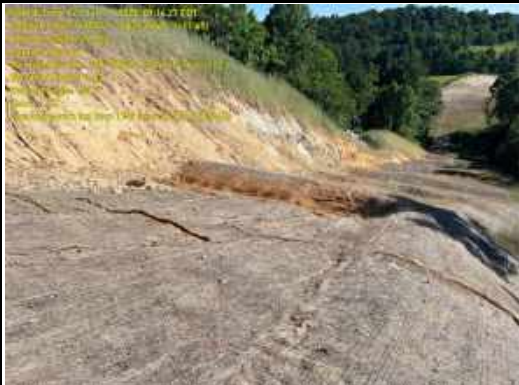
<b>GPS Location</b>	See photo		<b>GPS Location</b>	See photo	
<b>Field Station#</b>	12877+00		<b>Field Station#</b>	12900+00	
<b>Pic 17 Desc.</b>	Current ROW conditions. ROW is stable. ECDs are functional.		<b>Pic 18 Desc.</b>	Waterbar has been cleaned out

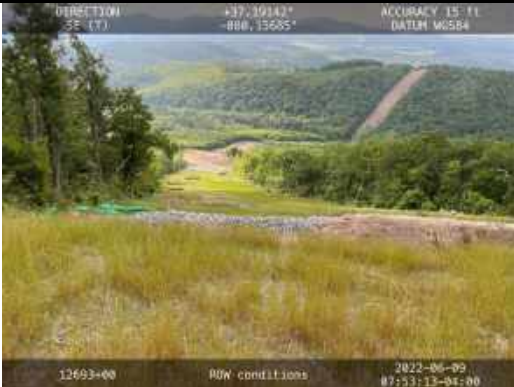
<b>GPS Location</b>	See photo for gps location data.		<b>GPS Location</b>	See photo for gps location data.	
<b>Field Station#</b>	12693+00		<b>Field Station#</b>	12691+00	
<b>Pic 1 Desc.</b>	Photo shows the ROW condition. ECDs are installed and functioning as designed.		<b>Pic 2 Desc.</b>	Photo shows the level spreader.

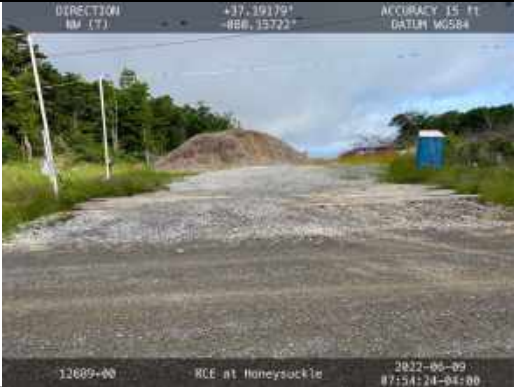
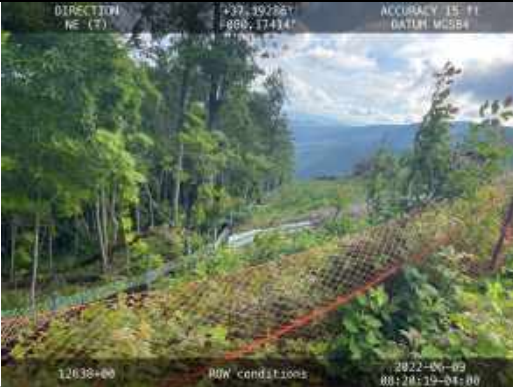
<b>GPS Location</b>	See photo for gps location data.		<b>GPS Location</b>	See photo for gps location data.	
<b>Field Station#</b>	12689+00		<b>Field Station#</b>	12638+00	
<b>Pic 3 Desc.</b>	Photo shows the RCE at Honeysuckle Road.		<b>Pic 4 Desc.</b>	Photo shows the ROW condition. ECDs are installed and functioning as designed.

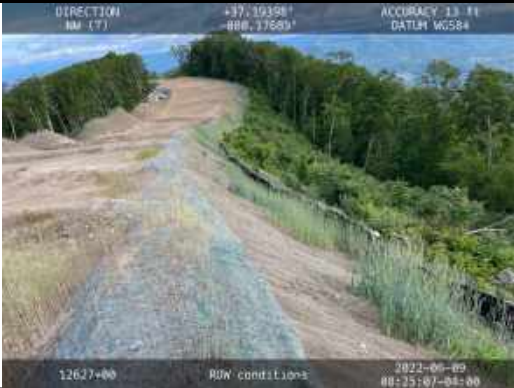
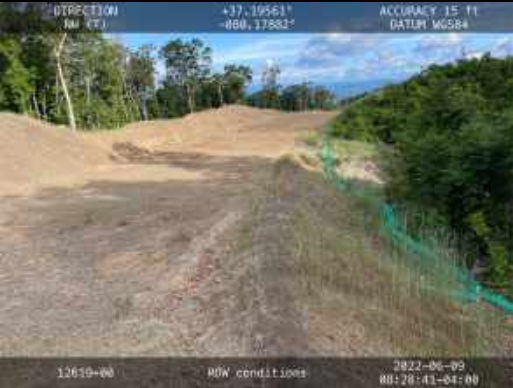
<b>Pic 5 Desc.</b>	Photo shows the ROW condition. ECDs are installed and functioning as designed.		<b>Pic 6 Desc.</b>	Photo shows the ROW condition. ECDs are installed and functioning as designed.

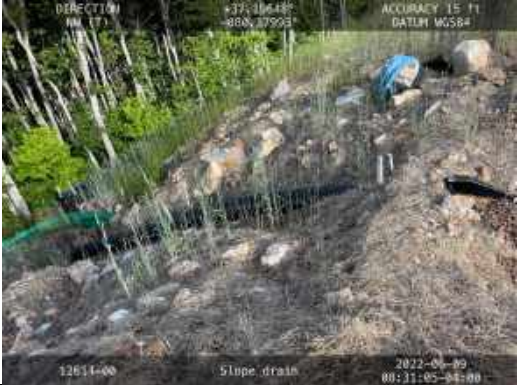
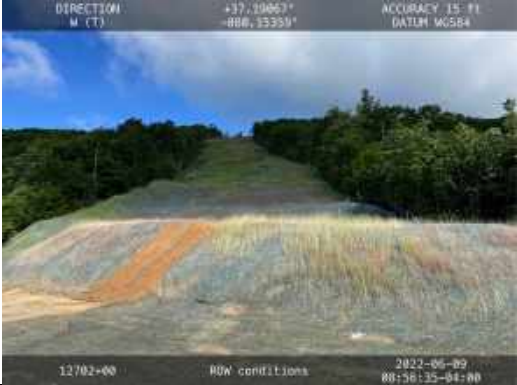
<b>GPS Location</b>	See photo for gps location data.		<b>GPS Location</b>	See photo for gps location data.	
<b>Field Station#</b>	12614+00		<b>Field Station#</b>	12702+00	
<b>Pic 7 Desc.</b>	Photo shows the slope drain.		<b>Pic 8 Desc.</b>	Photo shows the ROW condition. ECDs are installed and functioning as designed.

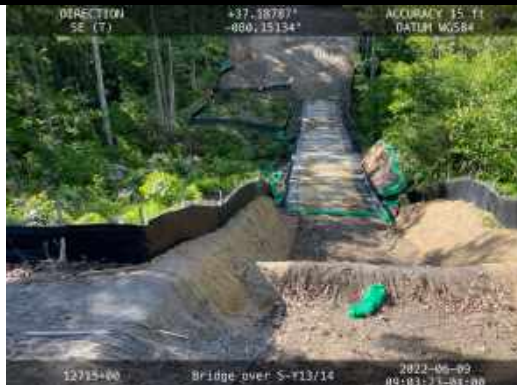
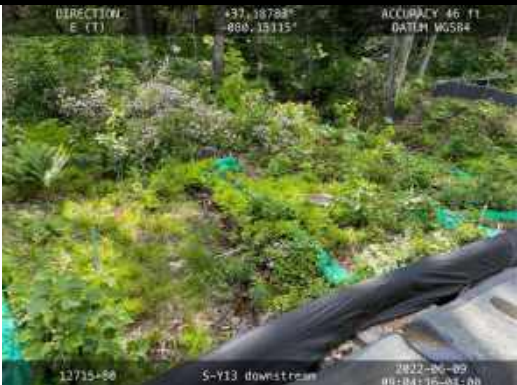
<b>Field Station#</b>	12715+00		<b>Field Station#</b>	12715+80	
<b>Pic 11 Desc.</b>	Photo shows the bridge over streams S-Y13 and S-Y14.		<b>Pic 12 Desc.</b>	Photo shows S-Y13 downstream from the bridge.

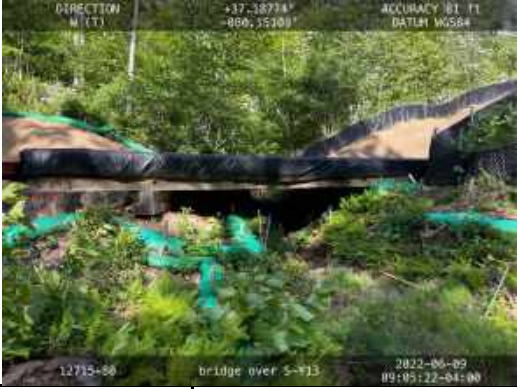
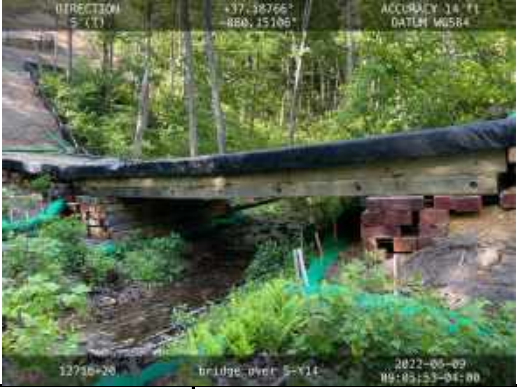
<b>GPS Location</b>	See photo for gps location data.		<b>GPS Location</b>	See photo for gps location data.	
<b>Field Station#</b>	12715+80		<b>Field Station#</b>	12716+20	
<b>Pic 13 Desc.</b>	Photo shows the bridge over stream S-Y13.		<b>Pic 14 Desc.</b>	Photo shows the bridge over stream S-Y14.

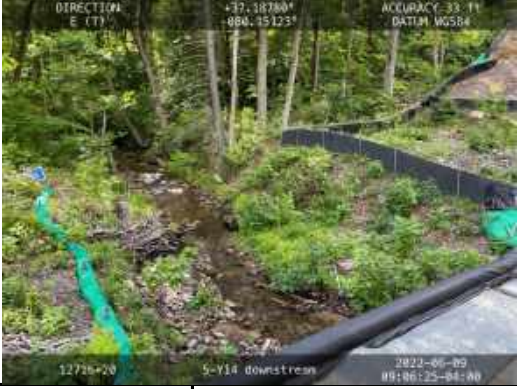
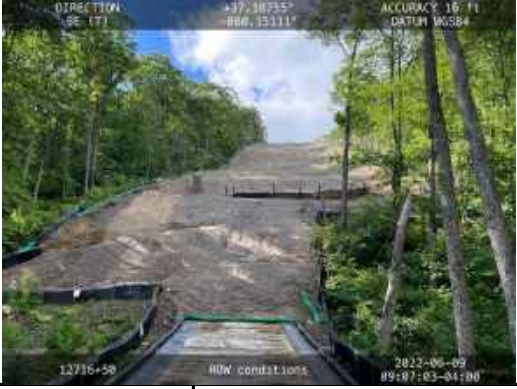
<b>GPS Location</b>	See photo for gps location data.		<b>GPS Location</b>	See photo for gps location data.	
<b>Field Station#</b>	12716+20		<b>Field Station#</b>	12716+50	
<b>Pic 15 Desc.</b>	Photo shows S-Y14 downstream from the bridge.		<b>Pic 16 Desc.</b>	Photo shows the ROW condition. ECDs are installed and functioning as designed.

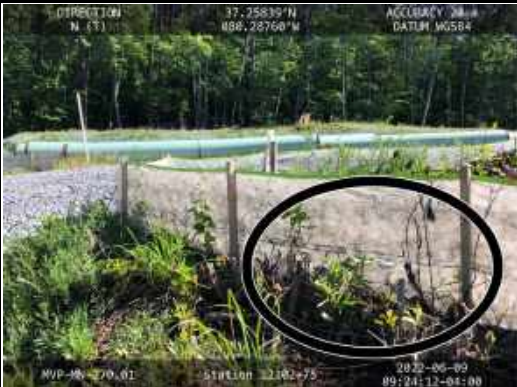
<b>A/E</b>	124300138	<b>Date/Time</b>	6/9/2022 3:00 PM	<b>Report #</b>	38591
<b>6. PCSM BMPs</b> (List BMPs and note if installed and maintained as per the plan. If corrective action is needed, a picture is required.)					
<b>PCSM BMPs</b>	<b>Compliance Level</b>	<b>Corrective Action</b>	<b>Corrective Time Frame</b>	<b>Date Repaired</b>	
Other	Acceptable	Permanent slope breaker			
Level Spreader	Acceptable				
<b>7. Identify all remedial measures that have been taken since the previous inspection was conducted.</b> One past 24hr punch list item of replacing flattened triangle diversion dike and fix rills above observed and found to be completed during todays VA DEQ SWPPP inspection. (Resolved on 6/03/2022).					
<b>Comments</b> (Reference above questions as appropriate.) Attended morning virtual conference call for inspection at 6:30am then traveled to MVP-MN-268.01. Here, the VA DEQ SWPPP inspection was performed on this date. From station 12005+00 to station 12119+17 the ROW was walked to evaluate that all ECDs are installed and functioning as designed along with the ROW that had been previously disturbed and is now inactive has been properly stabilized with either straw mulch, erosion control blanket or temporary or permanent vegetation. In which appeared to be adequate. - Final result of all areas observed and evaluated in todays inspection were found to be in compliance and have no environmental issues, no off ROW sediment as well as no stream or wetland impacts. - The ECDs observed today appeared to be installed and functioning as designed. Some of the ECDs are showing some wear but are still functioning. Located within todays SWPPP inspection area are the following resources that were evaluated and observed. Stream S-SG36 located at station number 12008+53. Stream S-G38 located at station number 12015+84. Stream S-G39 located at station number 12031+51. Stream S-G40 located at station number 12035+11. Stream S-PP23 located at station number 12035+75. Stream S-MM15 located at station number 12076+95. Stream S-MM14 located at station number 12086+56. Stream S-MM13 located at station number 12098+44. Stream S-MM11 located at station number 12101+57. Stream S-F15 located at station number 12108+41. Stream S-F16A/B located at station number 12112+23. Wetland W-F9-PFO located from station number 12108+40 to station number 12109+05. * (1) 72hr punch list item found today of repairing hole in P1 silt fence along MVP-MN-270.01. (Resolved 6/09/2022).

<b>GPS Location</b>	Please see photo for details.		<b>GPS Location</b>	Please see photo for details.	
<b>Field Station#</b>	12102+75		<b>Field Station#</b>	12102+75	
<b>Pic 17 Desc.</b>	Photo shows todays punch list item of hole in P1 silt fence along MVP-MN-270.01.		<b>Pic 18 Desc.</b>	Photo shows todays punch list item of hole in P1 silt fence resolved.

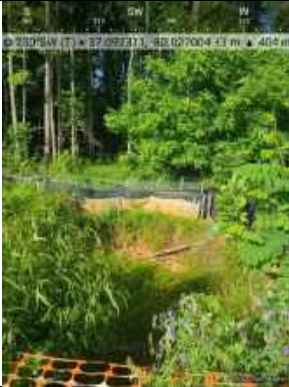
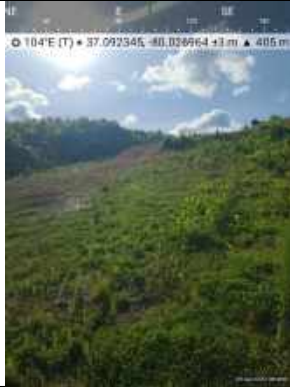
<b>GPS Location</b>	0000	<b>GPS Location</b>	0000		
<b>Field Station#</b>	13416+00	<b>Field Station#</b>	13418+00		
<b>Pic 1 Desc.</b>	Monitored sump pit and ECDs . All functioning properly at the time of inspection.		<b>Pic 2 Desc.</b>	Hill side photo showing stabilization and erosion control blanket functioning. No issues observed at the time of inspection.

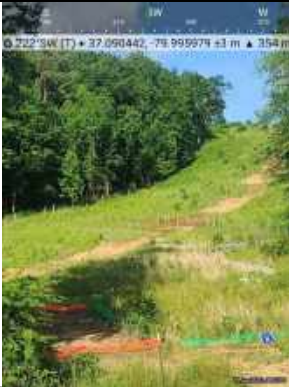
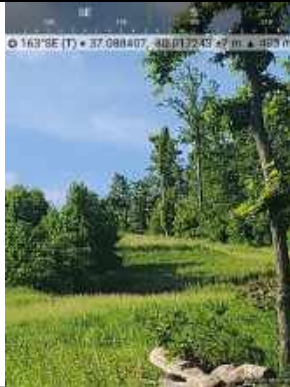
<b>GPS Location</b>	0000	<b>GPS Location</b>	0000		
<b>Field Station#</b>	13525+03	<b>Field Station#</b>	13453+33		
<b>Pic 3 Desc.</b>	Monitored area where recent punch list items were completed. Travel lane seeded and stabilized after work activities. No environmental issues observed at the time of inspection.		<b>Pic 4 Desc.</b>	Vegetation observation photo in permanent area of row, good stabilization noted.

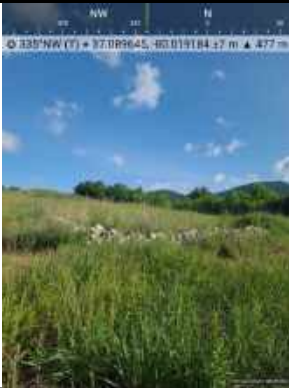
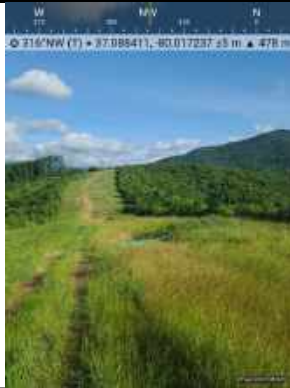
<b>GPS Location</b>	00000	<b>GPS Location</b>	0000		
<b>Field Station#</b>	13449+90	<b>Field Station#</b>	13448+00		
<b>Pic 5 Desc.</b>	Observed water bars and level spreaders in permanent areas of row during inspection today. No environmental issues observed at the time of inspection.		<b>Pic 6 Desc.</b>	Row photo showing stabilization and ECDs . No issues observed at the time of inspection.

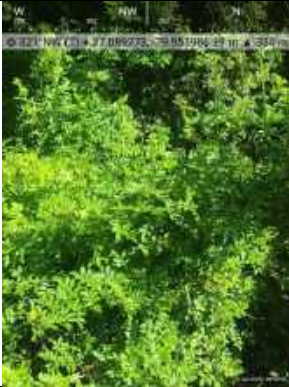
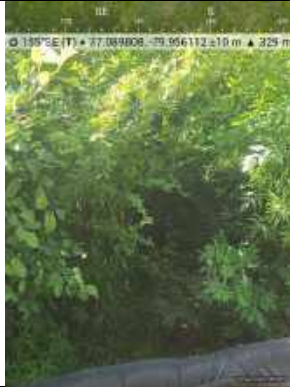
<b>GPS Location</b>	0000	<b>GPS Location</b>	0000		
<b>Field Station#</b>	13659+03	<b>Field Station#</b>	13659+04		
<b>Pic 1 Desc.</b>	Stream observation photo facing upstream during routine inspection. No issues were observed at the time of inspection.		<b>Pic 2 Desc.</b>	Stream observation photo facing downstream, no environmental issues observed at the time of inspection.

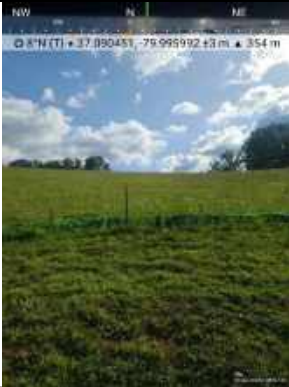
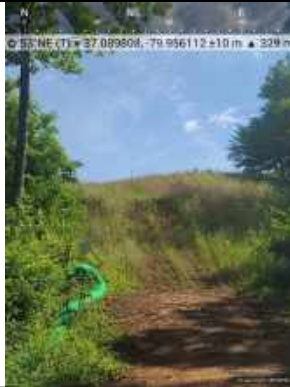
<b>GPS Location</b>	0000	<b>GPS Location</b>	0000		
<b>Field Station#</b>	13526+19	<b>Field Station#</b>	13659+80		
<b>Pic 3 Desc.</b>	Monitored ECDs and vegetation in permanent area of row where land owner keeps cattle. No issues observed at the time of inspection.		<b>Pic 4 Desc.</b>	Monitored ECDs and stabilization on hill side above stream crossing. No issues were observed at the time of inspection.

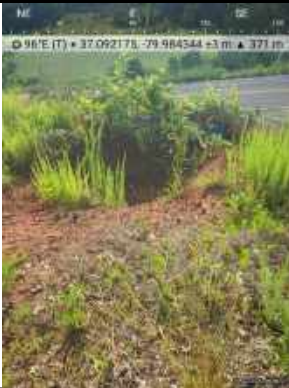
<b>GPS Location</b>	0000	<b>GPS Location</b>	00000		
<b>Field Station#</b>	13562+38	<b>Field Station#</b>	13657+90		
<b>Pic 5 Desc.</b>	Monitored sump pit and end treatment during routine inspection. No issues were observed at the time of inspection.		<b>Pic 6 Desc.</b>	P1 requires maintenance due to wildlife damages, documented and added to the punch list for repair.
