# Visual Site Inspection Report

<b>Project Name</b>	H-600 Pipeline Spread H	<b>AFE</b>	124300138	<b>Spread</b>	H-600 Pipeline Spread H
<b>Contractor</b>	Precision	<b>Report #</b>	38425		
<b>Inspector</b>	Pat Davis	<b>Date/Time</b>	6/6/2022 4:00 PM		
<b>Permit #</b>	TBD	<b>Inspection Type</b>	VA SWPP	<b>Station Begin</b>	+0
<b>State</b>	VA	<b>Inspection Area</b>	Partial	<b>Station End</b>	+0
<b>County</b>	Montgomery	<b>Ground</b>	Dry	<b>Temperature (°F)</b>	65.00
<b>Municipality</b>	N/A	<b>Weather</b>	Sunny	<b>Rain Gauge (in)</b>	0.00
				<b>Rain Accumulation Time (days)</b>	0.00

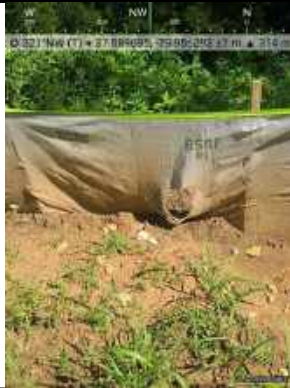
<b>GPS Location</b>	0000	<b>GPS Location</b>	00000		
<b>Field Station#</b>	13562+38	<b>Field Station#</b>	13657+90		
<b>Pic 5 Desc.</b>	Monitored sump pit and end treatment during routine inspection. No issues were observed at the time of inspection.		<b>Pic 6 Desc.</b>	P1 requires maintenance due to wildlife damages, documented and added to the punch list for repair.

<b>A/E</b>	124300138	<b>Date/Time</b>	6/10/2022 3:12 PM	<b>Report #</b>	38577
<b>6. PCSM BMPs</b> (List BMPs and note if installed and maintained as per the plan. If corrective action is needed, a picture is required.)					
<b>PCSM BMPs</b>	<b>Compliance Level</b>	<b>Corrective Action</b>	<b>Corrective Time Frame</b>	<b>Date Repaired</b>	
<b>7. Identify all remedial measures that have been taken since the previous inspection was conducted.</b>					
<b>Comments</b> (Reference above questions as appropriate.)					
<p>Traveled and inspected all ECDs throughout the row, monitored vegetation growth throughout.</p> <p>Inspected all stream and wetland crossings, checked equipment bridges and protection.</p> <p>Monitored RCEs and ECDs at road crossings during routine inspection.</p> <p>Monitored sump pits and end treatment throughout areas of row.</p> <p>During inspection today the EI observed a section of P1 that requires maintenance due to wildlife damages, the EI documented and added to the punch list for repair.</p> <p>No other environmental issues observed at the time of inspection.</p>

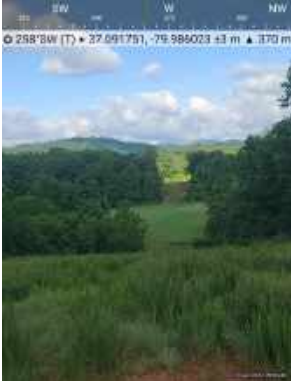
<p>Insert image here</p>		<p>Insert image here</p>	
<b>GPS Location</b>	0000	<b>GPS Location</b>			
<b>Field Station#</b>	13553+00	<b>Field Station#</b>			
<b>Pic 7 Desc.</b>	Row photo showing stabilization in permanent area of row.	<b>Pic 8 Desc.</b>			
<p>Insert image here</p>		<p>Insert image here</p>			
<b>GPS Location</b>		<b>GPS Location</b>			
<b>Field Station#</b>		<b>Field Station#</b>			
<b>Pic 9 Desc.</b>		<b>Pic 10 Desc.</b>			
<p>Insert image here</p>		<p>Insert image here</p>			
<b>GPS Location</b>		<b>GPS Location</b>			
<b>Field Station#</b>		<b>Field Station#</b>			
<b>Pic 11 Desc.</b>		<b>Pic 12 Desc.</b>

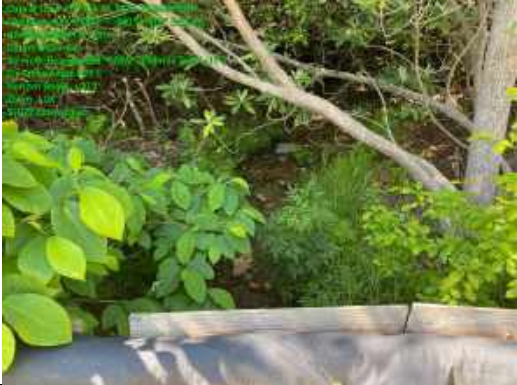
<b>GPS Location</b>	See photo for coordinate.		<b>GPS Location</b>	See photo for coordinate.	
<b>Field Station#</b>	13061+89		<b>Field Station#</b>	13062+96	
<b>Pic 7 Desc.</b>	S-G26, downstream, banks well vegetated.		<b>Pic 8 Desc.</b>	S-G27, downstream, no turbidity noted.

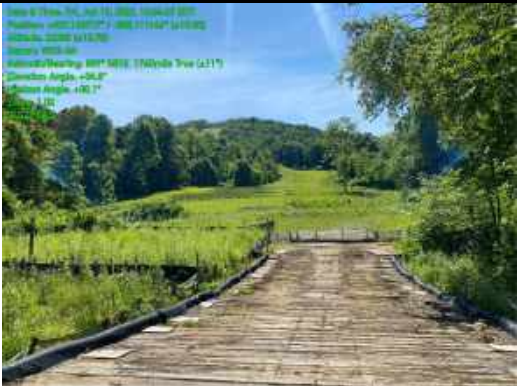
<b>GPS Location</b>	See photo for coordinate.		<b>GPS Location</b>	See photo for coordinate.	
<b>Field Station#</b>	13062+96		<b>Field Station#</b>	13062+96	
<b>Pic 9 Desc.</b>	S-G27, upstream, no right of way impacts observed.		<b>Pic 10 Desc.</b>	Right of way restored and vegetated on the going away side of S-G27.

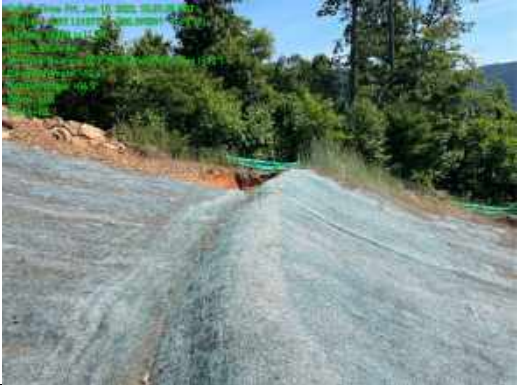
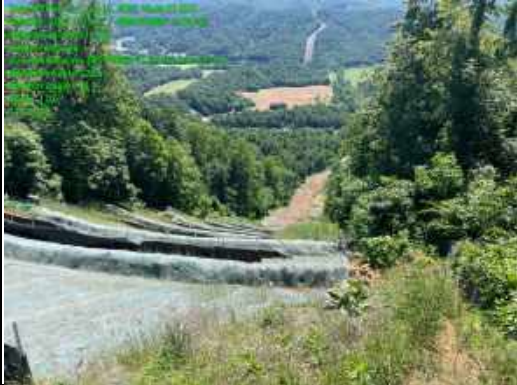
<b>GPS Location</b>	See photo for coordinate.		<b>GPS Location</b>	See photo for coordinate.	
<b>Field Station#</b>	13116+00		<b>Field Station#</b>	13119+00	
<b>Pic 13 Desc.</b>	Waterbar, sump, and end treatment in compliance.		<b>Pic 14 Desc.</b>	Right of way stabilized.

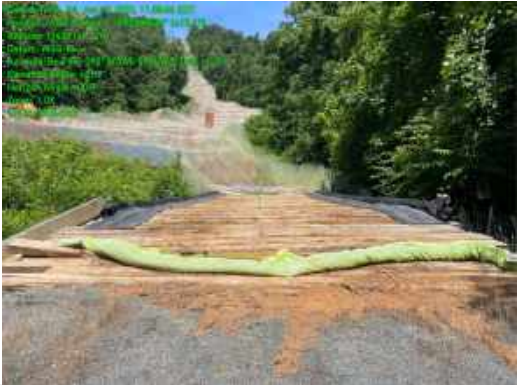
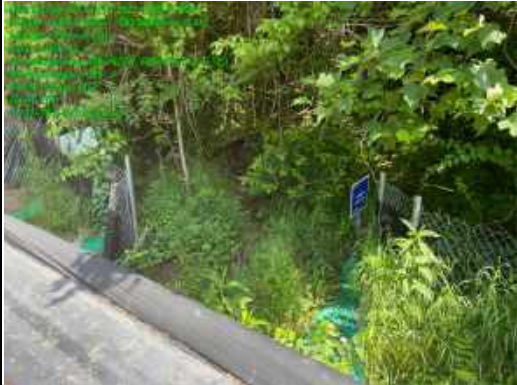
<b>GPS Location</b>	See photo for coordinate.		<b>GPS Location</b>	See photo for coordinate.	
<b>Field Station#</b>	13137+78		<b>Field Station#</b>	13137+78	
<b>Pic 15 Desc.</b>	Bridge over S-D17/14 in acceptable condition; right of way stabilized.		<b>Pic 16 Desc.</b>	S-D17/14, upstream, no impacts observed.

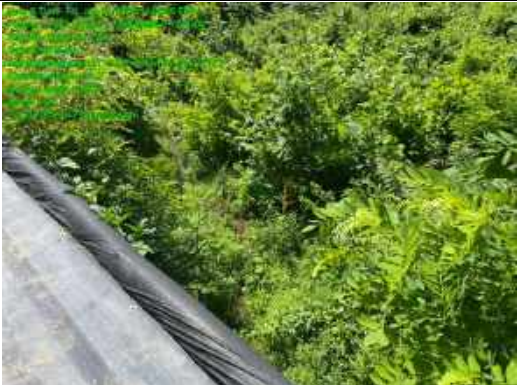
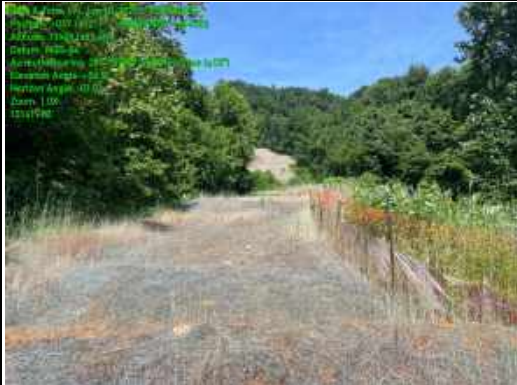
<b>GPS Location</b>	See photo for coordinate.		<b>GPS Location</b>	See photo for coordinate.	
<b>Field Station#</b>	13137+78		<b>Field Station#</b>	13141+00	
<b>Pic 17 Desc.</b>	S-D17/14, downstream, banks well vegetated; no impacts observed.		<b>Pic 18 Desc.</b>	Right of way stabilized.

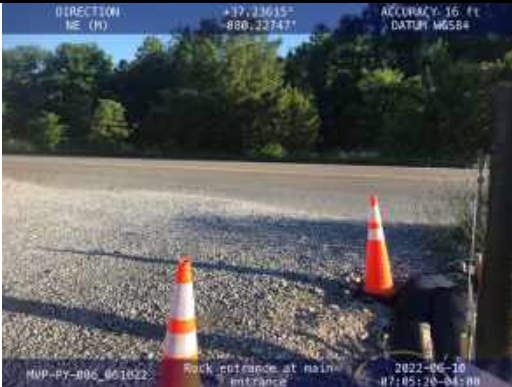
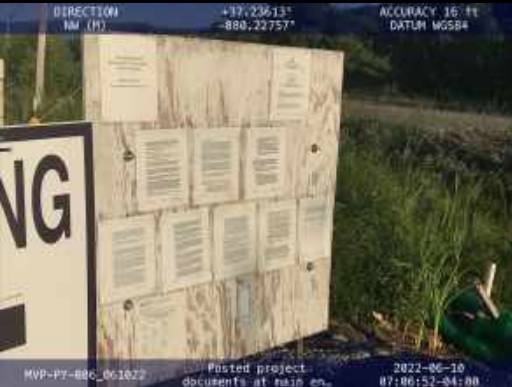
<b>GPS Location</b>	MVP-PY-006 See photo for gps data		<b>GPS Location</b>	MVP-PY-006 See photo for gps data	
<b>Field Station#</b>	+0		<b>Field Station#</b>	+0	
<b>Pic 1 Desc.</b>	Condition of rock entrance on north drive. No stone on public roadway. Looking NE.		<b>Pic 2 Desc.</b>	Condition of posted project documents at the main entrance. Looking NW.

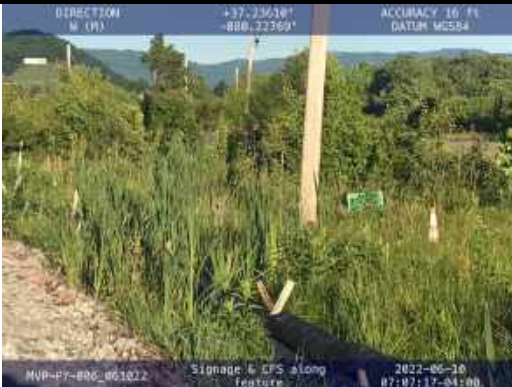
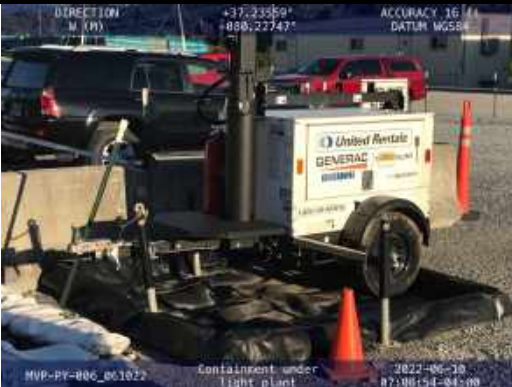
<b>GPS Location</b>	MVP-PY-006 See photo for gps data		<b>GPS Location</b>	MVP-PY-006 See photo for gps data	
<b>Field Station#</b>	+0		<b>Field Station#</b>	+0	
<b>Pic 3 Desc.</b>	Signage and triple stack compost filter sock at feature W-008. Overgrown with vegetation. Looking W.		<b>Pic 4 Desc.</b>	Secondary containment under light plant free of fluids. Looking W.

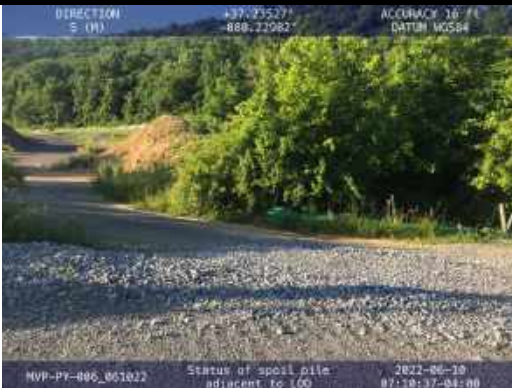
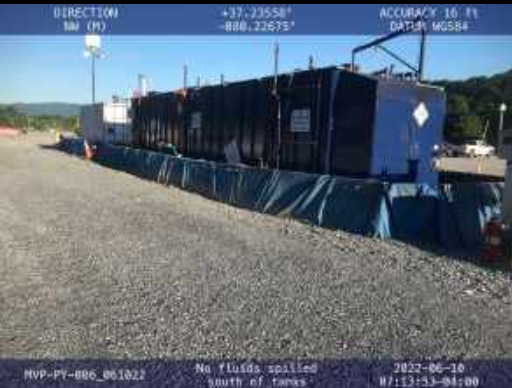
<b>Field Station#</b>	+0		<b>Field Station#</b>	+0	
<b>Pic 5 Desc.</b>	Status of spoil pile adjacent to LOD on VDOT property. Soil pile not stabilized. Looking S.		<b>Pic 6 Desc.</b>	Blue Bulk Fuel tanks no fluids spilled south of the tanks. Looking NW.

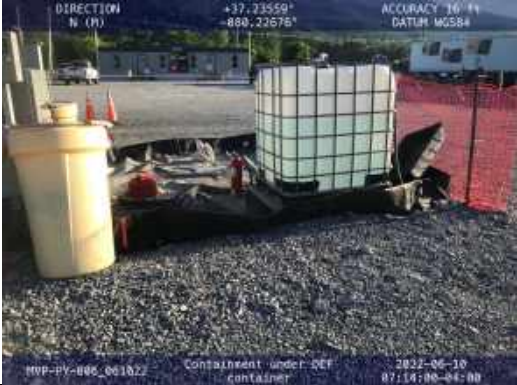
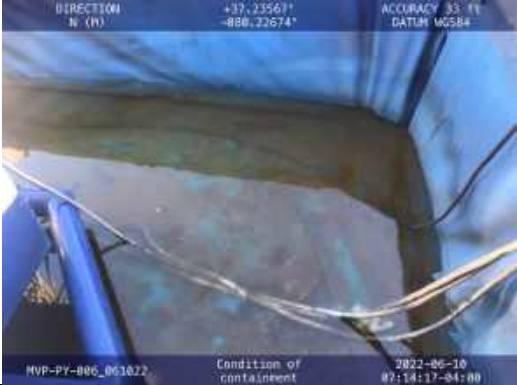
<b>GPS Location</b>	MVP-PY-006 See photo for gps data	<b>GPS Location</b>	MVP-PY-006 See photo for gps data		
<b>Field Station#</b>	+0	<b>Field Station#</b>	+0		
<b>Pic 7 Desc.</b>	Secondary containment under DEF container free of fluids. Looking N.	<b>Pic 8 Desc.</b>	Blue Bulk Fuel tanks containment holding stormwater. Looking N.

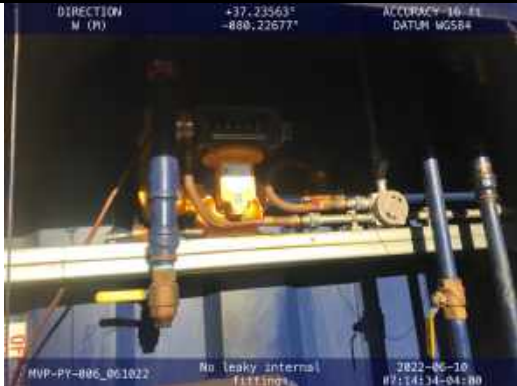
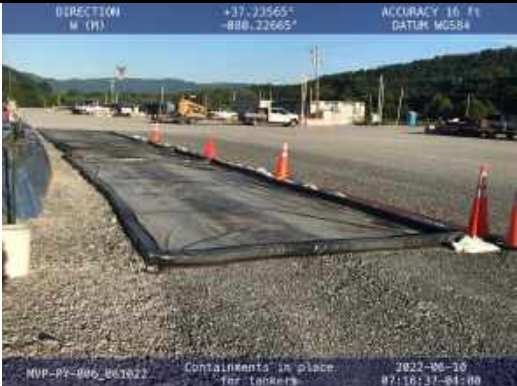
<b>GPS Location</b>	MVP-PY-006 See photo for gps data	<b>GPS Location</b>	MVP-PY-006 See photo for gps data		
<b>Field Station#</b>	+0	<b>Field Station#</b>	+0		
<b>Pic 9 Desc.</b>	Blue Bulk Fuel tanks no leaky internal fitting. Looking W.	<b>Pic 10 Desc.</b>	Blue Bulk Fuel tanks secondary containments in place for tankers offloading fuel. Looking W.

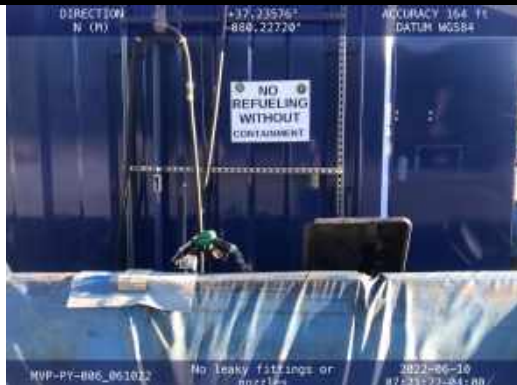
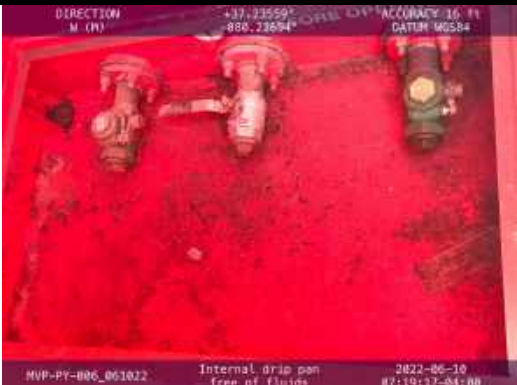
<b>Field Station#</b>	+0	<b>Field Station#</b>	+0		
<b>Pic 11 Desc.</b>	Blue Bulk Fuel tanks no leaky fittings or nozzles. Drip pans on site. Looking N.	<b>Pic 12 Desc.</b>	Off Road Fuel unit internal drip pan free of fluids. No leaky internal fittings. Looking W.

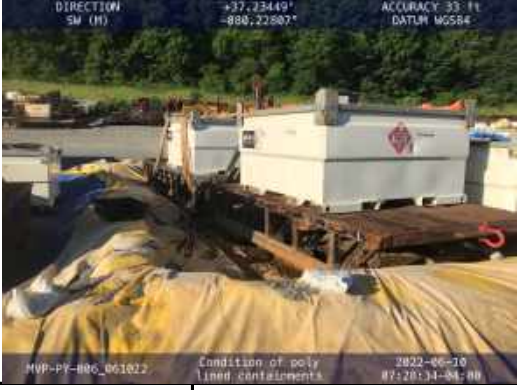
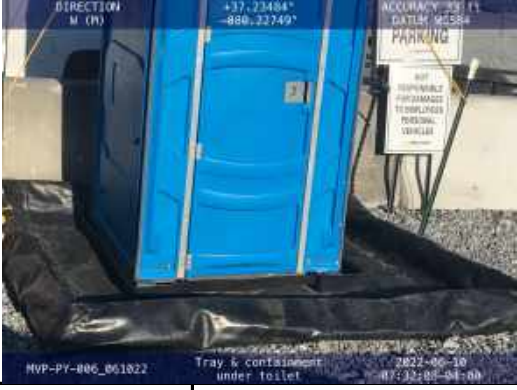
<b>Field Station#</b>	+0		<b>Field Station#</b>	+0	
<b>Pic 17 Desc.</b>	Poly lined rock berm containments free of stormwater. Looking SW.		<b>Pic 18 Desc.</b>	Tray and containment under toilet. Tray holding fluids. Looking W.

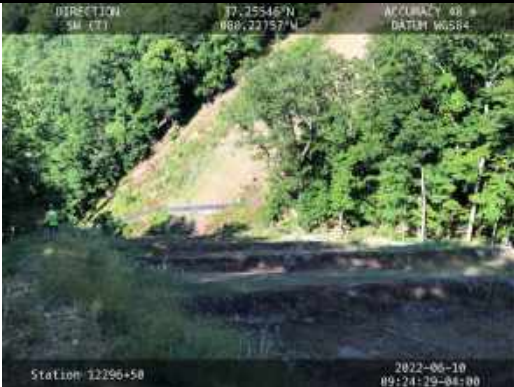
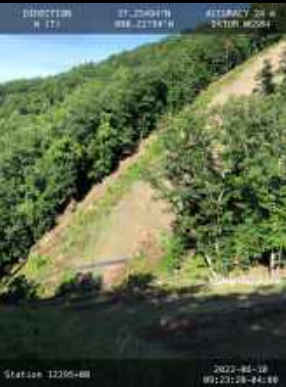
<b>GPS Location</b>	Please see photo for details.		<b>GPS Location</b>	Please see photo for details.	
<b>Field Station#</b>	12296+50		<b>Field Station#</b>	12295+00	
<b>Pic 1 Desc.</b>	Photo shows stabilized ROW conditions and employee over seeding ROW.		<b>Pic 2 Desc.</b>	Photo shows the stabilized ROW conditions with waterbars and that all ECDs are installed and are functioning as designed.

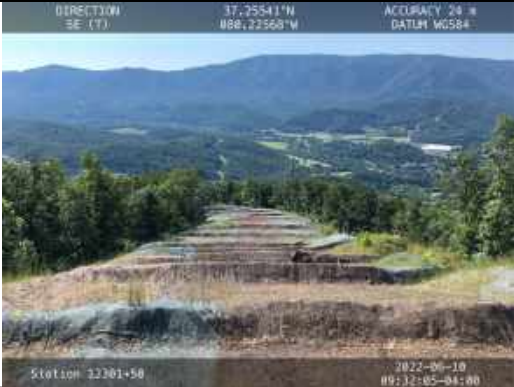
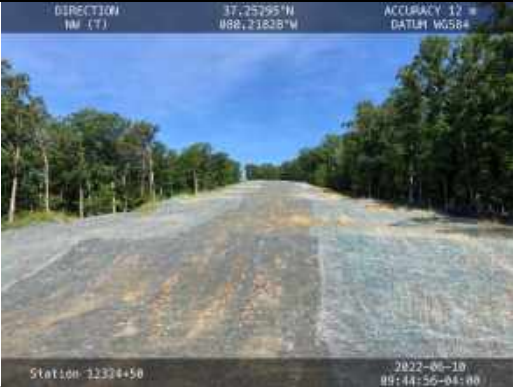
<b>GPS Location</b>	Please see photo for details.		<b>GPS Location</b>	Please see photo for details.	
<b>Field Station#</b>	12301+50		<b>Field Station#</b>	12324+50	
<b>Pic 3 Desc.</b>	Photo shows the stabilized ROW conditions with waterbars and that all ECDs are installed and are functioning as designed.		<b>Pic 4 Desc.</b>	Photo shows the stabilized ROW conditions with waterbars and that all ECDs are installed and are functioning as designed.

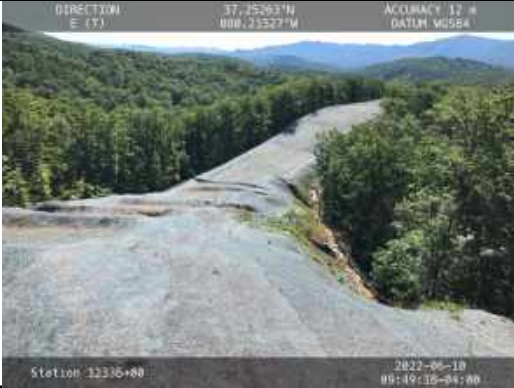
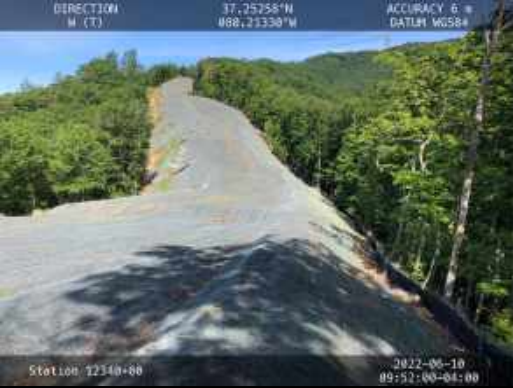
<b>GPS Location</b>	Please see photo for details.		<b>GPS Location</b>	Please see photo for details.	
<b>Field Station#</b>	12336+00		<b>Field Station#</b>	12340+00	
<b>Pic 5 Desc.</b>	Photo shows the stabilized ROW conditions with waterbars and that all ECDs are installed and are functioning as designed.		<b>Pic 6 Desc.</b>	Photo shows the stabilized ROW conditions with waterbars and that all ECDs are installed and are functioning as designed.

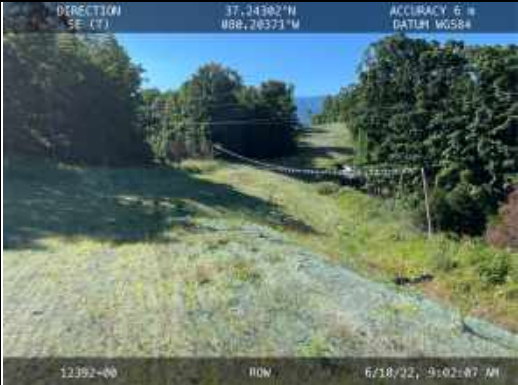
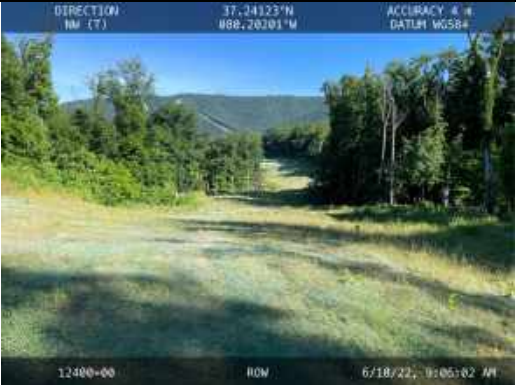
<b>GPS Location</b>	Please see photo for details.		<b>GPS Location</b>	Please see photo for details.	
<b>Field Station#</b>	12392+00		<b>Field Station#</b>	12400+00	
<b>Pic 13 Desc.</b>	Photo shows the stabilized ROW conditions with waterbars and that all ECDs are installed and are functioning as designed.		<b>Pic 14 Desc.</b>	Photo shows the stabilized ROW conditions with waterbars and that all ECDs are installed and are functioning as designed.

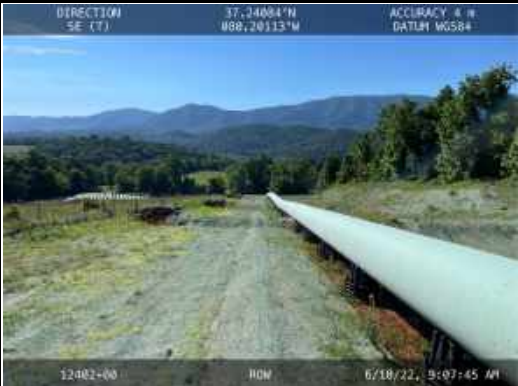
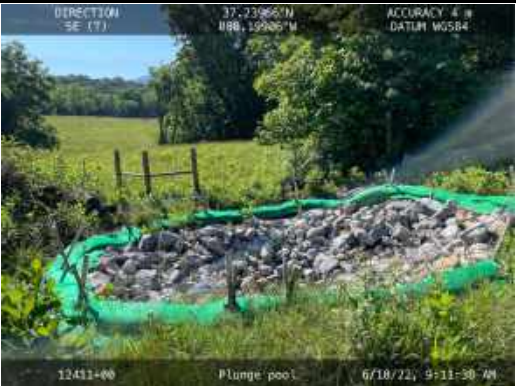
<b>GPS Location</b>	Please see photo for details.		<b>GPS Location</b>	Please see photo for details.	
<b>Field Station#</b>	12402+00		<b>Field Station#</b>	12411+00	
<b>Pic 15 Desc.</b>	Photo shows the stabilized ROW conditions with waterbars and that all ECDs are installed and are functioning as designed.		<b>Pic 16 Desc.</b>	Photo shows plunge pool with installed ECDs functioning as designed for clean water diversion pipe outlet.

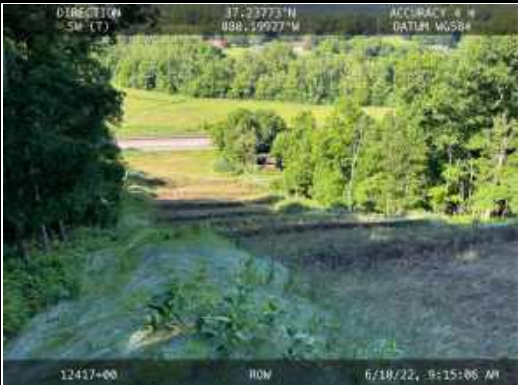
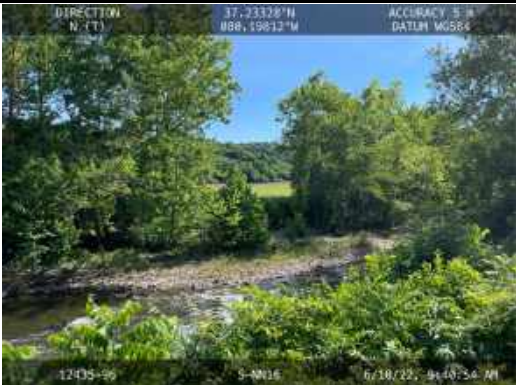
<b>GPS Location</b>	Please see photo for details.		<b>GPS Location</b>	Please see photo for details.	
<b>Field Station#</b>	12417+00		<b>Field Station#</b>	12435+96	
<b>Pic 17 Desc.</b>	Photo shows the stabilized ROW conditions with waterbars and that all ECDs are installed and are functioning as designed.		<b>Pic 18 Desc.</b>	Photo shows overview of Stream S-NN16 from the going away side.

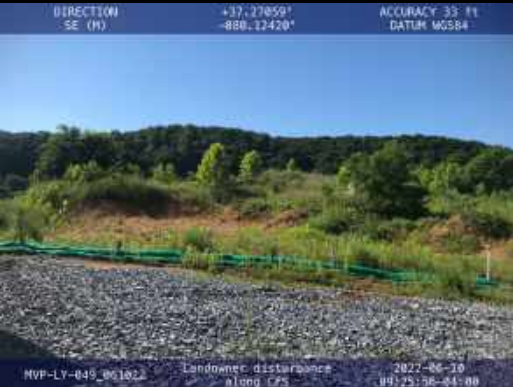
<b>GPS Location</b>	MVP-LY-049 See photo for gps data		<b>GPS Location</b>	MVP-LY-049 See photo for gps data	
<b>Field Station#</b>	+0		<b>Field Station#</b>	+0	
<b>Pic 1 Desc.</b>	Condition of rock entrance on north drive. No sediment or debris on stone. Looking SW.		<b>Pic 2 Desc.</b>	Landowner soil disturbance along triple stack compost filter sock. Looking SE.

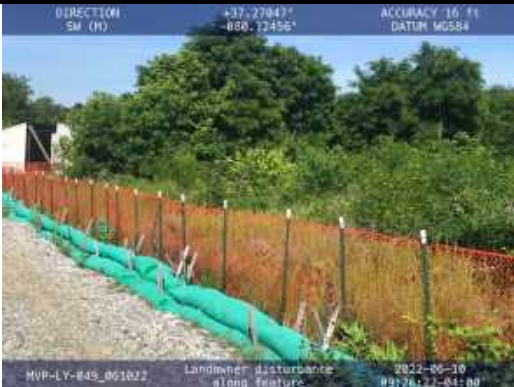
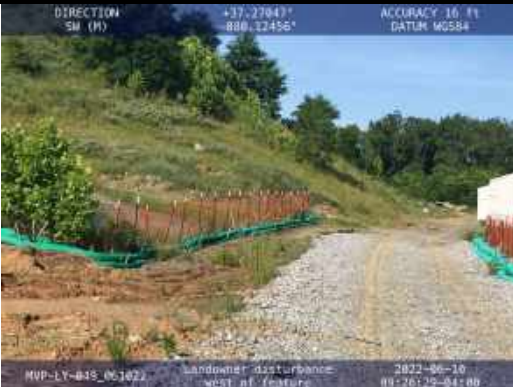
<b>GPS Location</b>	MVP-LY-049 See photo for gps data		<b>GPS Location</b>	MVP-LY-049 See photo for gps data	
<b>Field Station#</b>	+0		<b>Field Station#</b>	+0	
<b>Pic 3 Desc.</b>	Landowner soil disturbance along feature W-CV21A. Are not stabilized. Looking SW.		<b>Pic 4 Desc.</b>	Landowner disturbance west of feature W-CV21B. Areas not stabilized. Looking SW.

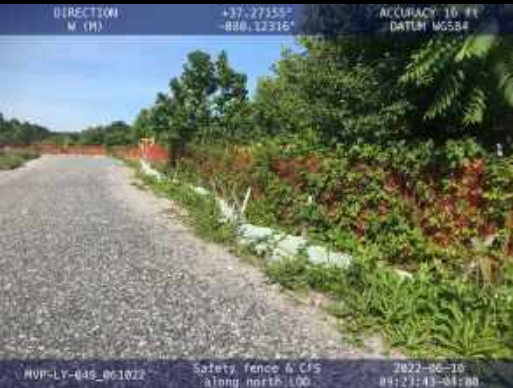
<b>Field Station#</b>	+0		<b>Field Station#</b>	+0	
<b>Pic 5 Desc.</b>	Landowner soil disturbance and debris piled along triple stack compost filter sock and east of feature W-CV21. Looking SW.		<b>Pic 6 Desc.</b>	Safety fence and triple stack compost filter sock along north LOD on north drive. Looking W.

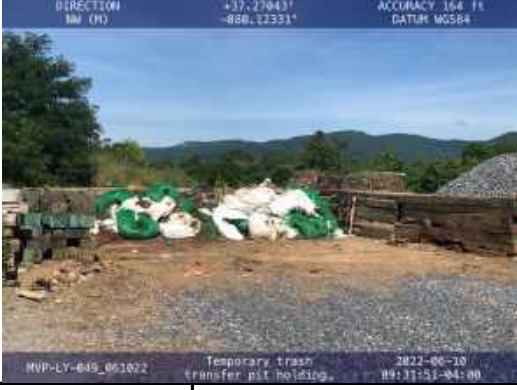
<b>GPS Location</b>	MVP-LY-049 See photo for gps data	<b>GPS Location</b>	MVP-LY-049 See photo for gps data		
<b>Field Station#</b>	+0	<b>Field Station#</b>	+0		
<b>Pic 11 Desc.</b>	Compost filter sock in place and functioning around sand pile. Looking W.	<b>Pic 12 Desc.</b>	Temporary trash transfer pit holding debris. Looking NW.
