Visual Site Inspection Report

Project Name	H-600 Pipeline Spread I	AFE	124300139	Spread	H-600 Pipeline Spread I
Contractor	Precision			Report #	37701
Inspector	Justin Burch			Date/Time	5/16/2022 11:23 AM
Permit #	TBD	Inspection Type	VA SWPP	Station Begin	15370+62
State	VA	Inspection Area	Full	Station End	15480+67
County	Pittsylvania	Ground	Wet	Temperature (°F)	80.00
Municipality	Chatham	Weather	Cloudy	Rain Gauge (in)	0.60
				Rain Accumulation Time (days)	6.00

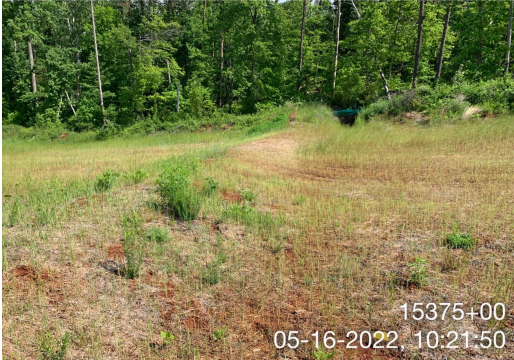
15375+00 05-16-2022, 10:22:34			
GPS Location	0	GPS Location	0		
Field Station#	15375+00	Field Station#	15375+00		
Pic 1 Desc.	Waterbar in acceptable condition	Pic 2 Desc.	Waterbar end treatment in acceptable condition		
18°N (T) 36°55'15"N, 79°30'21"W ±360ft ▲788ft

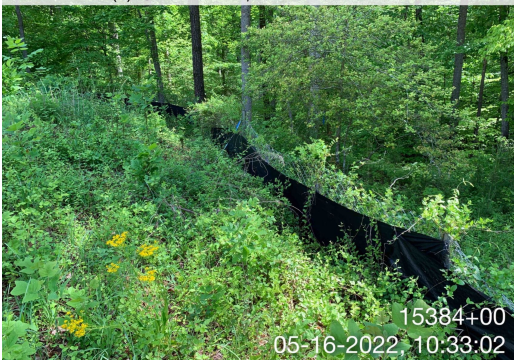
15401+00 05-16-2022, 10:42:46			
GPS Location	0	GPS Location	0		
Field Station#	15384+00	Field Station#	15401+00		
Pic 3 Desc.	Super silt fence in acceptable condition	Pic 4 Desc.	Temporary vegetative stabilization in acceptable condition		
305°NW (T) 36°54'59"N, 79°29'32"W ±669ft ▲774ft

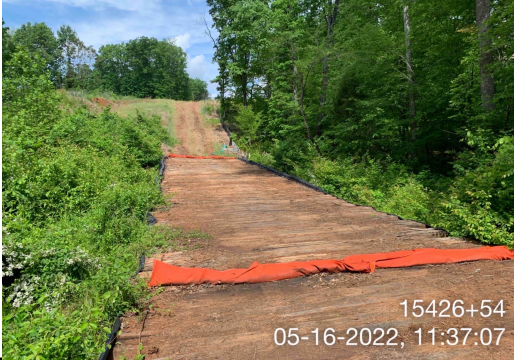
GPS Location	0	GPS Location	0		
Field Station#	15426+54	Field Station#	15404+00		
Pic 5 Desc.	Equipment bridge in acceptable condition	Pic 6 Desc.	Clean water diversion pipe and berm in acceptable conditions

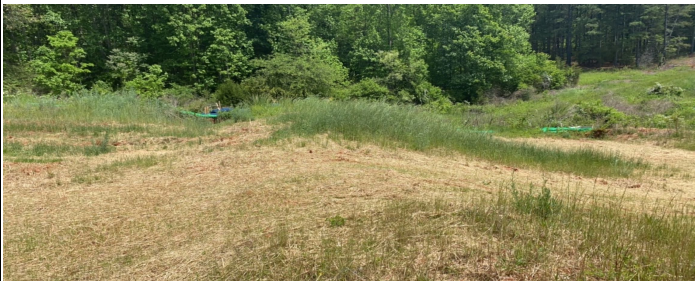
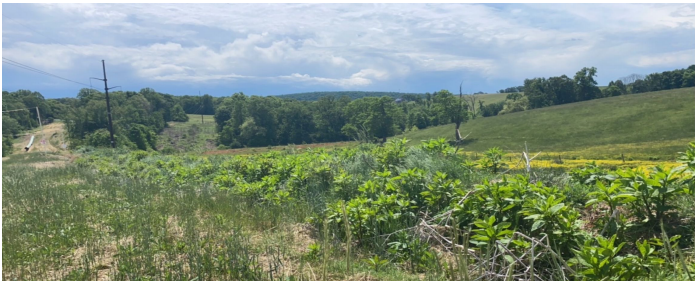
37°0'4" N 79°44'53" W 58°NE COURSE 126' GPS 05.16.2022 12:35:45 594 Tobacco Rd, Glade Hill, VA 24092, United States Accur +/-213.9 Ft ALT 919 Ft			36°59'48" N 79°44'15" W 131°SE COURSE -1' GPS 05.16.2022 12:21:29 504-798 Simmons Creek Rd, Union Hall, VA 24176, United States Accur +/-21.8 Ft ALT 916 Ft		
GPS Location	5	GPS Location	6		
Field Station#	14585+00	Field Station#	14605+00		
Pic 5 Desc.	Water bar performing intended function.		Pic 6 Desc.	Temporary diversion berm stabilized and vegetated.

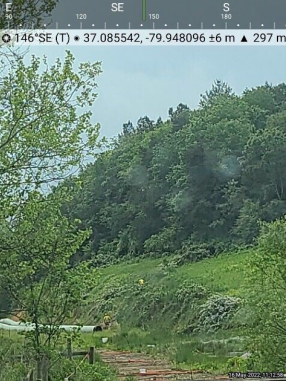
GPS Location	0000	GPS Location	0000		
Field Station#	13697+00	Field Station#	13678+71		
Pic 1 Desc.	During row inspection today the EI observed the environmental crew hand cutting small trees under 3" from areas of the row.		Pic 2 Desc.	Monitored ECDs at stream crossings during routine inspection, no issues were observed at the time of inspection.

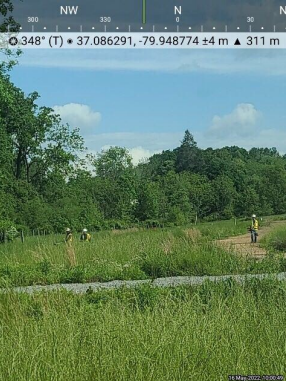
GPS Location	0000	GPS Location	0000		
Field Station#	13687+50	Field Station#	13743+30		
Pic 3 Desc.	During row inspection today the EI observed the environmental crew hand cutting small trees under 3" from areas of the row.		Pic 4 Desc.	Observed perimeter ECDs along the row edge during routine inspection. All in place and functioning at the time of inspection.

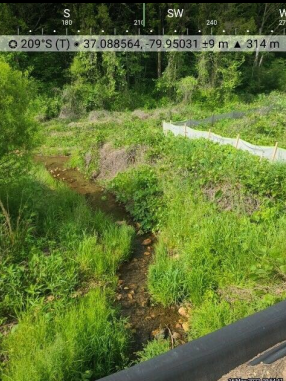
GPS Location	0000	GPS Location	0000		
Field Station#	13678+71	Field Station#	13674+00		
Pic 5 Desc.	Stream observation photo facing downstream during routine inspection today. No issues were observed at the time of inspection.		Pic 6 Desc.	Vegetation observation photo taken during routine inspection. No issues were observed at the time of inspection.

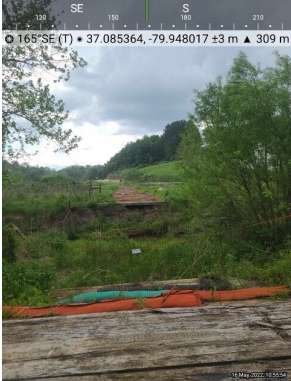
<div style="text-align: center;">Insert image here</div>			
GPS Location	0000	GPS Location			
Field Station#	13692+64	Field Station#			
Pic 7 Desc.	During inspection today the EI observed the location of Avian bird survey where a section of row was marked off to protect a nesting		Pic 8 Desc.		
<div style="text-align: center;">Insert image here</div>		<div style="text-align: center;">Insert image here</div>			
GPS Location		GPS Location			
Field Station#		Field Station#			
Pic 9 Desc.		Pic 10 Desc.			
<div style="text-align: center;">Insert image here</div>		<div style="text-align: center;">Insert image here</div>			
GPS Location		GPS Location			
Field Station#		Field Station#			
Pic 11 Desc.		Pic 12 Desc.

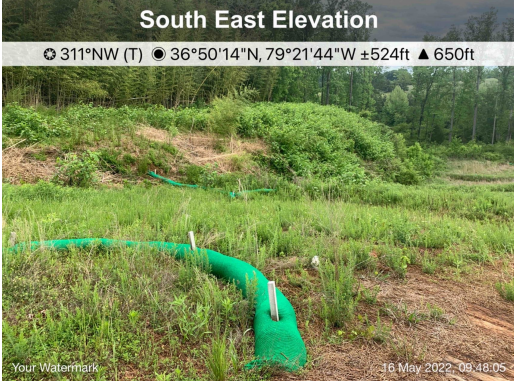
GPS Location	O	GPS Location	O		
Field Station#	15946+00	Field Station#	15836+00		
Pic 1 Desc.	Observing temporary stabilization,CFS check and water bar.	Pic 2 Desc.	Observing temporary stabilization,rock drain and ECD's		
South East Elevation 333°NW (T) 36°51'20"N, 79°23'35"W ±154ft ▲845ft

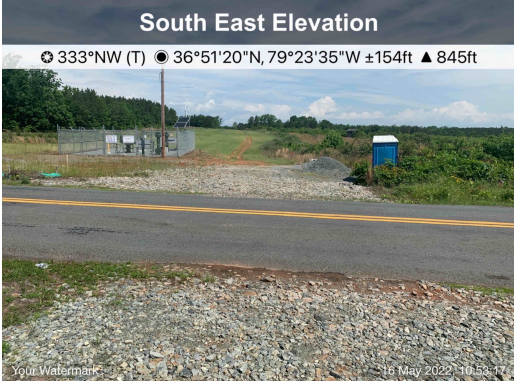
GPS Location	O	GPS Location	O		
Field Station#	15826+77	Field Station#	15825+00		
Pic 3 Desc.	Observing road crossing and RCE's	Pic 4 Desc.	Observing temporary stabilization,plunge pool and ECD's		
South East Elevation 294°NW (T) 36°51'6"N, 79°23'8"W ±4360ft ▲786ft

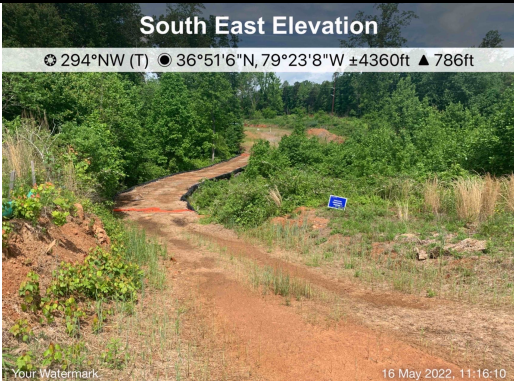
GPS Location	O	GPS Location	O		
Field Station#	15852+88	Field Station#	15774+00		
Pic 5 Desc.	Observing temporary stabilization, signage, buffer, equipment crossing and ECD's	Pic 6 Desc.	Observing temporary stabilization, sump and end treatment

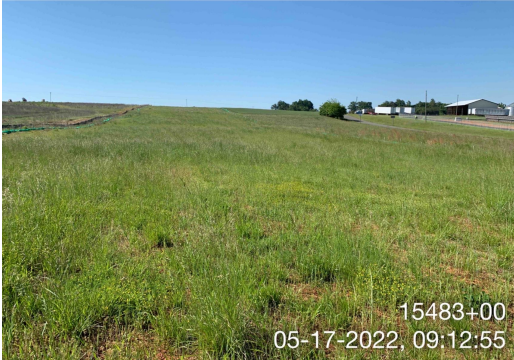
<p>15483+00 05-17-2022, 09:12:55</p>

<p>15517+00 05-17-2022, 10:02:03</p>		
GPS Location	0		GPS Location	0	
Field Station#	15483+00		Field Station#	15517+00	
Pic 1 Desc.	Permanent vegetative stabilization in acceptable condition		Pic 2 Desc.	Temporary vegetative stabilization in acceptable condition

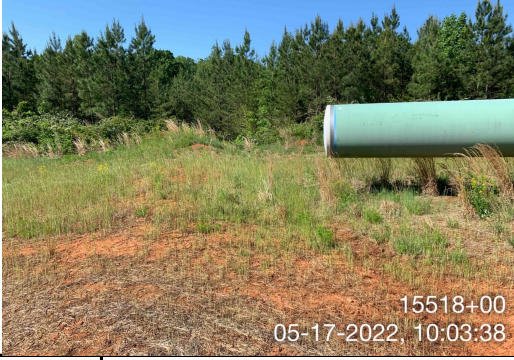
<p>15518+00 05-17-2022, 10:03:38</p>

<p>15518+00 05-17-2022, 10:04:00</p>		
GPS Location	0		GPS Location	0	
Field Station#	15518+00		Field Station#	15518+00	
Pic 3 Desc.	Waterbar in acceptable condition		Pic 4 Desc.	Waterbar end treatment in acceptable condition

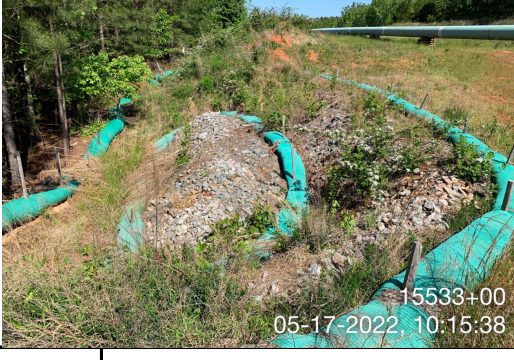
<p>15533+00 05-17-2022, 10:15:38</p>

<p>15532+00 05-17-2022, 10:42:34</p>		
GPS Location	0		GPS Location	0	
Field Station#	15533+00		Field Station#	15532+00	
Pic 5 Desc.	Clean water diversion pipe and CFS in acceptable conditions		Pic 6 Desc.	Clean water diversion berm and temporary vegetative stabilization in acceptable conditions

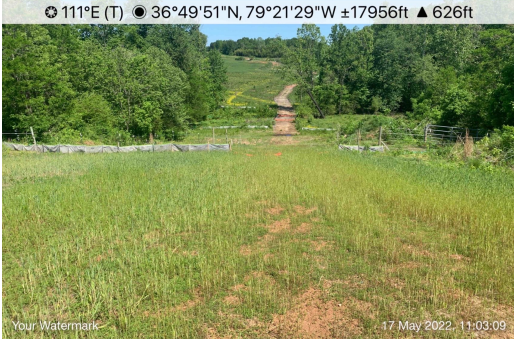
<small>Your Watermark 17 May 2022 10:57:42</small>			
GPS Location	O	GPS Location	O		
Field Station#	15964+50	Field Station#	15977+35		
Pic 1 Desc.	Observing temporary stabilization,equipment crossing and ECD's	Pic 2 Desc.	Observing temporary stabilization,water bar,signage, buffer, equipment crossing and ECD's		
North West Elevation 153°SE (T) 36°49'52"N, 79°21'27"W ±2145ft ▲640ft

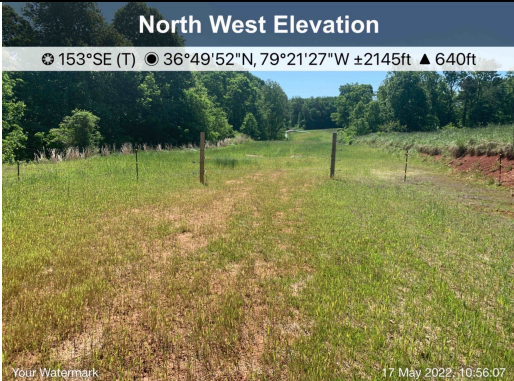
Pic 3 Desc.	Observing temporary stabilization CWD berm and fencing	Pic 4 Desc.	Observing temporary stabilization,CWD outlet and ECD's		
East Elevation 267°W (T) 36°49'55"N, 79°21'31"W ±13ft ▲640ft

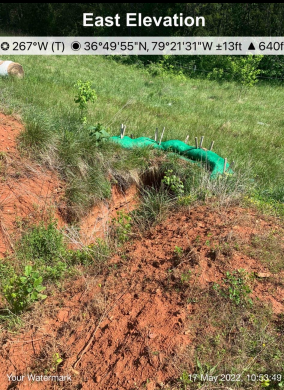
<small>Your Watermark 17 May 2022 10:52:48</small>			
GPS Location	O	GPS Location	O		
Field Station#	15967+00	Field Station#	15970+00		
Pic 5 Desc.	Observing temporary stabilization, sump and end treatment	Pic 6 Desc.	Observing temporary stabilization and CWD berm

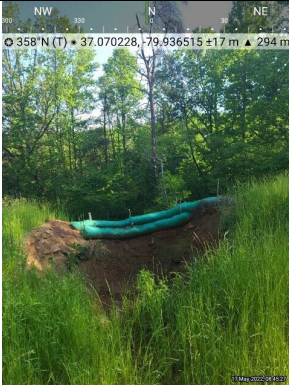
GPS Location	0000	GPS Location	0000		
Field Station#	13772+02	Field Station#	13803+67		
Pic 1 Desc.	Monitored sump pit and end treatment, all functioning properly at the time of inspection.		Pic 2 Desc.	Monitored sump pit and end treatment, all functioning properly at the time of inspection.

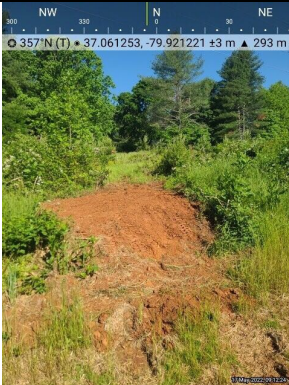
GPS Location	0000	GPS Location	0000		
Field Station#	13844+65	Field Station#	13844+65		
Pic 3 Desc.	3rd party disturbance to top soil pile, recommended stabilizing the disturbed area.		Pic 4 Desc.	3rd party disturbance to top soil pile, recommended stabilizing the disturbed area.

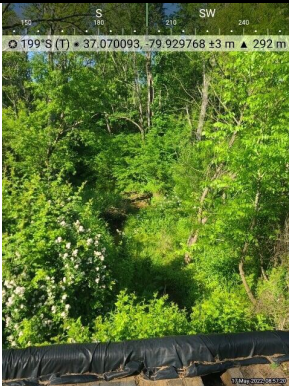
GPS Location	0000	GPS Location	0000		
Field Station#	13794+57	Field Station#	13794+57		
Pic 5 Desc.	Stream observation photo facing upstream during routine inspection. No issues observed at the time of inspection.		Pic 6 Desc.	Stream observation photo facing downstream during routine inspection today. No environmental issues observed at the time of inspection.

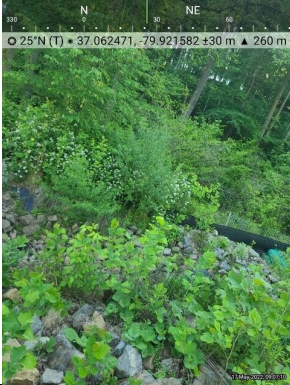
GPS Location	0000	GPS Location	0000		
Field Station#	13840+20	Field Station#	13816+60		
Pic 7 Desc.	Clean water diversion pipe and plunge pool observed during routine inspection. All functioning at the time of inspection.	Pic 8 Desc.	Clean water diversion pipe and ECDs monitored during routine inspection, no issues observed at the time of inspection.		
Insert image here		Insert image here			
GPS Location		GPS Location			
Field Station#		Field Station#			
Pic 9 Desc.		Pic 10 Desc.			
Insert image here		Insert image here			
GPS Location		GPS Location			
Field Station#		Field Station#			
Pic 11 Desc.		Pic 12 Desc.

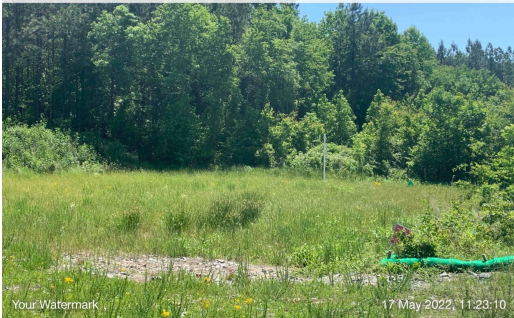
<small>Your Watermark 17 May 2022, 11:23:57</small>		
GPS Location	O		GPS Location	O	
Field Station#	14+00		Field Station#	22+00	
Pic 1 Desc.	Observing temporary stabilization,RCE, signage, buffer and ECD's		Pic 2 Desc.	Observing temporary stabilization, signage and buffer	
West Elevation ☺ 104°E (T) ● 36°50'6"N, 79°20'23"W ±13ft ▲ 651ft

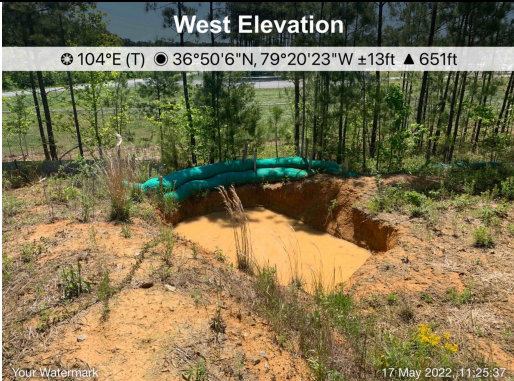
<small>Your Watermark 17 May 2022, 11:25:46</small>		
GPS Location	O		GPS Location	O	
Field Station#	12+00		Field Station#	8+00	
Pic 3 Desc.	Observing temporary stabilization, sump and end treatment		Pic 4 Desc.	Observing temporary stabilization and water bar

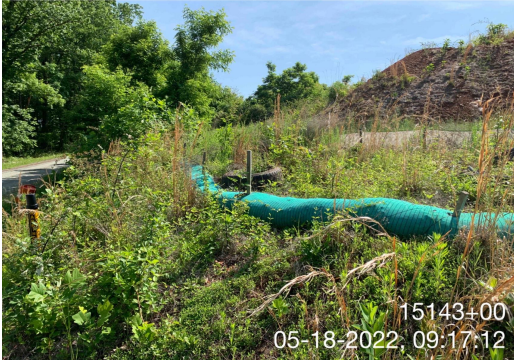
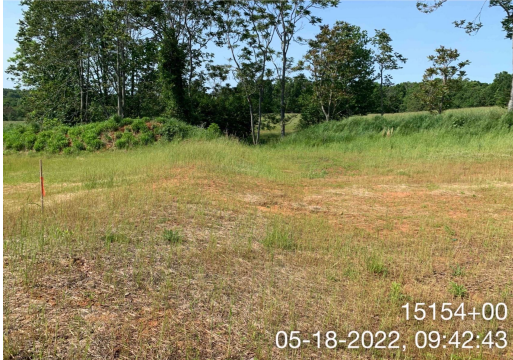
GPS Location	0	GPS Location	0		
Field Station#	15143+00	Field Station#	15154+00		
Pic 1 Desc.	CFS in acceptable condition	Pic 2 Desc.	Waterbar in acceptable condition

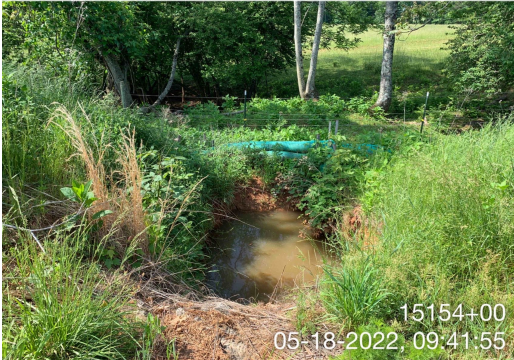
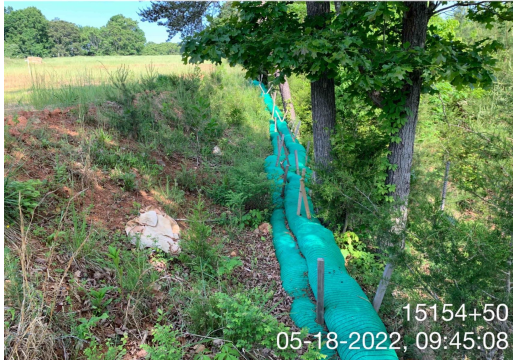
GPS Location	0	GPS Location	0		
Field Station#	15154+00	Field Station#	15154+50		
Pic 3 Desc.	Waterbar end treatment in acceptable condition	Pic 4 Desc.	Perimeter CFS in acceptable condition

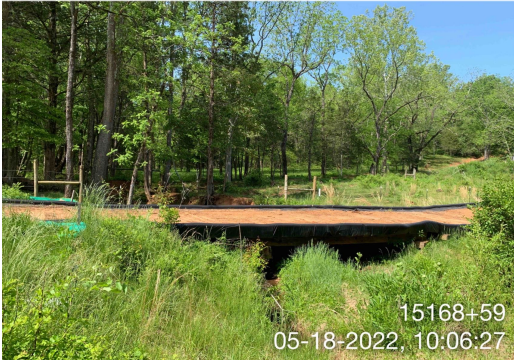
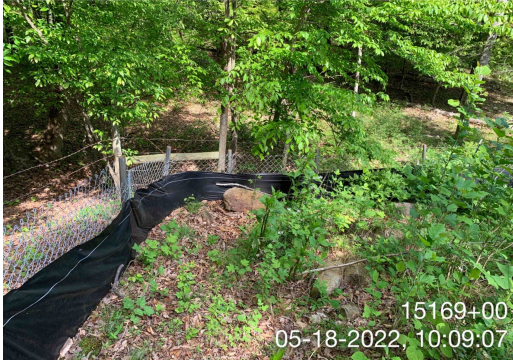
GPS Location	0	GPS Location	0		
Field Station#	15168+59	Field Station#	15169+00		
Pic 5 Desc.	Equipment bridge in acceptable condition	Pic 6 Desc.	Super silt fence in acceptable condition

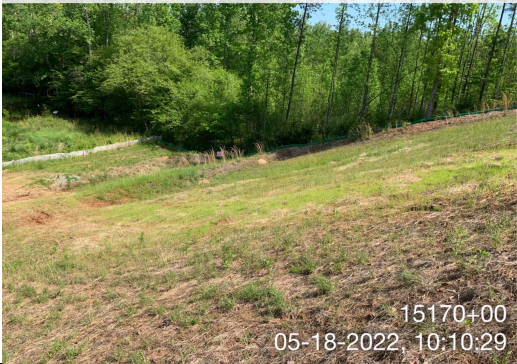
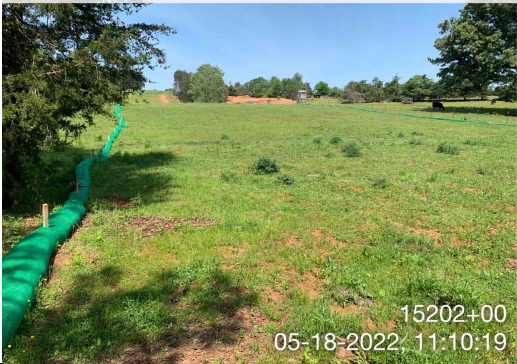
15202+00 05-18-2022, 11:10:19			
GPS Location	0	GPS Location	0		
Field Station#	15170+00	Field Station#	15202+00		
Pic 7 Desc.	Temporary vegetative stabilization in acceptable condition	Pic 8 Desc.	Permanent vegetative stabilization and perimeter CFS in acceptable conditions		
178°S (T) 36°56'23"N, 79°33'27"W ±52ft ▲848ft

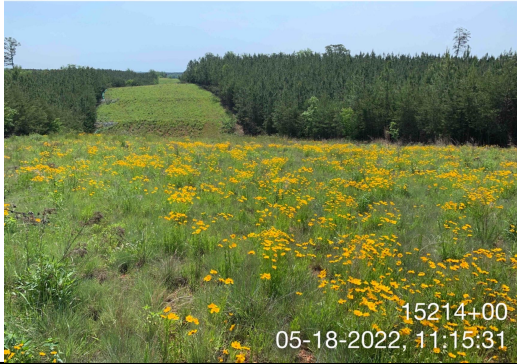
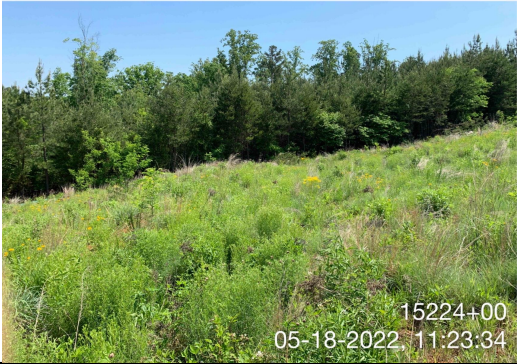
15224+00 05-18-2022, 11:23:34			
GPS Location	0	GPS Location	0		
Field Station#	15214+00	Field Station#	15224+00		
Pic 9 Desc.	Permanent vegetative stabilization in acceptable condition	Pic 10 Desc.	Waterbar in acceptable condition		
40°NE (T) 36°56'18"N, 79°33'15"W ±26ft ▲819ft

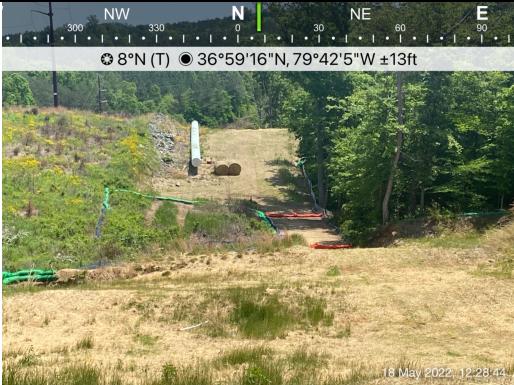
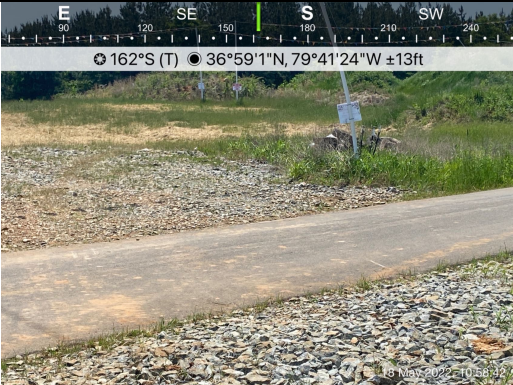
GPS Location	0	GPS Location	0		
Field Station#	14766+11	Field Station#	14758+00		
Pic 3 Desc.	Approximately 14766+11. Overview of stream crossing, equipment bridge and ECDs at stream S-MM44.		Pic 4 Desc.	Approximately 14758+00. Overview of road crossing and RCEs.

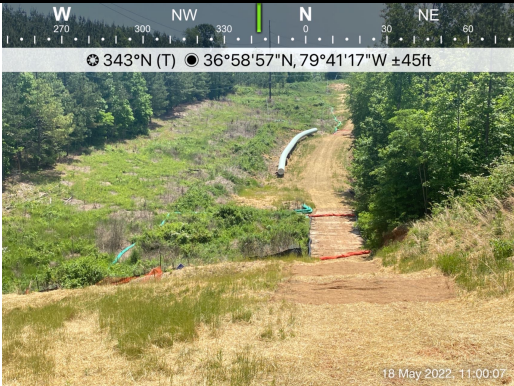
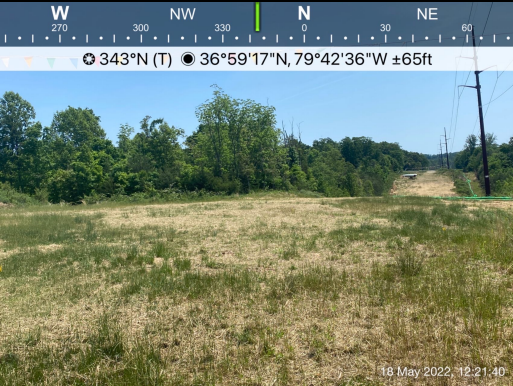
GPS Location	0	GPS Location	0		
Field Station#	14722+60	Field Station#	14698+00		
Pic 5 Desc.	Approximately 14722+60. Overview of stream crossing, equipment bridge and ECDs at stream S-A18.		Pic 6 Desc.	Approximately 14698+00. Overview of ROW.

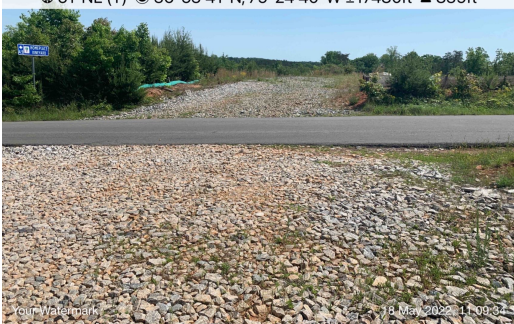
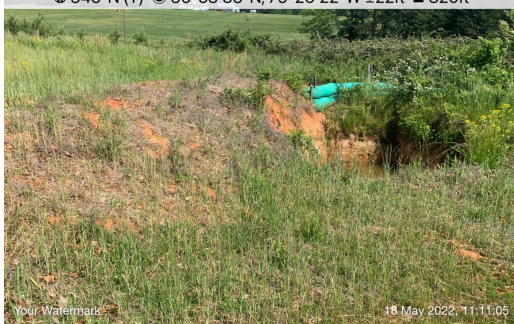
GPS Location	O	GPS Location	O		
Field Station#	15619+48	Field Station#	15616+00		
Pic 1 Desc.	Observing road crossing and RCE's	Pic 2 Desc.	Observing temporary stabilization, water bar, sump and end treatment		
	South Elevation 340°N (T) 36°53'33"N, 79°26'23"W ±13ft ▲ 817ft

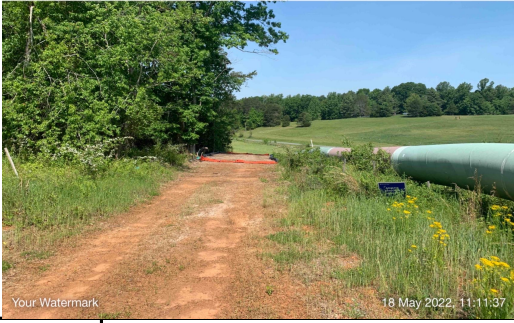
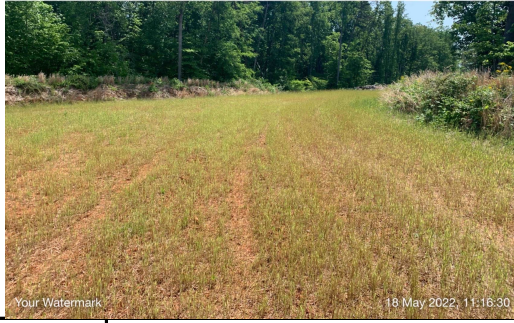
GPS Location	O	GPS Location	O		
Field Station#	15614+94	Field Station#	15627+00		
Pic 3 Desc.	Observing temporary stabilization, signage, buffer, equipment crossing and ECD's	Pic 4 Desc.	Observing temporary stabilization and CWD berm		
	North Elevation 170°S (T) 36°53'35"N, 79°26'9"W ±734ft ▲ 809ft

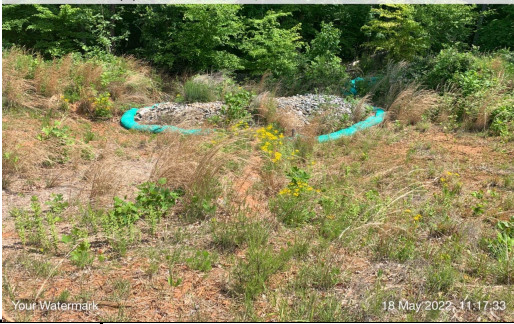
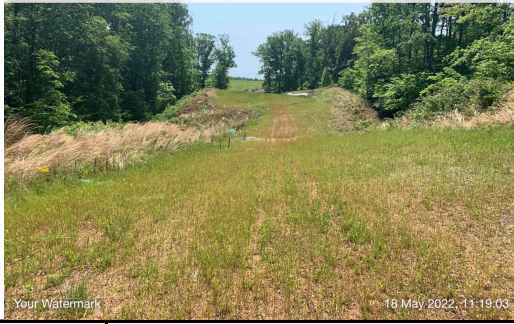
GPS Location	O	GPS Location	O		
Field Station#	15630+00	Field Station#	15633+00		
Pic 5 Desc.	Observing temporary stabilization, CWD outlet and ECD's	Pic 6 Desc.	Observing temporary stabilization, water bars and ECD's

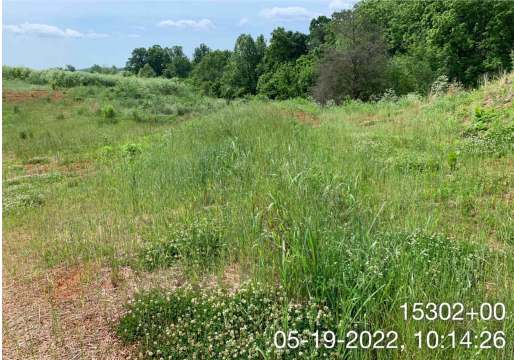
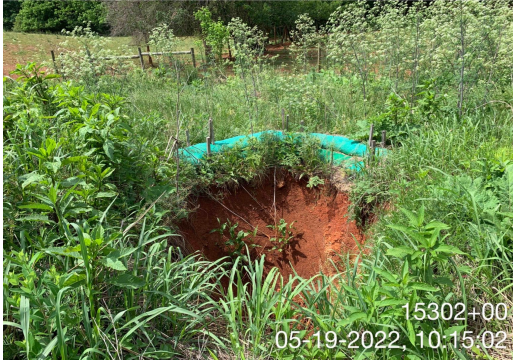
15302+00 05-19-2022, 10:15:02			
GPS Location	0	GPS Location	0		
Field Station#	15302+00	Field Station#	15302+00		
Pic 1 Desc.	Waterbar in acceptable condition		Pic 2 Desc.	Waterbar end treatment in acceptable condition	
147°SE (T) 36°55'51"N, 79°31'41"W ±623ft ▲ 781ft

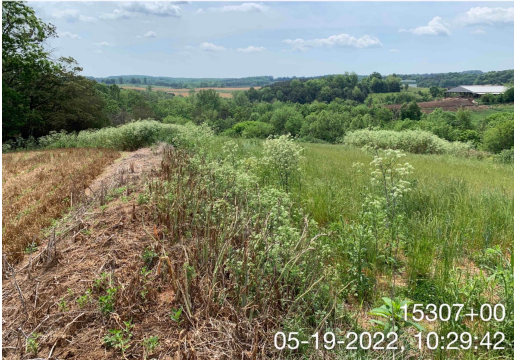
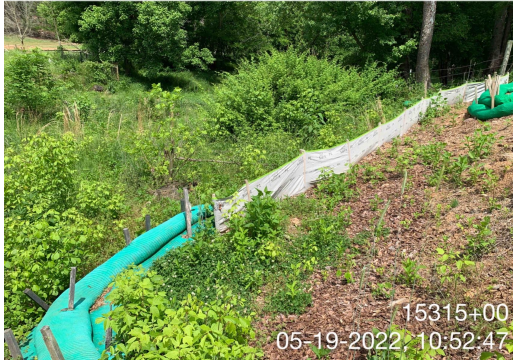
15315+00 05-19-2022, 10:52:47			
GPS Location	0	GPS Location	0		
Field Station#	15307+00	Field Station#	15315+00		
Pic 3 Desc.	Clean water diversion berm and temporary vegetative stabilization in acceptable conditions		Pic 4 Desc.	CFS and P1 silt fence in acceptable conditions	
65°NE (T) 36°55'47"N, 79°31'35"W ±26ft ▲ 664ft

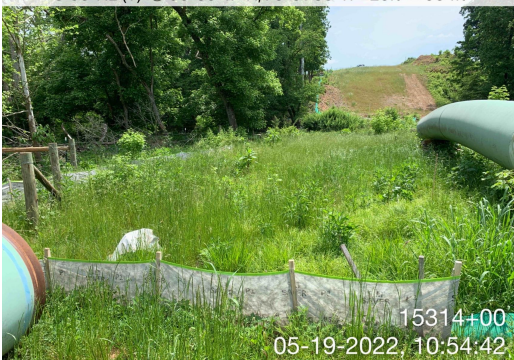
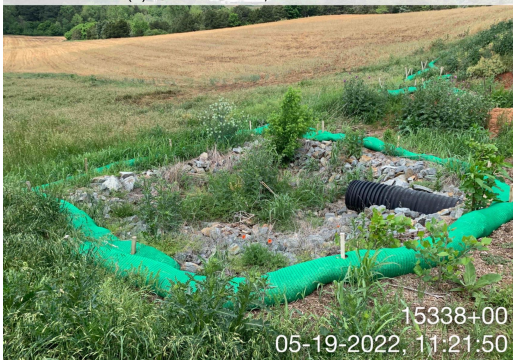
GPS Location	0	GPS Location	0		
Field Station#	15314+00	Field Station#	15338+00		
Pic 5 Desc.	P1 silt fence and sensitive resource buffer in acceptable conditions		Pic 6 Desc.	Clean water diversion pipe and plunge pool in acceptable conditions

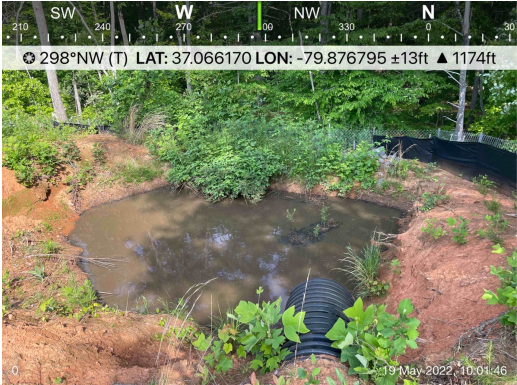
<p>298°NW (T) LAT: 37.066170 LON: -79.876795 ±13ft ▲ 1174ft</p> <p>19 May 2022, 10:01:46</p>		<p style="text-align: center;">Insert image here</p>			
GPS Location	See photo		GPS Location		
Field Station#	14053+00		Field Station#		
Pic 15 Desc.	Slope drain is in good condition and functioning.		Pic 16 Desc.		
<p style="text-align: center;">Insert image here</p>			<p style="text-align: center;">Insert image here</p>		
GPS Location			GPS Location

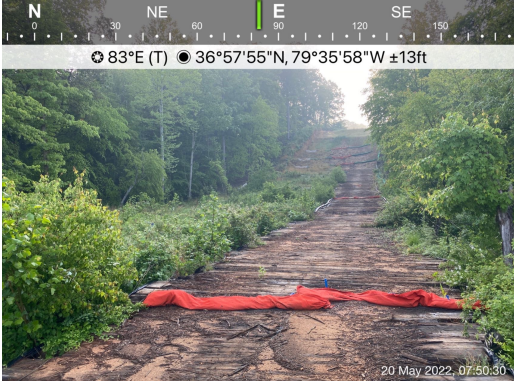
GPS Location	0	GPS Location	0		
Field Station#	15045+00	Field Station#	14981+25		
Pic 3 Desc.	Approximately 15045+00. Overview of stream crossing, equipment bridge and ECDs at stream S-D2.		Pic 4 Desc.	Approximately 14981+25. Overview of road crossing and RCEs.

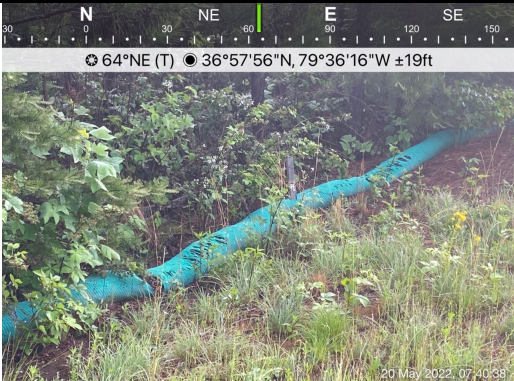
GPS Location	0	GPS Location	0		
Field Station#	15028+60	Field Station#	15028+70		
Pic 5 Desc.	Approximately 15028+60. CFS at resource buffer requires maintenance.		Pic 6 Desc.	Approximately 15028+70. P-1 requires maintenance.

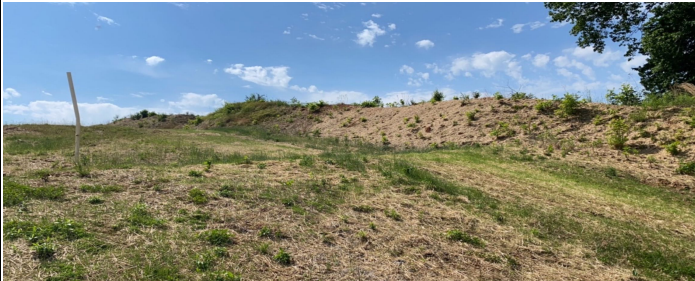
37°01' N 79°44'31" W 183°S COURSE 100° GPS Glade Hill, VA 24092, United States 05.20.2022 10:43:57 Accur +/-113.6 Ft ALT 884 Ft			36°59'51" N 79°44'20" W 353°N COURSE 53° GPS 753 Simmons Creek Rd, Union Hall, VA 24176, United States 05.20.2022 10:27:44 Accur +/-263.0 Ft ALT 948 Ft		
GPS Location	5	GPS Location	6		
Field Station#	14586+00	Field Station#	14595+00		
Pic 5 Desc.	Temporary diversion berm stabilized and vegetated; water bars performing intended functions.	Pic 6 Desc.	ROW stabilized and vegetated in temporary area.

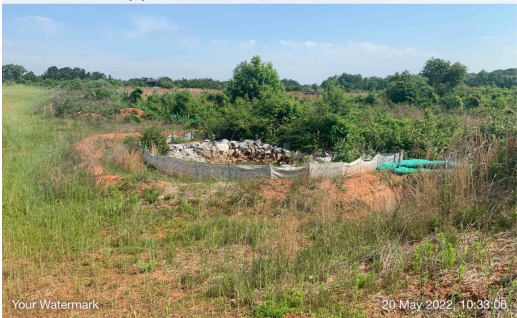
Insert image here			
GPS Location	O	GPS Location			
Field Station#	15825+00	Field Station#			
Pic 7 Desc.	Observing temporary stabilization,plunge pool and ECD's	Pic 8 Desc.			
Insert image here		Insert image here			
GPS Location		GPS Location			
Field Station#		Field Station#			
Pic 9 Desc.		Pic 10 Desc.			
Insert image here		Insert image here			
GPS Location		GPS Location			
Field Station#		Field Station#			
Pic 11 Desc.		Pic 12 Desc.

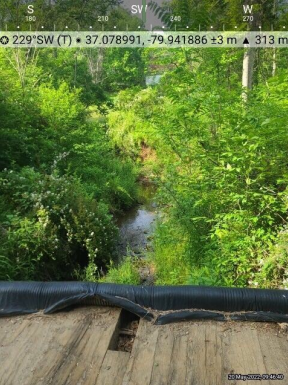
GPS Location	0000	GPS Location	0000		
Field Station#	13728+11	Field Station#	13672+90		
Pic 1 Desc.	Stream observation photo facing downstream during routine inspection today, no issues observed at the time of inspection.	Pic 2 Desc.	CFS requires maintenance, documented and added to the punch list for repairs.

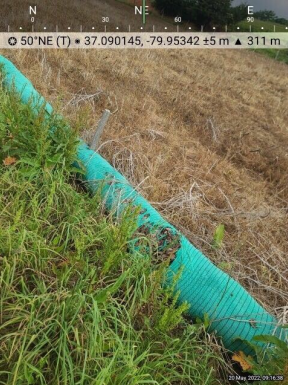
GPS Location	0000	GPS Location	0000		
Field Station#	13670+00	Field Station#	13670+40		
Pic 3 Desc.	CFS requires maintenance, documented and added to the punch list.	Pic 4 Desc.	Vegetation observation photo facing down row. No issues observed at the time of inspection.

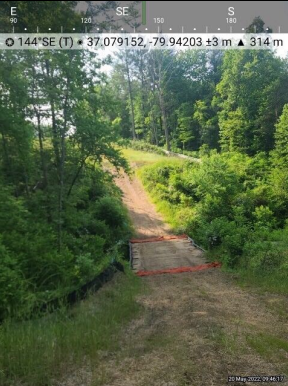
GPS Location	0000	GPS Location	0000		
Field Station#	13728+00	Field Station#	13728+11		
Pic 5 Desc.	Monitored equipment bridge and protection, ECDs in place and functioning at the time of inspection.	Pic 6 Desc.	Stream observation photo facing upstream during routine inspection, no issues observed at the time of inspection.

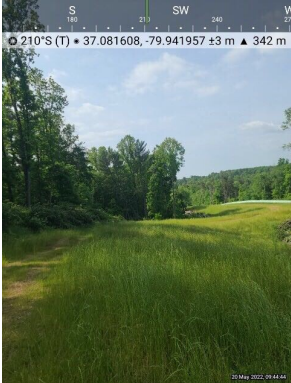
GPS Location	0000	GPS Location			
Field Station#	13717+50	Field Station#			
Pic 7 Desc.	Row photo showing vegetation during routine inspection, no issues observed at the time of inspection.	Pic 8 Desc.			
GPS Location		GPS Location			
Field Station#		Field Station#			
Pic 9 Desc.		Pic 10 Desc.			
GPS Location		GPS Location			
Field Station#		Field Station#			
Pic 11 Desc.		Pic 12 Desc.

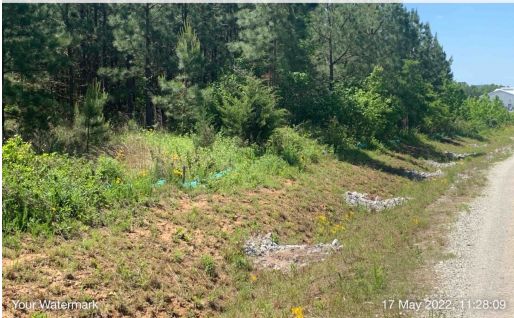
GPS Location	O	GPS Location	O		
Field Station#	00+00	Field Station#	00+00		
Pic 1 Desc.	Observing temporary stabilization,rock check dams and ECD's	Pic 2 Desc.	Observing temporary stabilization,rock drain and ECD's		
North West Elevation 127°SE (T) 36°49'57"N, 79°20'36"W ±39ft ▲648ft

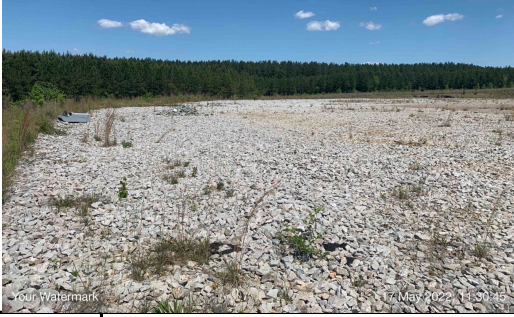
GPS Location	O	GPS Location	O		
Field Station#	00+00	Field Station#	00+00		
Pic 3 Desc.	Observing lay down yard	Pic 4 Desc.	Observing temporary stabilization and sediment basin		
West Elevation 109°E (T) 36°50'5"N, 79°20'31"W ±360ft ▲662ft

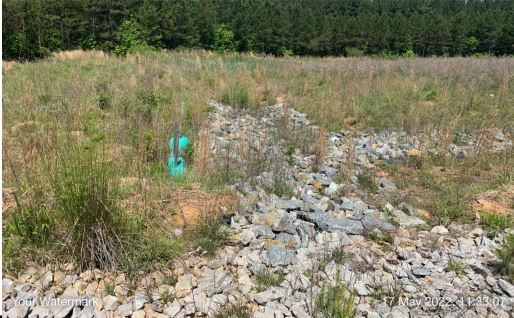
Field Station#	00+00	Field Station#	00+00		
Pic 5 Desc.	Observing temporary stabilization rock drain and ECD's	Pic 6 Desc.	Observing temporary stabilization,storm water pond and ECD's
