Visual Site Inspection Report

Project Name	H-600 Pipeline Spread I	AFE	124300139	Spread	H-600 Pipeline Spread I
Contractor	Precision			Report #	37935
Inspector	Glenn Mike Renfro			Date/Time	5/23/2022 12:15 PM
Permit #	TBD	Inspection Type	VA SWPP	Station Begin	0000+00
State	VA	Inspection Area	Full	Station End	0000+00
County	Franklin	Ground	Dry	Temperature (°F)	70.00
Municipality	N/A	Weather	Cloudy	Rain Gauge (in)	0.20
				Rain Accumulation Time (days)	6.00

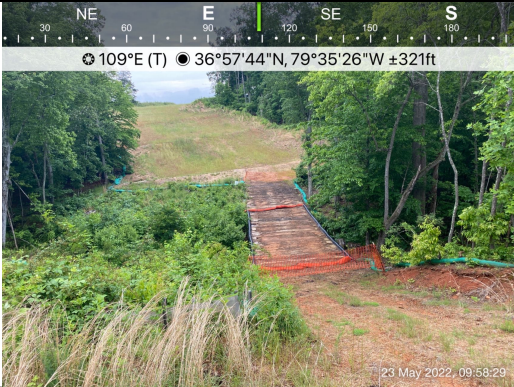
GPS Location	0	GPS Location	0		
Field Station#	15072+86	Field Station#	15113+50		
Pic 3 Desc.	Approximately 15072+86. Overview of stream crossing, equipment bridge and ECDs at stream S-G11.		Pic 4 Desc.	Approximately 15113+50. Overview of road crossing and RCEs.

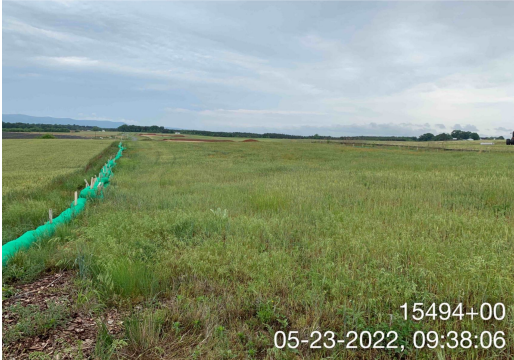
15494+00 05-23-2022, 09:38:06		⚙ 33°NE (T) ● 36°54'22"N, 79°28'27"W ±16ft ▲ 934ft

15499+00 05-23-2022, 09:49:23			
GPS Location	0	GPS Location	0		
Field Station#	15494+00	Field Station#	15499+00		
Pic 1 Desc.	Permanent vegetative stabilization and perimeter CFS in acceptable conditions	Pic 2 Desc.	Waterbar in acceptable condition		
⚙ 96°E (T) ● 36°54'22"N, 79°28'26"W ±32ft ▲ 934ft

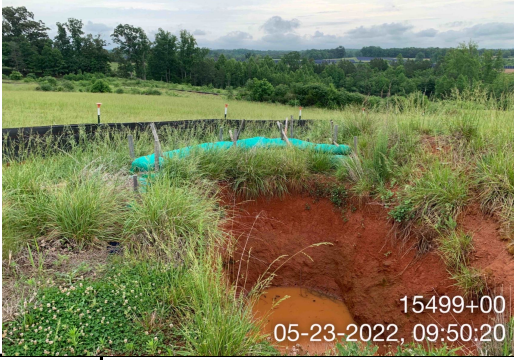
15502+00 05-23-2022, 09:53:50			
GPS Location	0	GPS Location	0		
Field Station#	15499+00	Field Station#	15502+00		
Pic 3 Desc.	Waterbar end treatment in acceptable condition	Pic 4 Desc.	Temporary vegetative stabilization in acceptable condition		
⚙ 35°NE (T) ● 36°53'58"N, 79°27'47"W ±114ft ▲ 789ft

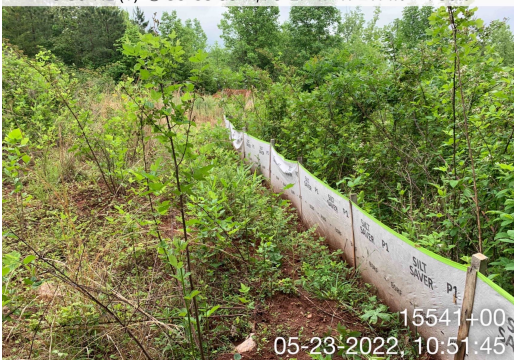
GPS Location	0	GPS Location	0		
Field Station#	15541+00	Field Station#	15496+50		
Pic 5 Desc.	P1 silt fence in acceptable condition	Pic 6 Desc.	Rock construction entrance in acceptable condition

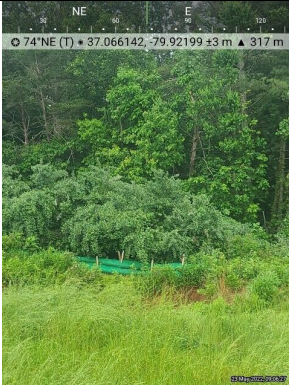
GPS Location	0000	GPS Location	0000		
Field Station#	13826+50	Field Station#	13808+65		
Pic 1 Desc.	Monitored sump pit and ECDs throughout during routine inspection. No environmental issues observed at the time of inspection.		Pic 2 Desc.	Vegetation observation photo showing good stabilization in temporary area of row.

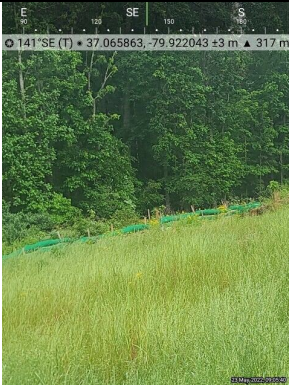
GPS Location	0000	GPS Location	0000		
Field Station#	13827+60	Field Station#	13806+00		
Pic 3 Desc.	Monitored perimeter ECDs during row inspection. No environmental issues observed at the time of inspection.		Pic 4 Desc.	Stream crossing photo showing equipment bridge and ECDs in place and functioning at the time of inspection.

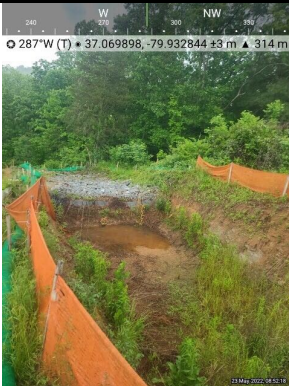
GPS Location	0000	GPS Location	0000		
Field Station#	13784+00	Field Station#	13783+67		
Pic 5 Desc.	Observed large sump pit and rock lined channel after overnight rain events. All functioning properly at the time of inspection.		Pic 6 Desc.	Stabilization photo above stream crossing observed after overnight rain events. Row conditions were saturated as rain events continued.

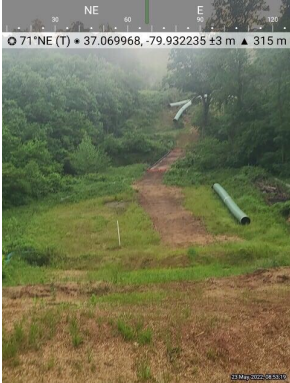
Insert image here		Insert image here	
GPS Location	0000	GPS Location			
Field Station#	13786+90	Field Station#			
Pic 7 Desc.	Row photo taken during light rain events showing stabilization on hill side above stream crossing. No environmental issues observed at the time of inspection.	Pic 8 Desc.			
Insert image here		Insert image here			
GPS Location		GPS Location			
Field Station#		Field Station#			
Pic 9 Desc.		Pic 10 Desc.			
Insert image here		Insert image here			
GPS Location		GPS Location			
Field Station#		Field Station#			
Pic 11 Desc.		Pic 12 Desc.

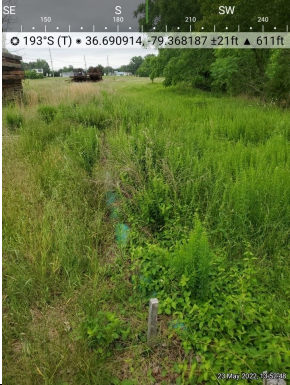
GPS Location	0	GPS Location	0		
Field Station#	0+00	Field Station#	0+00		
Pic 7 Desc.	LY-048 West perimeter CFS	Pic 8 Desc.	LY-048 North perimeter CFS		
Insert image here		Insert image here			
GPS Location		GPS Location			
Field Station#		Field Station#			
Pic 9 Desc.		Pic 10 Desc.			
Insert image here		Insert image here			
GPS Location		GPS Location			
Field Station#		Field Station#			
Pic 11 Desc.		Pic 12 Desc.

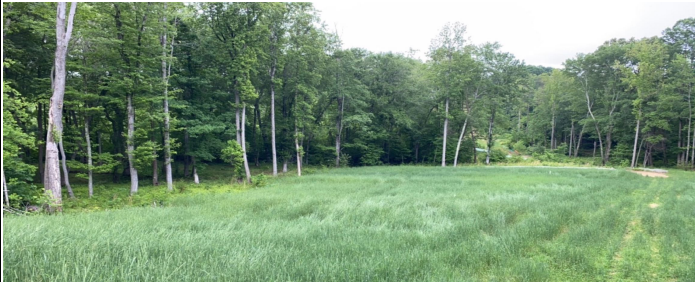
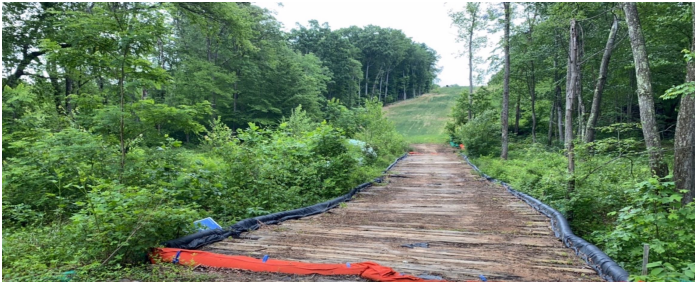
36°59'23" N 79°43'24" W 150°SE COURSE -1° GPS 05.23.2022 11:16:36 Accur +/-42.5 Ft ALT 959 Ft			36°59'22" N 79°43'21" W 143°SE COURSE 13° GPS 05.23.2022 11:18:01 Sorry no results found Accur +/-55.7 Ft ALT 931 Ft		
GPS Location	1	GPS Location	2		
Field Station#	14655+00	Field Station#	14657+00		
Pic 1 Desc.	ROW stabilized and vegetated in final cleanup area.	Pic 2 Desc.	Equipment bridge and surrounding ECDs in place and functional at stream crossing and resource buffer; signage visible and intact.

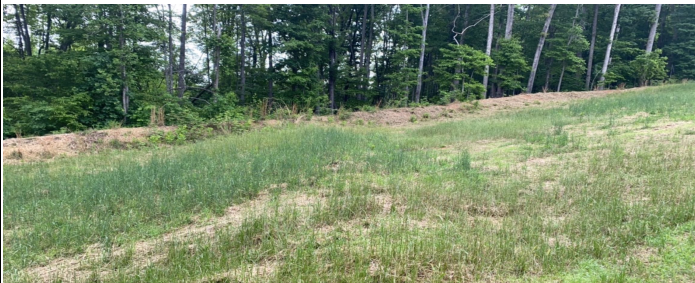
Pic 3 Desc.	Water bar performing intended function; ROW stabilized and vegetated in temporary area.	Pic 4 Desc.	Sump pit and CFS triple stack in good condition.

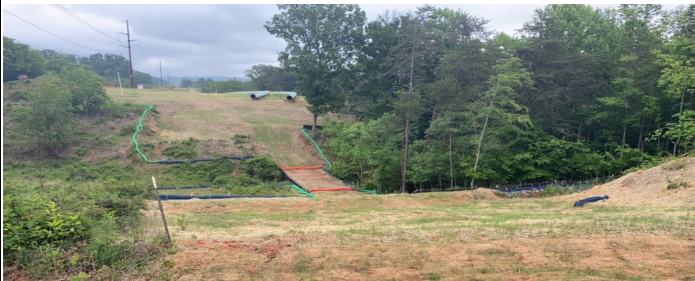
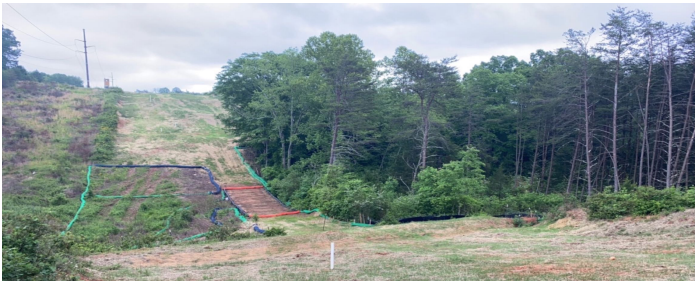
36°59'17" N 79°43'4" W 152°SE COURSE 112° GPS 05.23.2022 11:25:04 Union Hall, VA 24176, United States Accur +/-27.8 Ft ALT 979 Ft			36°59'17" N 79°42'55" W 154°SE COURSE 81° GPS 05.23.2022 11:29:33 Union Hall, VA 24176, United States Accur +/-98.6 Ft ALT 964 Ft		
GPS Location	5	GPS Location	6		
Field Station#	14673+10	Field Station#	14680+55		
Pic 5 Desc.	Equipment bridge and surrounding ECDs in place and functional at stream crossing and resource buffer; signage visible and intact.	Pic 6 Desc.	Equipment bridge and surrounding ECDs in place and functional at stream crossing and resource buffer; signage visible and intact.

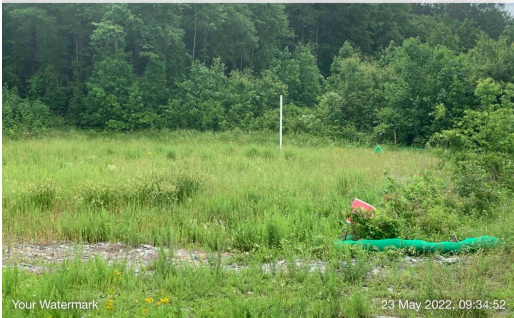
Your Watermark 23 May 2022, 09:35:51		
GPS Location	O		GPS Location	O	
Field Station#	14+00		Field Station#	22+00	
Pic 1 Desc.	Observing temporary stabilization,RCE, signage, buffer and ECD's		Pic 2 Desc.	Observing temporary stabilization	
South East Elevation 338°NW (T) 36°50'6"N, 79°20'24"W ±13ft ▲ 653ft

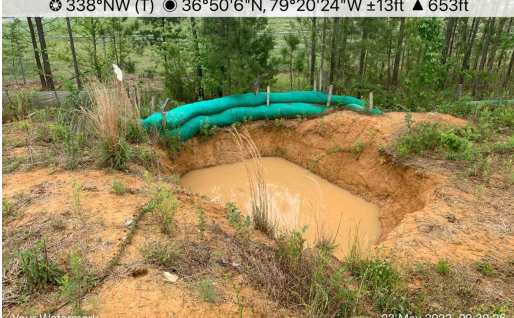
Your Watermark 23 May 2022, 09:39:38		
GPS Location	O		GPS Location	O	
Field Station#	12+00		Field Station#	6+00	
Pic 3 Desc.	Observing temporary stabilization, sump and end treatment		Pic 4 Desc.	Observing temporary stabilization and water bar	
Insert image here			Insert image here

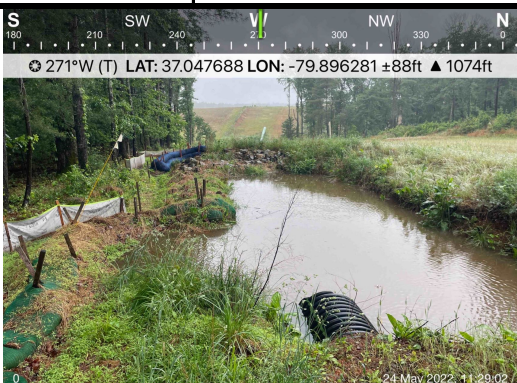
GPS Location	See photo		GPS Location	See photo	
Field Station#	13939+50		Field Station#	13955+00	
Pic 11 Desc.	SSF is in good condition		Pic 12 Desc.	Slope drain outlet is in good condition and functioning

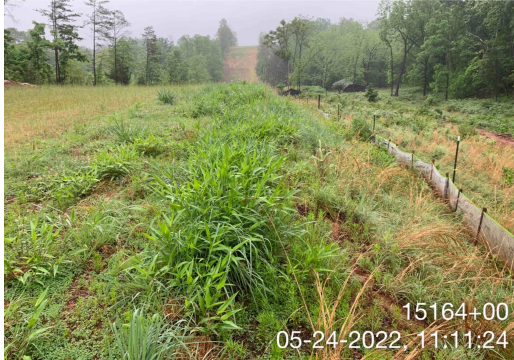
15164+00 05-24-2022, 11:11:24			
GPS Location	0	GPS Location	0		
Field Station#	15145+00	Field Station#	15164+00		
Pic 1 Desc.	Permanent vegetative stabilization in acceptable condition	Pic 2 Desc.	Temporary vegetative stabilization and perimeter P1 silt fence in acceptable conditions		
185°S (T) 36°56'41"N, 79°34'21"W ±26ft ▲779ft   15165+00 05-24-2022, 11:12:37		263°W (T) 36°56'40"N, 79°34'21"W ±22ft ▲760ft

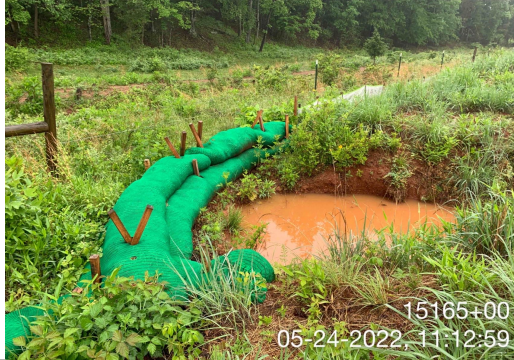
15165+00 05-24-2022, 11:12:59			
GPS Location	0	GPS Location	0		
Field Station#	15165+00	Field Station#	15165+00		
Pic 3 Desc.	Waterbar in acceptable condition	Pic 4 Desc.	Waterbar end treatment in acceptable condition		
214°SW (T) 36°53'44"N, 79°36'9"W ±2781ft ▲750ft

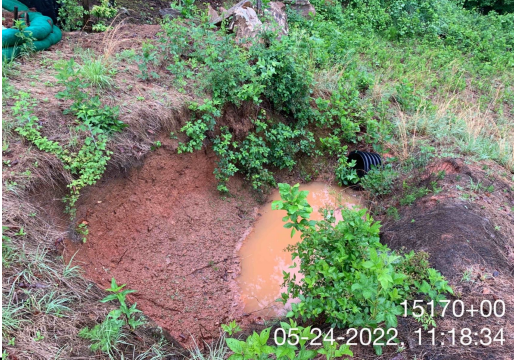
GPS Location	0	GPS Location	0		
Field Station#	15170+00	Field Station#	15170+00		
Pic 5 Desc.	Sump pit and slope drain pipe in acceptable conditions	Pic 6 Desc.	CFS and perimeter super silt fence in acceptable conditions

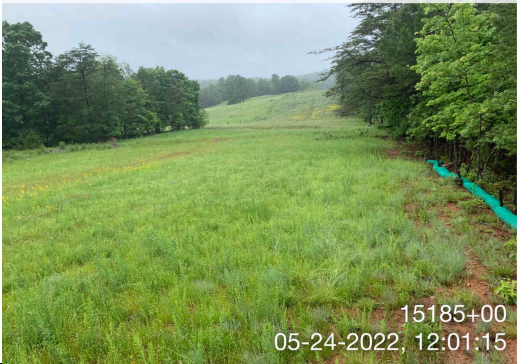
15222+00 05-24-2022, 12:45:12			
GPS Location	0	GPS Location	0		
Field Station#	15185+00	Field Station#	15222+00		
Pic 7 Desc.	Permanent vegetative stabilization and perimeter CFS in acceptable conditions		Pic 8 Desc.	Permanent vegetative stabilization in acceptable condition	
221°SW (T) 36°56'15"N, 79°33'5"W ±984ft ▲ 805ft

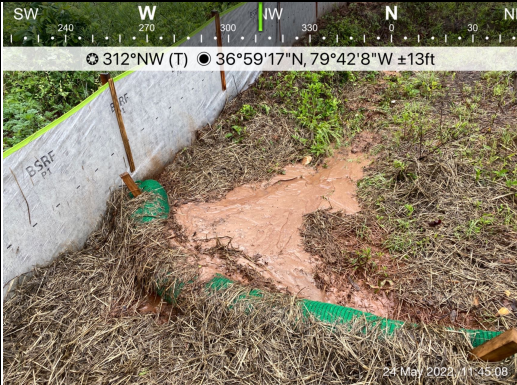
GPS Location	0		GPS Location	0	
Field Station#	14717+50		Field Station#	14717+45	
Pic 7 Desc.	Approximately 14717+50. CFS check requires maintenance. Check over 50% full of sediment due to runoff from adjacent properties land clearing and ground disturbance activities.		Pic 8 Desc.	Approximately 14717+45. P-1 requires maintenance. Fence has been undermined from off ROW runoff from adjacent properties

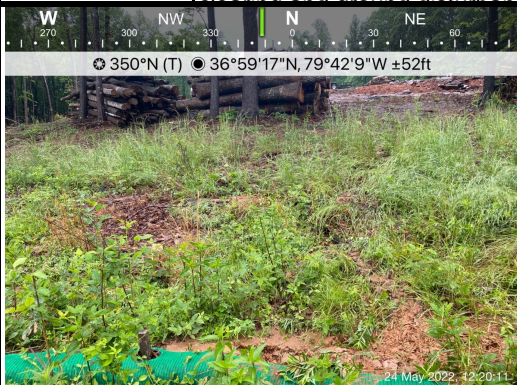
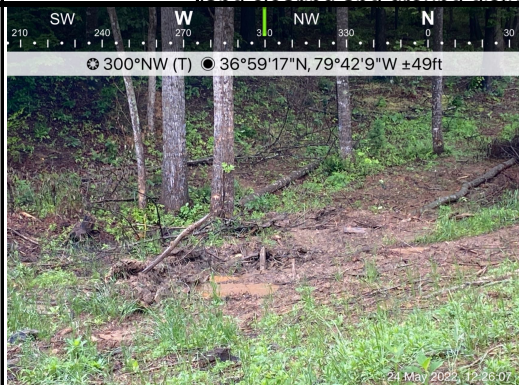
GPS Location	0		GPS Location	0	
Field Station#	14717+00		Field Station#	14716+00	
Pic 9 Desc.	Approximately 14717+00. Overview of sediment runoff from adjacent properties land clearing and ground disturbance activities. North side of ROW and backfill from method		Pic 10 Desc.	Approximately 14716+00. Overview of sediment runoff from adjacent properties land clearing and ground disturbance activities. North side of ROW and backfill from method

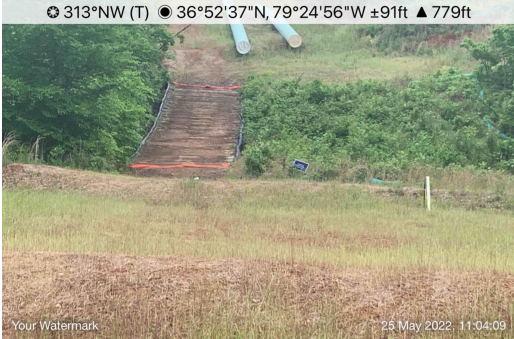
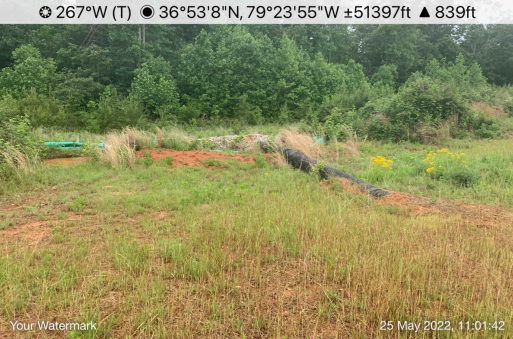
Your Watermark 25 May 2022, 11:01:42		
GPS Location	O		GPS Location	O	
Field Station#	15713+52		Field Station#	15720+00	
Pic 1 Desc.	Observing temporary stabilization, water bars, signage, buffer, equipment crossing and ECD's		Pic 2 Desc.	Observing temporary stabilization, CWD outlet and ECD's	
South East Elevation 312°NW (T) 36°52'36"N, 79°24'36"W ±2158ft ▲854ft

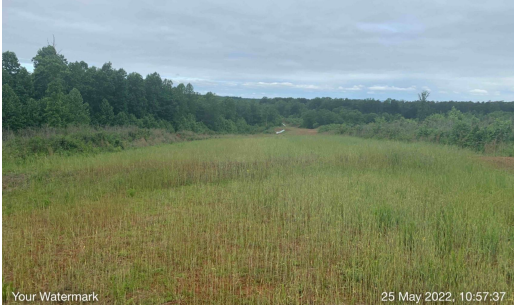
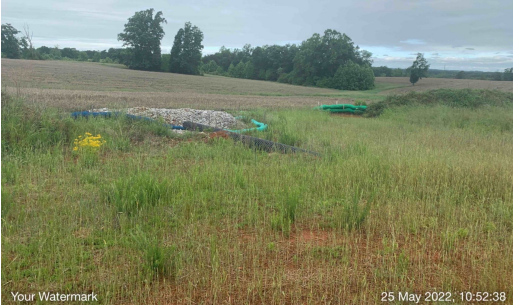
Your Watermark 25 May 2022, 10:52:38		
GPS Location	O		GPS Location	O	
Field Station#	15726+00		Field Station#	15735+00	
Pic 3 Desc.	Observing temporary stabilization and water bars		Pic 4 Desc.	Observing temporary stabilization, CWD outlet, sump and end treatment

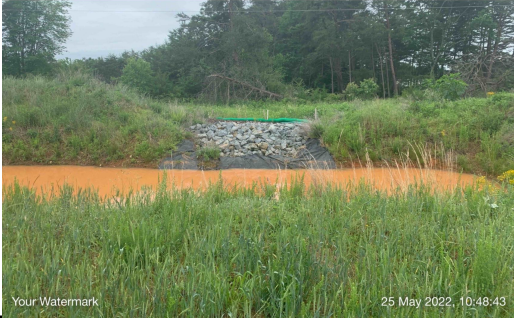
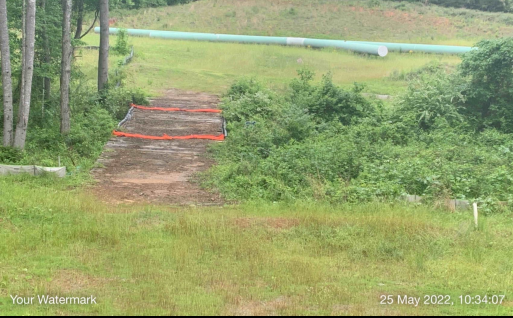
Your Watermark 25 May 2022, 10:34:07		
GPS Location	O		GPS Location	O	
Field Station#	15740+00		Field Station#	15763+80	
Pic 5 Desc.	Observing temporary stabilization, sump and end treatment		Pic 6 Desc.	Observing temporary stabilization, water bar, signage, buffer, equipment crossing and ECD's

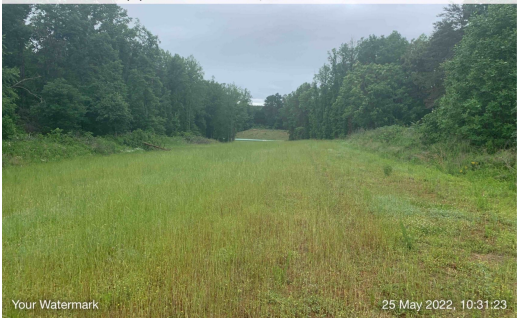
Insert image here			
GPS Location	O	GPS Location			
Field Station#	15768+00	Field Station#			
Pic 7 Desc.	Observing temporary stabilization and water bar	Pic 8 Desc.			
Insert image here		Insert image here			
GPS Location		GPS Location			
Field Station#		Field Station#			
Pic 9 Desc.		Pic 10 Desc.			
Insert image here		Insert image here			
GPS Location		GPS Location			
Field Station#		Field Station#			
Pic 11 Desc.		Pic 12 Desc.

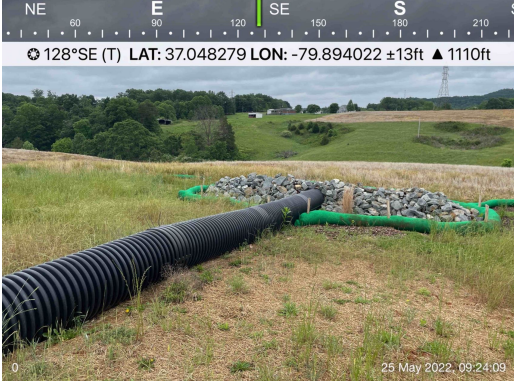
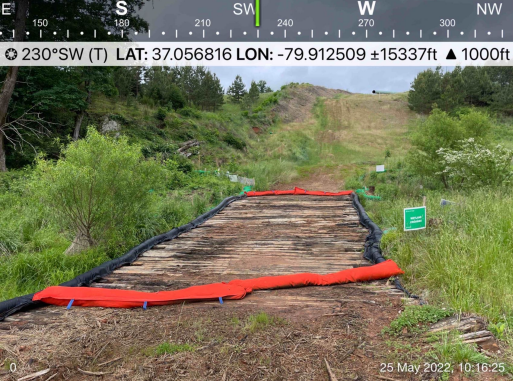
GPS Location	See photo	GPS Location	See photo		
Field Station#	13960+00	Field Station#	13991+69		
Pic 1 Desc.	CWDs are functioning as intended	Pic 2 Desc.	Equipment bridge ECDs are in good condition

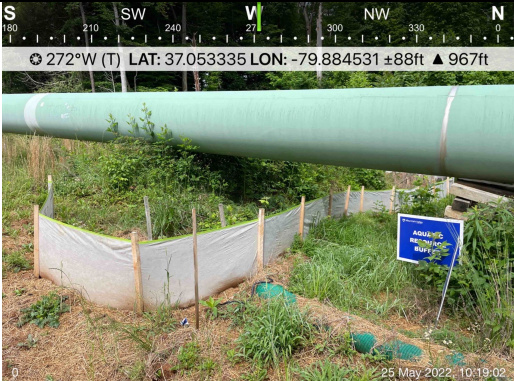
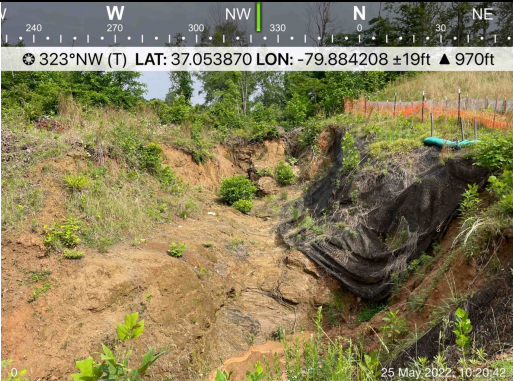
GPS Location	See photo	GPS Location	See photo		
Field Station#	13998+00	Field Station#	14000+00		
Pic 3 Desc.	P1 is in good condition at all stream and wetland buffers	Pic 4 Desc.	No evidence of 3rd party pond discharging onto ROW

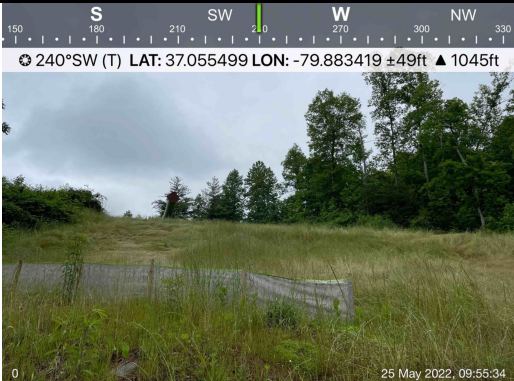
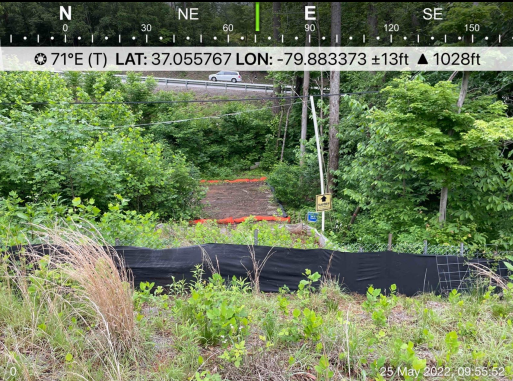
GPS Location	See photo	GPS Location	See photo		
Field Station#	14009+11	Field Station#	14009+50		
Pic 5 Desc.	Slope remains stabilized	Pic 6 Desc.	SSF is in good condition

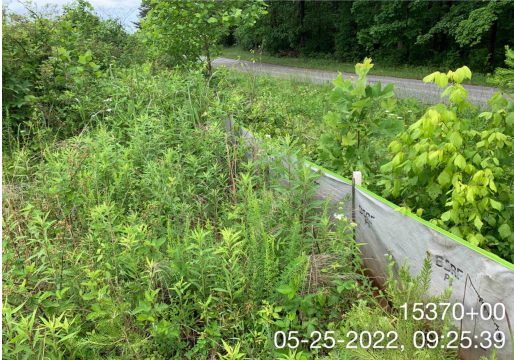
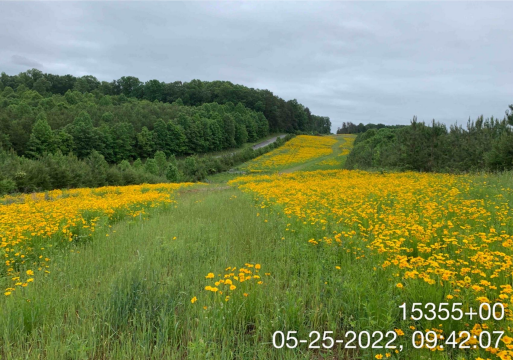
15355+00 05-25-2022, 09:42:07		
GPS Location	0		GPS Location	0	
Field Station#	15370+00		Field Station#	15355+00	
Pic 1 Desc.	P1 silt fence in acceptable condition		Pic 2 Desc.	Permanent vegetative stabilization in acceptable condition	
327°NW (T) 36°55'23"N, 79°30'51"W ±16ft ▲756ft

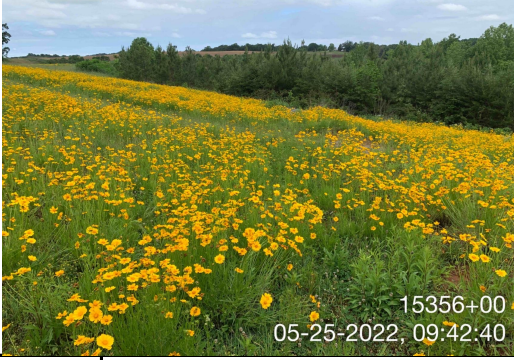
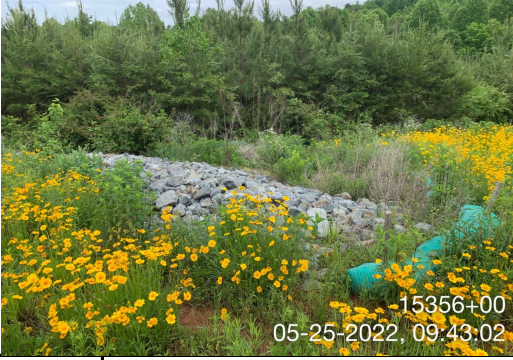
15356+00 05-25-2022, 09:43:02		
GPS Location	0		GPS Location	0	
Field Station#	15356+00		Field Station#	15356+00	
Pic 3 Desc.	Waterbar in acceptable condition		Pic 4 Desc.	Waterbar end treatment and CFS in acceptable conditions	
348°N (T) 36°55'46"N, 79°31'27"W ±32ft ▲741ft

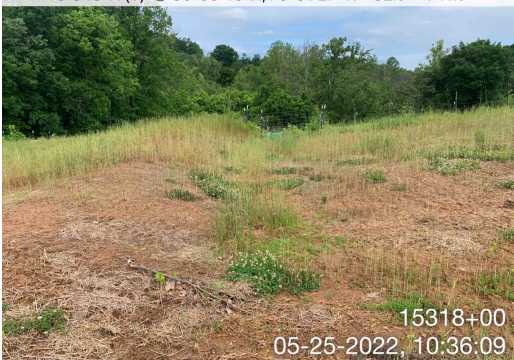
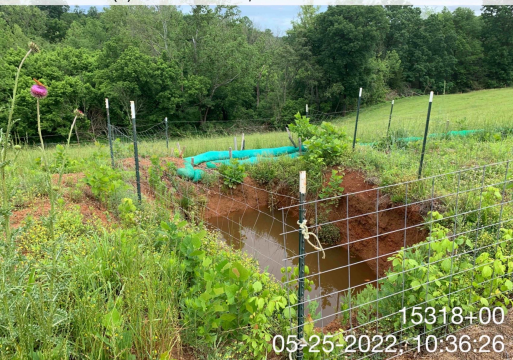
GPS Location	0		GPS Location	0	
Field Station#	15318+00		Field Station#	15318+00	
Pic 5 Desc.	Waterbar in acceptable condition		Pic 6 Desc.	Waterbar end treatment in acceptable condition

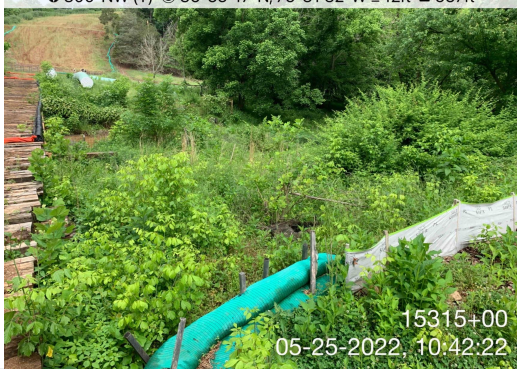
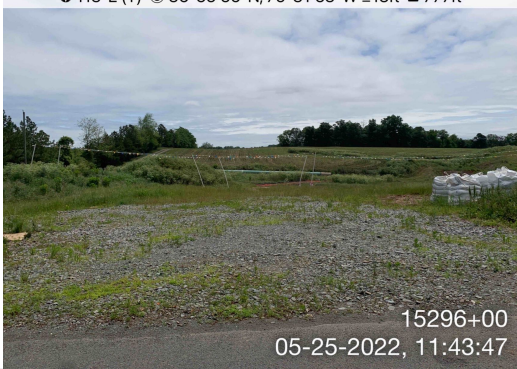
GPS Location	0	GPS Location	0		
Field Station#	15315+00	Field Station#	15296+00		
Pic 9 Desc.	P1 silt fence and sensitive resource buffer in acceptable conditions		Pic 10 Desc.	Rock construction entrance in acceptable condition	
Insert image here			Insert image here		
GPS Location		GPS Location			
Field Station#		Field Station#			
Pic 11 Desc.		Pic 12 Desc.

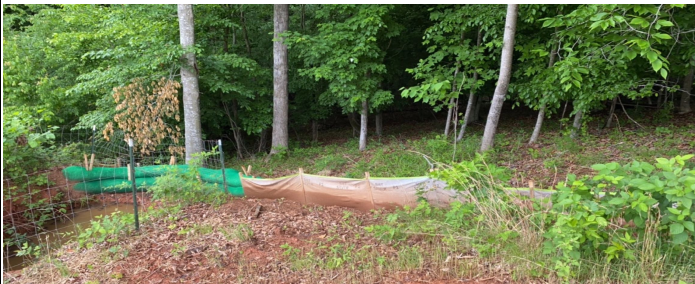
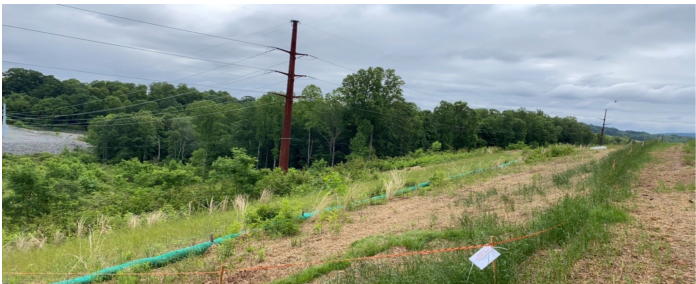
37°1'11" N 79°45'44" W 260°W COURSE 185° GPS Glade Hill, VA 24092, United States 05.25.2022 09:38:57 Accur +/-15.5 Ft ALT 922 Ft			37°1'34" N 79°46'3" W 165°S COURSE 175° GPS 2750 Webster Rd, Glade Hill, VA 24092, United States 05.25.2022 09:27:10 Accur +/-31.5 Ft ALT 1107 Ft		
GPS Location	1	GPS Location	2		
Field Station#	14485+00	Field Station#	14458+00		
Pic 1 Desc.	Routine maintenance. Replace row of P1 silt fence beyond effective lifespan.		Pic 2 Desc.	Sensitive resource area marked and staked off along ROW.

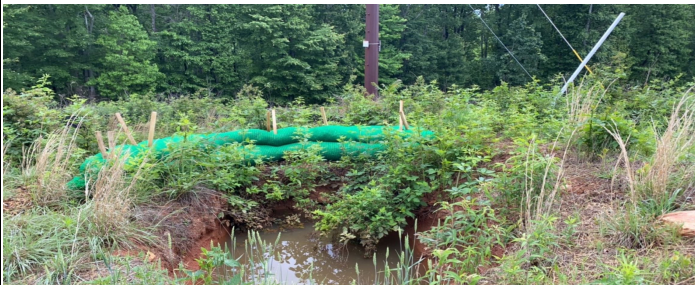
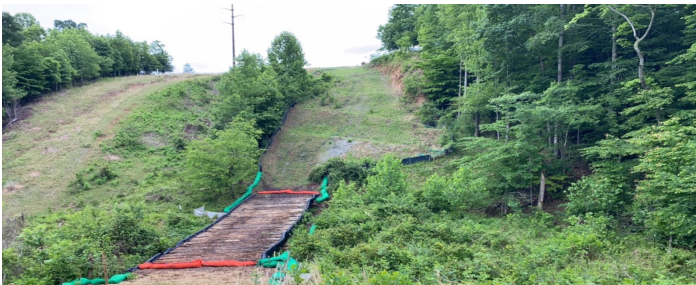
Field Station#	14465+00	Field Station#	14486+68		
Pic 3 Desc.	Sump pit and CFS end treatment performing intended functions.		Pic 4 Desc.	Equipment bridge and surrounding ECDs in place and functional at stream crossing and resource buffer.

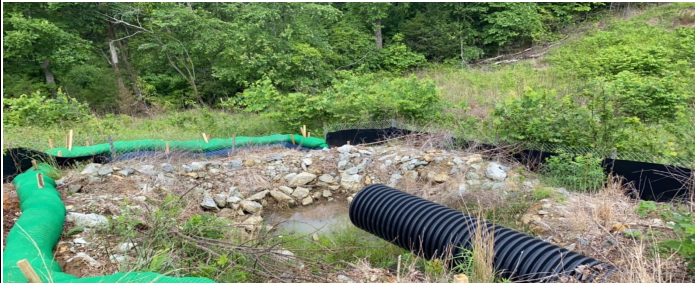
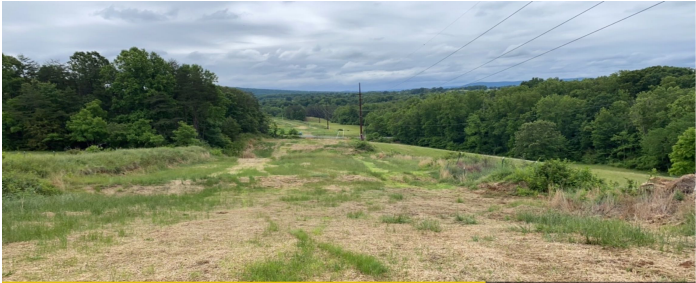
37°0'32" N 79°45'15" W 324°NW COURSE 337° GPS 1886 SR-674, Glade Hill, VA 24092, United States 05.25.2022 10:10:40 Accur +/-47.0 Ft ALT 1016 Ft			37°0'27" N 79°45'15" W 225°SW COURSE 177° GPS Glade Hill, VA 24092, United States 05.25.2022 10:07:50 Accur +/-27.6 Ft ALT 1043 Ft		
GPS Location	5	GPS Location	6		
Field Station#	14532+50	Field Station#	14537+50		
Pic 5 Desc.	Plunge pool performing intended function.		Pic 6 Desc.	ROW stabilized and vegetated in temporary area.

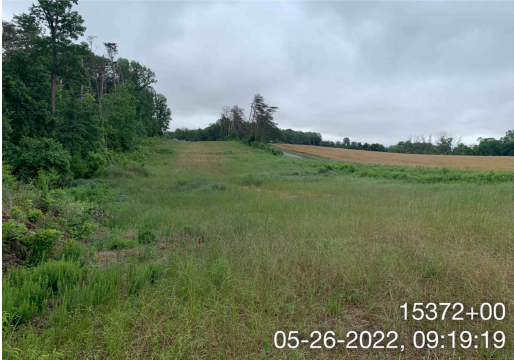
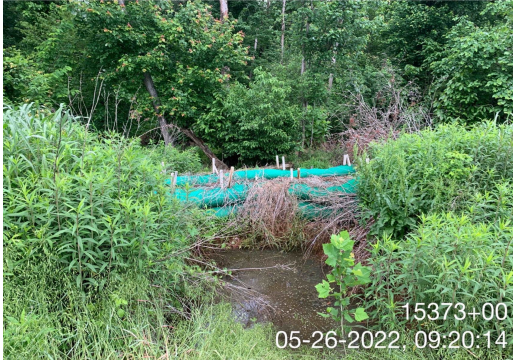
GPS Location	0	GPS Location	0		
Field Station#	15372+00	Field Station#	15373+00		
Pic 1 Desc.	Temporary vegetative stabilization in acceptable condition	Pic 2 Desc.	Sump pit in acceptable condition

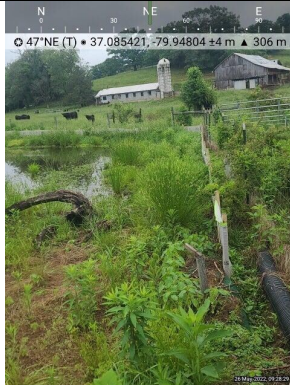
GPS Location	00000	GPS Location	00000		
Field Station#	13678+71	Field Station#	13678+28		
Pic 1 Desc.	Stream observation photo facing downstream during routine inspection today. No issues observed at the time of inspection.		Pic 2 Desc.	Monitored ECDs along the perimeter of the row.

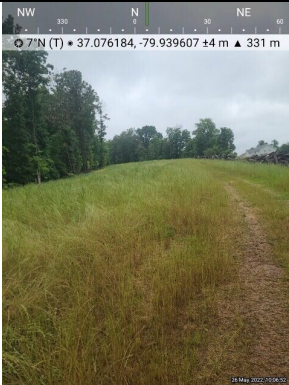
GPS Location	0000	GPS Location	0000		
Field Station#	13740+00	Field Station#	13748+11		
Pic 3 Desc.	Vegetation observation photo showing good stabilization.		Pic 4 Desc.	Monitored RCEs and ECDs at stream crossing. No environmental issues observed at the time of inspection.

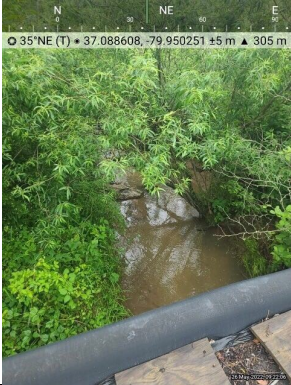
GPS Location	0000	GPS Location	00000		
Field Station#	13678+71	Field Station#			
Pic 7 Desc.	Stream observation photo facing upstream during routine inspection today. No issues were observed at the time of inspection.		Pic 8 Desc.

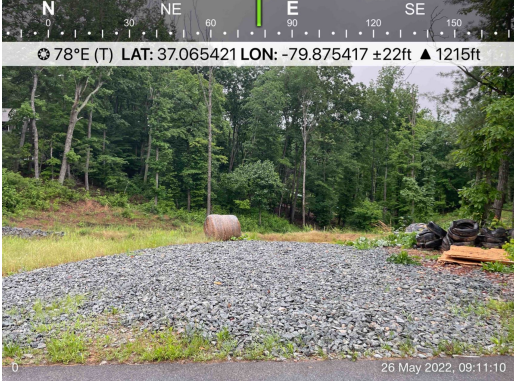
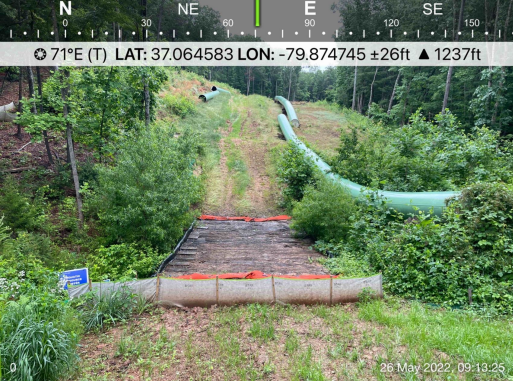
GPS Location	See photo		GPS Location	See photo	
Field Station#	14062+17		Field Station#	14066+77	
Pic 1 Desc.	RCEs are in good condition and functioning		Pic 2 Desc.	Equipment bridge ECDs are functioning as intended

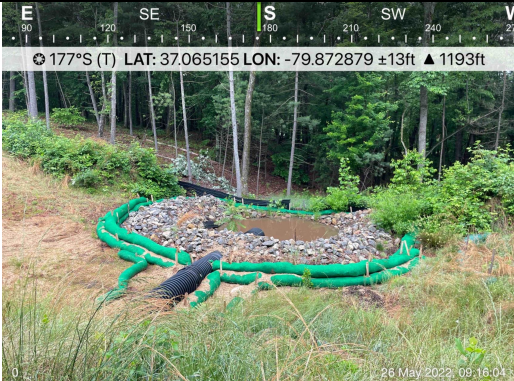
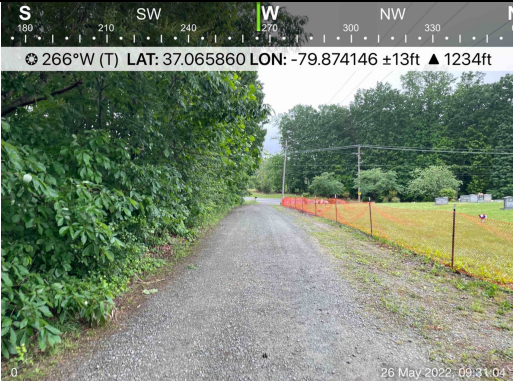
GPS Location	See photo		GPS Location	See photo	
Field Station#	14070+00		Field Station#	14081+46	
Pic 3 Desc.	CWDs are functioning as intended		Pic 4 Desc.	MVP-FR-309.05 is in good condition with controls in place.

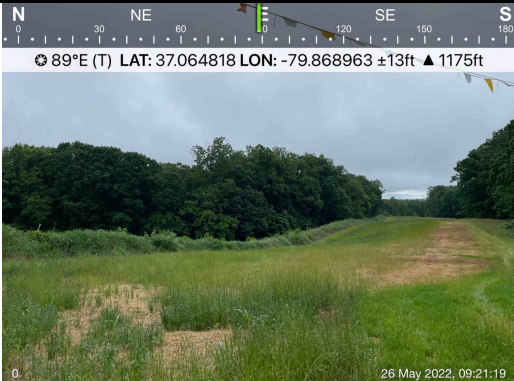
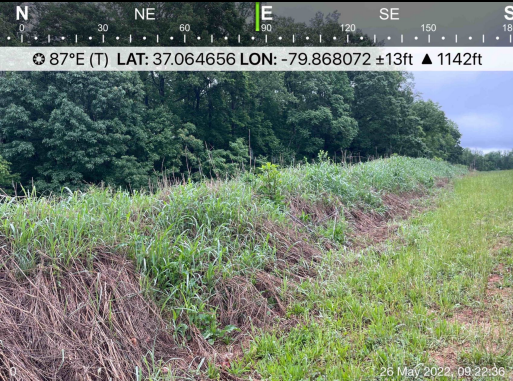
GPS Location	See photo		GPS Location	See photo	
Field Station#	14085+00		Field Station#	14090+00	
Pic 5 Desc.	Vegetation continues to fill in throughout this section		Pic 6 Desc.	Topsoil berms remain stabilized

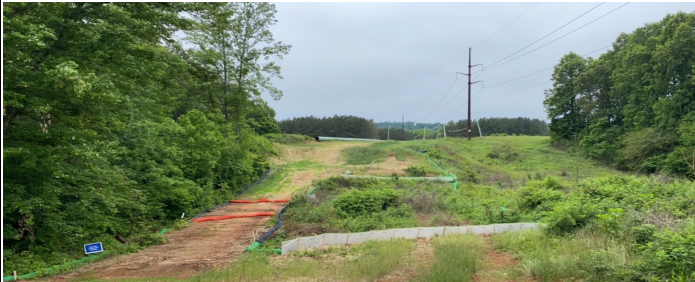
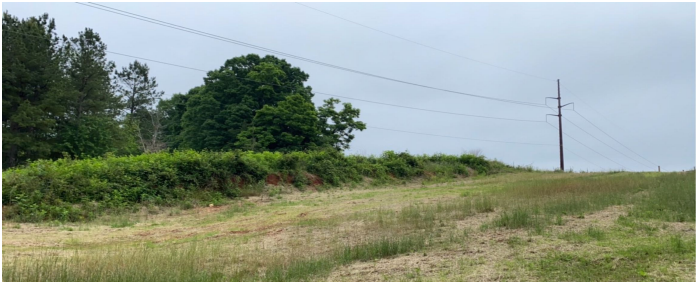
05.26.2022 13:08:59 Accur +/-19091.2 Ft ALT 862 Ft			05.26.2022 13:09:31 Accur +/-46.4 Ft ALT 877 Ft		
GPS Location	1		GPS Location	2	
Field Station#	14568+10		Field Station#	14570+00	
Pic 1 Desc.	Equipment bridge and surrounding ECDs in place and functional at stream crossing and resource buffer.		Pic 2 Desc.	Temporary diversion berm stabilized and vegetated.

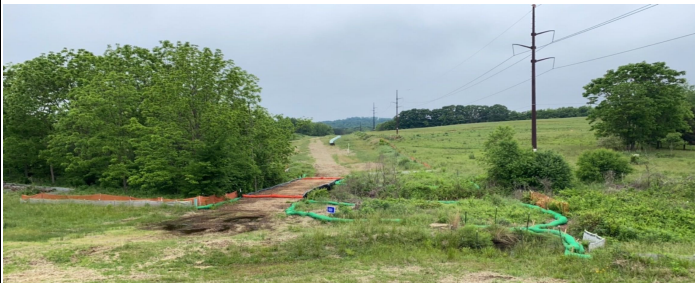
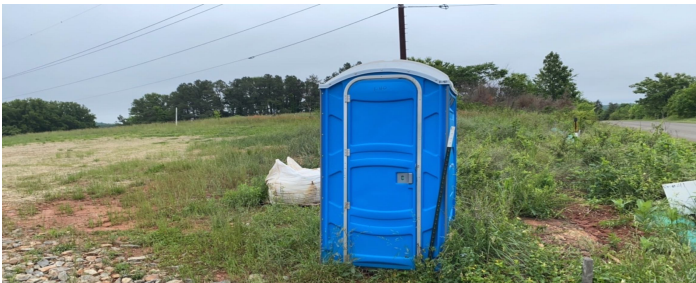
05.26.2022 13:00:41 Accur +/-106.2 Ft ALT 933 Ft			05.26.2022 12:53:17 Accur +/-27.1 Ft ALT 948 Ft		
GPS Location	3		GPS Location	4	
Field Station#	14582+85		Field Station#	14599+00	
Pic 3 Desc.	Equipment bridge and surrounding ECDs in place and functional at stream crossing and resource buffer.		Pic 4 Desc.	Portajon properly contained in secondary containment at road crossing.

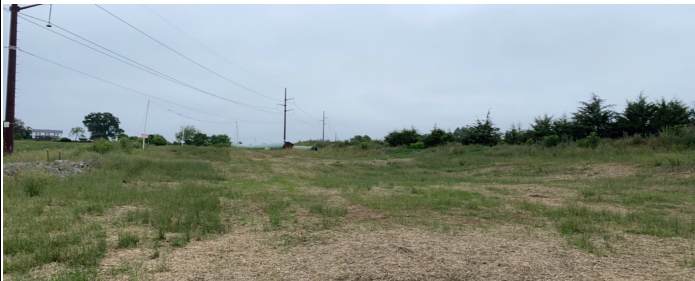
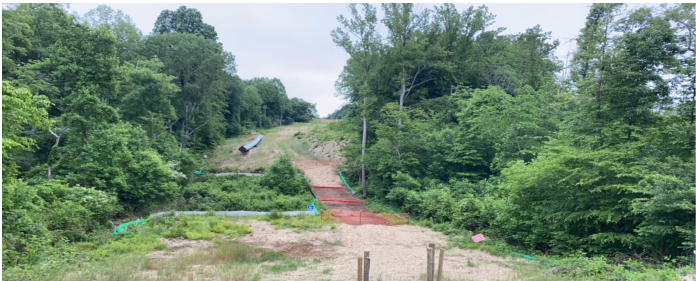
05.26.2022 12:49:15 Accur +/-67.0 Ft ALT 871 Ft			05.26.2022 12:48:34 Accur +/-63.0 Ft ALT 0 Ft		
GPS Location	5		GPS Location	6	
Field Station#	14606+00		Field Station#	14611+17	
Pic 5 Desc.	ROW stabilized and vegetated in temporary area.		Pic 6 Desc.	Equipment bridge and surrounding ECDs in place and functional at stream crossing and resource buffer.

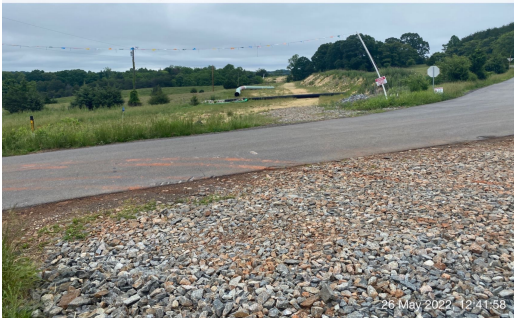
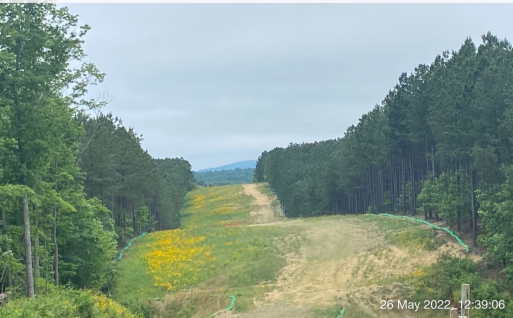
GPS Location	0	GPS Location	0		
Field Station#	14981+50	Field Station#	14972+00		
Pic 1 Desc.	Approximately 14981+50. Overview of road crossing and RCEs.	Pic 2 Desc.	Approximately 14972+00. Overview of ROW. Permanent vegetation.

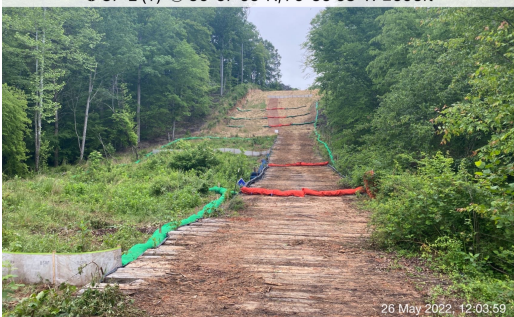
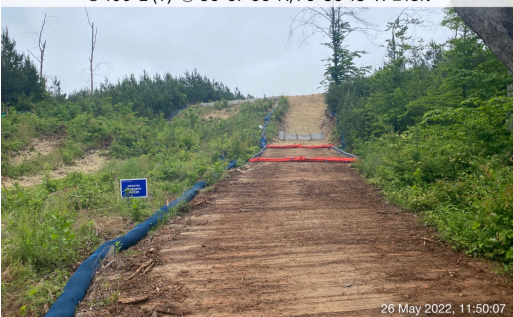
GPS Location	0	GPS Location	0		
Field Station#	15044+90	Field Station#	15028+12		
Pic 3 Desc.	Approximately 15044+90. Overview of stream crossing, equipment bridge and ECDs at stream S-D2.	Pic 4 Desc.	Approximately 15028+12. Overview of stream crossing, equipment bridge and ECDs at stream S-D4.

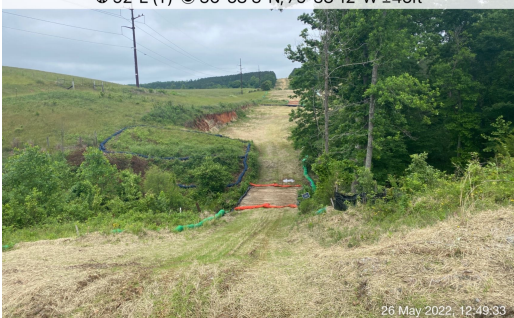
GPS Location	0	GPS Location	0		
Field Station#	14935+00	Field Station#	15042+00		
Pic 5 Desc.	Approximately 14935+00. Overview of ROW.	Pic 6 Desc.	Approximately 15042+00. Area along water bar and trough requires stabilization.

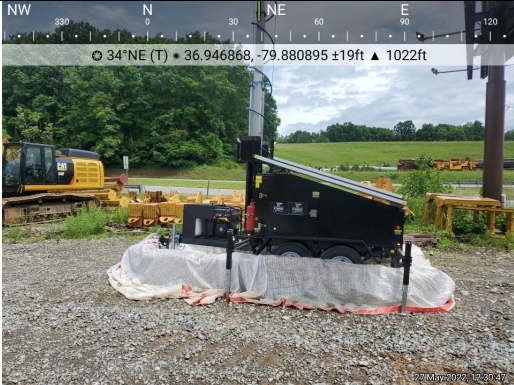
GPS Location	0	GPS Location	0		
Field Station#	0+00	Field Station#	0+00		
Pic 1 Desc.	LY-032 Secondary containment		Pic 2 Desc.	LY-032 Secondary containment

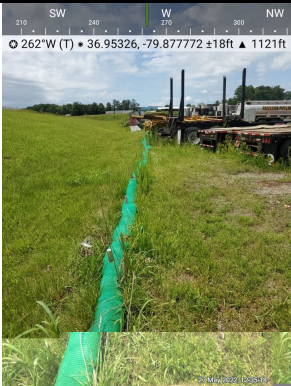
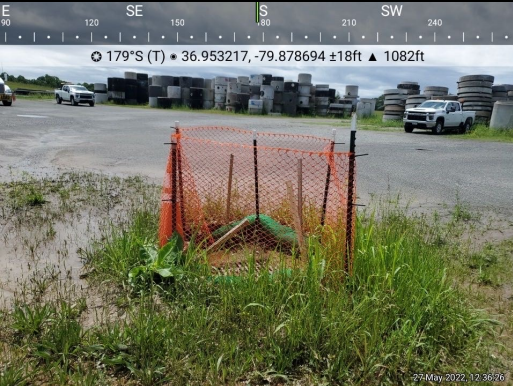
GPS Location	0	GPS Location	0		
Field Station#	0+00	Field Station#	0+00		
Pic 5 Desc.	ANC-006 Perimeter CFS		Pic 6 Desc.	ANC-006 Stormwater drain inlet protection

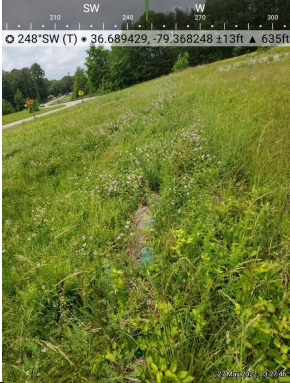
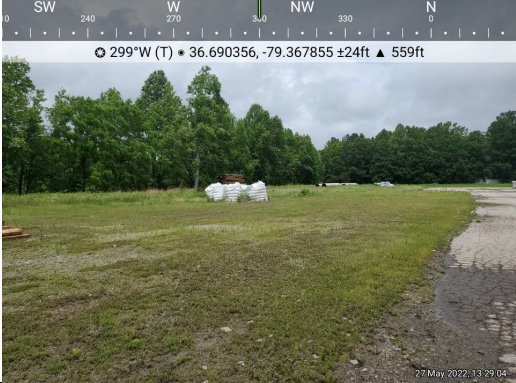
GPS Location	0	GPS Location	0		
Field Station#	0+00	Field Station#	0+00		
Pic 7 Desc.	LY-048 South perimeter CFS	Pic 8 Desc.	LY-048 Temporary vegetation		
Insert image here		Insert image here			
GPS Location		GPS Location			
Field Station#		Field Station#			
Pic 9 Desc.		Pic 10 Desc.			
Insert image here		Insert image here			
GPS Location		GPS Location			
Field Station#		Field Station#			
Pic 11 Desc.		Pic 12 Desc.

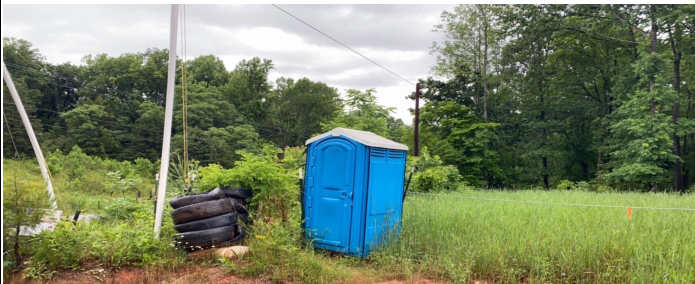
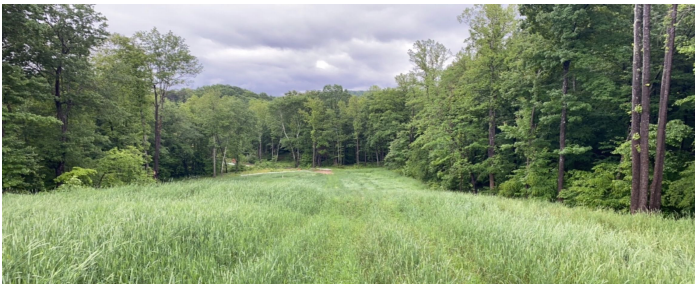
36°59'26" N 79°43'26" W 359°N COURSE 36° GPS 9400-9598 Old Franklin Tpke, Union Hall, VA 24176, United States 05.27.2022 09:09:34 Accur +/-15.6 Ft ALT 996 Ft			36°59'25" N 79°43'25" W 69°E COURSE 138° GPS 9400-9598 Old Franklin Tpke, Union Hall, VA 24176, United States 05.27.2022 09:10:58 Accur +/-15.5 Ft ALT 988 Ft		
GPS Location	1	GPS Location	2		
Field Station#	14650+00	Field Station#	14653+00		
Pic 1 Desc.	Portajon properly contained in secondary containment at road crossing.		Pic 2 Desc.	ROW stabilized and vegetated in final cleanup area.

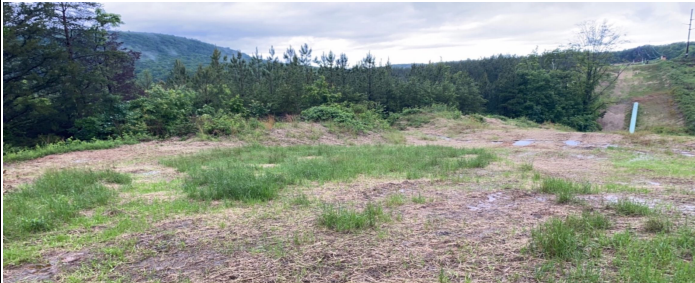
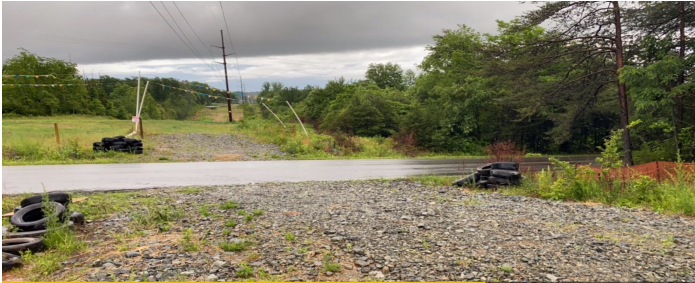
36°59'16" N 79°42'38" W 296°NW COURSE 151° GPS 1559-2499 Jacks Creek Rd, Union Hall, VA 24176, United States 05.27.2022 09:04:09 Accur +/-15.4 Ft ALT 958 Ft			36°59'17" N 79°42'37" W 124°SE COURSE -1° GPS Sorry no results found 05.27.2022 09:02:17 Accur +/-31.0 Ft ALT 955 Ft		
GPS Location	5	GPS Location	6		
Field Station#	14692+00	Field Station#	14694+77		
Pic 5 Desc.	ROW stabilized and vegetated in temporary area.		Pic 6 Desc.	RCE at Jacks Creek Rd in good condition.

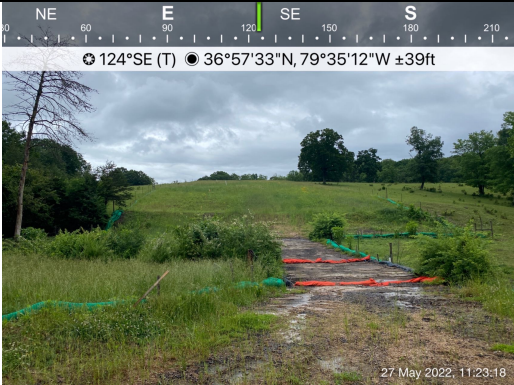
GPS Location	0	GPS Location	0		
Field Station#	15092+95	Field Station#	15096+00		
Pic 3 Desc.	Approximately 15092+95. Overview of stream crossing, equipment bridge and ECDs at stream S-G9.	Pic 4 Desc.	Approximately 15096+00. Overview of ROW. Permanent vegetation.

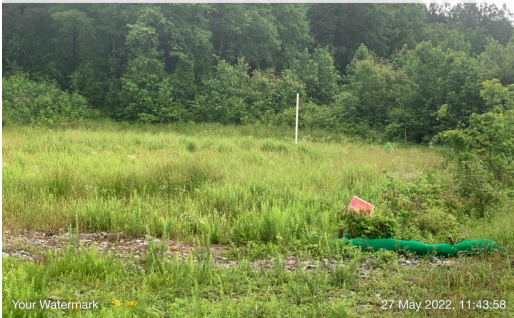
<small>Your Watermark 27 May 2022, 11:45:00</small>		
GPS Location	O		GPS Location	O	
Field Station#	14+00		Field Station#	22+00	
Pic 1 Desc.	Observing RCE, temporary stabilization, signage, buffer and ECD's		Pic 2 Desc.	Observing temporary stabilization, signage and buffer	
North West Elevation 147°SE (T) 36°50'8"N, 79°20'25"W ±892ft ▲ 650ft

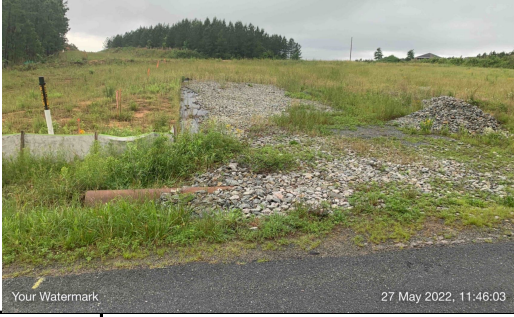
<small>Your Watermark 27 May 2022, 11:47:16</small>		
GPS Location	O		GPS Location	O	
Field Station#	13+77		Field Station#	12+00	
Pic 3 Desc.	Observing RCE, temporary stabilization, flume pipe and ECD's		Pic 4 Desc.	Observing temporary stabilization, water bar, sump and end treatment

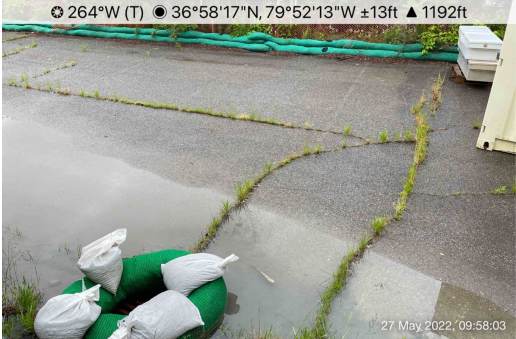
<p>27 May 2022, 09:56:38</p>	
GPS Location	See picture		GPS Location	See picture	
Field Station#	0000+00		Field Station#	0000+00	
Pic 1 Desc.	Inlet protection and perimeter ECD's on west side of LY-046 near storage building in good condition.		Pic 2 Desc.	Secondary containment structure for fuel cell at LY-046 in good condition.	
	<p>North East Elevation</p> <p>☉ 233°SW (T) ● 36°58'16"N, 79°52'9"W ±13ft ▲ 1204ft</p>

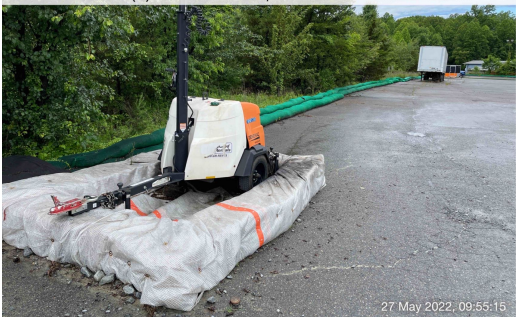
Pic 3 Desc.	Secondary containment structure for light plant and perimeter ECD's on south end of LY-046 in good condition.		Pic 4 Desc.	General Construction permits and contact information posted at main entrance of LY-046 as required.	
	<p>North East Elevation</p> <p>☉ 225°SW (T) ● 36°58'14"N, 79°52'9"W ±13ft ▲ 1213ft</p>

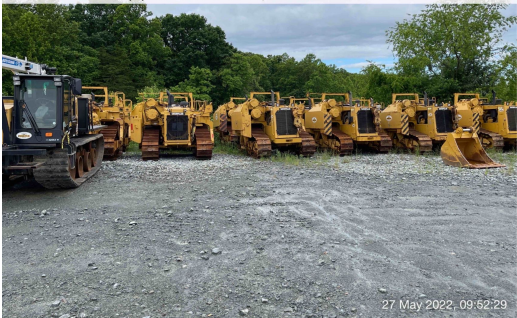
GPS Location	See picture	GPS Location	See picture		
Field Station#	0000+00	Field Station#	0000+00		
Pic 7 Desc.	Equipment at LY-045 inspected and no leaks observed at the time of inspection.	Pic 8 Desc.	Perimeter ECD's on northwest corner of LY-045 in good condition.		
West Elevation 89°E (T) 36°58'12"N, 79°52'5"W ±13ft ▲ 1216ft

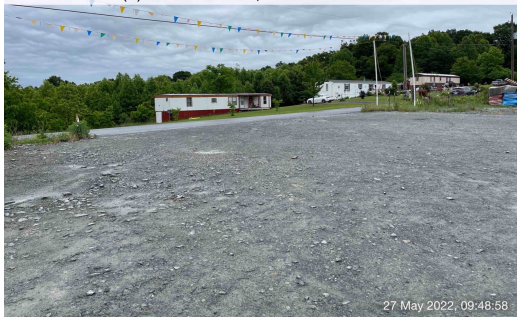
Insert image here			
GPS Location	See picture	GPS Location			
Field Station#	0000+00	Field Station#			
Pic 9 Desc.	RCE at LY-045 in good condition.	Pic 10 Desc.			
Insert image here		Insert image here			
GPS Location		GPS Location			
Field Station#		Field Station#			
Pic 11 Desc.		Pic 12 Desc.

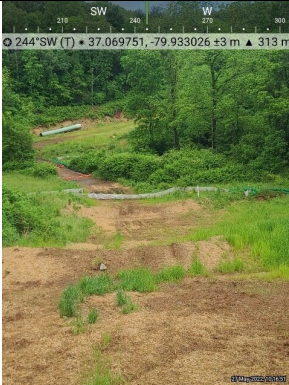
GPS Location	00000	GPS Location	0000		
Field Station#	13784+35	Field Station#	13817+00		
Pic 1 Desc.	Monitored hotspot areas after rain events. Hill side stabilized and ECDs functioning at the time of inspection.		Pic 2 Desc.	Monitored perimeter ECDs during routine inspection today. No issues observed at the time of inspection.

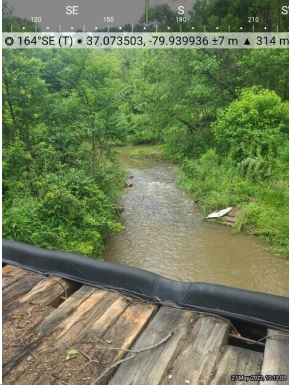
GPS Location	0000	GPS Location	0000		
Field Station#	13755+49	Field Station#	13755+49		
Pic 3 Desc.	Stream observation photo facing upstream during routine inspection today. No issues observed at the time of inspection.		Pic 4 Desc.	Stream observation photo facing downstream during routine inspection today. No issues observed at the time of inspection.

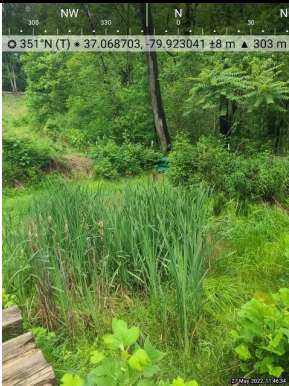
GPS Location	00000	GPS Location	0000		
Field Station#	13816+80	Field Station#	13784+40		
Pic 5 Desc.	Monitored clean water diversion and plunge pool. No issues observed at the time of inspection.		Pic 6 Desc.	Monitored plunge pool and ECDs after recent rain events . All functioning at the time of inspection.

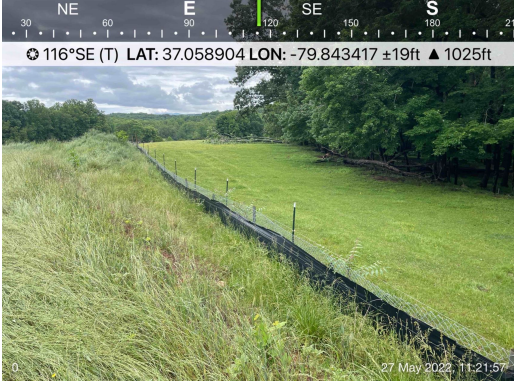
GPS Location	See photo		GPS Location	See photo	
Field Station#	14183+00		Field Station#	14213+75	
Pic 1 Desc.	SSF is in good condition throughout this section		Pic 2 Desc.	Equipment bridge ECDs are in good condition and functioning

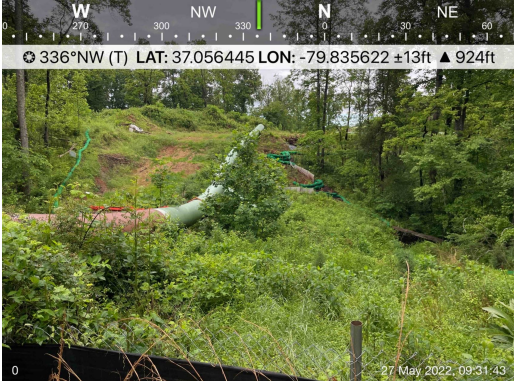
GPS Location	See photo		GPS Location	See photo	
Field Station#	14213+75		Field Station#	14220+00	
Pic 3 Desc.	Resource buffers remain well vegetated		Pic 4 Desc.	Waterbars are functioning as intended

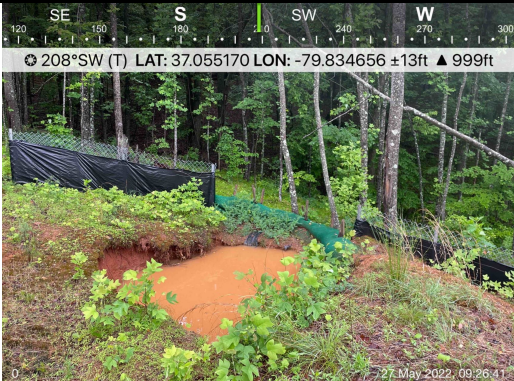
GPS Location	See photo		GPS Location	See photo	
Field Station#	14220+00		Field Station#	14223+41	
Pic 5 Desc.	End treatments are in good condition and functioning		Pic 6 Desc.	MVP-FR-311 is in good condition with controls in place
