Visual Site Inspection Report

Project Name	H-600 Pipeline Spread I	AFE	124300139	Spread	H-600 Pipeline Spread I
Contractor	Precision			Report #	37935
Inspector	Glenn Mike Renfro			Date/Time	5/23/2022 12:15 PM
Permit #	TBD	Inspection Type	VA SWPP	Station Begin	0000+00
State	VA	Inspection Area	Full	Station End	0000+00
County	Franklin	Ground	Dry	Temperature (°F)	70.00
Municipality	N/A	Weather	Cloudy	Rain Gauge (in)	0.20
				Rain Accumulation Time (days)	6.00

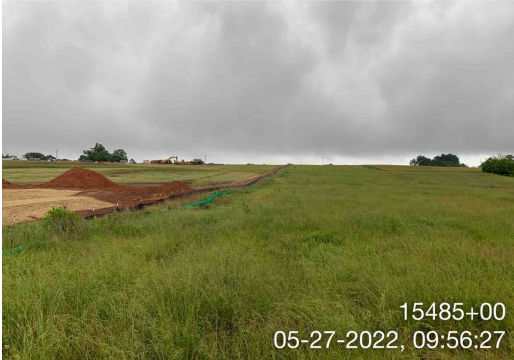
15481+00 05-27-2022, 10:07:50			
GPS Location	0	GPS Location	0		
Field Station#	15485+00	Field Station#	15481+00		
Pic 1 Desc.	Permanent vegetative stabilization in acceptable condition	Pic 2 Desc.	Rock construction entrance in acceptable condition		
126°SE (T) 36°54'21"N, 79°28'25"W ±13ft ▲ 919ft

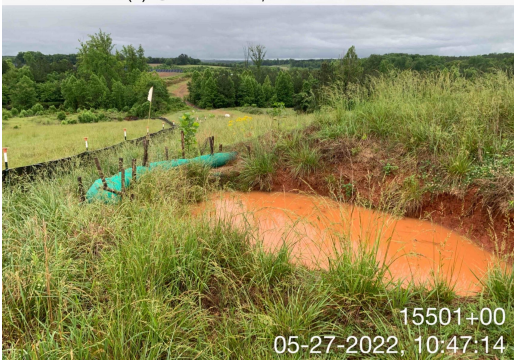
15501+00 05-27-2022, 10:47:25			
GPS Location	0	GPS Location	0		
Field Station#	15501+00	Field Station#	15501+00		
Pic 3 Desc.	Waterbar end treatment in acceptable condition	Pic 4 Desc.	Waterbar in acceptable condition		
127°SE (T) 36°54'10"N, 79°28'6"W ±26ft ▲ 825ft

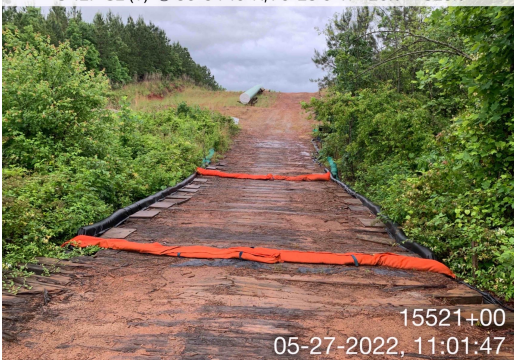
GPS Location	0	GPS Location	0		
Field Station#	15521+00	Field Station#	15521+00		
Pic 5 Desc.	Equipment bridge in acceptable condition	Pic 6 Desc.	Turbid water entering the ROW at stream S-MM8 (from activities not related to MVP)

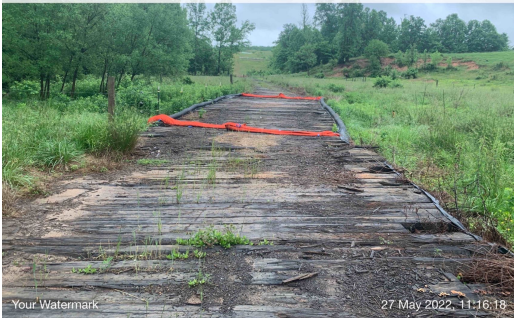
<small>Your Watermark 27 May 2022, 11:21:16</small>		
GPS Location	O		GPS Location	O	
Field Station#	15958+19		Field Station#	15965+00	
Pic 1 Desc.	Observing temporary stabilization,buffer, equipment crossing and ECD's		Pic 2 Desc.	Observing temporary stabilization,equipment crossing and ECD's	
South West Elevation 56°NE (T) 36°49'56"N, 79°21'32"W ±13ft ▲ 643ft

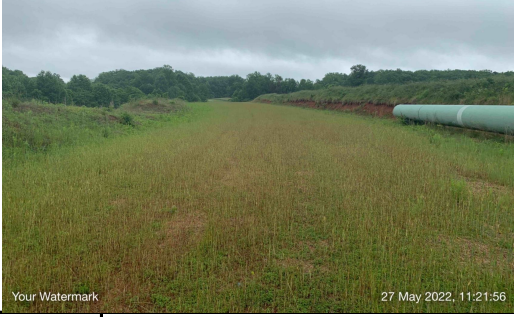
<small>Your Watermark 27 May 2022, 11:23:30</small>		
GPS Location	O		GPS Location	O	
Field Station#	15970+00		Field Station#	15974+00	
Pic 3 Desc.	Observing temporary stabilization,and CWD berm		Pic 4 Desc.	Observing temporary stabilization,CWD outlet and ECD's

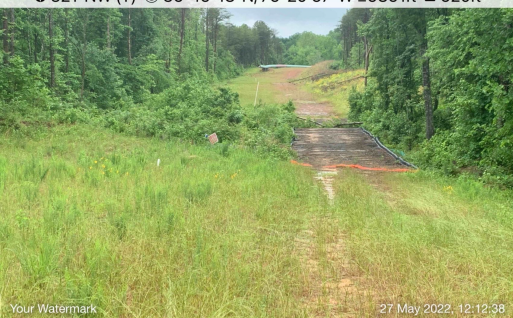
<small>Your Watermark 27 May 2022, 12:12:38</small>		
GPS Location	O		GPS Location	O	
Field Station#	16022+00		Field Station#	16016+36	
Pic 5 Desc.	Observing temporary stabilization and water bar		Pic 6 Desc.	Observing temporary stabilization, signage, buffer, equipment crossing and ECD's

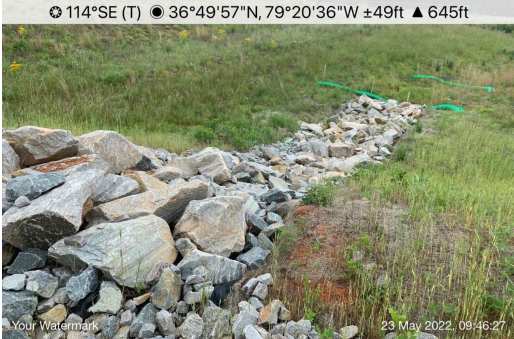
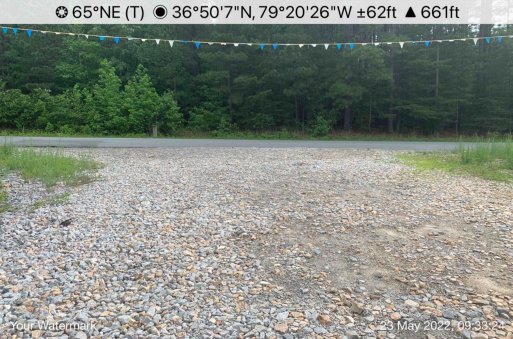
GPS Location	O	GPS Location	O		
Field Station#	00+00	Field Station#	00+00		
Pic 1 Desc.	Observing temporary stabilization, erosion control blanket, rock drain and ECD's	Pic 2 Desc.	Observing RCE		
East Elevation 280°W (T) 36°49'57"N, 79°20'36"W ±13ft ▲ 648ft

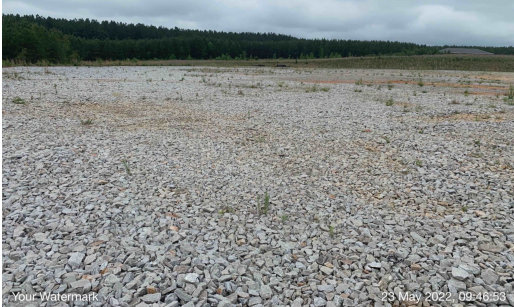
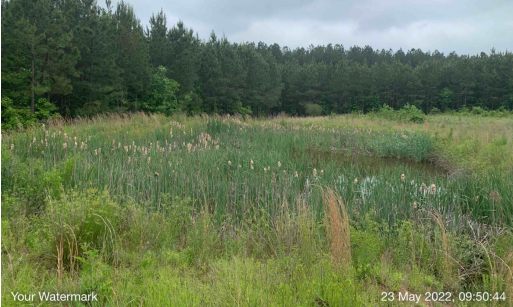
GPS Location	O	GPS Location	O		
Field Station#	00+00	Field Station#	00+00		
Pic 3 Desc.	Observing lay down yard	Pic 4 Desc.	Observing temporary stabilization and sediment basin		
North East Elevation 206°SW (T) 36°49'53"N, 79°20'35"W ±321ft ▲ 649ft

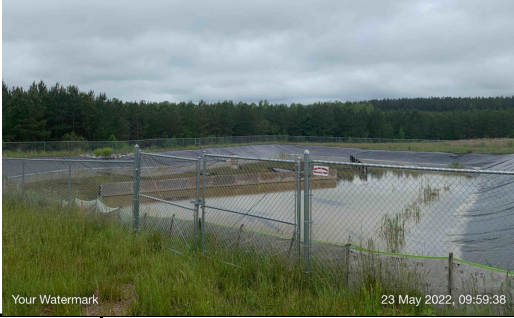
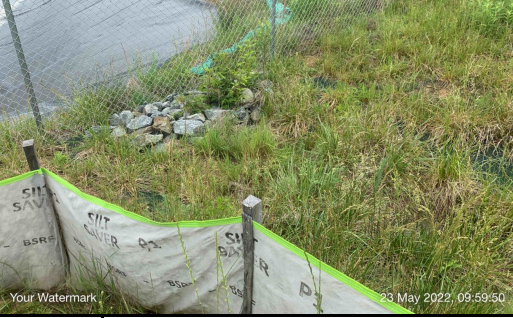
Field Station#	00+00	Field Station#	00+00		
Pic 5 Desc.	Observing temporary stabilization, storm water pond and ECD's	Pic 6 Desc.	Observing temporary stabilization, rock check dam and ECD's

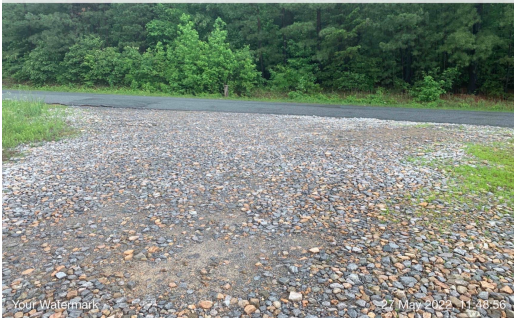
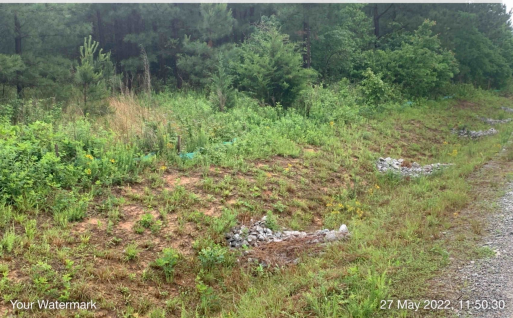
GPS Location	O		GPS Location	O	
Field Station#	00+00		Field Station#	00+00	
Pic 1 Desc.	Observing RCE		Pic 2 Desc.	Observing temporary stabilization, rock check dams and ECD's	
North West Elevation ☉ 152°SE (T) ● 36°50'1"N, 79°20'32"W ±1571ft ▲ 663ft

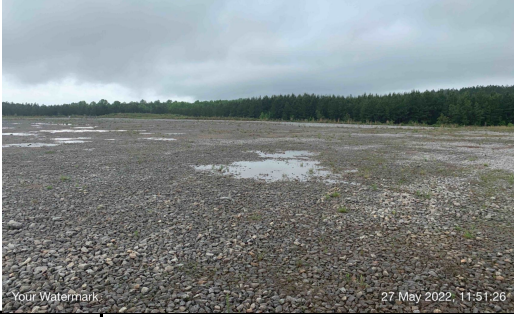
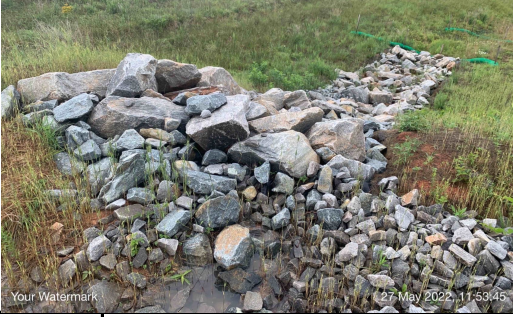
GPS Location	O		GPS Location	O	
Field Station#	00+00		Field Station#	00+00	
Pic 3 Desc.	Observing lay down yard		Pic 4 Desc.	Observing rock drain, temporary stabilization and ECD's	
North West Elevation ☉ 137°SE (T) ● 36°49'57"N, 79°20'36"W ±19ft ▲ 645ft

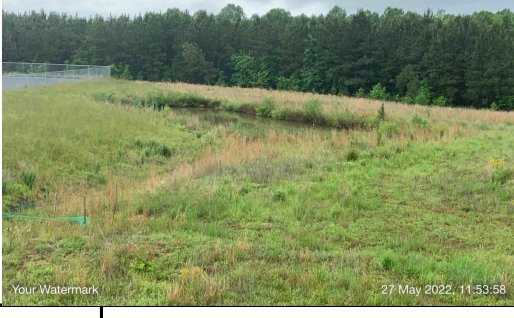
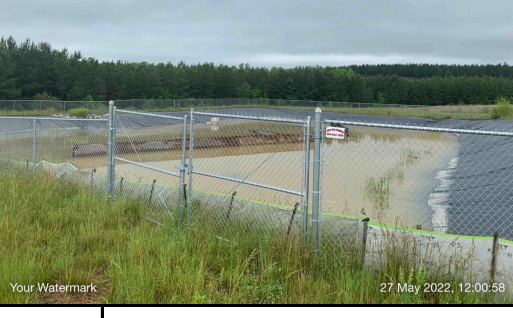
Field Station#	00+00		Field Station#	00+00	
Pic 5 Desc.	Observing temporary stabilization, sediment basin and cfs check		Pic 6 Desc.	Observing temporary stabilization, storm water pond and ECD's
