Visual Site Inspection Report

Project Name	H-600 Pipeline Spread I	AFE	124300139	Spread	H-600 Pipeline Spread I
Contractor	Precision			Report #	38203
Inspector	Frank Craycroft			Date/Time	5/30/2022 2:02 PM
Permit #	TBD	Inspection Type	VA SWPP	Station Begin	14694+77
State	VA	Inspection Area	Full	Station End	14802+19
County	Franklin	Ground	Wet	Temperature (°F)	85.00
Municipality	N/A	Weather	Sunny	Rain Gauge (in)	0.00
				Rain Accumulation Time (days)	1.00

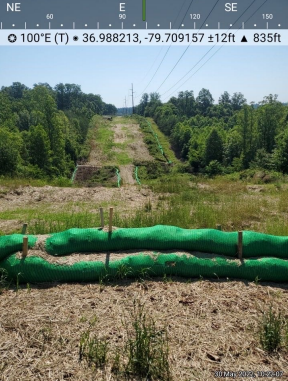
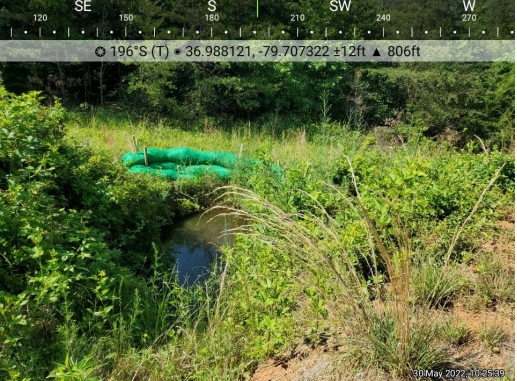
GPS Location	0	GPS Location	0		
Field Station#	14698+00	Field Station#	14705+00		
Pic 1 Desc.	CFS check and CIS S-H32	Pic 2 Desc.	Sump and CFS J-hook

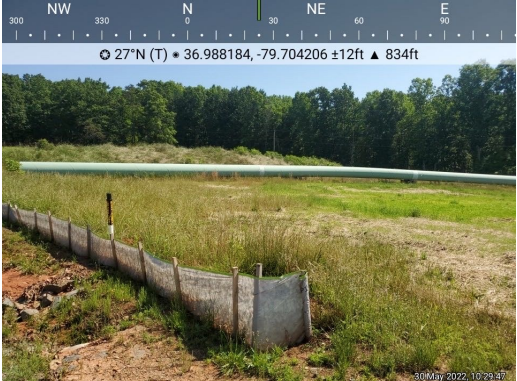
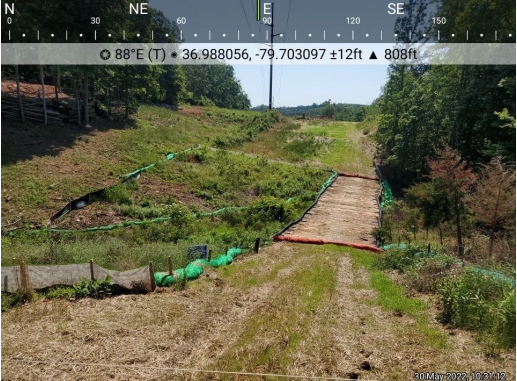
GPS Location	0	GPS Location	0		
Field Station#	14719+50	Field Station#	14721+00		
Pic 3 Desc.	Perimeter silt fence and vegetation	Pic 4 Desc.	CIS W-A8

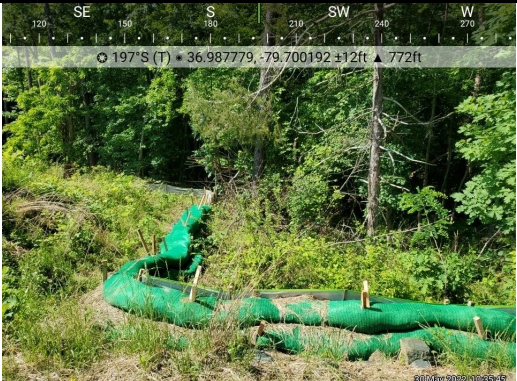
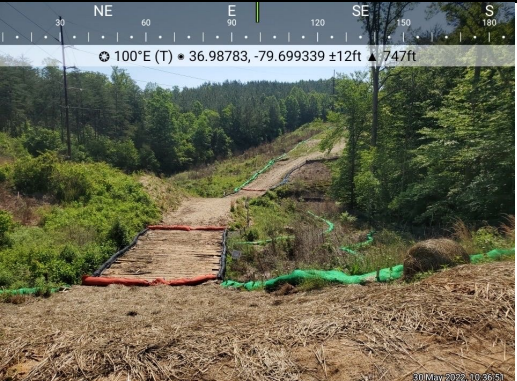
GPS Location	0	GPS Location	0		
Field Station#	14724+50	Field Station#	14727+00		
Pic 5 Desc.	Perimeter ECDs	Pic 6 Desc.	CIS S-A19/H26

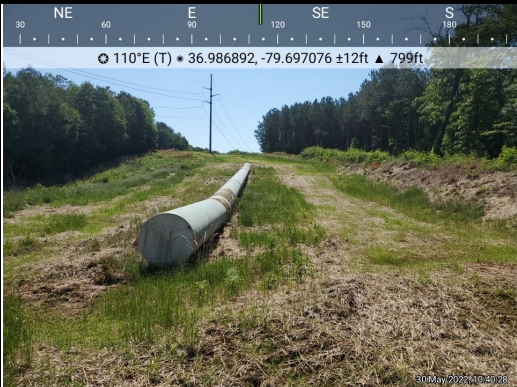
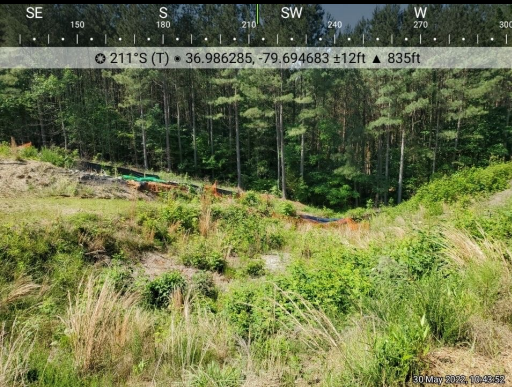
GPS Location		0		GPS Location		0	
Field Station#		14732+00		Field Station#		14742+00	
Pic 7 Desc.		Vegetation		Pic 8 Desc.		Dry swale and perimeter ECDs

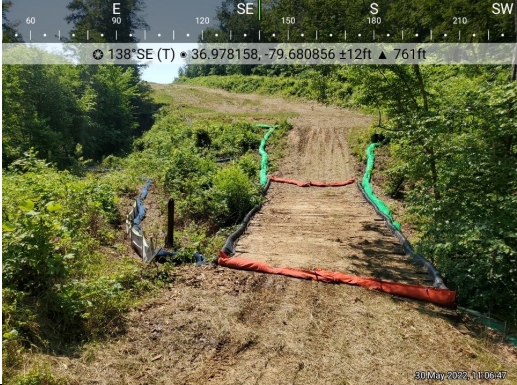
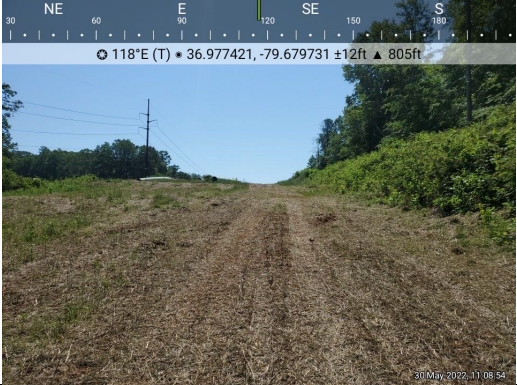
GPS Location	0	GPS Location	0		
Field Station#	14793+00	Field Station#	14796+00		
Pic 13 Desc.	CIS S-H24	Pic 14 Desc.	Travel lane stabilization		
Insert image here		Insert image here			
GPS Location		GPS Location			
Field Station#		Field Station#			
Pic 15 Desc.		Pic 16 Desc.			
Insert image here		Insert image here			
GPS Location		GPS Location			
Field Station#		Field Station#			
Pic 17 Desc.		Pic 18 Desc.

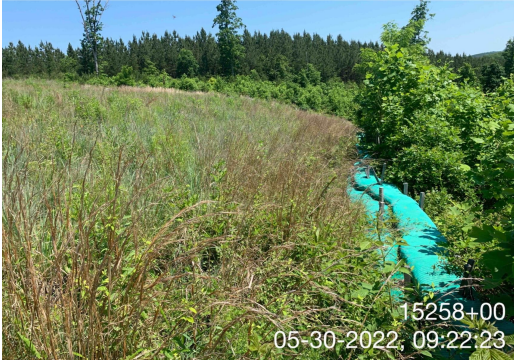
15258+00 05-30-2022, 09:22:23		97°E (T) 36°56'5"N, 79°32'42"W ±18435ft ▲ 776ft

15215+00 05-30-2022, 09:32:34			
GPS Location	0	GPS Location	0		
Field Station#	15258+00	Field Station#	15215+00		
Pic 1 Desc.	Permanent vegetative stabilization and perimeter CFS in acceptable conditions	Pic 2 Desc.	Waterbar in acceptable condition		
51°NE (T) 36°56'22"N, 79°33'23"W ±13ft ▲ 819ft

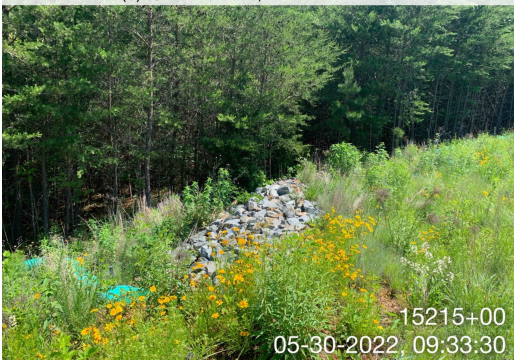
15222+00 05-30-2022, 10:10:05			
GPS Location	0	GPS Location	0		
Field Station#	15215+00	Field Station#	15222+00		
Pic 3 Desc.	Waterbar end treatment in acceptable condition	Pic 4 Desc.	Permanent vegetative stabilization in acceptable condition		
198°S (T) 36°56'42"N, 79°34'25"W ±82ft ▲ 783ft

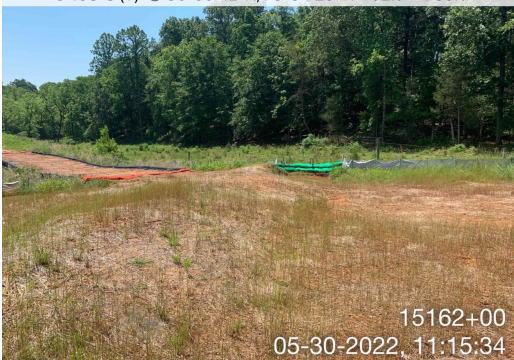
GPS Location	0	GPS Location	0		
Field Station#	15162+00	Field Station#	15162+00		
Pic 5 Desc.	Waterbar in acceptable condition	Pic 6 Desc.	Waterbar end treatment and P1 silt fence in acceptable conditions

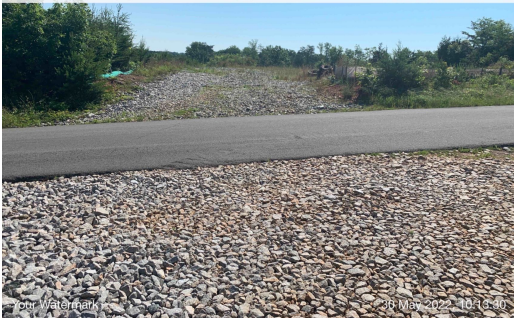
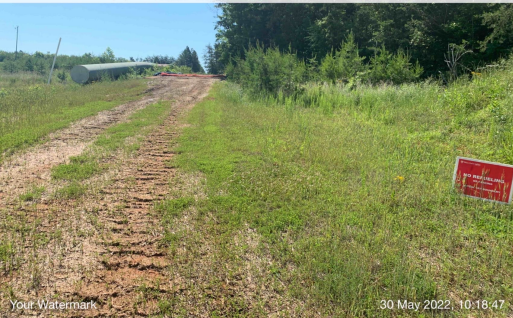
GPS Location	O		GPS Location	O	
Field Station#	15619+48		Field Station#	15614+94	
Pic 1 Desc.	Observing road crossing and RCE's		Pic 2 Desc.	Observing temporary stabilization, signage, buffer, equipment crossing and ECD's	
North Elevation ☉ 195°S (T) ● 36°53'34"N, 79°26'26"W ±26ft ▲ 805ft

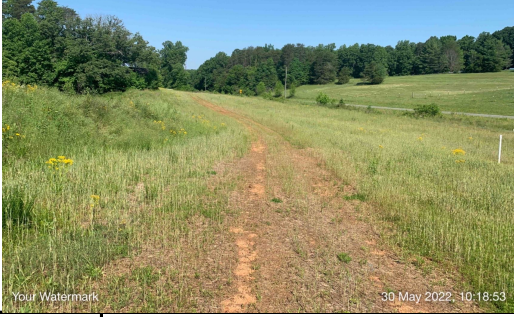
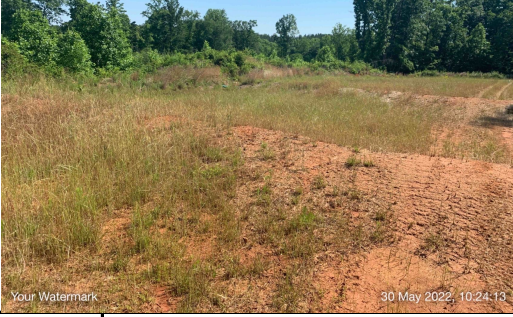
GPS Location	O		GPS Location	O	
Field Station#	15610+00		Field Station#	15625+00	
Pic 3 Desc.	Observing temporary stabilization		Pic 4 Desc.	Observing temporary stabilization and water bars	
North Elevation ☉ 181°S (T) ● 36°53'34"N, 79°26'9"W ±206ft ▲ 823ft

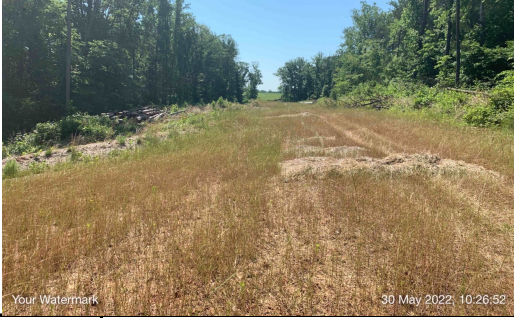
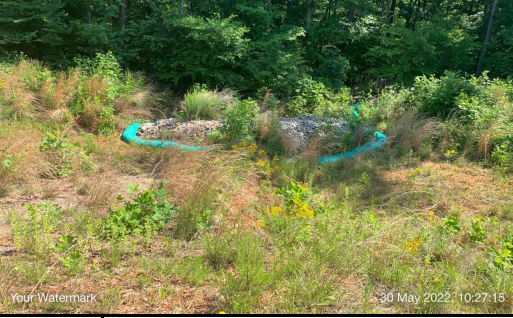
GPS Location	O		GPS Location	O	
Field Station#	15632+00		Field Station#	15630+00	
Pic 5 Desc.	Observing temporary stabilization and water bar		Pic 6 Desc.	Observing temporary stabilization, CWD outlet and ECD's

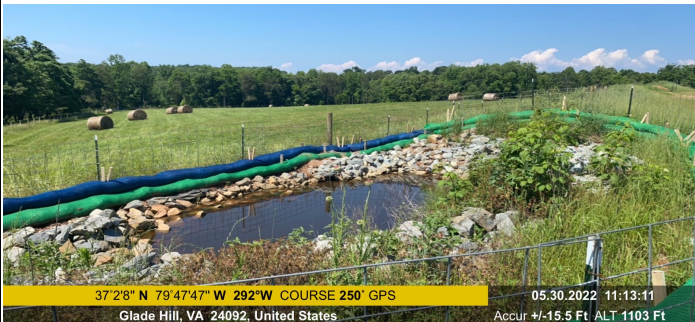
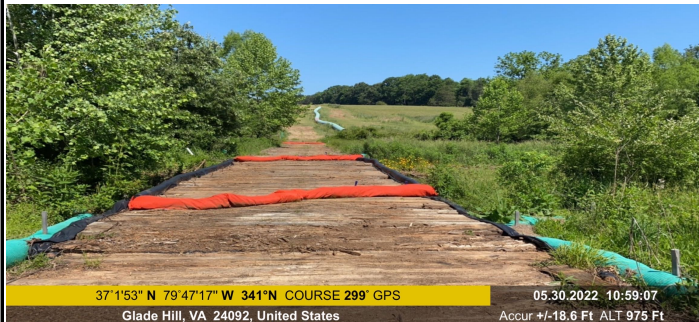
GPS Location	3	GPS Location	4		
Field Station#	14362+00	Field Station#	14391+47		
Pic 3 Desc.	Plunge pool performing intended function.		Pic 4 Desc.	Equipment bridge and surrounding ECDs in place and functional at stream crossing and resource buffer.

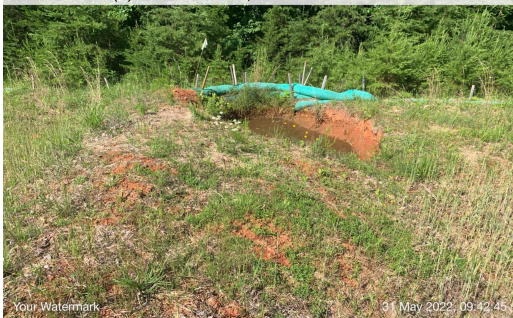
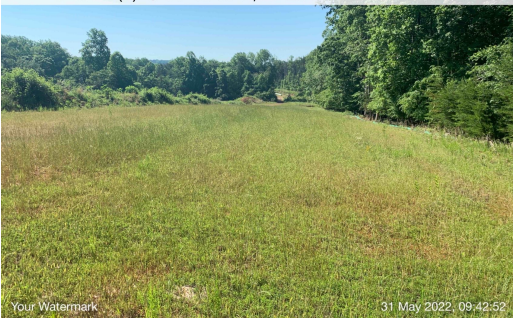
</div> <div>Your Watermark 31 May 2022 09:42:52</div>		
GPS Location	O		GPS Location	O	
Field Station#	15650+00		Field Station#	15654+00	
Pic 1 Desc.	Observing temporary stabilization,water bar, sump and end treatment		Pic 2 Desc.	Observing temporary stabilization and water bar	
<div>North Elevation</div> <div>174°S (T) 36°53'10"N, 79°25'51"W ±22ft ▲ 747ft</div> <div>

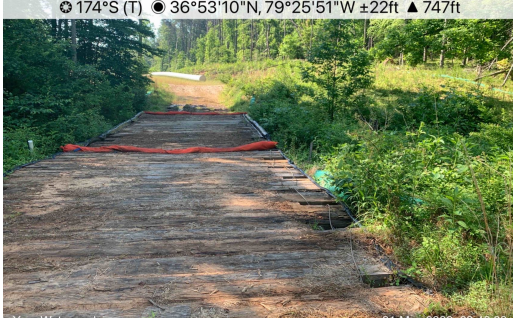
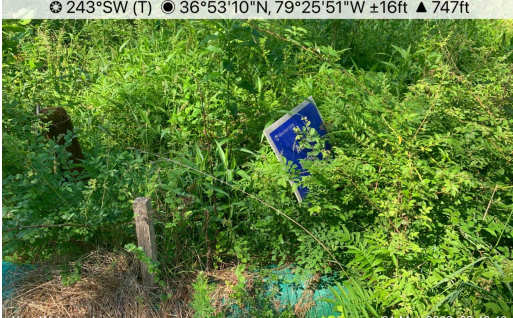
Field Station#	15658+43		Field Station#	15658+43	
Pic 3 Desc.	Observing temporary stabilization,buffer, equipment crossing and ECD's		Pic 4 Desc.	Observing temporary stabilization,buffer signage and ECD's	
<div>North Elevation</div> <div>158°S (T) 36°52'59"N, 79°25'30"W ±3635ft ▲ 748ft</div> <div>

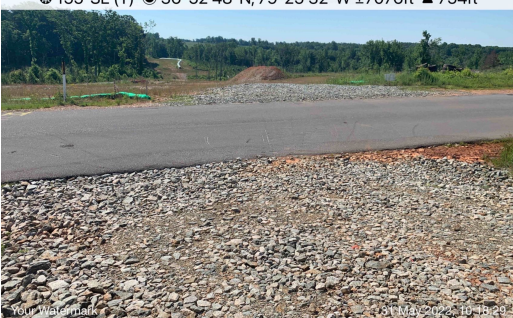
</div> <div>Your Watermark 31 May 2022 10:18:35</div>		
GPS Location	O		GPS Location	O	
Field Station#	15677+00		Field Station#	15693+89	
Pic 5 Desc.	Observing temporary stabilization,CWD outlet and ECD's		Pic 6 Desc.	Observing road crossing and RCE's

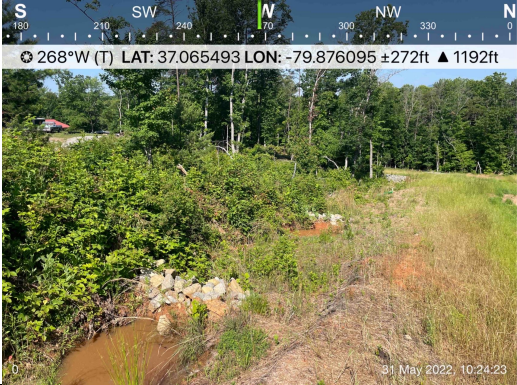
GPS Location	See photo	GPS Location			
Field Station#	14060+00	Field Station#			
Pic 13 Desc.	Check dams are functioning as intended	Pic 14 Desc.			
Insert image here		Insert image here			
GPS Location		GPS Location			
Field Station#		Field Station#			
Pic 15 Desc.		Pic 16 Desc.			
Insert image here		Insert image here			
GPS Location		GPS Location			
Field Station#		Field Station#			
Pic 17 Desc.		Pic 18 Desc.

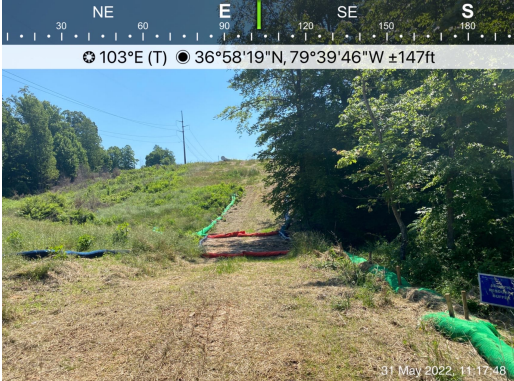
GPS Location	0	GPS Location	0		
Field Station#	14854+75	Field Station#	14819+00		
Pic 3 Desc.	Approximately 14854+75. Overview of stream crossing, equipment bridge and ECDs at stream S-A7.	Pic 4 Desc.	Approximately 14819+00. Overview of ROW.

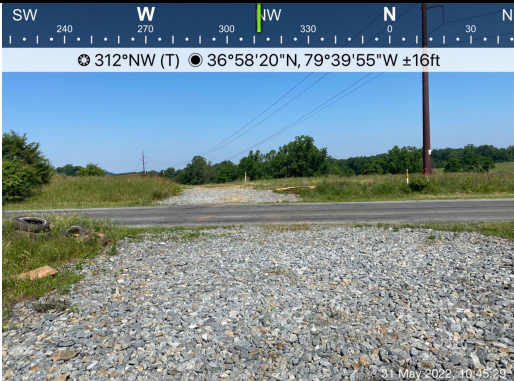
GPS Location	0	GPS Location	0		
Field Station#	14846+00	Field Station#	14823+54		
Pic 5 Desc.	Approximately 14846+00. Overview of road crossing and RCEs.	Pic 6 Desc.	Approximately 14823+54. Overview of stream crossing, equipment bridge and ECDs at stream S-A13.

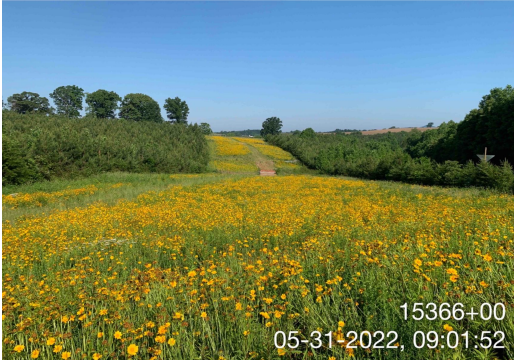
15346+80 05-31-2022, 09:08:30			
GPS Location	0	GPS Location	0		
Field Station#	15366+00	Field Station#	15346+80		
Pic 1 Desc.	Permanent vegetative stabilization in acceptable condition	Pic 2 Desc.	Equipment bridge in acceptable condition		
⬤ 79°E (T) ⬤ 36°55'30"N, 79°31'4"W ±13ft ▲724ft

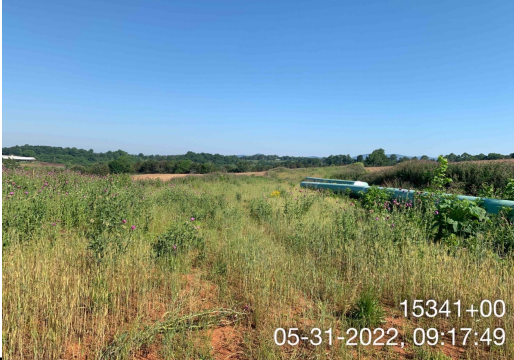
GPS Location	0	GPS Location	0		
Field Station#	15341+00	Field Station#	15338+00		
Pic 5 Desc.	Temporary vegetative stabilization in acceptable condition	Pic 6 Desc.	Clean water diversion pipe and plunge pool in acceptable conditions

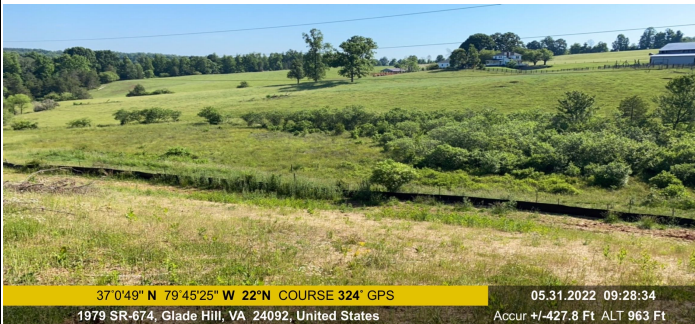
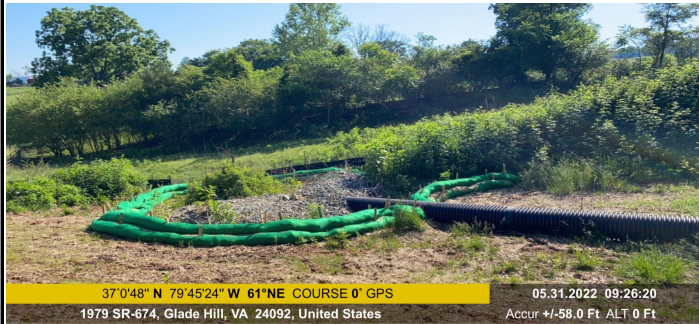
37°0'49" N 79°45'25" W 22°N COURSE 324° GPS 05.31.2022 09:28:34 1979 SR-674, Glade Hill, VA 24092, United States Accur +/-427.8 Ft ALT 963 Ft			37°0'48" N 79°45'24" W 61°NE COURSE 0° GPS 05.31.2022 09:26:20 1979 SR-674, Glade Hill, VA 24092, United States Accur +/-58.0 Ft ALT 0 Ft		
GPS Location	5	GPS Location	6		
Field Station#	14509+00	Field Station#	14521+00		
Pic 5 Desc.	ROW stabilized and vegetated in temporary area; perimeter P1 silt fence in place and functional.		Pic 6 Desc.	Plunge pool performing intended function.

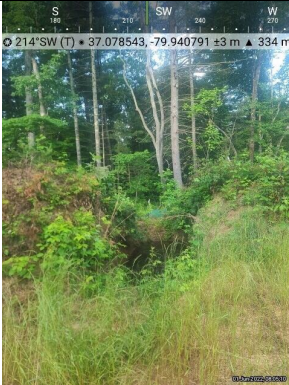
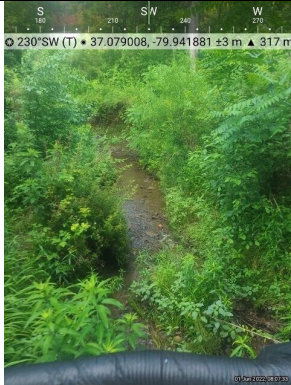
GPS Location	0000	GPS Location	0000		
Field Station#	13734+70	Field Station#	13728+23		
Pic 1 Desc.	Monitored sump pits and end treatment during routine inspection. No environmental issues observed at the time of inspection.		Pic 2 Desc.	Stream observation photo facing downstream during routine inspection today. No environmental issues observed at the time of inspection.

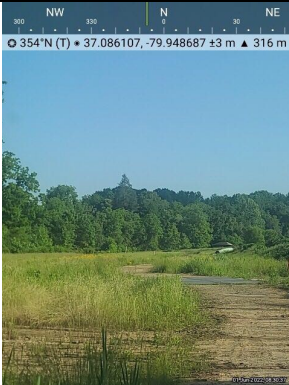
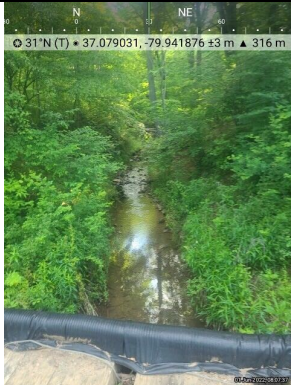
GPS Location	0000	GPS Location	0000		
Field Station#	13689+00	Field Station#	13728+23		
Pic 3 Desc.	Row photo showing equipment mats in place in low lying area of row. Good vegetation noted.		Pic 4 Desc.	Stream observation photo facing upstream during routine inspection today. No environmental issues observed.

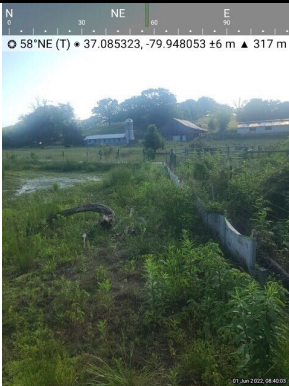
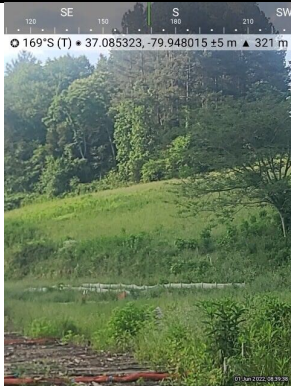
GPS Location	0000	GPS Location	0000		
Field Station#	13692+60	Field Station#	13693+80		
Pic 5 Desc.	Monitored perimeter ECDs throughout. All functioning at the time of inspection.		Pic 6 Desc.	Monitored ECDs around wetland area. No issues were observed at the time of inspection.

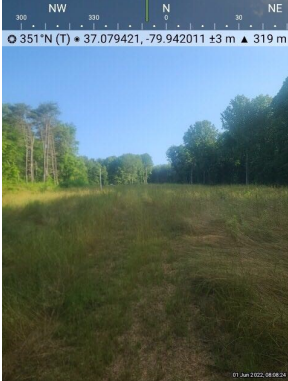
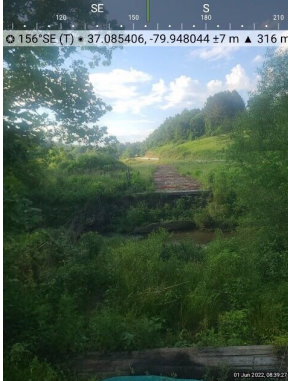
GPS Location	0000	GPS Location	0000		
Field Station#	13726+00	Field Station#	13692+72		
Pic 7 Desc.	Stabilization photo up row from stream crossing showing good coverage.		Pic 8 Desc.	Stream crossing photo showing stabilization and ECDs on banks where mats were removed previously. No issues were observed at the time of inspection.	
Insert image here		Insert image here			
GPS Location		GPS Location			
Field Station#		Field Station#			
Pic 9 Desc.		Pic 10 Desc.			
Insert image here		Insert image here			
GPS Location		GPS Location			
Field Station#		Field Station#			
Pic 11 Desc.		Pic 12 Desc.

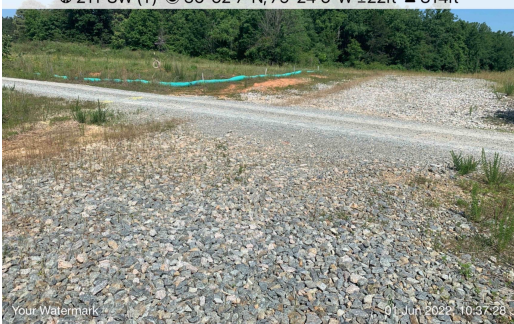
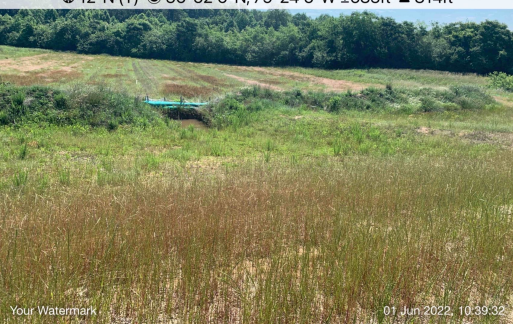
GPS Location	O	GPS Location	O		
Field Station#	15772+27	Field Station#	15776+00		
Pic 1 Desc.	Observing access road and RCE's	Pic 2 Desc.	Observing temporary stabilization, water bar, sump and end treatment		
South West Elevation 49°NE (T) 36°52'0"N, 79°24'2"W ±78ft ▲ 810ft

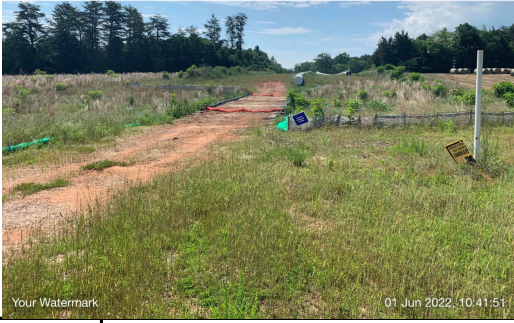
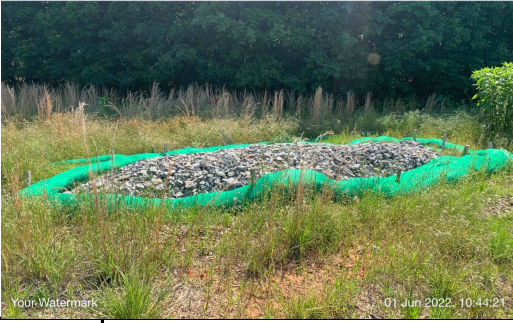
GPS Location	O	GPS Location	O		
Field Station#	15781+22	Field Station#	15790+00		
Pic 3 Desc.	Observing temporary stabilization, signage, buffer, equipment crossing and ECD's	Pic 4 Desc.	Observing temporary stabilization, CWD outlet and ECD's		
East Elevation 271°W (T) 36°51'21"N, 79°23'31"W ±39ft ▲ 836ft

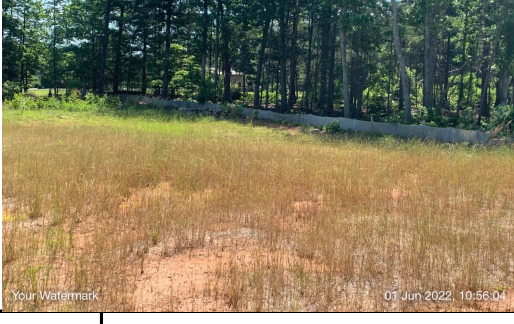
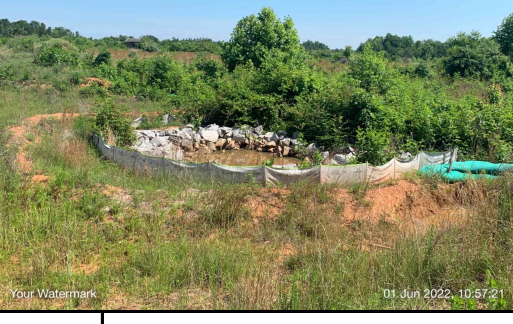
GPS Location	O	GPS Location	O		
Field Station#	15830+00	Field Station#	15825+00		
Pic 5 Desc.	Observing temporary stabilization and ECD's	Pic 6 Desc.	Observing temporary stabilization, plunge pool and ECD's

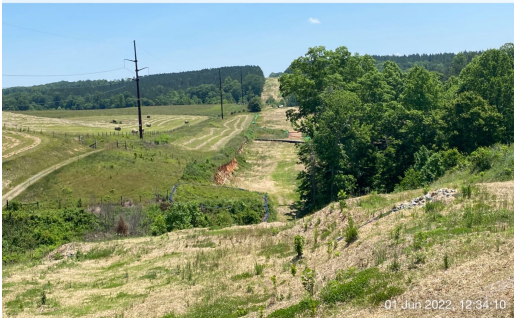
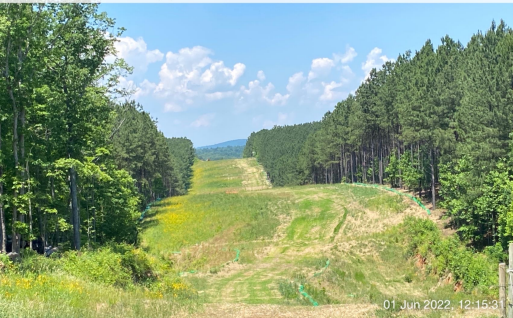
GPS Location	0	GPS Location	0		
Field Station#	14930+00	Field Station#	14968+00		
Pic 1 Desc.	Approximately 14930+00. Overview of ROW.		Pic 2 Desc.	Approximately 14968+00. Overview of ROW. Permanent vegetation.

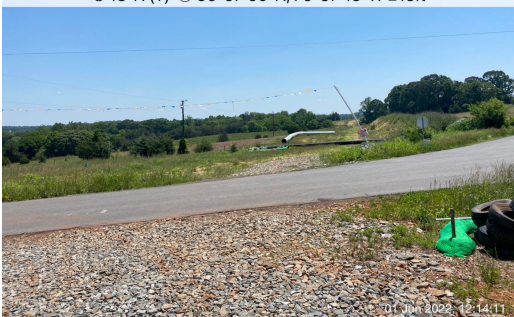
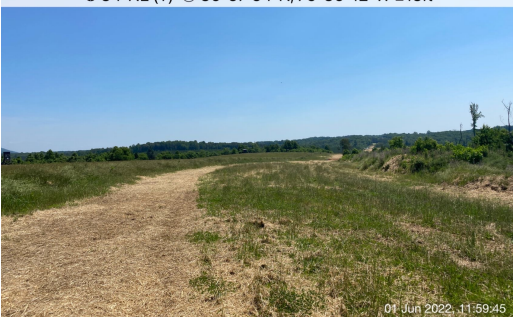
GPS Location	0	GPS Location	0		
Field Station#	14981+00	Field Station#	15010+00		
Pic 3 Desc.	Approximately 14981+00. Overview of ROW, road crossing and RCEs.		Pic 4 Desc.	Approximately 15010+00. Overview of ROW.

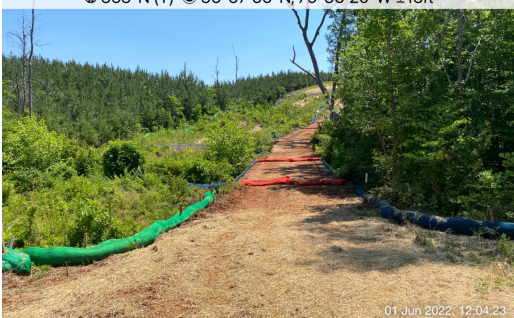
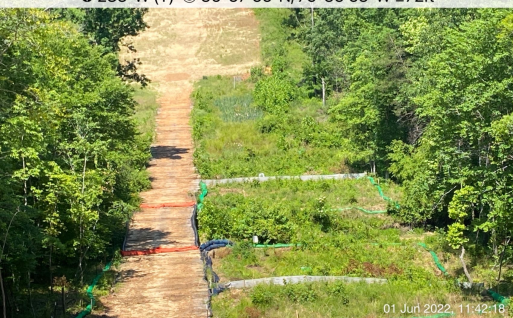
GPS Location	0	GPS Location	0		
Field Station#	15026+00	Field Station#	15045+00		
Pic 5 Desc.	Approximately 15026+00. Overview of stream crossing, equipment bridge and ECDs at stream S-D3.		Pic 6 Desc.	Approximately 15045+00. Overview of stream crossing, equipment bridge and ECDs at stream S-D2.

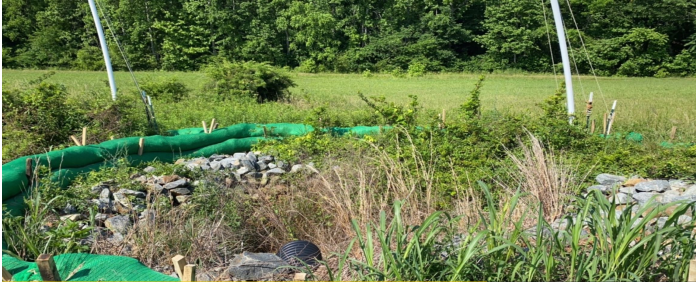
<small>37°0'15" N 79°45'7" W 148°SE COURSE 256° GPS 06.01.2022 10:12:32 Sorry no results found Accur +/-17.9 Ft ALT 937 Ft</small>			<small>37°0'15" N 79°45'6" W 200°S COURSE 145° GPS 06.01.2022 10:12:57 Sorry no results found Accur +/-40.1 Ft ALT 936 Ft</small>		
GPS Location	1		GPS Location	2	
Field Station#	14553+00		Field Station#	14560+00	
Pic 1 Desc.	Plunge pool performing intended function.		Pic 2 Desc.	Temporary diversion berm stabilized and vegetated.

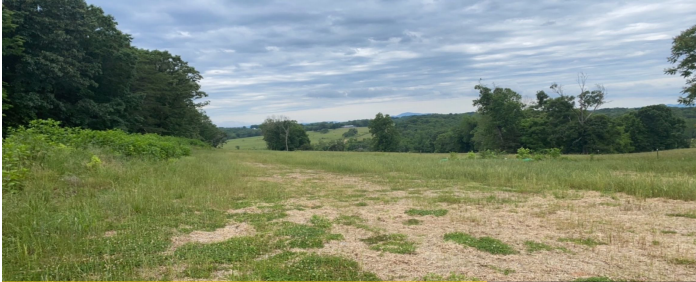
37°15'1" N 79°46'56" W 23°NE COURSE 296° GPS Glade Hill, VA 24092, United States 06.03.2022 09:56:56 Accur +/-50.3 Ft ALT 1089 Ft			37°1'52" N 79°47'1" W 291°W COURSE -1° GPS Glade Hill, VA 24092, United States 06.03.2022 10:00:06 Accur +/-16420.6 Ft ALT 1067 Ft		
GPS Location	1		GPS Location	2	
Field Station#	14396+00		Field Station#	14404+00	
Pic 1 Desc.	ROW stabilized and vegetated in temporary area.		Pic 2 Desc.	Rock lined channel in good condition.

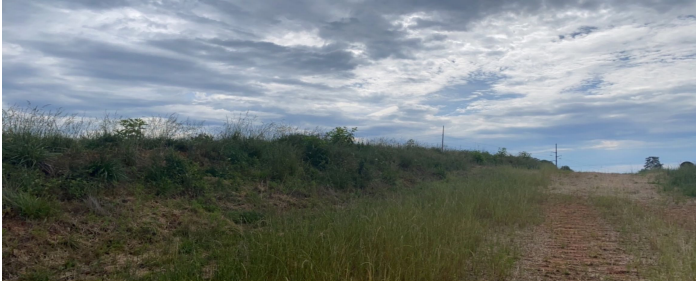
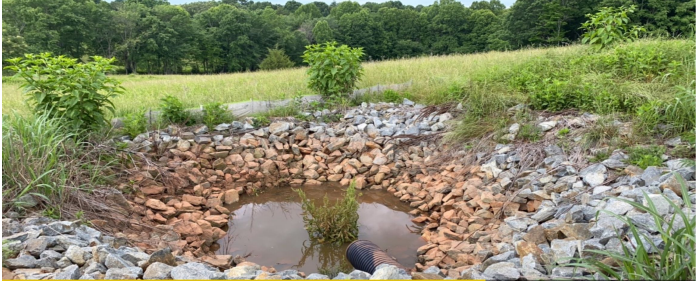
37°1'39" N 79°46'13" W 26°NE COURSE 257° GPS 201-483 Old Carriage Rd, Glade Hill, VA 24092, United States 06.03.2022 09:45:56 Accur +/-108.7 Ft ALT 1119 Ft			37°1'37" N 79°46'10" W 302°NW COURSE 282° GPS 2750 Webster Rd, Glade Hill, VA 24092, United States 06.03.2022 09:42:03 Accur +/-15.4 Ft ALT 1098 Ft		
GPS Location	5		GPS Location	6	
Field Station#	14441+00		Field Station#	14452+00	
Pic 5 Desc.	Temporary diversion berm stabilized and vegetated.		Pic 6 Desc.	Plunge pool performing intended function.

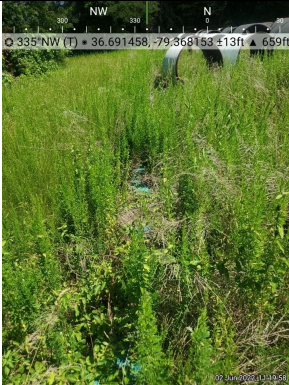
GPS Location	0	GPS Location	0		
Field Station#	0+00	Field Station#	0+00		
Pic 1 Desc.	LY-048 Temporary vegetation		Pic 2 Desc.	LY-048 West perimeter CFS

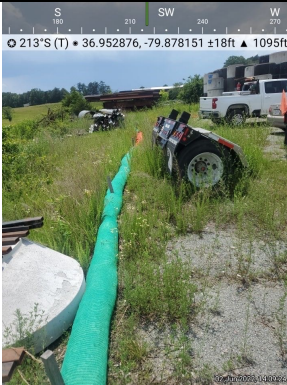
GPS Location	0	GPS Location	0		
Field Station#	0+00	Field Station#	0+00		
Pic 3 Desc.	ANC-006 Southeast perimeter CFS		Pic 4 Desc.	ANC-006 Secondary containment

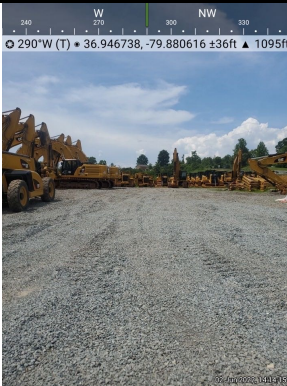
GPS Location	0	GPS Location	0		
Field Station#	0+00	Field Station#	0+00		
Pic 5 Desc.	LY-032 Rock construction entrance		Pic 6 Desc.	LY-032 Secondary containment

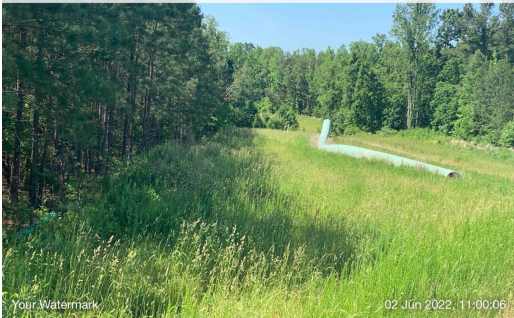
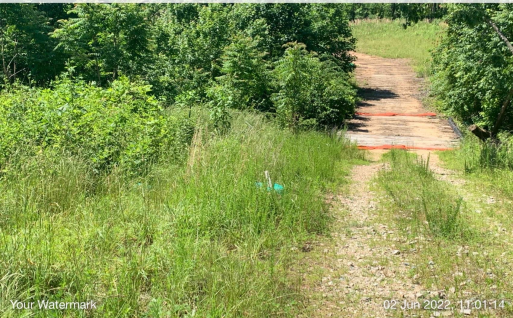
GPS Location	O		GPS Location	O	
Field Station#	6+00		Field Station#	12+65	
Pic 1 Desc.	Observing temporary stabilization		Pic 2 Desc.	Observing temporary stabilization,buffer, equipment crossing and ECD's	
South Elevation 13°N (T) 36°49'43"N, 79°20'40"W ±13ft ▲620ft

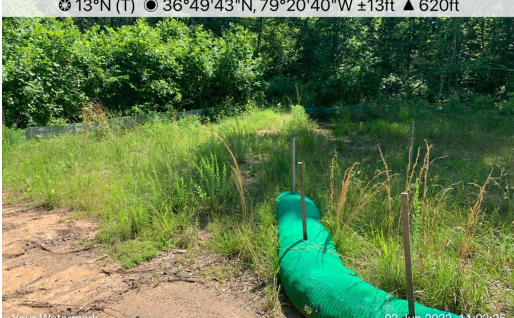
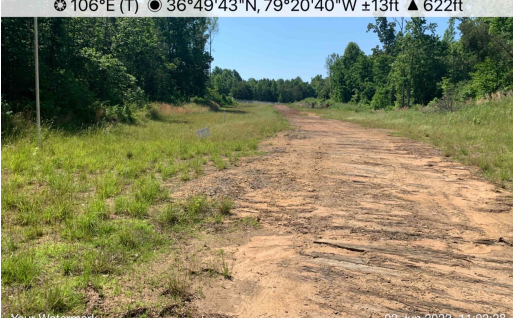
GPS Location	O		GPS Location	O	
Field Station#	13+50		Field Station#	15+00	
Pic 3 Desc.	Observing temporary stabilization,water bar, sump, end treatment and ECD's		Pic 4 Desc.	Observing temporary stabilization and signage	
Insert image here			Insert image here		
GPS Location			GPS Location		
Field Station#			Field Station#		
Pic 5 Desc.			Pic 6 Desc.

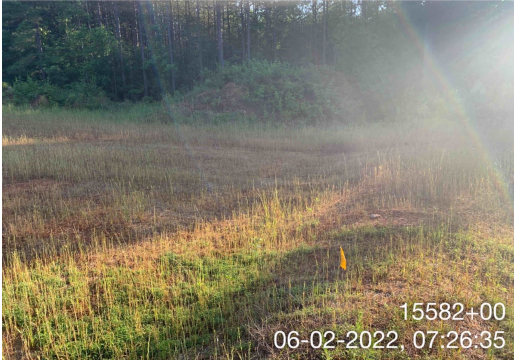
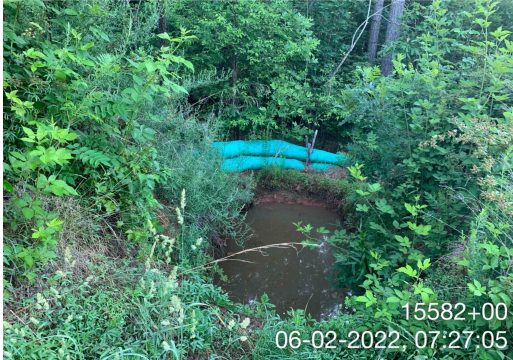
GPS Location	0		GPS Location	0	
Field Station#	15582+00		Field Station#	15582+00	
Pic 1 Desc.	Waterbar in acceptable condition		Pic 2 Desc.	Waterbar end treatment in acceptable condition

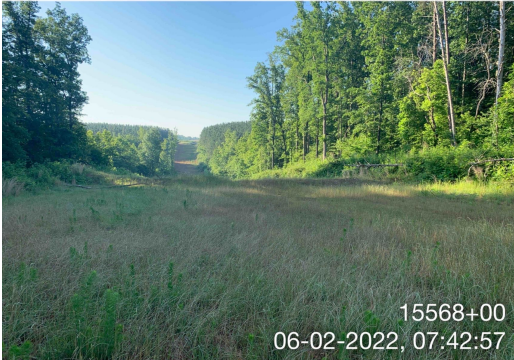
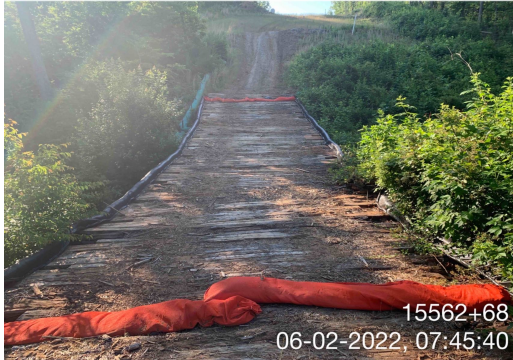
GPS Location	0		GPS Location	0	
Field Station#	15568+00		Field Station#	15562+68	
Pic 3 Desc.	Temporary vegetative stabilization in acceptable condition		Pic 4 Desc.	Equipment bridge in acceptable condition

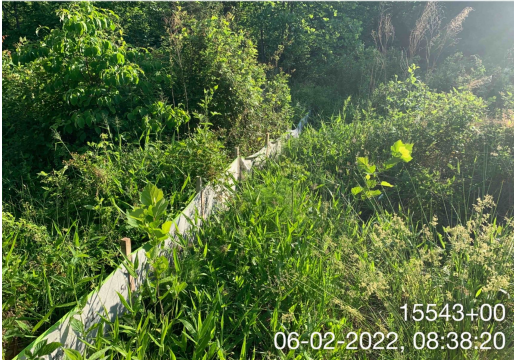
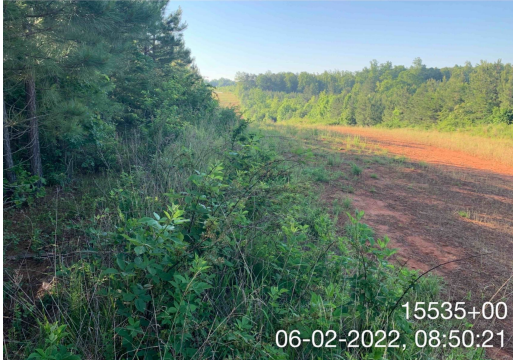
GPS Location	0		GPS Location	0	
Field Station#	15543+00		Field Station#	15535+00	
Pic 5 Desc.	P1 silt fence in acceptable condition		Pic 6 Desc.	Clean water diversion berm in acceptable condition

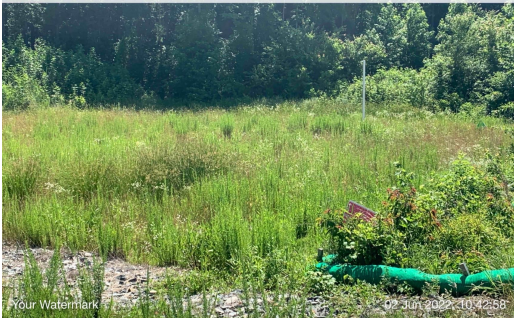
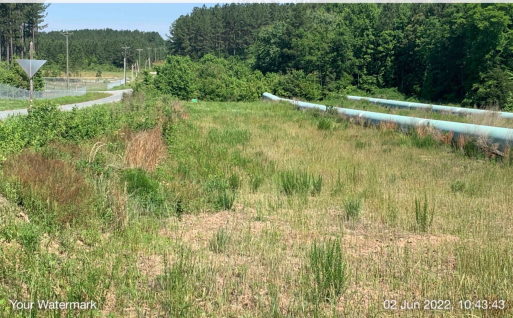
GPS Location	O	GPS Location	O		
Field Station#	14+00	Field Station#	22+00		
Pic 1 Desc.	Observing temporary stabilization, RCE, signage, buffer and ECD's	Pic 2 Desc.	Observing temporary stabilization, signage and buffer		
West Elevation 100°E (T) 36°50'5"N, 79°20'31"W ±157ft ▲652ft

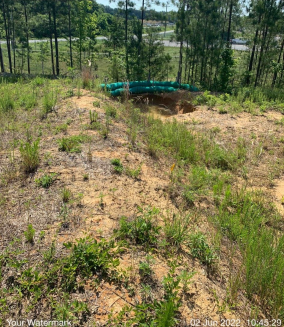
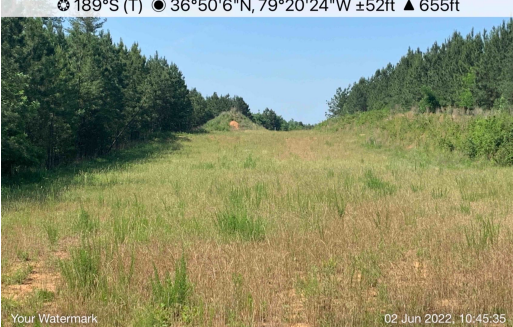
GPS Location	O	GPS Location	O		
Field Station#	12+00	Field Station#	6+00		
Pic 3 Desc.	Observing temporary stabilization, water bar, sump and end treatment	Pic 4 Desc.	Observing temporary stabilization and water bar		
Insert image here			Insert image here		
GPS Location		GPS Location			
Field Station#		Field Station#			
Pic 5 Desc.		Pic 6 Desc.

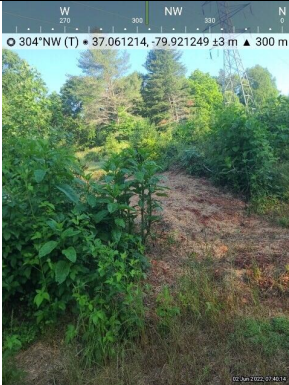
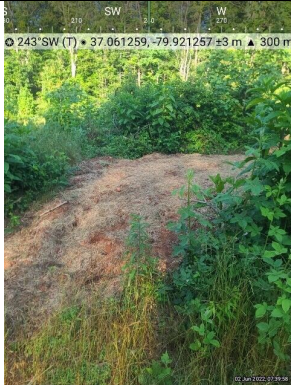
GPS Location	0000	GPS Location	0000		
Field Station#	13844+65	Field Station#	13844+65		
Pic 1 Desc.	Additional photo showing stabilization in area where a land owner disturbed a spoil pile. Punch list item completed.		Pic 2 Desc.	Monitored completed punch list item, disturbed area stabilized after land owner activities.

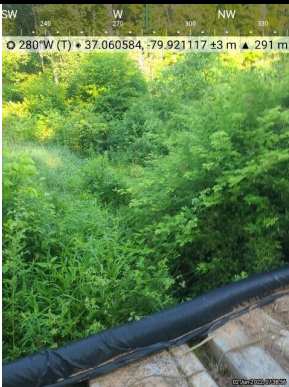
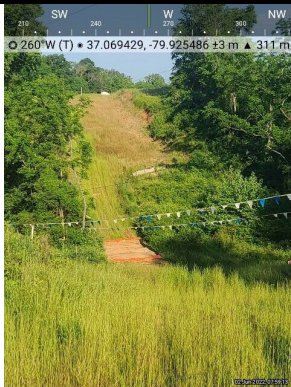
GPS Location	0000	GPS Location	0000		
Field Station#	13846+78	Field Station#	13806+90		
Pic 3 Desc.	Stream observation photo facing upstream during routine inspection. No issues observed at the time of inspection.		Pic 4 Desc.	Photo showing stabilization and equipment bridge in place and functioning. No issues observed at the time of inspection.

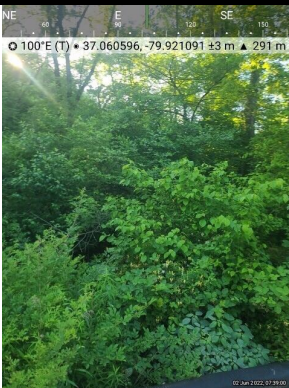
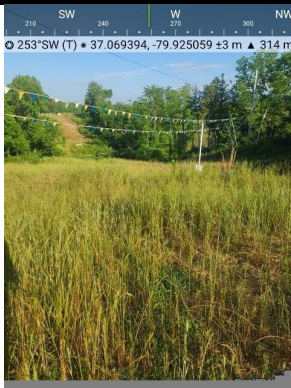
GPS Location	0000	GPS Location	0000		
Field Station#	13846+78	Field Station#	13810+00		
Pic 5 Desc.	Stream observation photo facing downstream during routine inspection today. O issues observed at the time of inspection.		Pic 6 Desc.	Vegetation observation photo in temporary area of row.

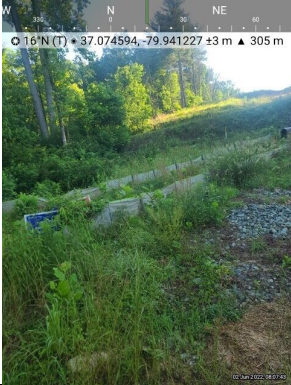
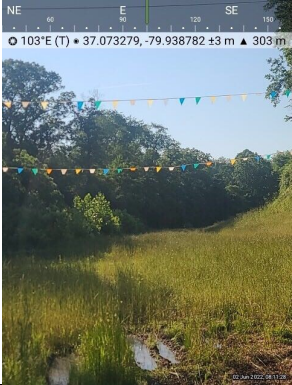
<p>GPS photo showing a field with vegetation. The photo includes a compass rose and coordinates: 103°E (T) • 37.073279, -79.938782 ±3 m ▲ 303 m.</p>			
GPS Location	0000	GPS Location	0000		
Field Station#	13748+97	Field Station#	13756+77		
Pic 7 Desc.	Stream observation photo showing ECDs in place and functioning at the time of inspection.		Pic 8 Desc.	Row photo showing vegetation in temporary area of row. No issues observed at the time of inspection.	
Insert image here		Insert image here			
GPS Location		GPS Location			
Field Station#		Field Station#			
Pic 9 Desc.			Pic 10 Desc.		
Insert image here		Insert image here			
GPS Location		GPS Location			
Field Station#		Field Station#

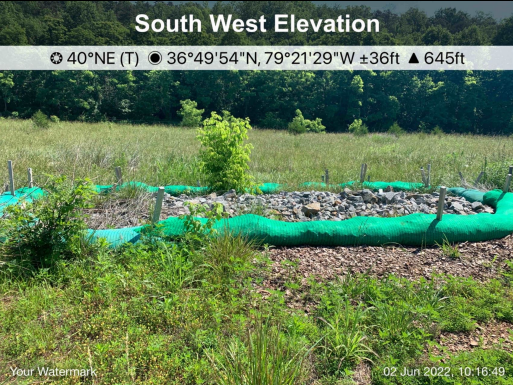
<p style="text-align: right;">02 Jun 2022, 10:18:49</p>			
GPS Location	O	GPS Location	O		
Field Station#	15977+35	Field Station#	15974+00		
Pic 1 Desc.	Observing temporary stabilization, water bar, signage, buffer, equipment crossing and ECD's	Pic 2 Desc.	Observing temporary stabilization, CWD outlet and ECD's		
<p style="text-align: center;">North West Elevation</p> <p style="text-align: center;">☉ 127°SE (T) ☉ 36°49'56"N, 79°21'33"W ±2375ft ▲ 637ft</p>

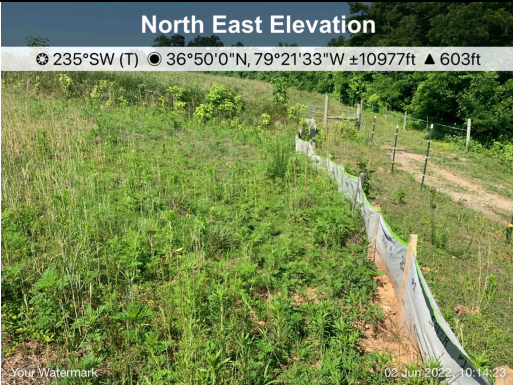
GPS Location	O	GPS Location	O		
Field Station#	15970+00	Field Station#	15965+00		
Pic 3 Desc.	Observing temporary stabilization and CWD berm	Pic 4 Desc.	Observing temporary stabilization and ECD's		
<p style="text-align: center;">East Elevation</p> <p style="text-align: center;">☉ 285°W (T) ☉ 36°49'50"N, 79°20'38"W ±4983ft ▲ 640ft</p>

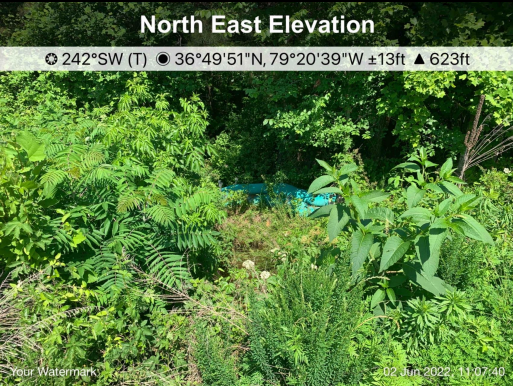
<p style="text-align: right;">02 Jun 2022, 11:07:40</p>			
GPS Location	O	GPS Location	O		
Field Station#	16023+00	Field Station#	16020+00		
Pic 5 Desc.	Observing temporary stabilization and water bar	Pic 6 Desc.	Observing temporary stabilization, sump and end treatment

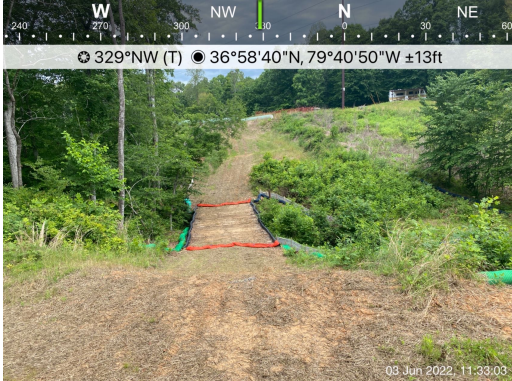
GPS Location		0		GPS Location		0	
Field Station#		14795+00		Field Station#		14701+00	
Pic 3 Desc.		Approximately 14795+00. Overview of stream crossing, equipment bridge and ECDs at stream S-H24.		Pic 4 Desc.		Approximately 14701+00. Overview of ROW.

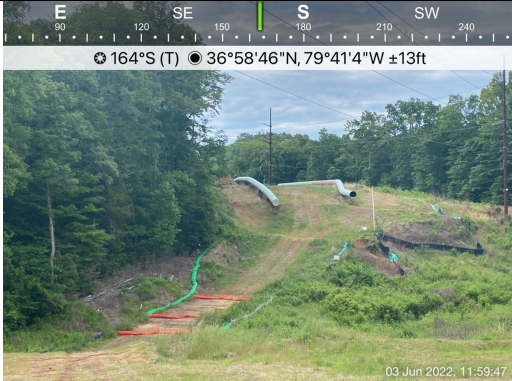
GPS Location		0		GPS Location		0	
Field Station#		14783+00		Field Station#		14749+00	
Pic 5 Desc.		Approximately 14783+00. Overview of ROW.		Pic 6 Desc.		Approximately 14749+00. Overview of ROW.

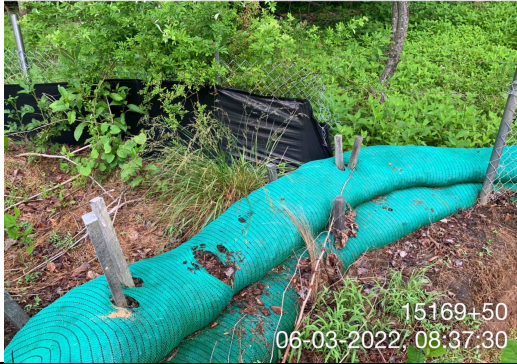
<p>15169+50 06-03-2022, 08:38:11</p>			
GPS Location	0	GPS Location	0		
Field Station#	15169+50	Field Station#	15169+50		
Pic 9 Desc.	CFS end treatment is deteriorated		Pic 10 Desc.	CFS at sump pit is deteriorated

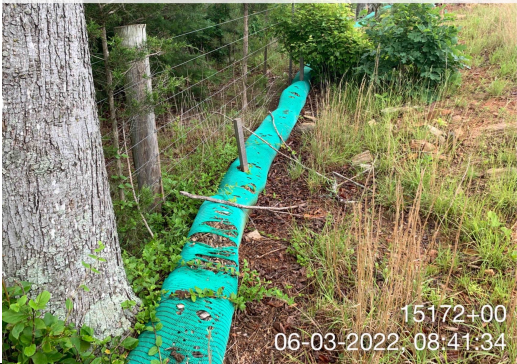
<p>15172+50 06-03-2022, 08:41:52</p>			
GPS Location	0	GPS Location	0		
Field Station#	15172+00	Field Station#	15172+50		
Pic 13 Desc.	CFS is deteriorated from 15172+00 to 15173+00	Pic 14 Desc.	P1 silt fence is deteriorated

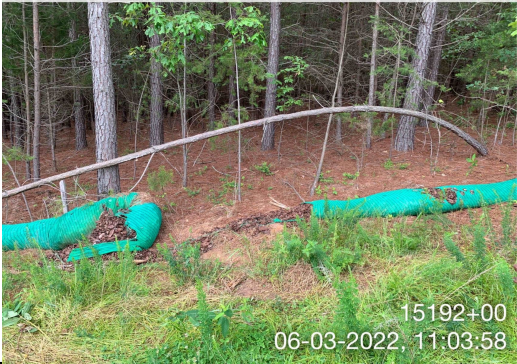
<p>15191+00 06-03-2022, 10:59:37</p>			
GPS Location	0	GPS Location	0		
Field Station#	15192+00	Field Station#	15191+00		
Pic 15 Desc.	CFS damaged by wildlife	Pic 16 Desc.	Electric fence requires maintenance

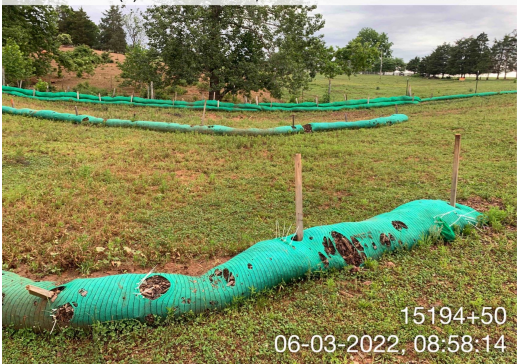
<p>15209+50 06-03-2022, 09:17:40</p>			
GPS Location	0	GPS Location	0		
Field Station#	15194+50	Field Station#	15209+50		
Pic 17 Desc.	CFS checks are deteriorated	Pic 18 Desc.	CFS is deteriorated from 15209+00 to 15210+00

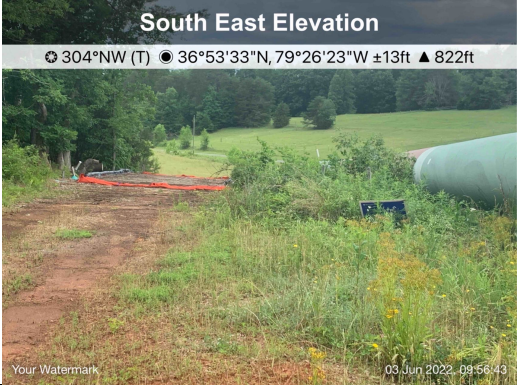
<p>South East Elevation 304°NW (T) 36°53'33"N, 79°26'23"W ±13ft ▲ 822ft Your Watermark 03 Jun 2022 09:56:43</p>					
GPS Location	O	GPS Location			
Field Station#	15614+94	Field Station#			
Pic 7 Desc.	Observing temporary stabilization, signage, buffer, equipment crossing and ECD's	Pic 8 Desc.			
Insert image here		Insert image here			
GPS Location		GPS Location			
Field Station#		Field Station#			
Pic 9 Desc.		Pic 10 Desc.			
Insert image here		Insert image here			
GPS Location		GPS Location			
Field Station#		Field Station#			
Pic 11 Desc.		Pic 12 Desc.

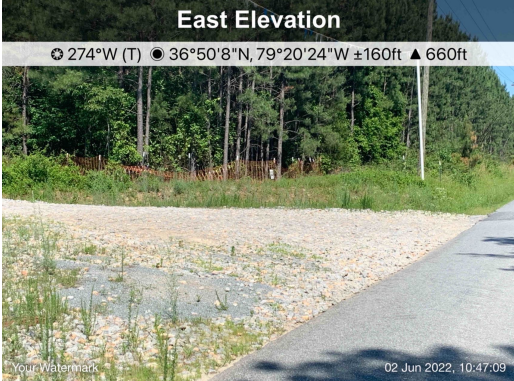
GPS Location	O	GPS Location	O		
Field Station#	00+00	Field Station#	00+00		
Pic 1 Desc.	Observing RCE	Pic 2 Desc.	Observing temporary stabilization and rock check dams		
North East Elevation 220°SW (T) 36°50'1"N, 79°20'33"W ±1437ft ▲ 660ft

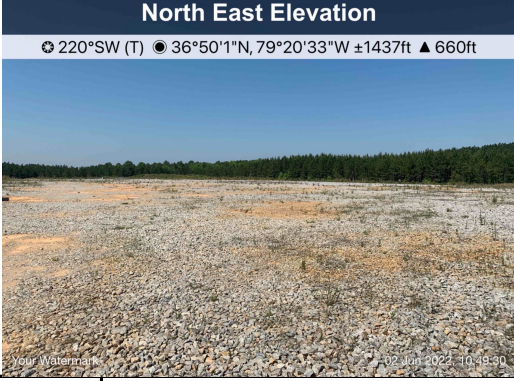
GPS Location	O	GPS Location	O		
Field Station#	00+00	Field Station#	00+00		
Pic 3 Desc.	Observing temporary stabilization and lay down yard	Pic 4 Desc.	Observing temporary stabilization, rock drain and ECD's		
North Elevation 201°S (T) 36°49'57"N, 79°20'36"W ±13ft ▲ 648ft

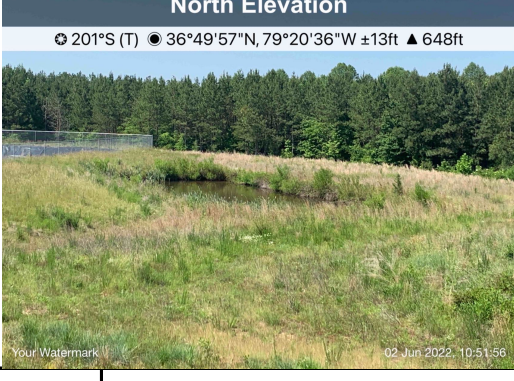
Field Station#	00+00	Field Station#	00+00		
Pic 5 Desc.	Observing temporary stabilization and sediment basin	Pic 6 Desc.	Observing temporary stabilization, storm water pond and ECD's
