Visual Site Inspection Report

Project Name	H-600 Pipeline Spread I	AFE	124300139	Spread	H-600 Pipeline Spread I
Contractor	Precision	Report #	38444		
Inspector	Ben Farmer	Date/Time	6/6/2022 12:58 PM		
Permit #	TBD	Inspection Type	VA SWPP	Station Begin	13958+31
State	VA	Inspection Area	Partial	Station End	14062+17
County	Franklin	Ground	Dry	Temperature (°F)	65.00
Municipality	N/A	Weather	Sunny	Rain Gauge (in)	0.00
				Rain Accumulation Time (days)	0.00

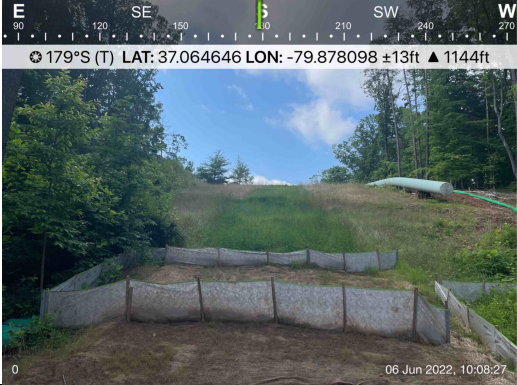
Insert image here			
GPS Location	See photo	GPS Location			
Field Station#	14050+00	Field Station#			
Pic 13 Desc.	Slope remains stabilized with controls in place.	Pic 14 Desc.			
Insert image here		Insert image here			
GPS Location		GPS Location			
Field Station#		Field Station#			
Pic 15 Desc.		Pic 16 Desc.			
Insert image here		Insert image here			
GPS Location		GPS Location			
Field Station#		Field Station#			
Pic 17 Desc.		Pic 18 Desc.

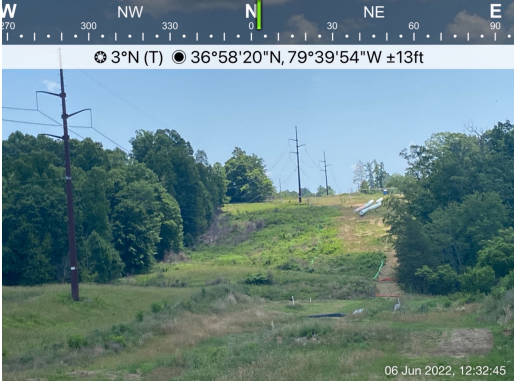
GPS Location	0	GPS Location	0		
Field Station#	14851+00	Field Station#	14845+60		
Pic 3 Desc.	Approximately 14851+00. Overview of ROW.	Pic 4 Desc.	Approximately 14845+60. Overview of road crossing and RCEs.

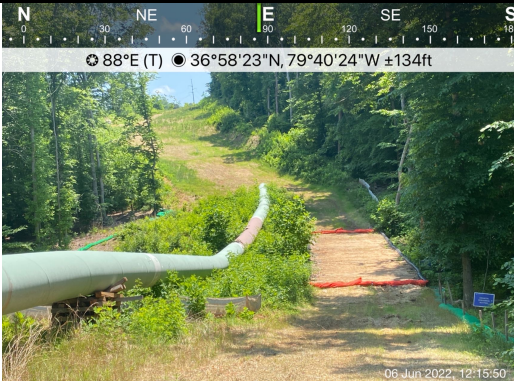
GPS Location	0	GPS Location	0		
Field Station#	14823+54	Field Station#	14805+00		
Pic 5 Desc.	Approximately 14823+54. Overview of stream crossing, equipment bridge and ECDs at stream S-A13.	Pic 6 Desc.	Approximately 14805+00. Overview of stream crossing, equipment bridge and ECDs at stream S-H23.

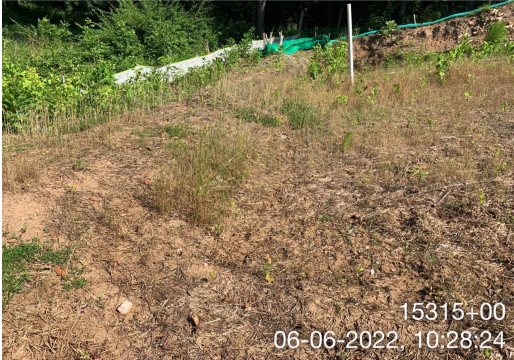
GPS Location	0	GPS Location	0		
Field Station#	15315+00	Field Station#	15315+00		
Pic 1 Desc.	Waterbar in acceptable condition	Pic 2 Desc.	Waterbar end treatment and P1 silt fence in acceptable conditions

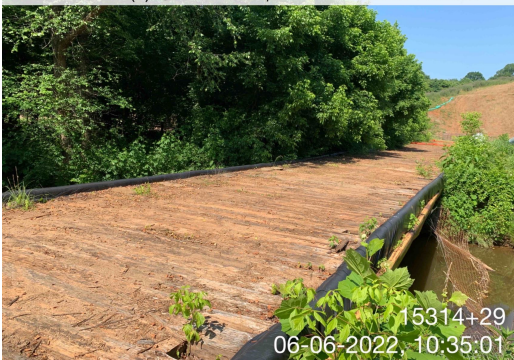
GPS Location	0	GPS Location	0		
Field Station#	15314+29	Field Station#	15333+00		
Pic 3 Desc.	Equipment bridge in acceptable condition	Pic 4 Desc.	CFS in acceptable condition

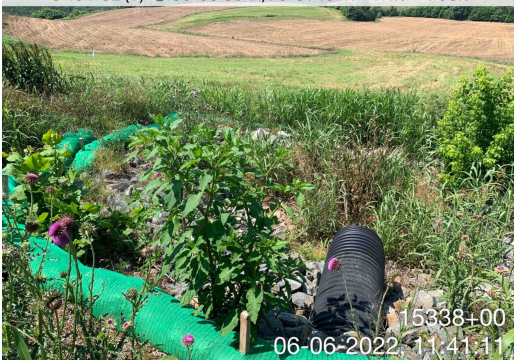
GPS Location	0	GPS Location	0		
Field Station#	15338+00	Field Station#	15345+00		
Pic 5 Desc.	Clean water diversion pipe and plunge pool in acceptable conditions	Pic 6 Desc.	P1 silt fence in acceptable condition

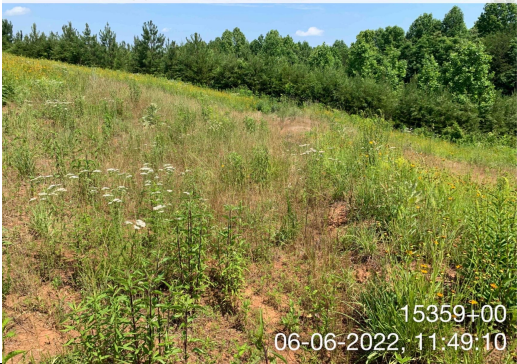
GPS Location	0	GPS Location	0		
Field Station#	15359+00	Field Station#	15359+00		
Pic 7 Desc.	Waterbar in acceptable condition	Pic 8 Desc.	Waterbar end treatment in acceptable condition		
<small>16°N (T) 36°55'25"N, 79°30'54"W ±288ft ▲758ft</small>  		<small>275°W (T) 36°56'38"N, 79°28'53"W ±15209ft ▲803ft</small>

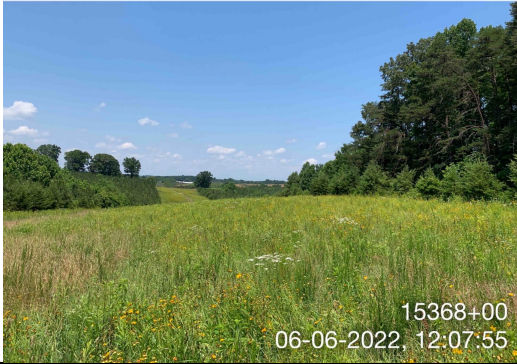
GPS Location	0	GPS Location	0		
Field Station#	15354+00	Field Station#	15368+00		
Pic 9 Desc.	Temporary vegetative stabilization in acceptable condition	Pic 10 Desc.	Permanent vegetative stabilization in acceptable condition		
Insert image here		Insert image here			
GPS Location		GPS Location			
Field Station#		Field Station#			
Pic 11 Desc.		Pic 12 Desc.

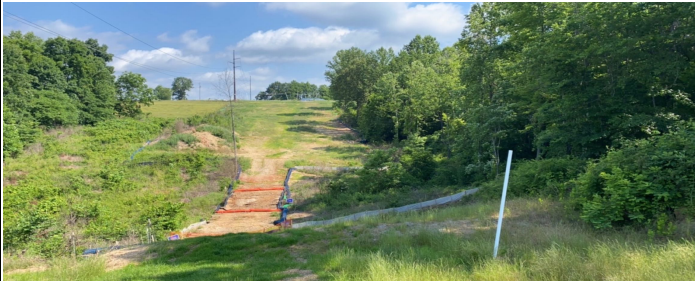
06.06.2022 10:27:57 Accur +/-41.1 Ft ALT 1028 Ft			06.06.2022 10:21:34 Accur +/-33.9 Ft ALT 951 Ft		
GPS Location	5	GPS Location	6		
Field Station#	14531+58	Field Station#	14545+83		
Pic 5 Desc.	Equipment bridge and surrounding ECDs in place and functional at stream crossing and resource buffer.		Pic 6 Desc.	P1 silt fence in place and functional at resource buffer; signage visible and intact.

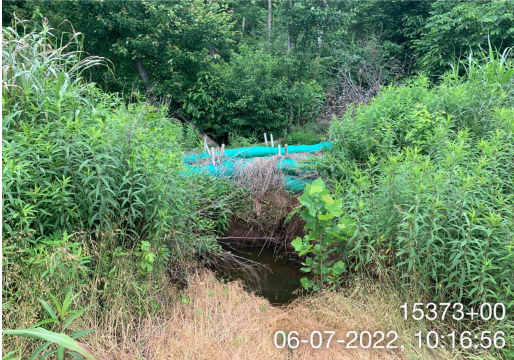
<p>15373+00 06-07-2022, 10:16:56</p>

<p>15374+00 06-07-2022, 10:17:56</p>			
GPS Location	0	GPS Location	0		
Field Station#	15373+00	Field Station#	15374+00		
Pic 1 Desc.	Sump pit in acceptable condition	Pic 2 Desc.	Perimeter CFS in acceptable condition

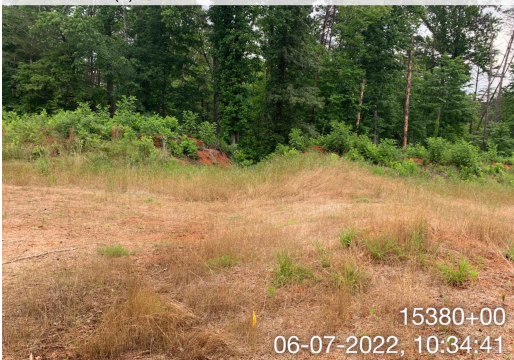
<p>15380+00 06-07-2022, 10:34:41</p>

<p>15380+00 06-07-2022, 10:35:01</p>			
GPS Location	0	GPS Location	0		
Field Station#	15380+00	Field Station#	15380+00		
Pic 3 Desc.	Waterbar in acceptable condition	Pic 4 Desc.	Waterbar end treatment in acceptable condition

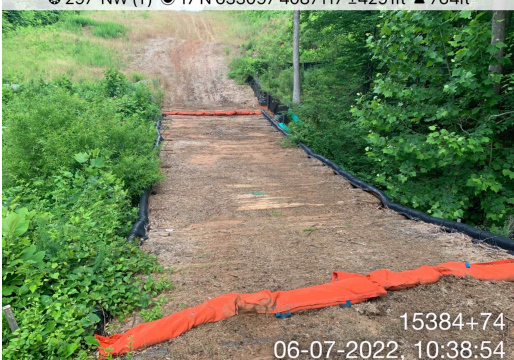
<p>15384+74 06-07-2022, 10:38:54</p>

<p>15384+00 06-07-2022, 10:39:29</p>			
GPS Location	0	GPS Location	0		
Field Station#	15384+74	Field Station#	15384+00		
Pic 5 Desc.	Equipment bridge in acceptable condition	Pic 6 Desc.	Super silt fence in acceptable condition

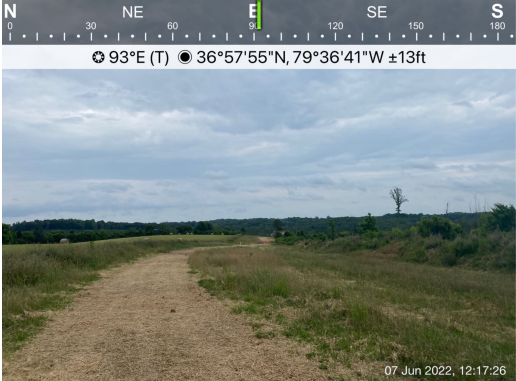
GPS Location	0	GPS Location	0		
Field Station#	15011+00	Field Station#	14993+50		
Pic 3 Desc.	Approximately 15011+00. Overview of ROW.	Pic 4 Desc.	Approximately 14993+50. Overview of ROW. Permanent vegetation.

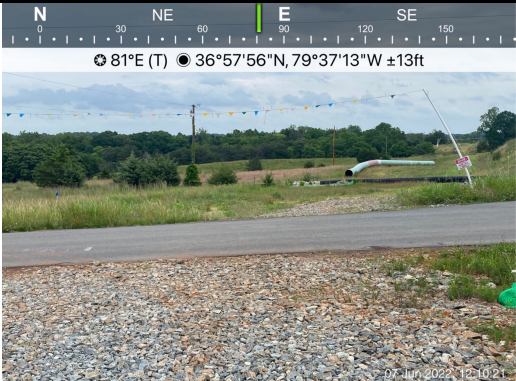
GPS Location	0	GPS Location	0		
Field Station#	14982+00	Field Station#	14970+00		
Pic 5 Desc.	Approximately 14982+00. Overview of road crossing, RCEs and ROW.	Pic 6 Desc.	Approximately 14970+00. Overview of ROW. Permanent vegetation.

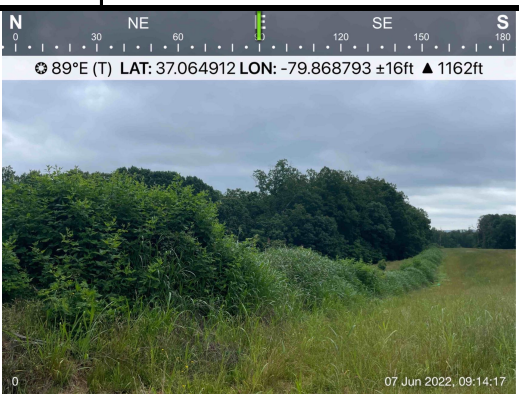
GPS Location		See photo			
Field Station#		14085+00			
Pic 5 Desc.		Topsoil berms and ROW remain stabilized.

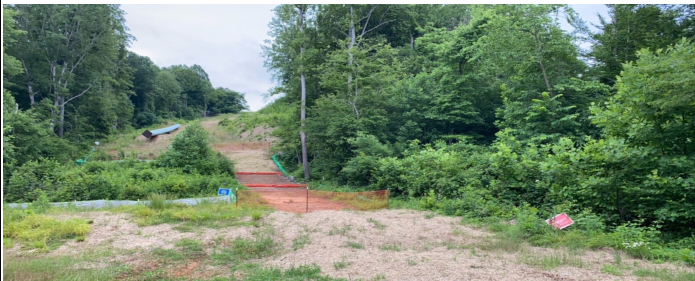
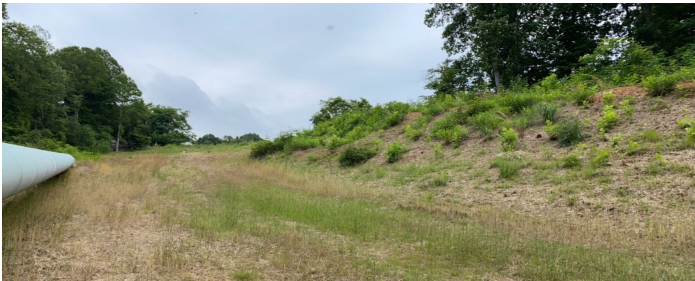
36°59'45" N 79°44'7" W 168°S COURSE 125' GPS Sorry no results found 06.07.2022 10:07:37 Accur +/-59.2 Ft ALT 866 Ft			36°59'44" N 79°44'4" W 149°SE COURSE 88' GPS Sorry no results found 06.07.2022 10:09:24 Accur +/-51.8 Ft ALT 886 Ft		
GPS Location	5		GPS Location	6	
Field Station#	14611+17		Field Station#	14615+00	
Pic 5 Desc.	Equipment bridge and surrounding ECDs in place and functional at stream crossing and resource buffer; signage visible and intact.		Pic 6 Desc.	Temporary diversion berm stabilized and vegetated; ROW stabilized and vegetated in temporary area.

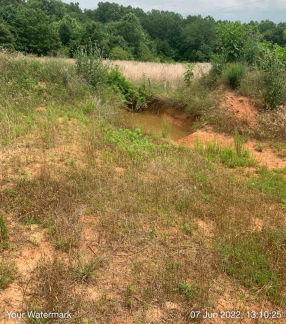
GPS Location	O	GPS Location	O		
Field Station#	15777+00	Field Station#	15781+22		
Pic 1 Desc.	Observing temporary stabilization, water bar, sump and end treatment	Pic 2 Desc.	Observing temporary stabilization, signage, buffer, equipment crossing and ECD's		
West Elevation 82°E (T) 36°51'55"N, 79°23'57"W ±656ft ▲ 802ft

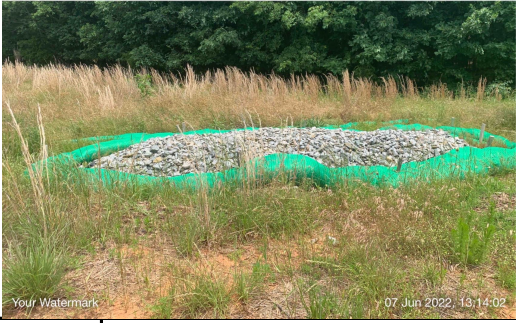
GPS Location	O	GPS Location	O		
Field Station#	15787+00	Field Station#	15794+77		
Pic 3 Desc.	Observing temporary stabilization, CWD outlet and ECD's	Pic 4 Desc.	Observing temporary stabilization, water bar, signage, buffer, equipment crossing and ECD's		
South East Elevation 297°NW (T) 36°51'22"N, 79°23'27"W ±1486ft ▲ 830ft

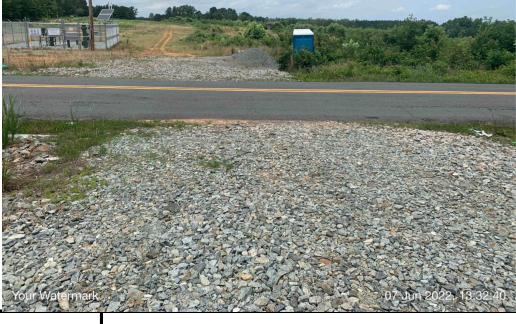
GPS Location	O	GPS Location	O		
Field Station#	15826+77	Field Station#	15825+00		
Pic 5 Desc.	Observing road crossing and RCE's	Pic 6 Desc.	Observing temporary stabilization, plunge pool and ECD's

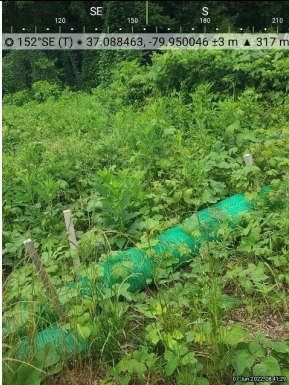
GPS Location	00000	GPS Location	0000		
Field Station#	13679+00	Field Station#	13704+90		
Pic 1 Desc.	Monitored CFS along the perimeter of the row throughout routine inspection. All in place and functioning at the time of inspection.		Pic 2 Desc.	Stream observation photo facing upstream during routine inspection today. No issues observed at the time of inspection.

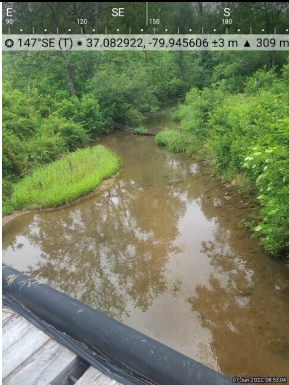
GPS Location	0000	GPS Location	0000		
Field Station#	13704+90	Field Station#	13748+11		
Pic 3 Desc.	Stream observation photo facing downstream during routine inspection today. No issues observed at the time of inspection.		Pic 4 Desc.	Monitored RCE and ECDs at the road crossing for Green Level road. No issues observed at the time of inspection.

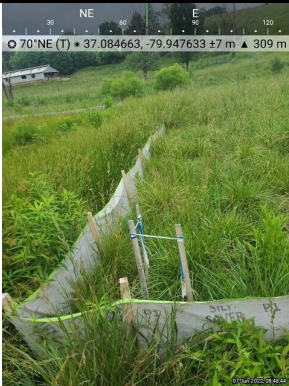
GPS Location	0000	GPS Location	0000		
Field Station#	13694+50	Field Station#	13700+00		
Pic 5 Desc.	ECDs monitored throughout inspection, all in place and functioning at the time of inspection.		Pic 6 Desc.	Monitored reinforced silt fence during routine inspection today. No environmental issues observed at the time of inspection.

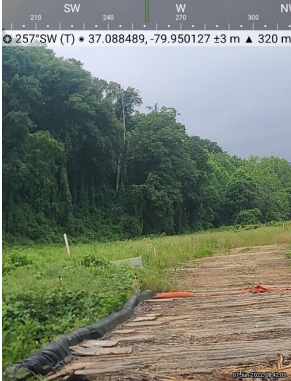
<div>Insert image here</div>		<div>Insert image here</div>	
GPS Location	0000	GPS Location			
Field Station#	13678+71	Field Station#			
Pic 7 Desc.	Observed equipment bridge and protection, ECDs in place and functioning at the time of inspection.	Pic 8 Desc.			
<div>Insert image here</div>		<div>Insert image here</div>			
GPS Location		GPS Location			
Field Station#		Field Station#			
Pic 9 Desc.		Pic 10 Desc.			
<div>Insert image here</div>		<div>Insert image here</div>			
GPS Location		GPS Location			
Field Station#		Field Station#			
Pic 11 Desc.		Pic 12 Desc.

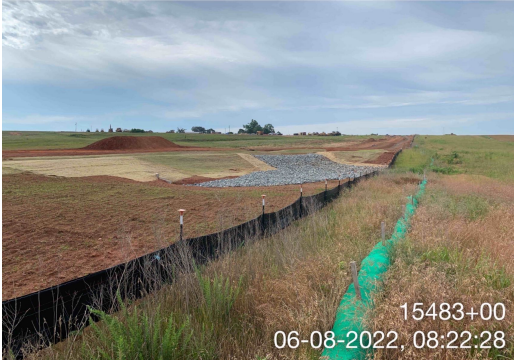
<p>15483+00 06-08-2022, 08:22:28</p>

<p>15505+00 06-08-2022, 08:32:07</p>			
GPS Location	0	GPS Location	0		
Field Station#	15483+00	Field Station#	15505+00		
Pic 1 Desc.	Perimeter CFS in acceptable condition and Solar farm ECDs	Pic 2 Desc.	Waterbar in acceptable condition

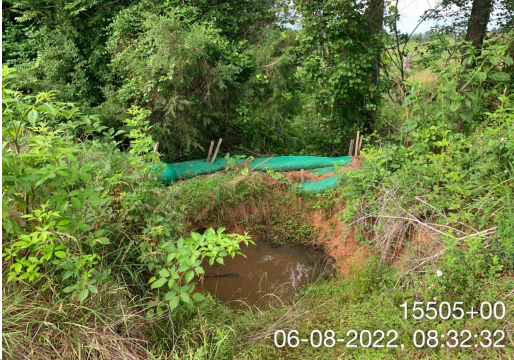
<p>15505+00 06-08-2022, 08:32:32</p>

<p>15533+00 06-08-2022, 08:45:16</p>			
GPS Location	0	GPS Location	0		
Field Station#	15505+00	Field Station#	15533+00		
Pic 3 Desc.	Waterbar end treatment in acceptable condition	Pic 4 Desc.	Clean water diversion pipe and CFS in acceptable conditions

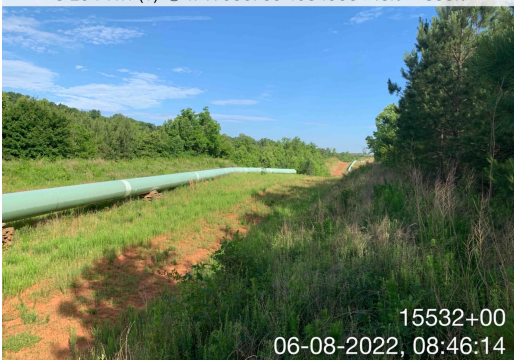
<p>15532+00 06-08-2022, 08:46:14</p>

<p>15549+00 06-08-2022, 08:56:15</p>			
GPS Location	0	GPS Location	0		
Field Station#	15532+00	Field Station#	15549+00		
Pic 5 Desc.	Clean water diversion berm and temporary vegetative stabilization in acceptable conditions	Pic 6 Desc.	Temporary vegetative stabilization in acceptable condition

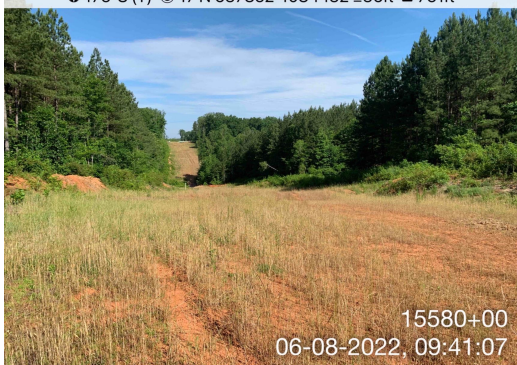
<p>15580+00 06-08-2022, 09:41:07</p>		  <p>15501+00 06-08-2022, 08:27:57</p>			
GPS Location	0	GPS Location	0		
Field Station#	15580+00	Field Station#	15501+00		
Pic 9 Desc.	Temporary vegetative stabilization in acceptable condition		Pic 10 Desc.	Solar farm perimeter ECDs appear to be in acceptable conditions	
Insert image here			Insert image here		
GPS Location		GPS Location			
Field Station#		Field Station#			
Pic 11 Desc.		Pic 12 Desc.

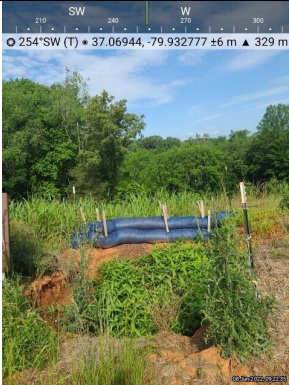
GPS Location	0000	GPS Location	0000		
Field Station#	13784+35	Field Station#	13834+04		
Pic 1 Desc.	Monitored sump pits and end treatment during routine inspection. All functioning properly at the time of inspection.		Pic 2 Desc.	Stream observation photo facing downstream during routine inspection today. No issues observed at the time of inspection today.

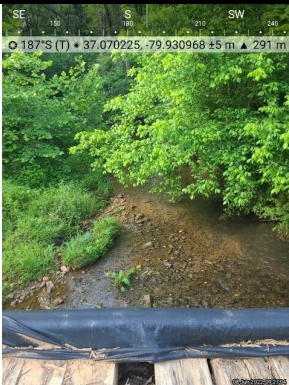
GPS Location	0000	GPS Location	0000		
Field Station#	13790+47	Field Station#	13789+30		
Pic 3 Desc.	Stream observation photo facing downstream during routine inspection today. No issues observed at the time of inspection.		Pic 4 Desc.	Monitored ECDs and equipment bridge during routine inspection today. No issues observed at the time of inspection.

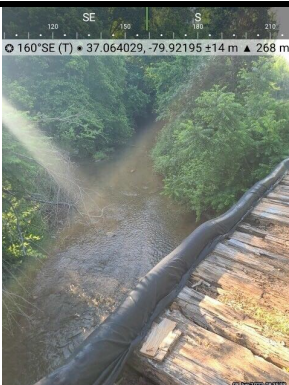
GPS Location	0000	GPS Location	0000		
Field Station#	13834+04	Field Station#	13786+50		
Pic 5 Desc.	Stream observation photo facing downstream during routine inspection today. No issues were observed at the time of inspection.		Pic 6 Desc.	CFS requires maintenance due to being weathered and torn. Added to the punch list to be repaired.

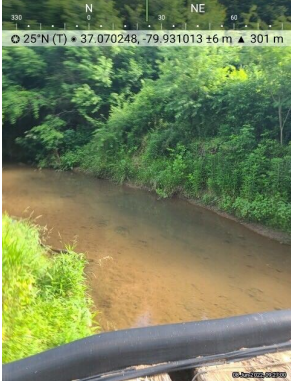
GPS Location	0000	GPS Location	0000		
Field Station#	13790+47	Field Station#	13834+54		
Pic 7 Desc.	Stream observation photo facing upstream during routine inspection. No environmental issues observed at the time of inspection.		Pic 8 Desc.	Monitored stream buffer ECDs during stream observations today. All in place and functioning at the time of inspection.	
Insert image here		Insert image here			
GPS Location		GPS Location			
Field Station#		Field Station#			
Pic 9 Desc.		Pic 10 Desc.			
Insert image here		Insert image here			
GPS Location		GPS Location			
Field Station#		Field Station#			
Pic 11 Desc.		Pic 12 Desc.

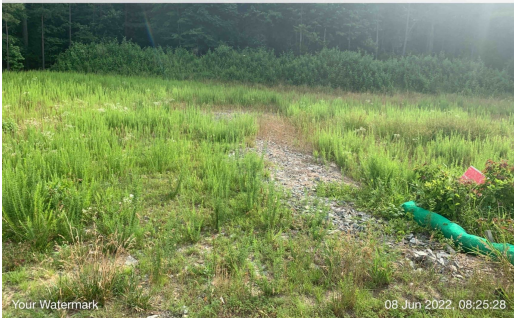
East Elevation 251°W (T) 36°50'2"N, 79°20'14"W ±456ft ▲ 630ft  		
GPS Location	O		GPS Location	O	
Field Station#	14+00		Field Station#	22+00	
Pic 1 Desc.	Observing temporary stabilization,RCE, signage and ECD's		Pic 2 Desc.	Observing temporary stabilization, signage and buffer	
South West Elevation 52°NE (T) 36°50'4"N, 79°20'23"W ±656ft ▲ 664ft

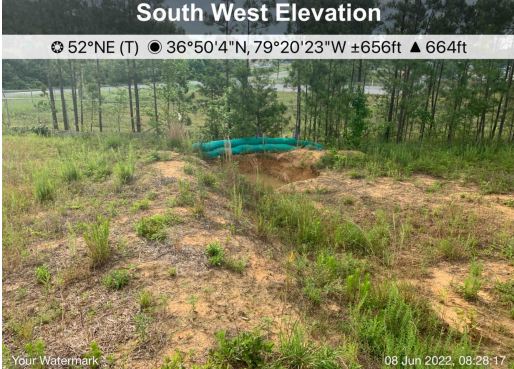
GPS Location	O		GPS Location	O	
Field Station#	11+00		Field Station#	6+00	
Pic 3 Desc.	Observing temporary stabilization,water bar, sump and end treatment		Pic 4 Desc.	Observing temporary stabilization	
Insert image here			Insert image here		
GPS Location			GPS Location		
Field Station#			Field Station#		
Pic 5 Desc.			Pic 6 Desc.

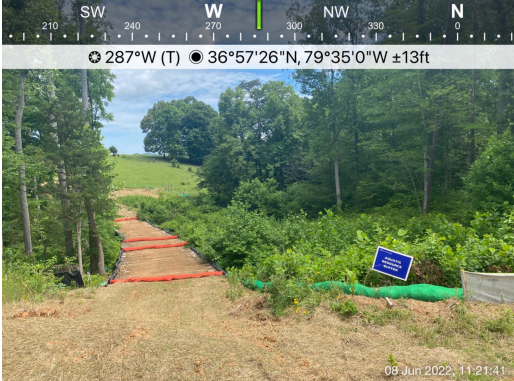
GPS Location	0	GPS Location	0		
Field Station#	15104+28	Field Station#	15113+50		
Pic 3 Desc.	Approximately 15104+28. Overview of stream crossing, equipment bridge and ECDs at stream S-Q15.	Pic 4 Desc.	Approximately 15113+50. Overview of road crossing and RCEs.

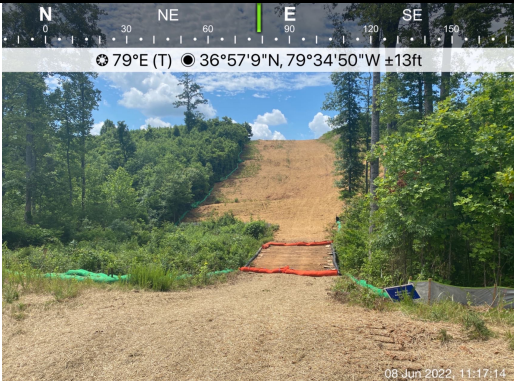
GPS Location	0	GPS Location	0		
Field Station#	15126+40	Field Station#	15140+00		
Pic 5 Desc.	Approximately 15126+40. Overview of stream crossing, equipment bridge and ECDs at stream S-A6.	Pic 6 Desc.	Approximately 15140+00. Overview of ROW.

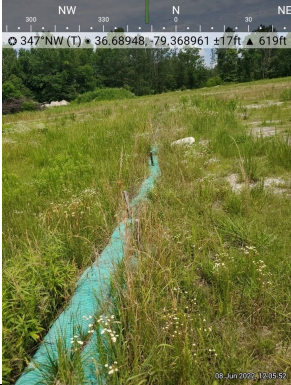
GPS Location	0	GPS Location	0		
Field Station#	0+00	Field Station#	0+00		
Pic 7 Desc.	LY-048 West perimeter CFS	Pic 8 Desc.	LY-048 South perimeter CFS		
Insert image here		Insert image here			
GPS Location		GPS Location			
Field Station#		Field Station#			
Pic 9 Desc.		Pic 10 Desc.			
Insert image here		Insert image here			
GPS Location		GPS Location			
Field Station#		Field Station#			
Pic 11 Desc.		Pic 12 Desc.

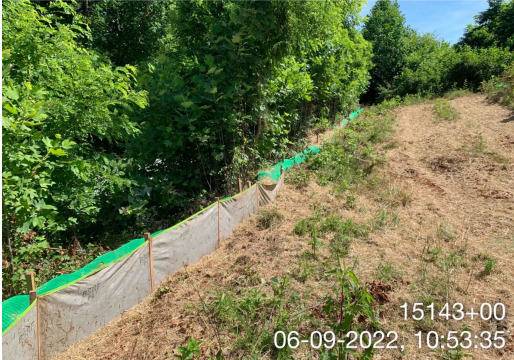
GPS Location	0	GPS Location	0		
Field Station#	15143+00	Field Station#	15143+50		
Pic 1 Desc.	P1 silt fence and perimeter CFS in acceptable conditions	Pic 2 Desc.	Waterbar end treatment and perimeter CFS in acceptable conditions

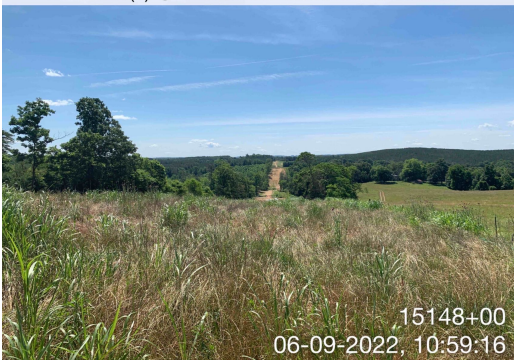
GPS Location	0	GPS Location	0		
Field Station#	15148+00	Field Station#	15154+00		
Pic 3 Desc.	Permanent vegetative stabilization in acceptable condition	Pic 4 Desc.	Waterbar in acceptable condition

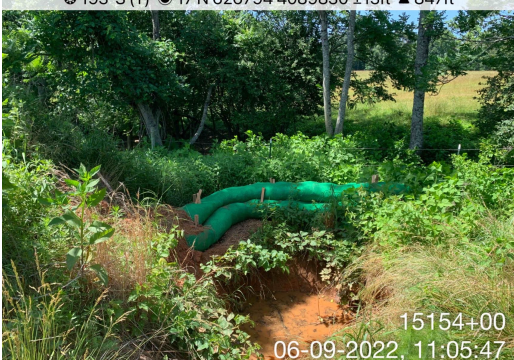
GPS Location	0	GPS Location	0		
Field Station#	15154+00	Field Station#	15168+59		
Pic 5 Desc.	Waterbar end treatment in acceptable condition	Pic 6 Desc.	Sensitive resource buffer and equipment bridge in acceptable conditions

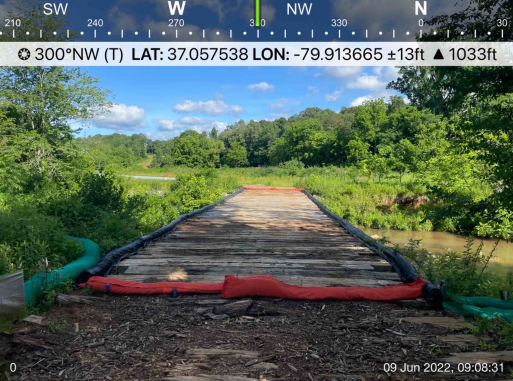
GPS Location	See photo	GPS Location	See photo		
Field Station#	13862+60	Field Station#	13875+73		
Pic 1 Desc.	Resource buffers remain well vegetated	Pic 2 Desc.	Equipment bridge ECDs are in good condition and functioning

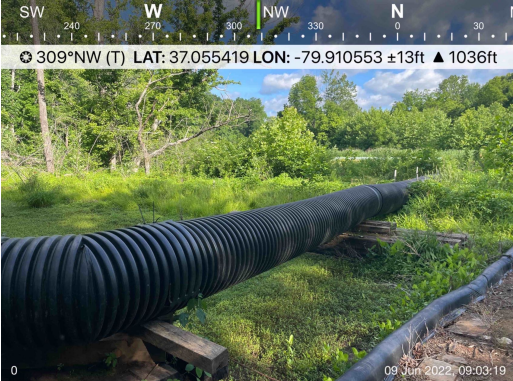
GPS Location	See photo	GPS Location	See photo		
Field Station#	13876+00	Field Station#	13889+00		
Pic 3 Desc.	P1 is in good condition at all stream and wetland buffers	Pic 4 Desc.	Slope drain is functioning as intended

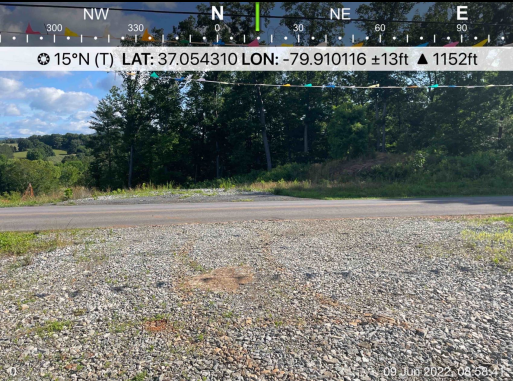
GPS Location	See photo	GPS Location	See photo		
Field Station#	13890+00	Field Station#	13892+45		
Pic 5 Desc.	Waterbars are in good condition	Pic 6 Desc.	RCEs are in good condition at all road crossings.

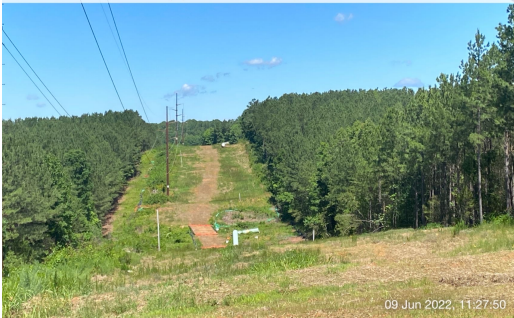
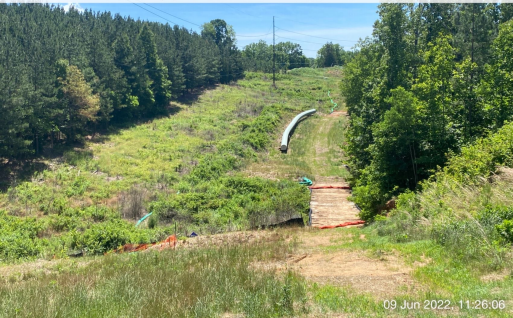
GPS Location	0	GPS Location	0		
Field Station#	14749+00	Field Station#	14766+00		
Pic 1 Desc.	Approximately 14749+00. Overview of ROW.	Pic 2 Desc.	Approximately 14766+00. Overview of ROW.

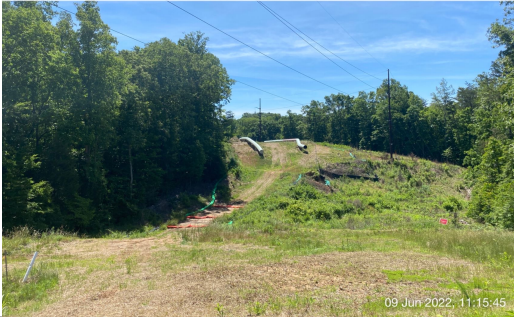
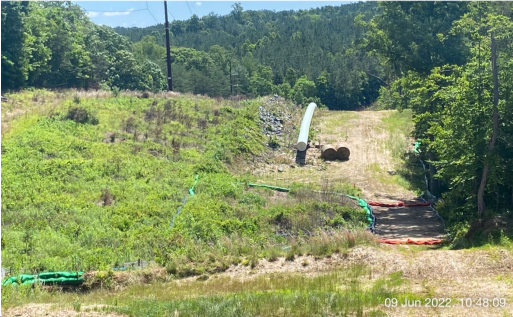
GPS Location	0	GPS Location	0		
Field Station#	14781+00	Field Station#	14722+00		
Pic 3 Desc.	Approximately 14781+00. Overview of ROW.	Pic 4 Desc.	Approximately 14722+00. Overview of ROW.

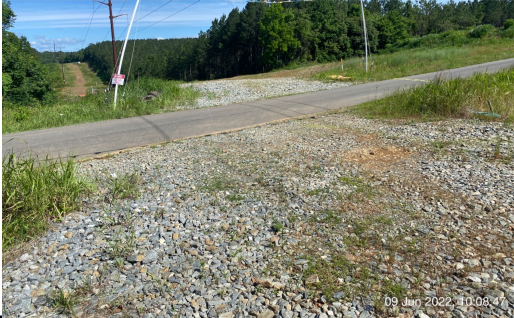
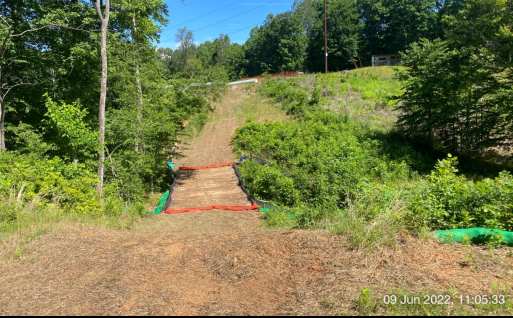
GPS Location	0	GPS Location	0		
Field Station#	14758+50	Field Station#	14793+82		
Pic 5 Desc.	Approximately 14758+50. Overview of road crossing and RCEs.	Pic 6 Desc.	Approximately 14793+82. Overview of stream crossing, equipment bridge and ECDs at stream S-H24.

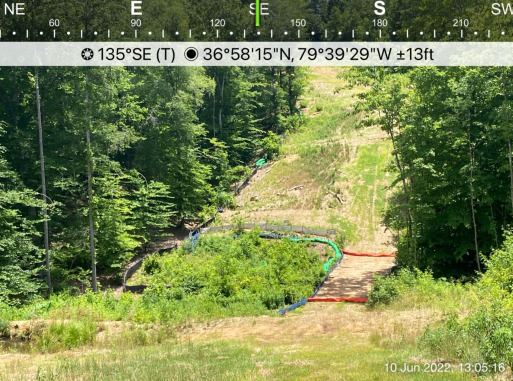
GPS Location	0	GPS Location	0		
Field Station#	14926+00	Field Station#	14870+43		
Pic 1 Desc.	Approximately 14926+00. Overview of ROW. Permanent vegetation.	Pic 2 Desc.	Approximately 14870+43. Overview of stream crossing, equipment bridge and ECDs at stream S-SS8.

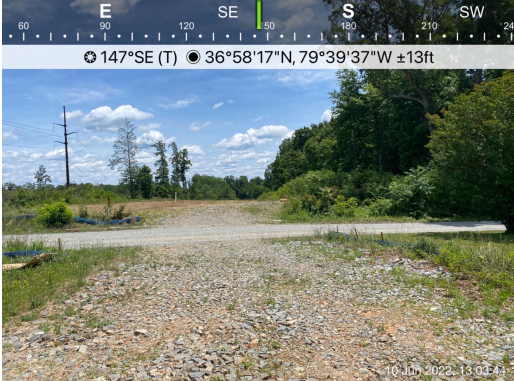
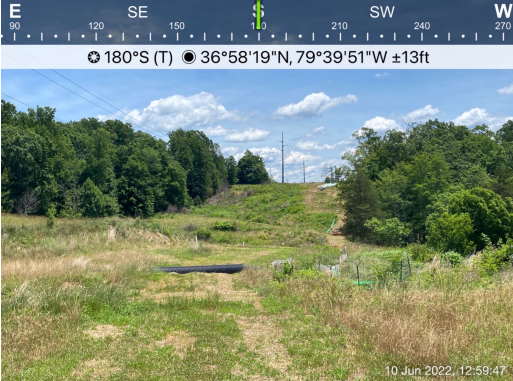
GPS Location	0	GPS Location	0		
Field Station#	14861+00	Field Station#	14850+00		
Pic 3 Desc.	Approximately 14861+00. Overview of road crossing and RCEs.	Pic 4 Desc.	Approximately 14850+00. Overview of ROW.

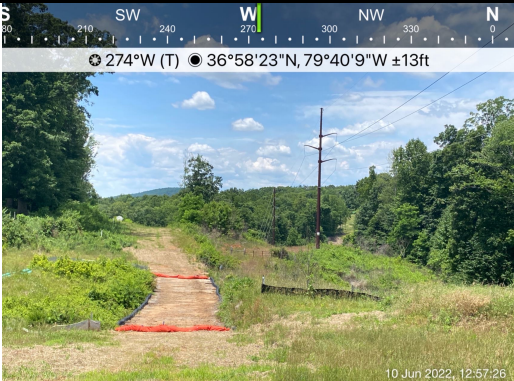
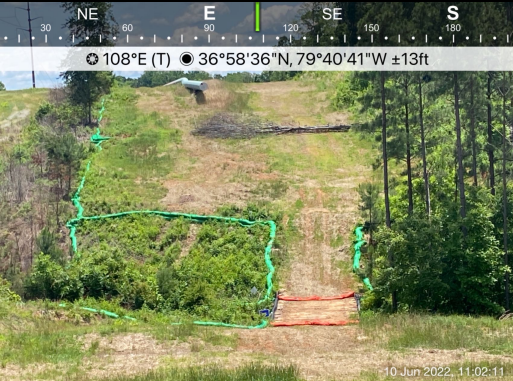
GPS Location	0	GPS Location	0		
Field Station#	14832+80	Field Station#	14805+00		
Pic 5 Desc.	Approximately 14832+80. Overview of stream crossing, equipment bridge and ECDs at stream S-A11.	Pic 6 Desc.	Approximately 14805+00. Overview of ROW.

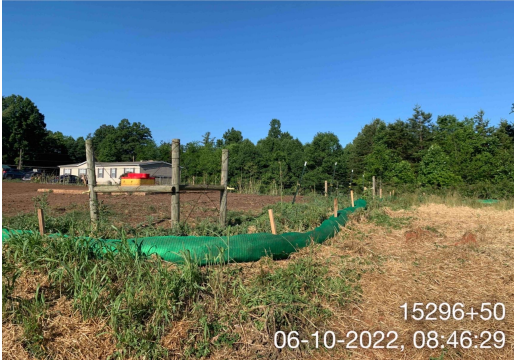
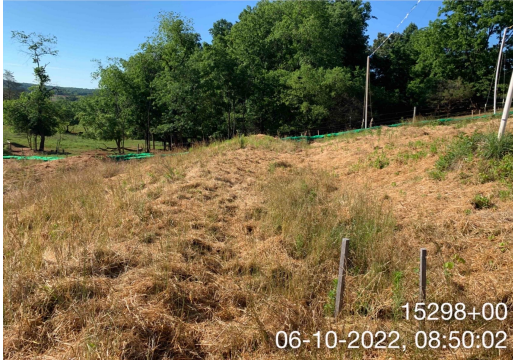
GPS Location	0	GPS Location	0		
Field Station#	15296+50	Field Station#	15298+00		
Pic 1 Desc.	Perimeter CFS in acceptable condition	Pic 2 Desc.	Waterbar in acceptable condition		
199°S (T) 17 N 630801 4088350 ±308ft ▲ 772ft

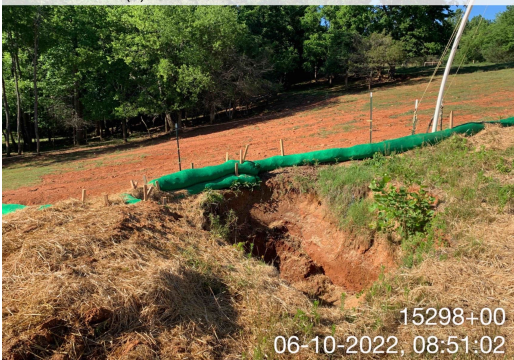
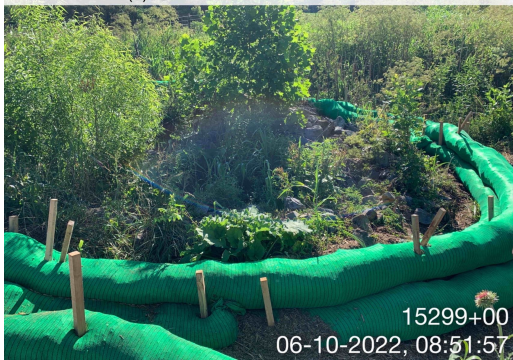
GPS Location	0	GPS Location	0		
Field Station#	15298+00	Field Station#	15299+00		
Pic 3 Desc.	Waterbar end treatment in acceptable condition	Pic 4 Desc.	Clean water diversion pipe and plunge pool in acceptable conditions		
135°SE (T) 17 N 631123 4088113 ±39ft ▲ 715ft

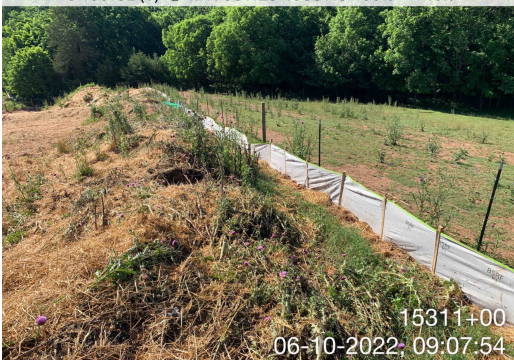
200°S (T) 17 N 631577 4088003 ±246ft ▲ 708ft  			
GPS Location	0	GPS Location	0		
Field Station#	15311+00	Field Station#	15327+00		
Pic 5 Desc.	P1 silt fence in acceptable condition	Pic 6 Desc.	Equipment bridge and CFS in acceptable conditions

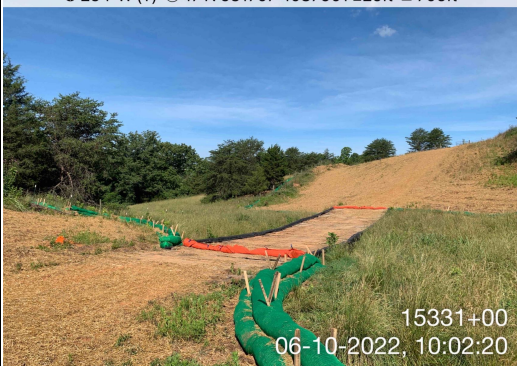
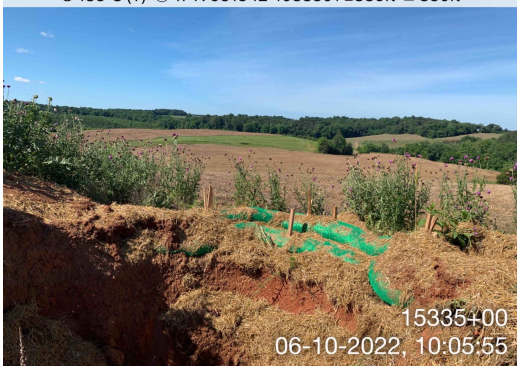
</div> <div>15335+00 06-10-2022, 10:05:55</div>			
GPS Location 0		GPS Location 0			
Field Station# 15331+00		Field Station# 15335+00			
Pic 7 Desc. Equipment bridge and temporary vegetative stabilization in acceptable conditions		Pic 8 Desc. Sump pit in acceptable condition			
<div>190°S (T) 17 N 631455 4088066 ±26ft ▲ 735ft</div> <div>

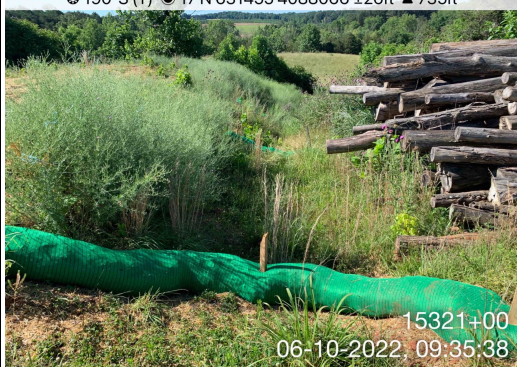
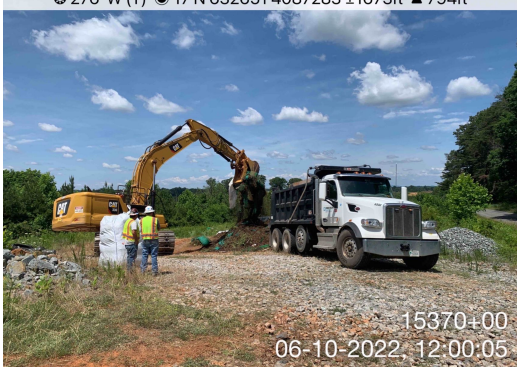
</div> <div>15370+00 06-10-2022, 12:00:05</div>			
GPS Location 0		GPS Location 0			
Field Station# 15321+00		Field Station# 15370+00			
Pic 9 Desc. CFS check in acceptable condition		Pic 10 Desc. Crews loading debris from old ECDs to haul away

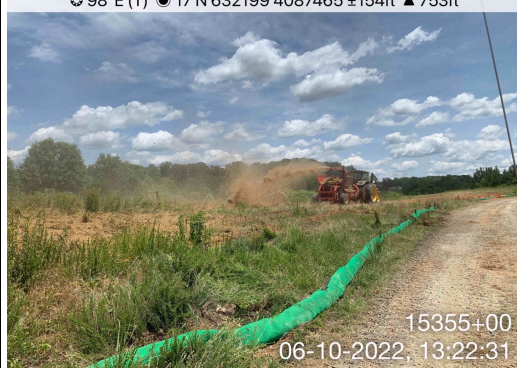
</div> <div>15355+00 06-10-2022, 13:22:31</div>		Insert image here			
GPS Location 0		GPS Location			
Field Station# 15355+00		Field Station#			
Pic 11 Desc. Contractor spreading mulch		Pic 12 Desc.

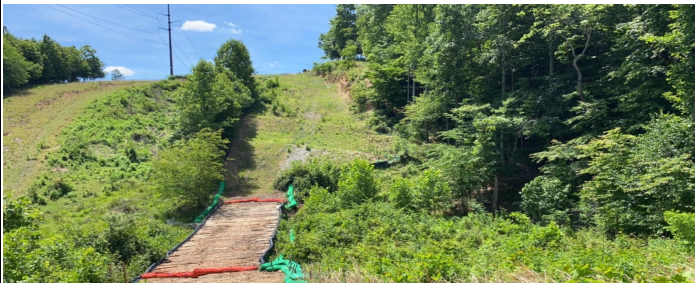
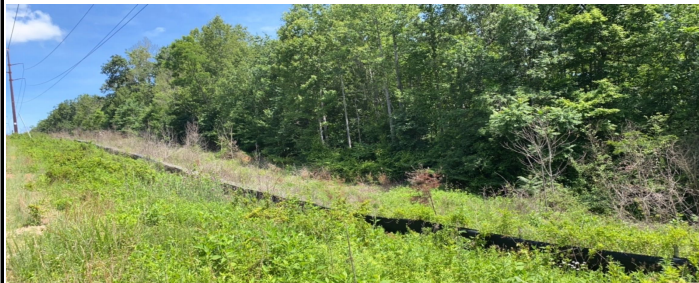
06.10.2022 11:35:10 Accur +/-15.4 Ft ALT 917 Ft			06.10.2022 11:41:15 Accur +/-167.7 Ft ALT 990 Ft		
GPS Location	3	GPS Location	4		
Field Station#	14486+56	Field Station#	14506+00		
Pic 3 Desc.	Equipment bridge and surrounding ECDs in place and functional at stream crossing and resource buffer.		Pic 4 Desc.	Perimeter SSF in place and functional.

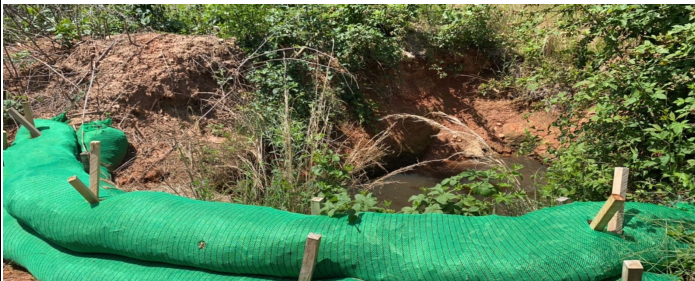
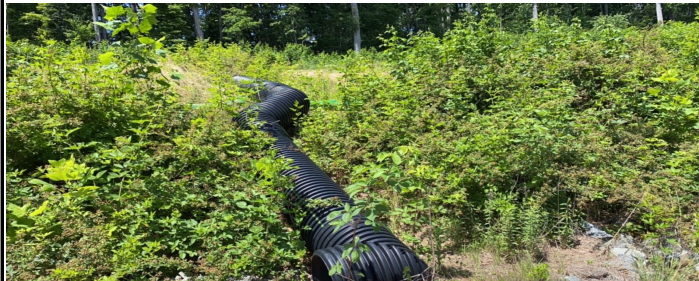
06.10.2022 11:43:29 Accur +/-186.9 Ft ALT 1014 Ft			06.10.2022 11:47:03 Accur +/-61.8 Ft ALT 1052 Ft		
GPS Location	5	GPS Location	6		
Field Station#	14494+00	Field Station#	14511+00		
Pic 5 Desc.	Sump pit and CFS end treatment performing intended functions.		Pic 6 Desc.	Slope drain tile performing intended function.

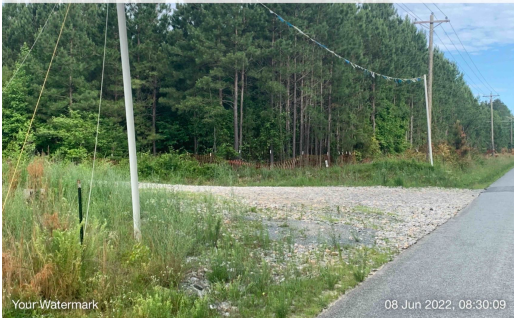
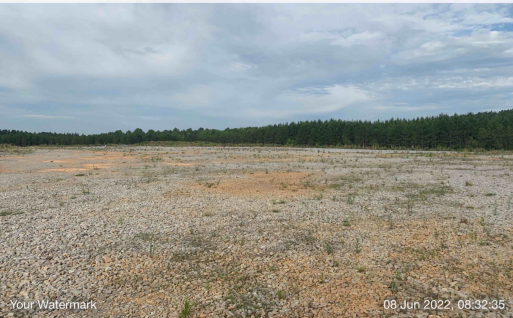
GPS Location	O		GPS Location	O	
Field Station#	00+00		Field Station#	00+00	
Pic 1 Desc.	Observing RCE		Pic 2 Desc.	Observing lay down yard	
South West Elevation ☉ 23°NE (T) ● 36°50'5"N, 79°20'31"W ±387ft ▲ 669ft

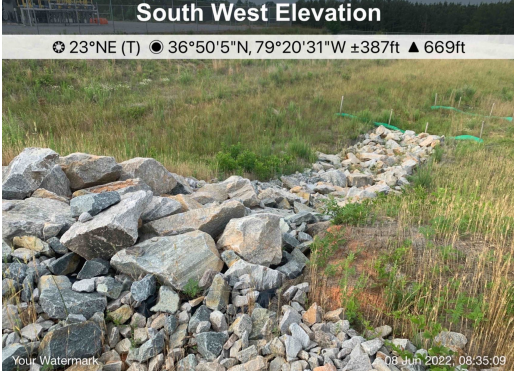
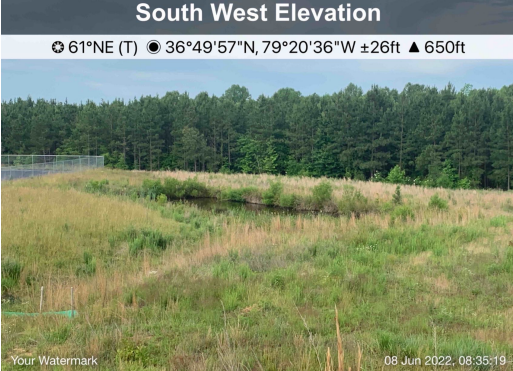
GPS Location	O		GPS Location	O	
Field Station#	00+00		Field Station#	00+00	
Pic 3 Desc.	Observing rock drain and cfs checks		Pic 4 Desc.	Observing temporary stabilization and sediment basin	
West Elevation ☉ 68°E (T) ● 36°50'1"N, 79°20'38"W ±32ft ▲ 653ft

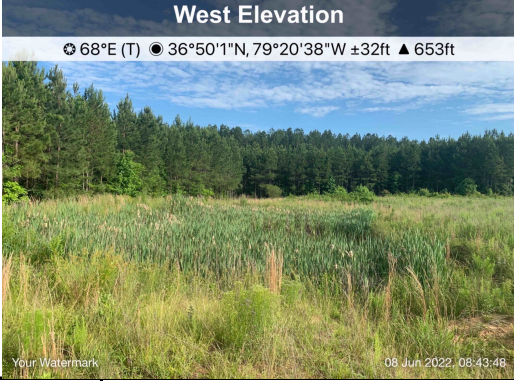
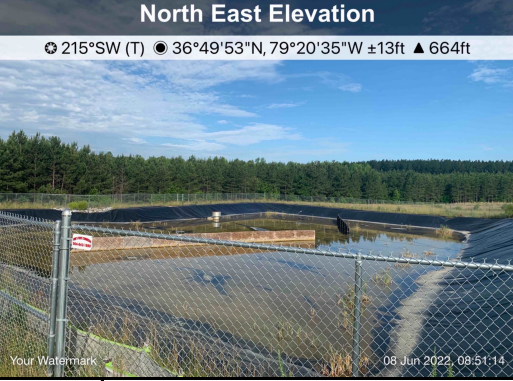
Pic 5 Desc.	Observing temporary stabilization and sediment basin		Pic 6 Desc.	Observing storm water pond and ECD's
