Visual Site Inspection Report

Project Name	H-600 Pipeline Spread G	AFE	124300137	Spread	H-600 Pipeline Spread G
Contractor	Precision			Report #	38959
Inspector	Jared Saunders			Date/Time	6/20/2022 7:10 PM
Permit #	TBD	Inspection Type	VA SWPP	Station Begin	11788+52
State	VA	Inspection Area	Partial	Station End	11899+89
County	Montgomery	Ground	Dry	Temperature (°F)	78.00
Municipality	N/A	Weather	Sunny	Rain Gauge (in)	0.00
				Rain Accumulation Time (days)	1.00

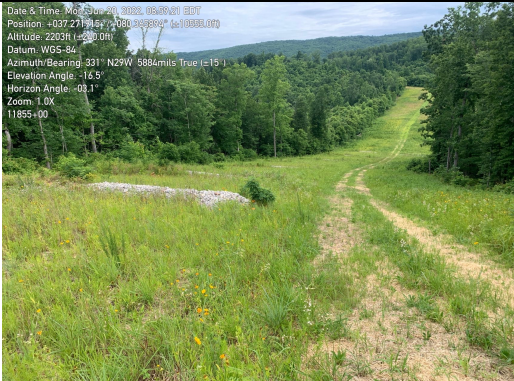
GPS Location	See photo for GPS location.		GPS Location	See photo for GPS location.	
Field Station#	11855+00		Field Station#	11830+00	
Pic 3 Desc.	ROW permanently restored. Waterbar with level spreader in place.		Pic 4 Desc.	ROW permanently restored. Waterbar with level spreader in place.

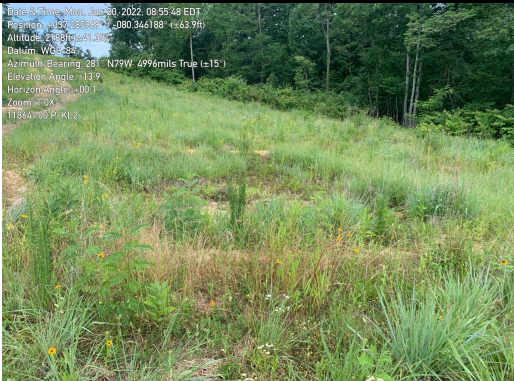
GPS Location	See photo for GPS location.		GPS Location	See photo for GPS location.	
Field Station#	11864+00		Field Station#	11789+00	
Pic 5 Desc.	Sensitive resource P-KL2.		Pic 6 Desc.	RCE in place at Mount Tabor Road.

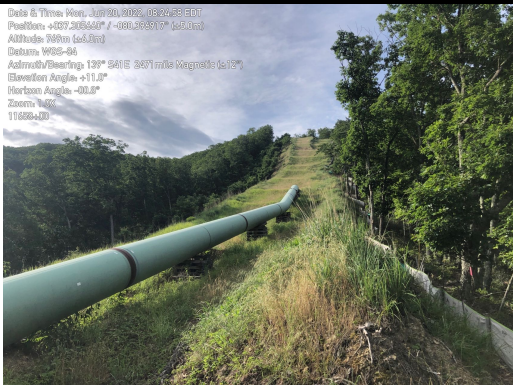
GPS Location				On photo				GPS Location				On photo			
Field Station#				11658+00				Field Station#				11656+00			
Pic 3 Desc.				ROW surface stable. Slope breakers functional. Perimeter ECDs are in place.				Pic 4 Desc.				Sumps and end treatments acceptable.

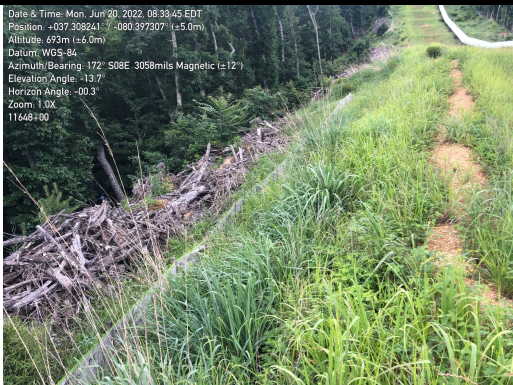
GPS Location				On photo				GPS Location				On photo			
Field Station#				11648+00				Field Station#				11642+00			
Pic 5 Desc.				ECDs along edge of ROW are acceptable.				Pic 6 Desc.				ROW stable.

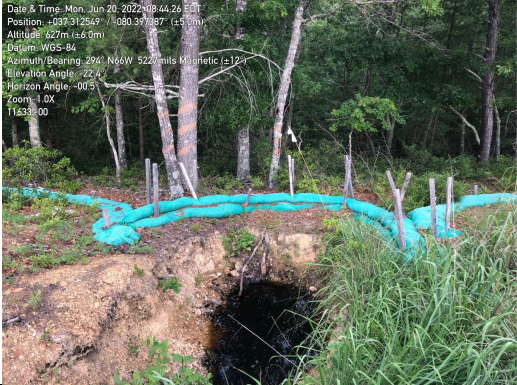
GPS Location	On photo	GPS Location	On photo		
Field Station#	11633+00	Field Station#	11628+00		
Pic 7 Desc.	Sumps and end treatments are acceptable.	Pic 8 Desc.	ROW stable with ECDs in place.		
<p>Date & Time: Mon, Jun 20, 2022 08:51:23 EDT Position: +037.313758 / -080.398567 (+5.0m) Altitude: 598m (+6.0m) Datum: WGS-84 Azimuth/Bearing: 246° S66W 437mils Magnetic (+12°) Elevation Angle: -27.2° Horizon Angle: -01.3° Zoom: 1.0X 11626+00</p>

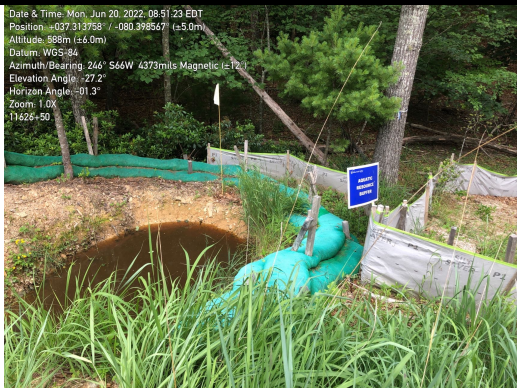
GPS Location	On photo	GPS Location	On photo		
Field Station#	11626+50	Field Station#	11626+04		
Pic 9 Desc.	ECDs in place and effective.	Pic 10 Desc.	The S-HH18 crossing is currently stable.		
<p>Date & Time: Mon, Jun 20, 2022 08:57:05 EDT Position: +037.314256 / -080.400353 (+5.0m) Altitude: 588m (+6.0m) Datum: WGS-84 Azimuth/Bearing: 053° N53E 0942mils Magnetic (+12°) Elevation Angle: -29.2° Horizon Angle: +01.0° Zoom: 1.0X 11620+00</p>

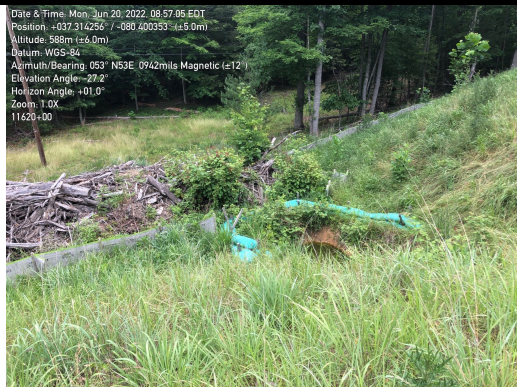
GPS Location	On photo	GPS Location	On photo		
Field Station#	11620+00	Field Station#	11617+00		
Pic 11 Desc.	ROW stable. ECDs are in place.	Pic 12 Desc.	ECDs in place. Surface stable.

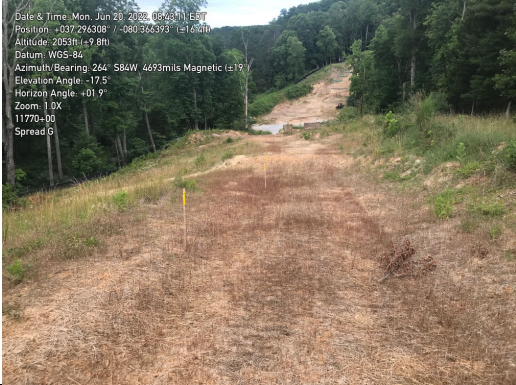
GPS Location	See photo	GPS Location	see		
Field Station#	11770+00	Field Station#	11783+00		
Pic 7 Desc.	S-IJ 52	Pic 8 Desc.	Drainage feature		
Insert image here		Insert image here			
GPS Location		GPS Location			
Field Station#		Field Station#			
Pic 9 Desc.		Pic 10 Desc.			
Insert image here		Insert image here			
GPS Location		GPS Location			
Field Station#		Field Station#			
Pic 11 Desc.		Pic 12 Desc.

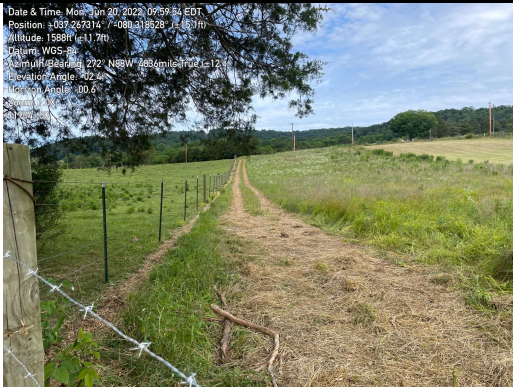
GPS Location		See photo				GPS Location		See photo			
Field Station#		11904+00				Field Station#		12001+00			
Pic 1 Desc.		Picture showing condition of row				Pic 2 Desc.		Picture showing condition of wetland			
<p>Date & Time: Mon Jun 20, 2022, 09:41:46 EDT Position: +38.2273333° / -80.216528° (+13.7m) Altitude: 1637ft (+11.7m) Datum: WGS-84 Azimuth/Heading: 350° N10W 8222mils True (+12°) Elevation Angle: -15.5° Horizon Angle: -01.3° Zoom: 1.0X 11922+00</p>

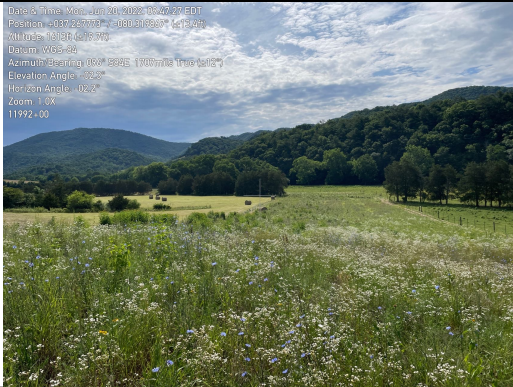
GPS Location		See photo				GPS Location		See photo			
Field Station#		11992+00				Field Station#		11978+00			
Pic 3 Desc.		Stabilization				Pic 4 Desc.		Perimeter controls in place			
<p>Date & Time: Mon Jun 20, 2022, 09:47:49 EDT Position: +38.2273333° / -80.216528° (+13.7m) Altitude: 1637ft (+11.7m) Datum: WGS-84 Azimuth/Heading: 188° N38E 1031mils True (+22°) Elevation Angle: -32° Horizon Angle: -00.6° Zoom: 1.0X 11973+00</p>

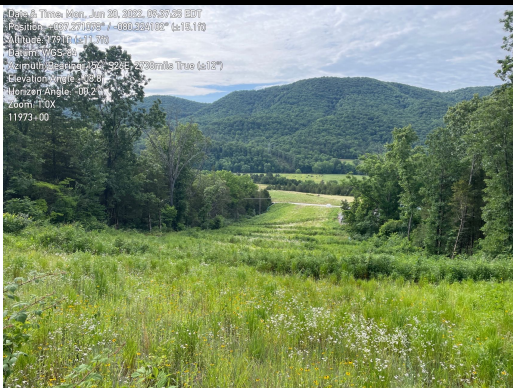
GPS Location		See photo				GPS Location		See photo			
Field Station#		11973+00				Field Station#		11929+42			
Pic 5 Desc.		Water bars in place				Pic 6 Desc.		Stabilization in place

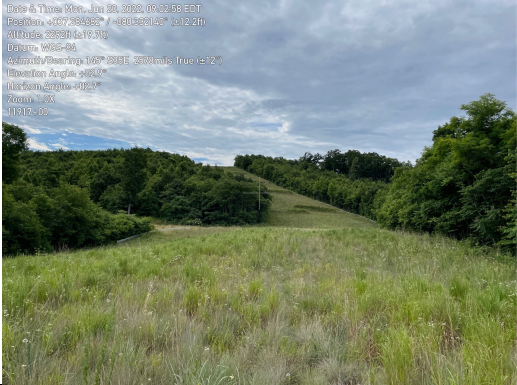
GPS Location	See photo	GPS Location	See photo		
Field Station#	11917+00	Field Station#	11903+00		
Pic 7 Desc.	Picture showing condition of row	Pic 8 Desc.	Permanent water bars and level spreader		
 		<p>Insert image here</p>			
GPS Location	See photo	GPS Location			
Field Station#	11899+89	Field Station#			
Pic 9 Desc.	RCE functional	Pic 10 Desc.			
<p>Insert image here</p>		<p>Insert image here</p>			
GPS Location		GPS Location			
Field Station#		Field Station#			
Pic 11 Desc.		Pic 12 Desc.

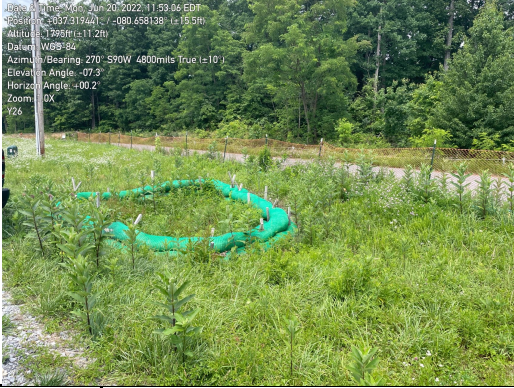
<p>Date & Time Mon, Jun 20, 2022, 11:59:06 EDT Position: +480.216141° / +480.656138° Lat/Lon Altitude: 1930ft Lat/Lon Datum: WGS-84 Azimuth/Bearing: 270° S90W 4800mils True (±10°) Elevation Angle: -07.3° Horizon Angle: +00.2° Zoom: 1.0X Y26</p>			
GPS Location	See photo	GPS Location	See photo		
Field Station#	12005+00	Field Station#	12005+00		
Pic 1 Desc.	CFS in place y26	Pic 2 Desc.	Housekeeping trash in good condition y26

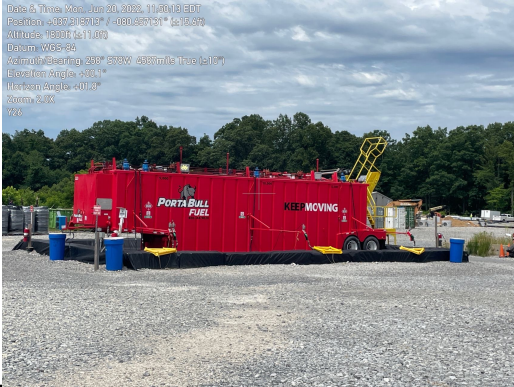
GPS Location	See photo	GPS Location	See photo		
Field Station#	12005+00	Field Station#	12005+00		
Pic 3 Desc.	Secondary containment in place y26	Pic 4 Desc.	Secondary containment in place y26

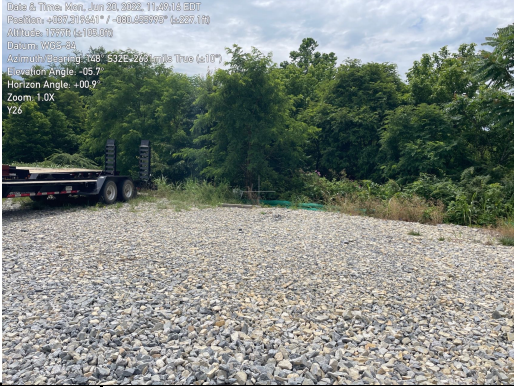
<p>Date & Time Mon, Jun 20, 2022, 11:59:06 EDT Position: +480.216141° / +480.656138° Lat/Lon Altitude: 1930ft Lat/Lon Datum: WGS-84 Azimuth/Bearing: 270° S90W 4800mils True (±10°) Elevation Angle: -05.7° Horizon Angle: +00.2° Zoom: 1.0X Y26</p>			
GPS Location	See photo	GPS Location	See photo		
Field Station#	12005+00	Field Station#	12005+00		
Pic 5 Desc.	Perimeter controls in place y26	Pic 6 Desc.	RCE functional y26

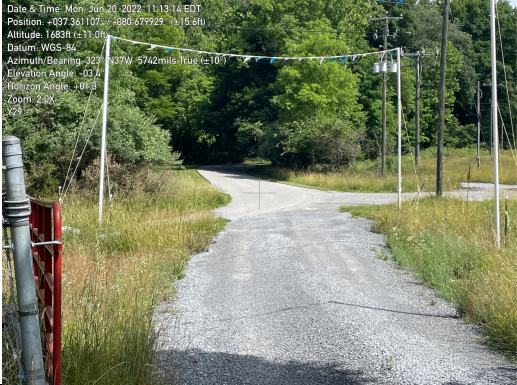
GPS Location	See photo	GPS Location	See photo		
Field Station#	12005+00	Field Station#	12005+00		
Pic 13 Desc.	RCE functional y29	Pic 14 Desc.	Broad base dips functional y29		
<p>Date & Time: Mon Jun 20, 2022, 11:06:30 EDT Position: +037.362412° / -080.679157° (+11.1ft) Altitude: 1718ft (+13.1ft) Datum: WGS-84 Azimuth/Bearing: 192° S12W 3613mils True (+10.1) Elevation Angle: -10.2 Horizon Angle: +00.0 Zoom: 1.0X Y29</p>

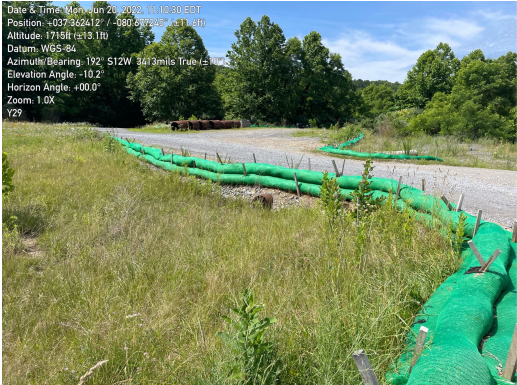
GPS Location	See photo	GPS Location	See photo		
Field Station#	12005+00	Field Station#	12005+00		
Pic 15 Desc.	Culvert in place y29	Pic 16 Desc.	Housekeeping trash in good condition y29		
<p>Date & Time: Mon Jun 20, 2022, 11:05:05 EDT Position: +037.363990° / -080.677036° (+11.1ft) Altitude: 1711ft (+13.1ft) Datum: WGS-84 Azimuth/Bearing: 010° N20W 5566mils True (+10.1) Elevation Angle: -01.7 Horizon Angle: +00.6 Zoom: 1.0X Y29</p>

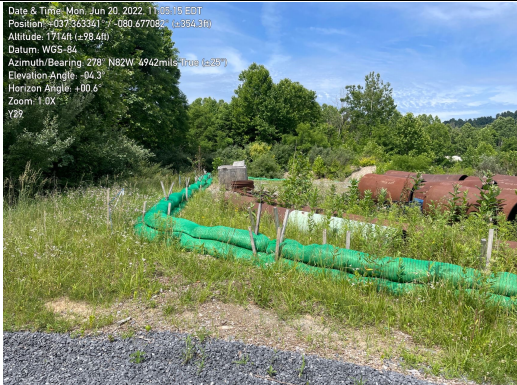
GPS Location	See photo	GPS Location	See photo		
Field Station#	12005+00	Field Station#	12005+00		
Pic 17 Desc.	Permanent stabilization in place y29	Pic 18 Desc.	CFS perimeter controls functional y29

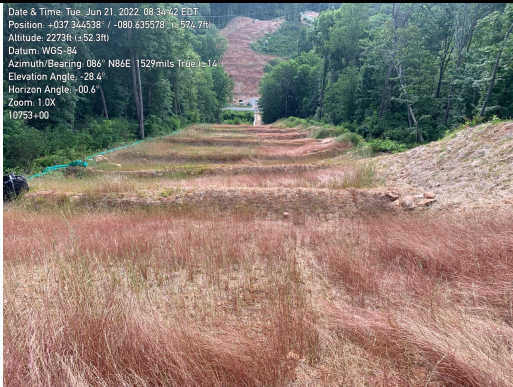
<p>Date & Time: Tue, Jun 21, 2022, 08:39:46 EDT Position: +037 344549 / -080 616833 (+19032.4m) Altitude: 2267ft (+694.2m) Datum: WGS-84 Azimuth/Bearing: 061° N61E 1086mils True (±17') Elevation Angle: -15.5° Horizon Angle: -03.8° Zoom: 1.0X 10758+50 S-G35</p>			
GPS Location				See photo for GPS location.				GPS Location				See photo for GPS location.			
Field Station#				10753+00				Field Station#				10758+50			
Pic 1 Desc.				ROW temporarily stabilized. Waterbars in place.				Pic 2 Desc.				Sensitive resource buffer in place at stream S-G35.

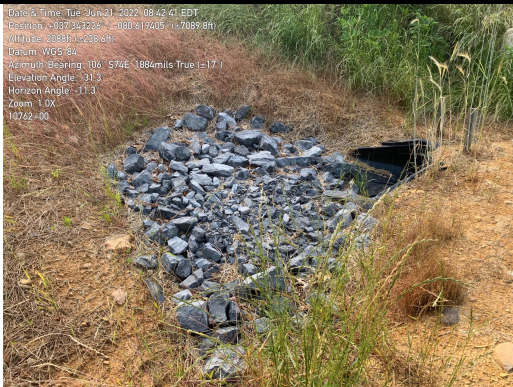
<p>Date & Time: Tue, Jun 21, 2022, 08:48:24 EDT Position: +037 344218 / -080 629118 (+135.4ft) Altitude: 2150ft (+655.2m) Datum: WGS-84 Azimuth/Bearing: 151° S29E 1264mils True (±14') Elevation Angle: -26.8° Horizon Angle: -04.5° Zoom: 1.0X 10772+00</p>			
GPS Location				See photo for GPS location.				GPS Location				See photo for GPS location.			
Field Station#				10762+00				Field Station#				10772+00			
Pic 3 Desc.				Rock inlet in place at slope drain pipe.				Pic 4 Desc.				Clean water diversion pipe and level spreader in place.

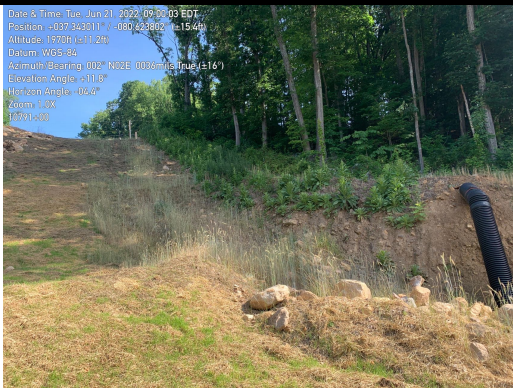
GPS Location				See photo for GPS location.				GPS Location				See photo for GPS location.			
Field Station#				10791+00				Field Station#				10797+00			
Pic 5 Desc.				Clean water diversion pipe inlet and clean water diversion berm in place.				Pic 6 Desc.				RCE in place at Cascade Road crossing.

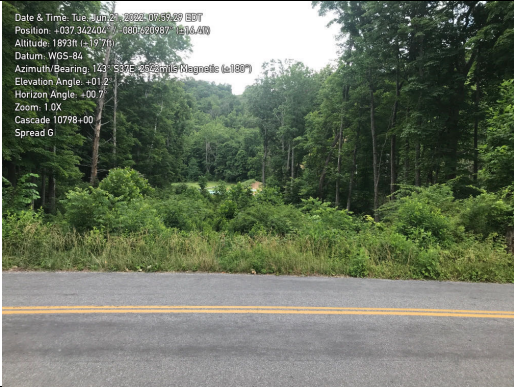
GPS Location	See photo		GPS Location	see photo	
Field Station#	10798+00		Field Station#	10812+00	
Pic 1 Desc.	Cascade		Pic 2 Desc.	Level spreader

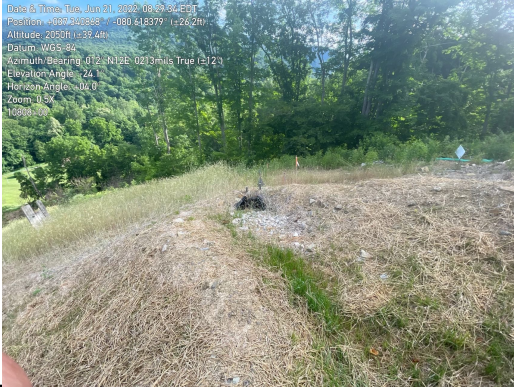
GPS Location	see photo		GPS Location	see photo	
Field Station#	10808+00		Field Station#	10839+00	
Pic 3 Desc.	Water bar/slope drain		Pic 4 Desc.	Stabilized ROW

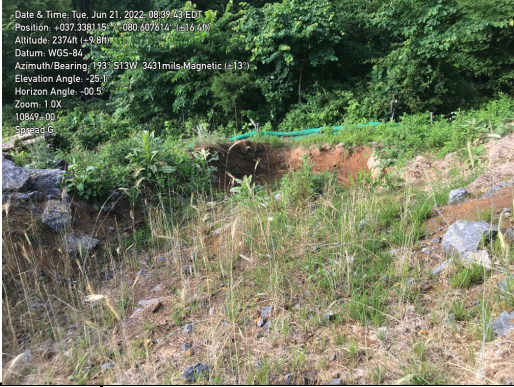
GPS Location	see photo		GPS Location	see photo	
Field Station#	10849+00		Field Station#	10855+55	
Pic 5 Desc.	End treatments		Pic 6 Desc.	S-A 33 & 34

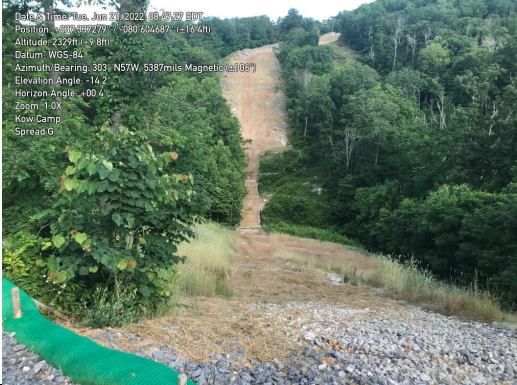
GPS Location		See photo		GPS Location	
Field Station#		10859+46		Field Station#	
Pic 7 Desc.		Kow camp		Pic 8 Desc.	
Insert image here		Insert image here			
GPS Location				GPS Location	
Field Station#				Field Station#	
Pic 9 Desc.				Pic 10 Desc.	
Insert image here		Insert image here			
GPS Location				GPS Location	
Field Station#				Field Station#	
Pic 11 Desc.				Pic 12 Desc.

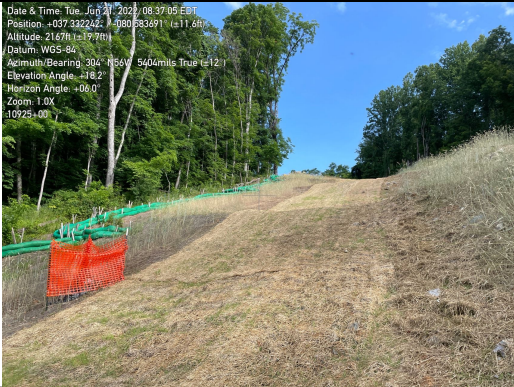
GPS Location	See photo	GPS Location	See photo		
Field Station#	10925+00	Field Station#	10908+00		
Pic 3 Desc.	Erosion control blanket in place	Pic 4 Desc.	Temporary stabilization in place

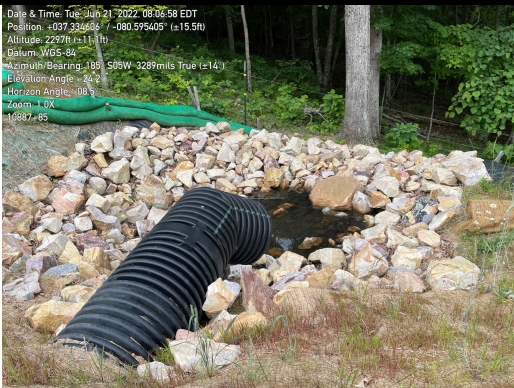
GPS Location	See photo	GPS Location	See photo		
Field Station#	10887+85	Field Station#	10883+00		
Pic 5 Desc.	Plunge pool in place	Pic 6 Desc.	Wattles and P1 in place

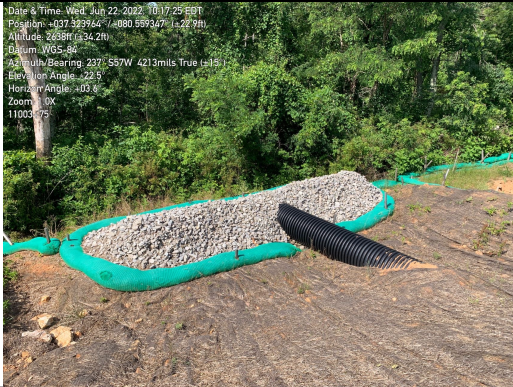
GPS Location				See photo for GPS location.				GPS Location				See photo for GPS location.			
Field Station#				11003+75				Field Station#				11001+00			
Pic 3 Desc.				Clean water diversion pipe and level spreader in place.				Pic 4 Desc.				ROW temporarily stabilized.

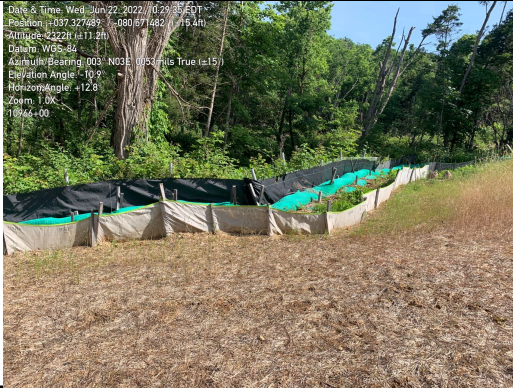
GPS Location				See photo for GPS location.				GPS Location				See photo for GPS location.			
Field Station#				10966+00				Field Station#				10960+00			
Pic 5 Desc.				Triple barrier ECDs in place at cave feature.				Pic 6 Desc.				ROW permanently restored.

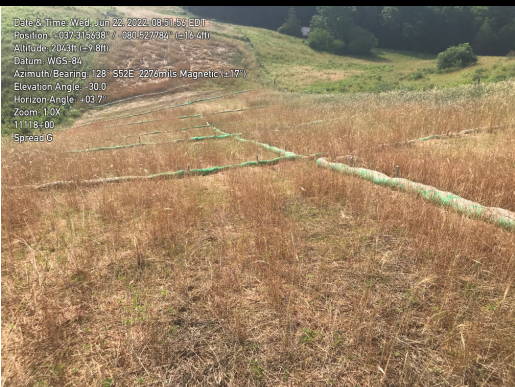
GPS Location	see photo	GPS Location	see photo		
Field Station#	11100+00	Field Station#	11118+00		
Pic 3 Desc.	Restored ROW	Pic 4 Desc.	Water bars (other)

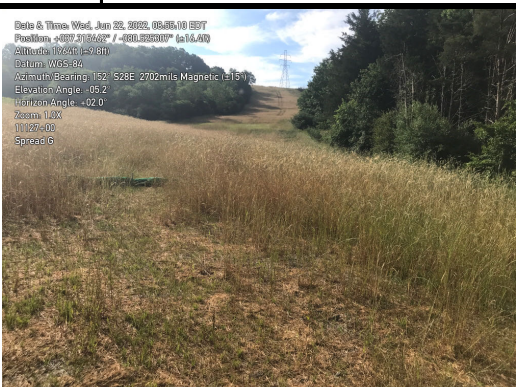
<p>Date & Time: Wed Jun 22, 2022, 08:55:10 EDT Position: +037.213475° / -080.533507° (-14.4ft) Altitude: 1924ft (-9.8ft) Datum: WGS-84 Azimuth/Bearing: 152° S26E 2702mils Magnetic (-151°) Elevation Angle: -05.2° Horizon Angle: -02.0° Zoom: 1.0X 11127+00 Spread: 0</p>		  <p>Date & Time: Wed Jun 22, 2022, 08:56:39 EDT Position: +037.311697° / -080.526343° (-14.4ft) Altitude: 1935ft (-9.8ft) Datum: WGS-84 Azimuth/Bearing: 155° S26E 2755mils Magnetic (-15°) Elevation Angle: -10.7° Horizon Angle: -01.6° Zoom: 1.0X 11129+00 Spread: 0</p>			
GPS Location	See photo	GPS Location	see photo		
Field Station#	11127+00	Field Station#	11129+00		
Pic 5 Desc.	Water bar (other), restored ROW	Pic 6 Desc.	Permanent vegetation

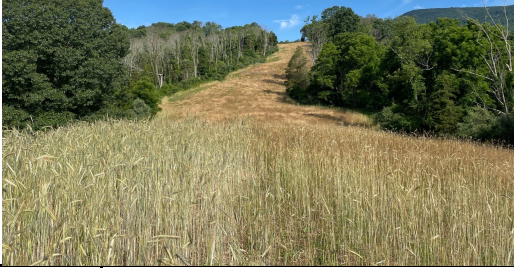
GPS Location	See photo	GPS Location	See photo		
Field Station#	11094+00	Field Station#	11178+40		
Pic 1 Desc.	Stabilization in place	Pic 2 Desc.	CFS water bars		
<p>Date & Time: Wed Jun 22, 2022 08:52:08 EDT Position: +037 316984 / -080 544674 (+38.7ft) Altitude: 2130ft (+38.6ft) Datum: WGS-84 Azimuth/Bearing: 109° S42E 245ymls True (+19°) Elevation Angle: -18.7° Horizon Angle: -02.1° Zoom: 1.0X 11064+53</p>

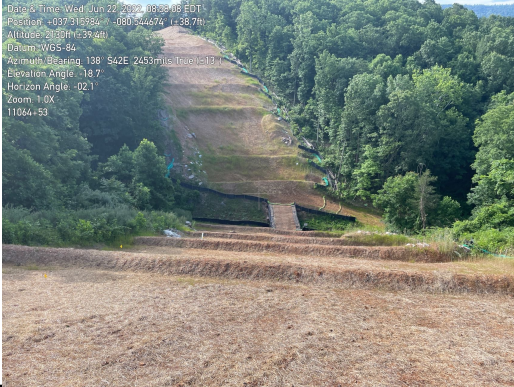
GPS Location	See photo	GPS Location	See photo		
Field Station#	11064+53	Field Station#	11060+00		
Pic 3 Desc.	Equipment bridge functional	Pic 4 Desc.	Open ditch		
<p>Date & Time: Wed Jun 22, 2022 08:59:55 EDT Position: +037 316266 / -080 545224 (+26.1ft) Altitude: 2124ft (+26.2ft) Datum: WGS-84 Azimuth/Bearing: 124° S54E 224ymls True (+13°) Elevation Angle: -04.1° Horizon Angle: +01.9° Zoom: 1.0X 11056+00</p>

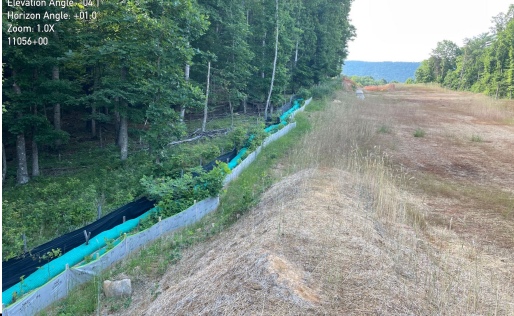
GPS Location	See photo	GPS Location	See photo		
Field Station#	11056+00	Field Station#	11050+10		
Pic 5 Desc.	Perimeter controls in place	Pic 6 Desc.	Resource buffers in place

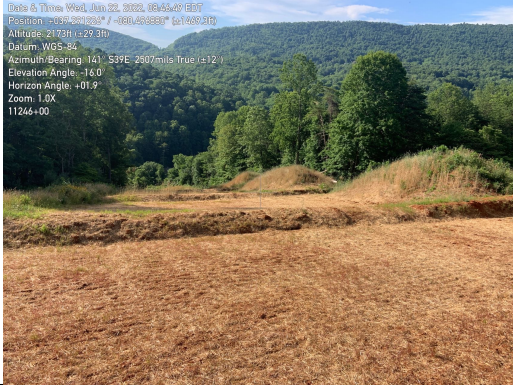
<p>Date & Time: Wed, Jun 22, 2022, 08:46:47 EDT Position: +037.259110° / +038.493337° (+19083ft) Altitude: 2173ft (+662m) Datum: WGS-84 Azimuth/Bearing: 141° S39E 2507mils True (+12°) Elevation Angle: -16.0° Horizon Angle: +01.9° Zoom: 1.0x 11246+00</p>			
GPS Location	See photo	GPS Location	See photo		
Field Station#	11254+30	Field Station#	11246+00		
Pic 1 Desc.	S-RR2 looking downstream	Pic 2 Desc.	Section of Row showing conditions and controls

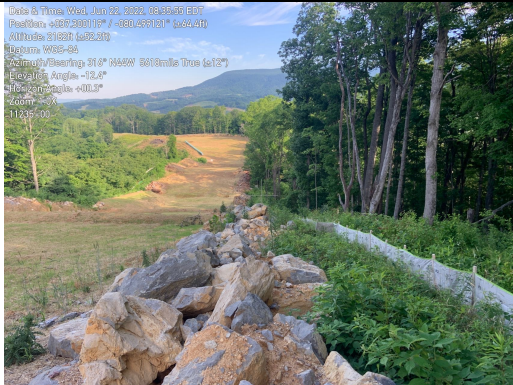
GPS Location	See photo	GPS Location	See photo		
Field Station#	11238+50	Field Station#	11235+00		
Pic 3 Desc.	Sump pit,slope drain pipe and perimeter controls are in acceptable condition	Pic 4 Desc.	Section of Row showing conditions and controls

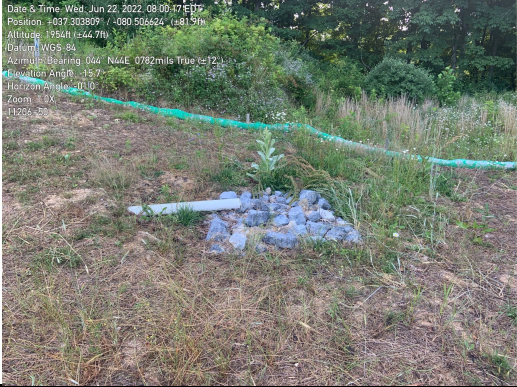
GPS Location	See photo	GPS Location	See photo		
Field Station#	11206+50	Field Station#	11201+00		
Pic 7 Desc.	Daylight drain with outlet protection in place	Pic 8 Desc.	Section of Row showing conditions and controls		
<small> Date & Time: Wed Jun 22 2022 07:42:05 EDT Position: +037.307808° / -080.509182° (-81.5th) Altitude: 1901ft (+30.0th) Datum: WGS-84 Azimuth/Bearing: 060° N60E 1067mils True (±14°) Elevation Angle: -07.4° Horizon Angle: -04.1° Zoom: 1.0X 11190+00 </small>

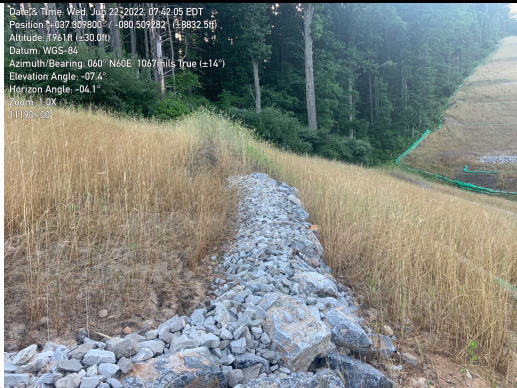
GPS Location	See photo	GPS Location	See photo		
Field Station#	11190+00	Field Station#	11187+00		
Pic 9 Desc.	Representational photo of water bar and level spreader	Pic 10 Desc.	Section of Row showing abundant vegetation		
<small> Date & Time: Wed Jun 22 2022 07:36:17 EDT Position: +037.306970° / -080.512469° (-81.5th) Altitude: 1894ft (+11.1th) Datum: WGS-84 Azimuth/Bearing: 055° N55E 0978mils True (±10°) Elevation Angle: -04.5° Horizon Angle: -00.31° Zoom: 1.0X 11184+85 </small>

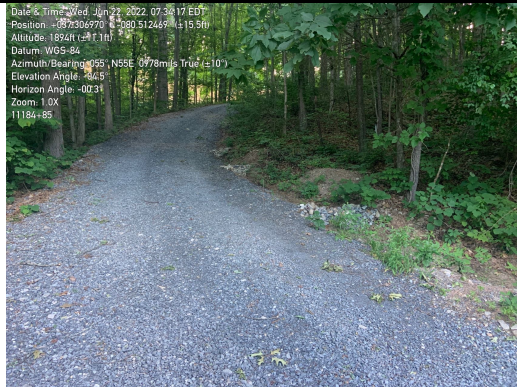
GPS Location	See photo	GPS Location	See photo		
Field Station#	11184+85	Field Station#	11249+00		
Pic 11 Desc.	AR 249.02 is maintained in acceptable condition	Pic 12 Desc.	Section of Row showing conditions and controls

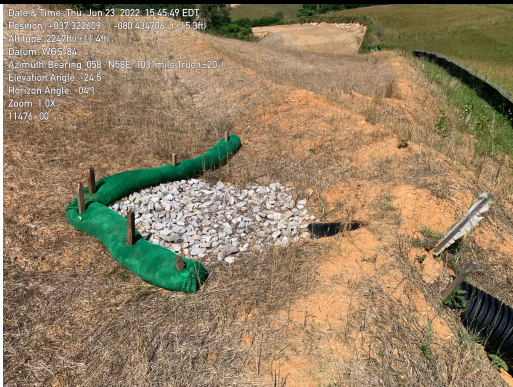
GPS Location		See photo for GPS location.						GPS Location		See photo for GPS location.	
Field Station#		11476+00						Field Station#		11490+00	
Pic 3 Desc.		Inlet protection in place at slope drain.						Pic 4 Desc.		RCE in place at Stevers Gap Road.

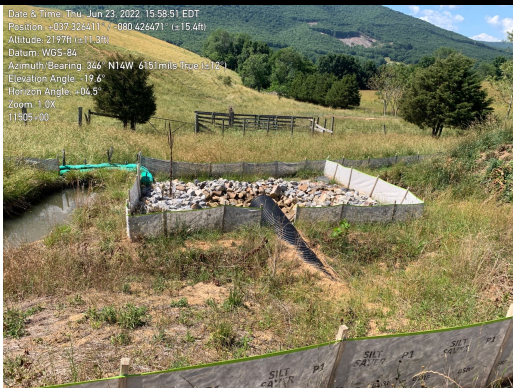
GPS Location		See photo for GPS location.						GPS Location		See photo for GPS location.	
Field Station#		11505+00						Field Station#		11519+00	
Pic 5 Desc.		Clean water diversion pipe and plunge pool in place.						Pic 6 Desc.		Sensitive resource buffer in place at stream S-PP4.

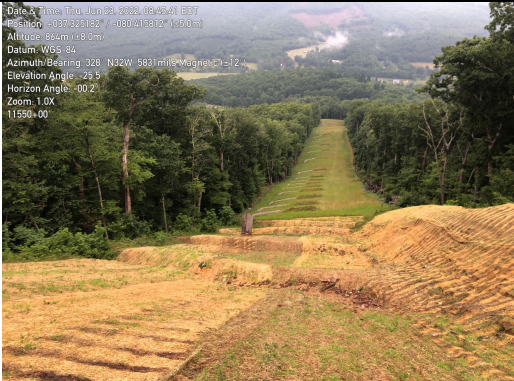
GPS Location	On photo	GPS Location	On photo		
Field Station#	11550+00	Field Station#	11553+00		
Pic 3 Desc.	Slope breakers effective. Blanketed surface is stable.	Pic 4 Desc.	ROW well vegetated. ECDs in place. No erosion discovered.

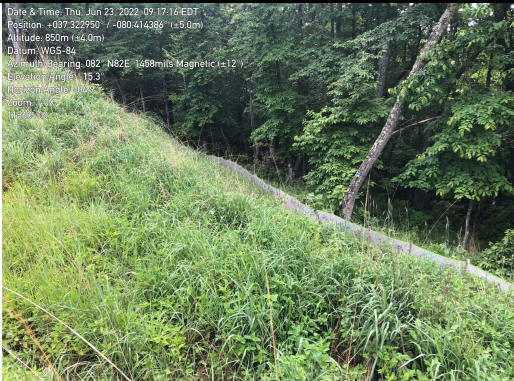
GPS Location	On photo	GPS Location	On photo		
Field Station#	11560+00	Field Station#	11561+00		
Pic 5 Desc.	Perimeter ECDs are in place.	Pic 6 Desc.	End treatments in place.

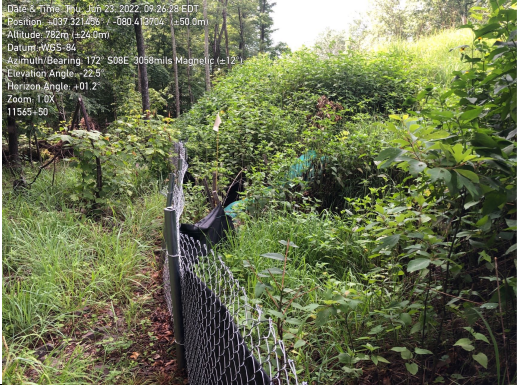
GPS Location	On photo		GPS Location	On photo	
Field Station#	11565+50		Field Station#	11566+00	
Pic 7 Desc.	Perimeter ECDs are acceptable.		Pic 8 Desc.	Perimeter ECDs are in place. Heavy vegetation.

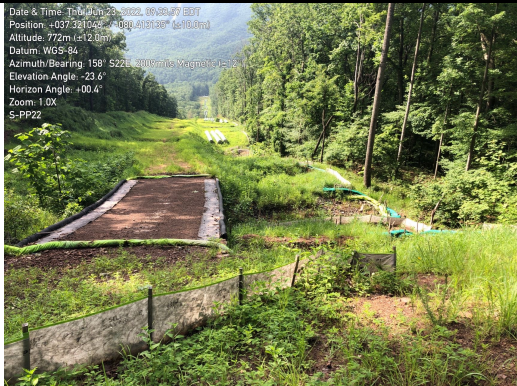
GPS Location	On photo		GPS Location	On photo	
Field Station#	11567+42		Field Station#	11570+00	
Pic 9 Desc.	No impact at the S-PP22 crossing.		Pic 10 Desc.	Rock lined channel functional.

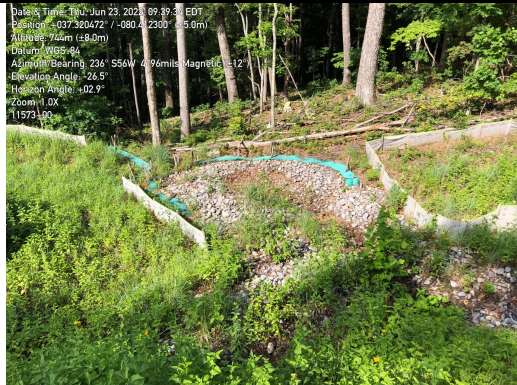
GPS Location	On photo		GPS Location	On photo	
Field Station#	11573+00		Field Station#	11576+00	
Pic 11 Desc.	Rock lined channel effective.		Pic 12 Desc.	Heavy vegetation. No sediment movement.

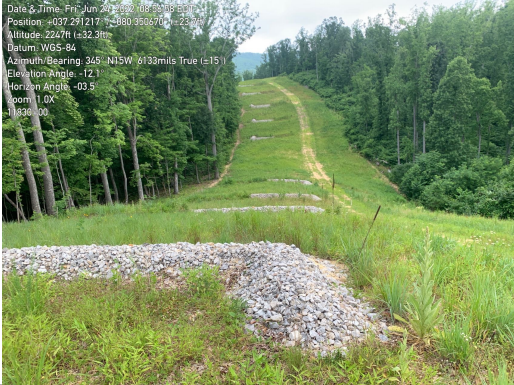
GPS Location	See photo for GPS location.		GPS Location	See photo for GPS location.	
Field Station#	11830+00		Field Station#	11818+00	
Pic 3 Desc.	ROW permanently restored. Waterbars with level spreaders in place.		Pic 4 Desc.	ROW permanently restored.

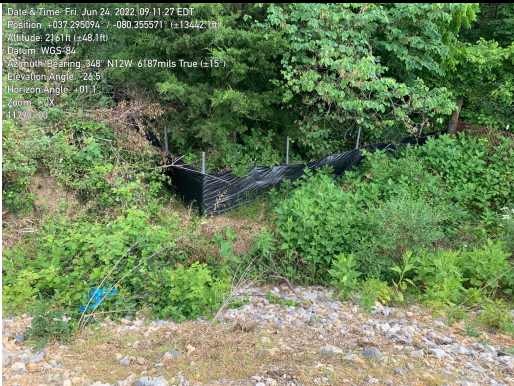
GPS Location	See photo for GPS location.		GPS Location	See photo for GPS location.	
Field Station#	11790+00		Field Station#	11789+00	
Pic 5 Desc.	Super silt fence in place along LOD.		Pic 6 Desc.	RCE in place at Mount Tabor Road.

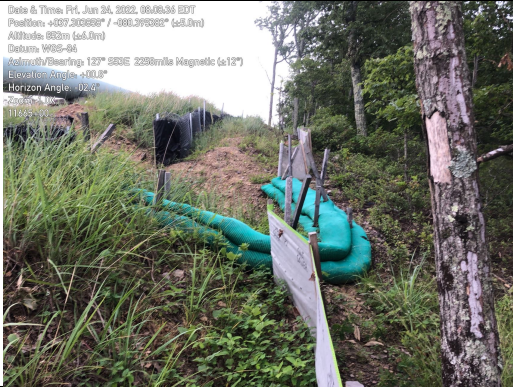
<p>Date & Time: Fri, Jun 24, 2022, 08:17:32 EDT Position: +037.307088 / -080.393901 (+5.0m) Altitude: 727m (+5.0m) Datum: WGS-84 Azimuth/Bearing: 136° N24W 5973mils Magnetic (+12°) Elevation Angle: +4.8° Horizon Angle: -00.1° Zoom: 1.0X 11661+00</p>			
GPS Location		On photo		GPS Location	
Field Station#		11665+00		Field Station#	
Pic 1 Desc.		Perimeter ECDs are acceptable. ROW stable.		Pic 2 Desc.

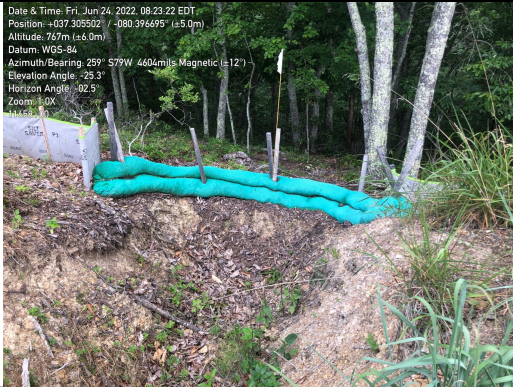
GPS Location		On photo		GPS Location	
Field Station#		11658+00		Field Station#	
Pic 3 Desc.		Sumps and end treatments are in place and functional.		Pic 4 Desc.

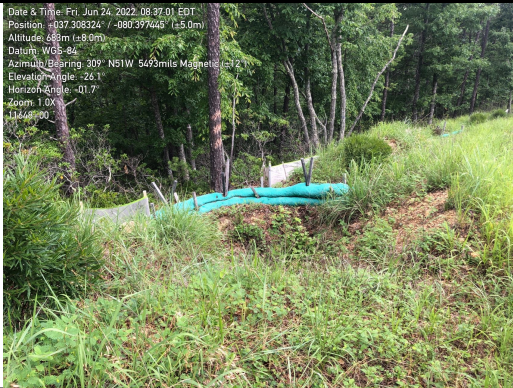
<p>Date & Time: Fri, Jun 24, 2022, 08:39:23 EDT Position: +037.303244 / -080.397449 (+5.0m) Altitude: 657m (+5.0m) Datum: WGS-84 Azimuth/Bearing: 033° N33E 6587mils Magnetic (+12°) Elevation Angle: +16.4° Horizon Angle: -00.2° Zoom: 1.0X 11634+00</p>			
GPS Location		On photo		GPS Location	
Field Station#		11648+00		Field Station#	
Pic 5 Desc.		ROW stable. ECDs functional.		Pic 6 Desc.

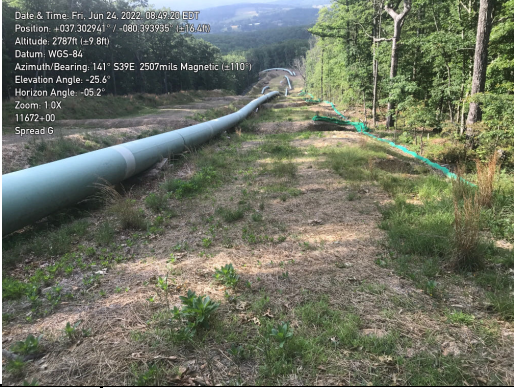
<p>Date & Time: Fri, Jun 24, 2022, 08:50:18 EDT Position: +037.299514° / -080.391530° (±16.40ft) Altitude: 2501ft (±13.1ft) Datum: WGS-84 Azimuth/Bearing: 134° S46E 2382mils Magnetic (±110°) Elevation Angle: -26.7° Horizon Angle: +01.2° Zoom: 1.0X 11687+00 Spread G</p>			
GPS Location	See photo		GPS Location	see photo	
Field Station#	11672+00		Field Station#	11687+00	
Pic 1 Desc.	Perimeter controls		Pic 2 Desc.	S-MN 21

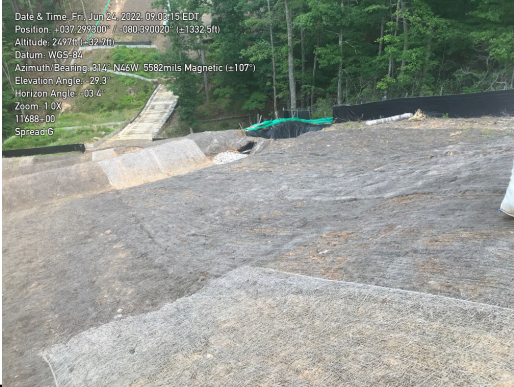
GPS Location	see photo		GPS Location	see photo	
Field Station#	11688+00		Field Station#	11704+45	
Pic 3 Desc.	Erosion blanket		Pic 4 Desc.	S-MN 22

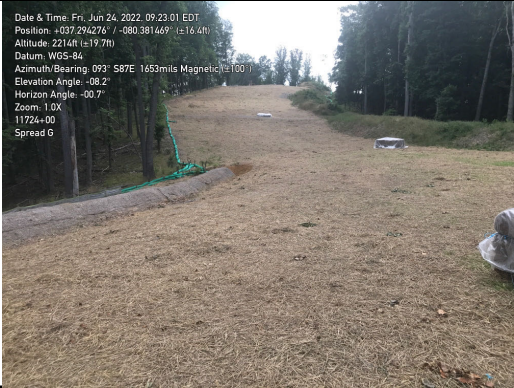
<p>Date & Time: Fri, Jun 24, 2022, 09:40:49 EDT Position: +037.295539° / -080.376477° (±16.40ft) Altitude: 1986ft (±39.4ft) Datum: WGS-84 Azimuth/Bearing: 005° N65E 1156mils Magnetic (±100°) Elevation Angle: -19.1° Horizon Angle: -02.3° Zoom: 1.0X 11740+00 Spread G</p>			
GPS Location	see photo		GPS Location	see photo	
Field Station#	11724+00		Field Station#	11740+00	
Pic 5 Desc.	Re-vegetation		Pic 6 Desc.	S-EEF 65

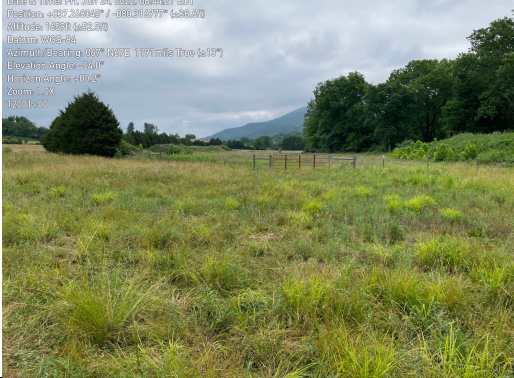
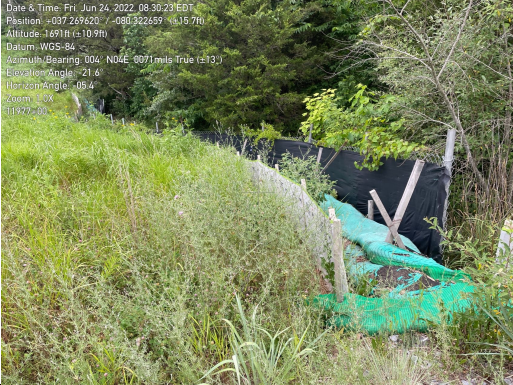
GPS Location		See photo		GPS Location	
Field Station#		12001+00		Field Station#	
Pic 1 Desc.		Picture showing condition of W-NN6		Pic 2 Desc.	
<p>Date & Time: Fri, Jun 24, 2022, 06:56:51 EDT Position: +407.252674° / +88.322674° (+16.17) Altitude: 1530ft (+11.8m) Datum: WGS-84 Azimuth/Bearing: 180° S00W 3943mils True (+13°) Elevation Angle: -02.5° Horizon Angle: +02.5° Zoom: 1.0X 11972+00</p>

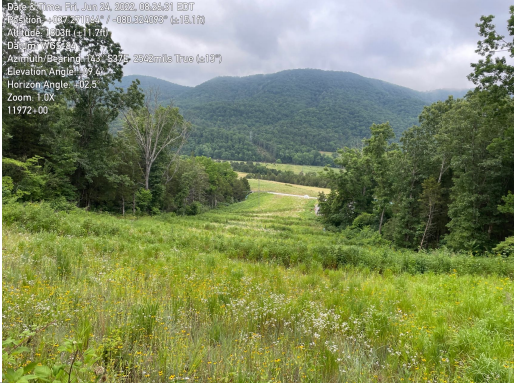
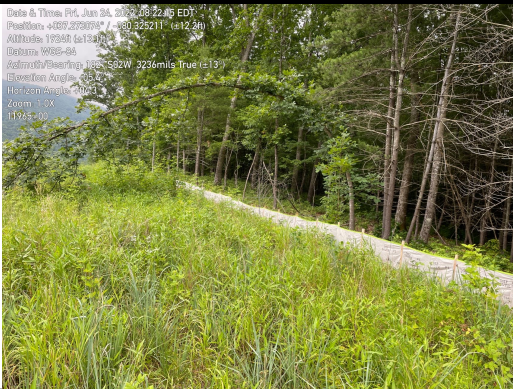
GPS Location		See photo		GPS Location	
Field Station#		11972+00		Field Station#	
Pic 3 Desc.		Stabilization in place		Pic 4 Desc.	
<p>Date & Time: Fri, Jun 24, 2022, 06:56:51 EDT Position: +407.252674° / +88.322674° (+16.17) Altitude: 1530ft (+11.8m) Datum: WGS-84 Azimuth/Bearing: 180° S00W 3943mils True (+13°) Elevation Angle: -02.5° Horizon Angle: +02.5° Zoom: 1.0X 11972+00</p>

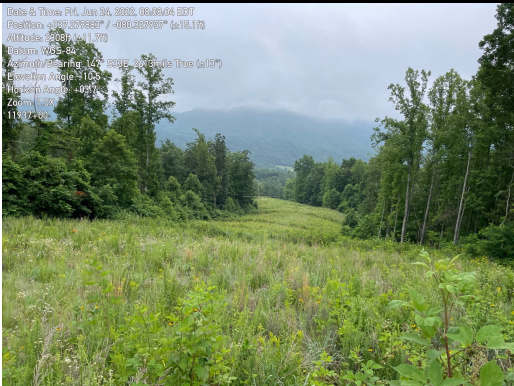
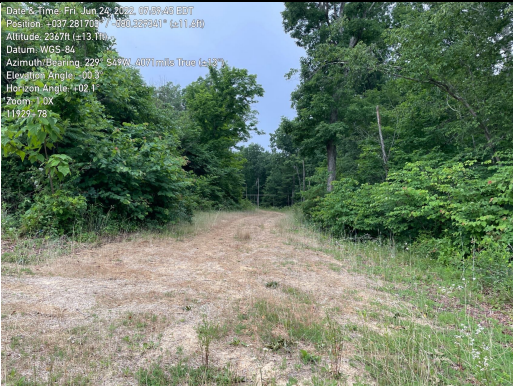
GPS Location		See photo		GPS Location	
Field Station#		11937+00		Field Station#	
Pic 5 Desc.		Water bars in place		Pic 6 Desc.

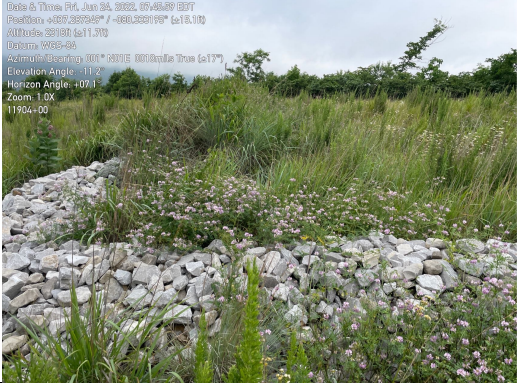
GPS Location	See photo	GPS Location	See photo		
Field Station#	11904+00	Field Station#	11899+89		
Pic 7 Desc.	Permanent water bars and level spreader in place	Pic 8 Desc.	RCE functional		
Insert image here		Insert image here			
GPS Location		GPS Location			
Field Station#		Field Station#			
Pic 9 Desc.		Pic 10 Desc.			
Insert image here		Insert image here			
GPS Location		GPS Location			
Field Station#		Field Station#			
Pic 11 Desc.		Pic 12 Desc.

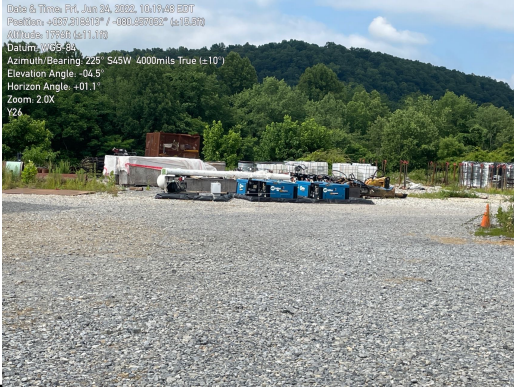
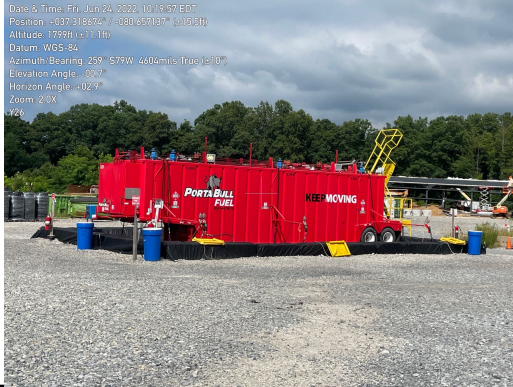
GPS Location	See photo	GPS Location	See photo		
Field Station#	12005+00	Field Station#	12005+00		
Pic 3 Desc.	Secondary containment in place y26	Pic 4 Desc.	Secondary containment in place y26

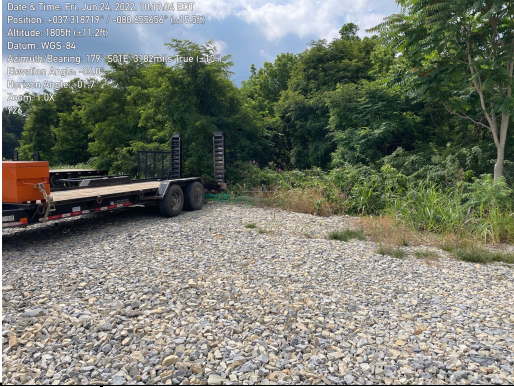
GPS Location	See photo	GPS Location	See photo		
Field Station#	12005+00	Field Station#	12005+00		
Pic 5 Desc.	CFS perimeter controls functional y26	Pic 6 Desc.	RCE functional y26

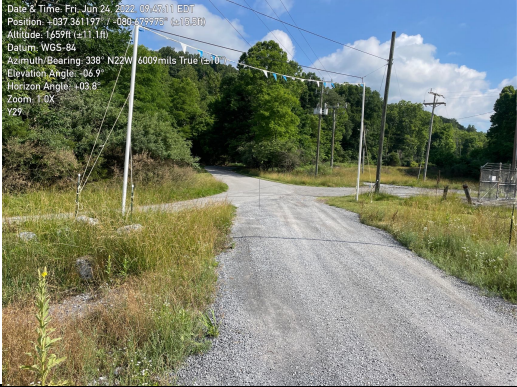
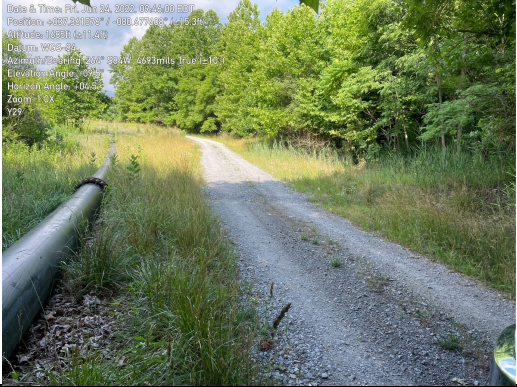
GPS Location		See photo		GPS Location	
Field Station#		12005+00		Field Station#	
Pic 13 Desc.		RCE functional y29		Pic 14 Desc.	
				Broad base dips in place y29	
<p>Date & Time: Fri, Jun 24, 2022 09:45:21 EDT Position: +037.362439° / -080.677363° (±15.8ft) Altitude: 1698ft (±11.1ft) Datum: WGS-84 Azimuth/Bearing: 171° S09E 3040mils True (±10°) Elevation Angle: -15.6° Horizon Angle: +00.3° Zoom: 1.0X Y29</p>  		<p>Date & Time: Fri, Jun 24, 2022 09:46:01 EDT Position: +037.363138° / -080.677363° (±15.8ft) Altitude: 1698ft (±11.1ft) Datum: WGS-84 Azimuth/Bearing: 111° S49E 1973mils True (±10°) Elevation Angle: -05.3° Horizon Angle: +01.2° Zoom: 1.0X Y29</p>

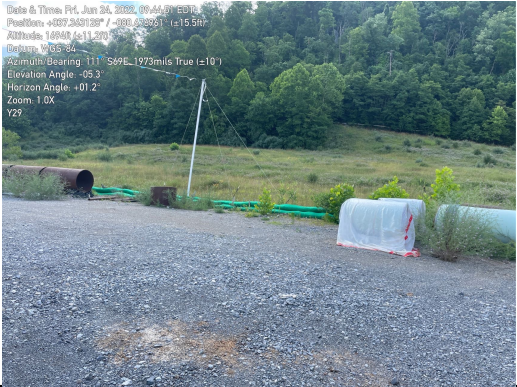
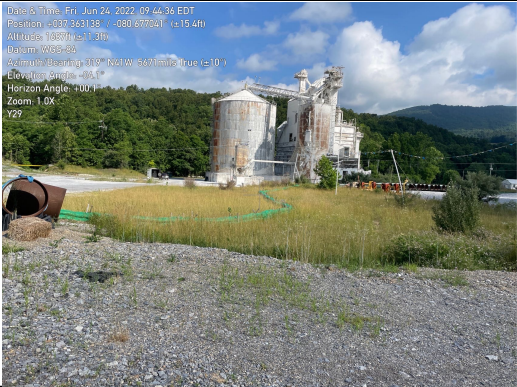
GPS Location		See photo		GPS Location	
Field Station#		12005+00		Field Station#	
Pic 15 Desc.		Culvert in place y29		Pic 16 Desc.	
				CFS perimeter controls functional y29	
<p>Date & Time: Fri, Jun 24, 2022 09:46:36 EDT Position: +037.363138° / -080.677363° (±15.8ft) Altitude: 1687ft (±11.1ft) Datum: WGS-84 Azimuth/Bearing: 010° N21W 5671mils True (±10°) Elevation Angle: +36.9° Horizon Angle: +00.1° Zoom: 1.0X Y29</p>

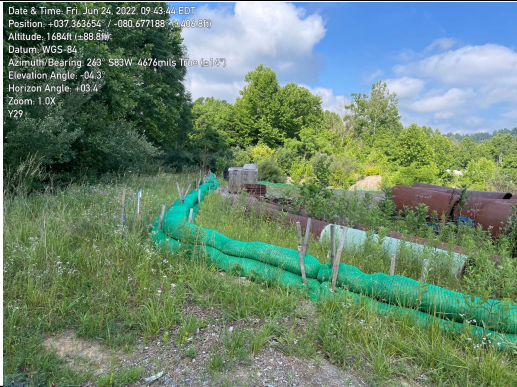
GPS Location		See photo		GPS Location	
Field Station#		12005+00		Field Station#	
Pic 17 Desc.		Stabilization in place y29		Pic 18 Desc.	
				CFS perimeter controls functional y29
