# Visual Site Inspection Report

<b>Project Name</b>	H-600 Pipeline Spread G	<b>AFE</b>	124300137	<b>Spread</b>	H-600 Pipeline Spread G
<b>Contractor</b>	Precision			<b>Report #</b>	39183
<b>Inspector</b>	Joe Sweeden			<b>Date/Time</b>	6/27/2022 6:29 AM
<b>Permit #</b>	TBD	<b>Inspection Type</b>	VA SWPP	<b>Station Begin</b>	10798+92
<b>State</b>	VA	<b>Inspection Area</b>	Partial	<b>Station End</b>	10859+46
<b>County</b>	Giles	<b>Ground</b>	Damp	<b>Temperature (°F)</b>	72.00
<b>Municipality</b>	N/A	<b>Weather</b>	Light Rain	<b>Rain Gauge (in)</b>	0.05
				<b>Rain Accumulation Time (days)</b>	1.00

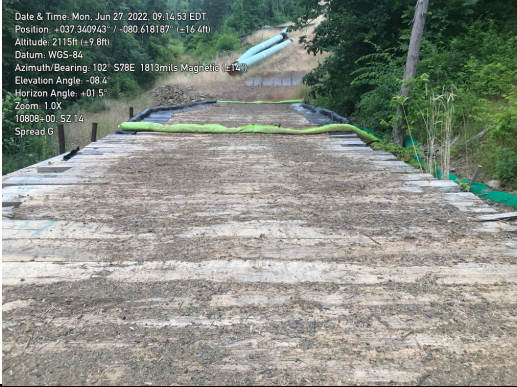
<p>Date &amp; Time: Mon, Jun 27, 2022, 09:14:53 EDT Position: +037.340943° / -080.618187° (+16.4ft) Altitude: 2115ft (+9.8ft) Datum: WGS-84 Azimuth/Bearing: 102° S78E 1813mils Magnetic (+105°) Elevation Angle: -08.4° Horizon Angle: +01.5° Zoom: 1.0X 10808+00 SZ 14 Spread G</p>

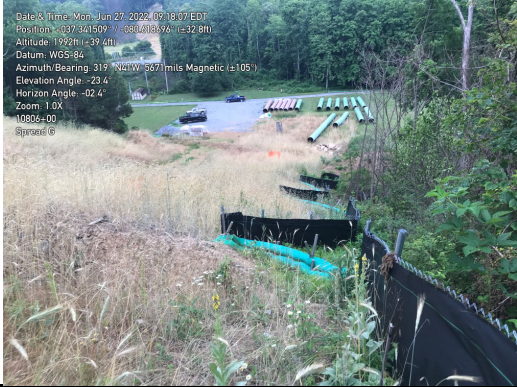
<p>Date &amp; Time: Mon, Jun 27, 2022, 09:18:07 EDT Position: +037.341509° / -080.601836° (+32.8ft) Altitude: 1921ft (+9.8ft) Datum: WGS-84 Azimuth/Bearing: 319° N21W 857mils Magnetic (+105°) Elevation Angle: -23.4° Horizon Angle: -02.4° Zoom: 1.0X 10806+00 Spread G</p>			
<b>GPS Location</b>	See photo	<b>GPS Location</b>	see photo		
<b>Field Station#</b>	10808+00	<b>Field Station#</b>	10806+00		
<b>Pic 7 Desc.</b>	SZ 14	<b>Pic 8 Desc.</b>	Archer Trail

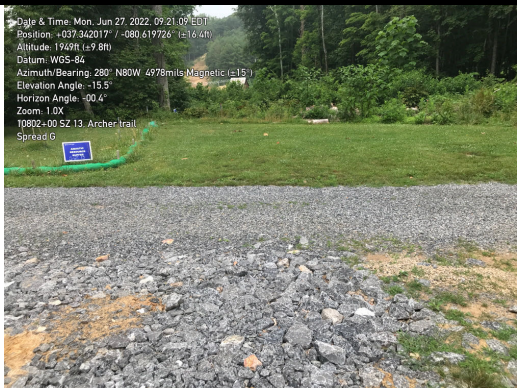
<b>GPS Location</b>	see photo	<b>GPS Location</b>			
<b>Field Station#</b>	10802+00	<b>Field Station#</b>			
<b>Pic 9 Desc.</b>	SZ 13	<b>Pic 10 Desc.</b>			
Insert image here		Insert image here			
<b>GPS Location</b>		<b>GPS Location</b>			
<b>Field Station#</b>		<b>Field Station#</b>			
<b>Pic 11 Desc.</b>		<b>Pic 12 Desc.</b>

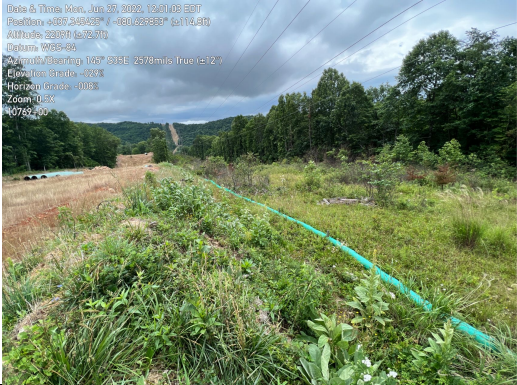
<b>GPS Location</b>	See photo	<b>GPS Location</b>	See photo		
<b>Field Station#</b>	10769+00	<b>Field Station#</b>	10771+75		
<b>Pic 7 Desc.</b>	CFS perimeter control in place	<b>Pic 8 Desc.</b>	Cleanwater diversion outlet protection in place		
<p><small>Date &amp; Time: Mon, Jun 27, 2022, 12:46:55 PM Position: +437.34433° / -080.42333° (±11.6 ft) Altitude: 2100 ft (±7.6 ft) Datum: WGS-84 Azimuth/Bearing: 108° S11E 257mils True (±12°) Elevation Grade: -00% Horizon Grade: -00% Zoom: 0.5X 10777+50</small></p>

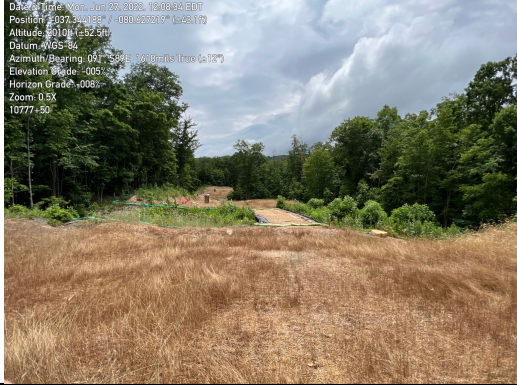
<b>GPS Location</b>	See photo	<b>GPS Location</b>	See photo		
<b>Field Station#</b>	10777+50	<b>Field Station#</b>	10783+25		
<b>Pic 9 Desc.</b>	Cleanwater drainage feature in place	<b>Pic 10 Desc.</b>	CFS perimeter control in place		
<p><small>Date &amp; Time: Mon, Jun 27, 2022, 12:49:55 PM Position: +437.34433° / -080.42333° (±11.6 ft) Altitude: 1948 ft (±7.6 ft) Datum: WGS-84 Azimuth/Bearing: 107° S53E 225mils True (±12°) Elevation Grade: -00% Horizon Grade: -01% Zoom: 0.5X 10792+00</small></p>

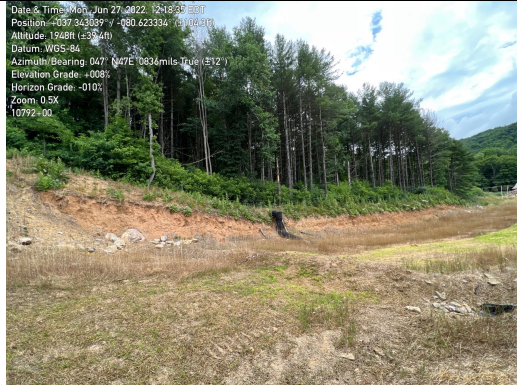
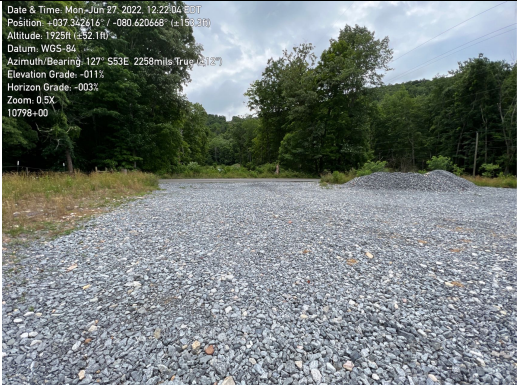
<b>Pic 11 Desc.</b>	Cleanwater diversion berm in place	<b>Pic 12 Desc.</b>	RCE in place

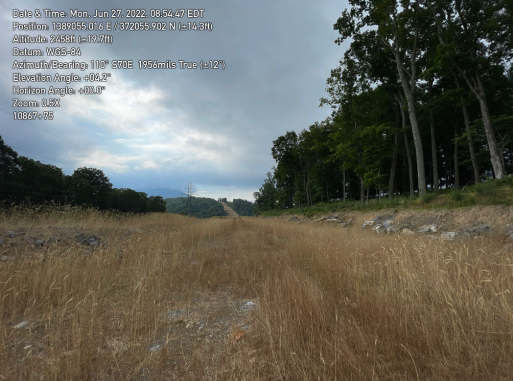
<b>GPS Location</b>	1	<b>GPS Location</b>	2		
<b>Field Station#</b>	10862+00	<b>Field Station#</b>	10867+75		
<b>Pic 1 Desc.</b>	CWDP outlet protection functional.	<b>Pic 2 Desc.</b>	Section of RoW showing conditions and controls.

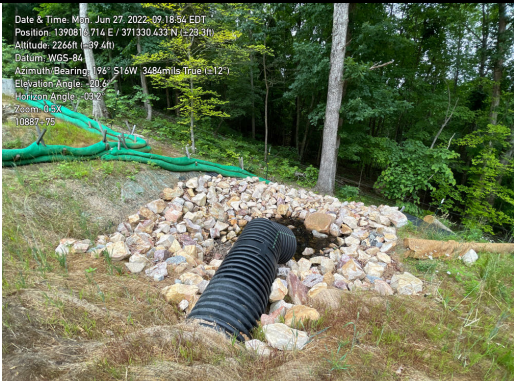
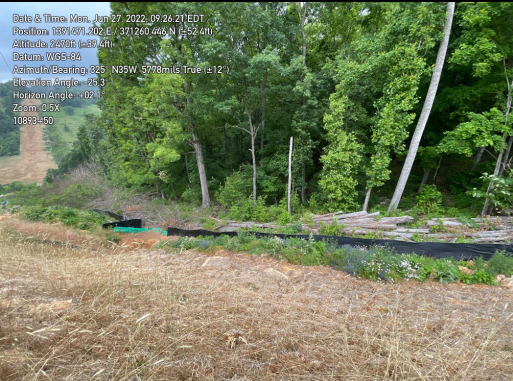
<b>GPS Location</b>	5	<b>GPS Location</b>	6		
<b>Field Station#</b>	10887+75	<b>Field Station#</b>	10893+50		
<b>Pic 5 Desc.</b>	Plunge pool functional.	<b>Pic 6 Desc.</b>	Perimeter controls functional.

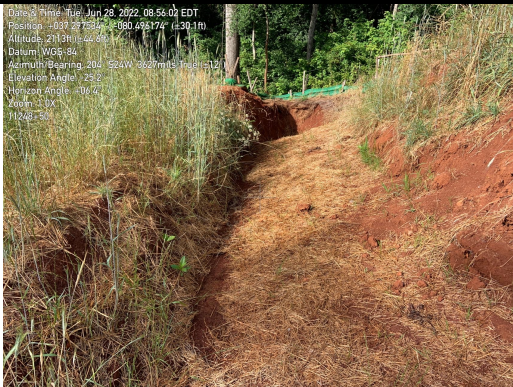
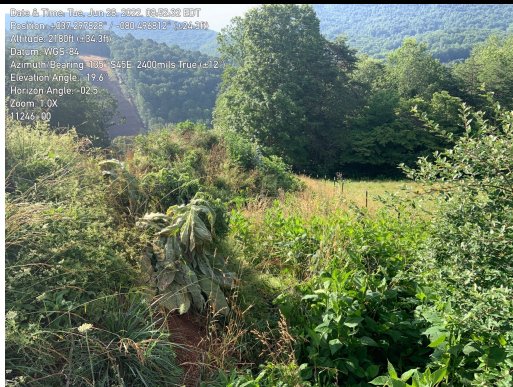
<b>GPS Location</b> See photo		<b>GPS Location</b> See photo			
<b>Field Station#</b> 11248+50		<b>Field Station#</b> 11246+00			
<b>Pic 3 Desc.</b> Rill erosion in throat of water bar		<b>Pic 4 Desc.</b> Temporary vegetation/ stabilization is sufficient

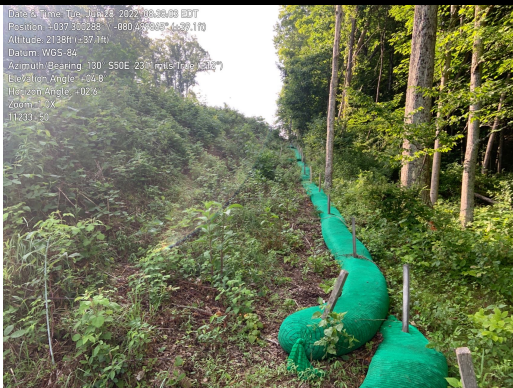
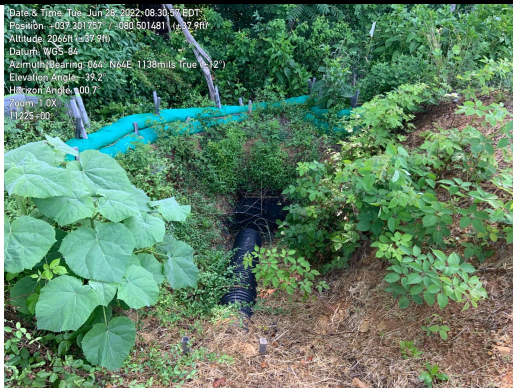
<p>Date &amp; Time: Tue Jun 28 2022 10:03:50 EDT Position: -039.277525 / -80.493174 (130.1M) Altitude: 2138ft (132.1M) Datum: WGS 84 Azimuth Bearing: 130 S50E 2330mils True (13°) Elevation Angle: -32.8 Horizon Angle: 102.5 Zoom: 1.0X 11233+50</p>		<p>Date &amp; Time: Tue Jun 28 2022 10:03:50 EDT Position: -039.277525 / -80.501481 (132.9M) Altitude: 2059ft (133.9M) Datum: WGS 84 Azimuth Bearing: 166 N44E 1138mils True (12°) Elevation Angle: -35.2 Horizon Angle: 100.7 Zoom: 1.0X 11225+00</p>			
<b>GPS Location</b> See photo		<b>GPS Location</b> See photo			
<b>Field Station#</b> 11233+50		<b>Field Station#</b> 11225+00			
<b>Pic 5 Desc.</b> Section of Row showing conditions and controls		<b>Pic 6 Desc.</b> Slope drain pipe, CFS and sump pit are in acceptable condition

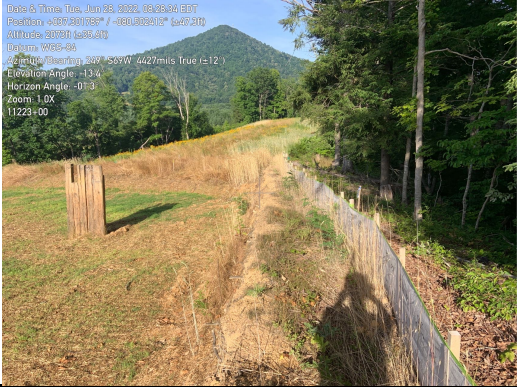
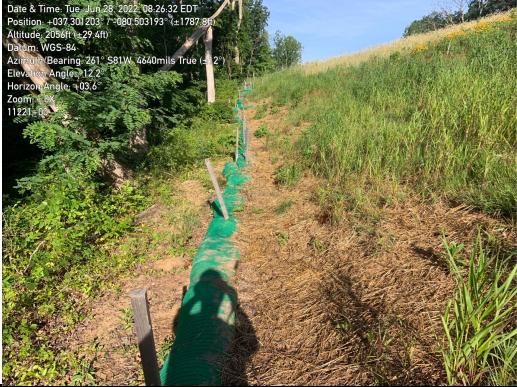
<b>GPS Location</b>	See photo	<b>GPS Location</b>	See photo		
<b>Field Station#</b>	11223+00	<b>Field Station#</b>	11221+00		
<b>Pic 7 Desc.</b>	Perimeter controls are in acceptable condition	<b>Pic 8 Desc.</b>	Previous punch list item has been addressed and is in acceptable condition

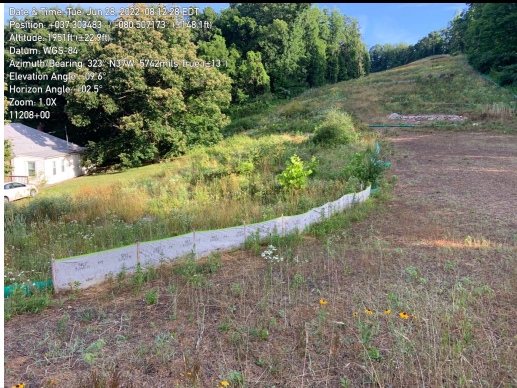
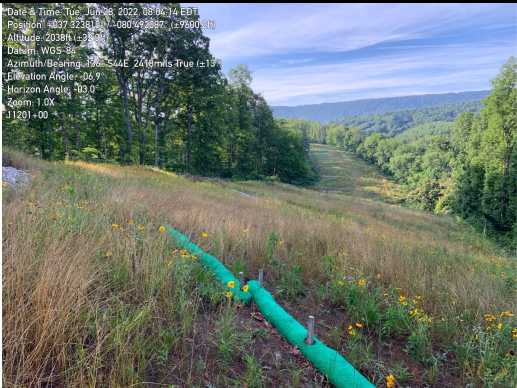
<b>GPS Location</b>	See photo	<b>GPS Location</b>	See photo		
<b>Field Station#</b>	11208+00	<b>Field Station#</b>	11201+00		
<b>Pic 9 Desc.</b>	Section of Row showing conditions and controls	<b>Pic 10 Desc.</b>	Section of Row showing conditions and controls		
<p>Date &amp; Time: Tue Jun 28 2022 07:52:33 EDT  Position: +037.306366° / -080.509702° (±2369.7ft)  Altitude: 1927ft (±30.5ft)  Datum: WGS-84  Azimuth/Bearing: 351° N09W 6240mils True (±13°)  Elevation Angle: -16.3°  Horizon Angle: -05.5°  Zoom: 1.0X  11191+25</p>

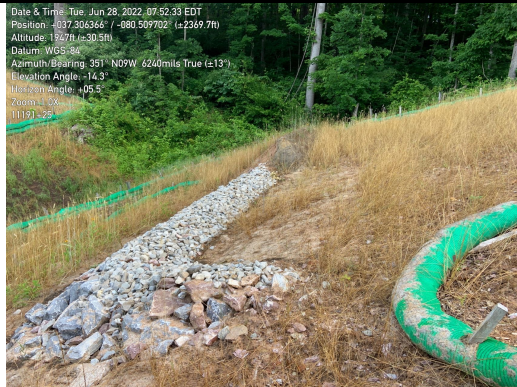
<b>GPS Location</b>	See photo	<b>GPS Location</b>	See photo		
<b>Field Station#</b>	11191+25	<b>Field Station#</b>	11189+50		
<b>Pic 11 Desc.</b>	Representational photo of water bar and level spreader	<b>Pic 12 Desc.</b>	Section of Row showing conditions and controls

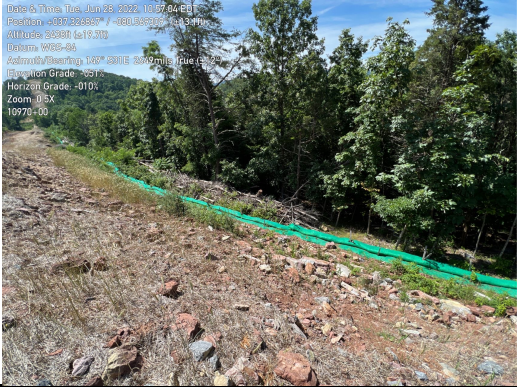
<b>GPS Location</b>	See photo	<b>GPS Location</b>	See photo		
<b>Field Station#</b>	10970+00	<b>Field Station#</b>	10966+35		
<b>Pic 7 Desc.</b>	CFS triple stack perimeter control in place	<b>Pic 8 Desc.</b>	Triple protection ECDs in place at karst feature		
<p>Date &amp; Time: Tue Jun 28, 2022, 11:03:24 EDT  Position: +037 322746 / -080 57205 (+15.1ft)  Altitude: 2320ft (+15.1ft)  Datum: WGS-84  Azimuth/Bearing: 254° S74W 510mils True (+12°)  Elevation Grade: +03%  Horizon Grade: +006%  Zoom: 0.5X  10963+25</p>

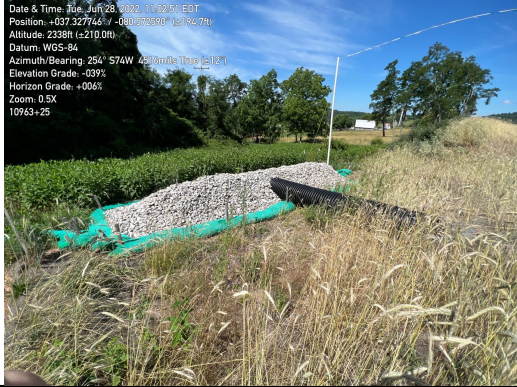
<b>GPS Location</b>	See photo	<b>GPS Location</b>	See photo		
<b>Field Station#</b>	10963+25	<b>Field Station#</b>	10961+00		
<b>Pic 9 Desc.</b>	Cleanwater diversion outlet protection in place	<b>Pic 10 Desc.</b>	CFS triple stack perimeter control in place		
<p>Date &amp; Time: Tue Jun 28, 2022, 11:11:13 EDT  Position: +037 329248 / -080 57205 (+15.1ft)  Altitude: 2186ft (+9.8ft)  Datum: WGS-84  Azimuth/Bearing: 207° N73W 510mils True (+12°)  Elevation Grade: +01%  Horizon Grade: +003%  Zoom: 0.5X  10946+00</p>

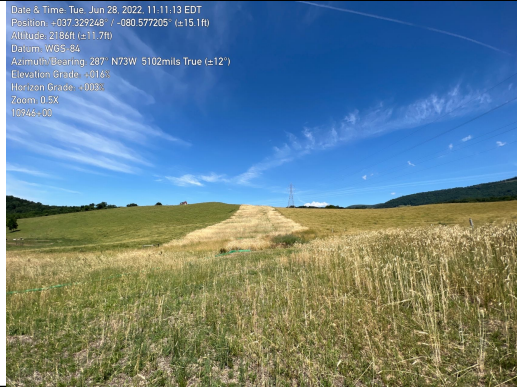
<b>Pic 11 Desc.</b>	Permanent vegetation present	<b>Pic 12 Desc.</b>	RCE in place

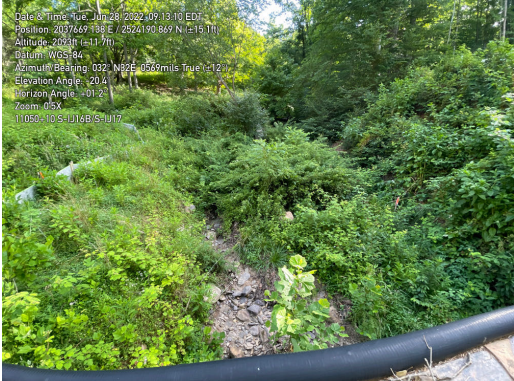
<b>GPS Location</b>	3	<b>GPS Location</b>	4		
<b>Field Station#</b>	11050+10	<b>Field Station#</b>	11055+50		
<b>Pic 3 Desc.</b>	S-IJ16B/S-IJ17.	<b>Pic 4 Desc.</b>	Karst feature protection functional.

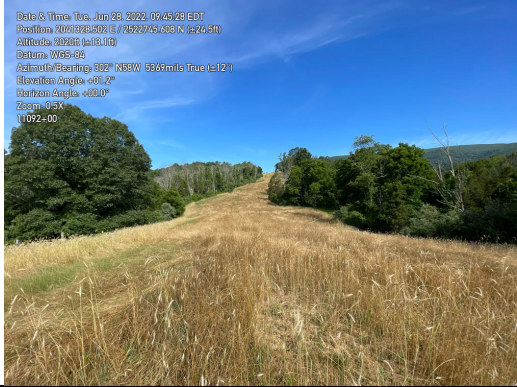
<b>GPS Location</b>	9	<b>GPS Location</b>	10		
<b>Field Station#</b>	11092+00	<b>Field Station#</b>	11098+47		
<b>Pic 9 Desc.</b>	Section of restored RoW showing conditions and controls.		<b>Pic 10 Desc.</b>	AR 245.02.	
Insert image here		Insert image here			
<b>GPS Location</b>		<b>GPS Location</b>			
<b>Field Station#</b>		<b>Field Station#</b>			
<b>Pic 11 Desc.</b>		<b>Pic 12 Desc.</b>

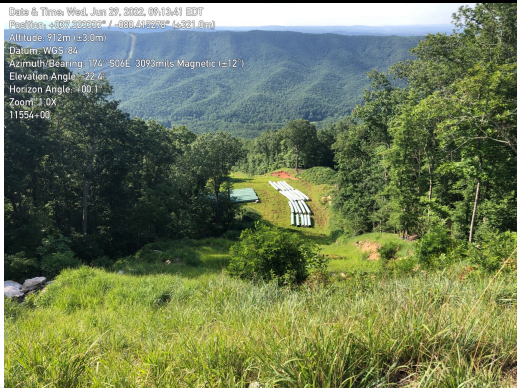
<b>GPS Location</b>	On photo	<b>GPS Location</b>	On photo		
<b>Field Station#</b>	11554+00	<b>Field Station#</b>	11585+48		
<b>Pic 9 Desc.</b>	ROW stable. ECDs in place.	<b>Pic 10 Desc.</b>	The S-PP21 crossing remains stable.

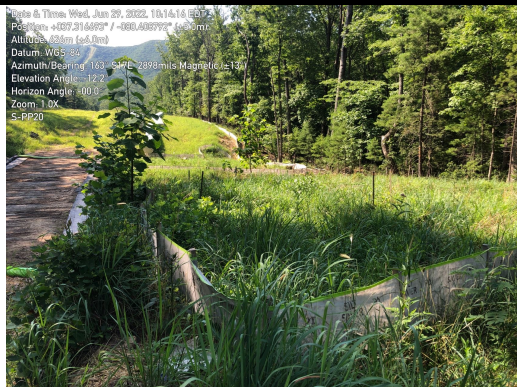
<p><small>Date &amp; Time: Wed, Jun 29, 2022, 10:14:14 EDT Position: +037.316693° / -080.408792° (±0.0m) Altitude: 634m (±0.0m) Datum: WGS-84 Azimuth/Bearing: 103° S40°E 2890mils Magnetic (+13°) Elevation Angle: +19.3° Horizon Angle: +00.0° Zoom: 1.0X S-PP20</small></p>				Insert image here	
<b>GPS Location</b>	On photo	<b>GPS Location</b>			
<b>Field Station#</b>	11588+41	<b>Field Station#</b>			
<b>Pic 11 Desc.</b>	The S-PP20 remains stable.	<b>Pic 12 Desc.</b>

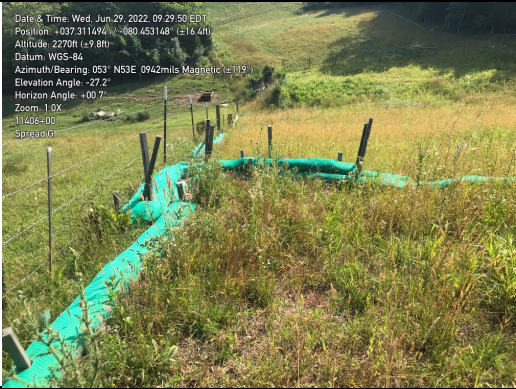
<p>Date &amp; Time: Wed Jun 29, 2022 09:36:13 EDT  Position: +037.3110134°W -080.455445°E (+16.4m)  Altitude: 2274ft (+9.8m)  Datum: WGS-84  Azimuth/Bearing: 187° S07W 3324mils Magnetic (+108°)  Elevation Angle: -08.8°  Horizon Angle: -04.1°  Zoom: 1.0x  11395+00  Spread G</p>			
<b>GPS Location</b>	See photo	<b>GPS Location</b>	see photo		
<b>Field Station#</b>	11406+00	<b>Field Station#</b>	11395+00		
<b>Pic 13 Desc.</b>	Perimeter controls	<b>Pic 14 Desc.</b>	Level spreader

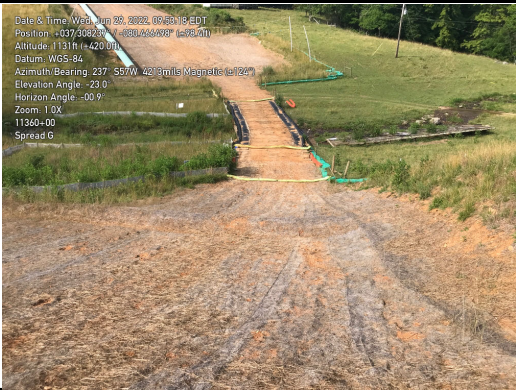
<b>GPS Location</b>	see photo	<b>GPS Location</b>			
<b>Field Station#</b>	11360+00	<b>Field Station#</b>			
<b>Pic 15 Desc.</b>	S-KL 43	<b>Pic 16 Desc.</b>			
<div style="text-align: center;">Insert image here</div>		<div style="text-align: center;">Insert image here</div>			
<b>GPS Location</b>		<b>GPS Location</b>			
<b>Field Station#</b>		<b>Field Station#</b>			
<b>Pic 17 Desc.</b>		<b>Pic 18 Desc.</b>

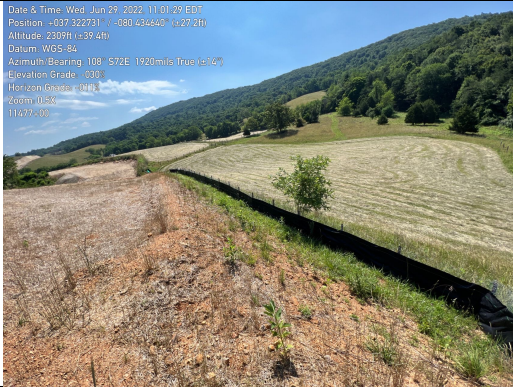
<b>GPS Location</b>		See photo		<b>GPS Location</b>	
<b>Field Station#</b>		11472+25		<b>Field Station#</b>	
<b>Pic 1 Desc.</b>		Triple protection ECDs in place at karst feature		<b>Pic 2 Desc.</b>	
<p>Date &amp; Time: Wed Jun 29 2022 11:05:05 EDT Position: +037 323023 / -080 433644 (±15.1ft) Altitude: 2223ft (±11.7ft) Datum: WGS-84 Azimuth/Bearing: 243 S63W 4320mils True (±12.1) Elevation Grade: +01% Horizon Grade: +01% Zoom: 0.5X 11479+00</p>

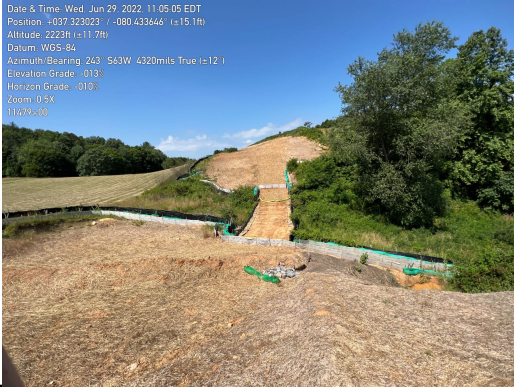
<b>GPS Location</b>		See photo		<b>GPS Location</b>	
<b>Field Station#</b>		11479+00		<b>Field Station#</b>	
<b>Pic 3 Desc.</b>		Cleanwater drainage feature in place		<b>Pic 4 Desc.</b>	
<p>Date &amp; Time: Wed Jun 29 2022 11:11:11 EDT Position: +037 324794 / -080 431918 (±33.5ft) Altitude: 2165ft (±11.3ft) Datum: WGS-84 Azimuth/Bearing: 012 N13E 0338mils True (±12.1) Elevation Grade: +03% Horizon Grade: +001% Zoom: 0.5X 11488+85</p>

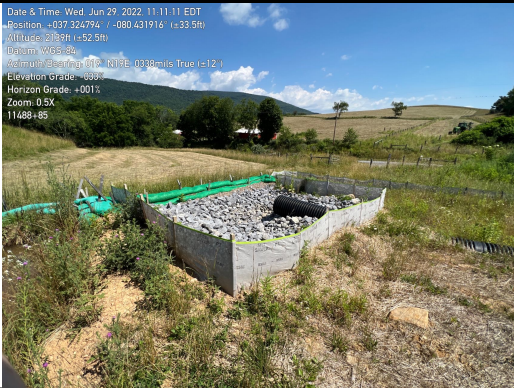
<b>GPS Location</b>		See photo		<b>GPS Location</b>	
<b>Field Station#</b>		11488+85		<b>Field Station#</b>	
<b>Pic 5 Desc.</b>		Plunge pool in place		<b>Pic 6 Desc.</b>	
				RCE in place

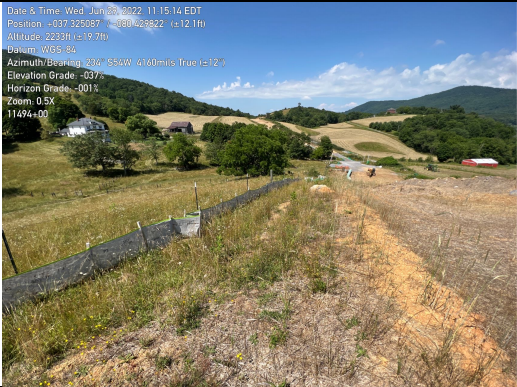
<b>GPS Location</b>		See photo		<b>GPS Location</b>	
<b>Field Station#</b>		11494+00		<b>Field Station#</b>	
<b>Pic 7 Desc.</b>		P1 silt fence perimeter control in place		<b>Pic 8 Desc.</b>	
				CFS perimeter control in place	
<p>Date &amp; Time: Wed Jun 29 2022 11:21:11 EDT  Position: +037 325778 / -080 427388 (+11 6ft)  Altitude: 2230ft (+13 1ft)  Datum: WGS 84  Azimuth/Bearing: 094° S84E 1671mils True (+12°)  Elevation Grade: -013%  Horizon Grade: -003%  Zoom: 0.5X  11503+50</p>

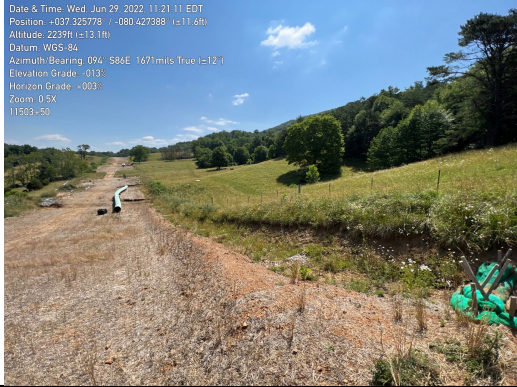
<b>GPS Location</b>		See photo		<b>GPS Location</b>	
<b>Field Station#</b>		11503+50		<b>Field Station#</b>	
<b>Pic 9 Desc.</b>		Cleanwater diversion berm in place		<b>Pic 10 Desc.</b>	
				Stream buffer in place	
<p>Date &amp; Time: Wed Jun 29 2022 11:28:46 EDT  Position: +037 328246 / -080 424151 (+44 8ft)  Altitude: 2178ft (+36 7ft)  Datum: WGS 84  Azimuth/Bearing: 212° S32W 3769mils True (+12°)  Elevation Grade: -010%  Horizon Grade: -000%  Zoom: 0.5X  11512+25</p>

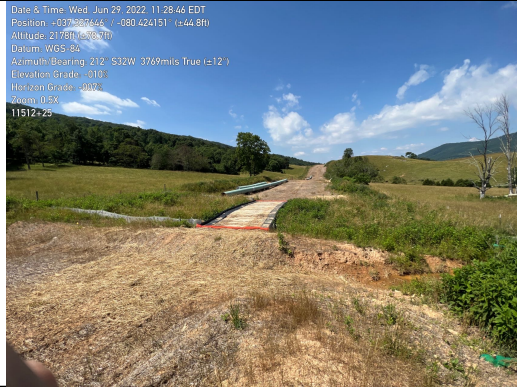
<b>GPS Location</b>		See photo		<b>GPS Location</b>	
<b>Field Station#</b>		11512+25		<b>Field Station#</b>	
<b>Pic 11 Desc.</b>		Cleanwater drainage feature in place		<b>Pic 12 Desc.</b>

Stream buffer in place

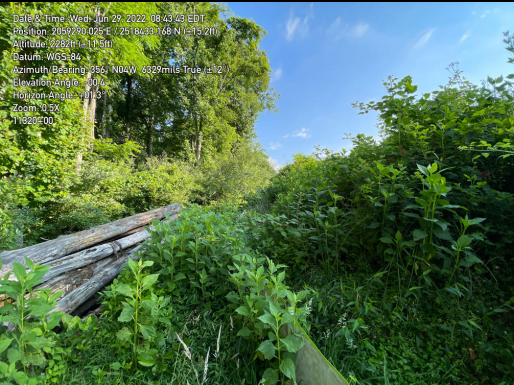
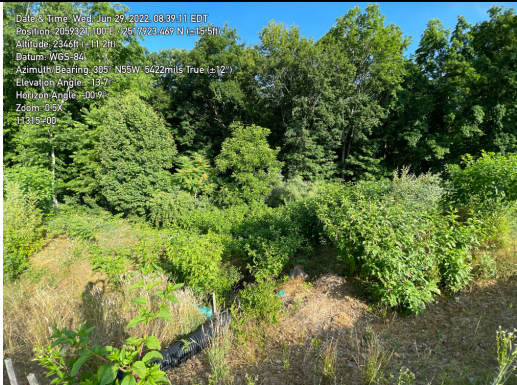
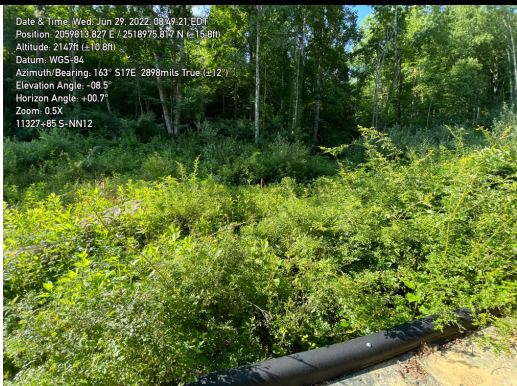
<b>GPS Location</b>	7		<b>GPS Location</b>	8	
<b>Field Station#</b>	11320+00		<b>Field Station#</b>	11315+00	
<b>Pic 7 Desc.</b>	Heavy vegetation impeding visibility/access to perimeter controls.		<b>Pic 8 Desc.</b>	Heavy vegetation impeding visibility/access to perimeter controls.

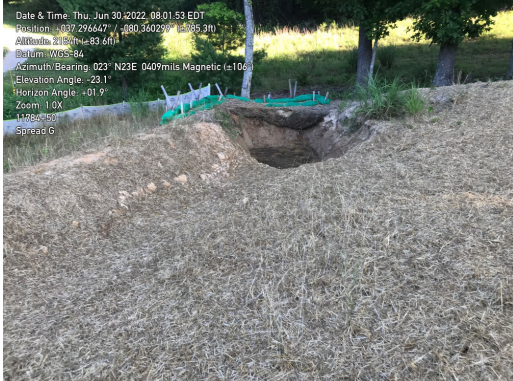
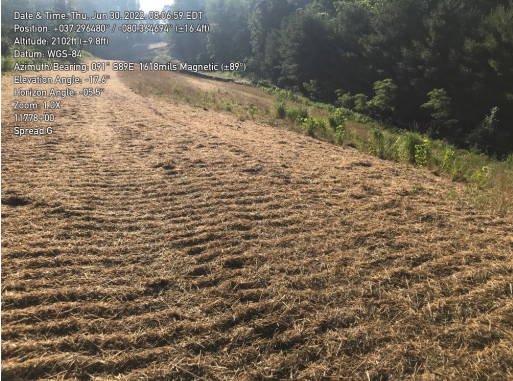
GPS Location		See photo				GPS Location		see photo					
Field Station#		11784+50				Field Station#		11778+00					
Pic 1 Desc.		Sump/end treatments				Pic 2 Desc.		Re-stabilized ROW

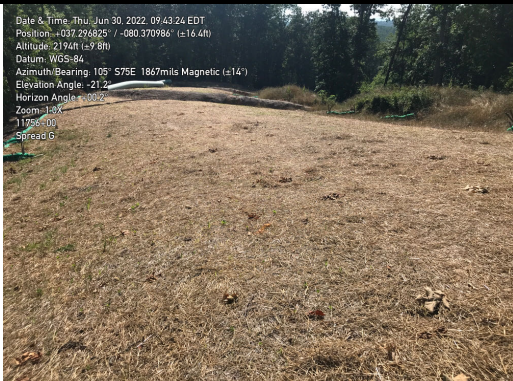
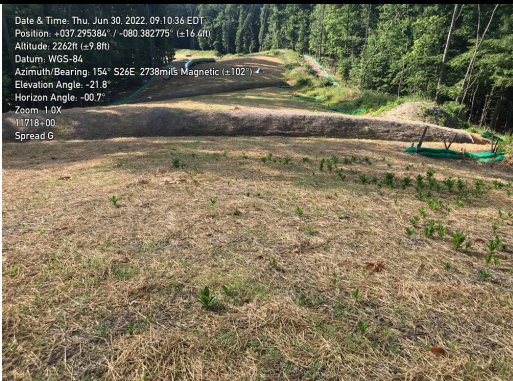
GPS Location		see photo				GPS Location		see photo					
Field Station#		11756+00				Field Station#		11718+00					
Pic 3 Desc.		Water bars				Pic 4 Desc.		Stabilized ROW

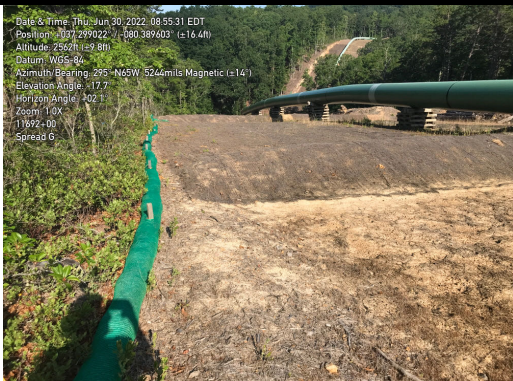
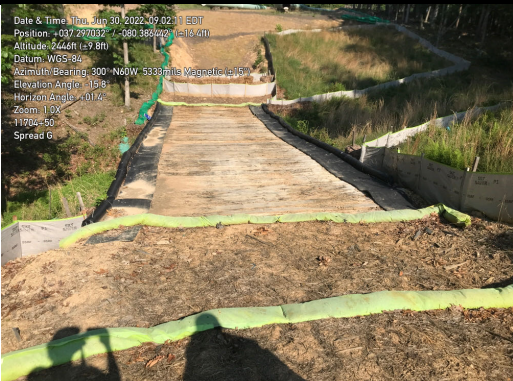
GPS Location		see photo				GPS Location		see photo					
Field Station#		11692+00				Field Station#		11704+50					
Pic 5 Desc.		Erosion blanket				Pic 6 Desc.		S-MN 22

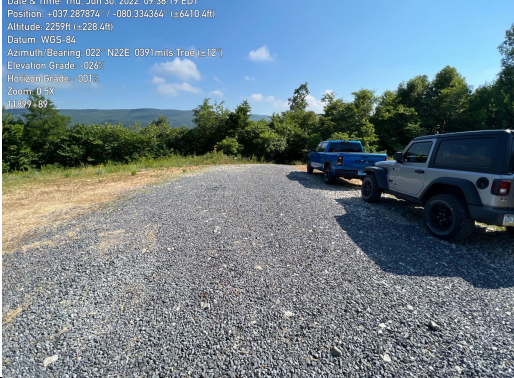
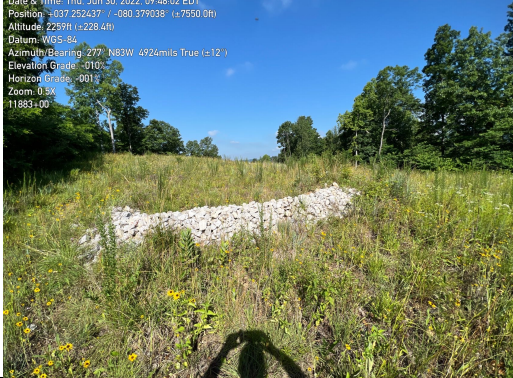
<b>GPS Location</b>	See photo	<b>GPS Location</b>	See photo		
<b>Field Station#</b>	11899+89	<b>Field Station#</b>	11883+00		
<b>Pic 1 Desc.</b>	RCE in place	<b>Pic 2 Desc.</b>	Level spreader in place		
<p>Date &amp; Time: Thu, Jun 30, 2022, 09:58:40 EDT  Position: -037.286161 / -080.348642 (±13.8ft)  Altitude: 2195ft (±9.8ft)  Datum: WGS-84  Azimuth/Bearing: 340° N20W 6964mils True (±12°)  Elevation Grade: -007°  Horizon Grade: -012°  Zoom: 0.5X  11854+00</p>

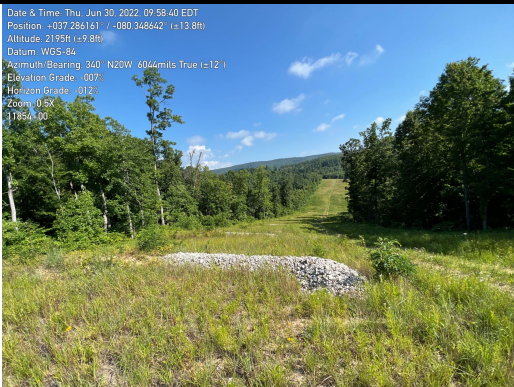
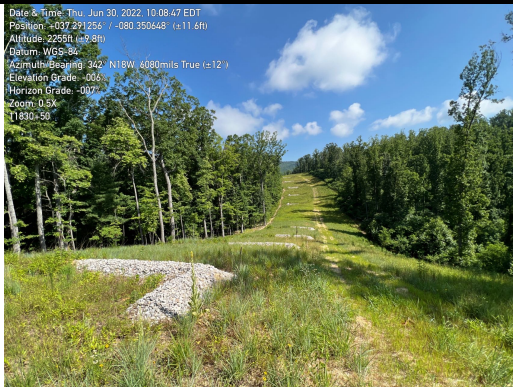
<b>GPS Location</b>	See photo	<b>GPS Location</b>	See photo		
<b>Field Station#</b>	11854+00	<b>Field Station#</b>	11830+50		
<b>Pic 3 Desc.</b>	Permanent waterbar with level spreader in place	<b>Pic 4 Desc.</b>	Permanent waterbars in place		
<p>Date &amp; Time: Thu, Jun 30, 2022, 10:19:48 EDT  Position: -037.234266 / -080.353714 (±15.4ft)  Altitude: 2205ft (±11.2ft)  Datum: WGS-84  Azimuth/Bearing: 265° S85W 4711mils True (±12°)  Elevation Grade: -008°  Horizon Grade: -001°  Zoom: 0.5X  11811+00</p>

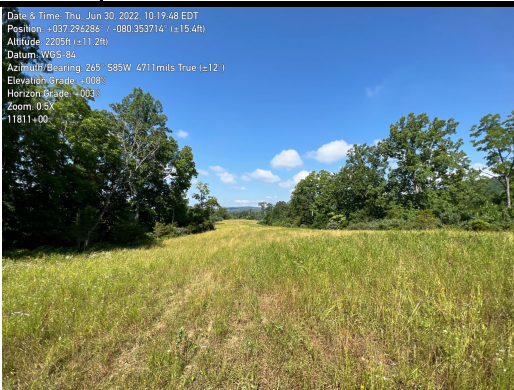
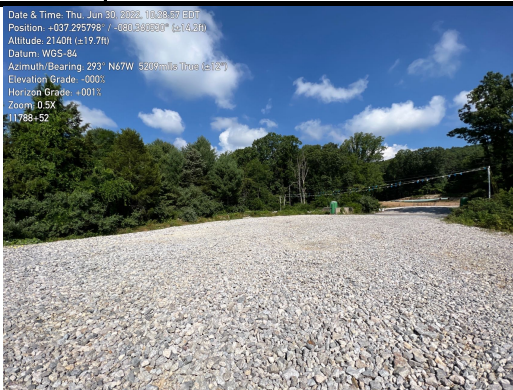
<b>GPS Location</b>	See photo	<b>GPS Location</b>	See photo		
<b>Field Station#</b>	11811+00	<b>Field Station#</b>	11788+52

<b>Pic 5 Desc.</b>	Permanent vegetation present	<b>Pic 6 Desc.</b>	RCE in place

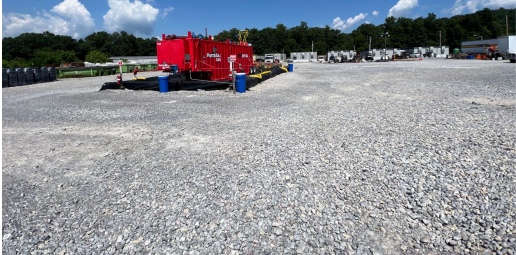
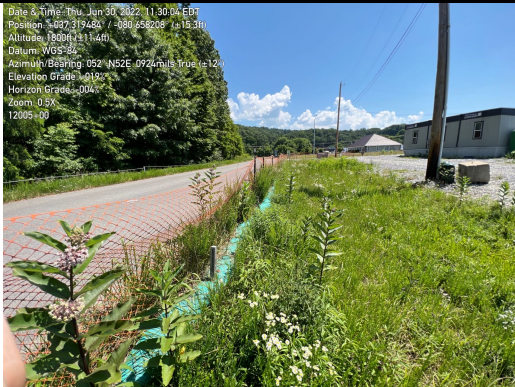
GPS Location	See photo		GPS Location	See photo	
Field Station#	12005+00		Field Station#	12005+00	
Pic 1 Desc.	Rock surface in acceptable condition		Pic 2 Desc.	CFS perimeter control in place	
		<p>Date &amp; Time: Thu, Jun 30, 2022, 11:35:05 EDT  Position: +037 319017 / -080 657678 (±15.4ft)  Altitude: 1800ft (±11.2ft)  Datum: WGS-84  Azimuth/Bearing: 092° E 1760mils True (±12°)  Elevation Grade: +005%  Horizon Grade: +002%  Zoom: 0.5X  12005+00</p>

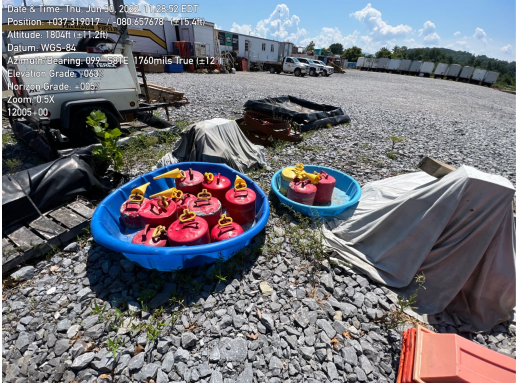
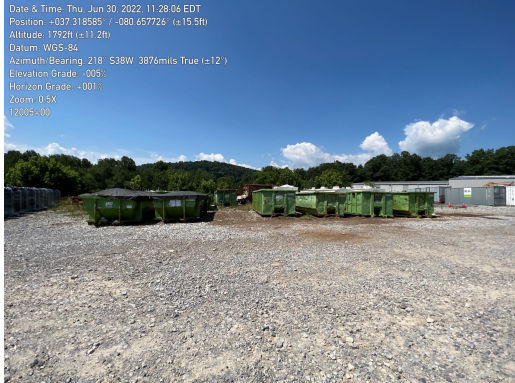
GPS Location	See photo		GPS Location	See photo	
Field Station#	12005+00		Field Station#	12005+00	
Pic 3 Desc.	Secondary containment in place		Pic 4 Desc.	Dumpsters in place	
		<p>Date &amp; Time: Thu, Jun 30, 2022, 11:36:54 EDT  Position: +037 319263 / -080 658395 (±15.2ft)  Altitude: 1763ft (±10.9ft)  Datum: WGS-84  Azimuth/Bearing: 238° S58W 4231mils True (±10°)  Elevation Grade: -023%  Horizon Grade: +011%  Zoom: 0.5X  12005+00</p>

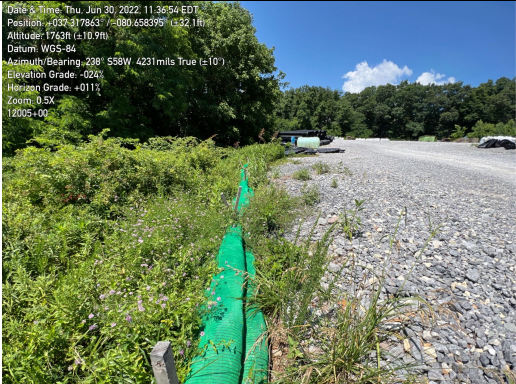
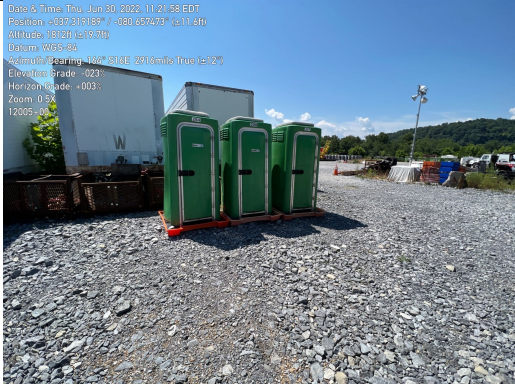
GPS Location	See photo		GPS Location	See photo	
Field Station#	12005+00		Field Station#	12005+00	
Pic 5 Desc.	CFS triple stack perimeter control in place		Pic 6 Desc.	Secondary containment in place

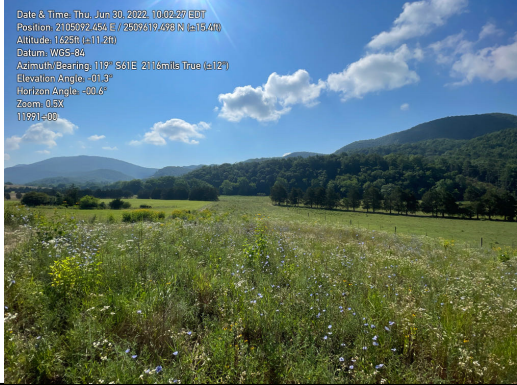
<b>GPS Location</b>	7	<b>GPS Location</b>	8		
<b>Field Station#</b>	11965+00	<b>Field Station#</b>	11978+50		
<b>Pic 7 Desc.</b>	Perimeter controls functional.	<b>Pic 8 Desc.</b>	Karst feature protection functional.

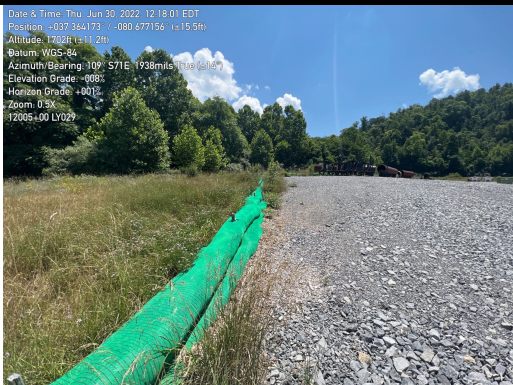
GPS Location	See photo		GPS Location	See photo	
Field Station#	12005+00		Field Station#	12005+00	
Pic 5 Desc.	Perimeter triple stacked CFS. No Issues.		Pic 6 Desc.	Perimeter controls no issues. Adequate installation.

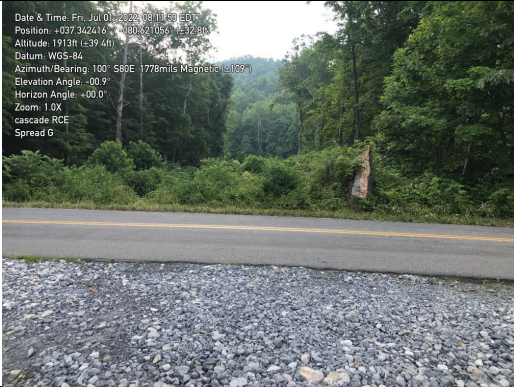
<p>Date &amp; Time: Fri, Jul 01, 2022, 09:20:51 EDT Position: +037.340949 / -080.618135 (+37.42°N, -80.618135°W) Altitude: 2128ft (+9.8ft) Datum: WGS-84 Azimuth/Bearing: 101° S79E 1796mils Magnetic (+12°) Elevation Angle: -10.0° Horizon Angle: +00.3° Zoom: 1.0X 10809+00 Spread G</p>			
<b>GPS Location</b>	See photo		<b>GPS Location</b>	see photo	
<b>Field Station#</b>	10798+83		<b>Field Station#</b>	10809+00	
<b>Pic 1 Desc.</b>	Cascade RCE		<b>Pic 2 Desc.</b>	SZ 14

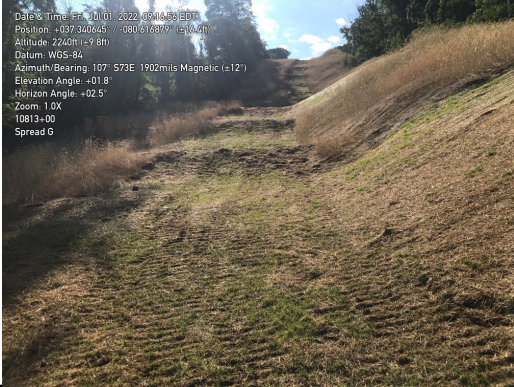
<b>GPS Location</b>	see photo		<b>GPS Location</b>	see photo	
<b>Field Station#</b>	10813+00		<b>Field Station#</b>	10818+00	
<b>Pic 3 Desc.</b>	Water bars/stabilized ROW		<b>Pic 4 Desc.</b>	Collins AR

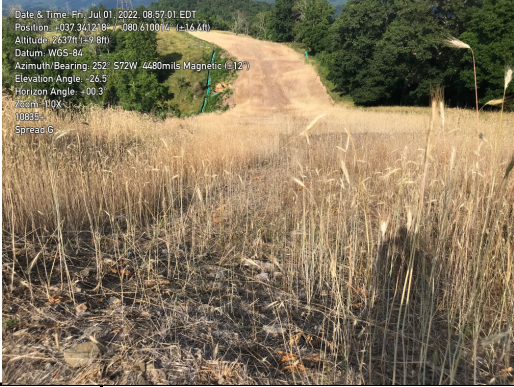
<b>Pic 5 Desc.</b>	Stabilized ROW/water bars		<b>Pic 6 Desc.</b>	Clean water diversion pipe

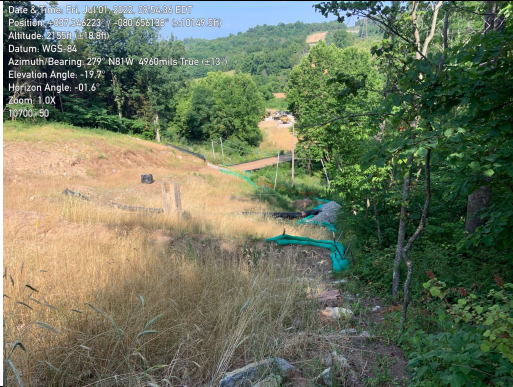
<b>GPS Location</b>	See photo	<b>GPS Location</b>	See photo		
<b>Field Station#</b>	10698+15	<b>Field Station#</b>	10700+50		
<b>Pic 1 Desc.</b>	Section of Row showing conditions and controls at S-G32	<b>Pic 2 Desc.</b>	Section of Row showing conditions and controls

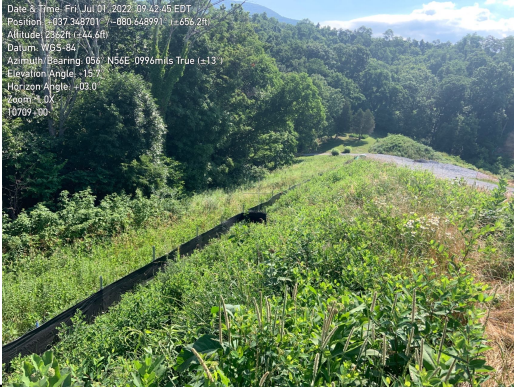
<b>GPS Location</b>	See photo	<b>GPS Location</b>	See photo		
<b>Field Station#</b>	10709+00	<b>Field Station#</b>	10710+00		
<b>Pic 3 Desc.</b>	Section of Row showing conditions and controls	<b>Pic 4 Desc.</b>	RCE is maintained and in acceptable condition

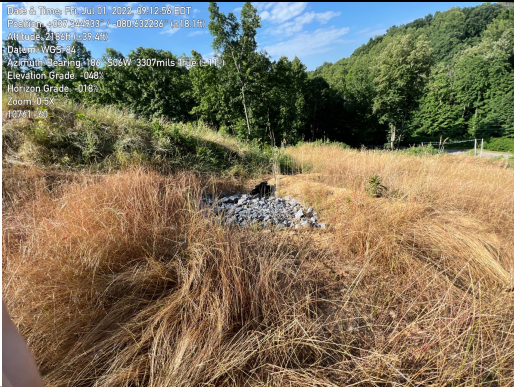
<b>GPS Location</b>	See photo	<b>GPS Location</b>	See photo		
<b>Field Station#</b>	10761+60	<b>Field Station#</b>	10764+75		
<b>Pic 3 Desc.</b>	Stone inlet protection in place	<b>Pic 4 Desc.</b>	Stream buffer in place

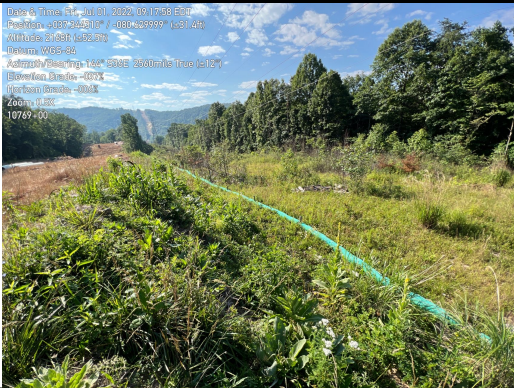
<b>GPS Location</b>	See photo	<b>GPS Location</b>	See photo		
<b>Field Station#</b>	10769+00	<b>Field Station#</b>	10771+75		
<b>Pic 5 Desc.</b>	CFS perimeter control in place	<b>Pic 6 Desc.</b>	Cleanwater diversion outlet protection in place

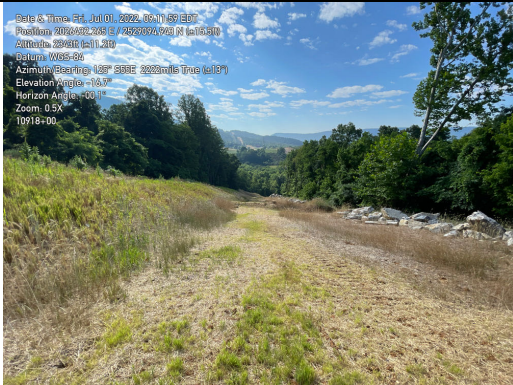
GPS Location				3				GPS Location				4			
Field Station#				10918+00				Field Station#				11910+00			
Pic 3 Desc.				Section of RoW showing conditions and controls.				Pic 4 Desc.				Perimeter controls functional.

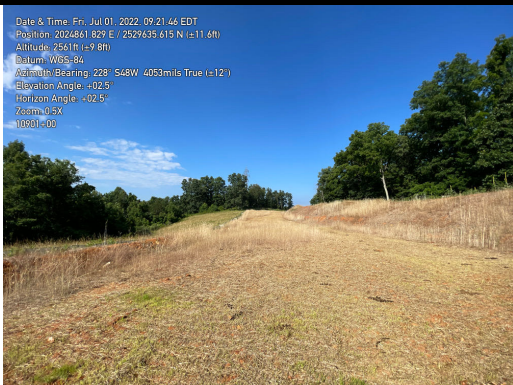
Date & Time: Fri, Jul 01, 2022, 09:21:44 EDT Position: 2024861.829 E / 2529435.615 N (±11.6M) Altitude: 2561m (±9.8M) Datum: WGS-84 Azimuth/Bearing: 228° S±8W 4053mils True (±12°) Elevation Angle: +02.5° Horizon Angle: +02.5° Zoom: 0.5X 10901+00				Date & Time: Fri, Jul 01, 2022, 09:31:12 EDT Position: 2023462.957 E / 2529402.522 N (±15.4M) Altitude: 2233m (±11.2M) Datum: WGS-84 Azimuth/Bearing: 193° S±3W 3433mils True (±12°) Elevation Angle: +32.4° Horizon Angle: +06.2° Zoom: 0.5X 10887+75											
GPS Location				5				GPS Location				6			
Field Station#				10901+00				Field Station#				10887+75			
Pic 5 Desc.				Section of RoW showing conditions and controls.				Pic 6 Desc.				Plunge pool functional.
