Visual Site Inspection Report

Project Name	H-602 Pipeline Spread I	AFE	124300139	Spread	H-602 Pipeline Spread I	
Contractor	Precision			Report #	38944	
Inspector	John White			Date/Time	6/20/2022 12:50 PM	
Permit #	TBD	Inspection Type	VA SWPP	Station Begin	00+00	
State	VA	Inspection Area	Full	Station End	19+25	
County	Pittsylvania	Ground	Dry	Temperature (°F)	74.00	
Municipality	Chatham	Weather	Cloudy	Rain Gauge (in)	0.80	
				Rain Accumulation Time (days)	6.00

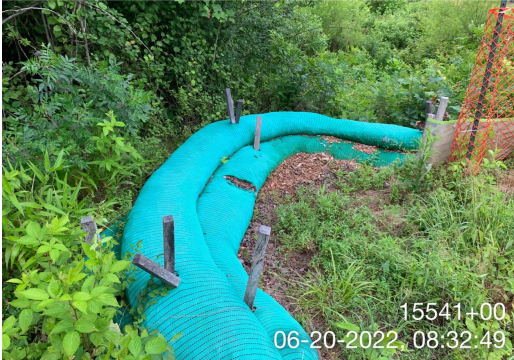
GPS Location	0	GPS Location	0		
Field Station#	15541+00	Field Station#	15541+00		
Pic 1 Desc.	CFS end treatment is deteriorated	Pic 2 Desc.	Perimeter CFS from 15540+50 to 15541+00 is deteriorated

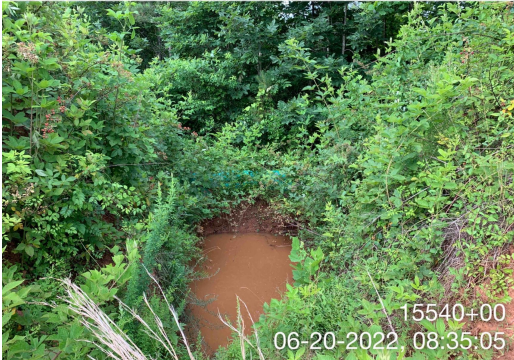
GPS Location	0	GPS Location	0		
Field Station#	15540+00	Field Station#	15538+00		
Pic 3 Desc.	CFS end treatment is deteriorated	Pic 4 Desc.	CFS end treatment is deteriorated

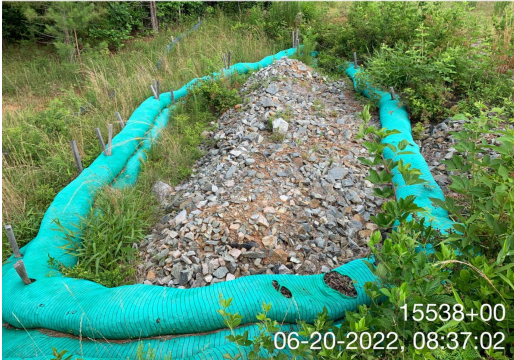
GPS Location	0	GPS Location	0		
Field Station#	15538+00	Field Station#	15537+00		
Pic 5 Desc.	CFS at clean water diversion outlet is deteriorated	Pic 6 Desc.	CFS end treatment is deteriorated

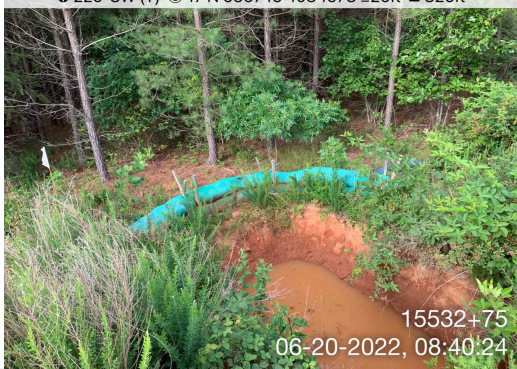
GPS Location	0	GPS Location	0		
Field Station#	15532+75	Field Station#	15530+00		
Pic 9 Desc.	CFS end treatment is deteriorated		Pic 10 Desc.	CFS end treatment is deteriorated

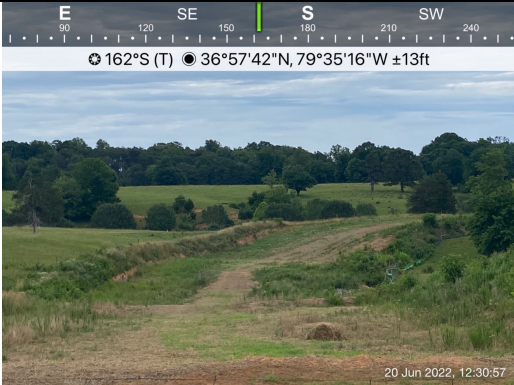
GPS Location	0	GPS Location	0		
Field Station#	15084+00	Field Station#	15109+50		
Pic 3 Desc.	Approximately 15084+00. Overview of ROW.		Pic 4 Desc.	Approximately 15109+50. Overview of ROW.

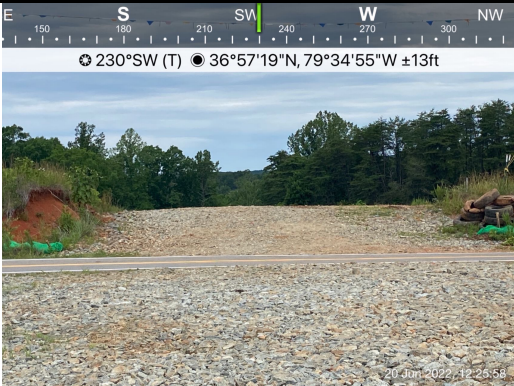
GPS Location	0	GPS Location	0		
Field Station#	15113+50	Field Station#	15139+00		
Pic 5 Desc.	Approximately 15113+50. Overview of road crossing and RCEs.		Pic 6 Desc.	Approximately 15139+00. Overview of ROW.

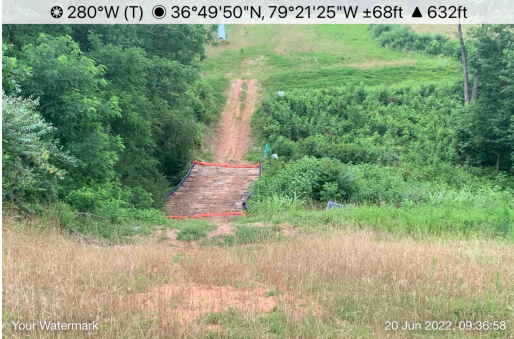
Your Watermark 20 Jun 2022, 09:34:24			
GPS Location	O	GPS Location	O		
Field Station#	15977+36	Field Station#	15974+00		
Pic 1 Desc.	Observing temporary stabilization, water bar, signage, buffer, equipment crossing and ECD's	Pic 2 Desc.	Observing temporary stabilization, CWD outlet and ECD's		
North West Elevation 145°SE (T) 36°49'57"N, 79°21'33"W ±1177ft ▲ 636ft

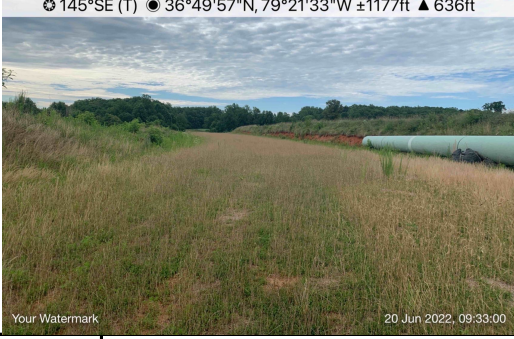
Your Watermark 20 Jun 2022, 09:32:13			
GPS Location	O	GPS Location	O		
Field Station#	15970+00	Field Station#	15965+50		
Pic 3 Desc.	Observing temporary stabilization and CWD berm	Pic 4 Desc.	Observing temporary stabilization and ECD's

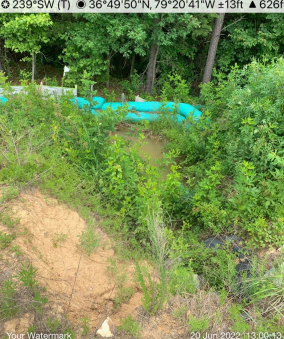
Your Watermark 20 Jun 2022, 12:58:50			
GPS Location	O	GPS Location	O		
Field Station#	16018+00	Field Station#	16022+00		
Pic 5 Desc.	Observing temporary stabilization, sump, end treatment and ECD's	Pic 6 Desc.	Observing temporary stabilization and water bar

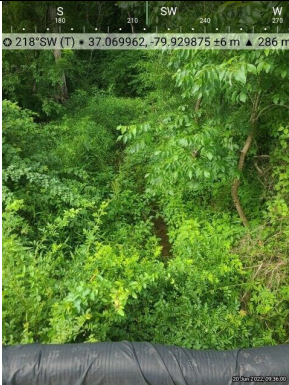
GPS Location	0000	GPS Location	0000		
Field Station#	13794+57	Field Station#	13812+02		
Pic 1 Desc.	Stream observation photo facing downstream during routine inspection today. No environmental issues observed at the time of inspection.	Pic 2 Desc.	P1 requires maintenance due to 3rd party mowing activities. Documented and added to the punch list.

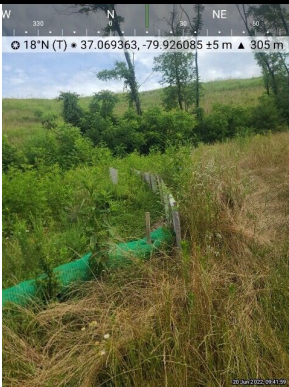
GPS Location	0000	GPS Location	0000		
Field Station#	13806+20	Field Station#	13794+57		
Pic 3 Desc.	Monitored ECDs at stream buffer. All in place and functioning at the time of inspection.	Pic 4 Desc.	Stream observation photo facing upstream during routine inspection. No issues observed at the time of inspection.

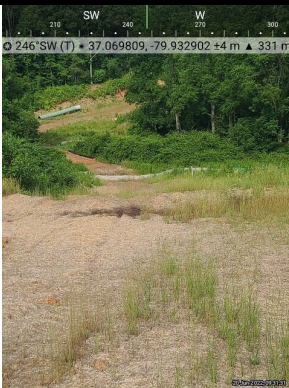
GPS Location	0000	GPS Location	0000		
Field Station#	13784+35	Field Station#	13786+50		
Pic 5 Desc.	Monitored stabilization on hill side above stream crossing. ECDs in place and functioning.	Pic 6 Desc.	Monitored completed punch list item.. CFS installed and functioning.

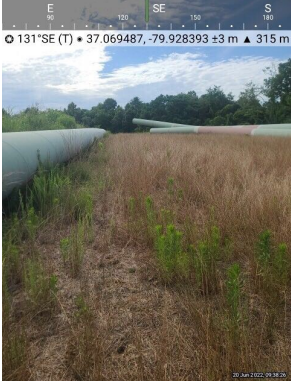
<p>Insert image here</p>		<p>Insert image here</p>	
GPS Location	0000	GPS Location			
Field Station#	13802+00	Field Station#			
Pic 7 Desc.	Row photo showing stabilization in upland area . No issues observed during inspection.	Pic 8 Desc.			
<p>Insert image here</p>		<p>Insert image here</p>			
GPS Location		GPS Location			
Field Station#		Field Station#			
Pic 9 Desc.		Pic 10 Desc.			
<p>Insert image here</p>		<p>Insert image here</p>			
GPS Location		GPS Location			
Field Station#		Field Station#			
Pic 11 Desc.		Pic 12 Desc.

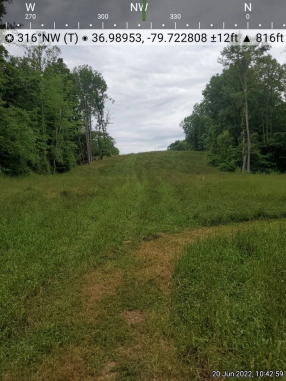
GPS Location	0	GPS Location	0		
Field Station#	14656+50	Field Station#	14656+00		
Pic 1 Desc.	CIS S-H38 Vegetation	Pic 2 Desc.	CIS S-H38 ECDs

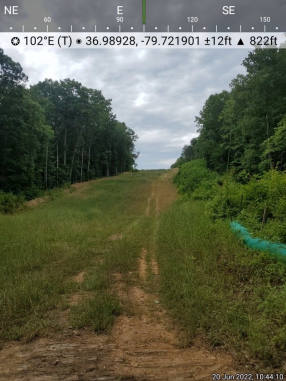
GPS Location	0	GPS Location	0		
Field Station#	14659+00	Field Station#	14667+00		
Pic 3 Desc.	GAS W-H17 Vegetation	Pic 4 Desc.	Sump and J-Hook

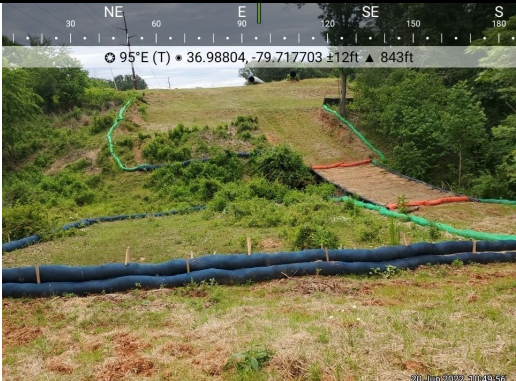
GPS Location	0	GPS Location	0		
Field Station#	14672+00	Field Station#	14679+00		
Pic 5 Desc.	CIS S-H37 ECDs	Pic 6 Desc.	CIS S-H36 ECDs

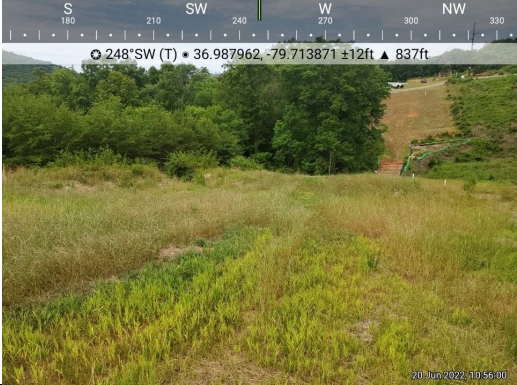
GPS Location	0	GPS Location	0		
Field Station#	14685+00	Field Station#	14687+00		
Pic 7 Desc.	Temporary vegetation	Pic 8 Desc.	Sump

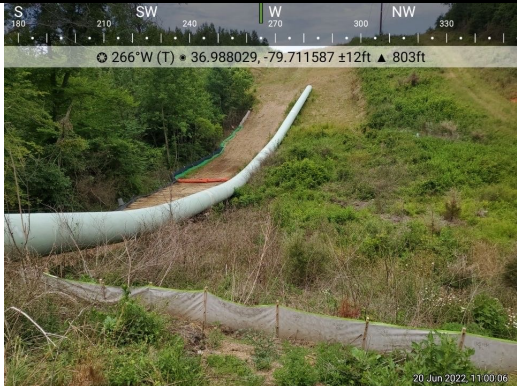
<p style="text-align: center;">Insert image here</p>			
GPS Location	0	GPS Location			
Field Station#	14691+00	Field Station#			
Pic 9 Desc.	GAS S-H34 Silt fence	Pic 10 Desc.			
<p style="text-align: center;">Insert image here</p>		<p style="text-align: center;">Insert image here</p>			
GPS Location		GPS Location			
Field Station#		Field Station#			
Pic 11 Desc.		Pic 12 Desc.

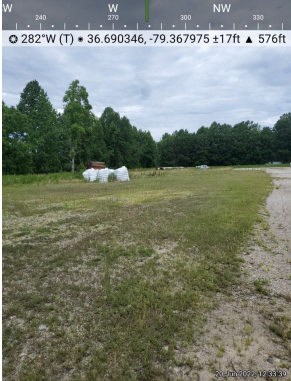
GPS Location	0	GPS Location	0		
Field Station#	0+00	Field Station#	0+00		
Pic 7 Desc.	LY-048 Temporary vegetation	Pic 8 Desc.	LY-048 West perimeter CFS		
Insert image here		Insert image here			
GPS Location		GPS Location			
Field Station#		Field Station#			
Pic 9 Desc.		Pic 10 Desc.			
Insert image here		Insert image here			
GPS Location		GPS Location			
Field Station#		Field Station#			
Pic 11 Desc.		Pic 12 Desc.

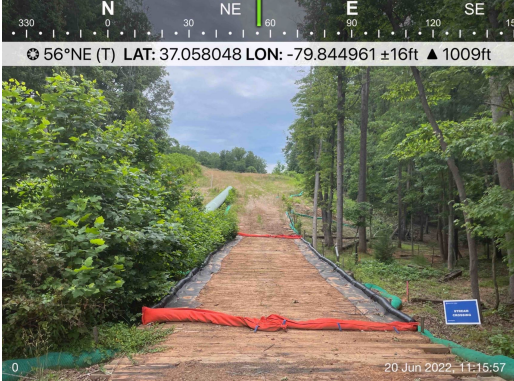
GPS Location	See photo		GPS Location	See photo	
Field Station#	14176+09		Field Station#	14180+00	
Pic 1 Desc.	Equipment bridge ECDs are in good condition and functioning		Pic 2 Desc.	CWDs are functioning as intended

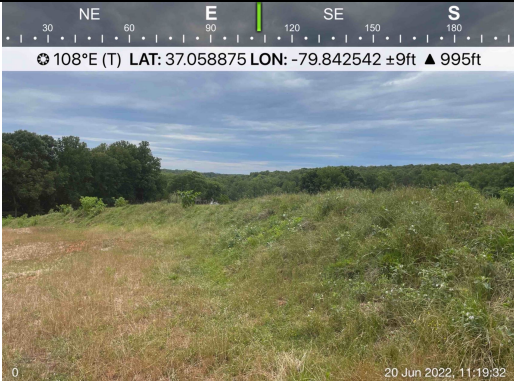
GPS Location	See photo		GPS Location	See photo	
Field Station#	14183+00		Field Station#	14209+00	
Pic 3 Desc.	Topsoil berms remain stabilized		Pic 4 Desc.	P1 has been damaged and needs to be replaced

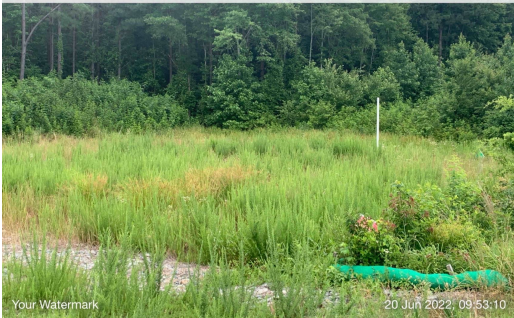
<small>Your Watermark 20 Jun 2022, 09:53:50</small>		
GPS Location	O		GPS Location	O	
Field Station#	14+00		Field Station#	22+00	
Pic 1 Desc.	Observing temporary stabilization,RCE, signage, buffer and ECD's		Pic 2 Desc.	Observing temporary stabilization and buffer	
South West Elevation 50°NE (T) 36°50'5"N, 79°20'23"W ±387ft ▲ 631ft

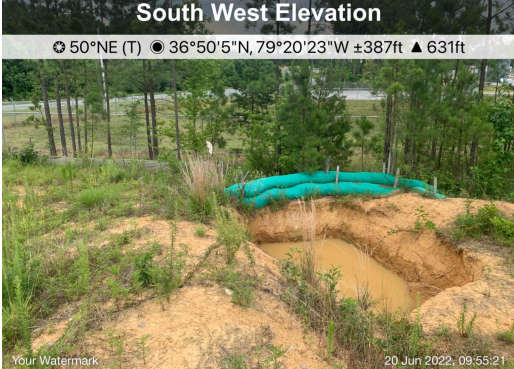
<small>Your Watermark 20 Jun 2022, 09:55:28</small>		
GPS Location	O		GPS Location	O	
Field Station#	12+00		Field Station#	6+00	
Pic 3 Desc.	Observing temporary stabilization, sump, end treatment and ECD's		Pic 4 Desc.	Observing temporary stabilization and water bar

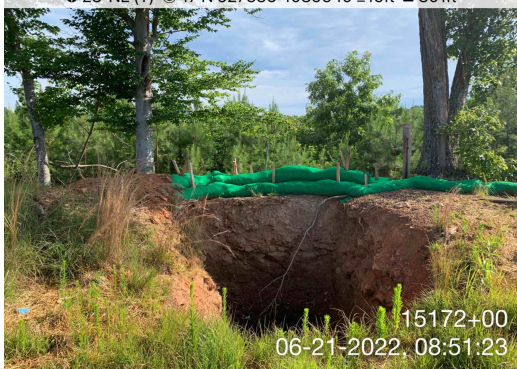
GPS Location	0	GPS Location	0		
Field Station#	15172+00	Field Station#	15235+00		
Pic 9 Desc.	Waterbar end treatment in acceptable condition		Pic 10 Desc.	Permanent vegetative stabilization in acceptable condition	
Insert image here			Insert image here		
GPS Location		GPS Location			
Field Station#		Field Station#			
Pic 11 Desc.			Pic 12 Desc.

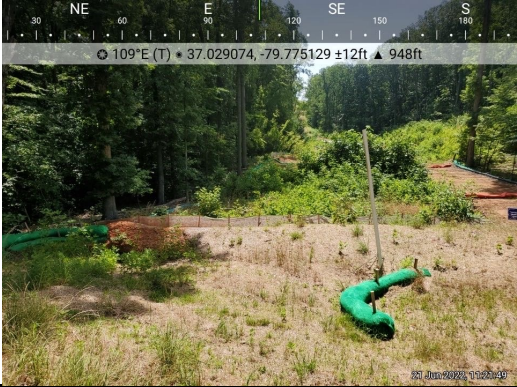
GPS Location	0	GPS Location	0		
Field Station#	14436+00	Field Station#	14441+00		
Pic 13 Desc.	CIS W-GH16 ECDs	Pic 14 Desc.	GAS W-GH16 Vegetation

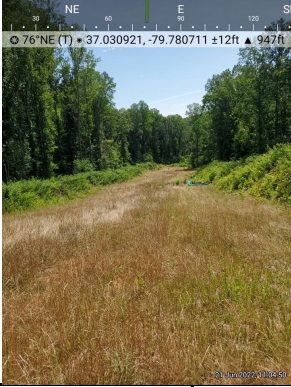
GPS Location	0	GPS Location			
Field Station#	14415+00	Field Station#			
Pic 15 Desc.	Temporary vegetation	Pic 16 Desc.

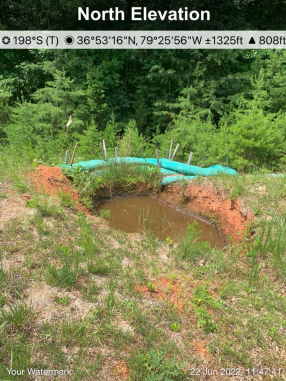
<p>West Elevation <small>103°E (T) 36°53'16"N, 79°25'56"W ±98ft ▲ 792ft</small></p>			
GPS Location	O	GPS Location	O		
Field Station#	15650+00	Field Station#	15654+00		
Pic 1 Desc.	Observing temporary stabilization,water bar, sump and end treatment	Pic 2 Desc.	Observing temporary stabilization

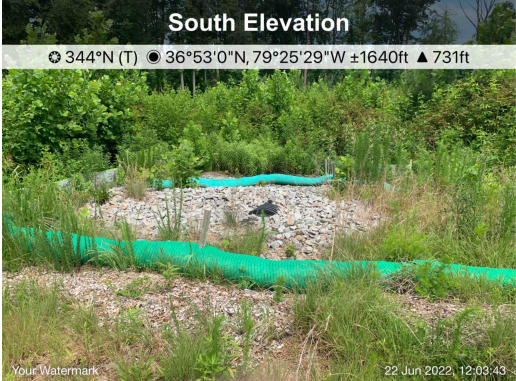
<p>North West Elevation <small>130°SE (T) 36°53'0"N, 79°25'29"W ±45ft ▲ 730ft</small></p>			
GPS Location	O	GPS Location	O		
Field Station#	15679+00	Field Station#	15682+00		
Pic 3 Desc.	Observing temporary stabilization,CWD outlet and ECD's	Pic 4 Desc.	Observing temporary stabilization,CWD berm and water bars

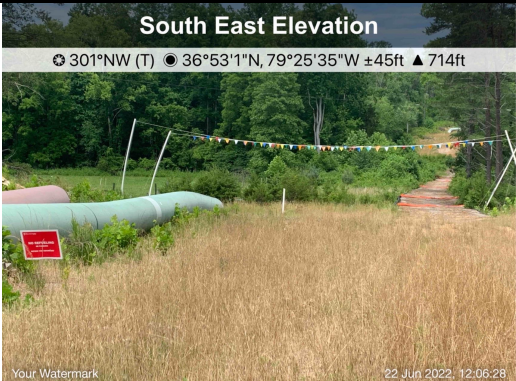
GPS Location	O	GPS Location	O		
Field Station#	15671+93	Field Station#	15647+03		
Pic 5 Desc.	Observing temporary stabilization,signage, buffer, equipment crossing and ECD's	Pic 6 Desc.	Observing road crossing and RCE's

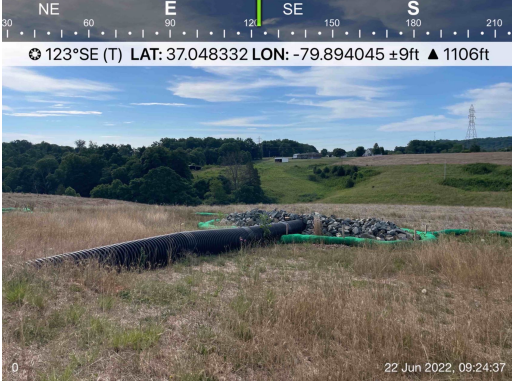
GPS Location	See photo	GPS Location	See photo		
Field Station#	13960+00	Field Station#	13970+00		
Pic 1 Desc.	CWDs are functioning as intended	Pic 2 Desc.	This section remains temporarily stabilized

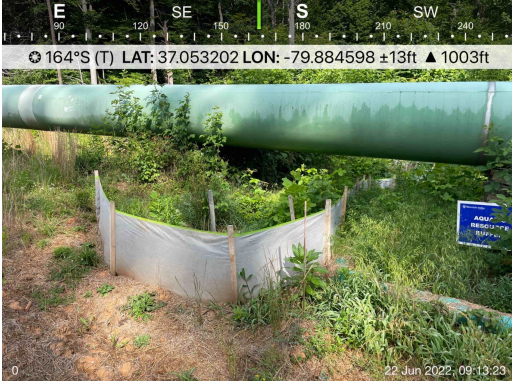
GPS Location	See photo	GPS Location	See photo		
Field Station#	13998+00	Field Station#	13998+15		
Pic 3 Desc.	P1 is in good condition at all stream and wetland buffers.	Pic 4 Desc.	Equipment bridge ECDs are in good condition and functioning

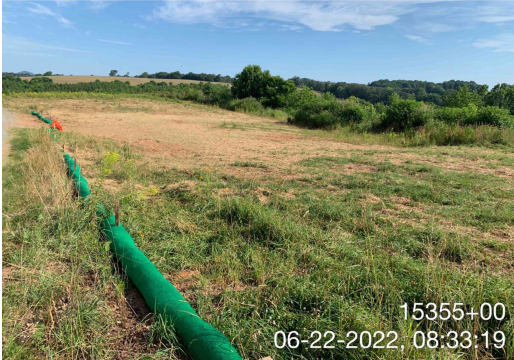
15355+00 06-22-2022, 08:33:19			217°SW (T) 17 N 631807 4087815 ±78ft ▲ 777ft

15335+00 06-22-2022, 09:16:41		
GPS Location	0		GPS Location	0	
Field Station#	15355+00		Field Station#	15335+00	
Pic 1 Desc.	Perimeter CFS and temporary vegetative stabilization in acceptable conditions		Pic 2 Desc.	Sump pit in acceptable condition	
66°NE (T) 17 N 631800 4087817 ±36ft ▲ 772ft

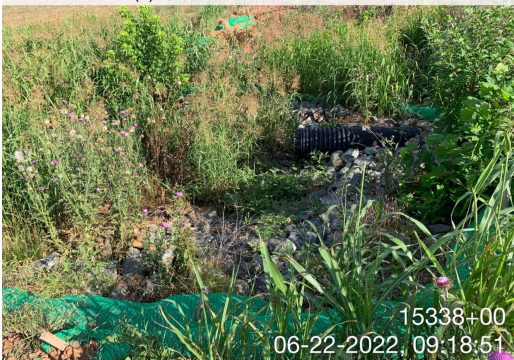
15338+00 06-22-2022, 09:18:51			347°N (T) 17 N 631376 4088072 ±150ft ▲ 724ft

15318+00 06-22-2022, 09:32:37		
GPS Location	0		GPS Location	0	
Field Station#	15338+00		Field Station#	15318+00	
Pic 3 Desc.	Clean water diversion pipe and plunge pool in acceptable conditions		Pic 4 Desc.	Waterbar in acceptable condition	
350°N (T) 17 N 631363 4088084 ±32ft ▲ 720ft

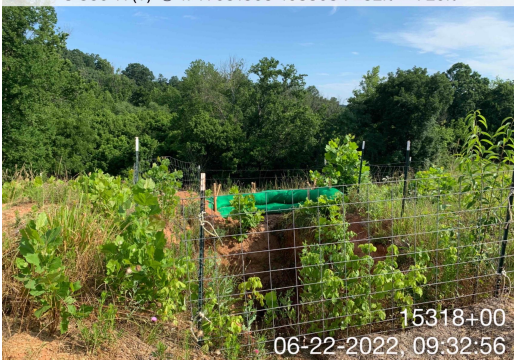
15318+00 06-22-2022, 09:32:56			250°W (T) 17 N 631278 4088089 ±62ft ▲ 660ft

GPS Location	0		GPS Location	0	
Field Station#	15318+00		Field Station#	15314+00	
Pic 5 Desc.	Waterbar end treatment in acceptable condition		Pic 6 Desc.	Equipment bridge in acceptable condition

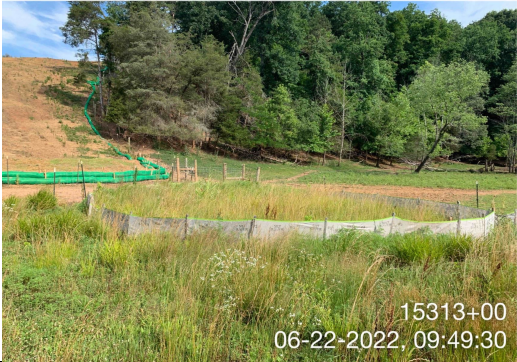
<p>15313+00 06-22-2022, 09:49:30</p>

<p>15305+00 06-22-2022, 10:21:38</p>			
GPS Location	0	GPS Location	0		
Field Station#	15313+00	Field Station#	15305+00		
Pic 7 Desc.	P1 silt fence in acceptable condition	Pic 8 Desc.	Temporary vegetative stabilization in acceptable condition		
Insert image here		Insert image here			
GPS Location		GPS Location			
Field Station#		Field Station#			
Pic 9 Desc.		Pic 10 Desc.			
Insert image here		Insert image here			
GPS Location		GPS Location			
Field Station#		Field Station#			
Pic 11 Desc.		Pic 12 Desc.

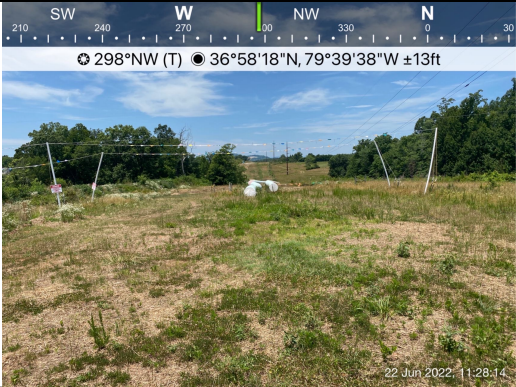
GPS Location	0	GPS Location	0		
Field Station#	14840+00	Field Station#	14805+00		
Pic 5 Desc.	Approximately 14840+00. Overview of ROW.	Pic 6 Desc.	Approximately 14805+00. Overview of ROW.

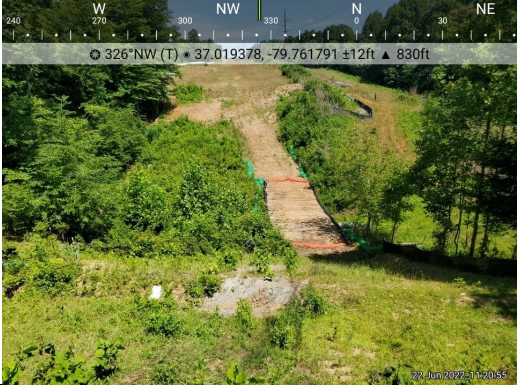
GPS Location	0	GPS Location	0		
Field Station#	14488+00	Field Station#	14488+00		
Pic 7 Desc.	GAS S-G22	Pic 8 Desc.	Dry drainage ECDs

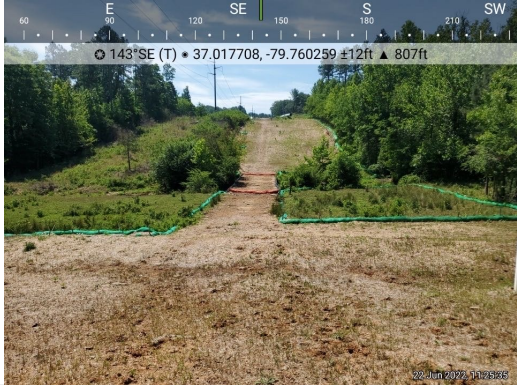
GPS Location	0	GPS Location	0		
Field Station#	14495+00	Field Station#	14506+00		
Pic 9 Desc.	CIS S-G20 ECDs	Pic 10 Desc.	Sideslope stabilization

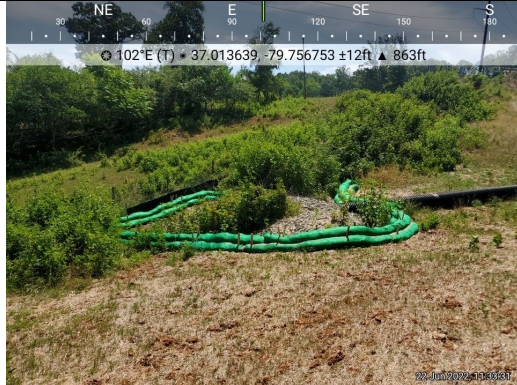
GPS Location	0	GPS Location	0		
Field Station#	14514+00	Field Station#	14525+00		
Pic 11 Desc.	Cleanwater diversion outlet	Pic 12 Desc.	GAS Timber Ridge Rd Vegetation

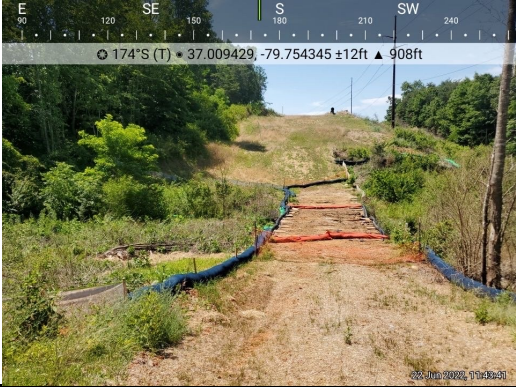
GPS Location	0	GPS Location	0		
Field Station#	14530+00	Field Station#	14537+00		
Pic 13 Desc.	S-G18 ECDS	Pic 14 Desc.	Temporary stabilization

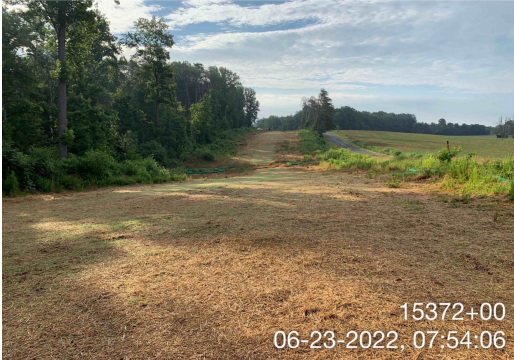
GPS Location	0		GPS Location	0	
Field Station#	15372+00		Field Station#	15480+00	
Pic 1 Desc.	Temporary vegetative stabilization in acceptable condition		Pic 2 Desc.	Sump pit in acceptable condition

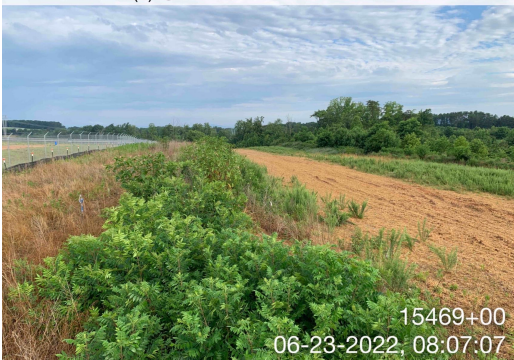
GPS Location	0		GPS Location	0	
Field Station#	15469+00		Field Station#	15461+00	
Pic 3 Desc.	Clean water diversion berm in acceptable condition		Pic 4 Desc.	Waterbar in acceptable condition

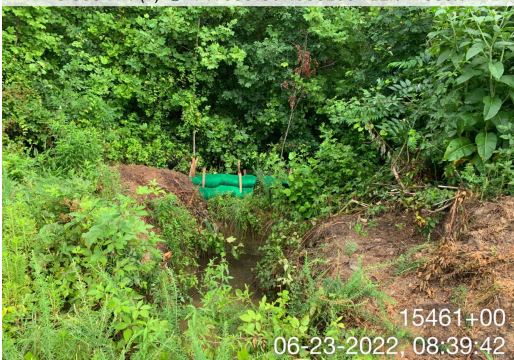
GPS Location	0		GPS Location	0	
Field Station#	15461+00		Field Station#	15460+00	
Pic 5 Desc.	Waterbar end treatment in acceptable condition		Pic 6 Desc.	Super silt fence in acceptable condition

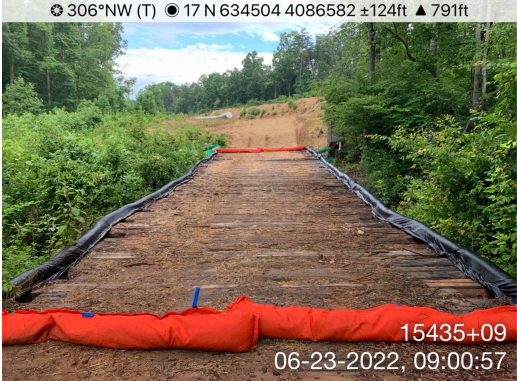
<p>306°NW (T) 17 N 634504 4086582 ±124ft ▲ 791ft 15435+09 06-23-2022, 09:00:57</p>

<p>49°NE (T) 17 N 634213 4086681 ±19ft ▲ 797ft 15425+00 06-23-2022, 09:09:23</p>			
GPS Location	0	GPS Location	0		
Field Station#	15435+09	Field Station#	15425+00		
Pic 7 Desc.	Equipment bridge in acceptable condition	Pic 8 Desc.	Waterbar in acceptable condition

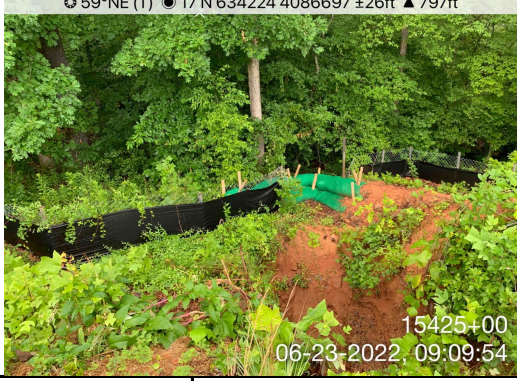
<p>59°NE (T) 17 N 634224 4086697 ±26ft ▲ 797ft 15425+00 06-23-2022, 09:09:54</p>

<p>327°NW (T) 17 N 635595 4089712 ±14173ft ▲ 808ft 15421+00 06-23-2022, 09:23:05</p>			
GPS Location	0	GPS Location	0		
Field Station#	15425+00	Field Station#	15421+00		
Pic 9 Desc.	Waterbar end treatment in acceptable condition	Pic 10 Desc.	Perimeter CFS in acceptable condition

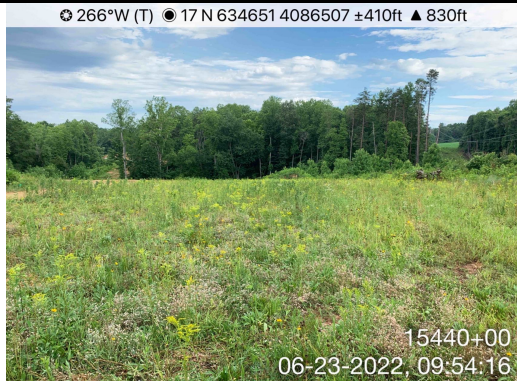
<p>266°W (T) 17 N 634651 4086507 ±410ft ▲ 830ft 15440+00 06-23-2022, 09:54:16</p>		<p style="text-align: center;">Insert image here</p>

GPS Location	0	GPS Location			
Field Station#	15440+00	Field Station#			
Pic 11 Desc.	Permanent vegetative stabilization in acceptable condition	Pic 12 Desc.

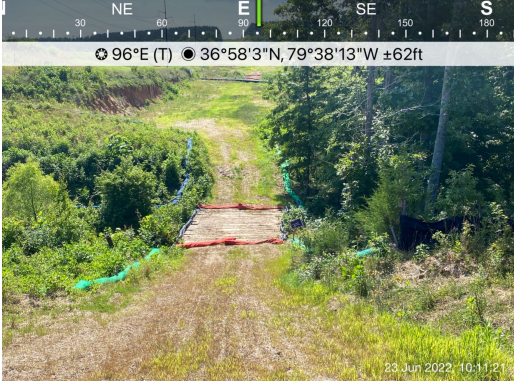
GPS Location	0	GPS Location	0		
Field Station#	14932+89	Field Station#	14950+47		
Pic 1 Desc.	Approximately 14932+89. Overview of stream crossing, equipment bridge and ECDs at stream S-G15.		Pic 2 Desc.	Approximately 14950+47. Overview of stream crossing, equipment bridge and ECDs at stream S-G13.

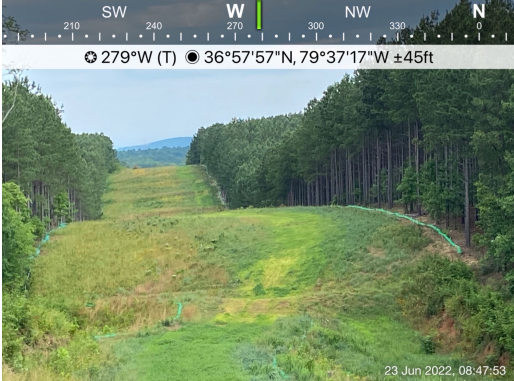
GPS Location	0	GPS Location	0		
Field Station#	14973+00	Field Station#	14981+50		
Pic 3 Desc.	Approximately 14973+00. Overview of ROW. Permanent vegetation.		Pic 4 Desc.	Approximately 14981+50. Overview of road crossing, RCEs and ROW.

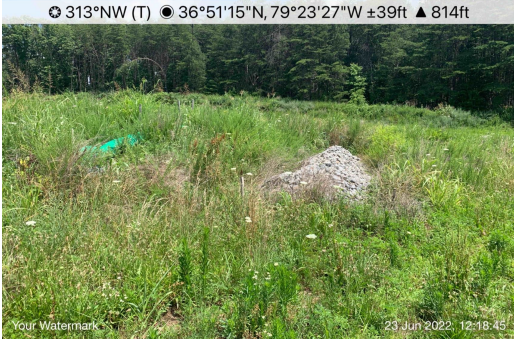
GPS Location	O	GPS Location	O		
Field Station#	15835+00	Field Station#	15836+00		
Pic 1 Desc.	Observing temporary stabilization,CWD outlet and ECD's	Pic 2 Desc.	Observing temporary stabilization,rock lined channel and ECD's		
North East Elevation 224°SW (T) 36°51'14"N, 79°23'26"W ±295ft ▲ 813ft

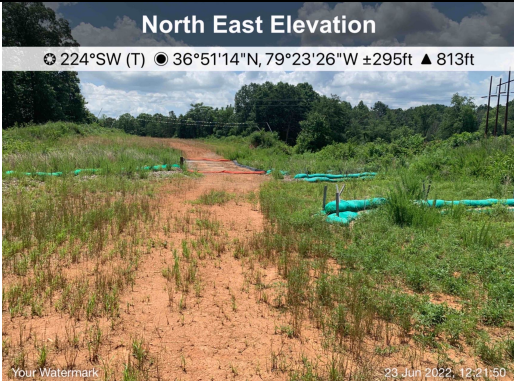
GPS Location	O	GPS Location	O		
Field Station#	15839+00	Field Station#	15826+77		
Pic 3 Desc.	Observing temporary stabilization,equipment crossing and ECD's	Pic 4 Desc.	Observing road crossing and RCE's		
South East Elevation 329°NW (T) 36°51'23"N, 79°23'32"W ±13ft ▲ 831ft

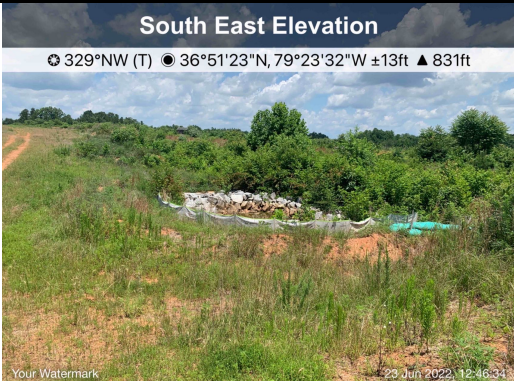
GPS Location	O	GPS Location	O		
Field Station#	15825+00	Field Station#	15825+50		
Pic 5 Desc.	Observing temporary stabilization,plunge pool and ECD's	Pic 6 Desc.	Observing temporary stabilization,seep and end treatment

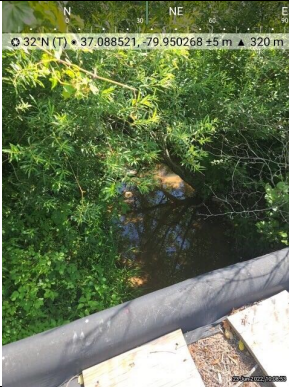
GPS Location	00000	GPS Location	00000		
Field Station#	13678+71	Field Station#	13687+70		
Pic 1 Desc.	Stream observation photo facing upstream during routine inspection. No issues were observed at the time of inspection.		Pic 2 Desc.	P1 requires maintenance due to wildlife damages, documented and added to the punch list.

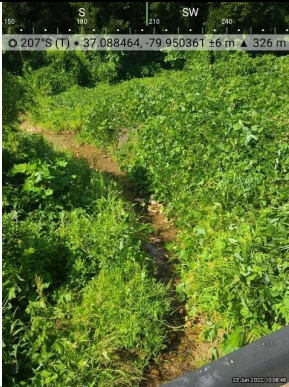
GPS Location	00000	GPS Location	00000		
Field Station#	13678+71	Field Station#	13748+10		
Pic 3 Desc.	Stream observation photo facing downstream during routine inspection today. Good vegetation on stream banks.		Pic 4 Desc.	Observed ECDs at road crossings to insure they were functioning properly. No issues observed at the time of inspection.

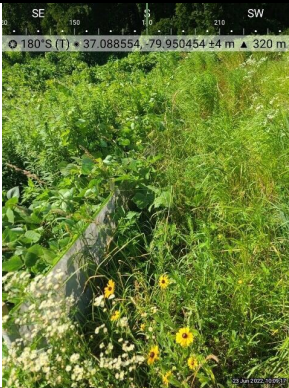
GPS Location	00000	GPS Location	00000		
Field Station#	13678+46	Field Station#	13687+70		
Pic 5 Desc.	Monitored ECDs throughout the row, no environmental issues observed at the time of inspection.		Pic 6 Desc.	Additional photo showing P1 that requires maintenance due to wildlife damages.

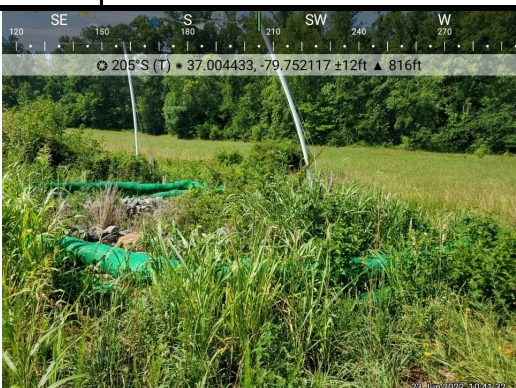
GPS Location	0		GPS Location	0	
Field Station#	14552+00		Field Station#	14567+00	
Pic 3 Desc.	Cleanwater diversion outlet		Pic 4 Desc.	CIS S-E18 Perimeter ECDs

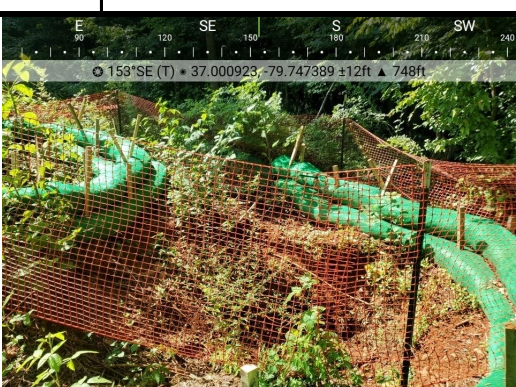
GPS Location	0		GPS Location	0	
Field Station#	14569+00		Field Station#	14583+00	
Pic 5 Desc.	Sumps and J-Hooks		Pic 6 Desc.	GAS S-E17 Vegetation

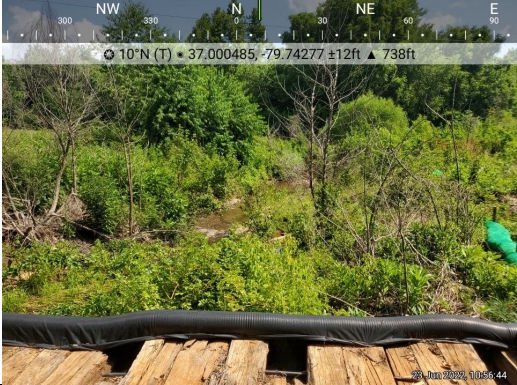
GPS Location	0	GPS Location	0		
Field Station#	14582+85	Field Station#	14583+50		
Pic 7 Desc.	S-E17 Buffer zone	Pic 8 Desc.	GAS S-E17 Perimeter ECDs

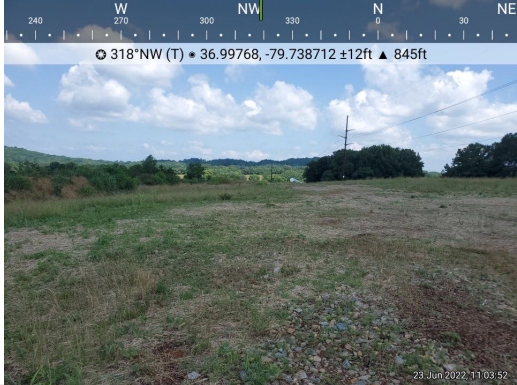
GPS Location	0	GPS Location	0		
Field Station#	14598+00	Field Station#	14601+00		
Pic 9 Desc.	CIS Simmons Creek Rd Temporary stabilization	Pic 10 Desc.	GAS Simmons Creek Rd Temporary stabilization

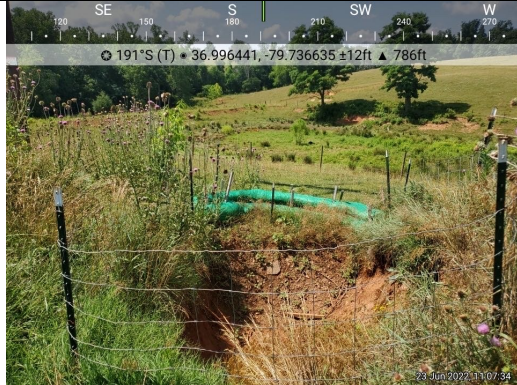
GPS Location	0	GPS Location	0		
Field Station#	14605+00	Field Station#	14607+00		
Pic 11 Desc.	Sump	Pic 12 Desc.	Cleanwater diversion plunge pool

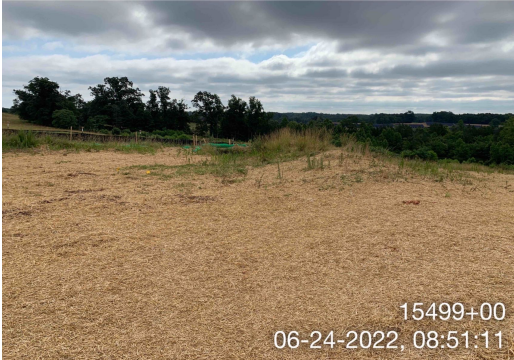
GPS Location	0	GPS Location	0		
Field Station#	15499+00	Field Station#	15499+00		
Pic 1 Desc.	Waterbar in acceptable condition	Pic 2 Desc.	Waterbar end treatment in acceptable condition

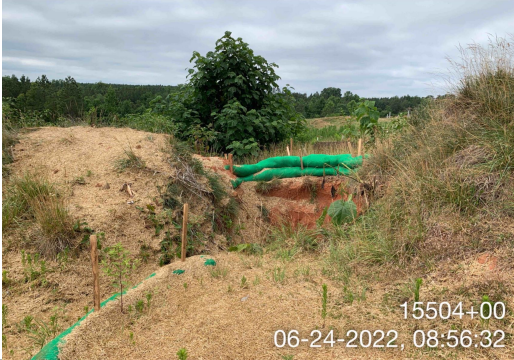
GPS Location	0	GPS Location	0		
Field Station#	15504+00	Field Station#	15520+00		
Pic 3 Desc.	Sump pit in acceptable condition	Pic 4 Desc.	P1 silt fence and sensitive resource buffer in acceptable conditions

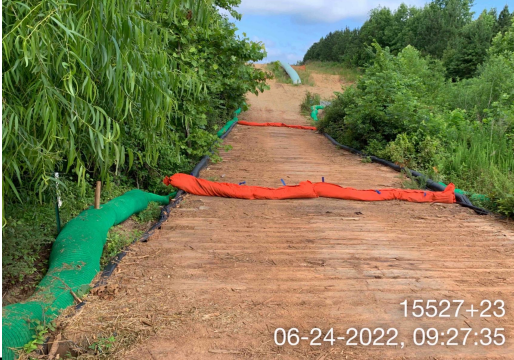
GPS Location	0	GPS Location	0		
Field Station#	15527+23	Field Station#	15528+00		
Pic 5 Desc.	Equipment bridge and CFS in acceptable conditions	Pic 6 Desc.	Sump pit in acceptable condition

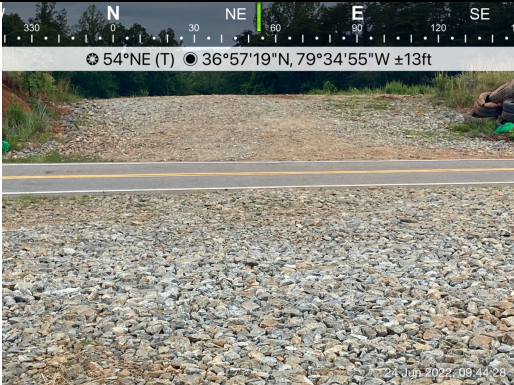
GPS Location	0	GPS Location	0		
Field Station#	15113+50	Field Station#	15084+00		
Pic 3 Desc.	Approximately 15113+50. Overview of road crossing and RCEs.	Pic 4 Desc.	Approximately 15084+00. Overview of ROW.

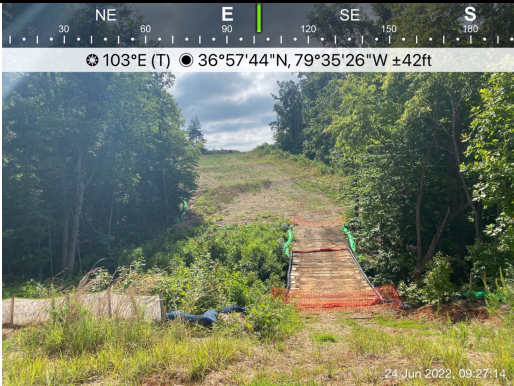
GPS Location	0	GPS Location	0		
Field Station#	15072+86	Field Station#	15066+00		
Pic 5 Desc.	Approximately 15072+86. Overview of stream crossing, equipment bridge and ECDs at stream S-G11.	Pic 6 Desc.	Approximately 15066+00. Overview of ROW.

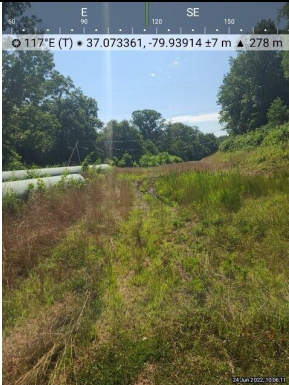
GPS Location	0000	GPS Location	0000		
Field Station#	13759+00	Field Station#	13847+60		
Pic 3 Desc.	Row photo showing vegetation in temporary area of row. Good stabilization noted.		Pic 4 Desc.	Monitored reinforced silt fence and CFS near stream crossing, no environmental issues observed at the time of inspection.

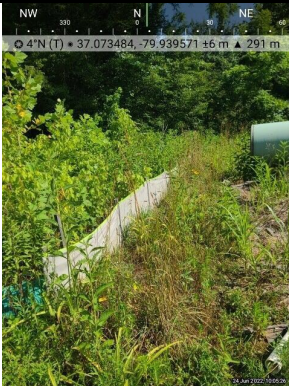
GPS Location	0000	GPS Location	0000		
Field Station#	13756+10	Field Station#	13846+93		
Pic 5 Desc.	Monitored ECDs throughout row inspection today. All in place and functioning at the time of inspection.		Pic 6 Desc.	Stream observation photo facing downstream, good stabilization observed on stream banks.

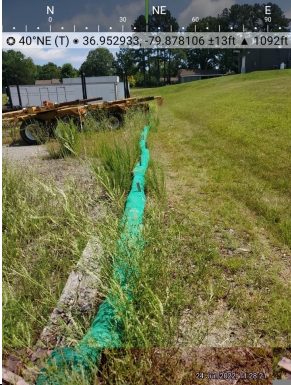
GPS Location	0	GPS Location	0		
Field Station#	0+00	Field Station#	0+00		
Pic 7 Desc.	ANC-006 Perimeter CFS	Pic 8 Desc.	LY-048 North perimeter CFS		
Insert image here		Insert image here			
GPS Location		GPS Location			
Field Station#		Field Station#			
Pic 9 Desc.		Pic 10 Desc.			
Insert image here		Insert image here			
GPS Location		GPS Location			
Field Station#		Field Station#			
Pic 11 Desc.		Pic 12 Desc.

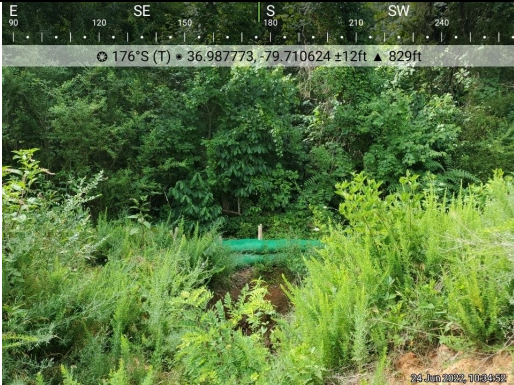
GPS Location	0	GPS Location	0		
Field Station#	14687+00	Field Station#	14682+00		
Pic 5 Desc.	Perimeter SSF	Pic 6 Desc.	GAS S-H36 SSF and CFS

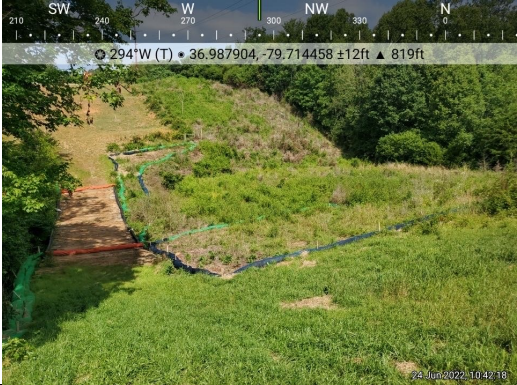
GPS Location	0	GPS Location	0		
Field Station#	14682+00	Field Station#	14679+00		
Pic 7 Desc.	GAS S-H36 Buffer zone	Pic 8 Desc.	CIS S-H36 Sump and ECDs

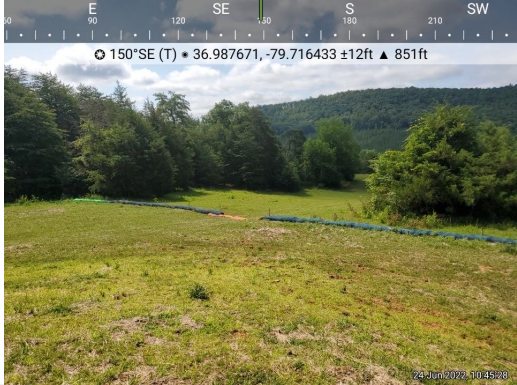
GPS Location	0	GPS Location	0		
Field Station#	14676+00	Field Station#	14675+00		
Pic 9 Desc.	ATWS Perimeter CFS	Pic 10 Desc.	Vegetation in active pasture

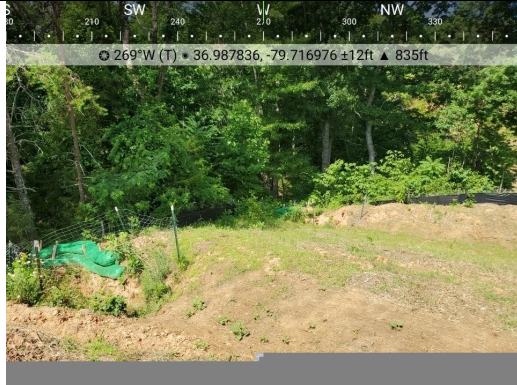
GPS Location	0	GPS Location	0		
Field Station#	14675+00	Field Station#	14672+00		
Pic 11 Desc.	GAS S-H37 Sumps and ECDs	Pic 12 Desc.	Perimeter SSF and CFS

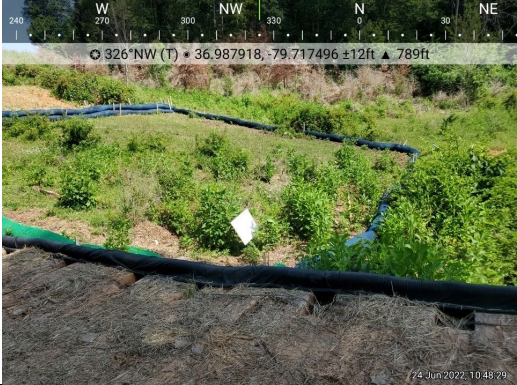
GPS Location	0	GPS Location			
Field Station#	14673+00	Field Station#			
Pic 13 Desc.	CIS S-H37 Buffer zone ECDs	Pic 14 Desc.			
Insert image here		Insert image here			
GPS Location		GPS Location			
Field Station#		Field Station#			
Pic 15 Desc.		Pic 16 Desc.			
Insert image here		Insert image here			
GPS Location		GPS Location			
Field Station#		Field Station#			
Pic 17 Desc.		Pic 18 Desc.

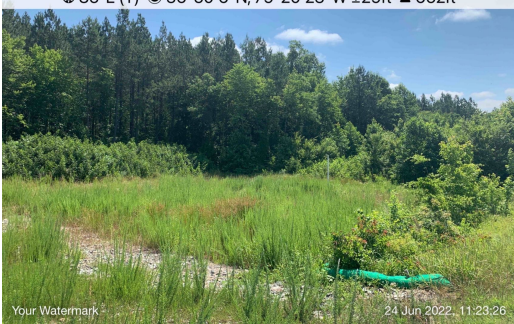
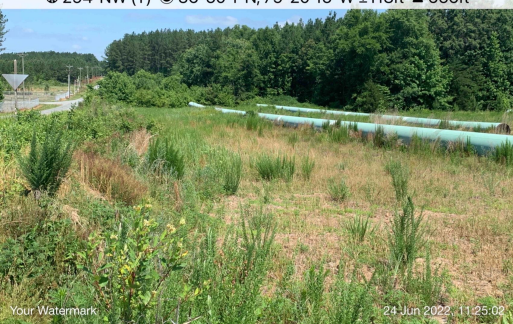
<small>Your Watermark 24 Jun 2022, 11:25:02</small>		
GPS Location	O		GPS Location	O	
Field Station#	14+00		Field Station#	22+00	
Pic 1 Desc.	Observing temporary stabilization,RCE,buffer and ECD's		Pic 2 Desc.	Observing temporary stabilization and buffer	
West Elevation 112°E (T) 36°50'7"N, 79°20'36"W ±176ft ▲ 646ft

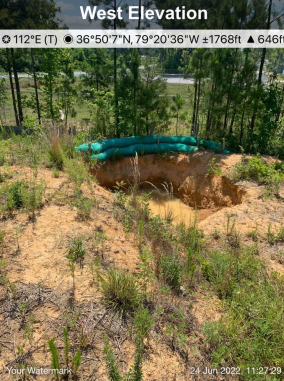
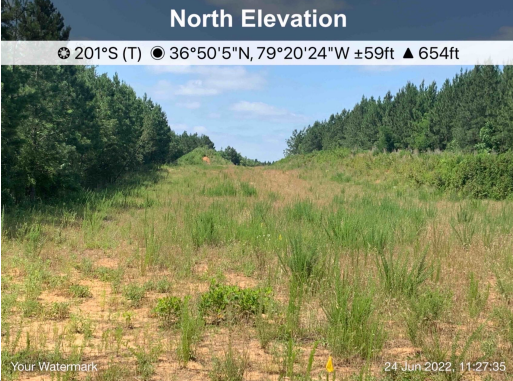
<small>Your Watermark 24 Jun 2022, 11:27:35</small>		
GPS Location	O		GPS Location	O	
Field Station#	12+00		Field Station#	6+00	
Pic 3 Desc.	Observing temporary stabilization,water bar, sump and end treatment		Pic 4 Desc.	Observing temporary stabilization and water bar

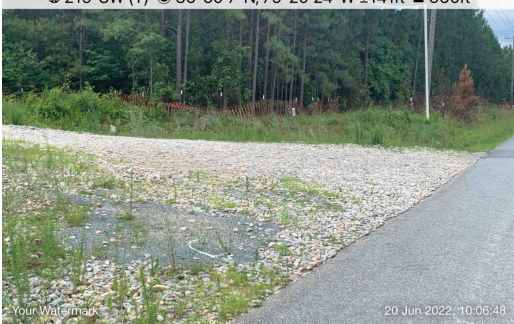
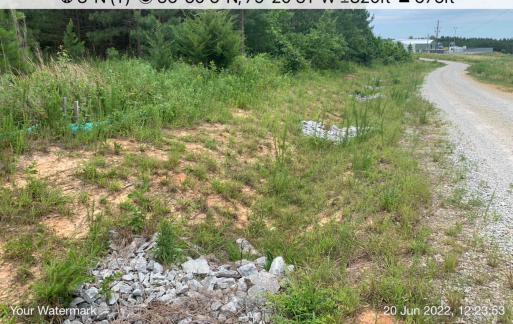
GPS Location	O		GPS Location	O	
Field Station#	00+00		Field Station#	00+00	
Pic 1 Desc.	Observing RCE		Pic 2 Desc.	Observing temporary stabilization and rock check dams	
South West Elevation 67°NE (T) 36°50'3"N, 79°20'30"W ±2283ft ▲669ft

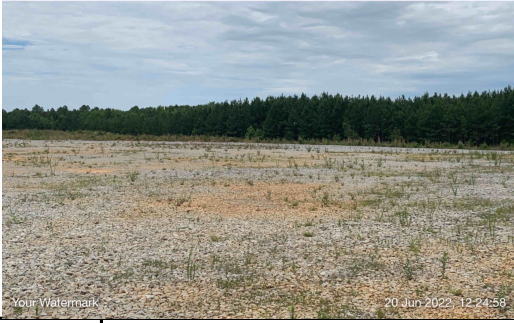
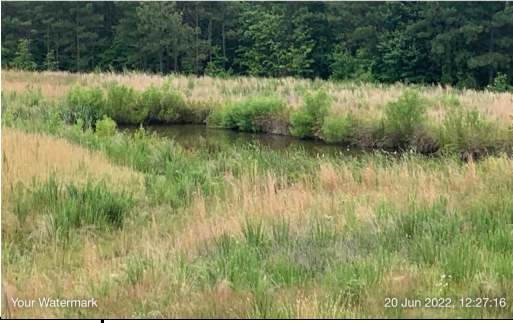
GPS Location	O		GPS Location	O	
Field Station#	00+00		Field Station#	00+00	
Pic 3 Desc.	Observing lay down yard		Pic 4 Desc.	Observing temporary stabilization and sediment basin	
South Elevation 9°N (T) 36°50'0"N, 79°20'36"W ±5223ft ▲667ft

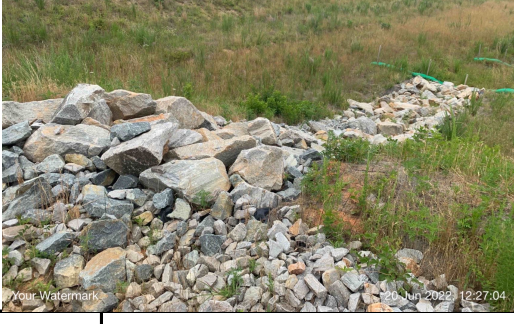
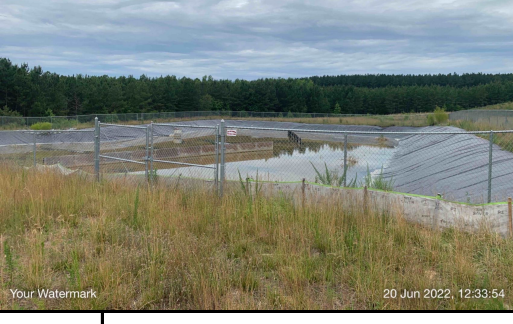
Pic 5 Desc.	Observing temporary stabilization, rock drain and ECD's		Pic 6 Desc.	Observing temporary stabilization, storm water pond and ECD's

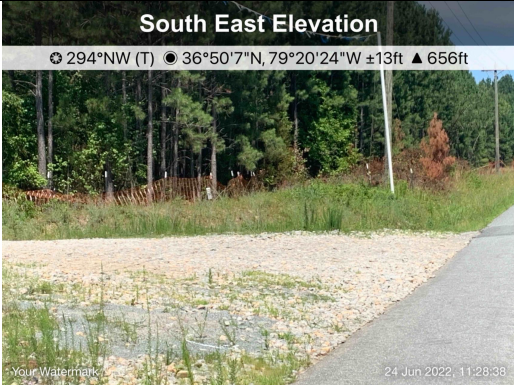
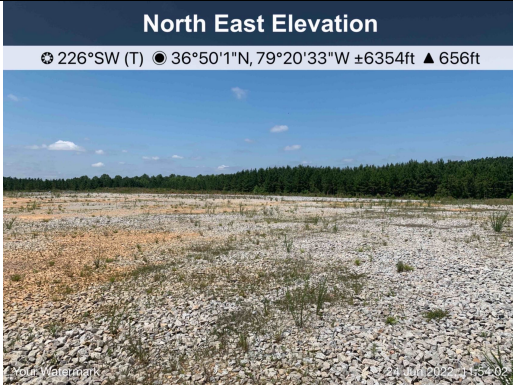
GPS Location	O		GPS Location	O	
Field Station#	00+00		Field Station#	00+00	
Pic 1 Desc.	Observing RCE		Pic 2 Desc.	Observing lay down yard	
North Elevation 171°S (T) 36°49'57"N, 79°20'36"W ±13ft ▲ 652ft

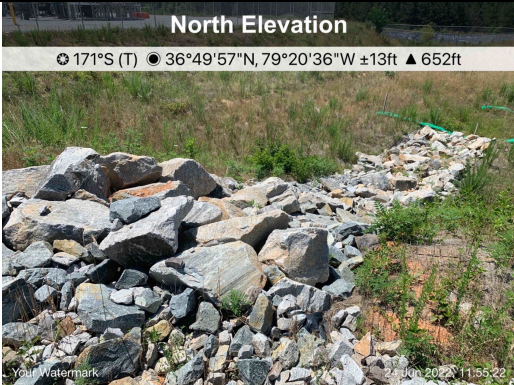
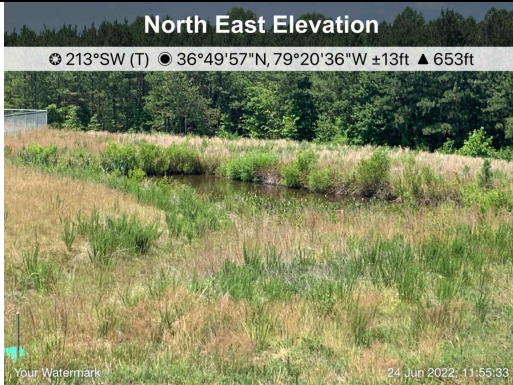
GPS Location	O		GPS Location	O	
Field Station#	00+00		Field Station#	00+00	
Pic 3 Desc.	Observing rock lined channel, temporary stabilization and CFS checks		Pic 4 Desc.	Observing temporary stabilization and sediment basin	
North West Elevation 151°SE (T) 36°49'59"N, 79°20'32"W ±262ft ▲ 668ft

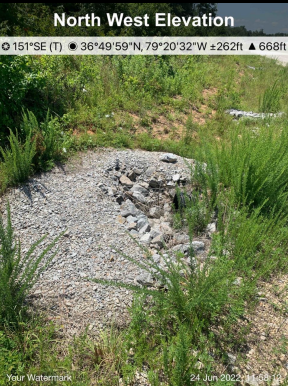
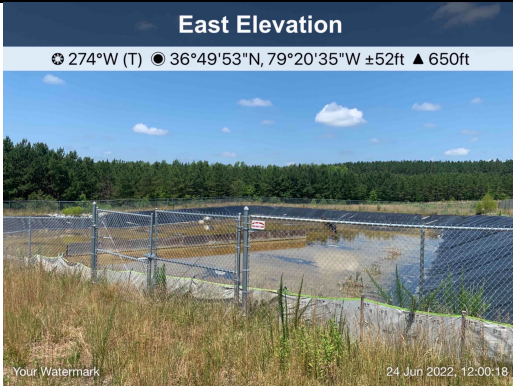
Field Station#	00+00		Field Station#	00+00	
Pic 5 Desc.	Observing temporary stabilization, outlet and outlet protection		Pic 6 Desc.	Observing temporary stabilization, storm water pond and ECD's
