Visual Site Inspection Report

| Project Name | H-600 Pipeline Spread I | AFE | 124300139 | Spread | H-600 Pipeline Spread I |
| Permit # | TBD | Inspection Type | VA SWPP | Station Begin | 15584+23 |

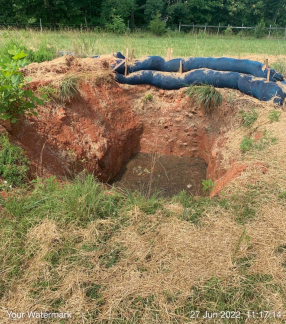
| Field Station# | 15646+00 | Field Station# | 15636+45 | | |

| Pic 1 Desc. | Observing temporary stabilization, sump and end treatment | Pic 2 Desc. | Observing temporary stabilization, signage, buffer, equipment crossing and ECD's | | |

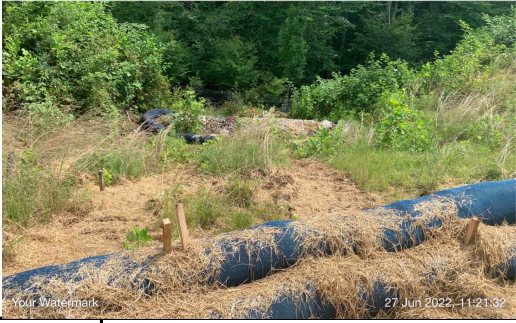
| Field Station# | 15632+00 | Field Station# | 15619+48 | | |

| Pic 3 Desc. | Observing temporary stabilization, CWD outlet and ECD's | Pic 4 Desc. | Observing road crossing and RCE's | | |

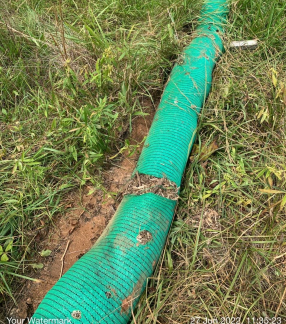
| Field Station# | 15606+50 | Field Station# | 15614+94 | | |

| Pic 5 Desc. | Observing temporary stabilization and CFS that requires maintenance (damaged by land owner) | Pic 6 Desc. | Observing temporary stabilization, signage, buffer, equipment crossing and ECD's | | |

| 3rd Party Damages | Communication | Perform maintenance, Land owner r | | | |

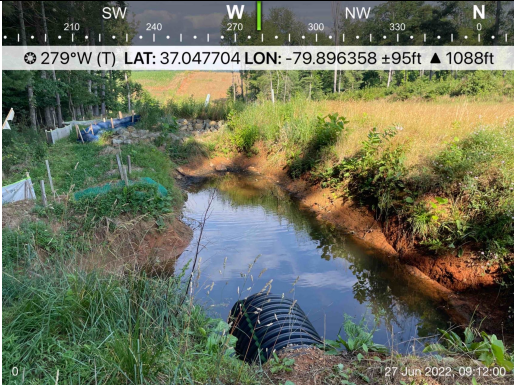
| Field Station# | 13955+00 | | Field Station# | 13948+00 | |

| Pic 1 Desc. | Slope drain outlet is in good condition and functioning | | Pic 2 Desc. | SSF is in good condition | |

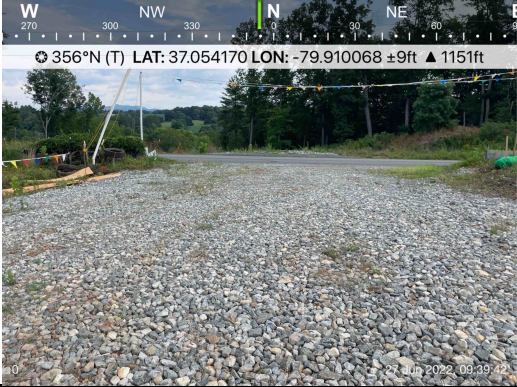
| Field Station# | 13892+45 | | Field Station# | 13891+00 | |

| Pic 7 Desc. | RCEs are in good condition at all road crossings | | Pic 8 Desc. | Waterbars are in good condition | |

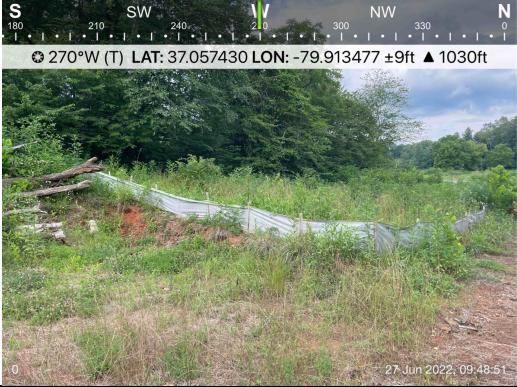
| Field Station# | 13889+00 | | Field Station# | 13875+16 | |

| Pic 9 Desc. | Slope drain is in good condition and functioning | | Pic 10 Desc. | P1 is in good condition at all stream and wetland buffers | |

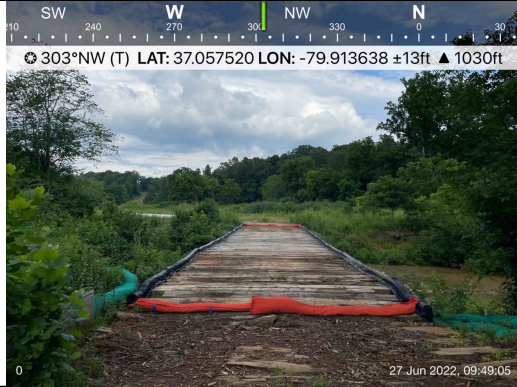
| Field Station# | 13875+16 | | Field Station# | 13863+01 | |

| Pic 11 Desc. | Equipment bridge ECDs are in good condition | | Pic 12 Desc. | Resource buffers remain well vegetated | |

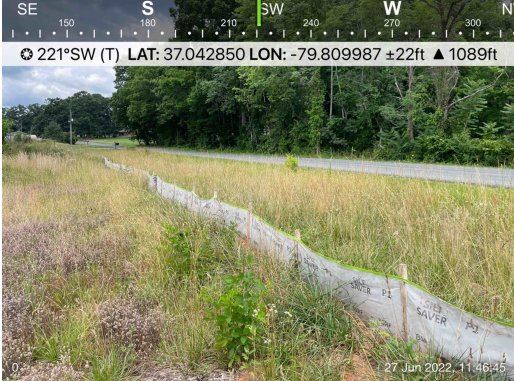
| Field Station# | 14312+00 | | Field Station# | 14335+00 | |

| Pic 1 Desc. | Perimeter P1 is in good condition | | Pic 2 Desc. | Waterbars are in good condition | |

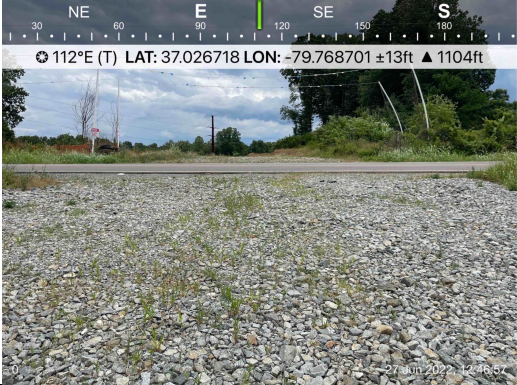
| Field Station# | 14454+22 | Field Station# | | | |

| Pic 13 Desc. | RCEs are in good condition at all road crossings | Pic 14 Desc. | | | |

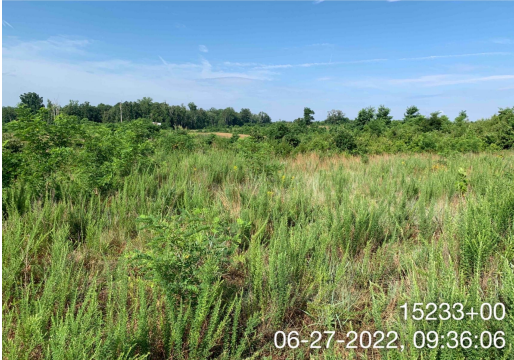
| Field Station# | 15233+00 | | Field Station# | 15233+00 | |

| Pic 1 Desc. | Waterbar and permanent vegetative stabilization in acceptable conditions | | Pic 2 Desc. | Waterbar end treatment in acceptable condition | |

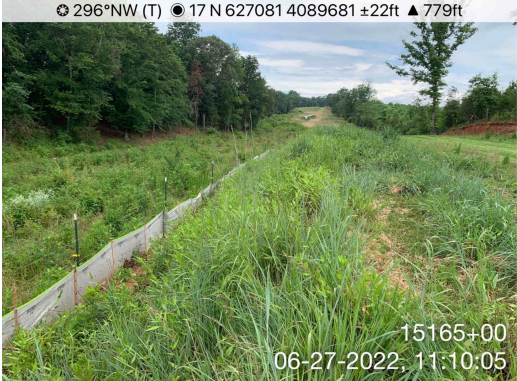
| Field Station# | 15165+00 | Field Station# | 15142+75 | | |

| Pic 7 Desc. | Temporary vegetative stabilization and P1 silt fence in acceptable conditions | | Pic 8 Desc. | Rock construction entrance in acceptable condition | |

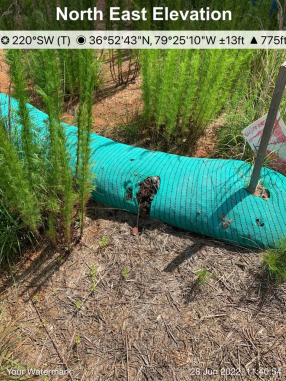
| Field Station# | 15716+00 | Field Station# | 15704+50 | | |

| Pic 1 Desc. | Observing CFS that requires maintenance | Pic 2 Desc. | Observing CFS that requires maintenance | | |

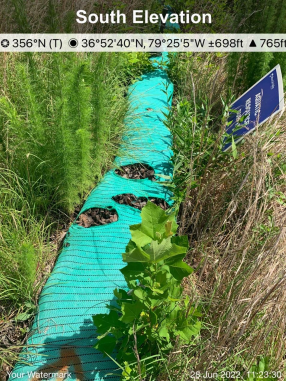
| Field Station# | 15707+50 | Field Station# | 15710+00 | | |

| Pic 3 Desc. | Observing temporary stabilization, signage and CFS that requires maintenance | Pic 4 Desc. | Observing CFS that requires maintenance | | |

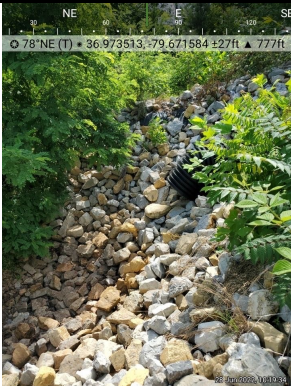
| Field Station# | 14827+00 | Field Station# | 14835+00 | | |

| Pic 3 Desc. | Sideslope perimeter ECDs | Pic 4 Desc. | GAS S-A13 Perimeter ECDs | | |

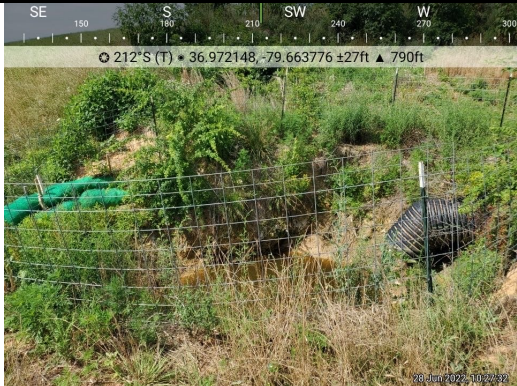
| Field Station# | 14852+00 | Field Station# | 14852+50 | | |

| Pic 7 Desc. | Sideslope stabilization | Pic 8 Desc. | Plunge pool | | |

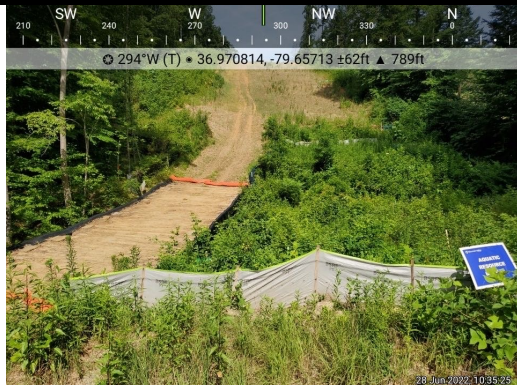
| Field Station# | 14872+00 | Field Station# | 14871+00 | | |

| Pic 9 Desc. | Waterbar relay sump | Pic 10 Desc. | CIS S-H17 | | |

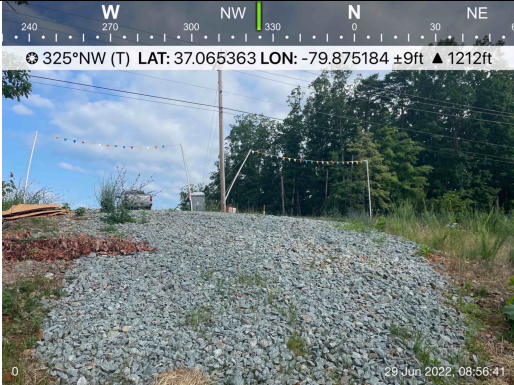
| Field Station# | 14062+17 | | Field Station# | 14066+77 | |

| Pic 1 Desc. | RCEs are in good condition at all road crossings | | Pic 2 Desc. | Equipment bridge ECDs are in good condition | |

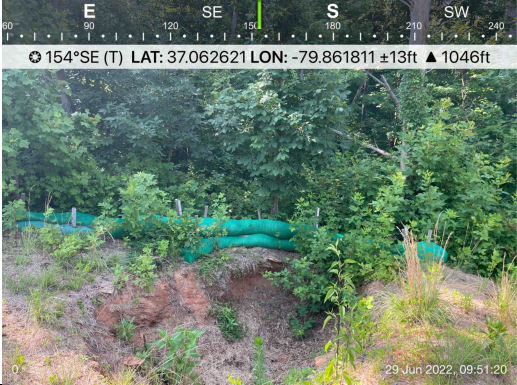
| Field Station# | 14110+00 | | Field Station# | 14118+00 | |

| Pic 7 Desc. | End treatments are in good condition | | Pic 8 Desc. | CFS is in good condition throughout this section | |

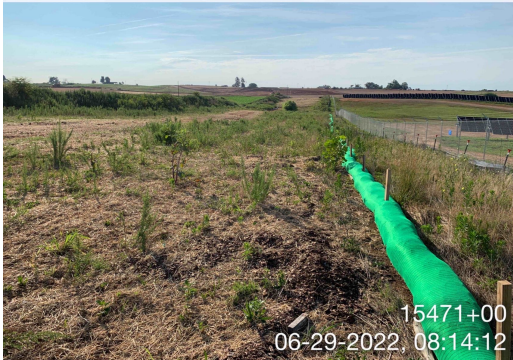
| Field Station# | | 15471+00 | | Field Station# | | 15459+00 | |

| Pic 1 Desc. | | Perimeter CFS in acceptable condition | | Pic 2 Desc. | | Waterbar in acceptable condition | |

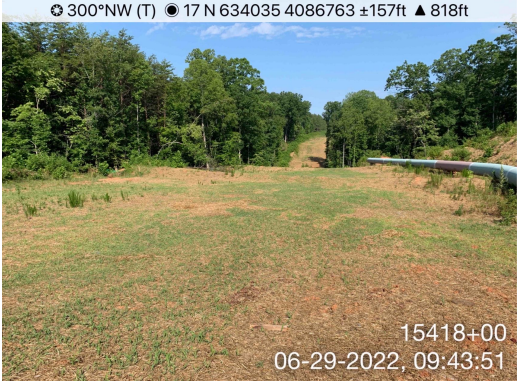
| Field Station# | 15418+00 | Field Station# | 15413+00 | | |

| Pic 7 Desc. | Temporary vegetative stabilization in acceptable condition | | Pic 8 Desc. | Super silt fence in acceptable condition | |

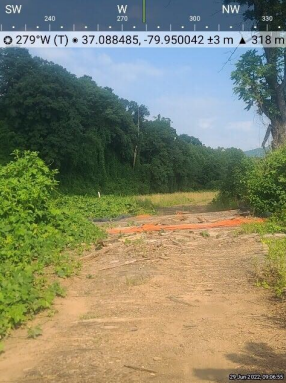
| Field Station# | 13678+71 | Field Station# | 13728+23 | | |

| Pic 1 Desc. | Monitored equipment bridge and protection. ECDs in place and functioning at the time of inspection. | | Pic 2 Desc. | Stream observation photo facing upstream during routine inspection. No issues were observed at the time of inspection. | |

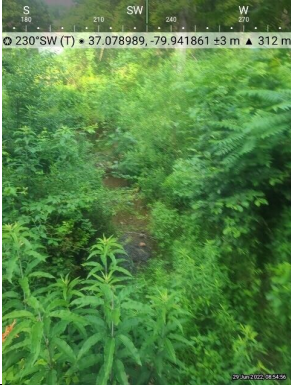
| Field Station# | 13728+23 | Field Station# | 13692+64 | | |

| Pic 7 Desc. | Stream observation photo facing downstream during routine inspection today. No issues were observed at the time of inspection. | | Pic 8 Desc. | Monitored stream crossing, good vegetation on banks. ECDs in place and functioning at the time of inspection. | |

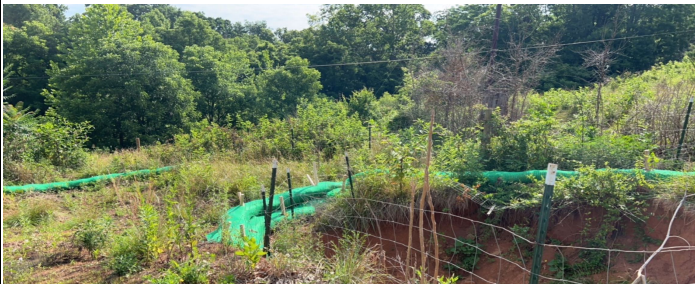
| Field Station# | 14567+00 | | Field Station# | 14582+85 | |

| Pic 1 Desc. | Sump pit and CFS end treatment performing intended functions. | | Pic 2 Desc. | Equipment bridge and surrounding ECDs in place and functional at stream crossing and resource buffer; signage visible and intact. | |

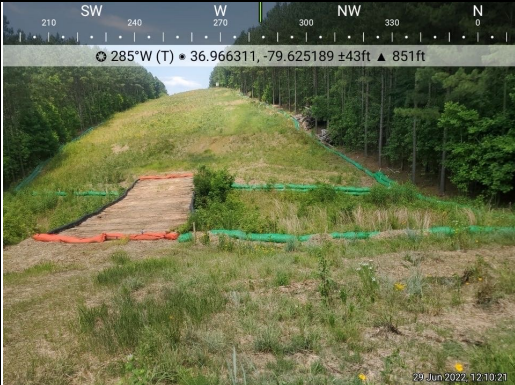
| Field Station# | 14967+00 | Field Station# | 14975+00 | | |

| Pic 7 Desc. | Dry swale | Pic 8 Desc. | Dry swale vegetation | | |

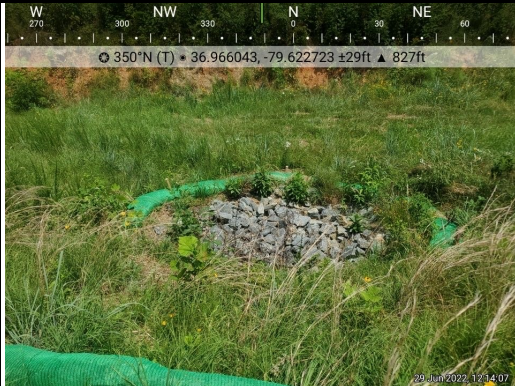
| Field Station# | 14974+50 | Field Station# | 14990+50 | | |

| Pic 9 Desc. | Cleanwater diversion outlet | Pic 10 Desc. | CIS S-D7 | | |

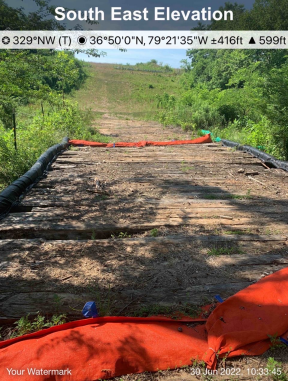
| Field Station# | 15962+32 | Field Station# | 15970+00 | | |

| Pic 1 Desc. | Observing equipment crossing and ECD's | Pic 2 Desc. | Observing temporary stabilization and CWD berm | | |

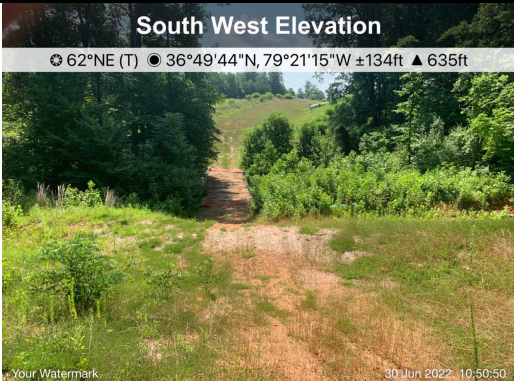
| Field Station# | 15976+82 | Field Station# | 15983+00 | | |

| Pic 3 Desc. | Observing temporary stabilization, signage, buffer, equipment crossing and ECD's | Pic 4 Desc. | Observing temporary stabilization, CWD outlet and ECD's | | |

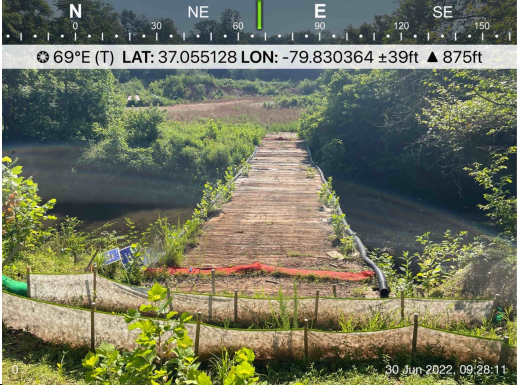
| Field Station# | 14233+00 | | Field Station# | 14273+00 | |

| Pic 7 Desc. | P1 is in good condition at all stream and wetland buffers | | Pic 8 Desc. | CFS is in good condition throughout this section | |

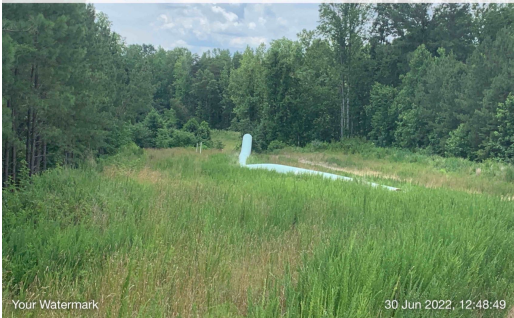
| Field Station# | 6+00 | | Field Station# | 12+65 | |

| Pic 1 Desc. | Observing temporary stabilization | | Pic 2 Desc. | Observing temporary stabilization,buffer, equipment crossing and ECD's | |

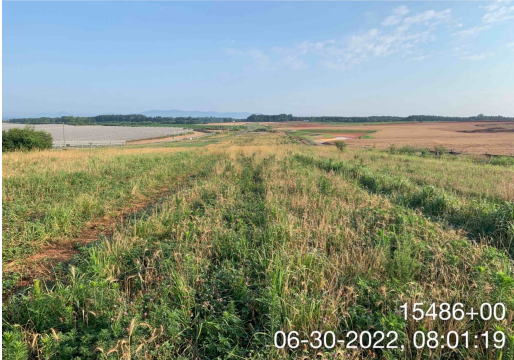
| Field Station# | 15486+00 | Field Station# | 15516+00 | | |

| Pic 1 Desc. | Permanent vegetative stabilization in acceptable condition | Pic 2 Desc. | Clean water diversion pipe in acceptable condition | | |

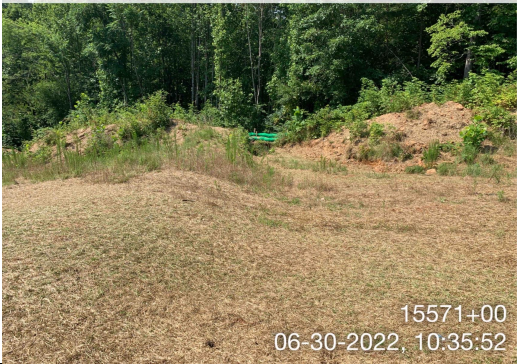
| Field Station# | 15571+00 | Field Station# | 15571+00 | | |

| Pic 7 Desc. | Waterbar in acceptable condition | | Pic 8 Desc. | Waterbar end treatment in acceptable condition | |

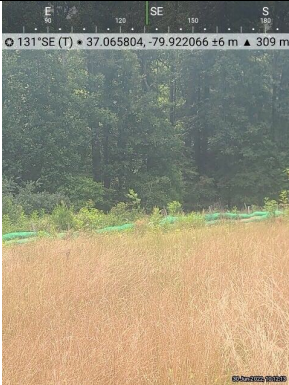
| Field Station# | 13829+00 | Field Station# | 13760+30 | | |

| Pic 1 Desc. | Observed perimeter ECDs during inspection. All in place and functioning at the time of inspection. | | Pic 2 Desc. | Monitored ECDs throughout row inspection today. No environmental issues observed at the time of inspection. | |

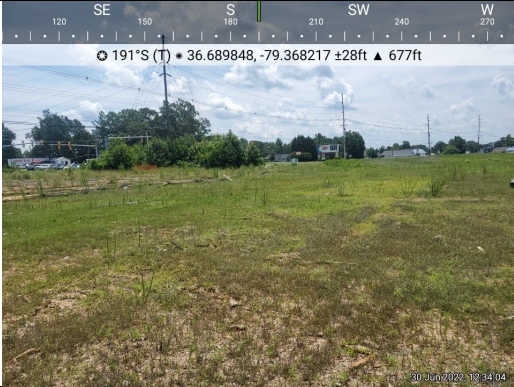
| Pic 1 Desc. | LY-048 Temporary vegetation | | Pic 2 Desc. | LY-048 South perimeter CFS | |

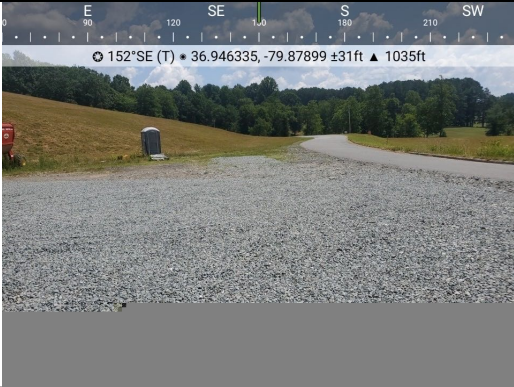
| Pic 3 Desc. | LY-033 Rock construction entrance | | Pic 4 Desc. | LY-033 Stormwater drain inlet protection | |

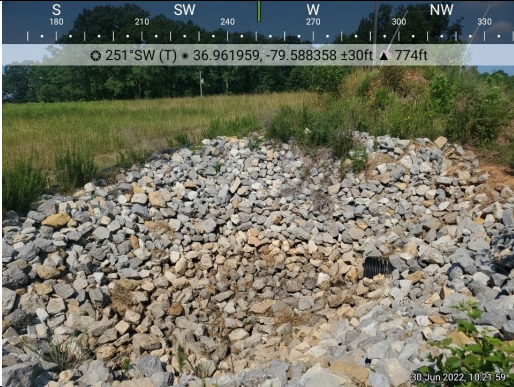
| Field Station# | 15080+00 | Field Station# | 15074+00 | | |

| Pic 1 Desc. | Plunge pool | Pic 2 Desc. | GAS S-G11 | | |

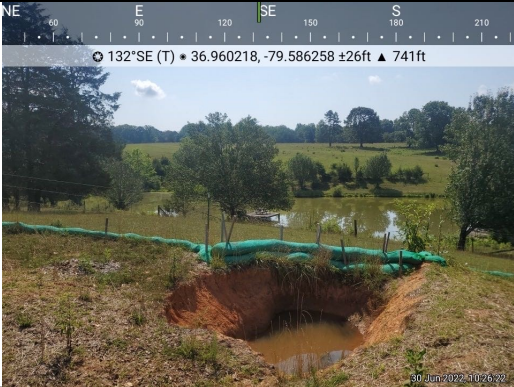
| Field Station# | 15090+00 | Field Station# | 15092+00 | | |

| Pic 3 Desc. | Sump and J-hook | Pic 4 Desc. | CIS S-G9 | | |

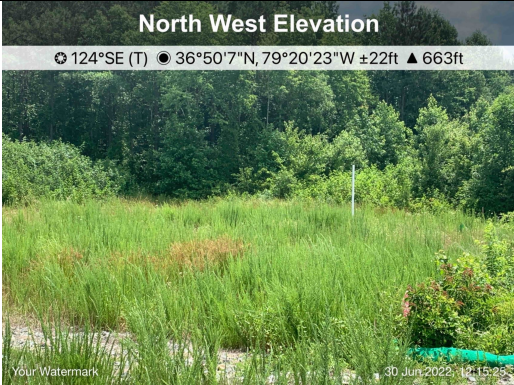
| Field Station# | 14+00 | Field Station# | 22+00 | | |

| Pic 1 Desc. | Observing temporary stabilization,RCE, signage, buffer and ECD's | | Pic 2 Desc. | Observing temporary stabilization,RCE and buffer | |

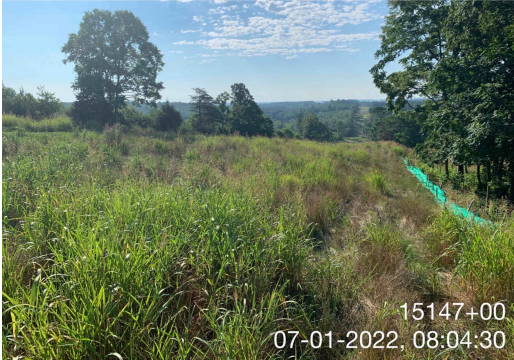
| 15147+00 07-01-2022, 08:04:30 | | | 15153+00 07-01-2022, 08:09:08 | | |

| Pic 1 Desc. | Permanent vegetative stabilization in acceptable condition | | Pic 2 Desc. | Waterbar in acceptable condition | |

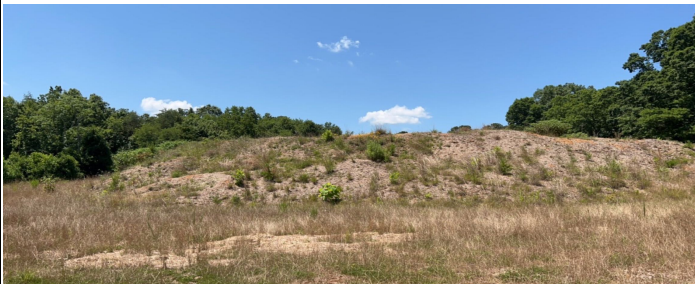
| Field Station# | 14313+00 | | Field Station# | 14314+79 | |

| Pic 1 Desc. | Temporary diversion berm stabilized and vegetated. | | Pic 2 Desc. | Equipment bridge and surrounding ECDs in place and functional at stream crossing and resource buffer. | |

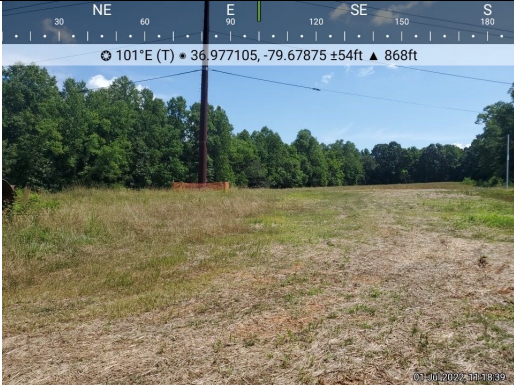
| Field Station# | 14800+00 | Field Station# | 14798+00 | | |

| Pic 1 Desc. | CIS MVP-FR-323 Vegetation | Pic 2 Desc. | Perimeter CFS triple stack | | |

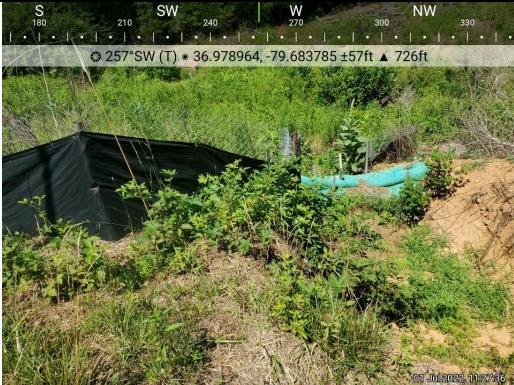
| Field Station# | 14783+00 | Field Station# | 14781+50 | | |

| Pic 3 Desc. | Sump and SSF | Pic 4 Desc. | CIS S-MM48 | | |
