Visual Site Inspection Report

Project Name	H-600 Pipeline Spread G	AFE	124300137	Spread	H-600 Pipeline Spread G
Contractor	Precision			Report #	40219
Inspector	Patrick Shields			Date/Time	7/25/2022 10:14 AM
Permit #	TBD	Inspection Type	VA SWPP	Station Begin	10749+92
State	VA	Inspection Area	Full	Station End	10798+92
County	Giles	Ground	Dry	Temperature (°F)	82.00
Municipality	N/A	Weather	Cloudy	Rain Gauge (in)	0.00
				Rain Accumulation Time (days)	1.00

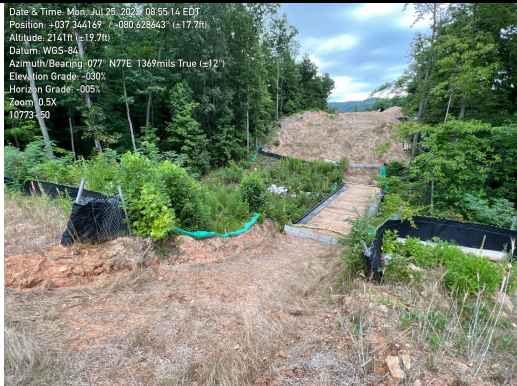
GPS Location	See photo	GPS Location	See photo		
Field Station#	10773+50	Field Station#	10777+50		
Pic 9 Desc.	Stream buffer in place	Pic 10 Desc.	Cleanwater drainage feature in place		
<p>Date & Time: Mon, Jul 25, 2022 09:00:14 EDT Position: +037.342923° / -080.623335° (+29.8ft) Altitude: 1956ft (+5.9ft) Datum: WGS-84 Azimuth/Bearing: 054°/N54E 0960mils True (+12°) Elevation Grade: -004% Horizon Grade: -007% Zoom: 0.5X 10792+00</p>

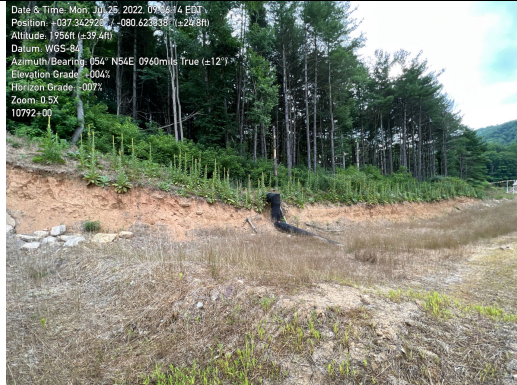
GPS Location	See photo	GPS Location	See photo		
Field Station#	10792+00	Field Station#	10798+00		
Pic 11 Desc.	Cleanwater diversion berm in place	Pic 12 Desc.	RCE in place

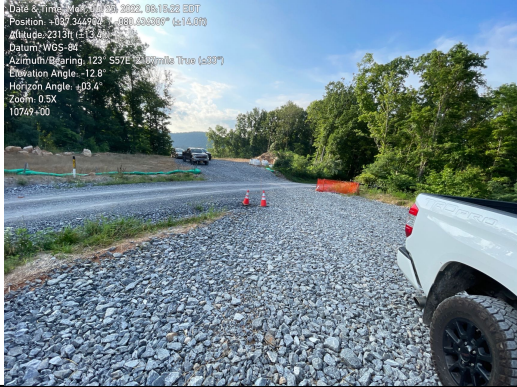
GPS Location	See photo	GPS Location	See photo		
Field Station#	10749+00	Field Station#	10746+00		
Pic 9 Desc.	RCE functional	Pic 10 Desc.	Crew 1704 stabilizing row

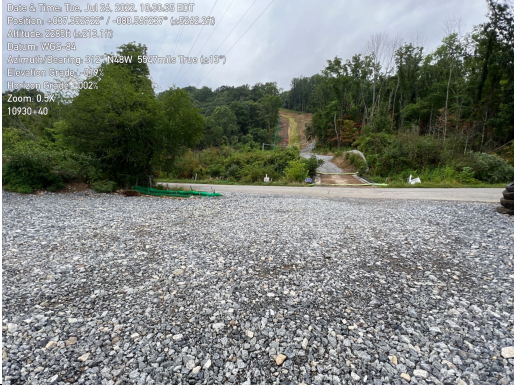
GPS Location	See photo	GPS Location	See photo		
Field Station#	10930+40	Field Station#	10939+00		
Pic 1 Desc.	RCE in place	Pic 2 Desc.	P1 silt fence perimeter control in place

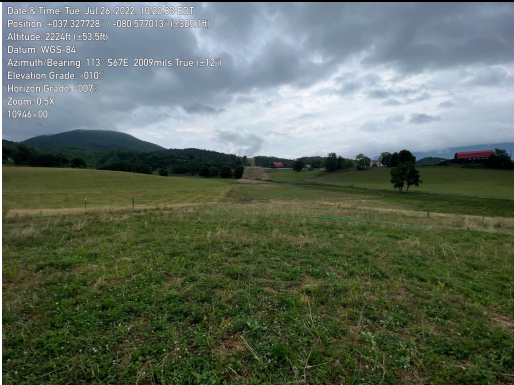
GPS Location	See photo	GPS Location	See photo		
Field Station#	10946+00	Field Station#	10961+00		
Pic 3 Desc.	Permanent vegetation present	Pic 4 Desc.	CFS triple stack perimeter control in place

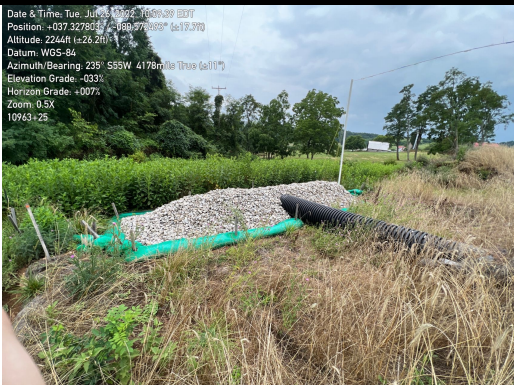
GPS Location	See photo	GPS Location	See photo		
Field Station#	10963+25	Field Station#	10966+85		
Pic 5 Desc.	Cleanwater diversion outlet protection in place	Pic 6 Desc.	Triple protection ECDs in place at karst feature

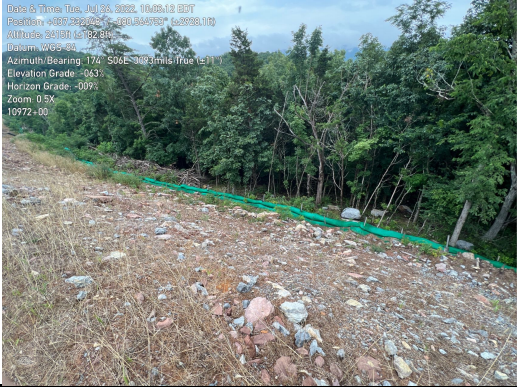
GPS Location	See photo	GPS Location	See photo		
Field Station#	10972+00	Field Station#	10976+75		
Pic 7 Desc.	CFS triple stack perimeter control in place	Pic 8 Desc.	Cleanwater drainage features in place		
<p>Date & Time: Tue, Jul 26, 2022, 09:44:28 EDT Position: +437.225766° / -880.545618° (±25.8m) Altitude: 2354ft (±6.5ft) Datum: WGS-84 Azimuth/Bearing: 185° S06W 328° (±11°) Elevation Grade: -0.53% Horizon Grade: -0.06% Zoom: 0.5X 10984+75</p>

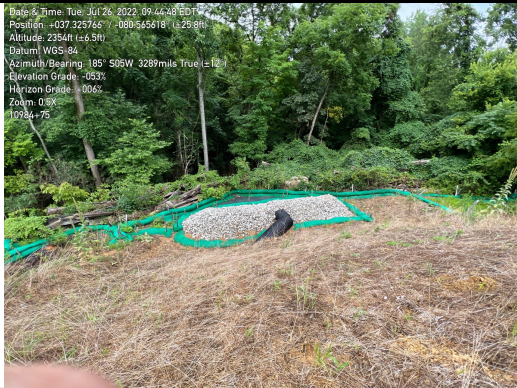
GPS Location	See photo	GPS Location	See photo		
Field Station#	10984+75	Field Station#	10994+00		
Pic 9 Desc.	Cleanwater diversion outlet protection in place	Pic 10 Desc.	P1 silt fence perimeter control in place		
<p>Date & Time: Tue, Jul 26, 2022, 09:45:45 EDT Position: +437.225766° / -880.545618° (±25.8m) Altitude: 2354ft (±6.5ft) Datum: WGS-84 Azimuth/Bearing: 021° N04W 570° (±12°) Elevation Grade: -0.12% Horizon Grade: -0.01% Zoom: 0.5X 11004+00</p>

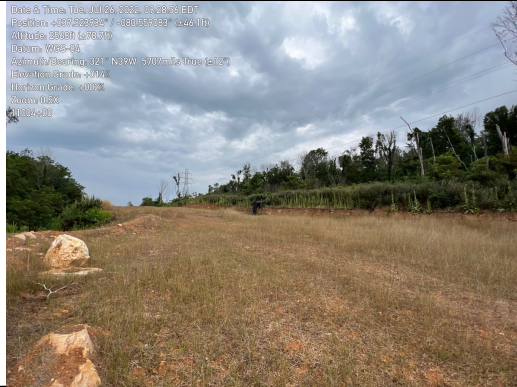
GPS Location	See photo	GPS Location	See photo		
Field Station#	11004+00	Field Station#	11016+00		
Pic 11 Desc.	Cleanwater diversion berm in place	Pic 12 Desc.	Stream buffer in place

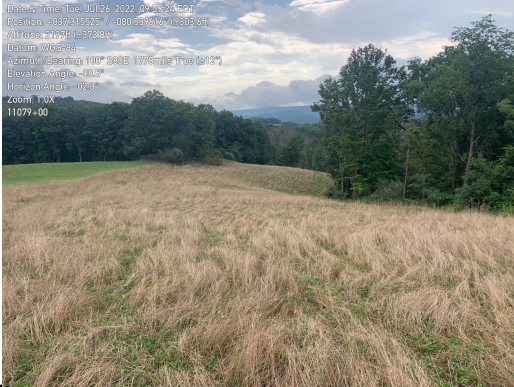
GPS Location	See photo	GPS Location	See photo		
Field Station#	11079+00	Field Station#	11076+50		
Pic 3 Desc.	Permanently restored section of Row	Pic 4 Desc.	Section of Row showing conditions and controls		
<p>Date & Time: Tue, Jul 26, 2022, 09:54:01 EDT Position: +037 213275+ / +080 55353+ (+9997 7ft) Altitude: 2197ft (+39.4ft) Datum: WGS-84 Azimuth/Bearing: 086° N85E 1511mils True (±12°) Elevation Angle: -02.5° Horizon Angle: +05.1° Zoom: 1.0x 11059+00</p>

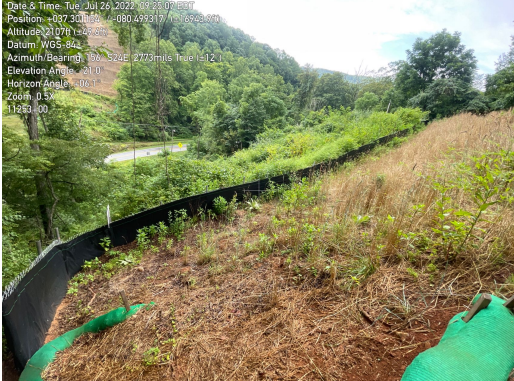
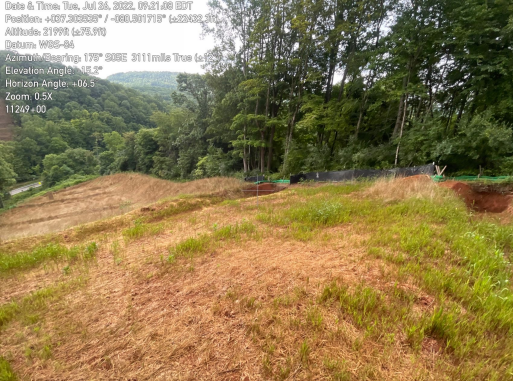
GPS Location	See photo	GPS Location	See photo		
Field Station#	11253+00	Field Station#	11249+00		
Pic 1 Desc.	SSF functional	Pic 2 Desc.	Erosion control blanket in place

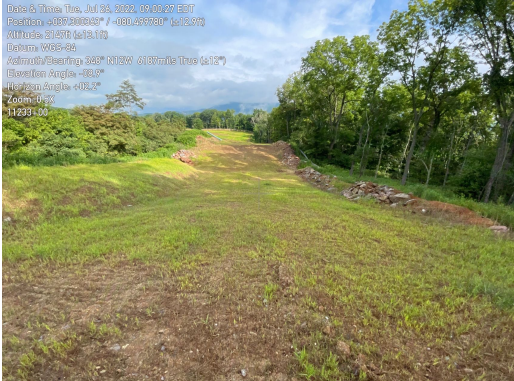
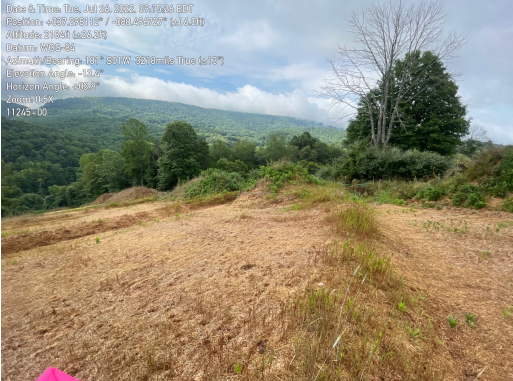
GPS Location	See photo	GPS Location	See photo		
Field Station#	11233+00	Field Station#	11245+00		
Pic 3 Desc.	Picture showing condition of row	Pic 4 Desc.	Water bars and end treatments in place

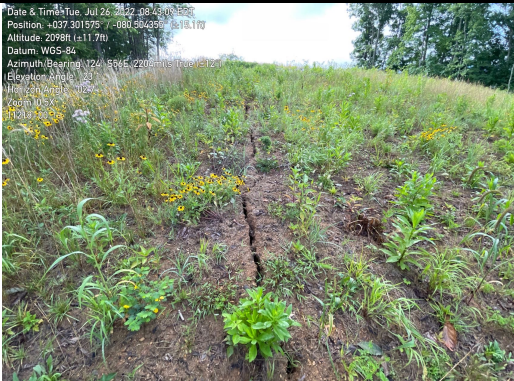
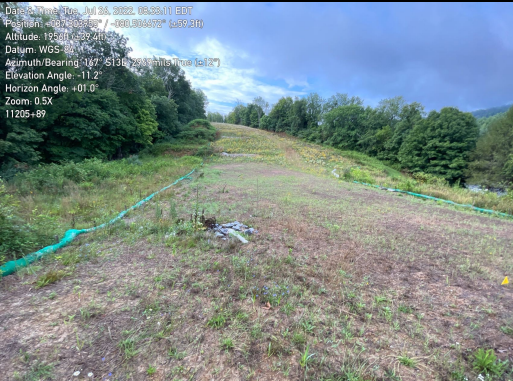
GPS Location	See photo	GPS Location	See photo		
Field Station#	11218+00	Field Station#	11205+89		
Pic 5 Desc.	Subsidence being monitored	Pic 6 Desc.	Stabilization thin being monitored

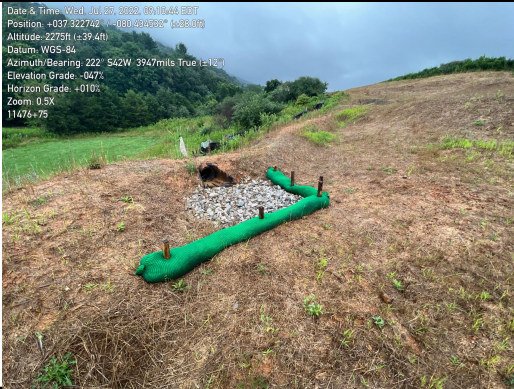
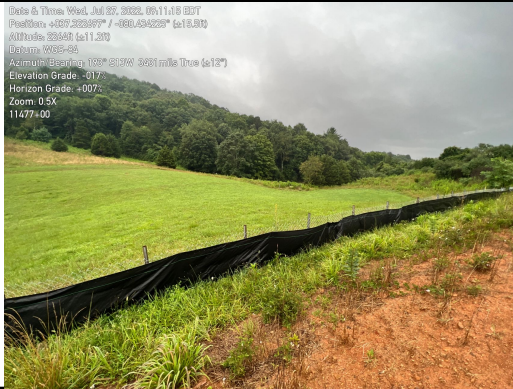
GPS Location	See photo	GPS Location	See photo		
Field Station#	11476+75	Field Station#	11477+00		
Pic 3 Desc.	Stone inlet protection in place	Pic 4 Desc.	Supersilt fence perimeter control in place		
<p>Date & Time Wed Jul 27, 2022, 05:16:55 EDT Position: +037.922742° / -80.494007° (±3.00') Altitude: 2230ft (±3.00') Datum: WGS-84 Azimuth/Bearing: 330° S30W 444mils True (±12°) Elevation Grade: -01% Horizon Grade: +00% Zoom: 0.5X 11479+00</p>

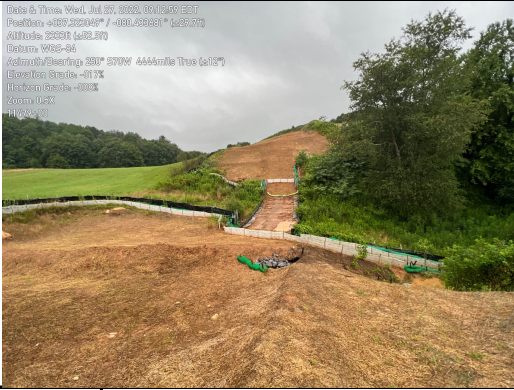
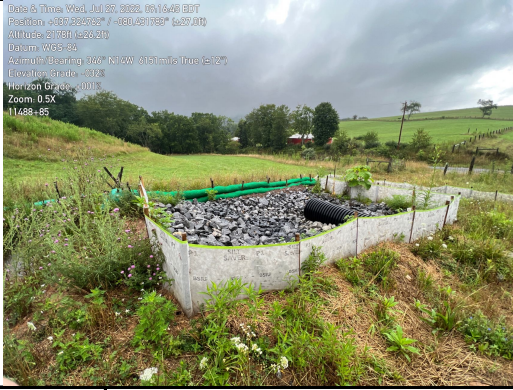
GPS Location	See photo	GPS Location	See photo		
Field Station#	11479+00	Field Station#	11488+85		
Pic 5 Desc.	Cleanwater drainage feature in place	Pic 6 Desc.	Plunge pool in place

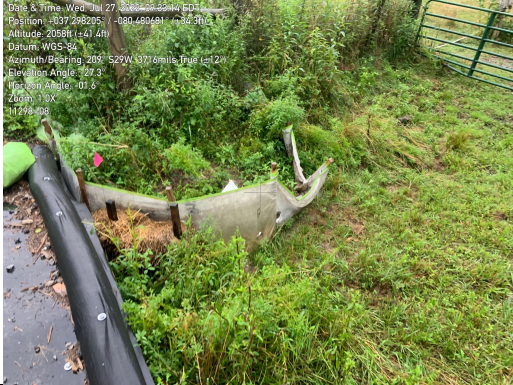
<p>Date & Time: Wed Jul 27, 2022, 09:59:55 EDT Position: -037.333417 / -080.480691 (-54532.9ft) Altitude: 2088ft (+4.4ft) Datum: WGS-84 Azimuth/Bearing: 205.529W 337.6mils True (+12°) Elevation Angle: -23.3 Horizon Angle: -01.8 Zoom: 1.0x 11298+08</p>		GPS Location	See photo
Field Station#	11329+42	Field Station#	11298+08	GPS Location	See photo
Pic 1 Desc.	Perimeter controls are in place	Pic 2 Desc.	Damaged P1	GPS Location	See photo

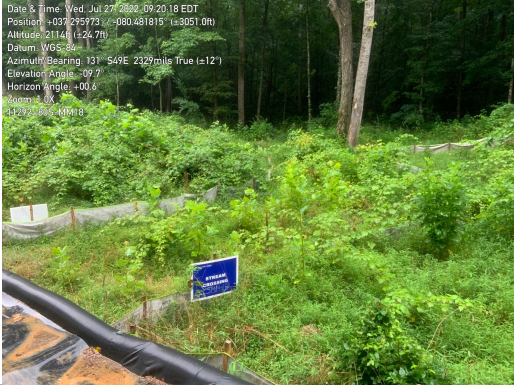
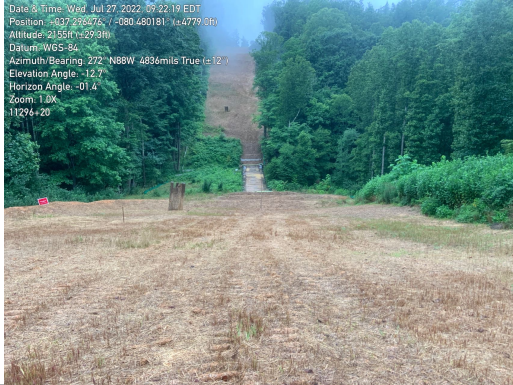
Field Station#	11292+80	Field Station#	11296+20	GPS Location	See photo
Pic 3 Desc.	Conditions and controls at S-MM18 looking upstream	Pic 4 Desc.	Overview of conditions and controls at S-MM18	GPS Location	See photo

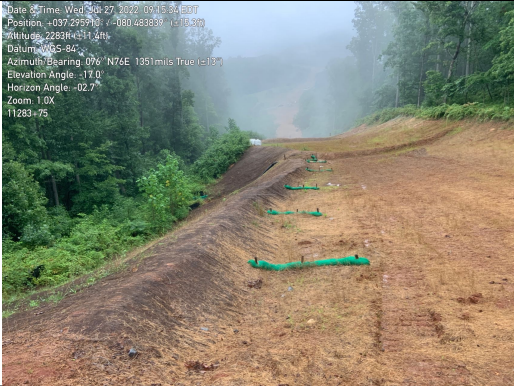
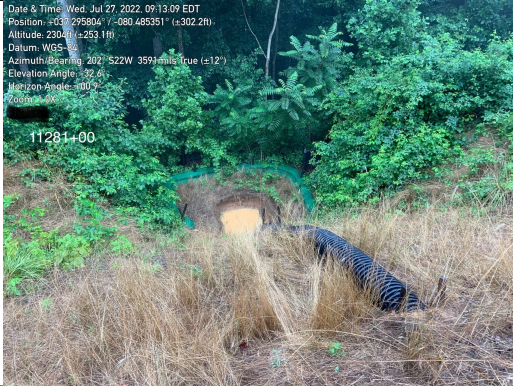
<p>Date & Time: Wed Jul 27, 2022, 09:13:09 EDT Position: -037.295973 / -080.485551 (-5302.2ft) Altitude: 2204ft (+23.1ft) Datum: WGS-84 Azimuth/Bearing: 202.522W 359.1mils True (+12°) Elevation Angle: -32.6 Horizon Angle: -00.3 Zoom: 1.0x 11281+00</p>		GPS Location	See photo
Field Station#	11283+75	Field Station#	11281+00	GPS Location	See photo
Pic 5 Desc.	Section of Row showing conditions and controls	Pic 6 Desc.	Slope drain pipe, sump pit and perimeter controls	GPS Location	See photo

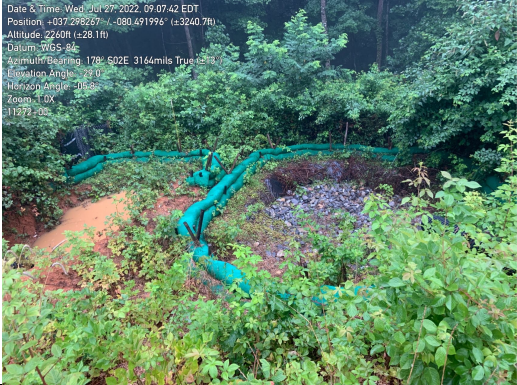
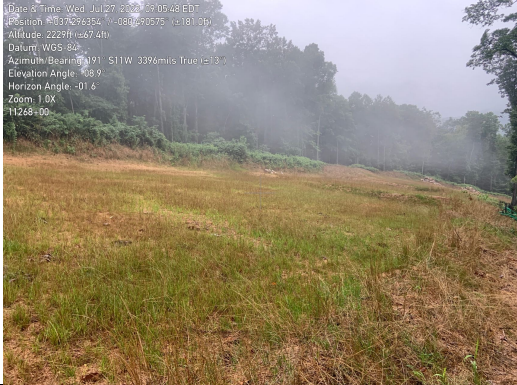
<p>Date & Time: Wed Jul 27, 2022 09:05:49 EDT Position: +037.298257° / -080.491996° (+3240.7ft) Altitude: 2229ft (+26.74ft) Datum: WGS-84 Azimuth/Bearing: 191° S11W 3396mils True (+13°) Elevation Angle: -04.9° Horizon Angle: -01.4° Zoom: 1.0X 11268+00</p>			
GPS Location	See photo	GPS Location	See photo		
Field Station#	11272+00	Field Station#	11268+00		
Pic 7 Desc.	Plunge pool and Perimeter controls are in acceptable condition	Pic 8 Desc.	Temporary vegetation/stabilization

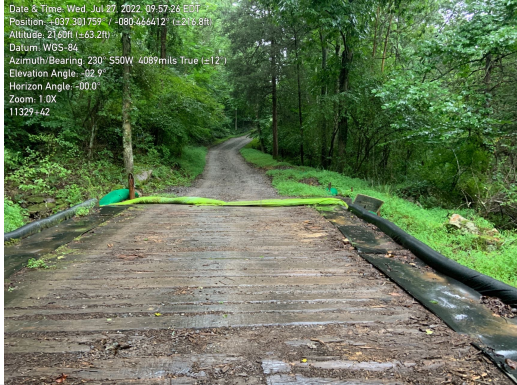
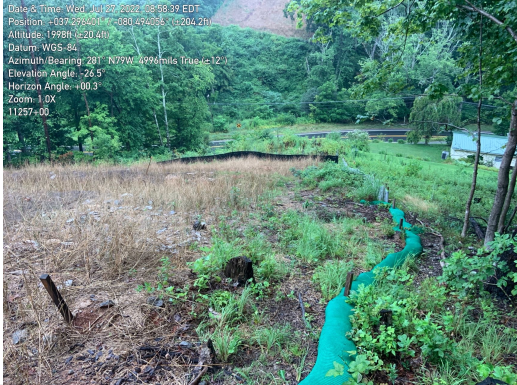
GPS Location	See photo	GPS Location	See photo		
Field Station#	11329+42	Field Station#	11257+00		
Pic 9 Desc.	AR256.02	Pic 10 Desc.	CFS perimeter controls and SSF are in acceptable condition

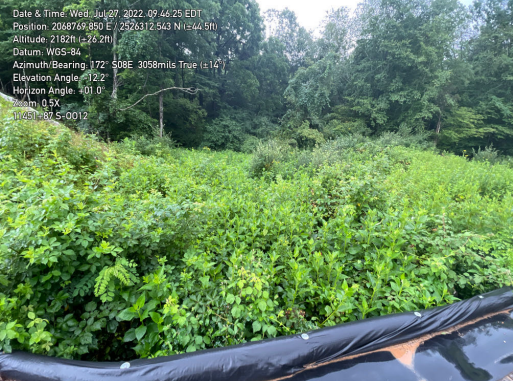
GPS Location	1	GPS Location	2		
Field Station#	11469+00	Field Station#	11451+87		
Pic 1 Desc.	Section of RoW showing conditions and controls.		Pic 2 Desc.	S-0012.

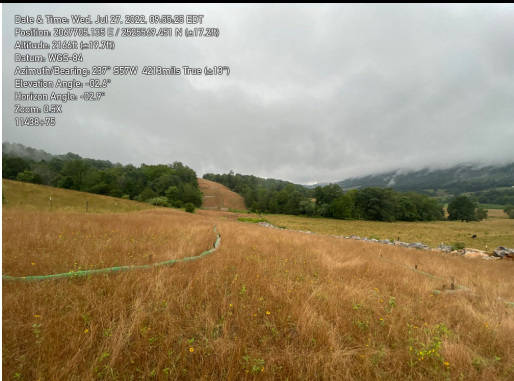
GPS Location	5	GPS Location	6		
Field Station#	11438+75	Field Station#	11432+00		
Pic 5 Desc.	Section of restored RoW showing conditions and controls.		Pic 6 Desc.	Representative photo of permanent waterbar and level spreaders installed.

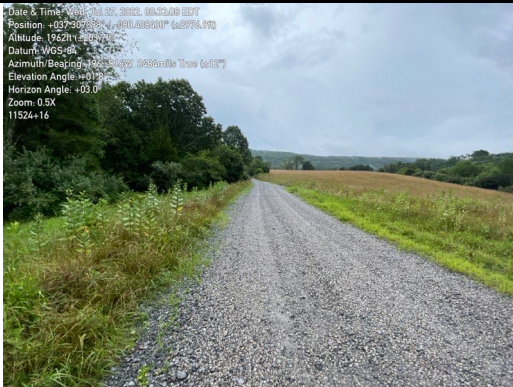
</div></div>			
GPS Location		On photo		GPS Location	
Field Station#		11524+16		Field Station#	
Pic 1 Desc.		Access points in good condition.		Pic 2 Desc.	
				Heavy vegetation. ECDs in place. ROW stable.	
<div><div><div>Date & Time: Wed Jul 27, 2022, 08:45:01 EDT Position: +037.328305° / +081.418179° (+18.30) Altitude: 2482ft (+11.4ft) Datum: WGS-84 Azimuth/Bearing: 165° S18E 2933mils True (+12.1) Elevation Angle: +01.2° Horizon Angle: +03.0° Zoom: 0.5X 11538+00</div>

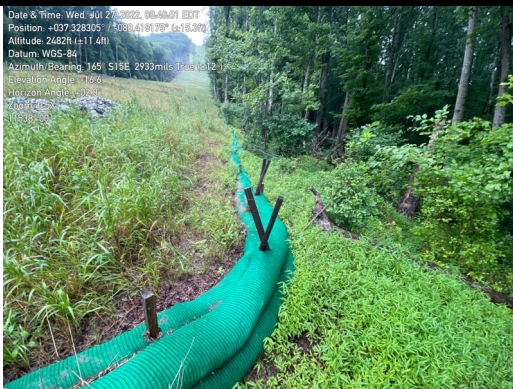
GPS Location		On photo		GPS Location	
Field Station#		11538+00		Field Station#	
Pic 3 Desc.		ECDs in place. No erosion occurring.		Pic 4 Desc.	
				ROW stable. Slope breakers in place.	
<div><div><div>Date & Time: Wed Jul 27, 2022, 09:12:51 EDT Position: +037.321044° / +88.0412506° (+10.0m) Altitude: 785m (+12.0m) Datum: WGS-84 Azimuth/Bearing: 288° N72W 5120mils Magnetic (+13.1) Elevation Angle: +00.0° Horizon Angle: +05.3° Zoom: 1.0X 11569+00</div>

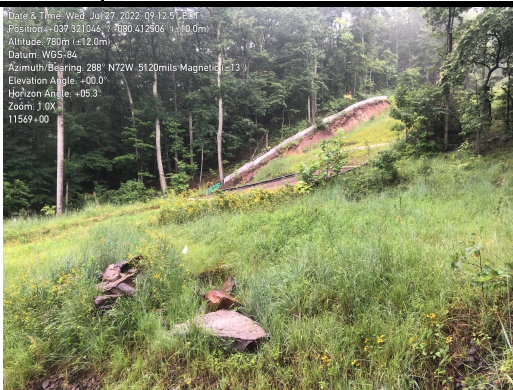
</div></div>			
GPS Location		On photo		GPS Location	
Field Station#		11569+00		Field Station#	
Pic 5 Desc.		The ROW is stable at S-PP22.		Pic 6 Desc.	
				Heavy vegetation. ECDs are in place.

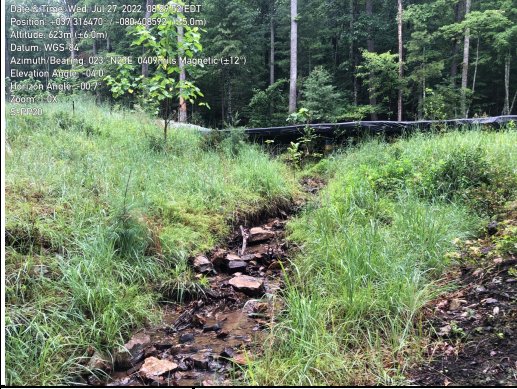
GPS Location	On photo	GPS Location	On photo		
Field Station#	11588+41	Field Station#	11589+25		
Pic 9 Desc.	The S-PP20 crossing is stable.	Pic 10 Desc.	Adjacent resource W-CD46 has not been impacted.

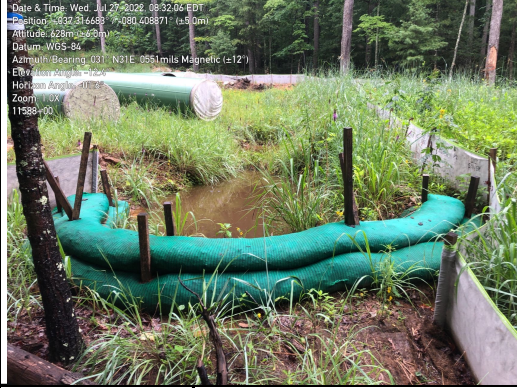
<p>Date & Time: Wed, Jul 27, 2022, 09:32:05 EDT Position: +037.316489, -080.408871 (+5.0m) Altitude: 628m (+5.0m) Datum: WGS-84 Azimuth/Bearing: 031.1630W (+0.00mils Magnetic (+12°)) Elevation Angle: -02° Horizon Angle: -02° Zoom: 1.0X 11588+00</p>		<p>Insert image here</p>			
GPS Location	On photo	GPS Location			
Field Station#	11588+00	Field Station#			
Pic 11 Desc.	ECDs in place along edge of LOD.	Pic 12 Desc.

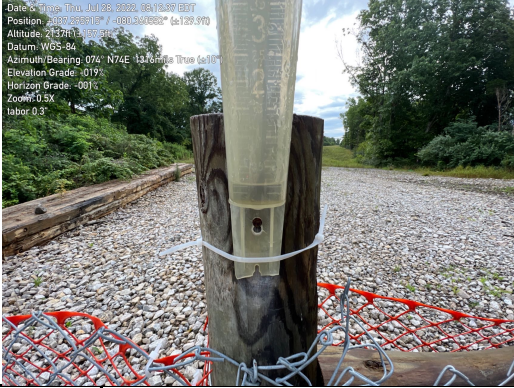
GPS Location	See photo	GPS Location	See photo		
Field Station#	11788+52	Field Station#	11899+89		
Pic 1 Desc.	MT Tabor rain gauge measured 0.3" of rainfall	Pic 2 Desc.	RCE in place

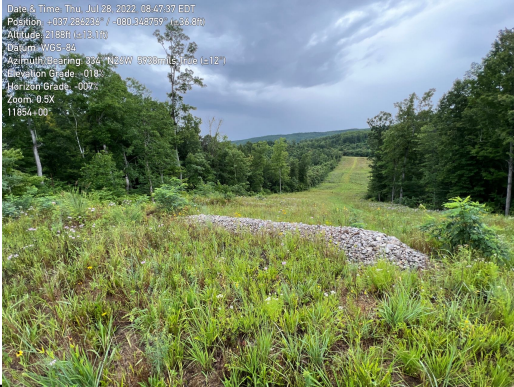
GPS Location	See photo	GPS Location	See photo		
Field Station#	11854+00	Field Station#	11830+50		
Pic 3 Desc.	Permanent waterbar in place	Pic 4 Desc.	Level spreader in place

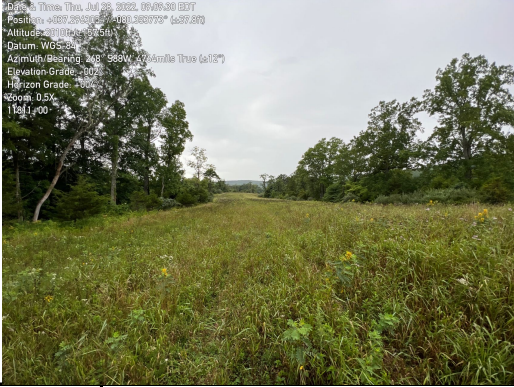
GPS Location	See photo	GPS Location	See photo		
Field Station#	11811+00	Field Station#	11788+52		
Pic 5 Desc.	Permanent vegetation present	Pic 6 Desc.	RCE in place

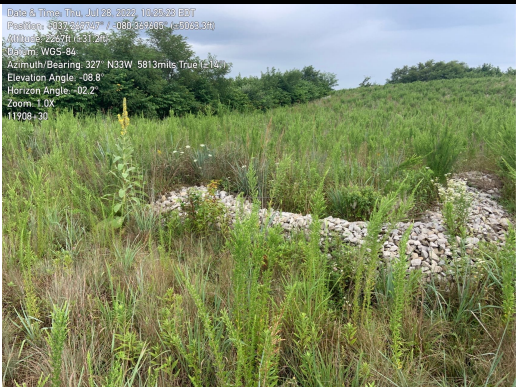
GPS Location		See photo		GPS Location	
Field Station#		11908+30		Field Station#	
Pic 3 Desc.		Representational photo of water bar and level spreader		Pic 4 Desc.	
<p>Date & Time: Thu, Jul 28, 2022 11:16:18 EDT Position: +31° 29' 59.9" / -80° 32' 41.1" (-11934) Altitude: 2079ft (-633m) Datum: WGS-84 Azimuth/Bearing: 163 S17E 899mils True (-12) Elevation Angle: +1.0° Horizon Angle: +0.1° Zoom: 1.0x 11899+89</p>

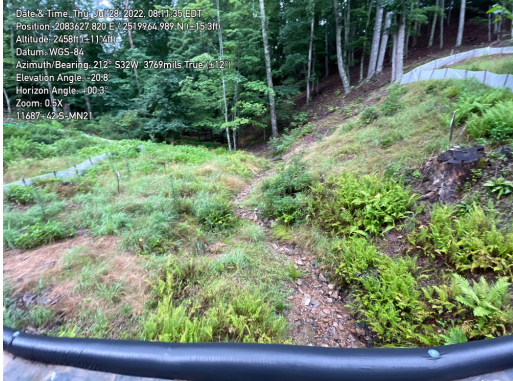
<p>Date & Time: Thu, Jul 28, 2022, 08:11:35 EDT Position: 2083627.820 E, 2519824.989 N (±26.4M) Altitude: 2458ft (±11.0M) Datum: WGS-84 Azimuth/Bearing: 212° S32W 376ft/mile True (±12°) Elevation Angle: -20.8° Horizon Angle: -09.3° Zoom: 0.5X 11687+42S-MN21</p>			
GPS Location	1	GPS Location	2		
Field Station#	11671+00	Field Station#	11687+42		
Pic 1 Desc.	Section of RoW showing conditions and controls.	Pic 2 Desc.	S-MN21.

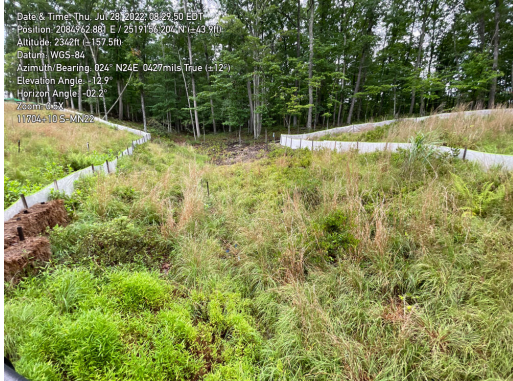
GPS Location	3	GPS Location	4		
Field Station#	11698+50	Field Station#	11704+10		
Pic 3 Desc.	Perimeter controls functional.	Pic 4 Desc.	S-MN22.

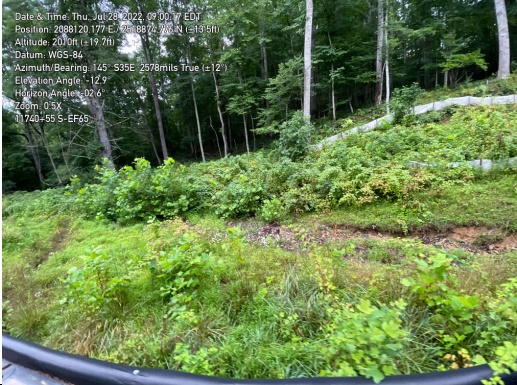
GPS Location	7	GPS Location	8		
Field Station#	11740+55	Field Station#	11743+97		
Pic 7 Desc.	S-EF65.	Pic 8 Desc.	S-EF62.

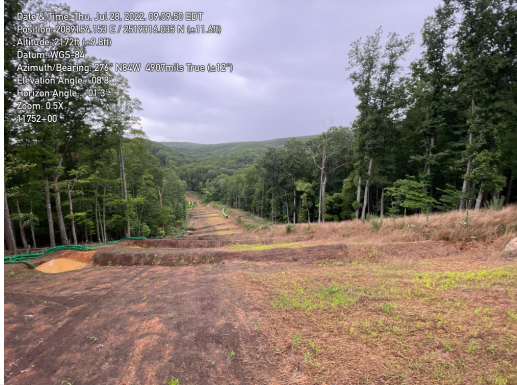
GPS Location	9	GPS Location	10		
Field Station#	11752+00	Field Station#	11767+44		
Pic 9 Desc.	Section of RoW showing conditions and controls.	Pic 10 Desc.	S-IJ52/W-IJ46.

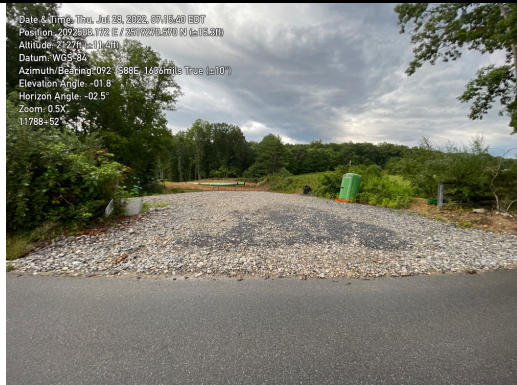
<p>Insert image here</p>			
GPS Location	11	GPS Location			
Field Station#	11788+52	Field Station#			
Pic 11 Desc.	RCE Mt Tabor rd.	Pic 12 Desc.

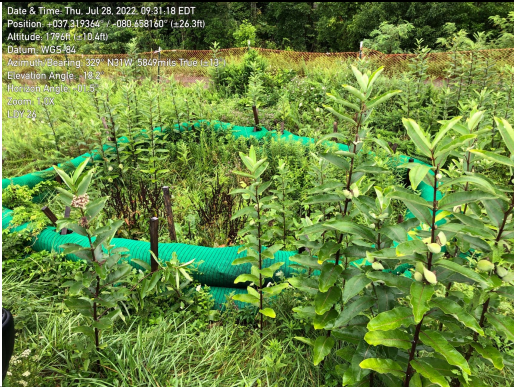
GPS Location	See photo for GPS location.		GPS Location	See photo for GPS location.	
Field Station#	12005+00		Field Station#	12005+00	
Pic 3 Desc.	Triple stack 18 inch CFS in place.		Pic 4 Desc.	Dumpsters utilized for waste management.

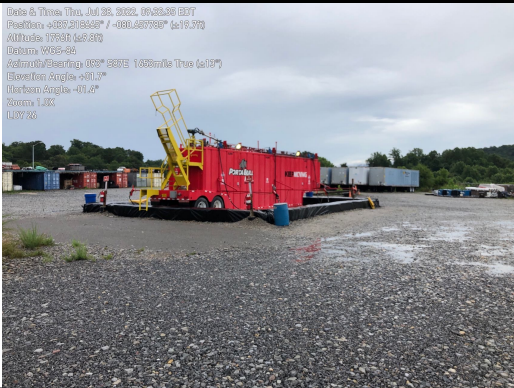
GPS Location	See photo for GPS location.		GPS Location	See photo for GPS location.	
Field Station#	12005+00		Field Station#	12005+00	
Pic 5 Desc.	Secondary containment in place under fuel cell.		Pic 6 Desc.	RCE in place at yard entrance.

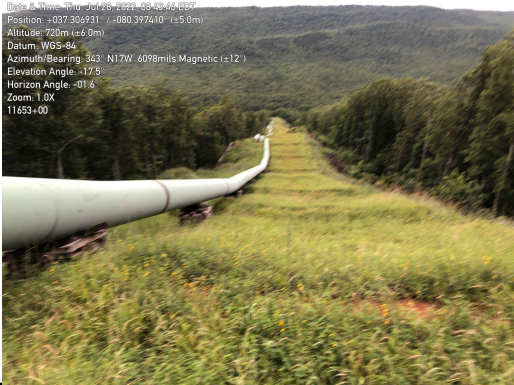
GPS Location	On photo	GPS Location	On photo		
Field Station#	11653+00	Field Station#	11651+00		
Pic 3 Desc.	Slope breakers functional. ROW well vegetated.	Pic 4 Desc.	ROW stable. ECDs are in place.

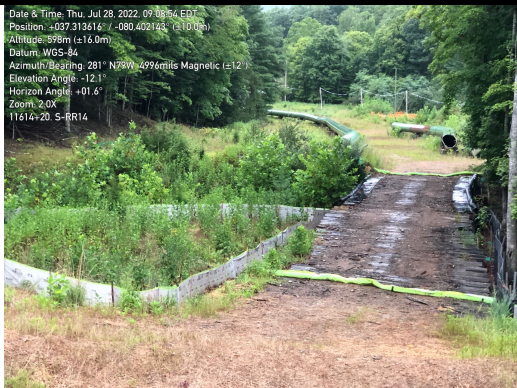
GPS Location	On photo	GPS Location	On photo		
Field Station#	11614+20	Field Station#	11607+81		
Pic 9 Desc.	The S-RR14 crossing is stable.	Pic 10 Desc.	The S-006 crossing is currently stable.		
Insert image here		Insert image here			
GPS Location		GPS Location			
Field Station#		Field Station#			
Pic 11 Desc.		Pic 12 Desc.

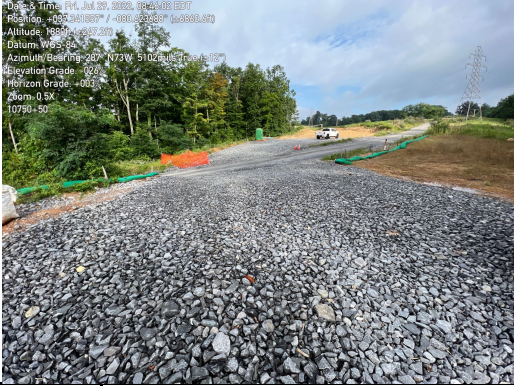
GPS Location	See photo	GPS Location	See photo		
Field Station#	10750+50	Field Station#	10752+50		
Pic 1 Desc.	RCE in place	Pic 2 Desc.	Waterbars in place

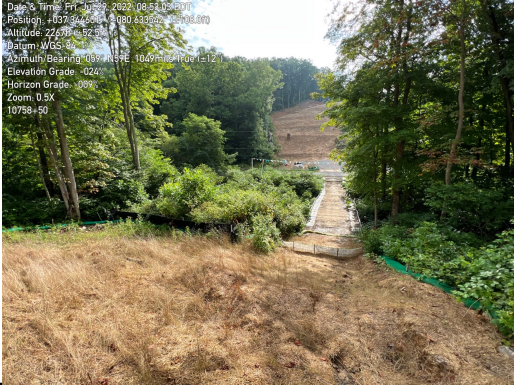
GPS Location	See photo	GPS Location	See photo		
Field Station#	10758+50	Field Station#	10761+60		
Pic 3 Desc.	Stream buffer in place	Pic 4 Desc.	Stone inlet protection in place

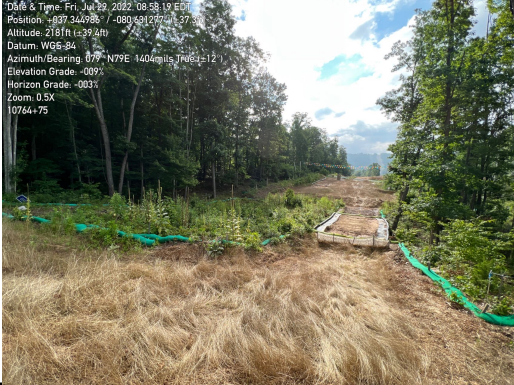
GPS Location	See photo	GPS Location	See photo		
Field Station#	10764+75	Field Station#	10765+85		
Pic 5 Desc.	Stream buffer in place	Pic 6 Desc.	Cleanwater diversion outlet protection in place

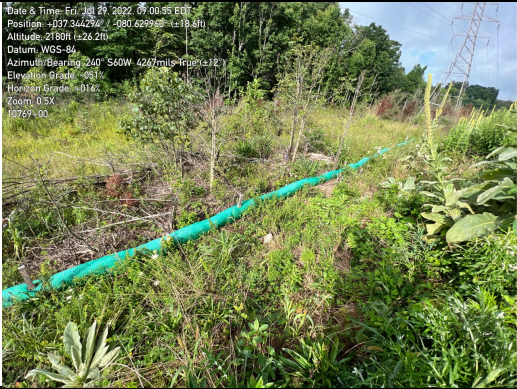
GPS Location	See photo		GPS Location	See photo	
Field Station#	10769+00		Field Station#	10771+75	
Pic 7 Desc.	CFS perimeter control in place		Pic 8 Desc.	Cleanwater diversion outlet protection in place	
<p>Date & Time: Fri Jul 29, 2022 09:06:25 EDT Position: +037.342782° / -080.627260° (±20.3ft) Altitude: 2195ft (±25.9ft) Datum: WGS-84 Azimuth/Bearing: 068° N08E 1249mils True (±12°) Elevation Grade: -000% Horizon Grade: -009% Zoom: 0.5X 10777+50</p>

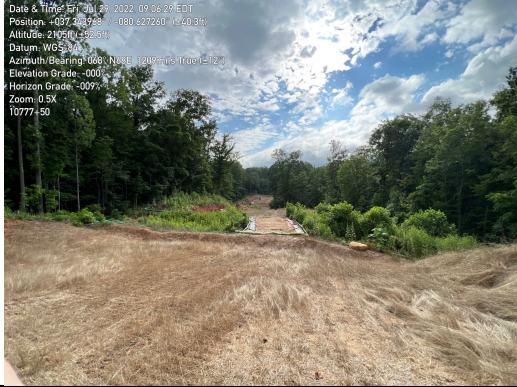
GPS Location	See photo		GPS Location	See photo	
Field Station#	10777+50		Field Station#	10784+00	
Pic 9 Desc.	Cleanwater drainage feature in place		Pic 10 Desc.	CFS perimeter control in place	
<p>Date & Time: Fri Jul 29, 2022 09:18:02 EDT Position: +037.342872° / -080.632235° (±15.4ft) Altitude: 1937ft (±11.2ft) Datum: WGS-84 Azimuth/Bearing: 089° N38E 0476mils True (±12°) Elevation Grade: -005% Horizon Grade: -005% Zoom: 0.5X 10792+00</p>

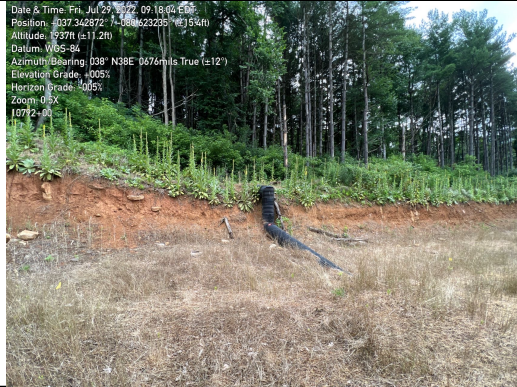
GPS Location	See photo		GPS Location	See photo	
Field Station#	10792+00		Field Station#	10798+00	
Pic 11 Desc.	Cleanwater diversion berm in place		Pic 12 Desc.	RCE in place

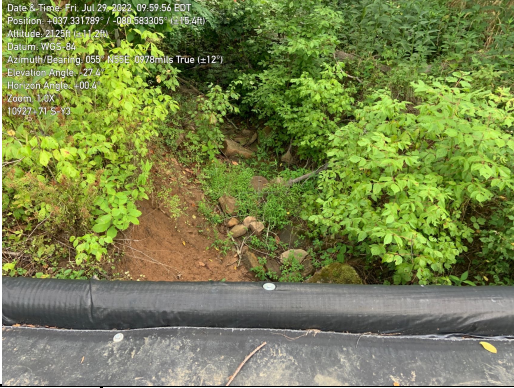
GPS Location	See photo	GPS Location	See photo		
Field Station#	10927+71	Field Station#	10920+00		
Pic 1 Desc.	Looking upstream at S-Y3	Pic 2 Desc.	Section of Row showing conditions and controls

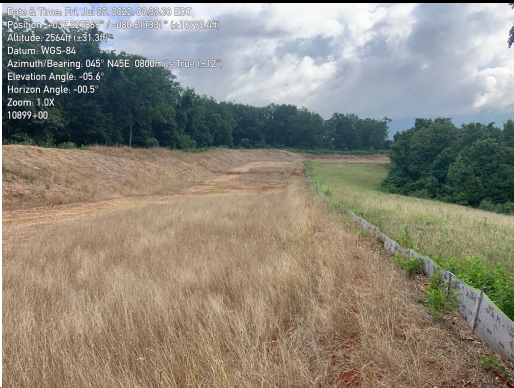
GPS Location	See photo	GPS Location	See photo		
Field Station#	10899+00	Field Station#	10891+75		
Pic 5 Desc.	Section of Row showing conditions and controls	Pic 6 Desc.	Section of Row showing conditions and controls

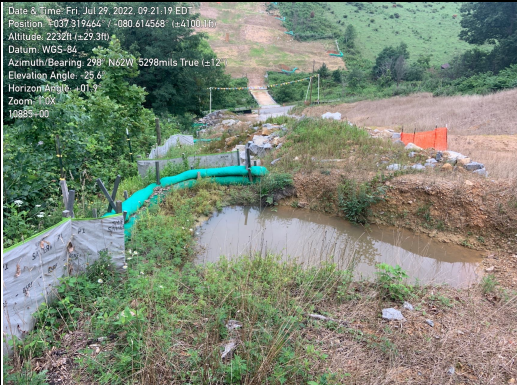
GPS Location	See photo	GPS Location	See photo		
Field Station#	10885+00	Field Station#	10883+87		
Pic 7 Desc.	Section of Row showing conditions and controls	Pic 8 Desc.	Rain gage at Kow camp with 0.1" inches of accumulation

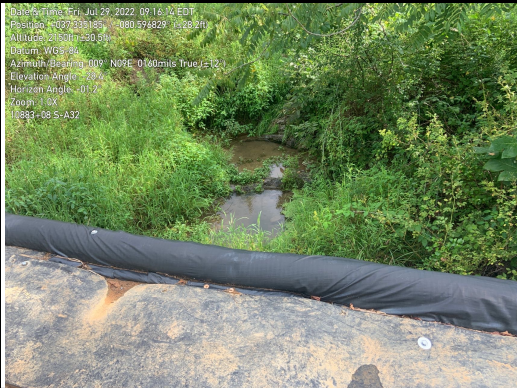
GPS Location	See photo	GPS Location	See photo		
Field Station#	10883+08	Field Station#	10882+42		
Pic 9 Desc.	Looking upstream at S-A32	Pic 10 Desc.	Section of Row showing conditions and controls

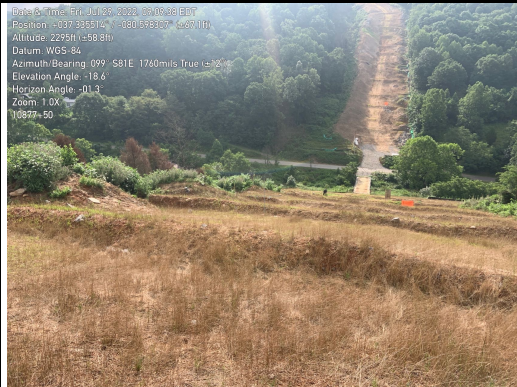
GPS Location	See photo	GPS Location	See photo		
Field Station#	10877+50	Field Station#	10864+55		
Pic 11 Desc.	Section of Row showing conditions and controls	Pic 12 Desc.	Level spreader in place

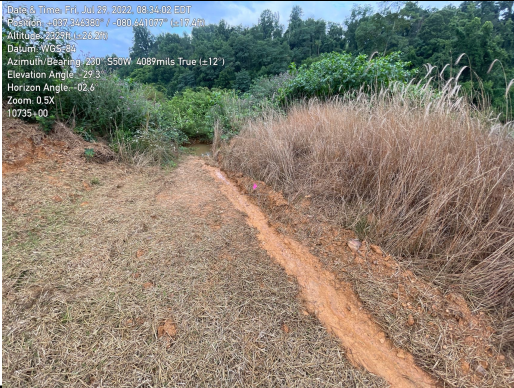
<p>Date & Time: Fri Jul 29, 2022 08:33:35 EDT Position: +039.34621 / -080.64029 (±15.1m) Altitude: 2276ft (±11.7m) Datum: WGS-84 Azimuth/Bearing: 262° S82W 4688mils True (±12°) Elevation Angle: -37.6° Horizon Angle: -00.4° Zoom: 0.5X 10737+00</p>			
GPS Location	See photo	GPS Location	See photo		
Field Station#	10735+00	Field Station#	10737+00		
Pic 5 Desc.	Water bar throat needs stabilized	Pic 6 Desc.	Rilling needs stabilized

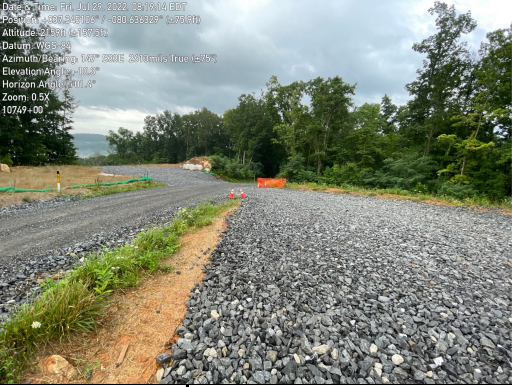
GPS Location	See photo	GPS Location			
Field Station#	10749+00	Field Station#			
Pic 7 Desc.	RCE functional	Pic 8 Desc.			
Insert image here		Insert image here			
GPS Location		GPS Location			
Field Station#		Field Station#			
Pic 9 Desc.		Pic 10 Desc.			
Insert image here		Insert image here			
GPS Location		GPS Location			
Field Station#		Field Station#			
Pic 11 Desc.		Pic 12 Desc.

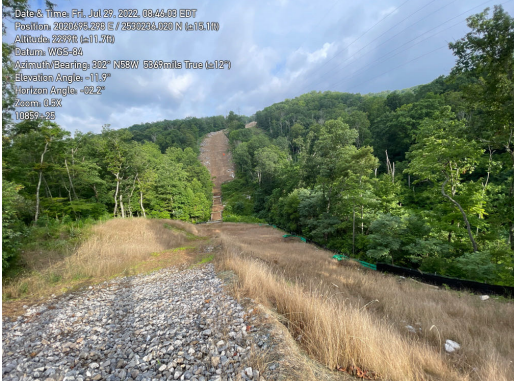
GPS Location	1	GPS Location	2		
Field Station#	10859+25	Field Station#	10856+04		
Pic 1 Desc.	Section of RoW showing conditions and controls.	Pic 2 Desc.	S-A33.

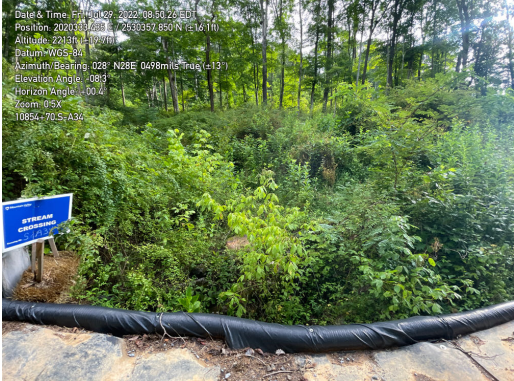
GPS Location	3	GPS Location	4		
Field Station#	10854+70	Field Station#	10843+00		
Pic 3 Desc.	S-A34.	Pic 4 Desc.	CWDP outlet protection functional.

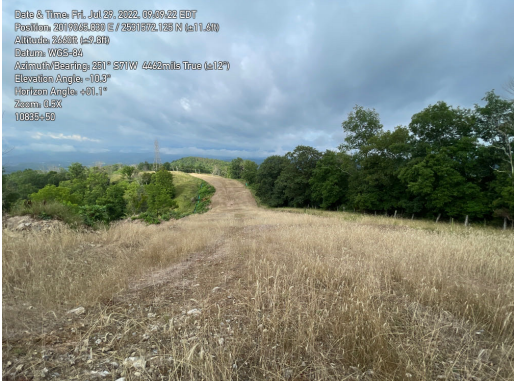
GPS Location	5	GPS Location	6		
Field Station#	10835+50	Field Station#	10826+00		
Pic 5 Desc.	Section of RoW showing conditions and controls.	Pic 6 Desc.	Perimeter controls functional.

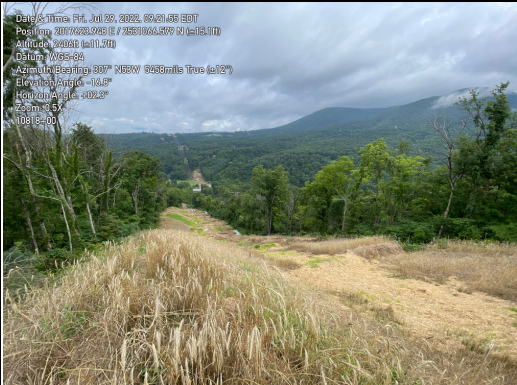
GPS Location		7		GPS Location		8					
Field Station#		10818+00		Field Station#		10809+04					
Pic 7 Desc.		Section of RoW showing conditions and controls.		Pic 8 Desc.		S-Z14.

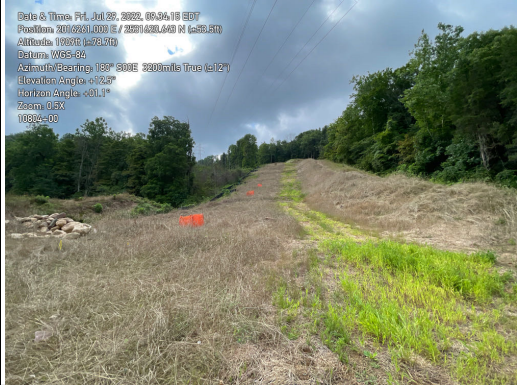
GPS Location		9		GPS Location		10					
Field Station#		10804+00		Field Station#		10801+52					
Pic 9 Desc.		Section of RoW showing conditions and controls.		Pic 10 Desc.		S-Z11/S-Z12/S-Z13.

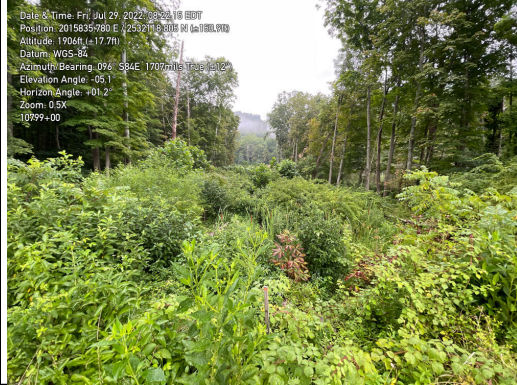
GPS Location		11		GPS Location							
Field Station#		10799+00		Field Station#							
Pic 11 Desc.		S-Z10/W-Z3.		Pic 12 Desc.
