Visual Site Inspection Report

| Project Name | H-600 Pipeline Spread G | AFE | 124300137 | Spread | H-600 Pipeline Spread G |
| Permit # | TBD | Inspection Type | VA SWPP | Station Begin | 10929+80 |

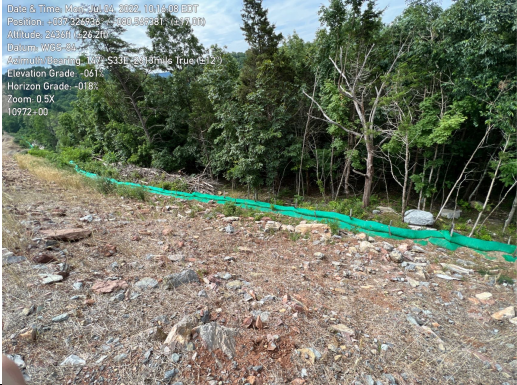
| AFE 124300137 | | Date/Time | 7/4/2022 2:10 PM | Report # | |
|---|--|--|---|---|--|
| Field Station# | | 10972+00 | | Field Station# | |

| AFE 124300137 | | Date/Time | 7/4/2022 2:10 PM | Report # | |
|---|--|--|---|---|--|
| Pic 7 Desc. | | CFS triple stack perimeter control in place | | Pic 8 Desc. | |

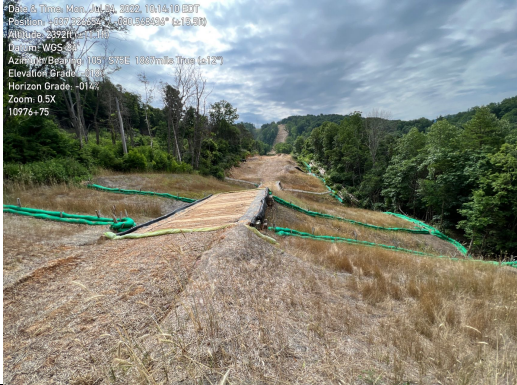
| AFE 124300137 | | Date/Time | 7/4/2022 2:10 PM | Report # | |
|---|--|--|---|---|--|
| | | | | Cleanwater drainage feature in place | |

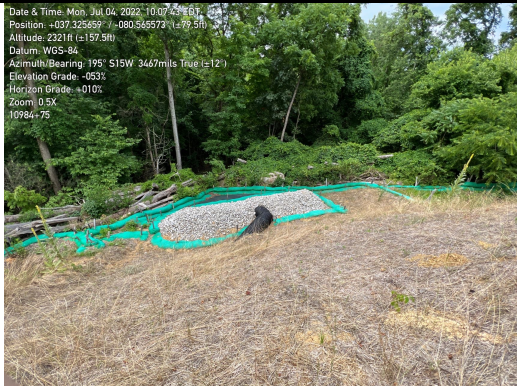
| AFE 124300137 | | Date/Time | 7/4/2022 2:10 PM | Report # | |
|---|--|--|---|---|--|
| Field Station# | | 10984+75 | | Field Station# | |

| AFE 124300137 | | Date/Time | 7/4/2022 2:10 PM | Report # | |
|---|--|--|---|---|--|
| Pic 9 Desc. | | Cleanwater diversion outlet protection in place | | Pic 10 Desc. | |

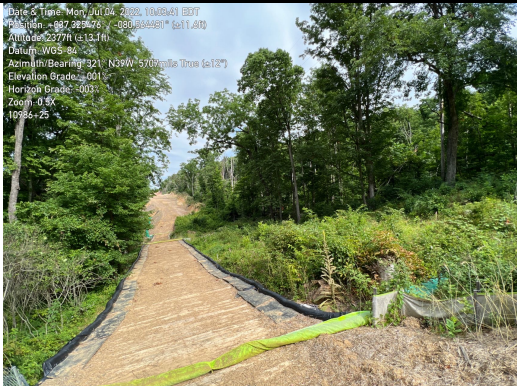
| AFE 124300137 | | Date/Time | 7/4/2022 2:10 PM | Report # | |
|---|--|--|---|---|--|
| | | | | Stream buffer in place | |

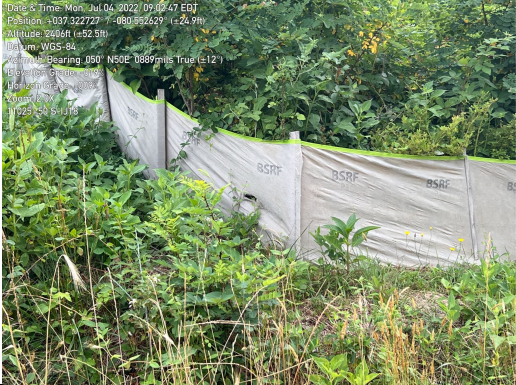
| Pic 1 Desc. | Damaged silt fence | Pic 2 Desc. | Approach to the S-IJ18 stream resource and well vegetated buffer zones. | | |

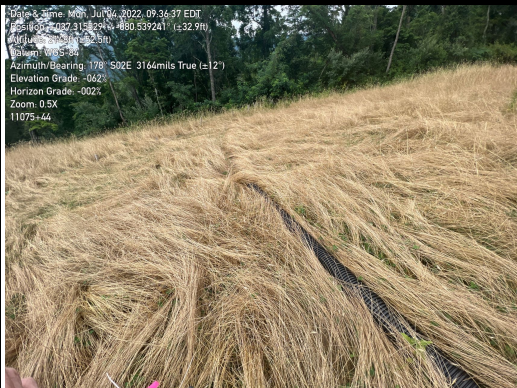
| Pic 9 Desc. | Permanent and final restoration conditions. Over flow drain pipe from private well remains functional | | Pic 10 Desc. | AR 245.02 and perimeter CFS, Final restoration area. | |

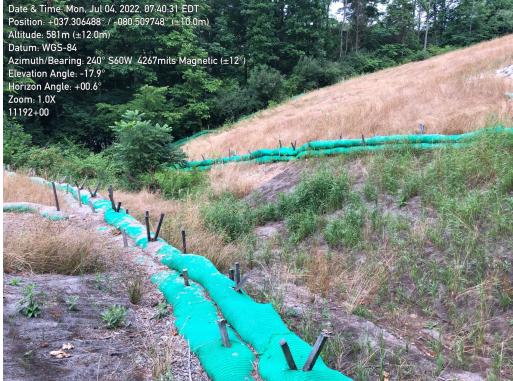
| Pic 3 Desc. | ROW is stable with ECDs in place. | | Pic 4 Desc. | ROW stable with ECDs in place. | |

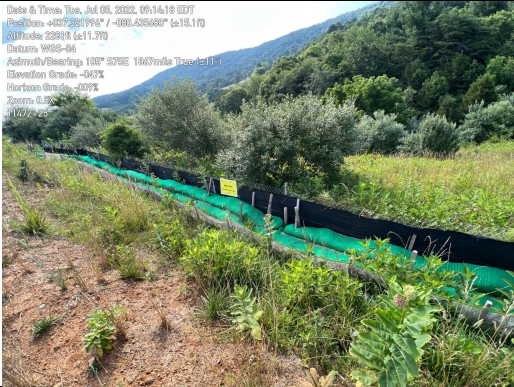
| AFE 124300137 | | Date/Time | 7/5/2022 11:05 AM | Report # | |
|---|--|--|---|---|--|
| Field Station# | | 11472+25 | | Field Station# | |

| AFE 124300137 | | Date/Time | 7/5/2022 11:05 AM | Report # | |
|---|--|--|---|---|--|
| Pic 1 Desc. | | Triple protection ECDs in place at karst feature | | Pic 2 Desc. | |

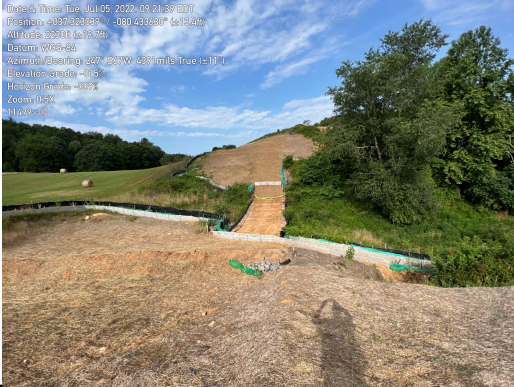
| AFE 124300137 | | Date/Time | 7/5/2022 11:05 AM | Report # | |
|---|--|--|---|---|--|
| Field Station# | | 11479+00 | | Field Station# | |

| AFE 124300137 | | Date/Time | 7/5/2022 11:05 AM | Report # | |
|---|--|--|---|---|--|
| Pic 3 Desc. | | Cleanwater drainage feature in place | | Pic 4 Desc. | |

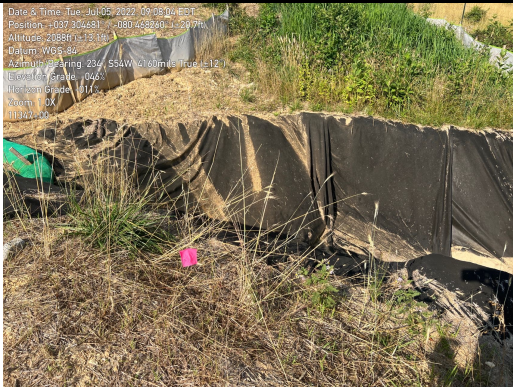
| <p>Completed a SWPP inspection from station # 11254+99 to 11353+67 (MP 213.6-215.04) Rte 42 to Old Furnace Rd. "Station numbers are approximate."</p> <p>Deficiencies Observed: Sediment packed P1 silt fence and Damaged filter lined fabric in presumed Karst sump pit, both at or near location 11347+00. This has been communicated to the LEI and the Precision environmental coordinator. This has been documented to the punch list for repairs.</p> <p>Observances: The ROW has been temporarily stabilized and remains at a stable repose overall.</p> <p>There is slightly visible temporary grasses throughout the areas of inspection. The water bars and compost sock remain in a functional condition in these areas as well as all other areas of inspection. Steep slopes have erosion control fabric (CC4) installed. There is limited visible growth where the CC4 ECB have been installed. There is visible vegetation that has began to re-emerge through out the travel lane area. Slope drains are functioning as intended without issues. Stone inlet protections are also functional at this time. There are three stream resources in the areas of inspection. Conditions are as follows:</p> <p>S-MM18 - near 11292+80 - Equipment bridge functional, vegetated buffer zones remain undisturbed. ECD's protecting resource functioning with no maintenance required.</p> <p>S-NN12 - near 11327+80 - Equipment bridge functional, vegetated buffer zones remain undisturbed. ECD's protecting resource functioning with no maintenance required.</p> <p>S-NN11 - near 11352+97 - Equipment bridge functional, vegetated buffer zones remain undisturbed. ECD's protecting resource functioning with no maintenance required.</p> | | | | | |

| AFE | | 124300137 | | Date/Time | | 7/5/2022 12:36 PM | | Report # | | | | | | | |
|---|--|---|--|--|--|---|--|--|--|--|--|--|--|--|--|
| Pic 1 Desc. | | View of damaged filter fabric lining to the presumed sump pit. Also in view is the silt matted P1 silt fence. | | | | Pic 2 Desc. | | Steep slope temporary vegetation and functional water bar conditions. | | | | | | | |

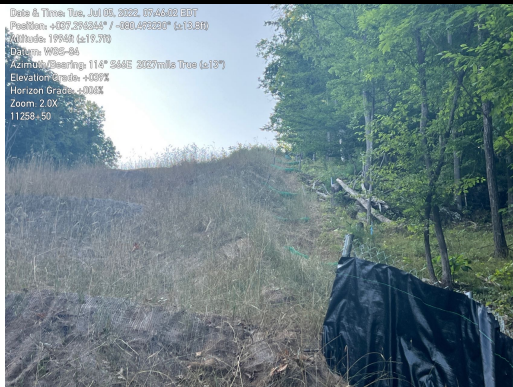
| AFE | | 124300137 | | Date/Time | | 7/5/2022 12:36 PM | | Report # | | | | | | | |
|---|--|---|--|--|--|---|--|--|--|--|--|--|--|--|--|
| Pic 3 Desc. | | Perimeter super silt fence conditions | | | | Pic 4 Desc. | | Steep slope temporary stabilization. | | | | | | | |

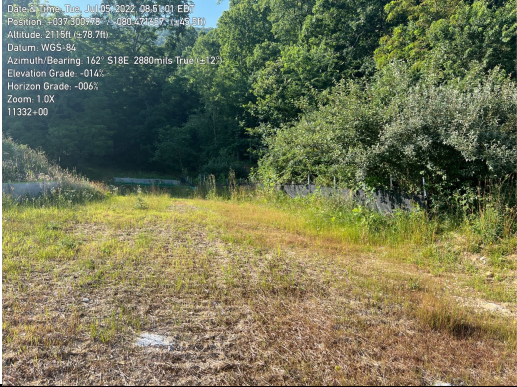
| Pic 13 Desc. | View of temporary stabilization within the ATWS. | Pic 14 Desc. | View of recently repaired water bar throat. | | |

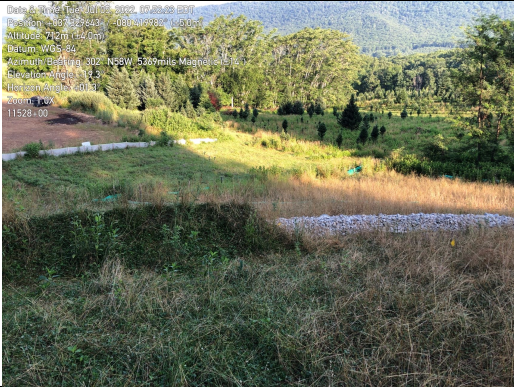
| Pic 1 Desc. | ROW stable with ECDs in place. | Pic 2 Desc. | ROW stable with ECDs in place. | | |

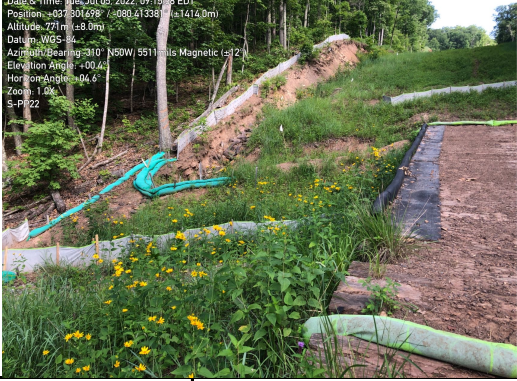
| AFE 124300137 | | Date/Time | 7/5/2022 10:28 AM | Report # | |
|---|--|--|---|---|--|
| Field Station# | | 11568+22 | | Field Station# | |

| AFE 124300137 | | Date/Time | 7/5/2022 10:28 AM | Report # | |
|---|--|--|---|---|--|
| Pic 7 Desc. | | The S-PP22 crossing is stable. | | Pic 8 Desc. | |

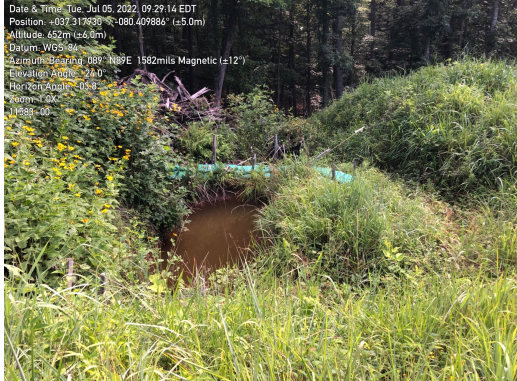
| AFE 124300137 | | Date/Time | 7/5/2022 10:28 AM | Report # | |
|---|--|--|---|---|--|
| Field Station# | | 11583+00 | | Field Station# | |

| AFE 124300137 | | Date/Time | 7/5/2022 10:28 AM | Report # | |
|---|--|--|---|---|--|
| Pic 9 Desc. | | No erosion issues or sediment migration beyond LOD. | | Pic 10 Desc. | |

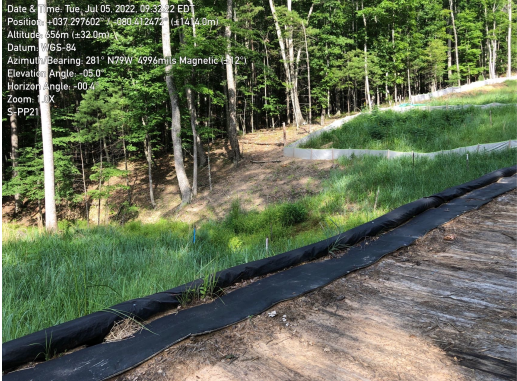
| AFE 124300137 | | Date/Time | 7/5/2022 10:28 AM | Report # | |
|---|--|--|---|---|--|
| | | | | The S-PP21 crossing is stable. | |

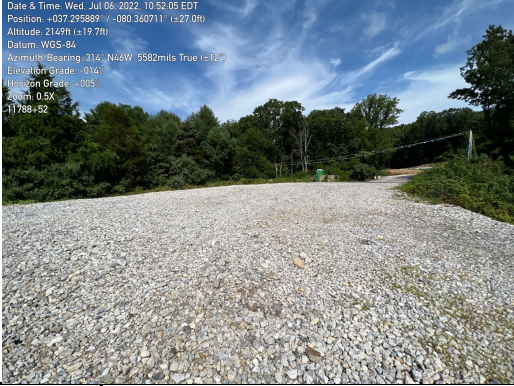
| Pic 1 Desc. | RCE in place | Pic 2 Desc. | Permanent vegetation present | | |

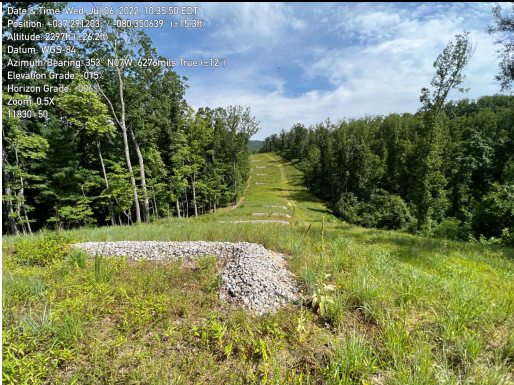
| Pic 3 Desc. | Permanent waterbars with level spreaders in place | Pic 4 Desc. | Level spreader in place | | |

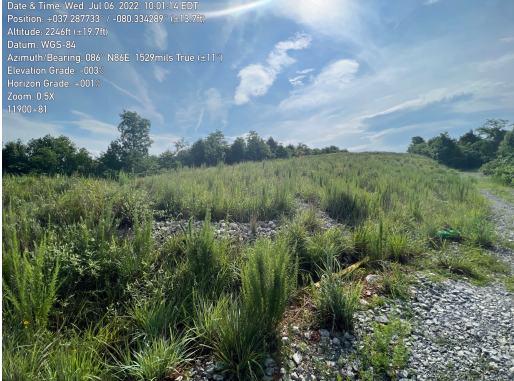
| Pic 1 Desc. | Final Restoration area. | Pic 2 Desc. | Perimeter CFS controls. | | |

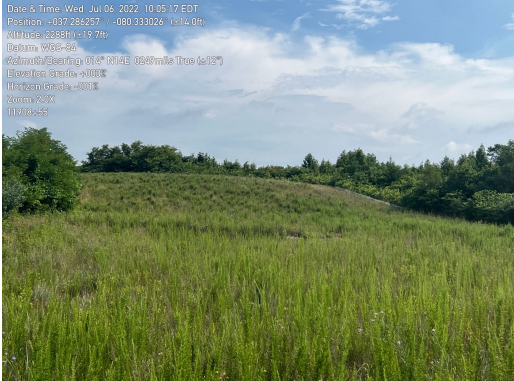
| Pic 3 Desc. | Permanent vegetative row status. No Issues. | Pic 4 Desc. | Level spreader and well vegetated row conditions. | | |

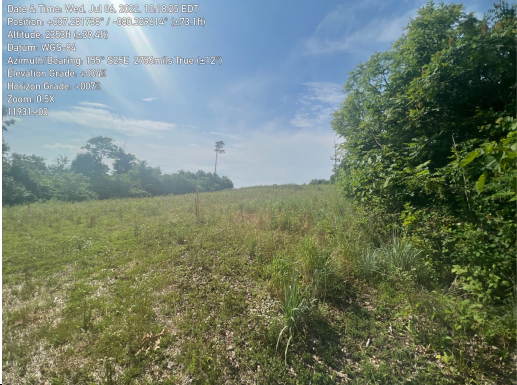
| Pic 7 Desc. | Final restoration area. | Pic 8 Desc. | End treatment to sump pit broad based dip on AR 266.0 | | |

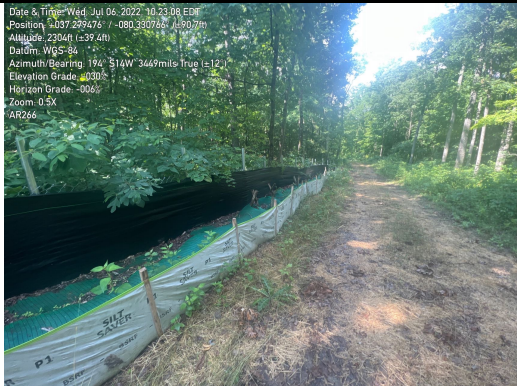
| Pic 9 Desc. | Station number approximate. View of AR 266.0 perimeter controls. No Issues at this time. | Pic 10 Desc. | Station number approximate. Road side ditch stabilization with CC4 ECB. | | |

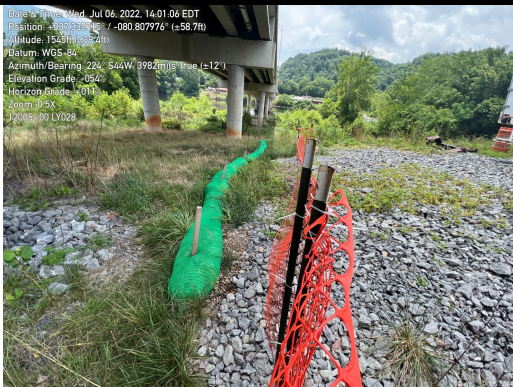
| Pic 1 Desc. | Perimeter CFS controls. | | Pic 2 Desc. | Transit bus storage area. | |

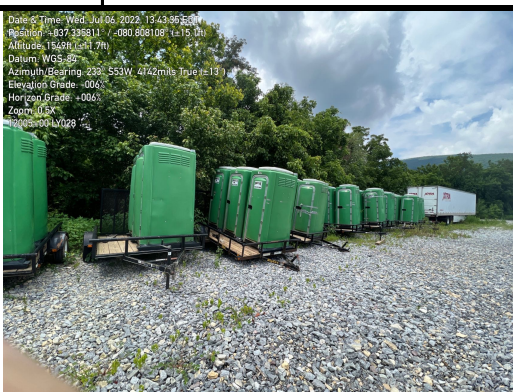
| Pic 3 Desc. | Porta-Jon storage area. | | Pic 4 Desc. | RCE and equipment storage area at LY028 | |

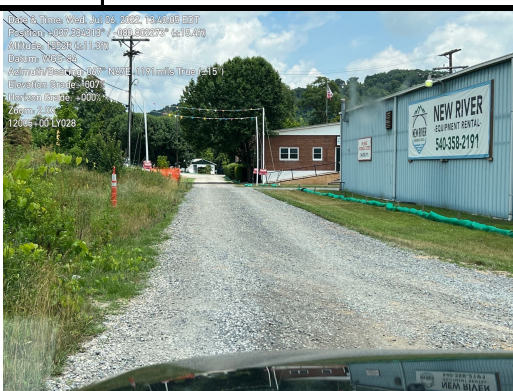
| Pic 5 Desc. | RCE entrance conditions to the LY028. No Issues observed at this time. | | Pic 6 Desc. | | |

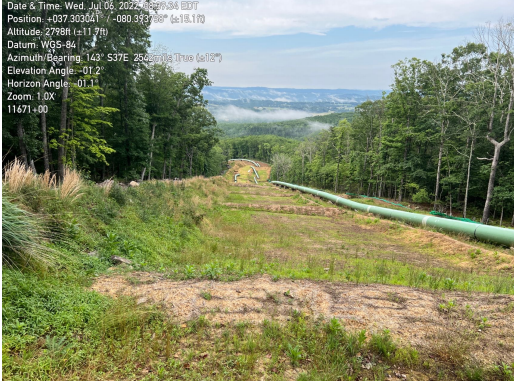
| Pic 1 Desc. | Waterbars | Pic 2 Desc. | Slope Drains and inlets | | |

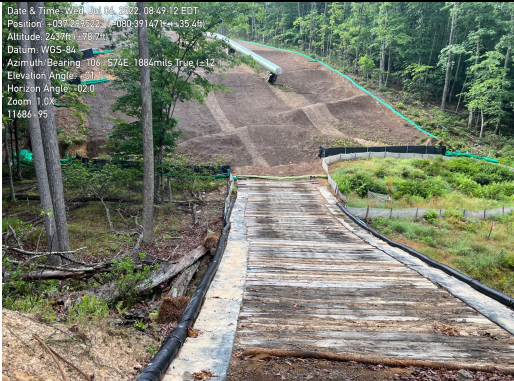
| Pic 3 Desc. | Equipment Bridge | Pic 4 Desc. | Stabilization | | |

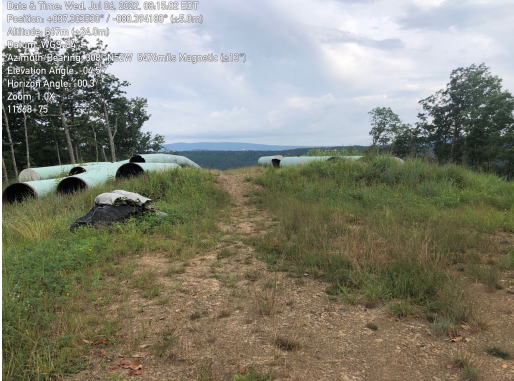
| Pic 1 Desc. | Top of Brush Mountain stable. No evidence of vandalism discovered. | Pic 2 Desc. | ROW stable. Slope breakers in good condition. | | |

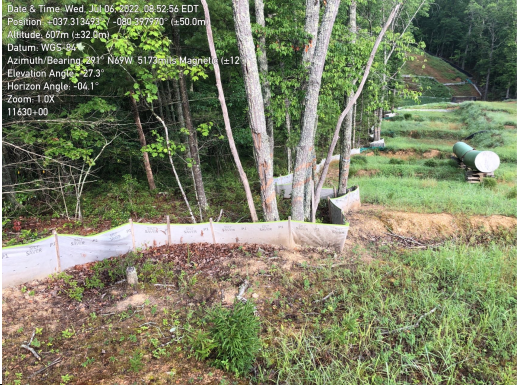
| Pic 7 Desc. | Perimeter ECDs in place and in acceptable condition. | Pic 8 Desc. | The S-HH18 crossing is stable. | | |

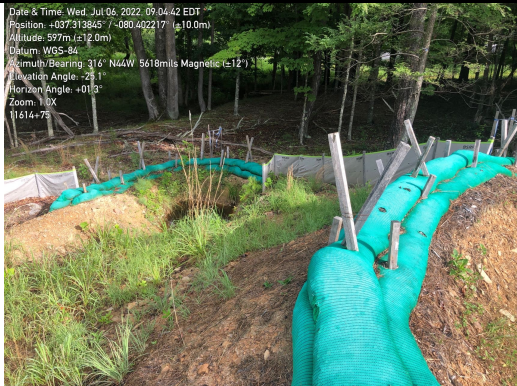
| Pic 9 Desc. | End treatments functional. | Pic 10 Desc. | S-RR14 crossing is stable. | | |

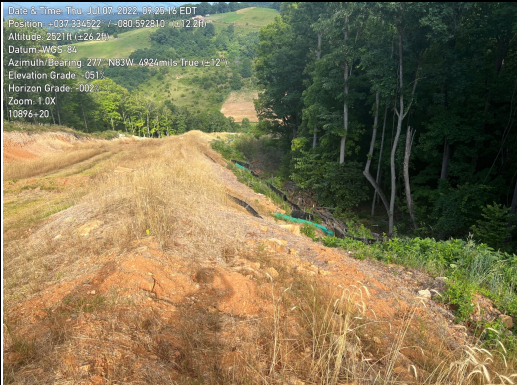
| Pic 7 Desc. | Perimeter super silt fence protecting a known off site karst area. | Pic 8 Desc. | Plunge pool conditions | | |

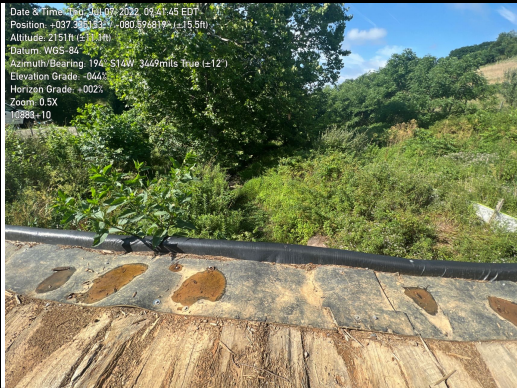
| Pic 9 Desc. | S-A32 stream resource found well vegetated and adequate ECD installation | Pic 10 Desc. | TLS and stabilization | | |

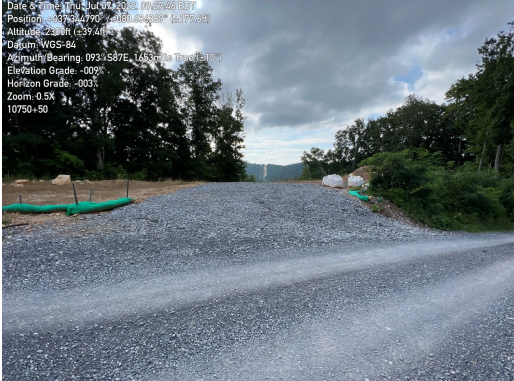
| Pic 1 Desc. | RCE in place | Pic 2 Desc. | Waterbars in place | | |

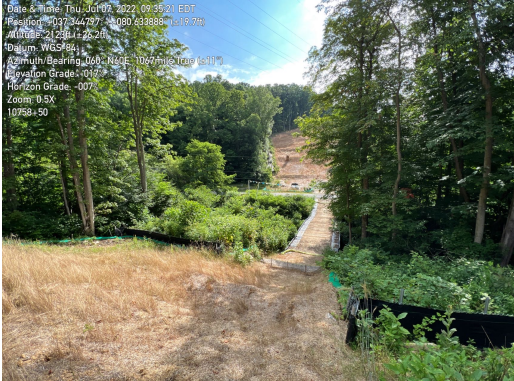
| Pic 3 Desc. | Stream buffer in place | Pic 4 Desc. | Stone inlet protection in place | | |

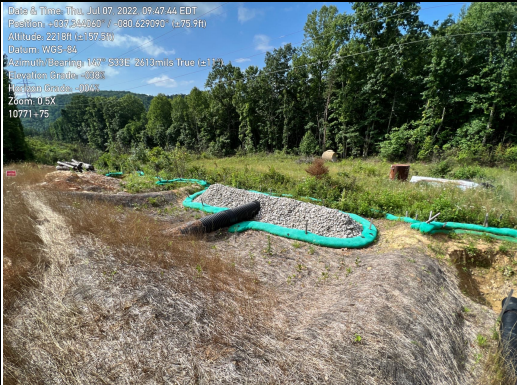
| AFE | | 124300137 | Date/Time | 7/7/2022 3:36 PM | Report # | |
|---|--|---|--|---|---|---|
| Pic 7 Desc. | | Cleanwater diversion outlet protection in place | | Pic 8 Desc. | | Cleanwater drainage feature in place |

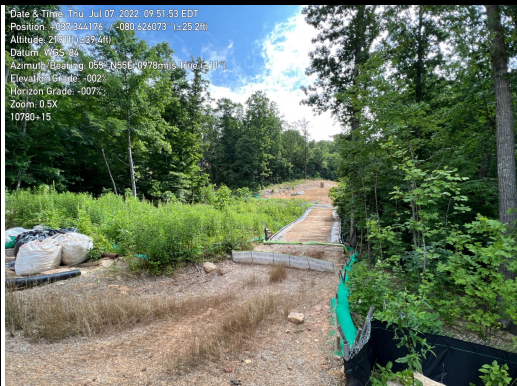
| AFE | | 124300137 | Date/Time | 7/7/2022 3:36 PM | Report # | |
|---|--|---|--|---|---|---|
| Pic 9 Desc. | | Stream buffer in place | | Pic 10 Desc. | | CFS perimeter control in place |

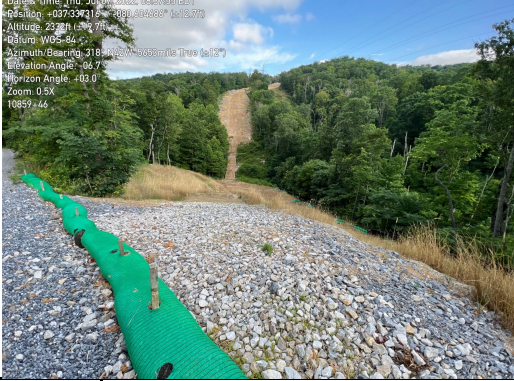
| Pic 1 Desc. | RCE | Pic 2 Desc. | Stream Overview | | |

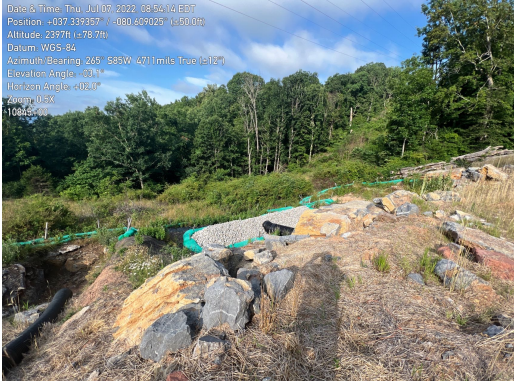
| Pic 3 Desc. | Clean water diversion outlet protection | Pic 4 Desc. | Stabilization | | |

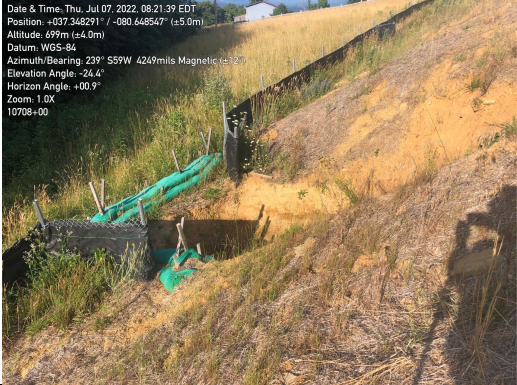
| Pic 7 Desc. | No issues being caused by runoff. Perimeter ECDs effective. | Pic 8 Desc. | ROW stable with ECDs in place. | | |

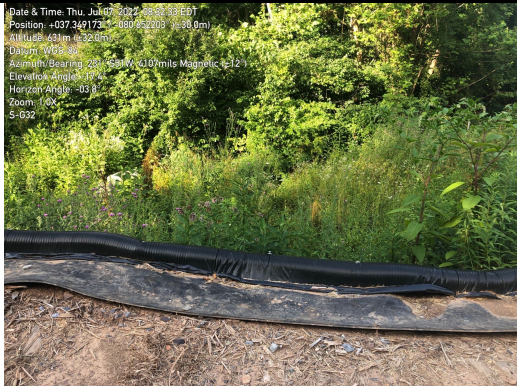
| Pic 9 Desc. | The S-G32 crossing is stable. | Pic 10 Desc. | The S-G30 crossing is stable. | | |

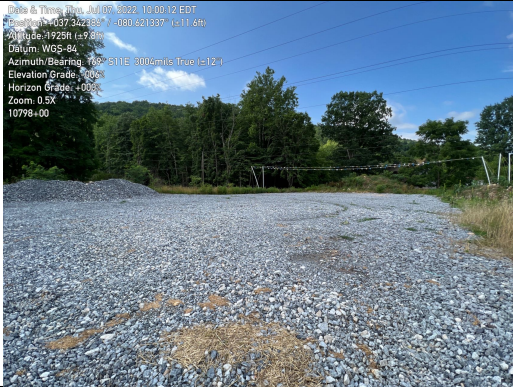
| AFE | | 124300137 | | Date/Time | | 7/8/2022 3:43 PM | | Report # | | | | | | | |
|---|--|---|--|--|--|---|--|---|--|--|--|--|--|--|--|
| Pic 1 Desc. | | | | RCE in place | | | | Pic 2 Desc. | | | | Permanent vegetation present | | | |

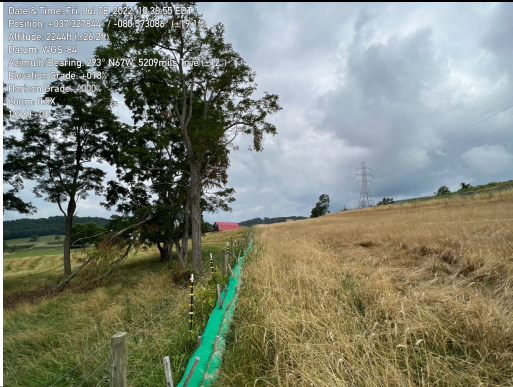
| AFE | | 124300137 | | Date/Time | | 7/8/2022 3:43 PM | | Report # | | | | | | | |
|---|--|---|--|--|--|---|--|---|--|--|--|--|--|--|--|
| Pic 3 Desc. | | | | CFS triple stack perimeter control in place | | | | Pic 4 Desc. | | | | Triple protection ECDs in place at karst feature | | | |

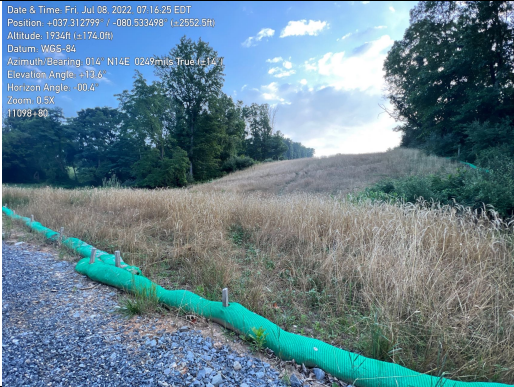
| Pic 1 Desc. | Restoration | Pic 2 Desc. | CFS Waterbars | | |

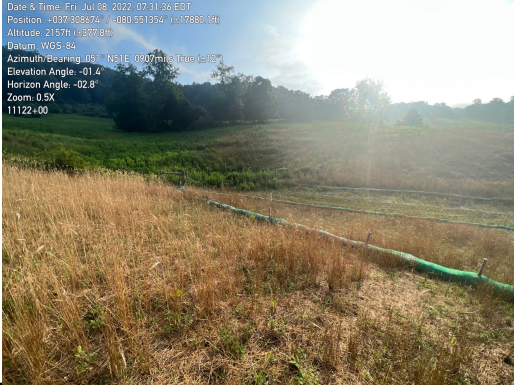
| Pic 3 Desc. | Section of ROW showing conditions and controls | Pic 4 Desc. | Level Spreader | | |
