Visual Site Inspection Report

Project Name	H-600 Pipeline Spread H	AFE	124300138	Spread	H-600 Pipeline Spread H
Contractor	Precision			Report #	40227
Inspector	Bryan Cole			Date/Time	7/25/2022 1:14 PM
Permit #	TBD	Inspection Type	VA SWPP	Station Begin	13141+65
State	VA	Inspection Area	Partial	Station End	13316+21
County	Franklin	Ground	Dry	Temperature (°F)	92.00
Municipality	N/A	Weather	Sunny	Rain Gauge (in)	0.00
				Rain Accumulation Time (days)	0.00

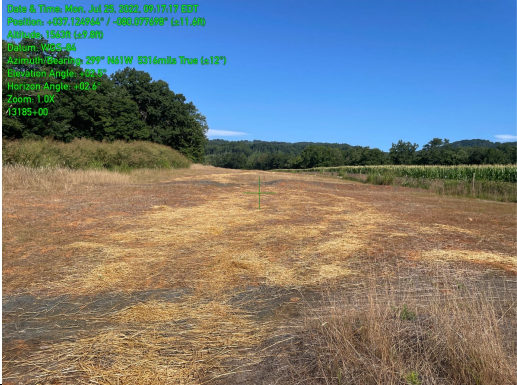
GPS Location	0	GPS Location	0		
Field Station#	13185+00	Field Station#	13193+00		
Pic 7 Desc.	ROW and ECDs In good condition		Pic 8 Desc.	ROW and ECDs In good condition	
<p>Date & Time: Mon, Jul 25, 2022, 09:40:49 EDT Position: +037.122758° / -080.076040° (s15.30) Altitude: 1400ft (s11.40) Datum: WGS-84 Azimuth/Bearing: 185° S32W 3785mils True (s12°) Elevation Angle: -09.3° Horizon Angle: -09.3° Zoom: 1.0X 13196+31</p>

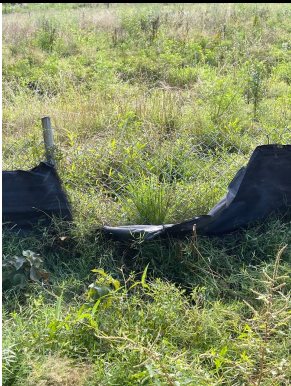
GPS Location	0	GPS Location	0		
Field Station#	13196+31	Field Station#	13196+31		
Pic 9 Desc.	3rd party damage to sock along access road, received approval to remove sock. 72 hour maintenance item		Pic 10 Desc.	3rd party damage to fence fabric along access road. 72 hour maintenance item	
<p>Date & Time: Mon, Jul 25, 2022, 12:30:11 EDT Position: +037.122880° / -080.076040° (s15.10) Altitude: 1408ft (s11.70) Datum: WGS-84 Azimuth/Bearing: 185° S04W 3307mils True (s12°) Elevation Angle: -09.9° Horizon Angle: +02.2° Zoom: 0.5X 13196+31</p>

E&S BMPs	Compliance Level	Corrective Action	Corrective Time Frame	Date Repaired
Cleanwater Diversion Berm	Acceptable			
Compost Filter Sock	Acceptable			
Equipment Bridge	Acceptable			
Erosion Control Blanket	Acceptable			
3rd Party Damages	Communication	Cattle damage to sock, remove - 72		7/25/2022
Silt Fence (Reinforce Filter Fence)	Acceptable			
Silt Fence (Reinforced Filter Fabric Fence)	Communication	Cattle damage to fabric, repair - 72h		7/25/2022
Slope Drain Pipe	Acceptable			
Waterbar	Acceptable

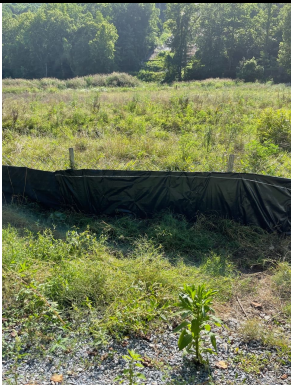
<p>ert image here</p>			
GPS Location	0	GPS Location	0		
Field Station#	13196+31	Field Station#	13196+31		
Pic 11 Desc.	Sock removed along access road and mulch spread from 3rd party cattle damage.		Pic 12 Desc.	Fence fabric repaired along access road from 3rd party cattle damage

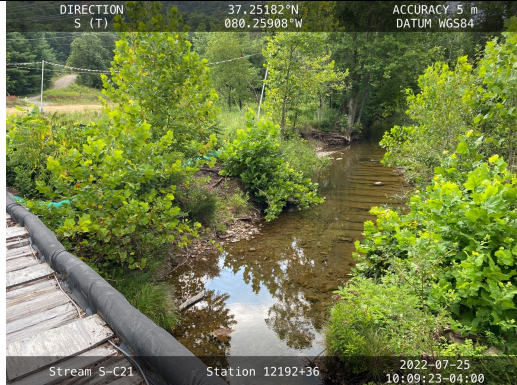
Pic 11 Desc.	Photo shows downstream view of S-C21 from the equipment bridge spanning the stream channel.		Pic 12 Desc.	Photo shows straw mulch recently installed on the going away side of ST RTE 629 BRADSHAW road where stabilization was thin.

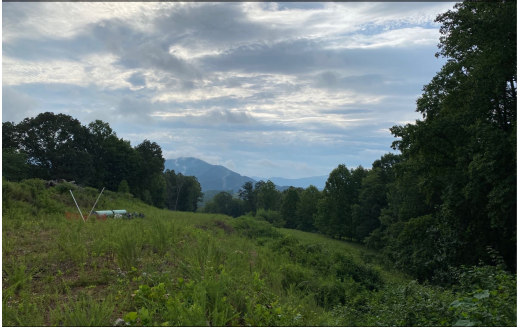
Station 12090+00 2022-07-26 09:02:34-04:00				DIRECTION SE (T) 37.25855°N 080.29127°W ACCURACY 11 m DATUM WGS84

Station 12093+00 2022-07-26 09:05:16-04:00	
GPS Location	Please see photo for details.		GPS Location	Please see photo for details.	
Field Station#	12090+00		Field Station#	12093+00	
Pic 13 Desc.	Photo shows the stabilized ROW conditions with water bars and that all ECDs are installed and are functioning as designed.		Pic 14 Desc.	Photo shows stabilized ROW conditions and view of clean water diversion pipe while standing on CWD on the coming in side.	
DIRECTION W (T) 37.25796°N 080.28989°W ACCURACY 19 m DATUM WGS84

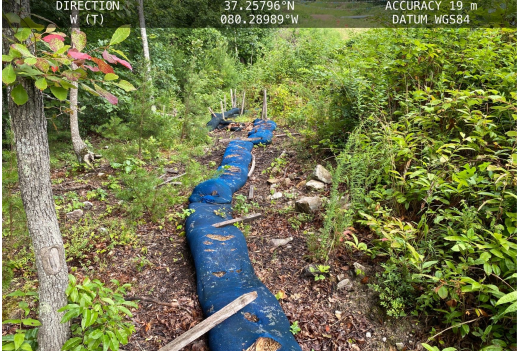
Station 12094+00 12095+00 2022-07-26 09:08:35-04:00				DIRECTION SW (T) 37.25824°N 080.28578°W ACCURACY 5 m DATUM WGS84

GPS Location	Please see photo for details.		GPS Location	Please see photo for details.	
Field Station#	12094+00		Field Station#	12108+41	
Pic 15 Desc.	Photo shows punch list item of perimeter CFS in need of holes being repaired from station 12094+00 to station 12095+00.		Pic 16 Desc.	Photo shows overview of Stream S-F15 and its buffer zone from the going away side while standing on clean water diversion.	
DIRECTION SE (T) 37.25799°N 080.28909°W ACCURACY 18 m DATUM WGS84

7. Identify all remedial measures that have been taken since the previous inspection was conducted. One remedial measure was observed and found to be completed since the last VA DEQ SWPPP inspection. This consisted of, Repair or replace panel of P1 at 12013+97. (MVP-MN-268.01).					
Comments (Reference above questions as appropriate.) Attended morning virtual conference call for inspection at 6:30am then traveled to MVP-MN-268.01. Here, the VA DEQ SWPPP inspection was performed on this date. From station 12005+00 to station 12119+17 the ROW was walked to evaluate that all ECDs are installed and functioning as designed along with the ROW that had been previously disturbed and is now inactive has been properly stabilized with either straw mulch, erosion control blanket or temporary or permanent vegetation. In which appeared to be adequate. - Final result of all areas observed and evaluated in todays inspection were found to be in compliance and have no environmental issues, no off ROW sediment as well as no stream or wetland impacts. - The ECDs observed today appeared to be installed and functioning as designed. Some of the ECDs are showing some wear but are still functioning. - Located within todays SWPPP inspection area are the following resources that were evaluated and observed. Stream S-SG36 located at station number 12008+53. Stream S-G38 located at station number 12015+84. Stream S-G39 located at station number 12031+51. Stream S-G40 located at station number 12035+11. Stream S-PP23 located at station number 12035+75. Stream S-MM15 located at station number 12076+95. Stream S-MM14 located at station number 12086+56. Stream S-MM13 located at station number 12098+44. Stream S-MM11 located at station number 12101+57. Stream S-F15 located at station number 12108+41. Stream S-F16A/B located at station number 12112+23. Wetland W-F9-PFO located from station number 12108+40 to station number 12109+05. * Three punch list items were found during todays VA DEQ SWPPP inspection and are as follows: (1) Repair holes in perimeter CFS from 12080+00 to 12080+50 (2) Repair holes in perimeter CFS from 12094+00 to 12095+00 (3) Repair hole in P1 silt fence at 12118+00.

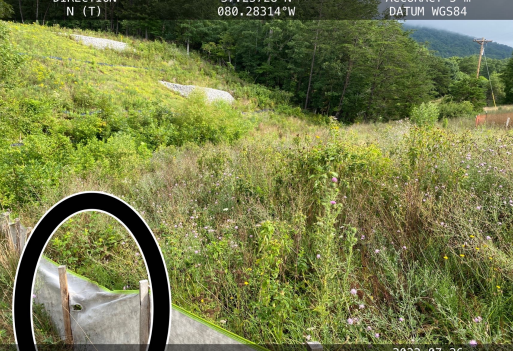
Station 12118+00 2022-07-26 09:30:56-04:00	
GPS Location	Please see photo for details.		GPS Location	Please see photo for details.	
Field Station#	12109+62		Field Station#	12118+00	
Pic 17 Desc.	Photo shows MVP-MN-271, RCE on the going away side and the coming in side buffer zone for Stream S-F16A/B.		Pic 18 Desc.	Photo shows punch list item of hole in P1 silt fence and permanent waterbars equipment with level spreaders in final restoration area.

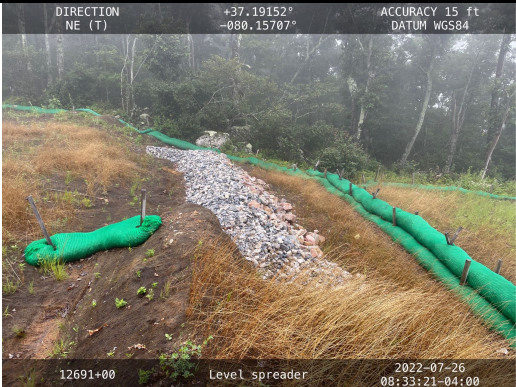
<p>DIRECTION NE (T) +37.19152° -080.15707° ACCURACY 15 ft DATUM WGS84</p> <p>12691+00 Level spreader 2022-07-26 08:33:21-04:00</p>

<p>DIRECTION W (T) +37.19175° -080.15714° ACCURACY 22 ft DATUM WGS84</p> <p>12689+00 RCE at Honeysuckle 2022-07-26 08:35:32-04:00</p>	
GPS Location	See photo for gps location data.		GPS Location	See photo for gps location data.	
Field Station#	12691+00		Field Station#	12689+00	
Pic 1 Desc.	Photo shows the level spreader.		Pic 2 Desc.	Photo shows the RCE at Honeysuckle Road.

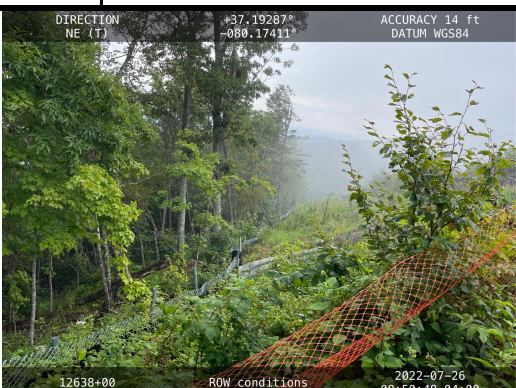
<p>DIRECTION NE (T) +37.19287° -080.17411° ACCURACY 14 ft DATUM WGS84</p> <p>12638+00 ROW conditions 2022-07-26 08:50:48-04:00</p>

Field Station#	12638+00		Field Station#	12629+00	
Pic 3 Desc.	Photo shows ROW condition. ECDs are installed and functioning as designed.		Pic 4 Desc.	Photo shows ROW condition. ECDs are installed and functioning as designed.

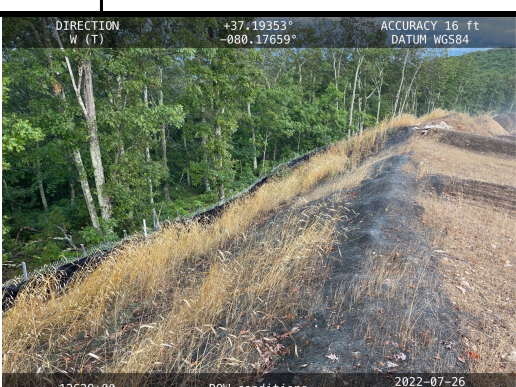
<p>DIRECTION W (T) +37.19353° -080.17659° ACCURACY 16 ft DATUM WGS84</p> <p>12629+00 ROW conditions 2022-07-26 08:55:47-04:00</p>

<p>DIRECTION NW (T) +37.19402° -080.17680° ACCURACY 12 ft DATUM WGS84</p> <p>12627+00 ROW conditions 2022-07-26 08:56:49-04:00</p>	
GPS Location	See photo for gps location data.		GPS Location	See photo for gps location data.	
Field Station#	12629+00		Field Station#	12627+00	
Pic 5 Desc.	Photo shows ROW condition. ECDs are installed and functioning as designed.		Pic 6 Desc.	Photo shows ROW condition. ECDs are installed and functioning as designed.

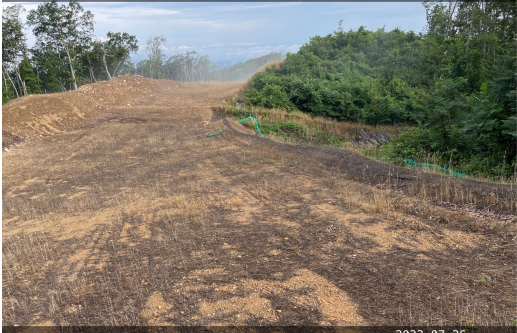
12619+00 ROW conditions 2022-07-26 09:00:52-04:00		DIRECTION +37.19647° ACCURACY 16 ft W (T) -080.17994° DATUM WGS84

12615+00 Slope drain 2022-07-26 09:03:37-04:00			
GPS Location	See photo for gps location data.		GPS Location	See photo for gps location data.	
Field Station#	12619+00		Field Station#	12615+00	
Pic 7 Desc.	Photo shows ROW condition. ECDs are installed and functioning as designed.		Pic 8 Desc.	Photo shows the slope drain.	
DIRECTION +37.19658° ACCURACY 15 ft NW (T) -080.18002° DATUM WGS84

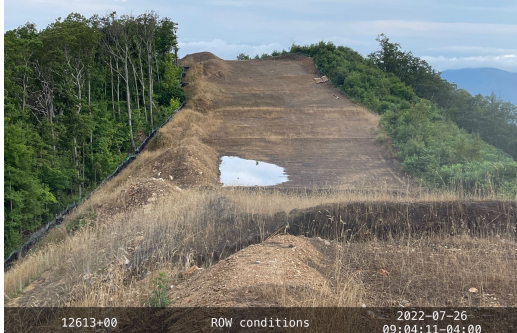
12613+00 ROW conditions 2022-07-26 09:04:11-04:00		DIRECTION +37.19252° ACCURACY 15 ft NW (T) -080.17484° DATUM WGS84

Field Station#	12613+00		Field Station#	12635+00	
Pic 9 Desc.	Photo shows ROW condition. ECDs are installed and functioning as designed.		Pic 10 Desc.	Photo shows ROW condition. ECDs are installed and functioning as designed.	
DIRECTION +37.19068° ACCURACY 16 ft W (T) -080.15359° DATUM WGS84

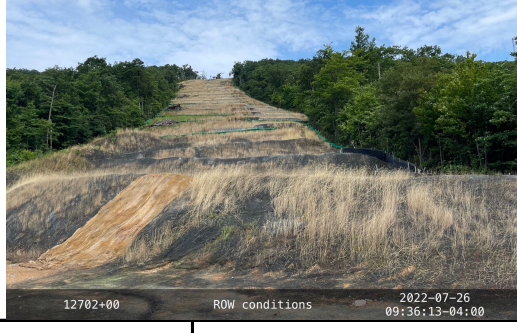
12702+00 ROW conditions 2022-07-26 09:36:13-04:00		DIRECTION +37.19073° ACCURACY 15 ft NE (T) -080.15344° DATUM WGS84

12703+00 ROW conditions 2022-07-26 09:36:29-04:00			
GPS Location	See photo for gps location data.		GPS Location	See photo for gps location data.	
Field Station#	12702+00		Field Station#	12703+00	
Pic 11 Desc.	Photo shows ROW condition. ECDs are installed and functioning as designed.		Pic 12 Desc.	Photo shows ROW condition. ECDs are installed and functioning as designed.

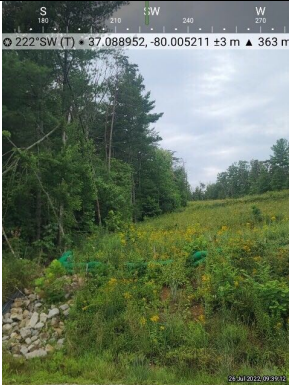
GPS Location	0000	GPS Location	0000		
Field Station#	13496+62	Field Station#	13415+60		
Pic 1 Desc.	Monitored ECDs and rock lined channel during routine inspection at road crossings. No environmental issues observed at the time of inspection.		Pic 2 Desc.	Monitored sump pit and end treatment during routine inspection. No issues were observed at the time of inspection.

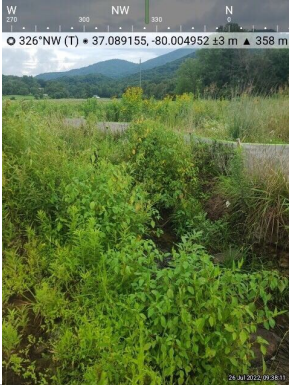
GPS Location	0000	GPS Location	0000		
Field Station#	13498+01	Field Station#	13436+50		
Pic 3 Desc.	Stream observation photo facing upstream during routine inspection. No issues were observed at the time of inspection.		Pic 4 Desc.	Photo showing where a land owner has traveled the row on a ATV, documented as non project related activities.

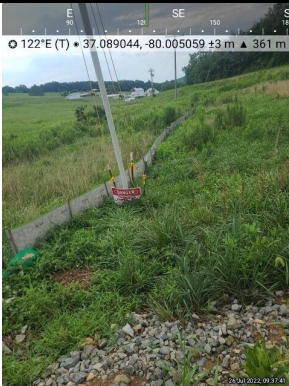
GPS Location	0000	GPS Location	0000		
Field Station#	13497+12	Field Station#	13498+30		
Pic 5 Desc.	Monitored ECDs at anode bed locations, all in place and functioning at the time of inspection.		Pic 6 Desc.	Row photo showing vegetation in permanent area. No issues were observed at the time of inspection.

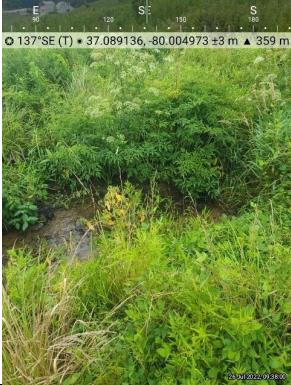
GPS Location	0000	GPS Location	000		
Field Station#	13498+01	Field Station#	13446+10		
Pic 7 Desc.	Stream observation photo facing downstream during routine inspection today. No environmental issues observed at the time of inspection.		Pic 8 Desc.	Monitored ECDs, level spreaders and water bars during routine inspection today. No environmental issues observed at the time of inspection.

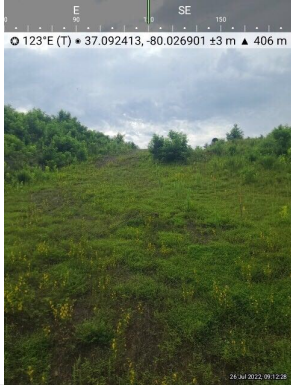
<div style="text-align: center;">Insert image here</div>			
GPS Location	0000	GPS Location			
Field Station#	13416+40	Field Station#			
Pic 9 Desc.	Monitored stabilization on hill side above road crossing. Good stabilization noted.		Pic 10 Desc.		
<div style="text-align: center;">Insert image here</div>		<div style="text-align: center;">Insert image here</div>			
GPS Location		GPS Location			
Field Station#		Field Station#			
Pic 11 Desc.			Pic 12 Desc.

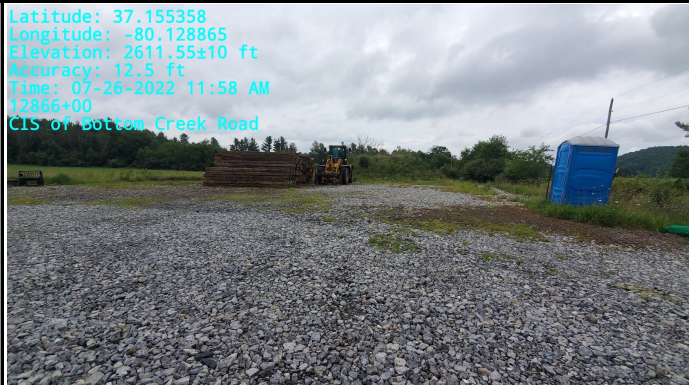
GPS Location	See pic.		GPS Location	See pic.	
Field Station#	12866+00		Field Station#	12866+00	
Pic 17 Desc.	Current ROW conditions.		Pic 18 Desc.	Current ROW conditions.

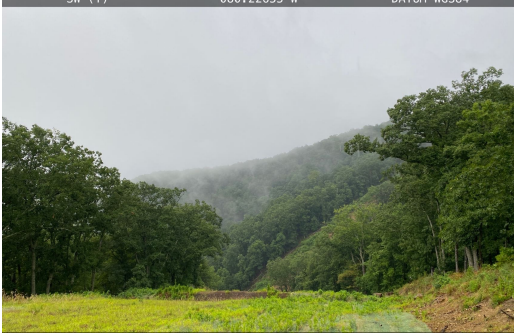
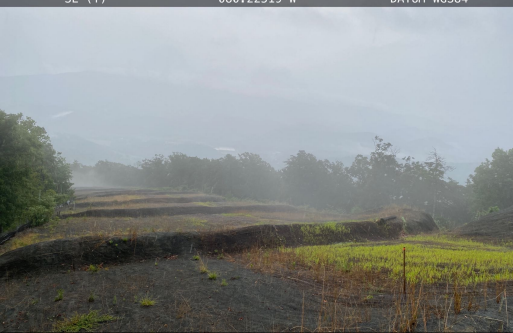
<div>Station 12303+00</div> <div>2022-07-27 08:13:17-04:00</div> </div>			
GPS Location	Please see photo for details.		GPS Location	Please see photo for details.	
Field Station#	12297+00		Field Station#	12303+00	
Pic 1 Desc.	Photo shows the stabilized ROW conditions with water bars and that all ECDs are installed and are functioning as designed.		Pic 2 Desc.	Photo shows the stabilized ROW conditions with water bars and that all ECDs are installed and are functioning as designed.	
<div> <div>DIRECTION E (T)</div> <div>37.25253°N 080.21737°W</div> <div>ACCURACY 5 m DATUM WGS84</div>

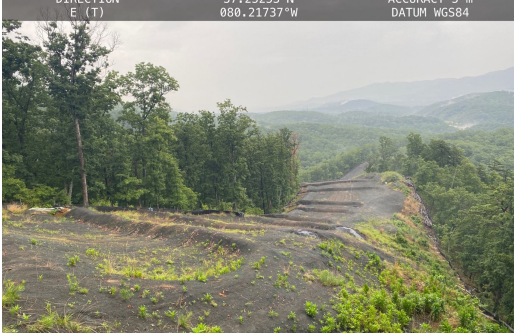
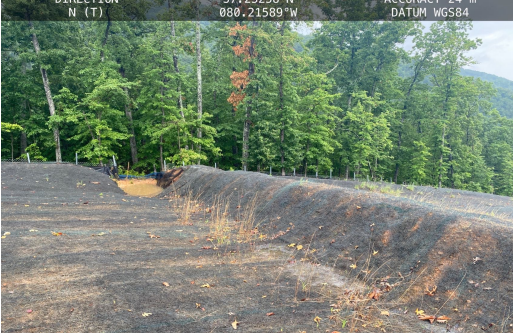
GPS Location	Please see photo for details.		GPS Location	Please see photo for details.	
Field Station#	12328+50		Field Station#	12332+85	
Pic 3 Desc.	Photo shows the stabilized ROW conditions with water bars and that all ECDs are installed and are functioning as designed.		Pic 4 Desc.	Photo shows stabilized ROW conditions and view of an installed water bar, sump and CFS waterbar end treatment.	
<div> <div>DIRECTION E (T)</div> <div>37.25259°N 080.21427°W</div> <div>ACCURACY 17 m DATUM WGS84</div>

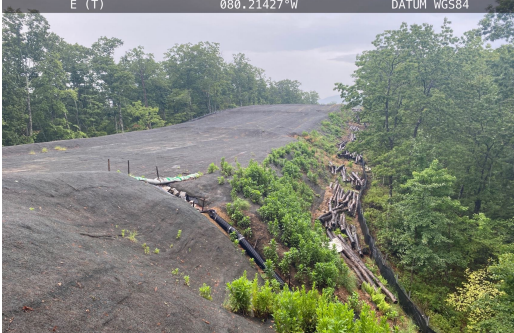
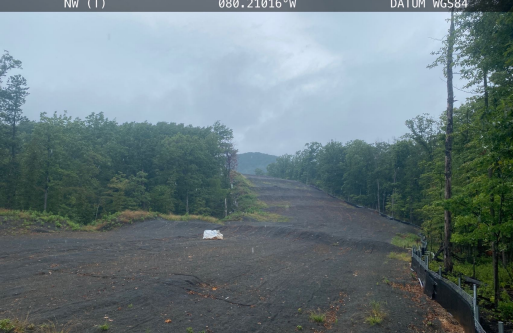
<div>Station 12353+00</div> <div>2022-07-27 08:45:24-04:00</div> </div>			
GPS Location	Please see photo for details.		GPS Location	Please see photo for details.	
Field Station#	12338+25		Field Station#	12353+00	
Pic 5 Desc.	Photo shows stabilized ROW and side slope with slope drain pipes equipped with stone inlet protection and plunge pools to discharge.		Pic 6 Desc.	Photo shows the stabilized ROW conditions with water bars and that all ECDs are installed and are functioning as designed.

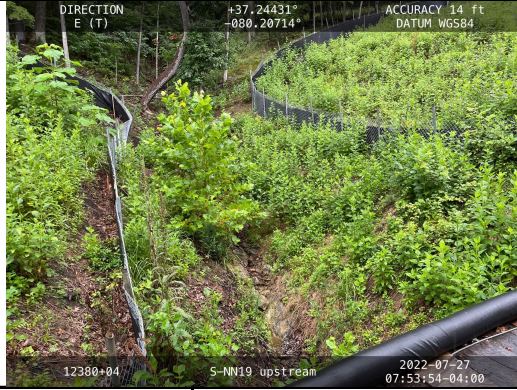
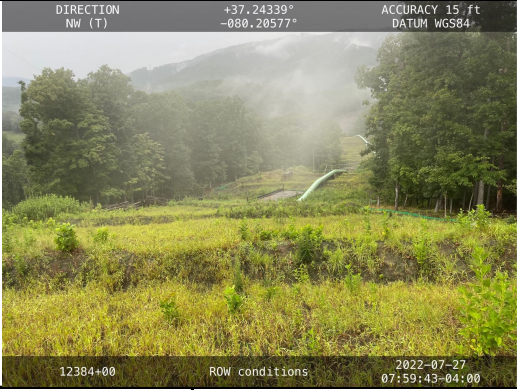
Field Station#	12380+04		Field Station#	12384+00	
Pic 11 Desc.	Photo shows upstream view of Stream S-NN19 from the equipment bridge spanning the stream channel.		Pic 12 Desc.	Photo shows the stabilized ROW conditions with water bars and that all ECDs are installed and are functioning as designed.

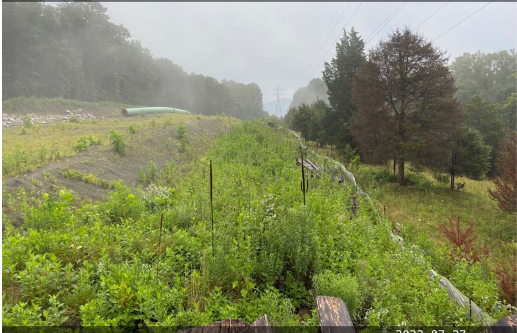
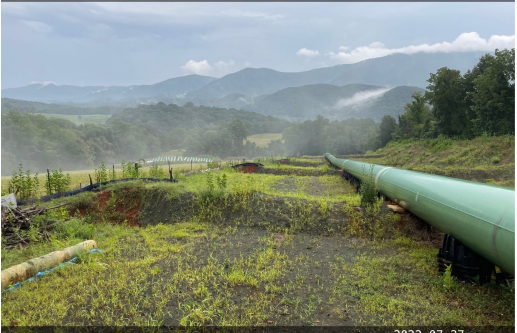
12401+00 ROW conditions 2022-07-27 08:10:23-04:00			
GPS Location	Please see photo for details.		GPS Location	Please see photo for details.	
Field Station#	12387+00		Field Station#	12401+00	
Pic 13 Desc.	Photo shows the stabilized ROW conditions with water bars and that all ECDs are installed and are functioning as designed.		Pic 14 Desc.	Photo shows the stabilized ROW conditions with water bars and that all ECDs are installed and are functioning as designed.	
DIRECTION SE (T) +37.23963° -080.19911° ACCURACY 12 ft DATUM WGS84

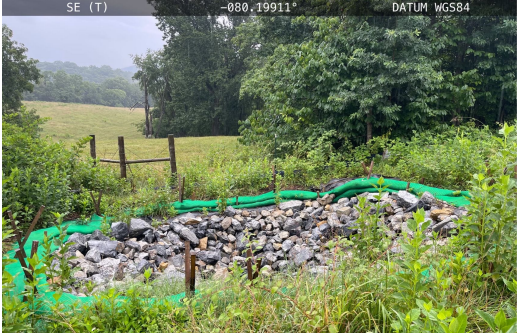
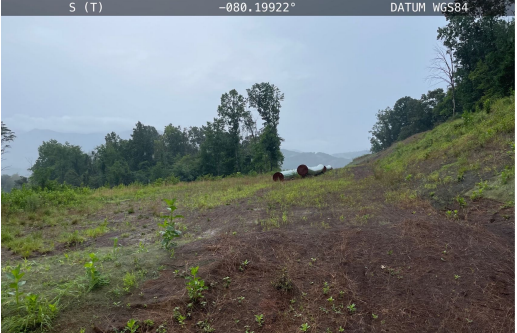
GPS Location	Please see photo for details.		GPS Location	Please see photo for details.	
Field Station#	12410+00		Field Station#	12411+00	
Pic 15 Desc.	Photo shows plunge pool for clean water diversion pipe discharge.		Pic 16 Desc.	Photo shows the stabilized ROW conditions with water bars and that all ECDs are installed and are functioning as designed.	
DIRECTION S (T) +37.23779° -080.19956° ACCURACY 16 ft DATUM WGS84

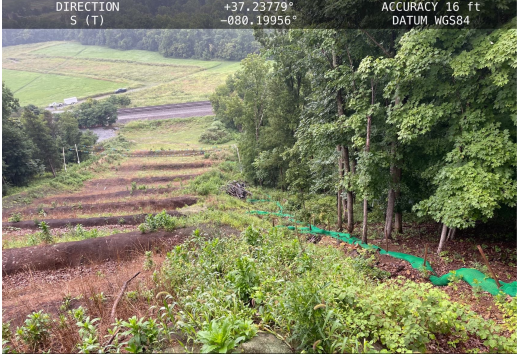
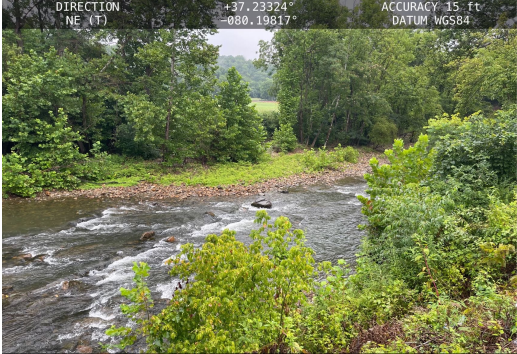
12441+50 S-NN16 2022-07-27 08:32:51-04:00			
GPS Location	Please see photo for details.		GPS Location	Please see photo for details.	
Field Station#	12417+00		Field Station#	12335+50	
Pic 17 Desc.	Photo shows the stabilized ROW conditions with water bars and that all ECDs are installed and are functioning as designed.		Pic 18 Desc.	Photo shows overview of Stream S-NN19 from the going away side.

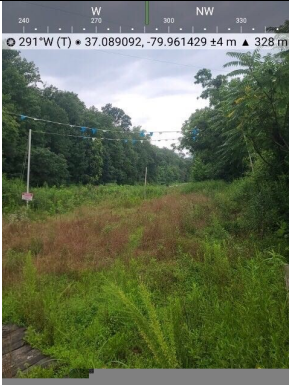
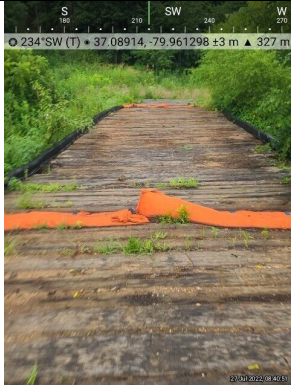
GPS Location	0000	GPS Location	0000		
Field Station#	13644+00	Field Station#	13643+67		
Pic 1 Desc.	Row photo taken during light rain events showing vegetation. No environmental issues observed at the time of inspection.		Pic 2 Desc.	Monitored equipment bridge and protection during light rain events. No issues were observed at the time of inspection.

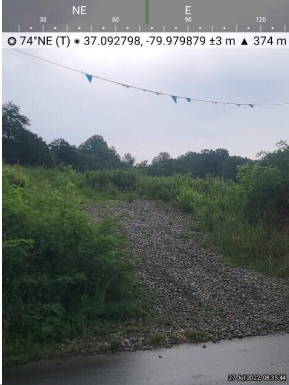
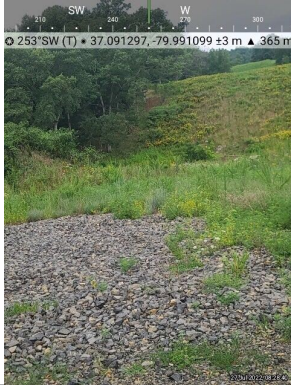
GPS Location	0000	GPS Location	0000		
Field Station#	13575+41	Field Station#	13541+50		
Pic 3 Desc.	Monitored RCEs at road crossings during rain events, no environmental issues observed at the time of inspection.		Pic 4 Desc.	Monitored RCEs and vegetation in permanent area of row. No issues were observed at the time of inspection.

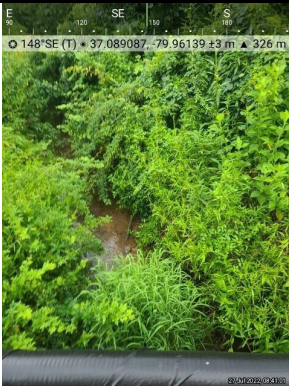
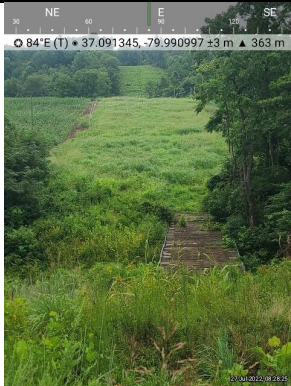
GPS Location	0000	GPS Location	0000		
Field Station#	13643+67	Field Station#	13542+70		
Pic 5 Desc.	Stream observation photo facing downstream during routine inspection today. No environmental issues observed during light rain events at the time of inspection.		Pic 6 Desc.	Row photo showing equipment bridge in place and functioning at the time of inspection. Light rain events in the inspection area.

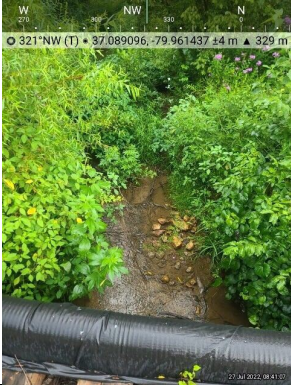
GPS Location	0000	GPS Location			
Field Station#	13643+67	Field Station#			
Pic 7 Desc.	Stream observation photo facing upstream during routine inspection as rain events continue. No issues were observed at the time of inspection.		Pic 8 Desc.

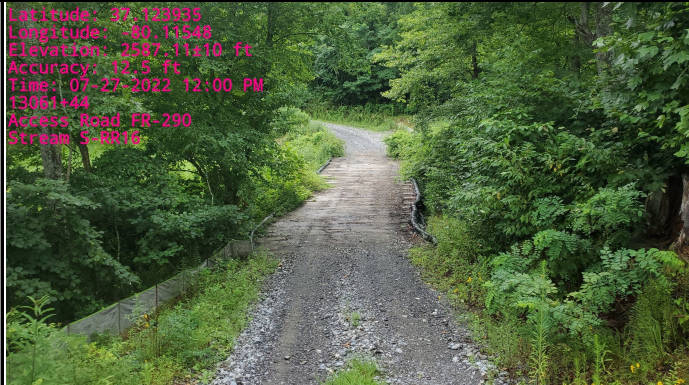
GPS Location	See pic.		GPS Location	See pic.	
Field Station#	13061+44		Field Station#	13061+44	
Pic 13 Desc.	Stream crossing S-RR18 on FR-290.		Pic 14 Desc.	Stream crossing S-RR16 on FR-290.	
<p>Latitude: 37.122326 Longitude: -80.096709 Elevation: 2704.69±8 ft Accuracy: 12.5 ft Time: 07-27-2022 12:19 PM 13113+00 CIS of FR-291</p>

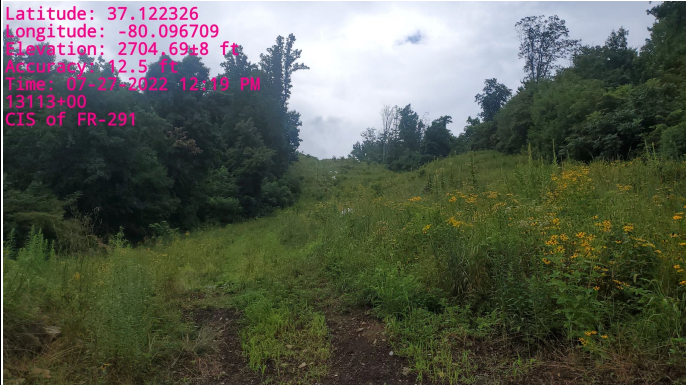
Field Station#	13113+00		Field Station#	13114+00	
Pic 15 Desc.	Current ROW conditions.		Pic 16 Desc.	Current ROW conditions.	
<p>Latitude: 37.121797 Longitude: -80.095648 Elevation: 2626.57±9 ft Accuracy: 12.5 ft Time: 07-27-2022 12:22 PM 13116+00 BAS of FR-291</p>  			<p>Latitude: 37.117843 Longitude: -80.095975 Elevation: 2348.16±35 ft Accuracy: 17.4 ft Time: 07-27-2022 12:23 PM 13115+97 Access Road FR-291 Stream S-EF17</p>  		
GPS Location	See pic.		GPS Location	See pic.	
Field Station#	13116+00		Field Station#	13115+97	
Pic 17 Desc.	Current ROW conditions.		Pic 18 Desc.	Stream crossing S-EF17 on access road FR-291.

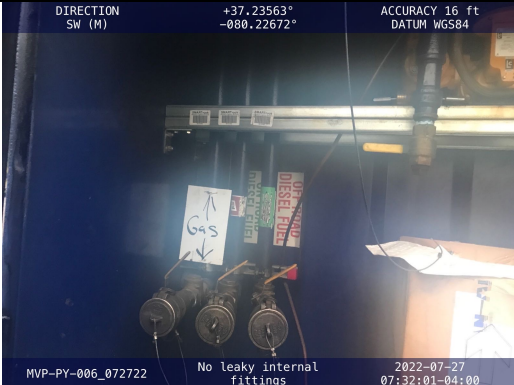
GPS Location	MVP-PY-006 See photo for gps data		GPS Location	MVP-PY-006 See photo for gps data	
Field Station#	+0		Field Station#	+0	
Pic 3 Desc.	Blue Bulk Fuel tanks no leaky internal fittings. Looking SW.		Pic 4 Desc.	Secondary containments in place for tankers offloading fuel. Looking W.

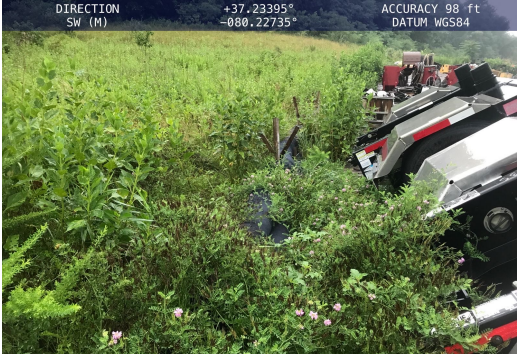
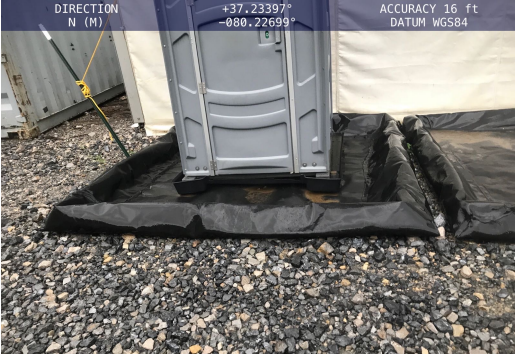
<p>DIRECTION N (M) +37.23397° -080.22699° ACCURACY 16 ft DATUM WGS84</p> <p>MVP-PY-006_072722 Tray & containment under toilet 2022-07-27 07:42:26-04:00</p>			
GPS Location	MVP-PY-006 See photo for gps data		GPS Location	MVP-PY-006 See photo for gps data	
Field Station#	+0		Field Station#	+0	
Pic 13 Desc.	Triple stack compost filter sock along south LOD. Overgrown with vegetation. Looking SW.		Pic 14 Desc.	Tray and containment under toilet. Tray holding fluids. Looking N.

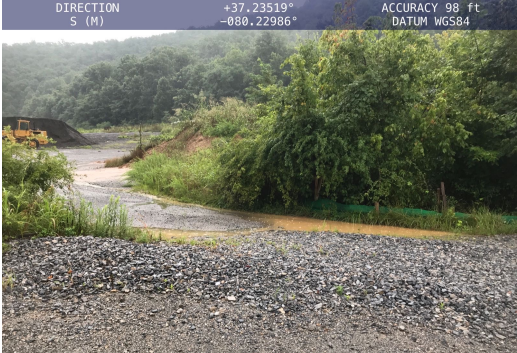
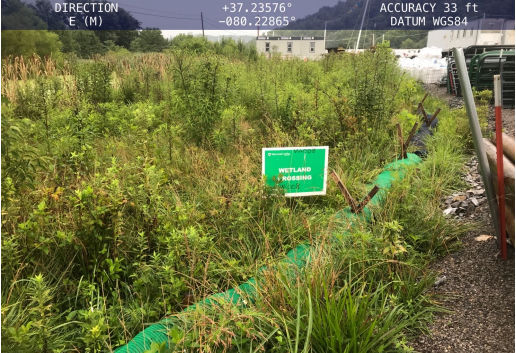
GPS Location	MVP-PY-006 See photo for gps data		GPS Location	MVP-PY-006 See photo for gps data	
Field Station#	+0		Field Station#	+0	
Pic 15 Desc.	Status of spoil pile adjacent to LOD on VDOT property. Soil pile not stabilized. Looking S.		Pic 16 Desc.	Triple stack compost filter sock and signage at feature W-008. Overgrown with vegetation. Looking E.

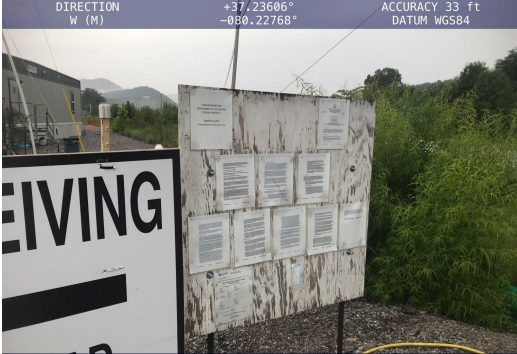
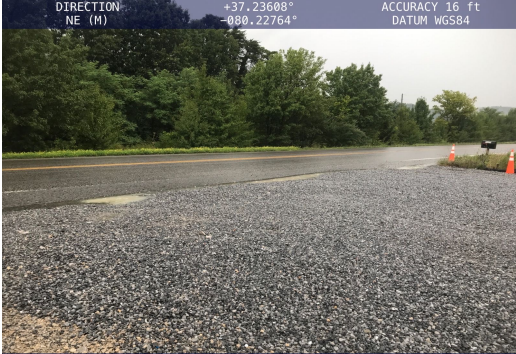
<p>DIRECTION NE (M) +37.23608° -080.22764° ACCURACY 16 ft DATUM WGS84</p> <p>MVP-PY-006_072722 Main entrance no stone on public road 2022-07-27 07:47:44-04:00</p>			
GPS Location	MVP-PY-006 See photo for gps data		GPS Location	MVP-PY-006 See photo for gps data	
Field Station#	+0		Field Station#	+0	
Pic 17 Desc.	Posted project documents at main entrance. Looking W.		Pic 18 Desc.	Main entrance no stone on public roadway. Looking NE.

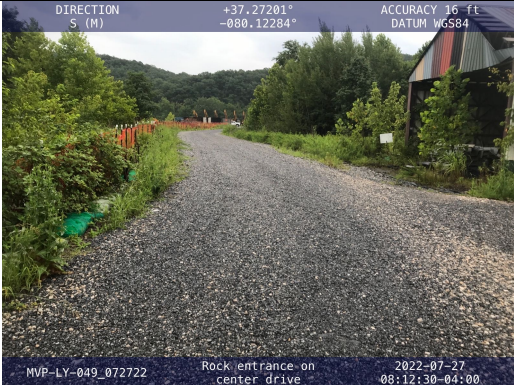
GPS Location	MVP-LY-049 See photo for gps data	GPS Location	MVP-LY-049 See photo for gps data		
Field Station#	+0	Field Station#	+0		
Pic 1 Desc.	Rock entrance on center drive. Smaller stone spread over larger stone. No sediment or debris on stone. Looking S.	Pic 2 Desc.	Rock entrance on north drive. No sediment or debris on stone. Looking SW.

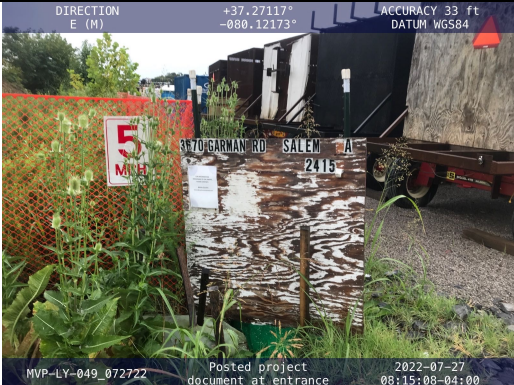
GPS Location	MVP-LY-049 See photo for gps data	GPS Location	MVP-LY-049 See photo for gps data		
Field Station#	+0	Field Station#	+0		
Pic 3 Desc.	Checked the posted project document at the main entrance. Looking E.	Pic 4 Desc.	Safety fence and triple stack compost filter sock along north LOD. Overgrown with vegetation. Looking E.

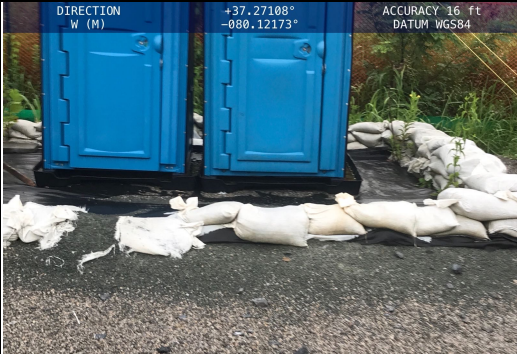
<div>MVP-LY-049_072722</div> <div>Trays & containment under toilets</div> <div>2022-07-27 08:16:03-04:00</div>		<div>DIRECTION N (M)</div> <div>+37.27112° -080.12145°</div> <div>ACCURACY 16 ft DATUM WGS84</div>   <div>MVP-LY-049_072722</div> <div>Restoration supplies under cover</div> <div>2022-07-27 08:16:18-04:00</div>			
GPS Location	MVP-LY-049 See photo for gps data		GPS Location	MVP-LY-049 See photo for gps data	
Field Station#	+0		Field Station#	+0	
Pic 7 Desc.	Trays and containment under toilets. Trays holding fluids. Looking W.		Pic 8 Desc.	Restoration supplies covered. Cover is secured. Looking N.	
<div>DIRECTION N (M)</div> <div>+37.27112° -080.12126°</div> <div>ACCURACY 16 ft DATUM WGS84</div>

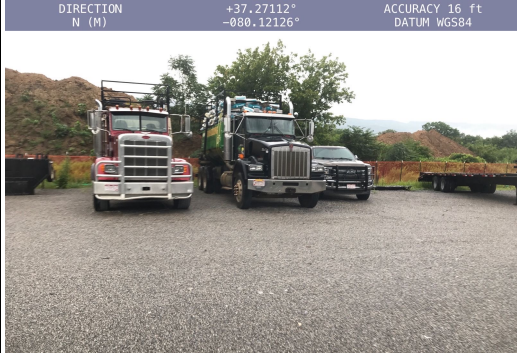
<div>MVP-LY-049_072722</div> <div>Checked stored vehicles for leaks</div> <div>2022-07-27 08:16:31-04:00</div>		<div>DIRECTION SW (M)</div> <div>+37.27088° -080.12092°</div> <div>ACCURACY 16 ft DATUM WGS84</div>   <div>MVP-LY-049_072722</div> <div>Checked stored equipment for leaks</div> <div>2022-07-27 08:21:56-04:00</div>

GPS Location	MVP-LY-049 See photo for gps data		GPS Location	MVP-LY-049 See photo for gps data	
Field Station#	+0		Field Station#	+0	
Pic 9 Desc.	Checked stored vehicles for new leaks. No new leaks found. Looking N.		Pic 10 Desc.	Checked stored equipment for new leaks. No new leaks found. Looking SW.	
<div>DIRECTION NW (M)</div> <div>+37.26967° -080.12320°</div> <div>ACCURACY 16 ft DATUM WGS84</div>

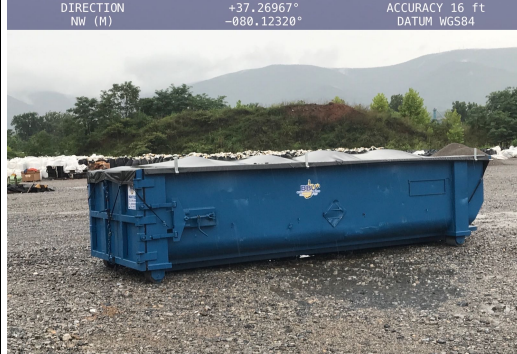
<div>MVP-LY-049_072722</div> <div>No deposits around hazardous waste dump...</div> <div>2022-07-27 08:23:32-04:00</div>		<div>DIRECTION W (M)</div> <div>+37.26937° -080.12359°</div> <div>ACCURACY 33 ft DATUM WGS84</div>

<div>MVP-LY-049_072722</div> <div>CFS in place around sand pile</div> <div>2022-07-27 08:24:19-04:00</div>			
GPS Location	MVP-LY-049 See photo for gps data		GPS Location	MVP-LY-049 See photo for gps data	
Field Station#	+0		Field Station#	+0	
Pic 11 Desc.	No deposits or fluids around hazardous waste dumpsters. Looking NW.		Pic 12 Desc.	Compost filter sock in place and functional around sand pile. Looking W.

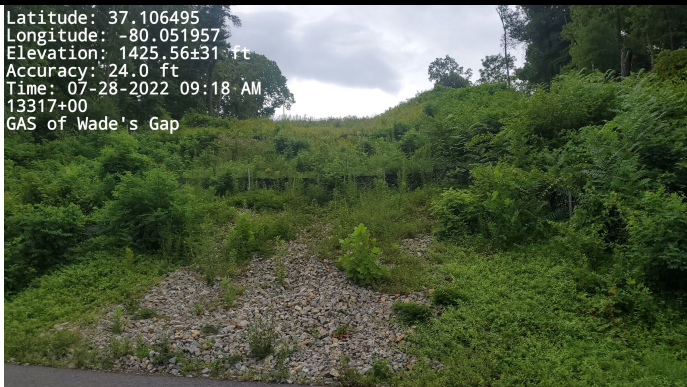
GPS Location	0		GPS Location	0	
Field Station#	13317+00		Field Station#	13317+00	
Pic 1 Desc.	ROW and ECDs In good condition and stable		Pic 2 Desc.	Private drive in good condition	
<div>Latitude: 37.106139 Longitude: -80.049919 Elevation: 1437.07±41 ft Accuracy: 24.3 ft Time: 07-28-2022 09:34 AM 13322+00 GAS of Wade's Gap Stream S-GH15</div>

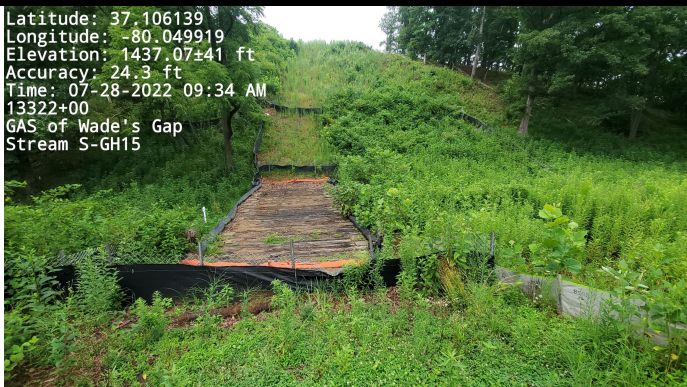
Field Station#	13322+00		Field Station#	13325+75	
Pic 3 Desc.	MVP-S-GH15 and corresponding buffer zone in good condition		Pic 4 Desc.	MVP-S-GH14 and corresponding buffer zone in good condition	
<div>Latitude: 37.106139 Longitude: -80.049919 Elevation: 1437.07±41 ft Accuracy: 24.3 ft Time: 07-28-2022 09:34 AM 13322+00 GAS of Wade's Gap Stream S-GH15</div>

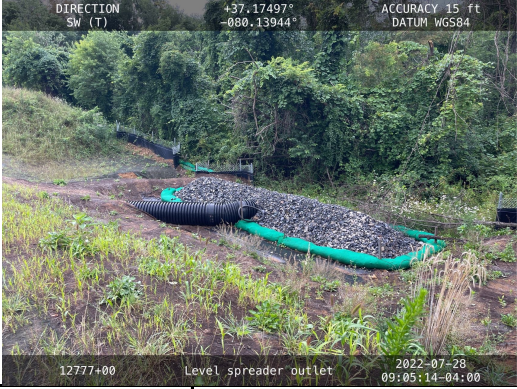
<p>DIRECTION S (T) +37.17249° -080.13875° ACCURACY 15 ft DATUM WGS84</p> <p>12786+75 Level spreader outlet 2022-07-28 09:11:12-04:00</p>			
GPS Location	See photo for gps location data.		GPS Location	See photo for gps location data.	
Field Station#	12777+00		Field Station#	12786+75	
Pic 7 Desc.	Photo shows the level spreader outlet.		Pic 8 Desc.	Photo shows the level spreader outlet.

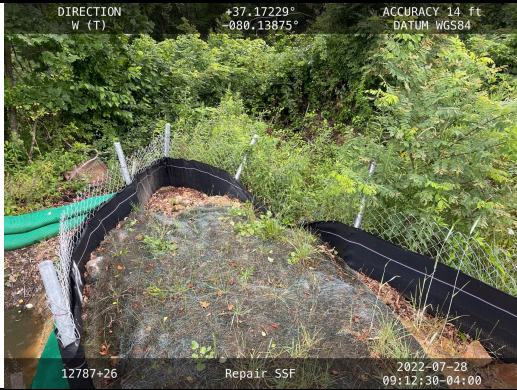
<p>DIRECTION W (T) +37.17229° -080.13875° ACCURACY 14 ft DATUM WGS84</p> <p>12787+26 Repair SSF 2022-07-28 09:12:30-04:00</p>

E&S BMPs	Compliance Level	Corrective Action	Corrective Time Frame	Date Repaired
Cleanwater Diversion Berm	Acceptable			
Compost Filter Sock	Acceptable			
Equipment Bridge	Acceptable			
Erosion Control Blanket	Acceptable			
Rock Construction Entrance	Acceptable			
Silt Fence (Filter Fabric Fence)	Acceptable			
Silt Fence (Reinforced Filter Fabric Fence)	Communication	Repair SSF bent over by wildlife	48 Hours	7/28/2022
Sump Pit				
Waterbar

GPS Location	See photo for gps location data.		GPS Location	See photo for gps location data.	
Field Station#	12787+26		Field Station#	12787+26	
Pic 9 Desc.	Photo shows the section of SSF bent over by wildlife.		Pic 10 Desc.	Photo shows the SSF after it was repaired.

7. Identify all remedial measures that have been taken since the previous inspection was conducted. Since the last SWPPP inspection a section of SSF was repaired at 12787+26 and routine ECD maintenance was completed in this area.					
Comments (Reference above questions as appropriate.) The VADEQ SWPPP Inspection was performed on this date. An inspection was performed from Station 12725+00 to Station 12865+00. All ECDs observed appeared to be in compliance and well maintained. ROW that has been disturbed and is inactive has been stabilized with either ECB, straw mulch, or temporary vegetation. Stabilization observed appeared to be adequate. No erosion was observed. Stream Crossings included in the inspection were S-EF55, S-EF56, S-EF34B, S-EF35, S-EF33, S-IJ82 and S-EF32. There were no issues noted at stream crossings or their corresponding buffer areas. Access roads RO-281, RO-281.01, and RO-282 were observed. There was 1 issue noted during today's inspection: Station 12787+36: Repair repair SSF that has been bent over by wildlife Precision's Environmental Crew was onsite and repaired this item today. This item was added to the punch list and completed. No additional environmental issues, off-row sediment or resource impacts were observed during this SWPPP inspection.

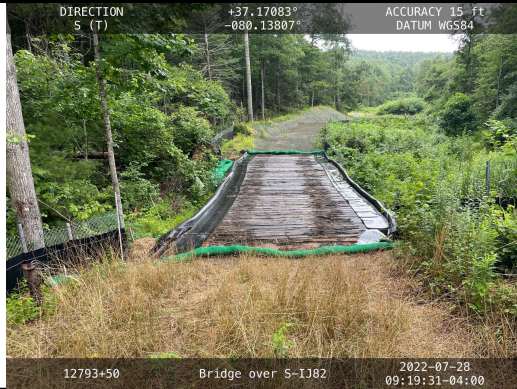
<p>DIRECTION S (T) +37.17083° -080.13807° ACCURACY 15 ft DATUM WGS84</p> <p>12793+50 Bridge over S-IJ82 2022-07-28 09:19:31-04:00</p>

<p>DIRECTION SW (T) +37.17072° -080.13810° ACCURACY 15 ft DATUM WGS84</p> <p>12793+71 S-IJ82 downstream 2022-07-28 09:20:14-04:00</p>			
GPS Location	See photo for gps location data.		GPS Location	See photo for gps location data.	
Field Station#	12793+50		Field Station#	12793+71	
Pic 11 Desc.	Photo shows the bridge over stream S-IJ82.		Pic 12 Desc.	Photo shows S-IJ82 downstream from the bridge.

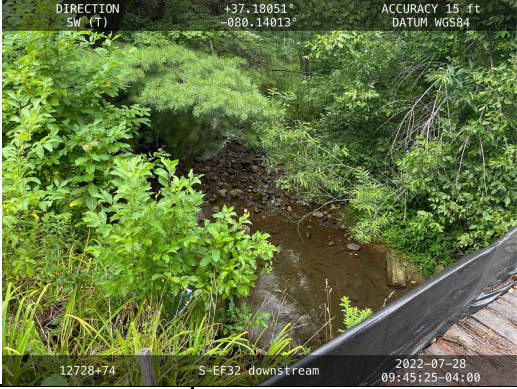
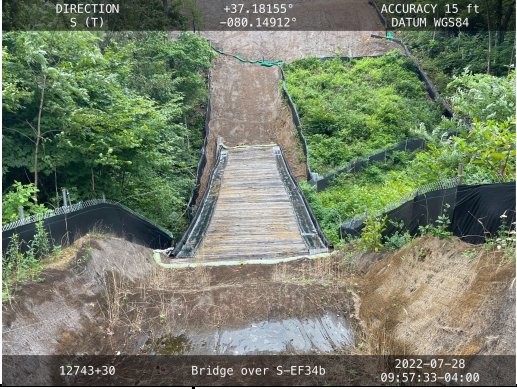
GPS Location	See photo for gps location data.		GPS Location	See photo for gps location data.	
Field Station#	12728+74		Field Station#	12743+30	
Pic 13 Desc.	Photo shows S-EF32 downstream from the bridge		Pic 14 Desc.	Photo shows the bridge over stream S-EF34b.

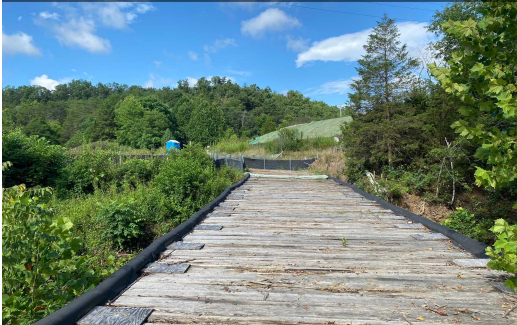
Station 12206+00 2022-07-29 09:47:01-04:00			
GPS Location	See Above		GPS Location	See Above	
Field Station#	12192+36		Field Station#	12206+00	
Pic 13 Desc.	Overview of Waterbody S-C21. ECDs functional and in good condition.		Pic 14 Desc.	ROW Overview. ECDs functional and in good condition and ROW is stable.	
DIRECTION SE (T) 37.25319°N 080.25357°W ACCURACY 45 m DATUM WGS84

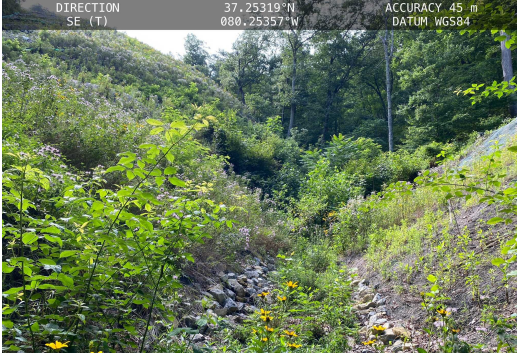
Station 12211+00 2022-07-29 09:39:09-04:00		DIRECTION W (T) 37.25270°N 080.25107°W ACCURACY 9 m DATUM WGS84

Pic 15 Desc.	ROW Overview. ECDs functional and in good condition and ROW is stable.		Pic 16 Desc.	ROW Overview. ECDs functional and in good condition and ROW is stable.	
DIRECTION W (T) 37.25164°N 080.24740°W ACCURACY 10 m DATUM WGS84

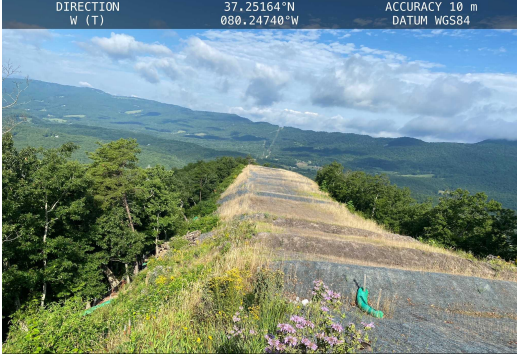
Station 12228+00 2022-07-29 09:20:42-04:00		DIRECTION N (T) 37.23774°N 080.23619°W ACCURACY 106 m DATUM WGS84

MVP-MN-276.03 Station 12284+75 2022-07-29 08:55:13-04:00			
GPS Location	See Above		GPS Location	See Above	
Field Station#	12228+00		Field Station#	12284+75	
Pic 17 Desc.	ROW Overview. ECDs functional and in good condition and ROW is stable.		Pic 18 Desc.	Precision environmental crew is working on routine maintenance of Access Road 276.03.
