# Visual Site Inspection Report

<b>Project Name</b>	H-600 Pipeline Spread I	<b>AFE</b>	124300139	<b>Spread</b>	H-600 Pipeline Spread I
<b>Contractor</b>	Precision			<b>Report #</b>	39673
<b>Inspector</b>	Ben Farmer			<b>Date/Time</b>	7/11/2022 1:49 PM
<b>Permit #</b>	TBD	<b>Inspection Type</b>	VA SWPP	<b>Station Begin</b>	13958+31
<b>State</b>	VA	<b>Inspection Area</b>	Partial	<b>Station End</b>	14062+17
<b>County</b>	Franklin	<b>Ground</b>	Damp	<b>Temperature (°F)</b>	65.00
<b>Municipality</b>	N/A	<b>Weather</b>	Sunny	<b>Rain Gauge (in)</b>	0.80
				<b>Rain Accumulation Time (days)</b>	0.00

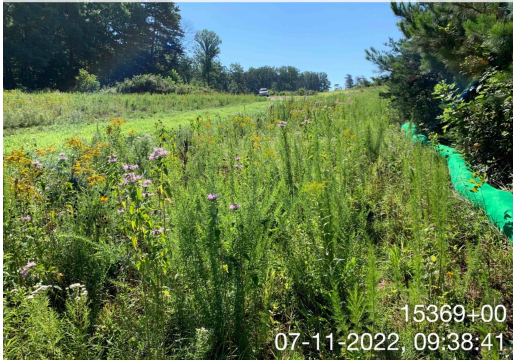
<div>15369+00 07-11-2022, 09:38:41</div>			<div>206°SW (T) 17 N 632498 4087350 ±13ft ▲ 765ft</div>

<div>15364+00 07-11-2022, 09:40:56</div>		
GPS Location			0		
Field Station#			15369+00		
Pic 1 Desc.			Permanent vegetative stabilization and perimeter CFS in acceptable conditions		
GPS Location			0		
Field Station#			15364+00		
Pic 2 Desc.			Waterbar in acceptable condition		
<div>258°W (T) 17 N 632502 4087319 ±13ft ▲ 764ft</div>

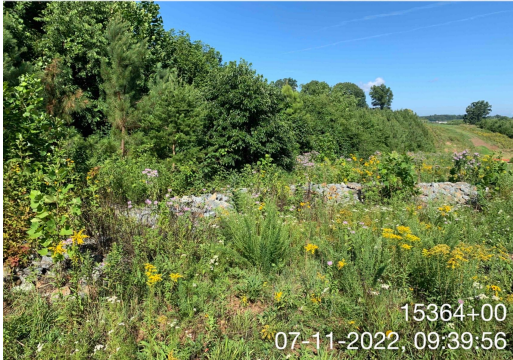
<div>15364+00 07-11-2022, 09:39:56</div>			<div>88°E (T) 17 N 632422 4087370 ±1190ft ▲ 732ft</div>

<div>15360+00 07-11-2022, 09:43:48</div>		
GPS Location			0		
Field Station#			15364+00		
Pic 3 Desc.			Waterbar end treatment in acceptable condition		
GPS Location			0		
Field Station#			15360+00		
Pic 4 Desc.			Equipment bridge in acceptable condition

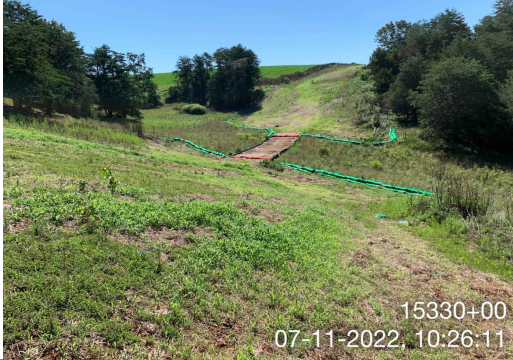
<div>15330+00 07-11-2022, 10:26:11</div>			<div>314°NW (T) 17 N 631576 4088004 ±131ft ▲ 709ft</div>

<div>15325+00 07-11-2022, 10:55:08</div>		
GPS Location			0		
Field Station#			15330+00		
Pic 5 Desc.			Temporary vegetative stabilization in acceptable condition		
GPS Location			0		
Field Station#			15325+00		
Pic 6 Desc.			CFS and temporary vegetative stabilization in acceptable condition

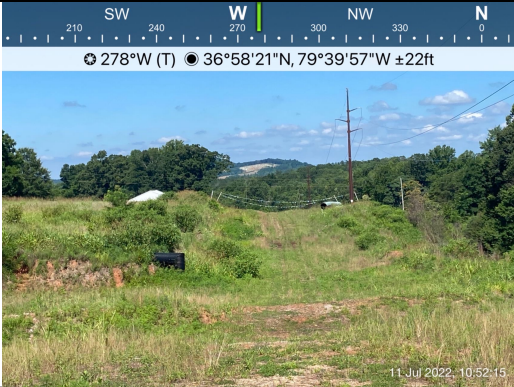
<b>GPS Location</b>	0	<b>GPS Location</b>	0		
<b>Field Station#</b>	14843+00	<b>Field Station#</b>	14846+00		
<b>Pic 3 Desc.</b>	Approximately 14843+00. Overview of ROW.		<b>Pic 4 Desc.</b>	Approximately 14846+00. Overview of road crossing and RCEs.

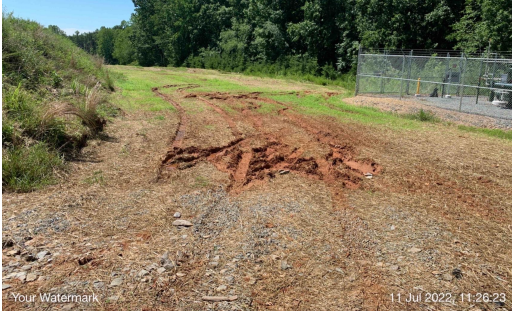
<b>GPS Location</b>	O		<b>GPS Location</b>	O	
<b>Field Station#</b>	15649+00		<b>Field Station#</b>	15700+40	
<b>Pic 1 Desc.</b>	Observing rut's that need to be dressed up, reseeded and stabilized.(3rd party damage)		<b>Pic 2 Desc.</b>	Observing temporary stabilization,buffer, equipment crossing and ECD's	
	<b>West Elevation</b> 109°E (T) 36°52'46"N, 79°25'15"W ±170ft ▲ 803ft

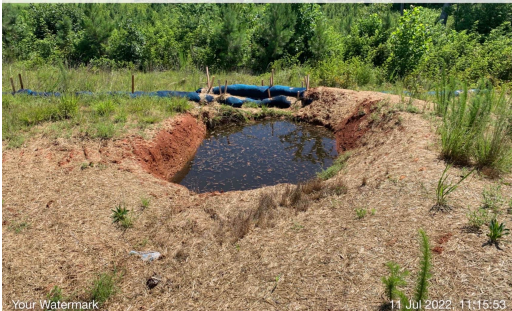
<b>GPS Location</b>	O		<b>GPS Location</b>	O	
<b>Field Station#</b>	15697+00		<b>Field Station#</b>	15693+89	
<b>Pic 3 Desc.</b>	Observing temporary stabilization, sump and end treatment		<b>Pic 4 Desc.</b>	Observing road crossing and RCE's

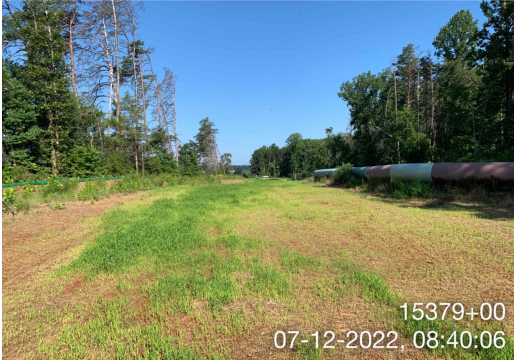
15379+00 07-12-2022, 08:40:06		71°E (T) 17 N 633066 4087111 ±49ft ▲ 760ft

15384+00 07-12-2022, 08:52:53			
<b>GPS Location</b>	0	<b>GPS Location</b>	0		
<b>Field Station#</b>	15379+00	<b>Field Station#</b>	15384+00		
<b>Pic 1 Desc.</b>	Temporary vegetative stabilization in acceptable condition	<b>Pic 2 Desc.</b>	P1 silt fence and sensitive resource buffer in acceptable conditions		
8°N (T) 17 N 633103 4087102 ±26ft ▲ 763ft

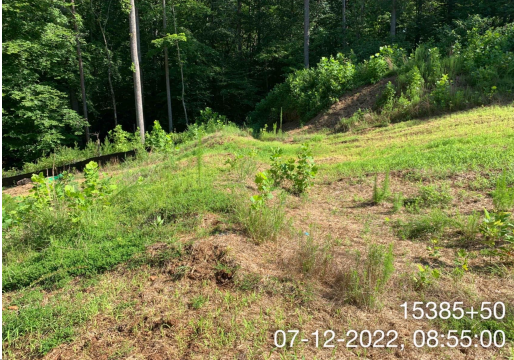
15385+50 07-12-2022, 08:55:00		8°N (T) 17 N 633090 4087129 ±137ft ▲ 759ft

15385+50 07-12-2022, 08:54:19			
<b>GPS Location</b>	0	<b>GPS Location</b>	0		
<b>Field Station#</b>	15385+50	<b>Field Station#</b>	15385+50		
<b>Pic 3 Desc.</b>	Waterbar in acceptable condition	<b>Pic 4 Desc.</b>	Waterbar end treatment in acceptable condition

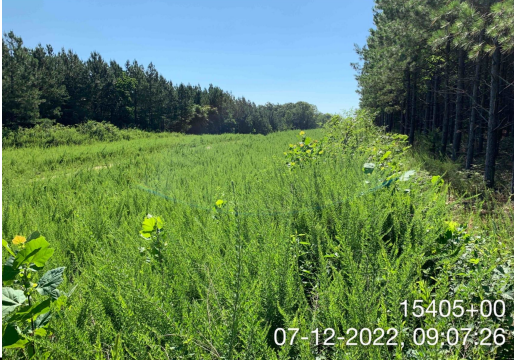
15405+00 07-12-2022, 09:07:26		244°SW (T) 17 N 633996 4086818 ±42ft ▲ 805ft

15417+00 07-12-2022, 09:47:38			
<b>GPS Location</b>	0	<b>GPS Location</b>	0		
<b>Field Station#</b>	15405+00	<b>Field Station#</b>	15417+00		
<b>Pic 5 Desc.</b>	Clean water diversion berm and temporary vegetative stabilization in acceptable conditions	<b>Pic 6 Desc.</b>	Super silt fence in acceptable condition

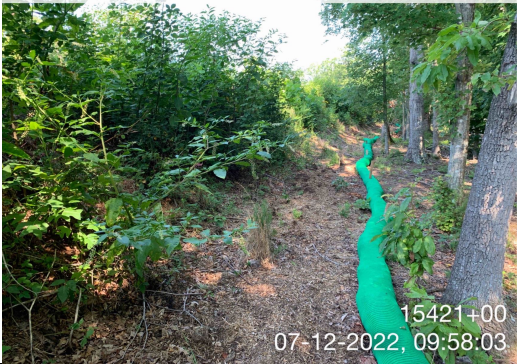
<p>15421+00 07-12-2022, 09:58:03</p>

<p>15444+00 07-12-2022, 10:11:13</p>			
<b>GPS Location</b>	0	<b>GPS Location</b>	0		
<b>Field Station#</b>	15421+00	<b>Field Station#</b>	15444+00		
<b>Pic 7 Desc.</b>	Perimeter CFS in acceptable condition		<b>Pic 8 Desc.</b>	Permanent vegetative stabilization in acceptable condition

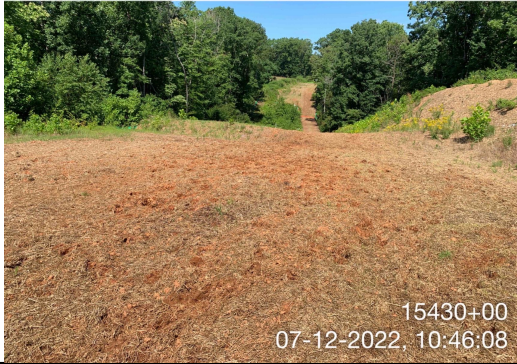
<p>15430+00 07-12-2022, 10:46:08</p>

<p>15434+00 07-12-2022, 10:06:51</p>			
<b>GPS Location</b>	0	<b>GPS Location</b>	0		
<b>Field Station#</b>	15430+00	<b>Field Station#</b>	14434+00		
<b>Pic 9 Desc.</b>	Location where cattle tracked up the ROW (15425+00 to 15430+00). Area will be monitored.		<b>Pic 10 Desc.</b>	Location where cattle tracked up the ROW (15434+00 to 15438+00). Area will be monitored.

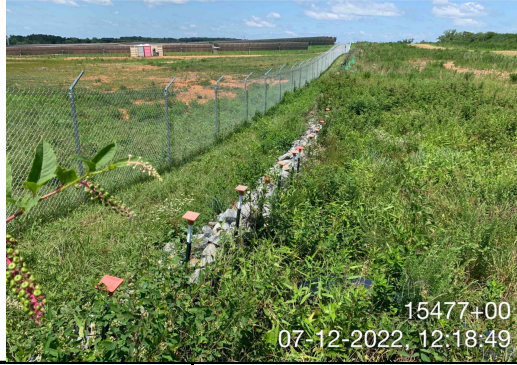
<p>15477+00 07-12-2022, 12:18:49</p>		<p style="text-align: center;">Insert image here</p>

<b>GPS Location</b>	0	<b>GPS Location</b>			
<b>Field Station#</b>	15477+00	<b>Field Station#</b>			
<b>Pic 11 Desc.</b>	Solar farm perimeter ECDs appear to be in acceptable conditions		<b>Pic 12 Desc.</b>

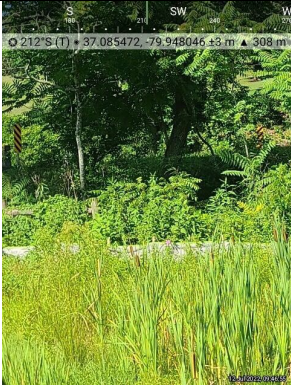
<b>GPS Location</b>	0000	<b>GPS Location</b>	0000		
<b>Field Station#</b>	13692+39	<b>Field Station#</b>	13748+07		
<b>Pic 1 Desc.</b>	Monitored perimeter ECDs along bar ditch . No issues observed at the time of inspection.		<b>Pic 2 Desc.</b>	Monitored perimeter ECDs at road crossing. No environmental issues observed at the time of inspection.

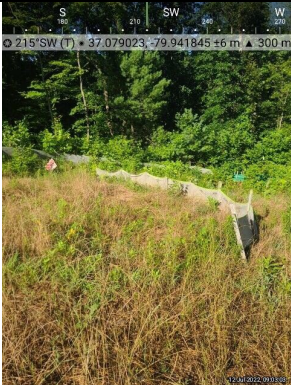
<b>GPS Location</b>	0000	<b>GPS Location</b>	00000		
<b>Field Station#</b>	13729+00	<b>Field Station#</b>	13678+71		
<b>Pic 3 Desc.</b>	Monitored ECDs up hill from stream crossing. All in place and functioning at the time of inspection.		<b>Pic 4 Desc.</b>	Monitored equipment bridge and ECDs throughout the inspection area. No environmental issues observed at the time of inspection.

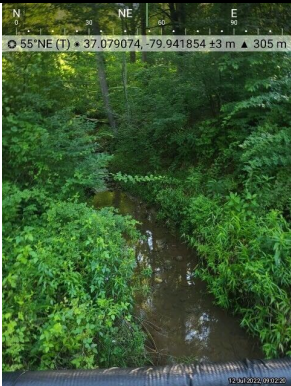
<b>Field Station#</b>	13728+23	<b>Field Station#</b>	13715+12		
<b>Pic 5 Desc.</b>	Stream observation photo facing upstream during routine inspection today. No issues were observed at the time of inspection.		<b>Pic 6 Desc.</b>	Vegetation observation photo showing good coverage. No issues were observed at the time of inspection.

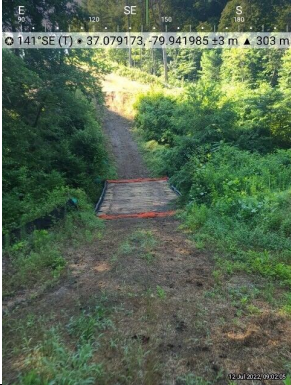
<p>Insert image here</p>		<p>Insert image here</p>	
<b>GPS Location</b>	00000	<b>GPS Location</b>			
<b>Field Station#</b>	13728+23	<b>Field Station#</b>			
<b>Pic 7 Desc.</b>	Photo showing equipment crossing , good stabilization on stream banks. No environmental issues observed at the time of inspection.		<b>Pic 8 Desc.</b>		
<p>Insert image here</p>		<p>Insert image here</p>			
<b>GPS Location</b>		<b>GPS Location</b>			
<b>Field Station#</b>		<b>Field Station#</b>			
<b>Pic 9 Desc.</b>			<b>Pic 10 Desc.</b>		
<p>Insert image here</p>		<p>Insert image here</p>			
<b>GPS Location</b>		<b>GPS Location</b>			
<b>Field Station#</b>		<b>Field Station#</b>			
<b>Pic 11 Desc.</b>			<b>Pic 12 Desc.</b>

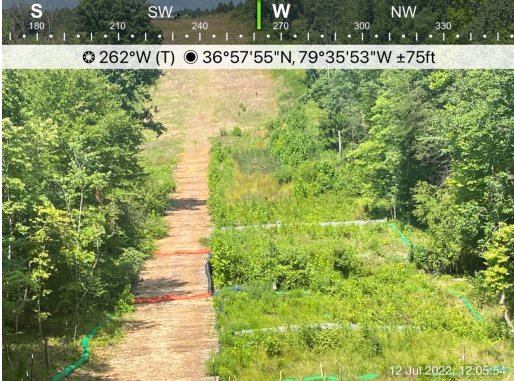
<b>GPS Location</b>	0	<b>GPS Location</b>	0		
<b>Field Station#</b>	14950+47	<b>Field Station#</b>	14947+00		
<b>Pic 5 Desc.</b>	Approximately 14950+47. Overview of stream crossing, equipment bridge and ECDs at stream S-G13.		<b>Pic 6 Desc.</b>	Approximately 14937+00. Overview of ROW.

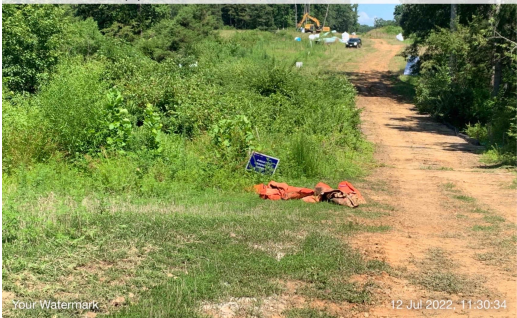
<b>GPS Location</b>	O	<b>GPS Location</b>	O		
<b>Field Station#</b>	15923+49	<b>Field Station#</b>	15910+00		
<b>Pic 7 Desc.</b>	Observing temporary stabilization, signage, buffer, equipment crossing and ECD's	<b>Pic 8 Desc.</b>	Observing the Contractor removing old ECD's		
<b>North West Elevation</b> 149°SE (T) 36°50'56"N, 79°22'35"W ±347ft ▲705ft

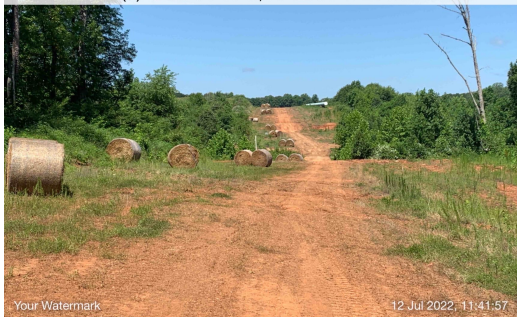
<b>GPS Location</b>	O	<b>GPS Location</b>	O		
<b>Field Station#</b>	15880+00	<b>Field Station#</b>	15870+00		
<b>Pic 9 Desc.</b>	Observing temporary stabilization and water bars	<b>Pic 10 Desc.</b>	Observing temporary stabilization, CWD outlet and ECD's

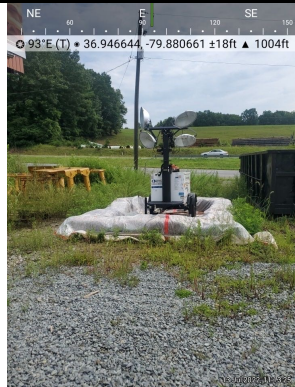
GPS Location	0	GPS Location	0		
Field Station#	0+00	Field Station#	0+00		
Pic 1 Desc.	LY-033 Equipment staging area		Pic 2 Desc.	LY-032 Secondary containment

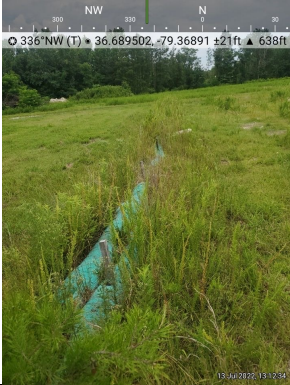
<b>GPS Location</b>	0	<b>GPS Location</b>	0		
<b>Field Station#</b>	0+00	<b>Field Station#</b>	0+00		
<b>Pic 7 Desc.</b>	LY-048 West perimeter CFS	<b>Pic 8 Desc.</b>	LY-048 West perimeter CFS		
Insert image here		Insert image here			
<b>GPS Location</b>		<b>GPS Location</b>			
<b>Field Station#</b>		<b>Field Station#</b>			
<b>Pic 9 Desc.</b>		<b>Pic 10 Desc.</b>			
Insert image here		Insert image here			
<b>GPS Location</b>		<b>GPS Location</b>			
<b>Field Station#</b>		<b>Field Station#</b>			
<b>Pic 11 Desc.</b>		<b>Pic 12 Desc.</b>

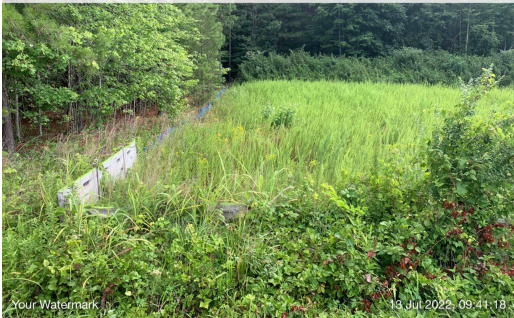
<small>Your Watermark 13 Jul 2022, 09:42:14</small>		
<b>GPS Location</b>	O		<b>GPS Location</b>	O	
<b>Field Station#</b>	14+00		<b>Field Station#</b>	22+00	
<b>Pic 1 Desc.</b>	Observing temporary stabilization and ECD's		<b>Pic 2 Desc.</b>	Observing temporary stabilization and buffer	
<b>North Elevation</b> ☉ 161°S (T) ● 36°50'6"N, 79°20'24"W ±75ft ▲ 655ft

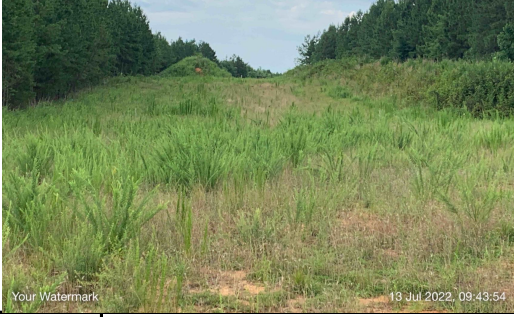
<b>Pic 3 Desc.</b>	Observing temporary stabilization and water bar		<b>Pic 4 Desc.</b>	Observing temporary stabilization, water bar, sump and end treatment	
Insert image here			Insert image here		
<b>GPS Location</b>			<b>GPS Location</b>		
<b>Field Station#</b>			<b>Field Station#</b>		
<b>Pic 5 Desc.</b>			<b>Pic 6 Desc.</b>

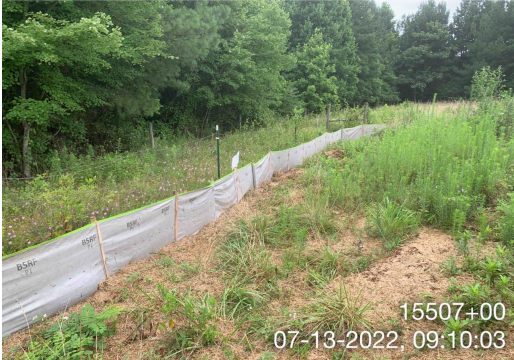
<b>GPS Location</b>	0	<b>GPS Location</b>	0		
<b>Field Station#</b>	15507+00	<b>Field Station#</b>	15512+00		
<b>Pic 1 Desc.</b>	P1 silt fence in acceptable condition	<b>Pic 2 Desc.</b>	Temporary vegetative stabilization in acceptable condition

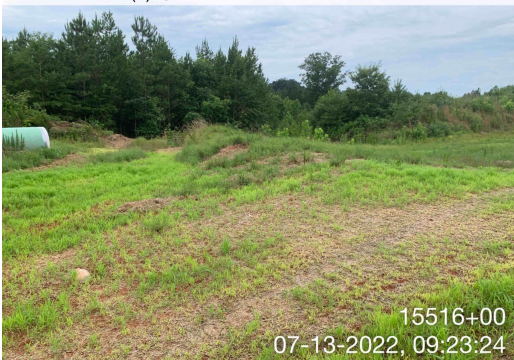
<b>GPS Location</b>	0	<b>GPS Location</b>	0		
<b>Field Station#</b>	15516+00	<b>Field Station#</b>	15516+00		
<b>Pic 3 Desc.</b>	Waterbar in acceptable condition	<b>Pic 4 Desc.</b>	Waterbar end treatment in acceptable condition

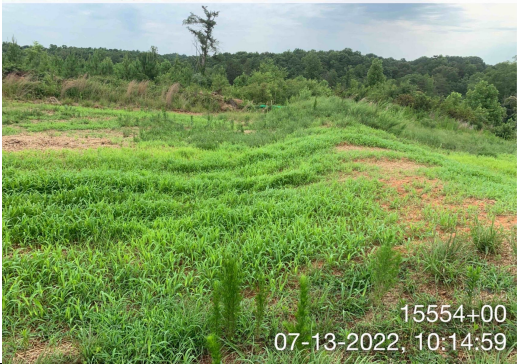
15554+00 07-13-2022, 10:14:59		43°NE (T) 17 N 637310 4084681 ±16ft ▲ 838ft

15554+00 07-13-2022, 10:15:19			
<b>GPS Location</b>	0	<b>GPS Location</b>	0		
<b>Field Station#</b>	15554+00	<b>Field Station#</b>	15554+00		
<b>Pic 7 Desc.</b>	Waterbar in acceptable condition	<b>Pic 8 Desc.</b>	Waterbar end treatment in acceptable condition		
294°NW (T) 17 N 637402 4084641 ±39ft ▲ 804ft

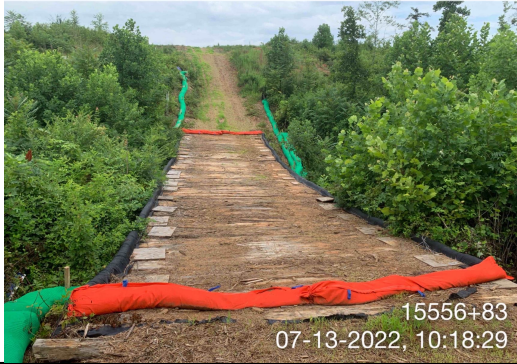
15556+83 07-13-2022, 10:18:29		117°SE (T) 17 N 637960 4084370 ±246ft ▲ 792ft

15579+00 07-13-2022, 12:37:41			
<b>GPS Location</b>	0	<b>GPS Location</b>	0		
<b>Field Station#</b>	15556+83	<b>Field Station#</b>	15579+00		
<b>Pic 9 Desc.</b>	Equipment bridge in acceptable condition	<b>Pic 10 Desc.</b>	Clean water diversion berm and temporary vegetative stabilization in acceptable conditions

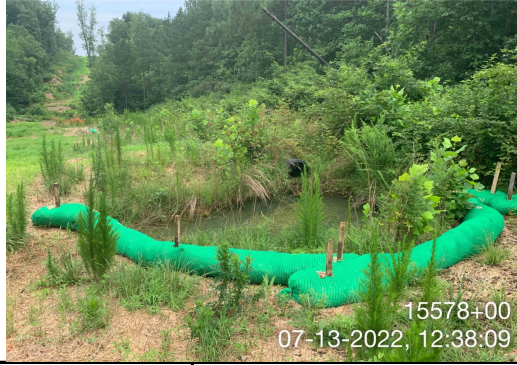
15578+00 07-13-2022, 12:38:09		245°SW (T) 17 N 636038 4085464 ±16ft ▲ 884ft

15504+00 07-13-2022, 09:07:26			
<b>GPS Location</b>	0	<b>GPS Location</b>	0		
<b>Field Station#</b>	15578+00	<b>Field Station#</b>	15504+00		
<b>Pic 11 Desc.</b>	Slope drain pipe and sump pit in acceptable conditions	<b>Pic 12 Desc.</b>	Solar farm perimeter ECDs appear to be in acceptable conditions

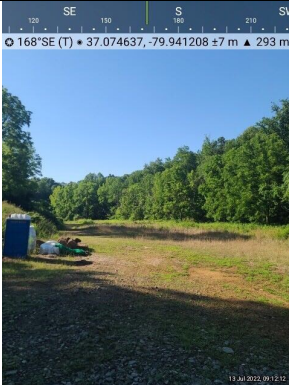
<b>GPS Location</b>	00000	<b>GPS Location</b>	00000		
<b>Field Station#</b>	13751+78	<b>Field Station#</b>	13826+00		
<b>Pic 1 Desc.</b>	Row photo showing stabilization. No issues were observed at the time of inspection.		<b>Pic 2 Desc.</b>	Monitored sump pit and end treatment during routine inspection. No environmental issues observed at the time of inspection.

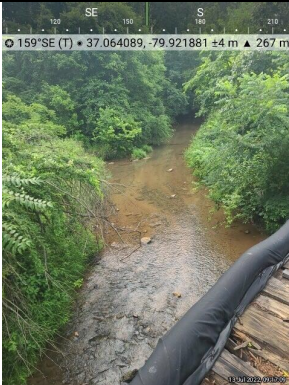
<b>GPS Location</b>	00000	<b>GPS Location</b>	00000		
<b>Field Station#</b>	13834+04	<b>Field Station#</b>	13833+00		
<b>Pic 3 Desc.</b>	Stream observation photo facing downstream during routine inspection today. No issues were observed at the time of inspection.		<b>Pic 4 Desc.</b>	Monitored equipment bridge and protection. All in place and functioning at the time of inspection.

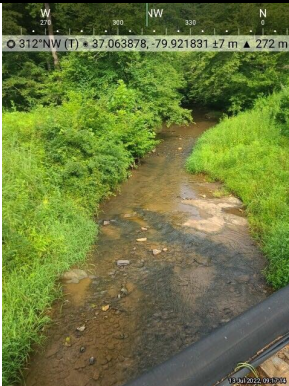
<b>Field Station#</b>	13834+04	<b>Field Station#</b>	13748+97		
<b>Pic 5 Desc.</b>	Stream observation photo facing upstream during routine inspection. No issues observed at the time of inspection.		<b>Pic 6 Desc.</b>	Monitored ECDs at stream crossing near RCE. No issues were observed at the time of inspection.

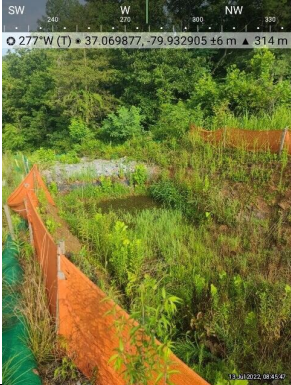
<p>SW 240 270 300 NW    245°SW (T) • 37.069723, -79.932959 +6 m ▲ 327 m</p>			
<b>GPS Location</b>	0000	<b>GPS Location</b>	0000		
<b>Field Station#</b>	13784+30	<b>Field Station#</b>	13782+70		
<b>Pic 7 Desc.</b>	Monitored sump pit and plunge pool after recent rain events, all functioning at the time of inspection.	<b>Pic 8 Desc.</b>	ECDs in place at stream crossing. Good stabilization on hill side. No environmental issues observed at the time of inspection.		
Insert image here		Insert image here			
<b>GPS Location</b>		<b>GPS Location</b>			
<b>Field Station#</b>		<b>Field Station#</b>			
<b>Pic 9 Desc.</b>		<b>Pic 10 Desc.</b>			
Insert image here		Insert image here			
<b>GPS Location</b>		<b>GPS Location</b>			
<b>Field Station#</b>		<b>Field Station#</b>

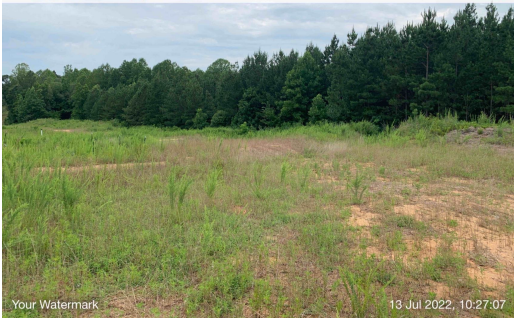
<small>Your Watermark 13 Jul 2022, 10:28:59</small>			
<b>GPS Location</b>	O	<b>GPS Location</b>	O		
<b>Field Station#</b>	16022+00	<b>Field Station#</b>	16017+00		
<b>Pic 1 Desc.</b>	Observing temporary stabilization and water bars	<b>Pic 2 Desc.</b>	Observing temporary stabilization, sump and end treatment		
<b>North Elevation</b> 201°S (T) 36°49'48"N, 79°20'43"W ±19ft ▲613ft

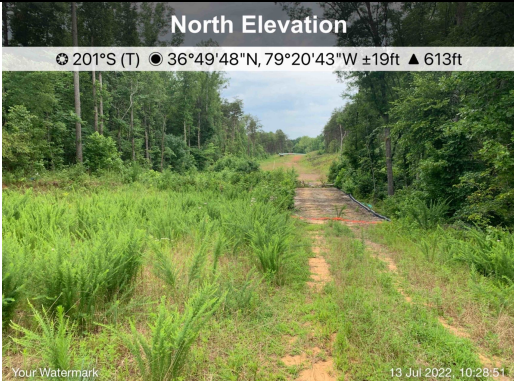
<b>Field Station#</b>	16016+36	<b>Field Station#</b>	16015+80		
<b>Pic 3 Desc.</b>	Observing temporary stabilization, buffer, equipment crossing and ECD's	<b>Pic 4 Desc.</b>	Observing temporary stabilization and ECD's		
<b>North East Elevation</b> 212°SW (T) 36°49'47"N, 79°20'46"W ±13ft ▲607ft

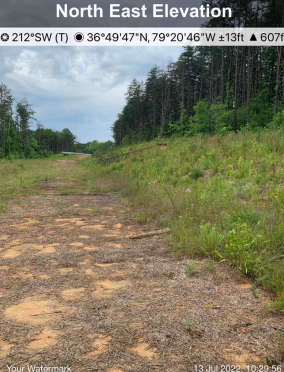
<small>Your Watermark 13 Jul 2022, 10:30:53</small>			
<b>GPS Location</b>	O	<b>GPS Location</b>	O		
<b>Field Station#</b>	16012+00	<b>Field Station#</b>	16010+00		
<b>Pic 5 Desc.</b>	Observing temporary stabilization and CWD berm	<b>Pic 6 Desc.</b>	Observing temporary stabilization, CWD outlet and ECD's

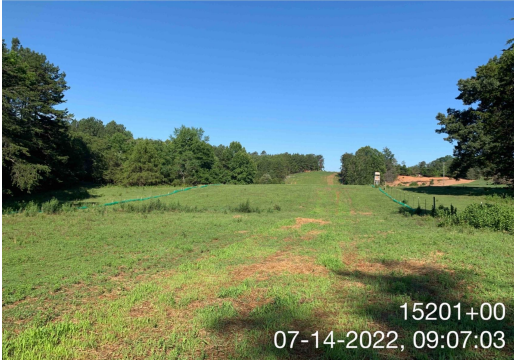
<p>15201+00 07-14-2022, 09:07:03</p>

<p>15195+00 07-14-2022, 09:09:46</p>			
<b>GPS Location</b>	0	<b>GPS Location</b>	0		
<b>Field Station#</b>	15201+00	<b>Field Station#</b>	15195+00		
<b>Pic 1 Desc.</b>	Permanent vegetative stabilization in acceptable condition	<b>Pic 2 Desc.</b>	CFS checks in acceptable condition

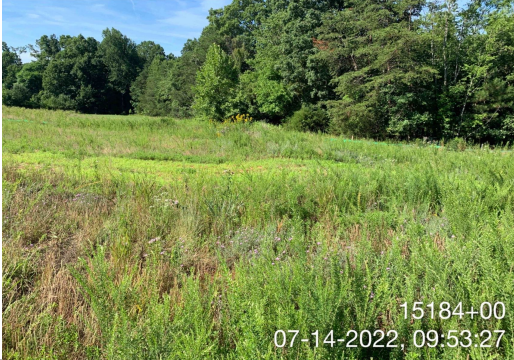
<p>15184+00 07-14-2022, 09:53:27</p>

<p>15184+00 07-14-2022, 09:54:51</p>			
<b>GPS Location</b>	0	<b>GPS Location</b>	0		
<b>Field Station#</b>	15184+00	<b>Field Station#</b>	15184+00		
<b>Pic 3 Desc.</b>	Waterbar in acceptable condition	<b>Pic 4 Desc.</b>	Waterbar end treatment in acceptable condition

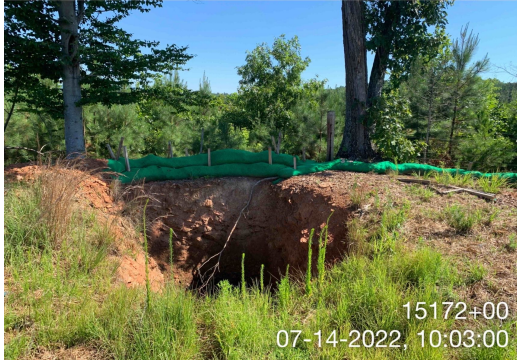
<p>15172+00 07-14-2022, 10:03:00</p>			
<b>GPS Location</b>	0	<b>GPS Location</b>	0

<b>Field Station#</b>	15172+00	<b>Field Station#</b>	15172+00		
<b>Pic 5 Desc.</b>	Waterbar in acceptable condition	<b>Pic 6 Desc.</b>	Waterbar end treatment in acceptable condition

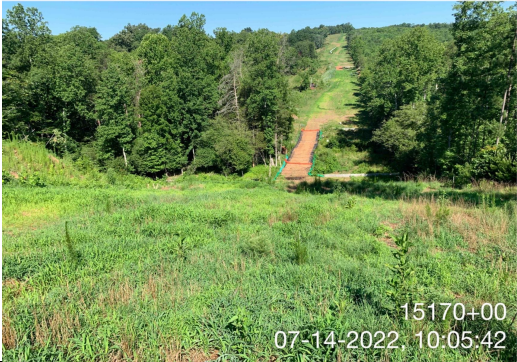
<p>15170+00 07-14-2022, 10:05:42</p>

<p>15169+00 07-14-2022, 11:01:37</p>			
<b>GPS Location</b>	0	<b>GPS Location</b>	0		
<b>Field Station#</b>	15170+00	<b>Field Station#</b>	15169+00		
<b>Pic 7 Desc.</b>	Temporary vegetative stabilization in acceptable condition	<b>Pic 8 Desc.</b>	Super silt fence in acceptable condition

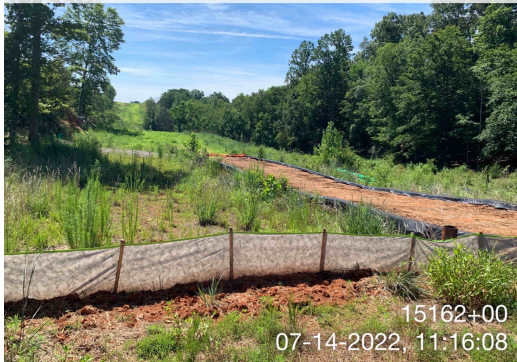
<p>15162+00 07-14-2022, 11:16:08</p>

<p>15142+80 07-14-2022, 11:36:01</p>			
<b>GPS Location</b>	0	<b>GPS Location</b>	0		
<b>Field Station#</b>	15162+00	<b>Field Station#</b>	15142+80		
<b>Pic 9 Desc.</b>	P1 silt fence and equipment bridge in acceptable conditions	<b>Pic 10 Desc.</b>	Rock construction entrance in acceptable condition

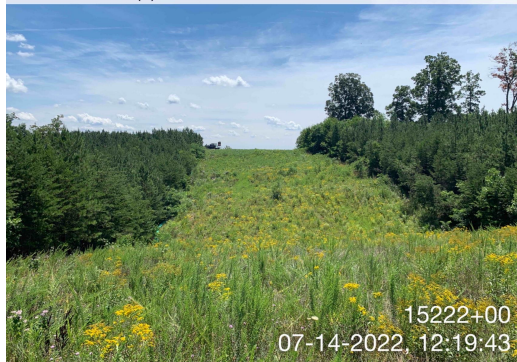
<p>15222+00 07-14-2022, 12:19:43</p>

<b>GPS Location</b>	0	<b>GPS Location</b>	0		
<b>Field Station#</b>	15222+00	<b>Field Station#</b>	15167+00		
<b>Pic 11 Desc.</b>	Permanent vegetative stabilization in acceptable condition	<b>Pic 12 Desc.</b>	Perimeter CFS and temporary vegetative stabilization in acceptable conditions

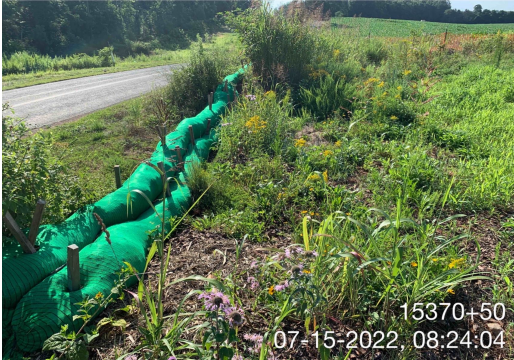
<p>15370+00 07-15-2022, 08:24:04</p>

<p>15352+00 07-15-2022, 08:48:22</p>			
<b>GPS Location</b>	0	<b>GPS Location</b>	0		
<b>Field Station#</b>	15370+50	<b>Field Station#</b>	15352+00		
<b>Pic 1 Desc.</b>	Perimeter CFS in acceptable condition	<b>Pic 2 Desc.</b>	Temporary vegetative stabilization in acceptable condition

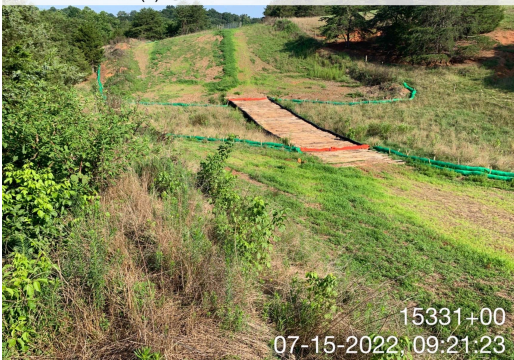
<p>15331+00 07-15-2022, 09:21:23</p>

<p>15330+00 07-15-2022, 09:22:57</p>			
<b>GPS Location</b>	0	<b>GPS Location</b>	0		
<b>Field Station#</b>	15331+00	<b>Field Station#</b>	15330+00		
<b>Pic 3 Desc.</b>	Clean water diversion berm and temporary vegetative stabilization in acceptable conditions	<b>Pic 4 Desc.</b>	Equipment bridge and CFS in acceptable conditions

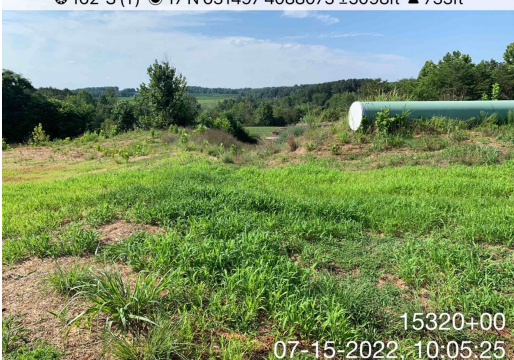
<p>15320+00 07-15-2022, 10:05:25</p>

<b>Field Station#</b>	15320+00	<b>Field Station#</b>	15320+00		
<b>Pic 5 Desc.</b>	Waterbar in acceptable condition	<b>Pic 6 Desc.</b>	Waterbar end treatment in acceptable condition

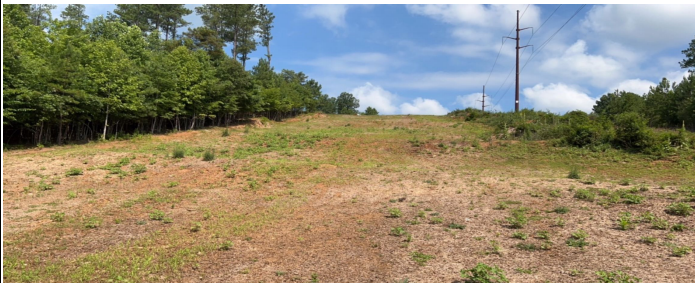
Field Station#	14493+00	Field Station#	14505+00		
Pic 3 Desc.	ROW stabilized and vegetated in temporary area; water bars performing intended functions.		Pic 4 Desc.	Perimeter SSF in place and functional.

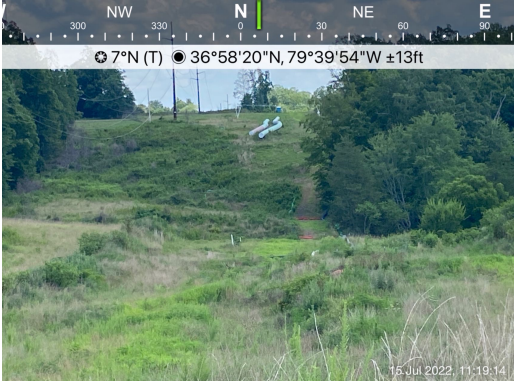
<b>GPS Location</b>	0	<b>GPS Location</b>	0		
<b>Field Station#</b>	14850+00	<b>Field Station#</b>	14846+00		
<b>Pic 3 Desc.</b>	Approximately 14850+00. Overview of ROW.		<b>Pic 4 Desc.</b>	Approximately 14846+00. Overview of road crossing and RCEs

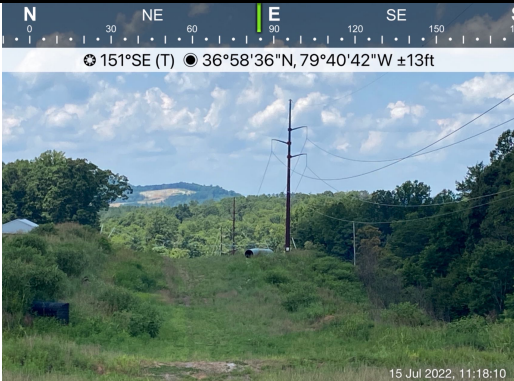
<b>GPS Location</b>	0	<b>GPS Location</b>	0		
<b>Field Station#</b>	14841+00	<b>Field Station#</b>	14805+00		
<b>Pic 5 Desc.</b>	Approximately 14841+00. Overview of ROW.		<b>Pic 6 Desc.</b>	Approximately 14805+00. Overview of stream crossing, equipment bridge and ECDs at stream S-H23.

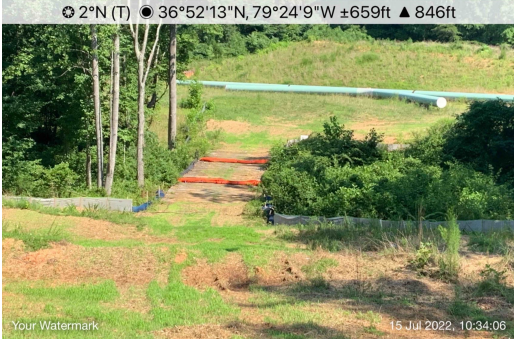
<b>GPS Location</b>	O	<b>GPS Location</b>	O		
<b>Field Station#</b>	15763+80	<b>Field Station#</b>	15770+00		
<b>Pic 1 Desc.</b>	Observing temporary stabilization, water bars, signage, buffer, equipment crossing and ECD's		<b>Pic 2 Desc.</b>	Observing CFS that requires maintenance	
<b>East Elevation</b> 256°W (T) 36°52'12"N, 79°24'5"W ±8628ft ▲838ft

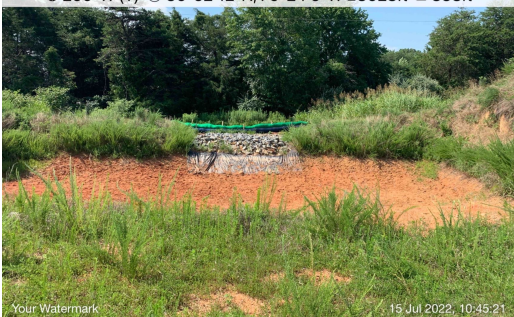
<b>GPS Location</b>	O	<b>GPS Location</b>	O		
<b>Field Station#</b>	15740+00	<b>Field Station#</b>	15735+00		
<b>Pic 3 Desc.</b>	Observing temporary stabilization, sump and end treatment		<b>Pic 4 Desc.</b>	Observing temporary stabilization, CWD outlet and ECD's

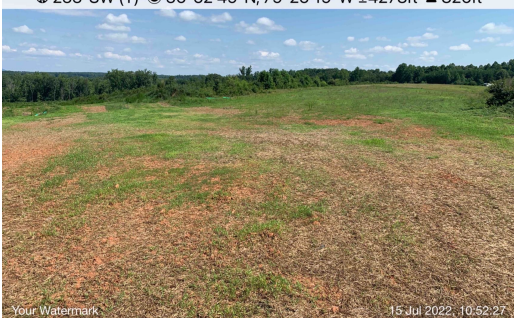
<b>GPS Location</b>	O	<b>GPS Location</b>	O		
<b>Field Station#</b>	15961+00	<b>Field Station#</b>	15693+89		
<b>Pic 5 Desc.</b>	Observing temporary stabilization and water bar		<b>Pic 6 Desc.</b>	Observing road crossing and RCE's
