Visual Site Inspection Report

Project Name	H-600 Pipeline Spread I	AFE	124300139	Spread	H-600 Pipeline Spread I
Contractor	Precision			Report #	39955
Inspector	Ben Farmer			Date/Time	7/18/2022 12:53 PM
Permit #	TBD	Inspection Type	VA SWPP	Station Begin	14062+17
State	VA	Inspection Area	Partial	Station End	14171+36
County	Franklin	Ground	Dry	Temperature (°F)	75.00
Municipality	N/A	Weather	Sunny	Rain Gauge (in)	0.00
				Rain Accumulation Time (days)	0.00

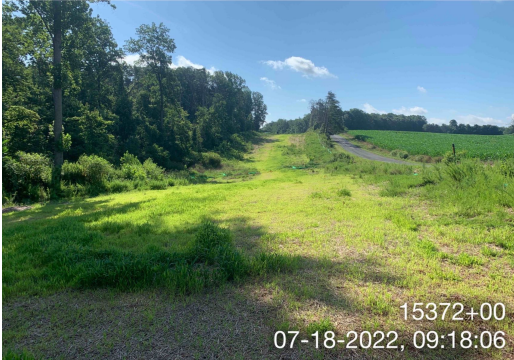
GPS Location	0	GPS Location	0		
Field Station#	15372+00	Field Station#	15395+00		
Pic 1 Desc.	Temporary vegetative stabilization in acceptable condition	Pic 2 Desc.	Waterbar in acceptable condition

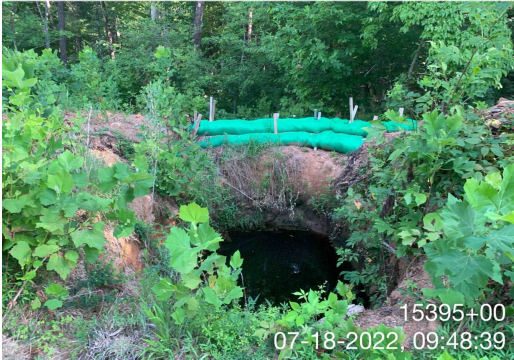
GPS Location	0	GPS Location	0		
Field Station#	15395+00	Field Station#	15404+00		
Pic 3 Desc.	Waterbar end treatment in acceptable condition	Pic 4 Desc.	Plunge pool in acceptable condition

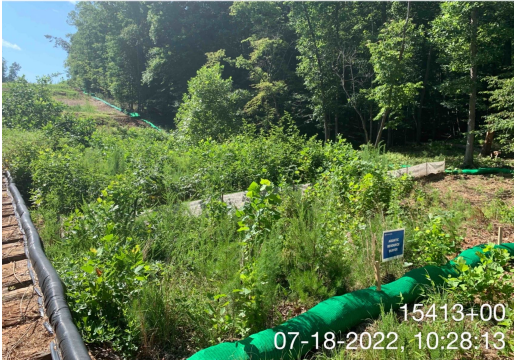
GPS Location	0	GPS Location	0		
Field Station#	15413+00	Field Station#	15421+00		
Pic 5 Desc.	P1 silt fence and sensitive resource buffer in acceptable conditions	Pic 6 Desc.	Waterbar in acceptable condition

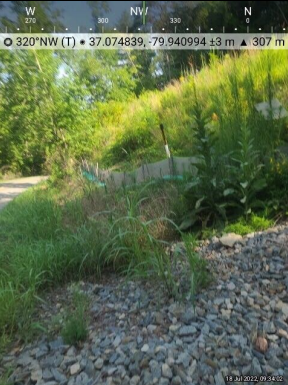
GPS Location	0000	GPS Location	0000		
Field Station#	13748+00	Field Station#	13678+71		
Pic 1 Desc.	Monitored ECDs at road crossings during routine inspection today. No issues were observed at the time of inspection.		Pic 2 Desc.	Stream observation photo facing upstream during routine inspection. No issues were observed at the time of inspection.

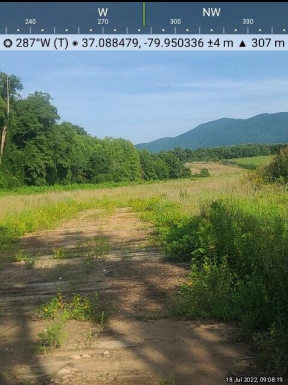
GPS Location	0000	GPS Location	0000		
Field Station#	13677+90	Field Station#	13692+77		
Pic 3 Desc.	Row photo showing vegetation, equipment mats in place. No environmental issues observed at the time of inspection.		Pic 4 Desc.	Photo showing stabilization at stream crossing where mats were previously removed during maintenance. No environmental issues observed at the time of inspection.

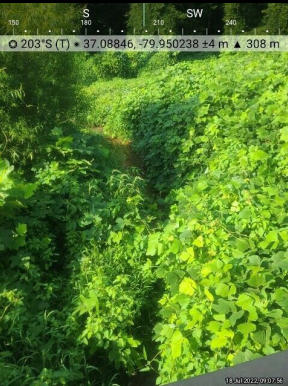
Pic 5 Desc.	Stream observation photo facing downstream during routine inspection today. Good vegetation on stream banks.		Pic 6 Desc.	Row photo showing vegetation in a permanent area of row. Good stabilization noted.

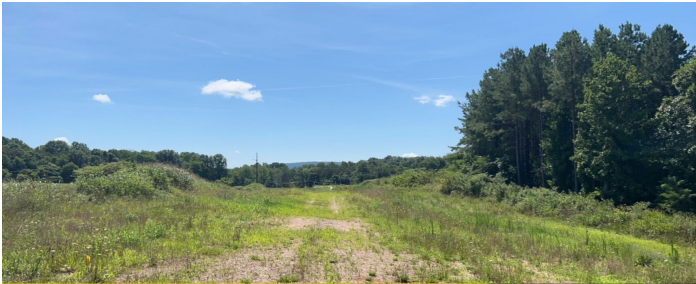
<small>37°0'10" N 79°45'2" W 162°S COURSE 219' GPS 594 Tobacco Rd, Glade Hill, VA 24092, United States 07.18.2022 11:51:43 Accur +/-25.8 Ft ALT 915 Ft</small>			<small>37°0'13" N 79°45'5" W 117°SE COURSE 209' GPS 594 Tobacco Rd, Glade Hill, VA 24092, United States 07.18.2022 11:49:56 Accur +/-15.5 Ft ALT 914 Ft</small>		
GPS Location	1		GPS Location	2	
Field Station#	14552+00		Field Station#	14558+00	
Pic 1 Desc.	ROW stabilized and vegetated in temporary area.		Pic 2 Desc.	Equipment bridge over natural drainage area in good condition.

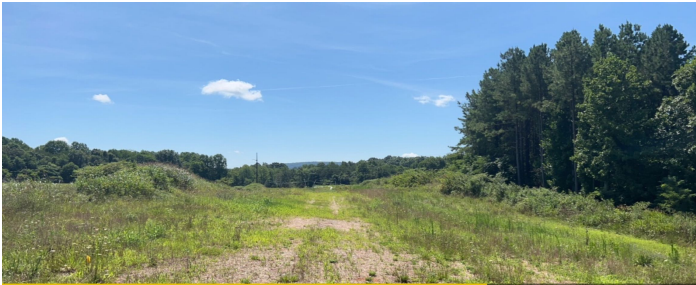
GPS Location	3		GPS Location	4	
Field Station#	14563+00		Field Station#	14566+00	
Pic 3 Desc.	ROW stabilized and vegetated in temporary area.		Pic 4 Desc.	Perimeter P1 silt fence in place and functional.

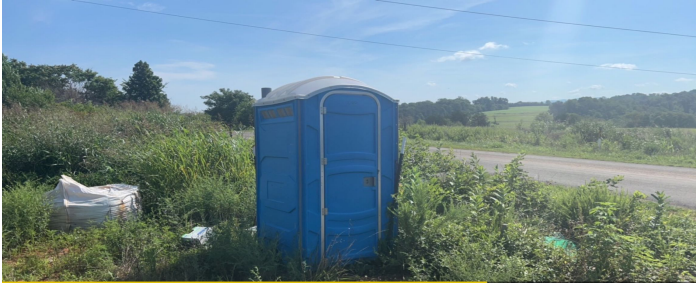
<small>36°59'51" N 79°44'19" W 52°NE COURSE 222' GPS 753 Simmons Creek Rd, Union Hall, VA 24176, United States 07.18.2022 10:19:08 Accur +/-15.4 Ft ALT 945 Ft</small>			<small>36°59'50" N 79°44'17" W 191°S COURSE 336' GPS 753 Simmons Creek Rd, Union Hall, VA 24176, United States 07.18.2022 10:20:12 Accur +/-15.5 Ft ALT 934 Ft</small>		
GPS Location	5		GPS Location	6	
Field Station#	14599+00		Field Station#	14601+00	
Pic 5 Desc.	Portajon properly contained in secondary containment at road crossing.		Pic 6 Desc.	ROW stabilized and vegetated in temporary area.

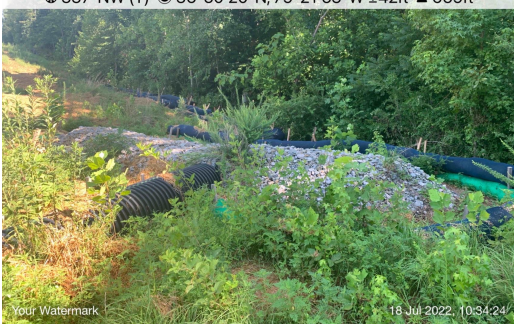
GPS Location	O	GPS Location	O		
Field Station#	15934+00	Field Station#	15938+00		
Pic 1 Desc.	Observing temporary stabilization,CWD outlet and ECD's	Pic 2 Desc.	Observing temporary stabilization, sump and end treatment		
West Elevation 88°E (T) 36°50'57"N, 79°23'18"W ±10925ft ▲ 812ft

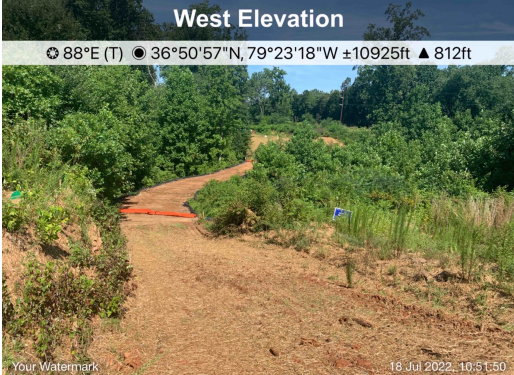
GPS Location	O	GPS Location	O		
Field Station#	15852+88	Field Station#	15826+00		
Pic 3 Desc.	Observing temporary stabilization, signage, buffer, equipment crossing and ECD's	Pic 4 Desc.	Observing temporary stabilization, plunge pool and ECD's		
East Elevation 274°W (T) 36°51'22"N, 79°23'31"W ±13ft ▲ 831ft

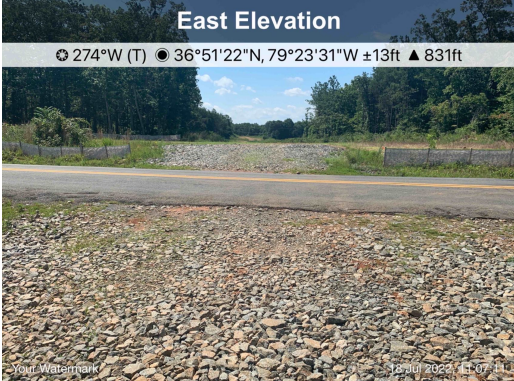
GPS Location	O	GPS Location	O		
Field Station#	15826+77	Field Station#	15777+00		
Pic 5 Desc.	Observing road crossing and RCE's	Pic 6 Desc.	Observing temporary stabilization, water bar, equipment crossing's and ECD's

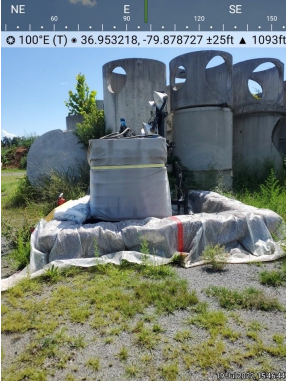
GPS Location	0	GPS Location	0		
Field Station#	0+00	Field Station#	0+00		
Pic 1 Desc.	ANC-006 Secondary containment	Pic 2 Desc.	ANC-006 Stormwater drain inlet protection

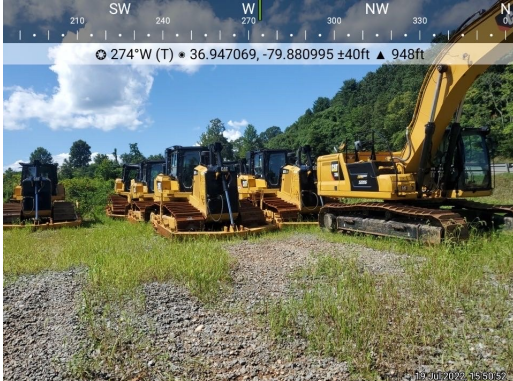
GPS Location	0	GPS Location	0		
Field Station#	0+00	Field Station#	0+00		
Pic 3 Desc.	LY-032 Equipment staging	Pic 4 Desc.	LY-032 Secondary containment

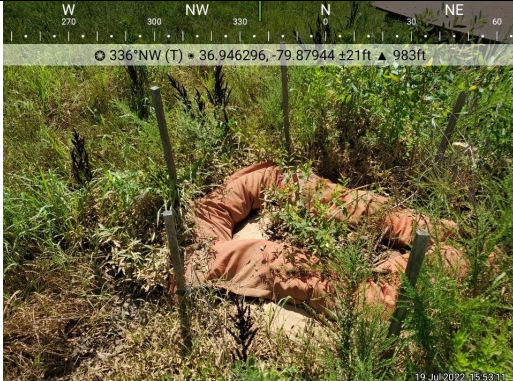
GPS Location	0	GPS Location	0		
Field Station#	0+00	Field Station#	0+00		
Pic 5 Desc.	LY-033 Stormwater drain inlet protection	Pic 6 Desc.	LY-033 Secondary containment

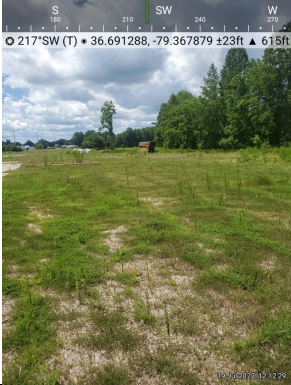
<p>GPS photo of temporary vegetation. GPS coordinates: 217°SW (T) • 36.691288, -79.367879 ±23ft ▲ 615ft.</p>

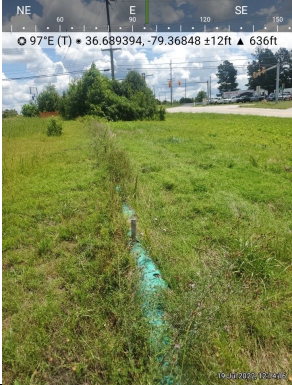
<p>GPS photo of south perimeter CFS. GPS coordinates: 97°E (T) • 36.689394, -79.36848 ±12ft ▲ 636ft.</p>			
GPS Location	0	GPS Location	0		
Field Station#	0+00	Field Station#	0+00		
Pic 7 Desc.	LY-048 Temporary vegetation	Pic 8 Desc.	LY-048 South perimeter CFS		
Insert image here		Insert image here			
GPS Location		GPS Location			
Field Station#		Field Station#			
Pic 9 Desc.		Pic 10 Desc.			
Insert image here		Insert image here			
GPS Location		GPS Location			
Field Station#		Field Station#			
Pic 11 Desc.		Pic 12 Desc.

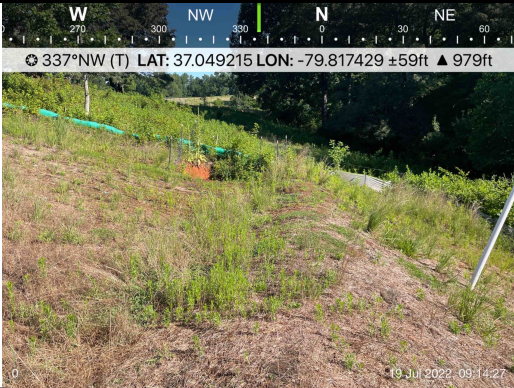
GPS Location	See photo		GPS Location	See photo	
Field Station#	14276+00		Field Station#	14276+00	
Pic 5 Desc.	Waterbars are in good condition		Pic 6 Desc.	Waterbar end treatments are functioning as intended

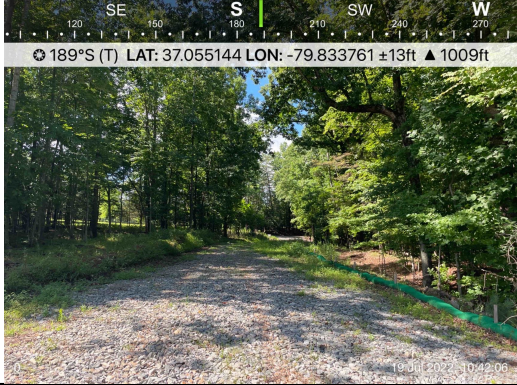
GPS Location	See photo		GPS Location	See photo	
Field Station#	14223+41		Field Station#	14208+69	
Pic 9 Desc.	MVP-FR-311 remains in good condition with controls in place		Pic 10 Desc.	Equipment bridge ECDs are in good condition at S-F8

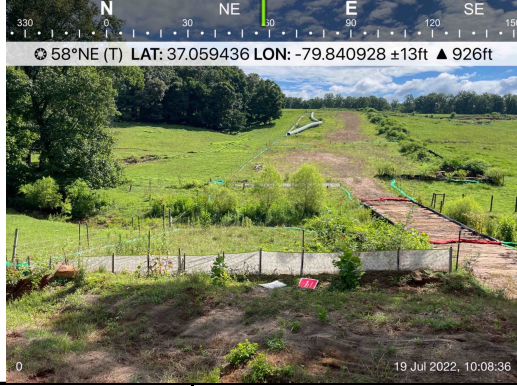
GPS Location	See photo		GPS Location	See photo	
Field Station#	14190+00		Field Station#	14181+00	
Pic 11 Desc.	P1 is in good condition at all stream and wetland buffers		Pic 12 Desc.	SSF is in good condition

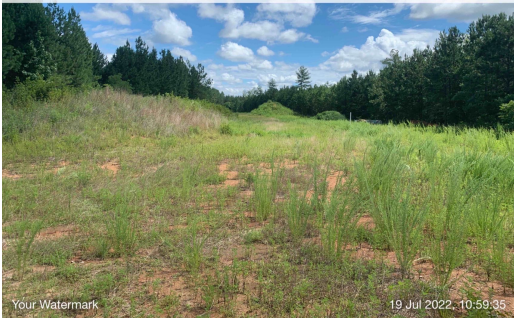
<small>Your Watermark 19 Jul 2022, 11:24:16</small>		
GPS Location	O		GPS Location	O	
Field Station#	4+00		Field Station#	14+00	
Pic 1 Desc.	Observing temporary stabilization		Pic 2 Desc.	Observing temporary stabilization,buffer and ECD's	
South West Elevation ☉ 23°NE (T) ● 36°50'1"N, 79°20'15"W ±269ft ▲ 663ft

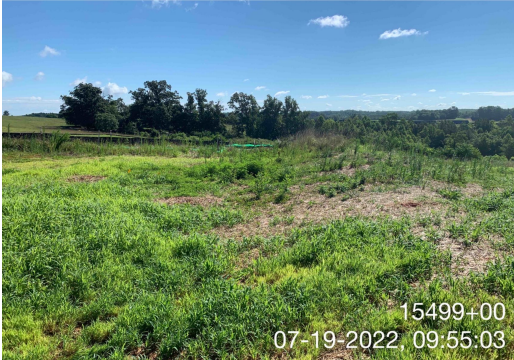
15499+00 07-19-2022, 09:55:23			
GPS Location	0	GPS Location	0		
Field Station#	15499+00	Field Station#	15499+00		
Pic 1 Desc.	Waterbar in acceptable condition	Pic 2 Desc.	Waterbar end treatment in acceptable condition		
209°SW (T) 17 N 636187 4085448 ±16ft ▲ 859ft

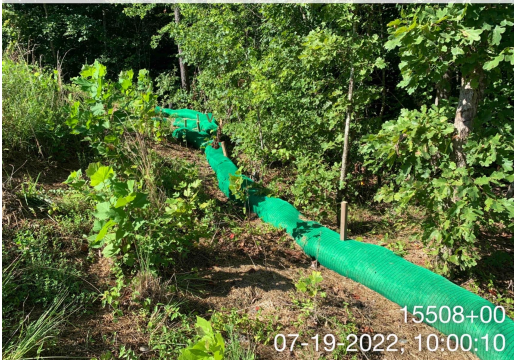
15516+00 07-19-2022, 10:07:19			
GPS Location	0	GPS Location	0		
Field Station#	15508+00	Field Station#	15516+00		
Pic 3 Desc.	CFS in acceptable condition	Pic 4 Desc.	Clean water diversion pipe in acceptable condition		
123°SE (T) 17 N 636540 4085148 ±13ft ▲ 842ft

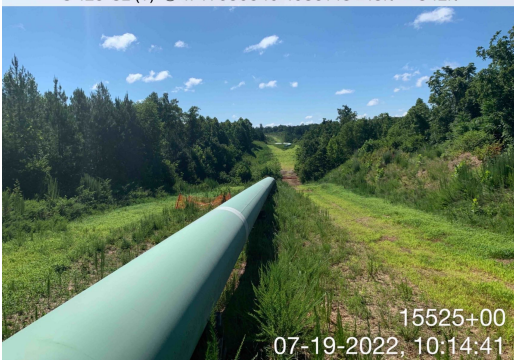
GPS Location	0	GPS Location	0		
Field Station#	15525+00	Field Station#	15542+19		
Pic 5 Desc.	Temporary vegetative stabilization in acceptable condition	Pic 6 Desc.	Equipment bridge in acceptable condition

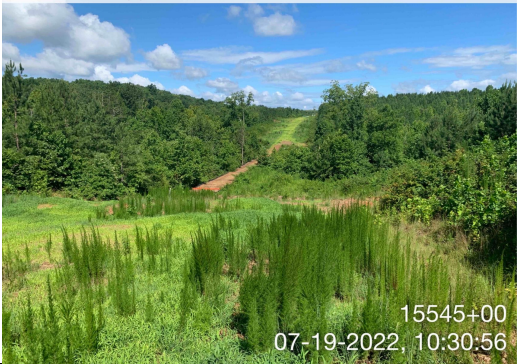
15536+00 07-19-2022, 10:21:42			
GPS Location	0	GPS Location	0		
Field Station#	15545+00	Field Station#	15536+00		
Pic 7 Desc.	Temporary vegetative stabilization in acceptable condition		Pic 8 Desc.	Clean water diversion berm and temporary vegetative stabilization in acceptable conditions	
245°SW (T) 17 N 636642 4085079 ±137ft ▲ 809ft

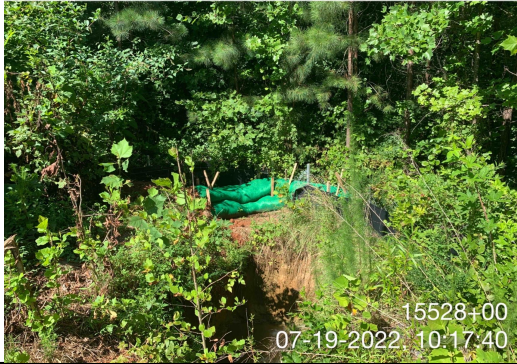
15493+00 07-19-2022, 12:33:31			
GPS Location	0	GPS Location	0		
Field Station#	15528+00	Field Station#	15493+00		
Pic 9 Desc.	Sump pit in acceptable condition		Pic 10 Desc.	Permanent vegetative stabilization in acceptable condition	
9°N (T) 17 N 636322 4085347 ±4570ft ▲ 868ft

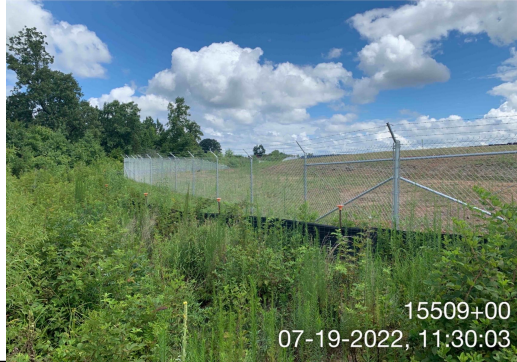
GPS Location	0	GPS Location	0		
Field Station#	15509+00	Field Station#	15558+00		
Pic 11 Desc.	Solar farm perimeter ECDs appear to be in acceptable conditions		Pic 12 Desc.	Grading operation in progress on south side of the ROW (tract VA-PI-3396)

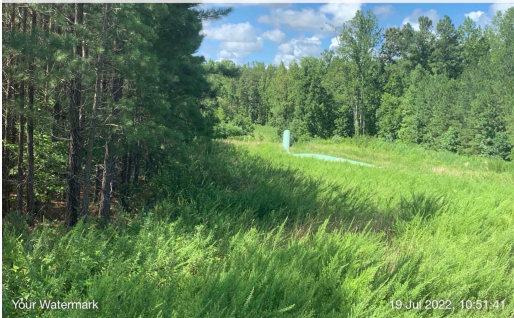
<small>Your Watermark 19 Jul 2022 10:53:23</small>			
GPS Location	O	GPS Location	O		
Field Station#	6+00	Field Station#	12+65		
Pic 1 Desc.	Observing temporary stabilization		Pic 2 Desc.	Observing temporary stabilization,buffer, equipment crossing and ECD's	
North Elevation 178°S (T) 36°49'43"N, 79°20'40"W ±13ft ▲616ft

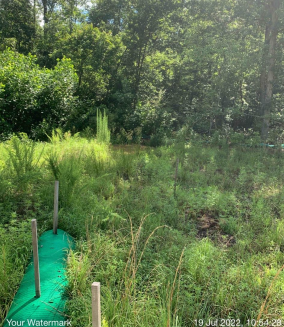
<small>Your Watermark 19 Jul 2022 10:54:34</small>			
GPS Location	O	GPS Location	O		
Field Station#	13+50	Field Station#	15+00		
Pic 3 Desc.	Observing temporary stabilization,water bar,buffer,seep and end treatment		Pic 4 Desc.	Observing temporary stabilization and signage

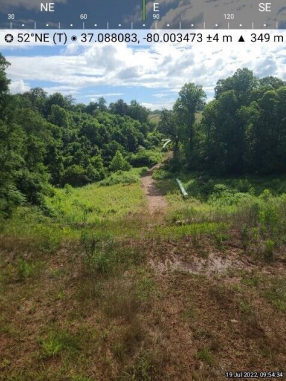
GPS Location	00000	GPS Location	00000		
Field Station#	13787+00	Field Station#	13784+30		
Pic 1 Desc.	Vegetation observation on hill side above stream crossing. No issues observed at the time of inspection.		Pic 2 Desc.	Monitored sump pit and plunge pool after recent rain events. No environmental issues observed at the time of inspection.

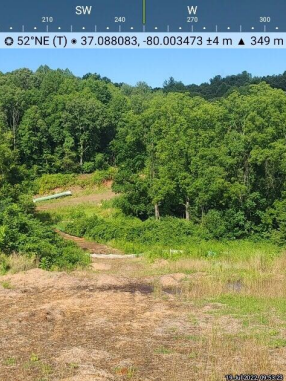
GPS Location	00000	GPS Location	00000		
Field Station#	13783+50	Field Station#	13811+66		
Pic 3 Desc.	Row photo showing stabilization on hill side above stream crossing.		Pic 4 Desc.	Monitored RCEs and ECDs at road crossings. No environmental issues observed at the time of inspection.

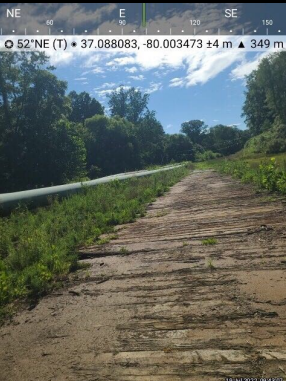
GPS Location	00000	GPS Location	00000		
Field Station#	13756+00	Field Station#	13755+71		
Pic 5 Desc.	Monitored timber mats and vegetation during inspection today. No environmental issues observed at the time of inspection.		Pic 6 Desc.	Monitored equipment bridge and protection after recent overnight rain events. No issues were observed at the time of inspection.

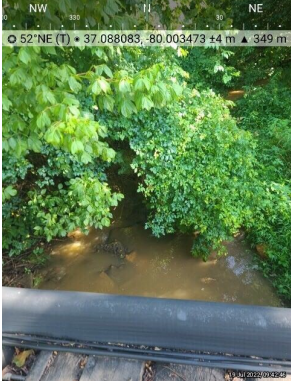
<p>Insert image here</p>		<p>Insert image here</p>	
GPS Location	0000	GPS Location			
Field Station#	13755+11	Field Station#			
Pic 7 Desc.	Stream observation photo facing downstream during routine inspection today. No environmental issues were observed at the time of inspection.		Pic 8 Desc.		
<p>Insert image here</p>		<p>Insert image here</p>			
GPS Location		GPS Location			
Field Station#		Field Station#			
Pic 9 Desc.			Pic 10 Desc.		
<p>Insert image here</p>		<p>Insert image here</p>			
GPS Location		GPS Location			
Field Station#		Field Station#			
Pic 11 Desc.			Pic 12 Desc.

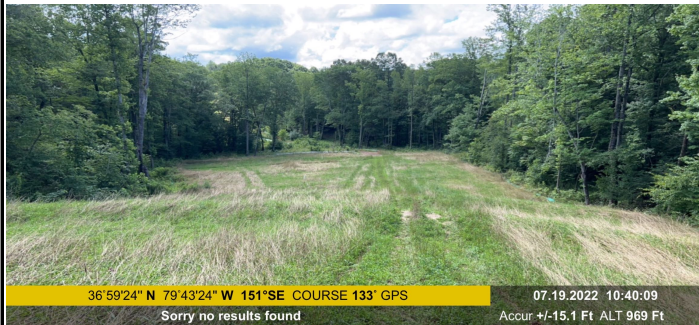
GPS Location	3		GPS Location	4	
Field Station#	14650+00		Field Station#	14654+00	
Pic 3 Desc.	Contractor replaced damaged perimeter CFS with wattles per punch list item.		Pic 4 Desc.	ROW stabilized and vegetated in final cleanup area.

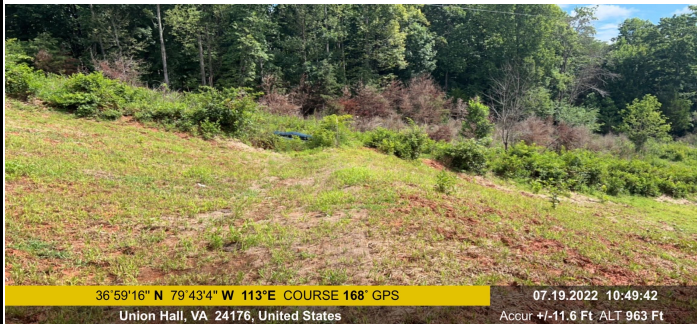
<div>36°59'16" N 79°43'4" W 113°E COURSE 168° GPS Union Hall, VA 24176, United States 07.19.2022 10:49:42 Accur +/-11.6 Ft ALT 963 Ft</div>			<div>36°59'16" N 79°43'3" W 145°SE COURSE 311° GPS Union Hall, VA 24176, United States 07.19.2022 10:50:34 Accur +/-11.6 Ft ALT 940 Ft</div>		
GPS Location	5		GPS Location	6	
Field Station#	14679+00		Field Station#	14671+00	
Pic 5 Desc.	Water bar performing intended function; erosion control blanket in place and functional.		Pic 6 Desc.	Plunge pool and perimeter ECDs in place and functional.

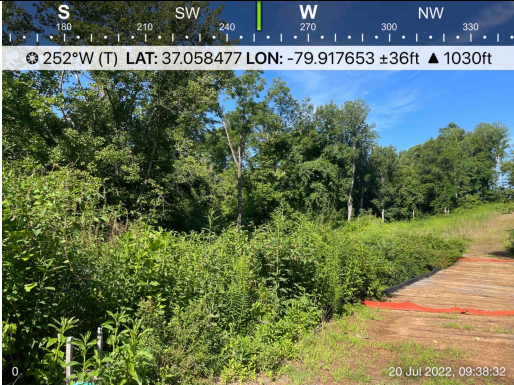
GPS Location	See photo		GPS Location	See photo	
Field Station#	13863+00		Field Station#	13875+73	
Pic 1 Desc.	Resource buffers remain well vegetated		Pic 2 Desc.	Equipment bridge ECDs are in good condition and functioning

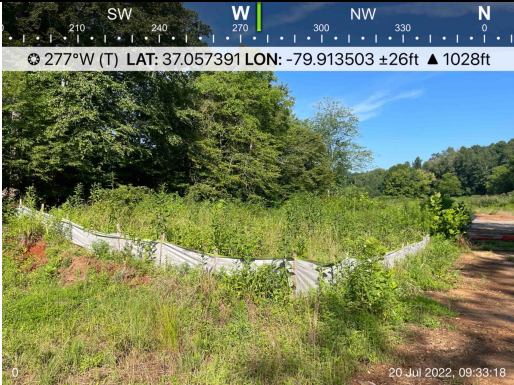
GPS Location	See photo		GPS Location	See photo	
Field Station#	13876+00		Field Station#	13888+00	
Pic 3 Desc.	P1 is in good condition at all stream and wetland buffers		Pic 4 Desc.	Slope drain is in good condition and functioning

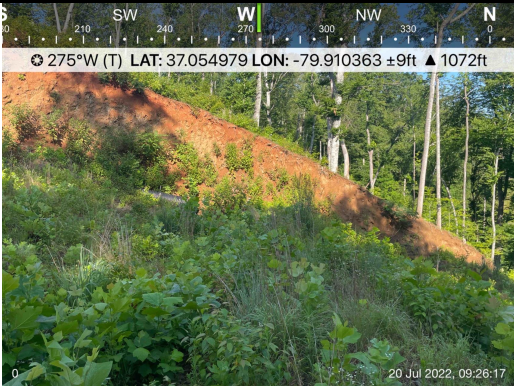
GPS Location	See photo		GPS Location	See photo	
Field Station#	13890+00		Field Station#	13892+45	
Pic 5 Desc.	Waterbars are in good condition		Pic 6 Desc.	RCEs are in good condition at all road crossings.

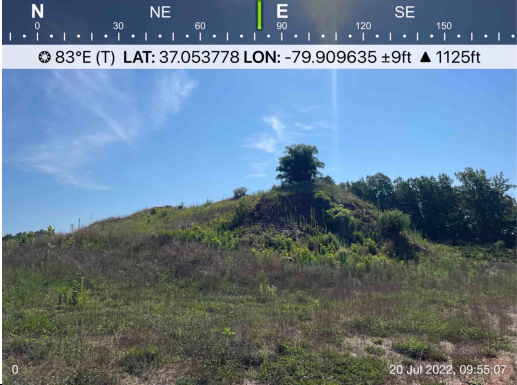
GPS Location	See photo	GPS Location	See photo		
Field Station#	13897+00	Field Station#	13897+00		
Pic 7 Desc.	Topsoil berm remains stabilized	Pic 8 Desc.	Sediment trap is functioning as intended

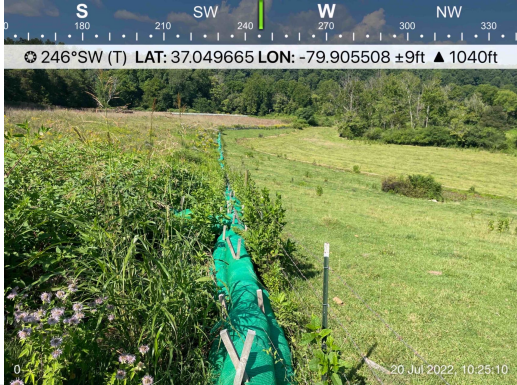
GPS Location	See photo	GPS Location	See photo		
Field Station#	13925+00	Field Station#	13939+50		
Pic 9 Desc.	CFS is in good condition	Pic 10 Desc.	SSF is in good condition

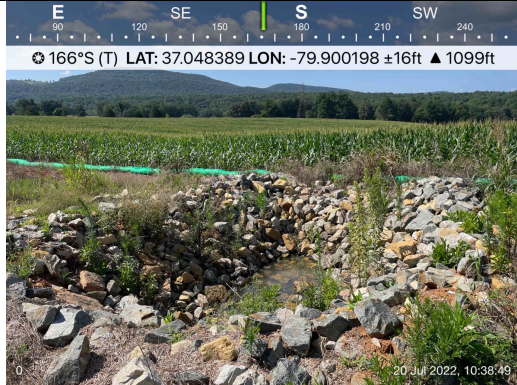
GPS Location	See photo	GPS Location	See photo		
Field Station#	13942+00	Field Station#	13953+00		
Pic 11 Desc.	CWDs are functioning as intended	Pic 12 Desc.	Slope drain outlet is functioning as intended

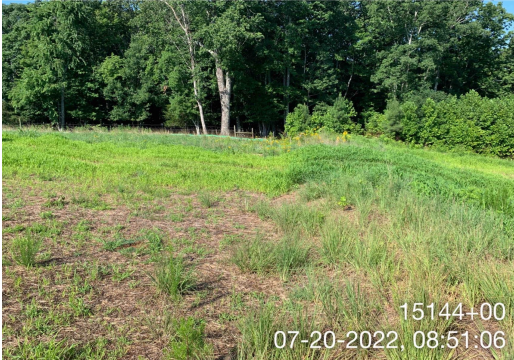
GPS Location	0	GPS Location	0		
Field Station#	15144+00	Field Station#	15144+00		
Pic 1 Desc.	Waterbar in acceptable condition	Pic 2 Desc.	Waterbar end treatment in acceptable condition

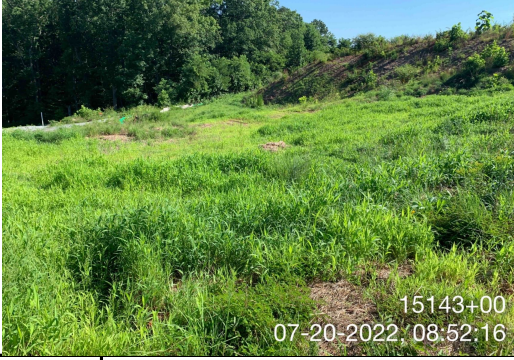
GPS Location	0	GPS Location	0		
Field Station#	15143+00	Field Station#	15154+00		
Pic 3 Desc.	Permanent vegetative stabilization in acceptable condition	Pic 4 Desc.	Temporary vegetative stabilization in acceptable condition

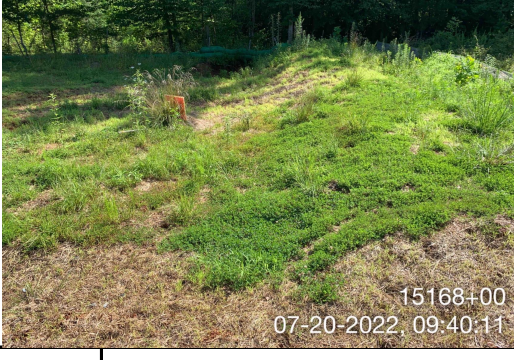
GPS Location	0	GPS Location	0		
Field Station#	15168+00	Field Station#	15168+00		
Pic 5 Desc.	Waterbar in acceptable condition	Pic 6 Desc.	Waterbar end treatment in acceptable condition

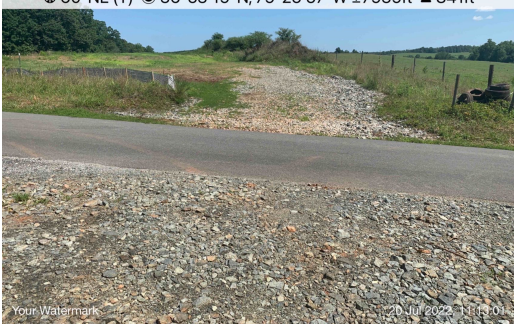
GPS Location	O	GPS Location	O		
Field Station#	15647+03	Field Station#	15645+00		
Pic 1 Desc.	Observing road crossing and RCE's	Pic 2 Desc.	Observing temporary stabilization, water bar, sump and end treatment		
2152-2298 Anderson Mill Rd Chatham VA 129°SE (T) 36°53'22"N, 79°25'58"W ±13ft ▲ 813ft

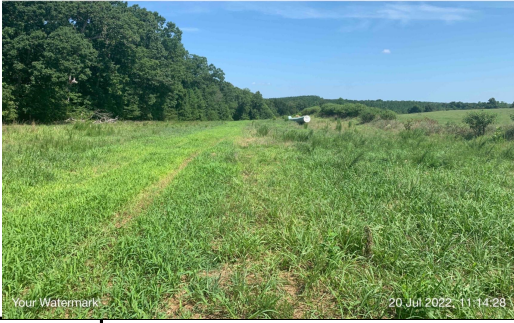
GPS Location	O	GPS Location	O		
Field Station#	15638+00	Field Station#	15623+00		
Pic 3 Desc.	Observing temporary stabilization	Pic 4 Desc.	Observing temporary stabilization and water bar		
2572 Anderson Mill Rd Chatham VA 284°W (T) 36°53'35"N, 79°26'13"W ±39ft ▲ 811ft

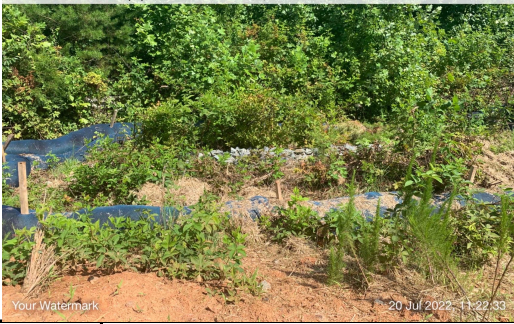
GPS Location	O	GPS Location	O		
Field Station#	15625+00	Field Station#	15614+94		
Pic 5 Desc.	Observing temporary stabilization, CWD outlet and ECD's	Pic 6 Desc.	Observing temporary stabilization, signage, buffer, equipment crossing and ECD's

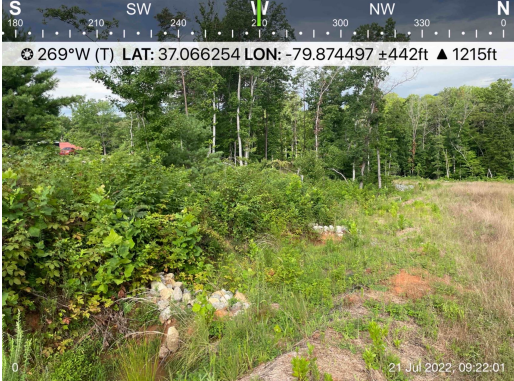
GPS Location	See photo		GPS Location	See photo	
Field Station#	14060+00		Field Station#	14057+00	
Pic 1 Desc.	Rock check dams are in good condition		Pic 2 Desc.	Slope drain outlet is functioning as intended

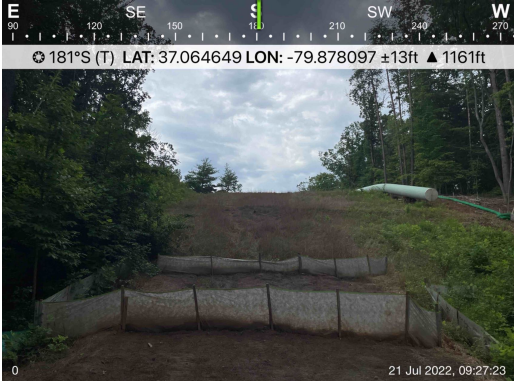
GPS Location	See photo		GPS Location	See photo	
Field Station#	14050+00		Field Station#	14045+71	
Pic 3 Desc.	Slope remains stabilized		Pic 4 Desc.	Equipment bridge fabric needs to be reattached

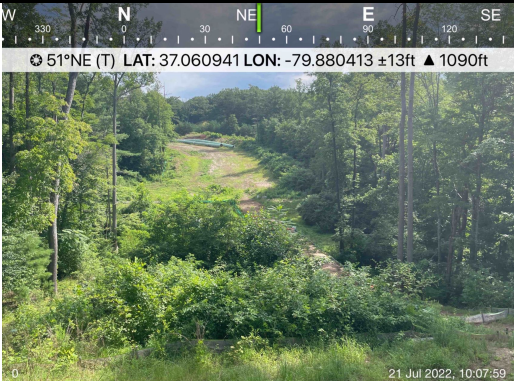
GPS Location	See photo		GPS Location	See photo	
Field Station#	14035+00		Field Station#	14033+00	
Pic 5 Desc.	Resource buffers remain well vegetated		Pic 6 Desc.	End treatments are functioning as intended

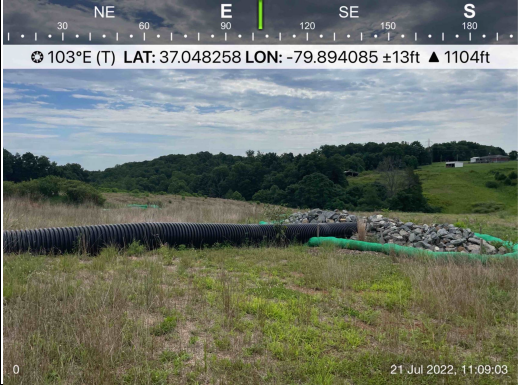
<p>Insert image here</p>			
GPS Location	See photo	GPS Location			
Field Station#	13960+00	Field Station#			
Pic 13 Desc.	CWDs are functioning as intended	Pic 14 Desc.			
<p>Insert image here</p>		<p>Insert image here</p>			
GPS Location		GPS Location			
Field Station#		Field Station#			
Pic 15 Desc.		Pic 16 Desc.			
<p>Insert image here</p>		<p>Insert image here</p>			
GPS Location		GPS Location			
Field Station#		Field Station#			
Pic 17 Desc.		Pic 18 Desc.

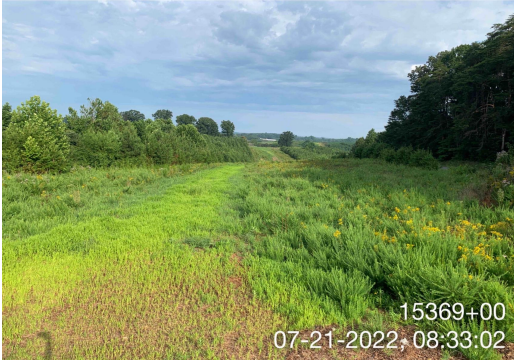
15357+00 07-21-2022, 08:43:19		
GPS Location	0		GPS Location	0	
Field Station#	15369+00		Field Station#	15357+00	
Pic 1 Desc.	Permanent vegetative stabilization in acceptable condition		Pic 2 Desc.	Waterbar in acceptable condition	
114°SE (T) 17 N 632312 4087421 ±39ft ▲ 750ft

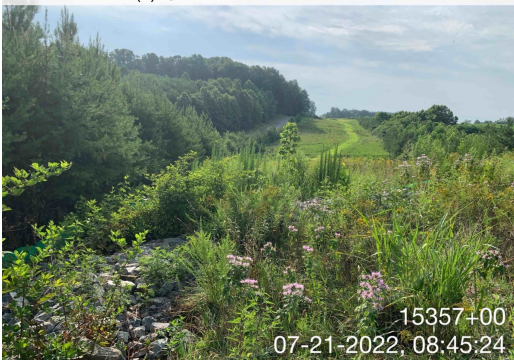
15340+00 07-21-2022, 09:05:32		
GPS Location	0		GPS Location	0	
Field Station#	15357+00		Field Station#	15340+00	
Pic 3 Desc.	Waterbar end treatment in acceptable condition		Pic 4 Desc.	Temporary vegetative stabilization in acceptable condition	
336°NW (T) 17 N 631846 4087745 ±13ft ▲ 769ft

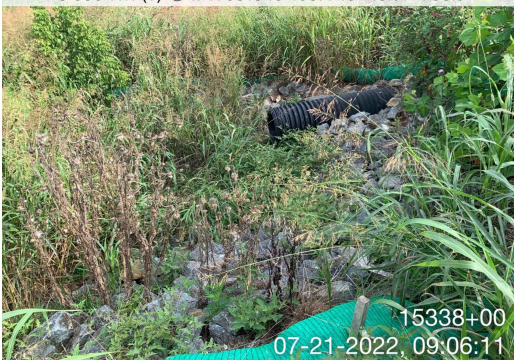
GPS Location	0		GPS Location	0	
Field Station#	15338+00		Field Station#	15337+50	
Pic 5 Desc.	Clean water diversion pipe and plunge pool in acceptable conditions		Pic 6 Desc.	Sump pit in acceptable condition

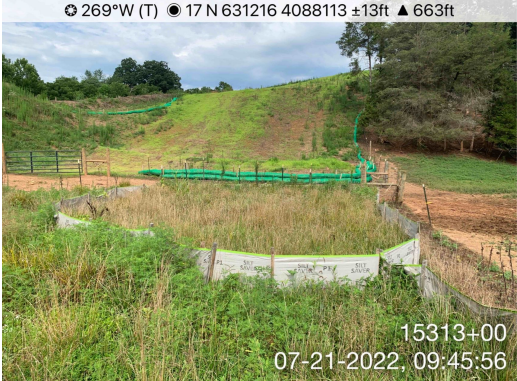
<p>15298+00 07-21-2022, 10:52:46</p>			
GPS Location	0	GPS Location	0		
Field Station#	15313+00	Field Station#	15298+00		
Pic 7 Desc.	P1 silt fence and CFS in acceptable conditions	Pic 8 Desc.	Temporary vegetative stabilization and P1 silt fence in acceptable conditions		
Insert image here		Insert image here			
GPS Location		GPS Location			
Field Station#		Field Station#			
Pic 9 Desc.		Pic 10 Desc.			
Insert image here		Insert image here			
GPS Location		GPS Location			
Field Station#		Field Station#			
Pic 11 Desc.		Pic 12 Desc.

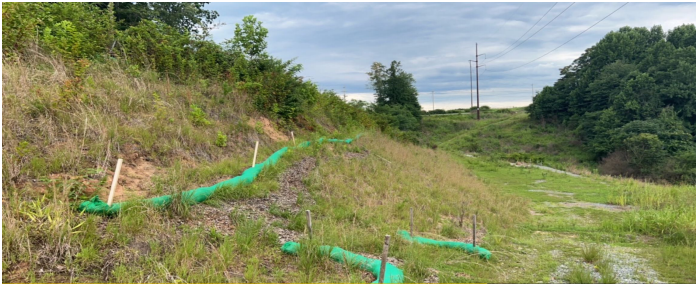
37°1'33" N 79°46'0" W 42°NE COURSE 329' GPS		07.21.2022 11:34:08		37°1'24" N 79°45'54" W 147°SE COURSE 52' GPS	
Glade Hill, VA 24092, United States		Accur +/-46.0 Ft ALT 1054 Ft		Glade Hill, VA 24092, United States	
GPS Location	1	GPS Location	2		
Field Station#	14459+00	Field Station#	14465+00		
Pic 1 Desc.	CFS along slope in good condition.	Pic 2 Desc.	Sump pit and CFS end treatment performing intended functions.

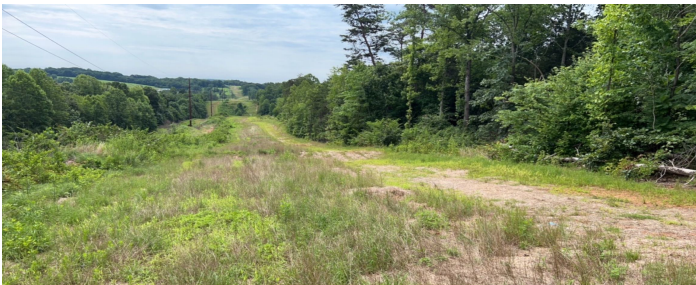
37°1'24" N 79°45'54" W 203°S COURSE 160' GPS		07.21.2022 11:15:35		37°1'11" N 79°45'43" W 201°S COURSE 146' GPS	
Glade Hill, VA 24092, United States		Accur +/-11.6 Ft ALT 1049 Ft		Glade Hill, VA 24092, United States	
GPS Location	3	GPS Location	4		
Field Station#	14474+00	Field Station#	14486+56		
Pic 3 Desc.	ROW stabilized and vegetated in temporary area.	Pic 4 Desc.	Equipment bridge and surrounding ECDs in place and functional at stream crossing and resource buffer.

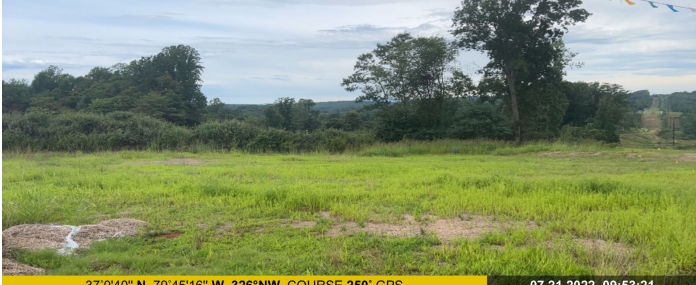
37°0'40" N 79°45'16" W 326°NW COURSE 250' GPS		07.21.2022 09:53:21		37°0'39" N 79°45'15" W 104°E COURSE 73' GPS	
1705 SR-674, Glade Hill, VA 24092, United States		Accur +/-15.5 Ft ALT 1069 Ft		1705 SR-674, Glade Hill, VA 24092, United States	
GPS Location	5	GPS Location	6		
Field Station#	14523+00	Field Station#	14525+00		
Pic 5 Desc.	ROW stabilized and vegetated in temporary area.	Pic 6 Desc.	Perimeter P1 silt fence in place and functional.

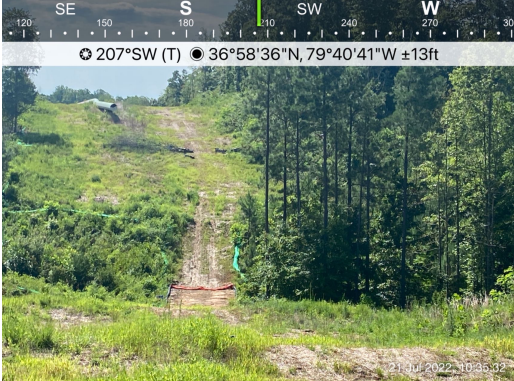
GPS Location	0	GPS Location	0		
Field Station#	14806+00	Field Station#	14846+00		
Pic 1 Desc.	Approximately 14806+00. Overview of ROW.		Pic 2 Desc.	Approximately 14846+00. Overview of road crossing and RCEs.

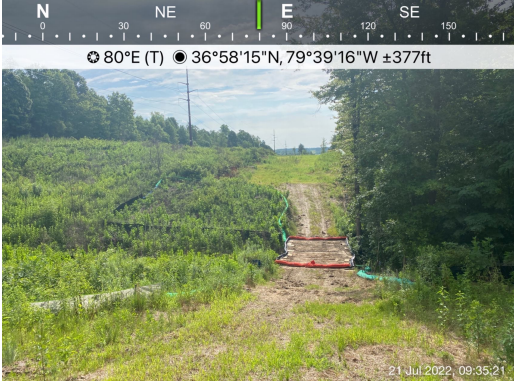
GPS Location	0	GPS Location	0		
Field Station#	14881+54	Field Station#	14894+00		
Pic 3 Desc.	Approximately 14881+54. Overview of stream crossing, equipment bridge and ECDs at stream S-CD8.		Pic 4 Desc.	Approximately 14894+00. Overview of ROW.

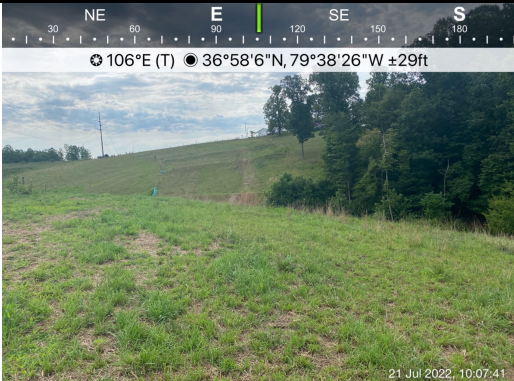
GPS Location	0	GPS Location	0		
Field Station#	14920+50	Field Station#	14925+00		
Pic 5 Desc.	Approximately 14920+50. Overview of ROW. Permanent vegetation. Livestock grazing area.		Pic 6 Desc.	Approximately 14925+00. P-1 requires maintenance. Damaged by livestock.

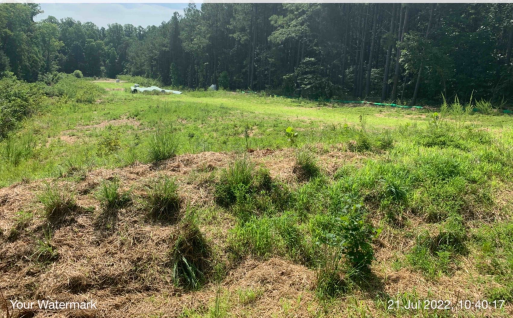
<small>Your Watermark 21 Jul 2022, 10:40:17</small>	
GPS Location	O		GPS Location	O	
Field Station#	15750+00		Field Station#	15752+00	
Pic 1 Desc.	Observing temporary stabilization, sump, end treatment and ECD's		Pic 2 Desc.	Observing temporary stabilization and water bars	
	Chatham VA 23°NE (T) 36°52'19"N, 79°24'24"W ±2011ft ▲ 831ft

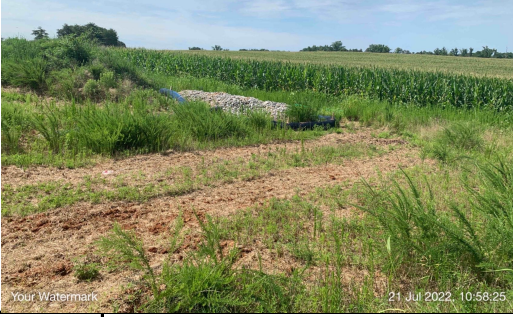
<small>Your Watermark 21 Jul 2022, 10:58:25</small>	
GPS Location	O		GPS Location	O	
Field Station#	15754+00		Field Station#	15735+00	
Pic 3 Desc.	Observing temporary stabilization, sump, end treatment and ECD's		Pic 4 Desc.	Observing temporary stabilization, CWD outlet and ECD's

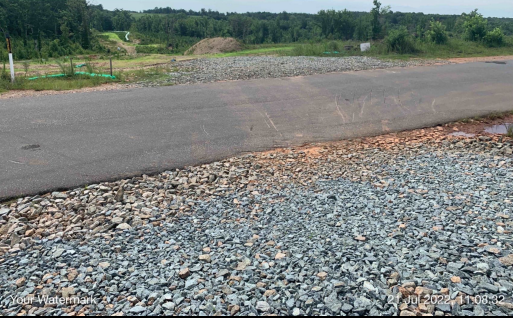
<small>Your Watermark 21 Jul 2022, 11:01:32</small>	
GPS Location	O		GPS Location	O	
Field Station#	15733+00		Field Station#	15693+89	
Pic 5 Desc.	Observing temporary stabilization		Pic 6 Desc.	Observing road crossing and RCE's

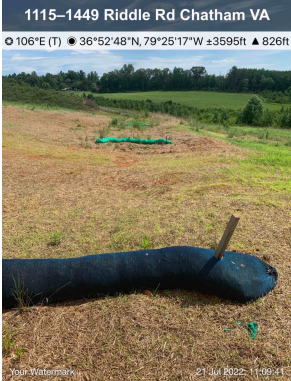
GPS Location	O	GPS Location	O		
Field Station#	15695+00	Field Station#	15700+40		
Pic 7 Desc.	Observing temporary stabilization, water bar and CFS Checks	Pic 8 Desc.	Observing temporary stabilization, buffer, equipment crossing and ECD's

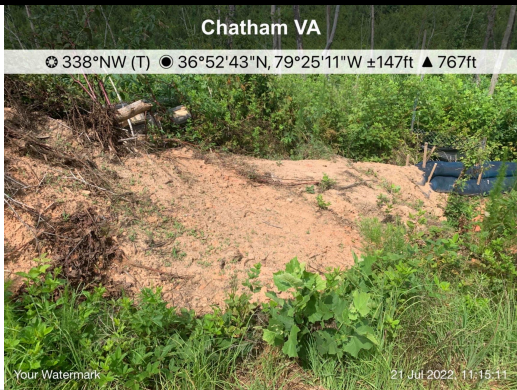
<p style="text-align: center;">Insert image here</p>			
GPS Location	O	GPS Location			
Field Station#	15701+50	Field Station#			
Pic 9 Desc.	Observing location that needs to be stabilized	Pic 10 Desc.			
<p style="text-align: center;">Insert image here</p>		<p style="text-align: center;">Insert image here</p>			
GPS Location		GPS Location			
Field Station#		Field Station#			
Pic 11 Desc.		Pic 12 Desc.

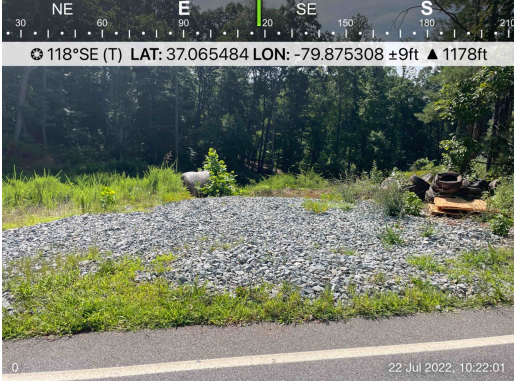
GPS Location	See photo		GPS Location	See photo	
Field Station#	14062+17		Field Station#	14066+77	
Pic 1 Desc.	RCEs are in good condition at all road crossings		Pic 2 Desc.	Equipment bridge ECDs are functioning as intended

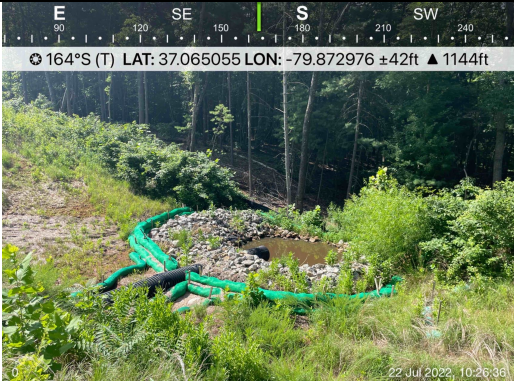
GPS Location	See photo		GPS Location	See photo	
Field Station#	14070+00		Field Station#	14081+46	
Pic 3 Desc.	CWDs are functioning as intended		Pic 4 Desc.	MVP-FR-309.05 is in good condition with controls in place

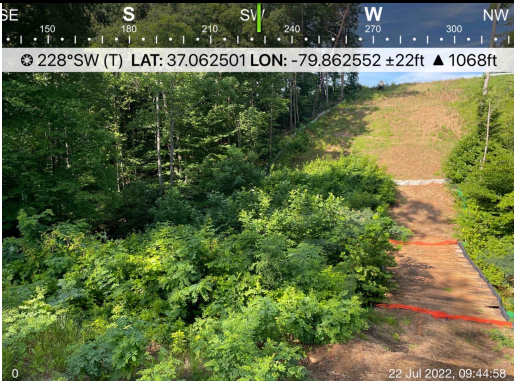
GPS Location	See photo		GPS Location	See photo	
Field Station#	14105+32		Field Station#	14109+00	
Pic 5 Desc.	Resource buffers remain well vegetated		Pic 6 Desc.	End treatments are functioning as intended

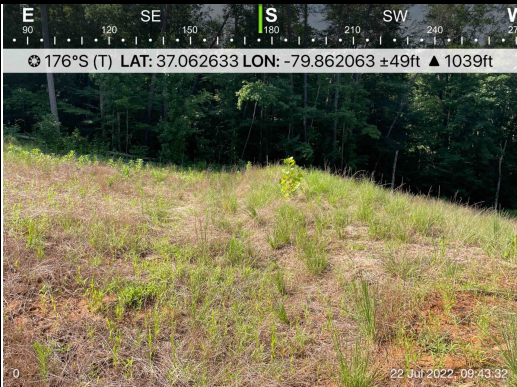
GPS Location	See photo		GPS Location	See photo	
Field Station#	14109+00		Field Station#	14115+00	
Pic 7 Desc.	Waterbars are in good condition		Pic 8 Desc.	CFS is in good condition throughout this section

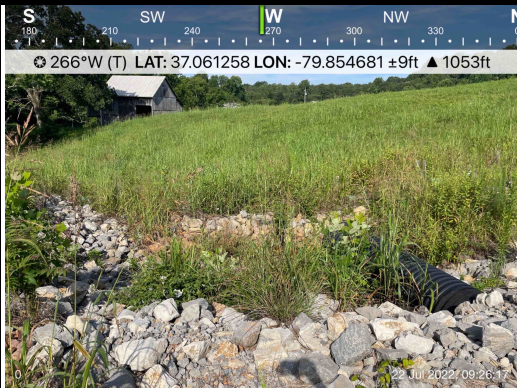
GPS Location	See photo		GPS Location	See photo	
Field Station#	14132+00		Field Station#	14141+62	
Pic 9 Desc.	CWDs are functioning as intended		Pic 10 Desc.	P1 is in good condition at all stream and wetland buffers

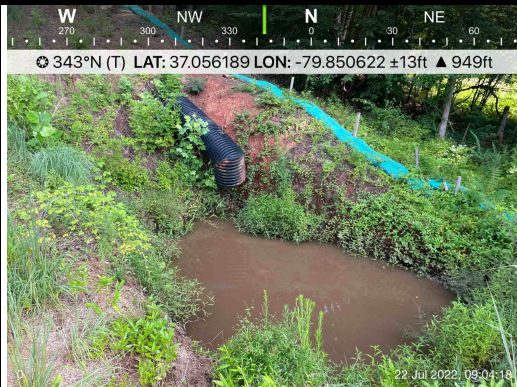
GPS Location	See photo		GPS Location	See photo	
Field Station#	14156+00		Field Station#	14171+36	
Pic 11 Desc.	Slope drain is in good condition and functioning		Pic 12 Desc.	SSF is in good condition.

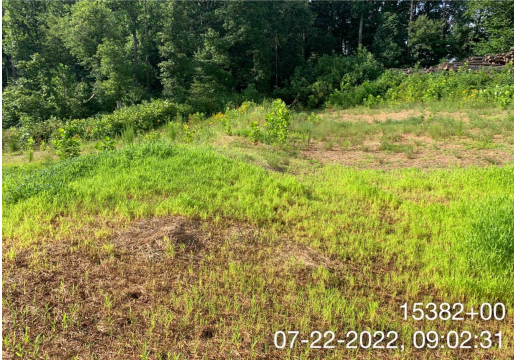
<p>15382+00 07-22-2022, 09:02:31</p>

<p>15382+00 07-22-2022, 09:03:22</p>			
GPS Location	0	GPS Location	0		
Field Station#	15382+00	Field Station#	15382+00		
Pic 1 Desc.	Waterbar in acceptable condition		Pic 2 Desc.	Waterbar end treatment in acceptable condition

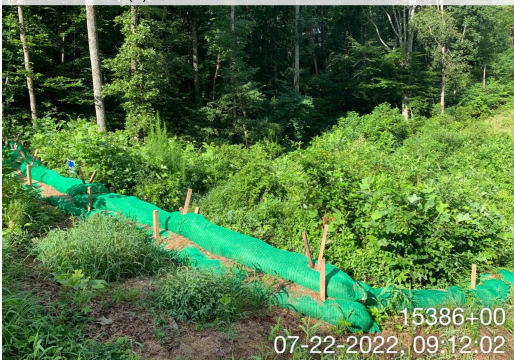
<p>15386+00 07-22-2022, 09:12:02</p>

<p>15389+00 07-22-2022, 09:25:19</p>			
GPS Location	0	GPS Location	0		
Field Station#	15386+00	Field Station#	15389+00		
Pic 3 Desc.	CFS and sensitive resource buffer in acceptable conditions		Pic 4 Desc.	Temporary vegetative stabilization in acceptable condition

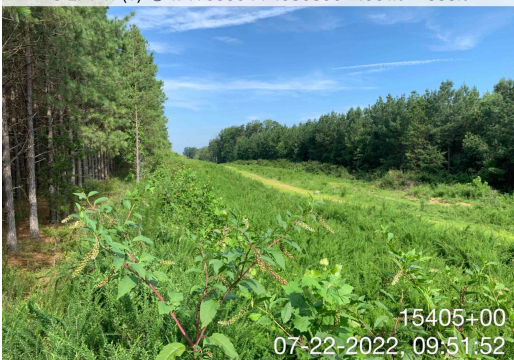
<p>15405+00 07-22-2022, 09:51:52</p>

<p>15423+00 07-22-2022, 10:21:43</p>			
GPS Location	0	GPS Location	0		
Field Station#	15405+00	Field Station#	15423+00		
Pic 5 Desc.	Clean water diversion berm and temporary vegetative stabilization in acceptable conditions		Pic 6 Desc.	Waterbar in acceptable condition

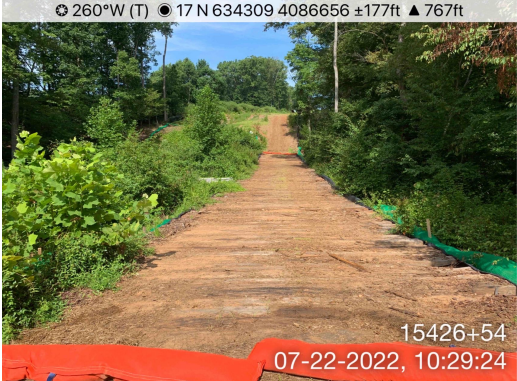
GPS Location	0	GPS Location	0		
Field Station#	15426+54	Field Station#	15427+00		
Pic 7 Desc.	Equipment bridge in acceptable condition	Pic 8 Desc.	Super silt fence in acceptable condition

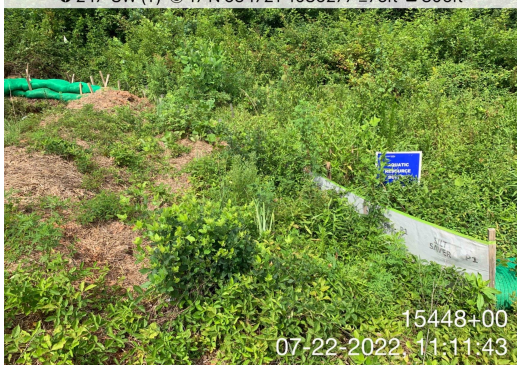
GPS Location	0	GPS Location	0		
Field Station#	15448+00	Field Station#	15469+00		
Pic 9 Desc.	P1 silt fence in acceptable condition	Pic 10 Desc.	Solar farm perimeter ECDs appear to be in acceptable conditions		
Insert image here		Insert image here			
GPS Location		GPS Location			
Field Station#		Field Station#			
Pic 11 Desc.		Pic 12 Desc.

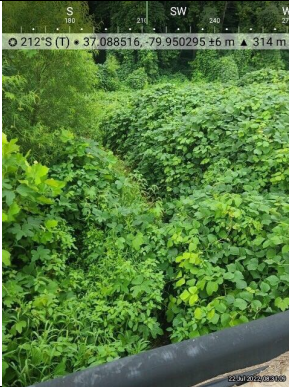
GPS Location	0000	GPS Location	0000		
Field Station#	13678+71	Field Station#	13692+67		
Pic 1 Desc.	Stream observation photo facing downstream during routine inspection today. No environmental issues observed at the time of inspection.	Pic 2 Desc.	Monitored ECDs along the row perimeter. All functioning at the time of inspection.

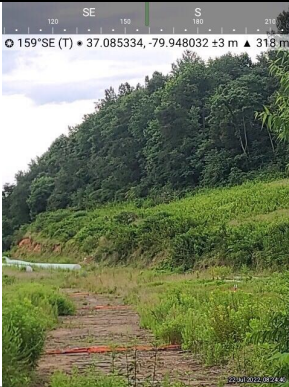
GPS Location	00000	GPS Location	00000		
Field Station#	13692+82	Field Station#	13748+00		
Pic 3 Desc.	Monitored ECDs throughout the inspection area. No environmental issues observed at the time of inspection.	Pic 4 Desc.	Observed ECDs during routine inspection. No environmental issues observed at the time of inspection.

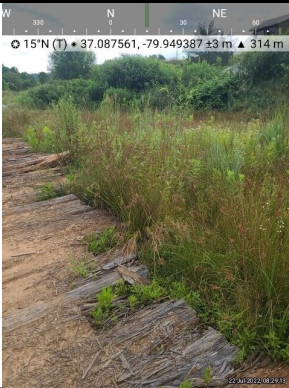
GPS Location	0000	GPS Location	00000		
Field Station#	13687+12	Field Station#	13748+10		
Pic 5 Desc.	Observed stabilization on spoil piles throughout the inspection area. No environmental issues observed at the time of inspection.	Pic 6 Desc.	Monitored ECDs at road crossings. No issues were observed at the time of inspection.
