Visual Site Inspection Report

Project Name	H-600 Pipeline Spread I	AFE	124300139	Spread	H-600 Pipeline Spread I
Contractor	Precision			Report #	40231
Inspector	Glenn Mike Renfro			Date/Time	7/25/2022 2:04 PM
Permit #	TBD	Inspection Type	VA SWPP	Station Begin	0000+00
State	VA	Inspection Area	Full	Station End	00000+00
County	Franklin	Ground	Dry	Temperature (°F)	87.00
Municipality	N/A	Weather	Cloudy	Rain Gauge (in)	0.00
				Rain Accumulation Time (days)	6.00

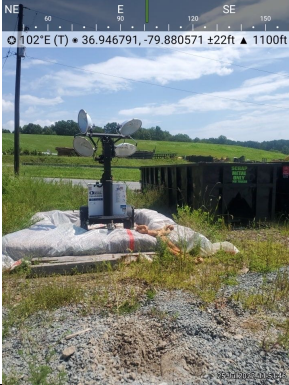
GPS Location	0	GPS Location	0		
Field Station#	0+00	Field Station#	0+00		
Pic 1 Desc.	LY-032 Secondary containment		Pic 2 Desc.	LY-033 Stormwater drain inlet

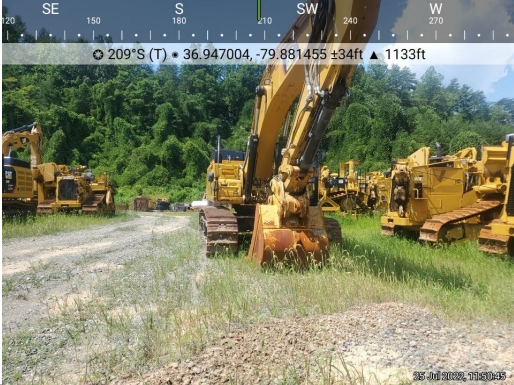
GPS Location	0	GPS Location	0		
Field Station#	0+00	Field Station#	0+00		
Pic 3 Desc.	LY-032 Staging area		Pic 4 Desc.	ANC-006 Stormwater drain inlet protection

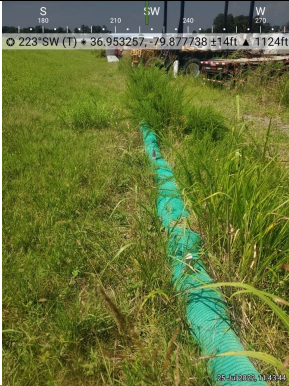
GPS Location	0	GPS Location	0		
Field Station#	0+00	Field Station#	0+00		
Pic 5 Desc.	ANC-006 Southeast perimeter CFS		Pic 6 Desc.	LY-048 Southern temporary vegetation

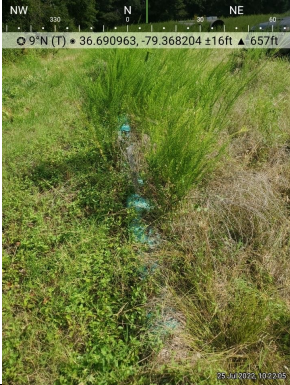
GPS Location	0	GPS Location	0		
Field Station#	0+00	Field Station#	0+00		
Pic 7 Desc.	LY-048 West perimeter CFS	Pic 8 Desc.	LY-033 Rock construction entrance		
Insert image here		Insert image here			
GPS Location		GPS Location			
Field Station#		Field Station#			
Pic 9 Desc.		Pic 10 Desc.			
Insert image here		Insert image here			
GPS Location		GPS Location			
Field Station#		Field Station#			
Pic 11 Desc.		Pic 12 Desc.

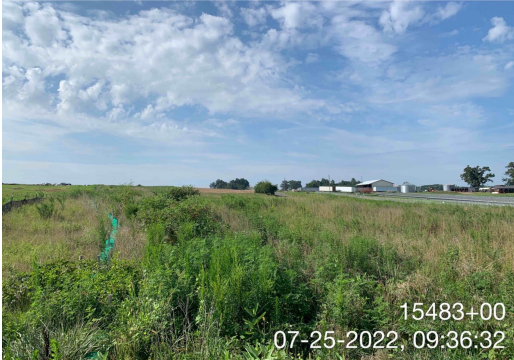
<p>15483+00 07-25-2022, 09:36:32</p>

<p>15511+00 07-25-2022, 10:11:29</p>		
GPS Location	0		GPS Location	0	
Field Station#	15483+00		Field Station#	15511+00	
Pic 1 Desc.	Permanent vegetative stabilization and perimeter CFS in acceptable conditions		Pic 2 Desc.	Waterbar in acceptable condition

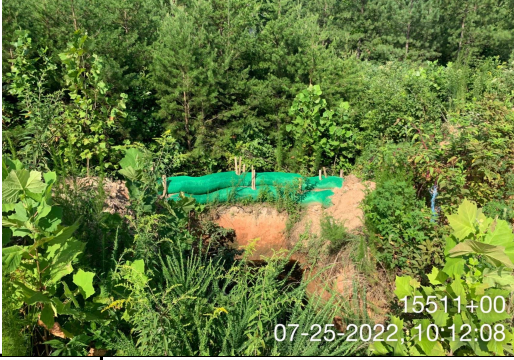
<p>15511+00 07-25-2022, 10:12:08</p>

<p>15516+00 07-25-2022, 10:17:24</p>		
GPS Location	0		GPS Location	0	
Field Station#	15511+00		Field Station#	15516+00	
Pic 3 Desc.	Waterbar end treatment in acceptable condition		Pic 4 Desc.	Sump pit and CFS in acceptable conditions

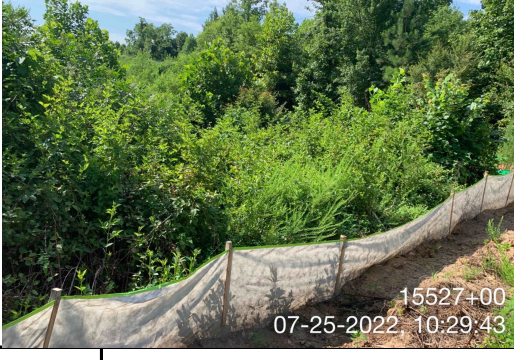
<p>15527+00 07-25-2022, 10:29:43</p>

<p>15533+00 07-25-2022, 10:45:30</p>		
GPS Location	0		GPS Location	0	
Field Station#	15527+00		Field Station#	15533+00	
Pic 5 Desc.	P1 silt fence in acceptable condition		Pic 6 Desc.	Temporary vegetative stabilization in acceptable condition

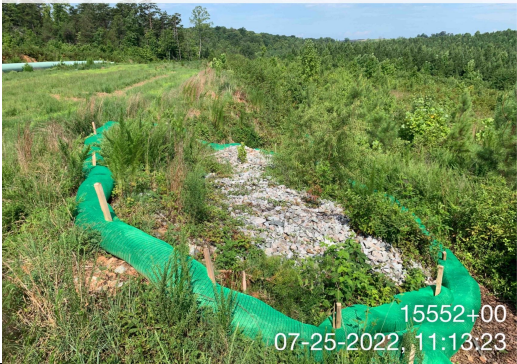
GPS Location	0	GPS Location	0		
Field Station#	15552+00	Field Station#	15551+00		
Pic 7 Desc.	Clean water diversion pipe in acceptable condition	Pic 8 Desc.	Temporary vegetative stabilization in acceptable condition

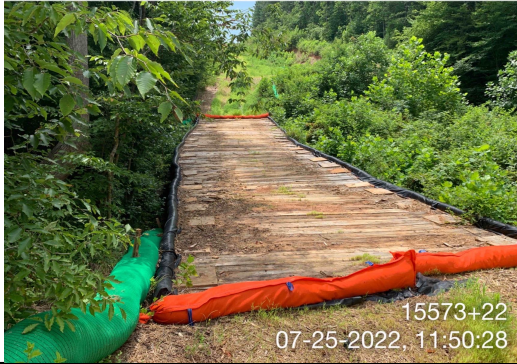
GPS Location	0	GPS Location	0		
Field Station#	15573+22	Field Station#	15483+00		
Pic 9 Desc.	Equipment bridge in acceptable condition	Pic 10 Desc.	Solar farm ECDs appear to be in acceptable conditions		
Insert image here		Insert image here			
GPS Location		GPS Location			
Field Station#		Field Station#			
Pic 11 Desc.		Pic 12 Desc.

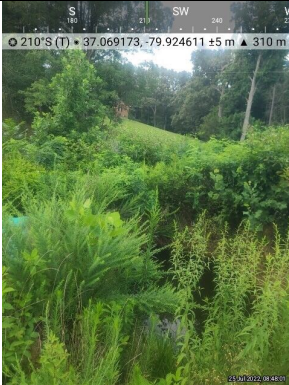
GPS Location	0000	GPS Location	0000		
Field Station#	13810+20	Field Station#	13755+49		
Pic 1 Desc.	Monitored sump pit and end treatment during routine inspection. No environmental issues observed at the time of inspection.		Pic 2 Desc.	Stream observation photo facing downstream during routine inspection today. No issues were observed at the time of inspection.

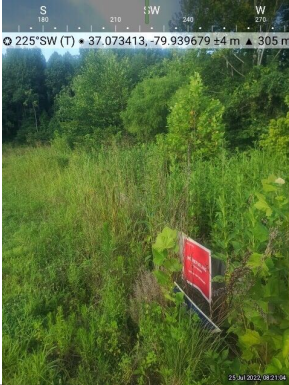
GPS Location	0000	GPS Location	0000		
Field Station#	13755+55	Field Station#	13806+00		
Pic 3 Desc.	Monitored stream buffer ECDs throughout. No environmental issues observed at the time of inspection.		Pic 4 Desc.	Monitored equipment bridge and ECDs. All in place and functioning at the time of inspection.

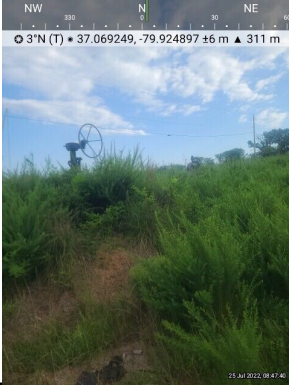
GPS Location	0000	GPS Location	0000		
Field Station#	13809+70	Field Station#	13755+49		
Pic 5 Desc.	Valve site photo showing vegetation. No environmental issues observed at the time of inspection.		Pic 6 Desc.	Stream observation photo facing upstream during routine inspection. No issues were observed at the time of inspection.

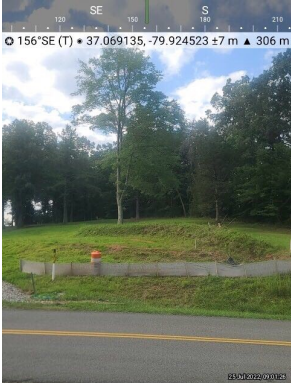
<p>Insert image here</p>		<p>Insert image here</p>	
GPS Location	0000	GPS Location			
Field Station#	13812+06	Field Station#			
Pic 7 Desc.	Observed ECDs at road crossing during routine row inspection. All in place and functioning at the time of inspection.		Pic 8 Desc.		
<p>Insert image here</p>		<p>Insert image here</p>			
GPS Location		GPS Location			
Field Station#		Field Station#			
Pic 9 Desc.		Pic 10 Desc.			
<p>Insert image here</p>		<p>Insert image here</p>			
GPS Location		GPS Location			
Field Station#		Field Station#			
Pic 11 Desc.		Pic 12 Desc.

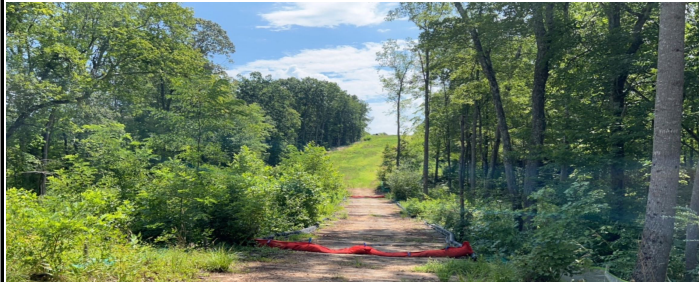
36°59'25" N 79°43'24" W 177°S COURSE 200' GPS 9400-9598 Old Franklin Tpke, Union Hall, VA 24176, United States 07.25.2022 11:36:27 Accur +/-15.4 Ft ALT 993 Ft			36°59'21" N 79°43'21" W 124°SE COURSE 112' GPS 9400-9598 Old Franklin Tpke, Union Hall, VA 24176, United States 07.25.2022 11:38:39 Accur +/-15.1 Ft ALT 954 Ft		
GPS Location	1		GPS Location	2	
Field Station#	14654+00		Field Station#	14657+00	
Pic 1 Desc.	ROW stabilized and vegetated in final cleanup area.		Pic 2 Desc.	Equipment bridge and surrounding ECDs in place and functional at stream crossing and resource buffer.

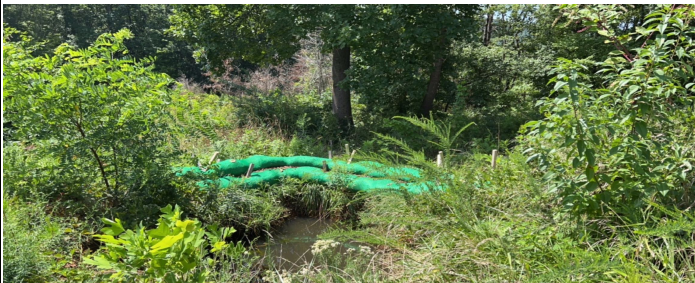
GPS Location	3		GPS Location	4	
Field Station#	14662+00		Field Station#	14670+00	
Pic 3 Desc.	Sump pit and CFS end treatment performing intended functions.		Pic 4 Desc.	ROW stabilized and vegetated in temporary area; perimeter controls in place and functional.

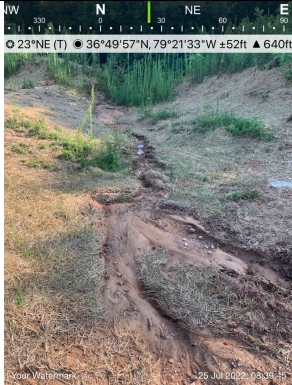
GPS Location	O	GPS Location	O		
Field Station#	15962+32	Field Station#	15965+00		
Pic 1 Desc.	Observing temporary stabilization,buffer, equipment crossing and ECD's	Pic 2 Desc.	Observing erosion that needs to be repaired (@water bar)

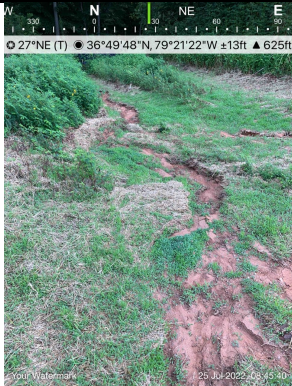
GPS Location	O	GPS Location	O		
Field Station#	15976+50	Field Station#	15978+50		
Pic 5 Desc.	Observing erosion that needs to be repaired and bridge cleaned	Pic 6 Desc.	Observing erosion that needs to be repaired

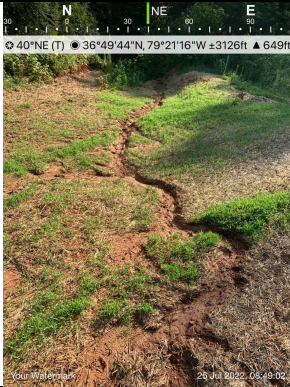
ert image here	
GPS Location	O		GPS Location	O	
Field Station#	15982+00		Field Station#	15986+00	
Pic 7 Desc.	Observing temporary stabilization,CWD outlet and ECD's		Pic 8 Desc.	Observing erosion that needs to be repaired (@water bar)

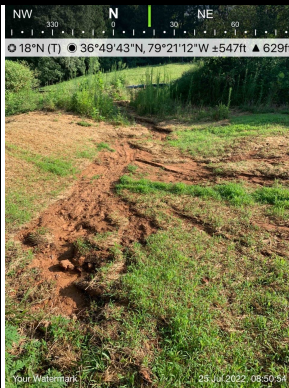
ert image here	
GPS Location	O		GPS Location	O	
Field Station#	15988+50		Field Station#	15995+50	
Pic 9 Desc.	Observing erosion that needs to be repaired (@water bar)		Pic 10 Desc.	Observing erosion that needs to be repaired (@water bar)

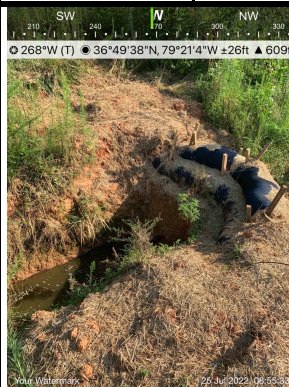
ert image here	
GPS Location	O		GPS Location	O	
Field Station#	15998+00		Field Station#	15999+00	
Pic 11 Desc.	Observing temporary stabilization, sump and end treatment		Pic 12 Desc.	Observing erosion that needs to be repaired (@water bar)

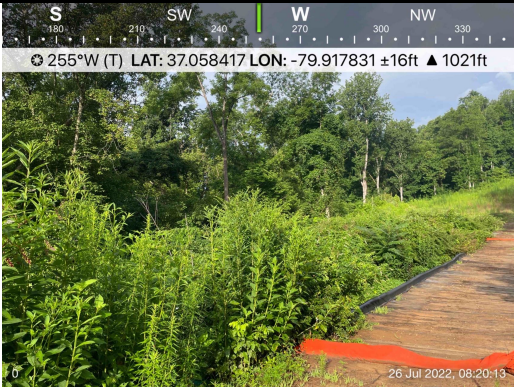
GPS Location	See photo	GPS Location	See photo		
Field Station#	13863+00	Field Station#	13875+73		
Pic 1 Desc.	Resource buffers remain well vegetated	Pic 2 Desc.	Equipment bridge ECDs are in good condition and functioning

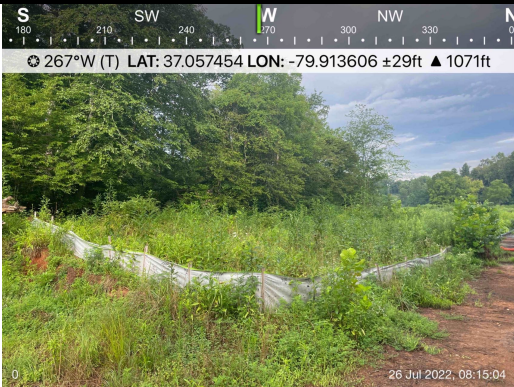
GPS Location	See photo	GPS Location	See photo		
Field Station#	13876+00	Field Station#	13888+00		
Pic 3 Desc.	P1 is in good condition at all stream and wetland buffers	Pic 4 Desc.	Slope drain is in good condition and functioning

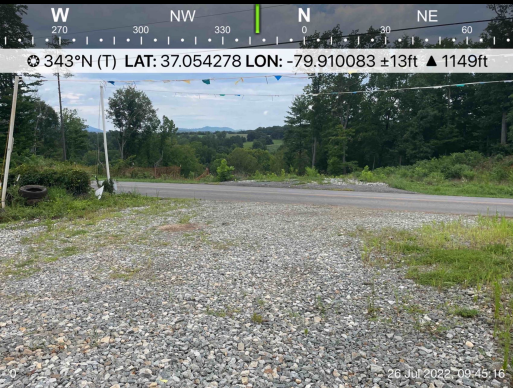
GPS Location	See photo	GPS Location	See photo		
Field Station#	13890+00	Field Station#	13892+45		
Pic 5 Desc.	Waterbars are in good condition	Pic 6 Desc.	RCEs are in good condition at all road crossings

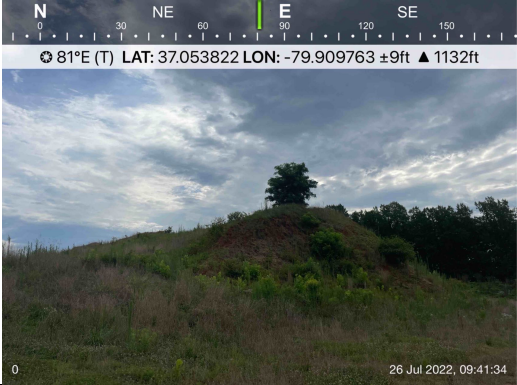
GPS Location	See photo		GPS Location	See photo	
Field Station#	13897+00		Field Station#	13897+00	
Pic 7 Desc.	Topsoil pile remains stabilized		Pic 8 Desc.	Sediment trap is functioning as intended

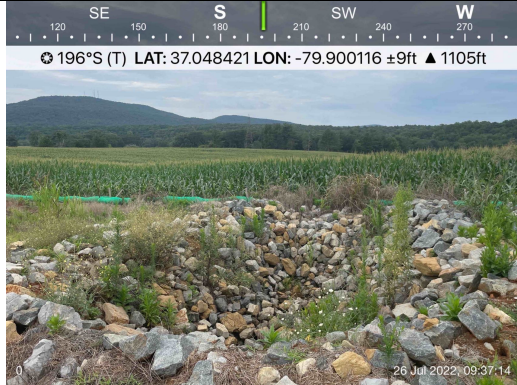
GPS Location	See photo		GPS Location	See photo	
Field Station#	13942+00		Field Station#	13939+50	
Pic 11 Desc.	CWDs are functioning as intended		Pic 12 Desc.	SSF is in good condition

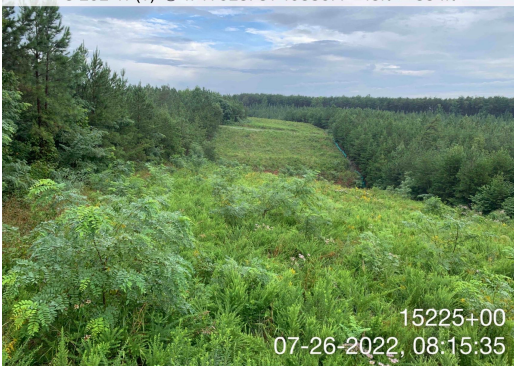
<p>15225+00 07-26-2022, 08:15:35</p>

<p>15223+00 07-26-2022, 08:18:24</p>			
GPS Location	0	GPS Location	0		
Field Station#	15225+00	Field Station#	15223+00		
Pic 1 Desc.	Permanent vegetative stabilization in acceptable condition	Pic 2 Desc.	Waterbar in acceptable condition

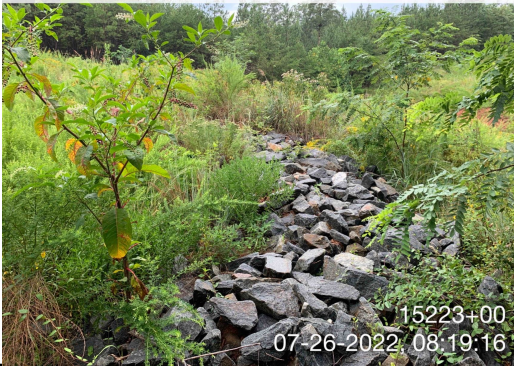
<p>15223+00 07-26-2022, 08:19:16</p>

<p>15203+00 07-26-2022, 09:11:13</p>			
GPS Location	0	GPS Location	0		
Field Station#	15223+00	Field Station#	15203+00		
Pic 3 Desc.	Waterbar end treatment in acceptable condition	Pic 4 Desc.	Perimeter CFS and permanent vegetative stabilization in acceptable conditions

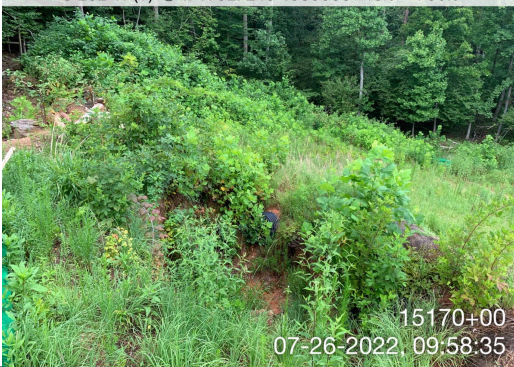
<p>15170+00 07-26-2022, 09:58:35</p>

<p>15169+00 07-26-2022, 10:00:36</p>			
GPS Location	0	GPS Location	0		
Field Station#	15170+00	Field Station#	15169+00		
Pic 5 Desc.	Slope drain pipe and sump pit in acceptable conditions	Pic 6 Desc.	Waterbar in acceptable condition

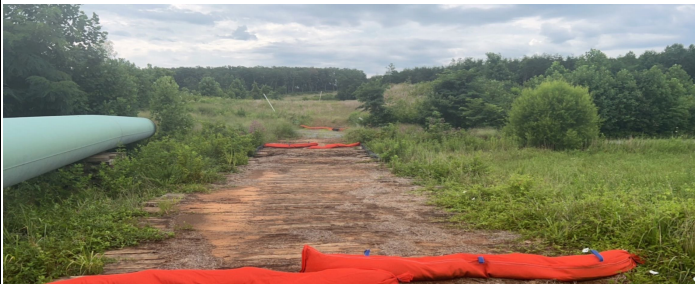
37°2'33" N 79°48'33" W 140°SE COURSE 102° GPS 362-532 Farm View Rd, Glade Hill, VA 24092, United States			07.26.2022 10:39:43 Accur +/-15.5 Ft ALT 1070 Ft		
37°2'32" N 79°48'30" W 145°SE COURSE 145° GPS 530 Farm View Rd, Glade Hill, VA 24092, United States			07.26.2022 10:41:05 Accur +/-11.6 Ft ALT 1098 Ft		
GPS Location	1		GPS Location	2	
Field Station#	14314+79		Field Station#	14318+00	
Pic 1 Desc.	Equipment bridge and surrounding ECDs in place and functional at stream crossing and resource buffer.		Pic 2 Desc.	Temporary diversion berm and ROW stabilized and vegetated in temporary area.

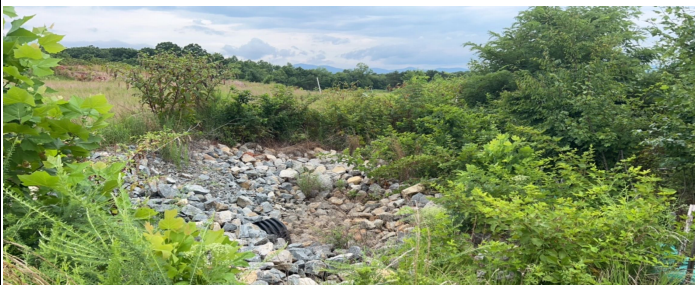
GPS Location	3		GPS Location	4	
Field Station#	14321+00		Field Station#	14402+00	
Pic 3 Desc.	Plunge pool performing intended function.		Pic 4 Desc.	Sump pit and CFS end treatment performing intended functions.

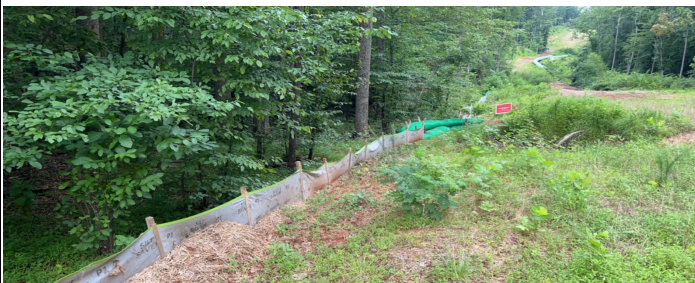
37°1'41" N 79°46'20" W 320°NW COURSE -1° GPS Glade Hill, VA 24092, United States			07.26.2022 12:01:33 Accur +/-14.0 Ft ALT 1052 Ft		
37°1'35" N 79°46'6" W 31°NE COURSE 82° GPS 2753-2799 Webster Rd, Glade Hill, VA 24092, United States			07.26.2022 12:07:40 Accur +/-11.6 Ft ALT 1125 Ft		
GPS Location	5		GPS Location	6	
Field Station#	14439+00		Field Station#	14454+22	
Pic 5 Desc.	Perimeter P1 silt fence in place and functional.		Pic 6 Desc.	RCE at Webster Rd in good condition.

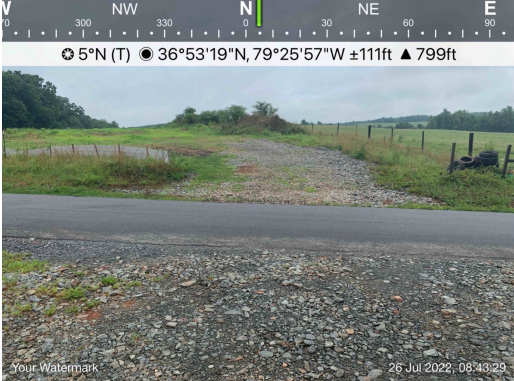
GPS Location	O	GPS Location	O		
Field Station#	15647+03	Field Station#	15642+00		
Pic 1 Desc.	Observing road crossing and RCE's	Pic 2 Desc.	Observing temporary stabilization

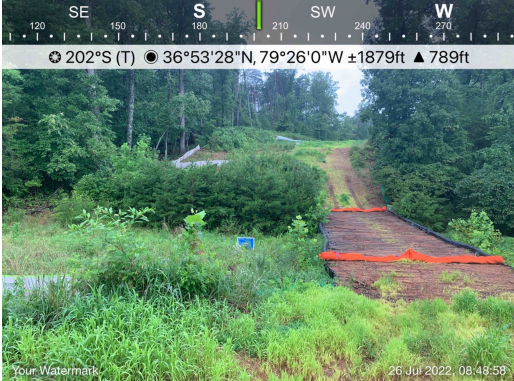
GPS Location	O	GPS Location	O		
Field Station#	15636+45	Field Station#	15625+00		
Pic 3 Desc.	Observing temporary stabilization, signage, buffer, equipment crossing and ECD's	Pic 4 Desc.	Observing temporary stabilization, CWD outlet and ECD's

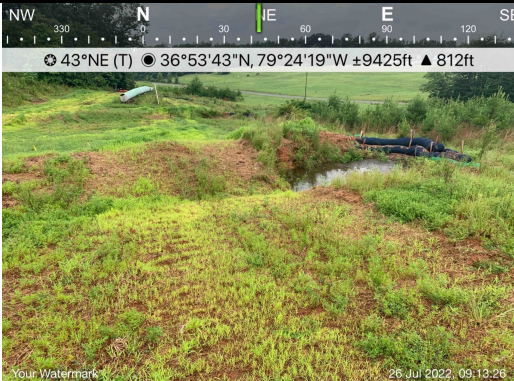
GPS Location	O	GPS Location	O		
Field Station#	15617+00	Field Station#	15610+00		
Pic 5 Desc.	Observing temporary stabilization, water bar, sump and end treatment	Pic 6 Desc.	Observing temporary stabilization

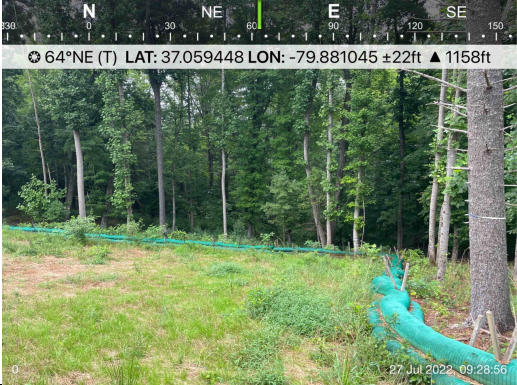
GPS Location	See photo		GPS Location	See photo	
Field Station#	14027+00		Field Station#	14033+00	
Pic 7 Desc.	CFS is in good condition throughout this section		Pic 8 Desc.	Waterbars are in good condition

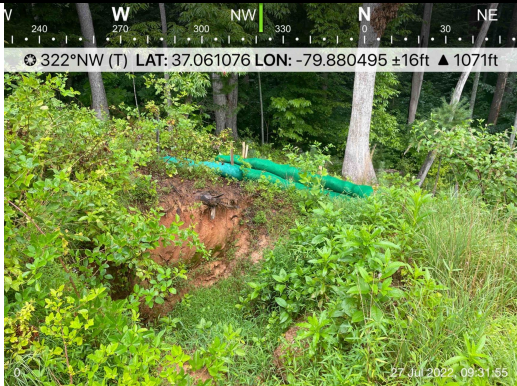
GPS Location	See photo		GPS Location	See photo	
Field Station#	14033+00		Field Station#	14035+00	
Pic 9 Desc.	End treatments are functioning as intended		Pic 10 Desc.	Resource buffers remain well vegetated

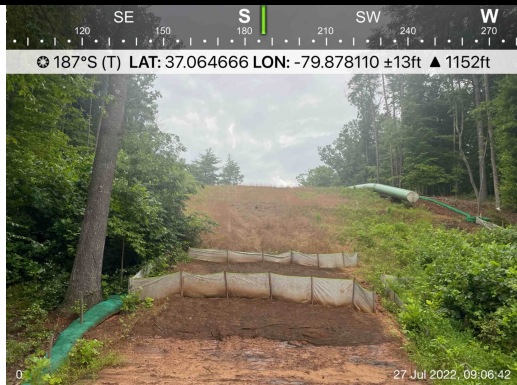
GPS Location	See photo		GPS Location	See photo	
Field Station#	14050+00		Field Station#	14057+00	
Pic 11 Desc.	Slope remains stabilized with controls in place		Pic 12 Desc.	Slope drain outlet is in good condition and functioning

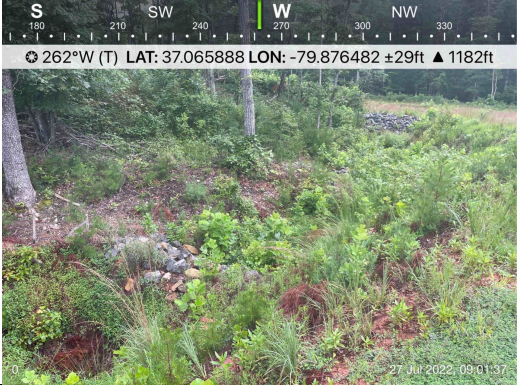
GPS Location	See photo	GPS Location			
Field Station#	14060+00	Field Station#			
Pic 13 Desc.	Rock check dams are functioning as intended	Pic 14 Desc.			
Insert image here		Insert image here			
GPS Location		GPS Location			
Field Station#		Field Station#			
Pic 15 Desc.		Pic 16 Desc.			
Insert image here		Insert image here			
GPS Location		GPS Location			
Field Station#		Field Station#			
Pic 17 Desc.		Pic 18 Desc.

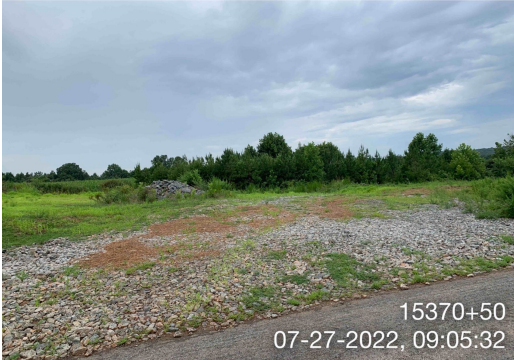
<p>15370+50 07-27-2022, 09:05:32</p>

<p>15349+00 07-27-2022, 09:34:35</p>			
GPS Location	0	GPS Location	0		
Field Station#	15370+50	Field Station#	15349+00		
Pic 1 Desc.	Rock construction entrance in acceptable condition	Pic 2 Desc.	Temporary vegetative stabilization in acceptable condition

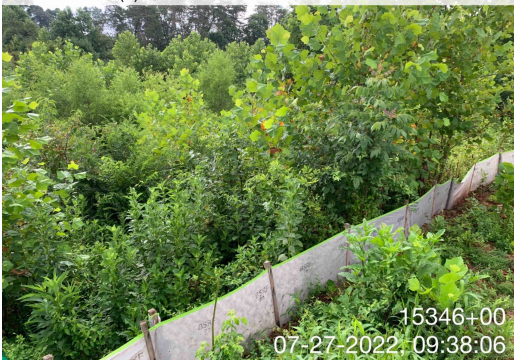
<p>15346+00 07-27-2022, 09:38:06</p>

<p>15345+50 07-27-2022, 09:39:16</p>			
GPS Location	0	GPS Location	0		
Field Station#	15346+00	Field Station#	15345+50		
Pic 3 Desc.	P1 silt fence and sensitive resource buffer in acceptable conditions	Pic 4 Desc.	Waterbar in acceptable condition

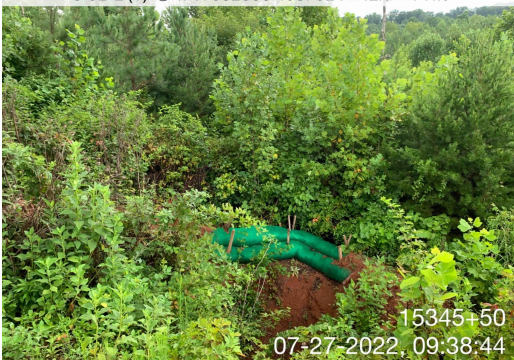
<p>15345+50 07-27-2022, 09:38:44</p>

<p>15327+00 07-27-2022, 10:20:14</p>			
GPS Location	0	GPS Location	0		
Field Station#	15345+50	Field Station#	15327+00		
Pic 5 Desc.	Waterbar end treatment in acceptable condition	Pic 6 Desc.	CFS and equipment bridge in acceptable conditions

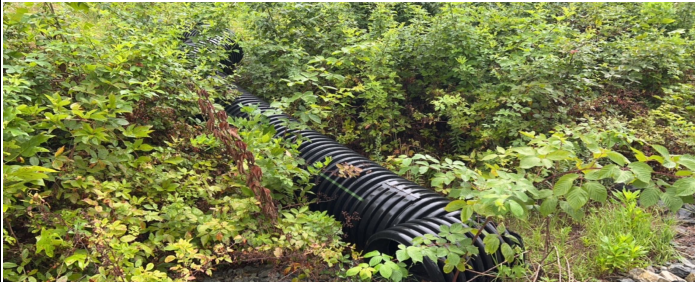
37°1'31" N 79°46'0" W 298°NW COURSE 338° GPS Glade Hill, VA 24092, United States 07.27.2022 09:21:16 Accur +/-15.4 Ft ALT 1100 Ft			37°1'30" N 79°45'58" W 96°E COURSE 69° GPS Glade Hill, VA 24092, United States 07.27.2022 09:20:20 Accur +/-15.5 Ft ALT 1115 Ft		
GPS Location	1	GPS Location	2		
Field Station#	14457+00	Field Station#	14462+00		
Pic 1 Desc.	Slope drain pipe in place and functional.		Pic 2 Desc.	Perimeter SSF in place and functional.

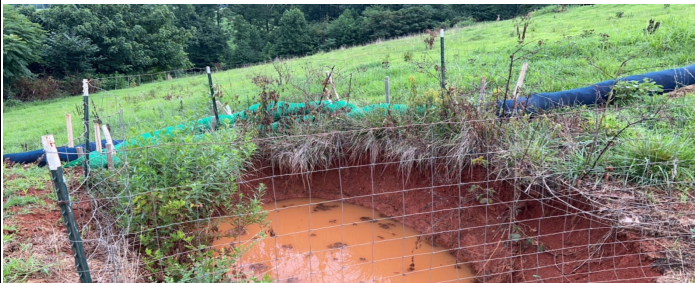
Pic 3 Desc.	Sump pit and CFS end treatment performing intended functions.		Pic 4 Desc.	Water bar performing intended function.

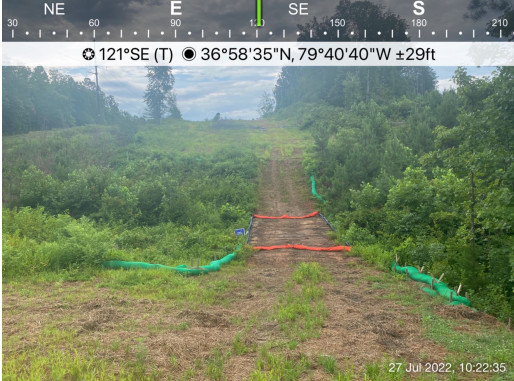
GPS Location	0	GPS Location	0		
Field Station#	14804+99	Field Station#	14811+00		
Pic 1 Desc.	Approximately 14804+99. Overview of stream crossing, equipment bridge and ECDs at stream S-H23.		Pic 2 Desc.	Approximately 14811+00. Overview of ROW. Permanent vegetation.

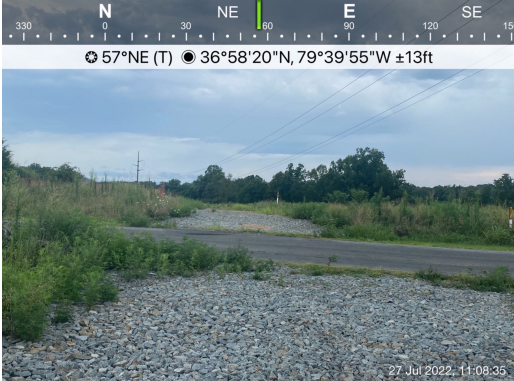
GPS Location	0	GPS Location	0		
Field Station#	14846+00	Field Station#	14870+43		
Pic 3 Desc.	Approximately 14846+00. Overview of road crossing and RCEs.		Pic 4 Desc.	Approximately 14870+43. Overview of stream crossing, equipment bridge and ECDs at stream S-SS8.

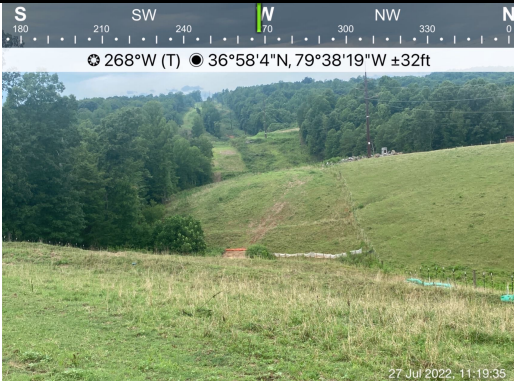
GPS Location	0	GPS Location	0		
Field Station#	14922+00	Field Station#	14824+00		
Pic 5 Desc.	Approximately 14922+00. Overview of ROW. Permanent vegetation.		Pic 6 Desc.	Approximately 14824+00. P-1 requires maintenance. Damaged by wildlife.

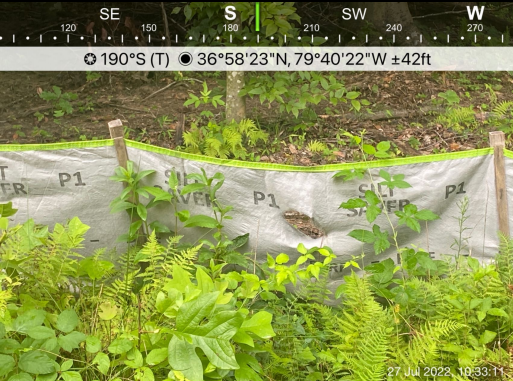
4. E&S BMPs (List BMPs and note if installed and maintained as per the plan. If corrective action is needed, a picture is required.)					
E&S BMPs	Compliance Level	Corrective Action	Corrective Time Frame	Date Repaired	
Compost Filter Sock	Acceptable				
Equipment Bridge	Acceptable				
Rock Construction Entrance	Acceptable				
Sensitive Resource Buffer	Acceptable				
Sensitive Resource Signage	Acceptable				
Silt Fence (Filter Fabric Fence)	Communication	Repair wildlife damage			
Silt Fence (Reinforce Filter Fence)	Acceptable				
Waterbar	Acceptable				
3rd Party Damages	Communication	Repair P-1 damaged by wildlife

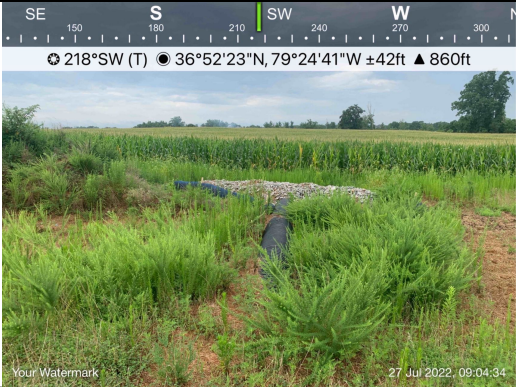
GPS Location	O	GPS Location	O		
Field Station#	15735+00	Field Station#	15732+00		
Pic 3 Desc.	Observing temporary stabilization,CWD outlet and ECD's	Pic 4 Desc.	Observing temporary stabilization

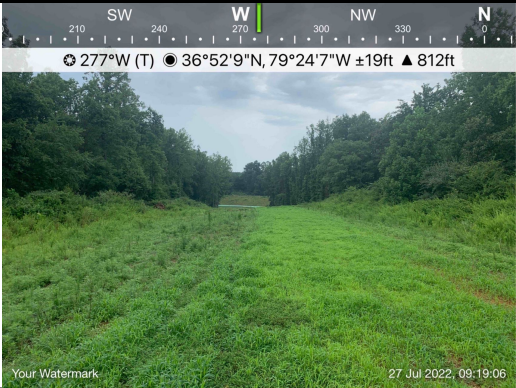
GPS Location	O	GPS Location	O		
Field Station#	15768+00	Field Station#	15690+00		
Pic 5 Desc.	Observing temporary stabilization and water bar	Pic 6 Desc.	Observing temporary stabilization and water bars

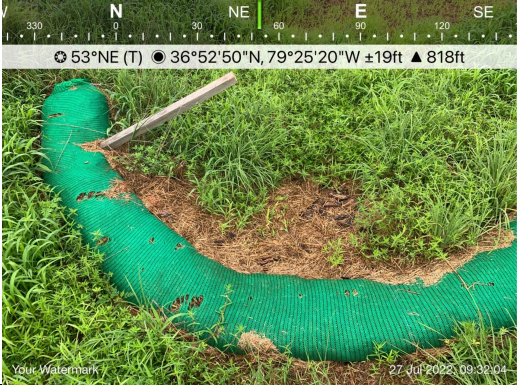
GPS Location	O	GPS Location	O		
Field Station#	15691+00	Field Station#	15697+00		
Pic 7 Desc.	Observing CFS that requires maintenance	Pic 8 Desc.	Observing temporary stabilization, water bar, sump and end treatment

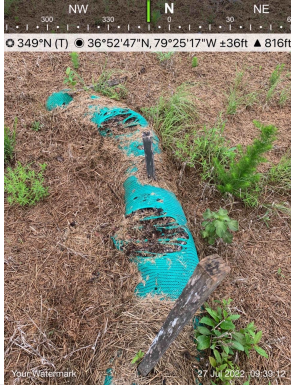
GPS Location	O	GPS Location	O		
Field Station#	15695+00	Field Station#	15678+50		
Pic 9 Desc.	Observing CFS that requires maintenance	Pic 10 Desc.	Observing limb that needs to be removed from CFS

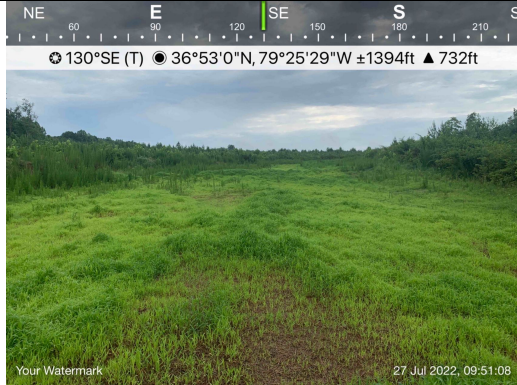
GPS Location	O	GPS Location	O		
Field Station#	15681+00	Field Station#	15679+00		
Pic 11 Desc.	Observing temporary stabilization, CWD berm and water bars	Pic 12 Desc.	Observing temporary stabilization, CWD outlet and ECD's

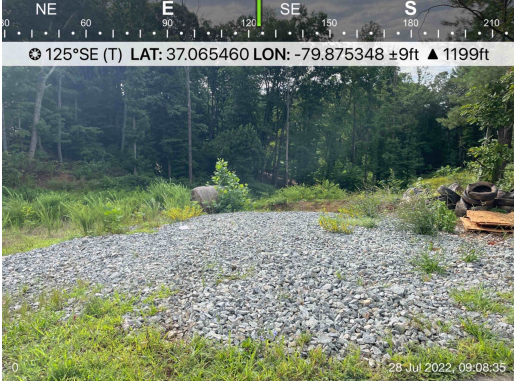
GPS Location	See photo	GPS Location	See photo		
Field Station#	14062+17	Field Station#	14066+00		
Pic 1 Desc.	RCEs are in good condition at all road crossings	Pic 2 Desc.	P1 has been damaged by 3rd party and needs to be replaced

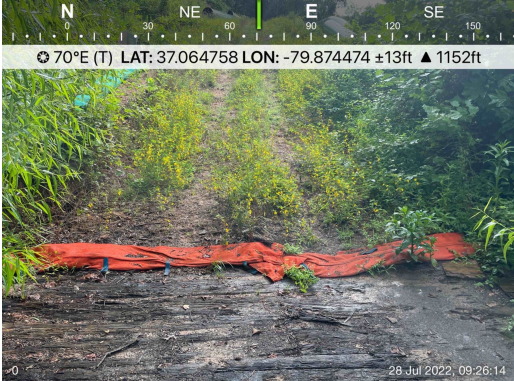
GPS Location	See photo	GPS Location	See photo		
Field Station#	14067+00	Field Station#	14067+00		
Pic 3 Desc.	Bridge waddles need to be replaced	Pic 4 Desc.	P1 has been damaged and needs to be replaced

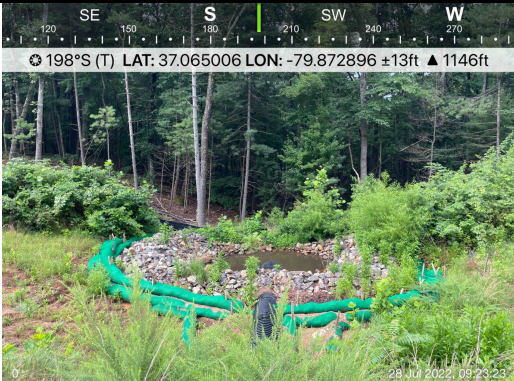
GPS Location	See photo	GPS Location	See photo		
Field Station#	14070+00	Field Station#	14081+53		
Pic 5 Desc.	CWDs are functioning as intended	Pic 6 Desc.	MVP-309.05 is in good condition with controls in place

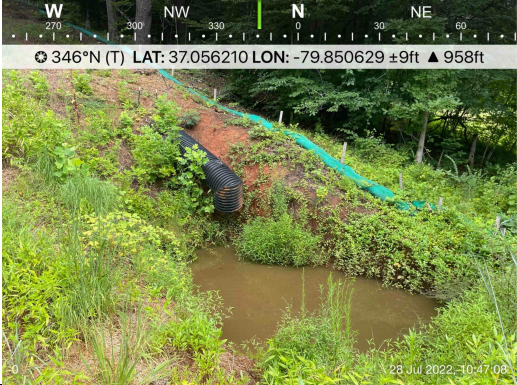
GPS Location	See photo	GPS Location			
Field Station#	14156+00	Field Station#			
Pic 13 Desc.	Slope drain is in good condition and functioning	Pic 14 Desc.			
Insert image here		Insert image here			
GPS Location		GPS Location			
Field Station#		Field Station#			
Pic 15 Desc.		Pic 16 Desc.			
Insert image here		Insert image here			
GPS Location		GPS Location			
Field Station#		Field Station#			
Pic 17 Desc.		Pic 18 Desc.

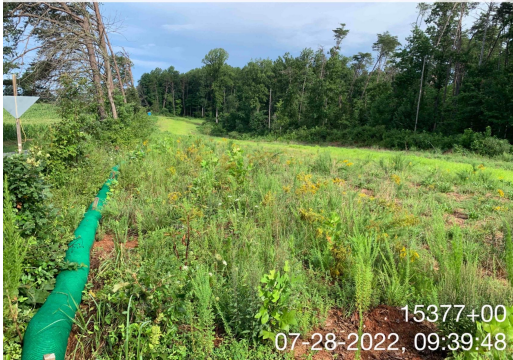
<div>15377+00 07-28-2022, 09:39:48</div>			<div>📍 345°N (T) ● 17 N 633064 4087142 ±26ft ▲ 757ft</div>

<div>15384+00 07-28-2022, 09:46:13</div>				
GPS Location		0		GPS Location		0	
Field Station#		15377+00		Field Station#		15384+00	
Pic 1 Desc.		Perimeter CFS and temporary vegetative stabilization in acceptable conditions		Pic 2 Desc.		Super silt fence in acceptable condition	
<div>📍 14°N (T) ● 17 N 633279 4087029 ±419ft ▲ 773ft</div>

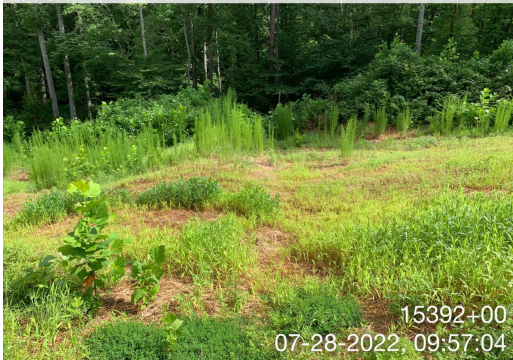
<div>15392+00 07-28-2022, 09:57:04</div>			<div>📍 17°N (T) ● 17 N 633267 4087059 ±82ft ▲ 769ft</div>

<div>15392+00 07-28-2022, 09:57:44</div>				
GPS Location		0		GPS Location		0	
Field Station#		15392+00		Field Station#		15392+00	
Pic 3 Desc.		Waterbar in acceptable condition		Pic 4 Desc.		Waterbar end treatment in acceptable condition

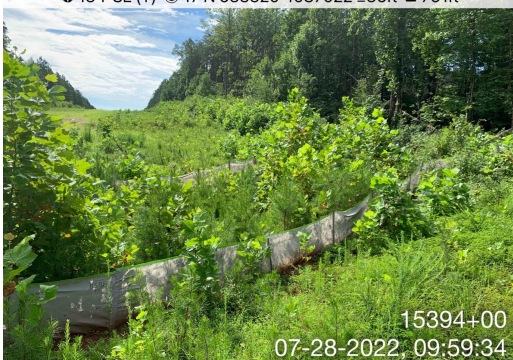
<div>15394+00 07-28-2022, 09:59:34</div>			<div>📍 121°SE (T) ● 17 N 633307 4087030 ±13ft ▲ 795ft</div>

<div>15394+00 07-28-2022, 09:58:57</div>				
GPS Location		0		GPS Location		0	
Field Station#		15394+00		Field Station#		15394+00	
Pic 5 Desc.		P1 silt fence in acceptable condition		Pic 6 Desc.		Equipment bridge and temporary vegetative stabilization in acceptable conditions

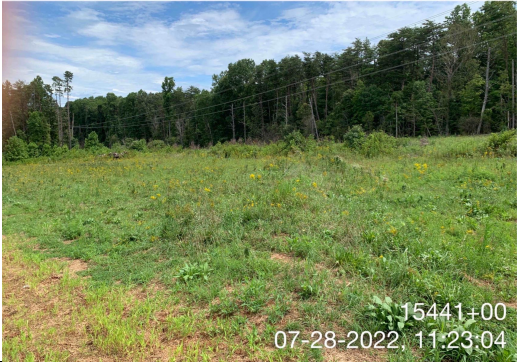
<p>15441+00 07-28-2022, 11:23:04</p>

<p>15460+00 07-28-2022, 11:37:23</p>			
GPS Location	0	GPS Location	0		
Field Station#	15541+00	Field Station#	15460+00		
Pic 7 Desc.	Permanent vegetative stabilization and waterbar in acceptable conditions		Pic 8 Desc.	Clean water diversion pipe in acceptable condition	
Insert image here			Insert image here		
GPS Location		GPS Location			
Field Station#		Field Station#			
Pic 9 Desc.			Pic 10 Desc.		
Insert image here			Insert image here		
GPS Location		GPS Location			
Field Station#		Field Station#			
Pic 11 Desc.			Pic 12 Desc.

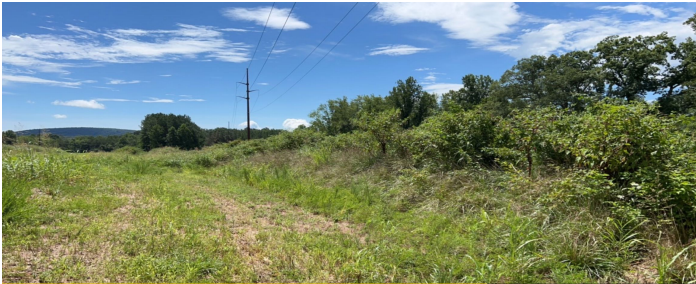
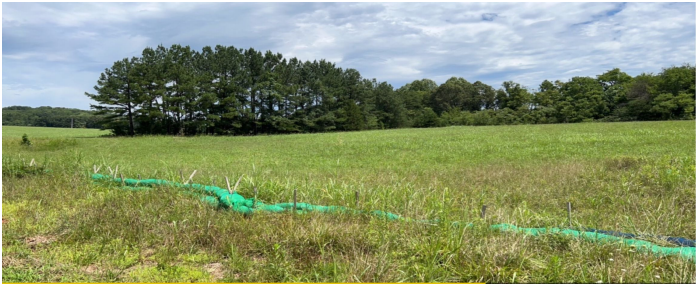
37°01'5" N 79°45'6" W 150°SE COURSE 125' GPS 594 Tobacco Rd, Glade Hill, VA 24092, United States 07.28.2022 12:11:53 Accur +/-13.1 Ft ALT 922 Ft			37°07" N 79°44'58" W 112°E COURSE -1' GPS 594 Tobacco Rd, Glade Hill, VA 24092, United States 07.28.2022 12:15:58 Accur +/-13.6 Ft ALT 922 Ft		
GPS Location	1		GPS Location	2	
Field Station#	14552+00		Field Station#	14563+00	
Pic 1 Desc.	Temporary diversion berm stabilized and vegetated.		Pic 2 Desc.	Perimeter CFS triple stack in good condition.

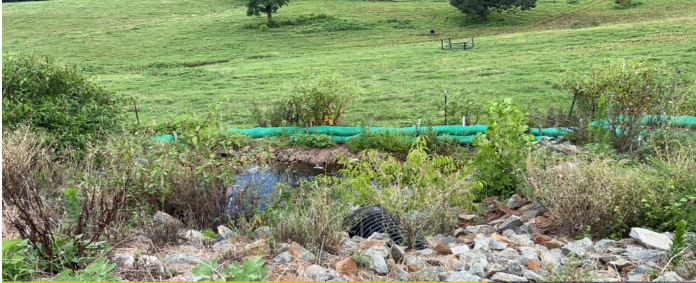
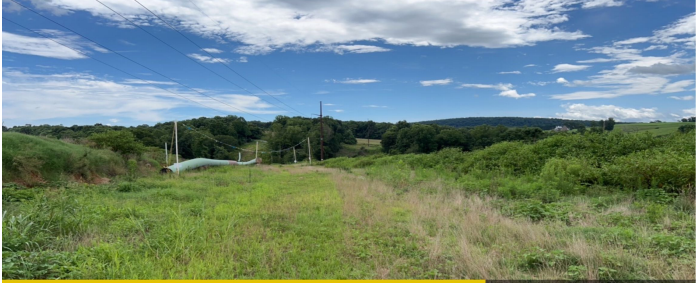
Field Station#	14590+00		Field Station#	14595+00	
Pic 3 Desc.	Sump pit and CFS end treatment performing intended functions.		Pic 4 Desc.	Contractor seeded and stabilized disturbed area at water bar where truck was stuck in previous daily report.

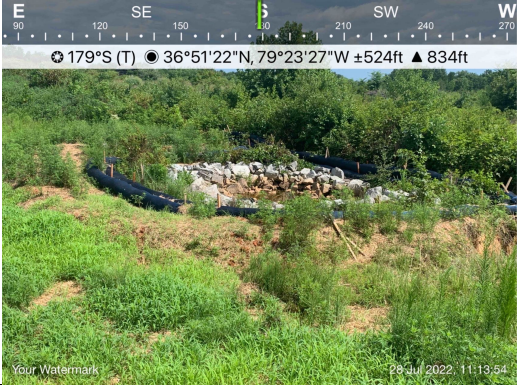
GPS Location	O	GPS Location			
Field Station#	15825+00	Field Station#			
Pic 7 Desc.	Observing temporary stabilization,plunge pool and ECD's	Pic 8 Desc.			
Insert image here		Insert image here			
GPS Location		GPS Location			
Field Station#		Field Station#			
Pic 9 Desc.		Pic 10 Desc.			
Insert image here		Insert image here			
GPS Location		GPS Location			
Field Station#		Field Station#			
Pic 11 Desc.		Pic 12 Desc.

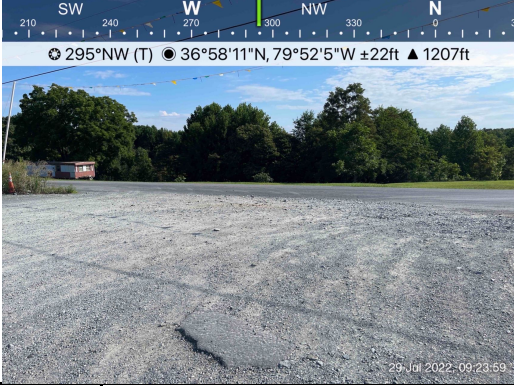
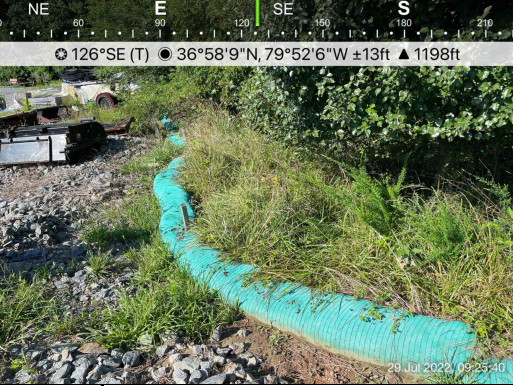
GPS Location	See picture	GPS Location	See picture		
Field Station#	0000+00	Field Station#	0000+00		
Pic 1 Desc.	RCE at LY-045 in good condition.	Pic 2 Desc.	Perimeter ECD's on west side of LY-045 in acceptable condition.

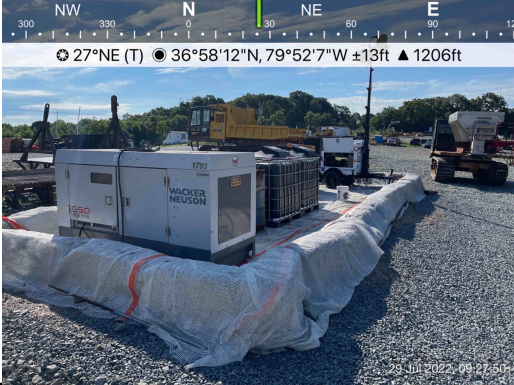
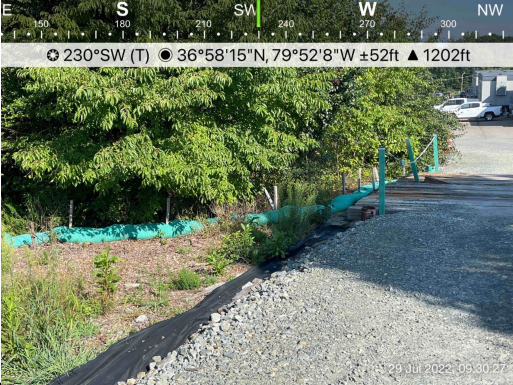
GPS Location	See picture	GPS Location	See picture		
Field Station#	0000+00	Field Station#	0000+00		
Pic 3 Desc.	Secondary containment structure on south end of tent at LY-045 in good condition.	Pic 4 Desc.	Perimeter ECD's on north end of LY-045 in good condition.

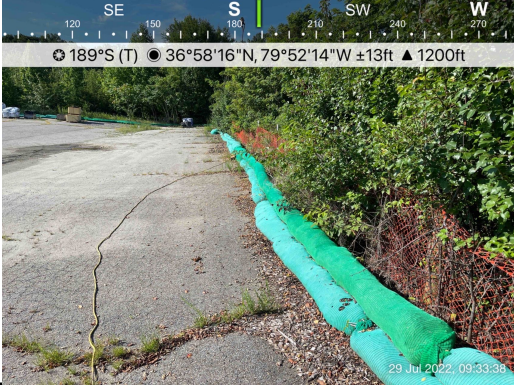
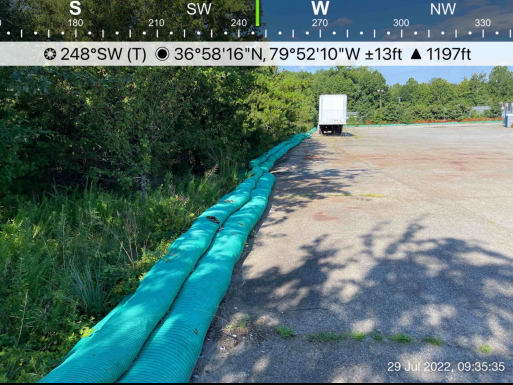
GPS Location	See picture	GPS Location	See picture		
Field Station#	0000+00	Field Station#	0000+00		
Pic 5 Desc.	Perimeter ECD's on west side of LY-046 in good condition.	Pic 6 Desc.	Perimeter ECD's on south end of LY-046 in good condition.

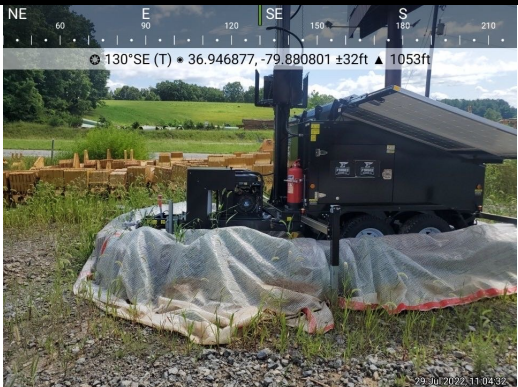
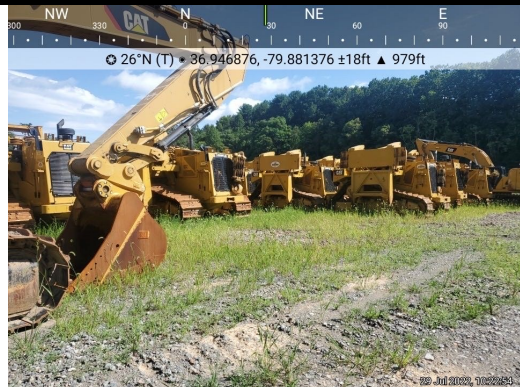
GPS Location	0	GPS Location	0		
Field Station#	0+00	Field Station#	0+00		
Pic 1 Desc.	LY-032 Secondary containment	Pic 2 Desc.	LY-032 Equipment staging area

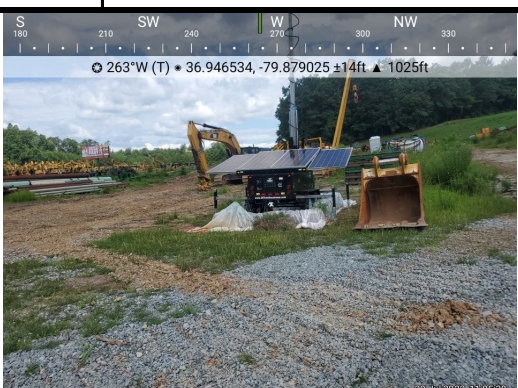
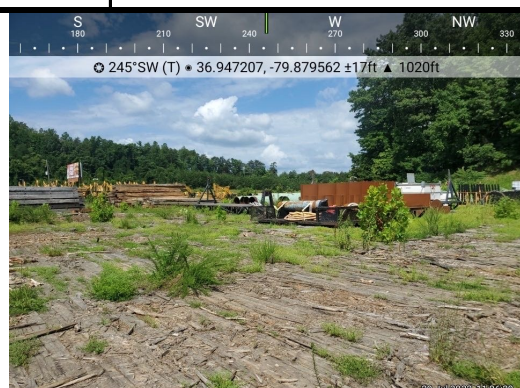
GPS Location	0	GPS Location	0		
Field Station#	0+00	Field Station#	0+00		
Pic 3 Desc.	LY-033 Secondary containment	Pic 4 Desc.	LY-033 Timber mat staging area

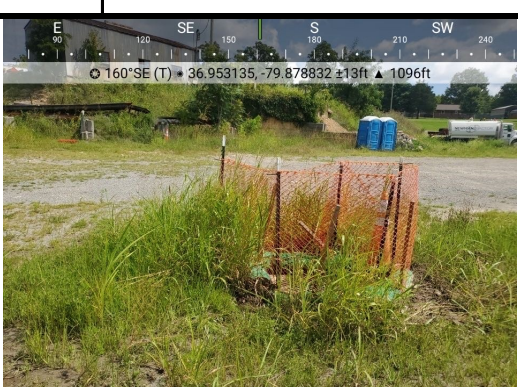
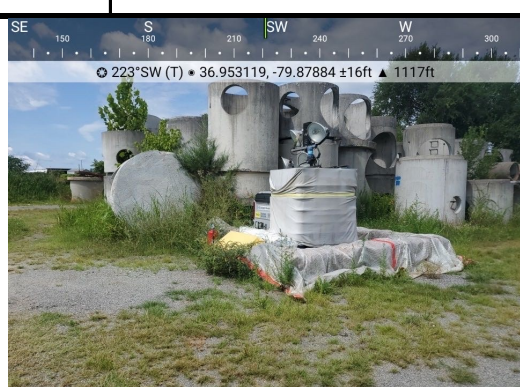
GPS Location	0	GPS Location	0		
Field Station#	0+00	Field Station#	0+00		
Pic 5 Desc.	ANC-006 Stormwater drain inlet protection	Pic 6 Desc.	ANC-006 Secondary containment

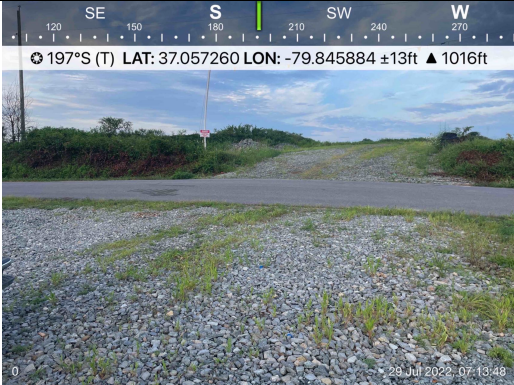
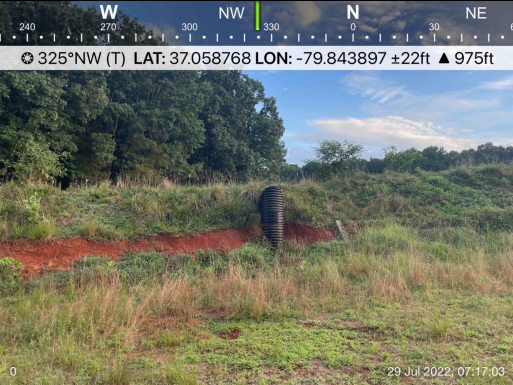
GPS Location	See photo		GPS Location	See photo	
Field Station#	14171+36		Field Station#	14180+00	
Pic 1 Desc.	RCEs are in good condition at all road crossings		Pic 2 Desc.	CWDs are functioning as intended

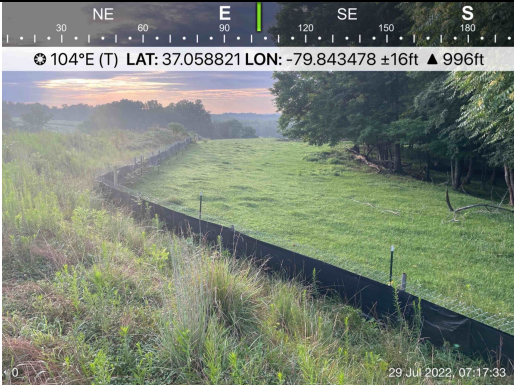
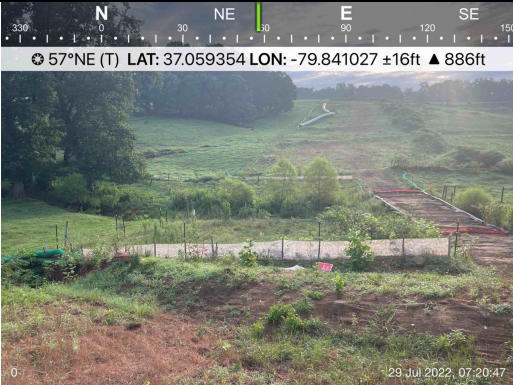
GPS Location	See photo		GPS Location	See photo	
Field Station#	14181+00		Field Station#	14190+00	
Pic 3 Desc.	SSF is in good condition		Pic 4 Desc.	P1 is in good condition at all stream and wetland buffers

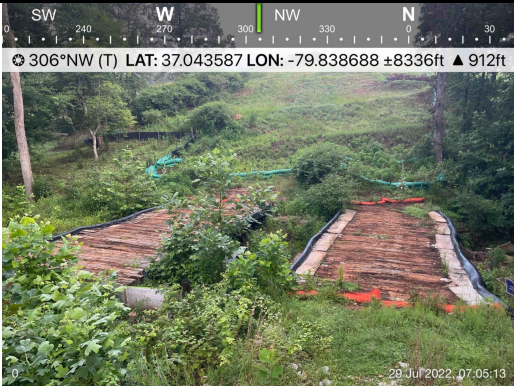
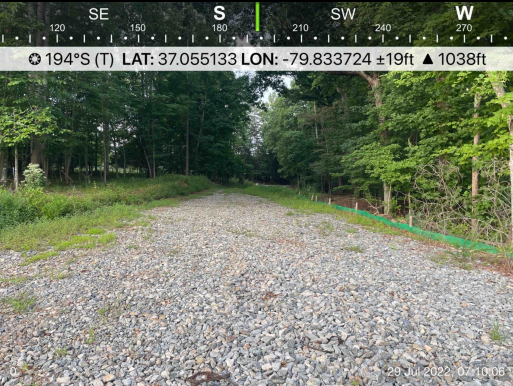
GPS Location	See photo		GPS Location	See photo	
Field Station#	14209+00		Field Station#	14223+41	
Pic 5 Desc.	Equipment bridge ECDs are in good condition and functioning		Pic 6 Desc.	MVP-FR-311 is in good condition with controls in place

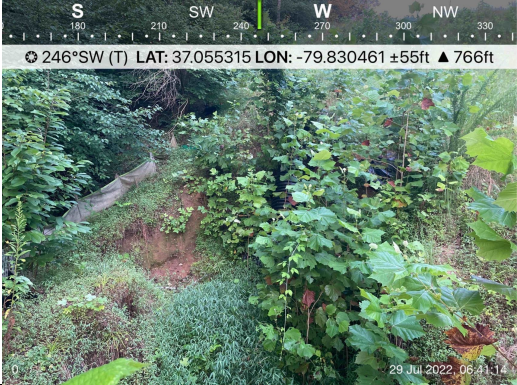
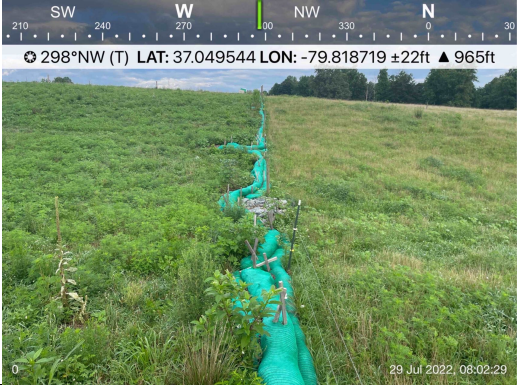
GPS Location	See photo	GPS Location	See photo		
Field Station#	14232+00	Field Station#	14274+00		
Pic 7 Desc.	Slope drain is in good condition and functioning	Pic 8 Desc.	CFS is in good condition throughout this section

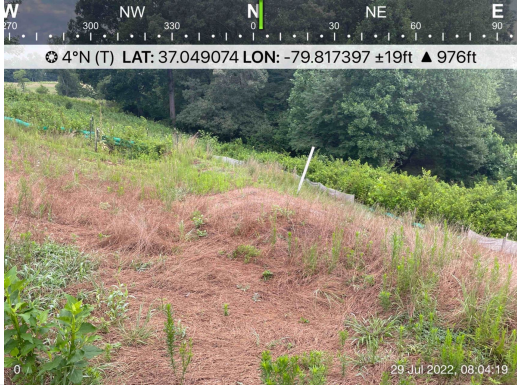
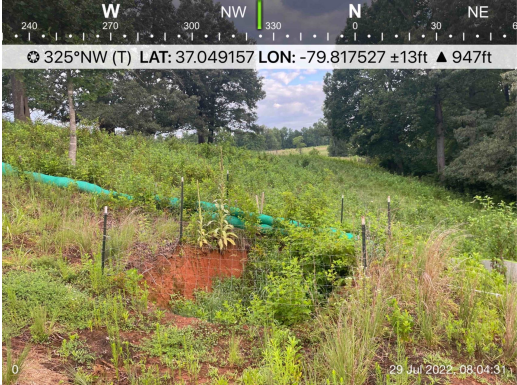
GPS Location	See photo	GPS Location	See photo		
Field Station#	14277+00	Field Station#	14277+00		
Pic 9 Desc.	Waterbars are in good condition	Pic 10 Desc.	End treatments are functioning as intended

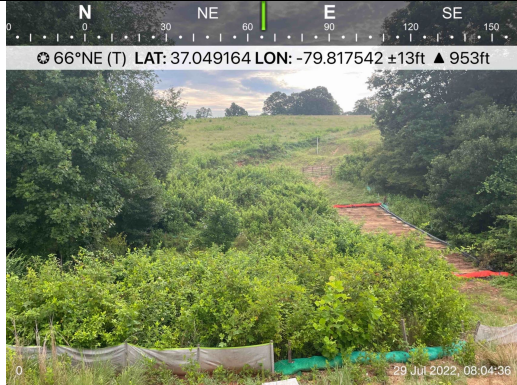
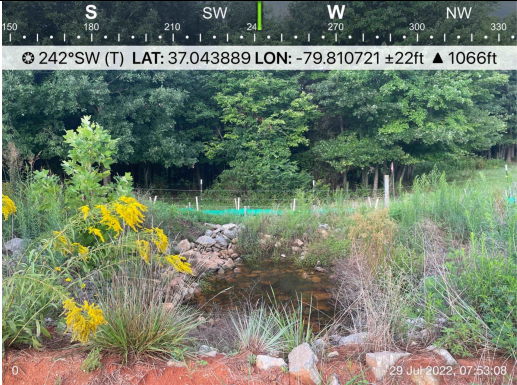
GPS Location	See photo	GPS Location	See photo		
Field Station#	14278+93	Field Station#	14305+00		
Pic 11 Desc.	Resource buffers remain well vegetated	Pic 12 Desc.	CWD is functioning as intended
