Visual Site Inspection Report

Project Name	H-600 Pipeline Spread I	AFE	124300139	Spread	H-600 Pipeline Spread I
Contractor	Precision			Report #	40231
Inspector	Glenn Mike Renfro			Date/Time	7/25/2022 2:04 PM
Permit #	TBD	Inspection Type	VA SWPP	Station Begin	0000+00
State	VA	Inspection Area	Full	Station End	00000+00
County	Franklin	Ground	Dry	Temperature (°F)	87.00
Municipality	N/A	Weather	Cloudy	Rain Gauge (in)	0.00
				Rain Accumulation Time (days)	6.00

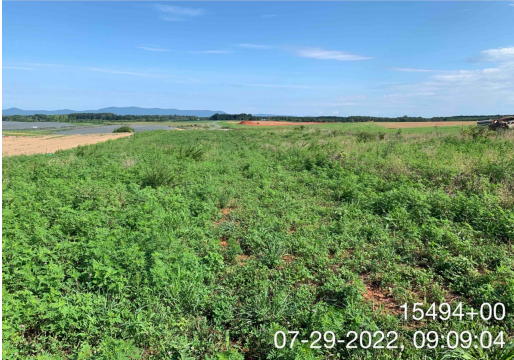
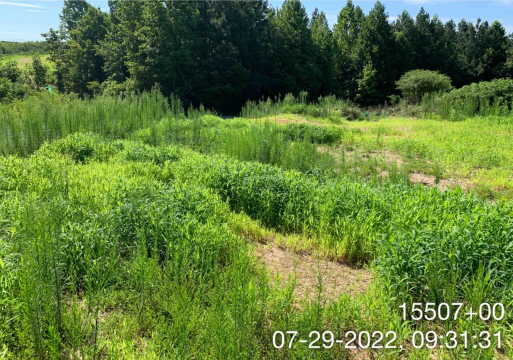
<p>15507+00 07-29-2022, 09:31:31</p>		
GPS Location	0		GPS Location	0	
Field Station#	15494+00		Field Station#	15507+00	
Pic 1 Desc.	Permanent vegetative stabilization in acceptable condition		Pic 2 Desc.	Waterbar in acceptable condition

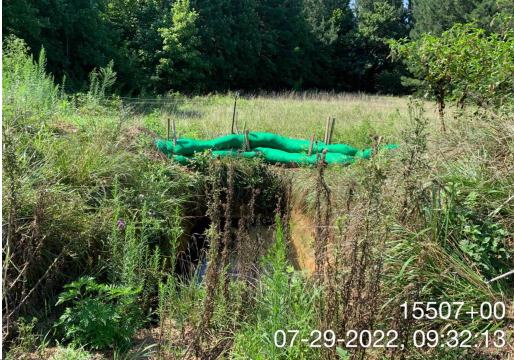
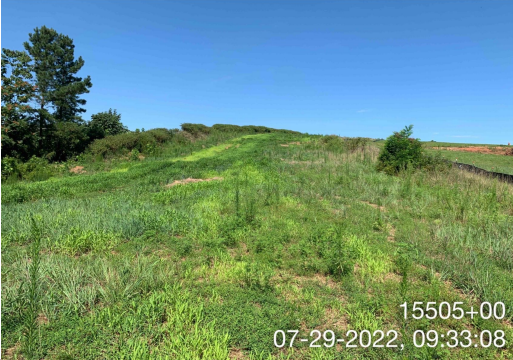
<p>15505+00 07-29-2022, 09:33:08</p>		
GPS Location	0		GPS Location	0	
Field Station#	15507+00		Field Station#	15505+00	
Pic 3 Desc.	Waterbar end treatment in acceptable condition		Pic 4 Desc.	Temporary vegetative stabilization in acceptable condition

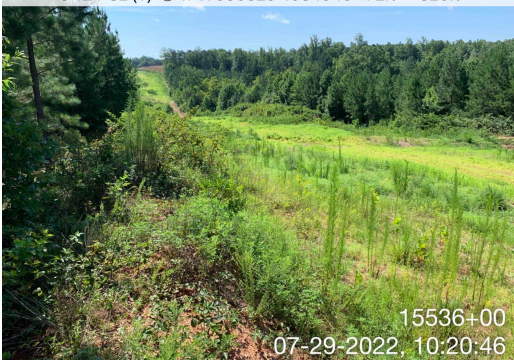
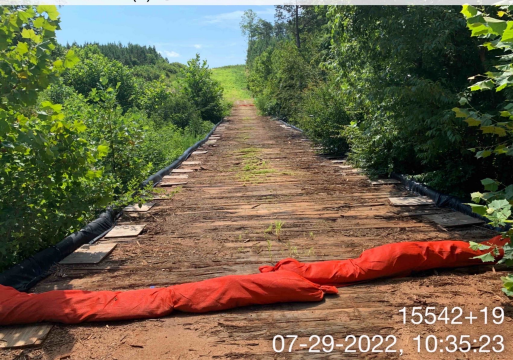
<p>15542+19 07-29-2022, 10:35:23</p>		
GPS Location	0		GPS Location	0	
Field Station#	15536+00		Field Station#	15542+19	
Pic 5 Desc.	Clean water diversion berm and temporary vegetative stabilization in acceptable conditions		Pic 6 Desc.	Equipment bridge in acceptable condition

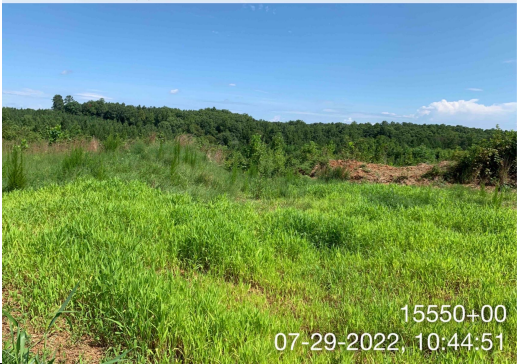
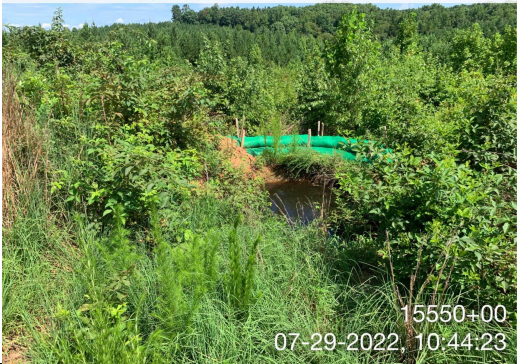
GPS Location	0	GPS Location	0		
Field Station#	15550+00	Field Station#	15550+00		
Pic 7 Desc.	Waterbar in acceptable condition	Pic 8 Desc.	Waterbar end treatment in acceptable condition		
40°NE (T) 17 N 637355 4084646 ±13ft ▲ 825ft

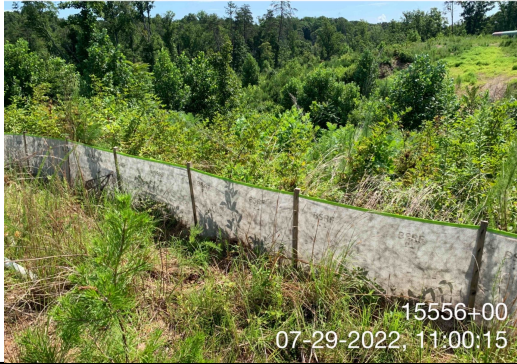
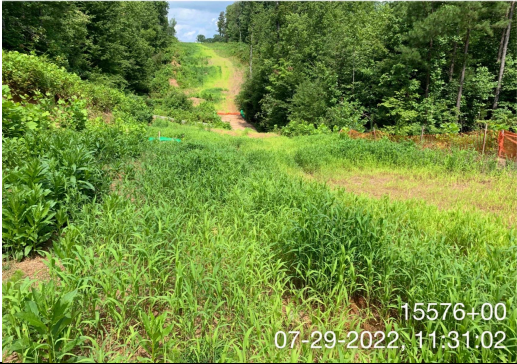
GPS Location	0	GPS Location	0		
Field Station#	15556+00	Field Station#	15576+00		
Pic 9 Desc.	P1 silt fence in acceptable condition	Pic 10 Desc.	Temporary vegetative stabilization in acceptable condition		
Insert image here		Insert image here			
GPS Location		GPS Location			
Field Station#		Field Station#			
Pic 11 Desc.		Pic 12 Desc.

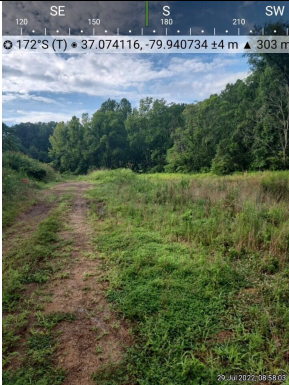
GPS Location	0000	GPS Location	0000		
Field Station#	13751+00	Field Station#	13755+49		
Pic 1 Desc.	Row photo showing vegetation in temporary area of row. No issues were observed at the time of inspection.		Pic 2 Desc.	Monitored equipment bridge and protection during routine inspection. No issues were observed at the time of inspection.

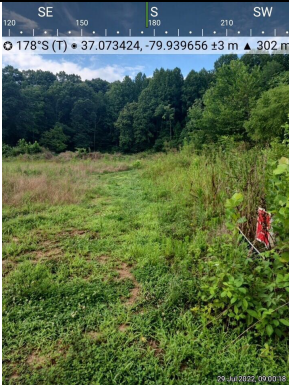
GPS Location	0000	GPS Location	00000		
Field Station#	13756+00	Field Station#	13755+49		
Pic 3 Desc.	Monitored sensitive resource signs and ECDs during routine inspection. No issues were observed at the time of inspection.		Pic 4 Desc.	Stream observation photo facing downstream during routine inspection today. No environmental issues observed at the time of inspection.

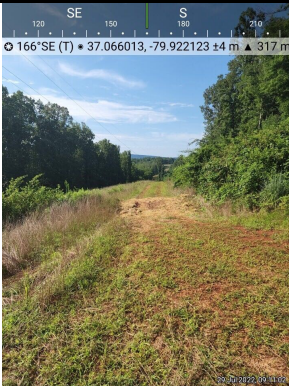
Pic 5 Desc.	Row photo showing water bar and stabilization. No environmental issues observed at the time of inspection.		Pic 6 Desc.	Stream observation photo facing upstream during routine inspection. No environmental issues observed at the time of inspection.

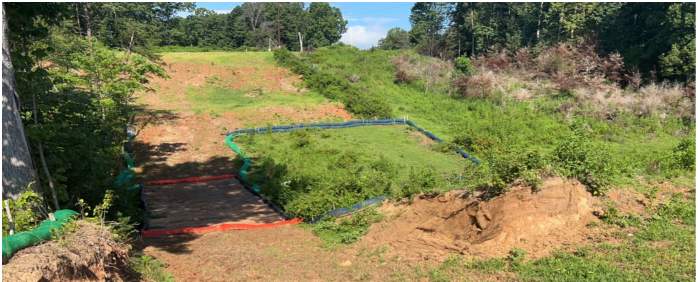
36°59'17" N 79°43'1" W 47°NE COURSE 4' GPS 10196 Old Franklin Turnpike, Union Hall, VA 24176, United States 07.29.2022 10:28:23 Accur +/-11.6 Ft ALT 981 Ft			36°59'16" N 79°43'1" W 345°N COURSE 30' GPS 10196 Old Franklin Turnpike, Union Hall, VA 24176, United States 07.29.2022 10:27:31 Accur +/-15.6 Ft ALT 966 Ft		
GPS Location	1		GPS Location	2	
Field Station#	14670+82		Field Station#	14673+10	
Pic 1 Desc.	Sump pit and CFS end treatment performing intended functions.		Pic 2 Desc.	Equipment bridge and surrounding ECDs in place and functional at stream crossing and resource buffer.

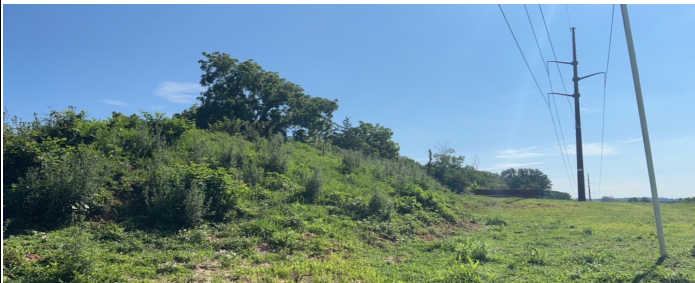
GPS Location	3		GPS Location	4	
Field Station#	14676+00		Field Station#	14677+00	
Pic 3 Desc.	Spoil pile stabilized and vegetated.		Pic 4 Desc.	ROW stabilized and vegetated in temporary area; water bars performing intended functions.

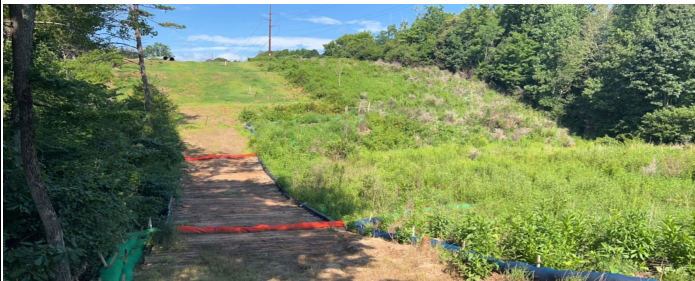
36°59'16" N 79°42'52" W 347°N COURSE -1' GPS Union Hall, VA 24176, United States 07.29.2022 10:22:59 Accur +/-15.1 Ft ALT 926 Ft			36°59'16" N 79°42'43" W 265°W COURSE -1' GPS Union Hall, VA 24176, United States 07.29.2022 10:18:45 Accur +/-15.1 Ft ALT 925 Ft		
GPS Location	5		GPS Location	6	
Field Station#	14680+55		Field Station#	14688+75	
Pic 5 Desc.	Equipment bridge and surrounding ECDs in place and functional at stream crossing and resource buffer.		Pic 6 Desc.	Perimeter controls in place and functional.

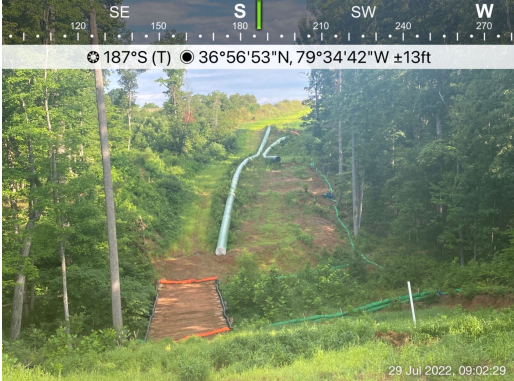
GPS Location	0	GPS Location	0		
Field Station#	15140+00	Field Station#	15092+95		
Pic 3 Desc.	Approximately 15140+00. Overview of ROW.	Pic 4 Desc.	Approximately 15092+95. Overview of stream crossing, equipment bridge and ECDs at stream S-G9.

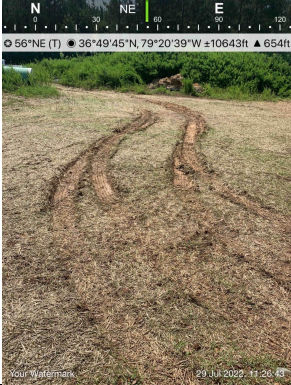
GPS Location	O	GPS Location	O		
Field Station#	15962+00	Field Station#	16024+00		
Pic 7 Desc.	Observing temporary stabilization,buffer, equipment crossing and ECD's	Pic 8 Desc.	Observing ruts that need to be repaired and restabilized

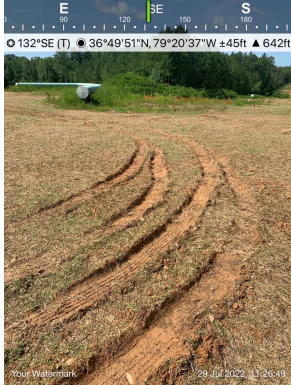
GPS Location	O	GPS Location			
Field Station#	16024+00	Field Station#			
Pic 9 Desc.	Observing ruts that need to be repaired and restabilized	Pic 10 Desc.

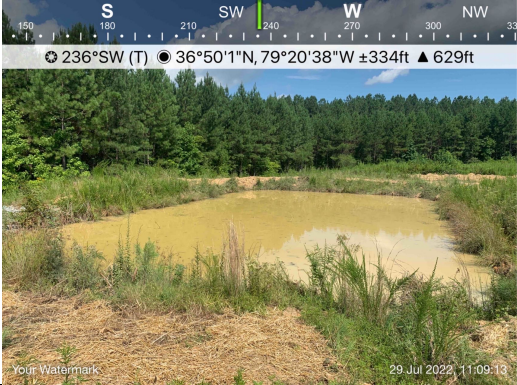
Insert image here			
GPS Location	O	GPS Location			
Field Station#	00+00	Field Station#			
Pic 7 Desc.	Observing temporary stabilization and sediment basin	Pic 8 Desc.			
Insert image here		Insert image here			
GPS Location		GPS Location			
Field Station#		Field Station#			
Pic 9 Desc.		Pic 10 Desc.			
Insert image here		Insert image here			
GPS Location		GPS Location			
Field Station#		Field Station#			
Pic 11 Desc.		Pic 12 Desc.
