# Visual Site Inspection Report

<b>Project Name</b>	H-600 Pipeline Spread I	<b>AFE</b>	124300139	<b>Spread</b>	H-600 Pipeline Spread I
<b>Contractor</b>	Precision			<b>Report #</b>	39476
<b>Inspector</b>	Ben Farmer			<b>Date/Time</b>	7/5/2022 1:26 PM
<b>Permit #</b>	TBD	<b>Inspection Type</b>	VA SWPP	<b>Station Begin</b>	13958+31
<b>State</b>	VA	<b>Inspection Area</b>	Partial	<b>Station End</b>	14062+17
<b>County</b>	Franklin	<b>Ground</b>	Dry	<b>Temperature (°F)</b>	75.00
<b>Municipality</b>	N/A	<b>Weather</b>	Sunny	<b>Rain Gauge (in)</b>	0.00
				<b>Rain Accumulation Time (days)</b>	0.00

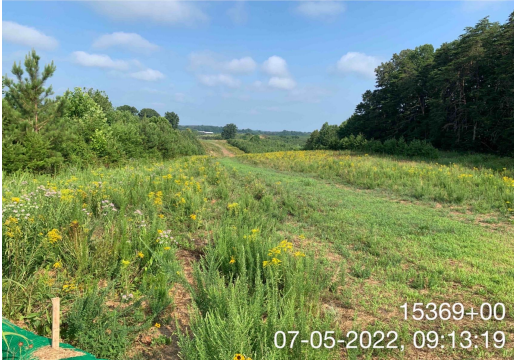
<b>GPS Location</b>	0	<b>GPS Location</b>	0		
<b>Field Station#</b>	15369+00	<b>Field Station#</b>	15350+00		
<b>Pic 1 Desc.</b>	Permanent vegetative stabilization in acceptable condition	<b>Pic 2 Desc.</b>	Temporary vegetative stabilization in acceptable condition

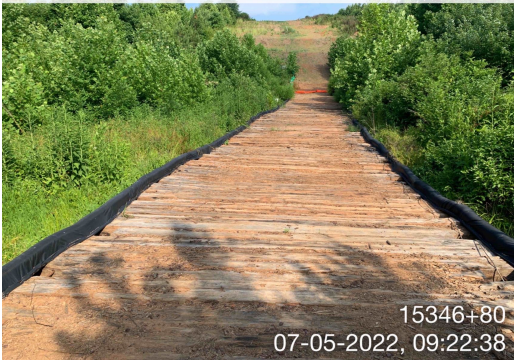
<b>GPS Location</b>	0	<b>GPS Location</b>	0		
<b>Field Station#</b>	15346+80	<b>Field Station#</b>	15343+00		
<b>Pic 3 Desc.</b>	Equipment bridge in acceptable condition	<b>Pic 4 Desc.</b>	Waterbar in acceptable condition

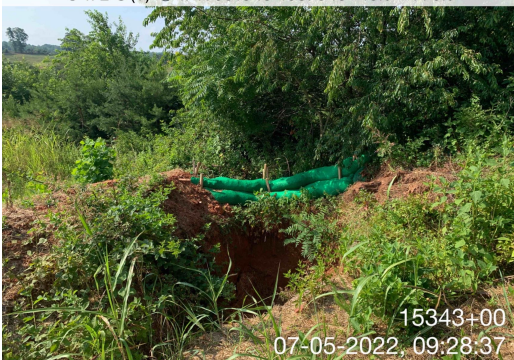
<b>GPS Location</b>	0	<b>GPS Location</b>	0		
<b>Field Station#</b>	15343+00	<b>Field Station#</b>	15338+00		
<b>Pic 5 Desc.</b>	Waterbar end treatment in acceptable condition	<b>Pic 6 Desc.</b>	Sump pit in acceptable condition

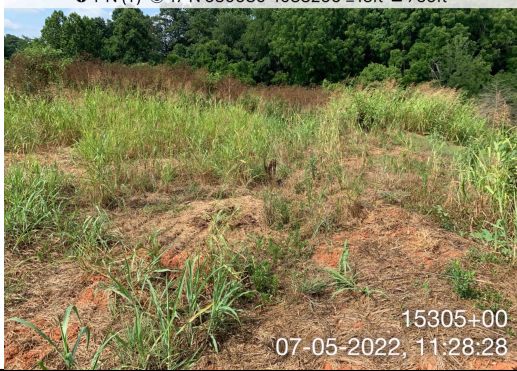
<b>GPS Location</b>	0	<b>GPS Location</b>	0		
<b>Field Station#</b>	15305+00	<b>Field Station#</b>	15305+00		
<b>Pic 9 Desc.</b>	Waterbar in acceptable condition		<b>Pic 10 Desc.</b>	Waterbar end treatment in acceptable condition	
Insert image here			Insert image here		
<b>GPS Location</b>		<b>GPS Location</b>			
<b>Field Station#</b>		<b>Field Station#</b>			
<b>Pic 11 Desc.</b>			<b>Pic 12 Desc.</b>

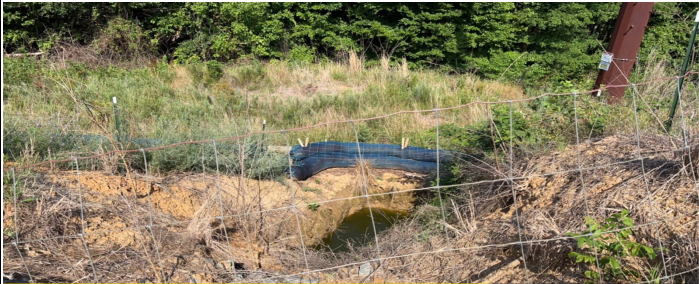
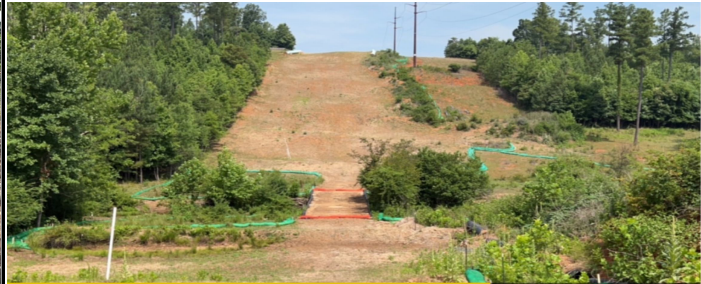
<p data-bbox="894 514 1182 531">37°1'0" N 79°45'34" W 347°N COURSE -1° GPS</p> <p data-bbox="1320 514 1443 531">07.05.2022 11:29:31</p> <p data-bbox="870 531 1170 548">1401 SR-674, Glade Hill, VA 24092, United States</p> <p data-bbox="1287 531 1455 548">Accur +/-15.1 Ft ALT 911 Ft</p>		
GPS Location	1	GPS Location	2	Field Station#	14477+00
Pic 1 Desc.	Sump pit and CFS end treatment performing intended functions.				
Pic 2 Desc.	Equipment bridge and surrounding ECDs in place and functional at stream crossing and resource buffer; ROW stabilized and vegetated in temporary area.

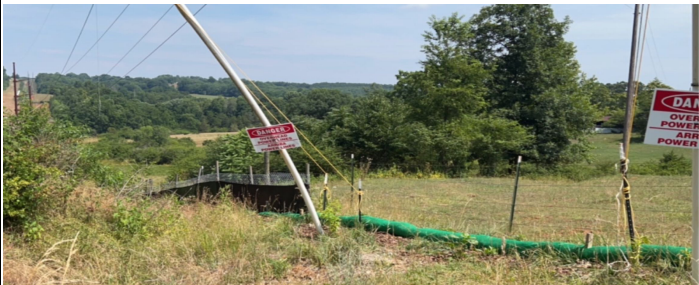
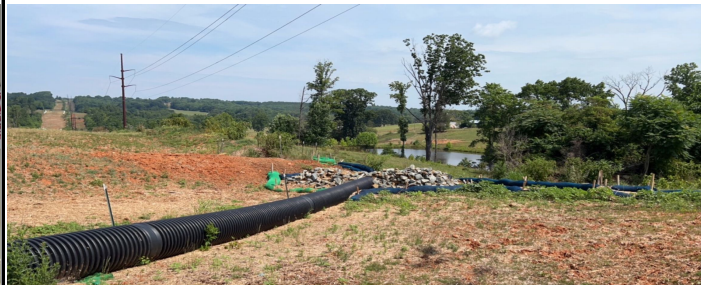
<p data-bbox="894 1094 1182 1110">37°0'43" N 79°45'18" W 6°N COURSE -1° GPS</p> <p data-bbox="1320 1094 1443 1110">07.05.2022 11:18:42</p> <p data-bbox="911 1110 1130 1127">Glade Hill, VA 24092, United States</p> <p data-bbox="1287 1110 1455 1127">Accur +/-15.1 Ft ALT 1016 Ft</p>		
GPS Location	3	GPS Location	4	Field Station#	14516+00
Pic 3 Desc.	Perimeter SSF and CFS performing intended functions.				
Pic 4 Desc.	Slope drain pipe in place and functional.

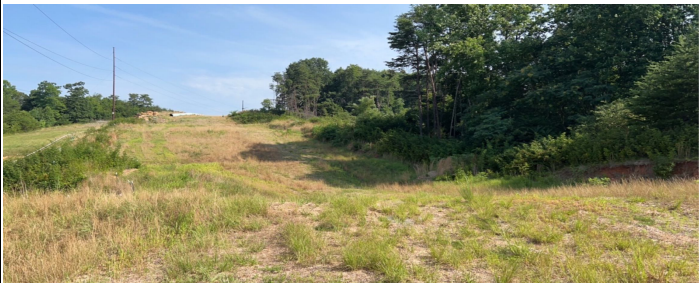
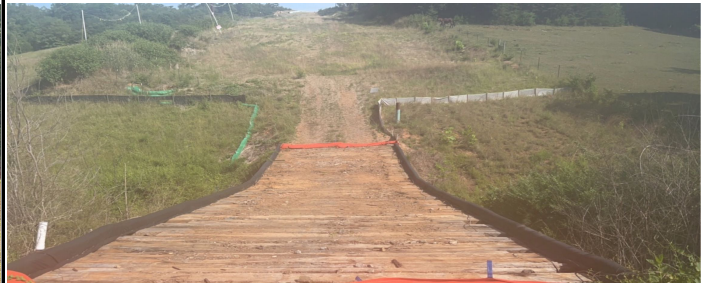
GPS Location	5	GPS Location	6	Field Station#	14537+00
Pic 5 Desc.	ROW stabilized and vegetated in temporary area; water bars performing intended functions.				
Pic 6 Desc.	Equipment bridge and surrounding ECDs in place and functional at stream crossing and resource buffer.

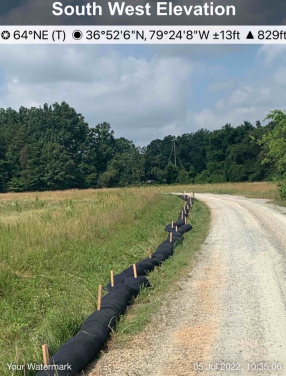
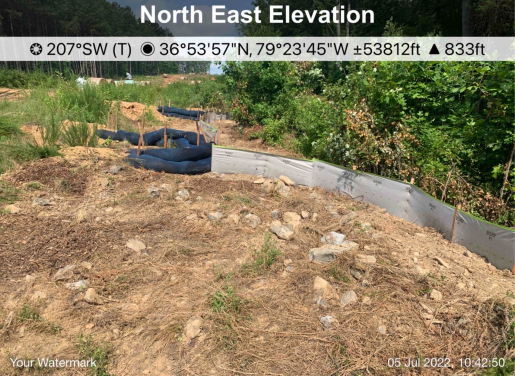
<p><b>North East Elevation</b>          207°SW (T) 36°53'57"N, 79°23'45"W ±53812ft ▲ 833ft          Your Watermark 05 Jul 2022 10:42:50</p>			
<b>GPS Location</b>	O	<b>GPS Location</b>	O		
<b>Field Station#</b>	15772+27	<b>Field Station#</b>	15756+00		
<b>Pic 1 Desc.</b>	Observing temporary stabilization,access road and ECD's	<b>Pic 2 Desc.</b>	Observing temporary stabilization,end treatment and ECD's

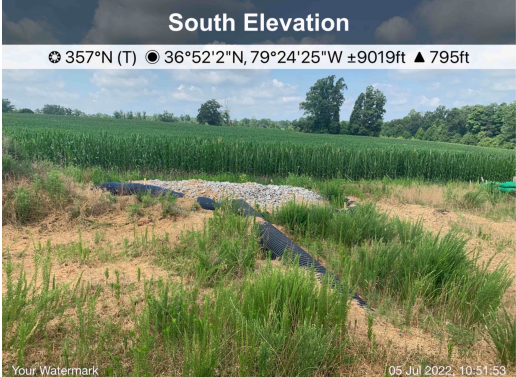
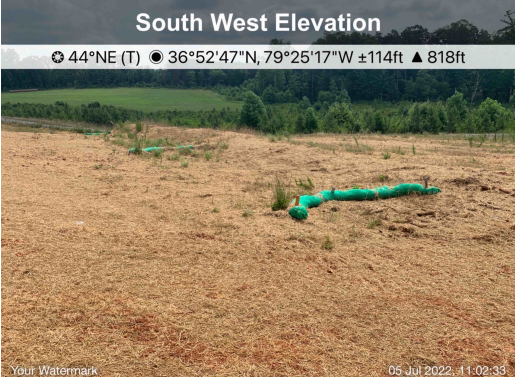
<b>GPS Location</b>	O	<b>GPS Location</b>	O		
<b>Field Station#</b>	15735+00	<b>Field Station#</b>	15695+00		
<b>Pic 3 Desc.</b>	Observing temporary stabilization,CWD outlet and ECD's	<b>Pic 4 Desc.</b>	Observing temporary stabilization,water bar and CFS checks

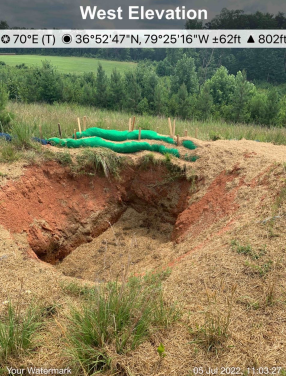
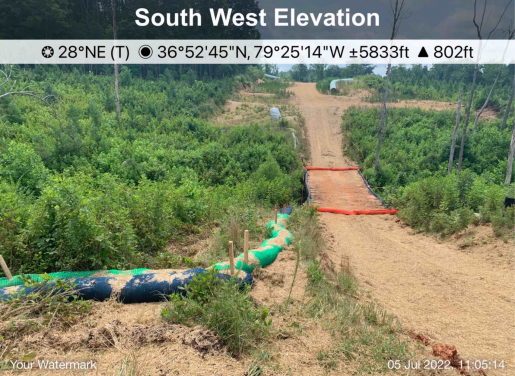
<p><b>South West Elevation</b>          28°NE (T) 36°52'45"N, 79°25'14"W ±5833ft ▲ 802ft          Your Watermark 05 Jul 2022 11:05:14</p>			
<b>GPS Location</b>	O	<b>GPS Location</b>	O		
<b>Field Station#</b>	15697+00	<b>Field Station#</b>	15700+40		
<b>Pic 5 Desc.</b>	Observing temporary stabilization,ump and end treatment	<b>Pic 6 Desc.</b>	Observing temporary stabilization,buffer, equipment crossing and ECD's

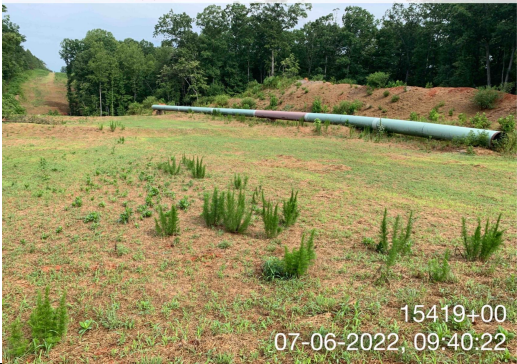
15424+00 07-06-2022, 09:55:20			
<b>GPS Location</b>	0	<b>GPS Location</b>	0		
<b>Field Station#</b>	15419+00	<b>Field Station#</b>	15424+00		
<b>Pic 7 Desc.</b>	Temporary vegetative stabilization in acceptable condition	<b>Pic 8 Desc.</b>	Waterbar in acceptable condition		
45°NE (T) 17 N 634211 4086720 ±16ft ▲ 800ft

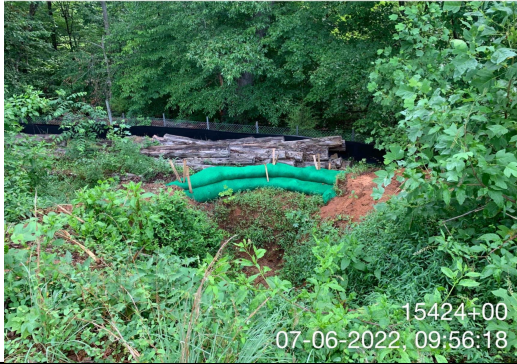
15427+00 07-06-2022, 10:10:59			
<b>GPS Location</b>	0	<b>GPS Location</b>	0		
<b>Field Station#</b>	15424+00	<b>Field Station#</b>	15427+00		
<b>Pic 9 Desc.</b>	Waterbar end treatment in acceptable condition	<b>Pic 10 Desc.</b>	Super silt fence in acceptable condition		
129°SE (T) 17 N 634631 4086461 ±26ft ▲ 843ft

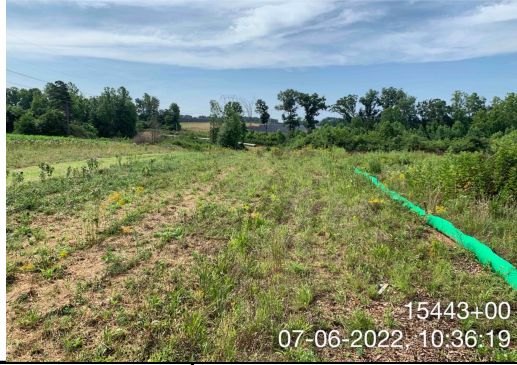
<b>GPS Location</b>	0	<b>GPS Location</b>	0		
<b>Field Station#</b>	15443+00	<b>Field Station#</b>	15464+00		
<b>Pic 11 Desc.</b>	Permanent vegetative stabilization and perimeter CFS in acceptable conditions	<b>Pic 12 Desc.</b>	Solar farm perimeter ECDs appear to be in acceptable conditions

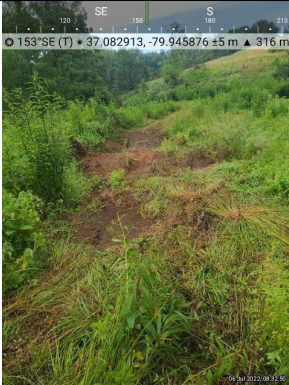
<b>GPS Location</b>	0000	<b>GPS Location</b>	0000		
<b>Field Station#</b>	13704+40	<b>Field Station#</b>	13704+90		
<b>Pic 1 Desc.</b>	Photo showing 3rd party activities where a land owner has made a travel lane across the row. Documented and added to the punch list to have the disturbed area stabilized.		<b>Pic 2 Desc.</b>	Additional photo showing where a land order has made a low water crossing downstream of the row outside the LOD. Documented as non project related activities.

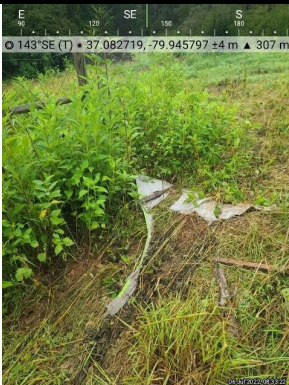
<b>GPS Location</b>	0000	<b>GPS Location</b>	0000		
<b>Field Station#</b>	13704+40	<b>Field Station#</b>	13704+90		
<b>Pic 3 Desc.</b>	3rd party damages to P1, Documented and sent in to be added to the punch list for repair.		<b>Pic 4 Desc.</b>	Additional photo showing where a land order has made a low water crossing downstream of the row outside the LOD. Documented as non project related activities.

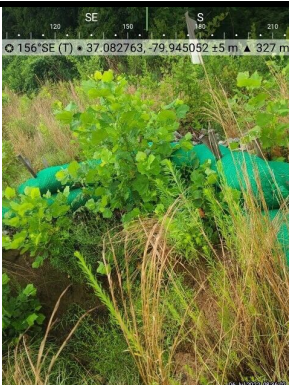
<b>GPS Location</b>	00000	<b>GPS Location</b>	00000		
<b>Field Station#</b>	13707+50	<b>Field Station#</b>	13696+03		
<b>Pic 5 Desc.</b>	Monitored sump pits and end treatment during routine inspection. No environmental issues observed at the time of inspection.		<b>Pic 6 Desc.</b>	Monitored ECDs at wetland area. All in place and functioning at the time of inspection.

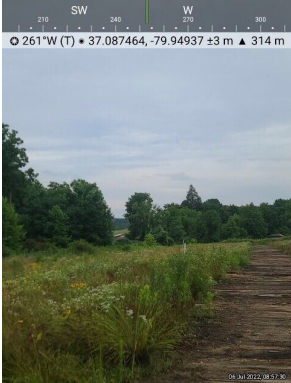
<p>Insert image here</p>		<p>Insert image here</p>	
<b>GPS Location</b>	00000	<b>GPS Location</b>			
<b>Field Station#</b>	13683+12	<b>Field Station#</b>			
<b>Pic 7 Desc.</b>	Row photo showing stabilization where equipment mats are in place in low area of row. No environmental issues observed at the time of inspection.	<b>Pic 8 Desc.</b>			
<p>Insert image here</p>		<p>Insert image here</p>			
<b>GPS Location</b>		<b>GPS Location</b>			
<b>Field Station#</b>		<b>Field Station#</b>			
<b>Pic 9 Desc.</b>		<b>Pic 10 Desc.</b>			
<p>Insert image here</p>		<p>Insert image here</p>			
<b>GPS Location</b>		<b>GPS Location</b>			
<b>Field Station#</b>		<b>Field Station#</b>			
<b>Pic 11 Desc.</b>		<b>Pic 12 Desc.</b>

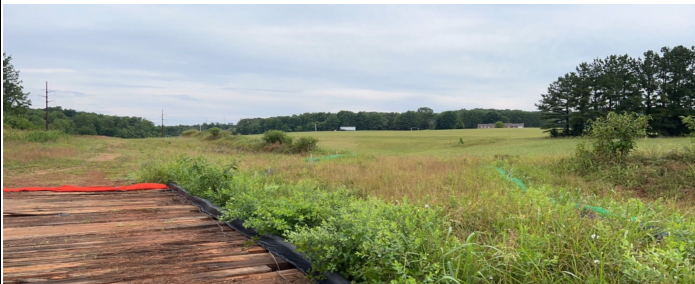
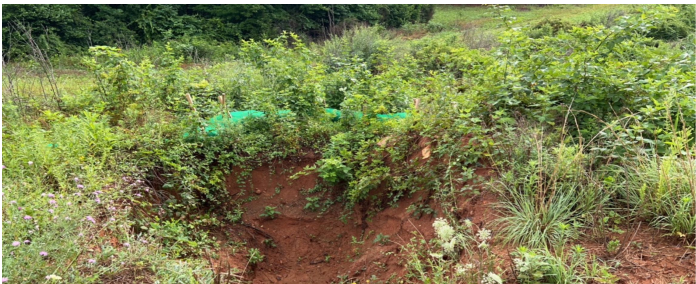
37°07' N 79°44'57" W 73°E COURSE 157' GPS 07.06.2022 08:56:40 Accur +/-15.4 Ft ALT 909 Ft			37°04' N 79°44'52" W 161°S COURSE 40' GPS 07.06.2022 09:02:35 594 Tobacco Rd, Glade Hill, VA 24092, United States Accur +/-15.4 Ft ALT 891 Ft		
<b>GPS Location</b>	1	<b>GPS Location</b>	2		
<b>Field Station#</b>	14563+00	<b>Field Station#</b>	14567+00		
<b>Pic 1 Desc.</b>	Natural drainage area in good condition.	<b>Pic 2 Desc.</b>	Sump pit and CFS end treatment performing intended functions.

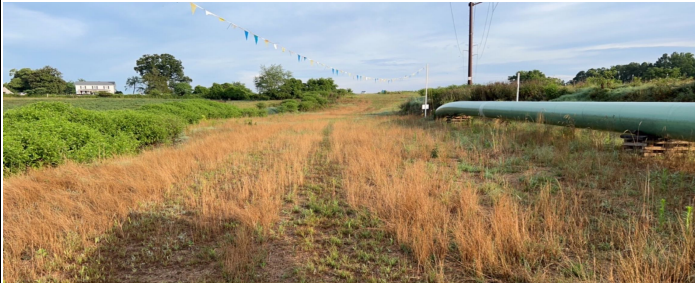
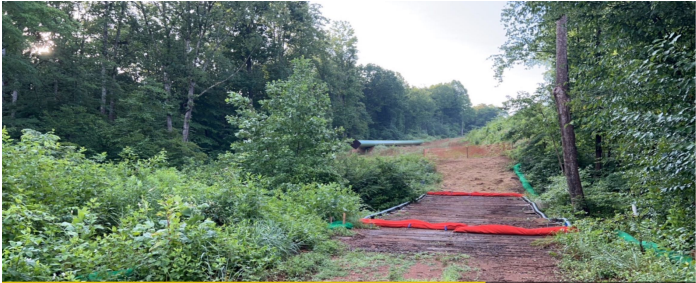
36°59'47" N 79°44'13" W 325°NW COURSE 230' GPS 07.06.2022 07:35:13 Sorry no results found Accur +/-17.9 Ft ALT 883 Ft			36°59'45" N 79°44'7" W 118°SE COURSE 31' GPS 07.06.2022 07:32:23 Union Hall, VA 24176, United States Accur +/-22.5 Ft ALT 909 Ft		
<b>GPS Location</b>	5	<b>GPS Location</b>	6		
<b>Field Station#</b>	14602+50	<b>Field Station#</b>	14611+17		
<b>Pic 5 Desc.</b>	ROW stabilized and vegetated in temporary area.	<b>Pic 6 Desc.</b>	Equipment bridge and surrounding ECDs in place and functional; signage visible and intact.

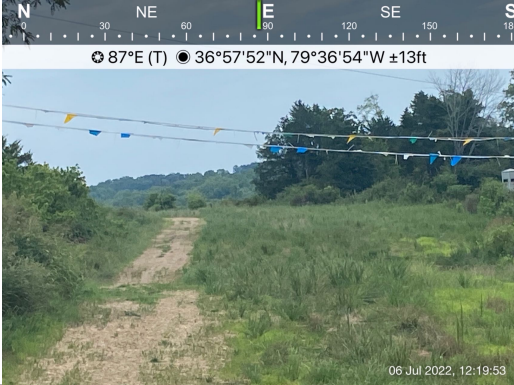
<b>GPS Location</b>	0	<b>GPS Location</b>	0		
<b>Field Station#</b>	15055+80	<b>Field Station#</b>	15044+90		
<b>Pic 1 Desc.</b>	Approximately 15055+80. Overview of stream crossing, equipment bridge and ECDs at stream S-D2-EPH.		<b>Pic 2 Desc.</b>	Approximately 15044+90. Overview of stream crossing, equipment bridge and ECDs at stream S-D2.

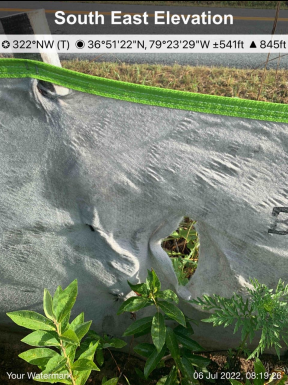
<b>GPS Location</b>	O	<b>GPS Location</b>	O		
<b>Field Station#</b>	15826+90	<b>Field Station#</b>	15827+50		
<b>Pic 1 Desc.</b>	Observing P1 that requires maintenance		<b>Pic 2 Desc.</b>	Observing P1 that requires maintenance

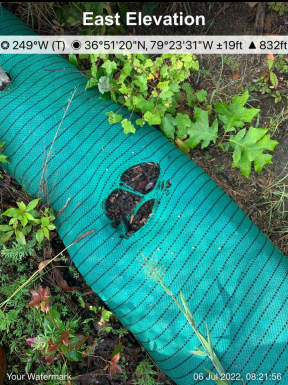
<b>GPS Location</b>	O	<b>GPS Location</b>	O		
<b>Field Station#</b>	15827+50	<b>Field Station#</b>	15849+30		
<b>Pic 3 Desc.</b>	Observing CFS that requires maintenance		<b>Pic 4 Desc.</b>	Observing CFS that requires maintenance

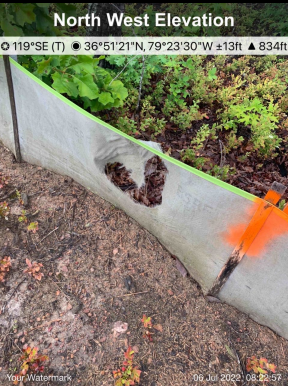
<b>GPS Location</b>	O	<b>GPS Location</b>	O		
<b>Field Station#</b>	15827+60	<b>Field Station#</b>	15830+00		
<b>Pic 5 Desc.</b>	Observing P1 that requires maintenance		<b>Pic 6 Desc.</b>	Observing CFS that requires maintenance

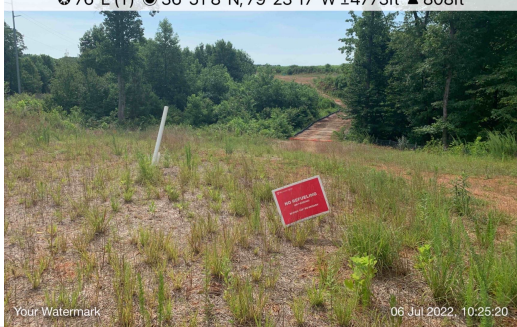
<b>GPS Location</b>	O	<b>GPS Location</b>	O		
<b>Field Station#</b>	15851+55	<b>Field Station#</b>	15835+00		
<b>Pic 9 Desc.</b>	Observing temporary stabilization, water bar, signage, buffer, equipment crossing and ECD's	<b>Pic 10 Desc.</b>	Observing the Contractor performing ECD maintenance

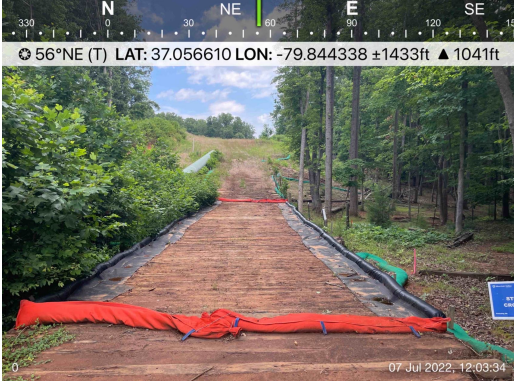
<b>GPS Location</b>	See photo	<b>GPS Location</b>	See photo		
<b>Field Station#</b>	14176+09	<b>Field Station#</b>	14180+00		
<b>Pic 1 Desc.</b>	Equipment bridge ECDs are in good condition and functioning	<b>Pic 2 Desc.</b>	CWDs are functioning as intended

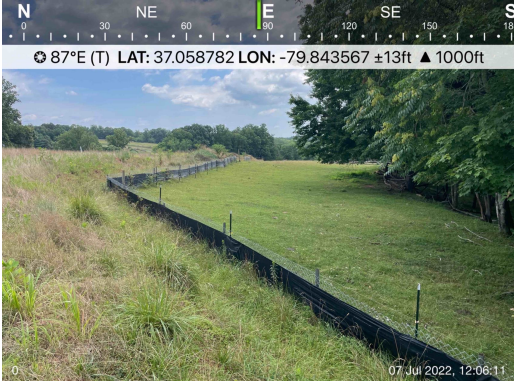
<b>GPS Location</b>	See photo	<b>GPS Location</b>	See photo		
<b>Field Station#</b>	14181+00	<b>Field Station#</b>	14209+02		
<b>Pic 3 Desc.</b>	SSF is in good condition throughout this section	<b>Pic 4 Desc.</b>	Equipment bridge ECDs are in good condition and functioning

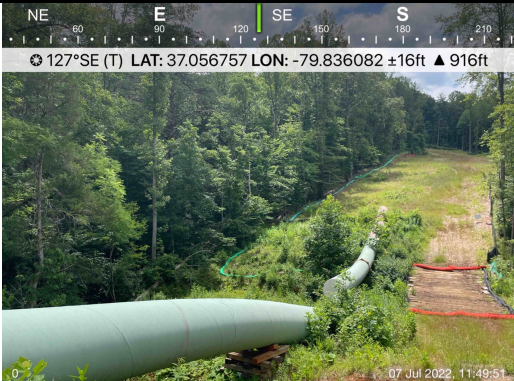
<b>GPS Location</b>	See photo	<b>GPS Location</b>	See photo		
<b>Field Station#</b>	14213+75	<b>Field Station#</b>	14223+41		
<b>Pic 5 Desc.</b>	Resource buffers remain well vegetated	<b>Pic 6 Desc.</b>	MVP-FR-311 remains in good condition with controls in place

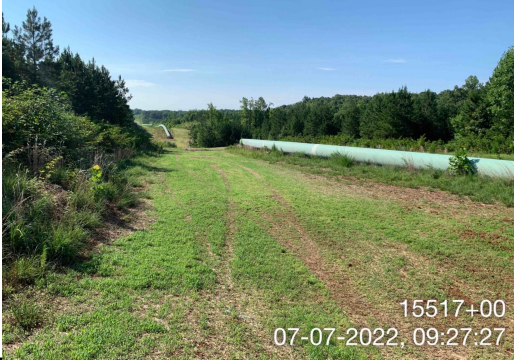
15521+00 07-07-2022, 09:35:20			
<b>GPS Location</b>	0	<b>GPS Location</b>	0		
<b>Field Station#</b>	15517+00	<b>Field Station#</b>	15521+00		
<b>Pic 5 Desc.</b>	Temporary vegetative stabilization in acceptable condition	<b>Pic 6 Desc.</b>	Equipment bridge in acceptable condition

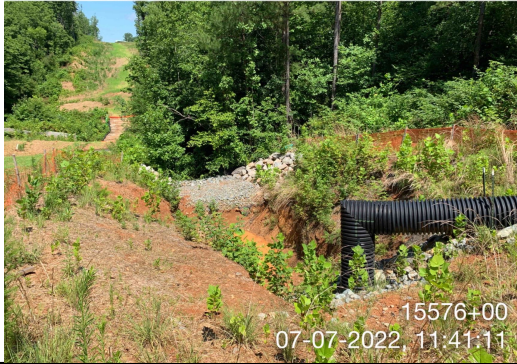
<b>GPS Location</b>	0	<b>GPS Location</b>	0		
<b>Field Station#</b>	15576+00	<b>Field Station#</b>	15584+00		
<b>Pic 9 Desc.</b>	Slope drain pipe and sump pit in acceptable condition	<b>Pic 10 Desc.</b>	Rock construction entrance in acceptable condition		
Insert image here		Insert image here			
<b>GPS Location</b>		<b>GPS Location</b>

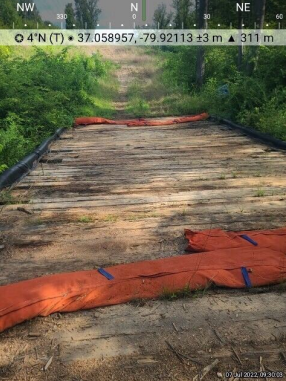
<b>GPS Location</b>	00000	<b>GPS Location</b>	0000		
<b>Field Station#</b>	13847+03	<b>Field Station#</b>	13846+93		
<b>Pic 1 Desc.</b>	Monitored equipment bridge and ECDs at stream crossing. No environmental issues observed at the time of inspection.		<b>Pic 2 Desc.</b>	Stream observation photo facing upstream during routine. No environmental issues observed at the time of inspection.

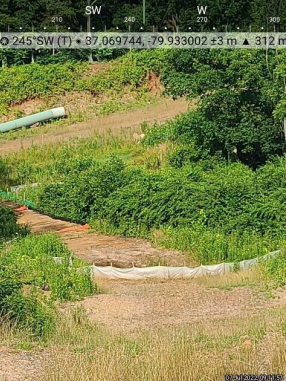
<b>GPS Location</b>	0000	<b>GPS Location</b>	0000		
<b>Field Station#</b>	13782+68	<b>Field Station#</b>	13845+89		
<b>Pic 3 Desc.</b>	Monitored ECDs throughout the row inspection. No environmental issues observed at the time of inspection.		<b>Pic 4 Desc.</b>	Stabilization observation on side slope. Good coverage noted.

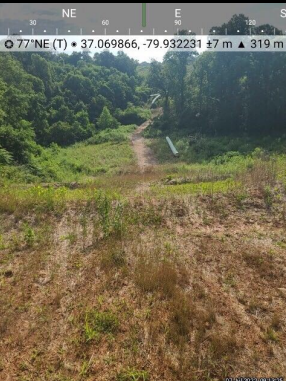
<b>Pic 5 Desc.</b>	Row photo showing water bars in place in a temporary area of row. Good stabilization noted during the time of inspection.		<b>Pic 6 Desc.</b>	Stream observation photo facing downstream during routine inspection. No environmental issues observed at the time of inspection.

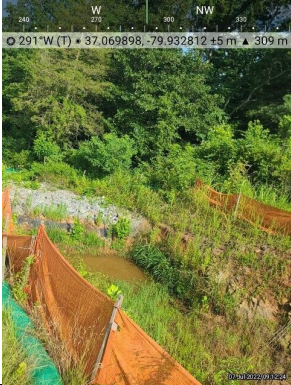
<p>Insert image here</p>		<p>Insert image here</p>	
<b>GPS Location</b>	00000	<b>GPS Location</b>	0000		
<b>Field Station#</b>	13784+20	<b>Field Station#</b>			
<b>Pic 7 Desc.</b>	Monitored sump pit and plunge pool after recent rain events, all in place and functioning at the time of inspection.		<b>Pic 8 Desc.</b>		
<p>Insert image here</p>		<p>Insert image here</p>			
<b>GPS Location</b>		<b>GPS Location</b>			
<b>Field Station#</b>		<b>Field Station#</b>			
<b>Pic 9 Desc.</b>		<b>Pic 10 Desc.</b>			
<p>Insert image here</p>		<p>Insert image here</p>			
<b>GPS Location</b>		<b>GPS Location</b>			
<b>Field Station#</b>		<b>Field Station#</b>			
<b>Pic 11 Desc.</b>		<b>Pic 12 Desc.</b>

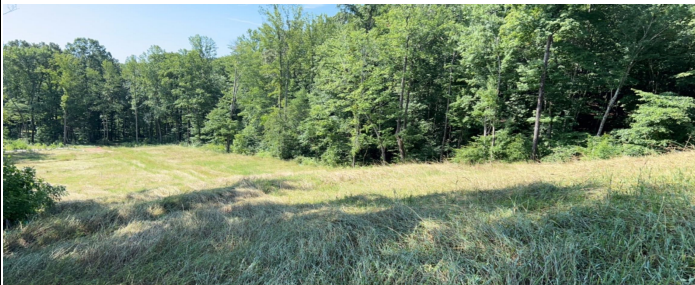
<b>Field Station#</b>	14654+00	<b>Field Station#</b>	14663+50		
<b>Pic 3 Desc.</b>	ROW stabilized and vegetated in final cleanup area.		<b>Pic 4 Desc.</b>	Temporary diversion berm stabilized and vegetated; ROW stabilized and vegetated.

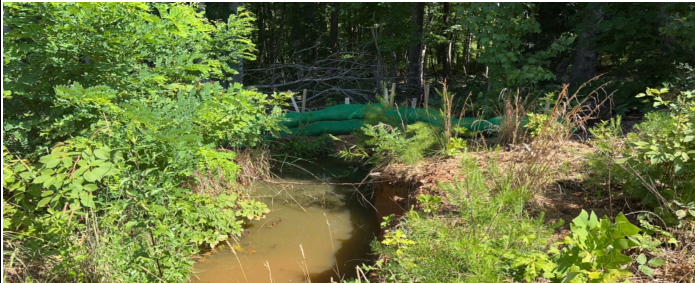
36°59'20" N 79°43'13" W 311°NW COURSE 160° GPS Union Hall, VA 24176, United States 07.07.2022 10:31:31 Accur +/-223.0 Ft ALT 941 Ft			36°59'22" N 79°43'21" W 94°E COURSE 307° GPS 07.07.2022 10:28:12 Accur +/-15.4 Ft ALT 952 Ft		
<b>GPS Location</b>	5	<b>GPS Location</b>	6		
<b>Field Station#</b>	14678+00	<b>Field Station#</b>	14681+00		
<b>Pic 5 Desc.</b>	Sump pit and CFS end treatment performing intended functions.		<b>Pic 6 Desc.</b>	Perimeter P1 silt fence in good condition.

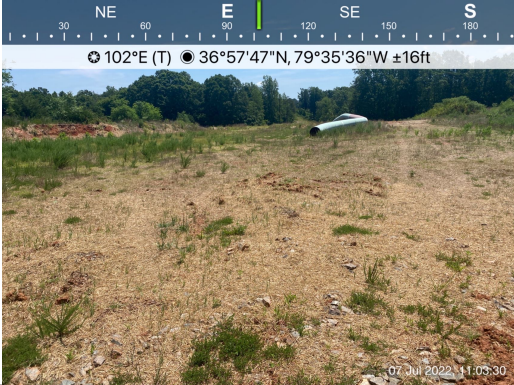
<b>GPS Location</b>	0	<b>GPS Location</b>	0		
<b>Field Station#</b>	15065+00	<b>Field Station#</b>	15072+86		
<b>Pic 3 Desc.</b>	Approximately 15065+00. Overview of ROW.	<b>Pic 4 Desc.</b>	Approximately 15072+86. Overview of stream crossing, equipment bridge and ECDs at stream S-G11.

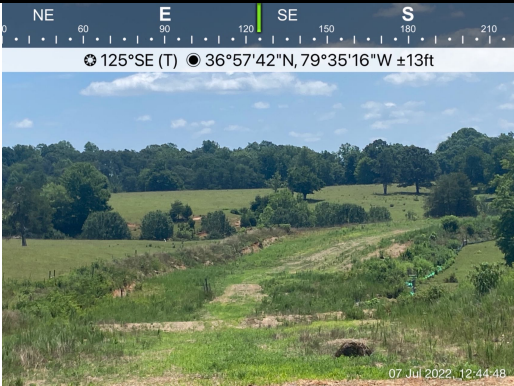
<b>GPS Location</b>	0	<b>GPS Location</b>	0		
<b>Field Station#</b>	15086+00	<b>Field Station#</b>	15116+00		
<b>Pic 5 Desc.</b>	Approximately 15086+00. Overview of ROW.	<b>Pic 6 Desc.</b>	Approximately 15116+00. Overview of ROW.

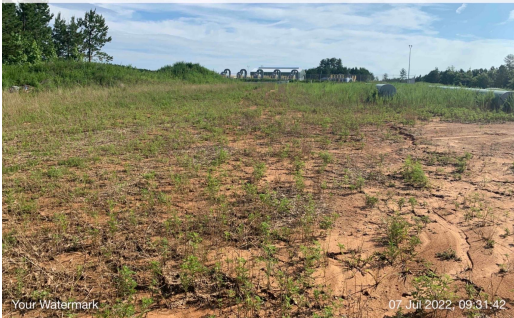
<small>Your Watermark 07 Jul 2022 09:31:53</small>	
<b>GPS Location</b>	O	<b>GPS Location</b>	O		
<b>Field Station#</b>	16023+00	<b>Field Station#</b>	16020+00		
<b>Pic 1 Desc.</b>	Observing temporary stabilization	<b>Pic 2 Desc.</b>	Observing temporary stabilization and water bar		
	<b>North West Elevation</b> 154°SE (T) 36°49'50"N, 79°20'41"W ±9297ft ▲ 638ft

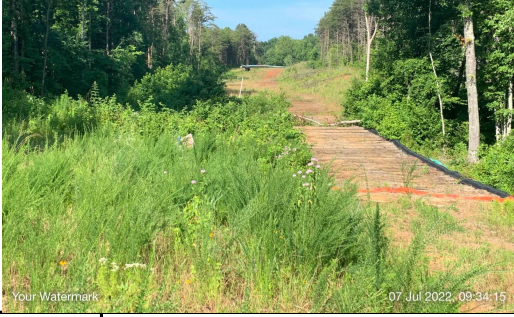
<b>Pic 3 Desc.</b>	Observing temporary stabilization, signage, buffer, equipment crossing and ECD's	<b>Pic 4 Desc.</b>	Observing temporary stabilization and CWD berm		
	<b>South West Elevation</b> 52°NE (T) 36°49'45"N, 79°20'49"W ±108ft ▲ 611ft

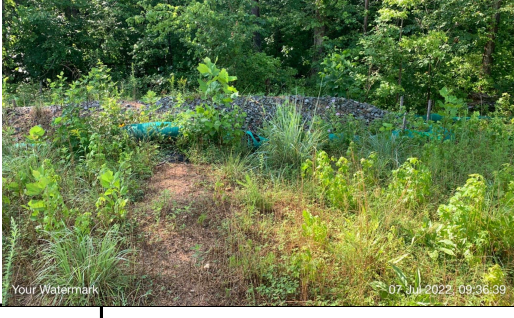
<small>Your Watermark 07 Jul 2022 09:37:07</small>	
<b>GPS Location</b>	O	<b>GPS Location</b>	O		
<b>Field Station#</b>	16010+00	<b>Field Station#</b>	16007+00		
<b>Pic 5 Desc.</b>	Observing temporary stabilization, CWD outlet and ECD's	<b>Pic 6 Desc.</b>	Observing temporary stabilization, sump and end treatment

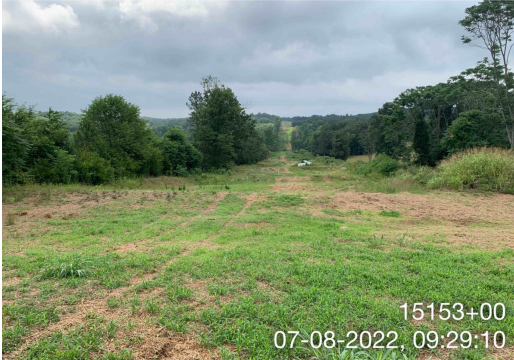
<b>GPS Location</b>	0	<b>GPS Location</b>	0		
<b>Field Station#</b>	15153+00	<b>Field Station#</b>	15159+00		
<b>Pic 1 Desc.</b>	Temporary vegetative stabilization in acceptable condition	<b>Pic 2 Desc.</b>	Waterbar in acceptable condition

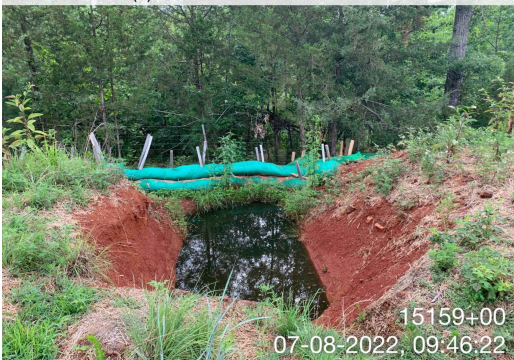
<b>GPS Location</b>	0	<b>GPS Location</b>	0		
<b>Field Station#</b>	15159+00	<b>Field Station#</b>	15165+00		
<b>Pic 3 Desc.</b>	Waterbar end treatment in acceptable condition	<b>Pic 4 Desc.</b>	Temporary vegetative stabilization in acceptable condition

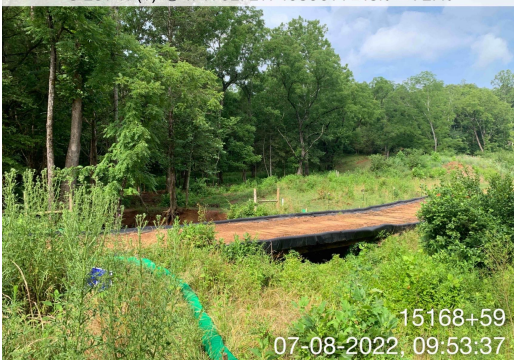
<b>GPS Location</b>	0	<b>GPS Location</b>	0		
<b>Field Station#</b>	15168+59	<b>Field Station#</b>	15169+00		
<b>Pic 5 Desc.</b>	Equipment bridge in acceptable condition	<b>Pic 6 Desc.</b>	P1 silt fence and temporary vegetative stabilization in acceptable conditions

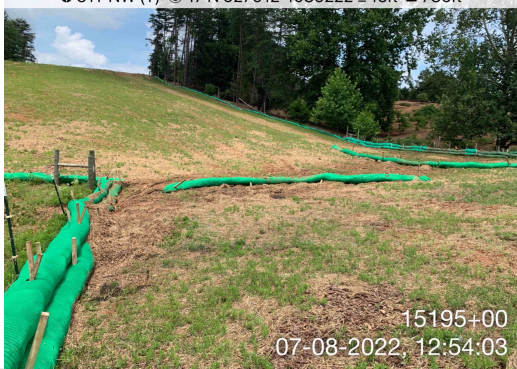
<b>GPS Location</b>	0	<b>GPS Location</b>	0		
<b>Field Station#</b>	15195+00	<b>Field Station#</b>	15229+00		
<b>Pic 9 Desc.</b>	CFS checks are dislocated and perimeter CFS on both sides of the ROW is covered with sediment and debris		<b>Pic 10 Desc.</b>	Waterbar end treatment in acceptable condition	
Insert image here			Insert image here		
<b>GPS Location</b>		<b>GPS Location</b>			
<b>Field Station#</b>		<b>Field Station#</b>			
<b>Pic 11 Desc.</b>			<b>Pic 12 Desc.</b>

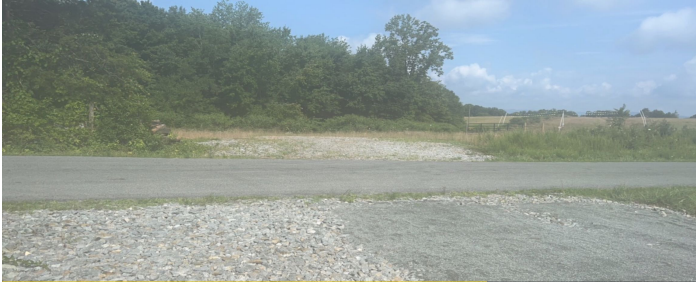
<small>37°23'34" N 79°48'35" W 258°W COURSE 0° GPS 530 Farm View Rd, Glade Hill, VA 24092, United States 07.08.2022 10:27:42 Accur +/-15.5 Ft ALT 1071 Ft</small>			<small>37°2'34" N 79°48'36" W 181°S COURSE 201° GPS 530 Farm View Rd, Glade Hill, VA 24092, United States 07.08.2022 10:28:30 Accur +/-11.6 Ft ALT 1068 Ft</small>		
<b>GPS Location</b>	1		<b>GPS Location</b>	2	
<b>Field Station#</b>	14311+57		<b>Field Station#</b>	14312+00	
<b>Pic 1 Desc.</b>	RCE in good condition.		<b>Pic 2 Desc.</b>	Perimeter P1 silt fence in place and functional.

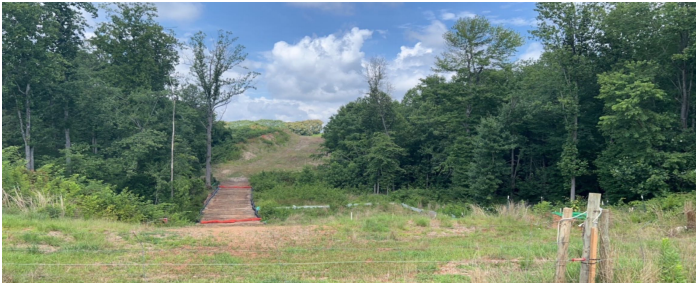
<b>GPS Location</b>	3		<b>GPS Location</b>	4	
<b>Field Station#</b>	14353+53		<b>Field Station#</b>	14362+00	
<b>Pic 3 Desc.</b>	Equipment bridge and surrounding ECDs in place and functional at stream crossing and resource buffer.		<b>Pic 4 Desc.</b>	Plunge pool in good condition.

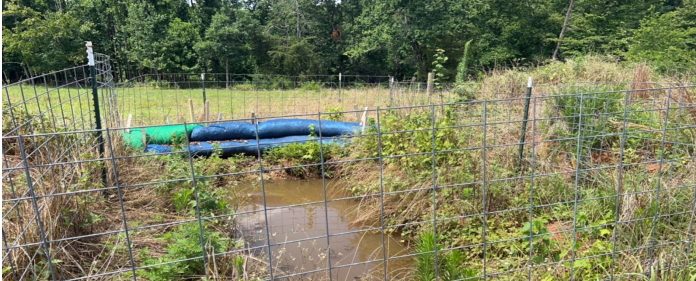
<small>37°2'9" N 79°47'54" W 309°NW COURSE -1° GPS Glade Hill, VA 24092, United States 07.08.2022 11:54:43 Accur +/-15.1 Ft ALT 1104 Ft</small>			<small>37°2'5" N 79°47'37" W 144°SE COURSE -1° GPS Glade Hill, VA 24092, United States 07.08.2022 12:02:21 Accur +/-15.1 Ft ALT 1084 Ft</small>		
<b>GPS Location</b>	5		<b>GPS Location</b>	6	
<b>Field Station#</b>	14371+00		<b>Field Station#</b>	14383+00	
<b>Pic 5 Desc.</b>	Sump pit and CFS end treatment performing intended functions.		<b>Pic 6 Desc.</b>	ROW stabilized and vegetated in temporary area; temporary diversion berm stabilized and vegetated.

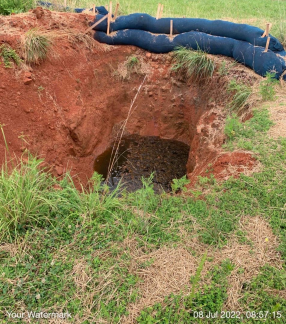
<b>GPS Location</b>	O	<b>GPS Location</b>	O		
<b>Field Station#</b>	15647+03	<b>Field Station#</b>	15646+00		
<b>Pic 1 Desc.</b>	Observing road crossing and RCE's	<b>Pic 2 Desc.</b>	Observing temporary stabilization, sump and end treatment		
<b>South Elevation</b> 347°N (T) 36°53'28"N, 79°26'0"W ±85ft ▲ 791ft

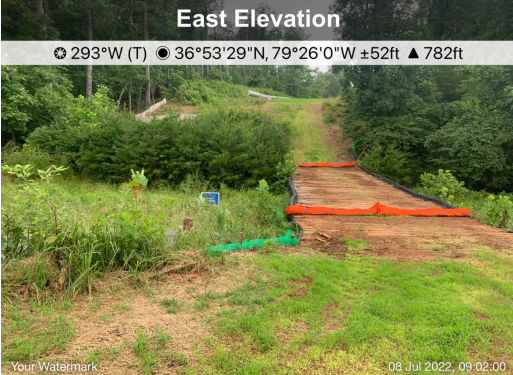
<b>GPS Location</b>	O	<b>GPS Location</b>	O		
<b>Field Station#</b>	15638+00	<b>Field Station#</b>	15636+45		
<b>Pic 3 Desc.</b>	Observing temporary stabilization and water bar	<b>Pic 4 Desc.</b>	Observing temporary stabilization, signage, buffer, equipment crossing and ECD's

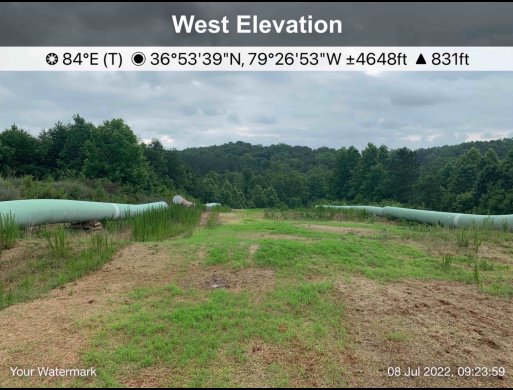
<b>GPS Location</b>	O	<b>GPS Location</b>	O		
<b>Field Station#</b>	15632+00	<b>Field Station#</b>	15590+00		
<b>Pic 5 Desc.</b>	Observing temporary stabilization, CWD outlet and ECD's	<b>Pic 6 Desc.</b>	Observing temporary stabilization and water bars
