Visual Site Inspection Report

Project Name H-600 Pipeline Spread H		AFE 124300138	Spread H-600 Pipeline Spread H
Contractor Precision		Report # 40745	
Inspector Jonathan Altizer		Date/Time 8/8/2022 3:16 PM	
Permit # TBD	Inspection Type VA SWPP	Station Begin 12284+75	
State VA	Inspection Area Partial	Station End 12443+75	
County Montgomery	Ground Wet	Temperature (°F) 90.00	
Municipality N/A	Weather Sunny	Rain Gauge (in) 3.20	
			Rain Accumulation Time (days) 2.00

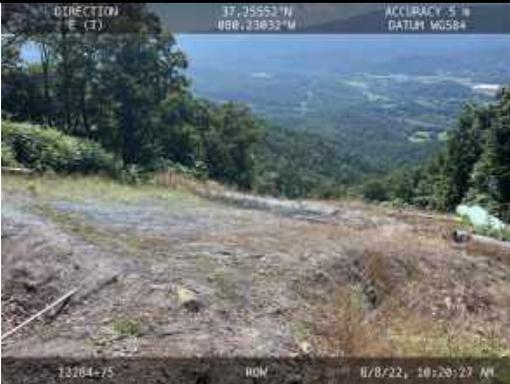
GPS Location	See photo		GPS Location	See photo	
Field Station#	12284+75		Field Station#	12298+00	
Pic 1 Desc.	Current ROW conditions. ROW is stable and ECDs are functional.		Pic 2 Desc.	Current ROW conditions. ROW is stable and ECDs are functional.

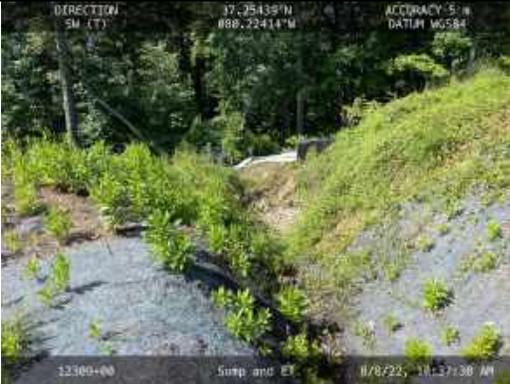
GPS Location	See photo		GPS Location	See photo	
Field Station#	12309+00		Field Station#	12310+00	
Pic 3 Desc.	Sump and End Treatment are functional		Pic 4 Desc.	Current ROW conditions. ROW is stable and ECDs are functional.

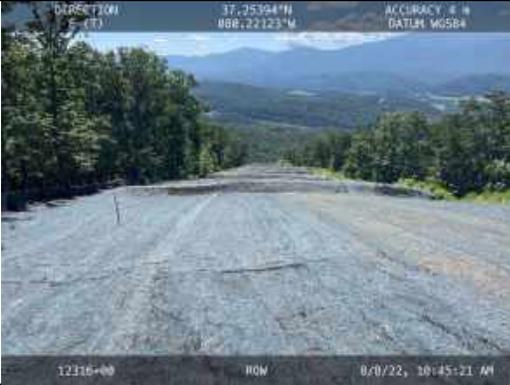
GPS Location	See photo		GPS Location	See photo	
Field Station#	12316+00		Field Station#	12325+00	
Pic 5 Desc.	Current ROW conditions. ROW is stable and ECDs are functional.		Pic 6 Desc.	Waterbars are functional

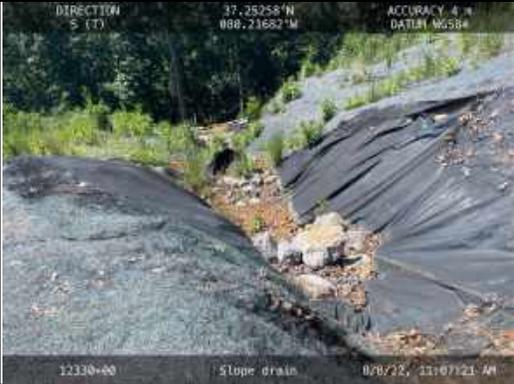
GPS Location	See photo			GPS Location	See photo
Field Station#	12330+00			Field Station#	12336+00
Pic 7 Desc.	Slope drain is functional			Pic 8 Desc.	Current ROW conditions. ROW is stable and ECDs are functional.

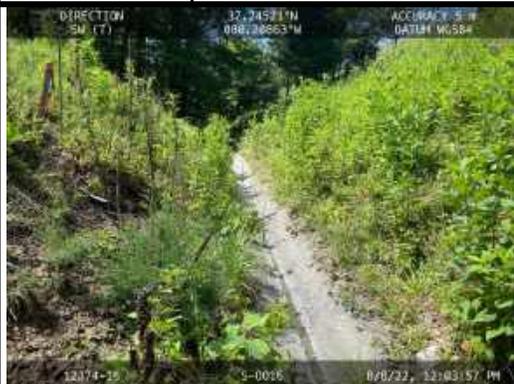
GPS Location	See photo			GPS Location	See photo
Field Station#	12374+16			Field Station#	12380+04
Pic 11 Desc.	Looking downstream at Stream S-0016			Pic 12 Desc.	Upstream of crossing at Stream S-NN19

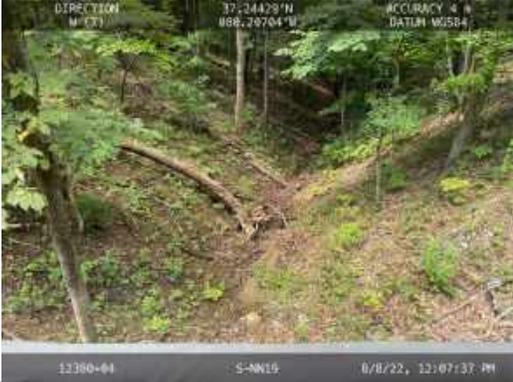
GPS Location	See photo		GPS Location	See photo	
Field Station#	12380+04		Field Station#	12382+00	
Pic 13 Desc.	Downstream of crossing at Stream S-NN19		Pic 14 Desc.	Drainage feature is functional

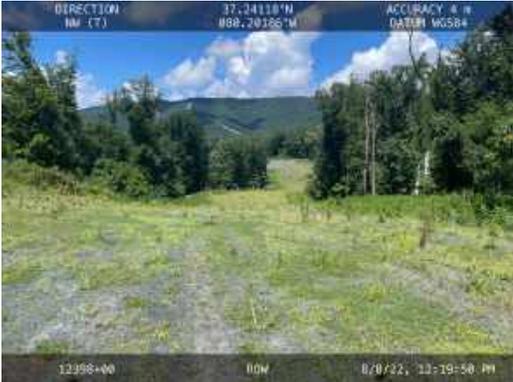
GPS Location	See photo		GPS Location	See photo	
Field Station#	12398+00		Field Station#	12407+00	
Pic 15 Desc.	Current ROW conditions. ROW is stable and ECDs are functional.		Pic 16 Desc.	Current ROW conditions. ROW is stable and ECDs are functional.

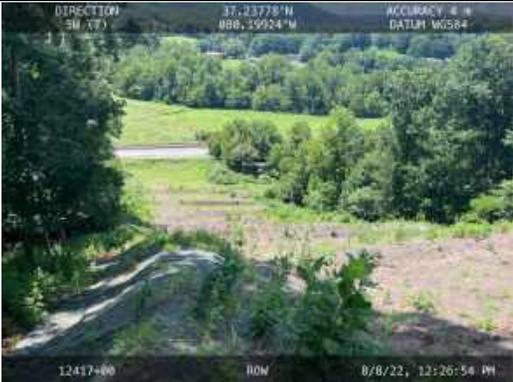
GPS Location	See photo		GPS Location	See photo	
Field Station#	12417+00		Field Station#	12420+00	
Pic 17 Desc.	Current ROW conditions. ROW is stable and ECDs are functional.		Pic 18 Desc.	Current ROW conditions. ROW is stable and ECDs are functional.

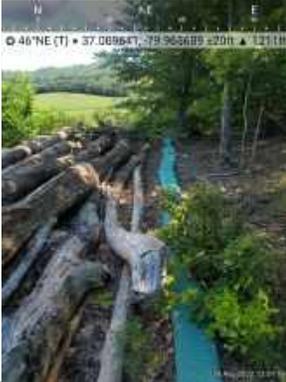
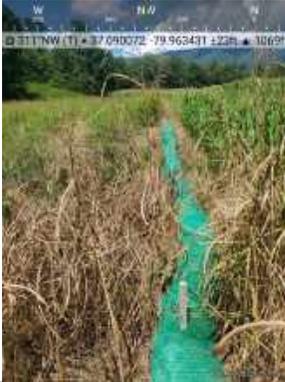
<p>ert image here</p>	
GPS Location 0		GPS Location 0			
Field Station# 13619+00		Field Station# 13635+00			
Pic 7 Desc. Perimeter CFS		Pic 8 Desc. Perimeter CFS

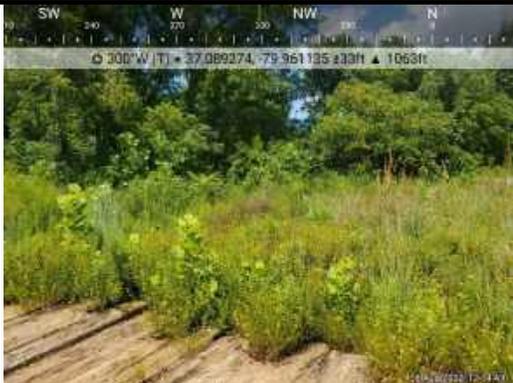
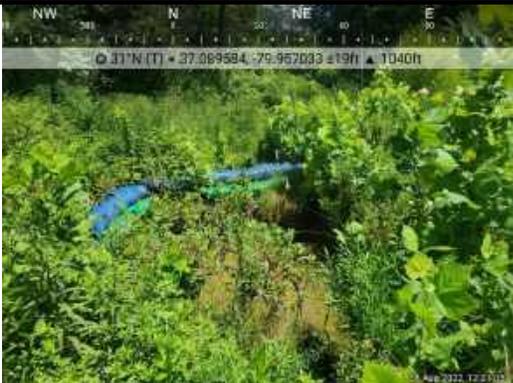
GPS Location 0		GPS Location 0			
Field Station# 13644+00		Field Station# 13655+50			
Pic 9 Desc. GAS S-E28 Vegetation		Pic 10 Desc. Sump

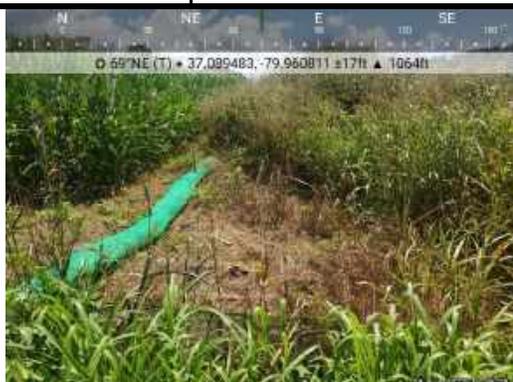
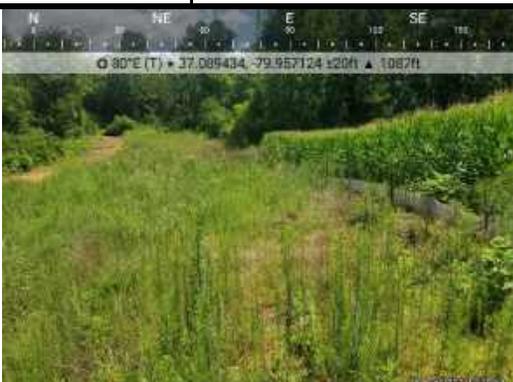
GPS Location 0		GPS Location 0			
Field Station# 13645+00		Field Station# 13656+00			
Pic 11 Desc. GAS Leaning Oak Rd Perimeter ECDs		Pic 12 Desc. CIS S-GH3 Perimeter silt fence

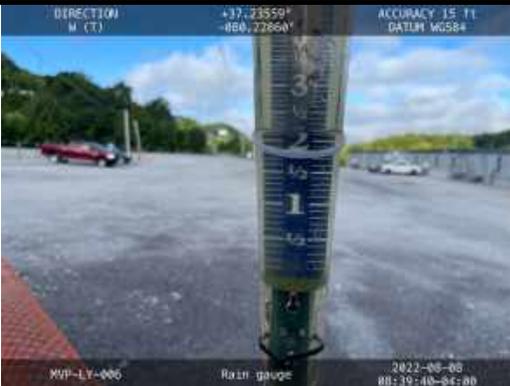
<p>DIRECTION M (T) +37.23559° -880.22668° ACCURACY 15 FT DATUM WGS84 MVP-LY-006 Rain gauge 2022-08-08 08:39:40-04:00</p>

<p>DIRECTION SM (T) +37.23555° -880.22667° ACCURACY 12 FT DATUM WGS84 MVP-LY-006 Yard Conditions 2022-08-08 08:40:57-04:00</p>		GPS Location See photo for gps location data.
	Field Station# +0		Field Station# +0		Pic 1 Desc. Photo shows the rain gauge at LY-006. 2.1" of rainfall was recorded within the last two days.

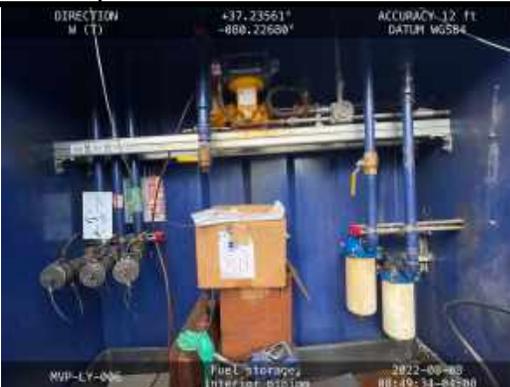
<p>DIRECTION M (T) +37.23561° -880.22658° ACCURACY 12 FT DATUM WGS84 MVP-LY-005 Fuel storage, interior piping 2022-08-08 08:49:34-04:00</p>

<p>DIRECTION SM (T) +37.23561° -880.22693° ACCURACY 12 FT DATUM WGS84 MVP-LY-005 Fuel storage 2022-08-08 08:59:23-04:00</p>		GPS Location See photo for gps location data.
	Field Station# +0		Field Station# +0		Pic 5 Desc. Photo shows the internal piping for the fuel storage tank. No leaks observed.
			Pic 6 Desc. Photo shows the fuel storage and containment. Contains stormwater. No sheen or product was observed.		GPS Location See photo for gps location data.

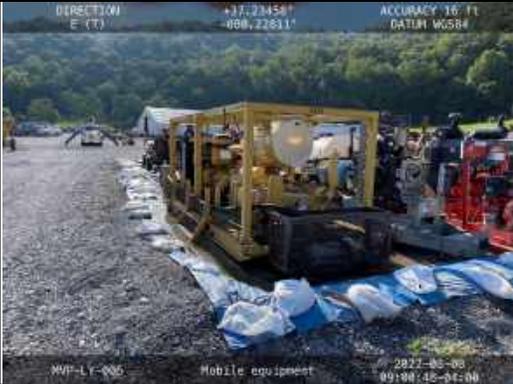
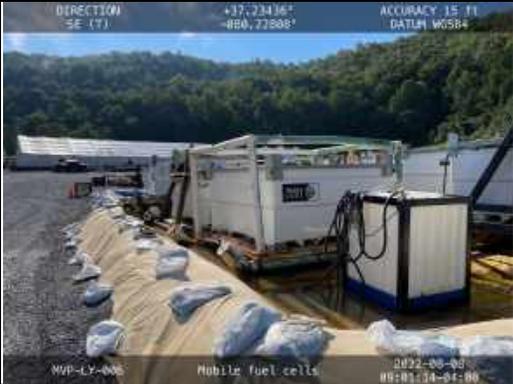
<p>DIRECTION: SE (T) +37.23436° ACCURACY 15 FT -890.22808° DATUM WGS84</p> <p>MVP-LY-006 Mobile fuel cells 2022-08-08 09:01:34-04:00</p>	
GPS Location	See photo for gps location data.		GPS Location	See photo for gps location data.	
Field Station#	+0		Field Station#	+0	
Pic 13 Desc.	Photo shows the mobile equipment and containment. Containment has accumulated stormwater, no sheen or product observed.		Pic 14 Desc.	Photo shows the mobile fuel cell storage and containment. Containment has accumulated stormwater, no sheen or product observed.

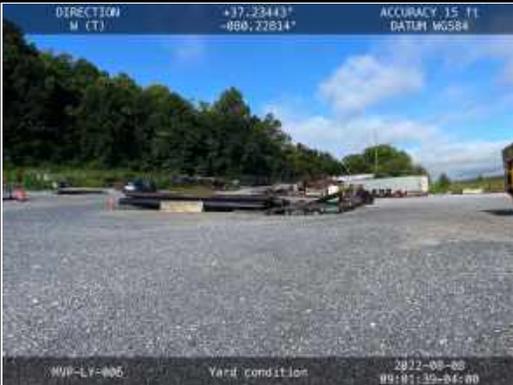
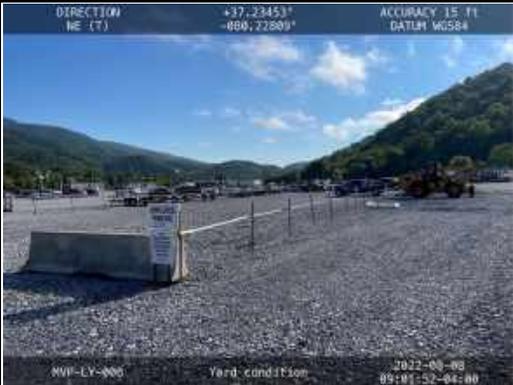
GPS Location	See photo for gps location data.		GPS Location	See photo for gps location data.	
Field Station#	+0		Field Station#	+0	
Pic 15 Desc.	Photo shows the lay down yard conditions. No environmental issues were observed.		Pic 16 Desc.	Photo shows the lay down yard conditions. No environmental issues were observed.

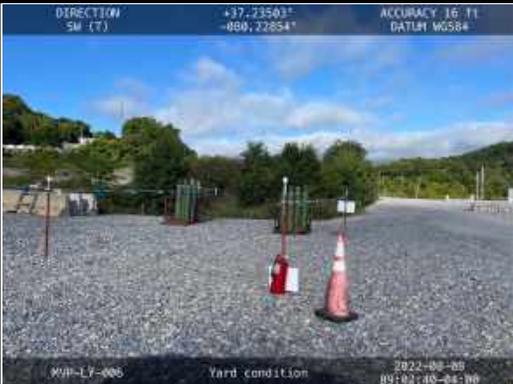
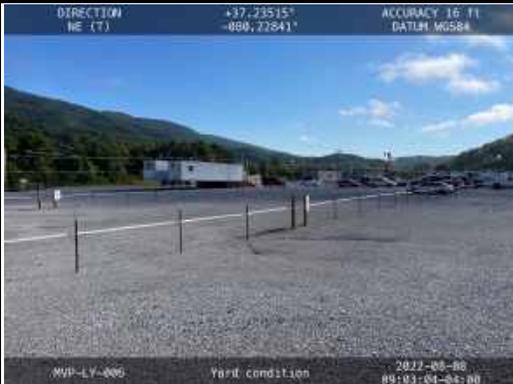
<p>DIRECTION: NE (T) +37.23515° ACCURACY 16 FT -890.22841° DATUM WGS84</p> <p>MVP-LY-006 Yard condition 2022-08-08 09:03:04-04:00</p>	
GPS Location	See photo for gps location data.		GPS Location	See photo for gps location data.	
Field Station#	+0		Field Station#	+0	
Pic 17 Desc.	Photo shows the lay down yard conditions. No environmental issues were observed.		Pic 18 Desc.	Photo shows the lay down yard conditions. No environmental issues were observed.

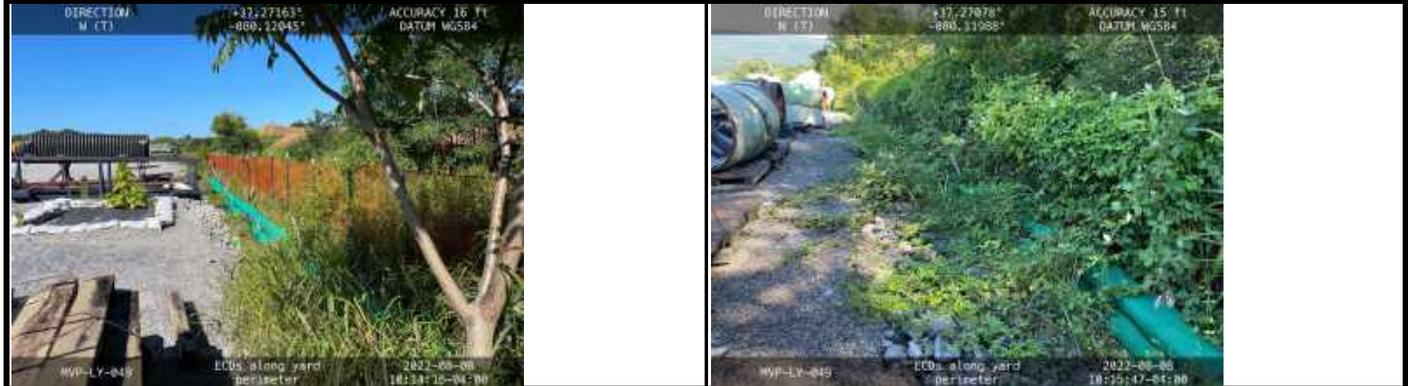
Pic 7 Desc.	Photo shows the ECDs along the yard perimeter. ECDs are installed and functioning as designed.	Pic 8 Desc.	Photo shows the ECDs along the yard perimeter. ECDs are installed and functioning as designed.
--------------------	--	--------------------	--

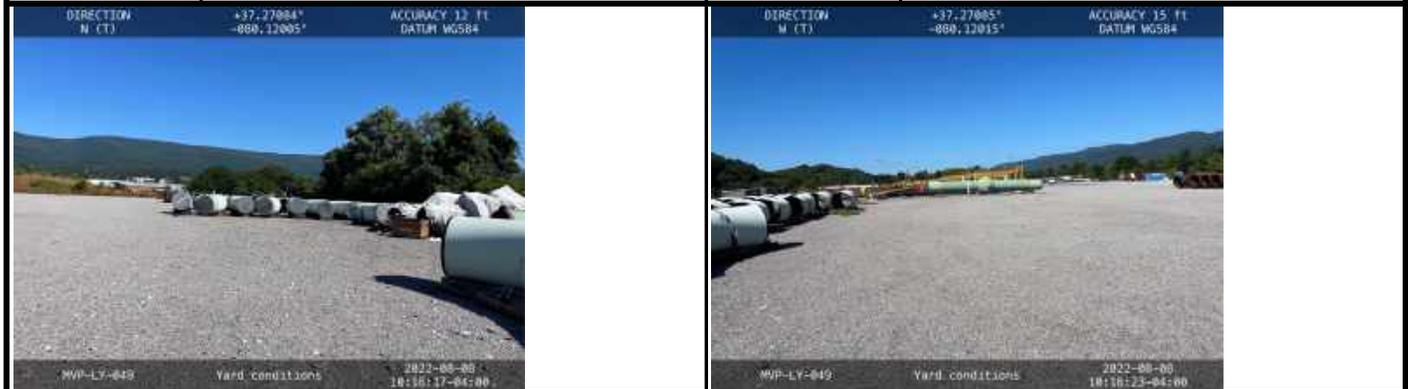
Pic 9 Desc.	Photo shows the lay down yard conditions. No environmental issues were observed.	Pic 10 Desc.	Photo shows the lay down yard conditions. No environmental issues were observed.
--------------------	--	---------------------	--

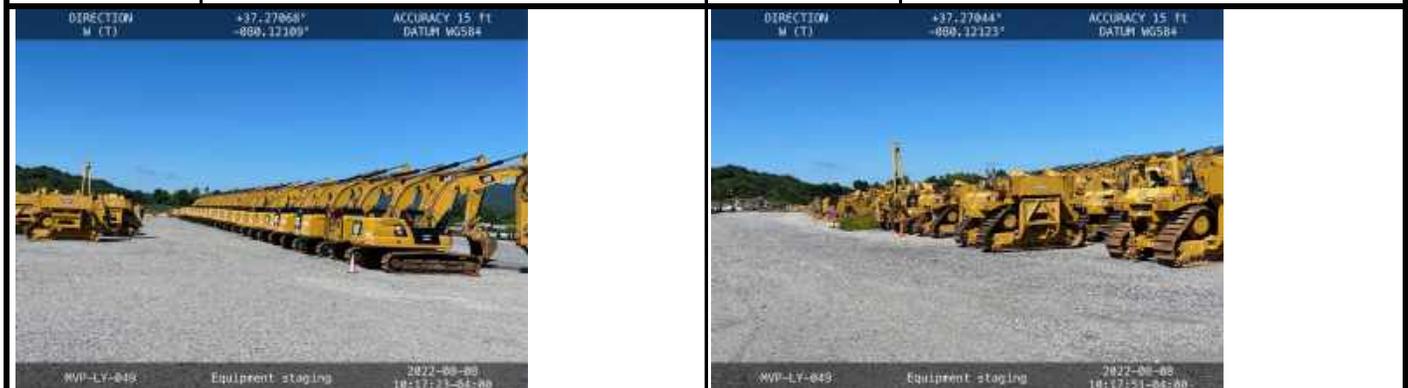
Pic 11 Desc.	Photo shows the equipment storage area. No environmental issues were observed.	Pic 12 Desc.	Photo shows the equipment storage area. No environmental issues were observed.
---------------------	--	---------------------	--

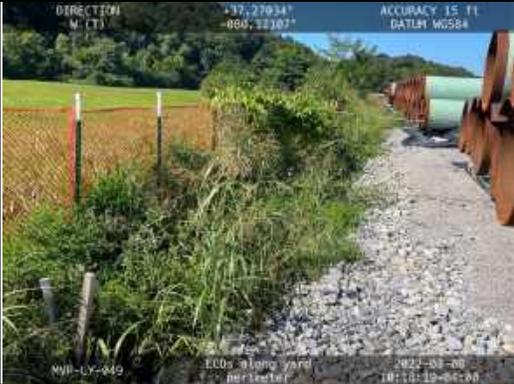
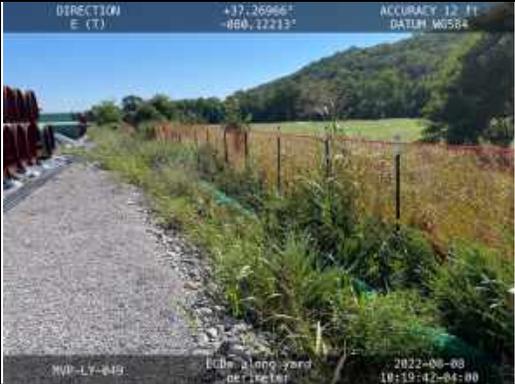
GPS Location	See photo for gps location data.		GPS Location	See photo for gps location data.	
Field Station#	+0		Field Station#	+0	
Pic 13 Desc.	Photo shows the ECDs along the yard perimeter. ECDs are installed and functioning as designed.		Pic 14 Desc.	Photo shows the ECDs along the yard perimeter. ECDs are installed and functioning as designed.

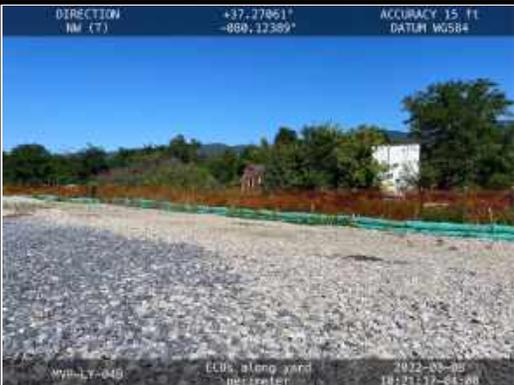
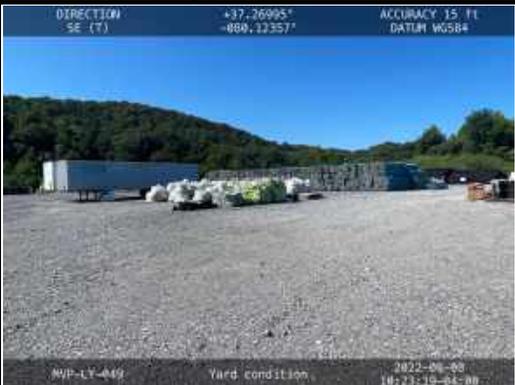
GPS Location	See photo for gps location data.		GPS Location	See photo for gps location data.	
Field Station#	+0		Field Station#	+0	
Pic 15 Desc.	Photo shows the ECDs along the yard perimeter. ECDs are installed and functioning as designed.		Pic 16 Desc.	Photo shows the lay down yard conditions. No environmental issues were observed.

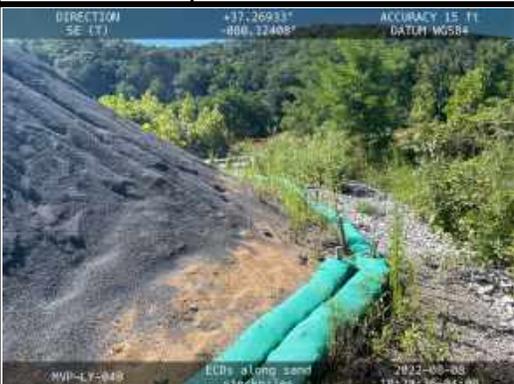
Pic 17 Desc.	Photo shows the ECDs along the sand stockpiles.		Pic 18 Desc.	Photo shows the lay down yard conditions. No environmental issues were observed.

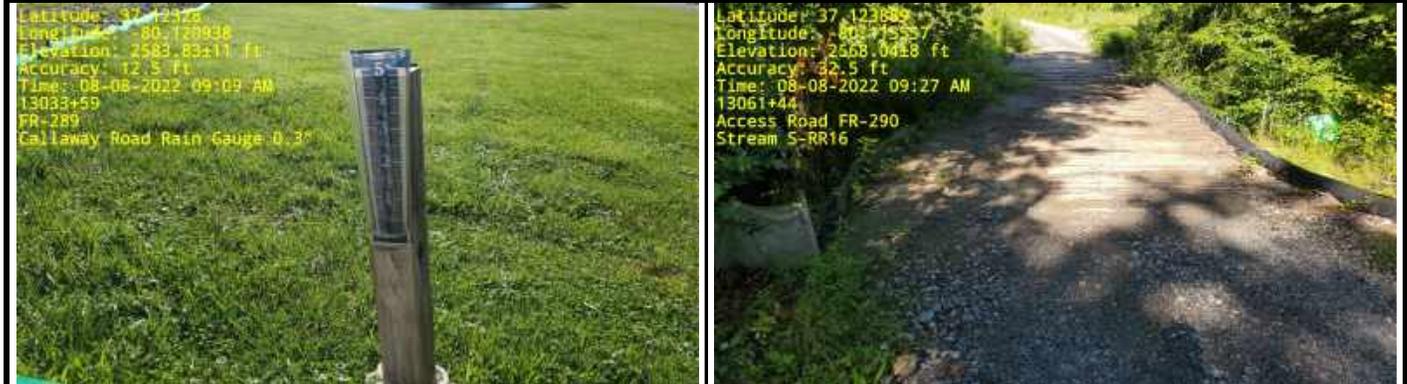
GPS Location	See pic.	GPS Location	See pic.
Field Station#	13033+59	Field Station#	13061+44
Pic 1 Desc.	0.3" total precipitation.	Pic 2 Desc.	Stream crossing S-RR16.

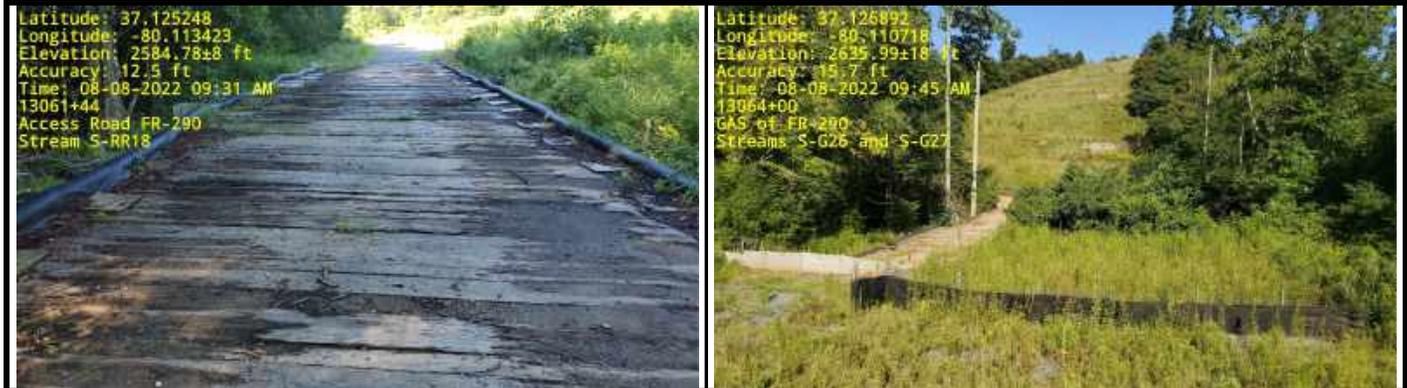
GPS Location	See pic.	GPS Location	See pic.
Field Station#	13061+44	Field Station#	13064+00
Pic 3 Desc.	Stream crossing S-RR18	Pic 4 Desc.	Streams S-G26 and S-G27 from the GAS.

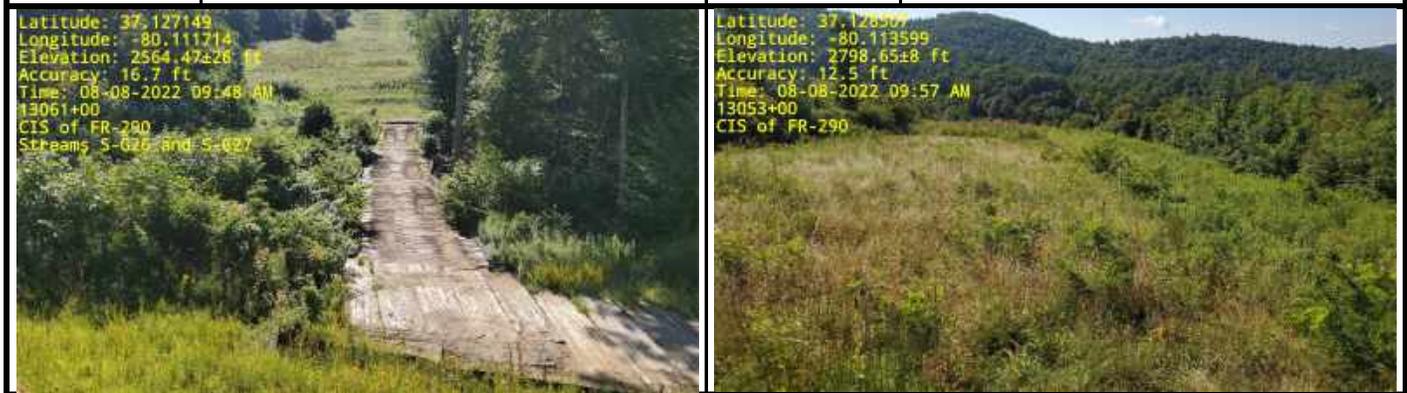
GPS Location	See pic.	GPS Location	See pic.
Field Station#	13061+00	Field Station#	13053+00
Pic 5 Desc.	Streams S-G26 and S-G27 from the CIS.	Pic 6 Desc.	Current ROW conditions.

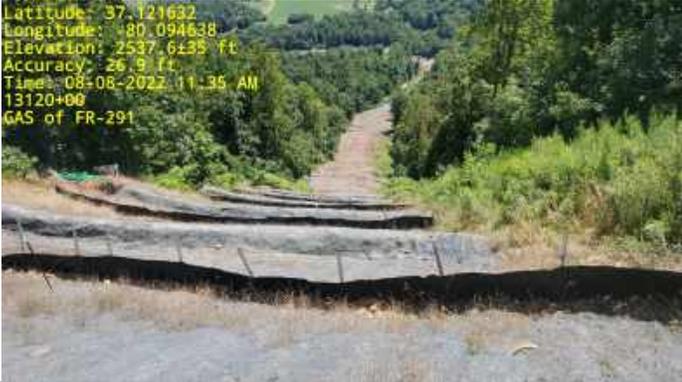
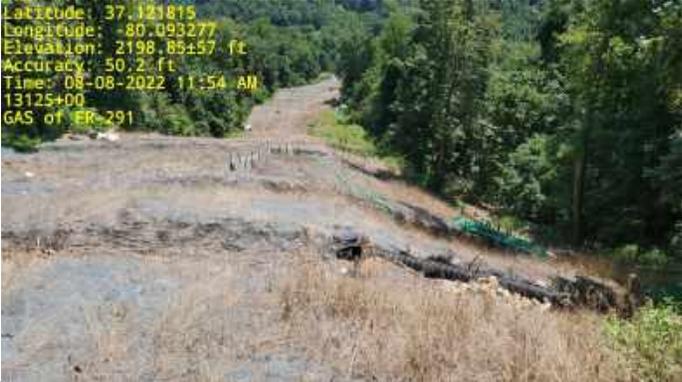
GPS Location		See pic.		GPS Location	
Field Station#		13120+00		Field Station#	
Pic 13 Desc.		Current ROW conditions.		Pic 14 Desc.	
Pic 14 Desc.		Current ROW conditions.			
<p>Latitude: 37.121676 Longitude: -80.090797 Elevation: 1954.2±37 ft Accuracy: 30.2 ft Time: 08-08-2022 12:04 PM 13131+00 CIS of FR-292</p>

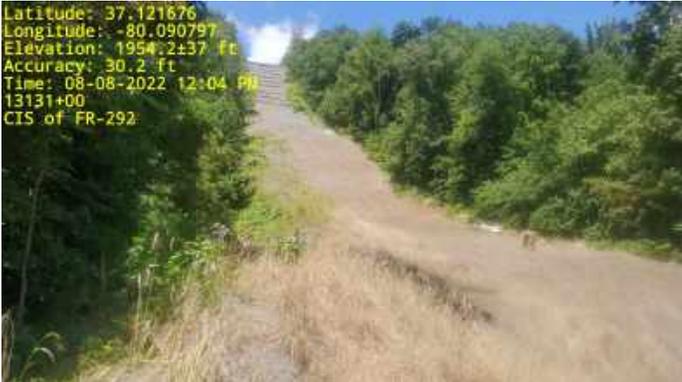
Pic 15 Desc.		Current ROW conditions.		Pic 16 Desc.	
Pic 16 Desc.		Stream crossing S-D17/14 from the CIS.			
<p>Latitude: 37.120822 Longitude: -80.086527 Elevation: 1650.03±19 ft Accuracy: 14.1 ft Time: 08-08-2022 12:17 PM 13141+65 FR-292 Stream S-D17/14</p>

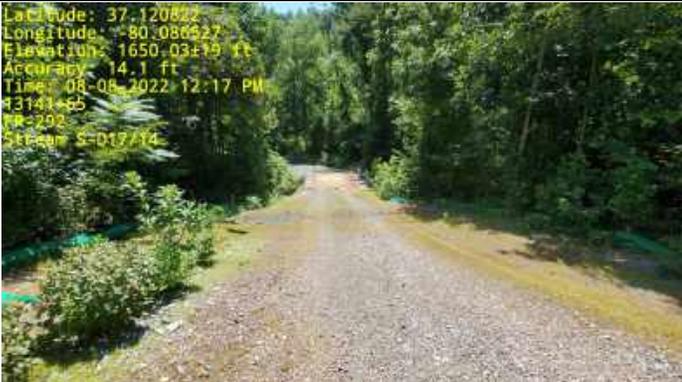
GPS Location		See pic.		GPS Location	
Field Station#		13141+65		Field Station#	
Pic 17 Desc.		Stream crossing S-D17/14 at access road FR-292.		Pic 18 Desc.	
Pic 18 Desc.		Stream crossing S-EF17.

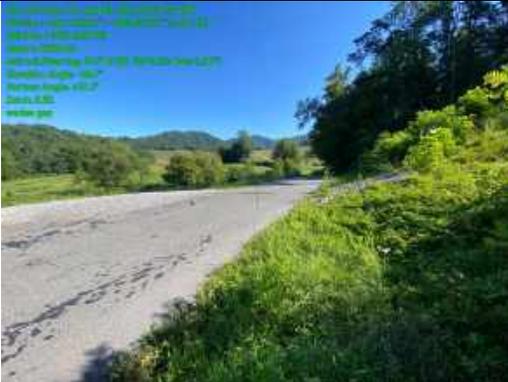
GPS Location 0		GPS Location 0			
Field Station# 13316+21		Field Station# 13317+02			
Pic 1 Desc. Wades Gap Road Crossing in good condition		Pic 2 Desc. Private drive in good condition

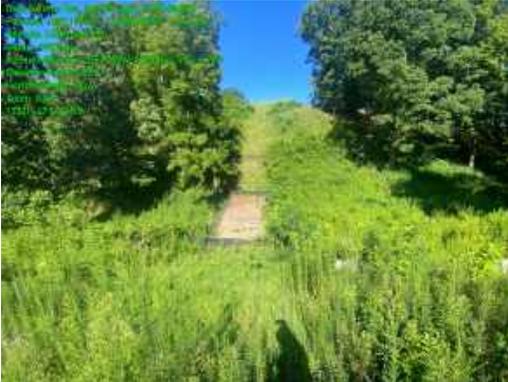
GPS Location 0		GPS Location 0			
Field Station# 13321+47		Field Station# 13323+43			
Pic 3 Desc. MVP-S-GH15 and corresponding buffer zone in good condition		Pic 4 Desc. ROW and ECDs in good condition and stable

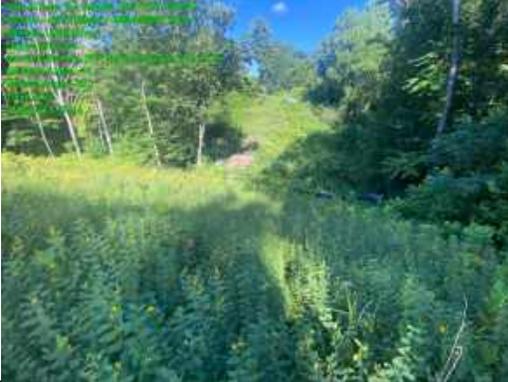
GPS Location 0		GPS Location 0			
Field Station# 13323+43		Field Station# 13331+00			
Pic 5 Desc. MVP-S-GH14 and corresponding buffer zone in good condition		Pic 6 Desc. ROW and ECDs in good condition and stable

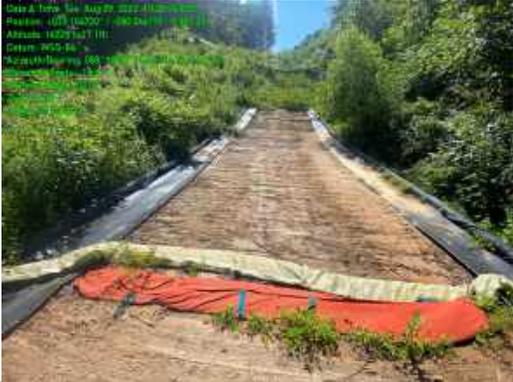
GPS Location	0	GPS Location	0		
Field Station#	13334+17	Field Station#	13337+13		
Pic 7 Desc.	MVP-S-GH11 and corresponding buffer zone in good condition	Pic 8 Desc.	MVP-S-GH9 Downstream and corresponding buffer zone in good condition

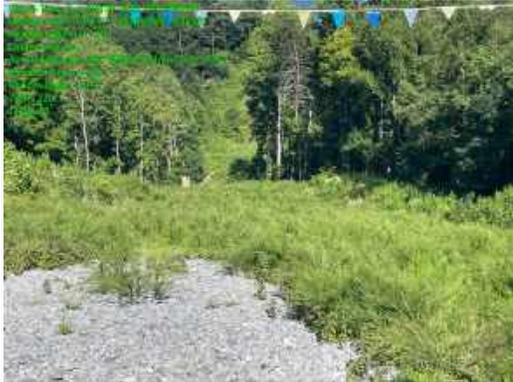
GPS Location	0	GPS Location	0		
Field Station#	13342+00	Field Station#	13342+67		
Pic 9 Desc.	ROW and ECDs In good condition and stable	Pic 10 Desc.	Websters Corner Road Crossing in good condition

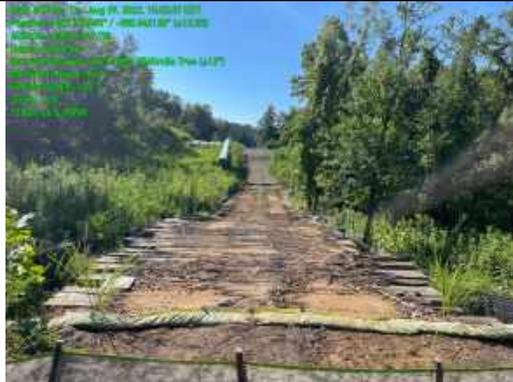
GPS Location	0	GPS Location	0		
Field Station#	13348+46	Field Station#	13352+23		
Pic 11 Desc.	MVP-S-RR08 and corresponding buffer zone in good condition	Pic 12 Desc.	MVP-S-RR09 and corresponding buffer zone in good condition

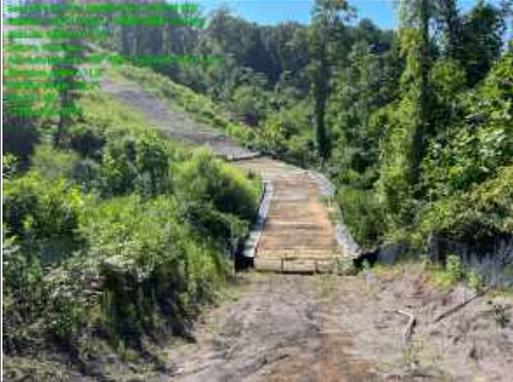
GPS Location	0		GPS Location	0	
Field Station#	13358+64		Field Station#	13365+30	
Pic 13 Desc.	MVP-S-RR11 and corresponding buffer zone in good condition		Pic 14 Desc.	ROW and ECDs In good condition and stable

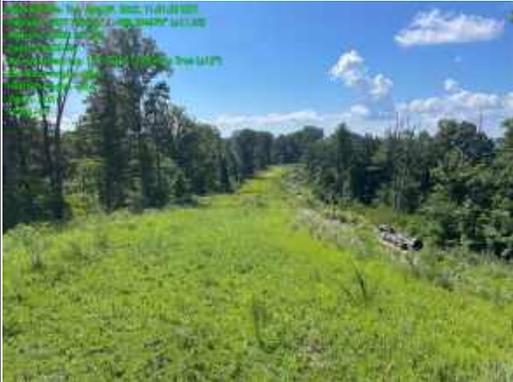
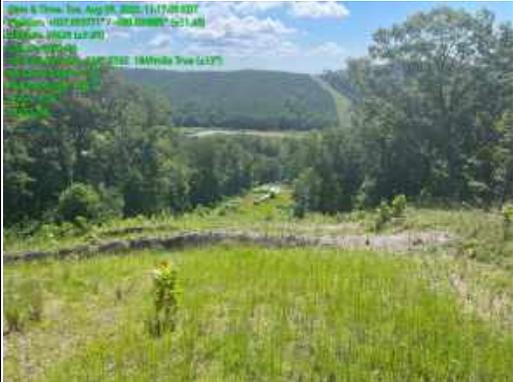
GPS Location	0		GPS Location	0	
Field Station#	13376+00		Field Station#	13403+00	
Pic 15 Desc.	ROW and ECDs In good condition and stable		Pic 16 Desc.	ROW and ECDs In good condition and stable

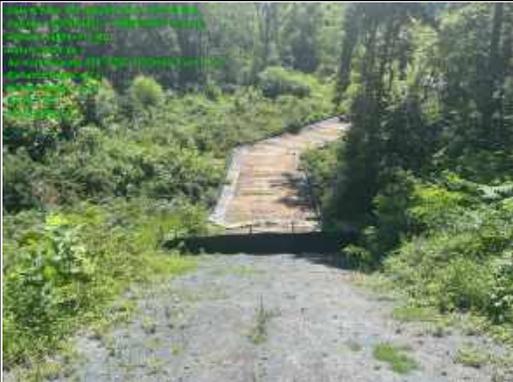
GPS Location	0		GPS Location	0	
Field Station#	13413+05		Field Station#	13415+51	
Pic 17 Desc.	MVP-S-IJ1 and corresponding buffer zone in good condition		Pic 18 Desc.	Cahas Mountain Road Crossing in good condition

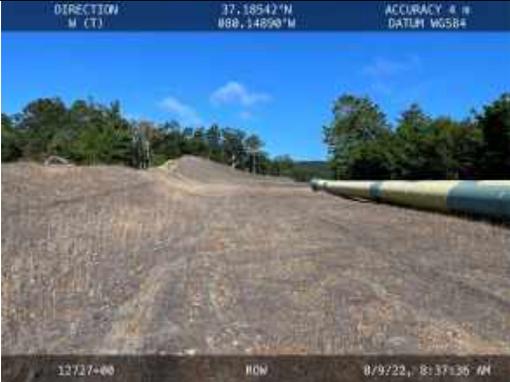
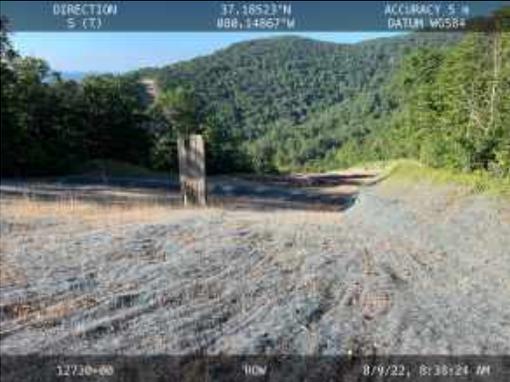
GPS Location See photo		GPS Location See photo			
Field Station# 12727+00		Field Station# 12730+00			
Pic 1 Desc. Current ROW conditions. ROW is stable and ECDs are functional		Pic 2 Desc. Current ROW conditions. ROW is stable and ECDs are functional

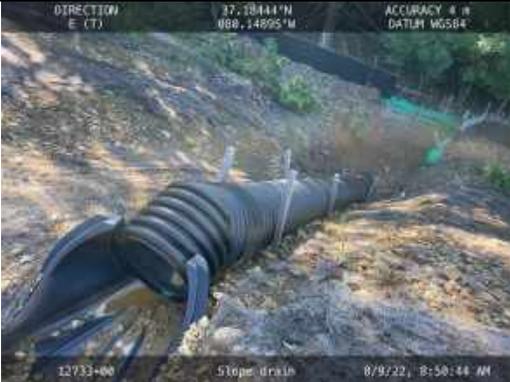
GPS Location See photo		GPS Location See photo			
Field Station# 12733+00		Field Station# 12735+00			
Pic 3 Desc. Slope drain is functional		Pic 4 Desc. Current ROW conditions. ROW is stable and ECDs are functional

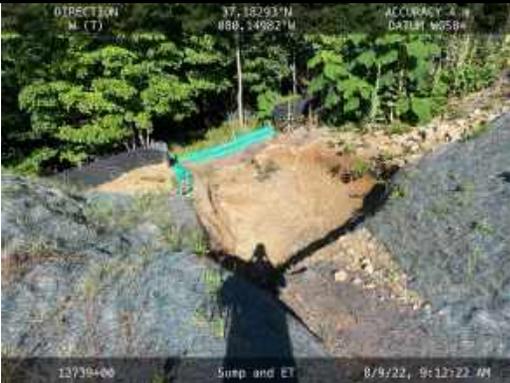
GPS Location See photo		GPS Location See photo			
Field Station# 12739+00		Field Station# 12742+00			
Pic 5 Desc. Sump and End Treatment are functional		Pic 6 Desc. Current ROW conditions. ROW is stable and ECDs are functional

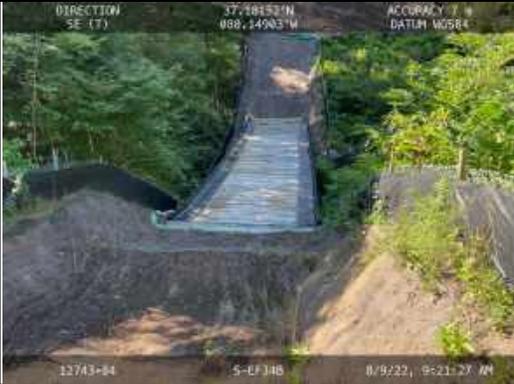
GPS Location	See photo	GPS Location	See photo
Field Station#	12743+84	Field Station#	12743+84
Pic 7 Desc.	Overview of Stream S-EF34B	Pic 8 Desc.	Downstream of crossing at Stream S-EF34B

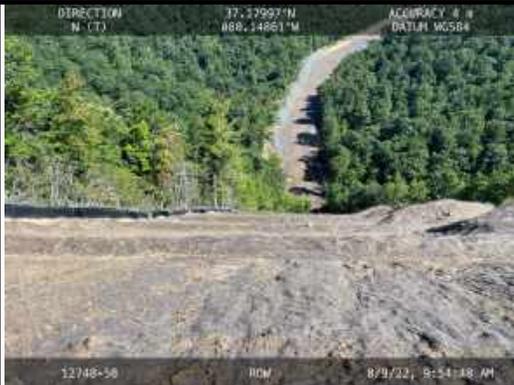
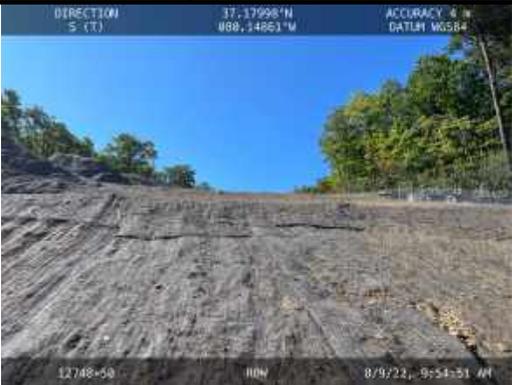
GPS Location	See photo	GPS Location	See photo
Field Station#	12748+50	Field Station#	12748+50
Pic 9 Desc.	Current ROW conditions. ROW is stable and ECDs are functional	Pic 10 Desc.	Current ROW conditions. ROW is stable and ECDs are functional

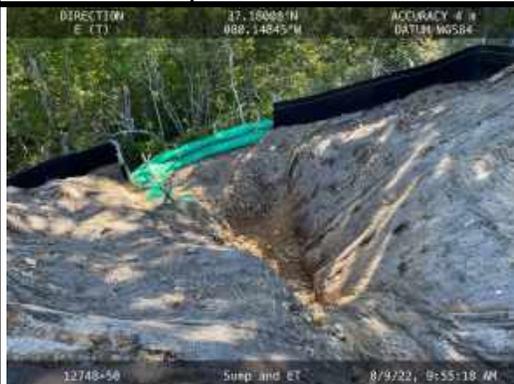
GPS Location	See photo	GPS Location	See photo
Field Station#	12748+50	Field Station#	12755+00
Pic 11 Desc.	Sump and End Treatment are functional	Pic 12 Desc.	Current ROW conditions. ROW is stable and ECDs are functional

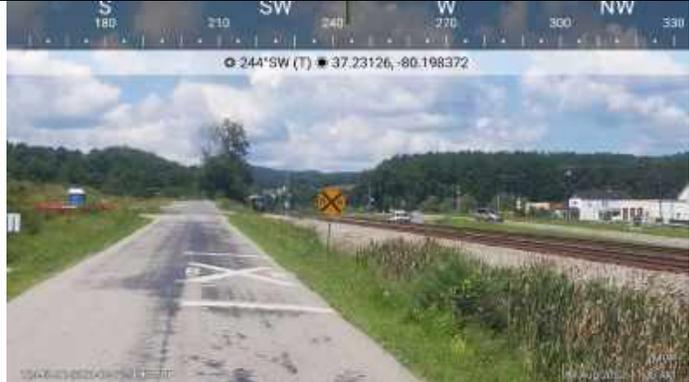
GPS Location	See Above	GPS Location	See Above
Field Station#	12445+01	Field Station#	12455+21
Pic 1 Desc.	Overview of Waterbody S-I1. ROW is stable. ROW is stable. No erosion or sedimentation concerns noted.	Pic 2 Desc.	Overview of Waterbody S-CD12b. ECDs are functional and ROW is stable.

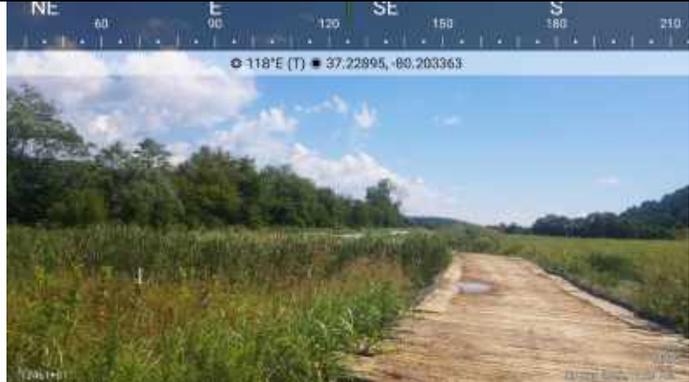
GPS Location	See Above	GPS Location	See Above
Field Station#	12461+81	Field Station#	12481+00
Pic 3 Desc.	Overview of Wetland W-KL58. ECDs are functional and ROW is stable.	Pic 4 Desc.	(reroute stationing) ROW Overview (temporary stabilization). ECDs are functional and ROW is stable.

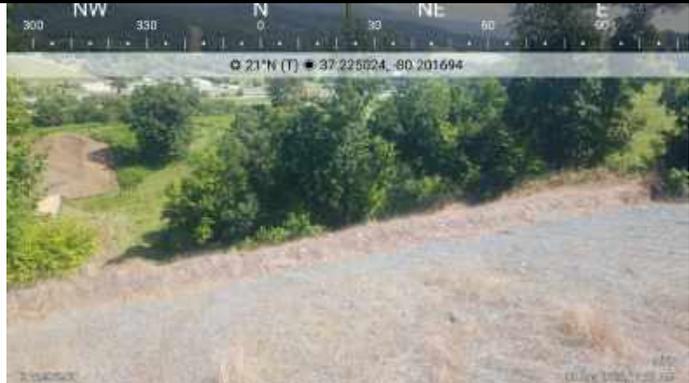
GPS Location	See Above	GPS Location	See Above
Field Station#	12485+00	Field Station#	12486+00
Pic 5 Desc.	(reroute stationing) ROW Overview (temporary stabilization). ECDs are functional and ROW is stable.	Pic 6 Desc.	ROW Overview (temporary stabilization). ECDs are functional and ROW is stable.

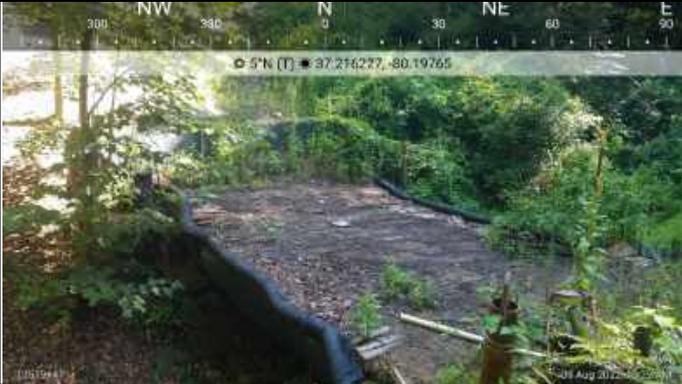
GPS Location		See Above		GPS Location	
Field Station#		12519+41		Field Station#	
Pic 13 Desc.		Overview of Waterbody S-EF19. ECDs are functional and ROW is stable.		Pic 14 Desc.	
				ROW Overview (temporary stabilization). ECDs are functional and ROW is stable.

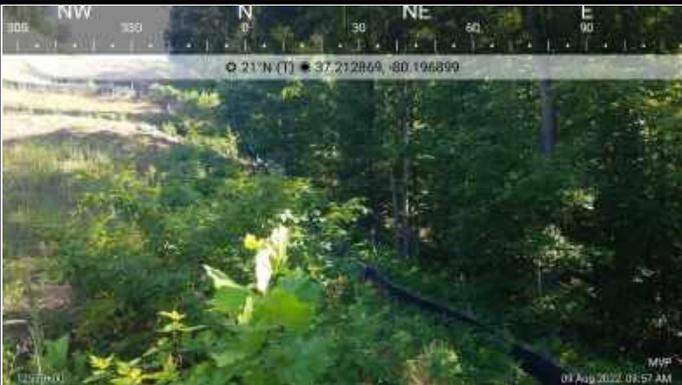
GPS Location		See Above		GPS Location	
Field Station#		12530+00		Field Station#	
Pic 15 Desc.		ROW Overview (temporary stabilization). ECDs are functional and ROW is stable.		Pic 16 Desc.	
				ROW Overview (temporary stabilization). ECDs are functional and ROW is stable.

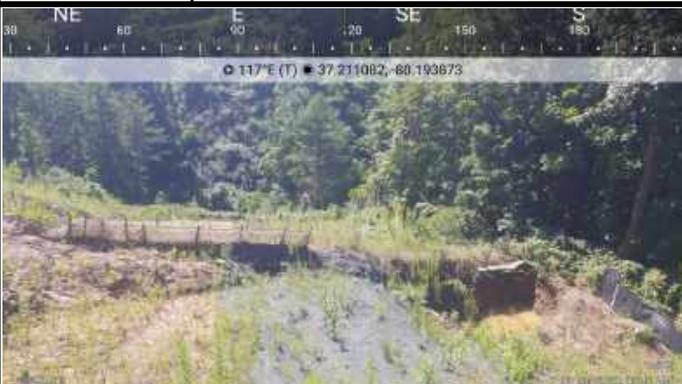
GPS Location		See Above		GPS Location	
Field Station#		12542+00		Field Station#	
Pic 17 Desc.		ROW Overview (temporary stabilization). ECDs are functional and ROW is stable.		Pic 18 Desc.	
				ECDs are functional and Access road MN-278.01 (Yellow Finch Lane) area is stable.

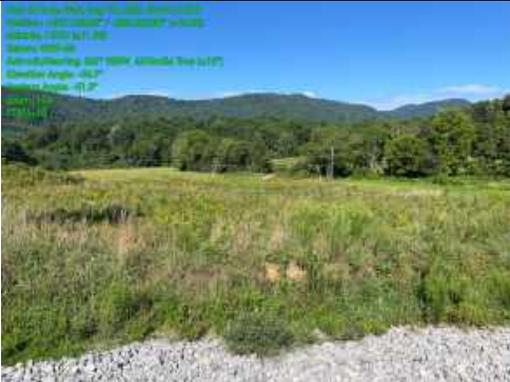
GPS Location 0		GPS Location 0			
Field Station# 13314+00		Field Station# 13309+09			
Pic 1 Desc. ROW and ECDs In good condition and stable		Pic 2 Desc. MVP-S-GH7 and corresponding buffer zone in good condition

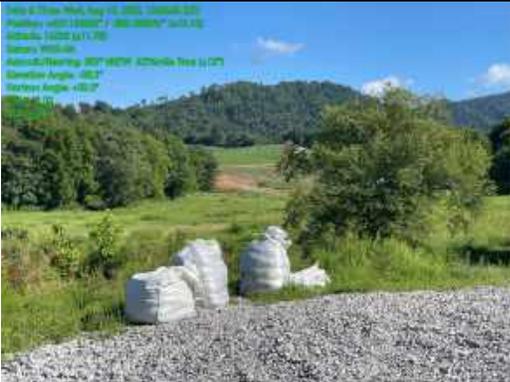
GPS Location 0		GPS Location 0			
Field Station# 13314+00		Field Station# 13309+09			
Pic 3 Desc. Neighboring property has active construction, continuing to monitor for impacts onto row		Pic 4 Desc. Upstream of MVP-S-GH7 monitoring for impacts from adjacent construction activity. Stream in good condition, no current impacts

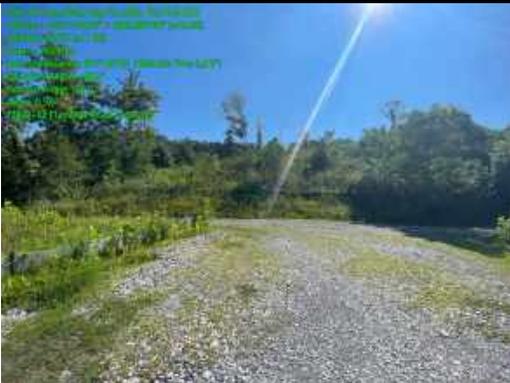
GPS Location 0		GPS Location 0			
Field Station# 13262+62		Field Station# 13260+66			
Pic 5 Desc. Flanders Road Crossing in good condition		Pic 6 Desc. MVP-S-GH7 and corresponding buffer zone in good condition

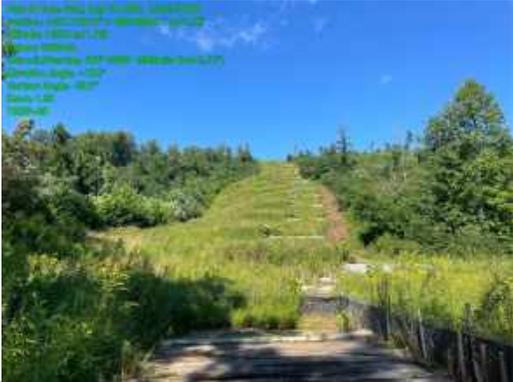
GPS Location	0	GPS Location	0		
Field Station#	13259+00	Field Station#	13196+00		
Pic 7 Desc.	ROW and ECDs In good condition and stable	Pic 8 Desc.	ROW and ECDs In good condition and stable

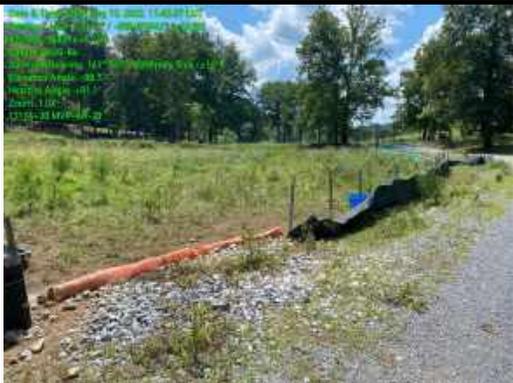
GPS Location	0	GPS Location	0		
Field Station#	13196+31	Field Station#	13175+00		
Pic 9 Desc.	Repair SSF from cattle damage - 72hr maintenance item	Pic 10 Desc.	ROW and ECDs In good condition and stable

2 - 72hr maintenance items were observed and noted. Repair Super Silt Fence from cattle damage along access road 292.01. Repair rills, seed and mulch denuded area on row from station 13163+00 to 13166+00.

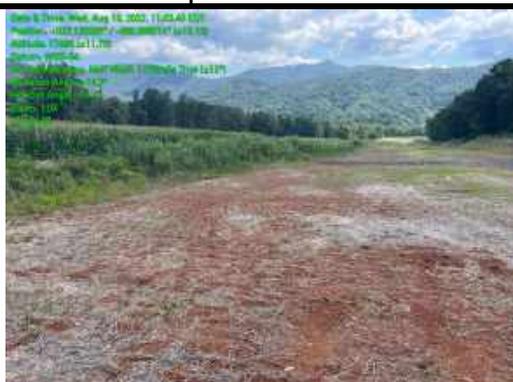
GPS Location	0	GPS Location	0		
Field Station#	13163+00	Field Station#	13162+50		
Pic 11 Desc.	Repair rills, seed and mulch on denuded area. 72hr maintenance item	Pic 12 Desc.	ROW and ECDs In good condition and stable

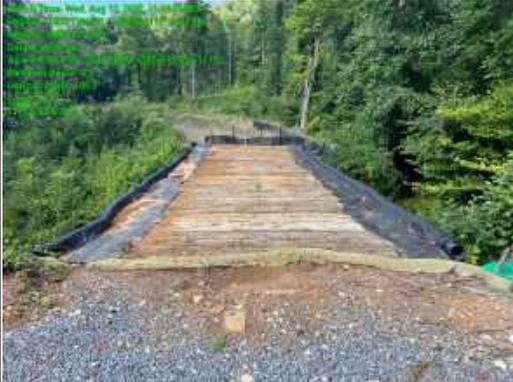
GPS Location	0	GPS Location	0		
Field Station#	13157+22	Field Station#	13154+00		
Pic 13 Desc.	MVP-S-D11 and corresponding buffer zone in good condition	Pic 14 Desc.	Slope drain pipe in good condition

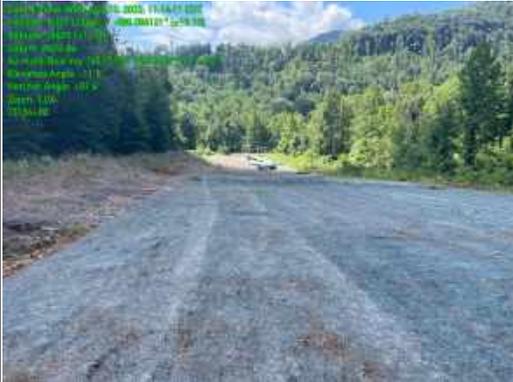
GPS Location	0	GPS Location	0		
Field Station#	13154+00	Field Station#	13146+56		
Pic 15 Desc.	ROW and ECDs In good condition and stable	Pic 16 Desc.	MVP-S-D12/13 and corresponding buffer zone in good condition

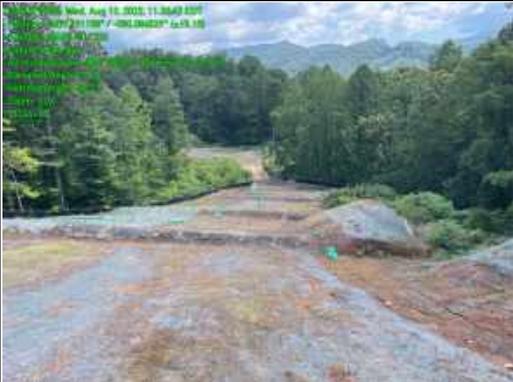
GPS Location	0	GPS Location	0		
Field Station#	13144+00	Field Station#	13141+53		
Pic 17 Desc.	ROW and ECDs In good condition and stable	Pic 18 Desc.	MVP-S-D14 and corresponding buffer zone in good condition

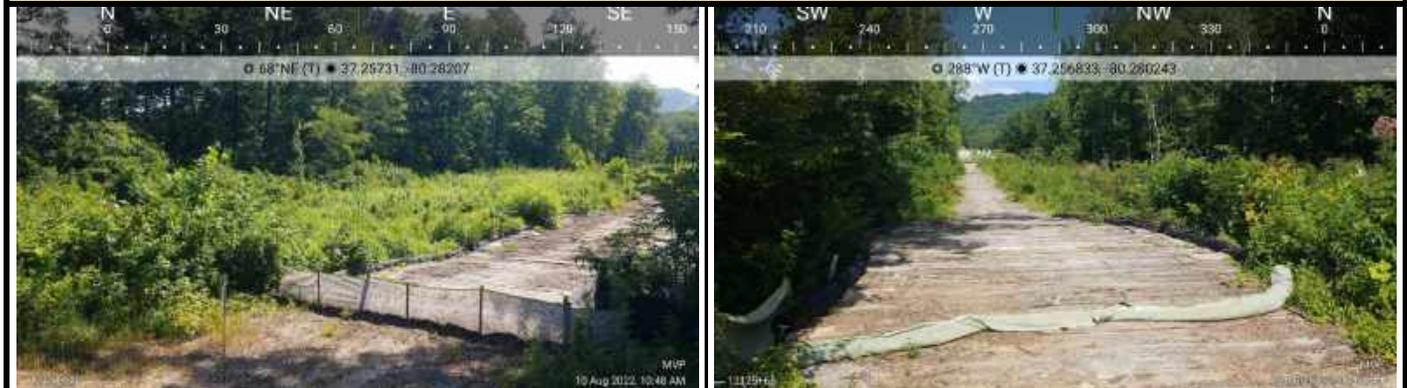
Field Station# 12121+29	Field Station# 12125+65
--------------------------------	--------------------------------

Pic 1 Desc. Overview of Wetland W-C12. ECDs functional and in good condition.	Pic 2 Desc. Overview of Waterbody S-MM31. ECDs functional and in good condition.
--	---

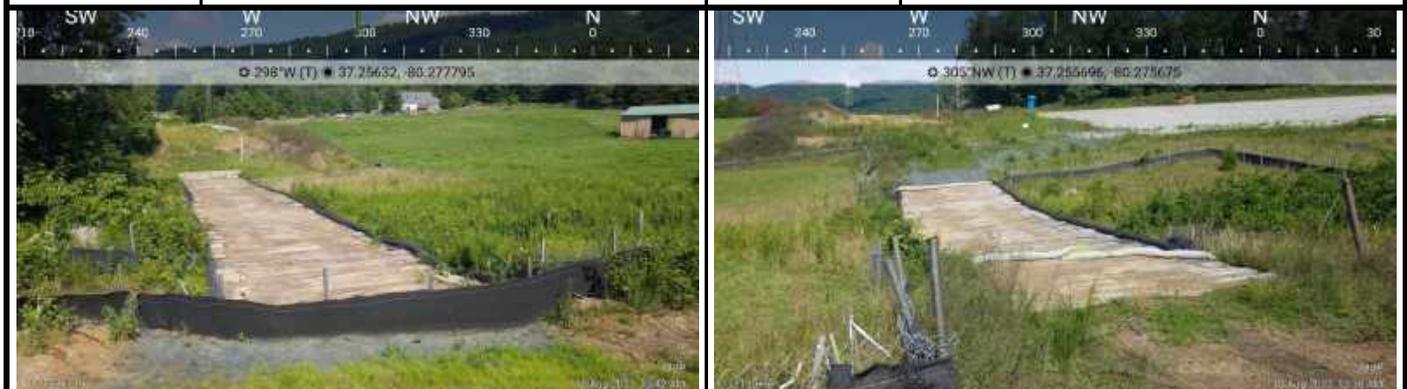
Field Station# 12132+73	Field Station# 12139+91
--------------------------------	--------------------------------

Pic 3 Desc. Overview of Waterbody S-C29. ECDs functional and in good condition.	Pic 4 Desc. Overview of Wetland W-C6. ECDs functional and in good condition.
--	---

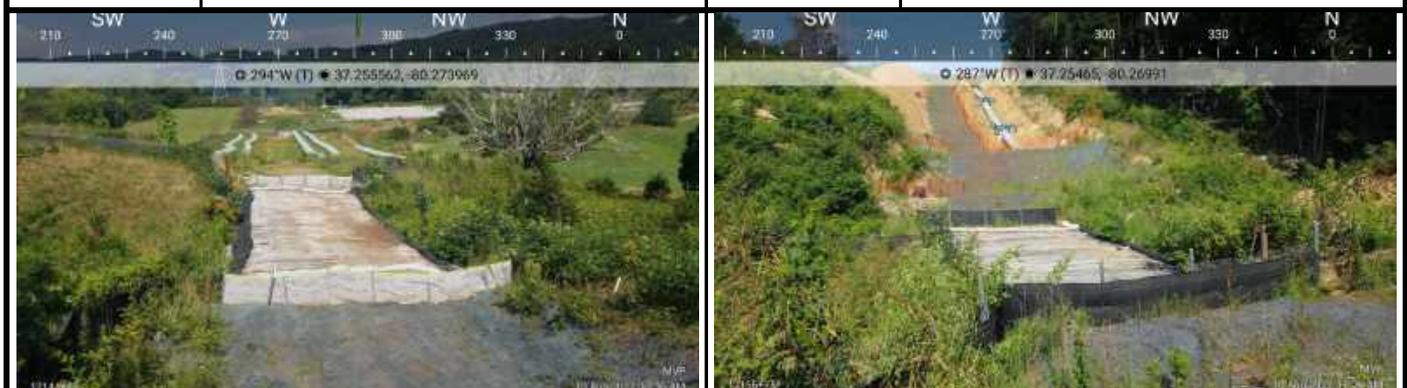
Field Station# 12144+47	Field Station# 12156+75
--------------------------------	--------------------------------

Pic 5 Desc. Overview of Wetland W-C5. ECDs functional and in good condition.	Pic 6 Desc. ROW Overview. ECDs functional and in good condition and ROW is stable.
---	---

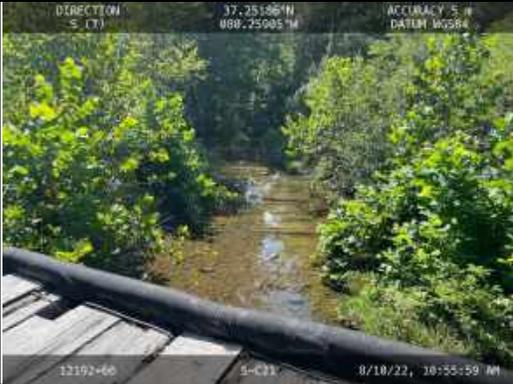
GPS Location	See Above	GPS Location	See Above		
Field Station#	12192+66	Field Station#	12209+00		
Pic 13 Desc.	Overview of Waterbody S-C21. ECDs functional and in good condition.	Pic 14 Desc.	ROW Overview. ECDs functional and in good condition and ROW is stable.
