Visual Site Inspection Report

Project Name H-600 Pipeline Spread H		AFE 124300138	Spread H-600 Pipeline Spread H
Contractor Precision		Report # 40745	
Inspector Jonathan Altizer		Date/Time 8/8/2022 3:16 PM	
Permit # TBD	Inspection Type VA SWPP	Station Begin 12284+75	
State VA	Inspection Area Partial	Station End 12443+75	
County Montgomery	Ground Wet	Temperature (°F) 90.00	
Municipality N/A	Weather Sunny	Rain Gauge (in) 3.20	
			Rain Accumulation Time (days) 2.00

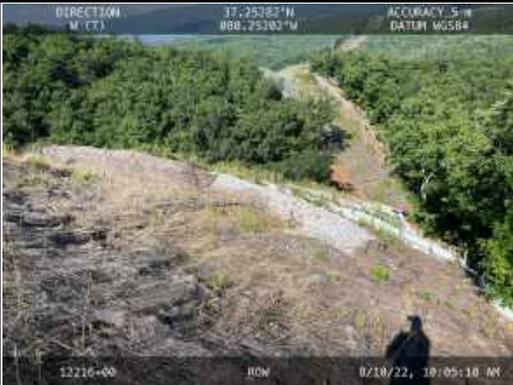
GPS Location	See Above	GPS Location	See Above		
Field Station#	12216+00	Field Station#	12225+00		
Pic 15 Desc.	ROW Overview. ECDs functional and in good condition and ROW is stable.	Pic 16 Desc.	ROW Overview. ECDs functional and in good condition and ROW is stable.

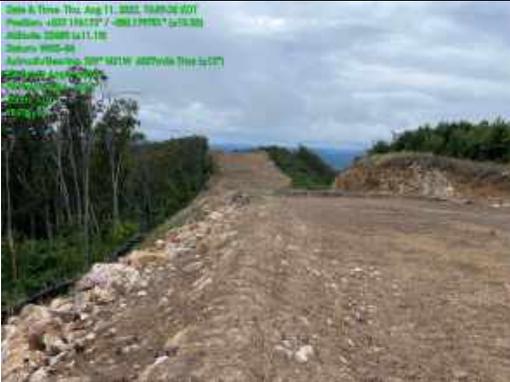
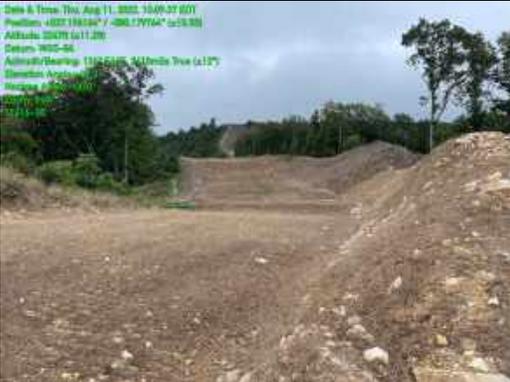
GPS Location 0		GPS Location 0			
Field Station# 12616+00		Field Station# 12616+00			
Pic 1 Desc. Photo shows the ROW condition. ECDs are installed and functioning as designed.		Pic 2 Desc. Photo shows the ROW condition. ECDs are installed and functioning as designed.

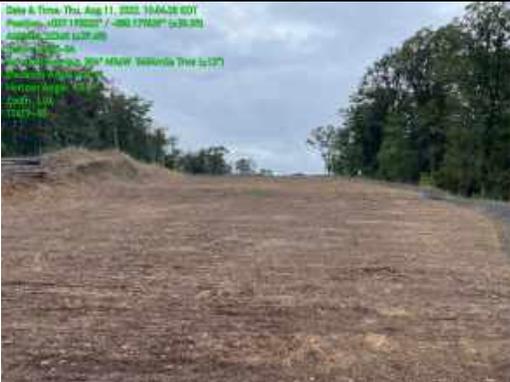
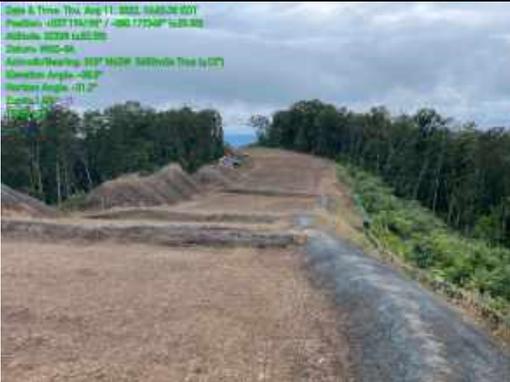
GPS Location 0		GPS Location 0			
Field Station# 12619+00		Field Station# 12626+00			
Pic 3 Desc. Photo shows the ROW condition. ECDs are installed and functioning as designed.		Pic 4 Desc. Photo shows the ROW condition. ECDs are installed and functioning as designed.

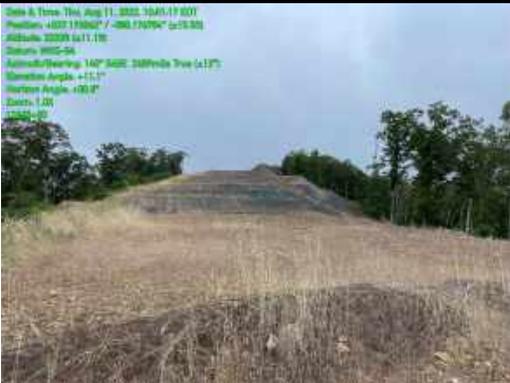
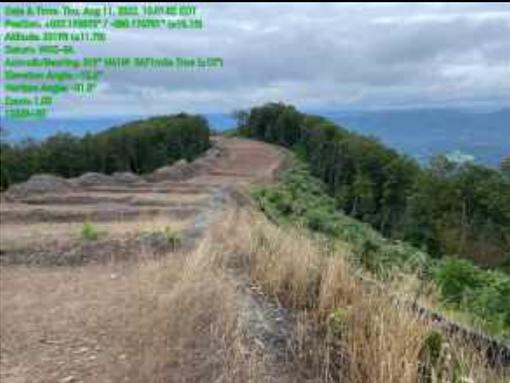
GPS Location 0		GPS Location 0			
Field Station# 12628+00		Field Station# 12628+00			
Pic 5 Desc. Photo shows the ROW condition. ECDs are installed and functioning as designed.		Pic 6 Desc. Photo shows the ROW condition. ECDs are installed and functioning as designed.

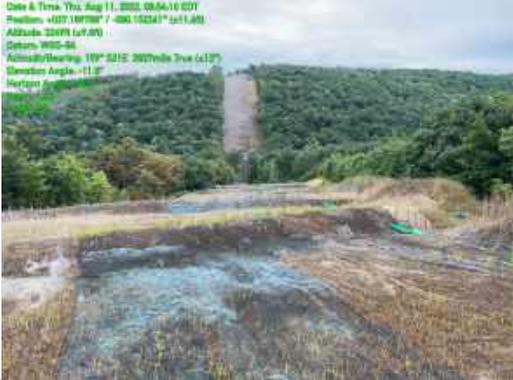
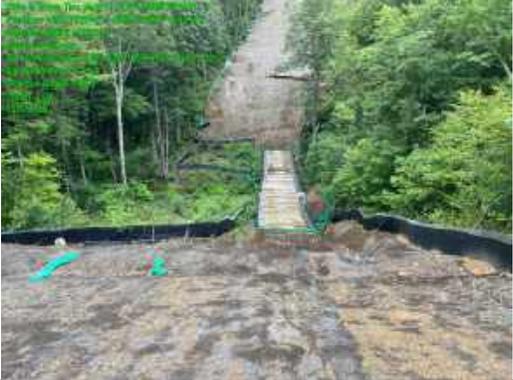
GPS Location 0		GPS Location 0			
Field Station# 12709+00		Field Station# 12715+00			
Pic 13 Desc. Photo shows the ROW condition. ECDs are installed and functioning as designed.		Pic 14 Desc. Photo shows the bridge over streams S-Y13 and S-Y14.

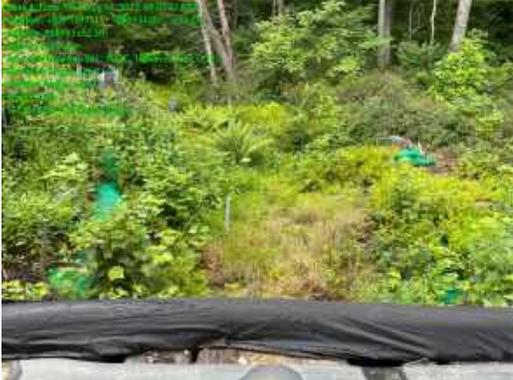
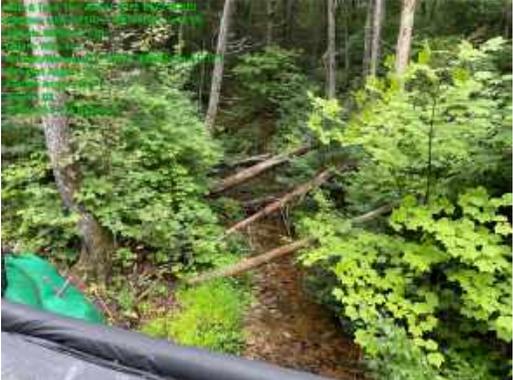
GPS Location 0		GPS Location 0			
Field Station# 12715+80		Field Station# 12716+20			
Pic 15 Desc. Photo shows stream S-Y13 downstream from the bridge		Pic 16 Desc. Photo shows stream S-Y14 upstream from the bridge

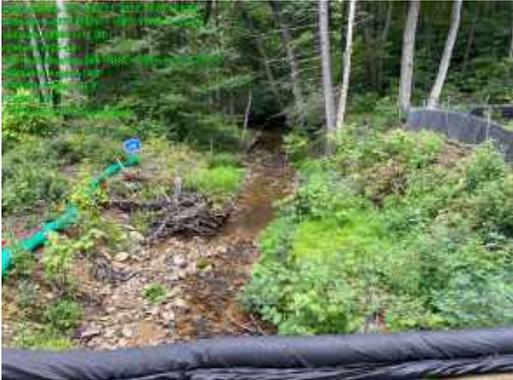
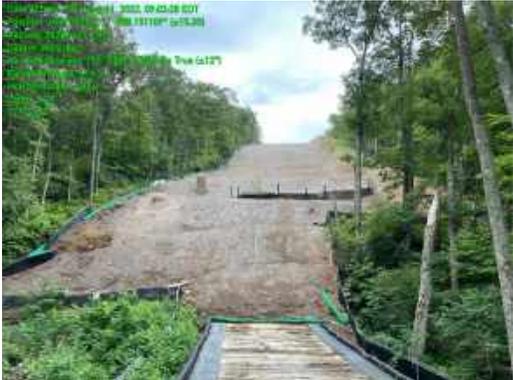
GPS Location 0		GPS Location 0			
Field Station# 12716+20		Field Station# 12716+50			
Pic 17 Desc. Photo shows stream S-Y14 downstream from the bridge		Pic 18 Desc. Photo shows the ROW condition. ECDs are installed and functioning as designed.

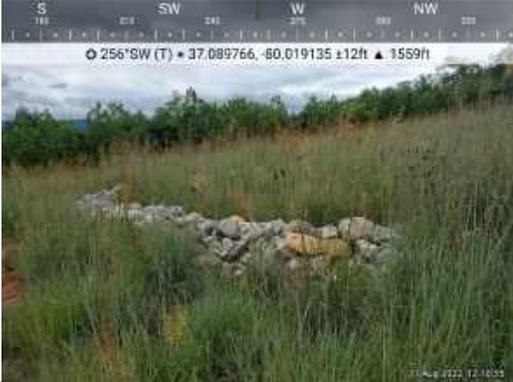
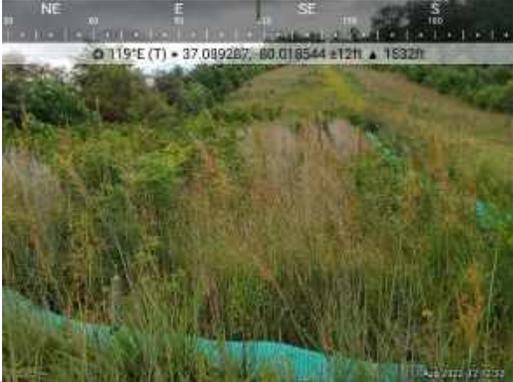
GPS Location 0		GPS Location 0			
Field Station# 13442+00		Field Station# 13444+40			
Pic 7 Desc. Level spreader		Pic 8 Desc. CIS S-IJ8 Perimeter CFS and Buffer zone vegetation

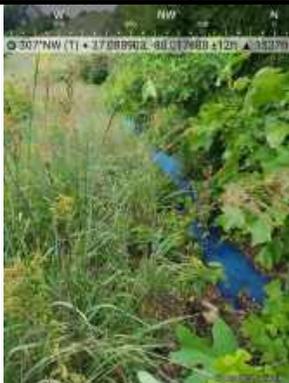
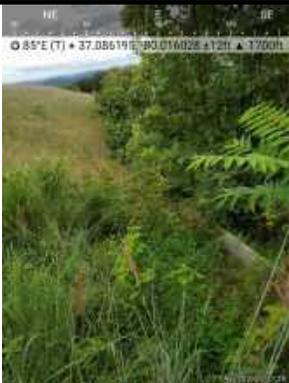
GPS Location 0		GPS Location 0			
Field Station# 13448+00		Field Station# 13463+00			
Pic 9 Desc. Perimeter CFS		Pic 10 Desc. Sideslope vegetation and perimeter silt fence

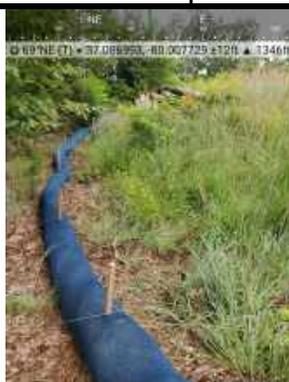
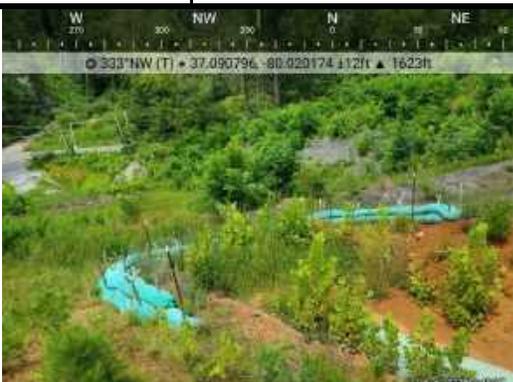
GPS Location 0		GPS Location 0			
Field Station# 13490+00		Field Station# 13416+50			
Pic 11 Desc. Perimeter CFS		Pic 12 Desc. GAS Cahas Mtn Rd #1 Ditch CFS and vegetation

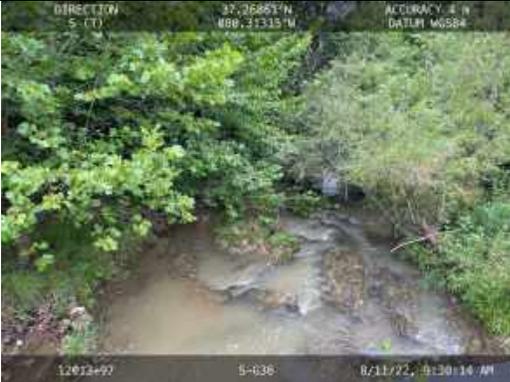
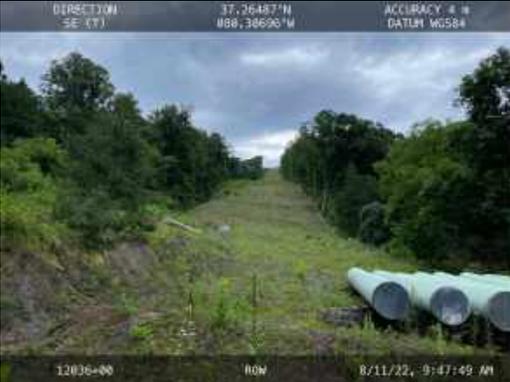
GPS Location	See photo		GPS Location	See photo	
Field Station#	12013+97		Field Station#	12036+00	
Pic 1 Desc.	Downstream of crossing S-G36		Pic 2 Desc.	Current ROW conditions. ROW is stable and ECDs are functional.

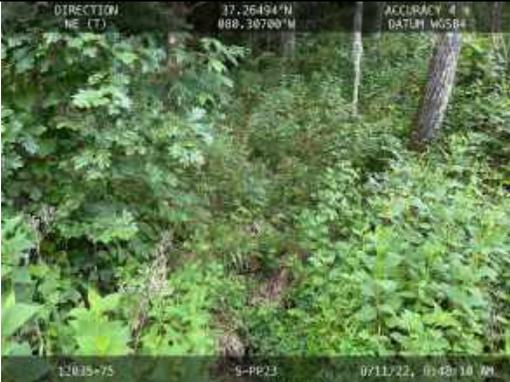
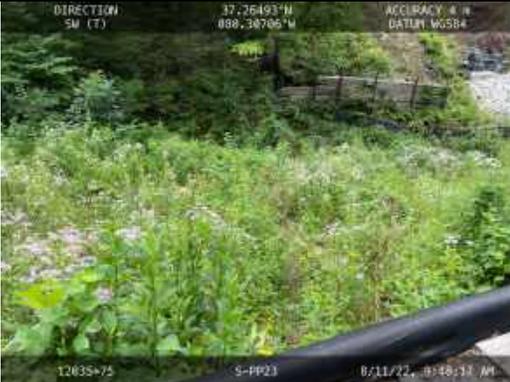
GPS Location	See photo		GPS Location	See photo	
Field Station#	12035+75		Field Station#	12035+75	
Pic 3 Desc.	Upstream of crossing at Stream S-PP23		Pic 4 Desc.	Downstream of crossing at Stream S-PP23

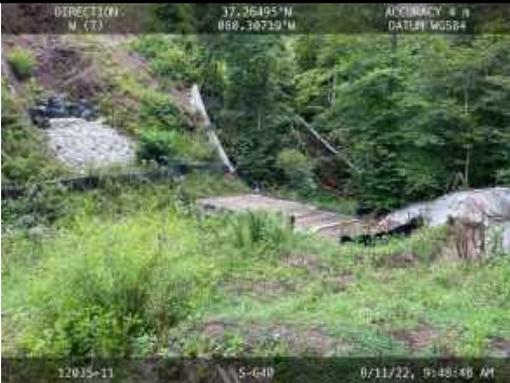
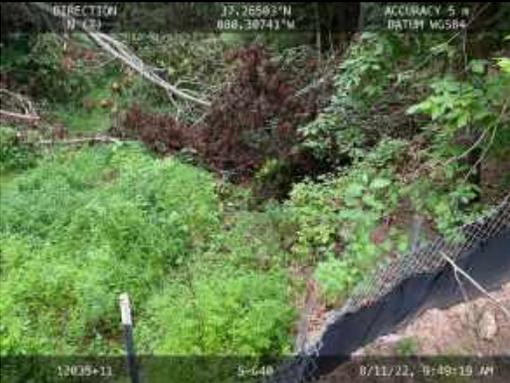
GPS Location	See photo		GPS Location	See photo	
Field Station#	12035+11		Field Station#	12035+11	
Pic 5 Desc.	Overview of Stream s-G40		Pic 6 Desc.	Downstream of crossing at Stream S-G40

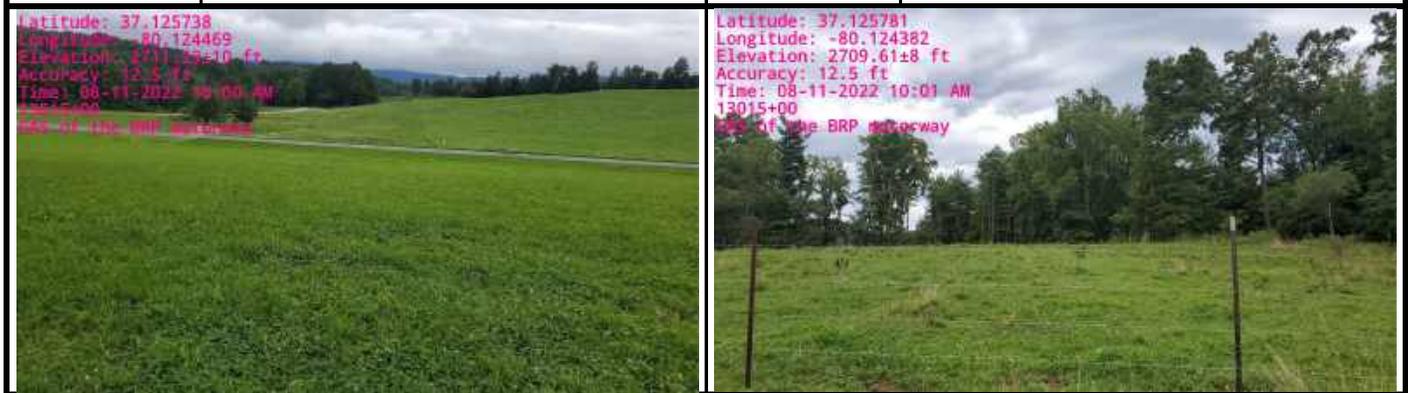
GPS Location	See pic.	GPS Location	See pic.
Field Station#	13015+00	Field Station#	13015+00
Pic 5 Desc.	Current ROW conditions.	Pic 6 Desc.	Current ROW conditions.

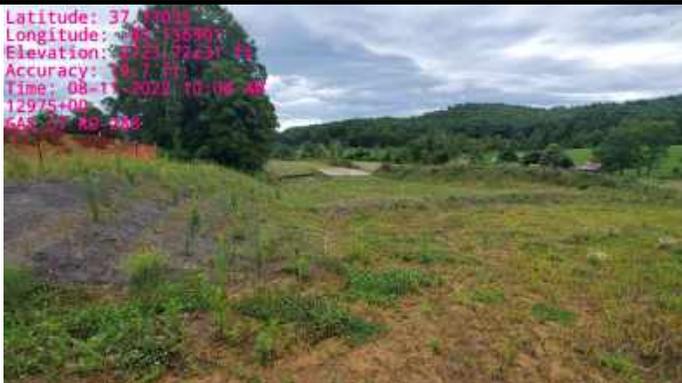
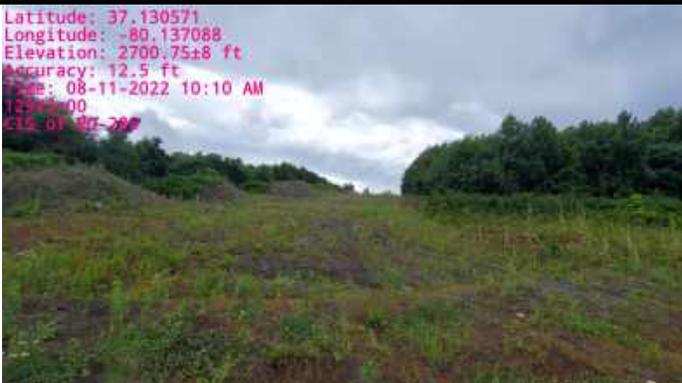
GPS Location		See pic.		GPS Location	
See pic.		See pic.		GPS Location	
Field Station#		12975+00		Field Station#	
12975+00		12973+00		Field Station#	
Pic 9 Desc.		Current ROW conditions.		Pic 10 Desc.	
Current ROW conditions.		Current ROW conditions.		Pic 10 Desc.

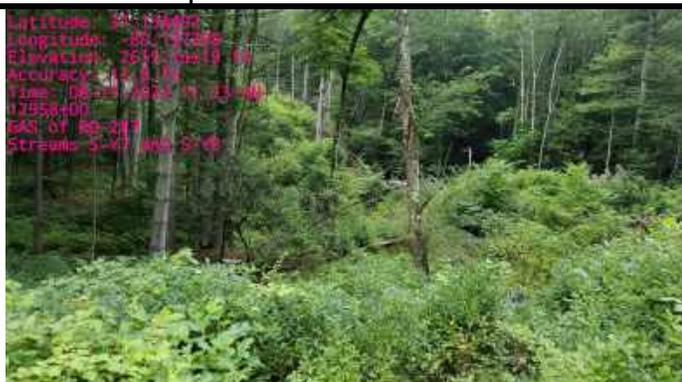
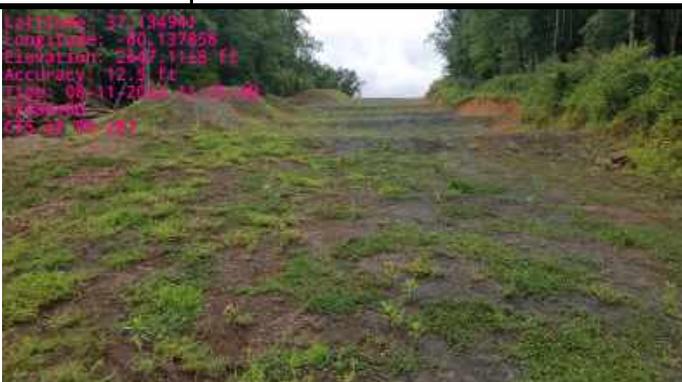
<p>Latitude: 37.134940 Longitude: -80.137826 Elevation: 2647.11±8 ft Accuracy: 12.5 ft Time: 08-11-2022 10:13 AM 12950+00 PIC 12 ROW 222</p>		
GPS Location		See pic.		GPS Location	
See pic.		See pic.		GPS Location	
Field Station#		12958+00		Field Station#	
12958+00		12950+00		Field Station#	
Pic 11 Desc.		Downstream side of streams S-Y7 and S-Y8.		Pic 12 Desc.	
Downstream side of streams S-Y7 and S-Y8.		Current ROW conditions.		Pic 12 Desc.	
Pic 11 Desc.		Current ROW conditions.		Pic 12 Desc.

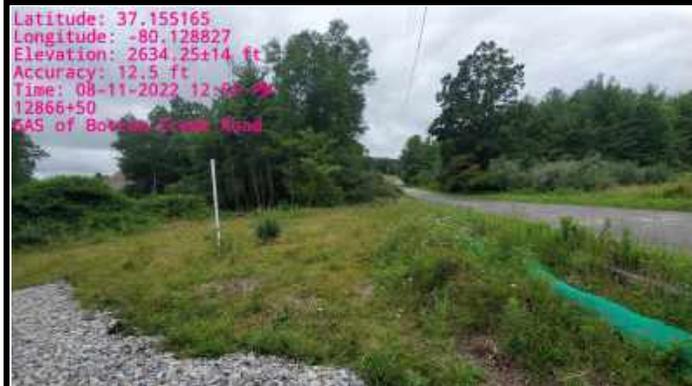
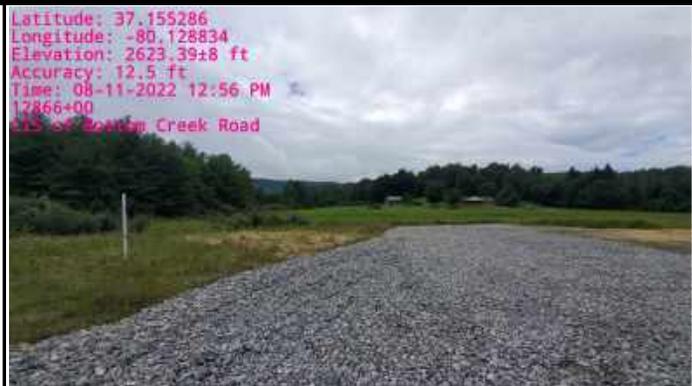
GPS Location	See pic.
Field Station#	12866+50
Pic 17 Desc.	Current ROW conditions.

GPS Location	See pic.
Field Station#	12866+00
Pic 18 Desc.	Current ROW conditions.

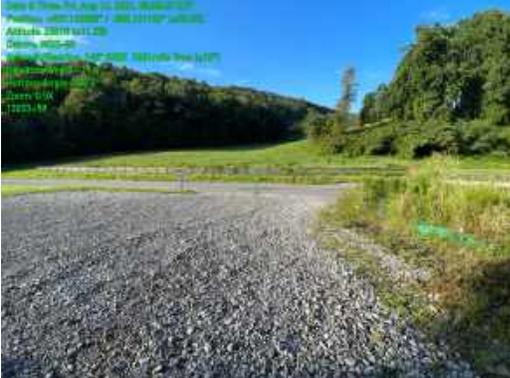
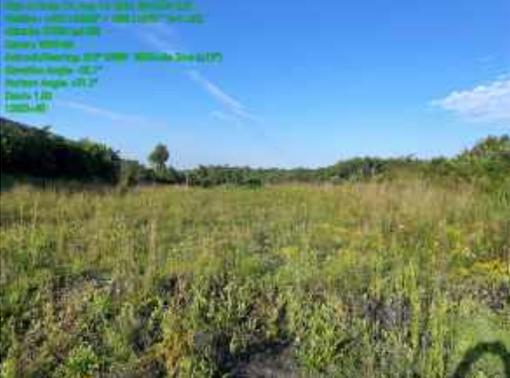
GPS Location	0	GPS Location	0		
Field Station#	13033+59	Field Station#	13033+00		
Pic 1 Desc.	RCE in good condition	Pic 2 Desc.	ROW and ECDs In good condition and stable

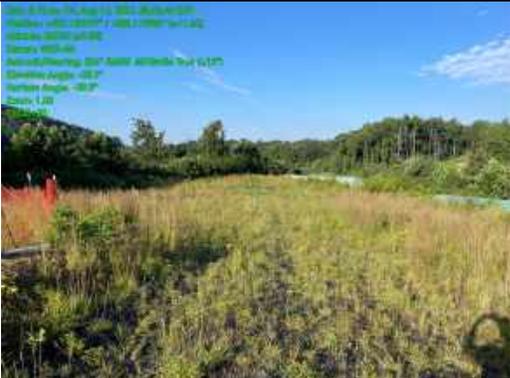
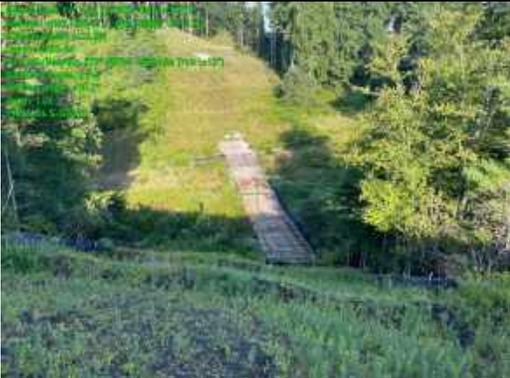
GPS Location	0	GPS Location	0		
Field Station#	13030+00	Field Station#	13024+06		
Pic 3 Desc.	ROW and ECDs In good condition and stable	Pic 4 Desc.	MVP-S-G24/25 and corresponding buffer zone in good condition

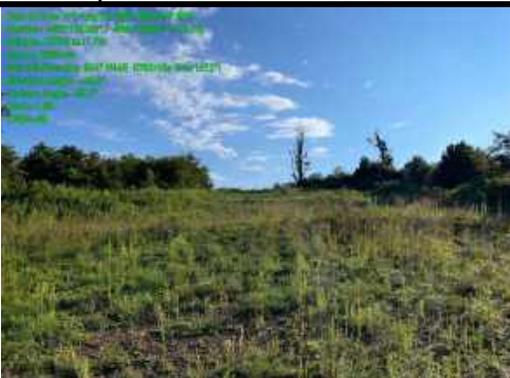
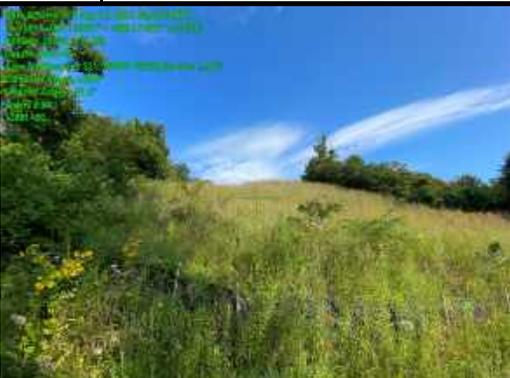
GPS Location	0	GPS Location	0		
Field Station#	13034+00	Field Station#	13061+00		
Pic 5 Desc.	ROW and ECDs In good condition and stable	Pic 6 Desc.	ROW and ECDs In good condition and stable

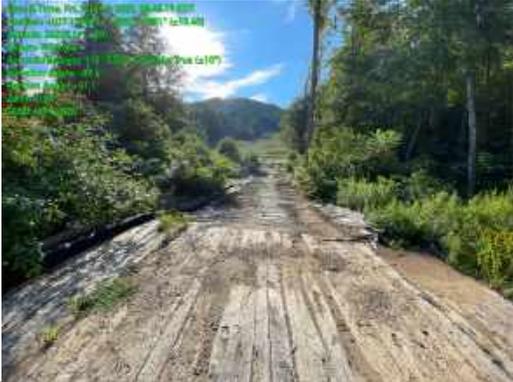
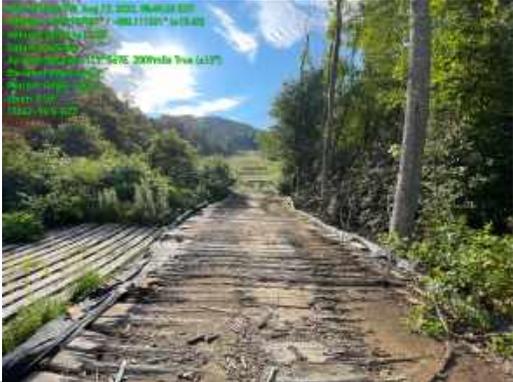
GPS Location	0		GPS Location	0	
Field Station#	13061+89		Field Station#	13062+96	
Pic 7 Desc.	MVP-S-G26 and corresponding buffer zone in good condition		Pic 8 Desc.	MVP-S-G27 and corresponding buffer zone in good condition

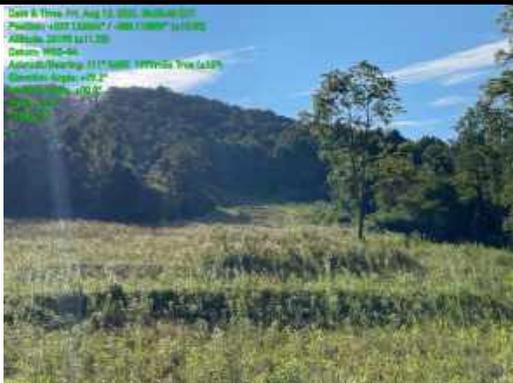
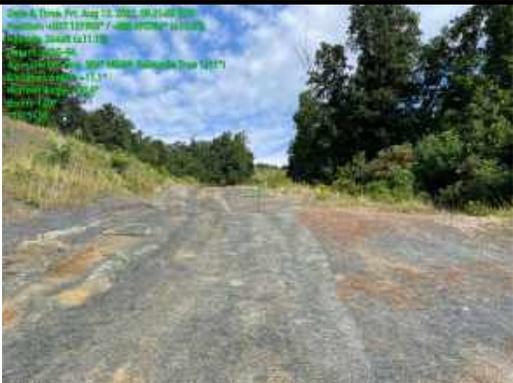
GPS Location	0		GPS Location	0	
Field Station#	13063+75		Field Station#	13115+00	
Pic 9 Desc.	ROW and ECDs In good condition and stable		Pic 10 Desc.	ROW and ECDs In good condition and stable

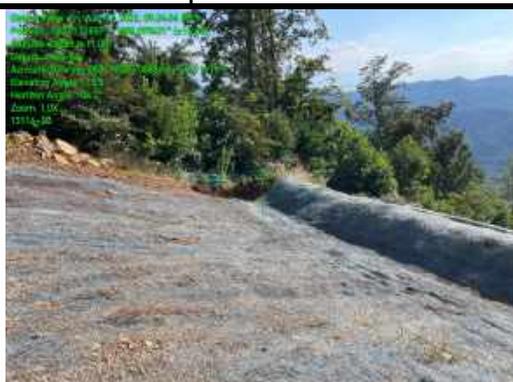
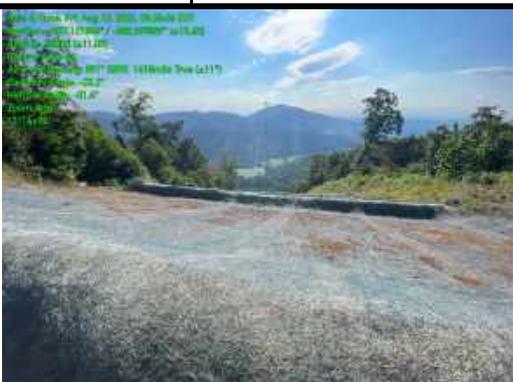
GPS Location	0		GPS Location	0	
Field Station#	13116+00		Field Station#	13116+00	
Pic 11 Desc.	ROW and ECDs In good condition and stable		Pic 12 Desc.	ROW and ECDs In good condition and stable

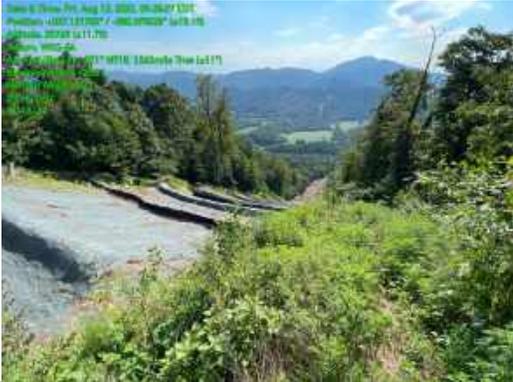
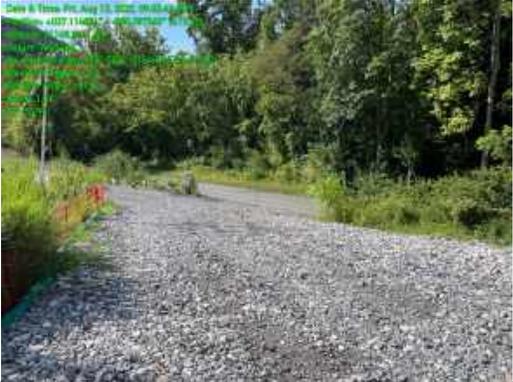
GPS Location	0	GPS Location	0		
Field Station#	13118+50	Field Station#	13115+96		
Pic 13 Desc.	ROW and ECDs In good condition and stable	Pic 14 Desc.	RCE in good condition

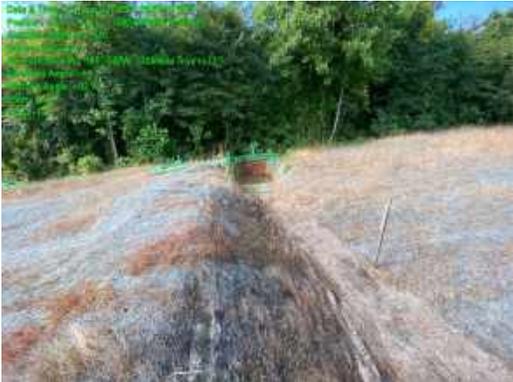
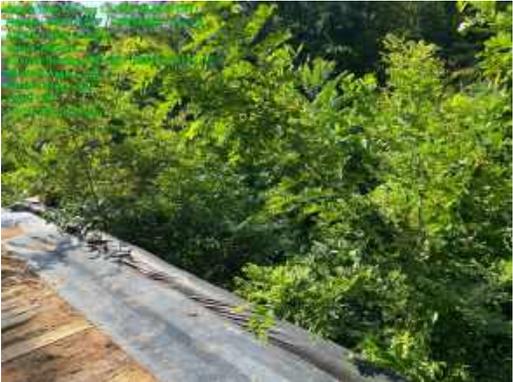
GPS Location	0	GPS Location	0		
Field Station#	13142+00	Field Station#	13137+78		
Pic 15 Desc.	ROW and ECDs In good condition and stable	Pic 16 Desc.	MVP-S-D17 Downstream and corresponding buffer zone in good condition

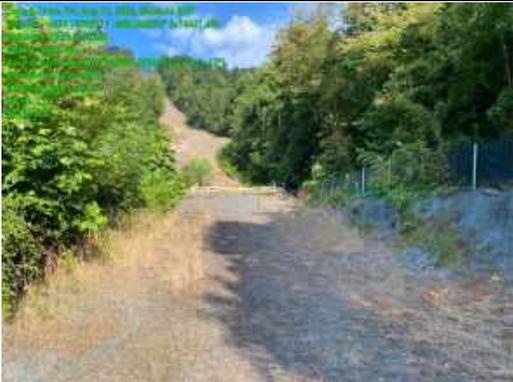
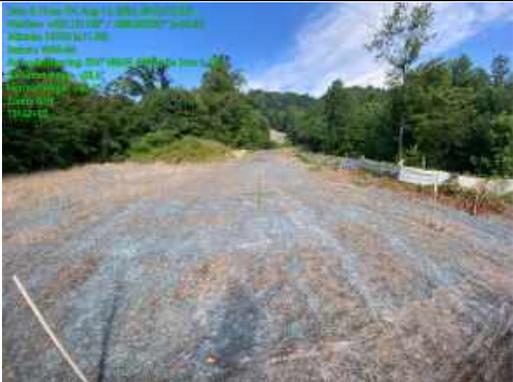
GPS Location	0	GPS Location	0		
Field Station#	13138+50	Field Station#	13142+03		
Pic 17 Desc.	MVP-S-D17 and corresponding buffer zone in good condition	Pic 18 Desc.	ROW and ECDs In good condition and stable

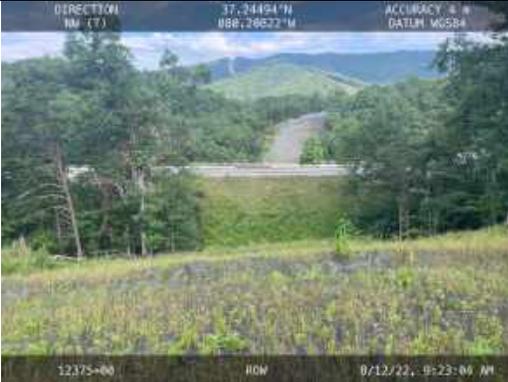
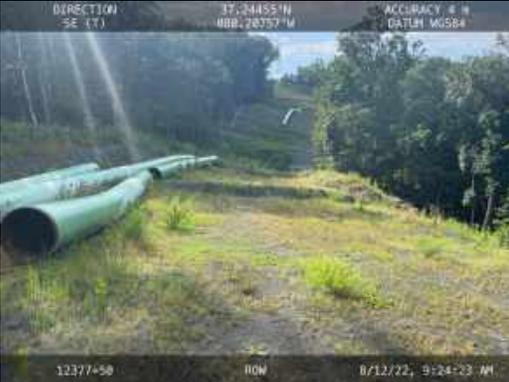
GPS Location	See photo	GPS Location	See photo
Field Station#	12375+00	Field Station#	12377+50
Pic 1 Desc.	Current ROW conditions. ROW is stable and ECDs are functional	Pic 2 Desc.	Current ROW conditions. ROW is stable and ECDs are functional

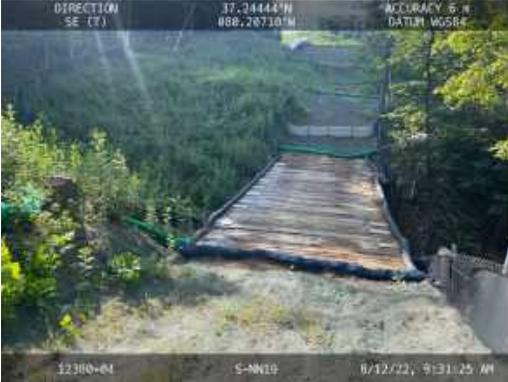
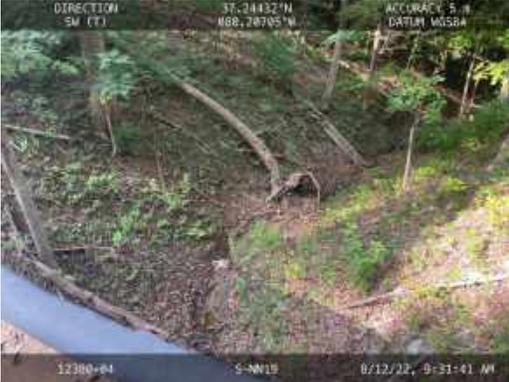
GPS Location	See photo	GPS Location	See photo
Field Station#	12380+04	Field Station#	12380+04
Pic 3 Desc.	Overview of Stream S-NN19	Pic 4 Desc.	Downstream of crossing at Stream S-NN19

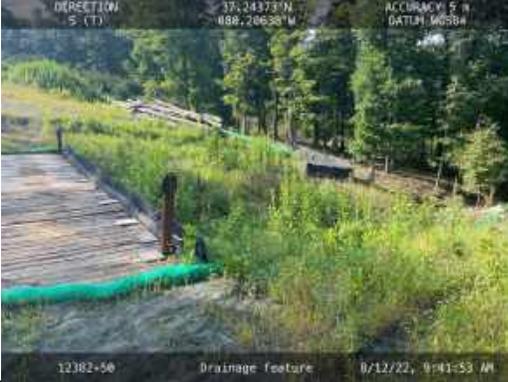
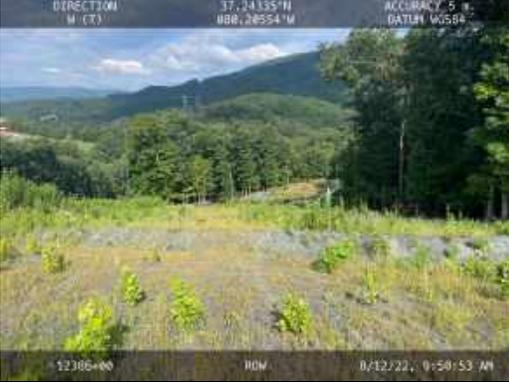
GPS Location	See photo	GPS Location	See photo
Field Station#	12382+50	Field Station#	12386+00
Pic 5 Desc.	Drainage feature is functional	Pic 6 Desc.	Current ROW conditions. ROW is stable and ECDs are functional

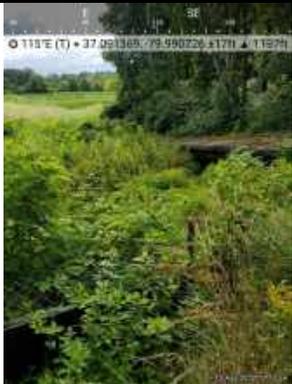
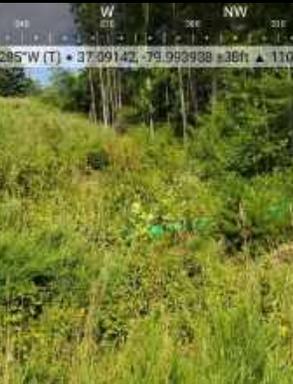
GPS Location	0		GPS Location	0	
Field Station#	13542+75		Field Station#	13534+00	
Pic 1 Desc.	CIS S-II9 Buffer zone vegetation and equipment bridge		Pic 2 Desc.	GAS S-II8 Buffer zone vegetation and ECDs

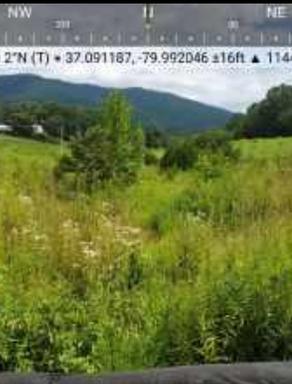
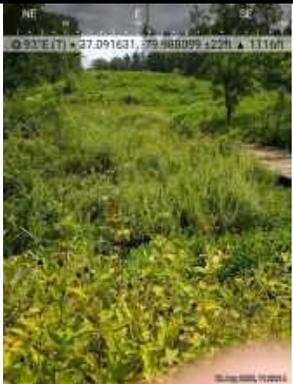
GPS Location	0		GPS Location	0	
Field Station#	13539+00		Field Station#	13551+00	
Pic 3 Desc.	S-II7 Channel and banks		Pic 4 Desc.	CIS S-II12 Buffer zone vegetation

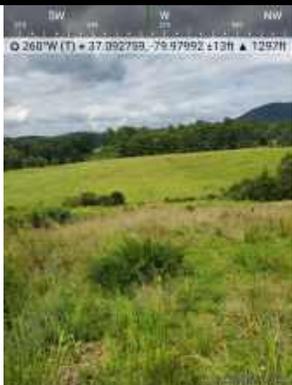
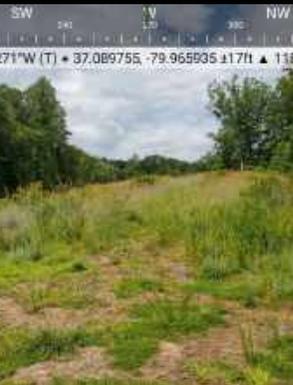
GPS Location	0		GPS Location	0	
Field Station#	13573+00		Field Station#	13616+00	
Pic 5 Desc.	CIS Monty Rd Permanent vegetation		Pic 6 Desc.	Permanent vegetation

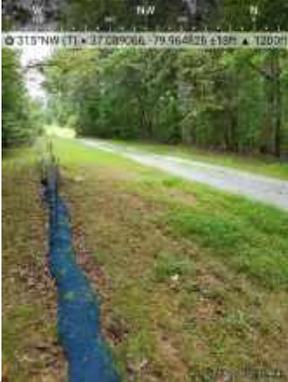
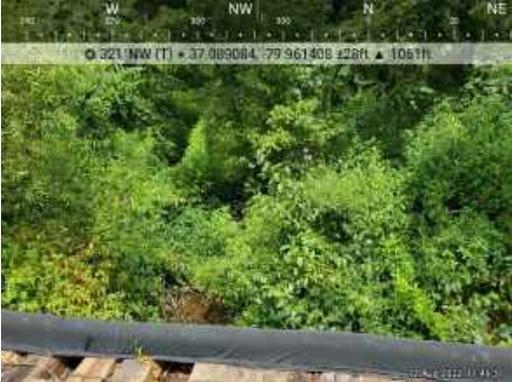
GPS Location	0	GPS Location	0		
Field Station#	13618+26	Field Station#	13643+60		
Pic 7 Desc.	MVP-FR-295 Perimeter CFS and RCE	Pic 8 Desc.	S-E28 Channel and banks

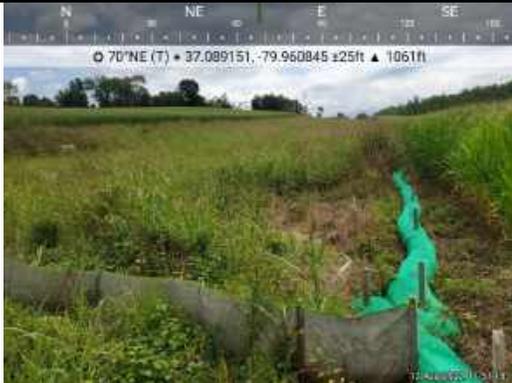
Insert image here			
GPS Location	0	GPS Location			
Field Station#	13645+00	Field Station#			
Pic 9 Desc.	GAS Leaning Oak Rd Perimeter ECDs	Pic 10 Desc.			
Insert image here			Insert image here		
GPS Location		GPS Location			
Field Station#		Field Station#			
Pic 11 Desc.		Pic 12 Desc.

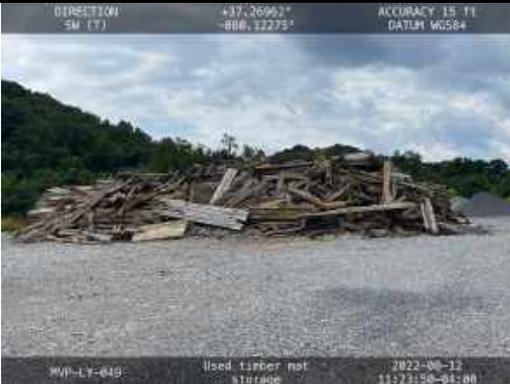
<p>DIRECTION: SW (T) +37.26963° -886.12273° ACCURACY 15 FT DATUM WGS84</p> <p>MVP-LY-849: Used timber mat storage 2022-08-12 11:21:50-04:00</p>

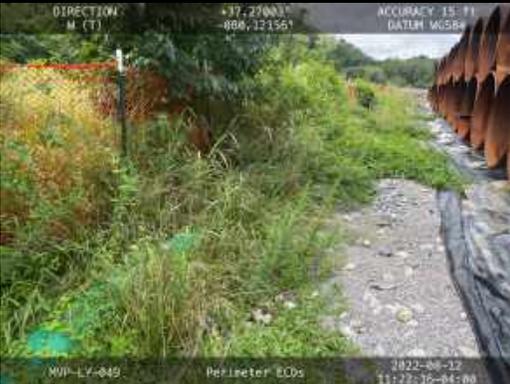
<p>DIRECTION: M (T) +37.27003° -886.12156° ACCURACY 15 FT DATUM WGS84</p> <p>MVP-LY-849: Perimeter ECDs 2022-08-12 11:22:16-04:00</p>			
GPS Location		See photo for gps location data.		GPS Location	
Field Station#		+0		Field Station#	
Pic 1 Desc.		Photo shows the used timber mat storage pile.		Pic 2 Desc.

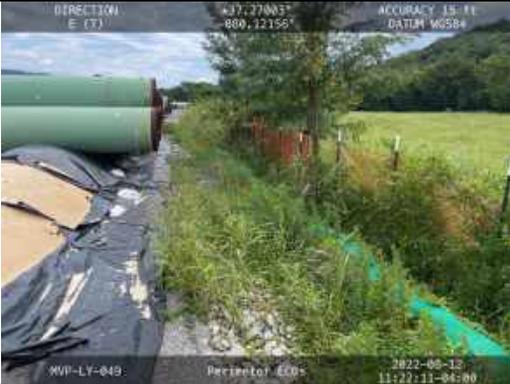
<p>DIRECTION: E (T) +37.27003° -886.12156° ACCURACY 15 FT DATUM WGS84</p> <p>MVP-LY-849: Perimeter ECDs 2022-08-12 11:22:11-04:00</p>

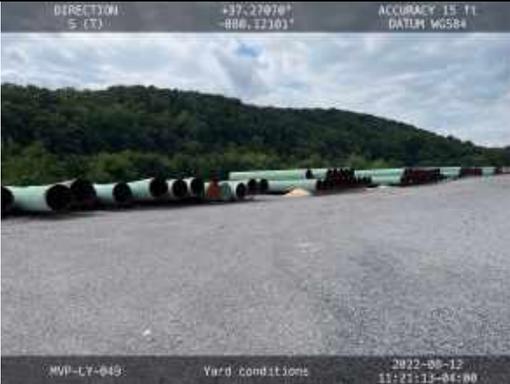
<p>DIRECTION: S (T) +37.27078° -886.12101° ACCURACY 15 FT DATUM WGS84</p> <p>MVP-LY-849: Yard conditions 2022-08-12 11:21:13-04:00</p>			
GPS Location		See photo for gps location data.		GPS Location	
Field Station#		+0		Field Station#

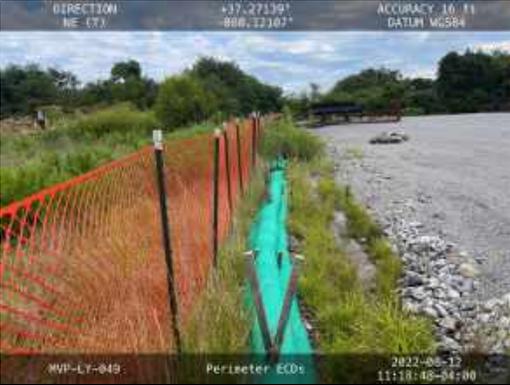
<p>DIRECTION: NE (T) +37.27139° -886.12107° ACCURACY 16 FT DATUM WGS84</p> <p>MVP-LY-849: Perimeter ECDs 2022-08-12 11:18:48-04:00</p>			
GPS Location		See photo for gps location data.		GPS Location	
Field Station#		+0		Field Station#	
Pic 5 Desc.		See photo for gps location data.		Pic 6 Desc.	
				Photo shows the perimeter ECDs

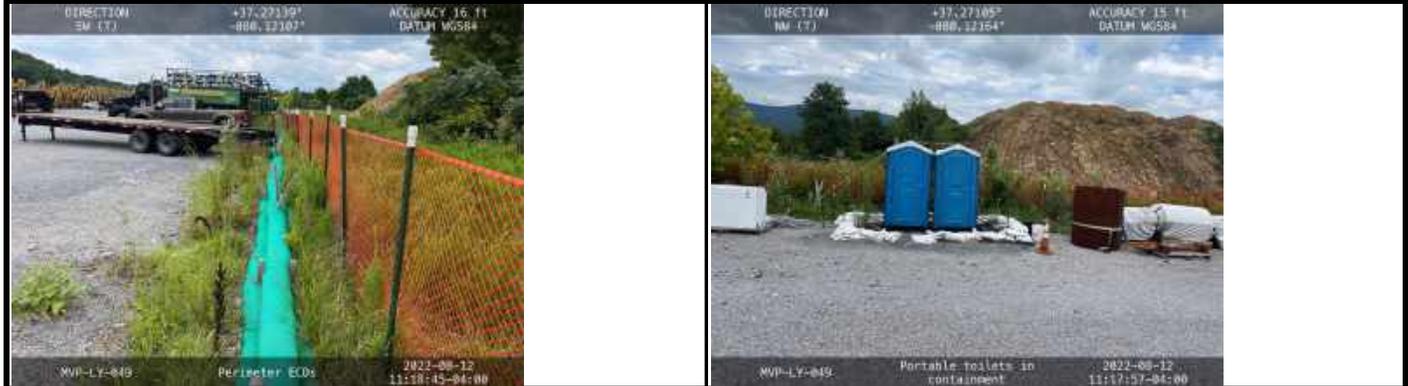
GPS Location	See photo for gps location data.	GPS Location	See photo for gps location data.
Field Station#	+0	Field Station#	+0
Pic 7 Desc.	Photo shows the perimeter ECDs.	Pic 8 Desc.	Photo shows the portable toilets and containment.

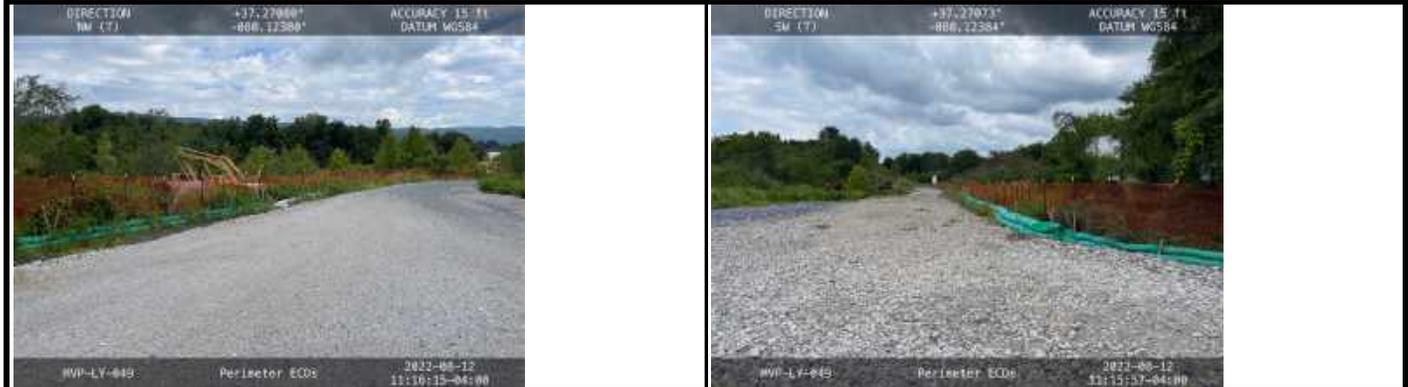
GPS Location	See photo for gps location data.	GPS Location	See photo for gps location data.
Field Station#	+0	Field Station#	+0
Pic 9 Desc.	Photo shows the perimeter ECDs.	Pic 10 Desc.	Photo shows the perimeter ECDs.

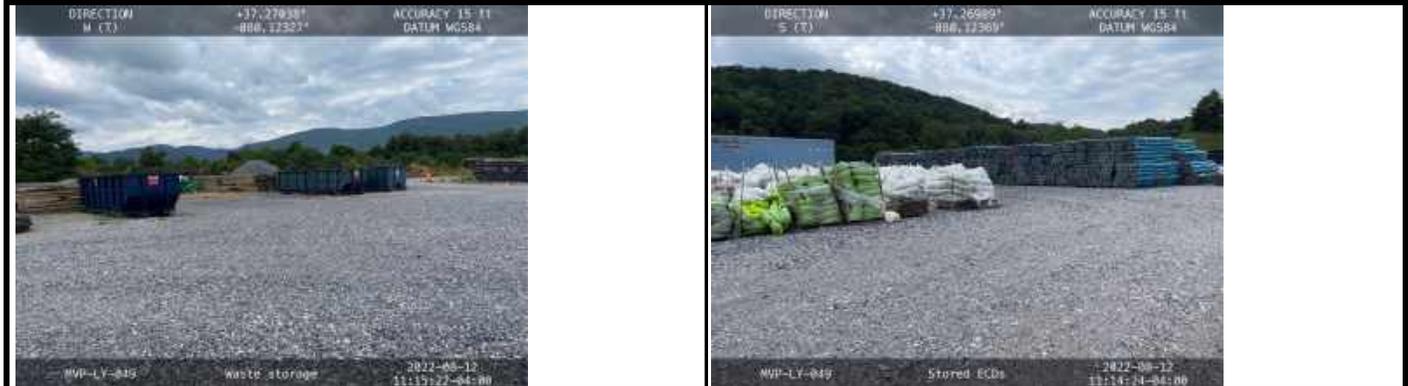
GPS Location	See photo for gps location data.	GPS Location	See photo for gps location data.
Field Station#	+0	Field Station#	+0
Pic 11 Desc.	Photo shows the waste storage containers	Pic 12 Desc.	Photo shows the ECDs stored in the yard.

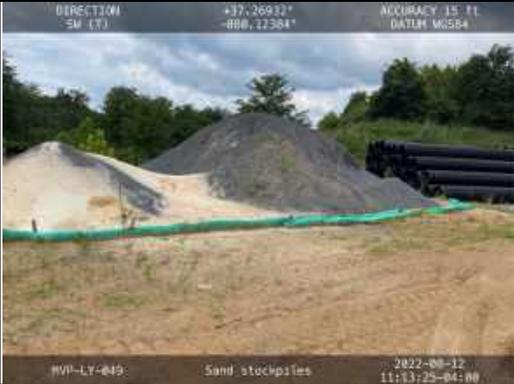
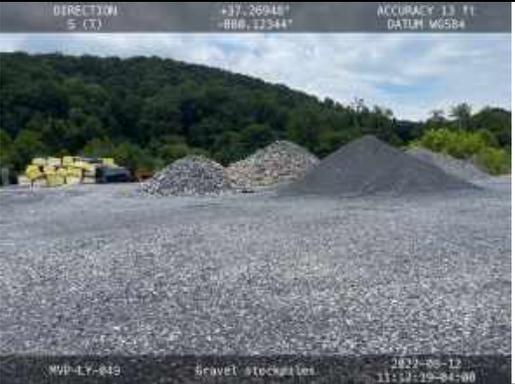
GPS Location	See photo for gps location data.		GPS Location	See photo for gps location data.	
Field Station#	+0		Field Station#	+0	
Pic 13 Desc.	Photo shows the sand stockpiles and ECDs.		Pic 14 Desc.	Photo shows the gravel stockpiles.

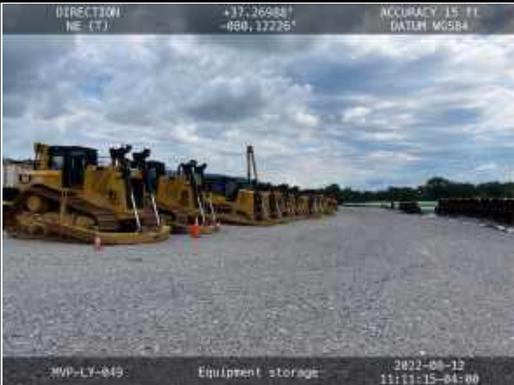
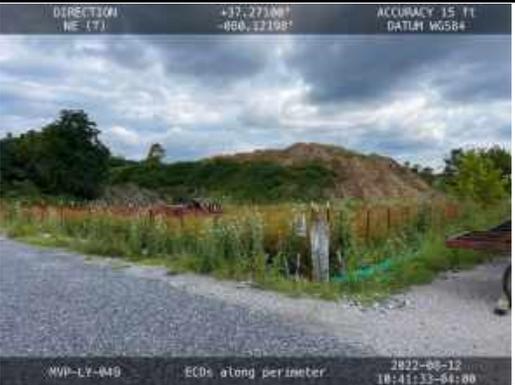
GPS Location	See photo for gps location data.		GPS Location	See photo for gps location data.	
Field Station#	+0		Field Station#	+0	
Pic 15 Desc.	Photo shows the equipment storage area. No leaks or spills were observed.		Pic 16 Desc.	Photo shows the perimeter ECDs and the landowners stockpile located outside the project work area.

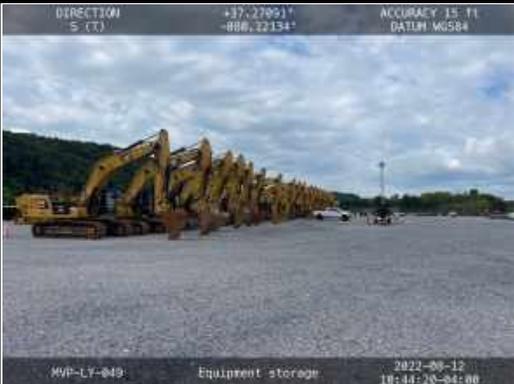
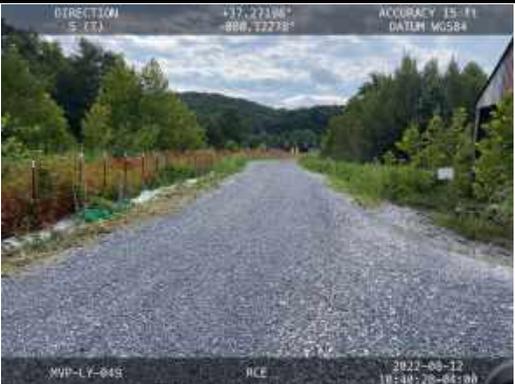
GPS Location	See photo for gps location data.		GPS Location	See photo for gps location data.	
Field Station#	+0		Field Station#	+0	
Pic 17 Desc.	Photo shows the equipment storage area. No leaks or spills were observed.		Pic 18 Desc.	Photo shows the RCE.

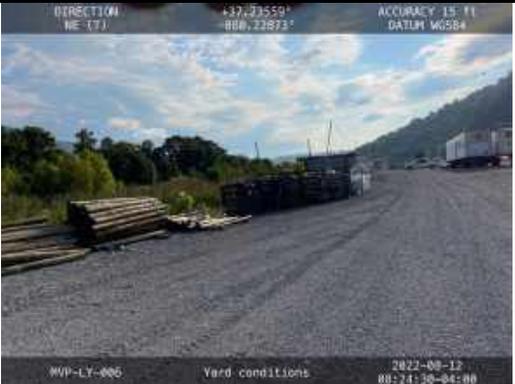
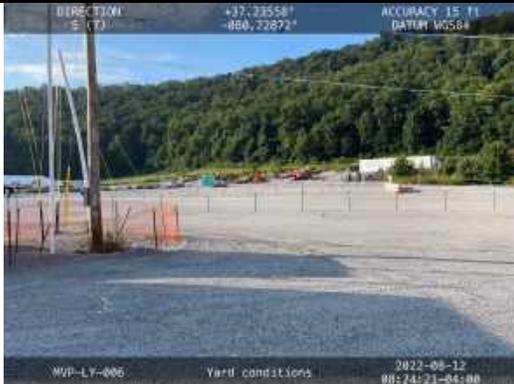
<p>DIRECTION: E (T) +37.23558° -888.22872° ACCURACY 15 FT DATUM WGS84 MVP-LY-006 Yard conditions 2022-08-12 08:24:23-04:00</p>	
GPS Location	See photo for gps location data.		GPS Location	See photo for gps location data.	
Field Station#	+0		Field Station#	+0	
Pic 1 Desc.	Photo shows the yard conditions. No environmental issues were observed.		Pic 2 Desc.	Photo shows the yard conditions. No environmental issues were observed.

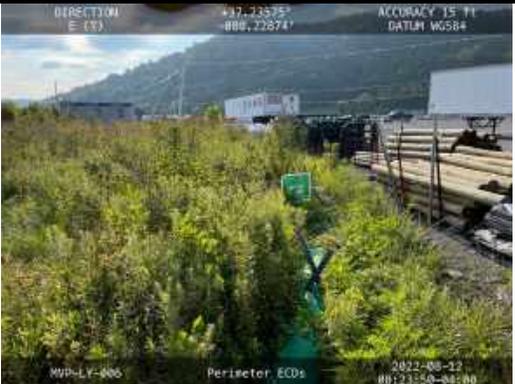
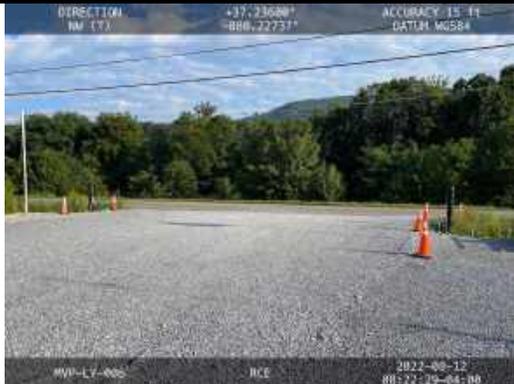
Field Station#	+0		Field Station#	+0	
Pic 3 Desc.	Photo shows the perimeter ECDs along W-008.		Pic 4 Desc.	Photo shows the RCE at Northfork Rd.

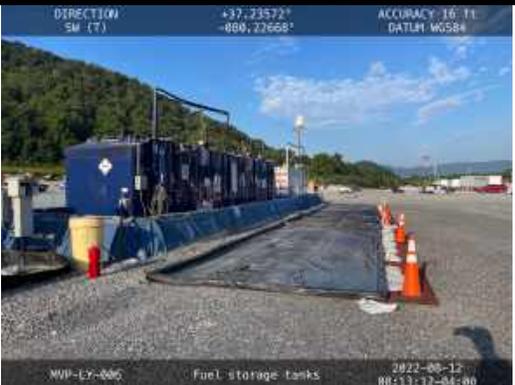
<p>DIRECTION: SW (T) +37.23572° -888.22668° ACCURACY 16 FT DATUM WGS84 MVP-LY-006 Fuel storage tanks 2022-08-12 08:13:32-04:00</p>

<p>DIRECTION: M (T) +37.23562° -888.22675° ACCURACY 15 FT DATUM WGS84 MVP-LY-006 Fuel storage tank Internal piping 2022-08-12 08:08:56-04:00</p>	
GPS Location	See photo for gps location data.		GPS Location	See photo for gps location data.	
Field Station#	+0		Field Station#	+0	
Pic 5 Desc.	Photo shows the bulk fuel storage tank. No leaks or spills were observed.		Pic 6 Desc.	Photo shows the bulk fuel storage tank internal piping. No leaks were observed.

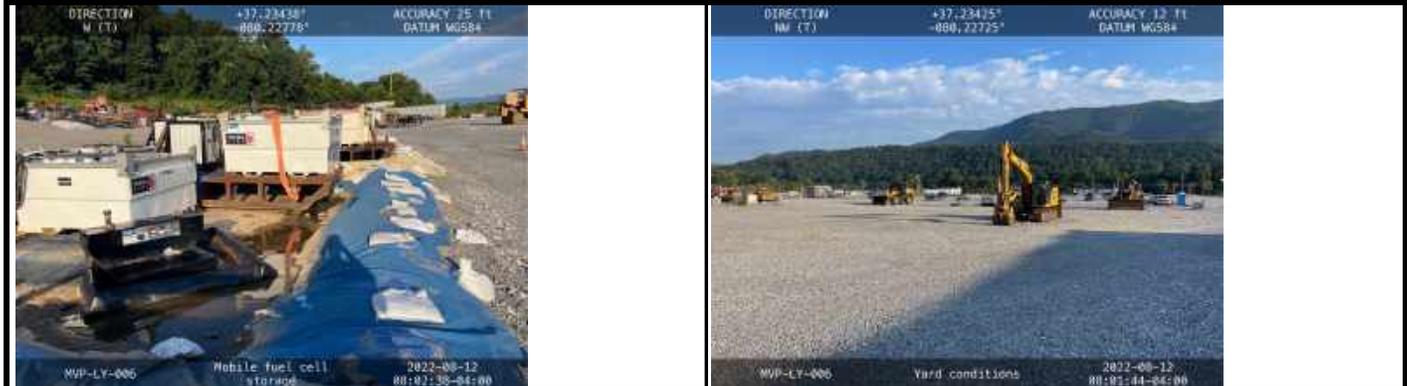
GPS Location	See photo for gps location data.	GPS Location	See photo for gps location data.
Field Station#	+0	Field Station#	+0
Pic 11 Desc.	Photo shows the mobile fuel cell storage.	Pic 12 Desc.	Photo shows the yard conditions. No environmental issues were observed.

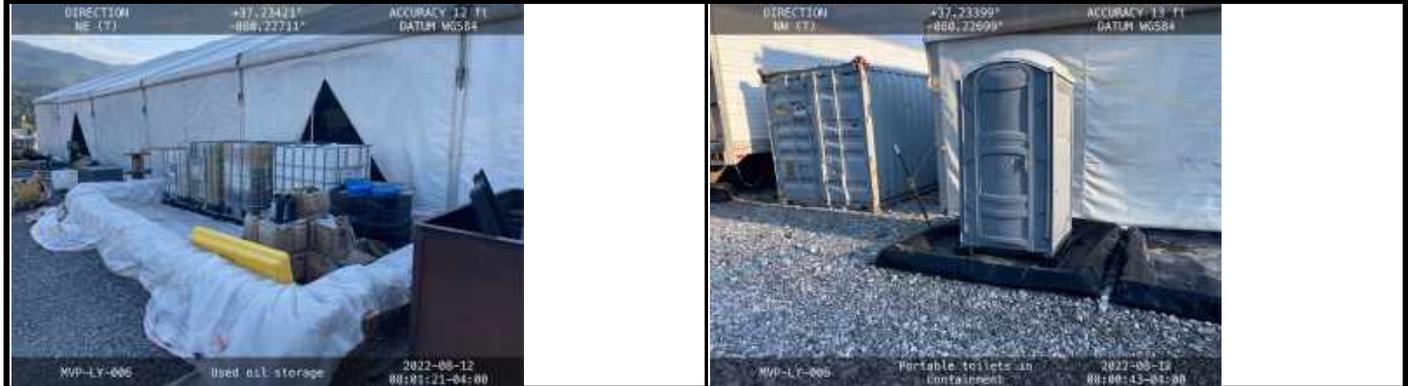
GPS Location	See photo for gps location data.	GPS Location	See photo for gps location data.
Field Station#	+0	Field Station#	+0
Pic 13 Desc.	Photo shows the used oil storage area. No leaks or spills were observed.	Pic 14 Desc.	Photo shows the portable toilets and containment.

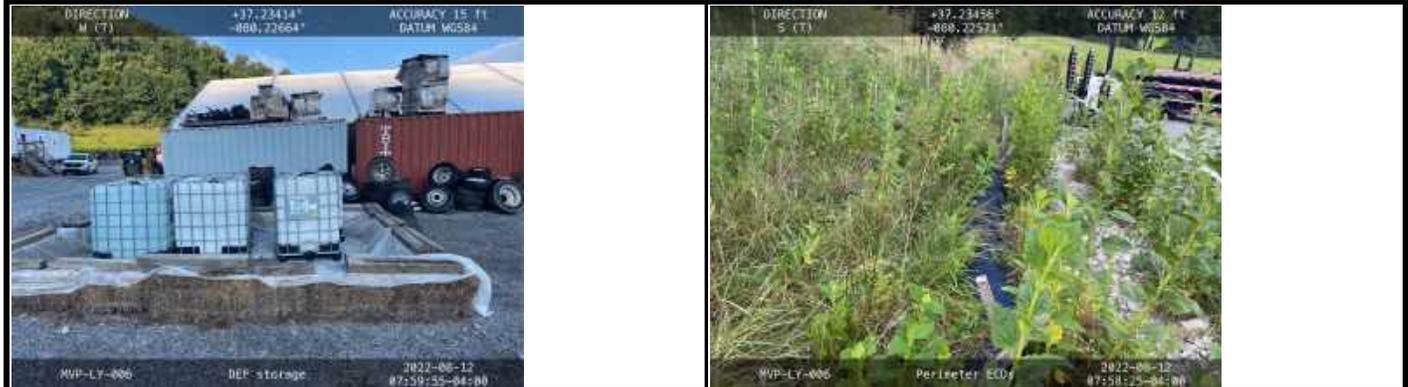
GPS Location	See photo for gps location data.	GPS Location	See photo for gps location data.
Field Station#	+0	Field Station#	+0
Pic 15 Desc.	Photo shows the DEF storage area. No leaks or spills were observed.	Pic 16 Desc.	Photo shows the perimeter ECDs overgrown with vegetation.
