Visual Site Inspection Report

Project Name H-600 Pipeline Spread H		AFE 124300138	Spread H-600 Pipeline Spread H
Contractor Precision		Report # 40745	
Inspector Jonathan Altizer		Date/Time 8/8/2022 3:16 PM	
Permit # TBD	Inspection Type VA SWPP	Station Begin 12284+75	
State VA	Inspection Area Partial	Station End 12443+75	
County Montgomery	Ground Wet	Temperature (°F) 90.00	
Municipality N/A	Weather Sunny	Rain Gauge (in) 3.20	
			Rain Accumulation Time (days) 2.00

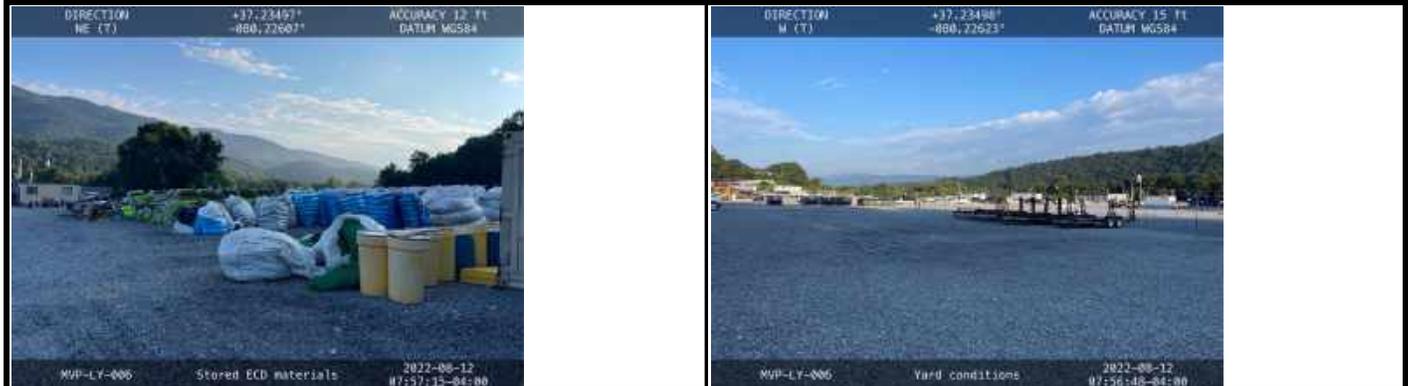
GPS Location	See photo for gps location data.	GPS Location	See photo for gps location data.
Field Station#	+0	Field Station#	+0
Pic 17 Desc.	Photo shows ECD materials stored in the yard.	Pic 18 Desc.	Photo shows the yard conditions. No environmental issues were observed.
