# Visual Site Inspection Report

<b>Project Name</b>	H-600 Pipeline Spread I	<b>AFE</b>	124300139	<b>Spread</b>	H-600 Pipeline Spread I
<b>Contractor</b>	Precision			<b>Report #</b>	41006
<b>Inspector</b>	Justin Burch			<b>Date/Time</b>	8/15/2022 11:57 AM
<b>Permit #</b>	TBD	<b>Inspection Type</b>	VA SWPP	<b>Station Begin</b>	15370+62
<b>State</b>	VA	<b>Inspection Area</b>	Full	<b>Station End</b>	15480+67
<b>County</b>	Pittsylvania	<b>Ground</b>	Wet	<b>Temperature (°F)</b>	72.00
<b>Municipality</b>	Chatham	<b>Weather</b>	Cloudy	<b>Rain Gauge (in)</b>	0.20
				<b>Rain Accumulation Time (days)</b>	6.00

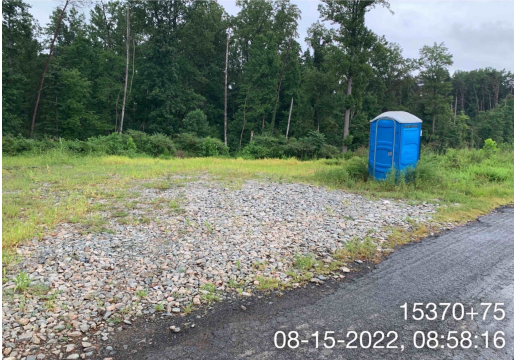
15388+00 08-15-2022, 10:34:58			
<b>GPS Location</b>	0	<b>GPS Location</b>	0		
<b>Field Station#</b>	15370+75	<b>Field Station#</b>	15388+00		
<b>Pic 1 Desc.</b>	Rock construction entrance in acceptable condition	<b>Pic 2 Desc.</b>	Temporary vegetative stabilization in acceptable condition		
351°N (T) 36.920117°, -79.503802° ±32ft ▲ 770ft

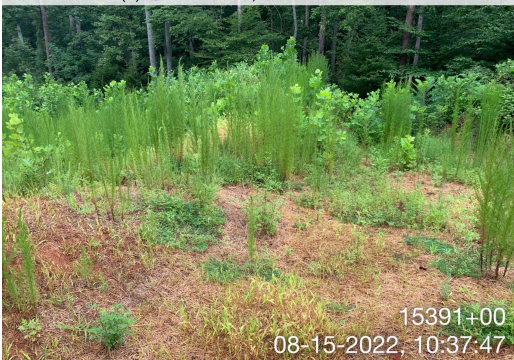
15391+00 08-15-2022, 10:38:02			
<b>GPS Location</b>	0	<b>GPS Location</b>	0		
<b>Field Station#</b>	15391+00	<b>Field Station#</b>	15391+00		
<b>Pic 3 Desc.</b>	Waterbar in acceptable condition	<b>Pic 4 Desc.</b>	Waterbar end treatment in acceptable condition

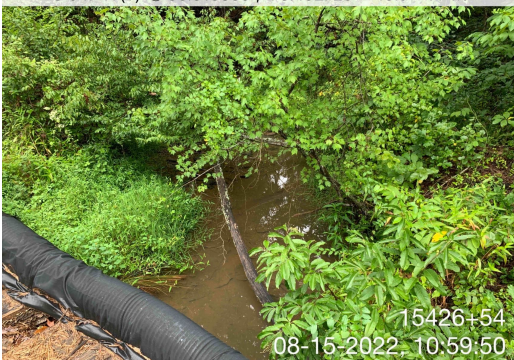
15427+00 08-15-2022, 11:00:20			
<b>GPS Location</b>	0	<b>GPS Location</b>	0		
<b>Field Station#</b>	15426+54	<b>Field Station#</b>	15427+00		
<b>Pic 5 Desc.</b>	Stream S-G4 is running clear	<b>Pic 6 Desc.</b>	P1 silt fence and sensitive resource buffer in acceptable conditions

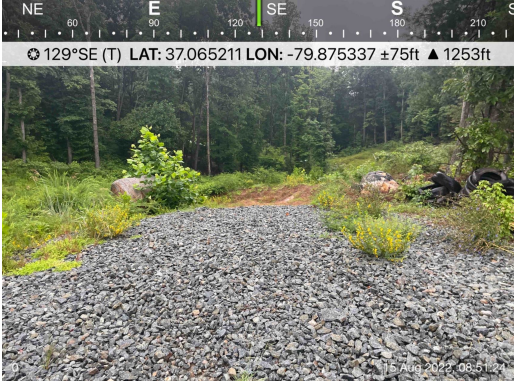
<b>GPS Location</b>	See photo		<b>GPS Location</b>	See photo	
<b>Field Station#</b>	14062+17		<b>Field Station#</b>	14066+77	
<b>Pic 1 Desc.</b>	RCEs are in good condition at all road crossings.		<b>Pic 2 Desc.</b>	Equipment bridge ECDs are in good condition and functioning

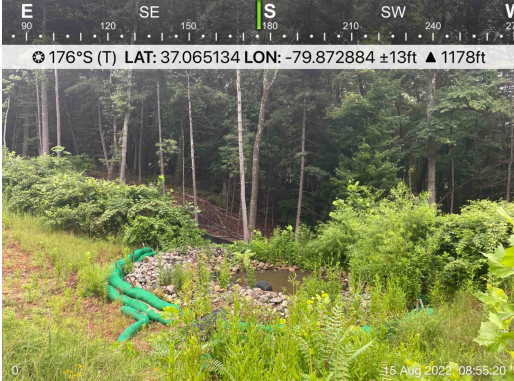
<b>GPS Location</b>	See photo		<b>GPS Location</b>	See photo	
<b>Field Station#</b>	14070+00		<b>Field Station#</b>	14090+00	
<b>Pic 3 Desc.</b>	CWDs are functioning as intended		<b>Pic 4 Desc.</b>	Topsoil berms remain stabilized

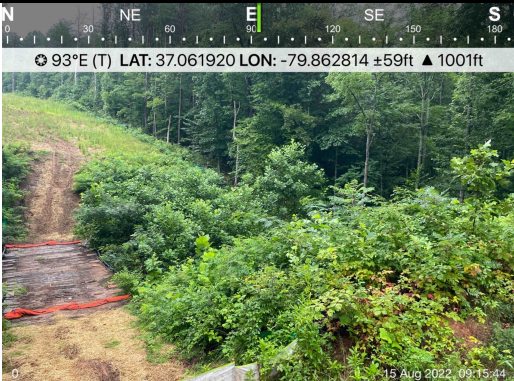
<b>GPS Location</b>	See photo		<b>GPS Location</b>	See photo	
<b>Field Station#</b>	14105+20		<b>Field Station#</b>	14110+00	
<b>Pic 5 Desc.</b>	Resource buffers remain well vegetated		<b>Pic 6 Desc.</b>	Waterbars are in good condition

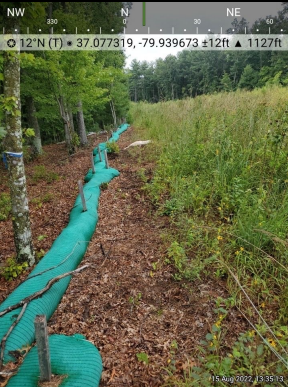
<b>GPS Location</b>	0	<b>GPS Location</b>	0		
<b>Field Station#</b>	13737+00	<b>Field Station#</b>	13728+20		
<b>Pic 3 Desc.</b>	Perimeter CFS	<b>Pic 4 Desc.</b>	S-EF4 Channel

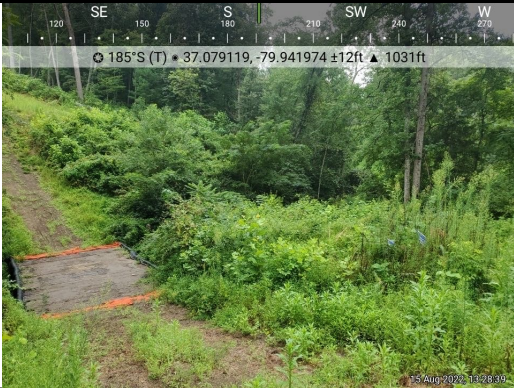
<b>GPS Location</b>	0	<b>GPS Location</b>	0		
<b>Field Station#</b>	13727+50	<b>Field Station#</b>	13717+00		
<b>Pic 5 Desc.</b>	CIS S-EF4 Buffer zone vegetation	<b>Pic 6 Desc.</b>	Vegetation

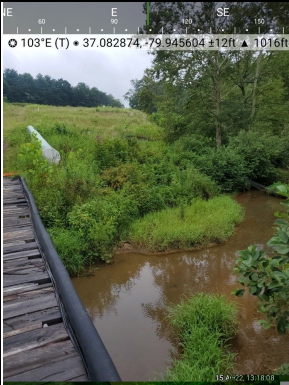
<b>GPS Location</b>	0	<b>GPS Location</b>	0		
<b>Field Station#</b>	13705+00	<b>Field Station#</b>	13697+00		
<b>Pic 7 Desc.</b>	S-E28 Channel and GAS Bank	<b>Pic 8 Desc.</b>	Fill slope vegetation and perimeter SSF

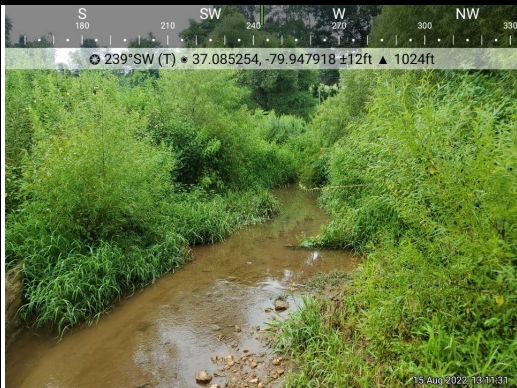
<b>GPS Location</b>	0	<b>GPS Location</b>	0		
<b>Field Station#</b>	13692+70	<b>Field Station#</b>	13691+75		
<b>Pic 9 Desc.</b>	S-E28 Channel and banks	<b>Pic 10 Desc.</b>	Perimeter silt fence

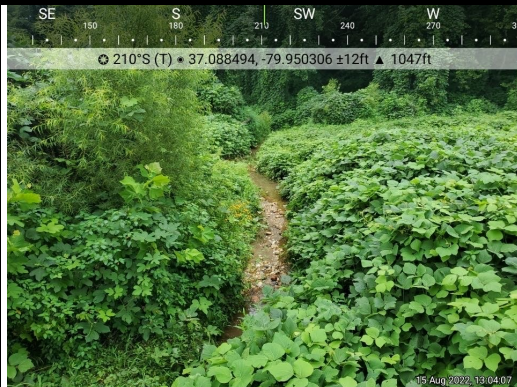
<b>GPS Location</b>	0	<b>GPS Location</b>	0		
<b>Field Station#</b>	13678+70	<b>Field Station#</b>	13673+00		
<b>Pic 11 Desc.</b>	S-E29 Channe	<b>Pic 12 Desc.</b>	Perimeter CFS

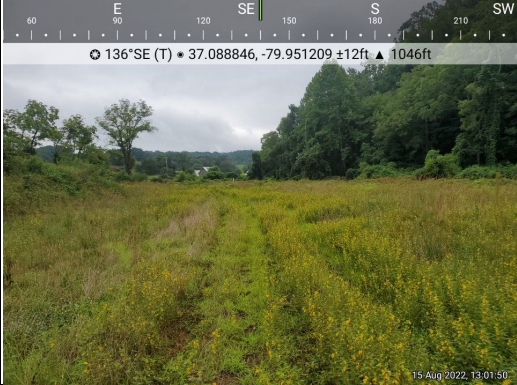
<b>GPS Location</b>	0	<b>GPS Location</b>	0		
<b>Field Station#</b>	13673+00	<b>Field Station#</b>	13745+00		
<b>Pic 13 Desc.</b>	Vegetation	<b>Pic 14 Desc.</b>	Perimeter silt fence		
Insert image here		Insert image here			
<b>GPS Location</b>		<b>GPS Location</b>			
<b>Field Station#</b>		<b>Field Station#</b>			
<b>Pic 15 Desc.</b>		<b>Pic 16 Desc.</b>			
Insert image here		Insert image here			
<b>GPS Location</b>		<b>GPS Location</b>			
<b>Field Station#</b>		<b>Field Station#</b>			
<b>Pic 17 Desc.</b>		<b>Pic 18 Desc.</b>

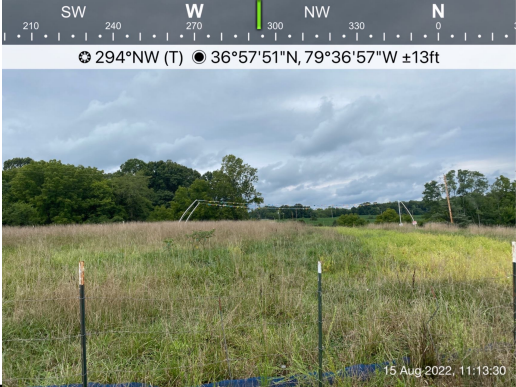
<b>GPS Location</b>	0	<b>GPS Location</b>	0		
<b>Field Station#</b>	14994+00	<b>Field Station#</b>	15055+83		
<b>Pic 3 Desc.</b>	Approximately 14994+00. Overview of ROW. Permanent vegetation.	<b>Pic 4 Desc.</b>	Approximately 15055+83. Overview of ROW.

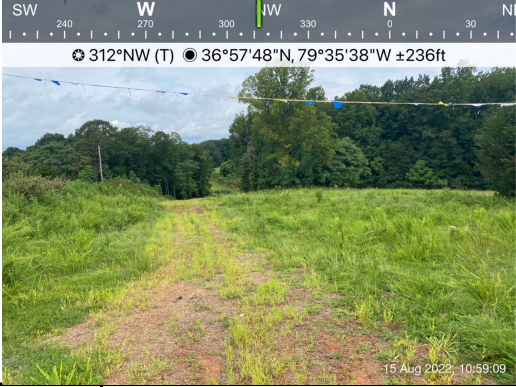
<b>GPS Location</b>	0	<b>GPS Location</b>	0		
<b>Field Station#</b>	15061+00	<b>Field Station#</b>	14932+89		
<b>Pic 5 Desc.</b>	Approximately 15061+00. Overview of ROW.	<b>Pic 6 Desc.</b>	Approximately 14932+89. Overview of stream crossing, equipment bridge, ROW and ECDs at stream S-G15.

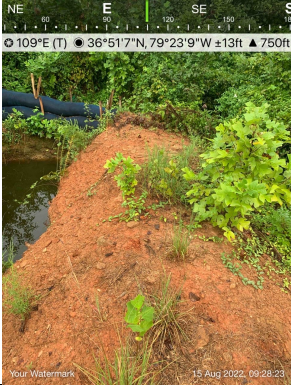
<p>Insert image here</p>		<p>Insert image here</p>	
<b>GPS Location</b>	O	<b>GPS Location</b>			
<b>Field Station#</b>	15851+00	<b>Field Station#</b>			
<b>Pic 7 Desc.</b>	Observing end of water bar that needs to be stabilized	<b>Pic 8 Desc.</b>			
<p>Insert image here</p>		<p>Insert image here</p>			
<b>GPS Location</b>		<b>GPS Location</b>			
<b>Field Station#</b>		<b>Field Station#</b>			
<b>Pic 9 Desc.</b>		<b>Pic 10 Desc.</b>			
<p>Insert image here</p>		<p>Insert image here</p>			
<b>GPS Location</b>		<b>GPS Location</b>			
<b>Field Station#</b>		<b>Field Station#</b>			
<b>Pic 11 Desc.</b>		<b>Pic 12 Desc.</b>

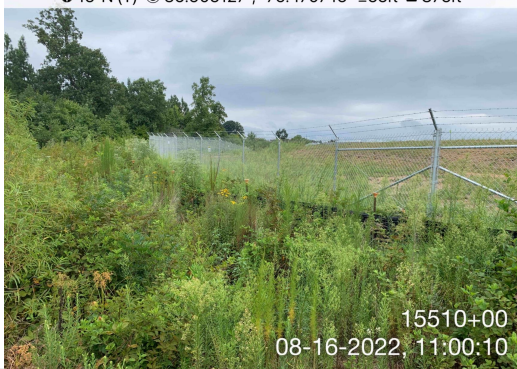
<b>GPS Location</b>	0	<b>GPS Location</b>	0		
<b>Field Station#</b>	15510+00	<b>Field Station#</b>	15578+00		
<b>Pic 9 Desc.</b>	Solar farm perimeter ECDs appear to be in acceptable conditions		<b>Pic 10 Desc.</b>	Temporary vegetative stabilization in acceptable condition

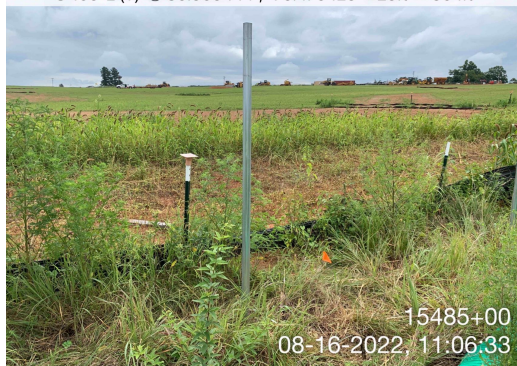
<div style="text-align: center; height: 150px;">Insert image here</div>			
<b>GPS Location</b>	0	<b>GPS Location</b>	0		
<b>Field Station#</b>	15485+00	<b>Field Station#</b>			
<b>Pic 11 Desc.</b>	Solar farm perimeter super silt fence is down where their fencing crew is working		<b>Pic 12 Desc.</b>

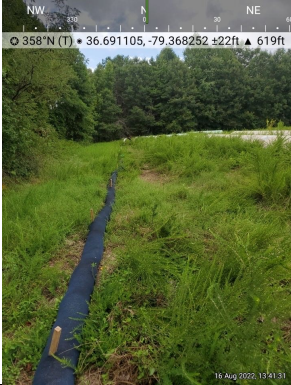
<b>GPS Location</b>	0	<b>GPS Location</b>	0		
<b>Field Station#</b>	0+00	<b>Field Station#</b>	0+00		
<b>Pic 7 Desc.</b>	LY-048 West perimeter CFS	<b>Pic 8 Desc.</b>	LY-048 North perimeter CFS		
Insert image here		Insert image here			
<b>GPS Location</b>		<b>GPS Location</b>			
<b>Field Station#</b>		<b>Field Station#</b>			
<b>Pic 9 Desc.</b>		<b>Pic 10 Desc.</b>			
Insert image here		Insert image here			
<b>GPS Location</b>		<b>GPS Location</b>			
<b>Field Station#</b>		<b>Field Station#</b>			
<b>Pic 11 Desc.</b>		<b>Pic 12 Desc.</b>

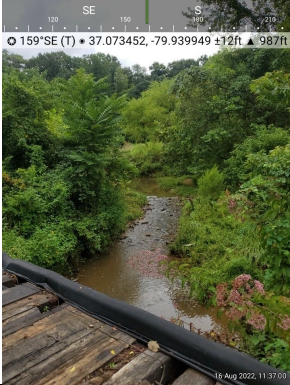
<b>GPS Location</b>	0	<b>GPS Location</b>	0		
<b>Field Station#</b>	13794+57	<b>Field Station#</b>	13800+00		
<b>Pic 9 Desc.</b>	S-D22 Banks	<b>Pic 10 Desc.</b>	Temporary vegetation

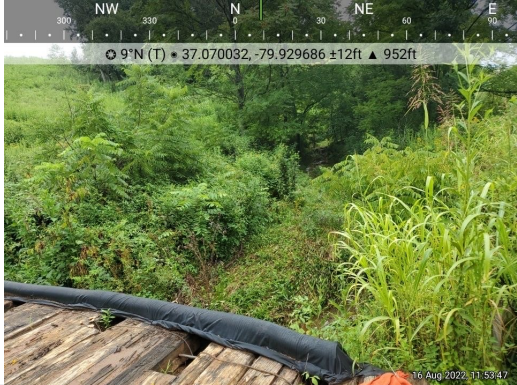
<b>GPS Location</b>	0	<b>GPS Location</b>	0		
<b>Field Station#</b>	13805+00	<b>Field Station#</b>	13805+70		
<b>Pic 11 Desc.</b>	J-hook and Super silt fence	<b>Pic 12 Desc.</b>	S-D18 Vegetated banks

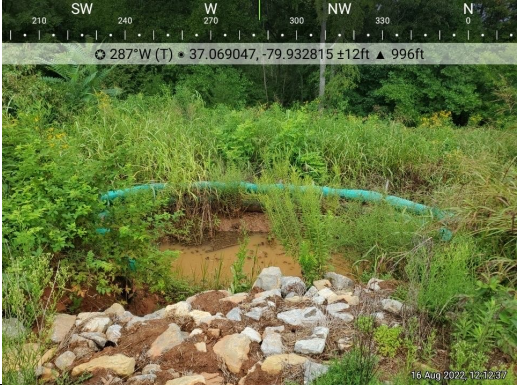
<b>GPS Location</b>	0	<b>GPS Location</b>			
<b>Field Station#</b>	13784+35	<b>Field Station#</b>			
<b>Pic 13 Desc.</b>	MVP-FR-300 Sump along access road.	<b>Pic 14 Desc.</b>			
Insert image here		Insert image here			
<b>GPS Location</b>		<b>GPS Location</b>			
<b>Field Station#</b>		<b>Field Station#</b>			
<b>Pic 15 Desc.</b>		<b>Pic 16 Desc.</b>			
Insert image here		Insert image here			
<b>GPS Location</b>		<b>GPS Location</b>			
<b>Field Station#</b>		<b>Field Station#</b>			
<b>Pic 17 Desc.</b>		<b>Pic 18 Desc.</b>

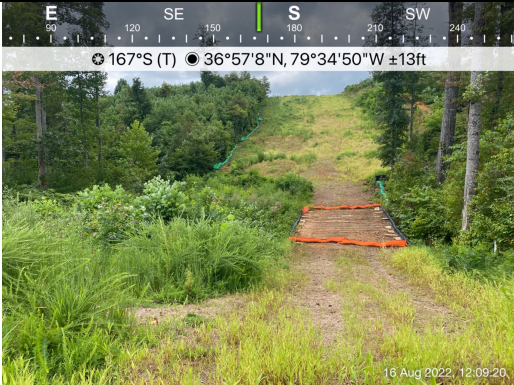
<b>GPS Location</b>	0	<b>GPS Location</b>	0		
<b>Field Station#</b>	15138+00	<b>Field Station#</b>	15131+00		
<b>Pic 1 Desc.</b>	Approximately 15138+00. Overview of ROW.		<b>Pic 2 Desc.</b>	Approximately 15131+00. Overview of ROW.

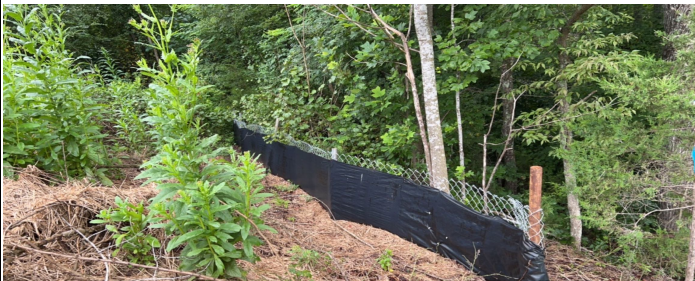
GPS Location	3		GPS Location	4	
Field Station#	14676+75		Field Station#	14680+29	
Pic 3 Desc.	RCE at access road in good condition.		Pic 4 Desc.	Equipment bridge and surrounding ECDs in place and functional at stream crossing and resource buffer.

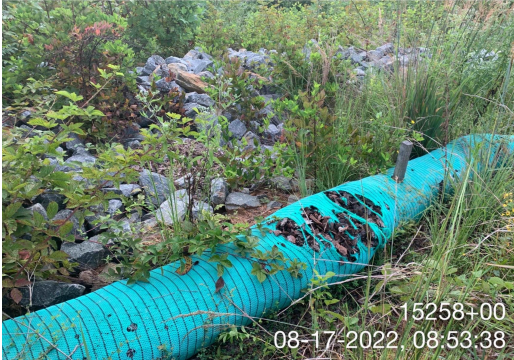
15258+00 08-17-2022, 08:53:38		15254+00 08-17-2022, 08:58:30			
<b>GPS Location</b>	0	<b>GPS Location</b>	0		
<b>Field Station#</b>	15258+00	<b>Field Station#</b>	15254+00		
<b>Pic 1 Desc.</b>	CFS damaged by wildlife from 15258+00 to 15259+00 at MVP-ATWS-1522		<b>Pic 2 Desc.</b>	Perimeter 18" triple stack CFS damaged by wildlife from 15253+00 to 15254+00	
56°NE (T) 36.937793°, -79.552749° ±249ft ▲ 803ft

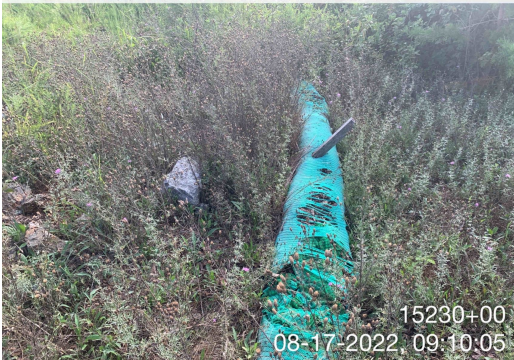
15230+00 08-17-2022, 09:10:05		15223+00 08-17-2022, 09:25:24			
<b>GPS Location</b>	0	<b>GPS Location</b>	0		
<b>Field Station#</b>	15230+00	<b>Field Station#</b>	15223+00		
<b>Pic 3 Desc.</b>	CFS is deteriorated from 15230+00 to 15231+00		<b>Pic 4 Desc.</b>	Waterbar end treatment in acceptable condition

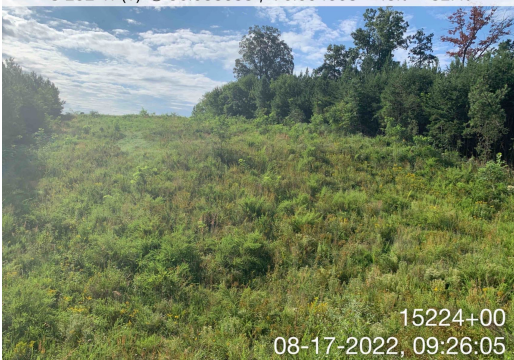
15224+00 08-17-2022, 09:26:05		15168+00 08-17-2022, 12:40:44			
<b>GPS Location</b>	0	<b>GPS Location</b>	0		
<b>Field Station#</b>	15224+00	<b>Field Station#</b>	15168+00		
<b>Pic 5 Desc.</b>	Permanent vegetative stabilization in acceptable condition		<b>Pic 6 Desc.</b>	Sensitive resource buffer in acceptable condition

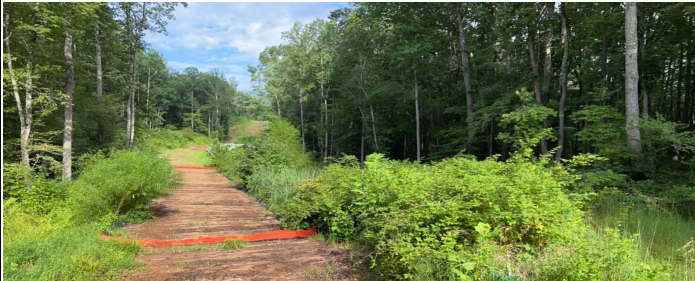
<b>GPS Location</b>	3		<b>GPS Location</b>	4	
<b>Field Station#</b>	14335+00		<b>Field Station#</b>	14338+56	
<b>Pic 3 Desc.</b>	Temporary diversion berm stabilized and vegetated.		<b>Pic 4 Desc.</b>	Equipment bridge and surrounding ECDs in place and functional at stream crossing and resource buffer.

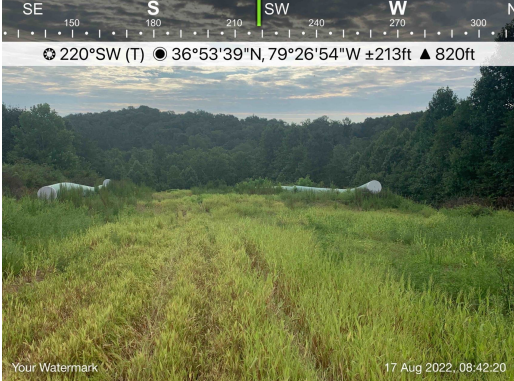
<b>GPS Location</b>	O	<b>GPS Location</b>	O		
<b>Field Station#</b>	15590+00	<b>Field Station#</b>	15588+00		
<b>Pic 1 Desc.</b>	Observing temporary stabilization and water bars	<b>Pic 2 Desc.</b>	Observing temporary stabilization, sump and end treatment

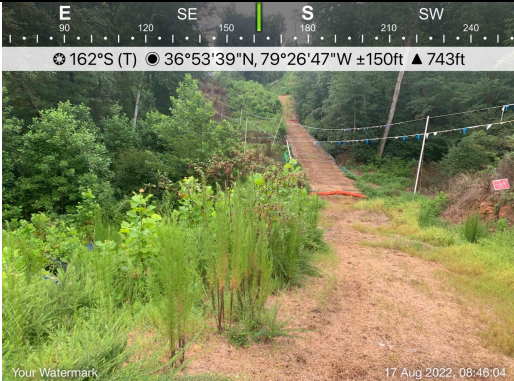
<b>GPS Location</b>	O	<b>GPS Location</b>	O		
<b>Field Station#</b>	15595+60	<b>Field Station#</b>	15619+48		
<b>Pic 3 Desc.</b>	Observing temporary stabilization, buffer, equipment crossing and ECD's	<b>Pic 4 Desc.</b>	Observing road crossing and RCE's

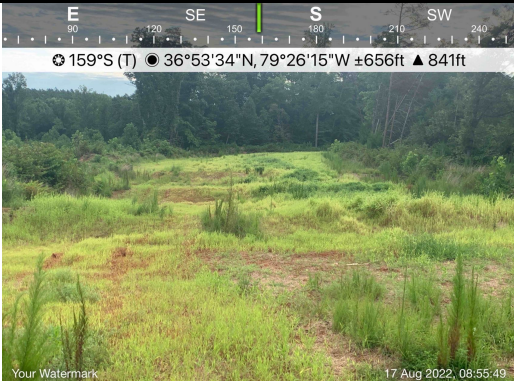
<b>GPS Location</b>	O	<b>GPS Location</b>	O		
<b>Field Station#</b>	15623+00	<b>Field Station#</b>	15632+00		
<b>Pic 5 Desc.</b>	Observing temporary stabilization, CWD berm and water bars	<b>Pic 6 Desc.</b>	Observing temporary stabilization, CWD outlet and ECD's

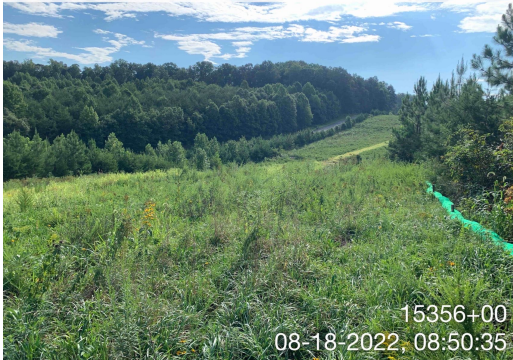
</div> <div>15354+08 08-18-2022, 08:57:32</div>				
GPS Location		0		GPS Location		0	
Field Station#		15356+00		Field Station#		15354+08	
Pic 1 Desc.		Permanent vegetative stabilization and perimeter CFS in acceptable conditions		Pic 2 Desc.		CFS in acceptable condition	
<div>243°SW (T) 36.924744°, -79.516471° ±26ft ▲ 713ft</div> <div>

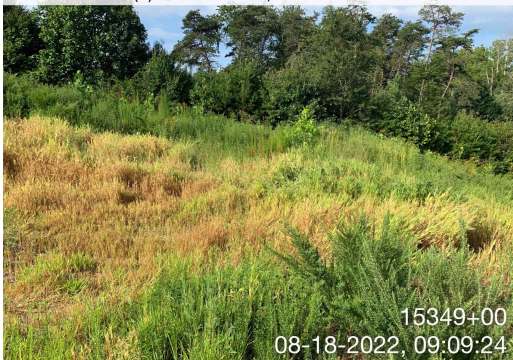
</div> <div>15349+00 08-18-2022, 09:09:57</div>				
GPS Location		0		GPS Location		0	
Field Station#		15349+00		Field Station#		15349+00	
Pic 3 Desc.		Waterbar in acceptable condition		Pic 4 Desc.		Waterbar end treatment in acceptable condition

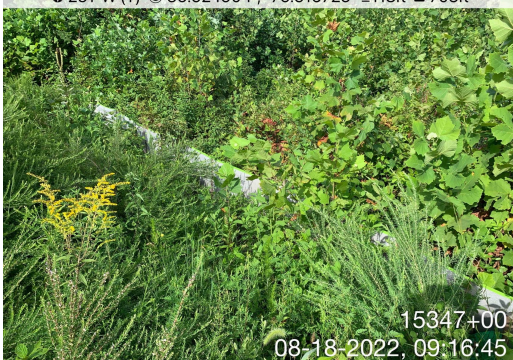
</div> <div>15328+00 08-18-2022, 09:48:00</div>				
GPS Location		0		GPS Location		0	
Field Station#		15347+00		Field Station#		15328+00	
Pic 5 Desc.		P1 silt fence in acceptable condition		Pic 6 Desc.		Temporary vegetative stabilization in acceptable condition

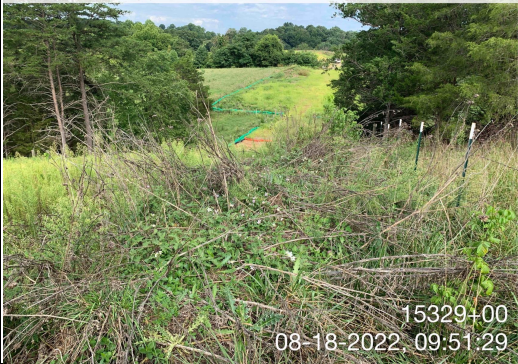
<b>GPS Location</b>	0	<b>GPS Location</b>	0		
<b>Field Station#</b>	15329+00	<b>Field Station#</b>	15303+00		
<b>Pic 7 Desc.</b>	Clean water diversion berm and temporary vegetative stabilization in acceptable conditions	<b>Pic 8 Desc.</b>	Sump pit in acceptable condition		
Insert image here		Insert image here			
<b>GPS Location</b>	0	<b>GPS Location</b>	0		
<b>Field Station#</b>		<b>Field Station#</b>			
<b>Pic 9 Desc.</b>		<b>Pic 10 Desc.</b>			
Insert image here		Insert image here			
<b>GPS Location</b>		<b>GPS Location</b>			
<b>Field Station#</b>		<b>Field Station#</b>			
<b>Pic 11 Desc.</b>		<b>Pic 12 Desc.</b>

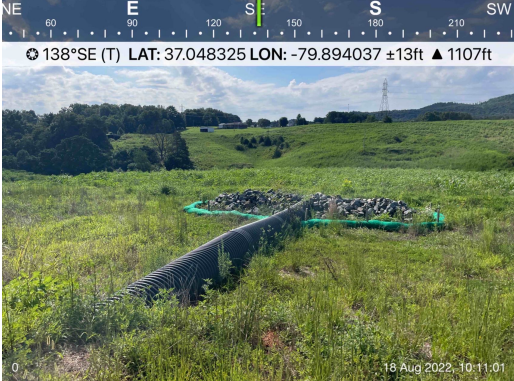
<b>GPS Location</b>	See photo		<b>GPS Location</b>	See photo	
<b>Field Station#</b>	13960+00		<b>Field Station#</b>	13997+50	
<b>Pic 1 Desc.</b>	CWDs are functioning as intended		<b>Pic 2 Desc.</b>	P1 is in good condition at all stream and wetland buffers

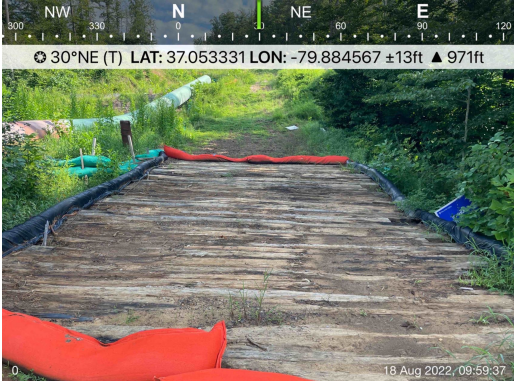
<b>GPS Location</b>	See photo		<b>GPS Location</b>	See photo	
<b>Field Station#</b>	13998+15		<b>Field Station#</b>	14000+00	
<b>Pic 3 Desc.</b>	Equipment bridge ECDs are in good condition and functioning		<b>Pic 4 Desc.</b>	No evidence of 3rd party pond discharging onto ROW.

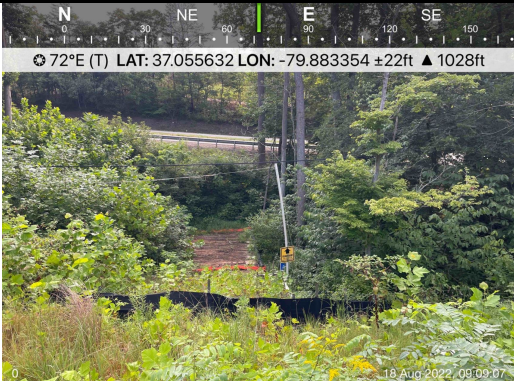
<b>GPS Location</b>	See photo		<b>GPS Location</b>	See photo	
<b>Field Station#</b>	14009+11		<b>Field Station#</b>	14022+00	
<b>Pic 5 Desc.</b>	SSF is in good condition		<b>Pic 6 Desc.</b>	Area needs to be re-stabilized

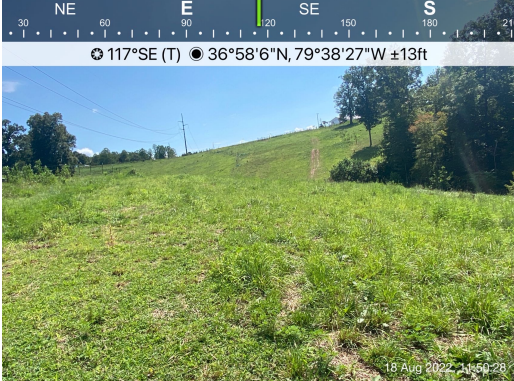
<b>GPS Location</b>	0	<b>GPS Location</b>	0		
<b>Field Station#</b>	14921+00	<b>Field Station#</b>	14907+57		
<b>Pic 1 Desc.</b>	Approximately 14921+00. Overview of ROW. Permanent vegetation. Livestock graze area.	<b>Pic 2 Desc.</b>	Approximately 14907+57. Overview of stream crossing, equipment bridge and ECDs at stream S-DD3.

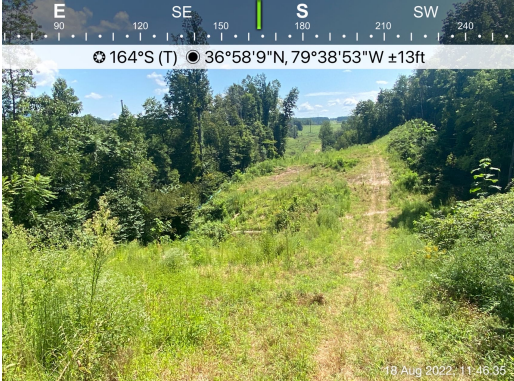
<b>GPS Location</b>	0	<b>GPS Location</b>	0		
<b>Field Station#</b>	14899+00	<b>Field Station#</b>	14823+54		
<b>Pic 3 Desc.</b>	Approximately 14899+00. Overview of ROW.	<b>Pic 4 Desc.</b>	Approximately 14823+54. Overview of stream crossing, equipment bridge and ECDs at stream S-A13.

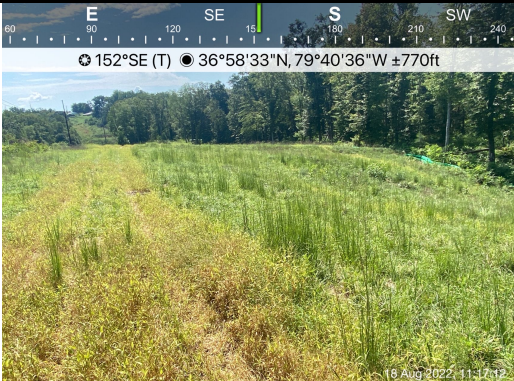
<b>GPS Location</b>	0	<b>GPS Location</b>	0		
<b>Field Station#</b>	14813+00	<b>Field Station#</b>	14804+99		
<b>Pic 5 Desc.</b>	Approximately 14813+00. Overview of ROW. Permanent vegetation.	<b>Pic 6 Desc.</b>	Approximately 14804+99. Overview of stream crossing, equipment bridge and ECDs at stream S-H23.

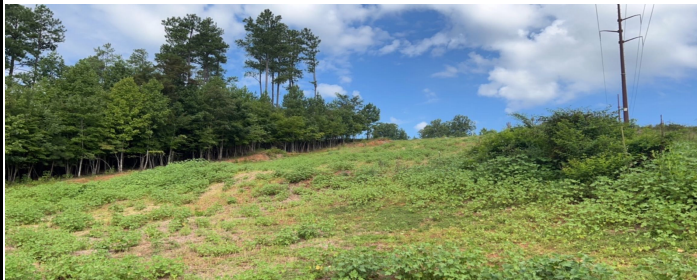
08.18.2022 10:33:10 Accur +/-15.5 Ft ALT 897 Ft			08.18.2022 10:33:33 Accur +/-15.5 Ft ALT 889 Ft		
GPS Location	1	GPS Location	2		
Field Station#	14492+00	Field Station#	14496+69		
Pic 1 Desc.	ROW stabilized and vegetated in temporary area; water bars performing intended functions.		Pic 2 Desc.	Equipment bridge and surrounding ECDs in place and functional at stream crossing and resource buffer.

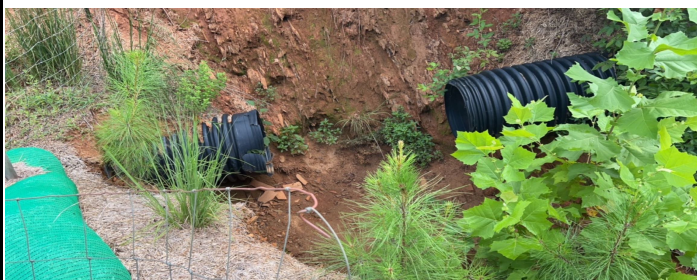
08.18.2022 10:35:18 Accur +/-15.4 Ft ALT 914 Ft			08.18.2022 10:38:56 Accur +/-28.6 Ft ALT 0 Ft		
GPS Location	3	GPS Location	4		
Field Station#	14500+00	Field Station#	14511+00		
Pic 3 Desc.	Slope drain pipe and sump in place and functional.		Pic 4 Desc.	Perimeter SSF in good condition.

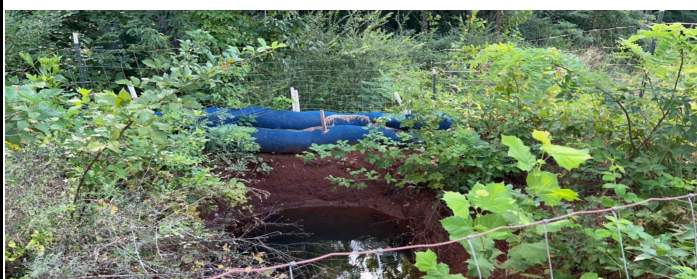
08.18.2022 10:16:45 Accur +/-11.9 Ft ALT 1021 Ft			08.18.2022 10:15:39 Accur +/-15.4 Ft ALT 1023 Ft		
GPS Location	5	GPS Location	6		
Field Station#	14530+00	Field Station#	14531+58		
Pic 5 Desc.	Sump pit and CFS end treatment performing intended functions.		Pic 6 Desc.	Equipment bridge and surrounding ECDs in place and functional at stream crossing and resource buffer.

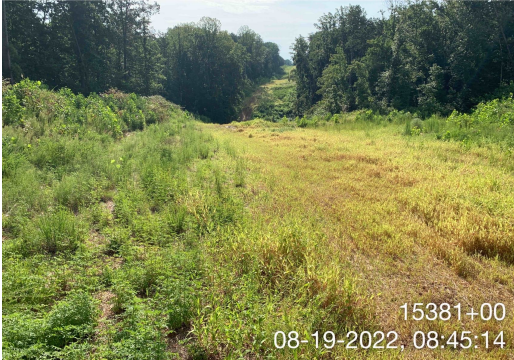
15391+00 08-19-2022, 09:06:09			
<b>GPS Location</b>	0	<b>GPS Location</b>	0		
<b>Field Station#</b>	15381+00	<b>Field Station#</b>	15391+00		
<b>Pic 1 Desc.</b>	Temporary vegetative stabilization in acceptable condition	<b>Pic 2 Desc.</b>	Perimeter CFS in acceptable condition		
108°E (T) 36.920282°, -79.504308° ±767ft ▲784ft

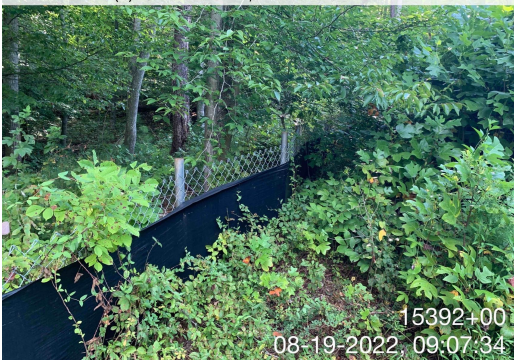
15400+00 08-19-2022, 09:28:51			
<b>GPS Location</b>	0	<b>GPS Location</b>	0		
<b>Field Station#</b>	15392+00	<b>Field Station#</b>	15400+00		
<b>Pic 3 Desc.</b>	Super silt fence in acceptable condition	<b>Pic 4 Desc.</b>	Waterbar in acceptable condition

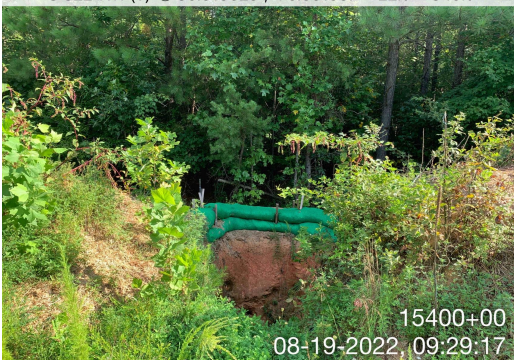
15426+54 08-19-2022, 10:07:55			
<b>GPS Location</b>	0	<b>GPS Location</b>	0		
<b>Field Station#</b>	15400+00	<b>Field Station#</b>	15426+54		
<b>Pic 5 Desc.</b>	Waterbar end treatment in acceptable condition	<b>Pic 6 Desc.</b>	Stream S-G4 is running clear

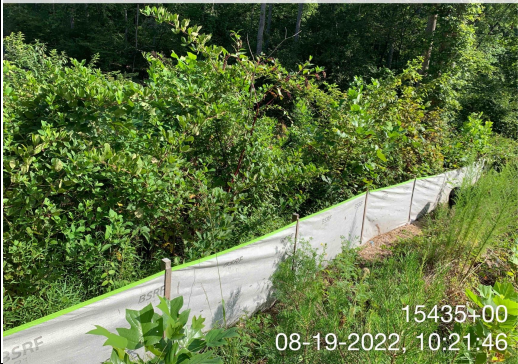
<b>GPS Location</b>	0	<b>GPS Location</b>	0		
<b>Field Station#</b>	15435+00	<b>Field Station#</b>	15452+00		
<b>Pic 7 Desc.</b>	P1 silt fence and sensitive resource buffer in acceptable conditions	<b>Pic 8 Desc.</b>	Temporary vegetative stabilization in acceptable condition

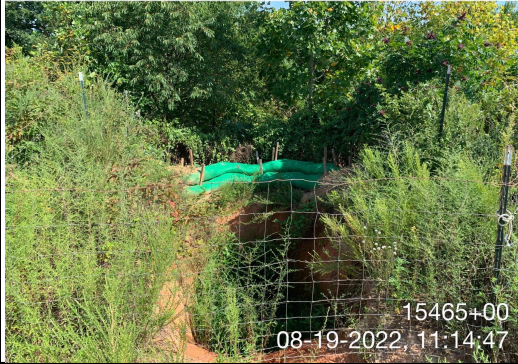
<b>GPS Location</b>	0	<b>GPS Location</b>	0		
<b>Field Station#</b>	15465+00	<b>Field Station#</b>	15477+00		
<b>Pic 9 Desc.</b>	Sump pit in acceptable condition	<b>Pic 10 Desc.</b>	Solar farm perimeter ECDs appear to be in acceptable conditions		
Insert image here		Insert image here			
<b>GPS Location</b>		<b>GPS Location</b>			
<b>Field Station#</b>		<b>Field Station#</b>			
<b>Pic 11 Desc.</b>		<b>Pic 12 Desc.</b>

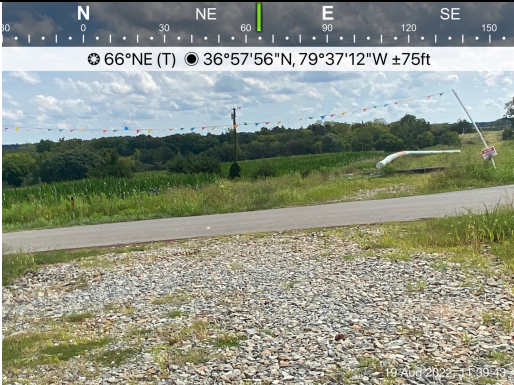
<b>GPS Location</b>	0	<b>GPS Location</b>	0		
<b>Field Station#</b>	14981+50	<b>Field Station#</b>	15028+12		
<b>Pic 3 Desc.</b>	Approximately 14981+50. Overview of road crossing and RCEs.		<b>Pic 4 Desc.</b>	Approximately 15028+12. Overview of stream crossing, equipment bridge and ECDs at stream S-D4.

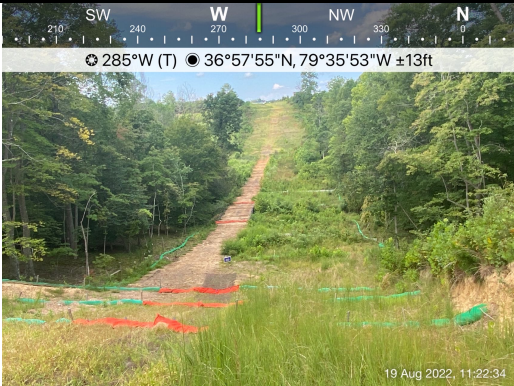
<b>GPS Location</b>	0	<b>GPS Location</b>	0		
<b>Field Station#</b>	15045+00	<b>Field Station#</b>	15061+00		
<b>Pic 5 Desc.</b>	Approximately 15045+00. Overview of ROW.		<b>Pic 6 Desc.</b>	Approximately 15061+00. Overview of ROW.

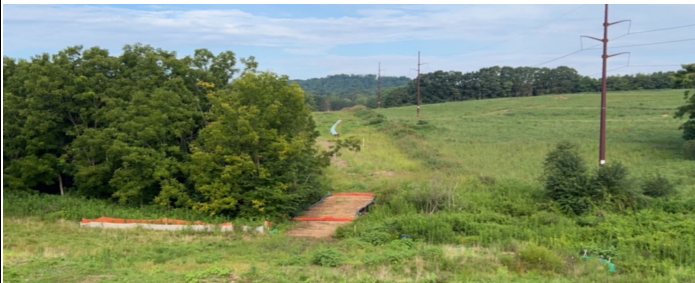
Pic 3 Desc.	Equipment bridge and surrounding ECDs in place and functional at stream crossing and resource buffer.		Pic 4 Desc.	Temporary diversion berm stabilized and vegetated.

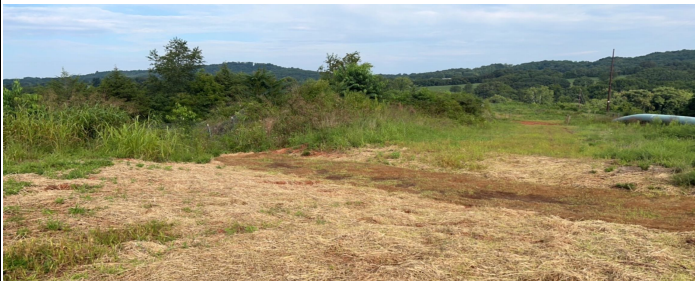
36°59'54" N 79°44'21" W 323°NW COURSE 323' GPS 08.19.2022 09:19:06 753 Simmons Creek Rd, Union Hall, VA 24176, United States Accur +/-15.5 Ft ALT 958 Ft			36°59'59" N 79°44'28" W 8°N COURSE 288' GPS 08.19.2022 09:22:53 753 Simmons Creek Rd, Union Hall, VA 24176, United States Accur +/-15.5 Ft ALT 908 Ft		
GPS Location	5		GPS Location	6	
Field Station#	14595+00		Field Station#	14601+00	
Pic 5 Desc.	Throat of water bar stabilized with erosion control blanket.		Pic 6 Desc.	Water bar performing intended function.

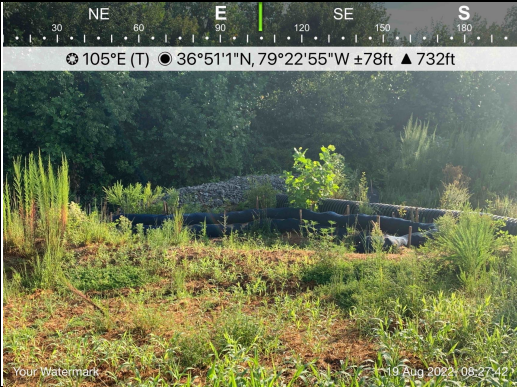
<p>105°E (T) 36°51'1"N, 79°22'55"W ±78ft ▲732ft</p> <p>19 Aug 2022 08:27:42</p>		  <p>159°S (T) 36°50'51"N, 79°22'22"W ±226ft ▲735ft</p> <p>19 Aug 2022 08:32:28</p>			
<b>GPS Location</b>	O	<b>GPS Location</b>	O		
<b>Field Station#</b>	15860+00	<b>Field Station#</b>	15900+00		
<b>Pic 7 Desc.</b>	Observing temporary stabilization,CWD outlet and ECD's	<b>Pic 8 Desc.</b>	Observing temporary stabilization and water bars		
Insert image here		Insert image here			
<b>GPS Location</b>		<b>GPS Location</b>			
<b>Field Station#</b>		<b>Field Station#</b>			
<b>Pic 9 Desc.</b>		<b>Pic 10 Desc.</b>			
Insert image here		Insert image here			
<b>GPS Location</b>		<b>GPS Location</b>			
<b>Field Station#</b>		<b>Field Station#</b>			
<b>Pic 11 Desc.</b>		<b>Pic 12 Desc.</b>
