Baseline Assessment – Stream Attributes

Reach S-J54 (Permanent Access Road)

Harrison County, West Virginia

Title
PROFILE AND CROSS-SECTIONS
BASELINE SURVEY
CROSSING S-J54 - UNNAMED TRIB. TO
LITTLE TENMILE CREEK (MP 15.20)
HARRISON COUNTY, WV

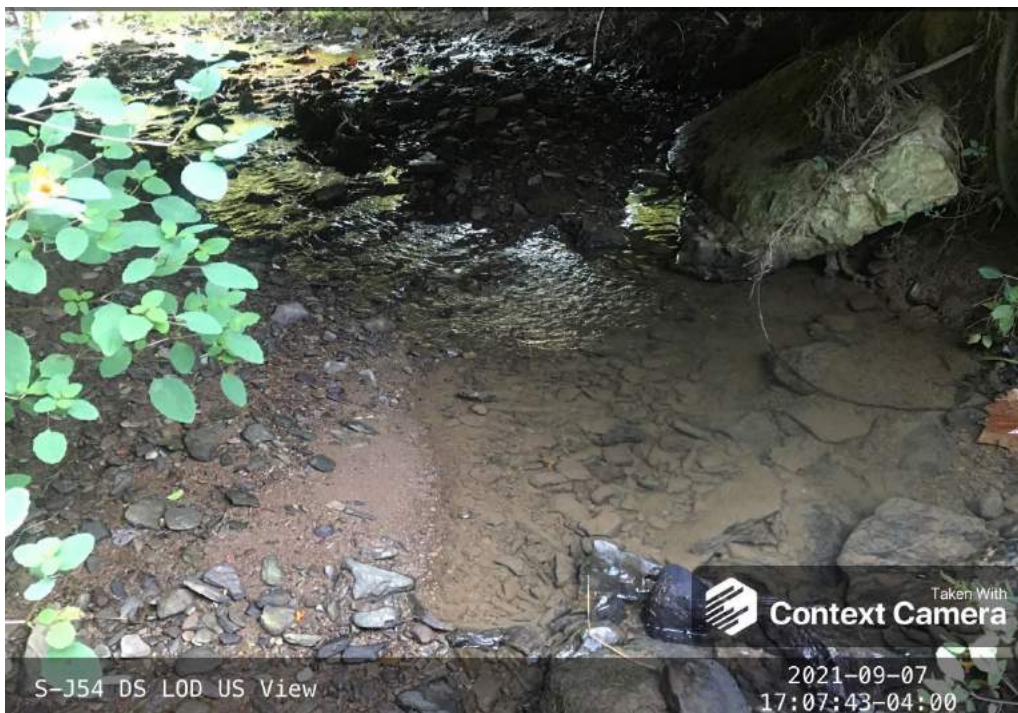
Photo Type: DS, US View

Location, Orientation, Photographer Initials: Downstream Edge of ROW, Upstream View, RFC/AJE
Lat: 39.400324 Long: -80.479967

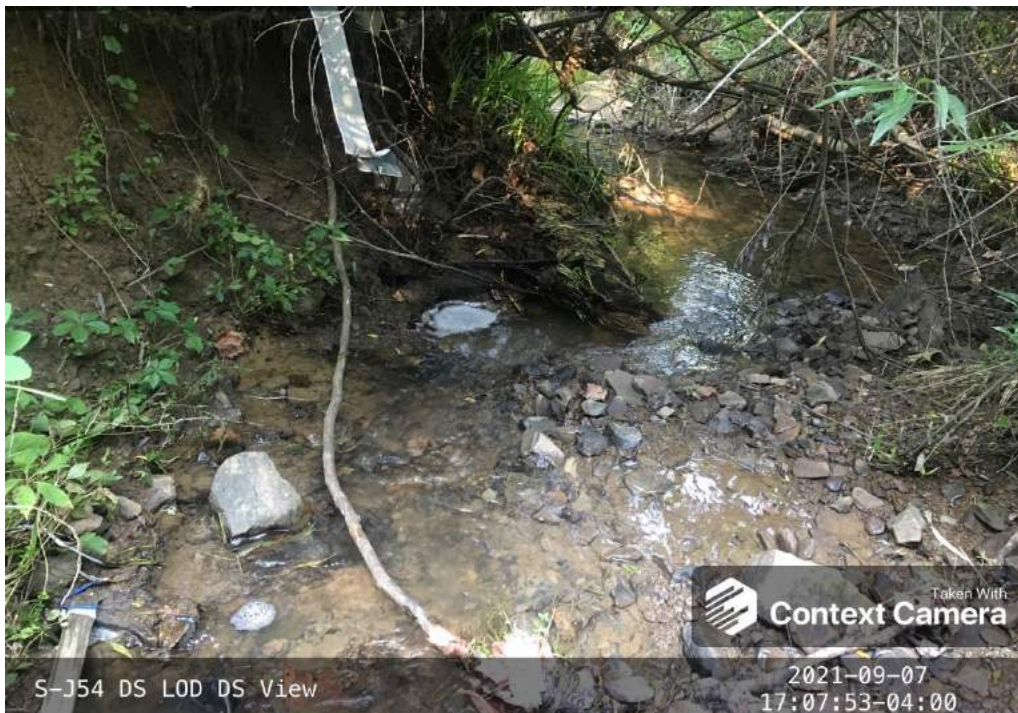
Photo Type: DS, DS View

Location, Orientation, Photographer Initials: Downstream Edge of ROW, Downstream View, RFC/AJE
Lat: 39.400324 Long: -80.479967

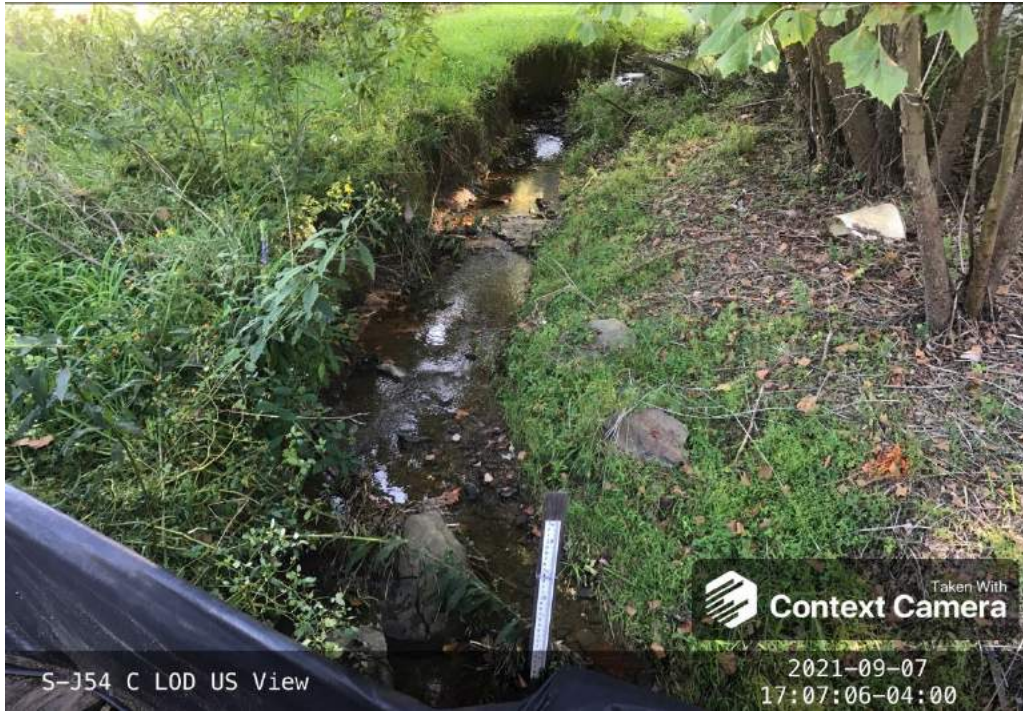
Photo Type: US View at Center
Location, Orientation, Photographer Initials: Center ROW, Upstream View, RFC/AJE
Lat: 39.400324 Long: -80.479967

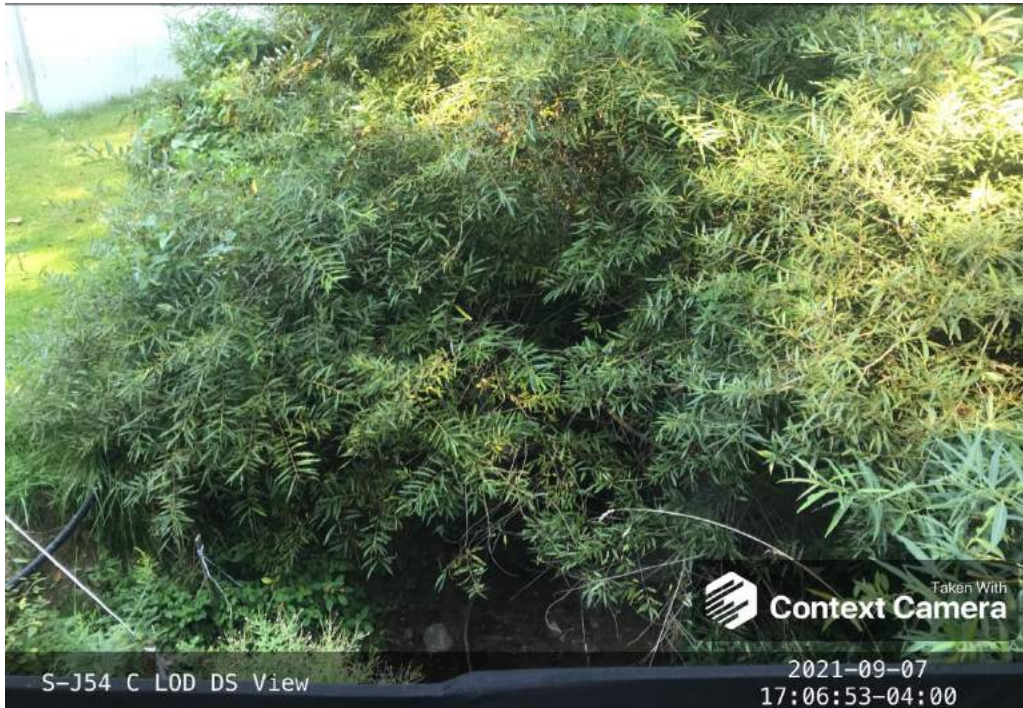
Photo Type: DS View at Center
Location, Orientation, Photographer Initials: ROW Center, Downstream View, RFC/AJE
Lat: 39.400324 Long: -80.479967

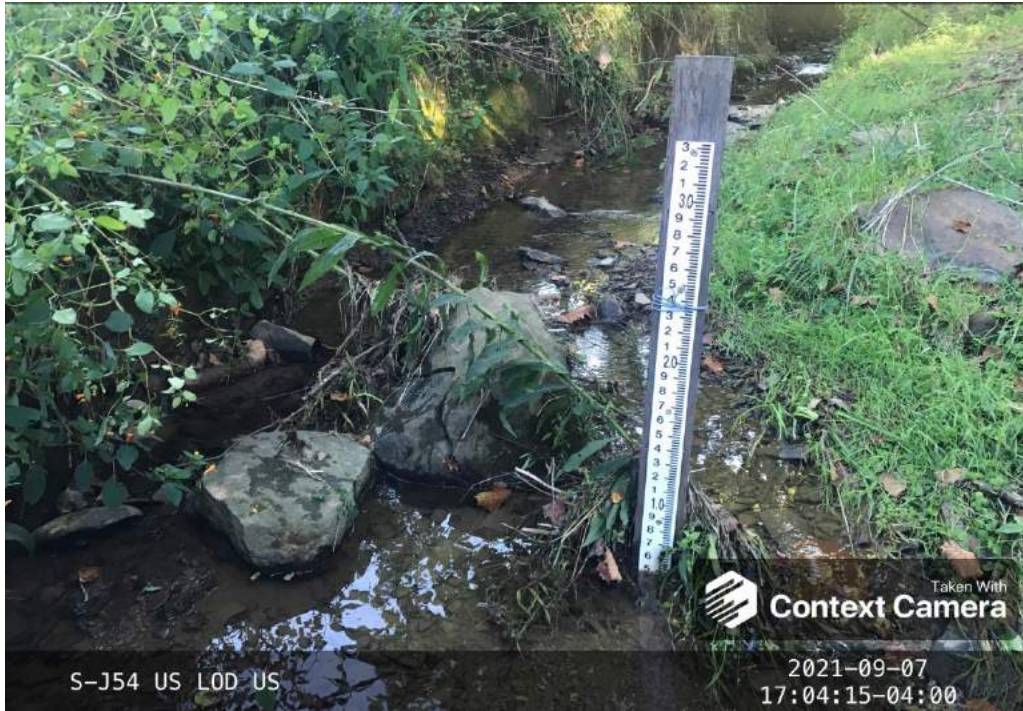
Photo Type: US, US View

Location, Orientation, Photographer Initials: Upstream Edge of ROW, Upstream View, RFC/AJE
Lat: 39.400324 Long: -80.479967

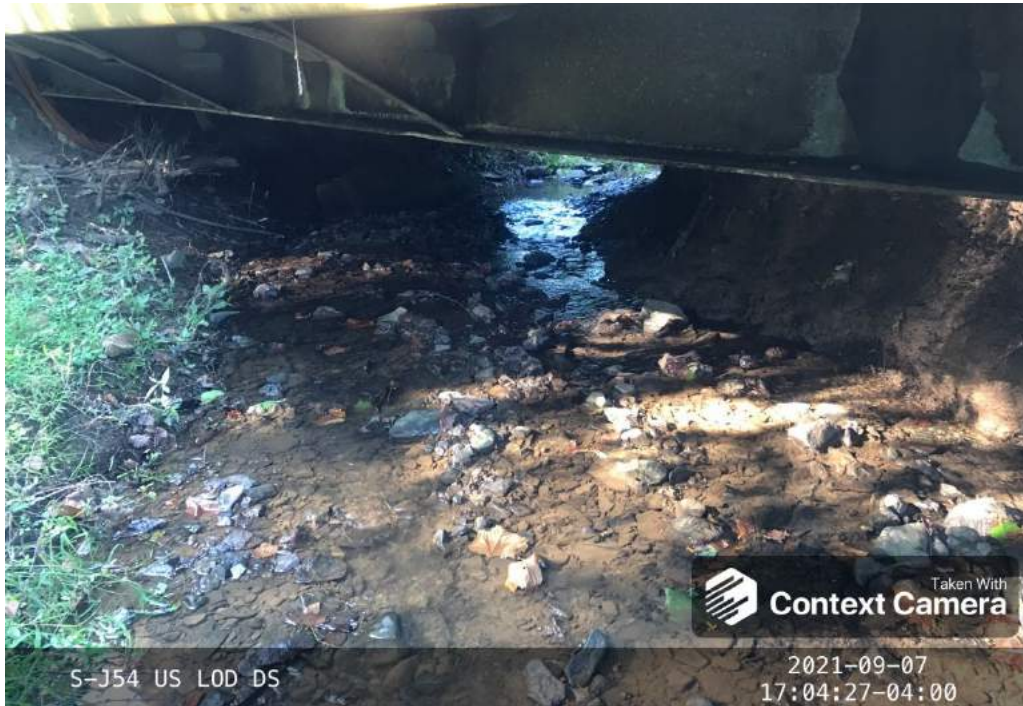
Photo Type: US, DS View

Location, Orientation, Photographer Initials: Upstream Edge of ROW, Downstream View, RFC/AJE
Lat: 39.400324 Long: -80.479967

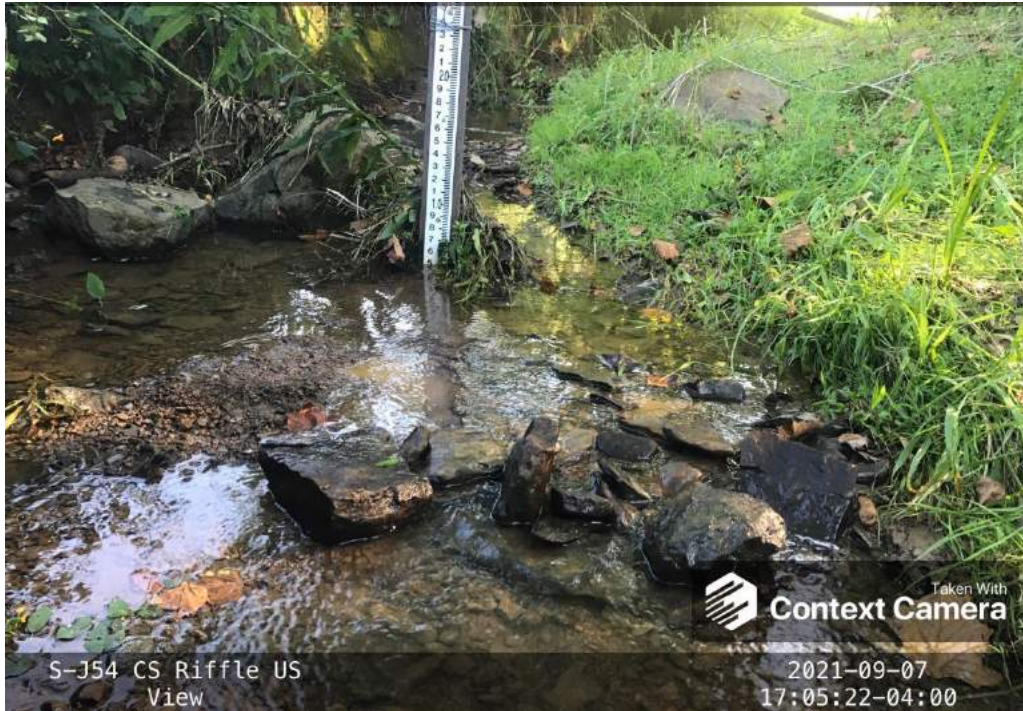
Photo Type: Riffle, US View
Location, Orientation, Photographer Initials: Downstream of Riffle, Upstream View, RFC/AJE
Lat: 39.400324 Long: -80.479967

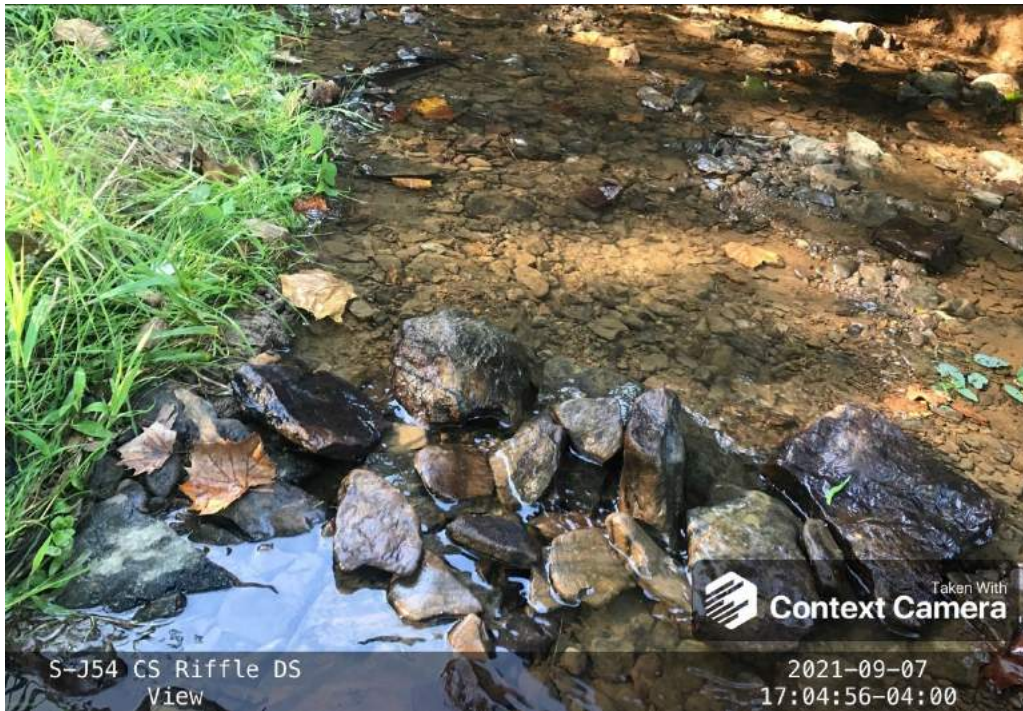
Photo Type: Riffle, DS View
Location, Orientation, Photographer Initials: Upstream of Riffle, Downstream View, RFC/AJE
Lat: 39.400324 Long: -80.479967

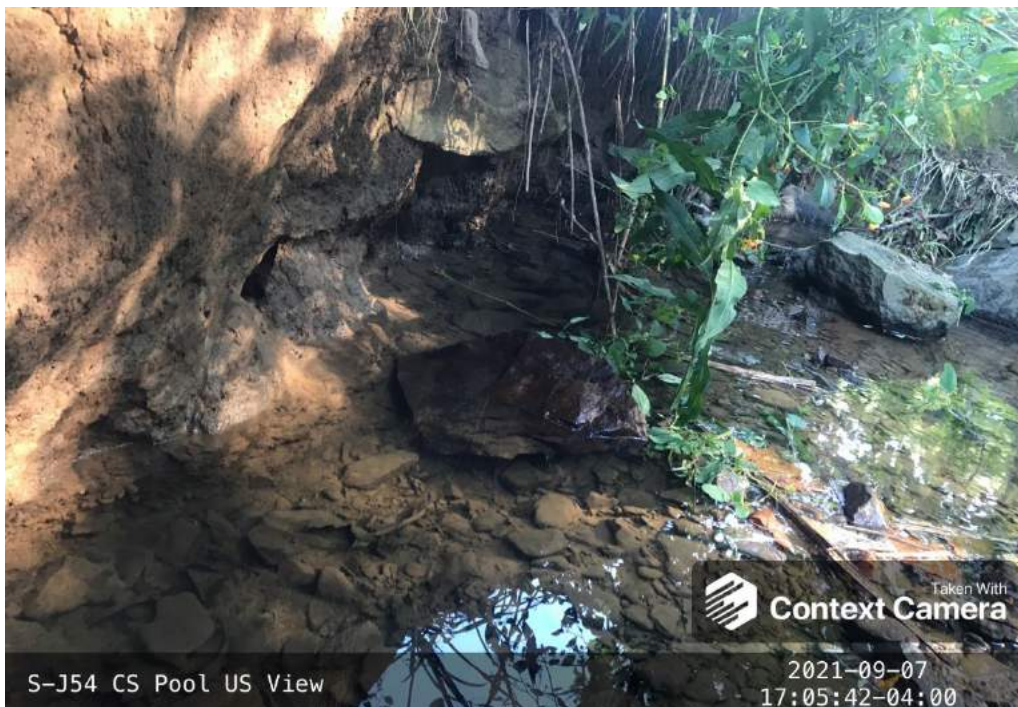
Photo Type: Pool, US View
Location, Orientation, Photographer Initials: Downstream of Pool, Upstream View, RFC/AJE
Lat: 39.400324 Long: -80.479967

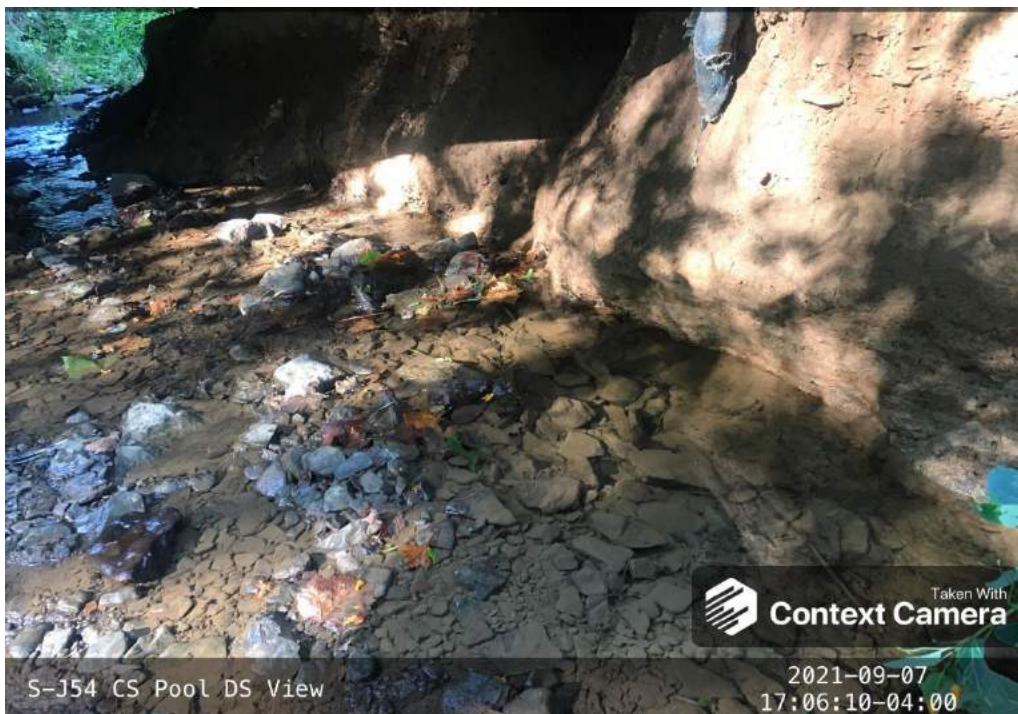
Photo Type: Pool, DS View
Location, Orientation, Photographer Initials: Upstream of Pool, Downstream View, RFC/AJE
Lat: 39.400324 Long: -80.479967

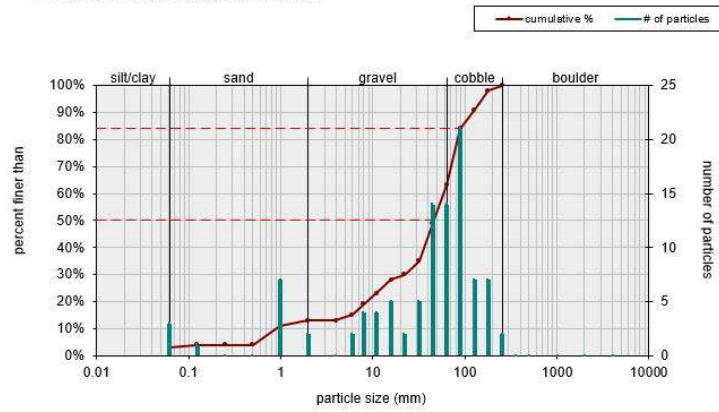
Bankfull Channel Pebble Count, S-J54

Size (mm)			Size Distribution			Type	
D16	6.4	3.4	mean	24.0	silt/clay	3%	
D35	32	12	dispersion	4.6	sand	10%	
D50	46	17	skewness	-0.26	gravel	50%	
D65	66	20			cobble	37%	
D84	90	29			boulder	0%	
D95	160	39

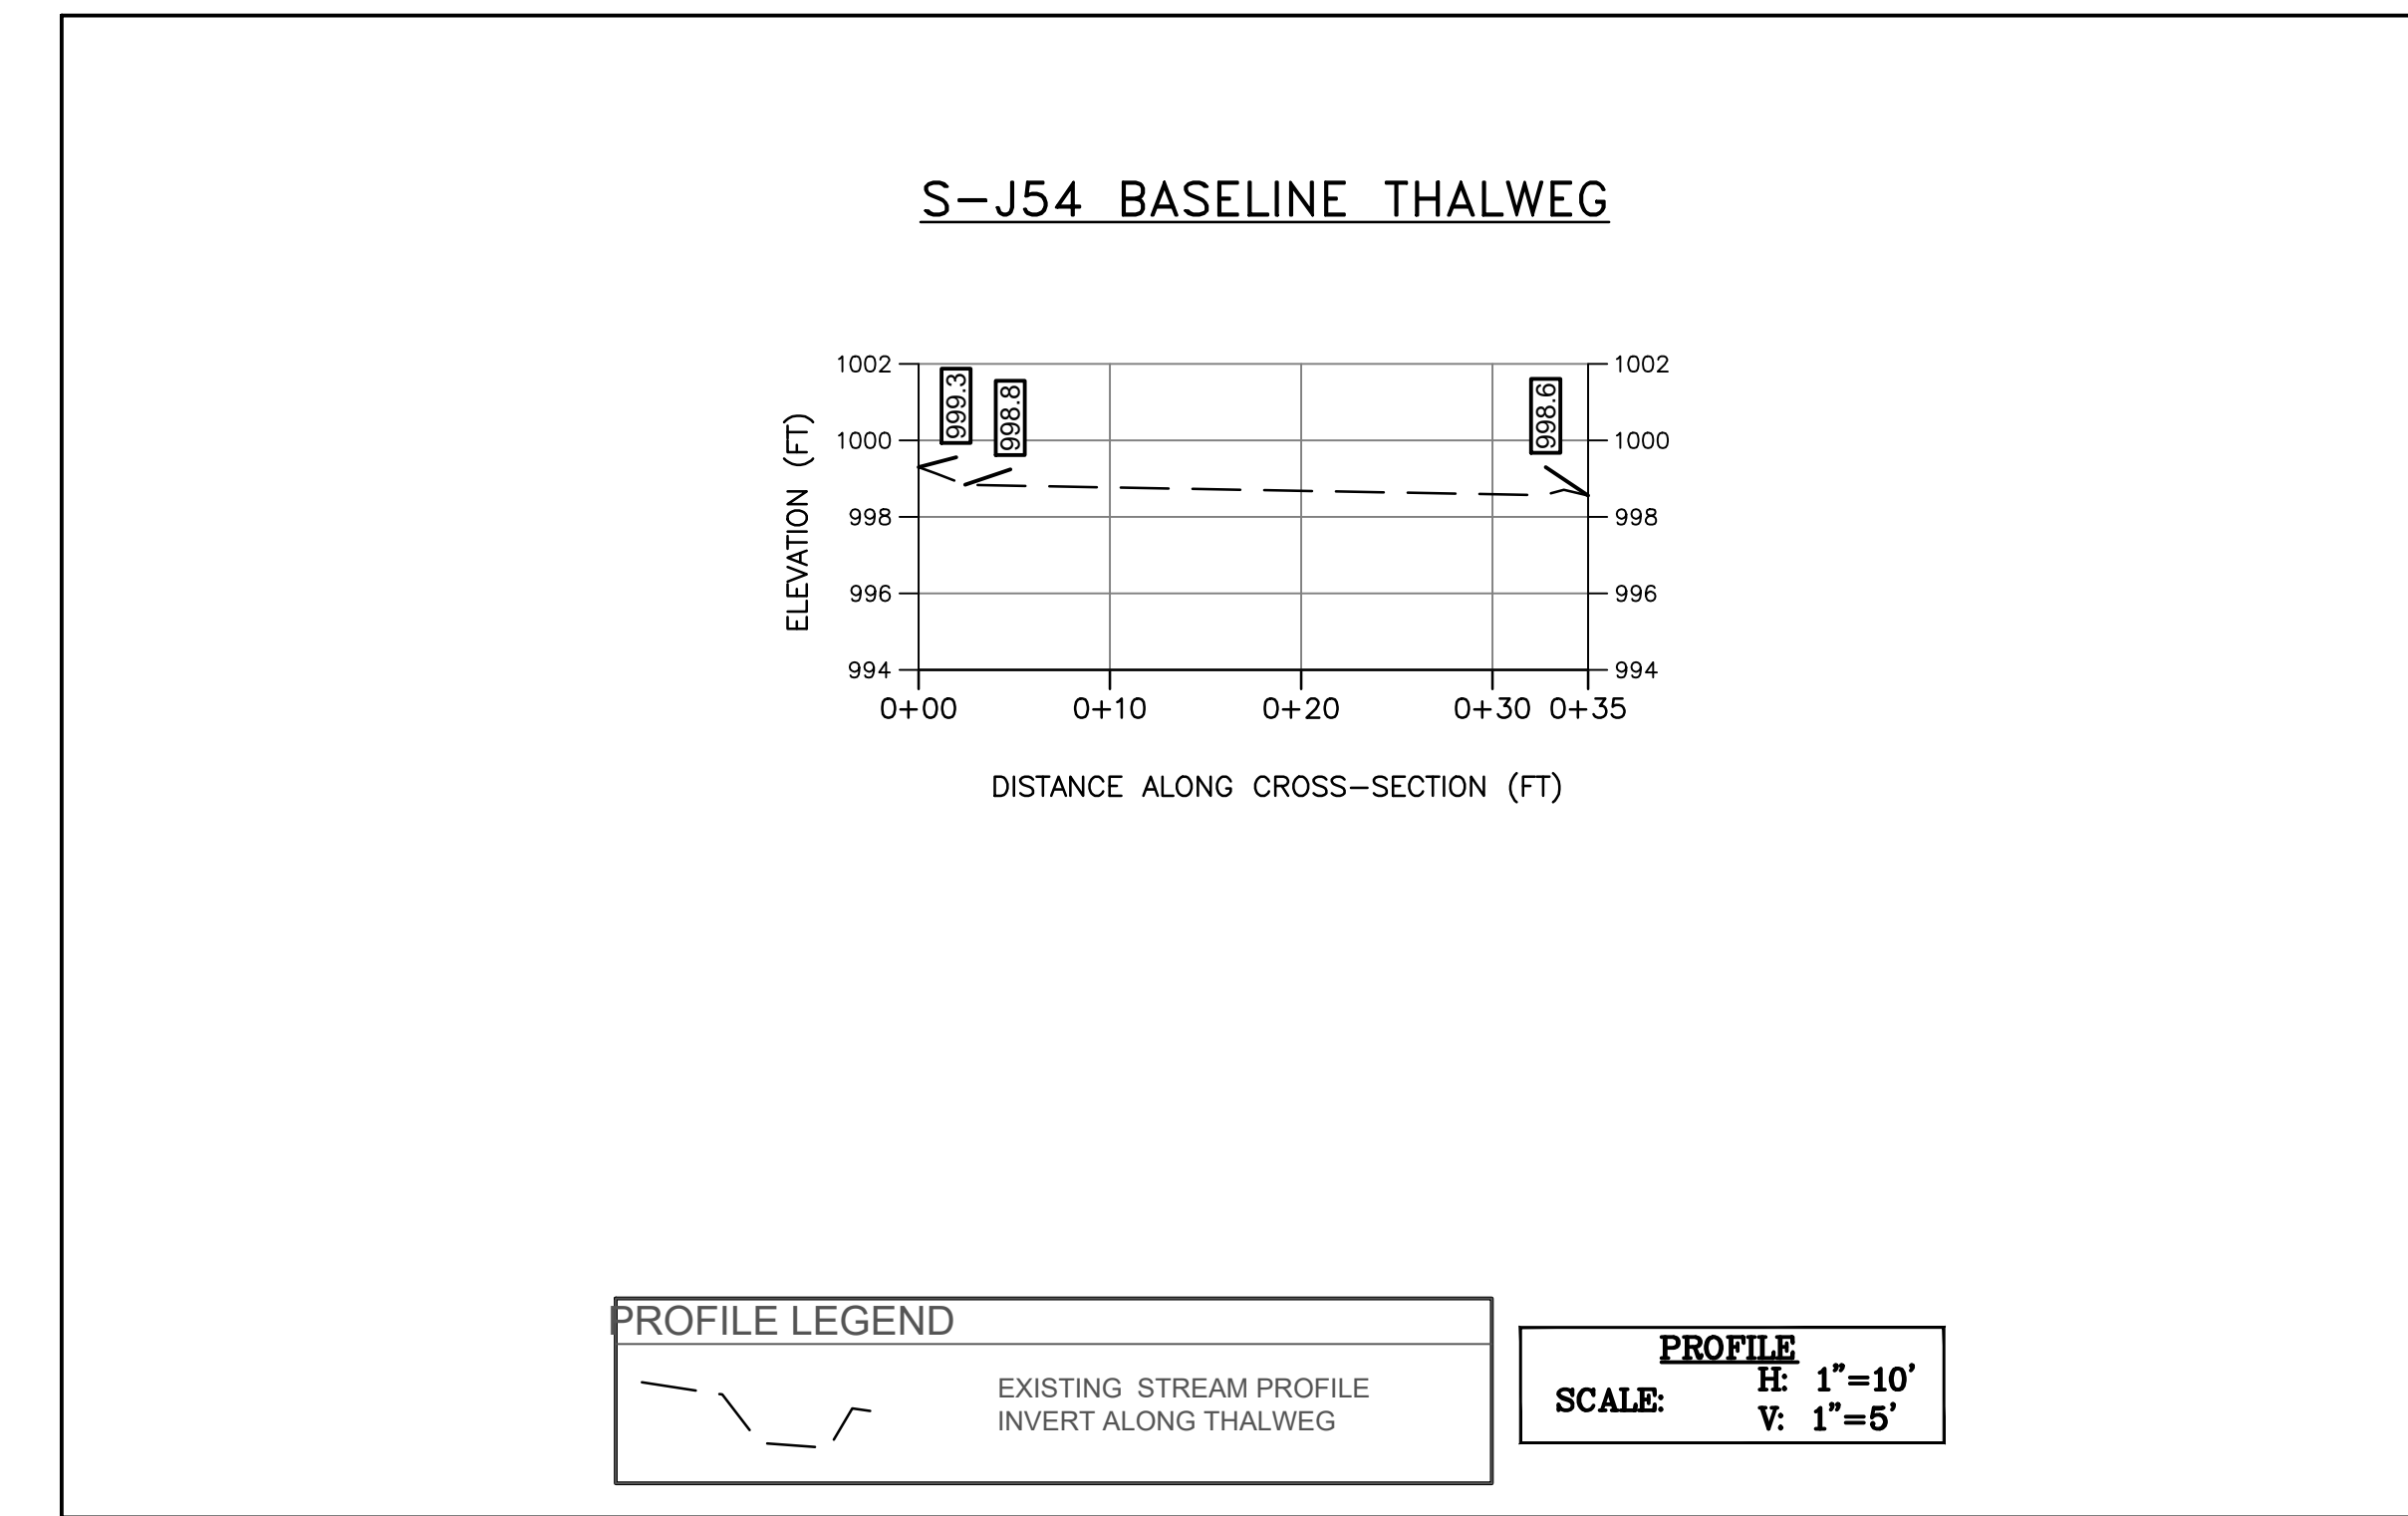
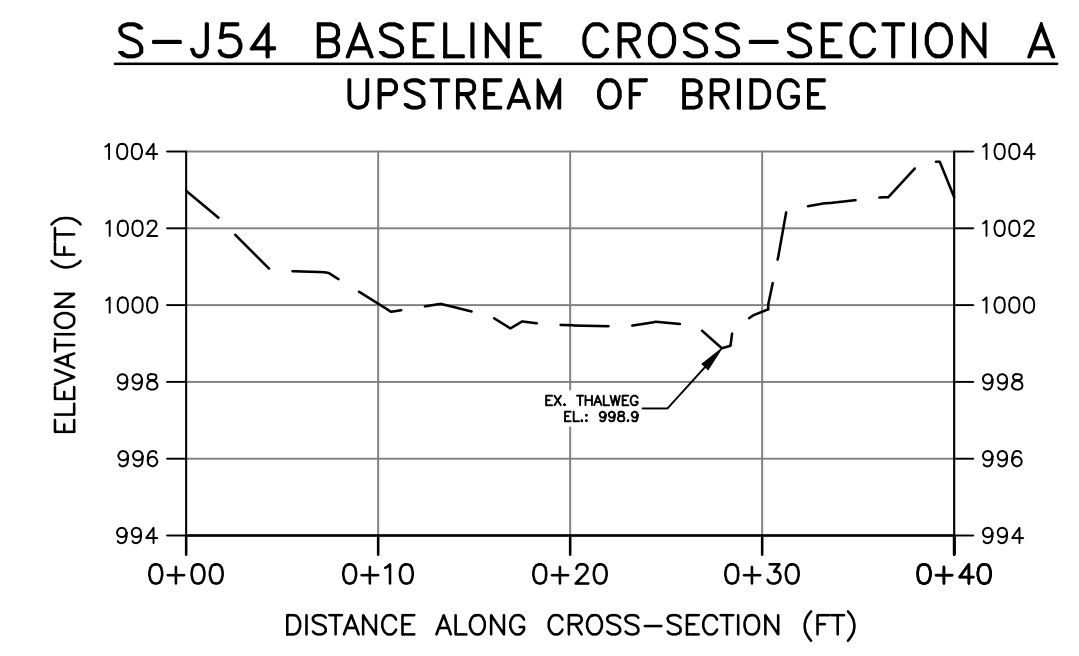
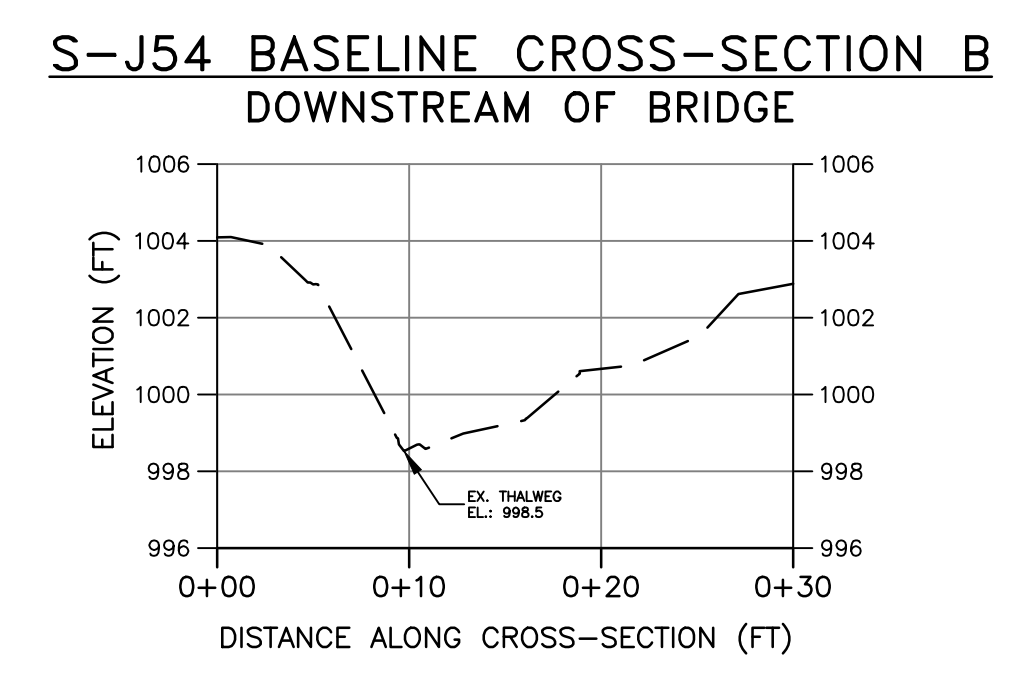
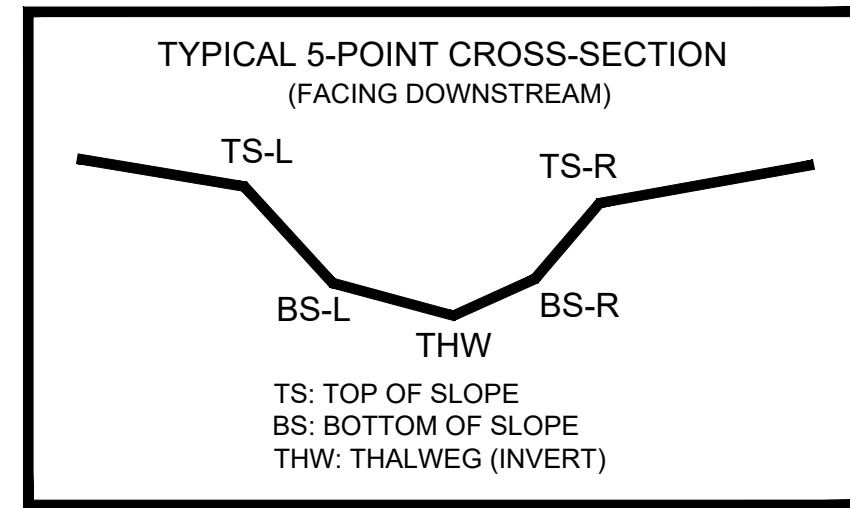
- SURVEY NOTES:**
- THIS MAP HAS BEEN ORIENTED TO NAD 1983 UTM ZONE 17N, AND VERTICALLY TO THE NORTH AMERICAN VERTICAL DATUM OF 1988 (NAVD 88), USING REAL TIME DGPS. FIELD LOCATIONS WERE COMPLETED ON SEPTEMBER 7, 2021.

- EASEMENT LINES SHOWN ON PLAN VIEW WERE PROVIDED BY MOUNTAIN VALLEY PIPELINE.
 - SURVEY POINTS FOR CROSS SECTIONS AND THALWEG PROFILES COLLECTED IN 2021 HAVE BEEN USED IN COMBINATION WITH SURVEY POINTS COLLECTED PREVIOUSLY IN 2020 IN ORDER TO GENERATE THE PRE-CROSSING SURFACE SHOWN IN PLAN. DUE TO NATURAL EROSIONAL STREAM PROCESSES THAT CAN OCCUR OVER TIME, MINOR ADJUSTMENTS TO THE PROFILE ALIGNMENTS MAY HAVE BEEN REQUIRED IN ORDER TO GENERATE A CLEAN PRE-CROSSING SURFACE.

- ALL SECTION VIEWS SHOWN LEFT TO RIGHT FACING DOWNSTREAM.
 - POST-CROSSING SURVEY INFORMATION SHOWN IN RED. DATA PENDING.
 - POST-CROSSING SURVEY POINTS FOR CROSS SECTIONS AND THALWEG ARE PROJECTED ONTO PRE-CROSSING SECTION AND PROFILE VIEWS FOR COMPARISON.

NOTE: ALL SECTIONS VIEWS SHOWN LEFT TO RIGHT FACING DOWNSTREAM.
