Baseline Assessment – Stream Attributes

Reach S-K34 (Timber Mat Crossing) Intermittent Spread C Braxton County, West Virginia

Spread C Stream S-K34 (Timber Mat Crossing) Braxton County

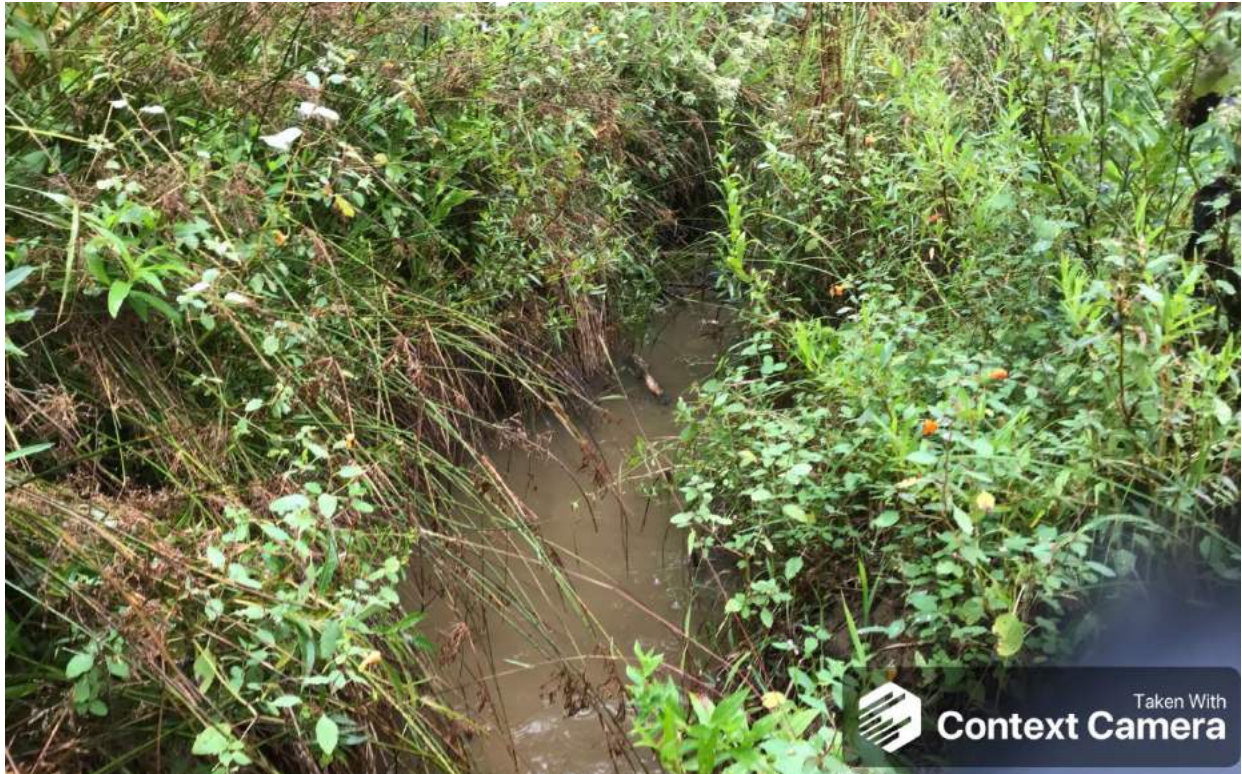
Photo Type: DS, US View
Location, Orientation, Photographer Initials: Downstream Edge of ROW, Upstream View, AE PL
Lat: 38.766123 Long: -80.520308

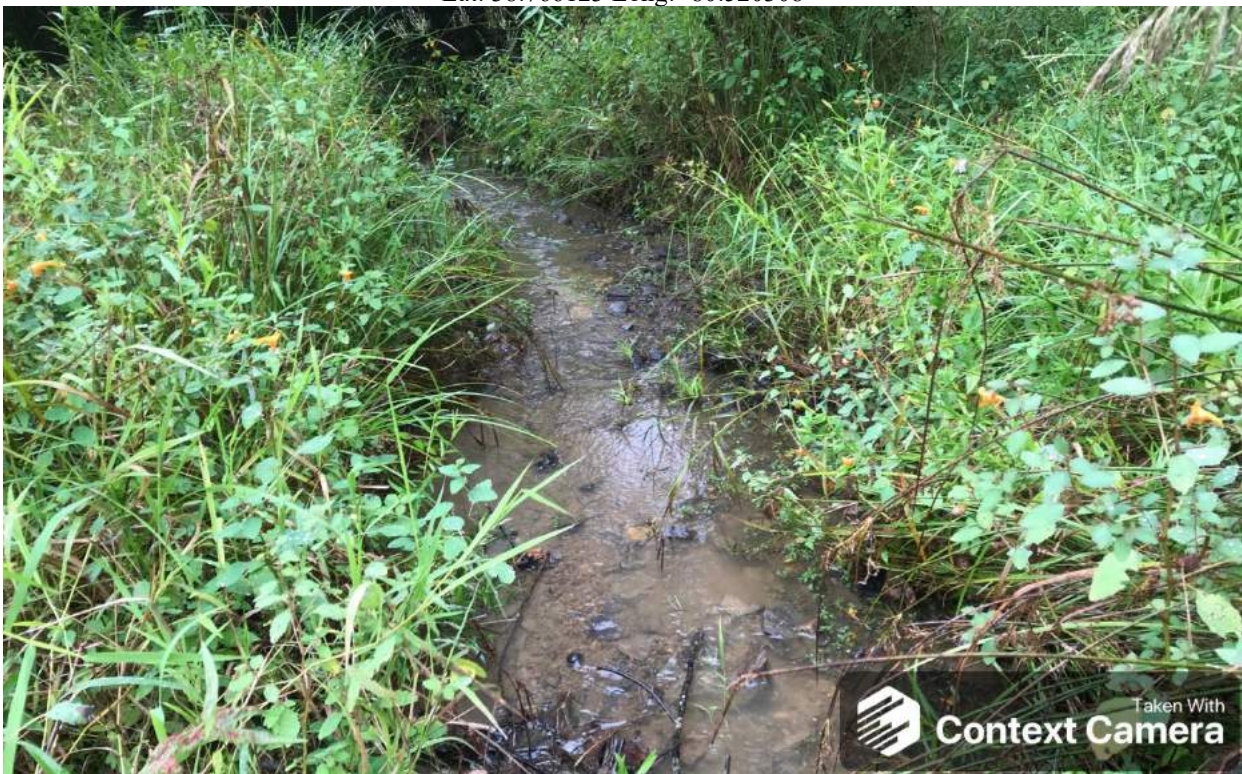
Photo Type: DS, DS View
Location, Orientation, Photographer Initials: Downstream Edge of ROW, Downstream View, AE PL
Lat: 38.766123 Long: -80.520308

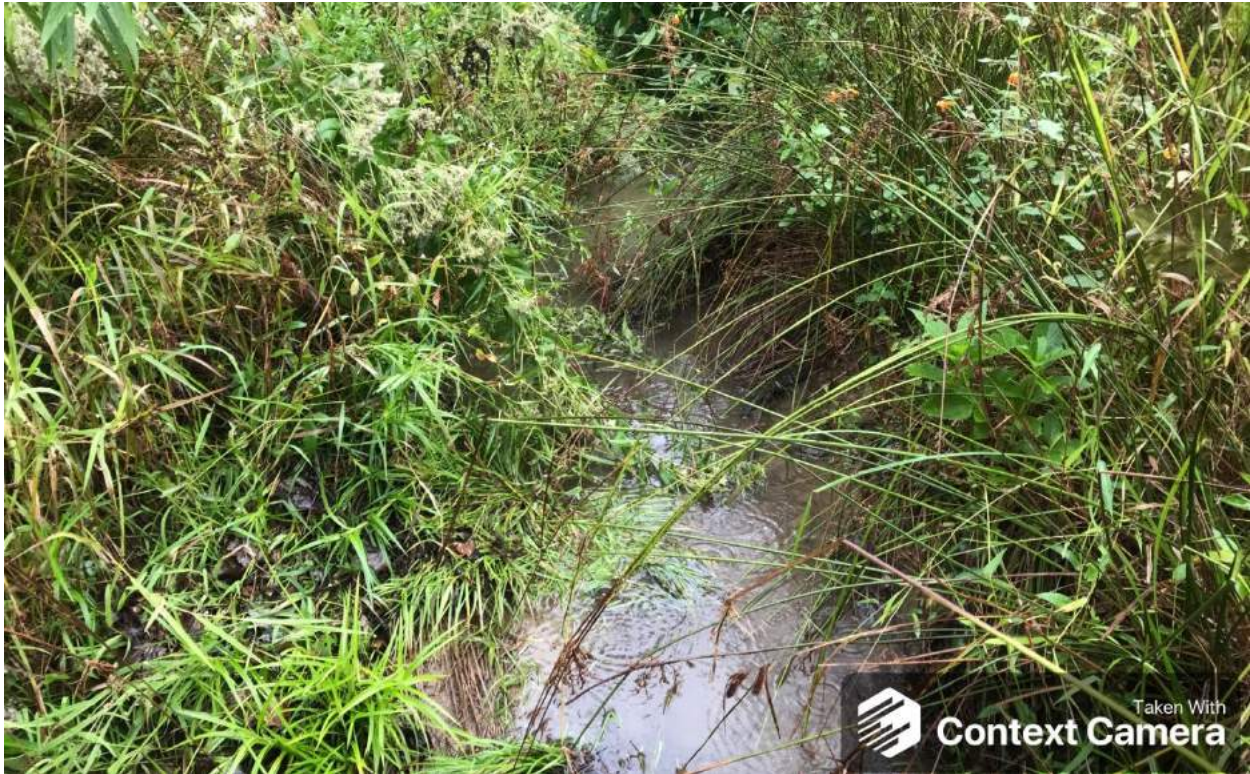
Photo Type: US View at Center
Location, Orientation, Photographer Initials: Center ROW, Upstream View, AE PL
Lat: 38.766123 Long: -80.520308

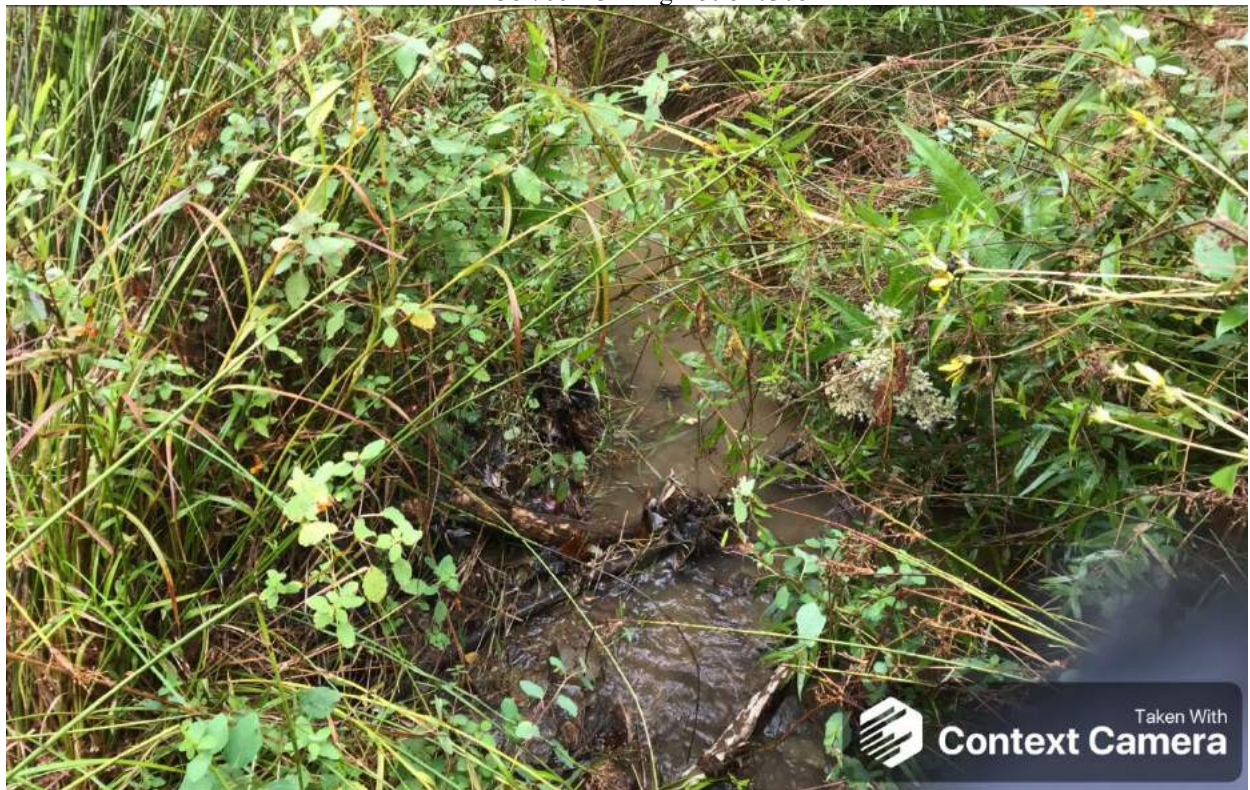
Photo Type: DS View at Center
Location, Orientation, Photographer Initials: ROW Center, Downstream View, AE PL
Lat: 38.766123 Long: -80.520308

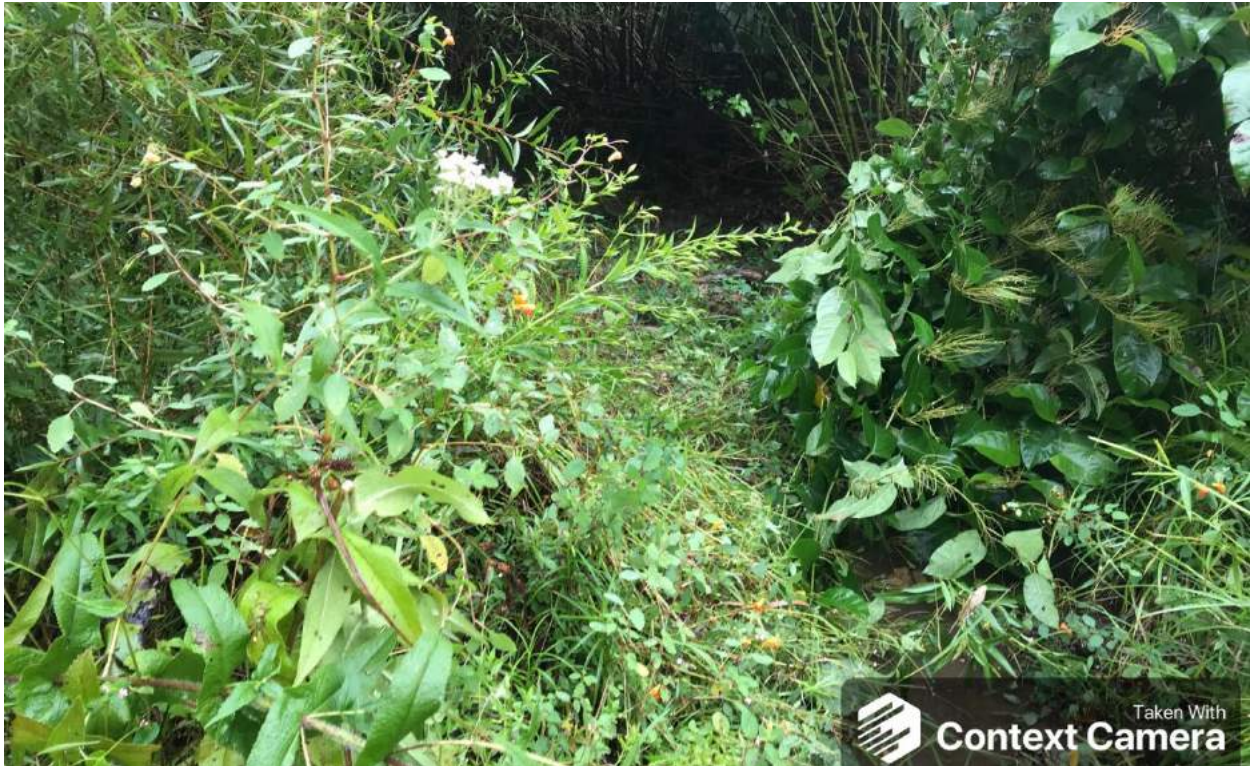
Photo Type: US, US View
Location, Orientation, Photographer Initials: Upstream Edge of ROW, Upstream View, AE PL
Lat: 38.766123 Long: -80.520308

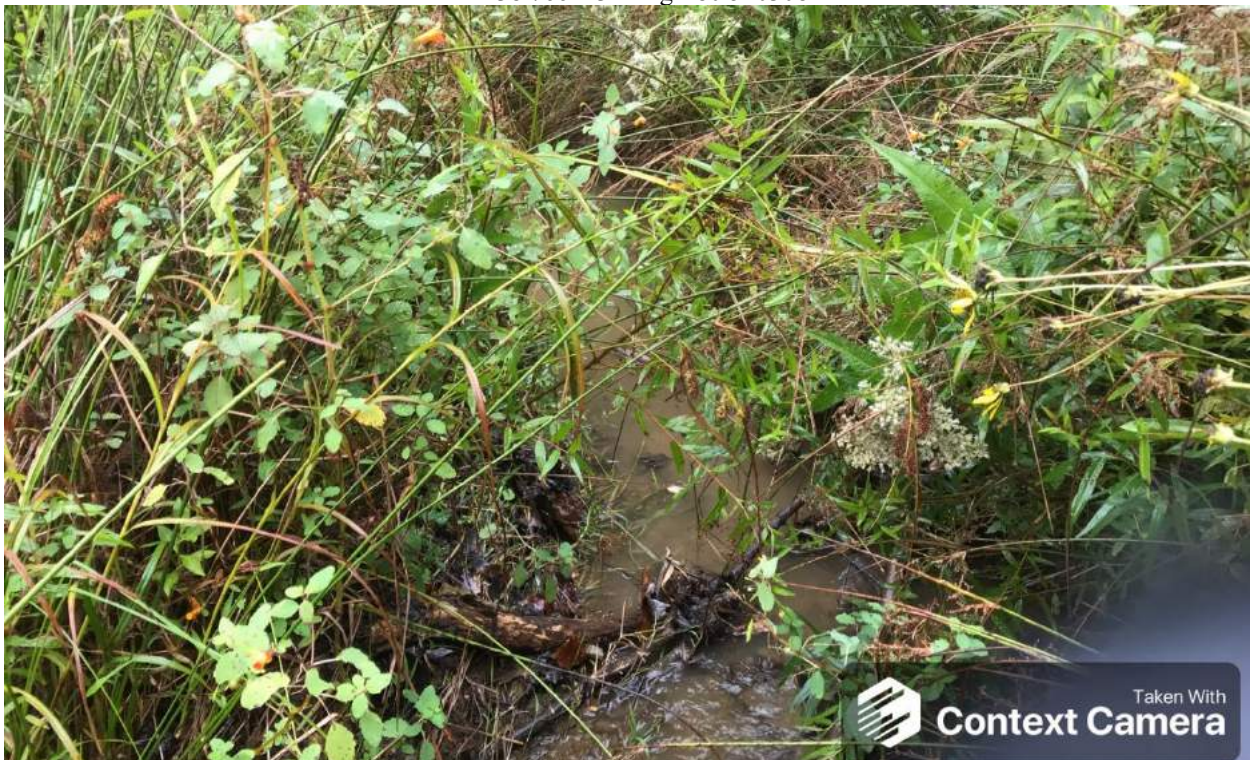
Photo Type: US, DS View
Location, Orientation, Photographer Initials: Upstream Edge of ROW, Downstream View, AE PL
Lat: 38.766123 Long: -80.520308

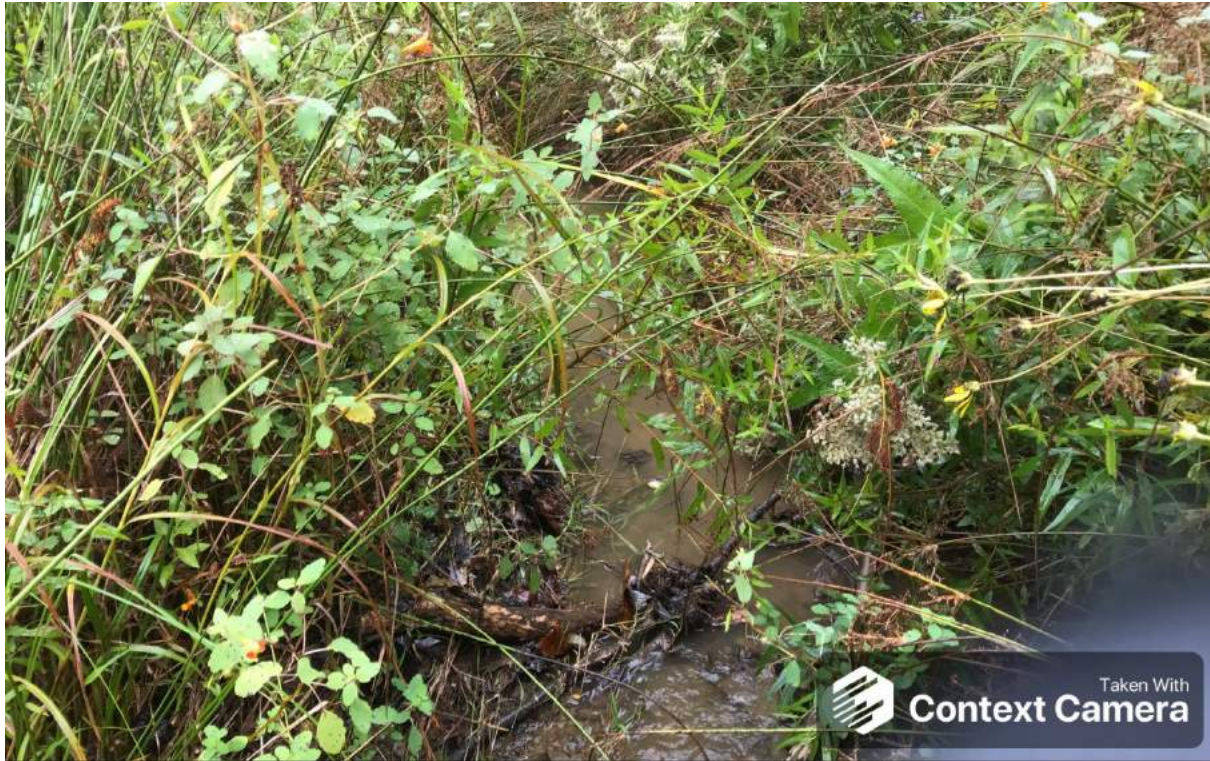
Photo Type: Riffle, DS View
Location, Orientation, Photographer Initials: Upstream of Riffle, Downstream View, AE PL
Lat: 38.766123 Long: -80.520308

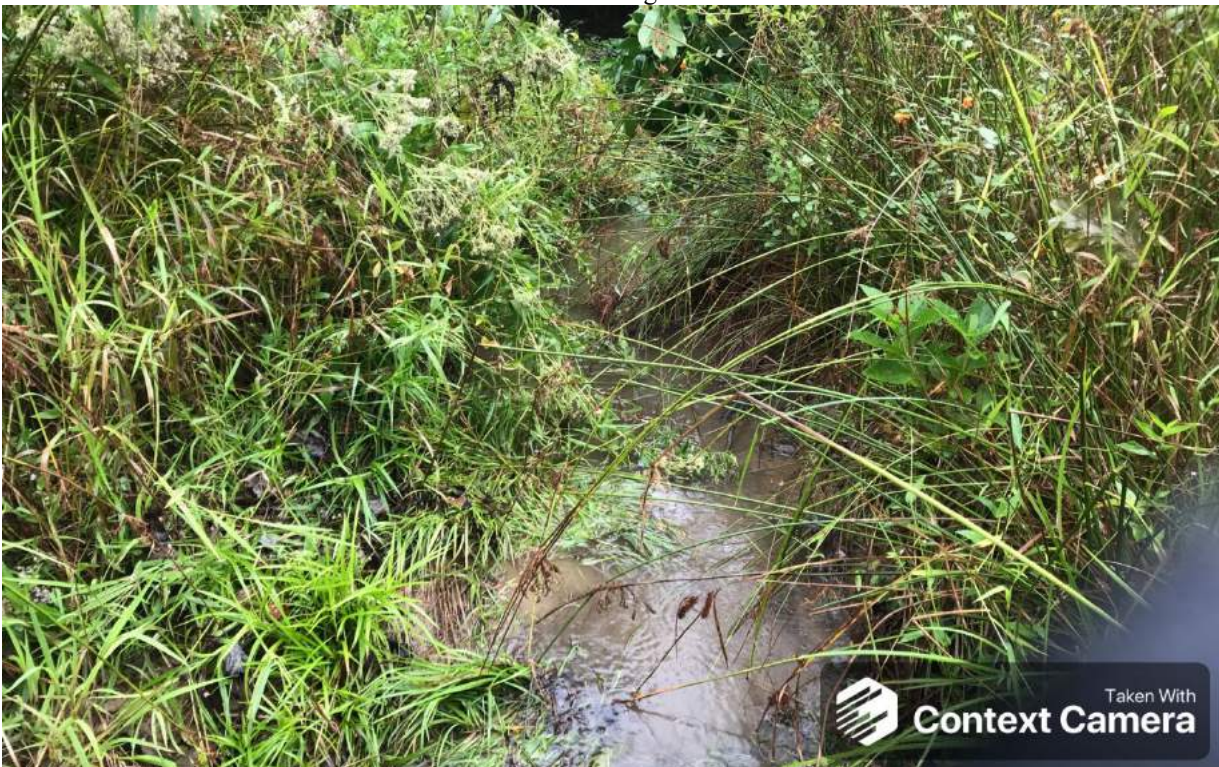
Photo Type: Riffle, US View
Location, Orientation, Photographer Initials: Downstream of Riffle, Upstream View, AE PL
Lat: 38.766123 Long: -80.520308

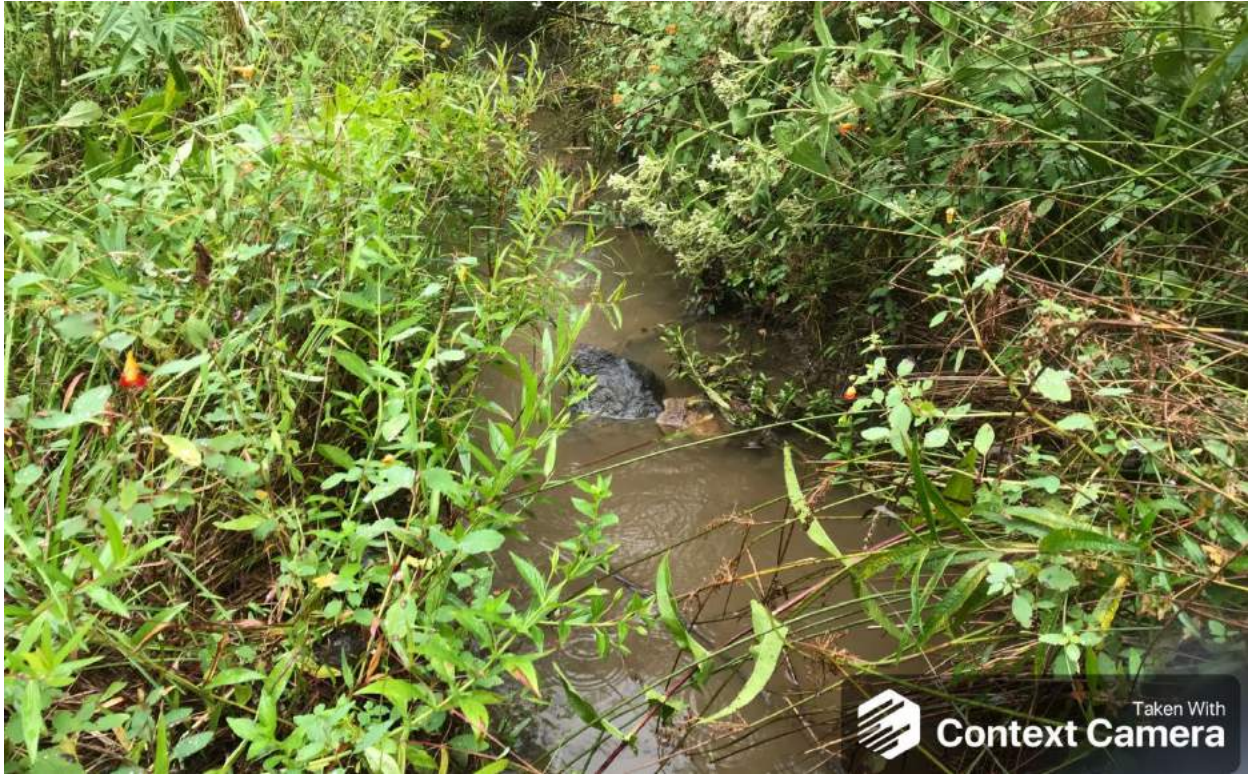
Photo Type: Pool, DS View
Location, Orientation, Photographer Initials: Upstream of Pool, Downstream View, AE PL
Lat: 38.766123 Long: -80.520308

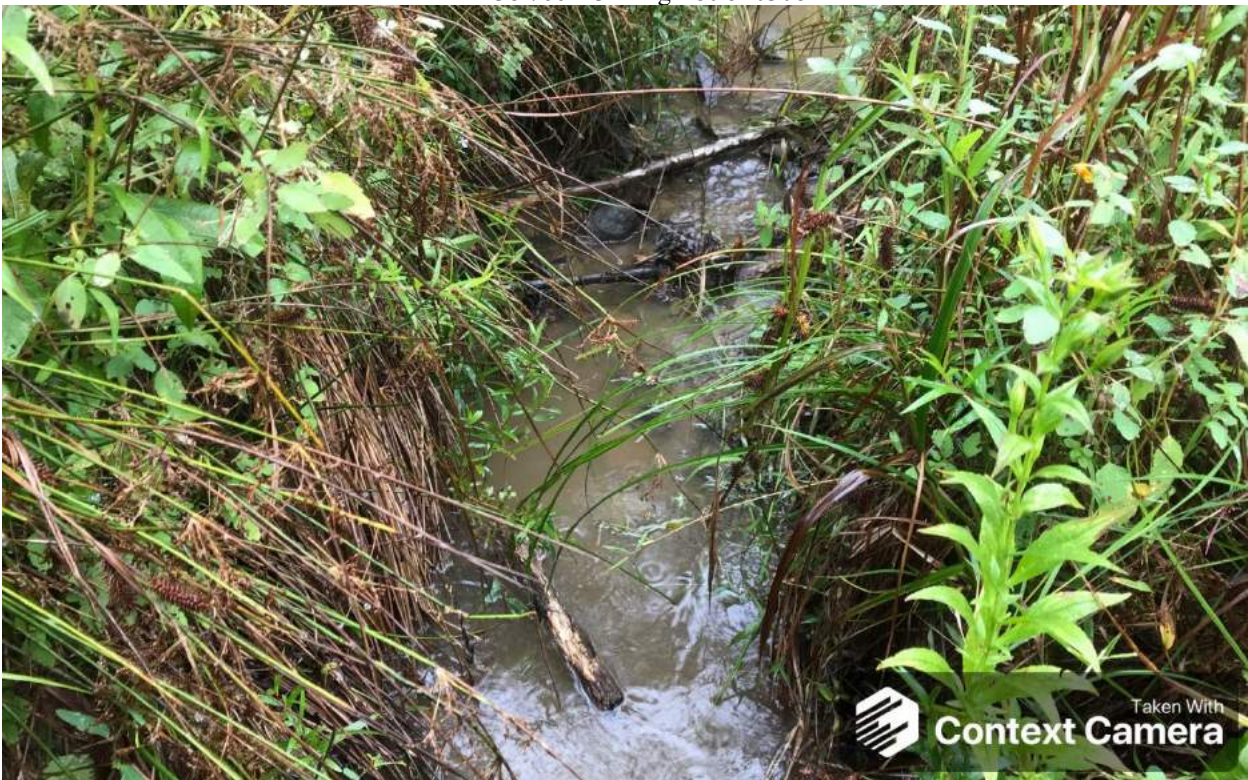
Photo Type: Pool, US View
Location, Orientation, Photographer Initials: Downstream of Pool, Upstream View, AE PL
Lat: 38.766123 Long: -80.520308

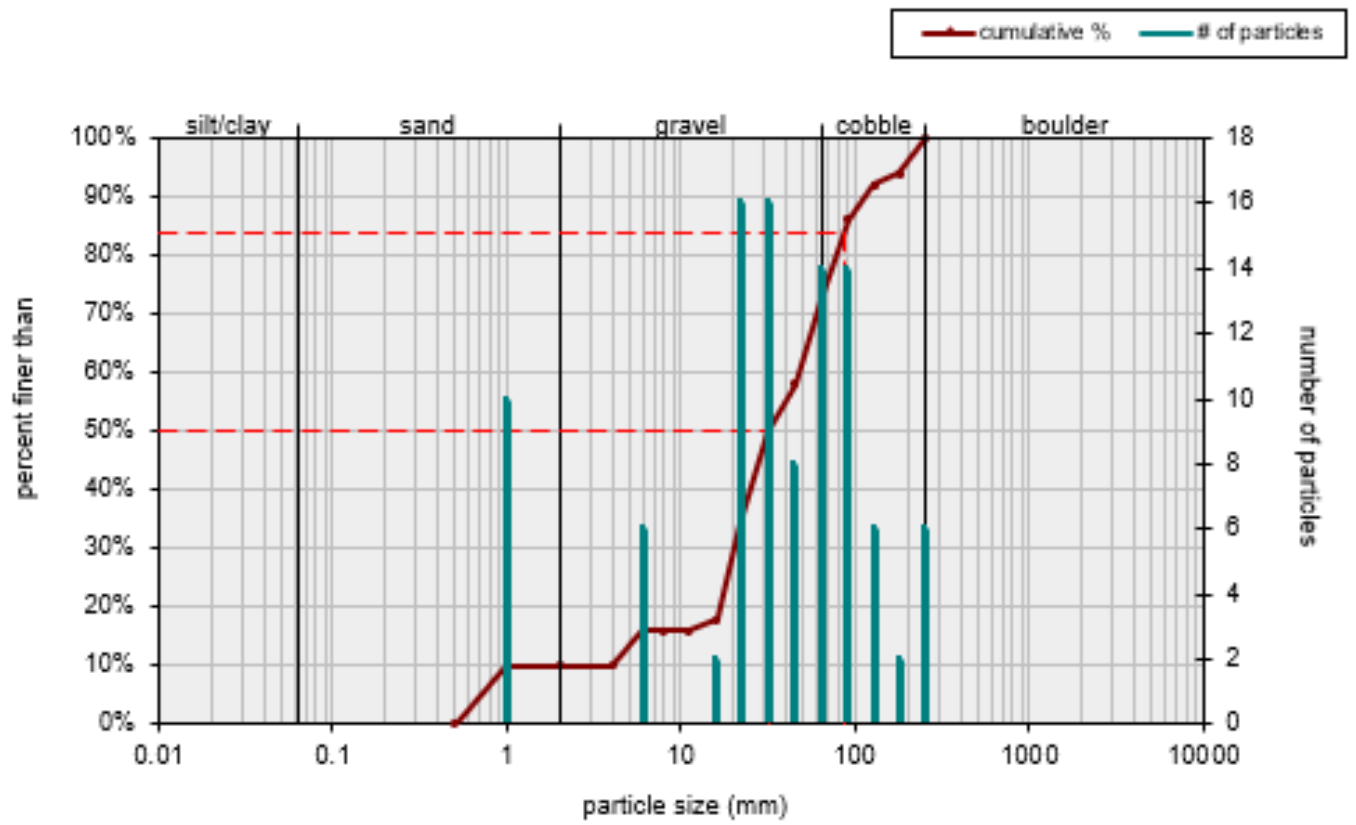
Bankfull Channel Pebble Count, S-K34

Size (mm)		Size Distribution		Type	
D16	11	mean	30.8	silt/clay	0%
D35	23	dispersion	2.8	sand	10%
D50	32	skewness	-0.02	gravel	62%
D65	54			cobble	28%
D84	86			boulder	0%
D95	190

5.0-7.1	Large	128-180	▲ ▼		2	2.00	94.00
7.1-10.1	Large	180-256	▲ ▼		6	6.00	100.00
10.1-14.3	Small	256-362	B O U L D E R	▲ ▼	0	0.00	100.00
14.3-20	Small	362-512		▲ ▼	0	0.00	100.00
20-40	Medium	512-1024		▲ ▼	0	0.00	100.00
40-80	Large	1024-2048		▲ ▼	0	0.00	100.00
80-160	Vry Large	2048-4096		▲ ▼	0	0.00	100.00
	Bedrock		BDRK	▲ ▼	0	0.00	100.00
				Totals:	100		
	Total Tally:

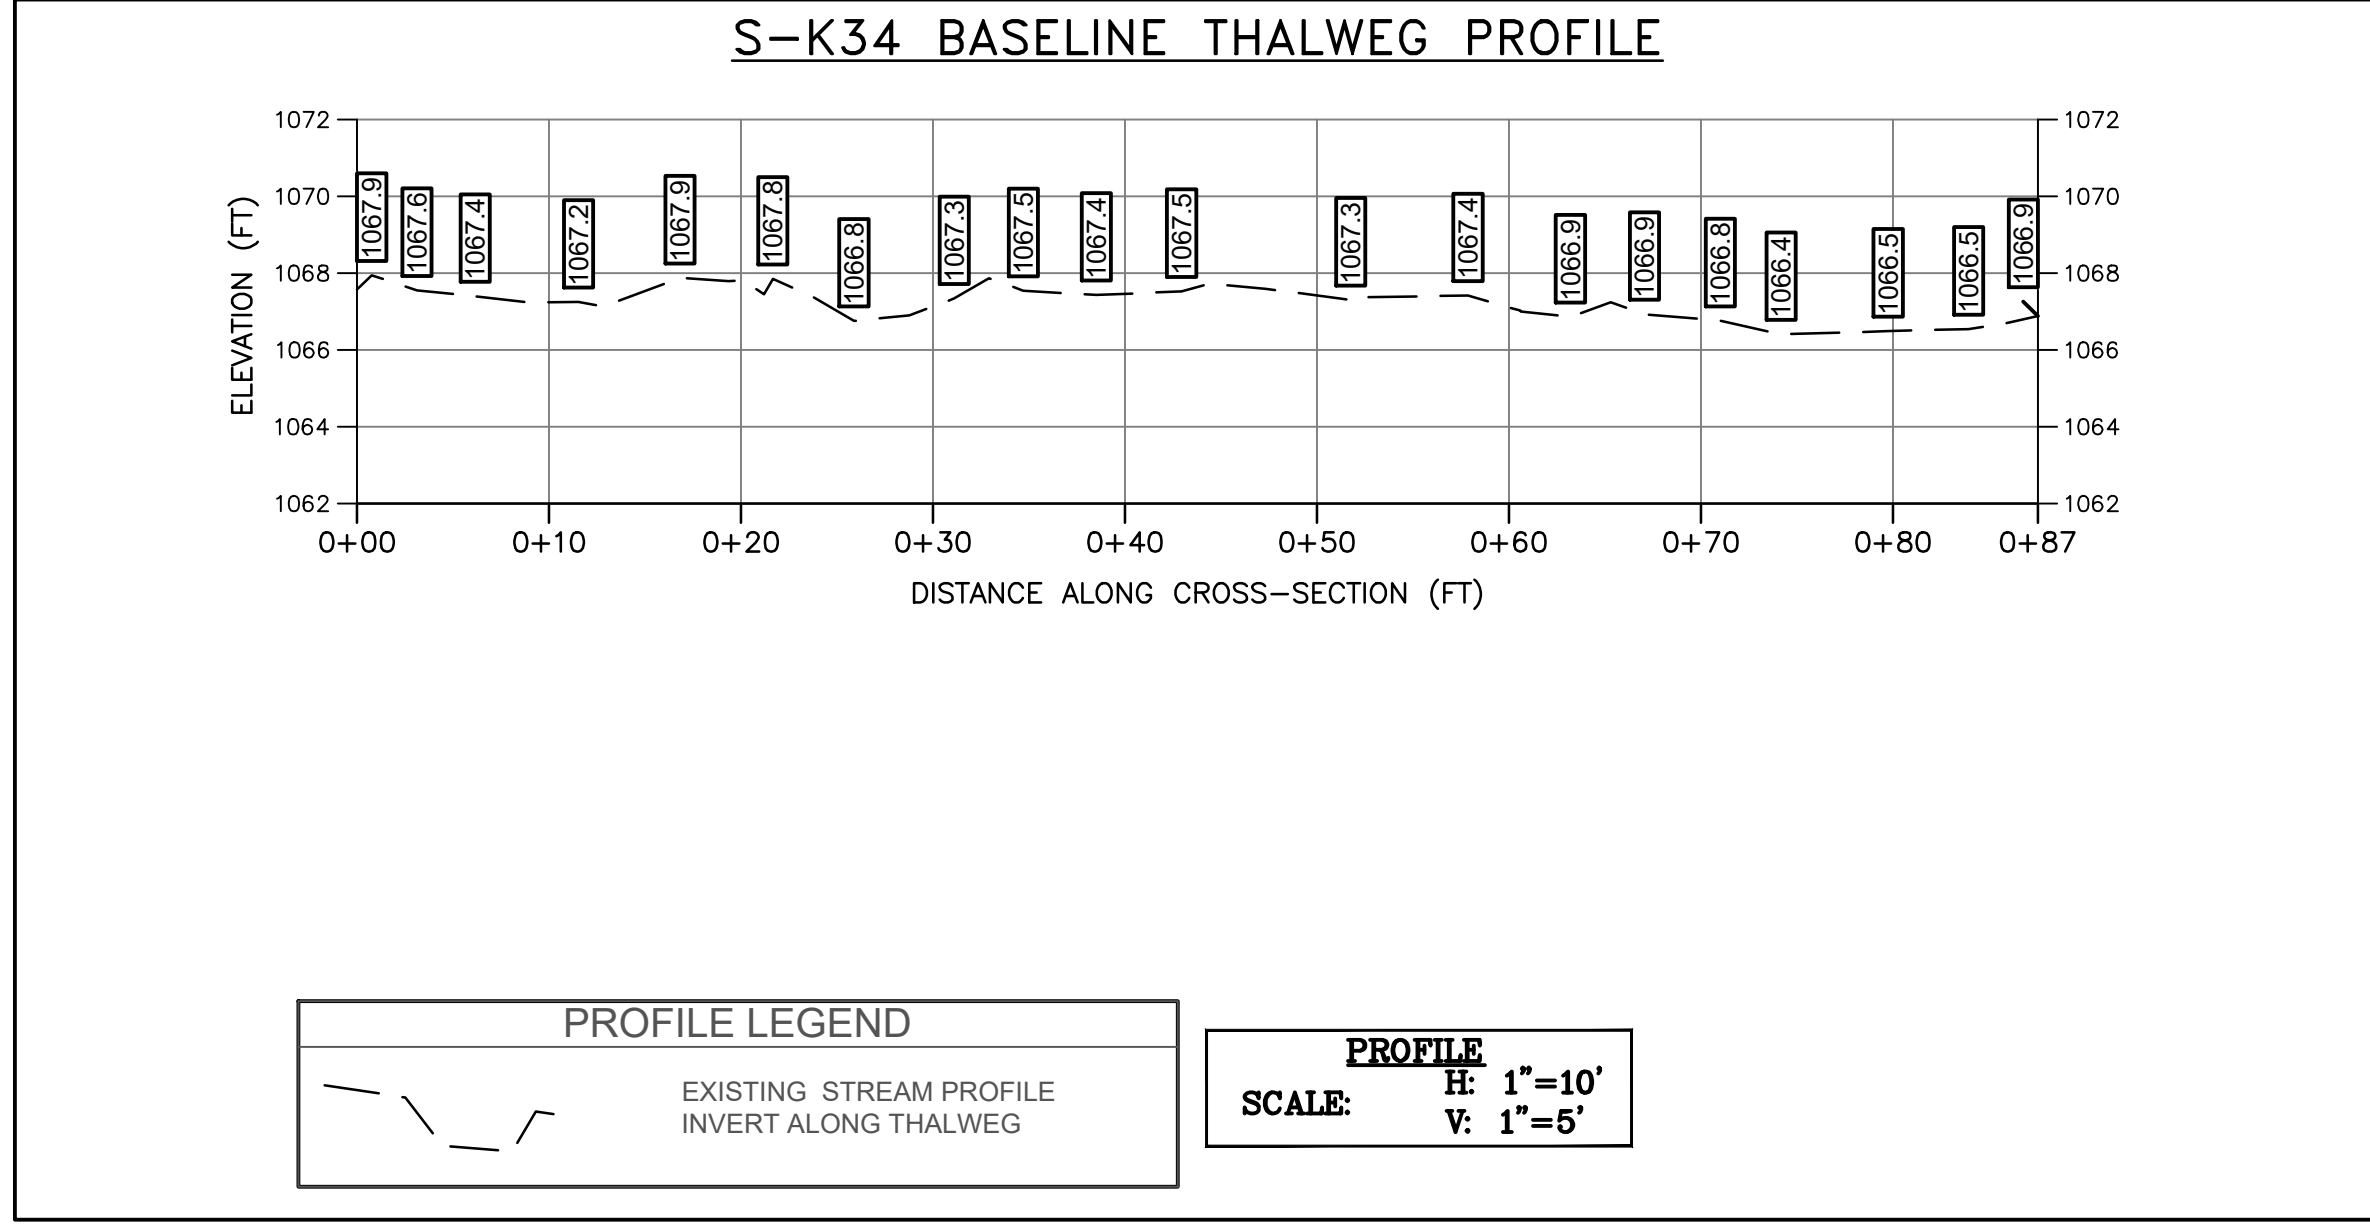
AS-BUILT TABLE: S-K34 CROSS SECTION A				
PT. LOC.	PRE-CROSSING			AS-BUILT
	NORTHING	EASTING	ELEV.	HORZ. DIFF.
TS-L	14077828.6300	1777130.4750	1067.767'	
BS-L	14077827.4780	1777129.9380	1067.482'	
THW	14077826.9590	1777127.0960	1066.863'	
BS-R	14077825.2610	1777129.0720	1067.444'	
TS-R	14077823.8520	1777129.0040	1067.950'
