**Mountain Valley Pipeline Project**

**New Impervious Cover Stormwater Drainage Exhibits**

**MLV-23 Spread 8**

Figure 001

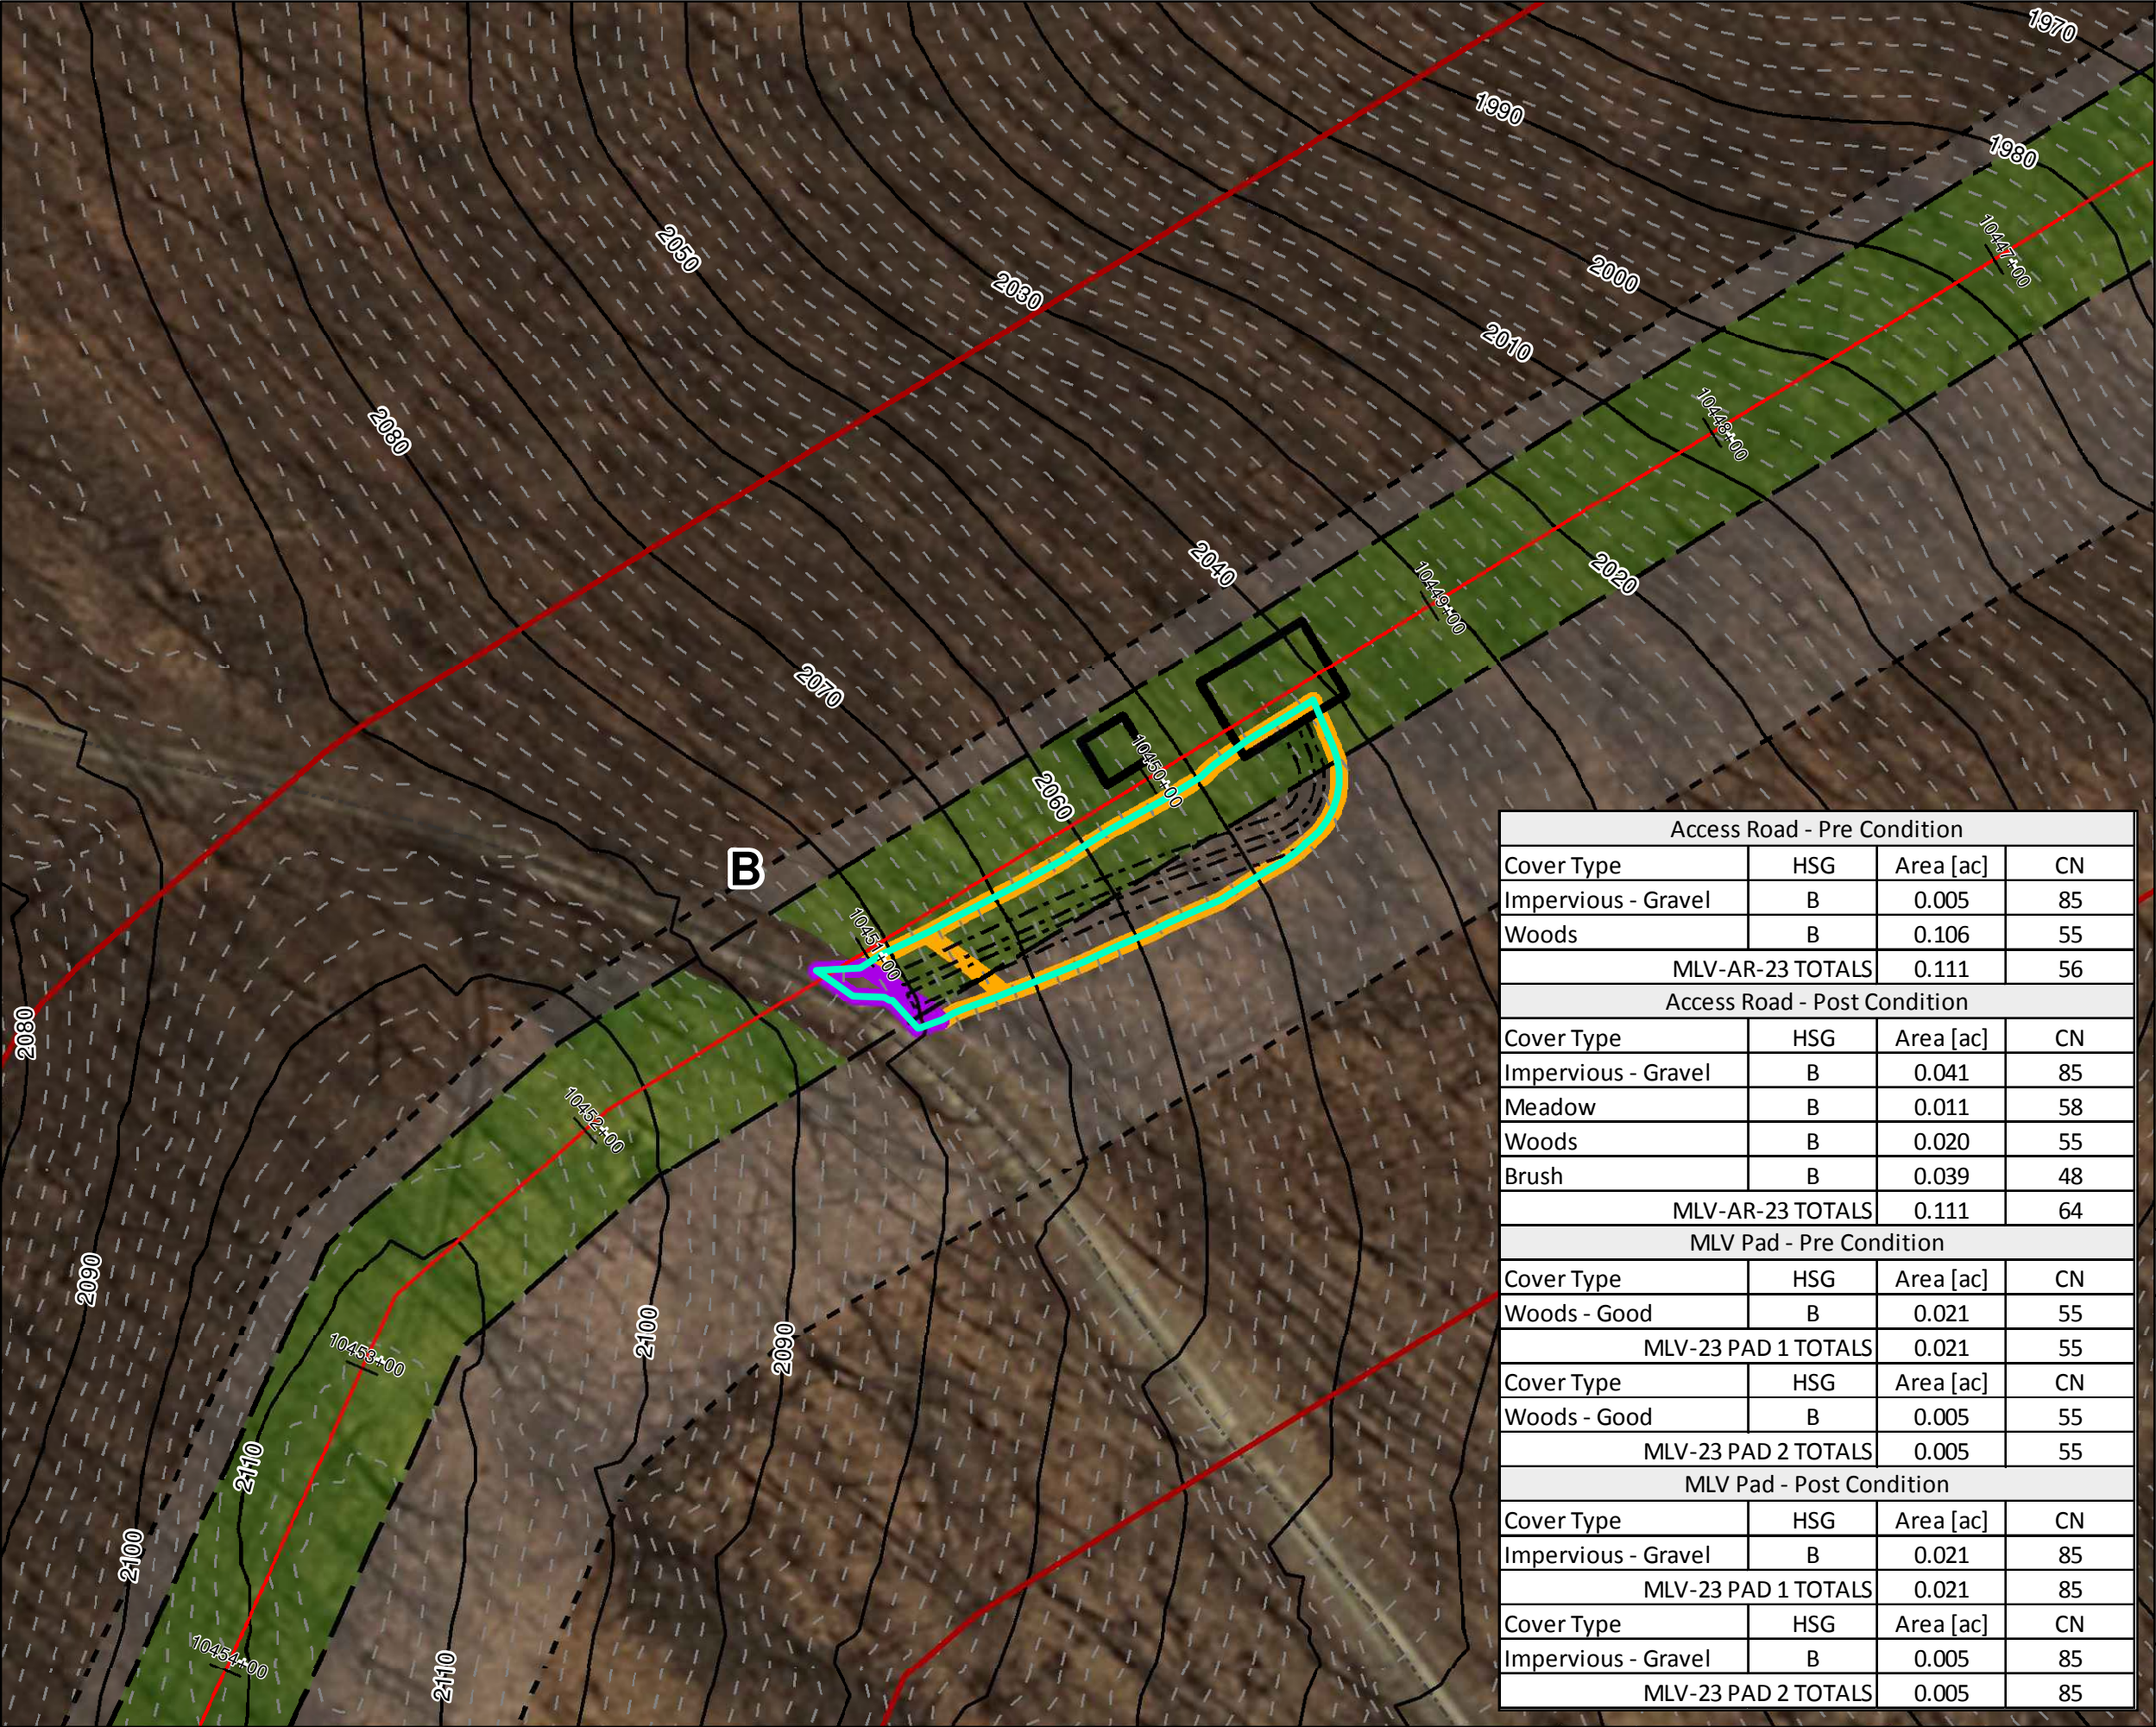
| Access Road - Pre Condition | | | |
| MLV-AR-23 TOTALS | | 0.111 | 56 |
| Access Road - Post Condition | | | |
| MLV-AR-23 TOTALS | | 0.111 | 64 |
| MLV Pad - Pre Condition | | | |
| MLV Pad - Post Condition | | | |

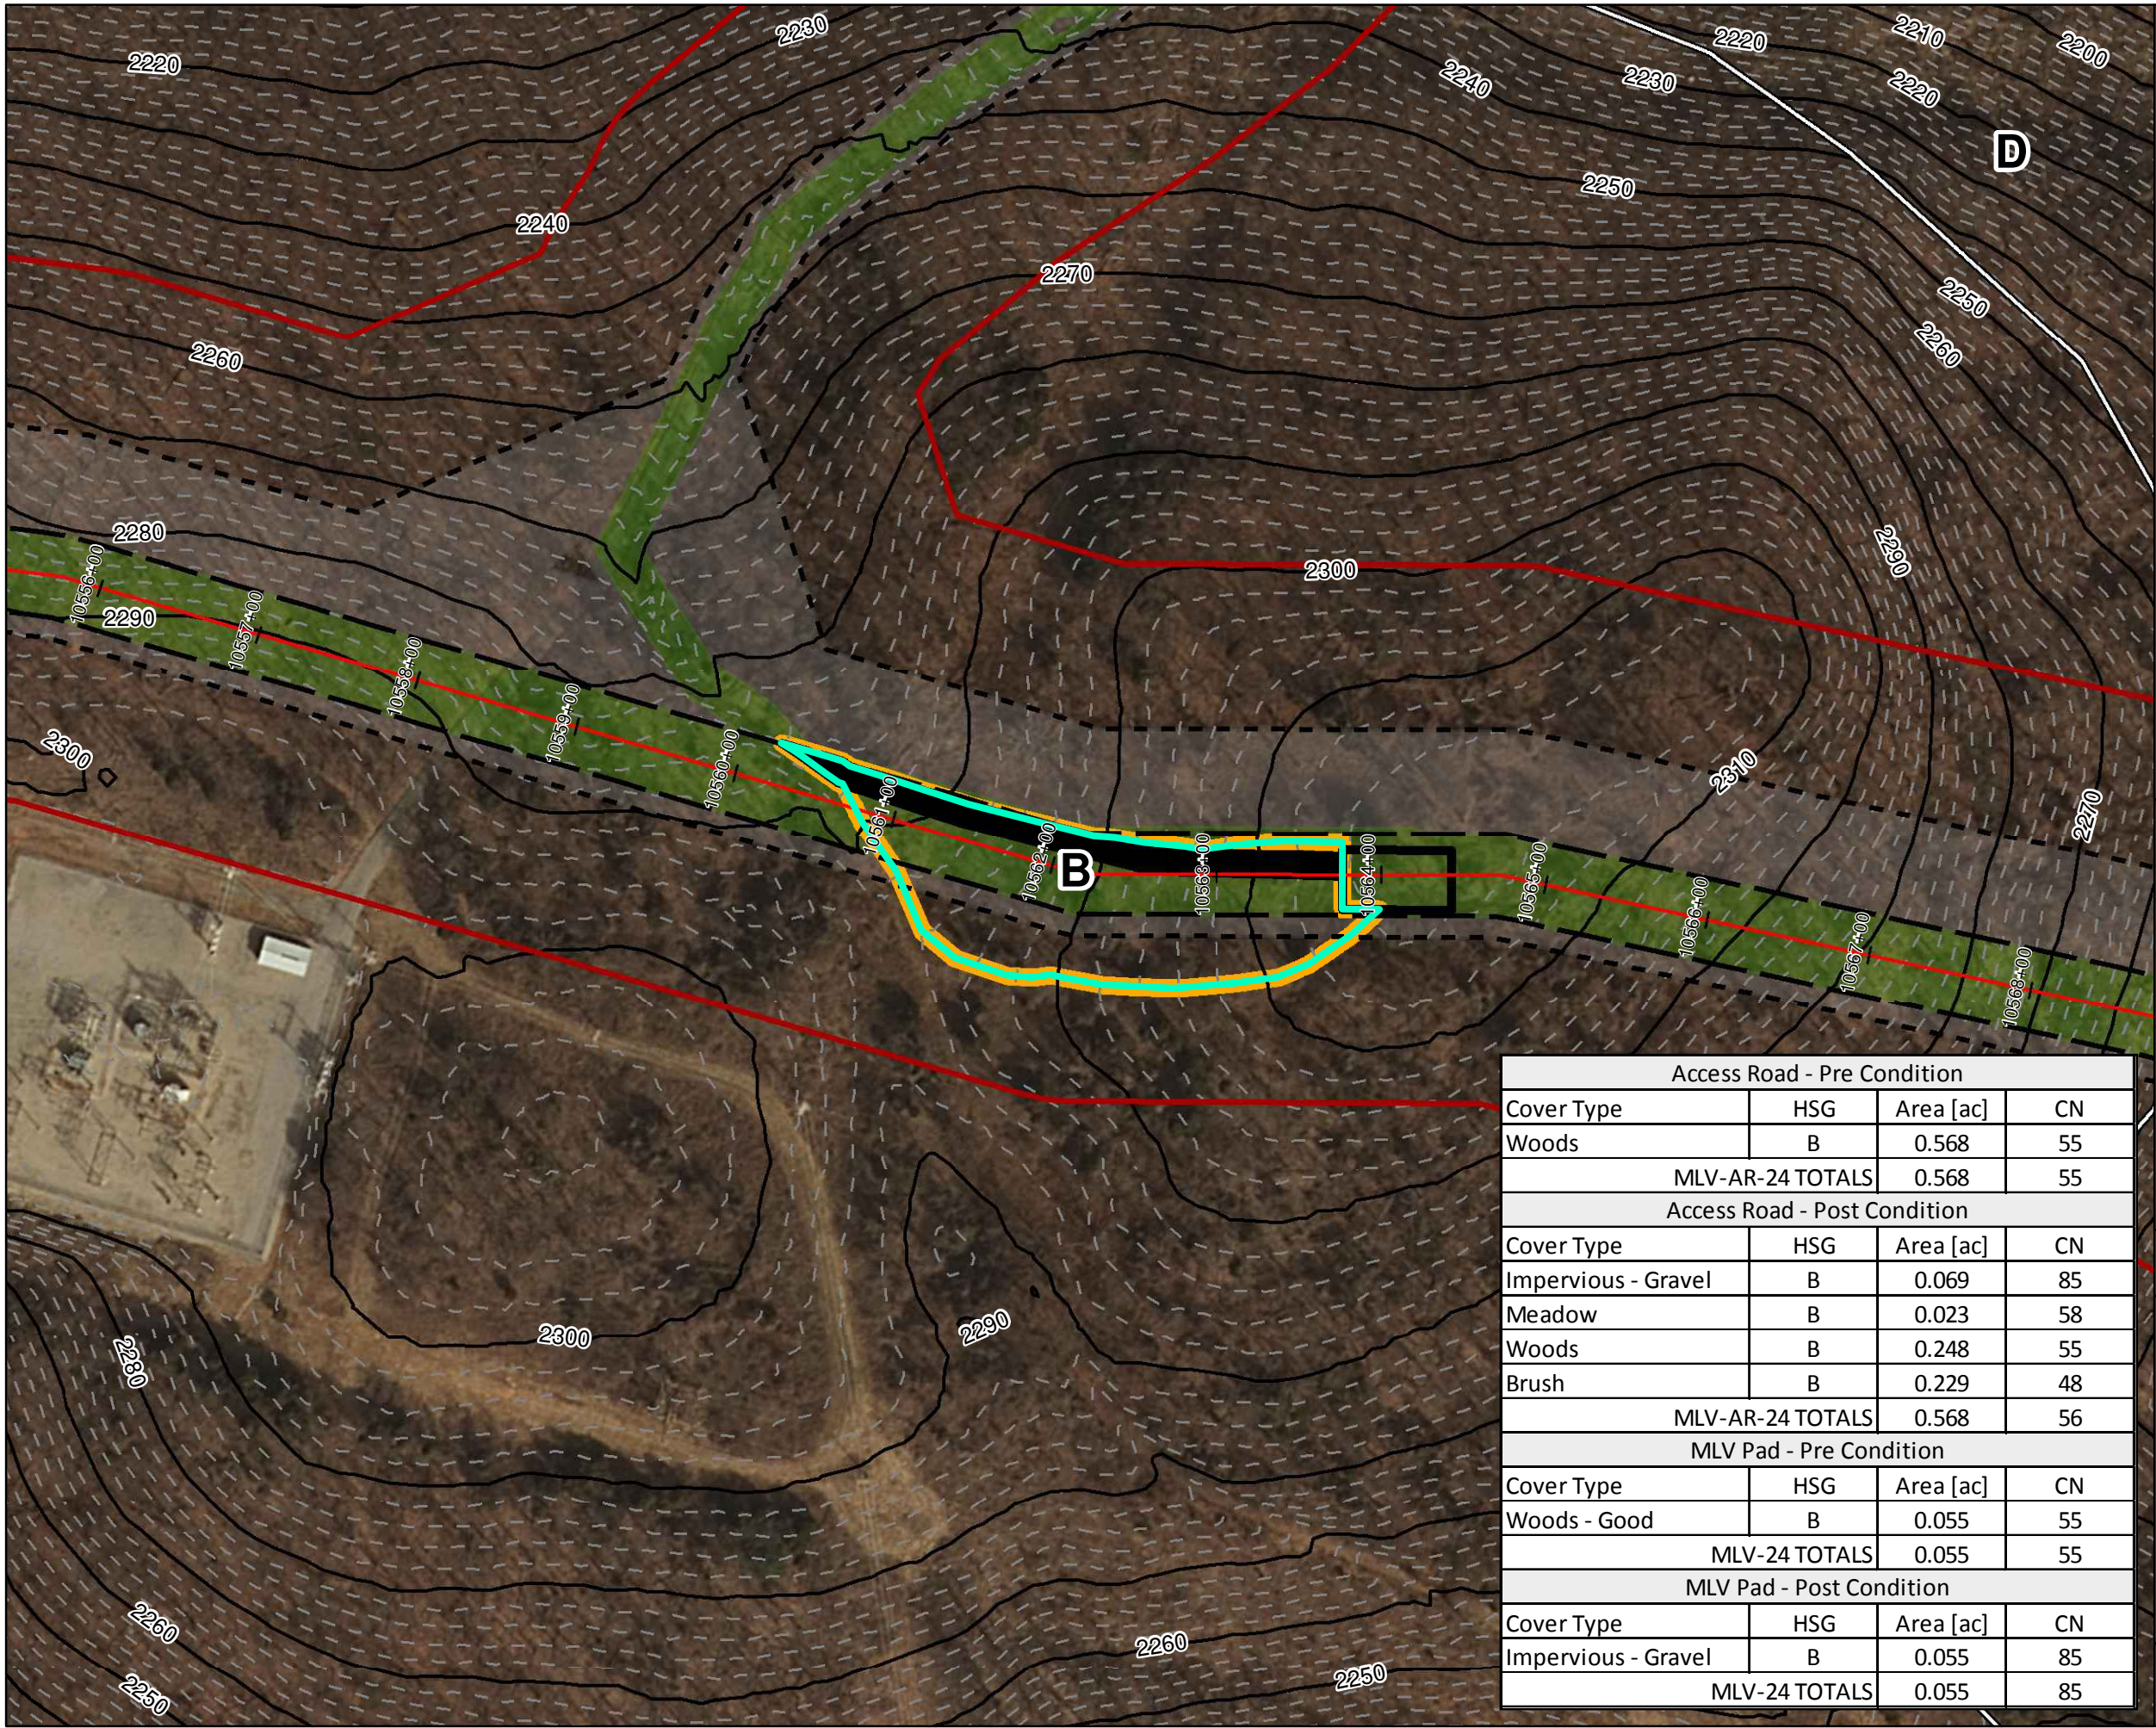
Figure 002

**MLV-24 Spread 8**

| Access Road - Pre Condition | | | |
| MLV-AR-24 TOTALS | | 0.568 | 55 |
| Access Road - Post Condition | | | |
| MLV-AR-24 TOTALS | | 0.568 | 56 |
| MLV-24 TOTALS | | 0.055 | 85 |

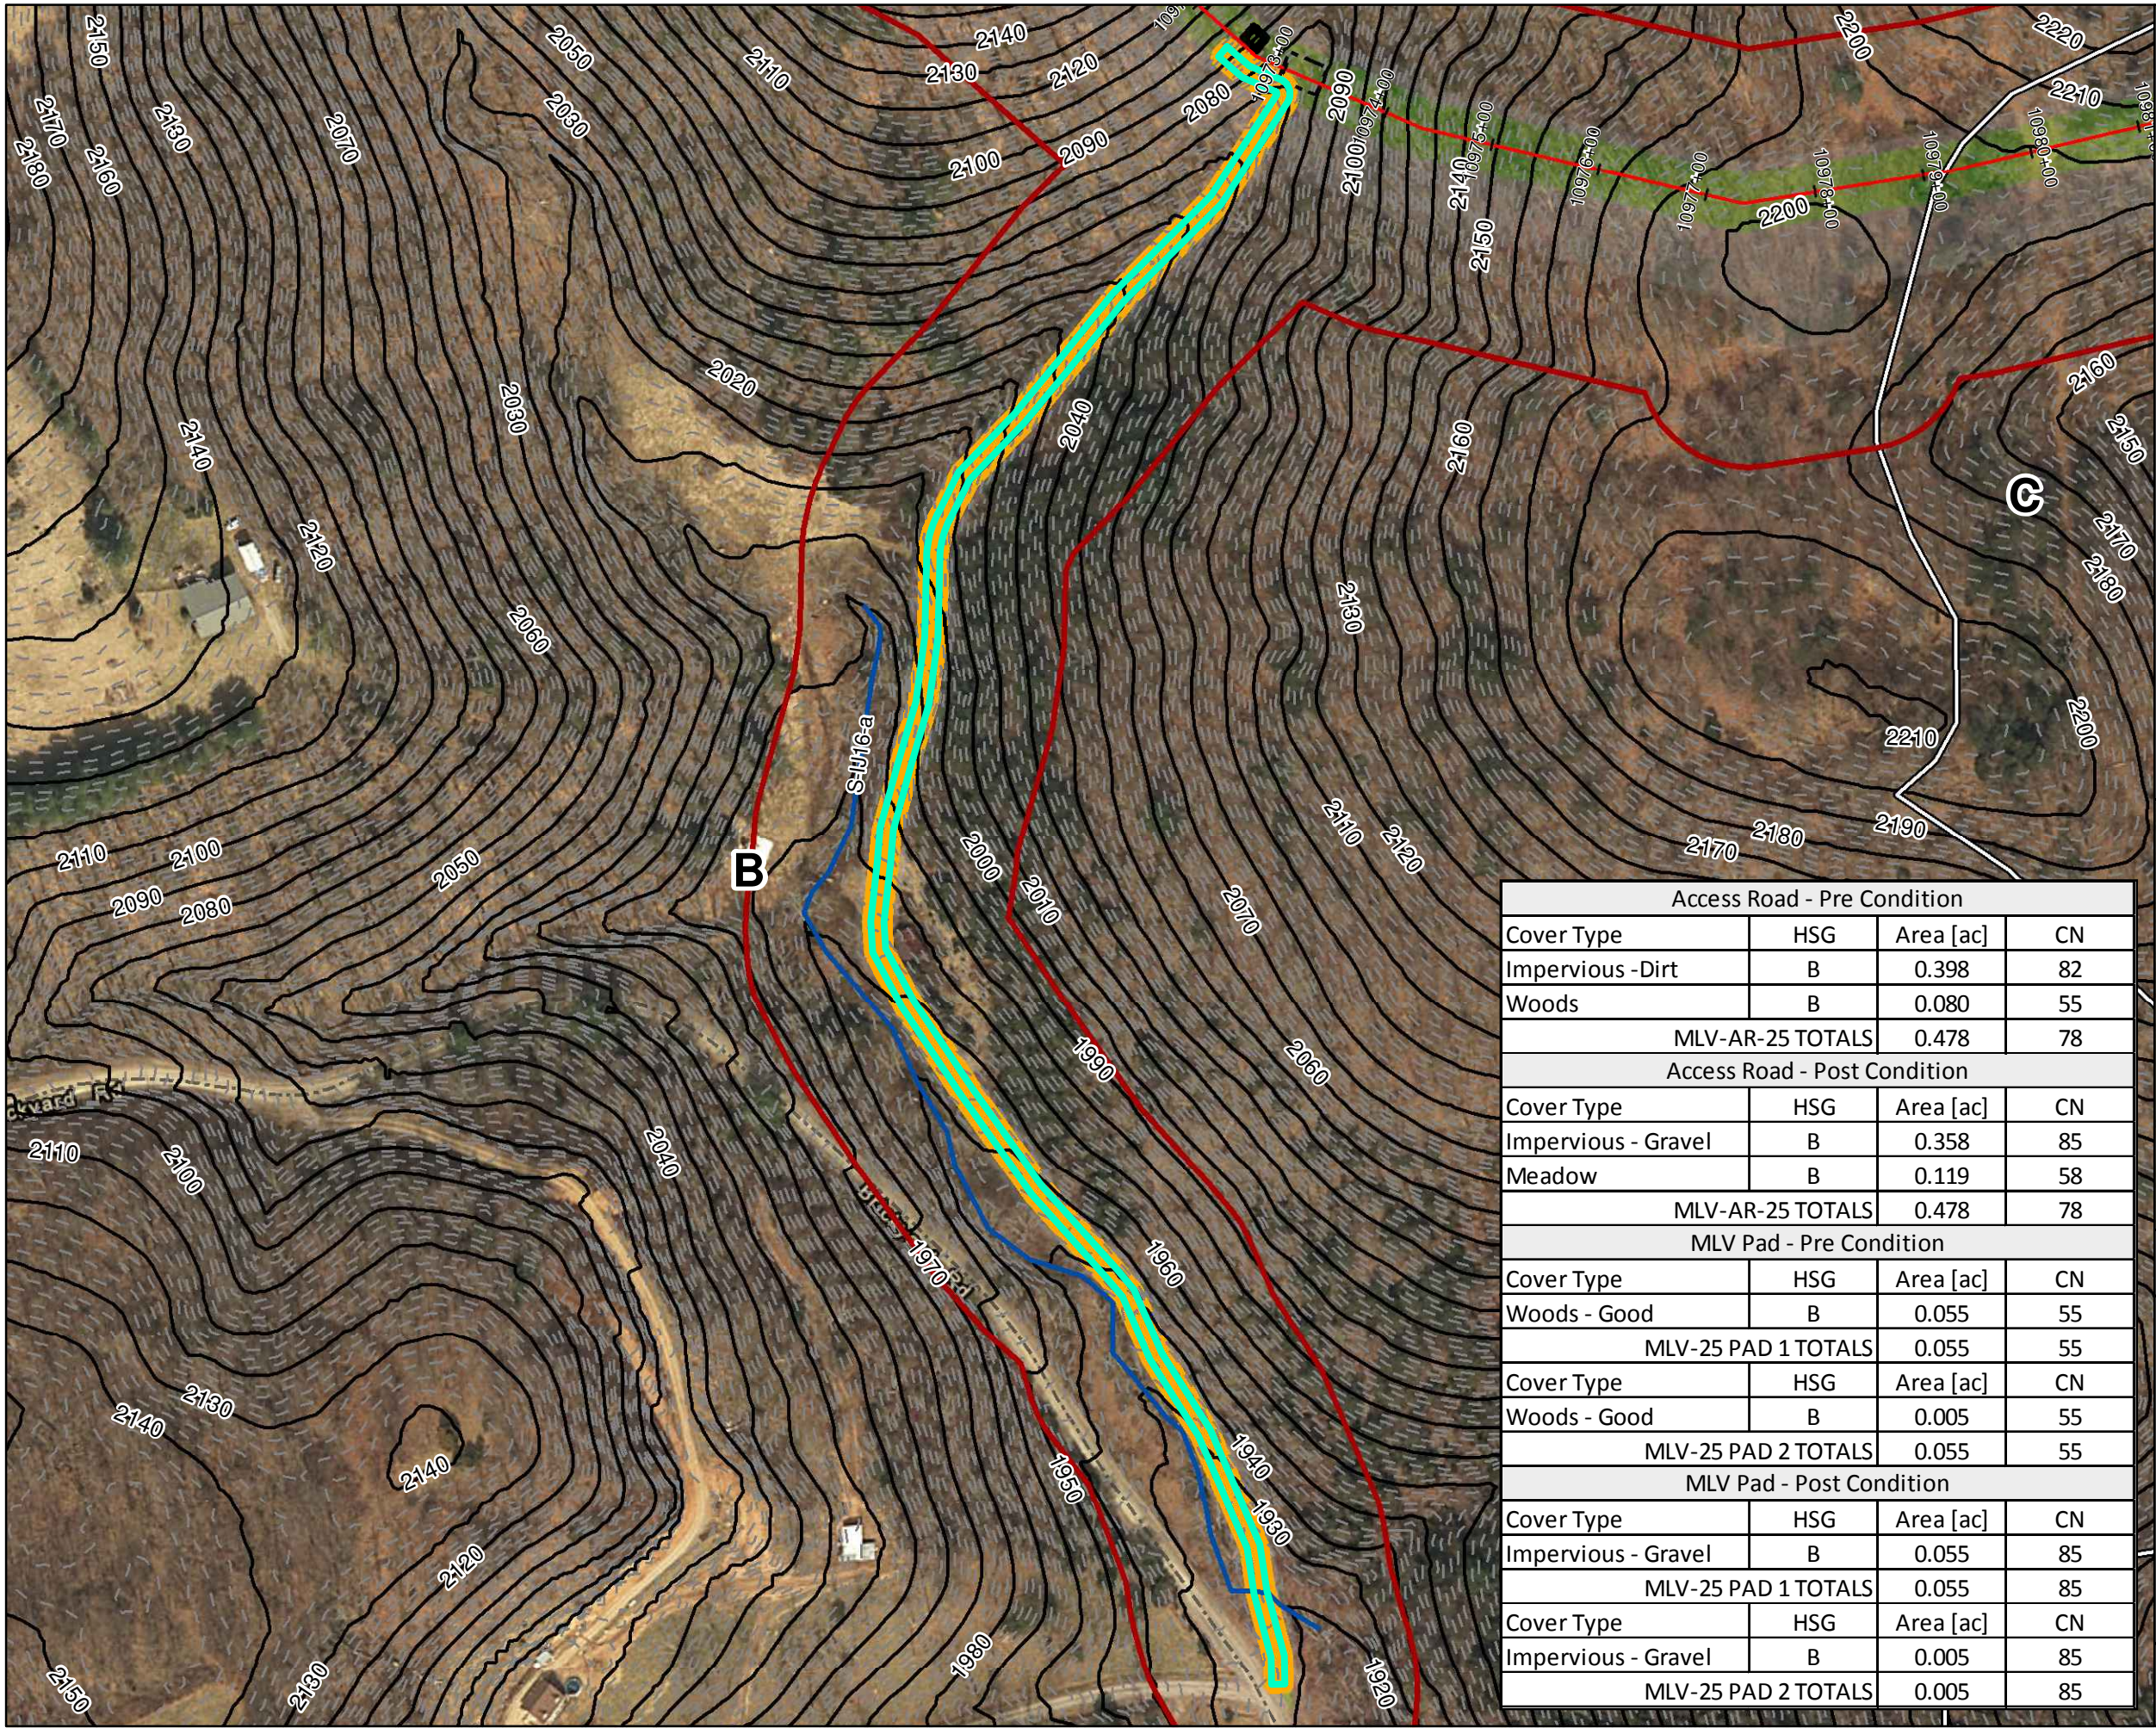
Figure 003  
Giles County, Virginia  
March, 2018

| Access Road - Pre Condition | | | |
| MLV-AR-25 TOTALS | | 0.478 | 78 |
| Access Road - Post Condition | | | |

**New Impervious Cover  
Stormwater Drainage Exhibits  
MLV-25  
Spread 9**

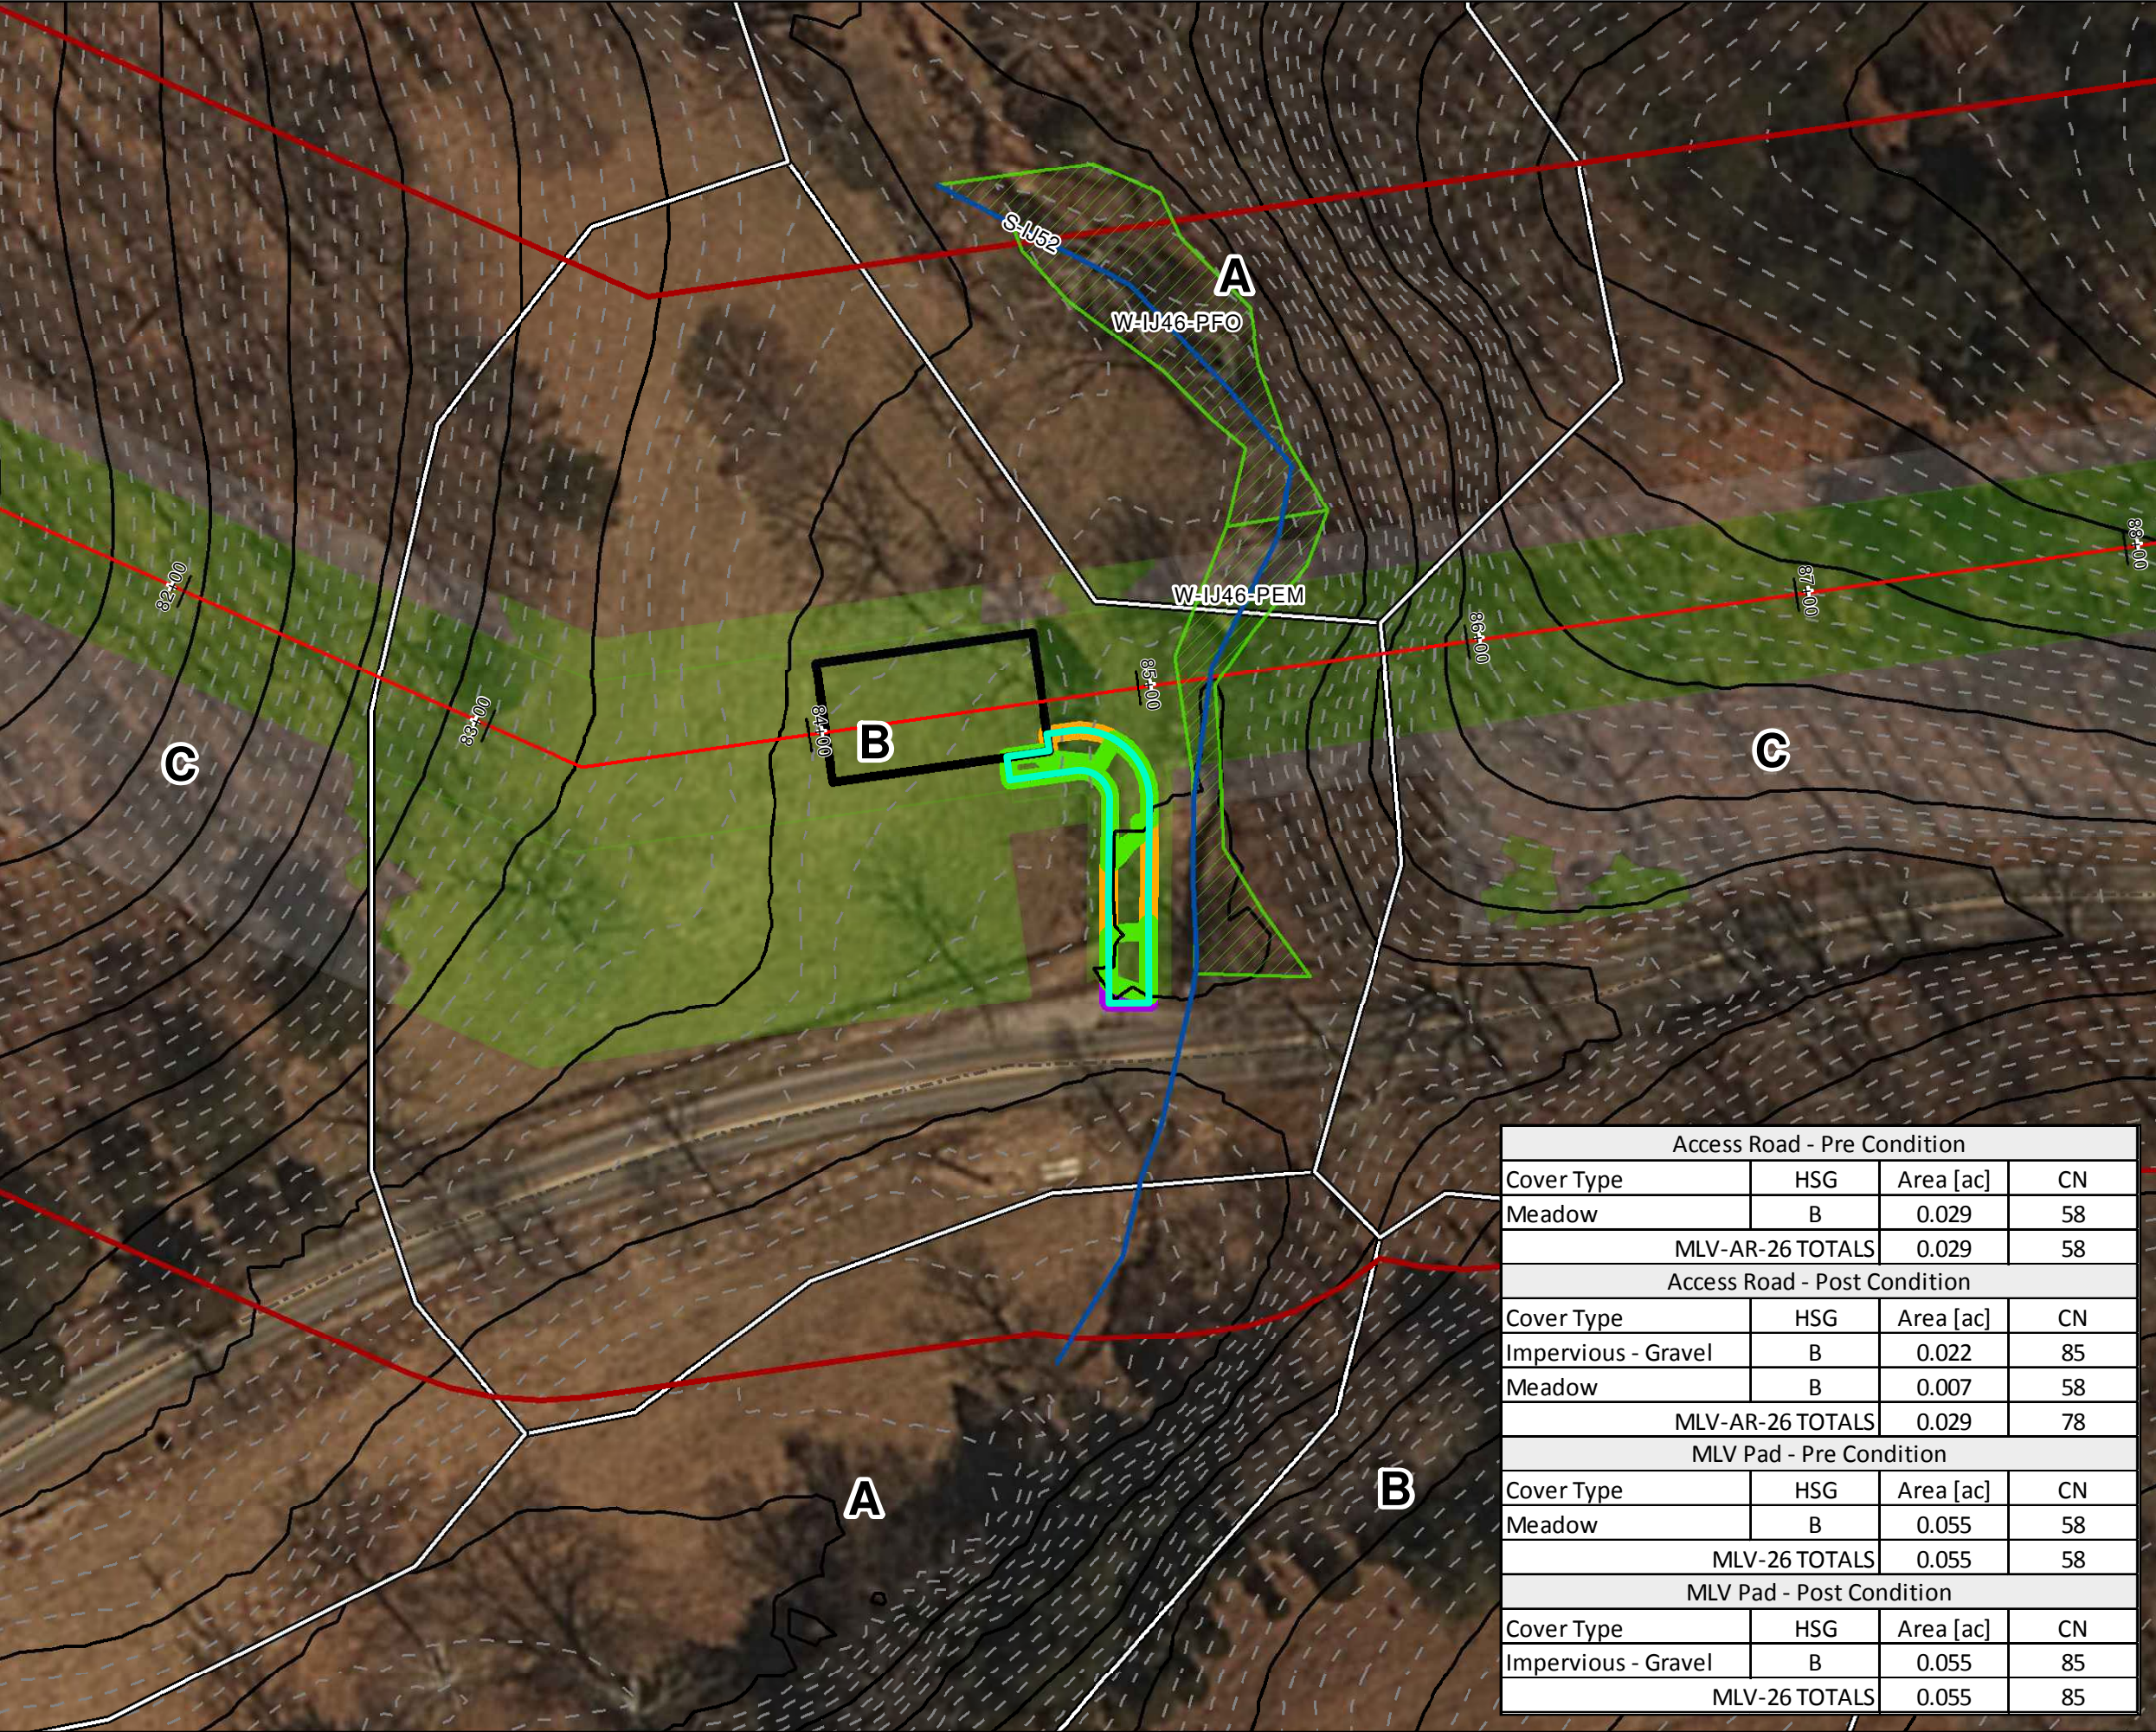
Figure 004  
Montgomery County, Virginia  
March, 2018

| Access Road - Pre Condition | | | |
| MLV-AR-26 TOTALS | | 0.029 | 58 |
| Access Road - Post Condition | | | |
| MLV-AR-26 TOTALS | | 0.029 | 78 |

**MLV-26  
Spread 9**

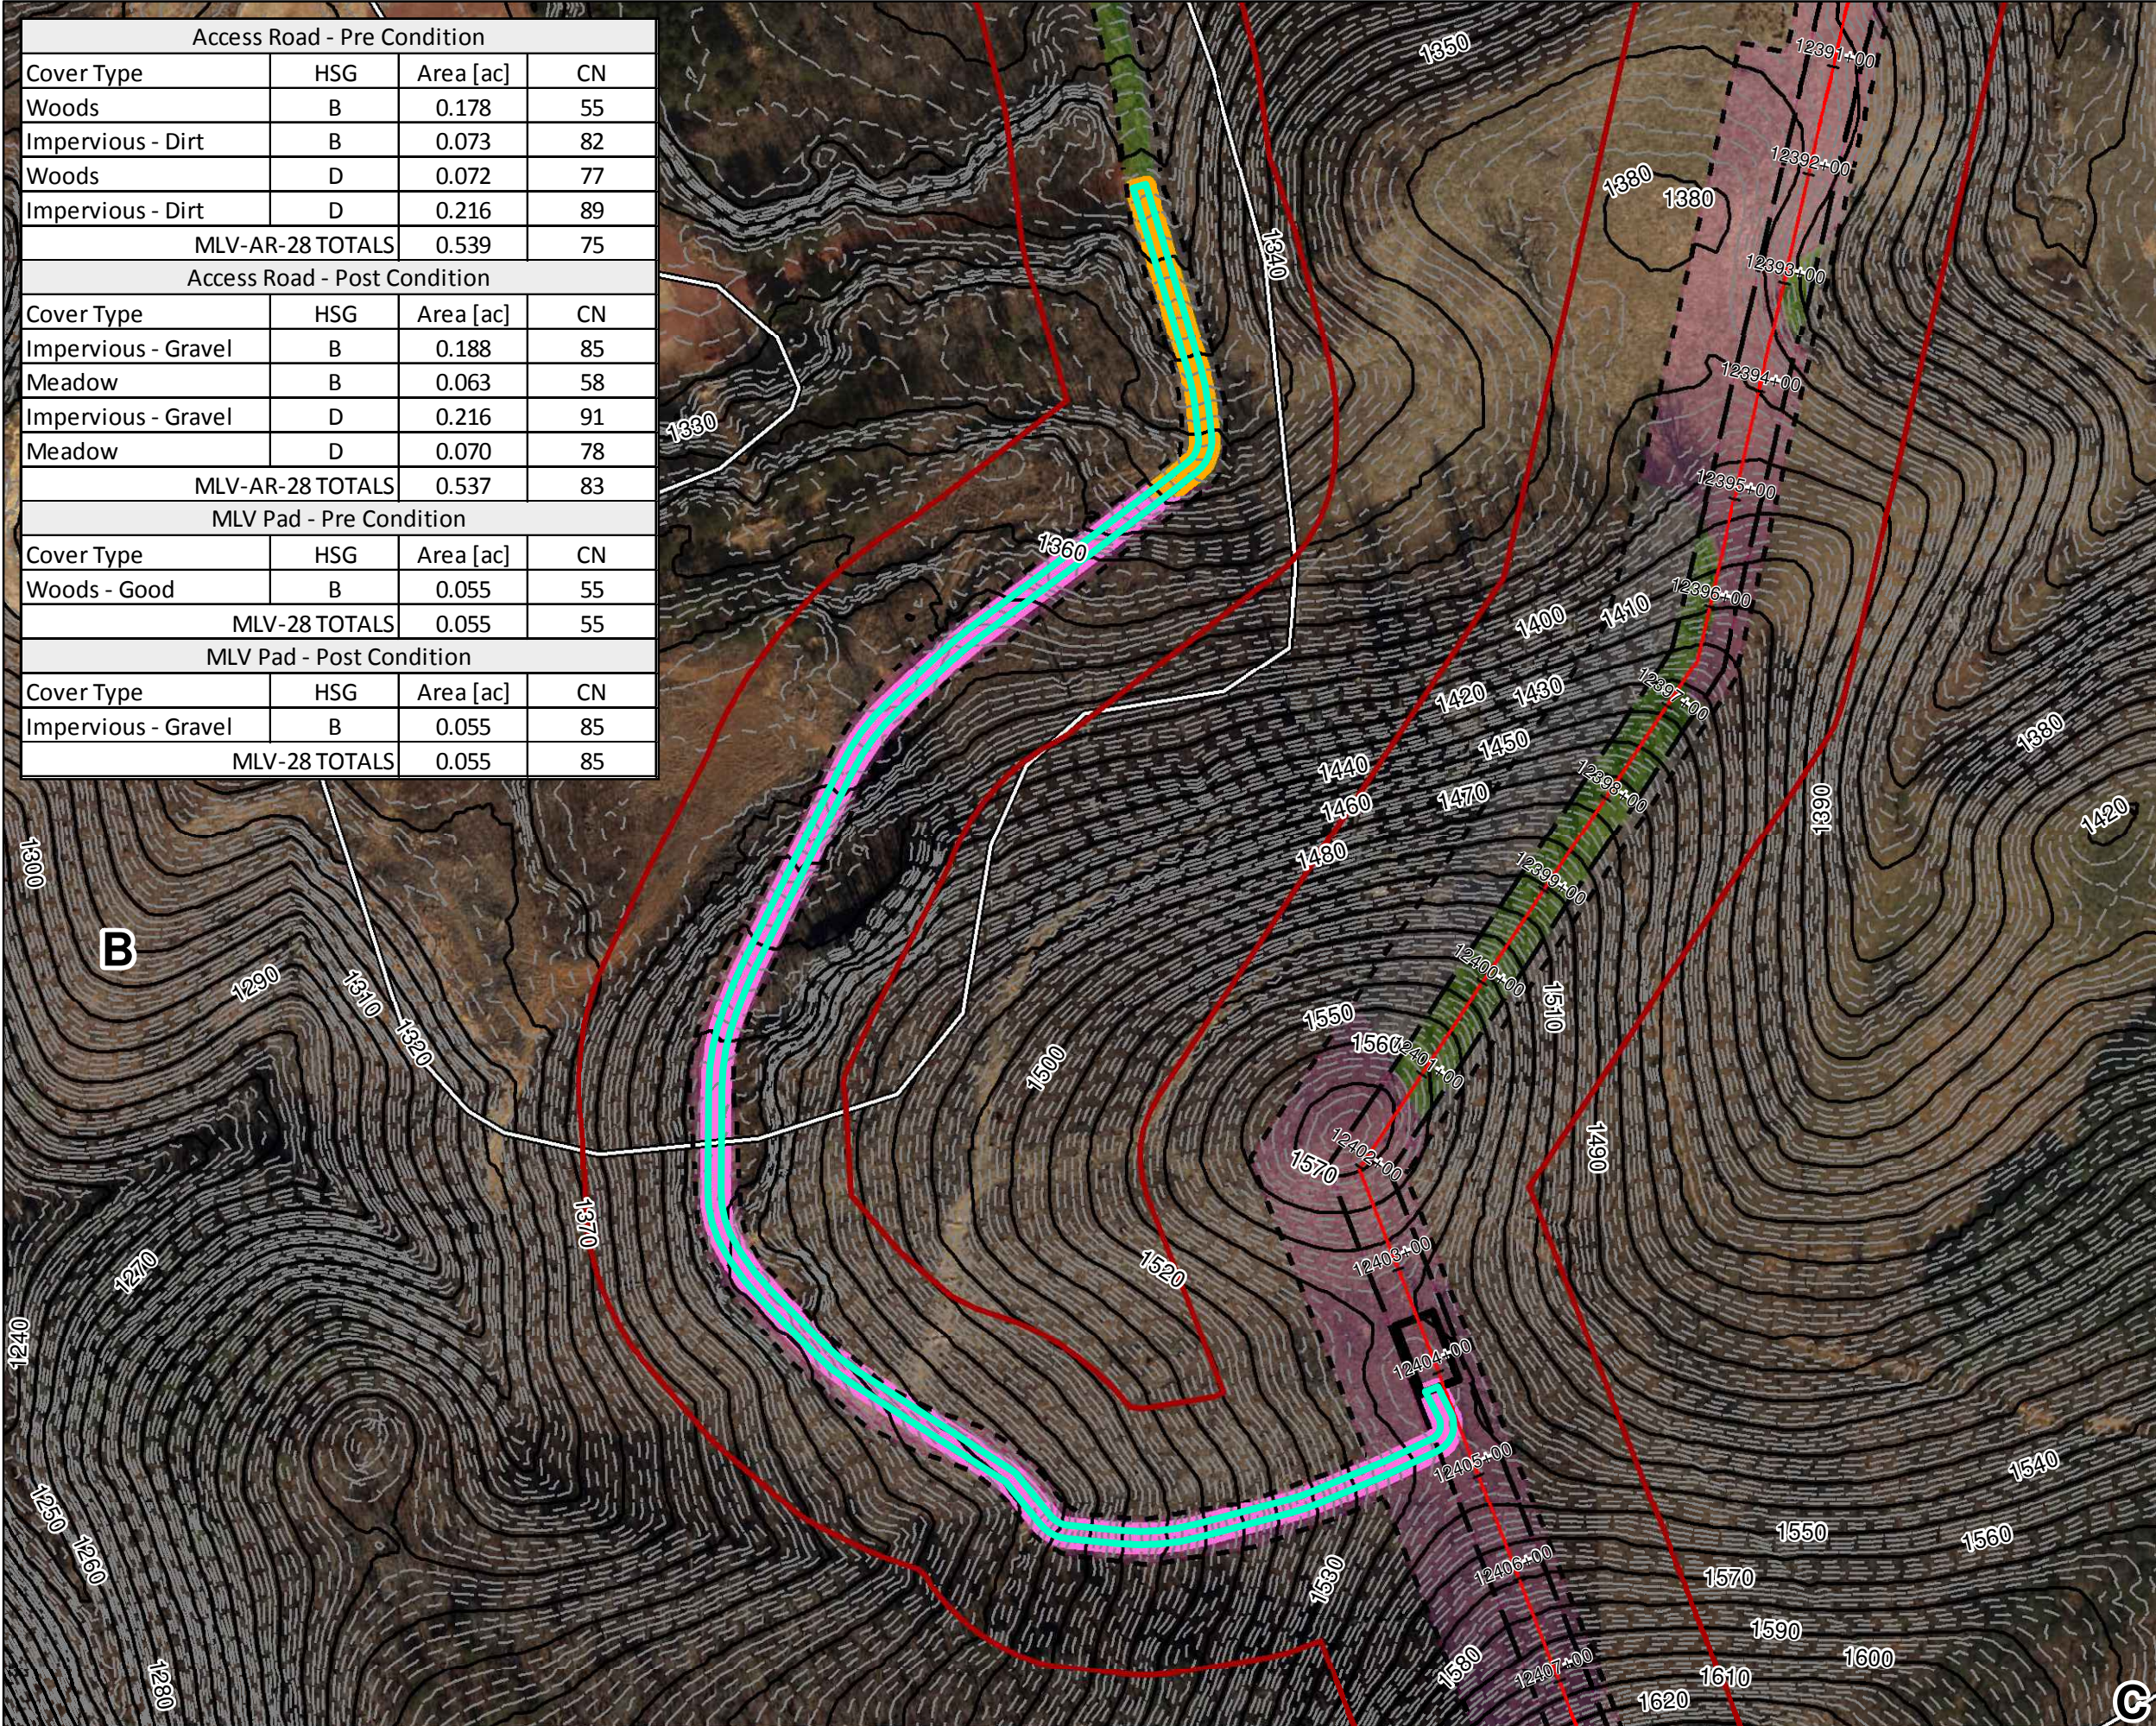
Figure 006

| Access Road - Pre Condition | | | |
| MLV-AR-28 TOTALS | | 0.539 | 75 |
| Access Road - Post Condition | | | |
| MLV-AR-28 TOTALS | | 0.537 | 83 |

#### MLV-28 Spread 10

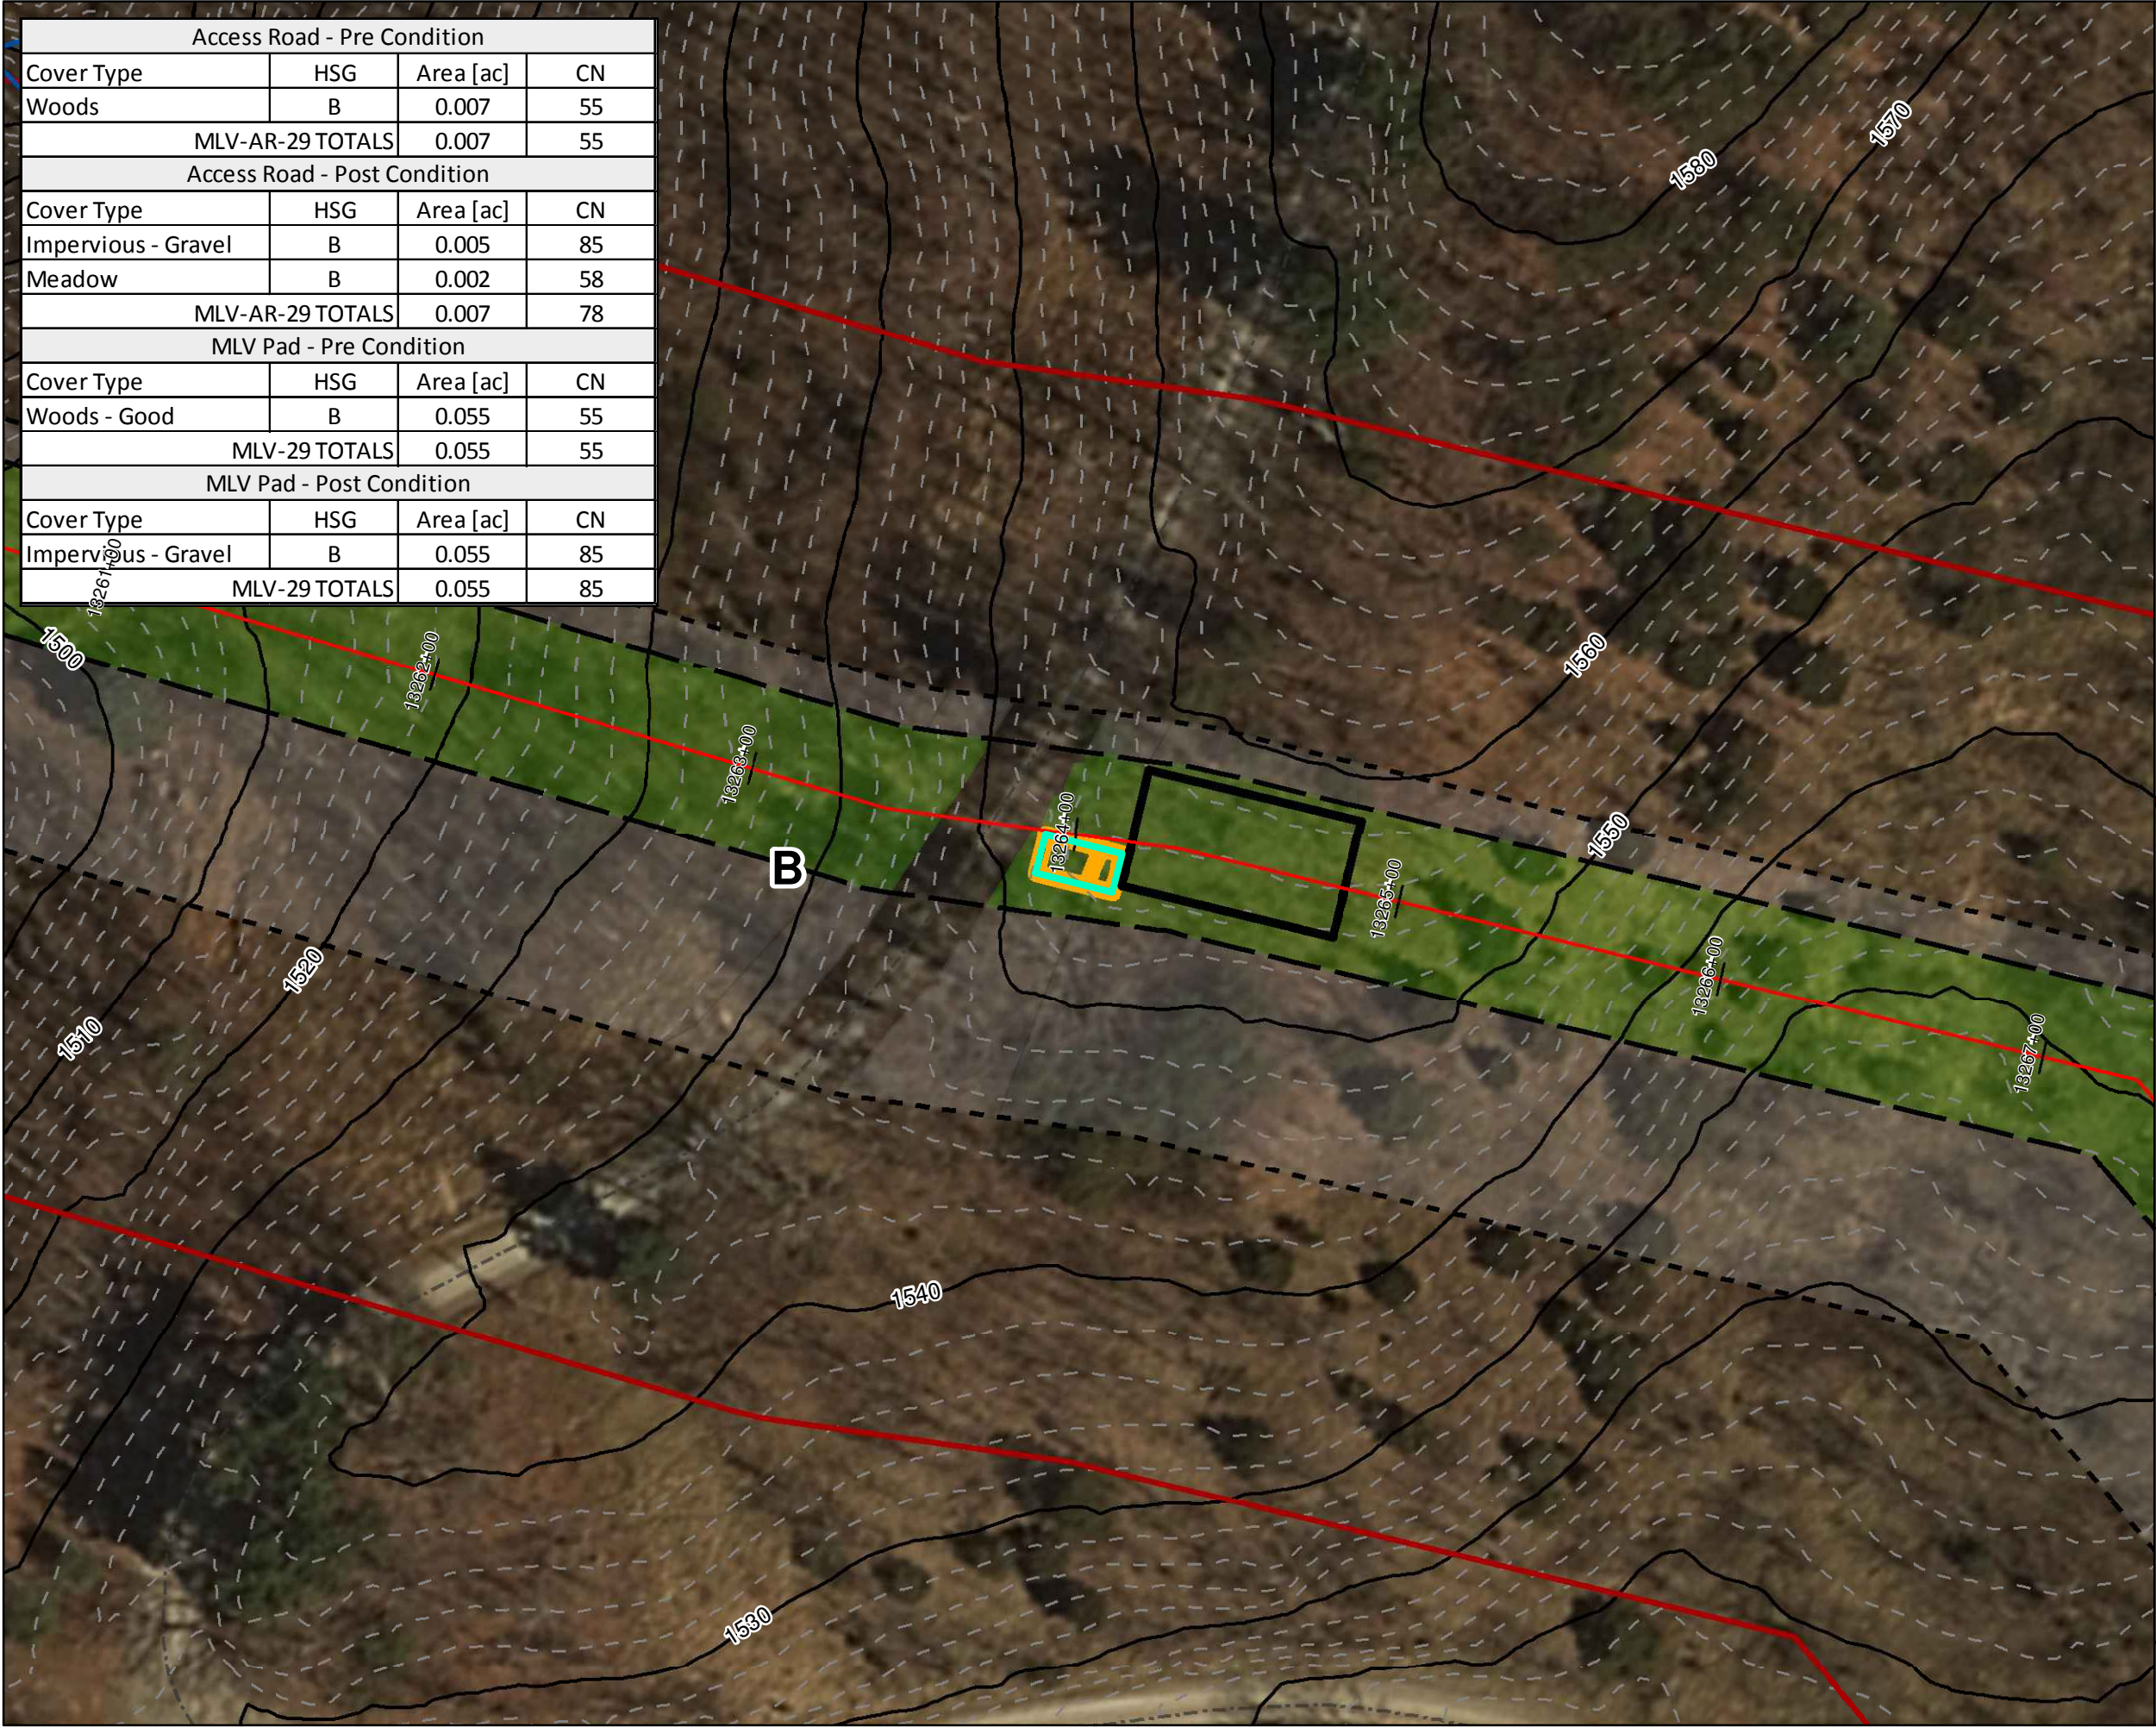
Figure 007  
Franklin County, Virginia  
March, 2018

| Access Road - Pre Condition | | | |
| MLV-AR-29 TOTALS | | 0.007 | 55 |
| Access Road - Post Condition | | | |
| MLV-AR-29 TOTALS | | 0.007 | 78 |

**New Impervious Cover  
Stormwater Drainage Exhibits  
MLV-29  
Spread 10**
