**Mountain Valley Pipeline Project**

**New Impervious Cover Stormwater Drainage Exhibits**

**MLV-23 Spread 8**

Figure 001

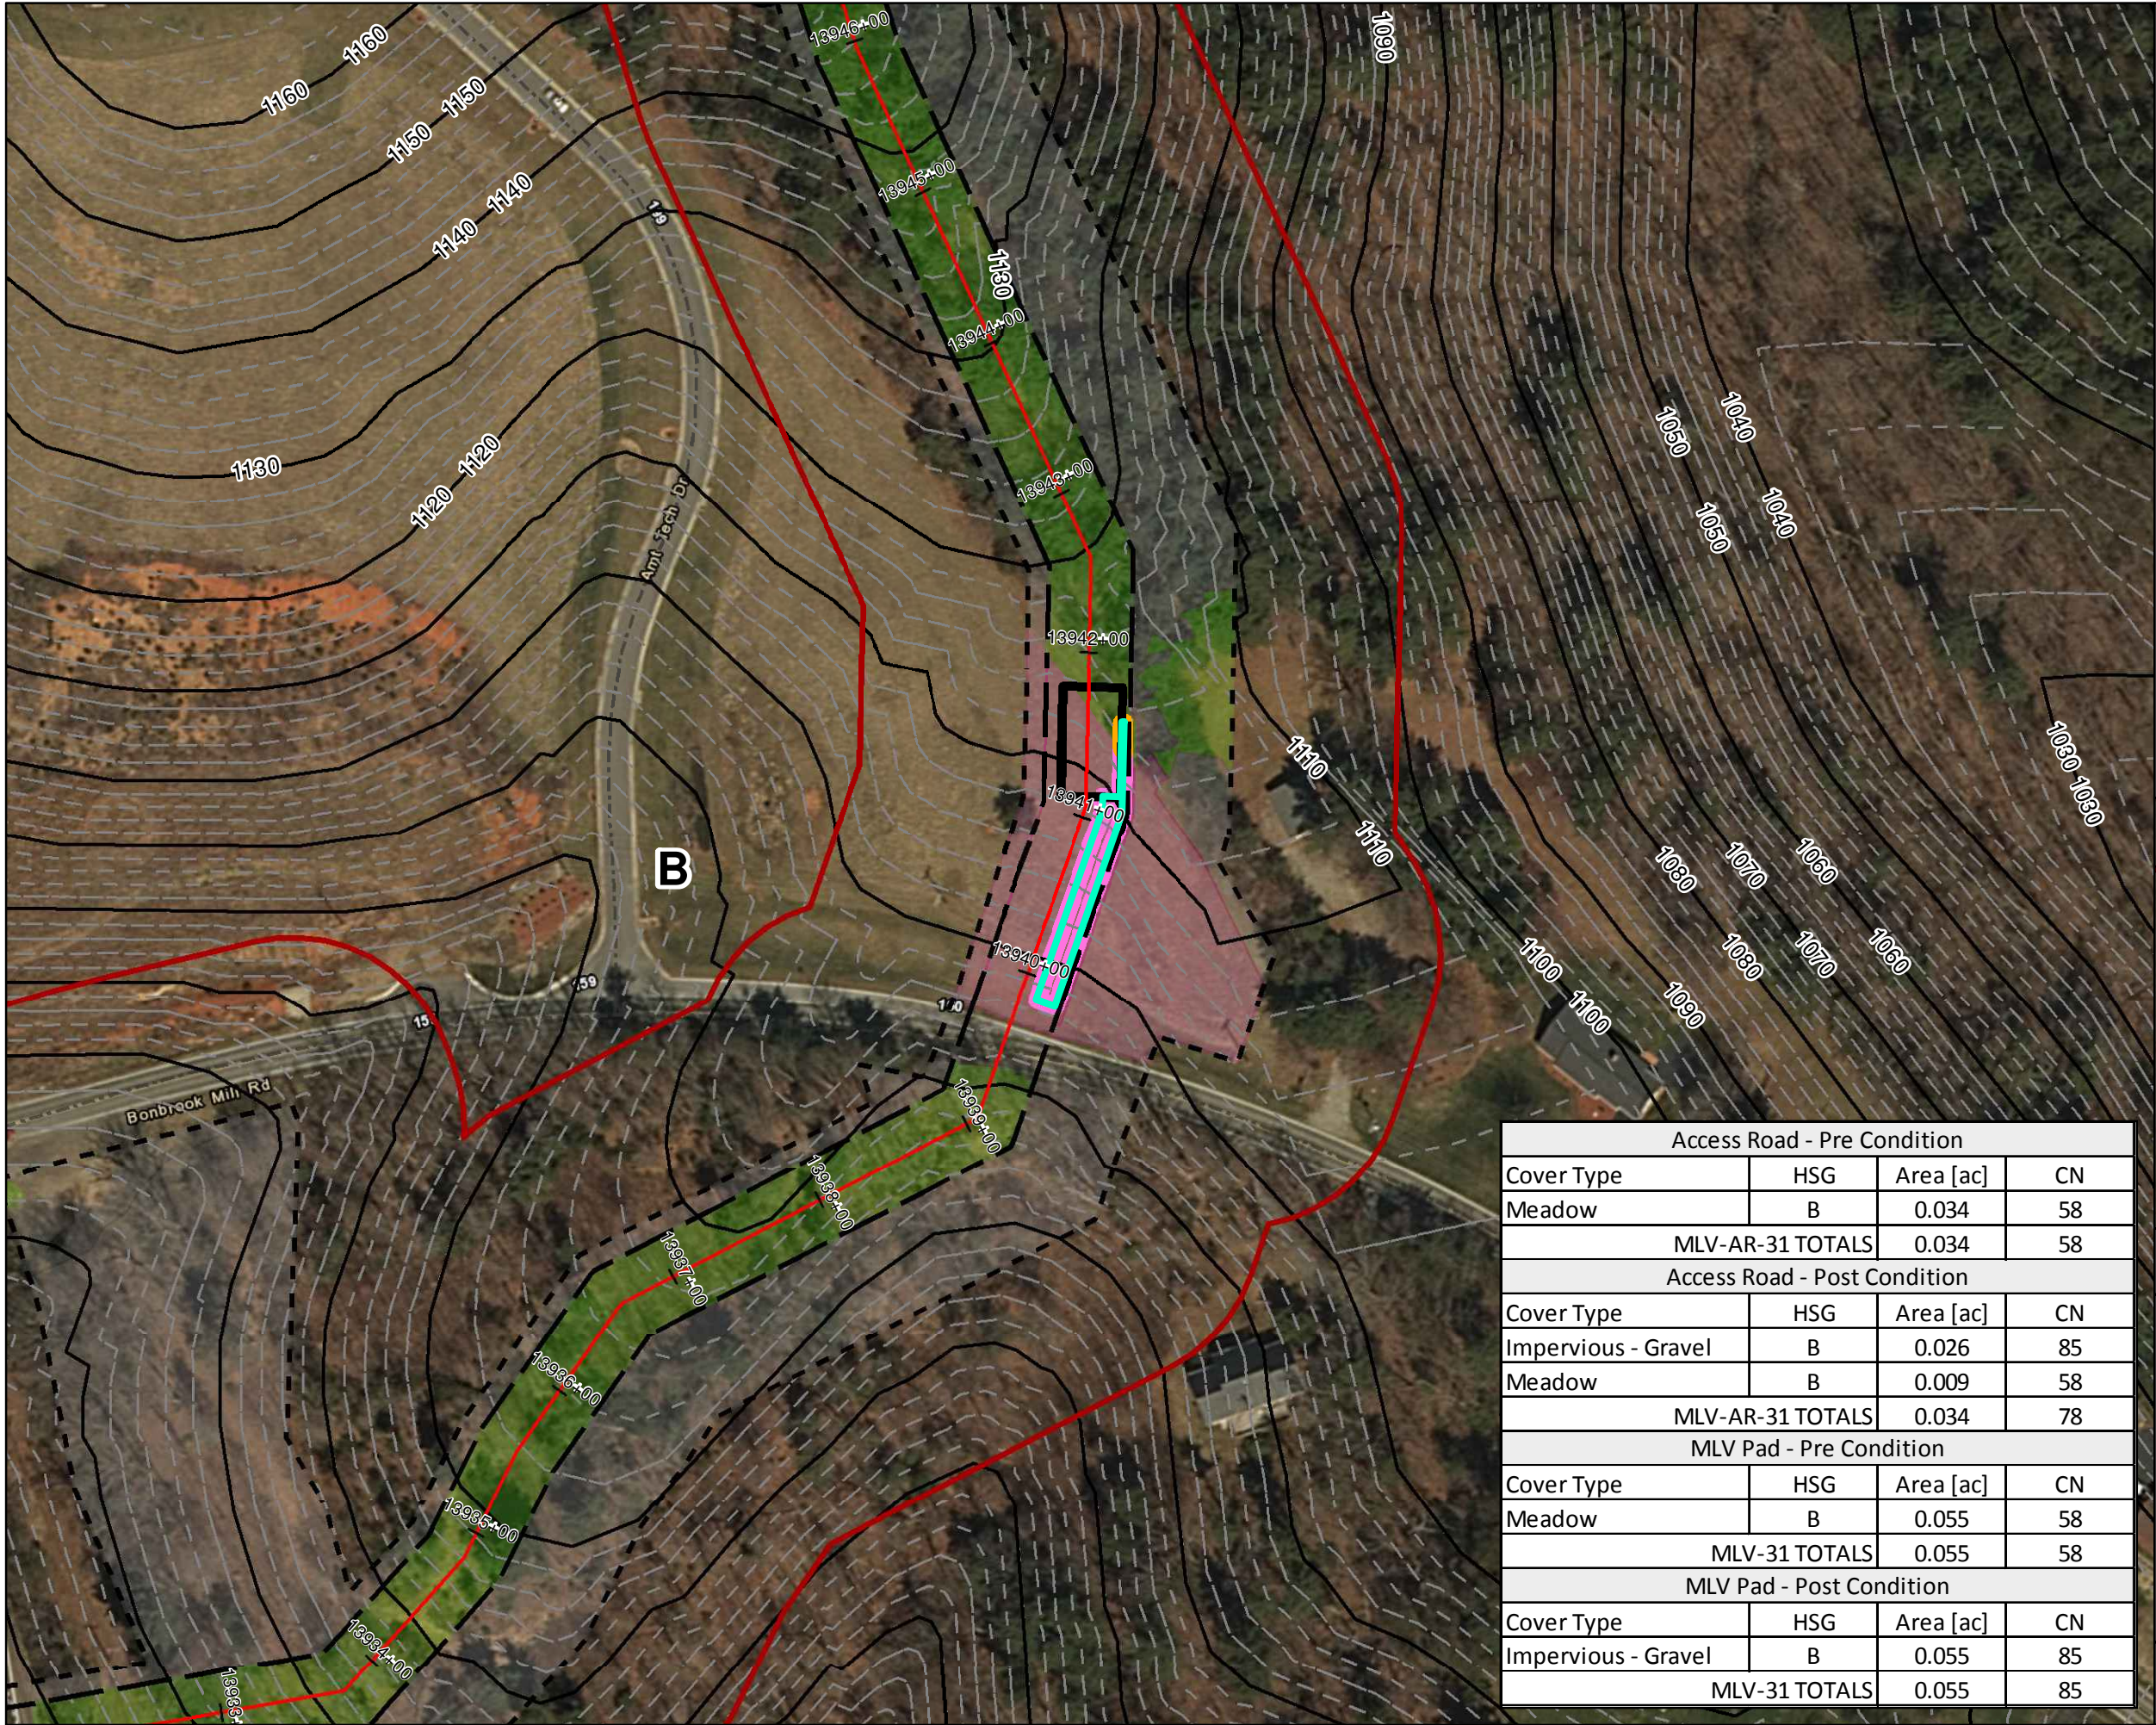
Figure 009  
Franklin County, Virginia  
March, 2018

### MLV-31 Spread 11

| Access Road - Pre Condition | | | |
| MLV-AR-31 TOTALS | | 0.034 | 58 |
| Access Road - Post Condition | | | |
| MLV-AR-31 TOTALS | | 0.034 | 78 |

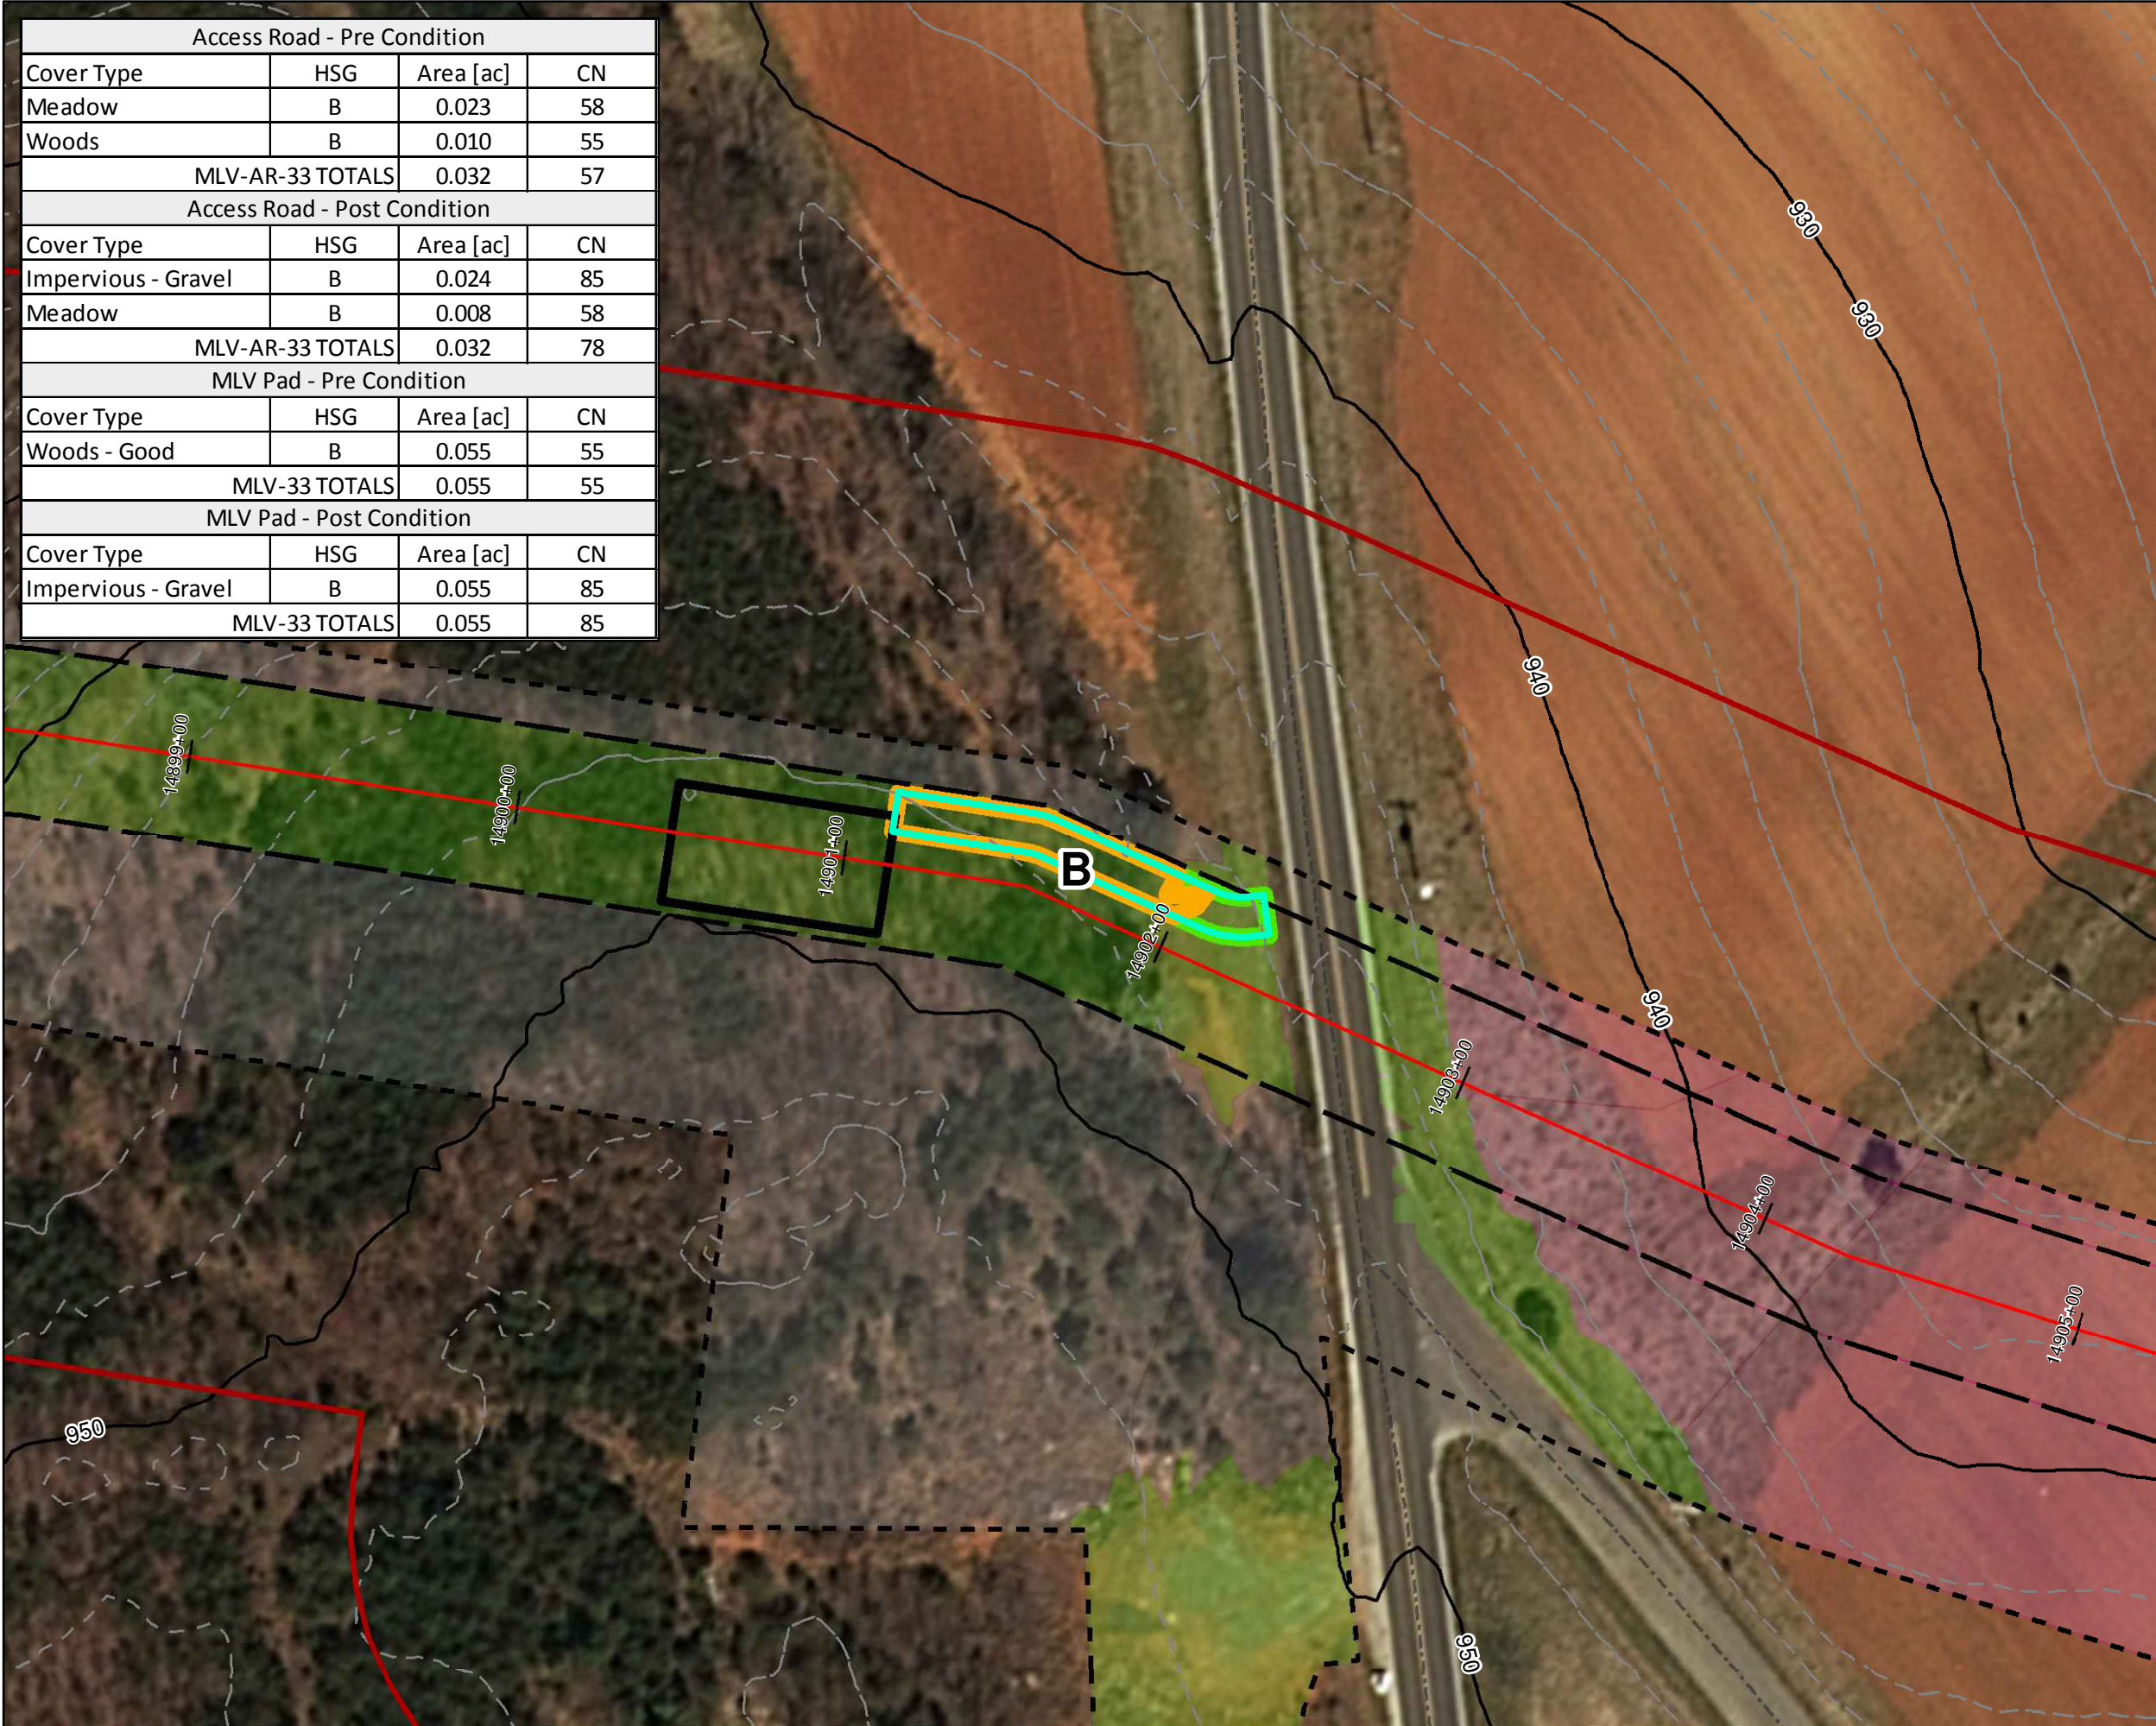
Figure 011

| Access Road - Pre Condition | | | |
| MLV-AR-33 TOTALS | | 0.032 | 57 |
| Access Road - Post Condition | | | |
| MLV-AR-33 TOTALS | | 0.032 | 78 |

### MLV-33 Spread 11

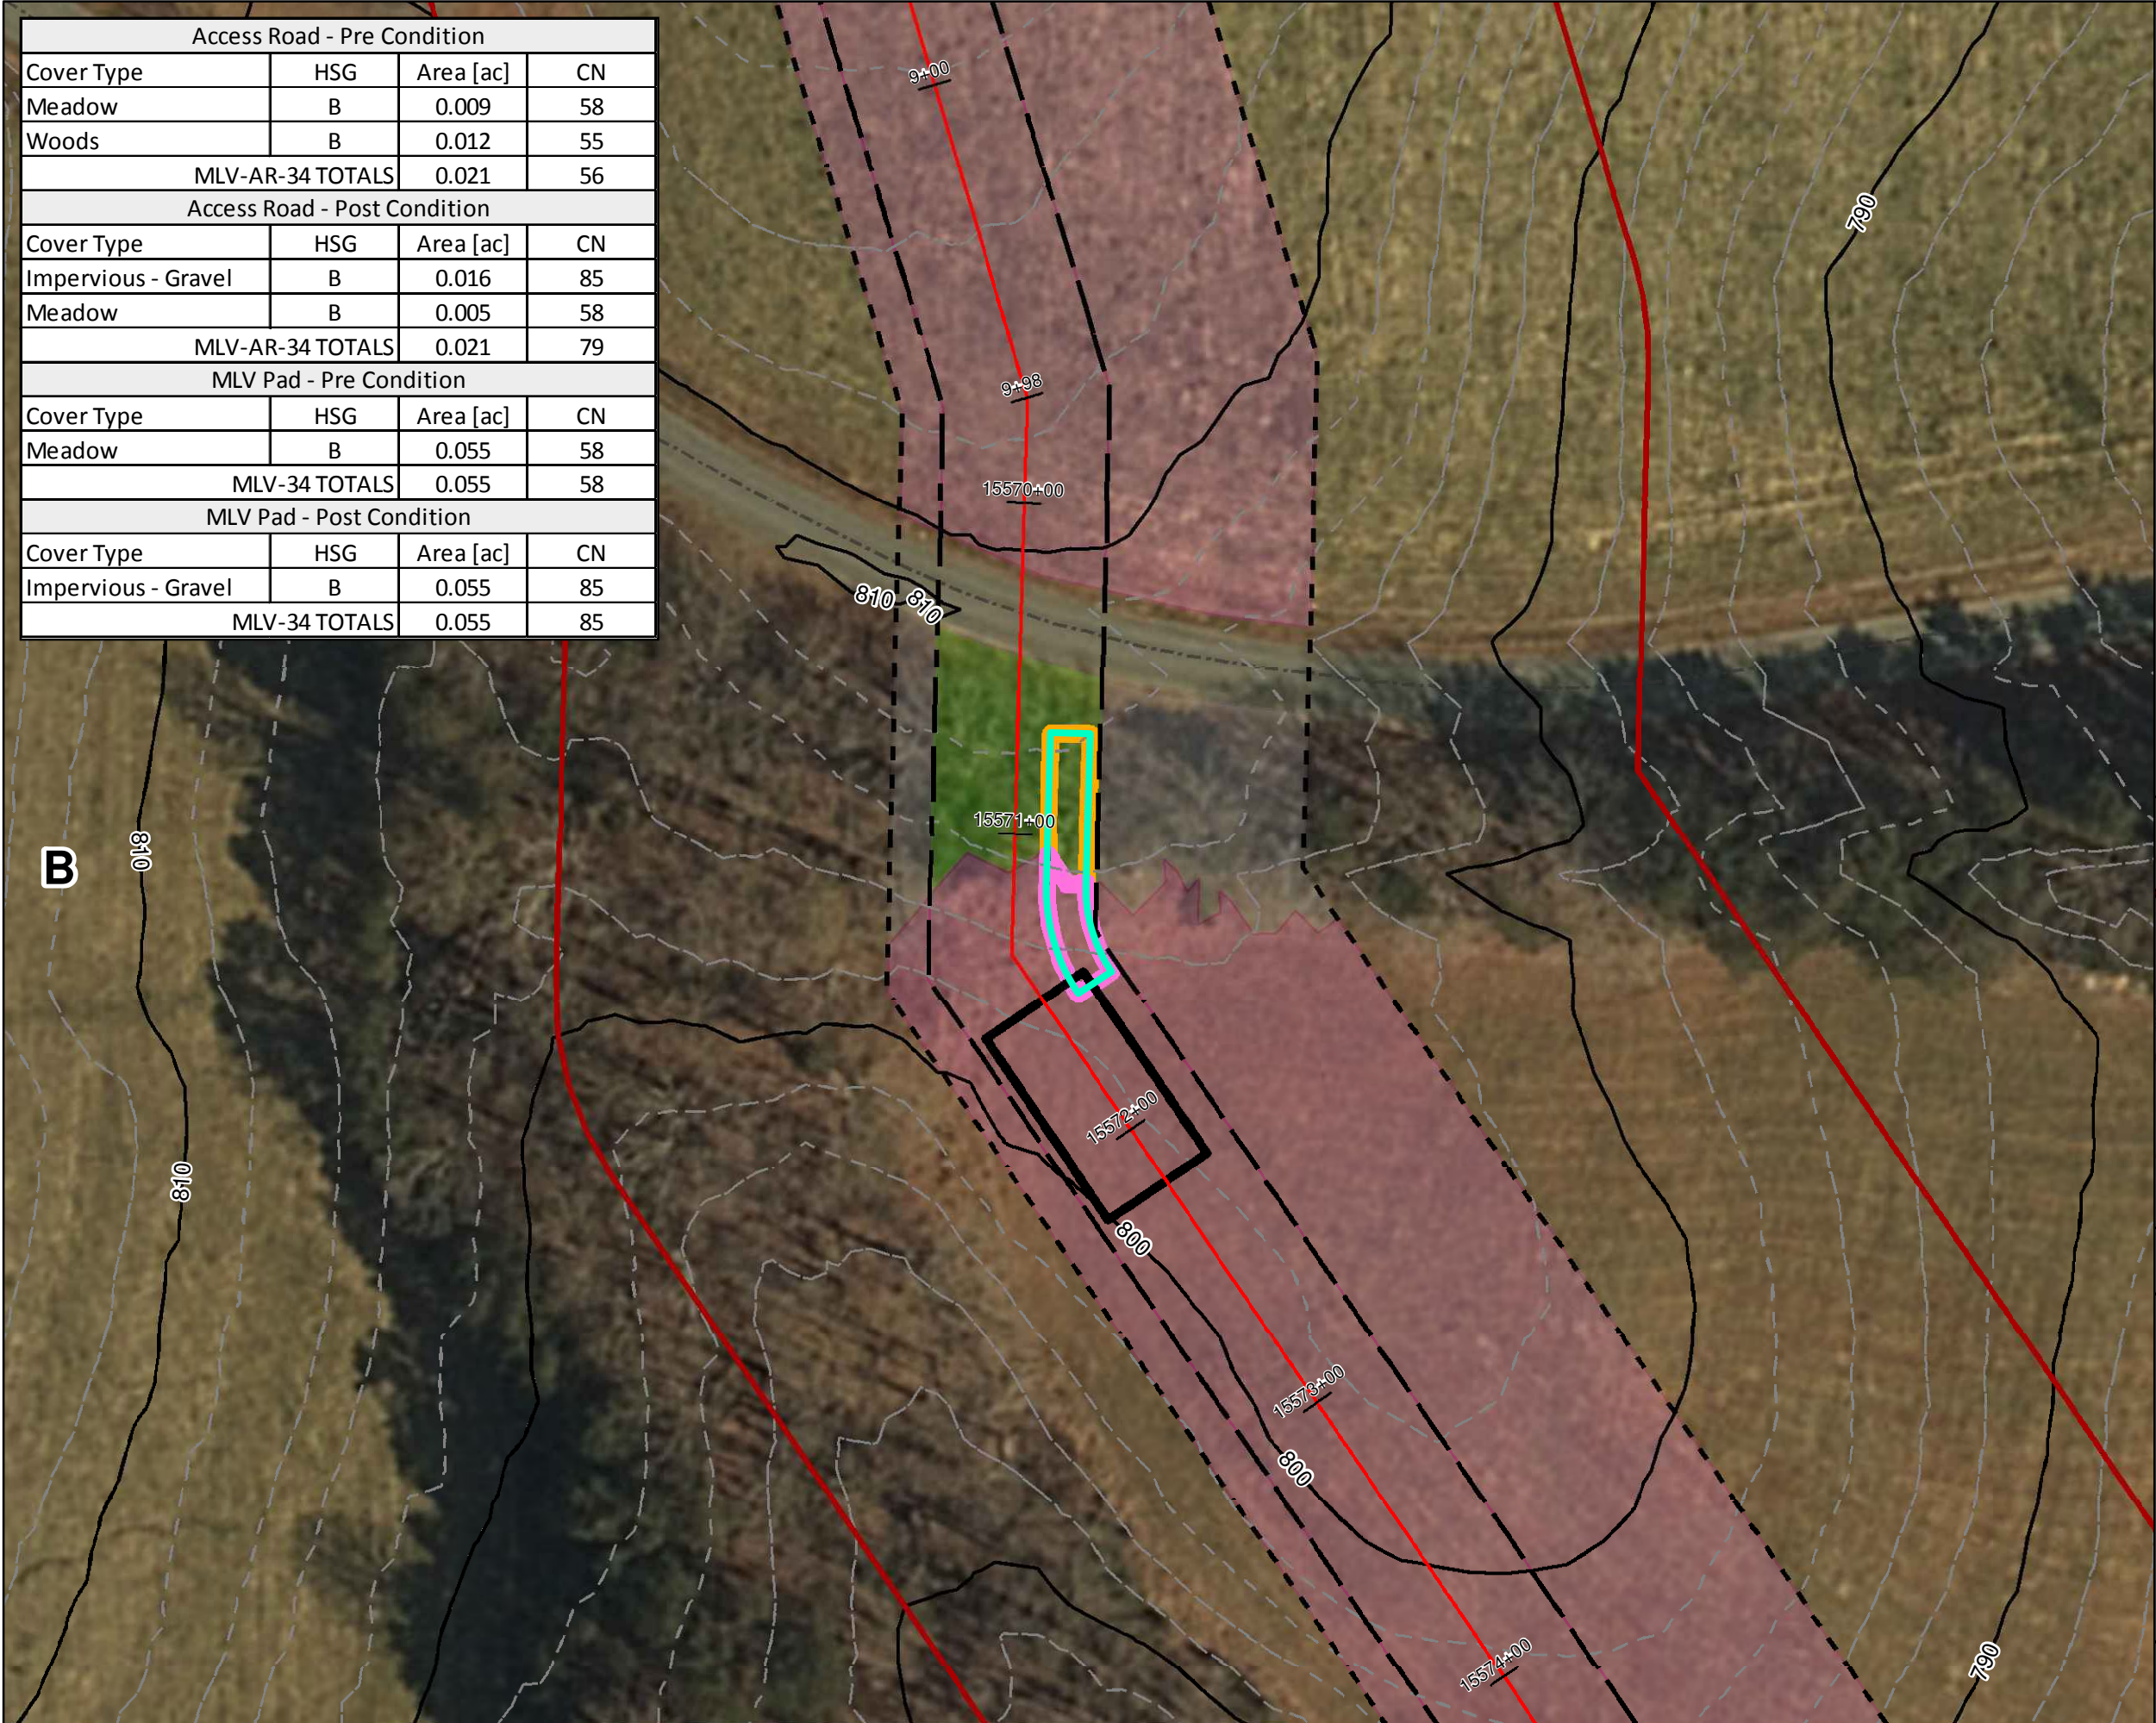
Figure 012  
Pittsylvania County, Virginia  
March, 2018

| Access Road - Pre Condition | | | |
| MLV-AR-34 TOTALS | | 0.021 | 56 |
| Access Road - Post Condition | | | |
| MLV-AR-34 TOTALS | | 0.021 | 79 |

#### MLV-34 Spread 11
