Re: Mountain Valley Pipeline, LLC  
Docket No. CP16-10-000  
Supplemental Materials

| <b><u>Attachment</u></b> | <b><u>Description of Materials</u></b> | <b><u>Filing Type</u></b> |
|---|---|---|
| A | Addendum: Phase I Reconnaissance Architectural Survey, Pittsylvania and Franklin Counties, Virginia | Public |

# **ADDENDUM**

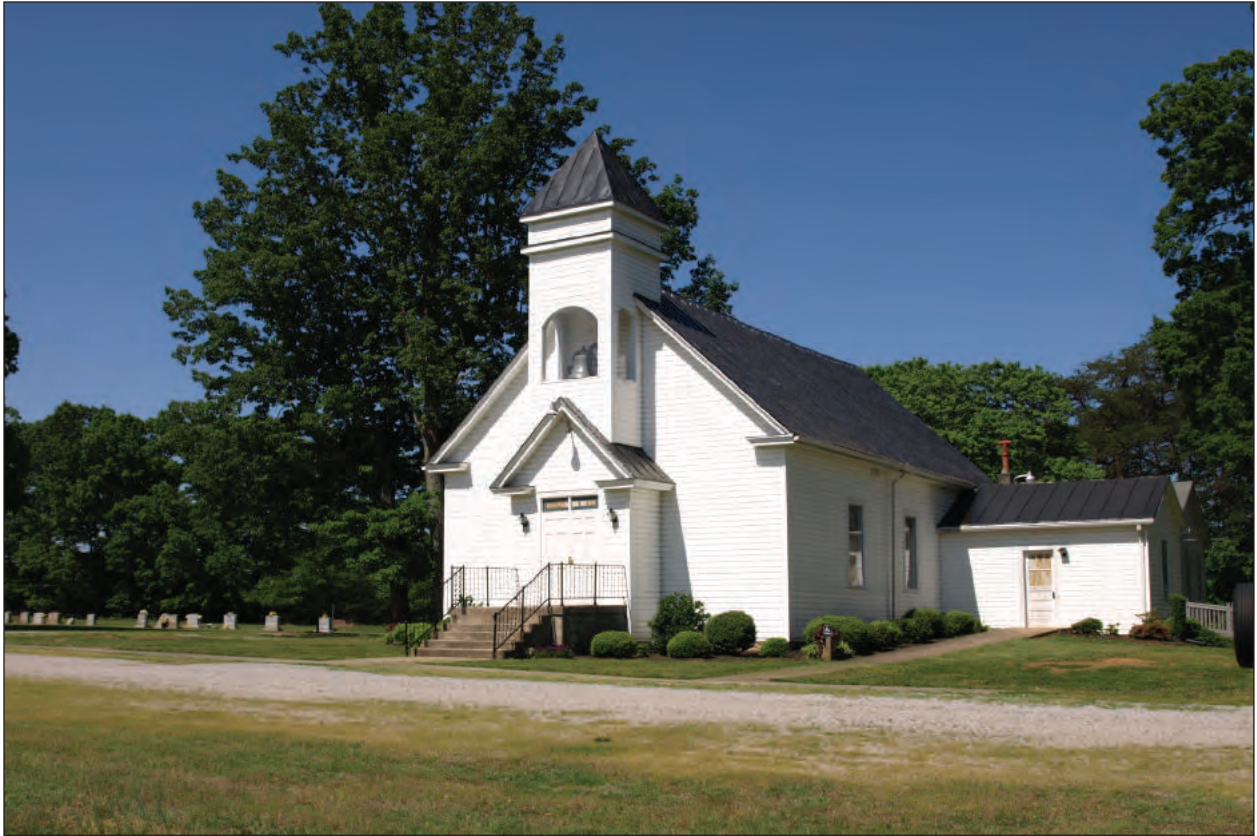
**Photograph 1. Oak Grove Christian Church and Cemetery (071-5483), View West**

The circa-1900 Gothic Revival-styled church features a front-gable roof and a projecting front entry vestibule surmounted by a square bell-tower with mid-level arched openings that expose the forged iron church bell. The tower has a pyramidal roof. The church has been enlarged in multiple phases with a rear wing on the west side, constructed in phases between 1950 and 1975, and a circa 1925 small side wing on the north elevation. The side-gable rear wing connects to the church with a hyphen. The church has been altered with vinyl siding. There are stained glass windows in the main block of the church, six-over-six wood and two-over-two horizontal metal sash windows in the hyphen and nine-over-nine wood sash windows in the rear wing. The church sits on stone and concrete foundations.

This resource is a well-preserved example of a turn-of-the-twentieth-century rural church. The only alteration observed was the application of vinyl siding, and the additions, which may possess historic or architectural significance. The vinyl siding erodes the resource's materials integrity, but the building retains its basic form, design and construction and its Vernacular Gothic Revival style. The associated cemetery contributes the church's historic setting. It is not known if the church may possess significance under Criteria A or B, for possible associations with person or events. New South Associates recommends further research and an intensive survey in order to make an individual NRHP eligibility determination for this property.

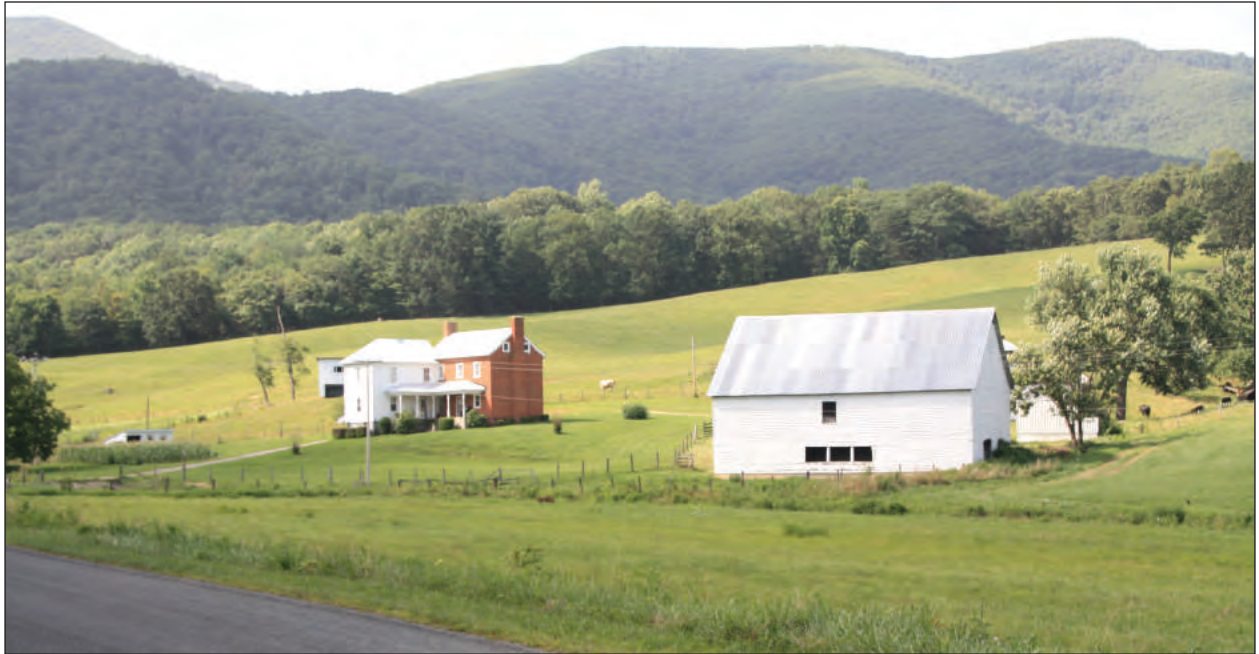
**Photograph 2. Flora Farmstead (033-0389), View Northeast**

This Flora Farm property contains a well-preserved Federal-period dwelling that was expanded in the early twentieth century. With the exception of the vinyl siding on the 1918 wing, both sections retain materials integrity. The presence of the original windows in the circa 1824 section is notable. The circa-1918 porch replaces the original one, but it serves to integrate the two parts of the dwelling and illustrates how the building evolved over time. The outbuildings appear to be twentieth-century agricultural buildings that contribute to resource's rural setting. The property has been associated with the Flora family since the 1880s, but their significance in local events is unknown. The VDHR determined the Flora Farmstead potentially eligible for listing in the NRHP in 1995. Additional architectural survey and background research is recommended to fully evaluate the Flora Farm's eligibility for listing in the NRHP.

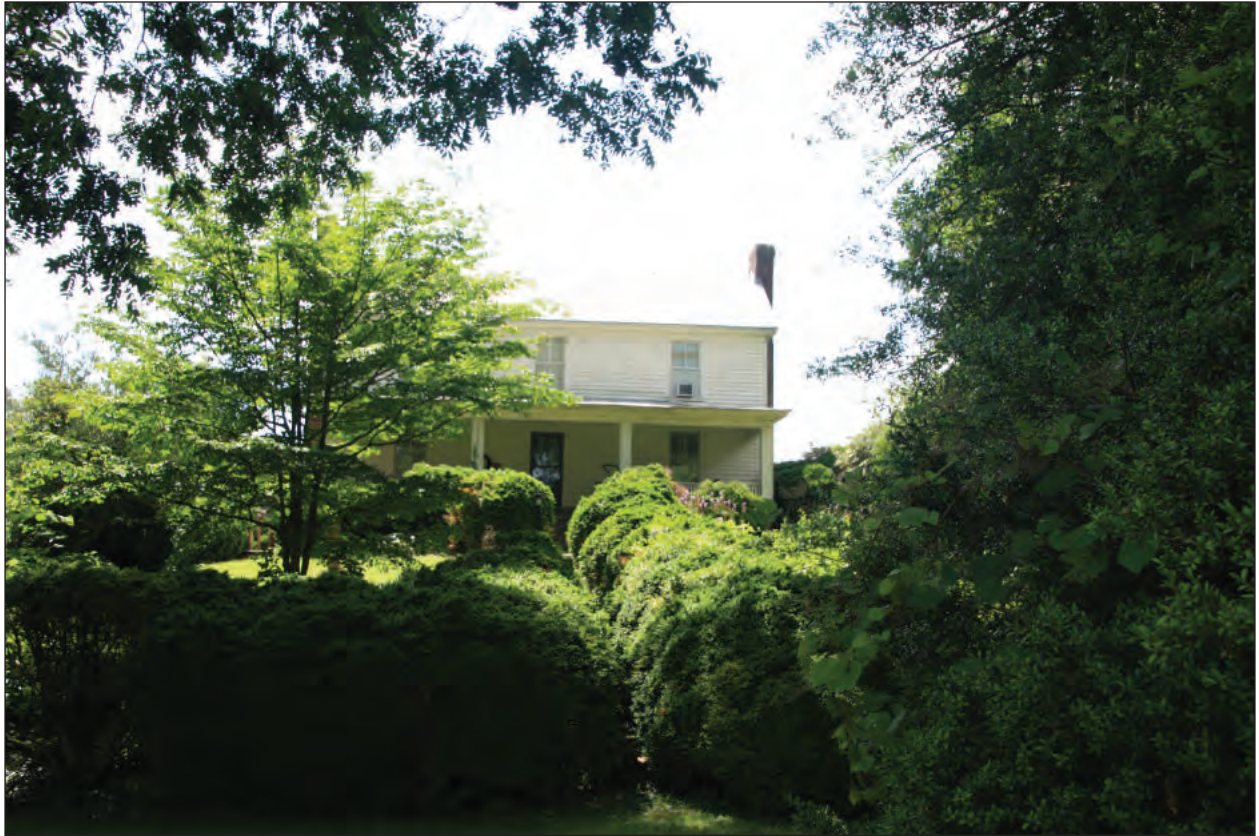
**Photograph 3. House (033-5398), View West**

This resource is a typical example of an early twentieth-century Craftsman-styled farmhouse lacking distinctive architectural features and materials integrity. The property is not known to have associations with events or persons significant in the past. For these reasons, the property is recommended not eligible for the NRHP under Criteria A, B, or C.

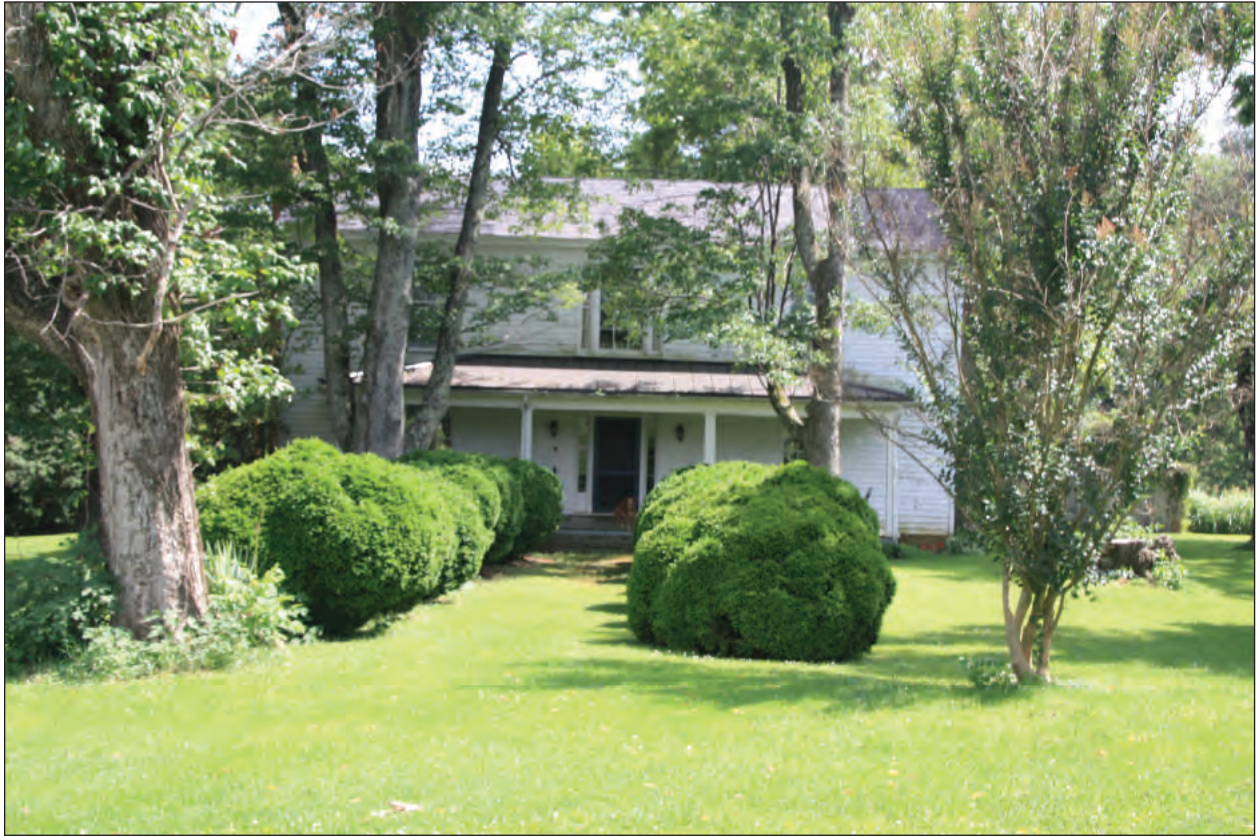
**Photograph 4. House (033-5400), View Southwest**

This circa-1850 farmhouse is located on a five-acre parcel on the south side of Leaning Oak Road and on the north side of Teels Creek (Figure 6; Photograph 4). In the south yard are several outbuildings, including a circa 1925 garage and a modern shop building. The front yard has mature deciduous trees and a boxwood allee in front of the house. Agricultural fields on all sides surround the parcel.

This house is a well-preserved example of an antebellum Greek Revival dwelling. It retains a high degree of integrity of materials, design, and construction as well as an intact rural setting. The resource is potentially eligible for the NRHP under Criterion C. Its historical association with important events or persons in the past is unknown. Additional research and an intensive survey are recommended to make an NRHP eligibility determination for this property.

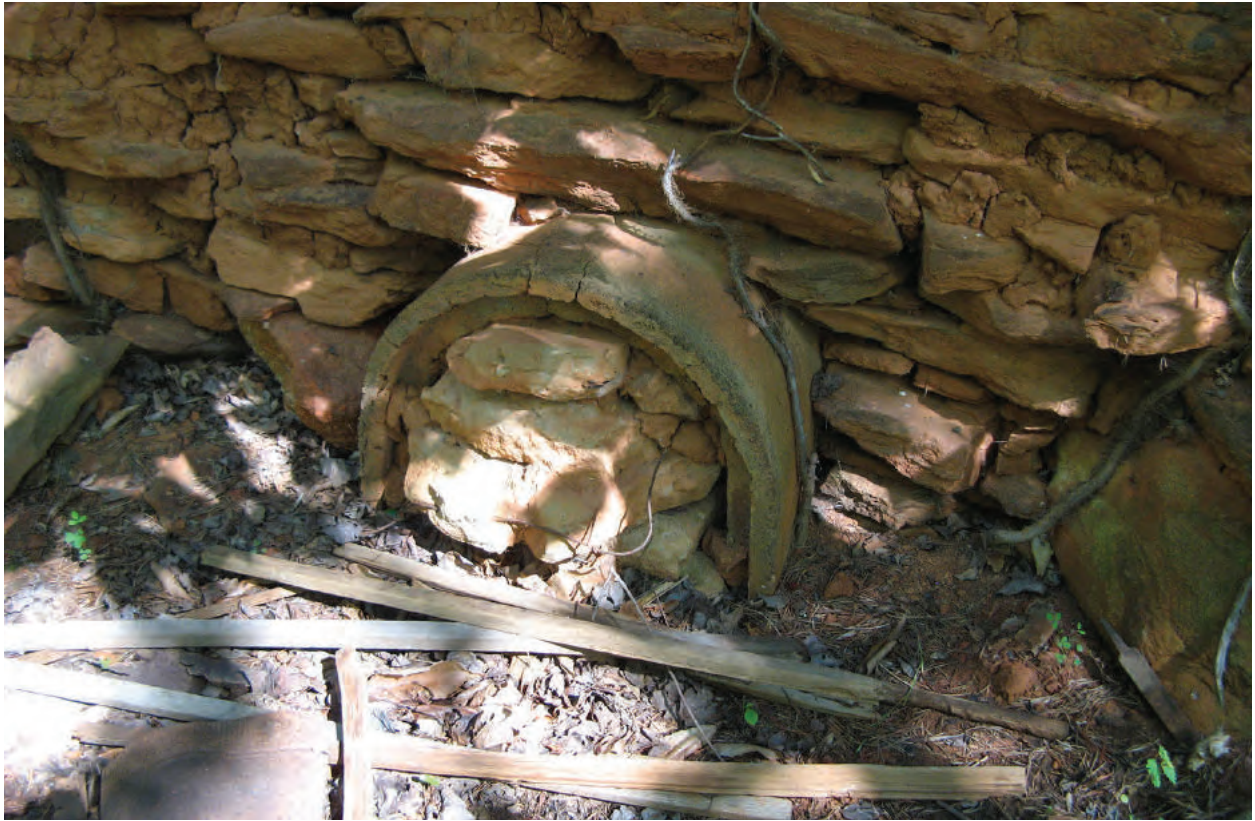
**McDaniel Tobacco Barn (071-5465), 2351 Anderson Mill Road (Route 649), Detail**

This resource consists of a single twentieth-century V-notched log tobacco barn. A 2012 V-CRIS record indicated there were two barns on the parcel, but only one barn was observed during the present survey. The barn has a metal roof and a stone foundation. The logs are chinked with mud daubing. Tobacco leaves from a long ago harvest are hanging from rafters. This barn was not visible from the public right-of-way and was recorded by Tetra Tech's archaeological field crew.

This circa-1940 stand-alone barn is not obviously associated with other barns or agricultural buildings that could place it within a historic context or landscape. The barn does not appear to possess significance of design or construction. This tobacco barn was recorded as part of Preservation Virginia's Pittsylvania Tobacco Barn Survey (2014-2015) and was recommended not eligible for the NRHP under Criterion A, B, or C. No changes are recommended to its NRHP status.
