**Subject: Mountain Valley Pipeline Project
DRAFT National Register of Historic Places Registration Form, Gum Farmstead
Historic District (Underwood Farmstead LE-0150)
WVDCH File #15-67-MULTI
FERC Docket #CP16-10**

National Register of Historic Places Registration Form

Historic name: Gum Farmstead Historic District

Other names/site number: Underwood Farmstead; LE-0150

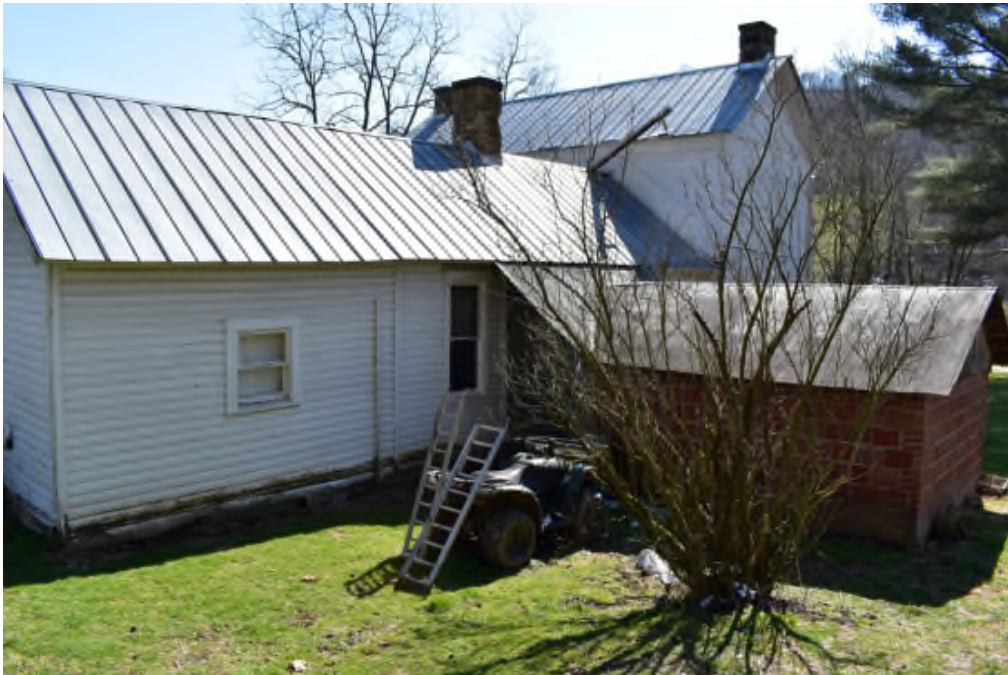
Photo 4

The west elevation of the rear element has an entrance left of center (**Photo 4**). It is fitted with a fully-glazed replacement door and is accessed by a low set of concrete stairs. Areas of the upper wall flanking this door are clad in unpainted plywood. There is a wide rectangular window opening fitted with a vinyl replacement window left of the door, a pair of small narrow windows fitted with wood sashes near the center of the elevation, and a pair of smaller wood sash windows near its north end. A metal cover creates an informal breezeway by connecting its roof eave to the roof of a low root cellar building just to

the west of the house (**Photo 4**). The asymmetrical north elevation has a screened vent at the gable end and two small wood sash windows left of center (**Photo 6**). An entrance below the gable is fitted with a metal screen door with plastic jalousie window and is accessed via a low set of concrete steps.

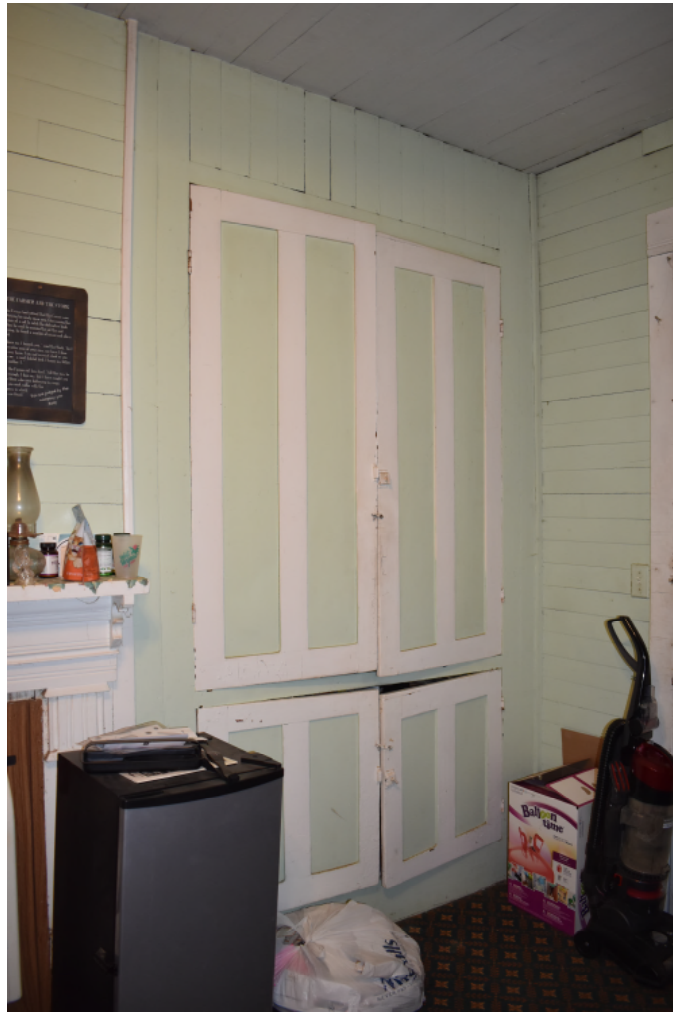
Photo 18

Leaving the bedroom heading north through a single wood paneled door one enters the farmhouse's original kitchen. The kitchen has two exterior doors, one on the west leading to the outdoor root cellar (**Photo 16**) and one on the east leading to the now enclosed rear porch. Both doors are single wood paneled doors (with transoms, surrounds with cornices). To the right of the door on the west wall is a window with a simple wood surround. The kitchen's interior wall (shared with the bedroom) features a fireplace with original mantle (**Photo 17**). Like the fireplaces in the bedroom and hall, the kitchen's mantle is composed of individual pieces of wood to form its design and has been modified to hold a gas wall heater. The room's walls and ceilings are the original painted tongue-and-groove; the original hardwood floors remain under modern carpet. To the right of the fireplace is a built-in cabinet with four painted wood panel doors (**Photo 18**).

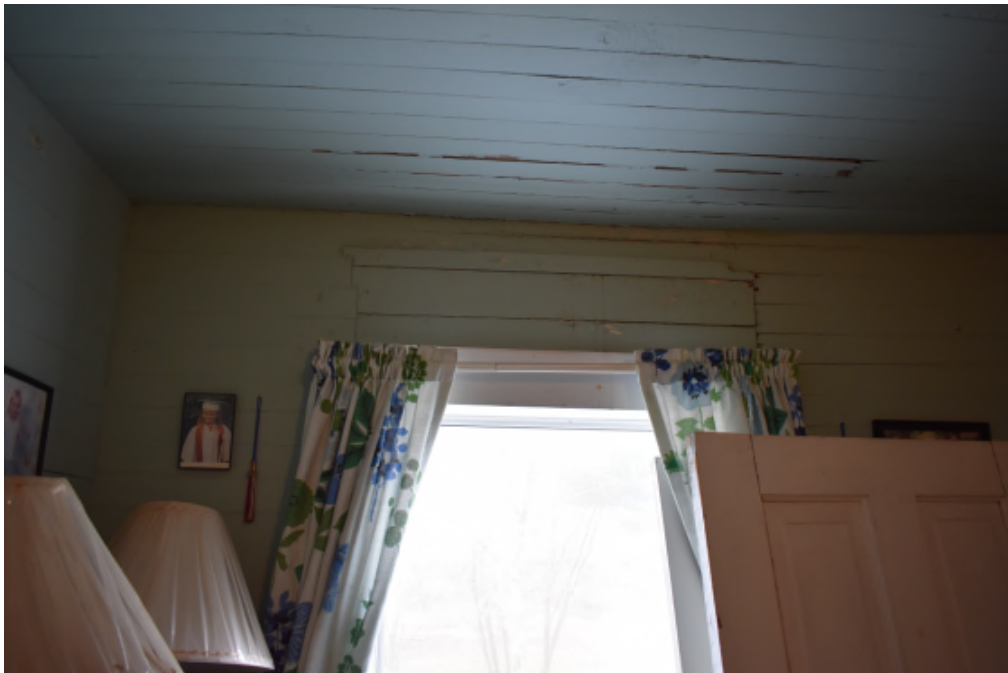
Photo 20

At the end of the hall there is a window with a simple wood surround. This window is the central window on the farmhouse's façade. There is evidence of patching in the south wall's tongue-and-groove above the window in the shape of cornice board where a door once led to a second-story porch (no longer extant) (**Photo 20**).

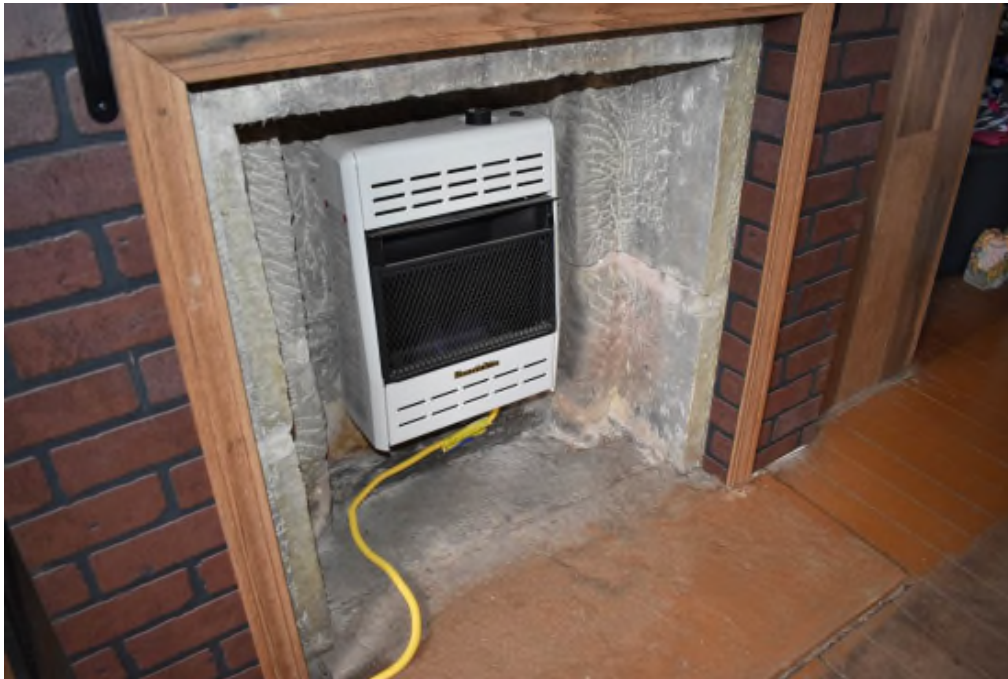
Photo 21

removed in the bedroom and the fireplace has been modified to hold a gas wall heater; however, the chimney stones have been left exposed (**Photo 21**). The room's walls and ceilings are the original painted tongue-and-groove; the original hardwood floors remain (**Photo 22**). The room's south wall has two windows and the north wall has one window—all with simple wood surrounds.

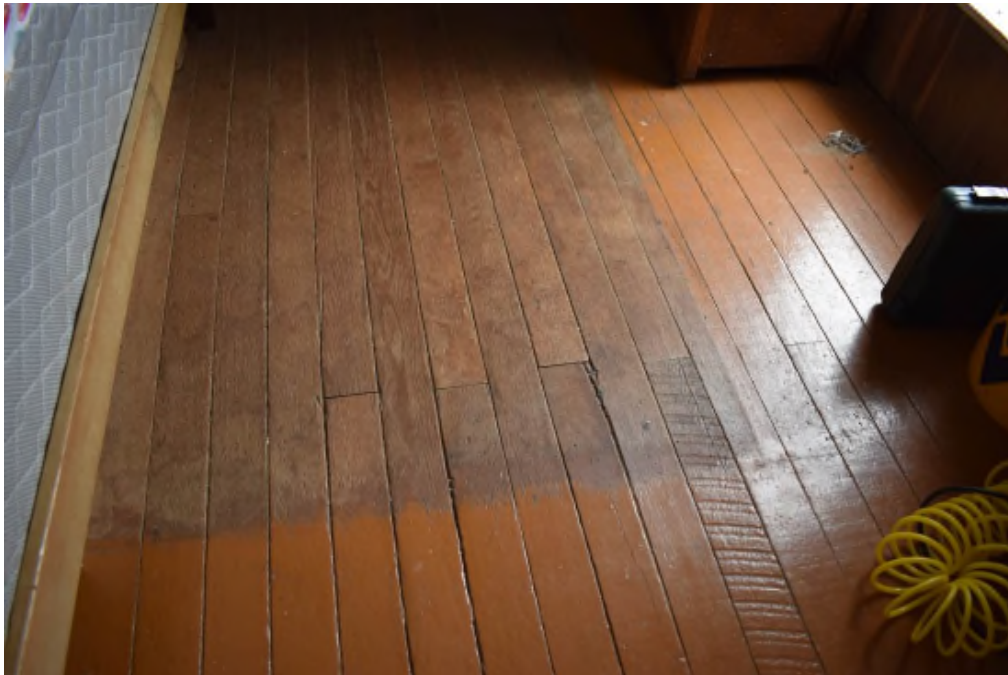
Photo 22 (WV_Lewis County_Gum Farmstead Historic District_0022)
Farmhouse (Interior) – Original hardwood floors in second floor east bedroom
Camera facing: East

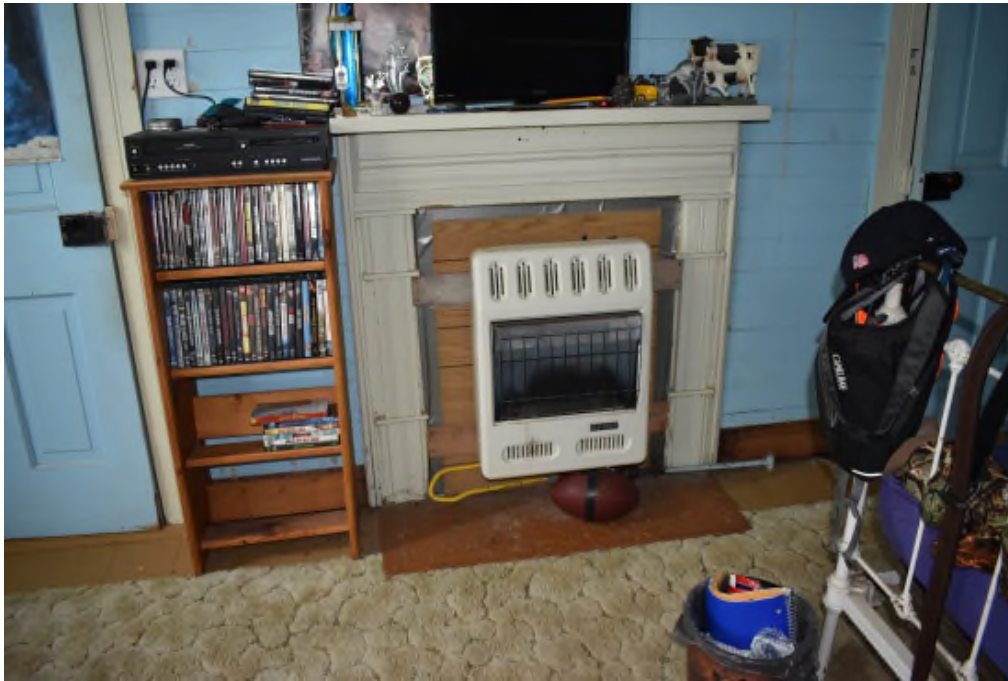
Photo 23 (WV_Lewis County_Gum Farmstead Historic District_0023)
Farmhouse (Interior) – Second floor west bedroom, original mantle, fireplace modified to hold a gas wall heater
Camera facing: West

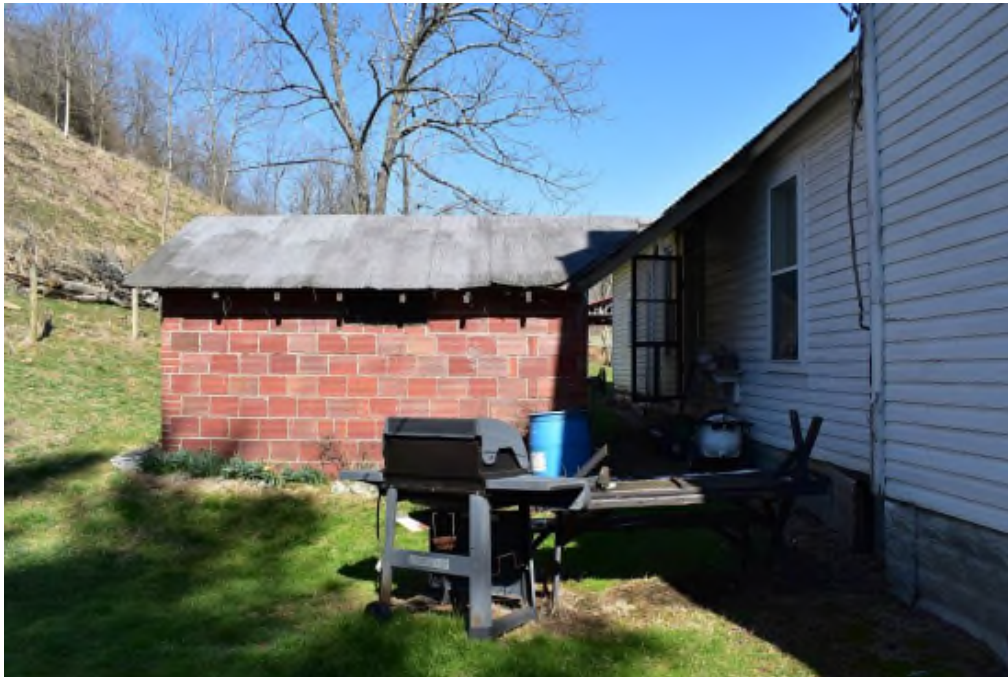
Photo 24 (WV_Lewis County_Gum Farmstead Historic District_0024)
Root Cellar appended to farmhouse's west elevation by a shed-roof connection over the farmhouse kitchen's exterior door
South Elevation
Camera facing: North

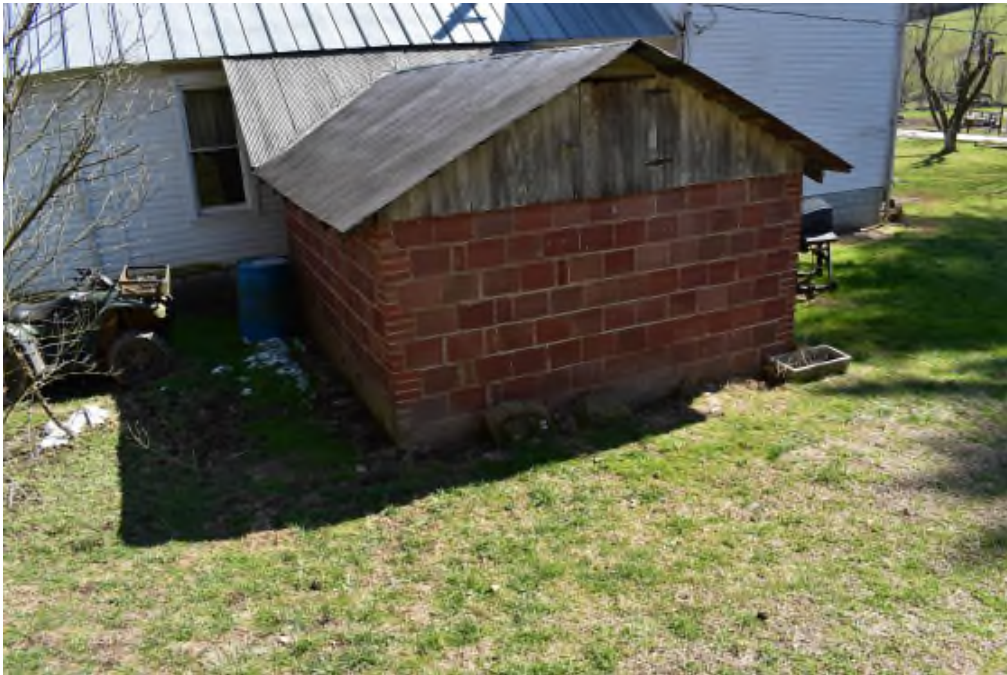
Photo 25 (WV_Lewis County_Gum Farmstead Historic District_0025)
Root cellar - attic story clad in vertical wood boards, access to attic provided by small wooden hinged door
West Elevation
Camera facing: East

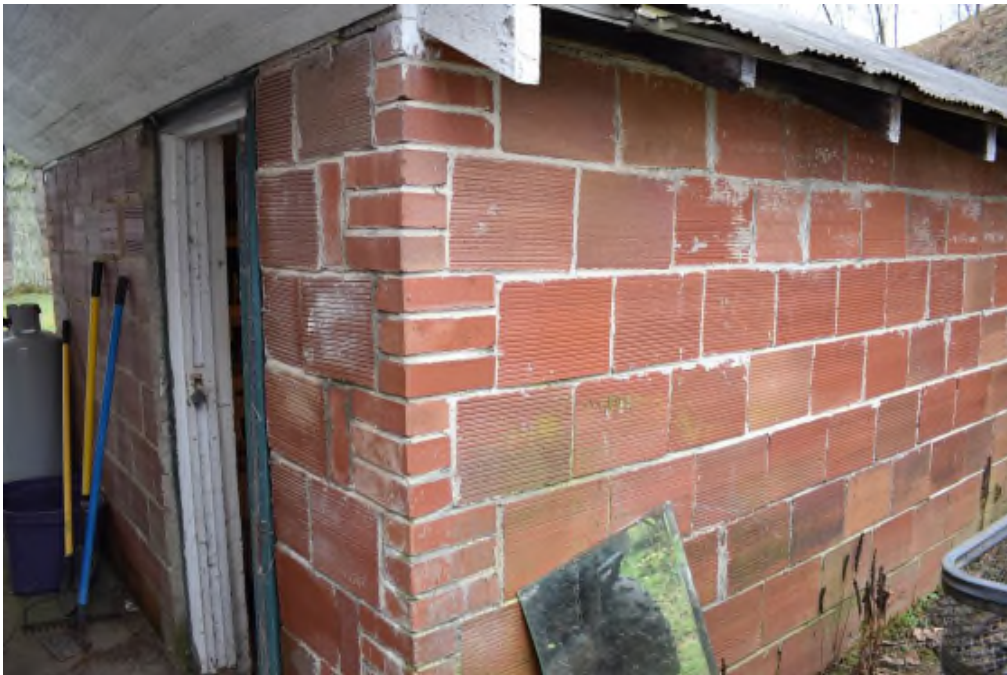
Photo 26 (WV_Lewis County_Gum Farmstead Historic District_0026)
Root cellar - Main level access provided by a solid wooden human door on the structure's east elevation directly across from an exterior door leading to the original farmhouse kitchen
East Elevation
Camera facing: North

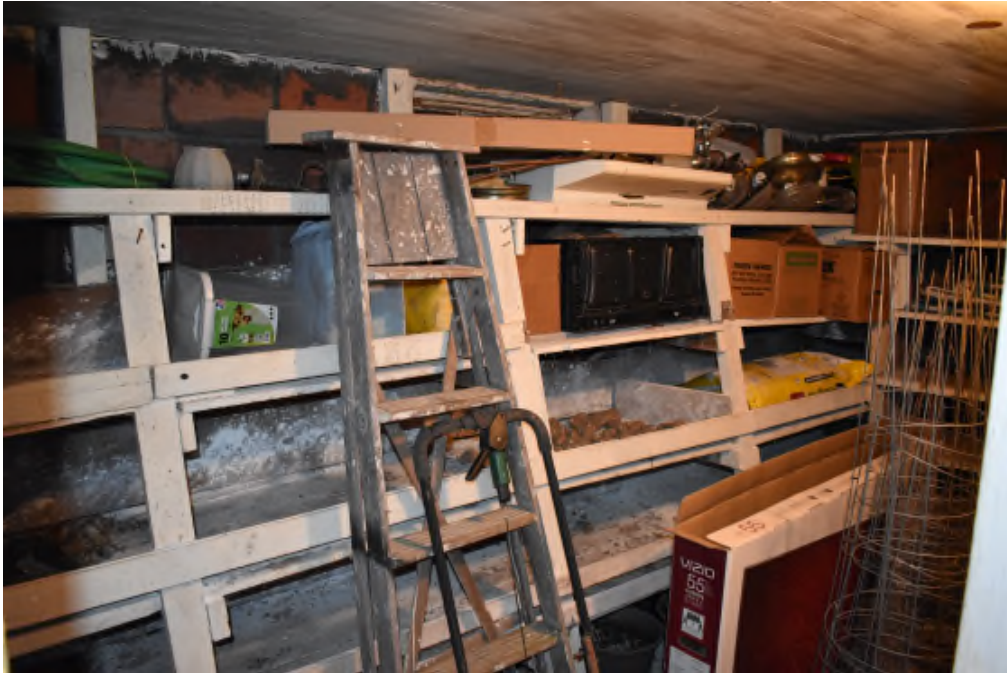
Photo 27

Appended to the farmhouse's west elevation by a shed-roof connection over the farmhouse kitchen's exterior door is a front gable root cellar measuring roughly 15 feet long by 14 feet wide (**Photo 24**). The circa-1920, one-story cellar is constructed of structural terra cotta block. The structure's front gable roof is covered in corrugated metal; rafter tails are exposed. The structure's attic story is clad in vertical wood boards and access to the attic is provided by a small wooden hinged door on the west elevation (**Photo 25**). Main level access is provided by a solid wooden human door on the structure's east elevation directly across from an exterior door leading to the original farmhouse kitchen (**Photo 26**). The shed roof connection between the root cellar and the farmhouse's kitchen is covered in corrugated metal. This structure exhibits characteristics typical of root cellars, the first being that it is in the farmhouse's orbit, in this instance, incorporated into the fabric of the farmhouse. Also, while root cellars range in size, like this cellar, they were commonly large enough for an adult to stand erect. Further, this cellar is floored in concrete, which is typical of this structure type and features storage bins for produce (**Photo 27**) and shelves for canned goods (**Photo 28**).

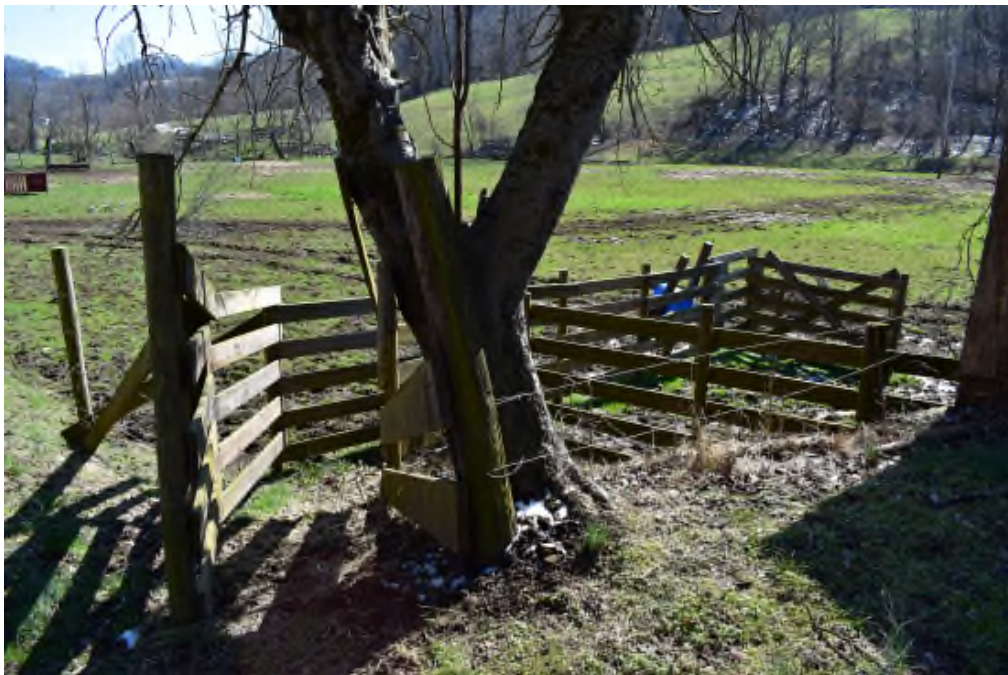
Photo 32

As noted previously, the circa-2013 wooden loading chute is located adjacent to Resource C along County Route 10 (**Photo 32**). The circa-1970 chicken house and circa-1960 feed house with shed addition are clustered directly south of Resource D (**Photo 38**). The chicken house is a timber frame structure measuring roughly 8.5 feet wide by 18 feet long. The structure's exterior walls are clad in vertical wood boards and its front gable roof is covered in standing seam metal. The timber frame feed house and addition are topped by a shed roof covered in standing seam metal. The structure measures roughly 11 feet wide by 16 feet long and its walls are clad in vertical wood boards.

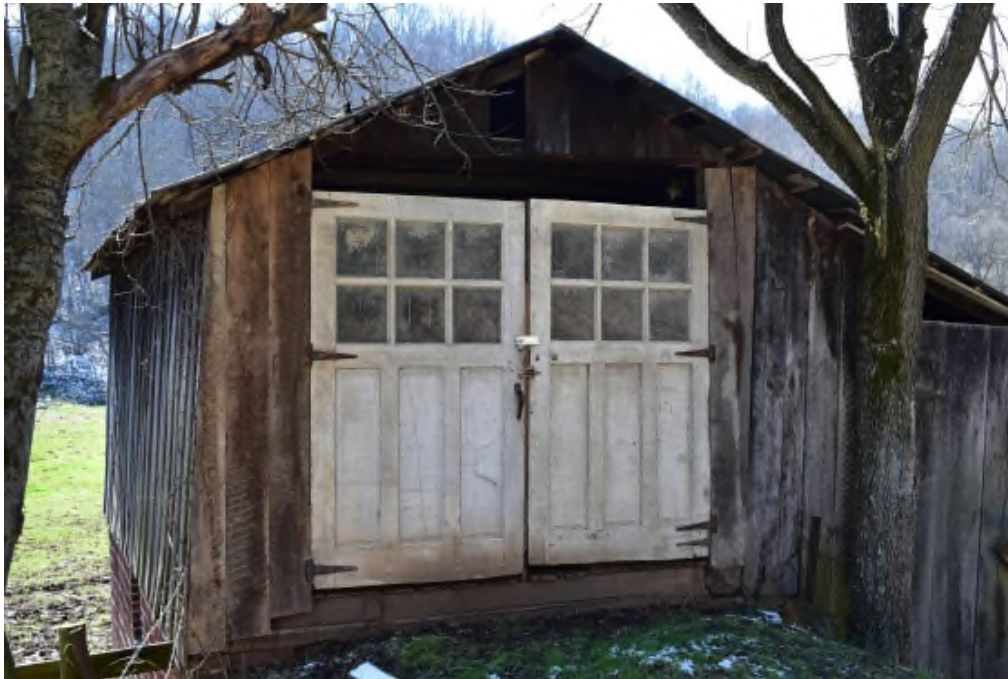
Photo 33

tractor/machinery storage space via an earthen ramp (**Photo 33**). Access on the lower level was through another gable-end door, on the opposite end (**Photo 34**).
