#### **Baseline Assessment – Stream Attributes**

# Reach S-E40 TEMP AR (Temporary Access Road) Perennial Spread F Monroe County, West Virginia

#### Spread F Stream S-E40 (Temporary Access Road) Monroe County

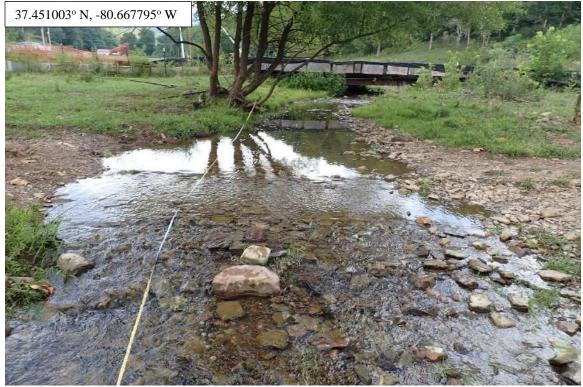
Photo Type: LOD, DS View Location, Orientation, Photographer Initials: Limit of Disturbance, Downstream View, AK/AG

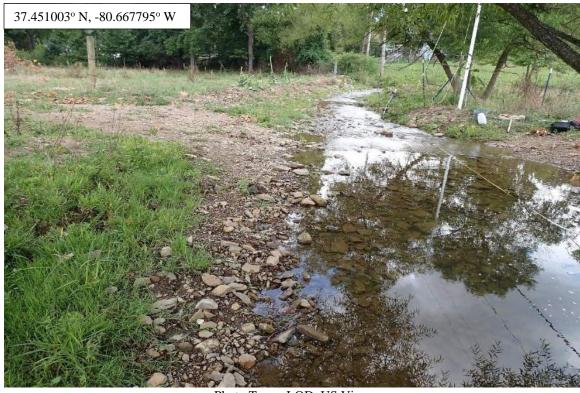
Photo Type: LOD, US View Location, Orientation, Photographer Initials: Limit of Disturbance, Upstream View, AK/AG

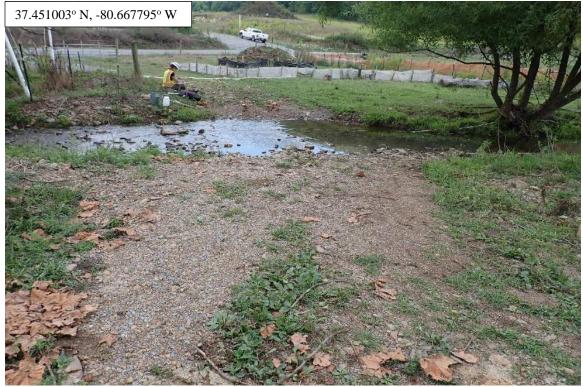
Photo Type: CL, Access, LDB
Location, Orientation, Photographer Initials: Center Line, Access, Left Descending Bank, AK/AG

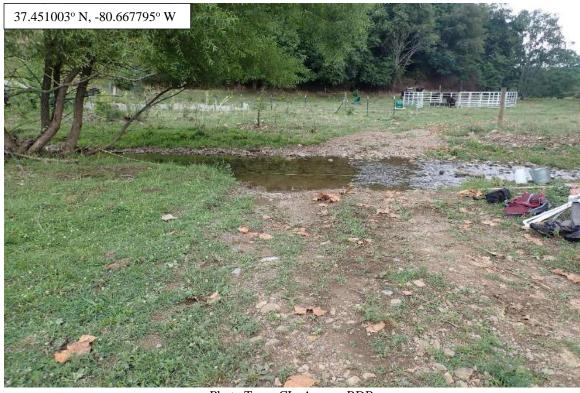
Photo Type: CL, Access, RDB Location, Orientation, Photographer Initials: Center Line, Access, Right Descending Bank, AK/AG

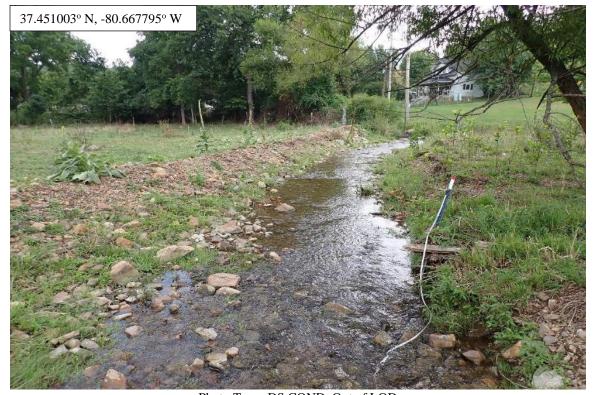
Photo Type: DS COND, Out of LOD Location, Orientation, Photographer Initials: Downstream COND, Out of Limit of Disturbance, AK/AG

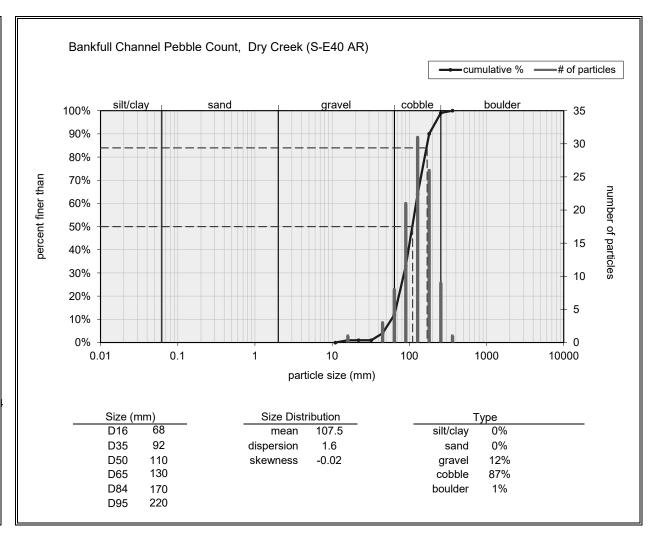
Bankfull Channel	
Material Size Range (mm)	Count
silt/clay 0 - 0.062	
very fine sand 0.062 - 0.125	
fine sand 0.125 - 0.25	
medium sand 0.25 - 0.5	
coarse sand 0.5 - 1	
very coarse sand 1 - 2	
very fine gravel 2 - 4	
fine gravel 4 - 6	
fine gravel 6 - 8	
medium gravel 8 - 11	
medium gravel 11 - 16	1
coarse gravel 16 - 22	
coarse gravel 22 - 32	
very coarse gravel 32 - 45	3
very coarse gravel 45 - 64	8
small cobble 64 - 90	21
medium cobble 90 - 128	31
large cobble 128 - 180	26
very large cobble 180 - 256	9
small boulder 256 - 362	1
small boulder <u>362 - 512</u>	
medium boulder 512 - 1024	
large boulder 1024 - 2048	
very large boulder 2048 - 4096	
total particle count:	100
bedrock	
clay hardpan	
detritus/wood	
artificial	
total count:	100
Note:

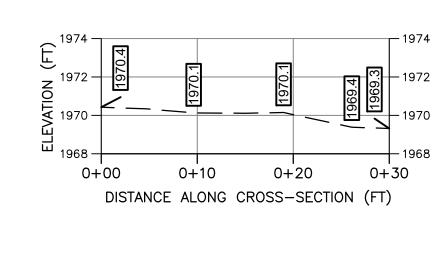
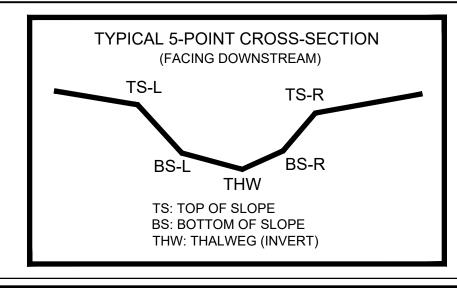
### S-E40 TEMP AR BASELINE CROSS-SECTION A

AS-BUILT TABLE: S-E40 TEMP AR CROSS SECTION A							
	Pi	AS-BUILT					
PT. LOC.	NORTHING	EASTING	ELEV	VERT. DIFF.	HORZ. DIFF.		
TS-L	13598911.97	1736835.33	1971.48				
BS-L	13598911.25	1736832.93	1970.58				
THW	13598910.53	1736830.49	1969.38				
BS-R	13598908.52	1736823.75	1970.55				
TS-R	13598907.61	1736820.71	1971.05

NOTE: ALL SECTIONS VIEWS SHOWN LEFT TO RIGHT FACING DOWNSTREAM.

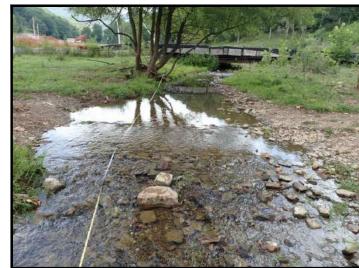
PHOTO TAKEN LOOKING DOWNSTREAM FROM UPSTREAM IMPACT LIMITS

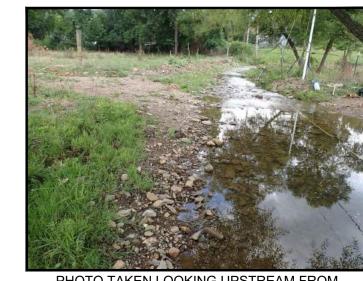
PHOTO TAKEN LOOKING UPSTREAM FROM DOWNSTREAM IMPACT LIMITS
