Baseline Assessment – Stream Attributes

Reach S-FF1 (Permanent Access Road) Ephemeral Spread F Greenbrier County, West Virginia

Spread F Stream S-FF1 (Permanent Access Road) Greenbrier County

Title
 PROFILE AND CROSS-SECTIONS
 BASELINE SURVEY
 CROSSING S-FF1 - UNNAMED TRIB.
 MEADOW RIVER (MP 157)
 GREENBRIER COUNTY, WV

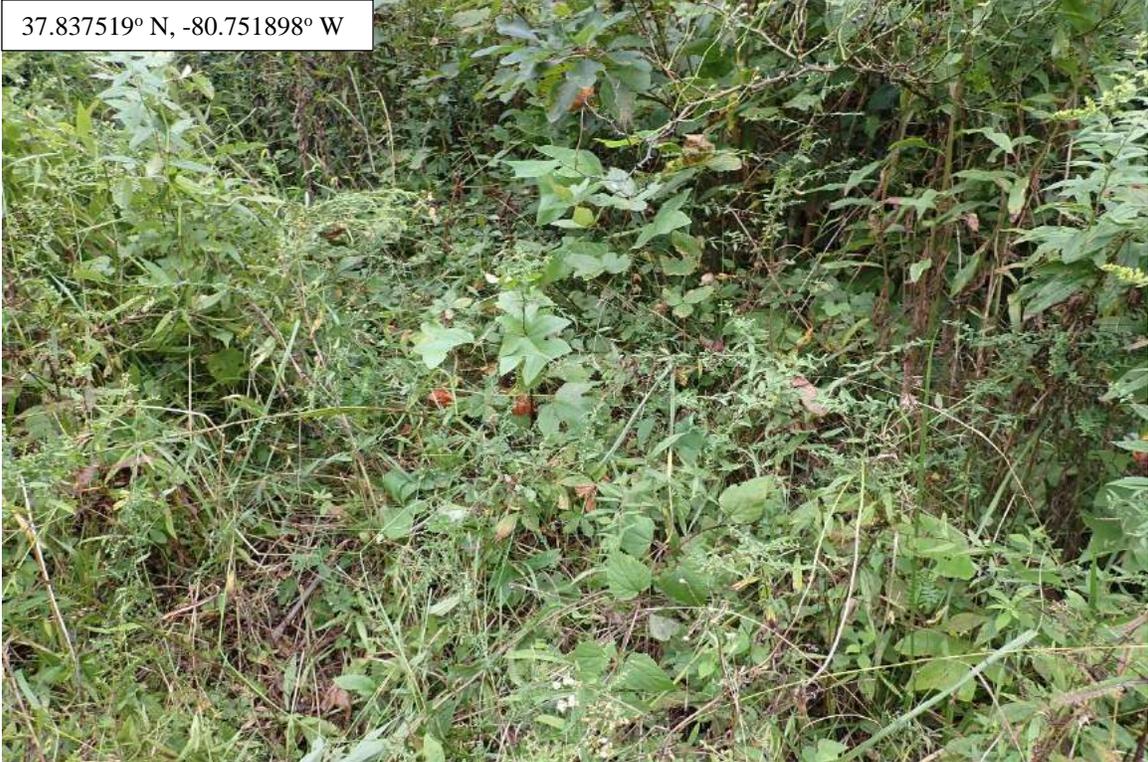
Photo Type: US, US View

Location, Orientation, Photographer Initials: Upstream Edge of Right of Way, Upstream View, AK/RA/TA

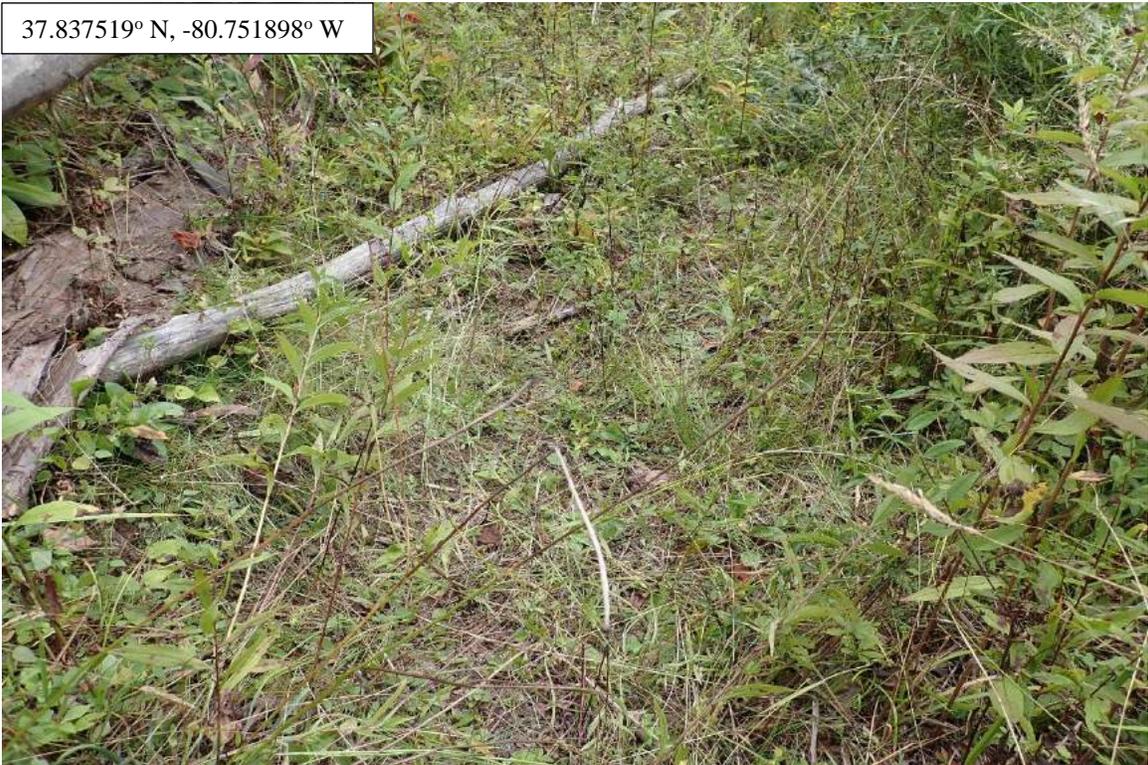
Photo Type: US, DS View

Location, Orientation, Photographer Initials: Upstream Edge of Right of Way, Downstream View, AK/RA/TA

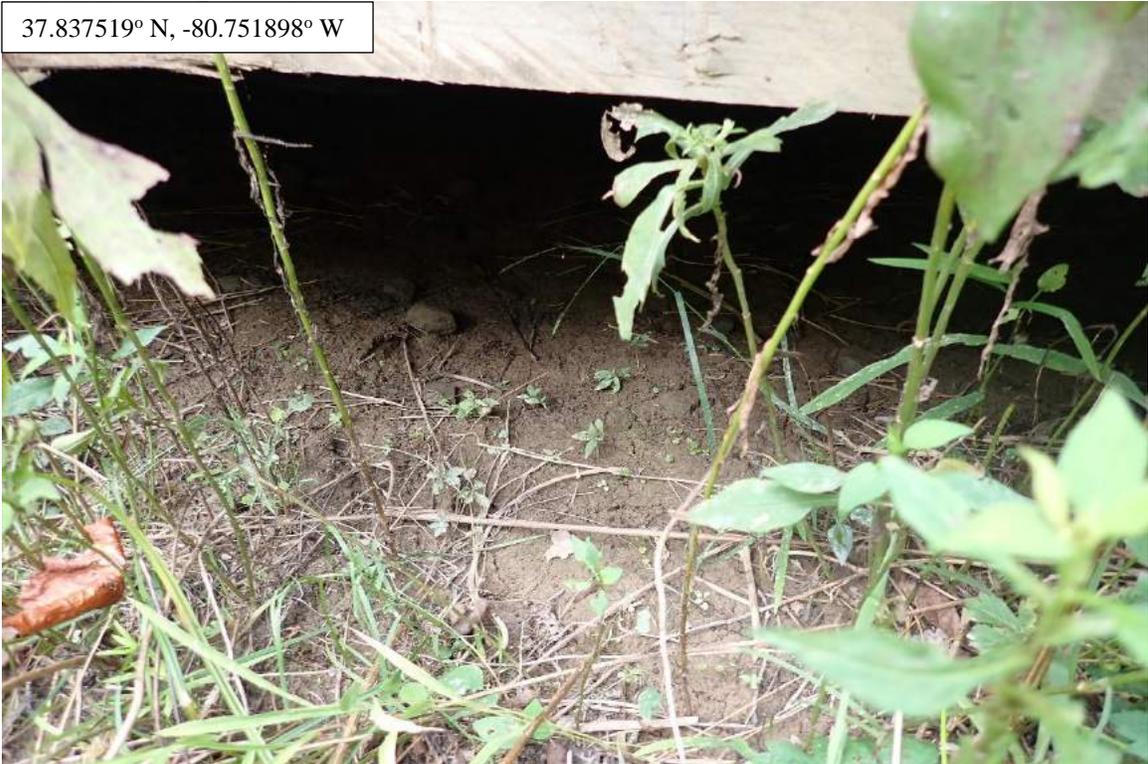
Photo Type: Where Vegetation Stops Where Streambed Is
Location, Orientation, Photographer Initials: Vegetation Stops Where Streambed Is, AK/RA/TA

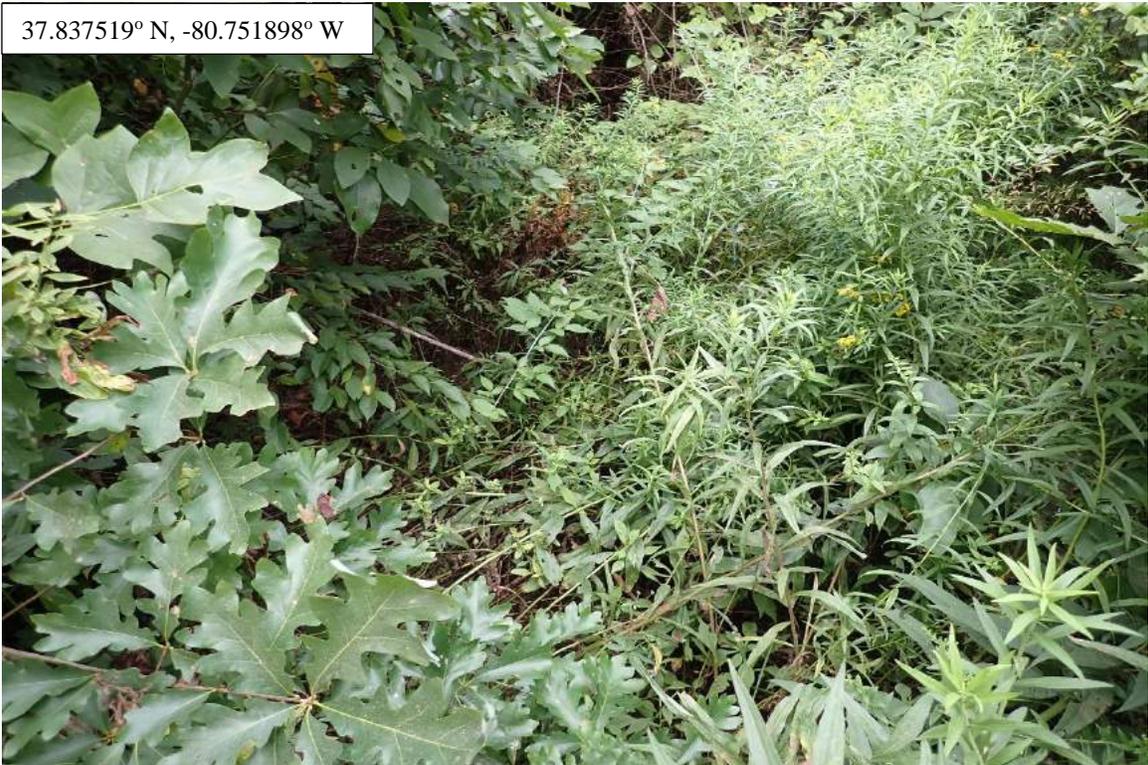
Photo Type: Edge ROW, DS View
Location, Orientation, Photographer Initials: Downstream Edge of ROW, Downstream View, AK/RA/TA
