Baseline Assessment – Stream Attributes

Reach S-I38 (Pipeline ROW) Intermittent Spread D Nicholas County, West Virginia

Title
PROFILE AND CROSS-SECTIONS
BASELINE SURVEY
CROSSING S-138 - UNNAMED TRIB.
HOMINY CREEK (MP 125.5)
NICHOLAS COUNTY, WV

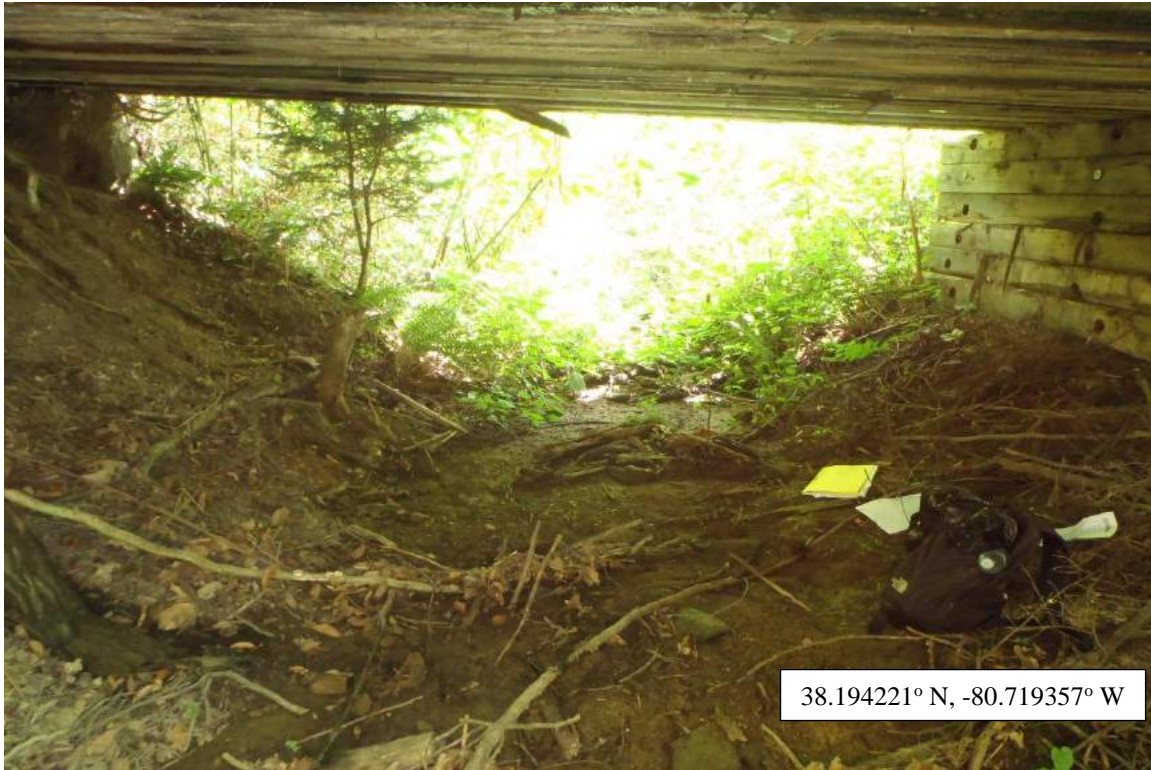
Photo Type: US View at DS Edge of LOD
Location, Orientation, Photographer Initials: Downstream Edge of Limit of Disturbance, Upstream View, TF/AG/TA

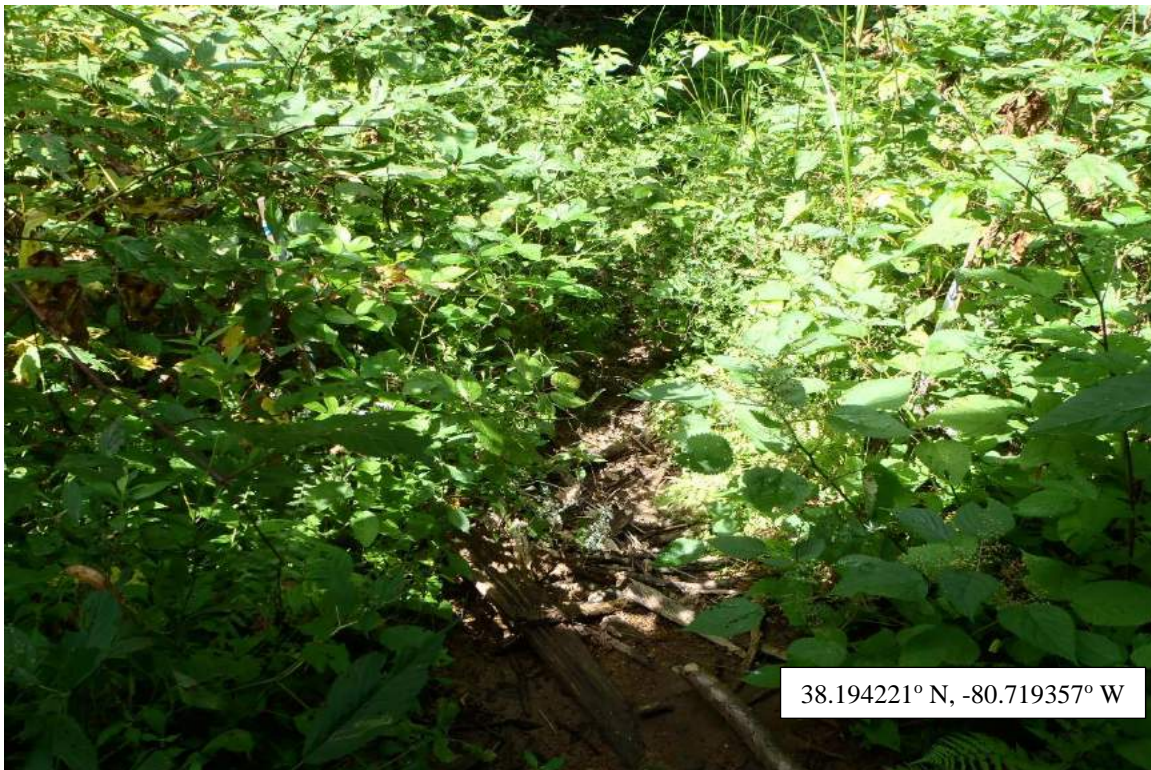
Photo Type: DS View at DS Edge of LOD
Location, Orientation, Photographer Initials: Downstream Edge of Limit of Disturbance, Downstream View, TF/AG/TA

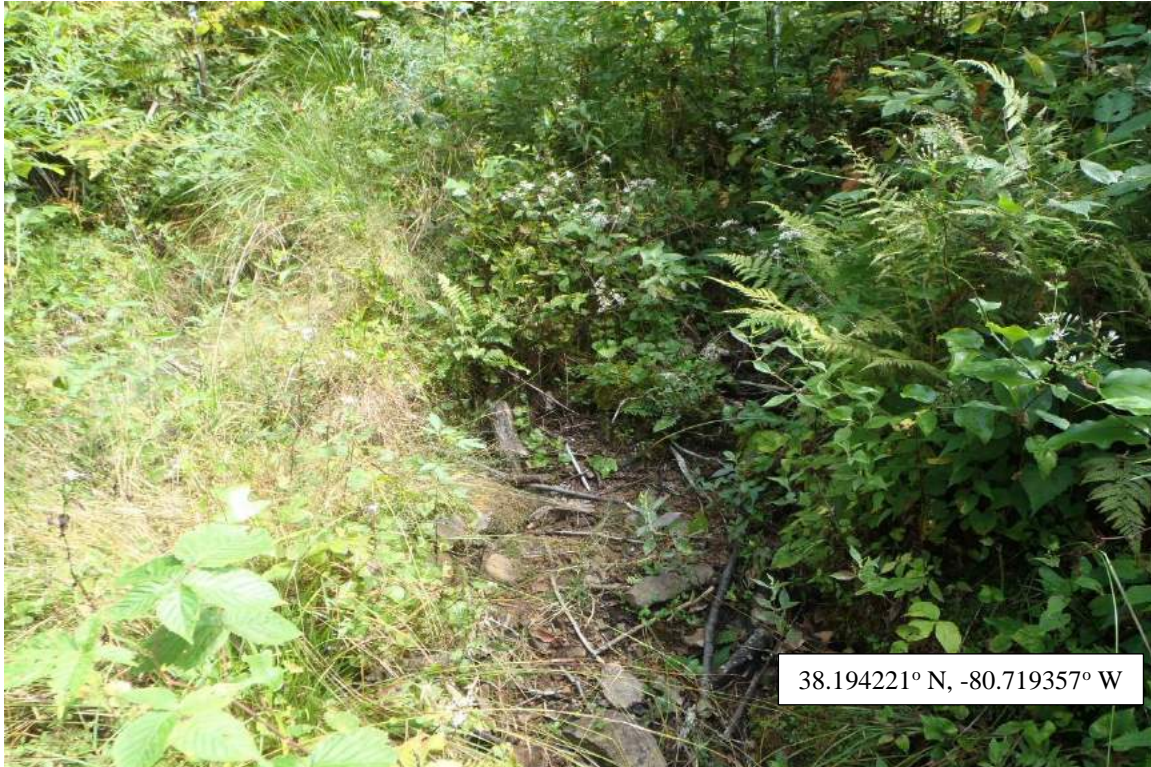
Photo Type: US View at Center of LOD
Location, Orientation, Photographer Initials: Center of Limit of Disturbance, Upstream View, TF/AG/TA

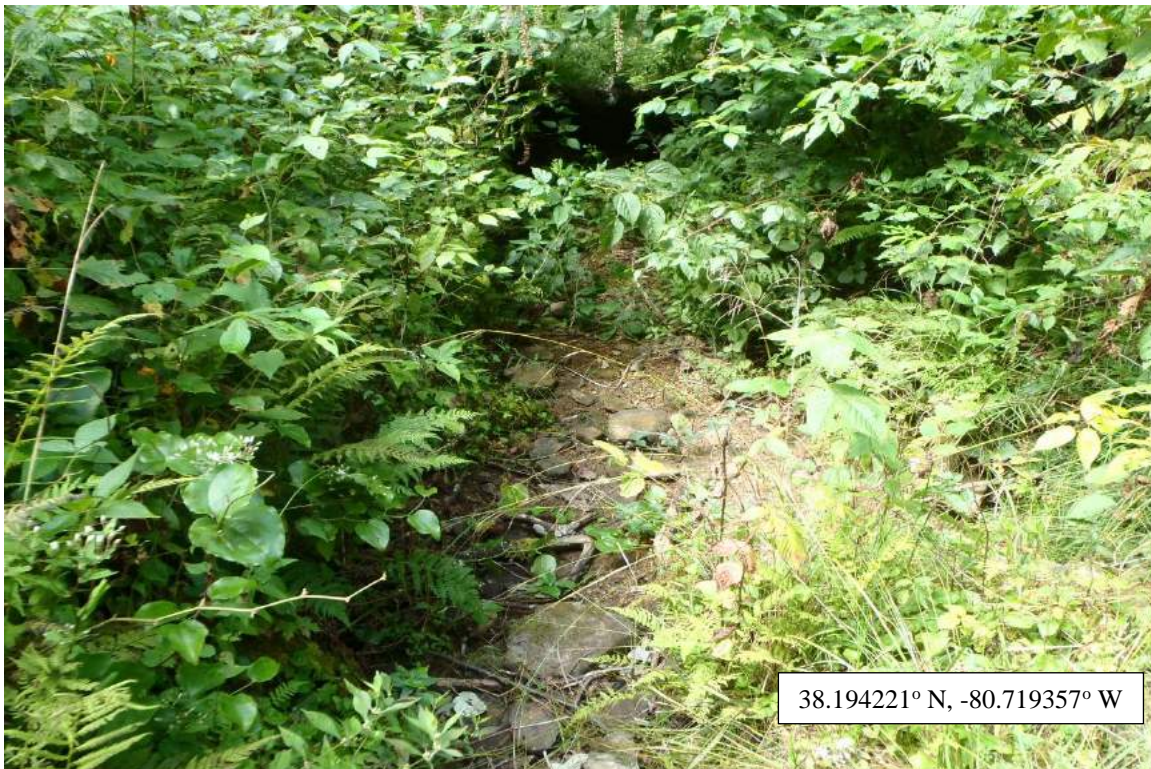
Photo Type: DS View at Center of LOD
Location, Orientation, Photographer Initials: Center of Limit of Disturbance, Downstream View, TF/AG/TA

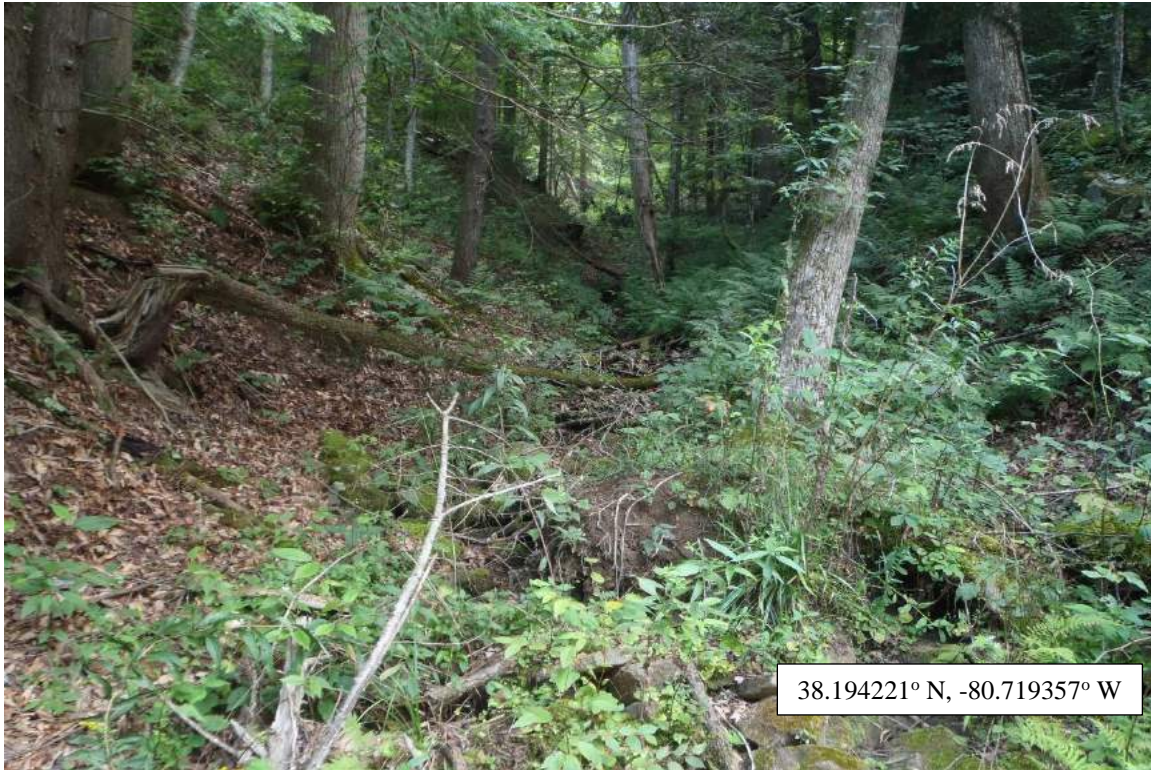
Photo Type: US View at US Edge of LOD

Location, Orientation, Photographer Initials: Upstream Edge of Limit of Disturbance, Upstream View, TF/AG/TA

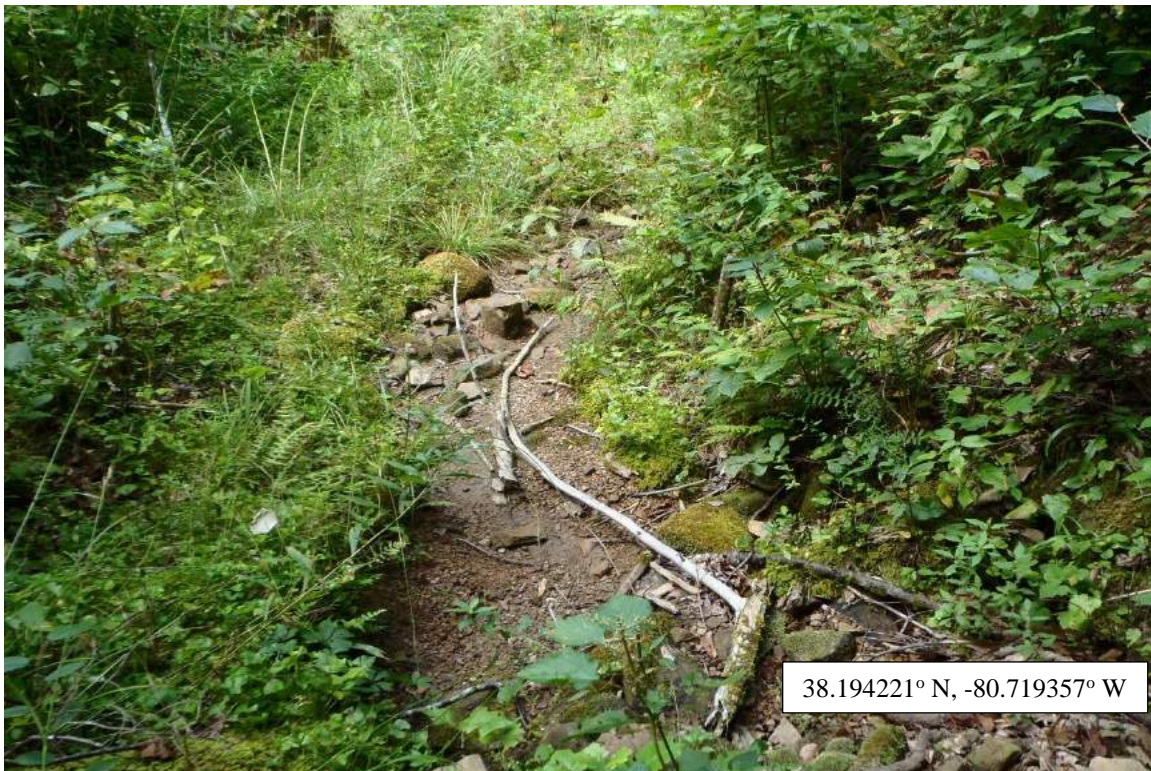
Photo Type: DS View at US Edge of LOD

Location, Orientation, Photographer Initials: Upstream Edge of Limit of Disturbance, Downstream View, TF/AG/TA

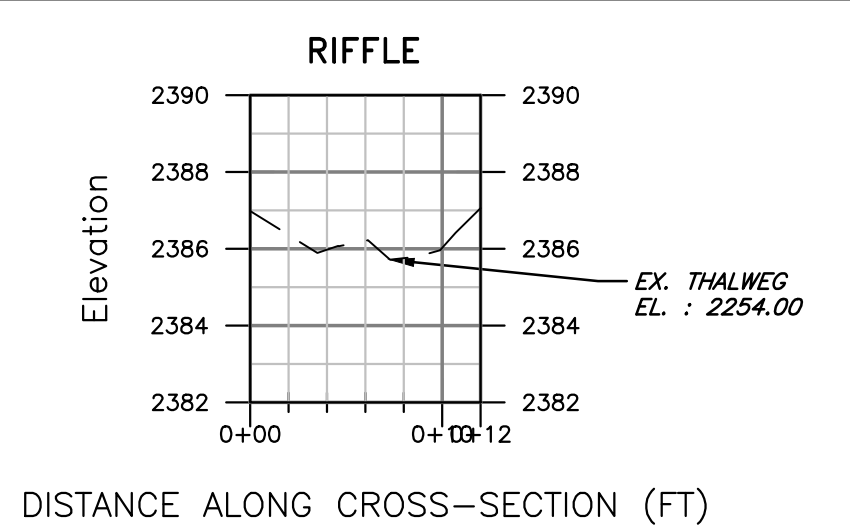
S-138 BASELINE CROSS-SECTION A

- ALL SECTION VIEWS SHOWN LEFT TO RIGHT FACING DOWNSTREAM.
 - POST-CROSSING SURVEY INFORMATION SHOWN IN RED. DATA PENDING.
 - POST-CROSSING SURVEY POINTS FOR CROSS SECTIONS AND THALWEG ARE PROJECTED ONTO PRE-CROSSING SECTION AND PROFILE VIEWS FOR COMPARISON.

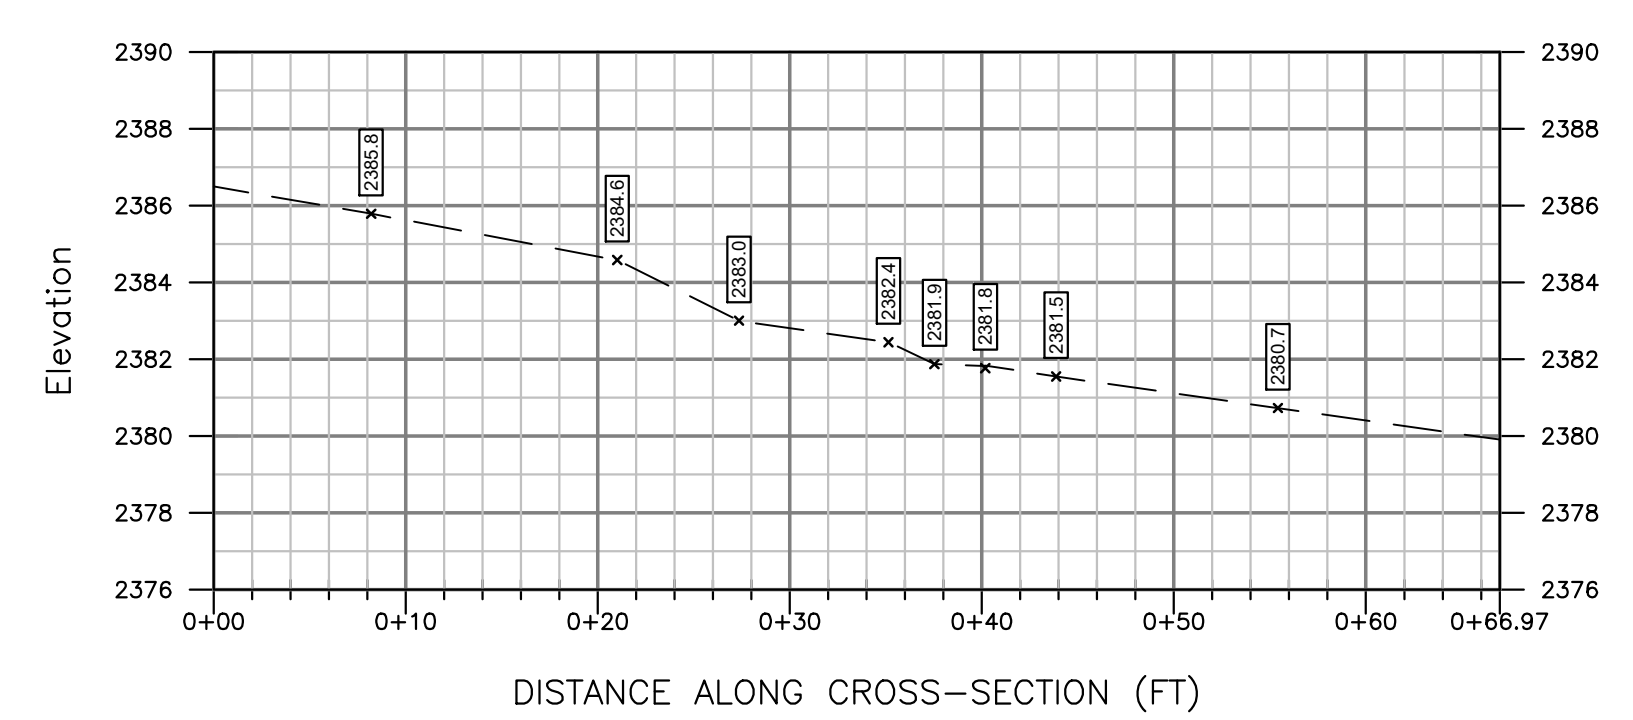
S-138 BASELINE THALWEG PROFILE

- EASEMENT LINES SHOWN ON PLAN VIEW WERE PROVIDED BY MOUNTAIN VALLEY PIPELINE.
 - SURVEY POINTS FOR CROSS SECTIONS AND THALWEG PROFILES COLLECTED IN 2021 HAVE BEEN USED IN COMBINATION WITH SURVEY POINTS AND COLLECTED PREVIOUSLY IN 2020 IN ORDER TO GENERATE THE PRE-CROSSING SURFACE SHOWN IN PLAN. DUE TO NATURAL EROSIONAL STREAM PROCESSES THAT OCCUR OVER TIME, MINOR ADJUSTMENTS TO THE PROFILE ALIGNMENTS MAY HAVE BEEN REQUIRED IN ORDER TO GENERATE A CLEAN PRE-CROSSING SURFACE.

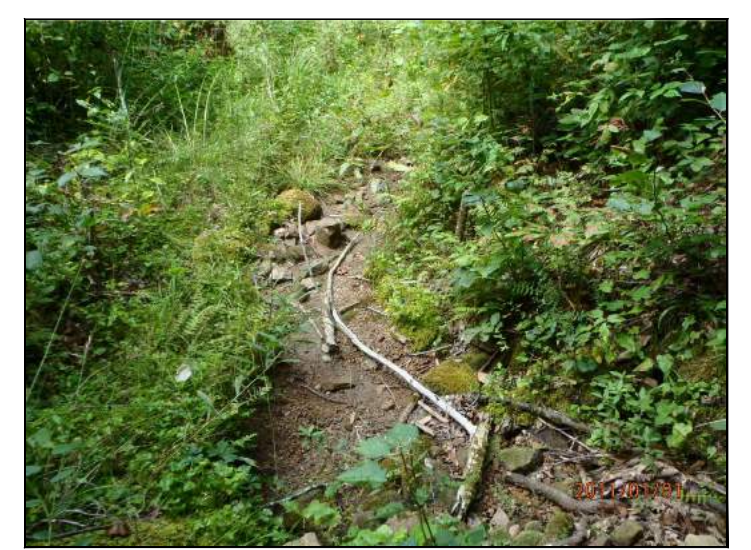
PHOTO TAKEN LOOKING DOWNSTREAM FROM UPSTREAM IMPACT LIMITS
