Baseline Assessment – Stream Attributes

Reach S-J4 (Timber Mat Crossing) Intermittent Spread F Summers County, West Virginia

Title
PROFILE AND CROSS-SECTIONS
BASELINE SURVEY
CROSSING S-J4 - UNNAMED TRIB.
KELLER CREEK (MP 173.14)
SUMMERS COUNTY, WV

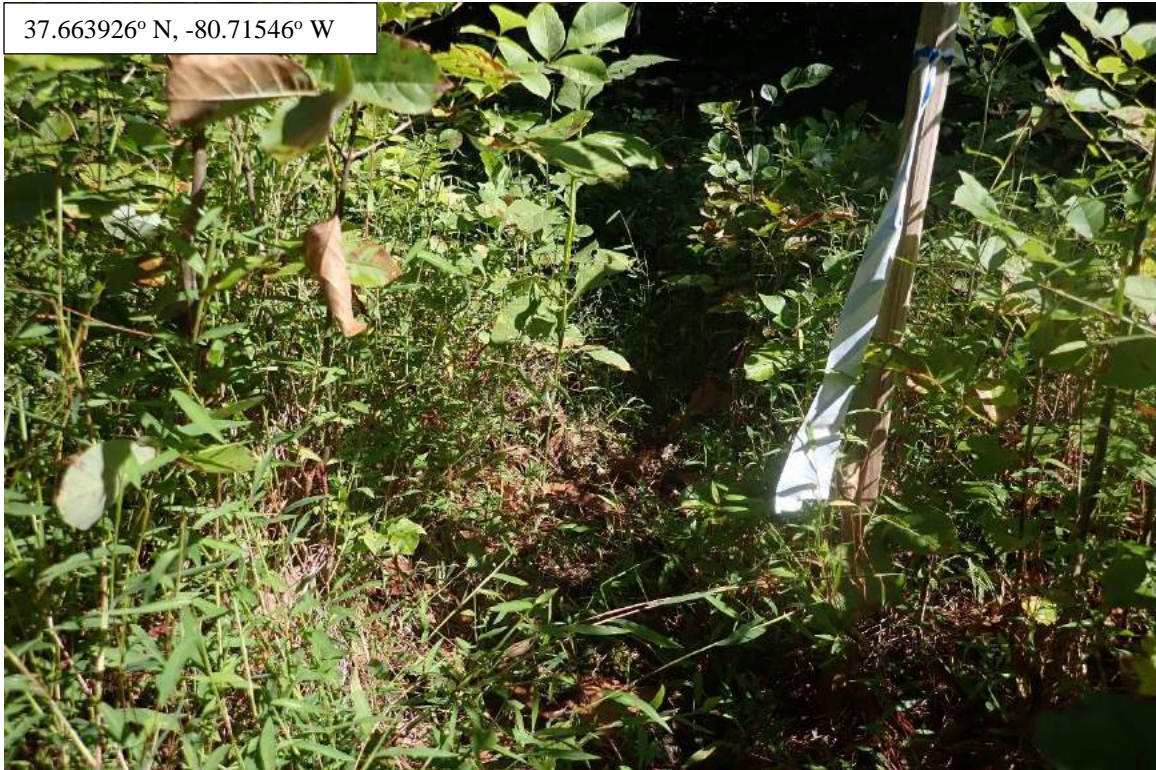
Photo Type: US Edge of ROW, US View

Location, Orientation, Photographer Initials: Upstream Edge of Right of Way, Upstream View, TF/EW/WP

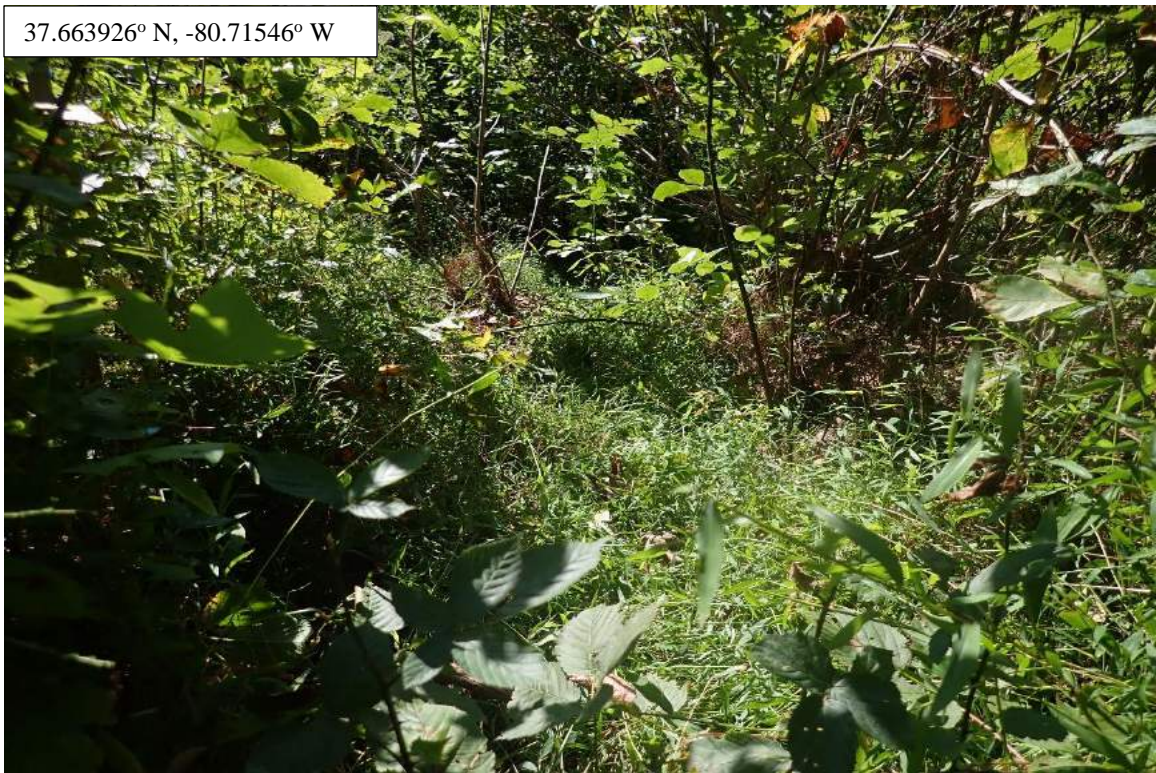
Photo Type: US Edge of ROW, DS View

Location, Orientation, Photographer Initials: Upstream Edge of Right of Way, Downstream View, TF/EW/WP

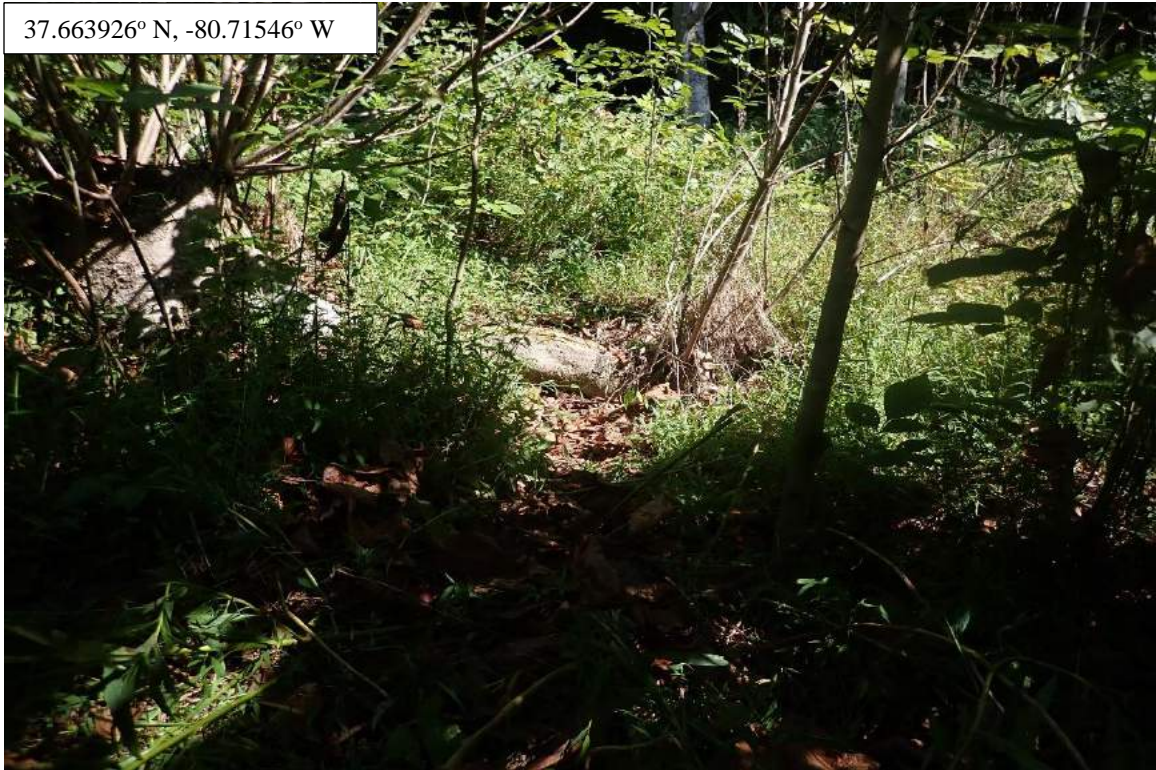
Photo Type: Center of ROW, US View
Location, Orientation, Photographer Initials: Center of Right of Way, Upstream View, TF/EW/WP

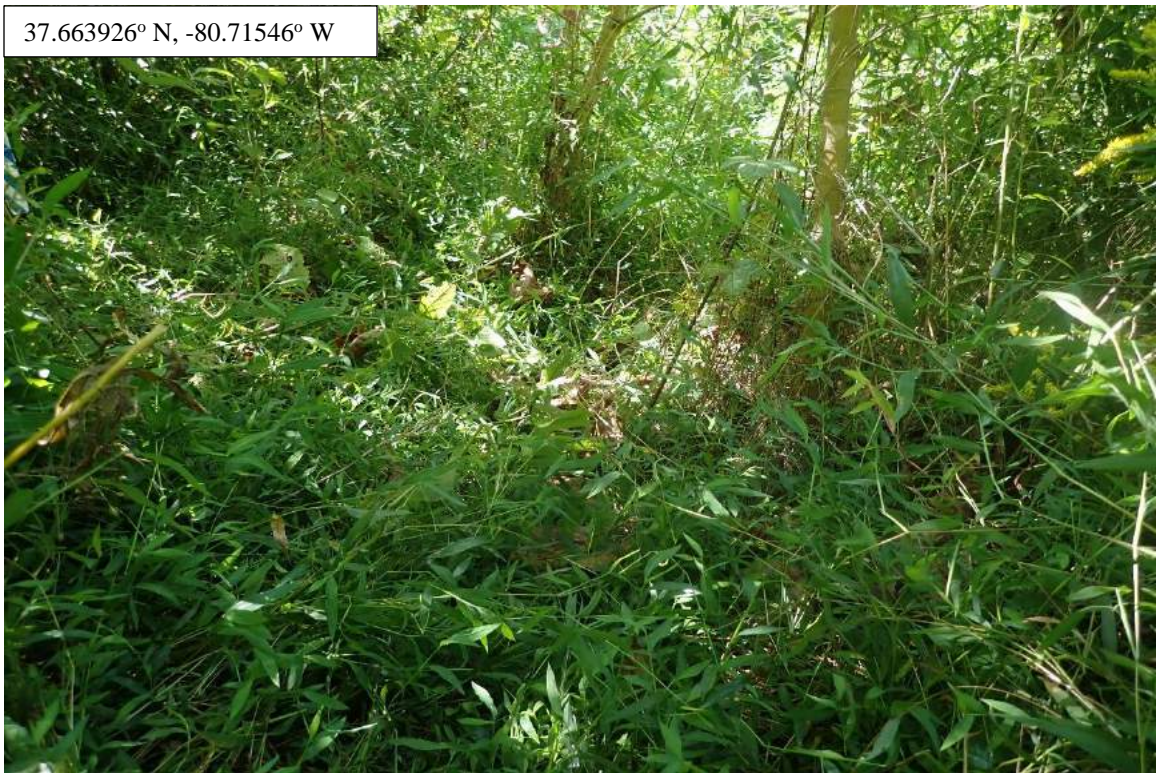
Photo Type: Center of ROW, DS View
Location, Orientation, Photographer Initials: Center of Right of Way, Downstream View, TF/EW/WP

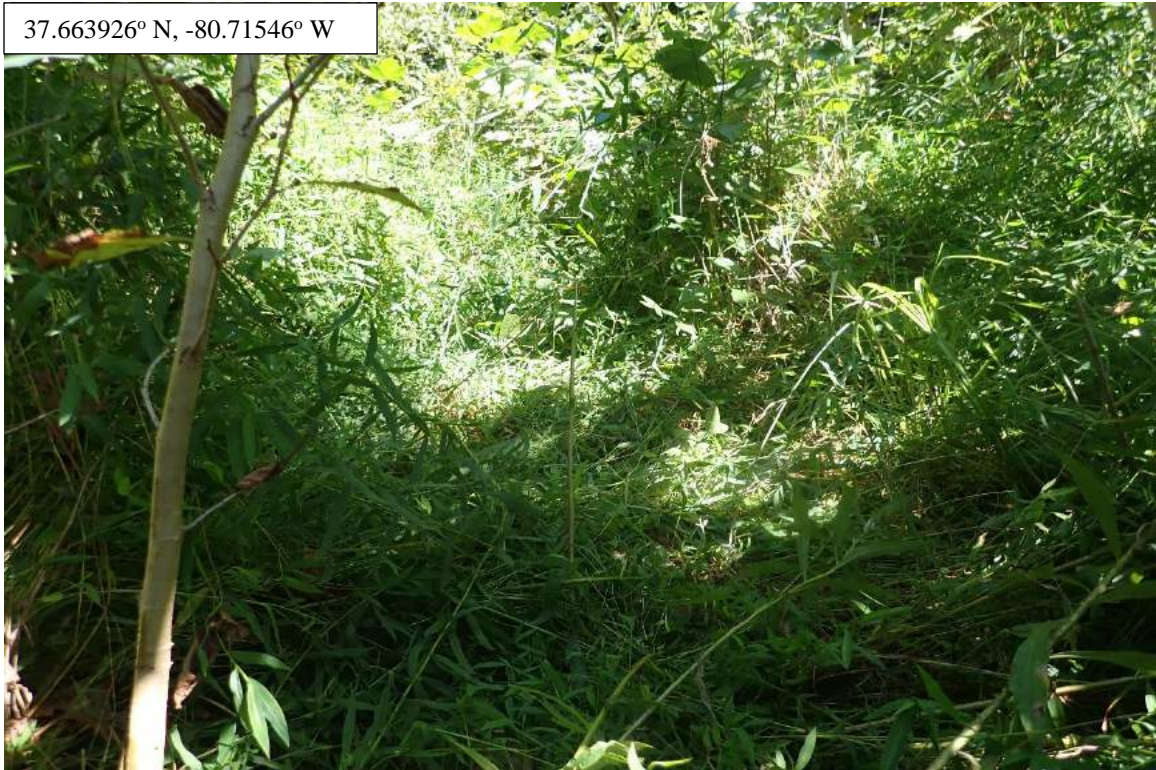
Photo Type: DS Edge of ROW, US View

Location, Orientation, Photographer Initials: Downstream Edge of Right of Way, Upstream View, TF/EW/WP

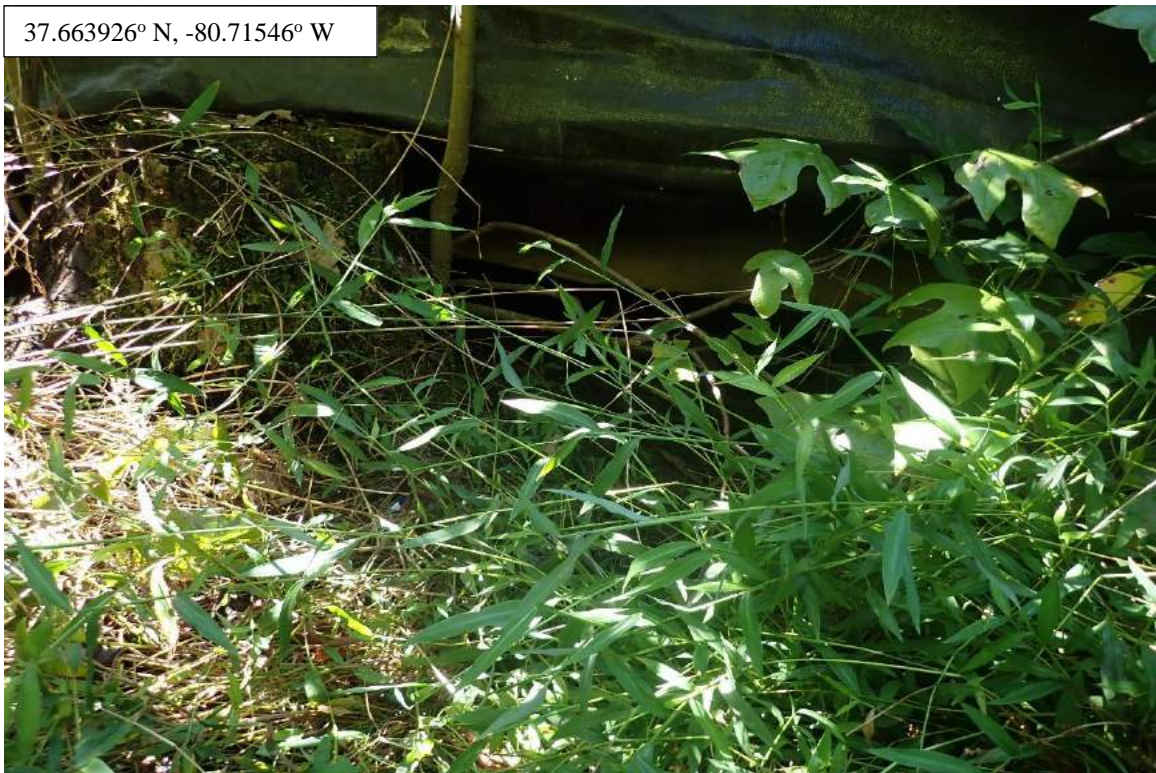
Photo Type: DS Edge of ROW, DS View

Location, Orientation, Photographer Initials: Downstream Edge of Right of Way, Downstream View, TF/EW/WP

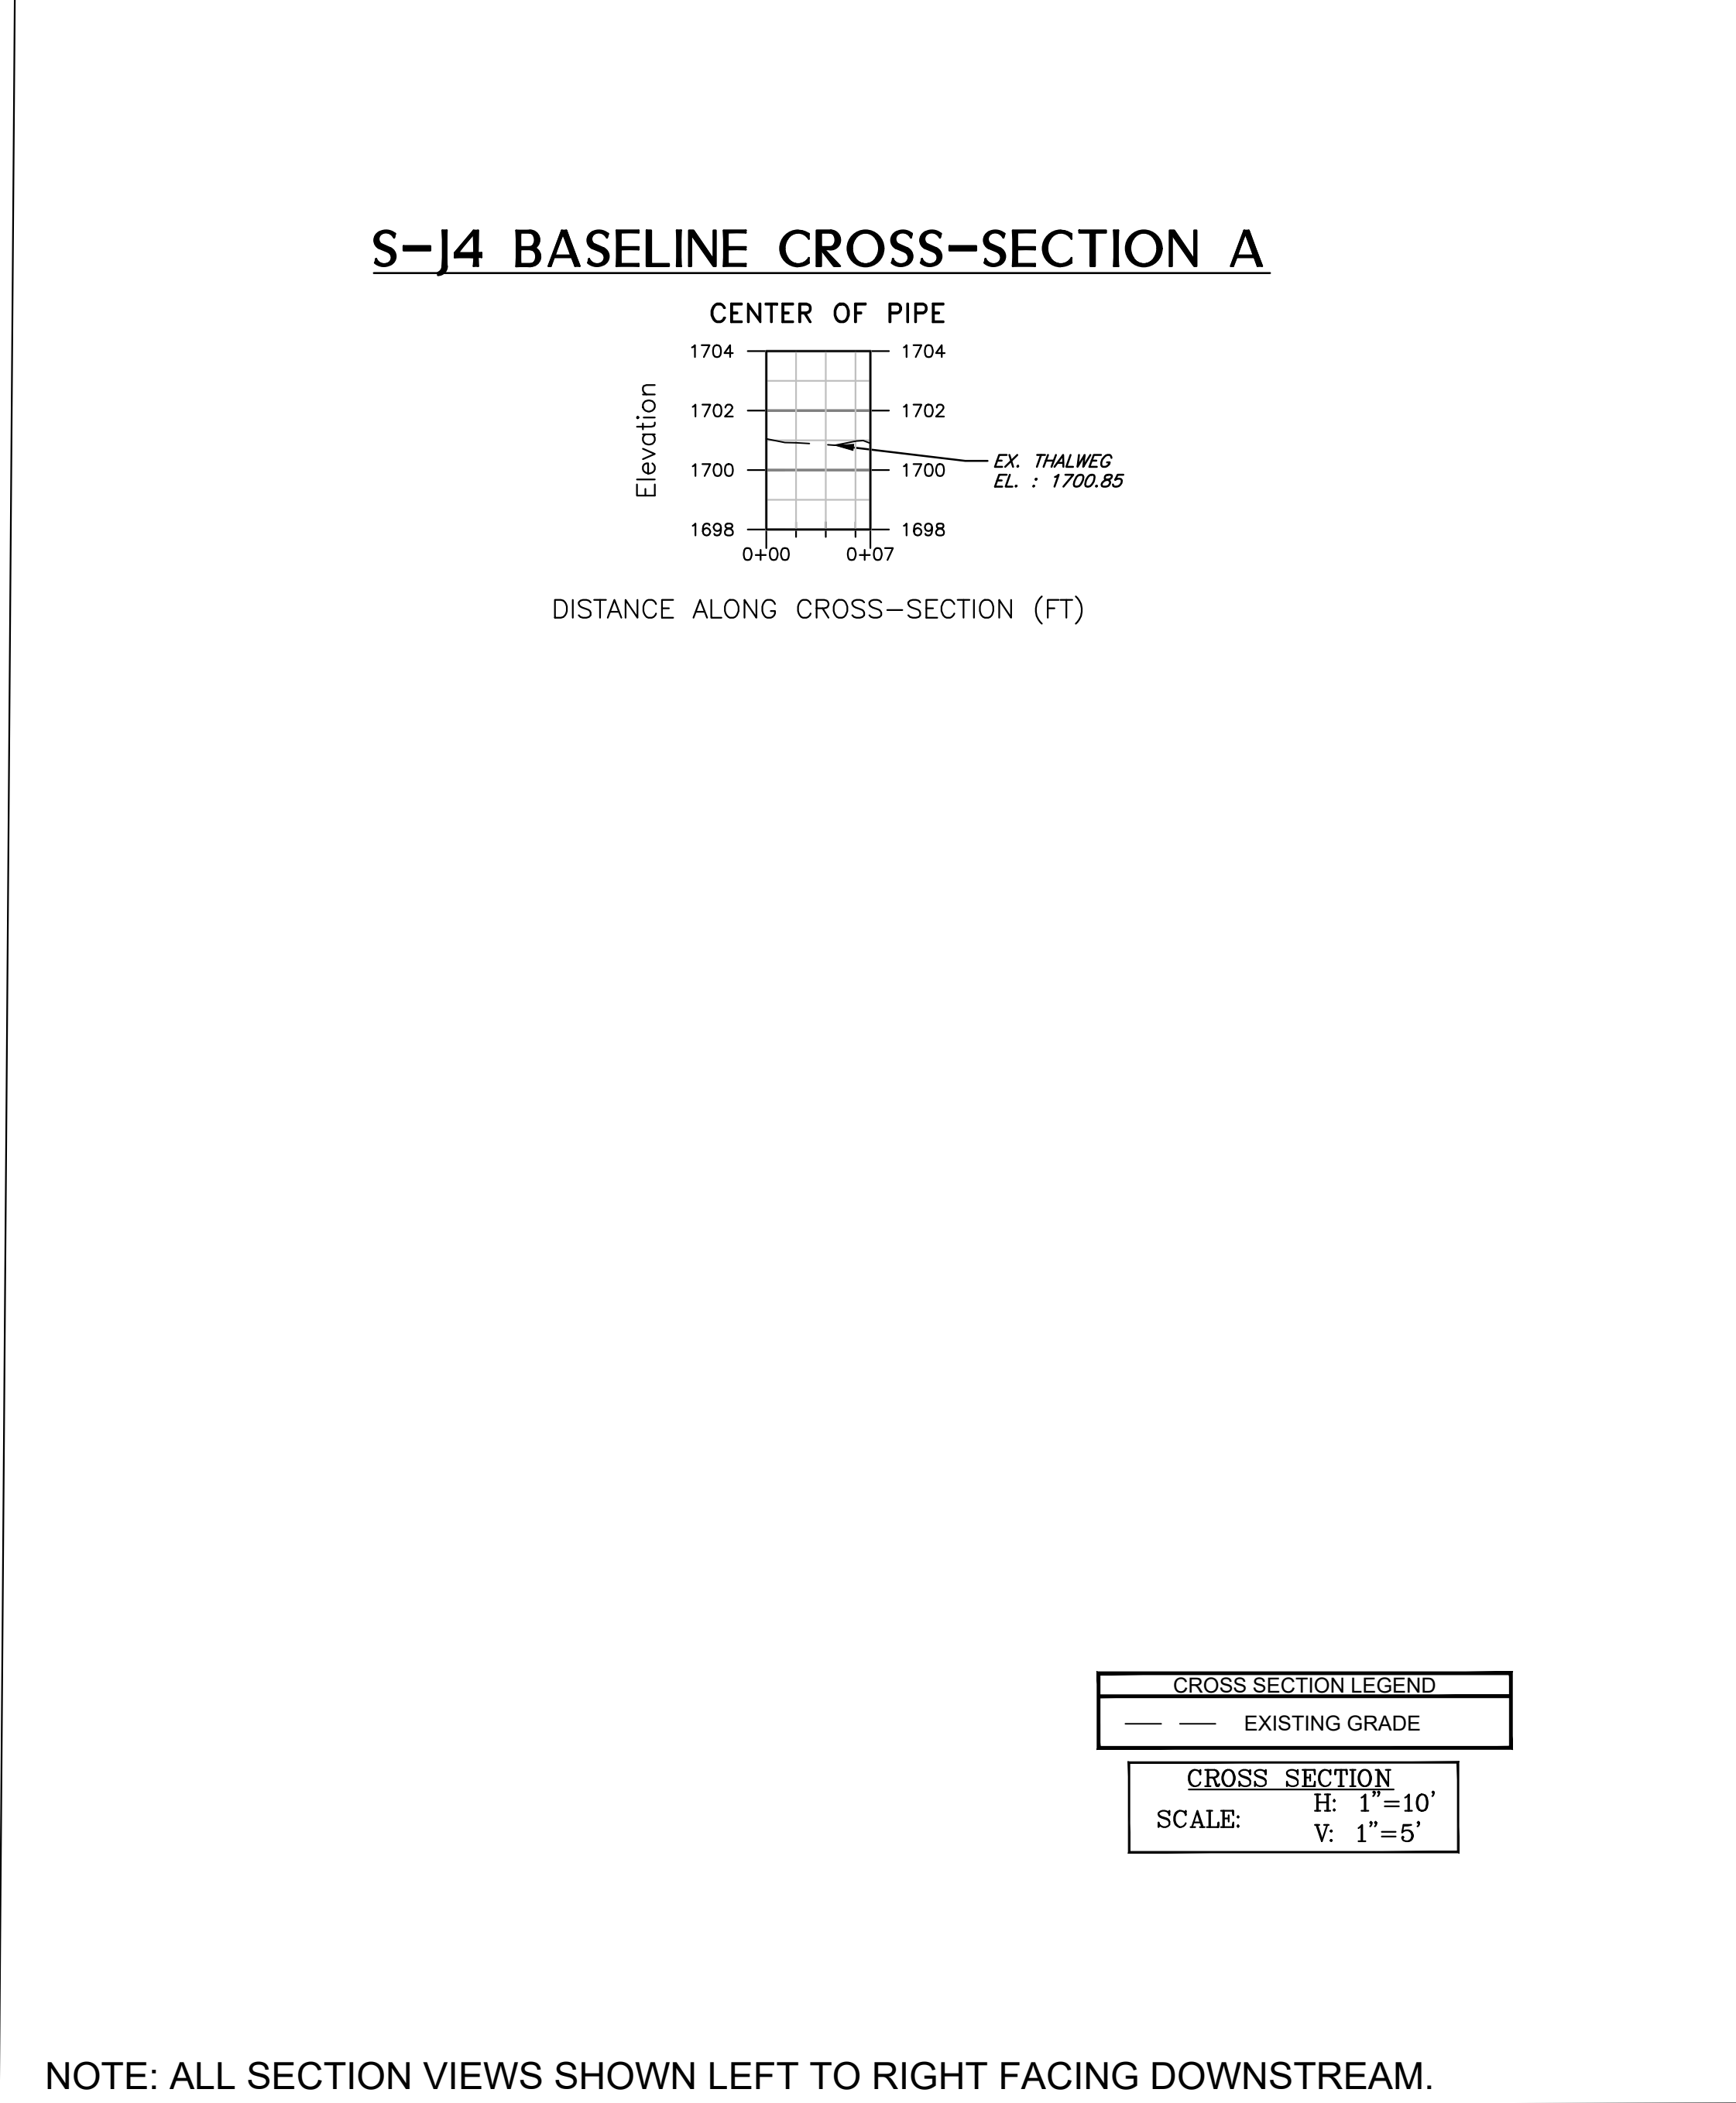
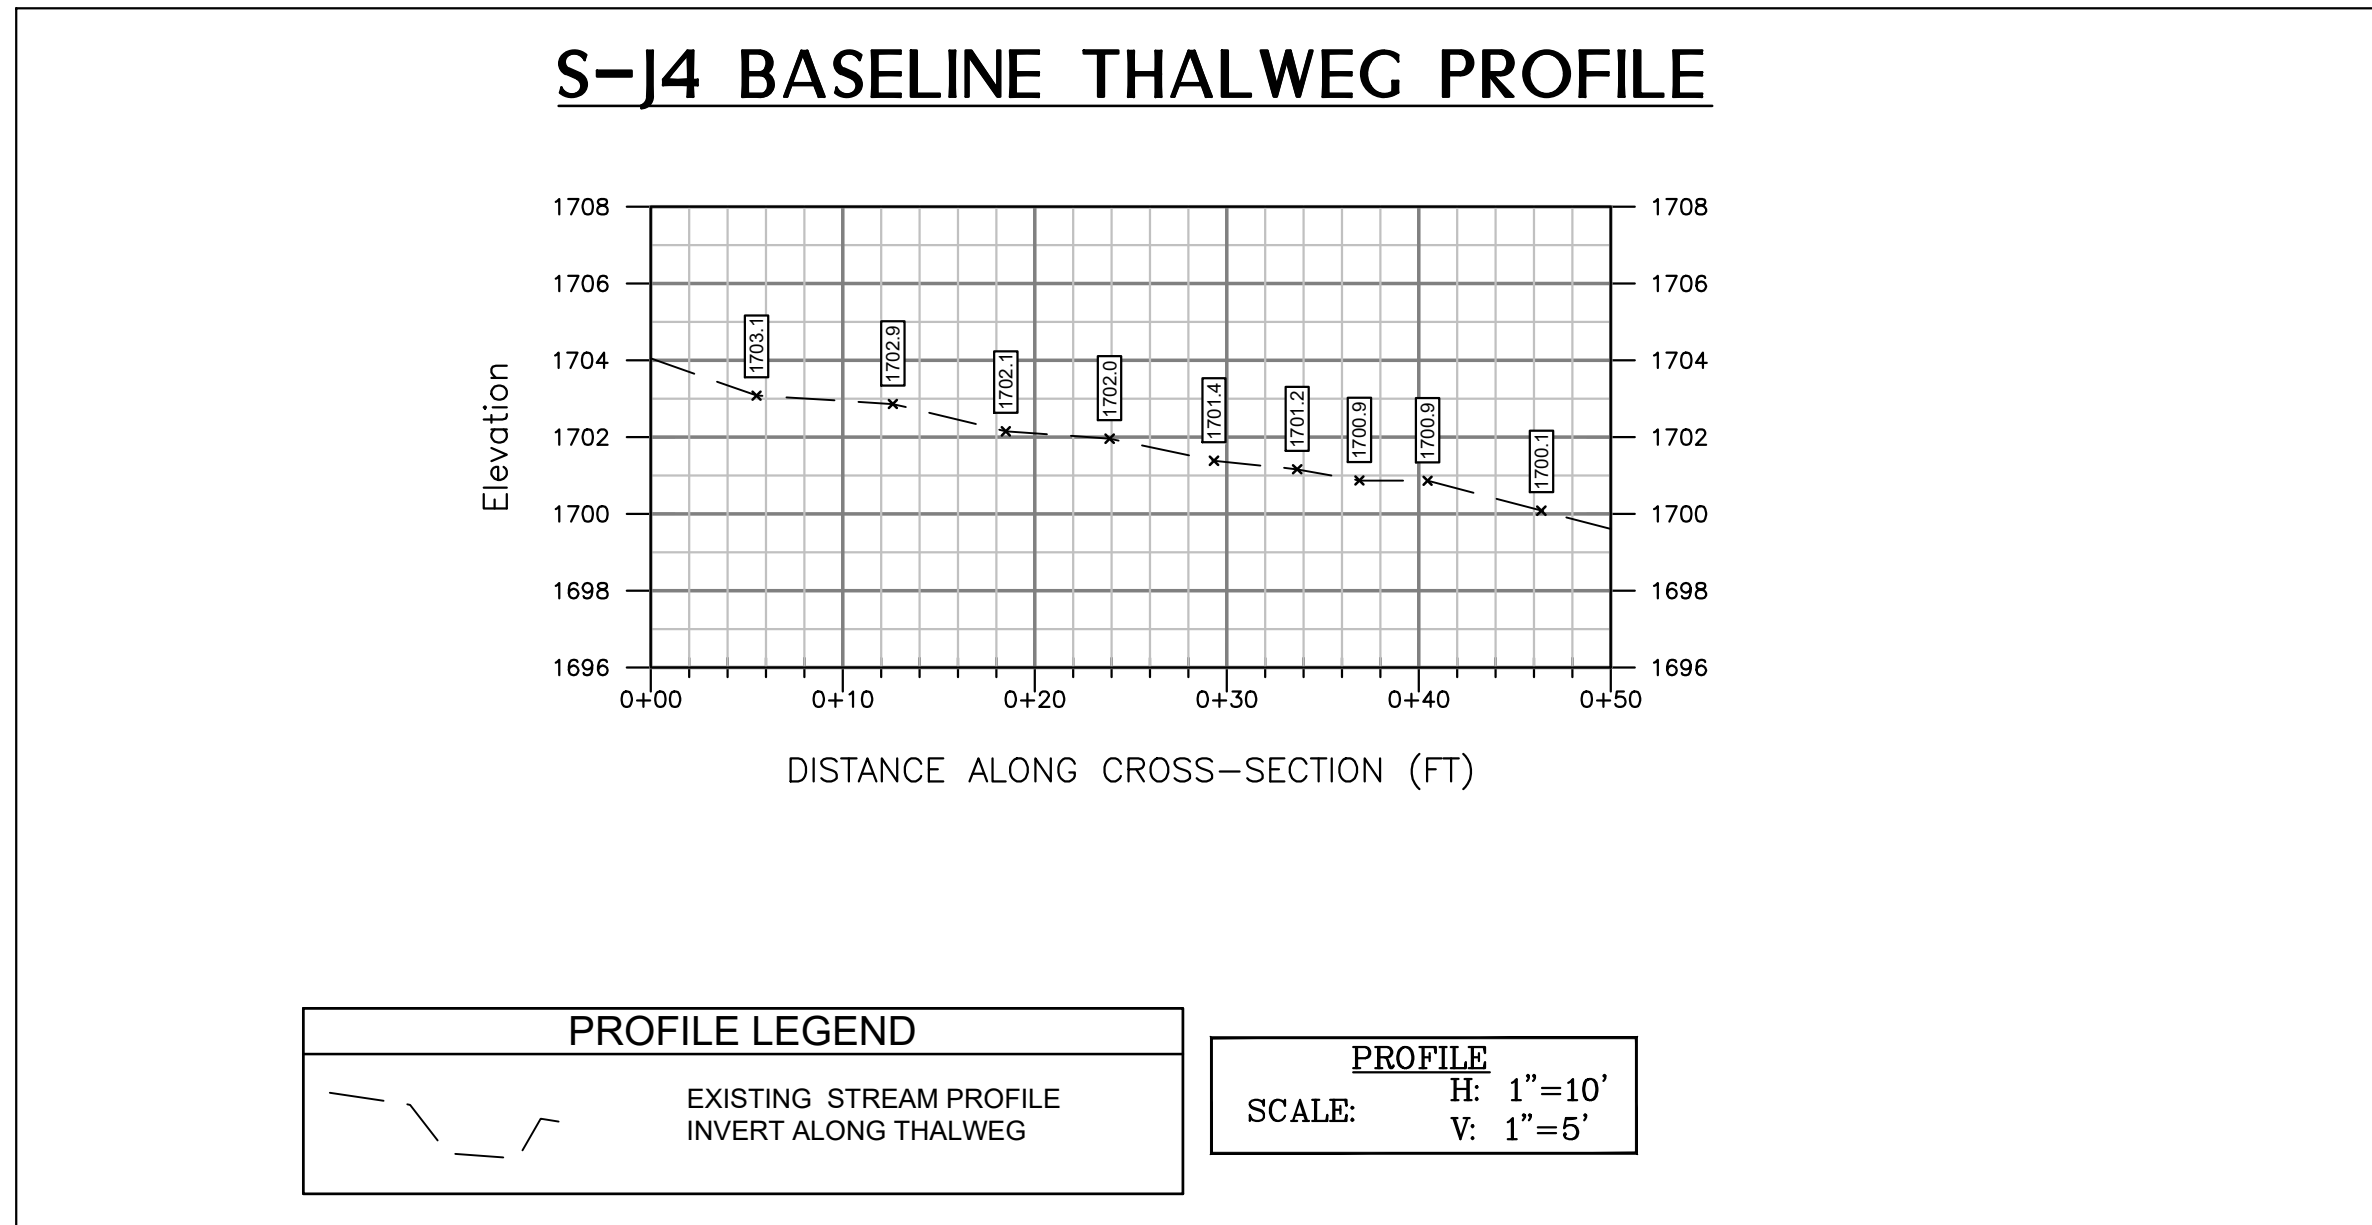
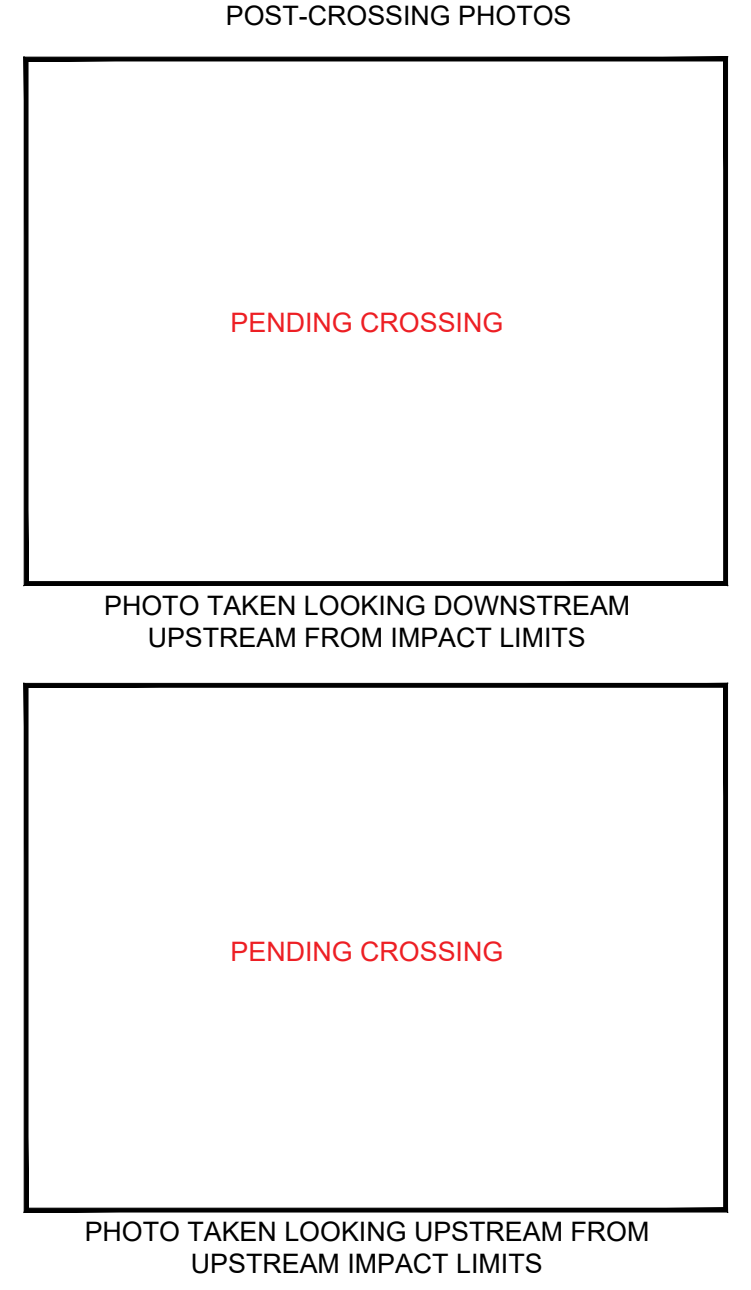
- SURVEY NOTES:**
- THIS MAP HAS BEEN ORIENTED TO NAD 1983 UTM ZONE 17N, AND VERTICALLY TO THE NORTH AMERICAN VERTICAL DATUM OF 1988 (NAVD 88), USING REAL TIME DGPS. FIELD LOCATIONS WERE COMPLETED ON 9-10-2021.

- EASEMENT LINES SHOWN ON PLAN VIEW WERE PROVIDED BY MOUNTAIN VALLEY PIPELINE.
 - SURVEY POINTS FOR CROSS SECTIONS AND THALWEG PROFILES COLLECTED IN 2021 HAVE BEEN USED IN COMBINATION WITH SURVEY POINTS AND COLLECTED PREVIOUSLY IN 2020 IN ORDER TO GENERATE THE PRE-CROSSING SURFACE SHOWN IN PLAN. DUE TO NATURAL EROSIONAL STREAM PROCESSES THAT OCCUR OVER TIME, MINOR ADJUSTMENTS TO THE PROFILE ALIGNMENTS MAY HAVE BEEN REQUIRED IN ORDER TO GENERATE A CLEAN PRE-CROSSING SURFACE.

- ALL SECTION VIEWS SHOWN LEFT TO RIGHT FACING DOWNSTREAM.
 - POST-CROSSING SURVEY INFORMATION SHOWN IN RED. DATA PENDING.
 - POST-CROSSING SURVEY POINTS FOR CROSS SECTIONS AND THALWEG ARE PROJECTED ONTO PRE-CROSSING SECTION AND PROFILE VIEWS FOR COMPARISON.
