## Baseline Assessment – Stream Attributes

### Reach S-M4 (Temporary Access Road) Ephemeral Spread F Summers County, West Virginia

Title: PROFILE AND CROSS-SECTIONS  
 BASELINE SURVEY  
 CROSSING S-M4 - UNNAMED TRIB. OF RED  
 SPRING BRANCH (MP 1612)  
 SUMMERS COUNTY, WV

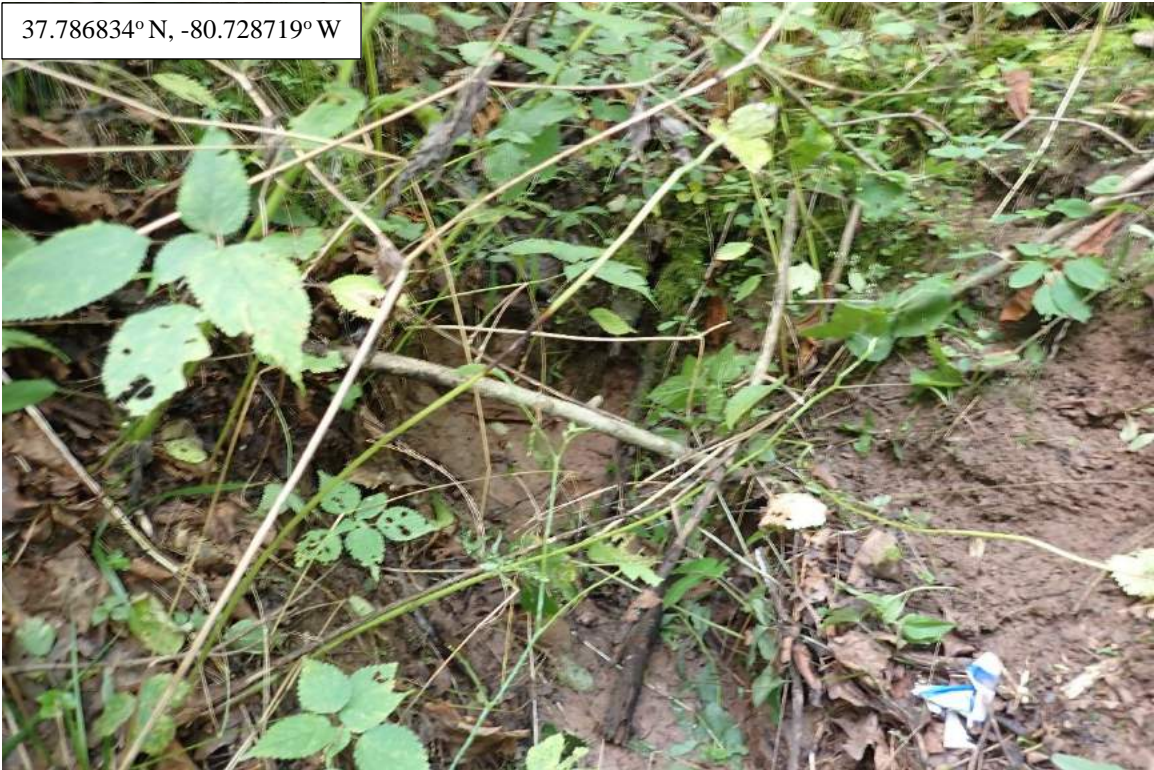
Photo Type: US, US View

Location, Orientation, Photographer Initials: Upstream Edge of Right of Way, Upstream View, AK/RA/TA

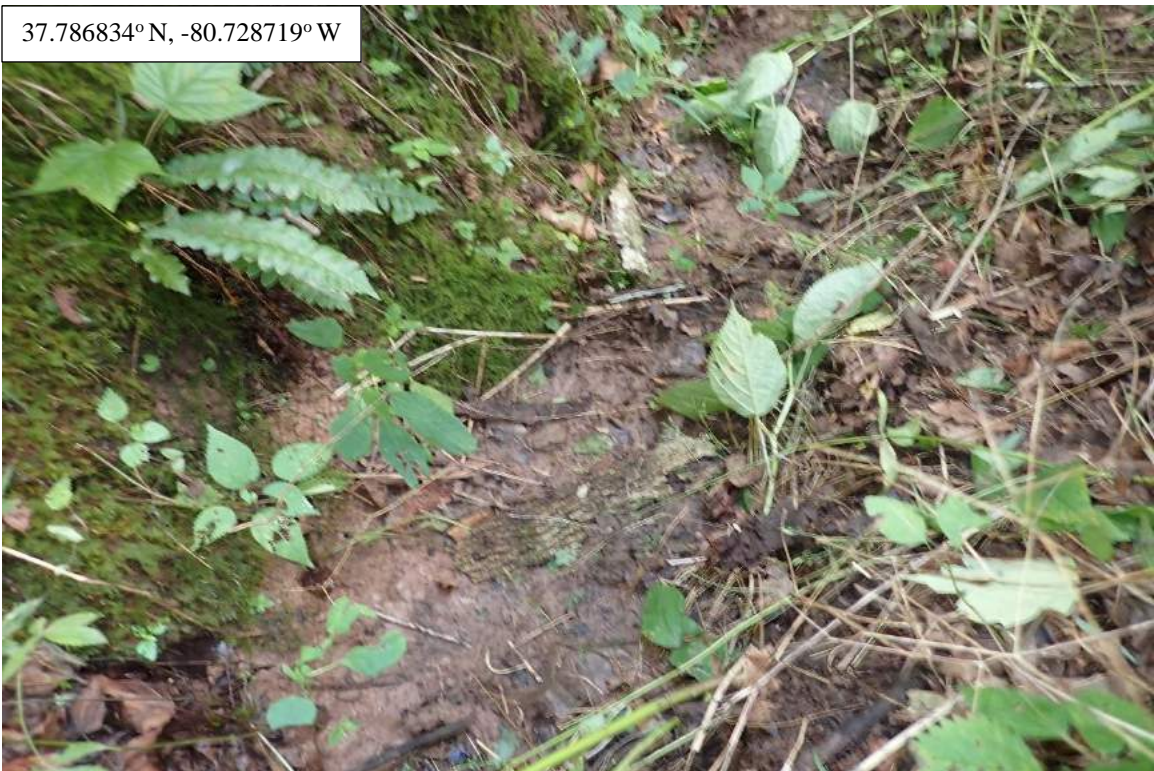
Photo Type: US, US View

Location, Orientation, Photographer Initials: Upstream Edge of Right of Way, Upstream View, AK/RA/TA

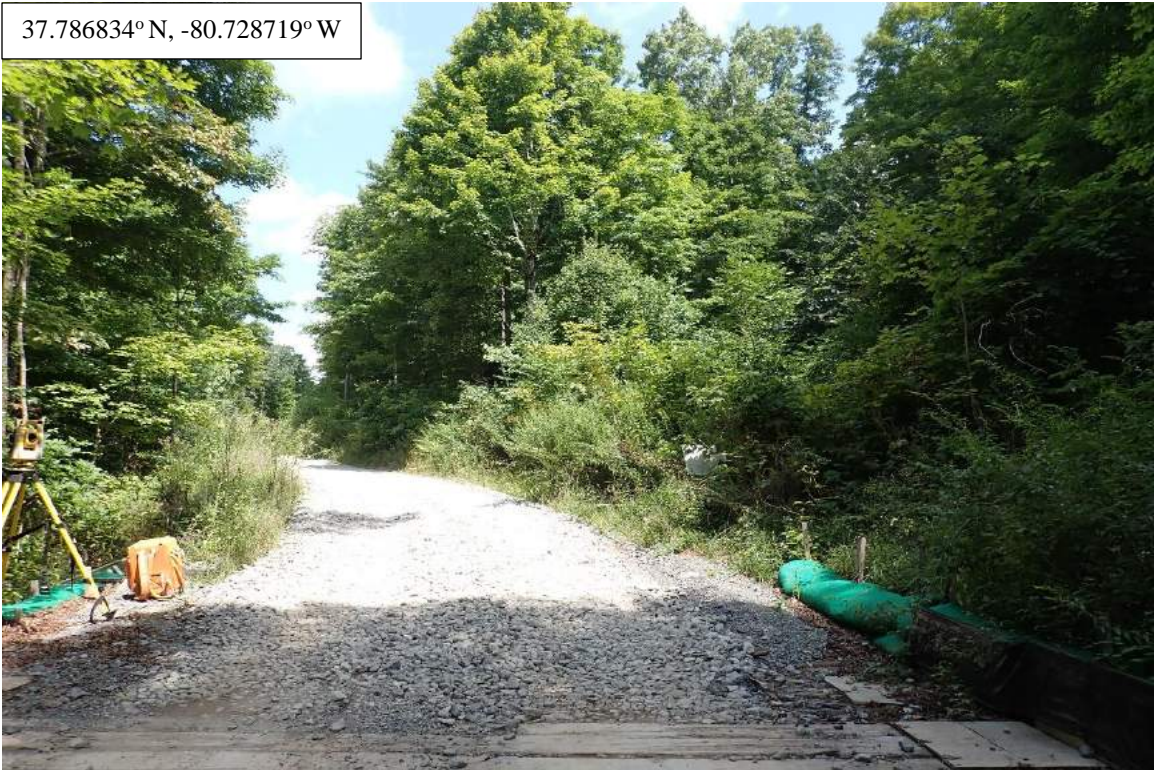
Photo Type: View Up AR  
Location, Orientation, Photographer Initials: Access Road – View Facing Up, AK/RA/TA

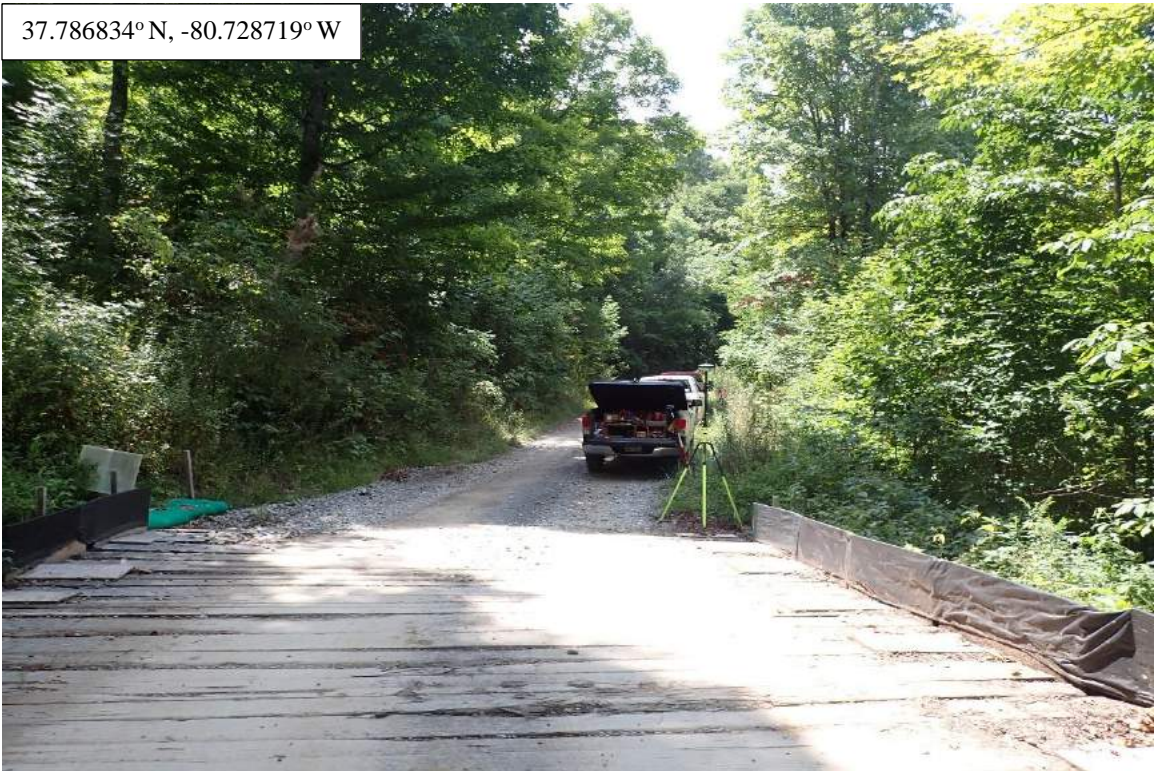
Photo Type: View Down AR  
Location, Orientation, Photographer Initials: Access Road, View Facing Down, AK/RA/TA

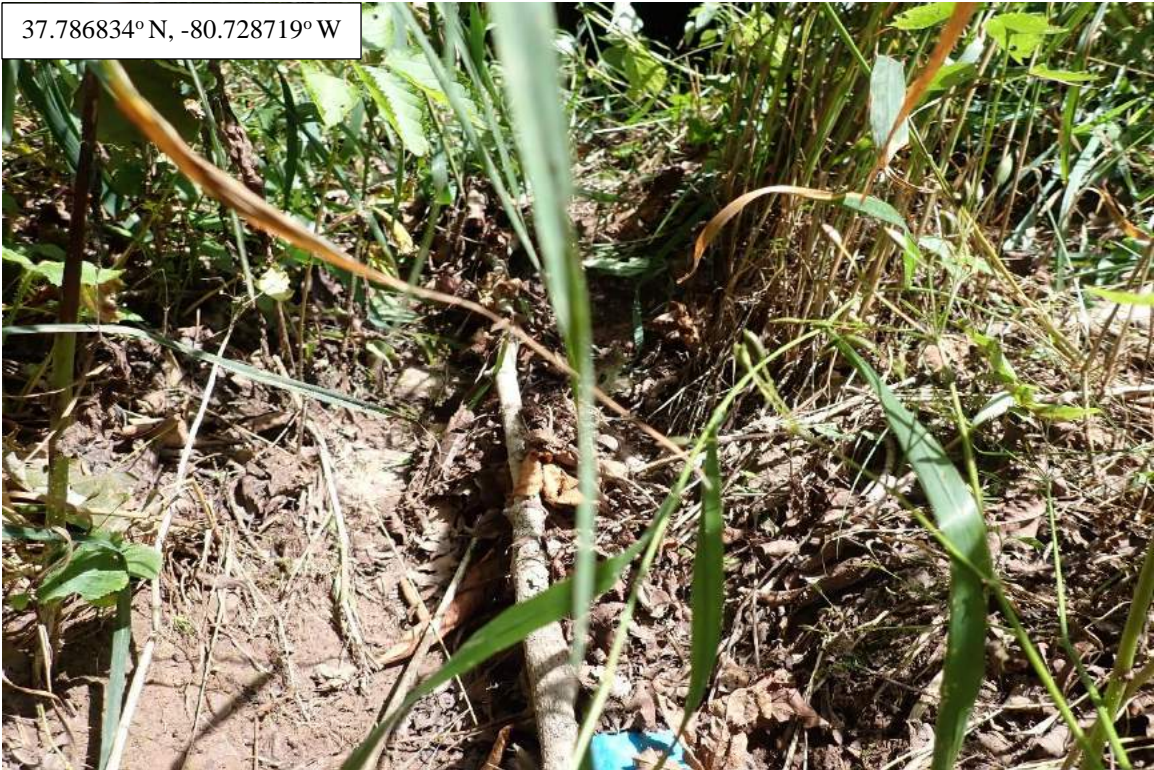
Photo Type: DS, US View

Location, Orientation, Photographer Initials: Downstream Edge of Right of Way, Upstream View, AK/RA/TA

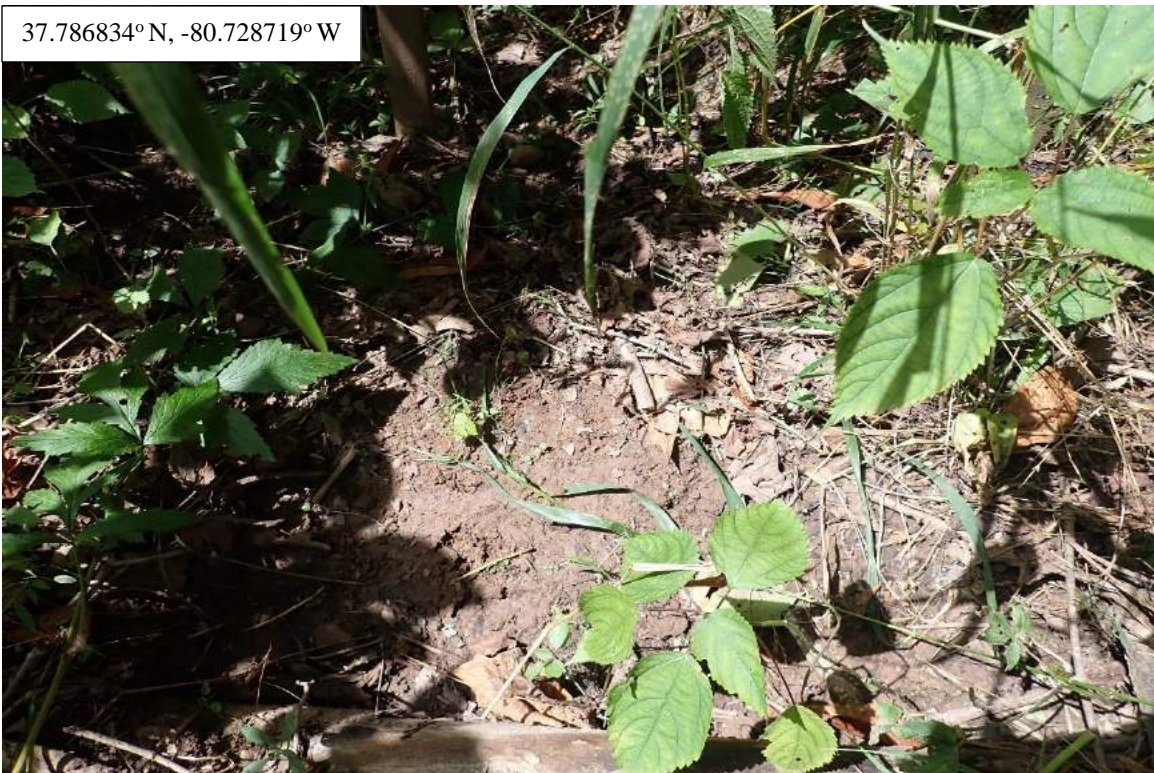
Photo Type: DS, DS View

Location, Orientation, Photographer Initials: Downstream Edge of ROW, Downstream View, AK/RA/TA

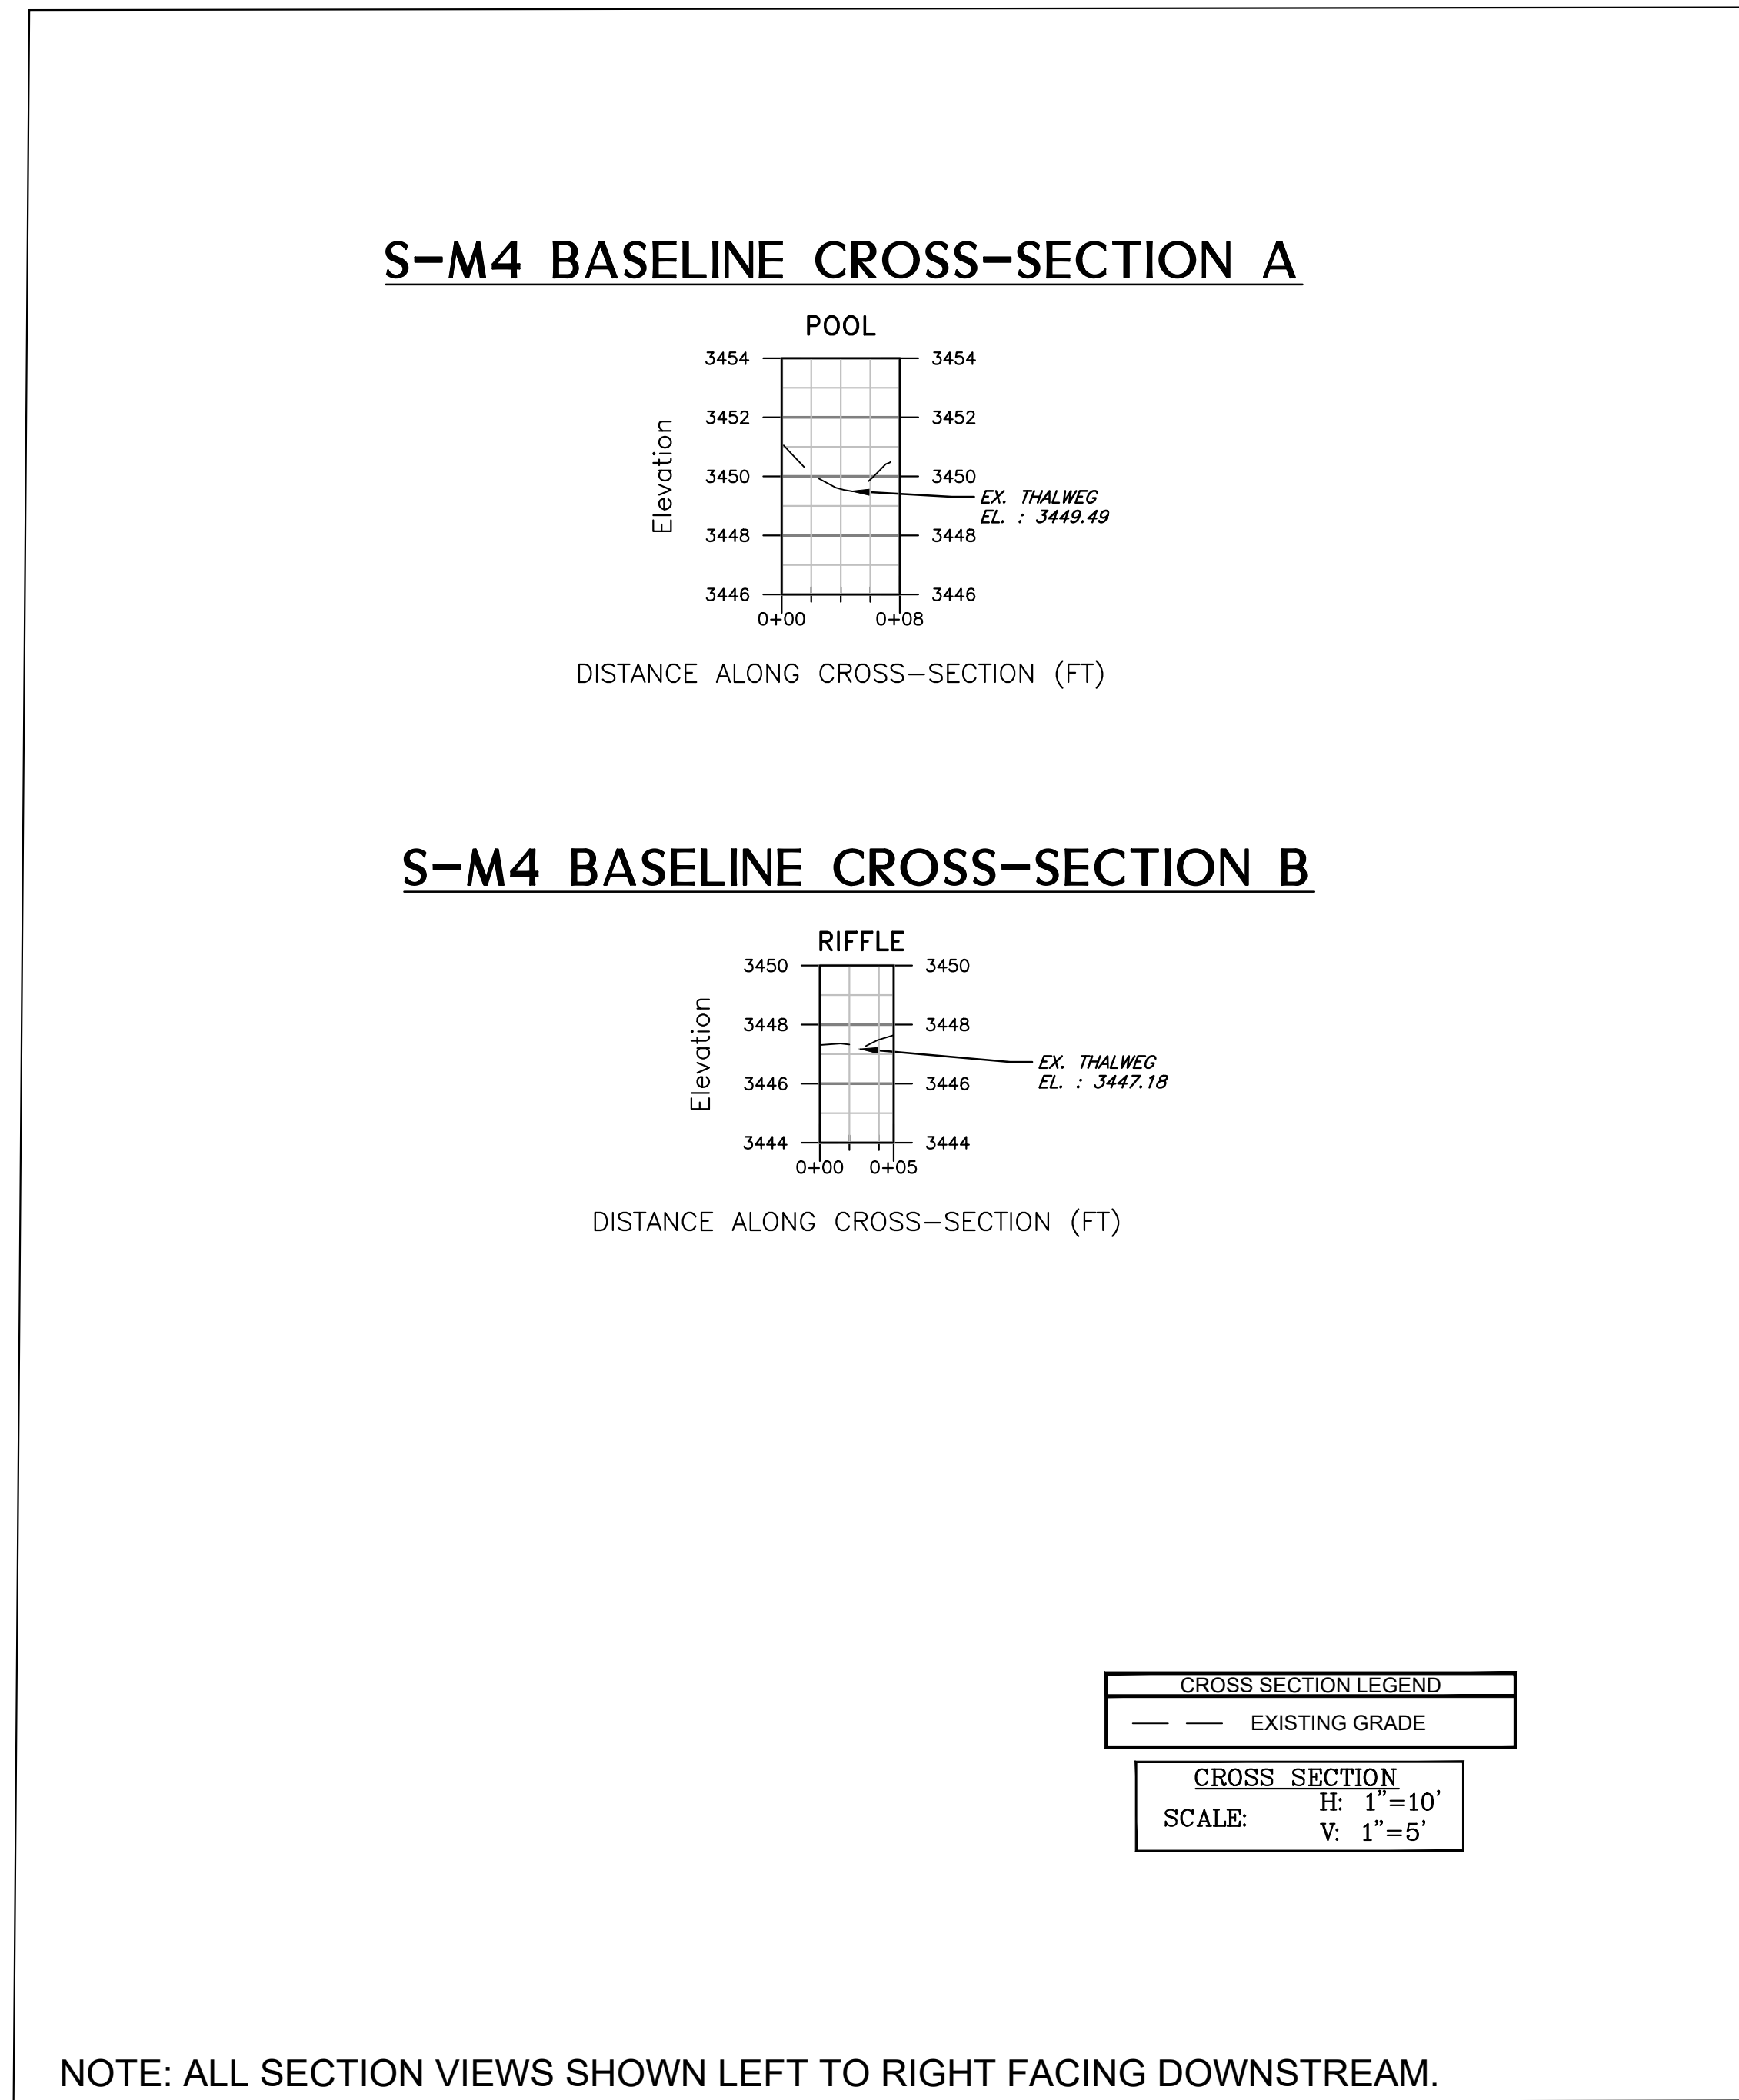
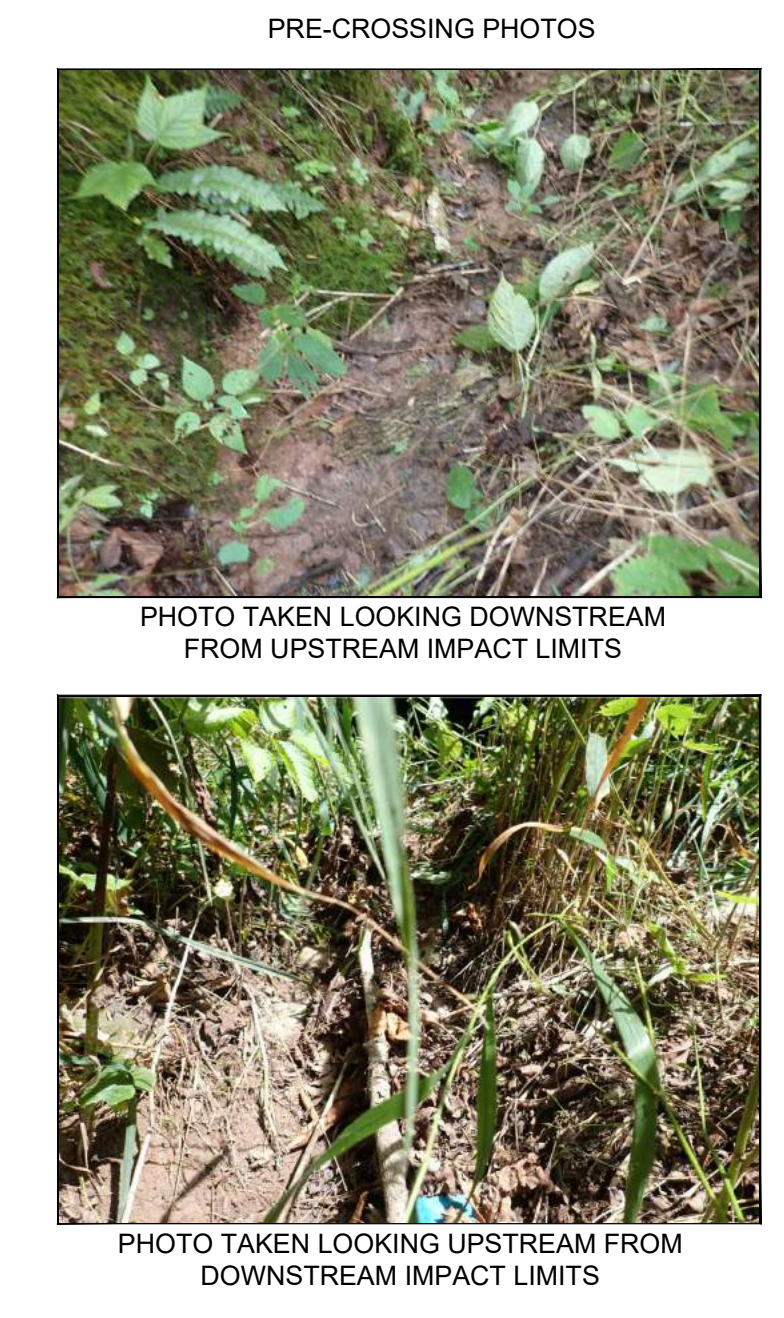
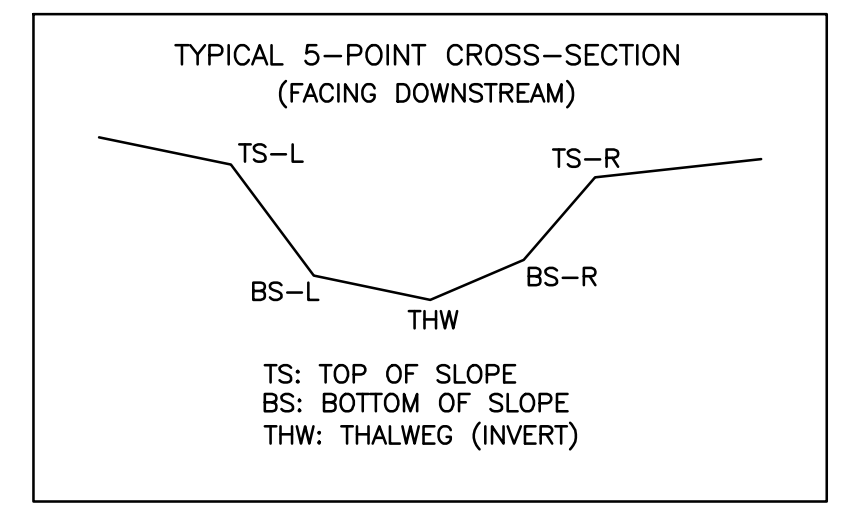
1  
Drawing No.

- ALL SECTION VIEWS SHOWN LEFT TO RIGHT FACING DOWNSTREAM.
  - POST-CROSSING SURVEY INFORMATION SHOWN IN RED. DATA PENDING.
  - POST-CROSSING SURVEY POINTS FOR CROSS SECTIONS AND THALWEG ARE PROJECTED ONTO PRE-CROSSING SECTION AND PROFILE VIEWS FOR COMPARISON.

AS-BUILT TABLE: S-M4 CROSS SECTION A					
	PRE-CROSSING			AS-BUILT	
PT. LOC.	NORTHING	EASTING	ELEV.	VERT. DIFF.	HORZ. DIFF.
TS-L	13721095.02	1718793.88	3451.04		
BS-L	13721099.06	1718794.69	3449.55		
THW	13721099.64	1718794.63	3449.49		
BS-R	13721100.19	1718794.89	3449.60		
TS-R	13721102.15	1718794.86	3450.43
