## Baseline Assessment – Stream Attributes

### Reach S-B39a/B46 (1) (Pipeline ROW) Ephemeral Spread C Webster County, West Virginia

## Spread C Stream S-B39a/B46 (1) (Pipeline ROW) Webster County

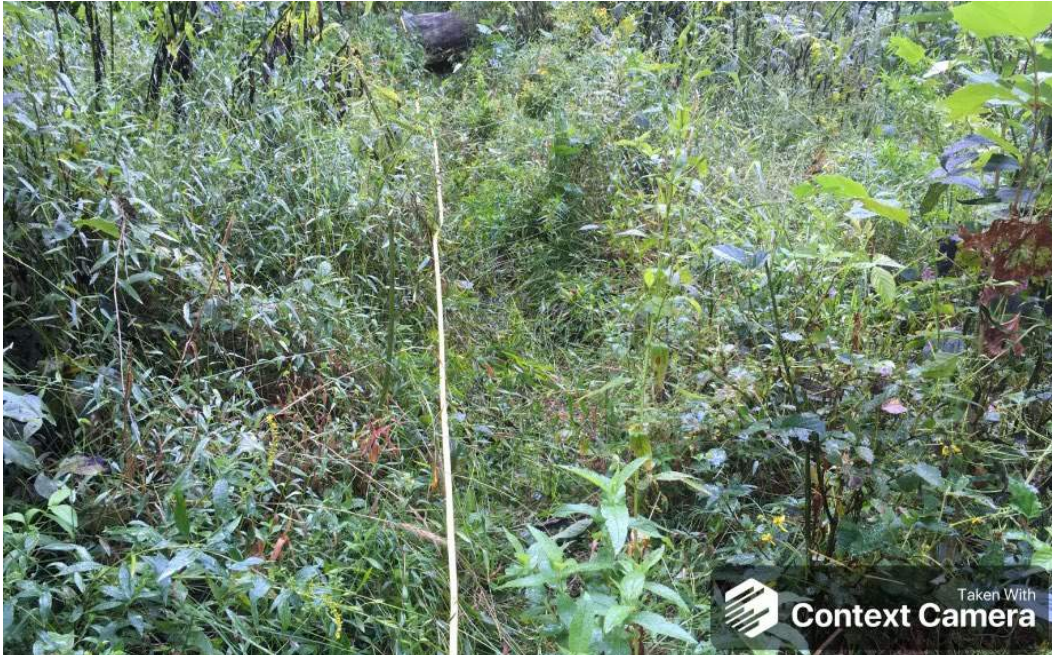
Photo Type: DS, US View

Location, Orientation, Photographer Initials: Downstream Edge of ROW, Upstream View, HC/VM  
Lat: 38.493363 Long: -80.560657

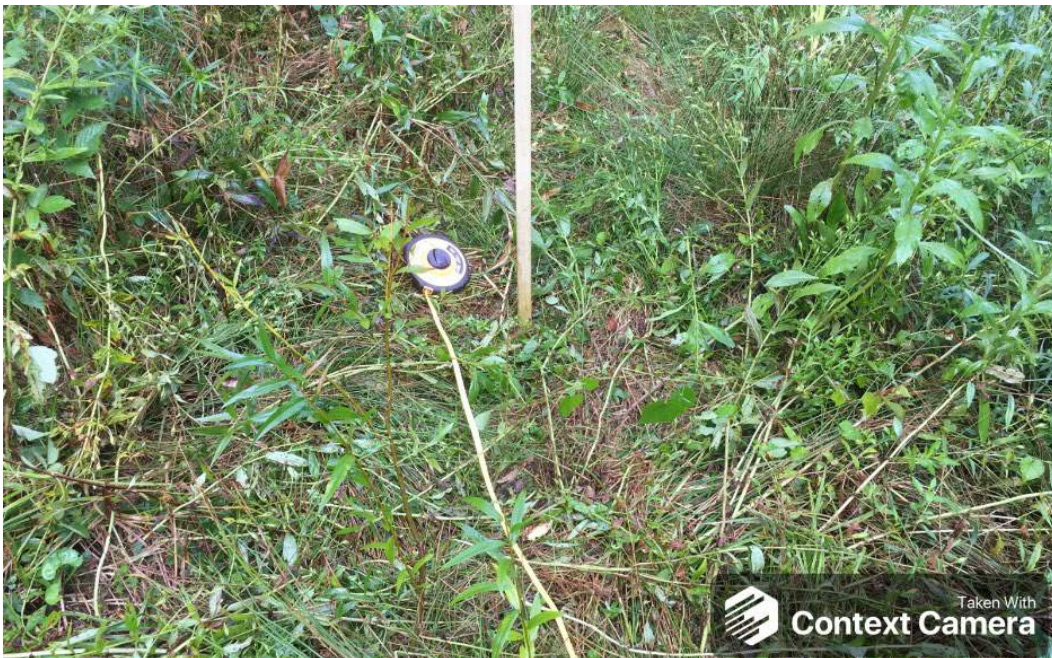
Photo Type: DS, DS View

Location, Orientation, Photographer Initials: Downstream Edge of ROW, Downstream View, HC/VM  
Lat: 38.493363 Long: -80.560657

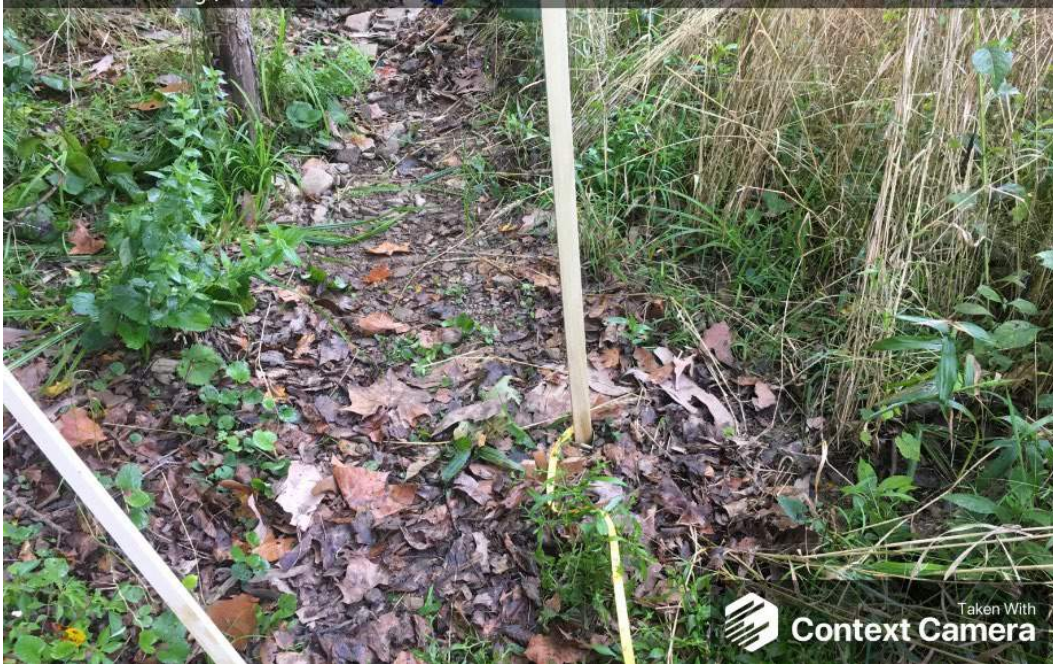
Photo Type: US View at Center  
Location, Orientation, Photographer Initials: Center ROW, Upstream View, HC/VM  
Lat: 38.493363 Long: -80.560657

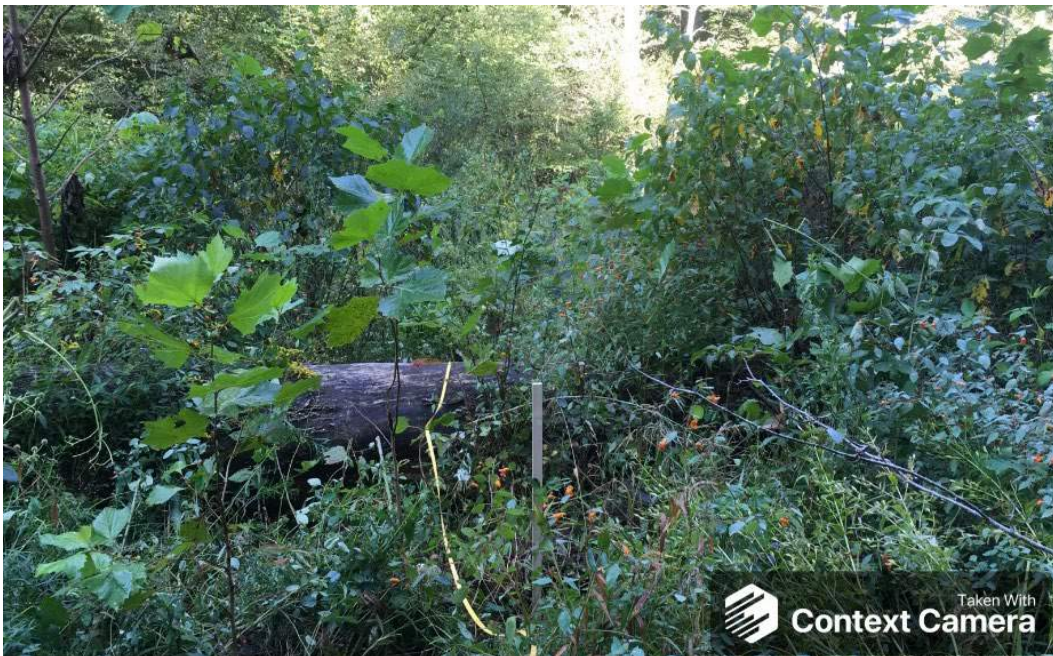
Photo Type: DS View at Center  
Location, Orientation, Photographer Initials: ROW Center, Downstream View, HC/VM  
Lat: 38.493363 Long: -80.560657

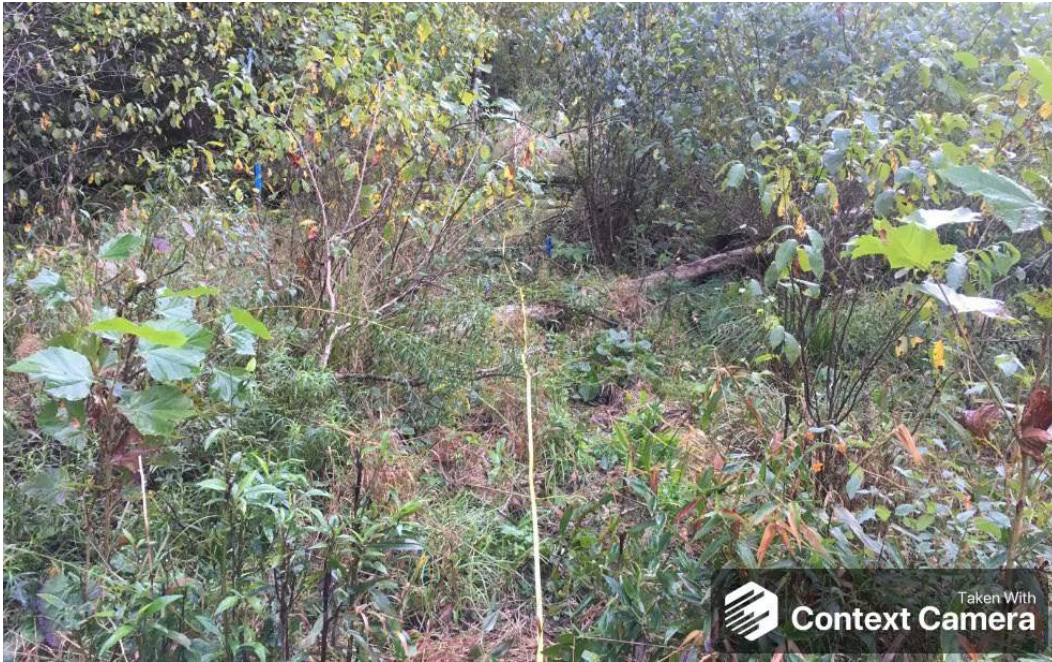
Photo Type: US, US View

Location, Orientation, Photographer Initials: Upstream Edge of ROW, Upstream View, HC/VM

Lat: 38.493363 Long: -80.560657

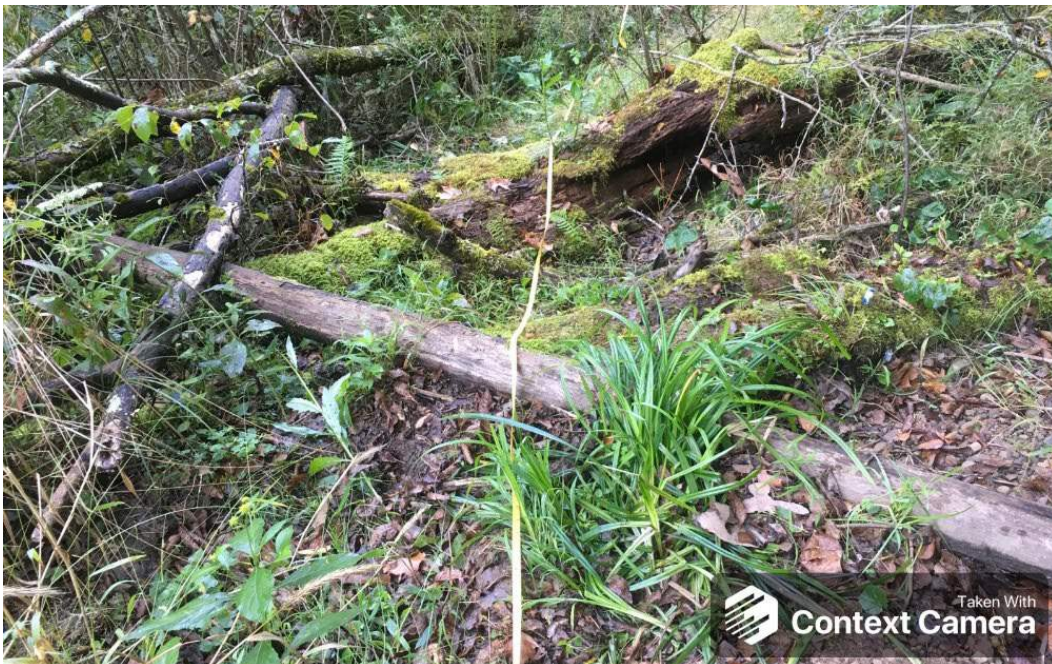
Photo Type: US, DS View

Location, Orientation, Photographer Initials: Upstream Edge of ROW, Downstream View, HC/VM

Lat: 38.493363 Long: -80.560657
