Baseline Assessment – Stream Attributes

Reach S-E52 (Timber Mat Crossing) Intermittent Spread D Webster County, West Virginia

Title: PROFILE AND CROSS-SECTIONS
BASELINE SURVEY
CROSSING S-E52 - UNNAMED TRIB. TO
GAULEY RIVER (MP 109.55)
WEBSTER COUNTY, WV

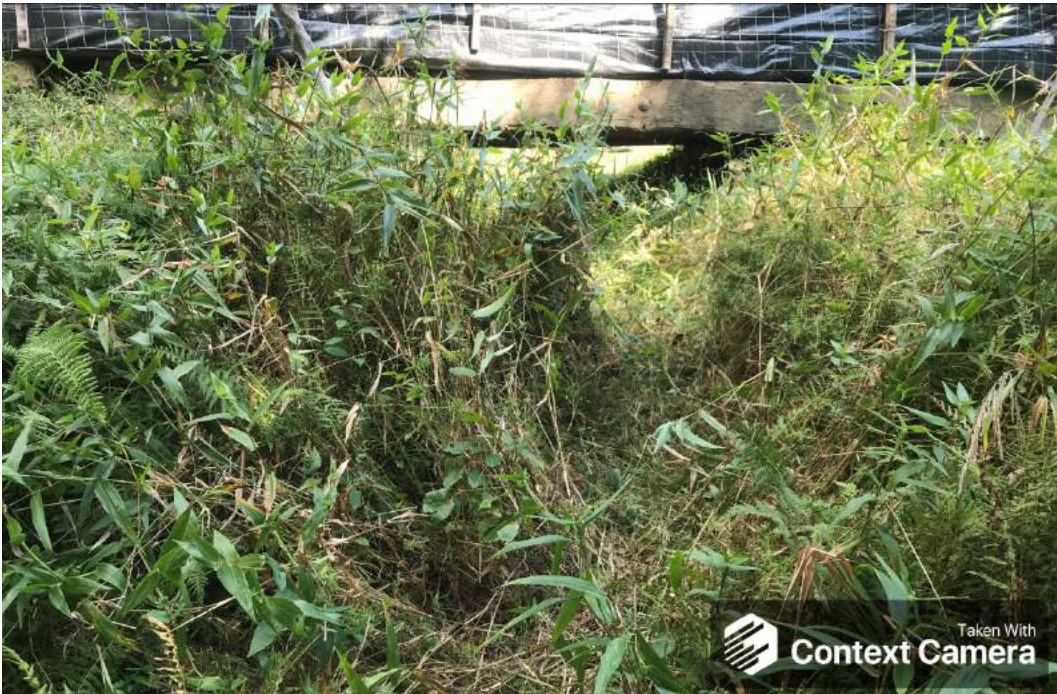
Photo Type: DS, US View
Location, Orientation, Photographer Initials: Downstream Edge of ROW, Upstream View, SM/MW
Lat: 38.36911 Long: -80.611761

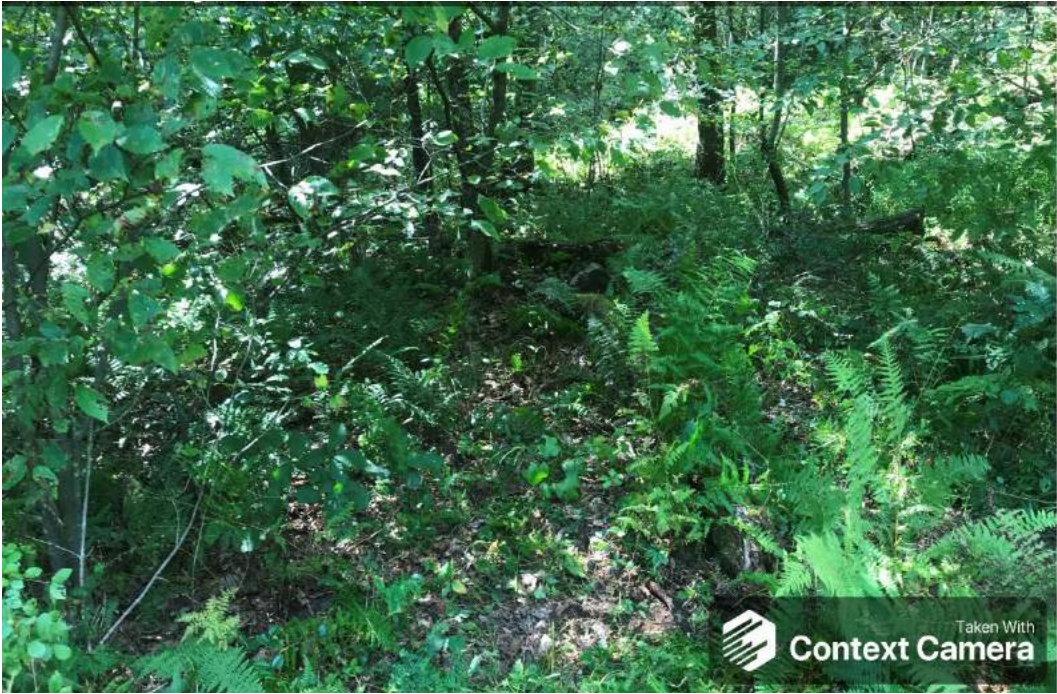
Photo Type: DS, DS View
Location, Orientation, Photographer Initials: Downstream Edge of ROW, Downstream View, SM/MW
Lat: 38.36911 Long: -80.611761

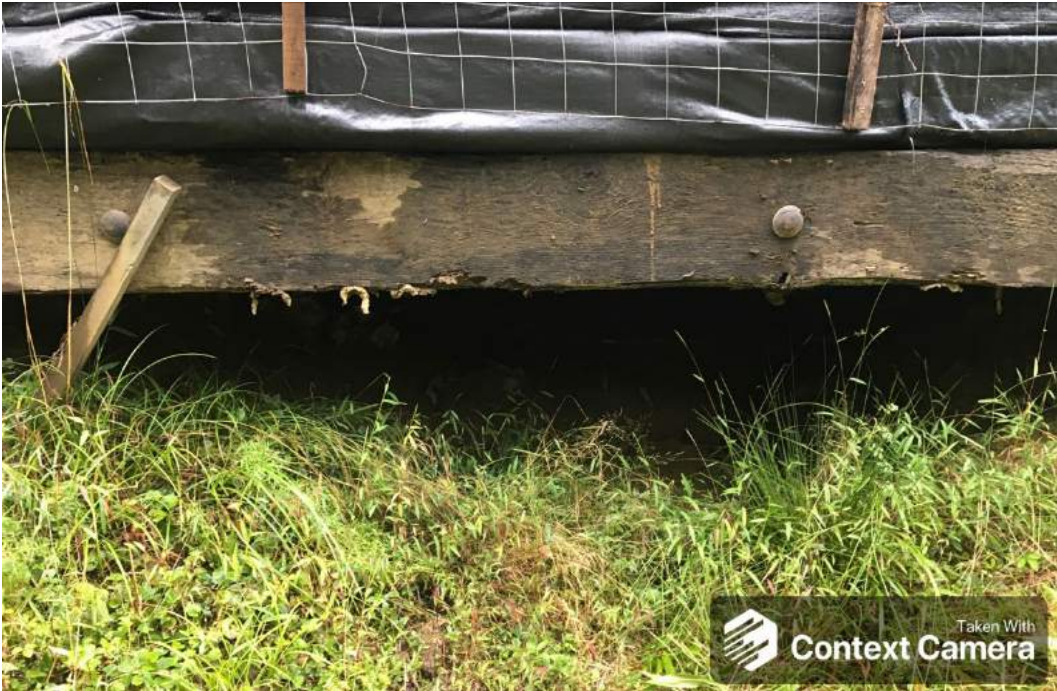
Photo Type: US View at Center
Location, Orientation, Photographer Initials: Center ROW, Upstream View, SM/MW
Lat: 38.36911 Long: -80.611761

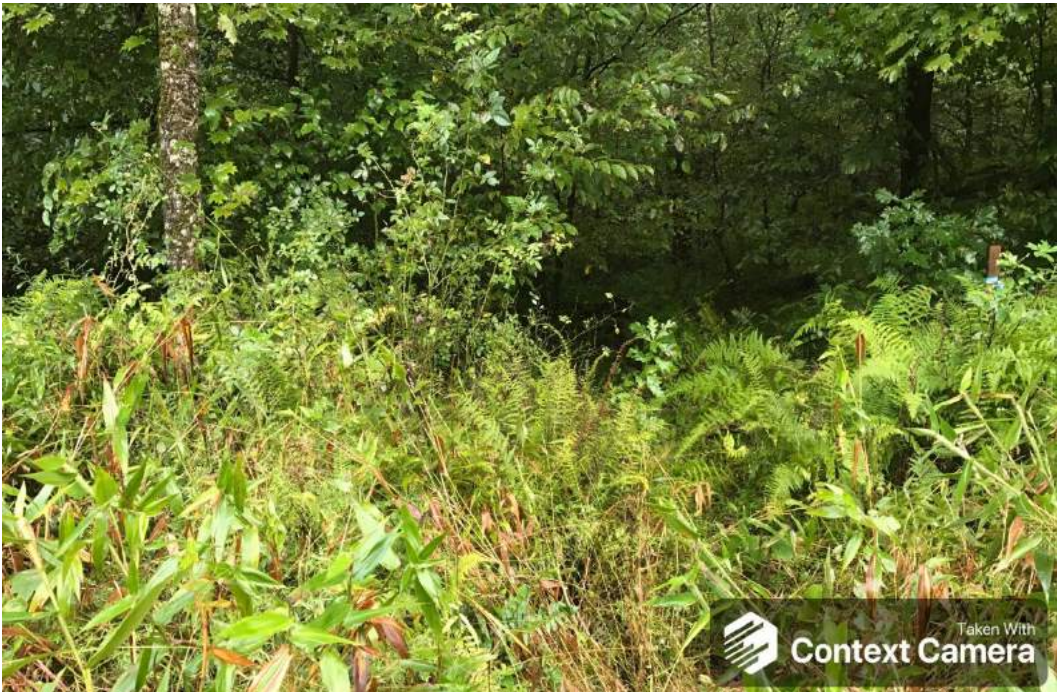
Photo Type: DS View at Center
Location, Orientation, Photographer Initials: ROW Center, Downstream View, SM/MW
Lat: 38.36911 Long: -80.611761

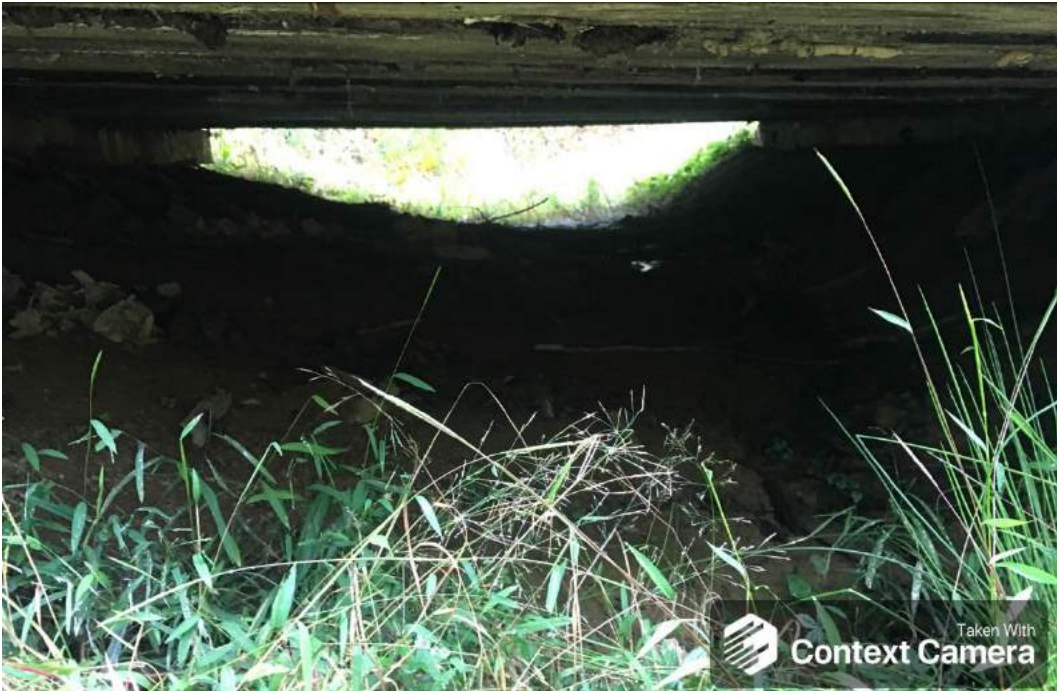
Photo Type: US, US View
Location, Orientation, Photographer Initials: Upstream Edge of ROW, Upstream View, SM/MW
Lat: 38.36911 Long: -80.611761

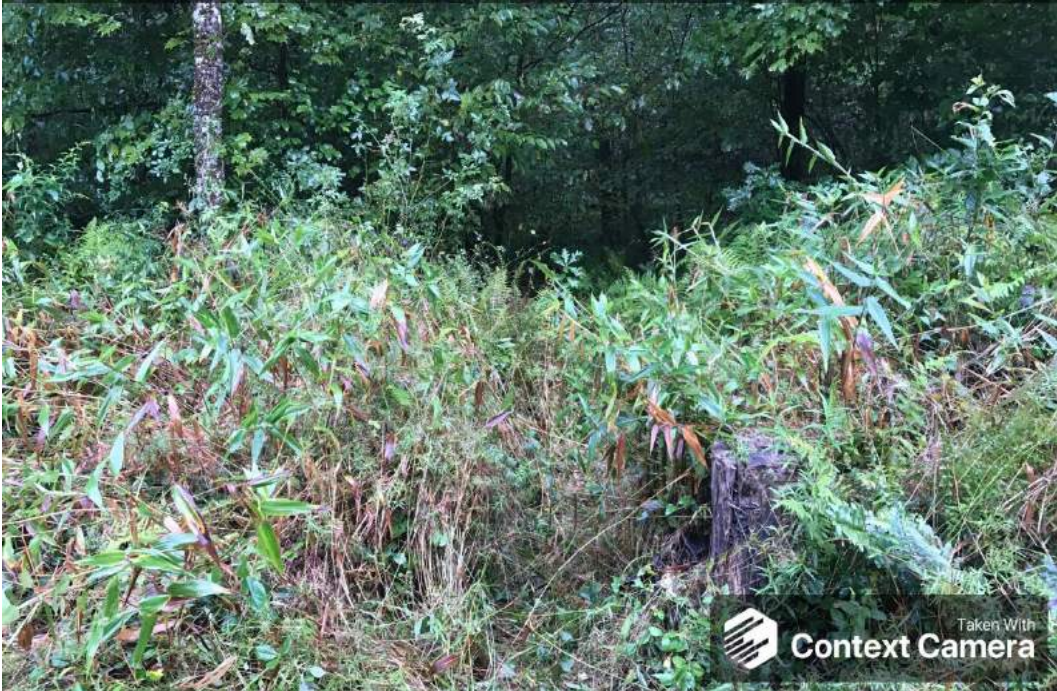
Photo Type: US, DS View
Location, Orientation, Photographer Initials: Upstream Edge of ROW, Downstream View, SM/MW
Lat: 38.36911 Long: -80.611761

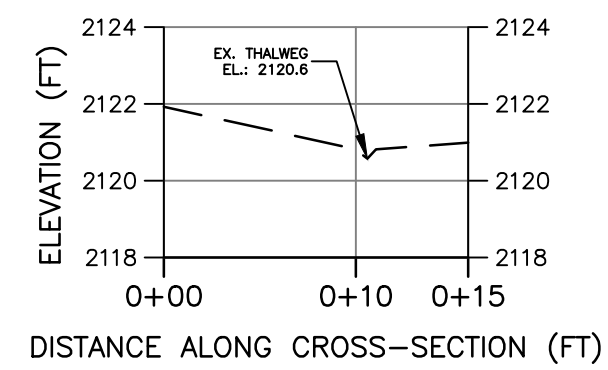
S-E52 BASELINE CROSS-SECTION A

PT. LOC.	PRE-CROSSING			AS-BUILT	
	NORTHING	EASTING	ELEV.	VERT. DIFF.	HORZ. DIFF.
TS-L	13933184.7100	1751678.5880	2119.315'		
BS-L	13933183.3400	1751678.6570	2118.887'		
THW	13933182.0800	1751678.6640	2118.717'		
BS-R	13933180.9500	1751678.8850	2118.969'		
TS-R	13933179.1500	1751678.7880	2119.817'

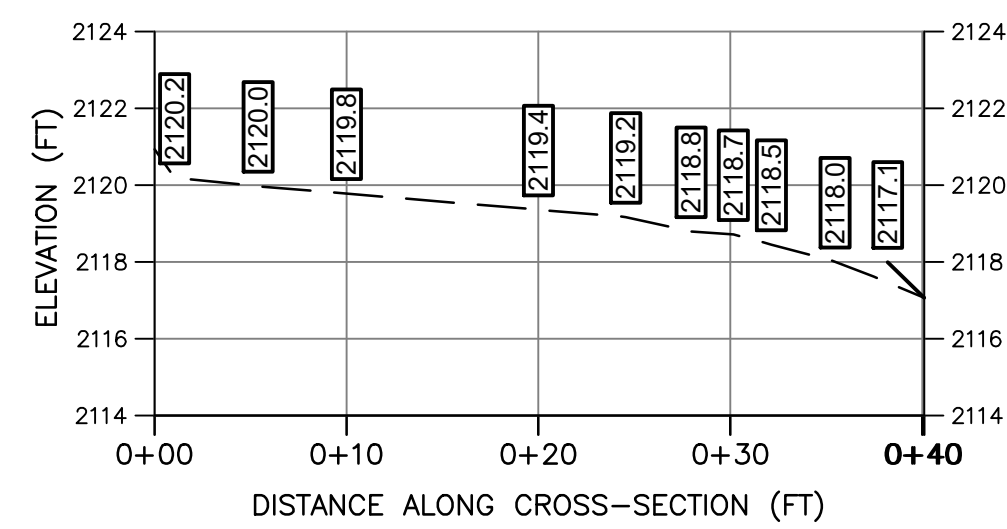
S-E52 BASELINE THALWEG PROFILE

PROFILE SCALE: H: 1"=10'
V: 1"=5'
